NC DEPARTMENT OF TRANSPORTATION  
DIVISION OF HIGHWAYS  
STRUCTURE MANAGEMENT UNIT

# Structure Safety Report

## Routine Element Inspection - Contract

DIVISION: 13 COUNTY: MCDOWELL STRUCTURE NUMBER: 580312 FREQUENCY: 24 MONTHS

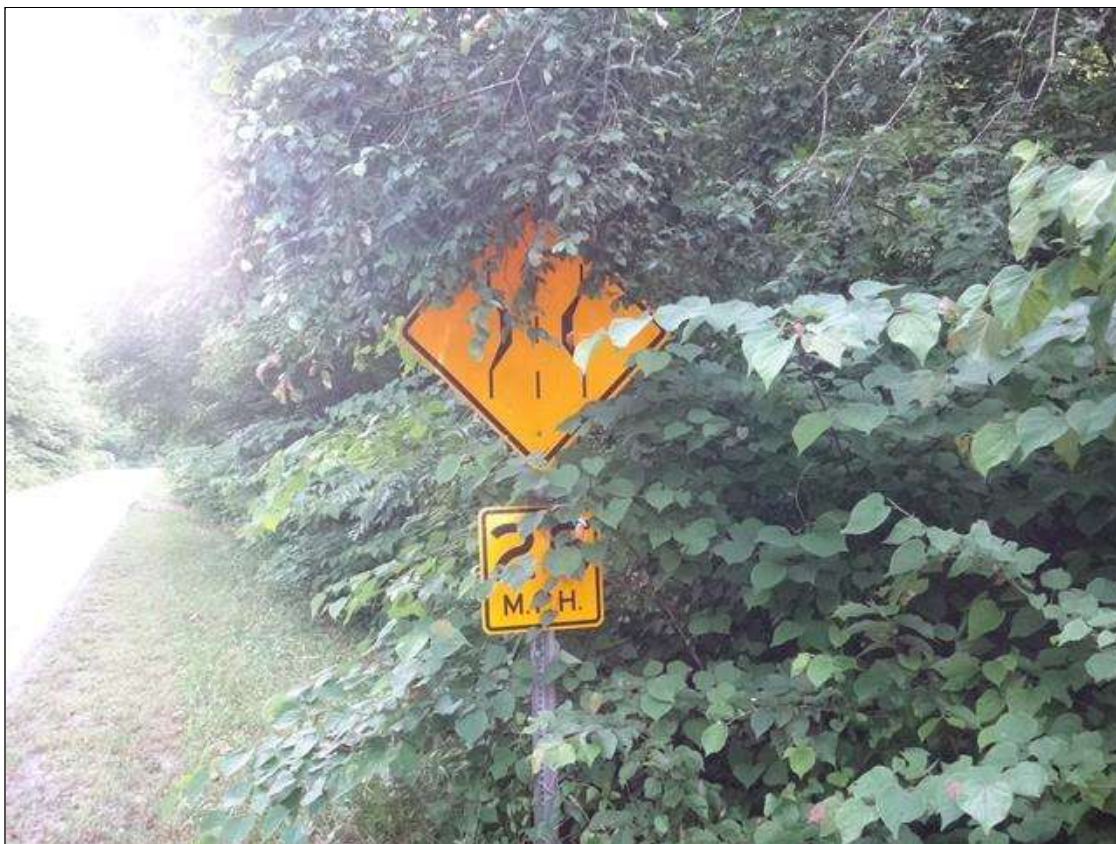
south approach narrow bridge sign covered with vegetation growth

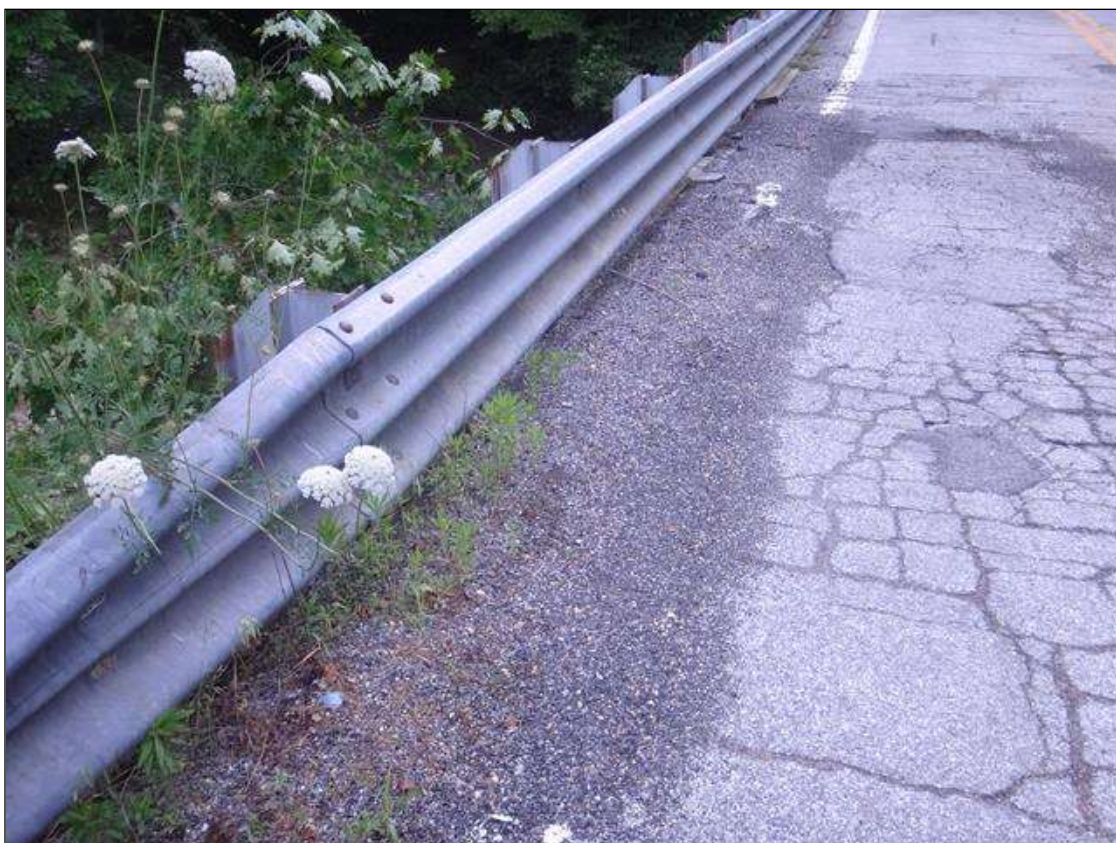
west shoulder, debris accumulation (full length x 2ft)

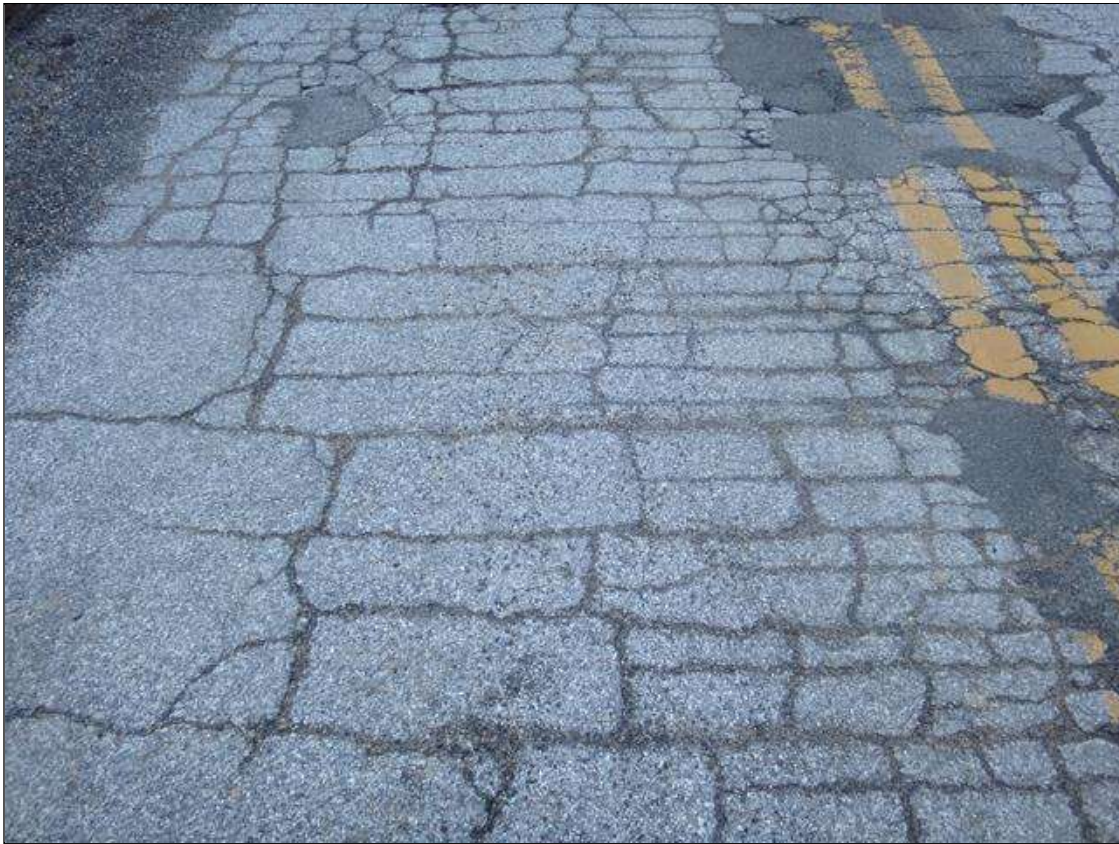
| Element Number | Defect Type | Defect Description | CS | CS Qty | Maint Qty | |
|---|---|---|---|---|---|---|
| 510 | Crack (Wearing Surface) | both lanes, scattered map cracking (75% of deck area x up to 1in) | 3 | 549 | 549 | Square Feet |

Span 1 Wearing Surface: both lanes, scattered map cracking (75% of deck area x up to 1in)

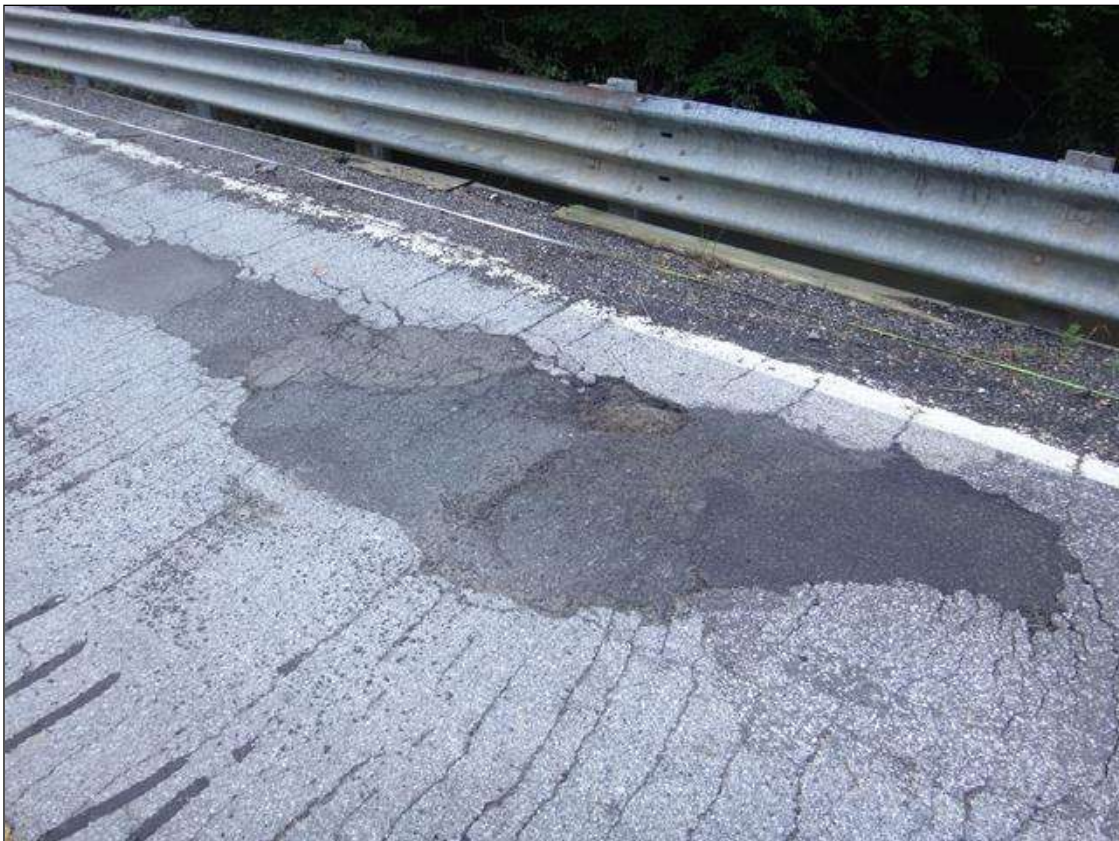
| Element Number | Defect Type | Defect Description | CS | CS Qty | Maint Qty | |
|---|---|---|---|---|---|---|
| 510 | Delamination/Spall (Wearing Surfaces) | northbound lane at 7ft from end bent 1, pothole (18in x 12in x full depth) | 3 | 2 | 2 | Square Feet |
| 510 | Patched Area/Pothole (Wearing Surface) | northbound lane at 3ft from end bent 1, patched area (14ft x 4ft) | 2 | 54 | | Square Feet |

Span 1 Wearing Surface: northbound lane at 3ft from end bent 1, patched area (14ft x 4ft) with pothole (18in x 12in x full depth)

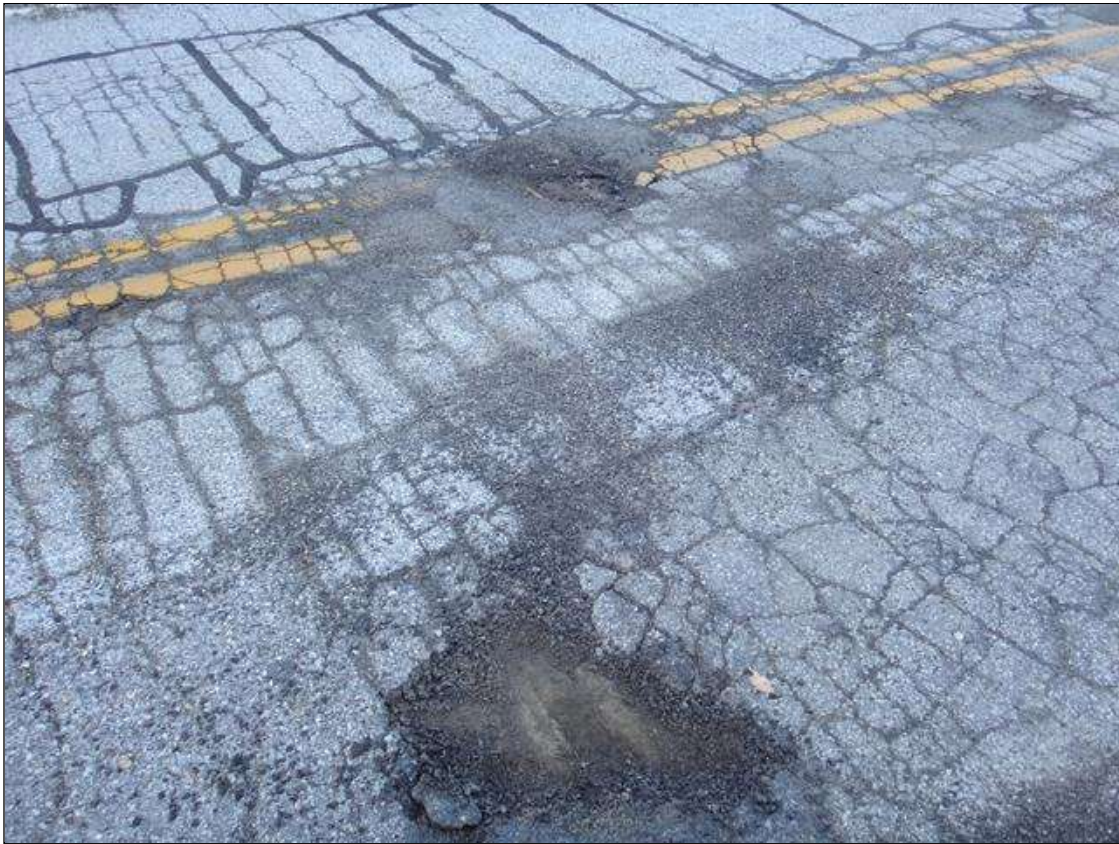
| Element Number | Defect Type | Defect Description | CS | CS Qty | Maint Qty | |
|---|---|---|---|---|---|---|
| 510 | Delamination/Spall (Wearing Surfaces) | southbound lane and center of lanes near bent 1, (2) potholes (up to 30in x 16in x full depth) | 3 | 5 | 5 | Square Feet |

Span 1 Wearing Surface: southbound lane and center of lanes near bent 1, (2) potholes (up to 30in x 16in x full depth)

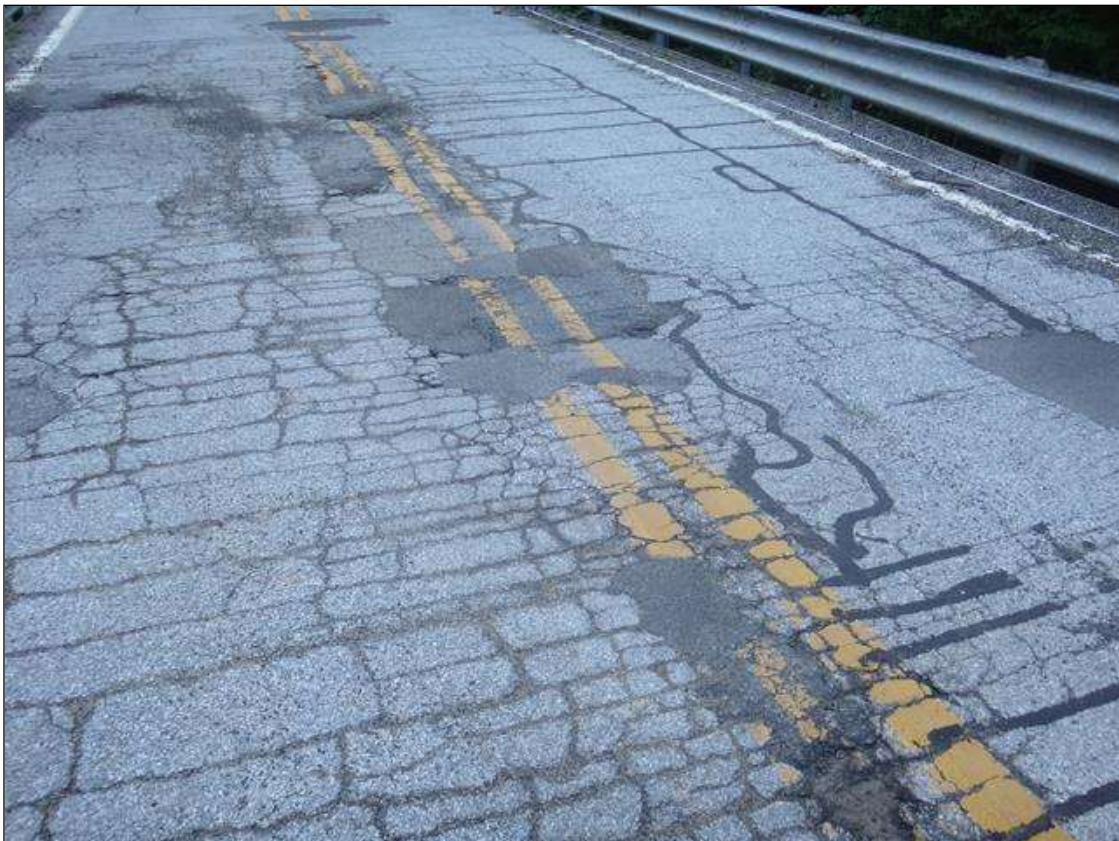
| Element Number | Defect Type | Defect Description | CS | CS Qty | Maint Qty | |
|---|---|---|---|---|---|---|
| 510 | Patched Area/Pothole (Wearing Surface) | center of lanes, multiple patched areas (up to 8ft x 4ft) | 2 | 60 | | Square Feet |

Span 1 Wearing Surface: center of lanes, multiple patched areas (up to 8ft x 4ft)

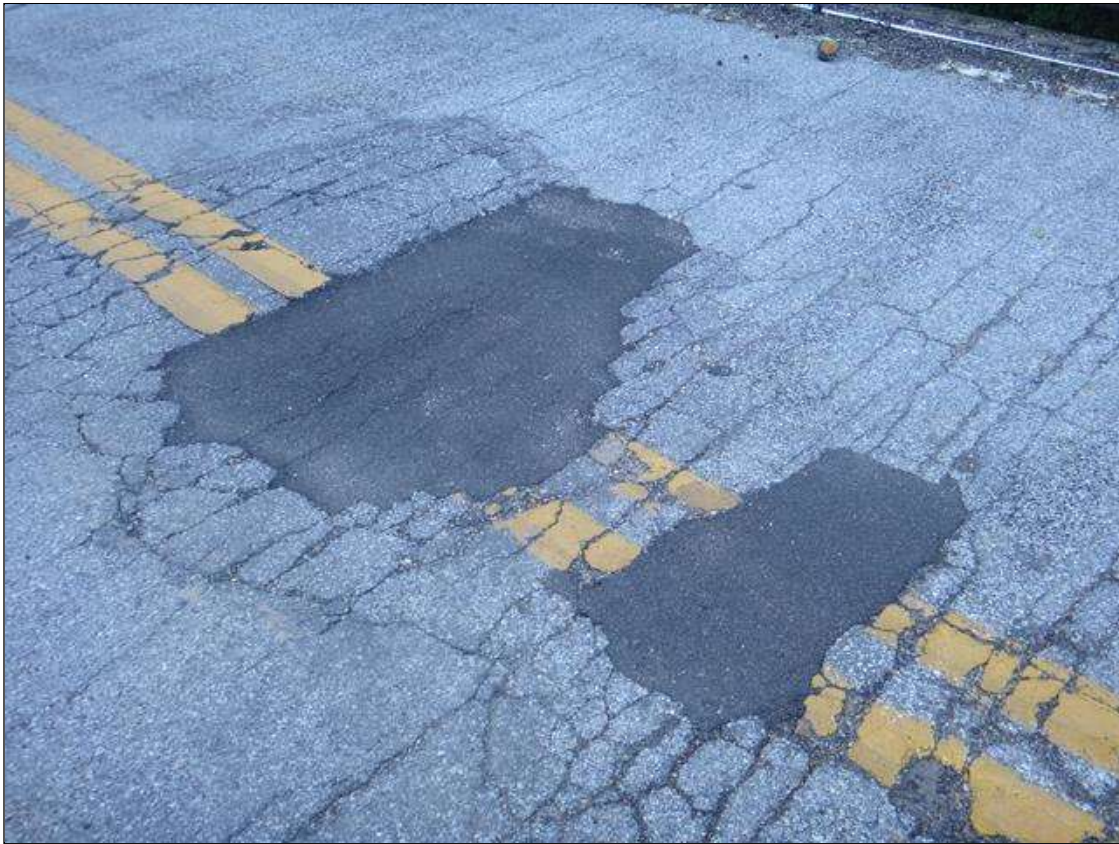
Span 2 Wearing Surface: center of lanes near midspan, (2) patched areas (up to 5-1/2ft x 3-1/2ft)

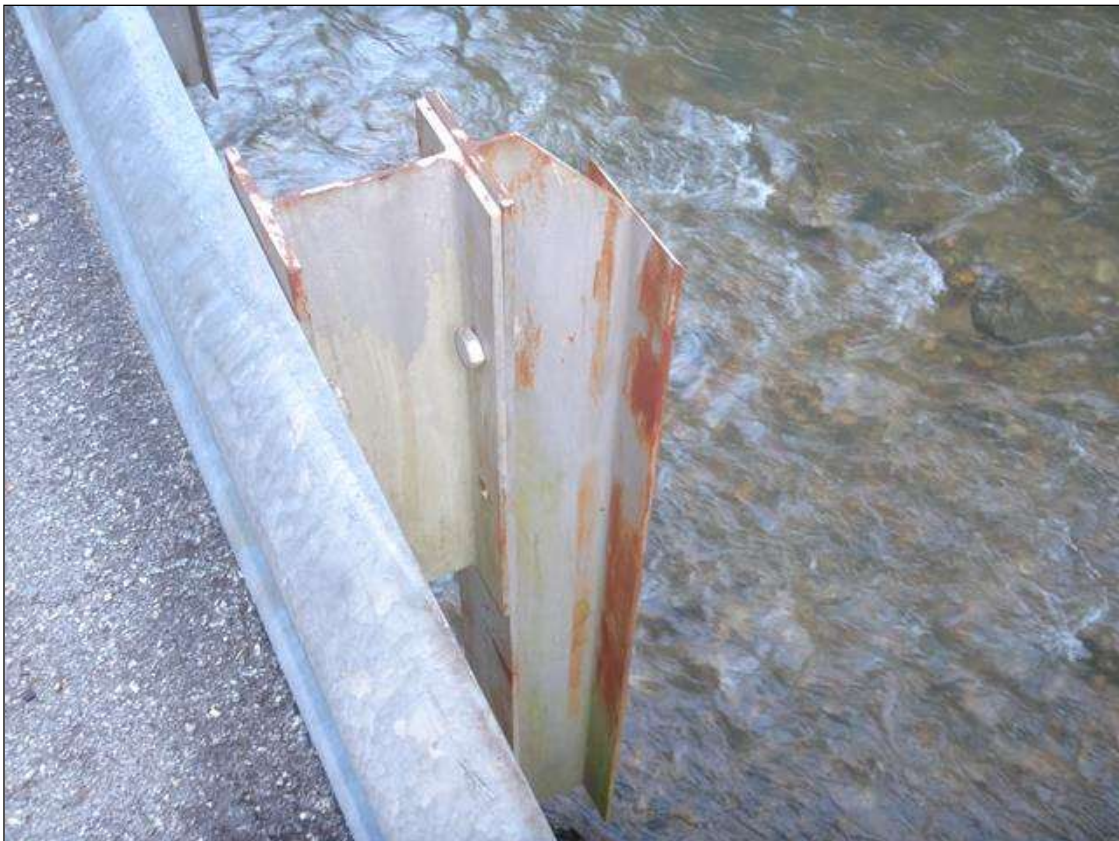
Span 2 Left Bridge Rail: all posts, coating with limited effectiveness and rust (5sf)

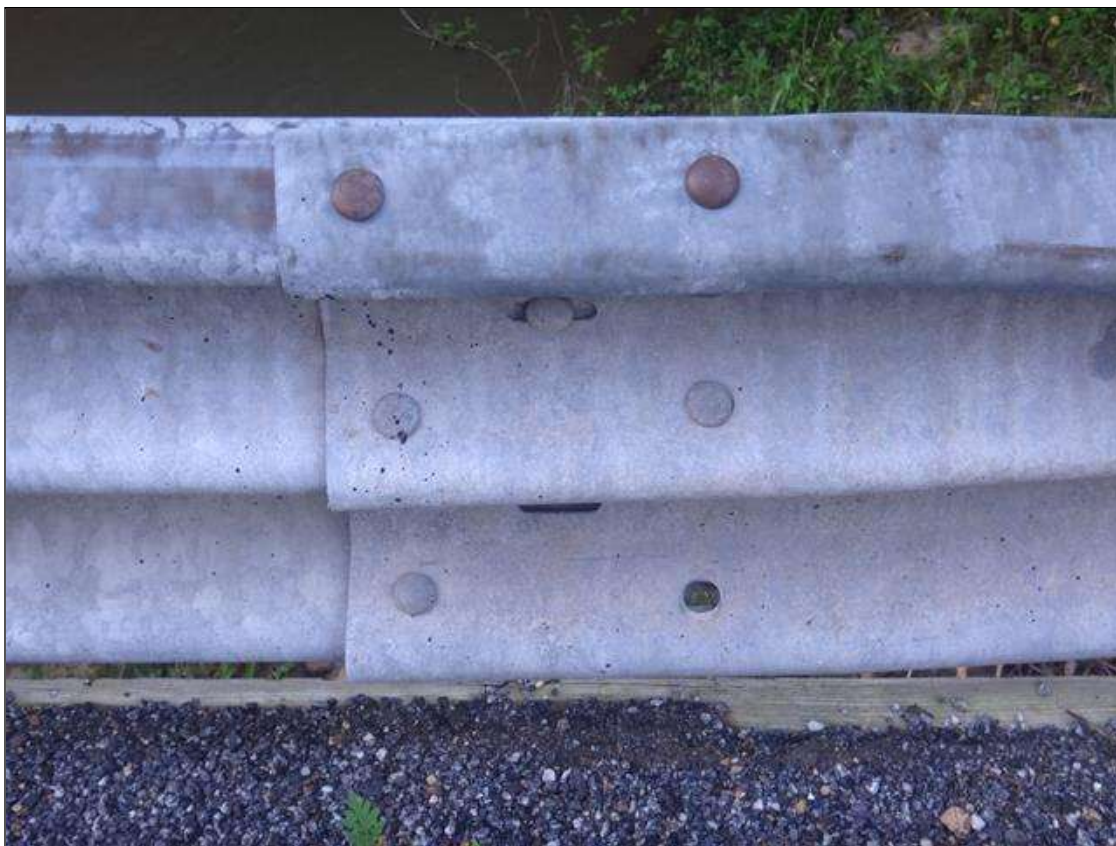
| Element Number | Defect Type | Defect Description | CS | CS Qty | Maint Qty |
|---|---|---|---|---|---|
| <b>330</b> | Connection | splice connection at 5ft from end bent 1, (1) missing bolt | 3 | 1 | 1 Feet |

Span 1 Right Bridge Rail: splice connection at 5ft from end bent 1, (1) missing bolt

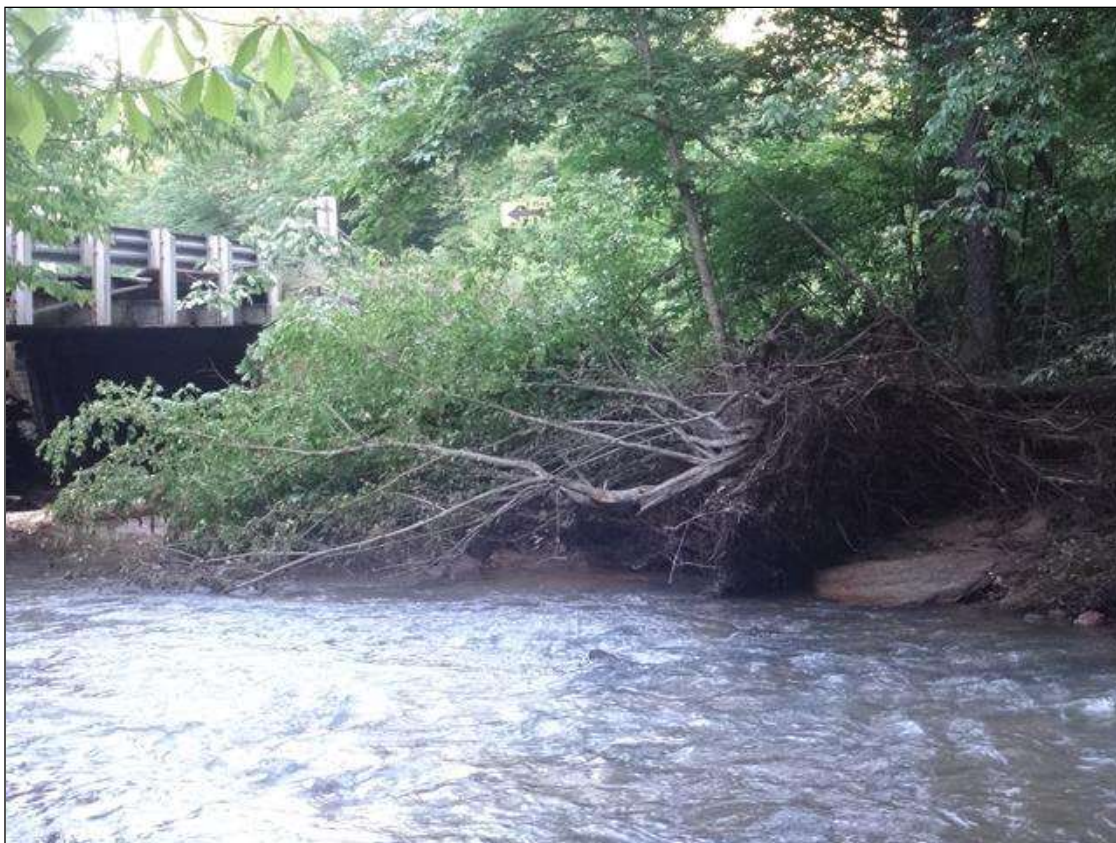
southwest streambank, (1) fallen tree

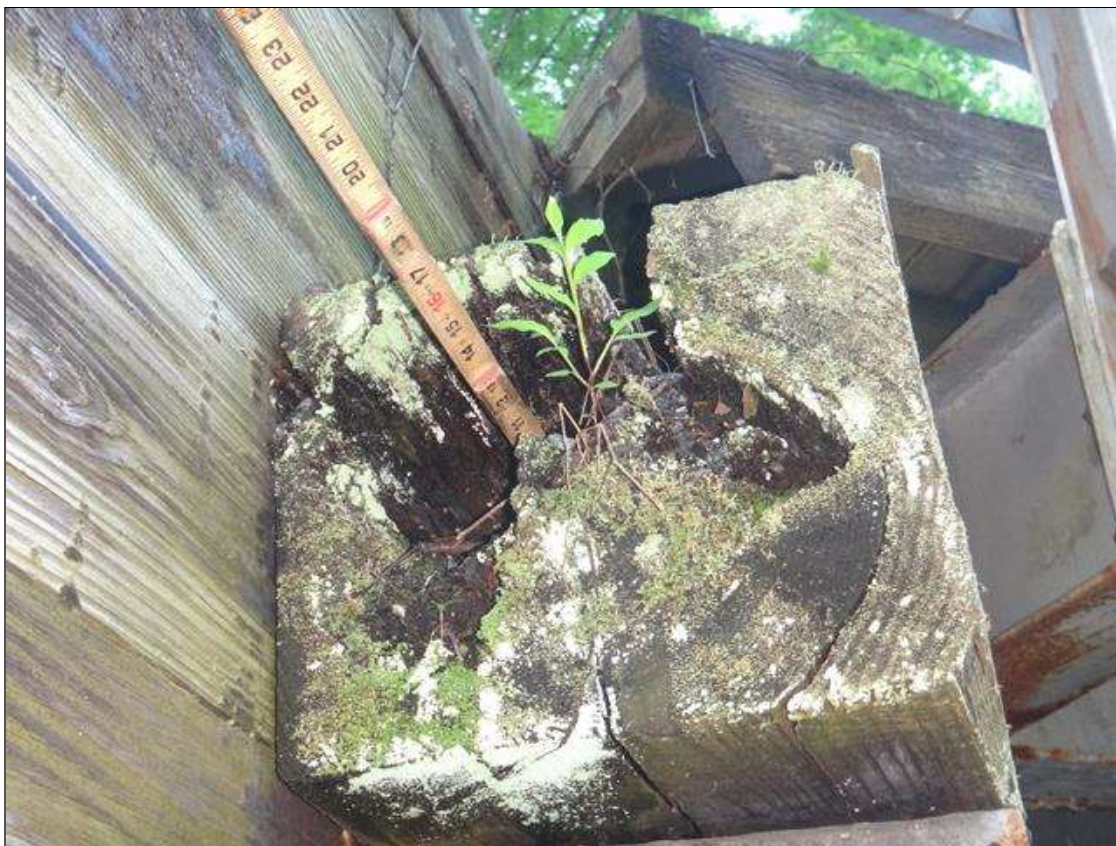
End Bent 2 Cap 1: (PM) west face, decay (10in x 8in x 14in)

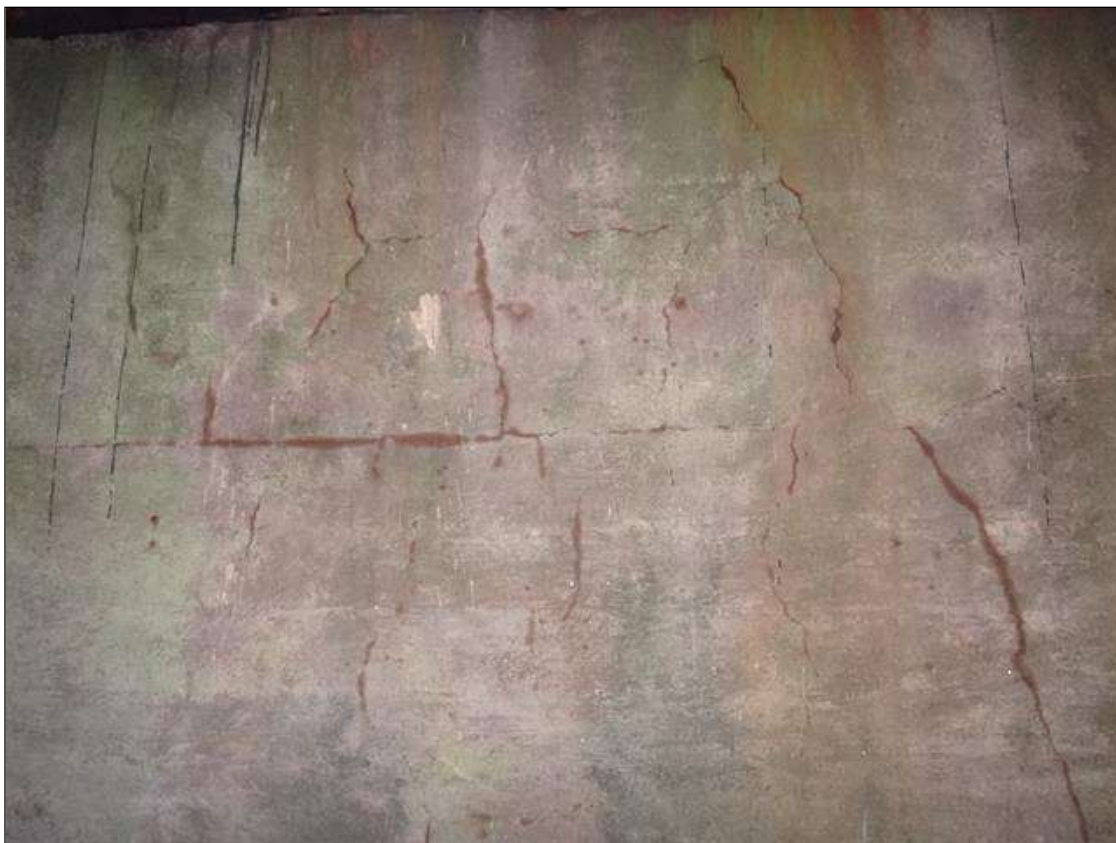
End Bent 2 Abutment/Backwall : under beams 4-8, map cracking (8ft x full height x up to 1/16in)

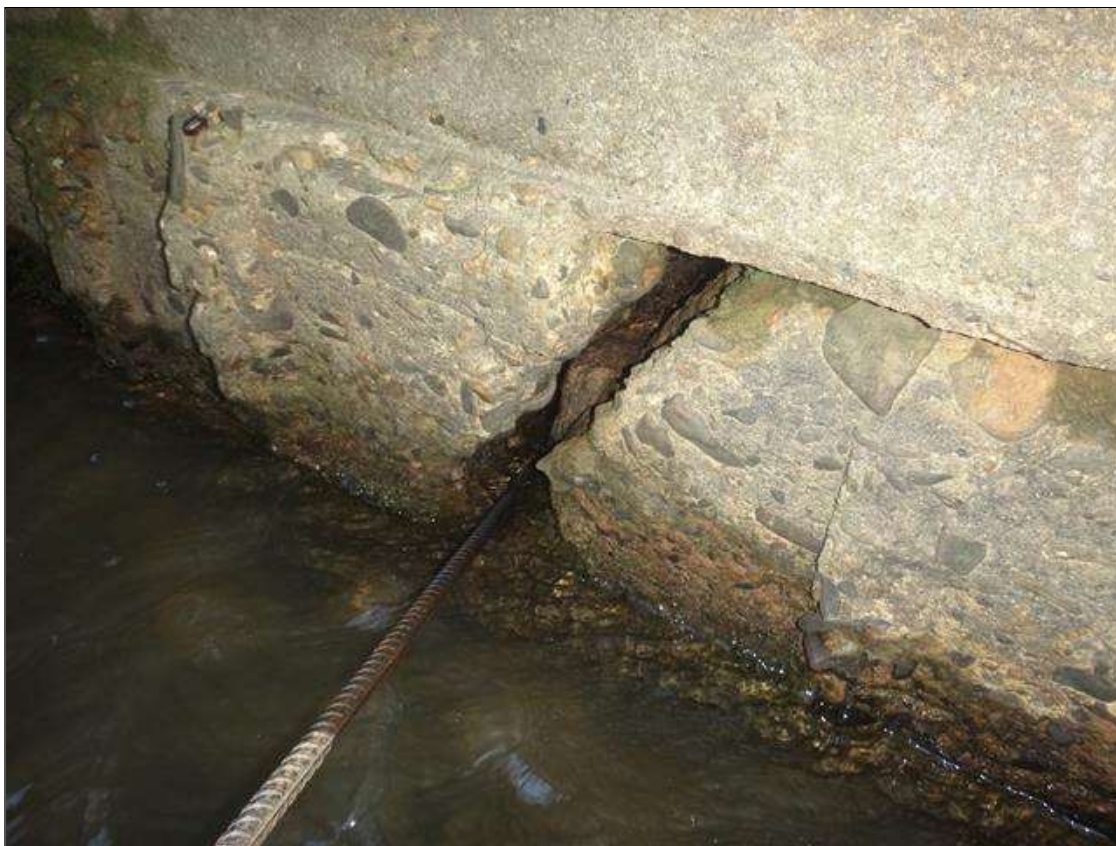
End Bent 2 Abutment/Backwall : northeast wingwall at base, spall (1ft x 3in x up to 2ft)

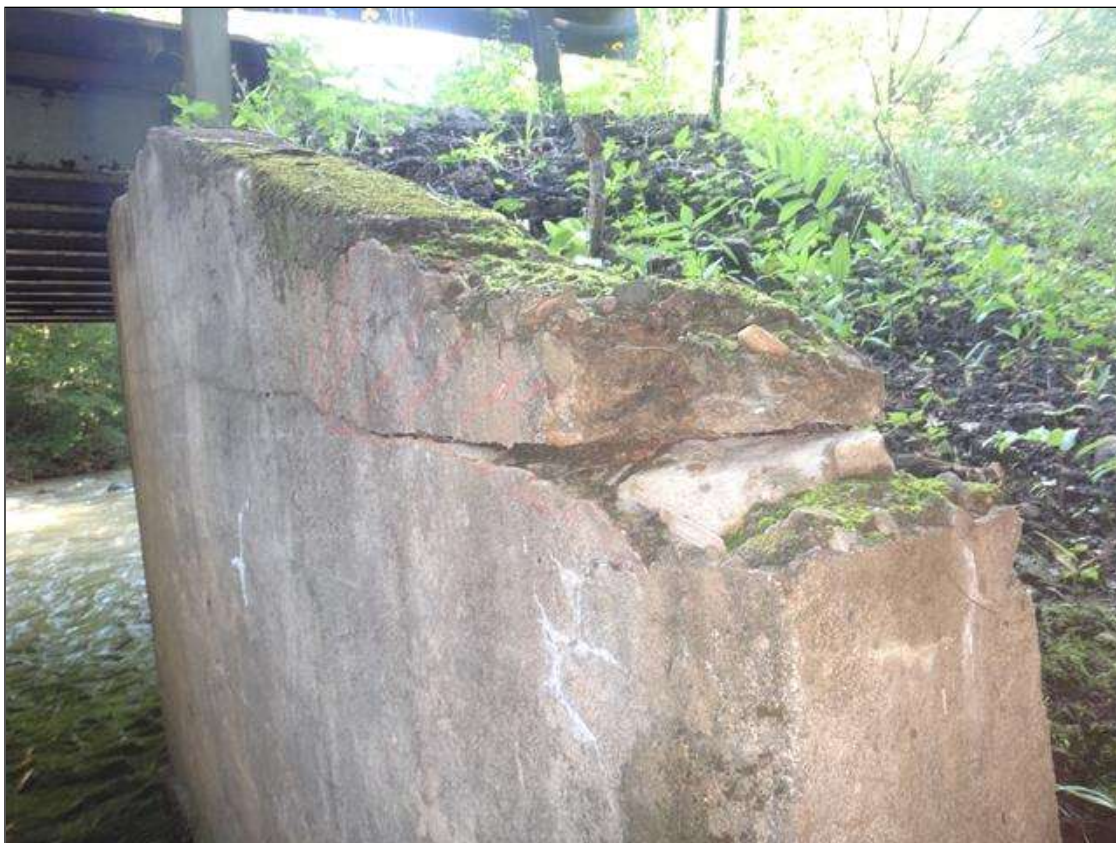
End Bent 2 Abutment/Backwall : top of northeast wingwall at end, spall (1ft x full width x 5in) with adjacent delamination (2ft x 10in)

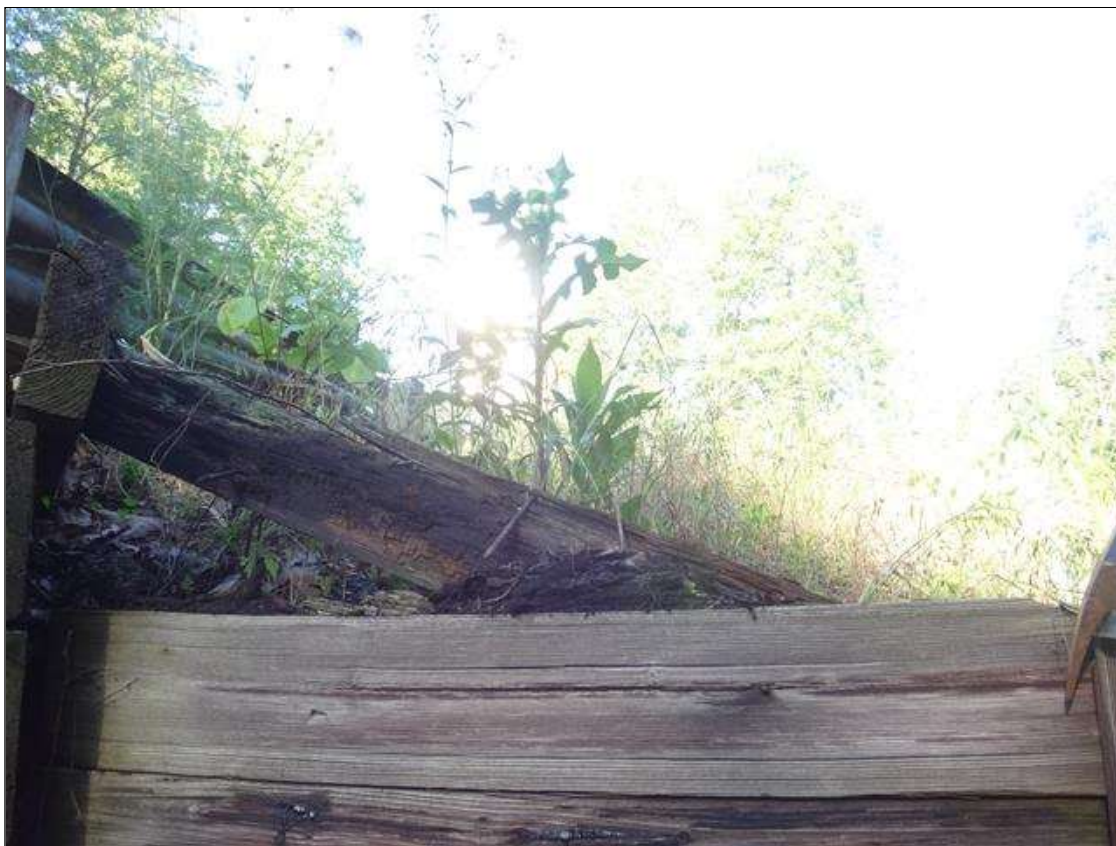
(PM) southwest wingwall top (2) boards, missing (3-1/2ft x full height x full depth)

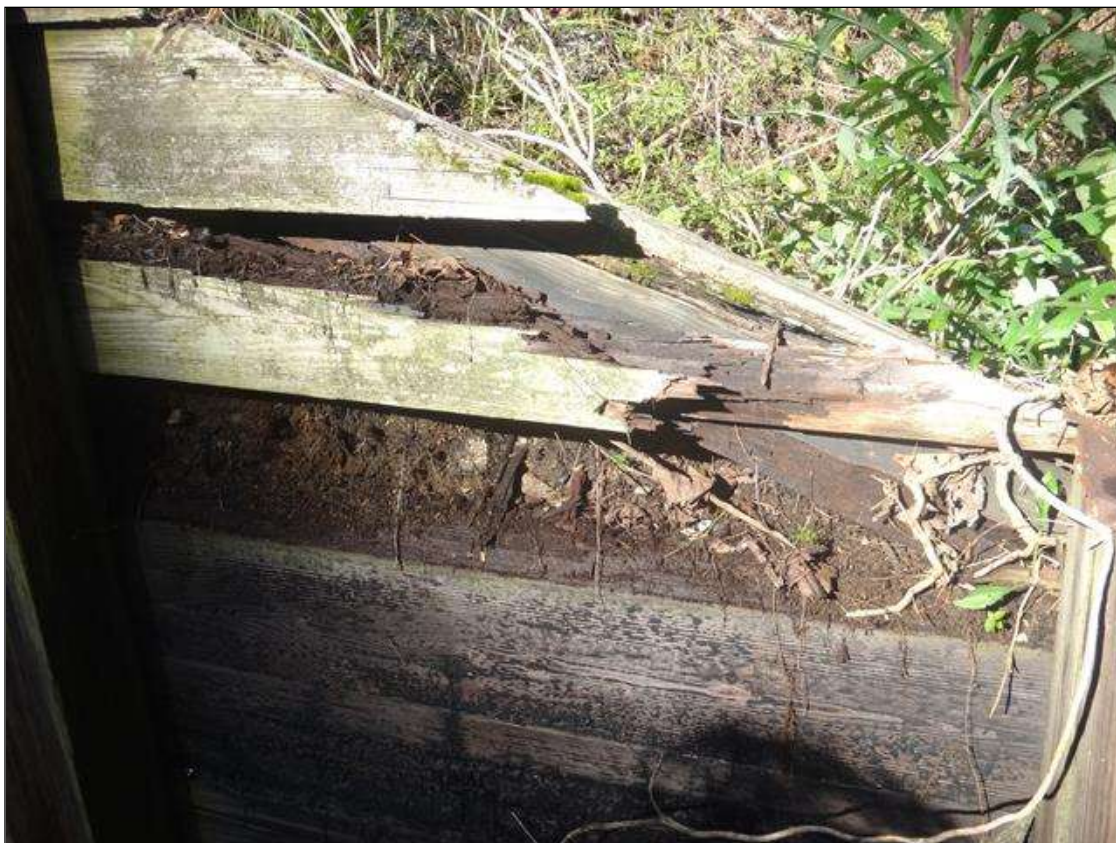
(PM) southwest wingwall 5th and 6th boards from top, decay (4ft x 16in x full depth) with backfill loss

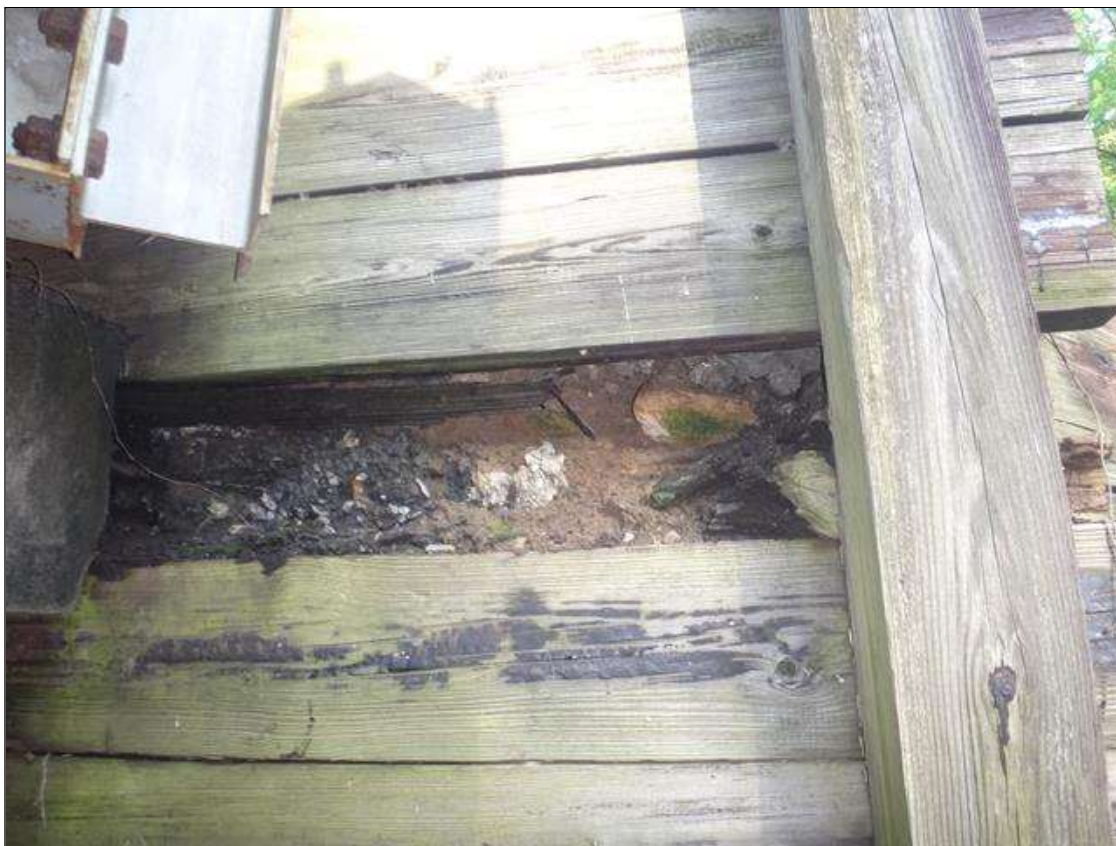
End Bent 1 Abutment/Backwall : (PM) 4th board from top at west end, missing (4ft x full height x full depth) with backfill loss

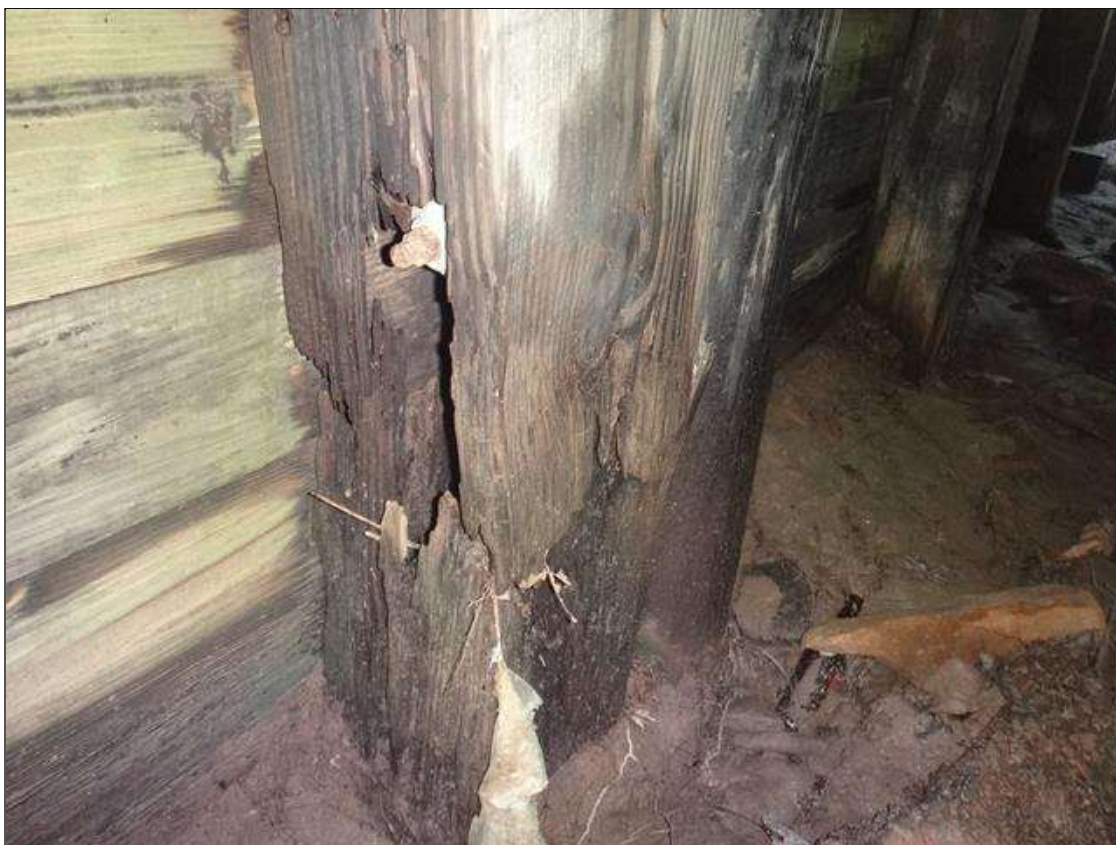
End Bent 1 Pile 6: (PM) at 2ft from base, decay (2ft x full width x full depth) with sister pile

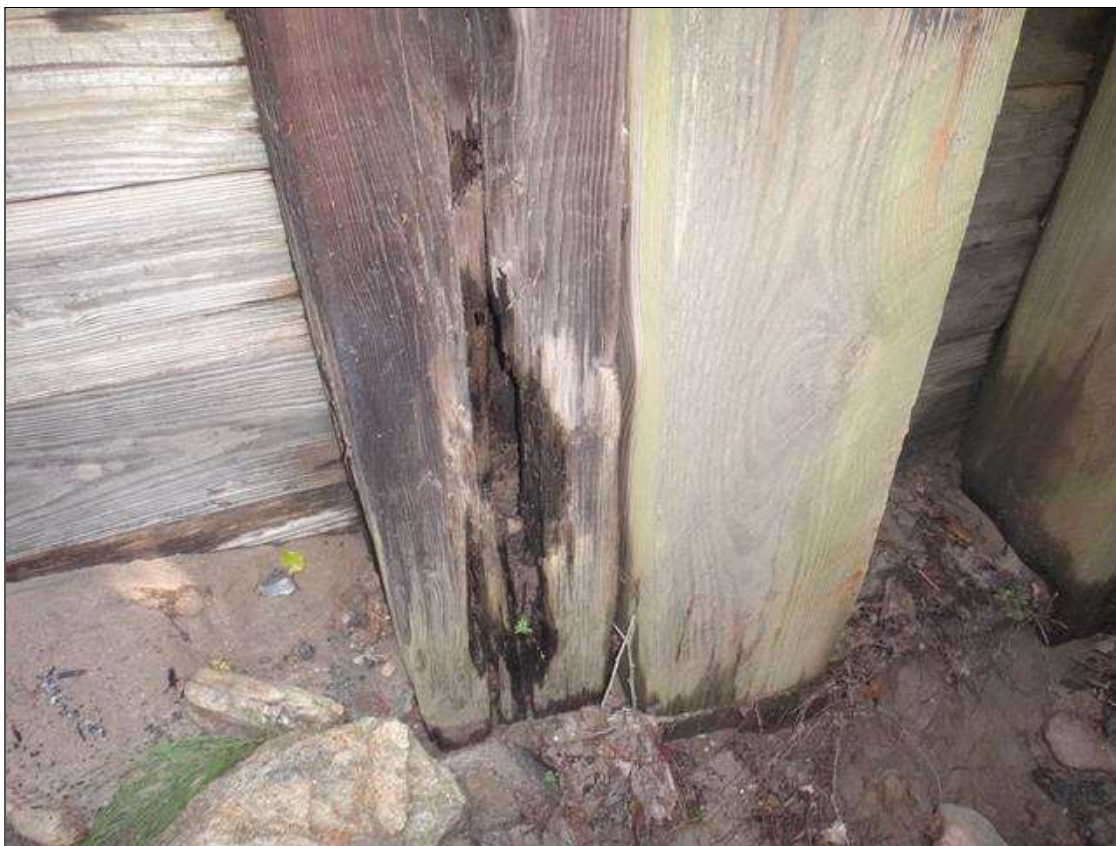
End Bent 1 Pile 9: (PM) north face at 1ft from base, decay (18in x 3in x 6in) with sister pile

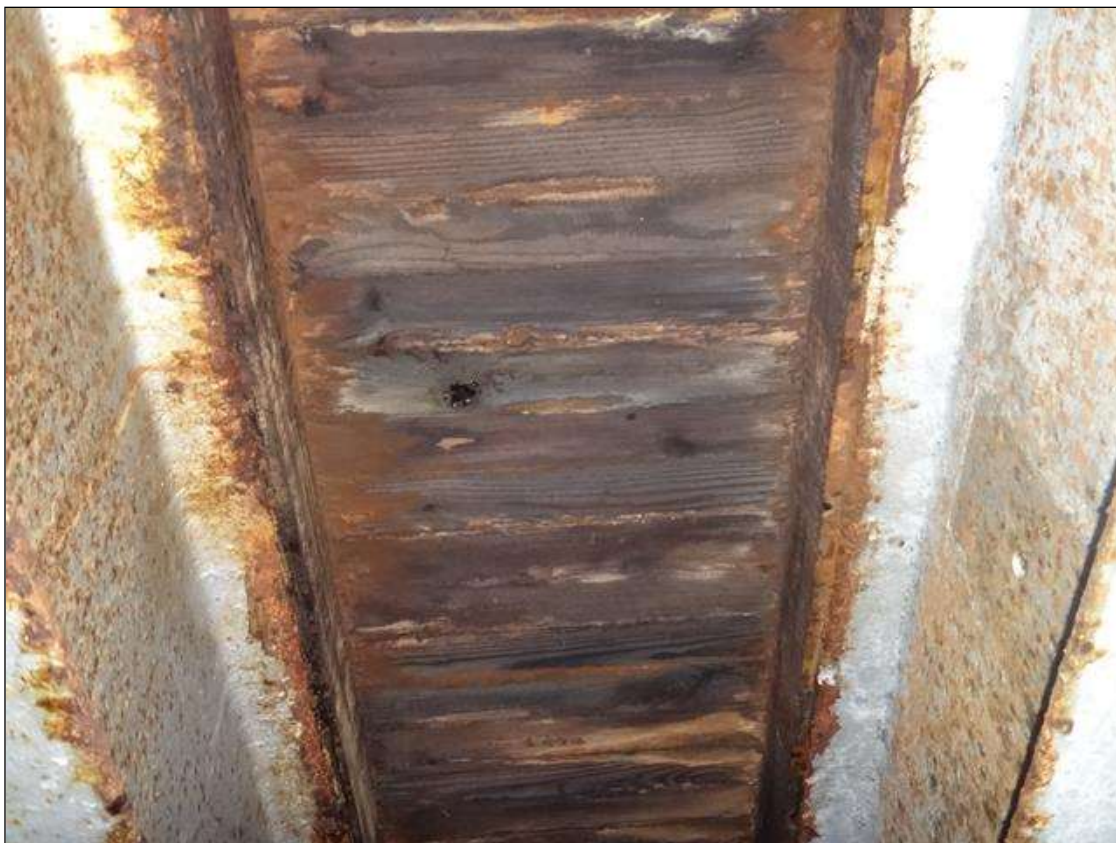
| Element Number | Defect Type | Defect Description | CS | CS Qty | Maint Qty | |
|---|---|---|---|---|---|---|
| 31 | Damage | underside throughout all bays, soft with water stains (75%) | 2 | 566 | 566 | Square Feet |

Span 1 Deck: underside throughout all bays, soft with water stains (75%)

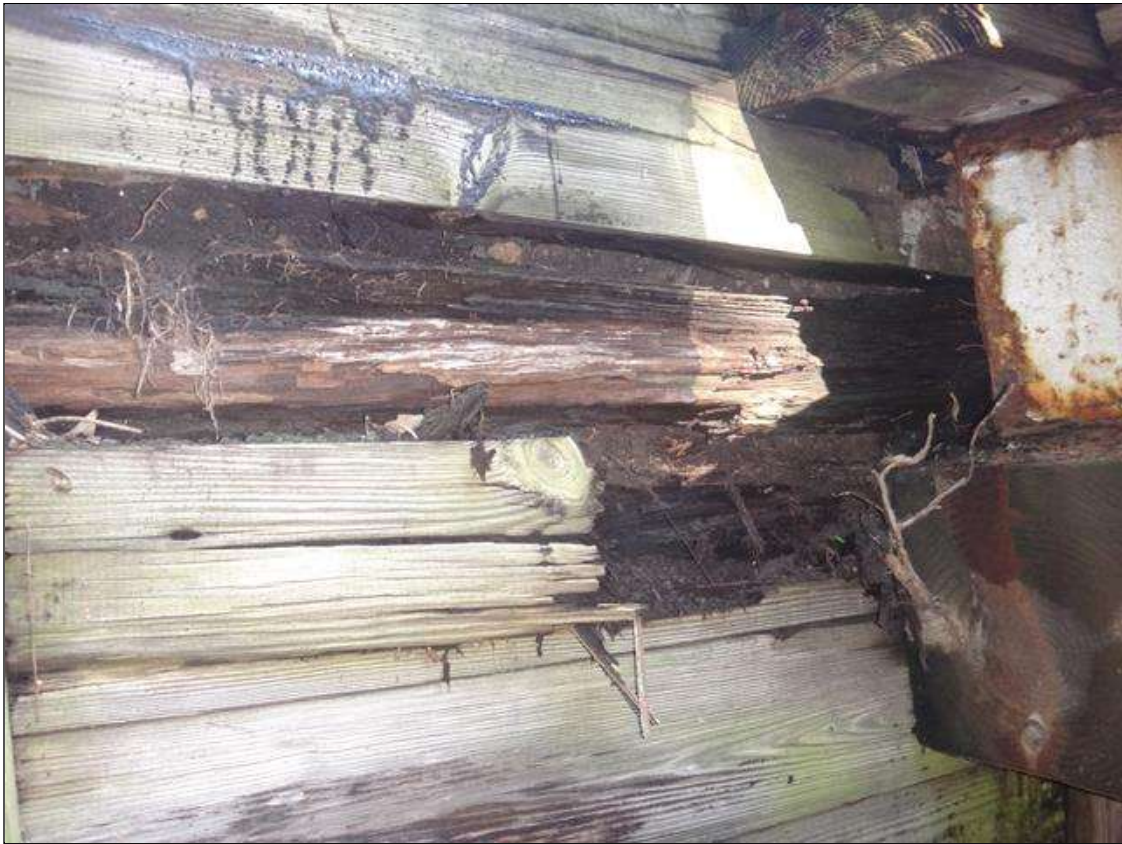
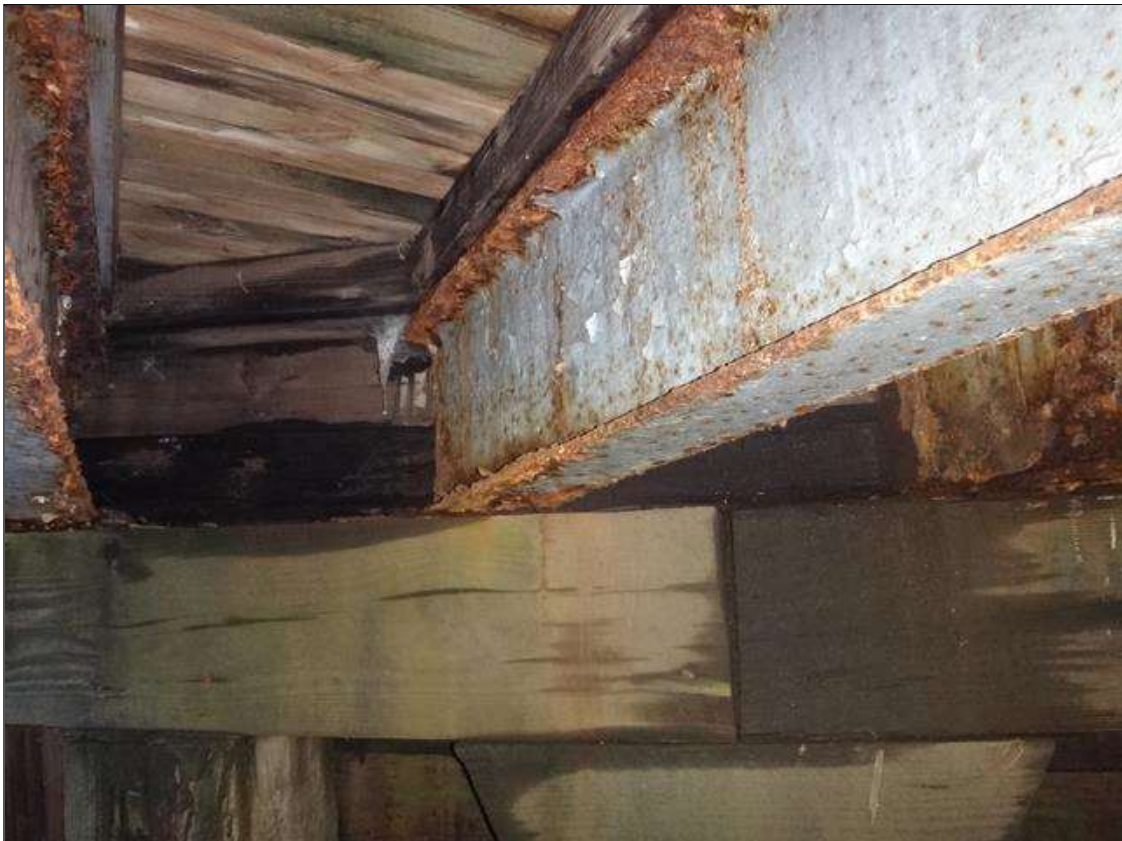
End Bent 1 Abutment/Backwall : (PM) 3rd and 4th boards from top starting at bay 9 moving towards east end, decay (9ft x 16in x up to full depth) with backfill loss (photo 1 of 2)

End Bent 1 Abutment/Backwall : (PM) 3rd and 4th boards from top starting at bay 9 moving towards east end, decay (9ft x 16in x up to full depth) with backfill loss (photo 2 of 2)

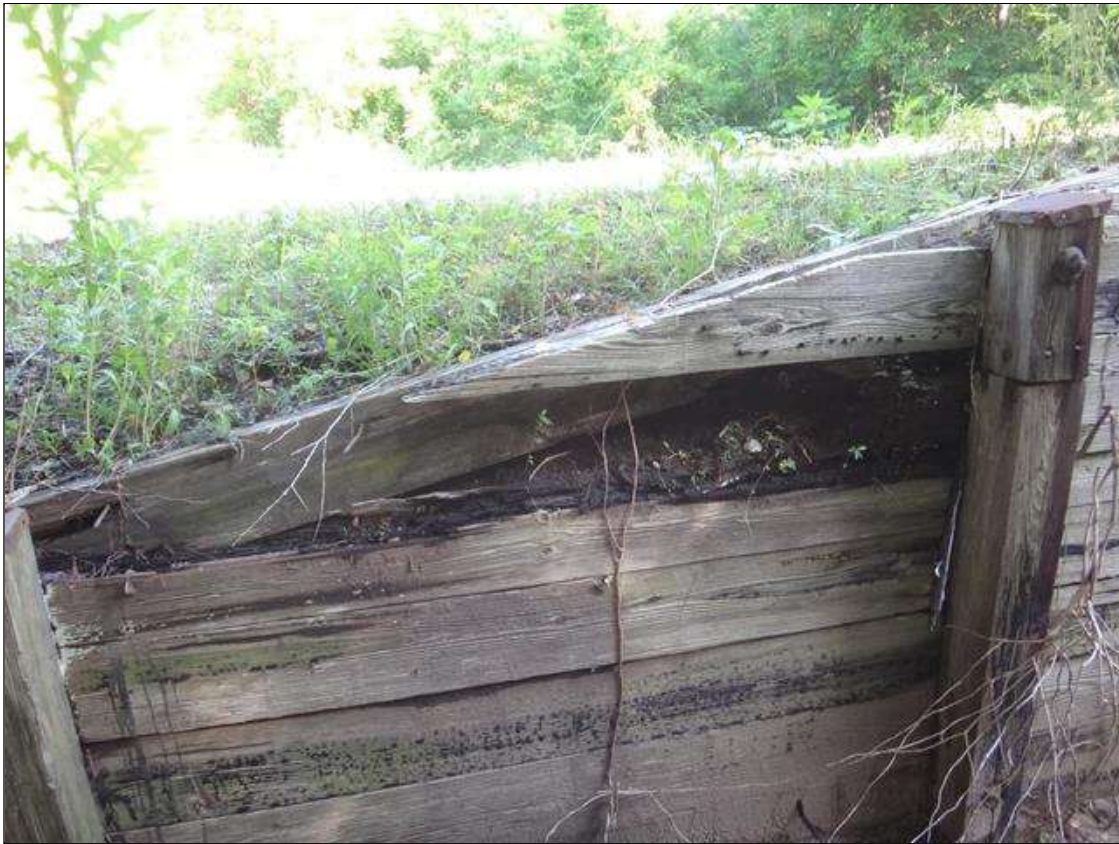
(PM) southeast wingwall 3rd board from top, decay (7ft x 10in x full depth) with backfill loss
