NC DEPARTMENT OF TRANSPORTATION  
DIVISION OF HIGHWAYS  
STRUCTURE MANAGEMENT UNIT

# Structure Safety Report

## Routine Element Inspection - Contract

DIVISION: 13 COUNTY: MCDOWELL STRUCTURE NUMBER: 580312 FREQUENCY: 24 MONTHS

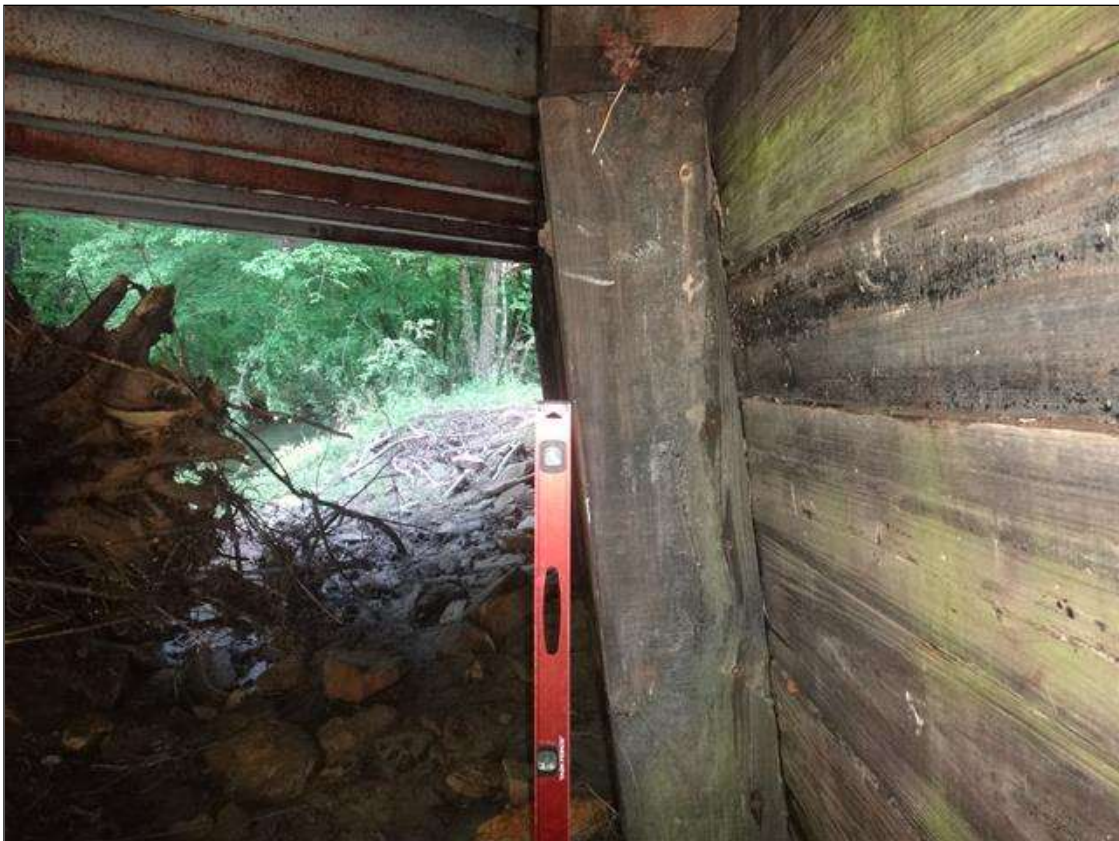
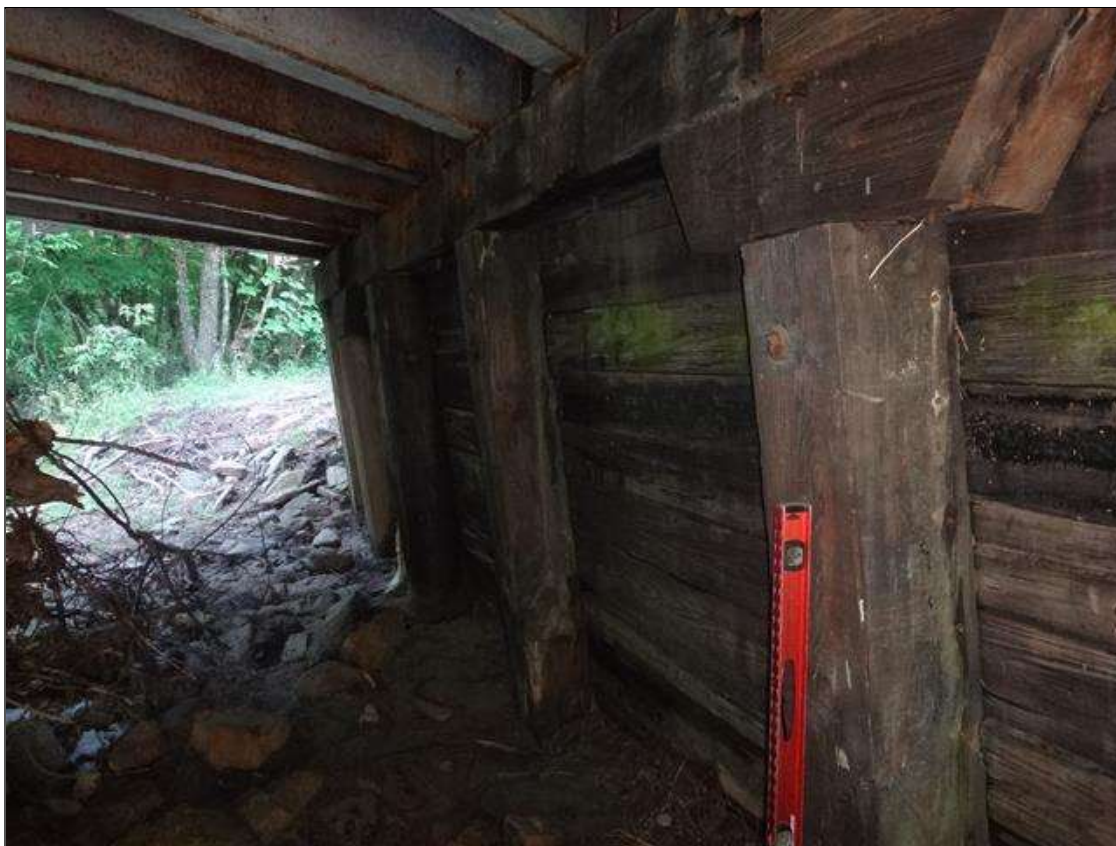
End Bent 1 Abutment/Backwall : leaning north (full length x up to 6in) (no change from 2016 inspection) (photo 1 of 2)

End Bent 1 Abutment/Backwall : leaning north (full length x up to 6in) (no change from 2016 inspection) (photo 2 of 2)

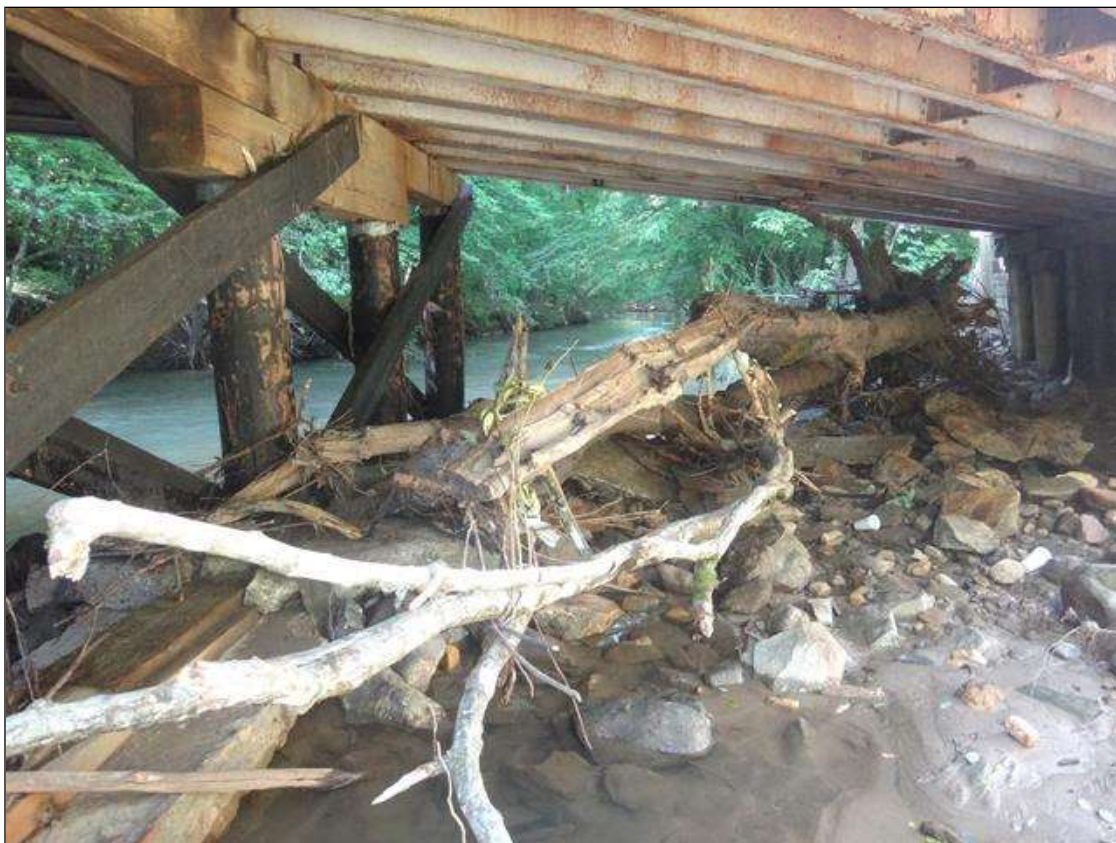
(PM) span 1, drift/tree accumulation (5cy)

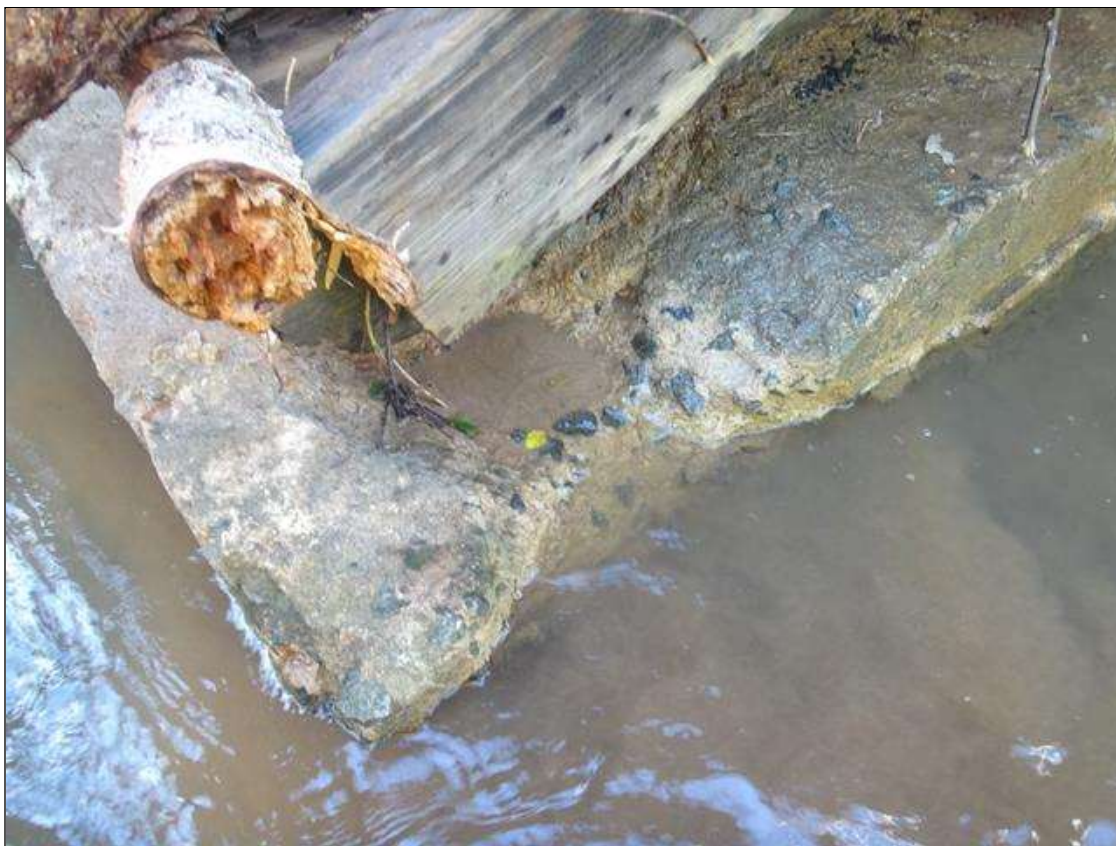
Bent 1 Footing: top southwest corner, spall (18in x 16in x 4in)

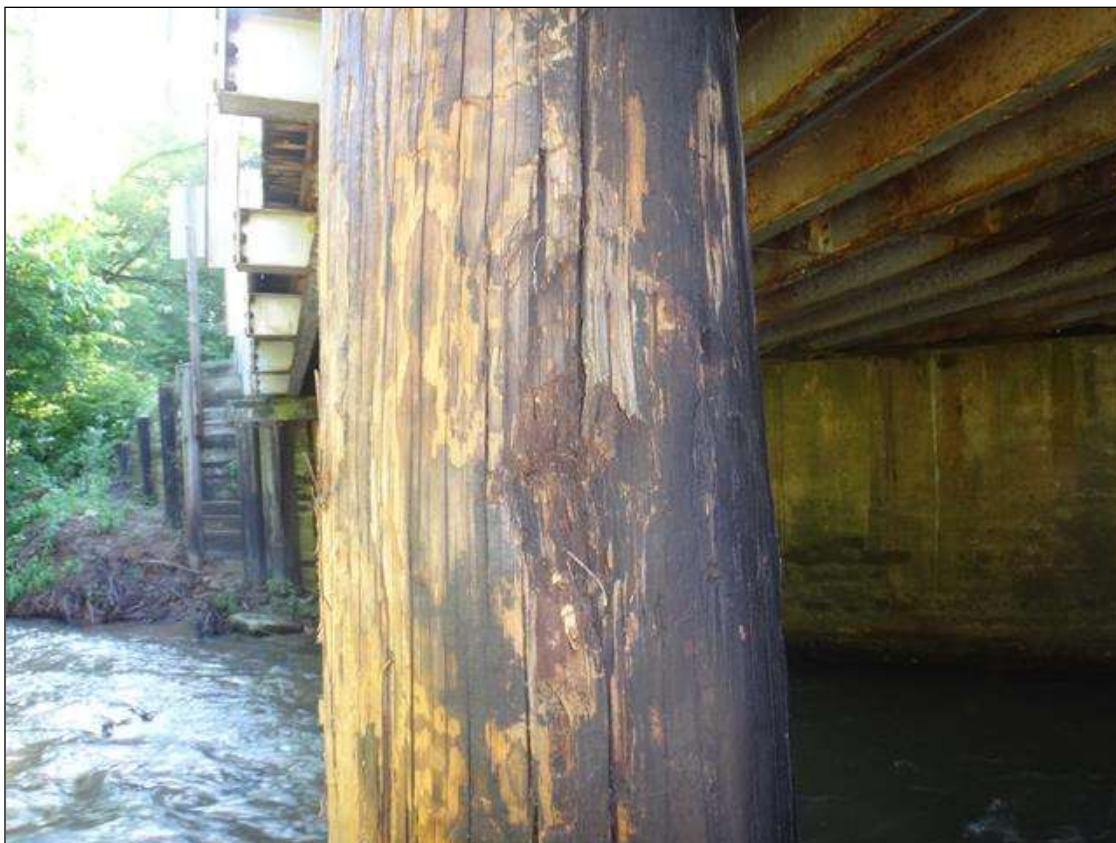
Bent 1 Pile 1: (PM) south face near mid-height, decay (9in x 3in x 3in)

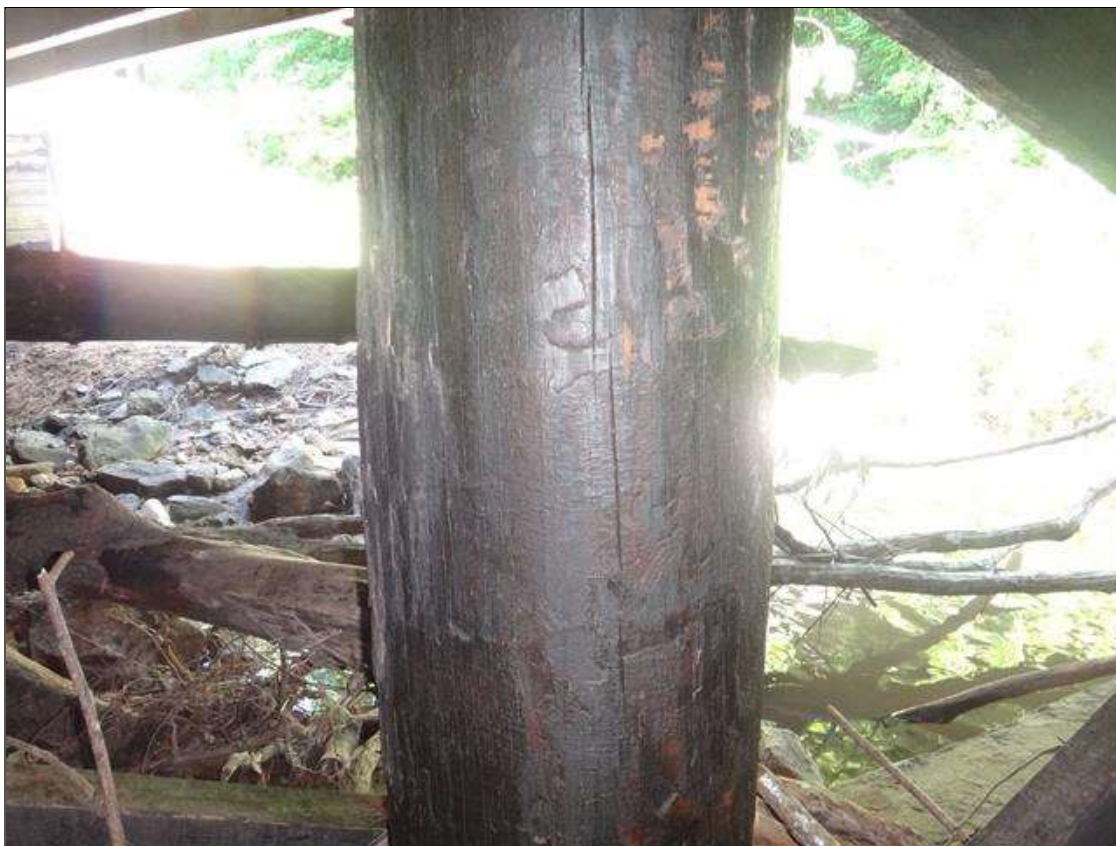
Bent 1 Pile 3: all faces, checks (full length x up to 1/16in)

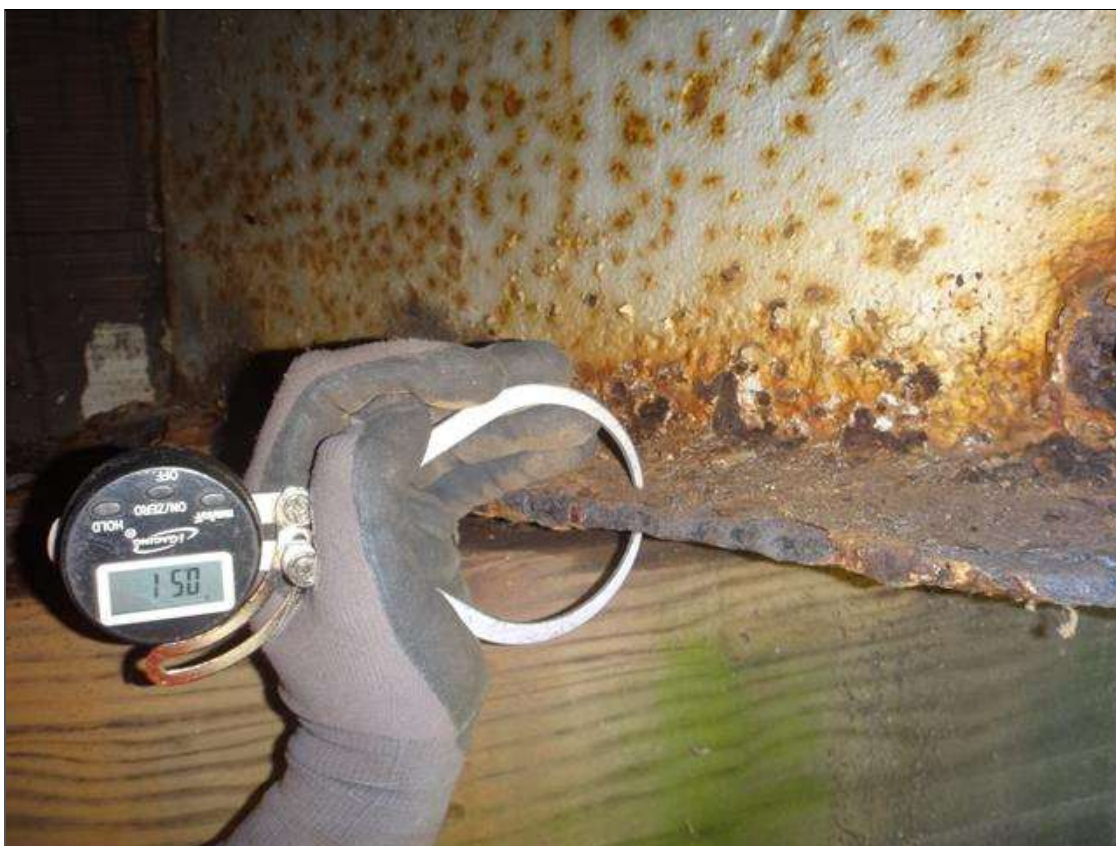
| Element Number | Defect Type | Defect Description | CS | CS Qty | Maint Qty | |
|---|---|---|---|---|---|---|
| 107 | Corrosion | bottom flange at end bent 1, rust scale with section loss (18in x full width) (0.51in avg rem) | 3 | 2 | 2 | Feet |

Span 1 Beam 1: bottom flange at end bent 1, rust scale with section loss (18in x full width) (0.51in avg rem)

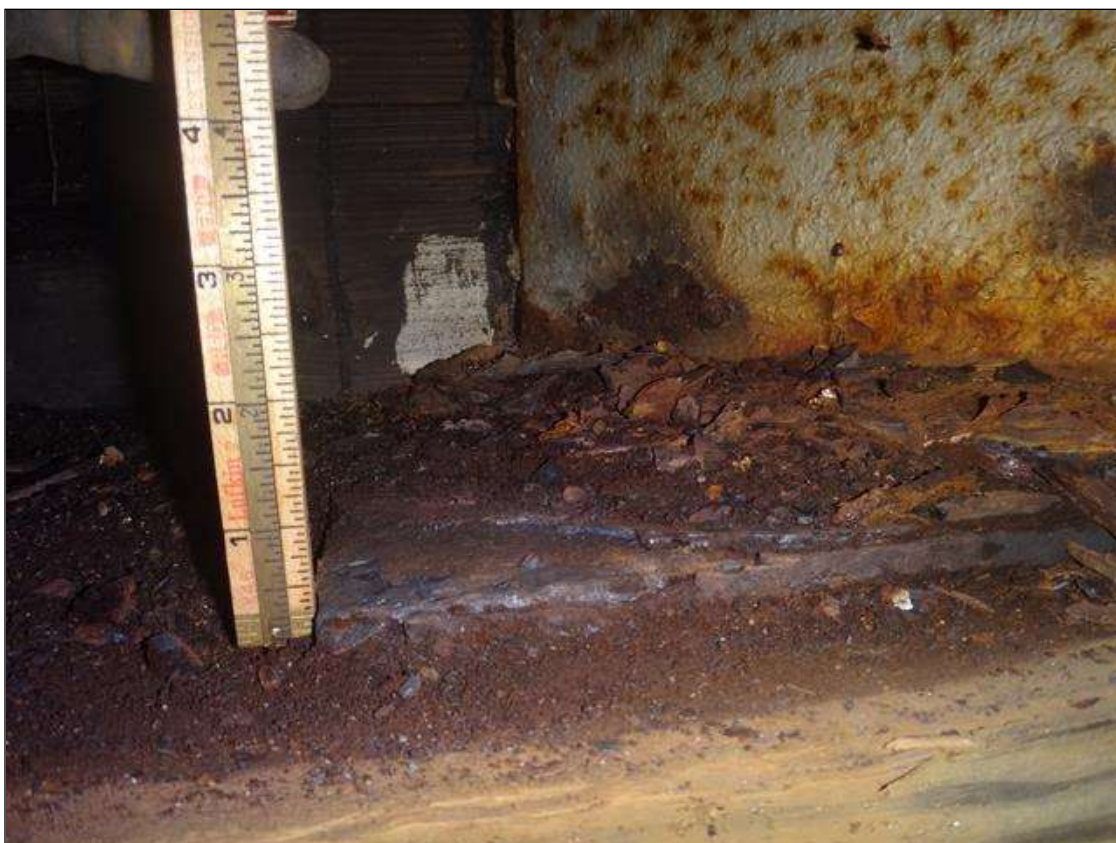
Span 1 Beam 1 Near Bearing: rust scale with section loss (10%)

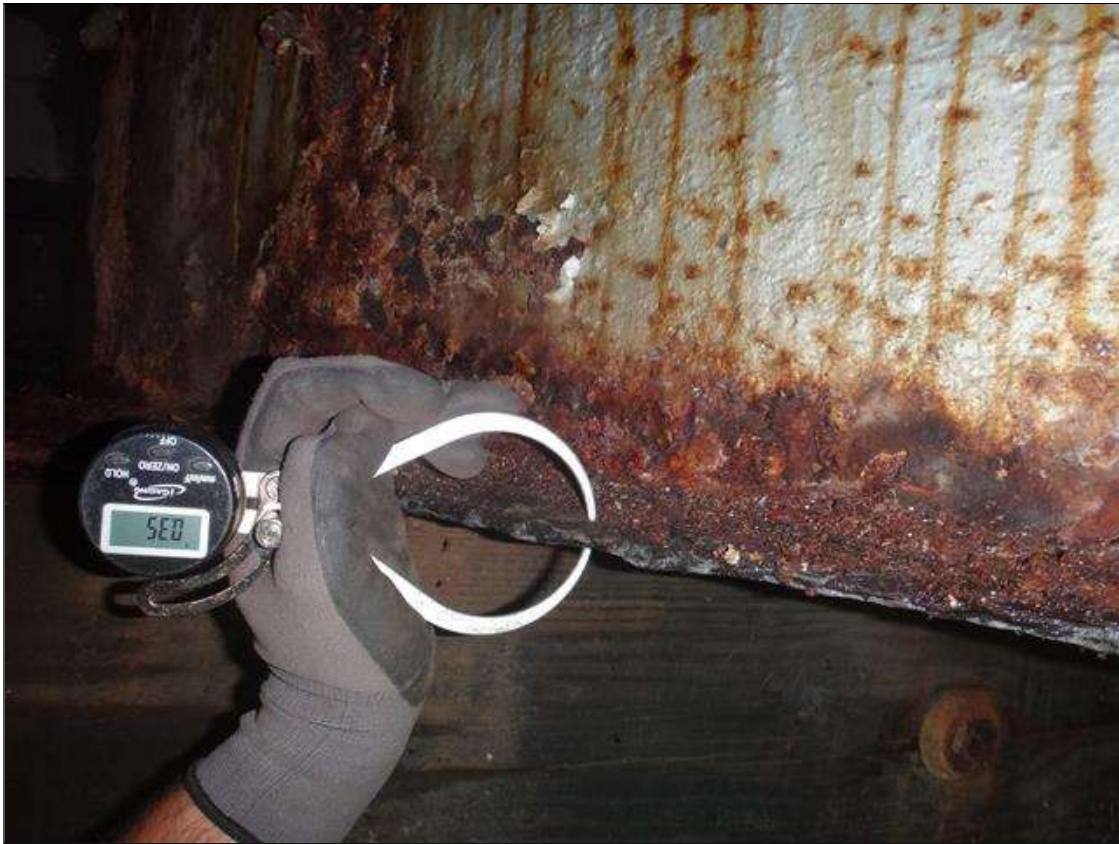
| Element Number | Defect Type | Defect Description | CS | CS Qty | Maint Qty | |
|---|---|---|---|---|---|---|
| 107 | Corrosion | (PM) bottom flange at end bent 1, rust scale with section loss (30in x full width) (0.35in avg rem) | 3 | 3 | 3 | Feet |

Span 1 Beam 9: (PM) bottom flange at end bent 1, rust scale with section loss (30in x full width) (0.35in avg rem)

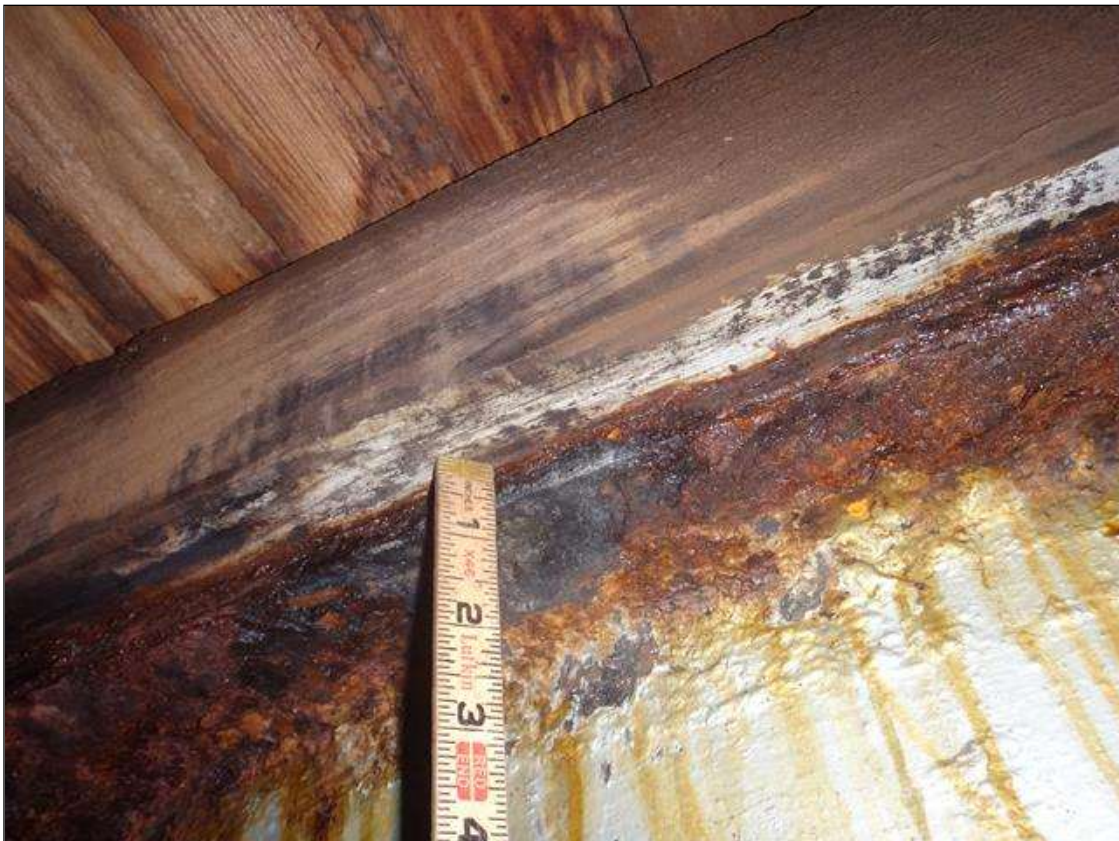
| Element Number | Defect Type | Defect Description | CS | CS Qty | Maint Qty | |
|---|---|---|---|---|---|---|
| 107 | Corrosion | top flange at end bent 1, rust scale with section loss (30in x full width) (1/2in avg rem) | 3 | | 3 | Feet |

Span 1 Beam 9: top flange at end bent 1, rust scale with section loss (30in x full width) (1/2in avg rem)

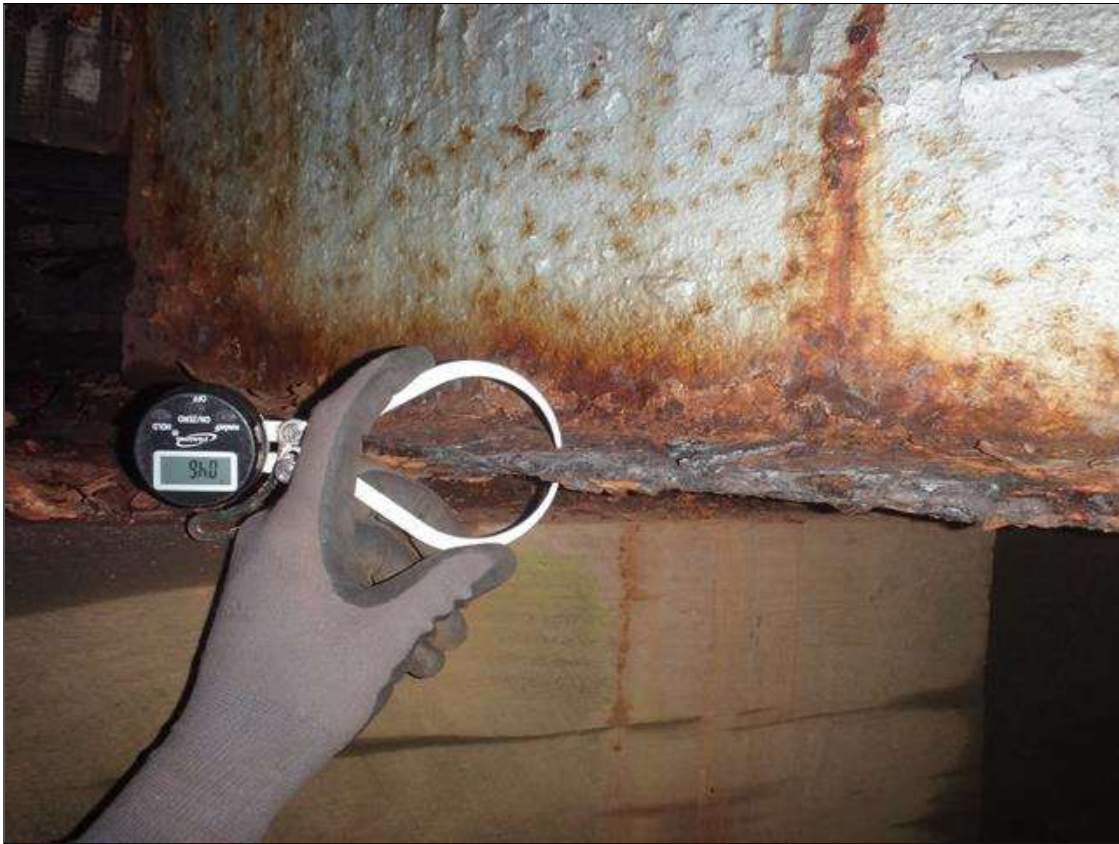
| Element Number | Defect Type | Defect Description | CS | CS Qty | Maint Qty | |
|---|---|---|---|---|---|---|
| 107 | Corrosion | (PM) bottom flange at end bent 1, rust scale with section loss (18in x full width) (0.46in avg rem) | 3 | 2 | 2 | Feet |

Span 1 Beam 10: (PM) bottom flange at end bent 1, rust scale with section loss (18in x full width) (0.46in avg rem)

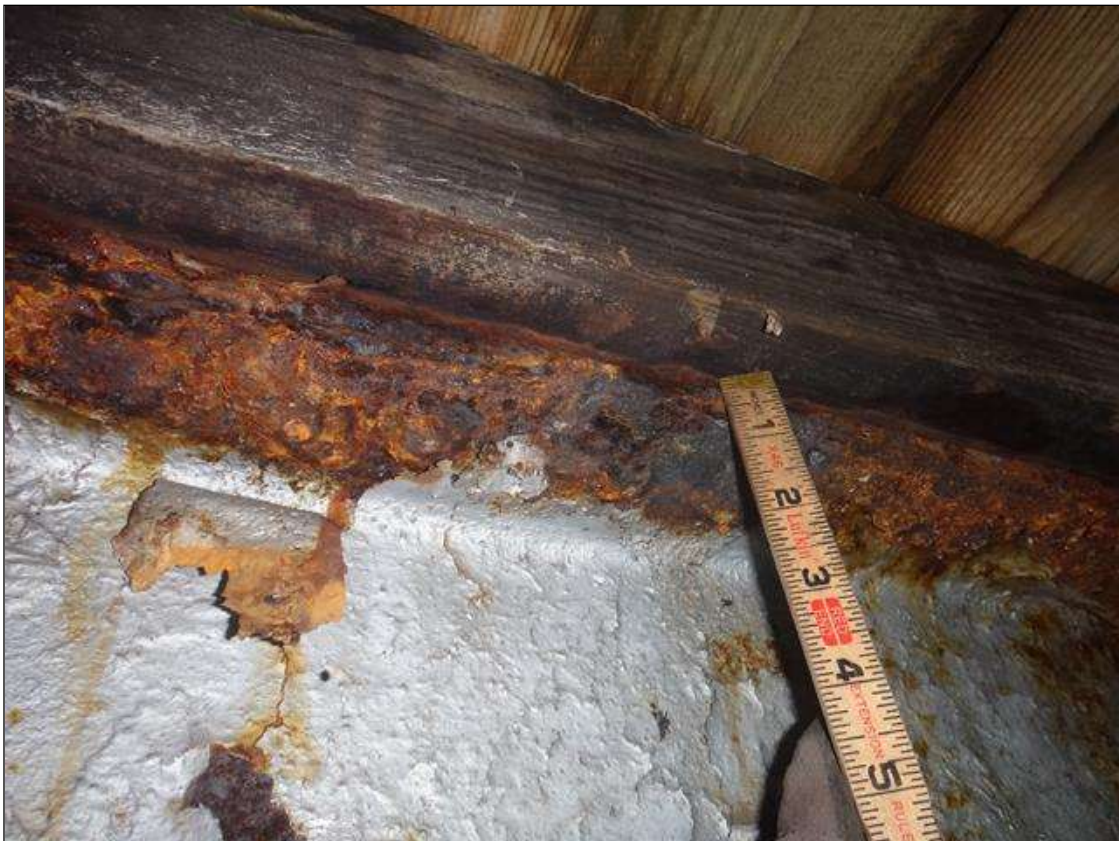
| Element Number | Defect Type | Defect Description | CS | CS Qty | Maint Qty | |
|---|---|---|---|---|---|---|
| 107 | Corrosion | top flange at end bent 1, rust scale with section loss (2ft x full width) (1/2in avg rem) | 3 | | 2 | Feet |

Span 1 Beam 10: top flange at end bent 1, rust scale with section loss (2ft x full width) (1/2in avg rem)

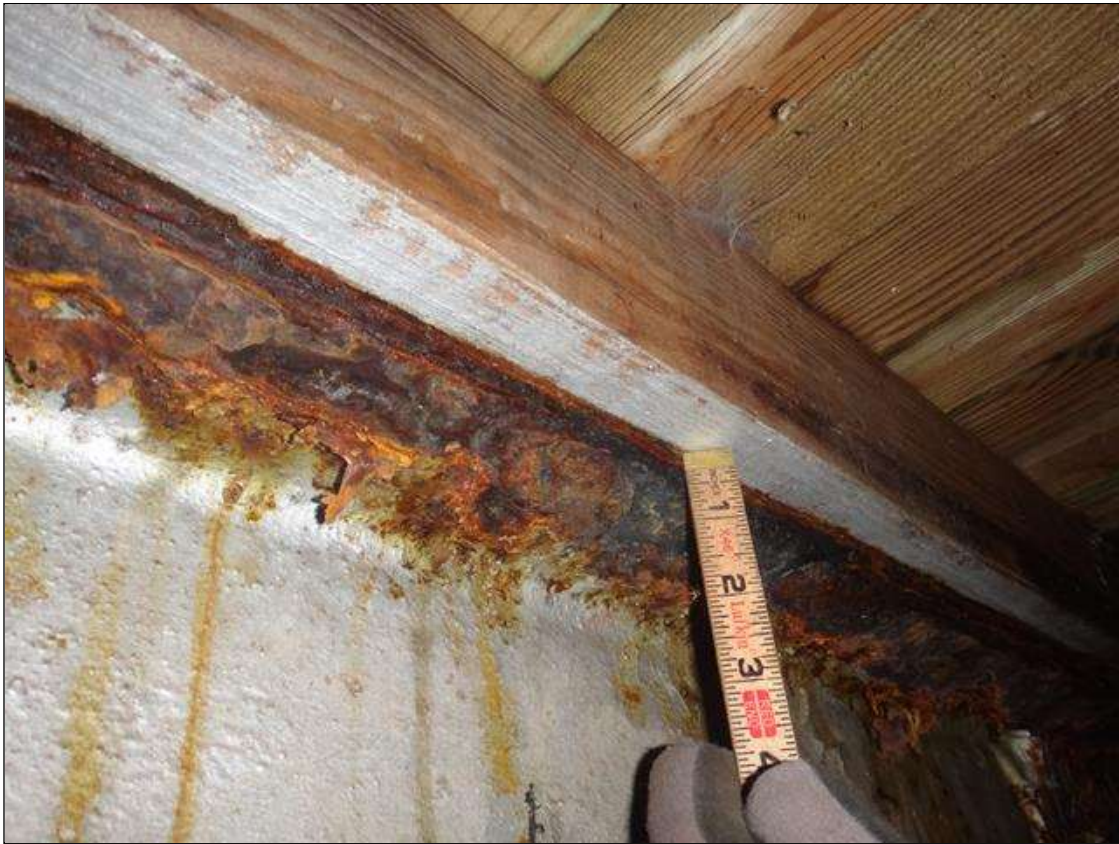
| Element Number | Defect Type | Defect Description | CS | CS Qty | Maint Qty | |
|---|---|---|---|---|---|---|
| 107 | Corrosion | top flange at end bent 1, rust scale with section loss (30in x full width) (1/2in avg rem) | 3 | | 2 | Feet |

Span 1 Beam 11: top flange at end bent 1, rust scale with section loss (30in x full width) (1/2in avg rem)

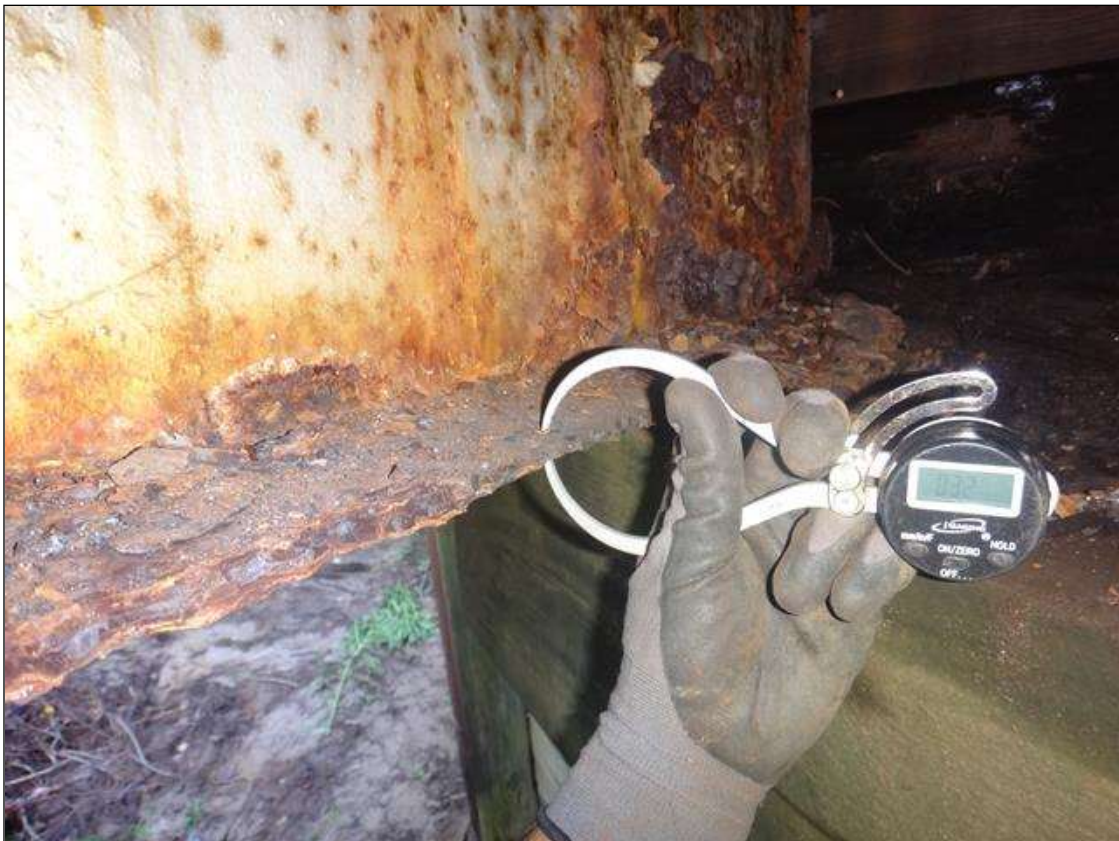
| Element Number | Defect Type | Defect Description | CS | CS Qty | Maint Qty | |
|---|---|---|---|---|---|---|
| 107 | Corrosion | (PM) bottom flange at end bent 1, rust scale with section loss (2ft x full width) (0.32in avg rem) | 3 | 2 | 2 | Feet |

Span 1 Beam 11: (PM) bottom flange at end bent 1, rust scale with section loss (2ft x full width) (0.32in avg rem)

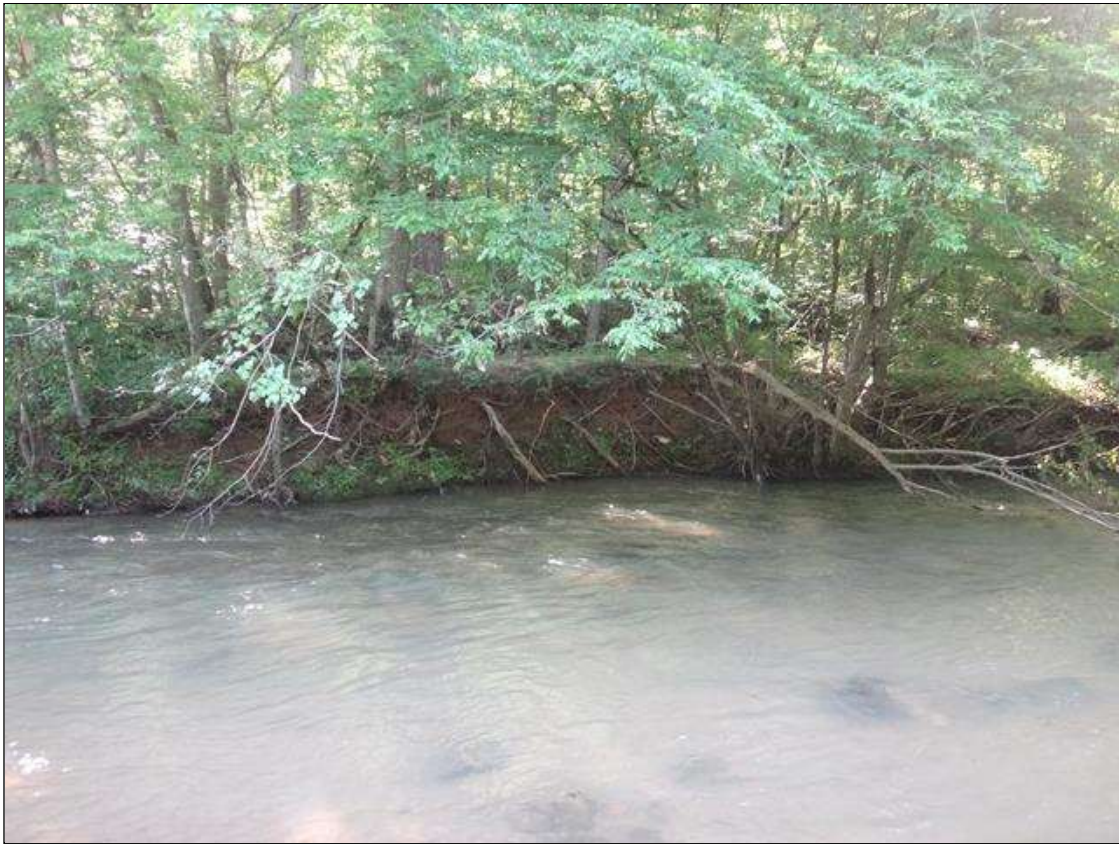
northeast streambank, erosion with vertical cuts and exposed tree roots (35ft x 3ft x 6ft)

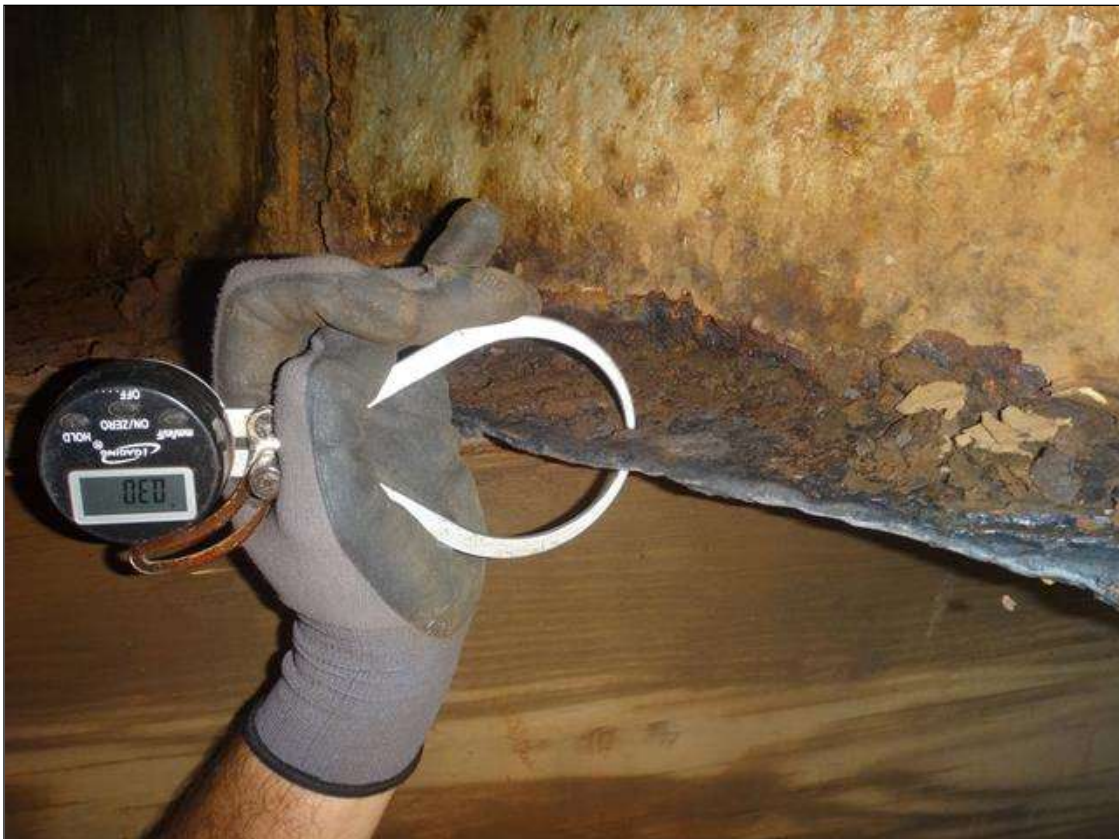
Span 2 Beam 3: (PM) bottom flange at bent 1, rust scale with section loss (18in x full width x 0.12in at edge) (0.30in avg rem)

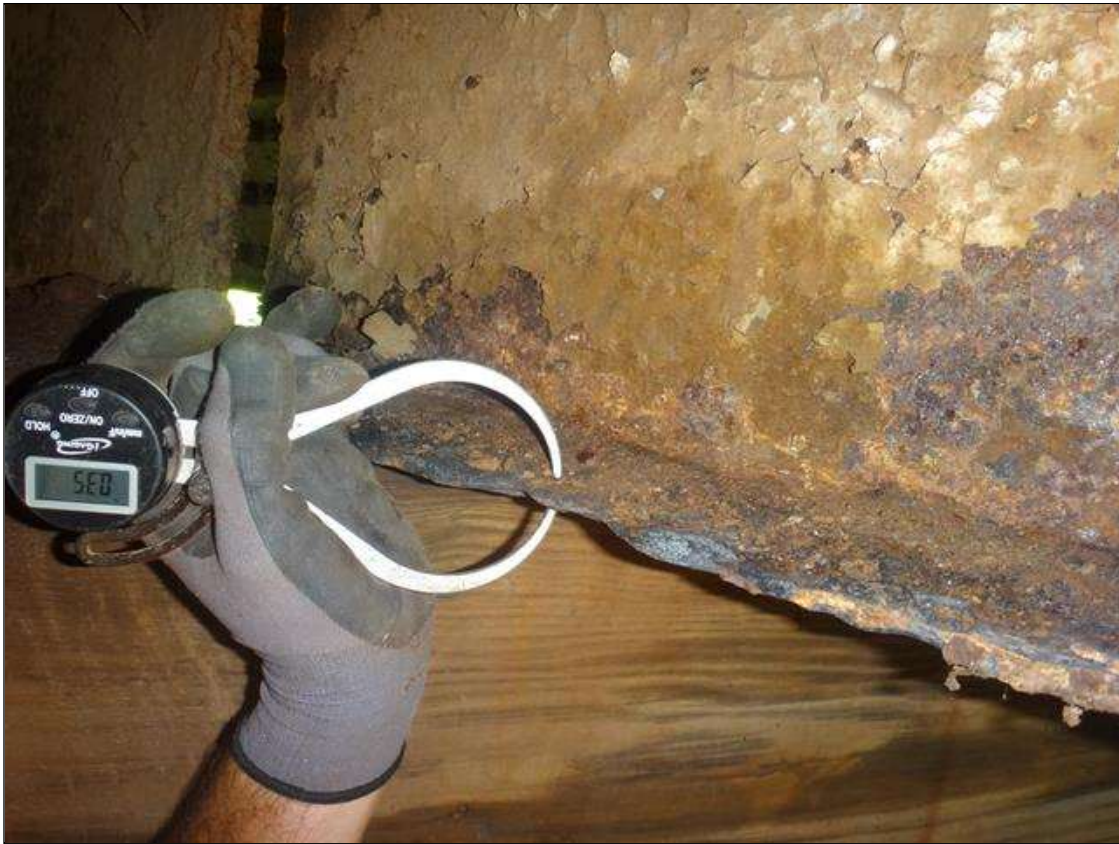
Span 2 Beam 2: (PM) bottom flange at bent 1, rust scale with section loss (18in x full width x 0.15in at edge) (0.35in avg rem)

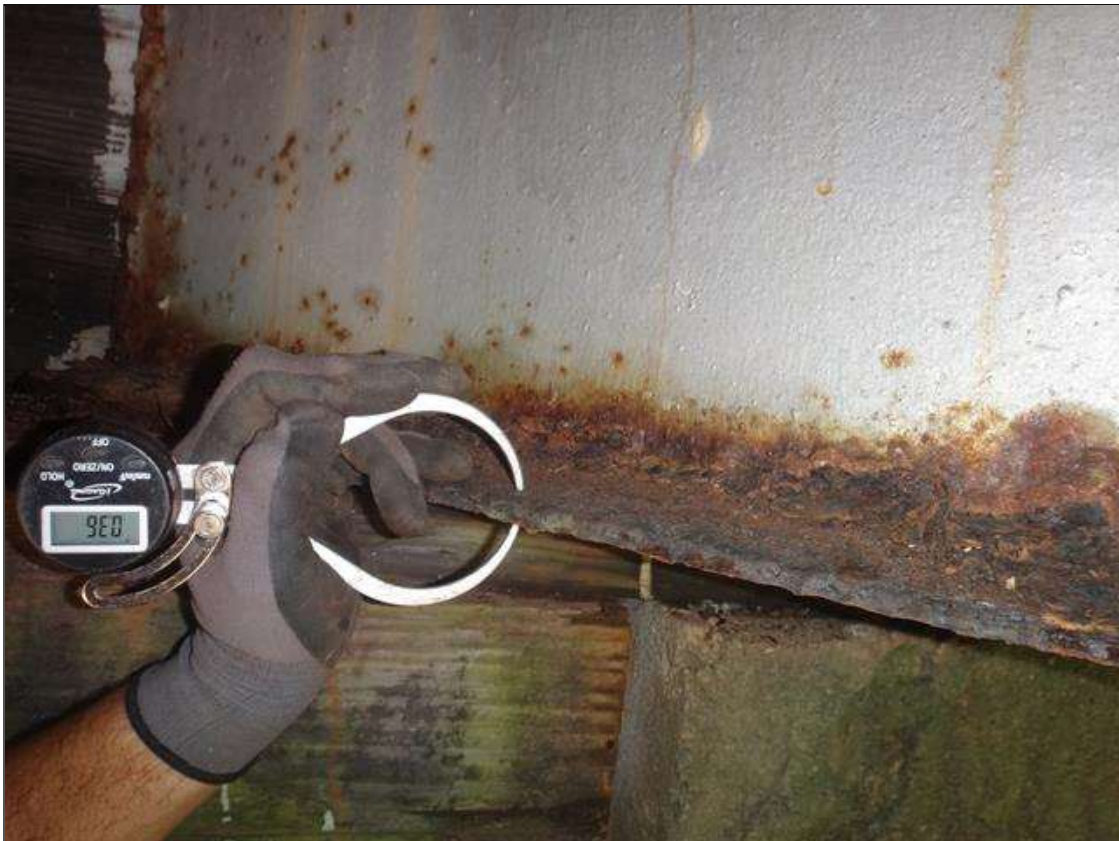
Span 2 Beam 2: (PM) bottom flange at end bent 2, rust scale with section loss (30in x full width) (0.36in avg rem)

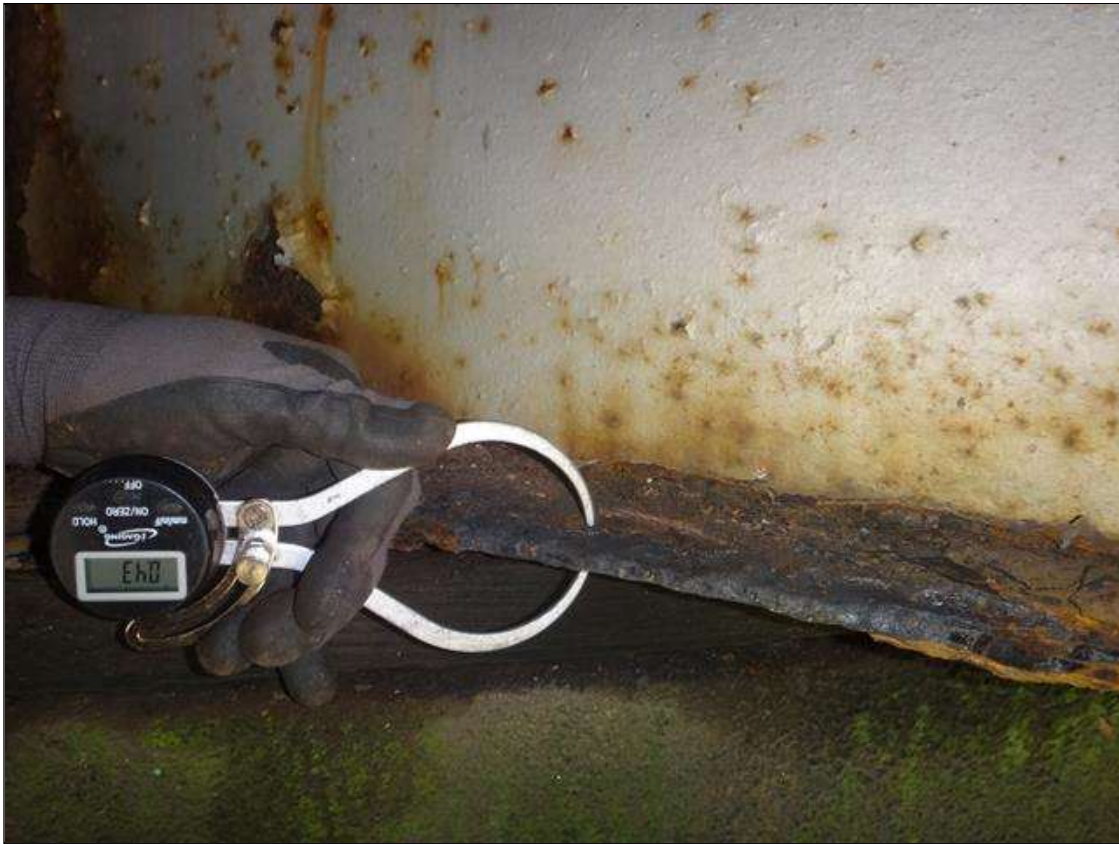
Span 2 Beam 3: (PM) bottom flange at end bent 2, rust scale with section loss (2ft x full width) (0.43in avg rem)

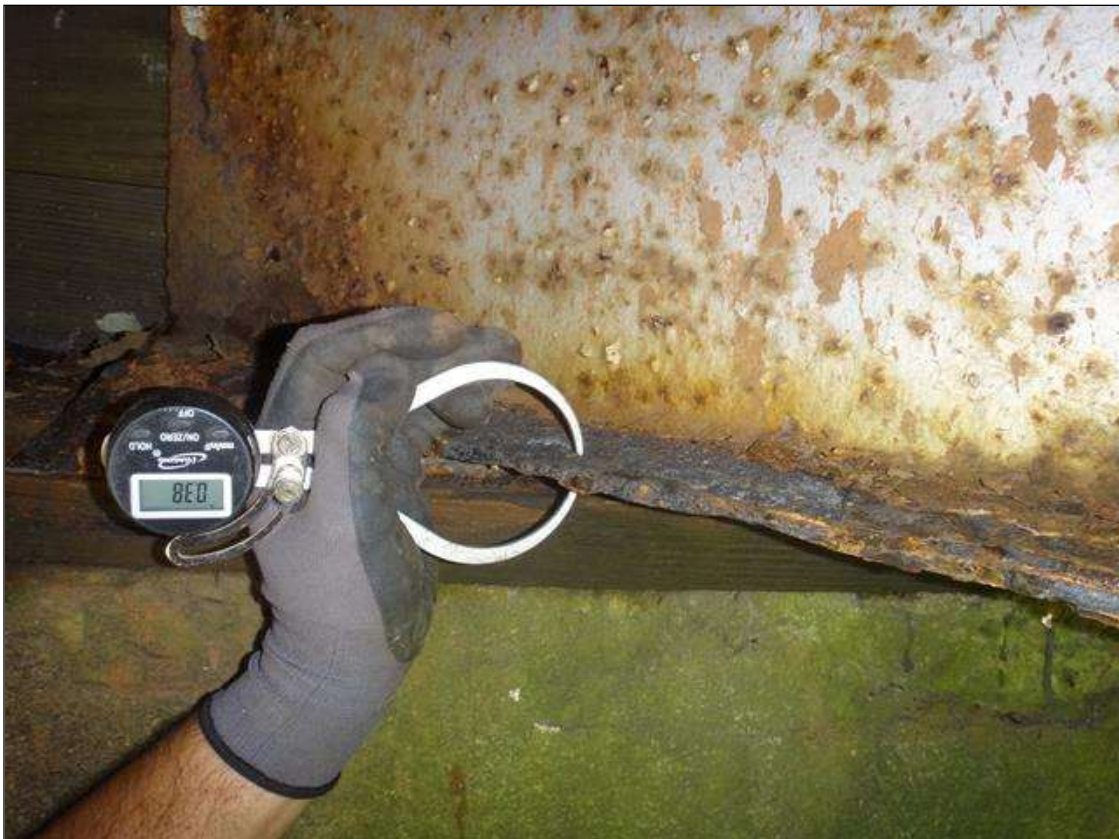
Span 2 Beam 4: (PM) bottom flange at end bent 2, rust scale with section loss (2ft x full width) (0.38in avg rem)

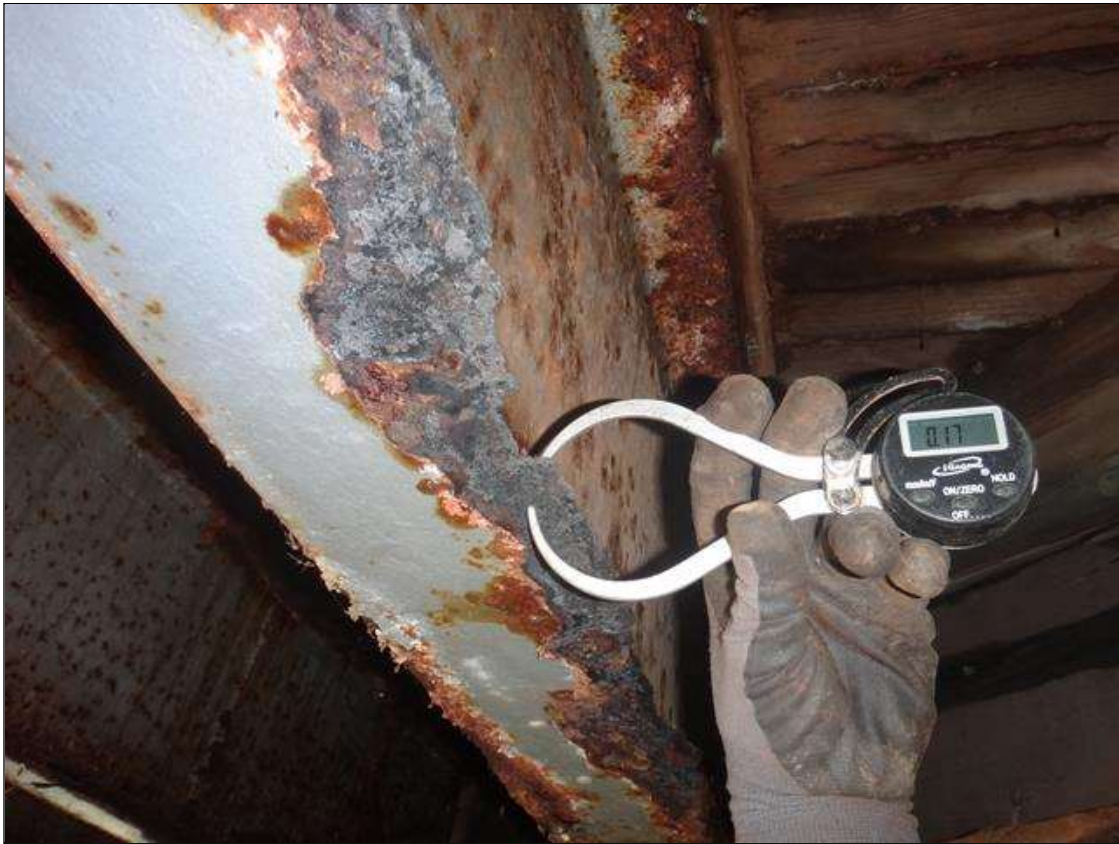
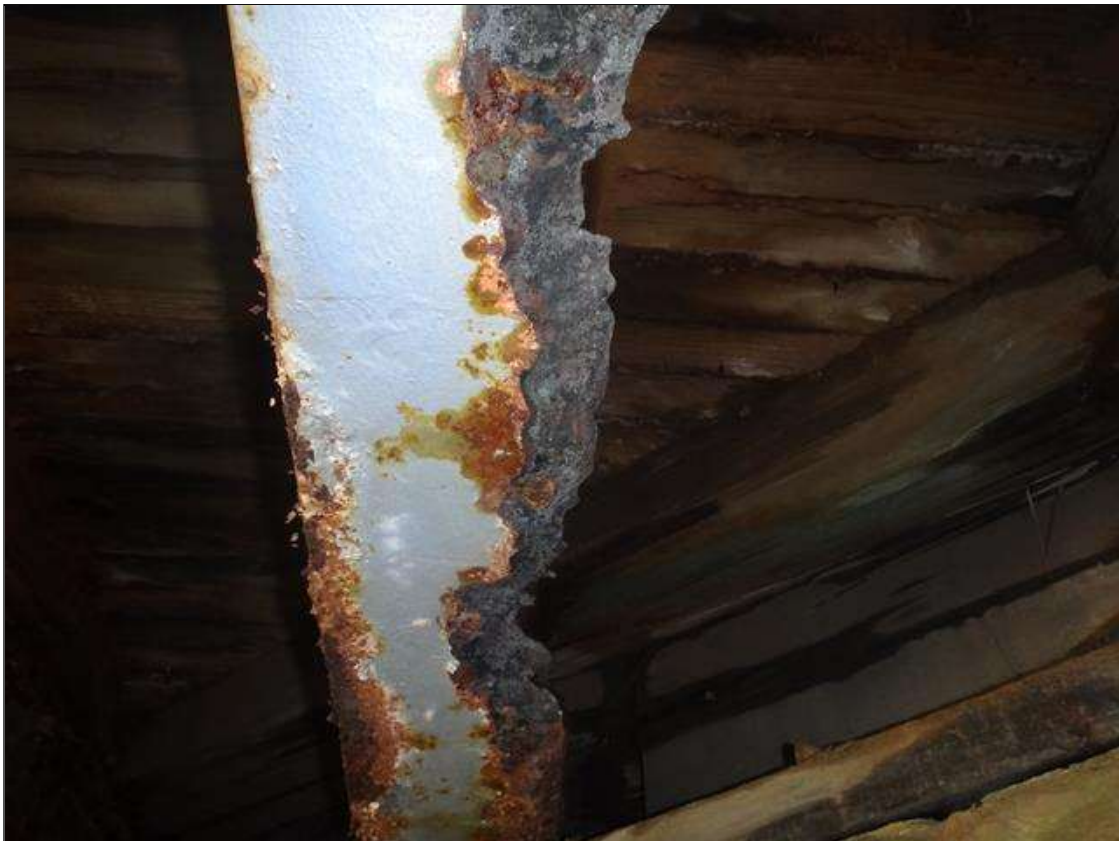
Span 2 Beam 5: (PM) bottom flange at end bent 2, rust scale with section loss (4ft x full width x down to knife edge) (0.17in avg rem) with (2) corrosion holes (up to 7in x 1-1/2in) (photo 1 of 2)

Span 2 Beam 5: (PM) bottom flange at end bent 2, rust scale with section loss (4ft x full width x down to knife edge) (0.17in avg rem) with (2) corrosion holes (up to 7in x 1-1/2in) (photo 2 of 2)

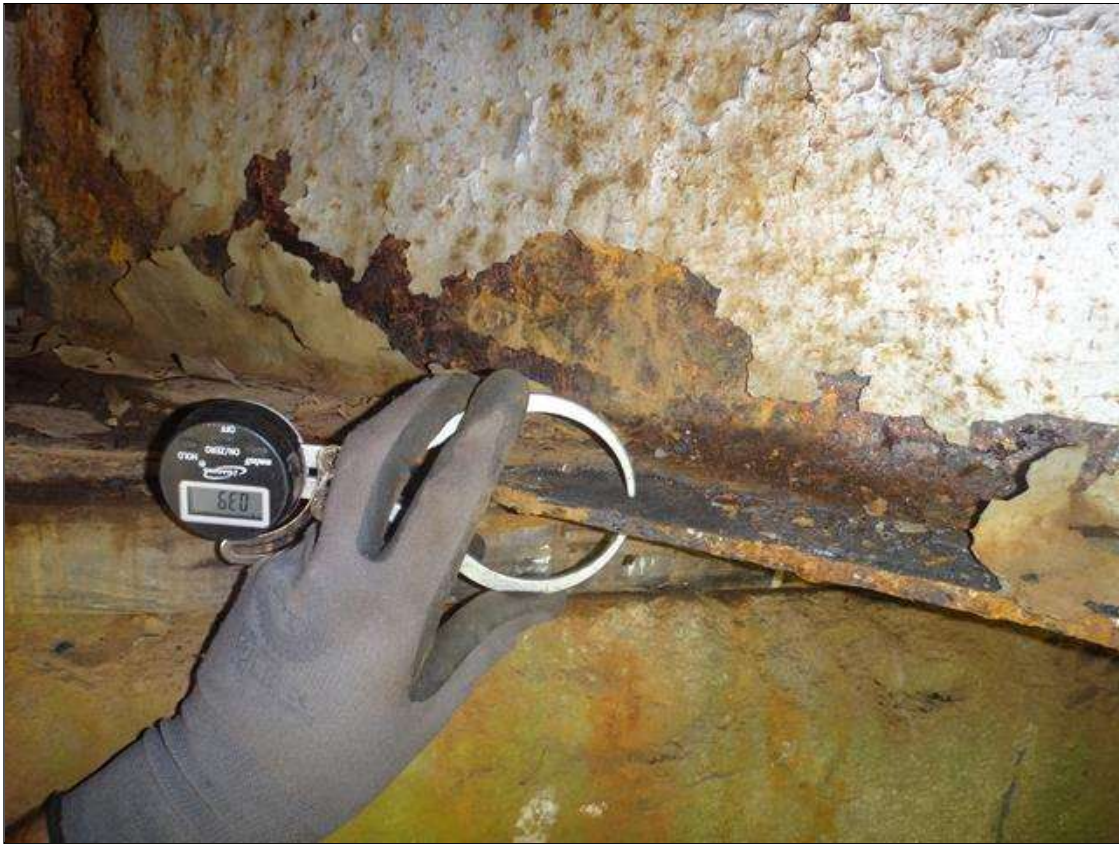
Span 2 Beam 6: (PM) bottom flange at end bent 2, rust scale with section loss (2ft x full width) (0.39in avg rem)
