NC DEPARTMENT OF TRANSPORTATION  
DIVISION OF HIGHWAYS  
STRUCTURE MANAGEMENT UNIT

# Structure Safety Report

## Routine Element Inspection - Contract

DIVISION: 13 COUNTY: MCDOWELL STRUCTURE NUMBER: 580312 FREQUENCY: 24 MONTHS

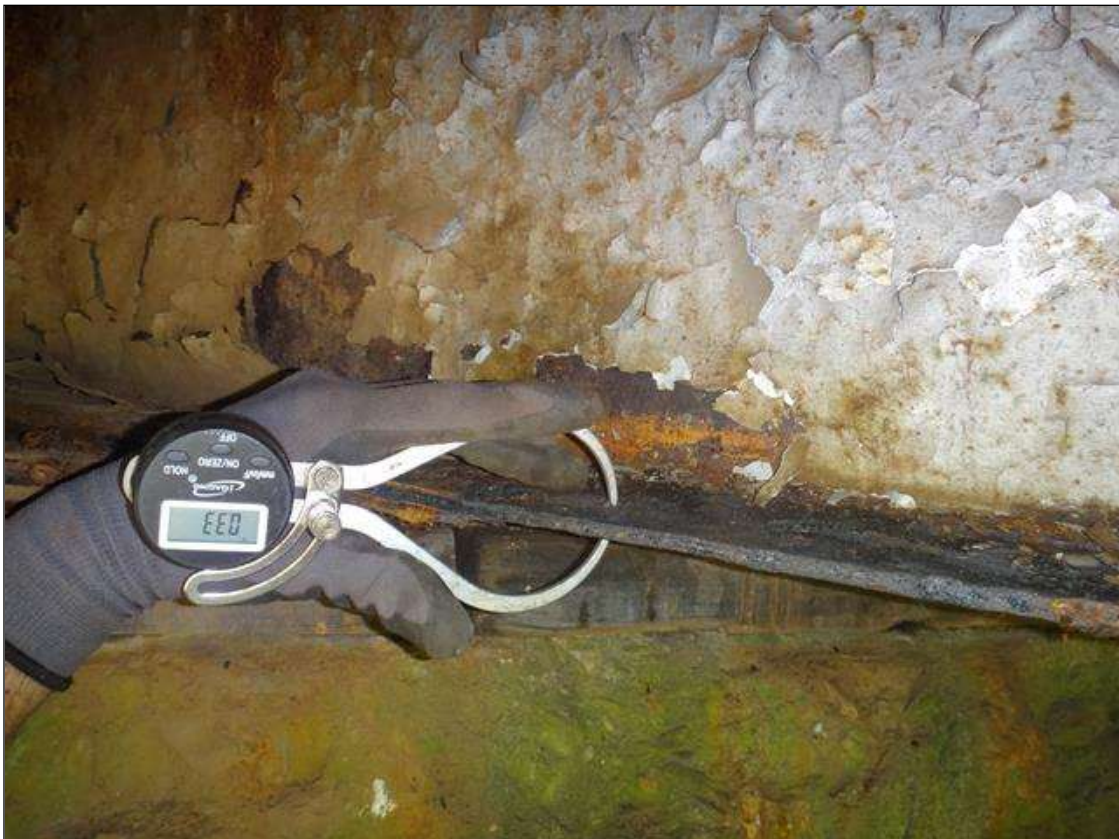
Span 2 Beam 7: (PM) bottom flange at end bent 2, rust scale with section loss (2ft x full width) (0.33in avg rem)

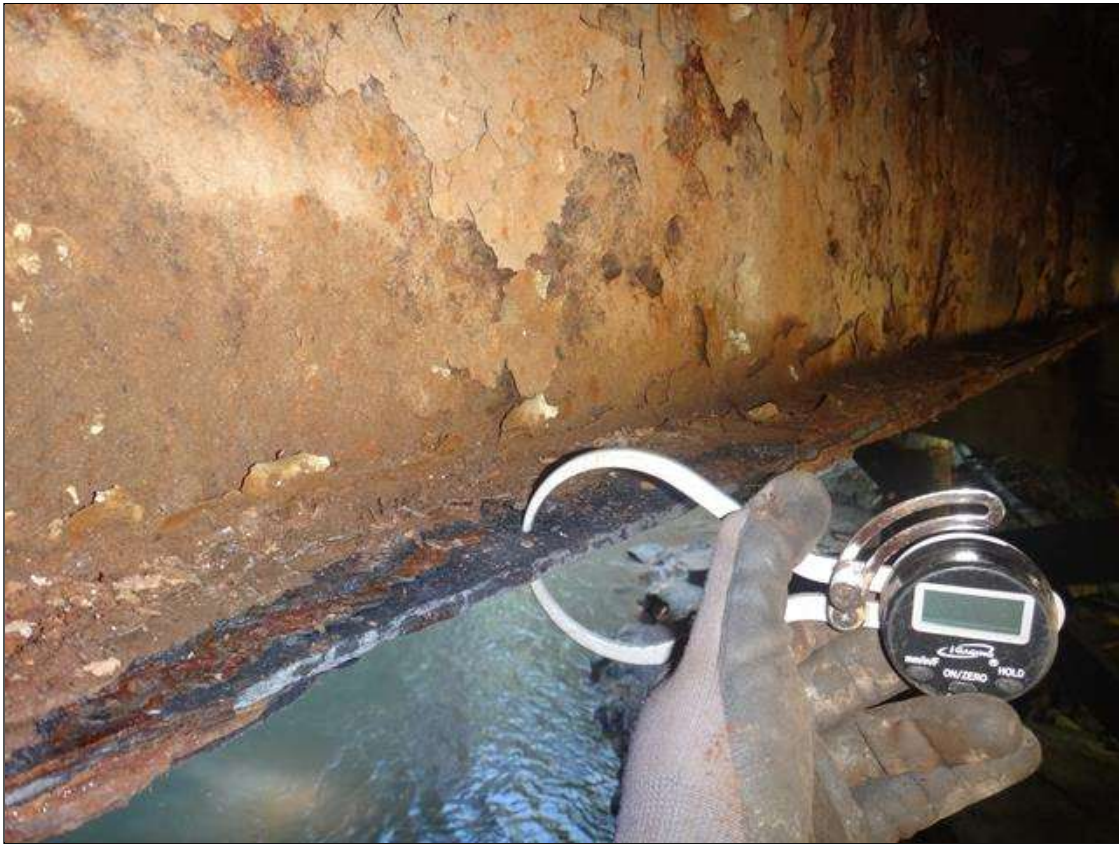
Span 2 Beam 7: (PM) bottom flange near midspan, rust scale with section loss (12ft x full width) (0.32in avg rem)

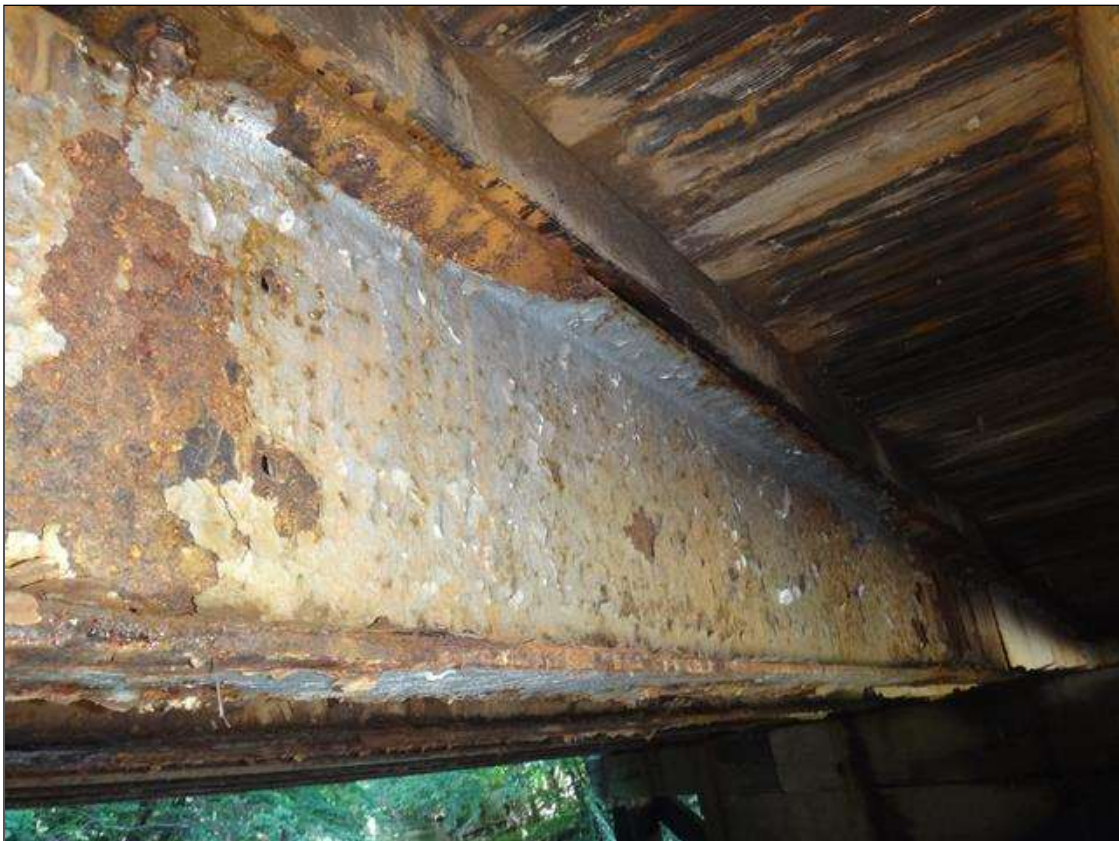
Span 2 Beam 6: both flanges and web, scattered paint failure with rust scale (full length x full width) on flanges, and (full length x up to full height) on web

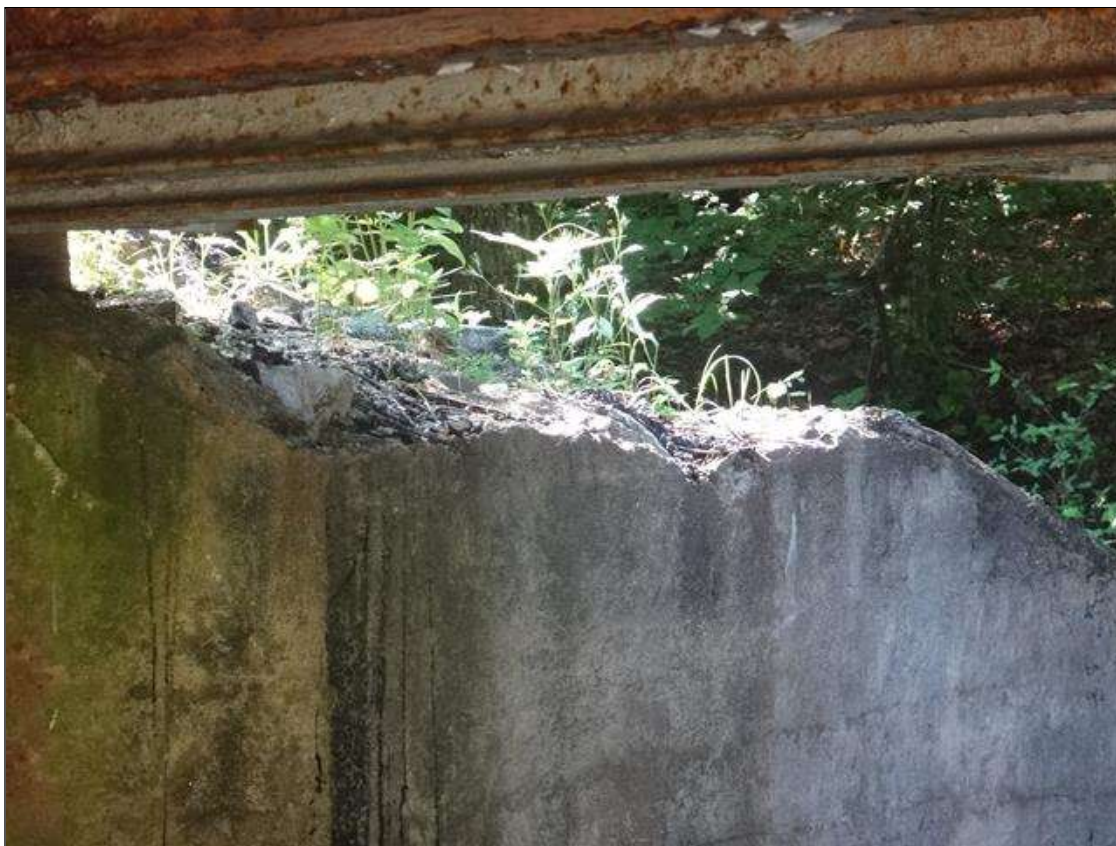
End Bent 2 Abutment/Backwall : top of northeast wingwall, spall (4ft x full width x 4in)
