NC DEPARTMENT OF TRANSPORTATION  
DIVISION OF HIGHWAYS  
STRUCTURE MANAGEMENT UNIT

## Structure Safety Report

### Routine Element Inspection

COUNTY: MITCHELL STRUCTURE NUMBER: 600207 FREQUENCY: 24 MONTHS

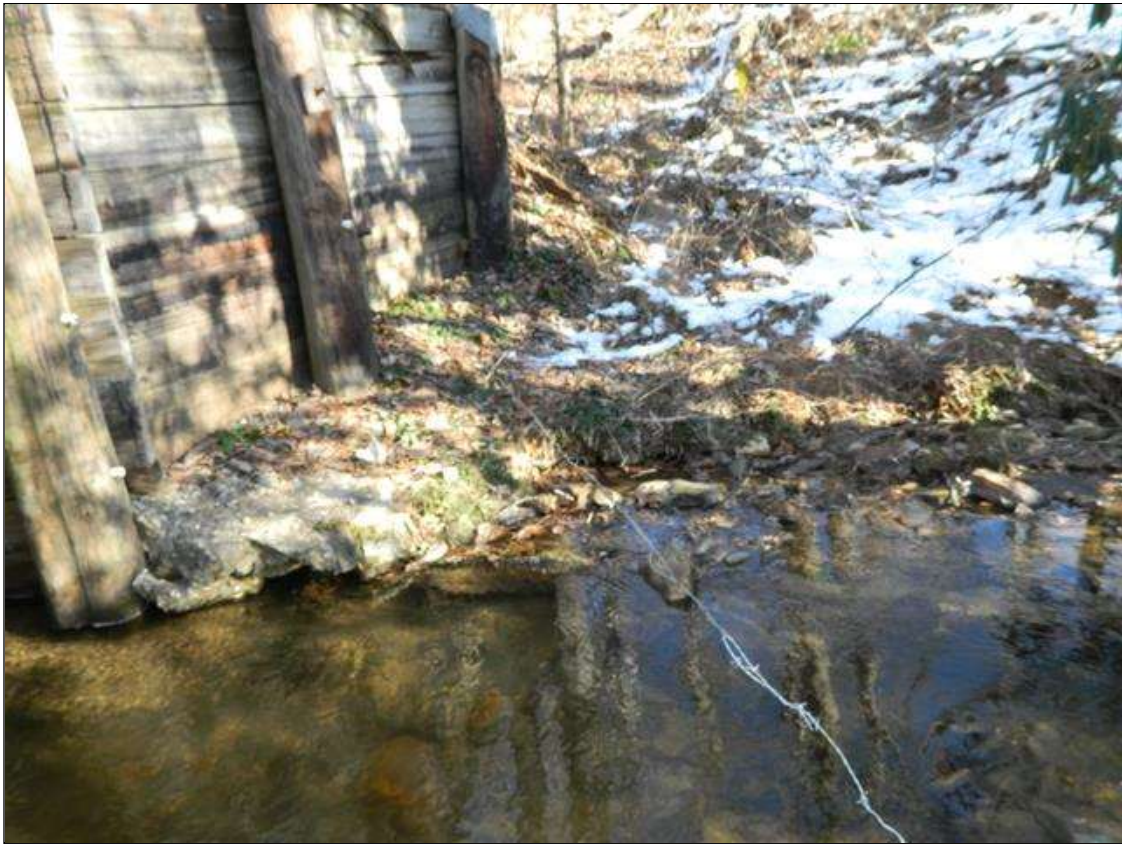
ELECTRIC FENCE ATTACHED TO DOWNSTREAM END OF THE BRIDGE.

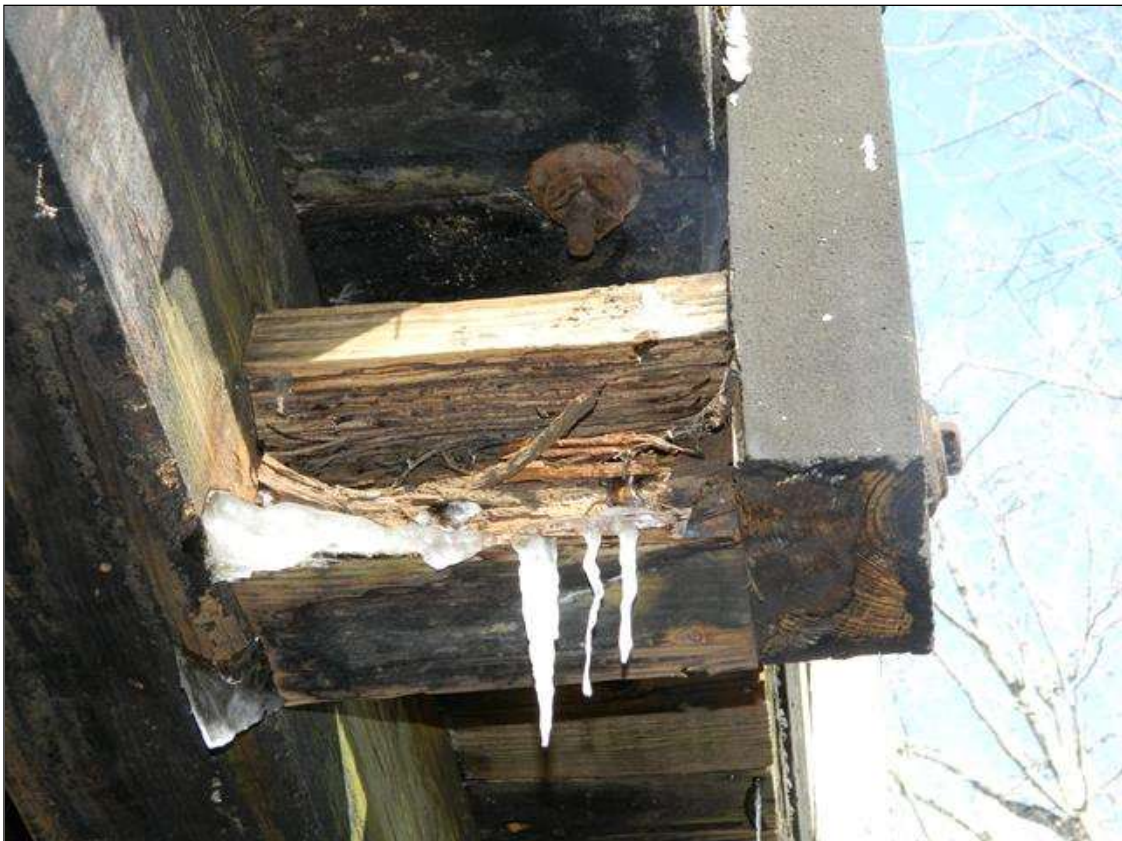
| Element Number | Defect Type | Defect Description | CS | CS Qty | Maint Qty |
|---|---|---|---|---|---|
| 332 | Decay/Section Loss | POST BLOCK W HAS 2" HIGH X 2" WIDE X 2" DEEP DECAY. | 3 | 1 | 1 Feet |

Span 1 Right Bridge Rail: POST BLOCK W HAS 2" HIGH X 2" WIDE X 2" DEEP DECAY.

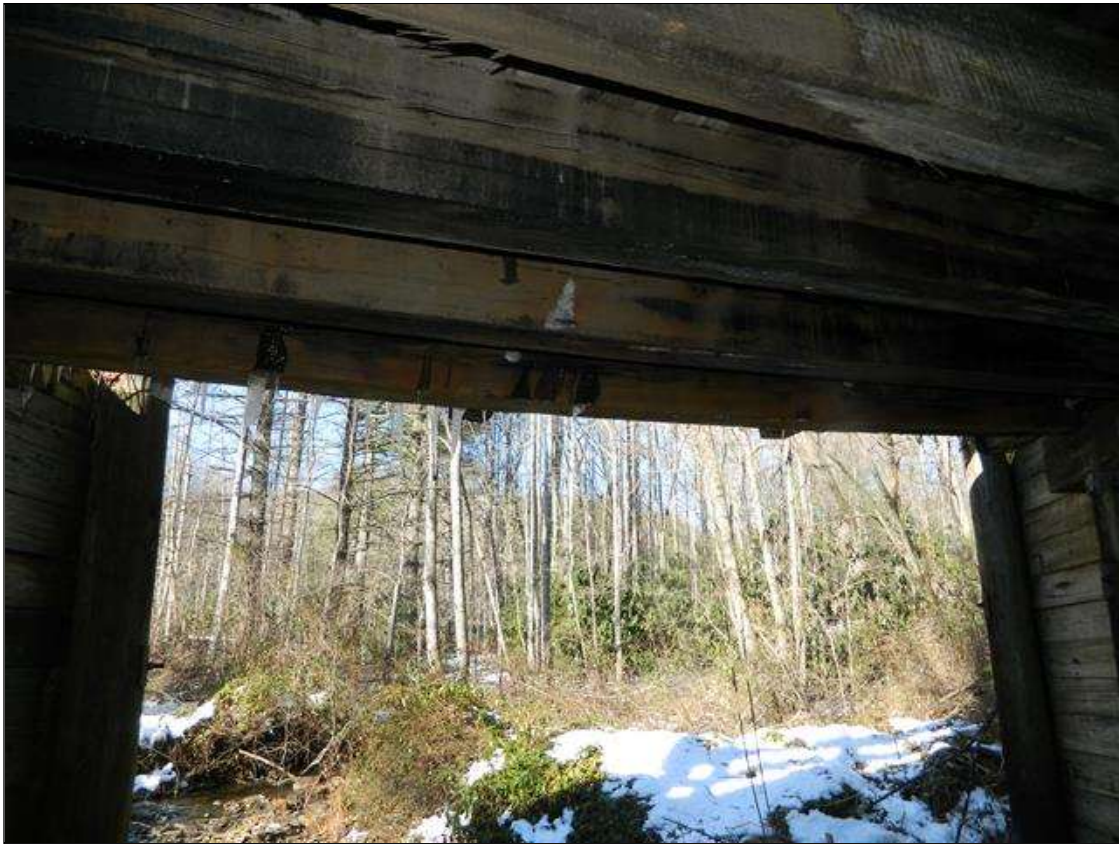
| Element Number | Defect Type | Defect Description | CS | CS Qty | Maint Qty | |
|---|---|---|---|---|---|---|
| 111 | Split/Delamination (Timber) | MULTIPLE SPLITS / DELAMINATIONS UP TO 4' LONG AND BETWEEN 4" - 6" FROM THE TOP OF THE JOISTS. WATER IS EMANATING FROM THE SPLITS AND WAS FROZEN AT THE TIME OF INSPECTION. JOIST IS SAGGING 0.75" AT MIDSPAN. A PRIORITY MAINTENANCE IS REQUESTED. | 4 | 19 | 19 | Feet |

Span 1 Beam 1: MULTIPLE SPLITS / DELAMINATIONS UP TO 4' LONG AND BETWEEN 4" - 6" FROM THE TOP OF THE JOISTS. WATER IS EMANATING FROM THE SPLITS AND WAS FROZEN AT THE TIME OF INSPECTION. JOIST IS SAGGING 0.75" AT MIDSPAN. A PRIORITY MAINTENANCE IS REQUESTED.

| MMS Code | Description of Function | Unit | Quantity | Remarks | Est. Cost |
|---|---|---|---|---|---|
| 3304 | Maintain/Replace Timber Superstructure Components | LF | 19 | Span 1 Beam 1: MULTIPLE SPLITS / DELAMINATIONS UP TO 4' LONG AND BETWEEN 4" - 6" FROM THE TOP OF THE JOISTS. WATER IS EMANATING FROM THE SPLITS AND WAS FROZEN AT THE TIME OF INSPECTION. JOIST IS SAGGING 0.75" AT MIDSPAN. A PRIORITY MAINTENANCE IS REQUESTED. | |

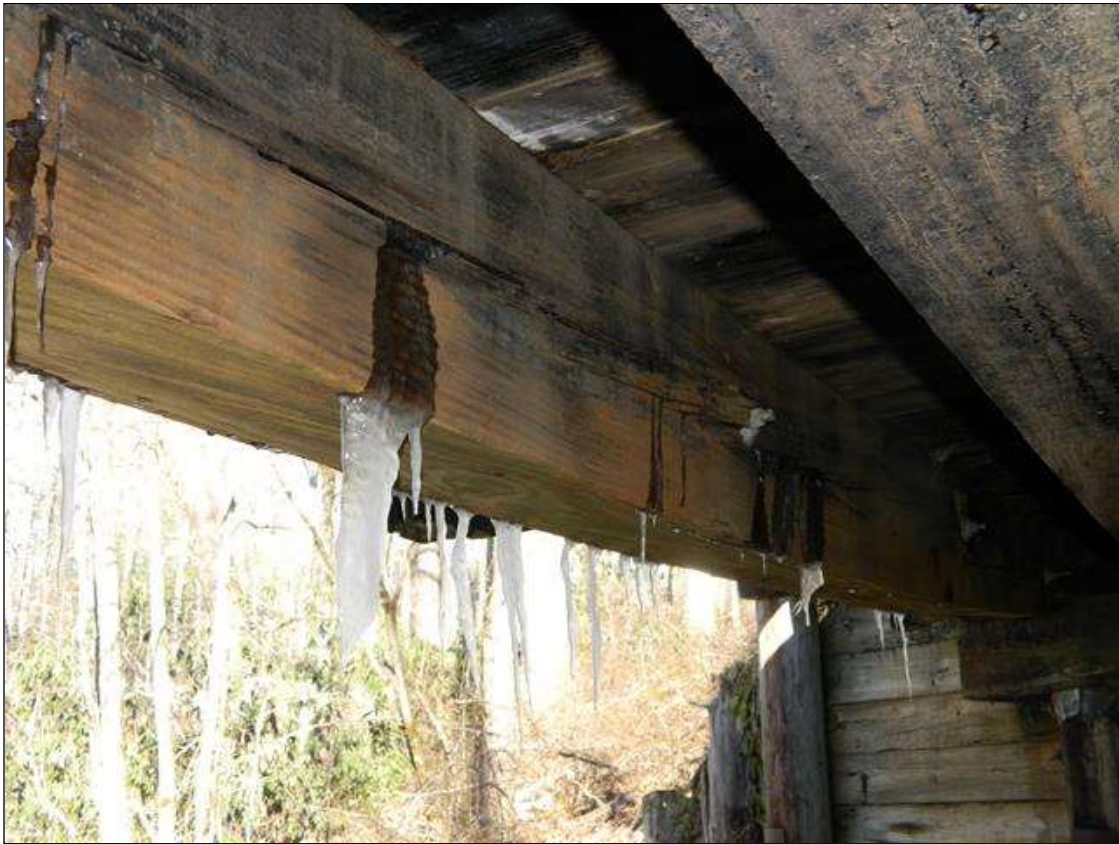
Span 1 Beam 1: MULTIPLE SPLITS / DELAMINATIONS UP TO 4' LONG AND BETWEEN 4" - 6" FROM THE TOP OF THE JOISTS. WATER IS EMANATING FROM THE SPLITS AND WAS FROZEN AT THE TIME OF INSPECTION. JOIST IS SAGGING 0.75" AT MIDSPAN. A PRIORITY MAINTENANCE IS REQUESTED.

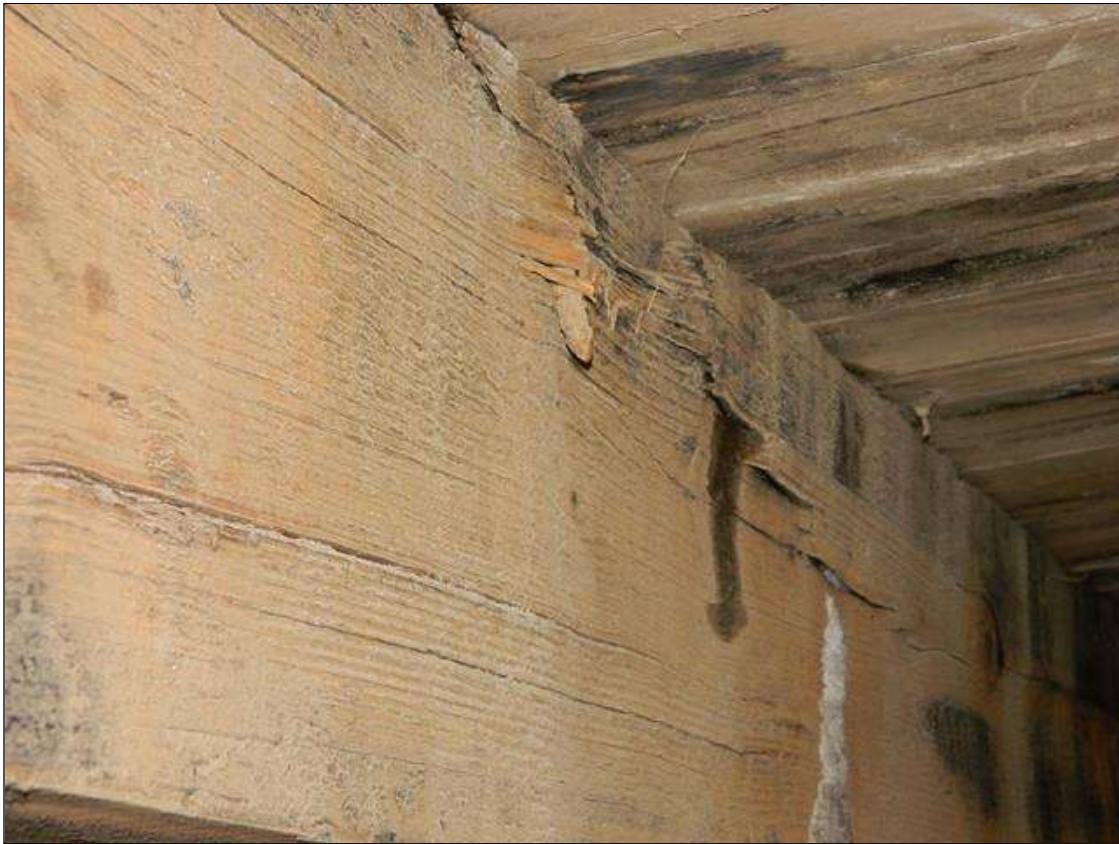
| Element Number | Defect Type | Defect Description | CS | CS Qty | Maint Qty | |
|---|---|---|---|---|---|---|
| 111 | Split/Delamination (Timber) | 2.5' LONG X 5" HIGH DELAMINATION IN THE TOP OF THE JOIST, RIGHT FACE AT 5.5' FROM THE NEAR END. DELAMINATED AREA IS BULGING OUT 0.75". A PRIORITY MAINTENANCE IS REQUESTED. | 4 | 3 | 3 | Feet |

Span 1 Beam 2: 2.5' LONG X 5" HIGH DELAMINATION IN THE TOP OF THE JOIST, RIGHT FACE AT 5.5' FROM THE NEAR END. DELAMINATED AREA IS BULGING OUT 0.75". A PRIORITY MAINTENANCE IS REQUESTED.

| MMS Code | Description of Function | Unit | Quantity | Remarks | Est. Cost |
|---|---|---|---|---|---|
| 3304 | Maintain/Replace Timber Superstructure Components | LF | 3 | Span 1 Beam 2: 2.5' LONG X 5" HIGH DELAMINATION IN THE TOP OF THE JOIST, RIGHT FACE AT 5.5' FROM THE NEAR END. DELAMINATED AREA IS BULGING OUT 0.75". A PRIORITY MAINTENANCE IS REQUESTED. | |

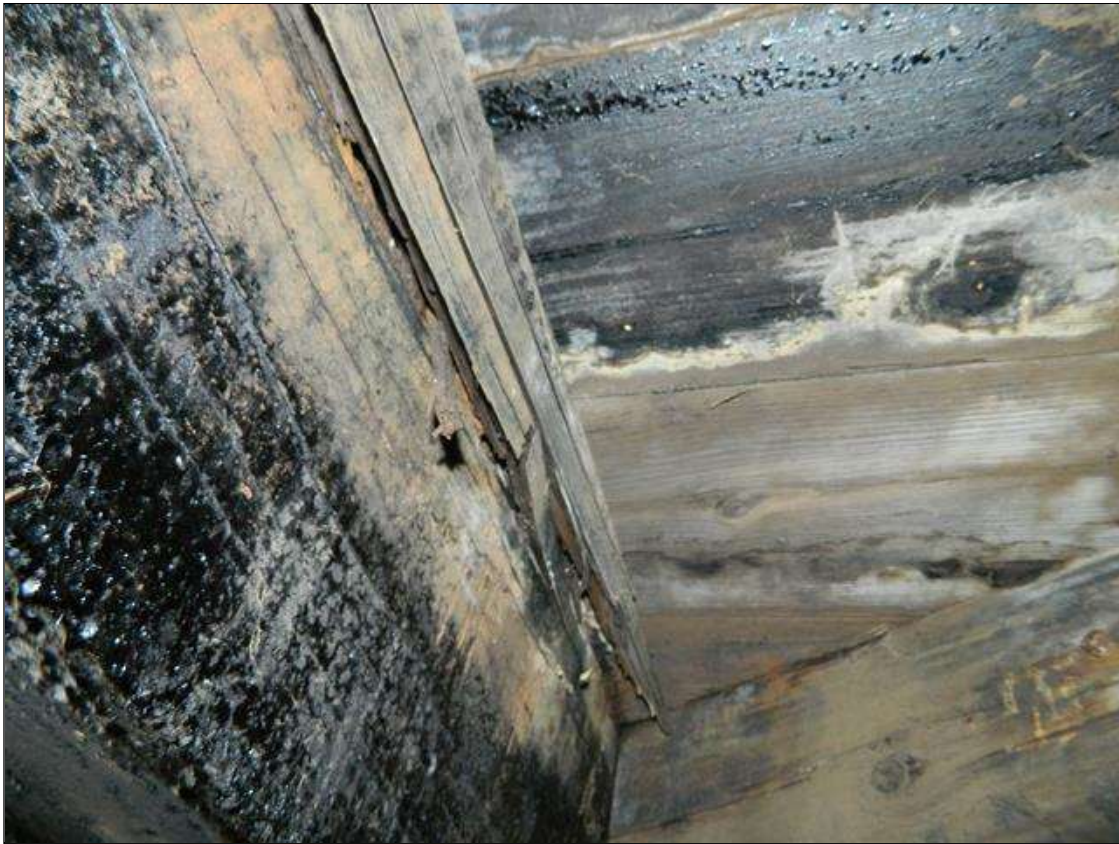
| Element Number | Defect Type | Defect Description | CS | CS Qty | Maint Qty | |
|---|---|---|---|---|---|---|
| 111 | Split/Delamination (Timber) | 9' LONG X 5" HIGH DELAMINATED AREA AT THE TOP OF THE JOIST, BOTH FACES, BEGINNING AT THE NEAR END OF THE JOIST. THE DELAMINATED AREA IS CRUSHING / BULGING OUT UP TO 1". A PRIORITY MAINTENANCE IS REQUESTED. | 4 | 9 | 9 | Feet |

Span 1 Beam 3: 9' LONG X 5" HIGH DELAMINATED AREA AT THE TOP OF THE JOIST, BOTH FACES, BEGINNING AT THE NEAR END OF THE JOIST. THE DELAMINATED AREA IS CRUSHING / BULGING OUT UP TO 1". A PRIORITY MAINTENANCE IS REQUESTED.

| MMS Code | Description of Function | Unit | Quantity | Remarks | Est. Cost |
|---|---|---|---|---|---|
| 3304 | Maintain/Replace Timber Superstructure Components | LF | 9 | Span 1 Beam 3: 9' LONG X 5" HIGH DELAMINATED AREA AT THE TOP OF THE JOIST, BOTH FACES, BEGINNING AT THE NEAR END OF THE JOIST. THE DELAMINATED AREA IS CRUSHING / BULGING OUT UP TO 1". A PRIORITY MAINTENANCE IS REQUESTED. | |

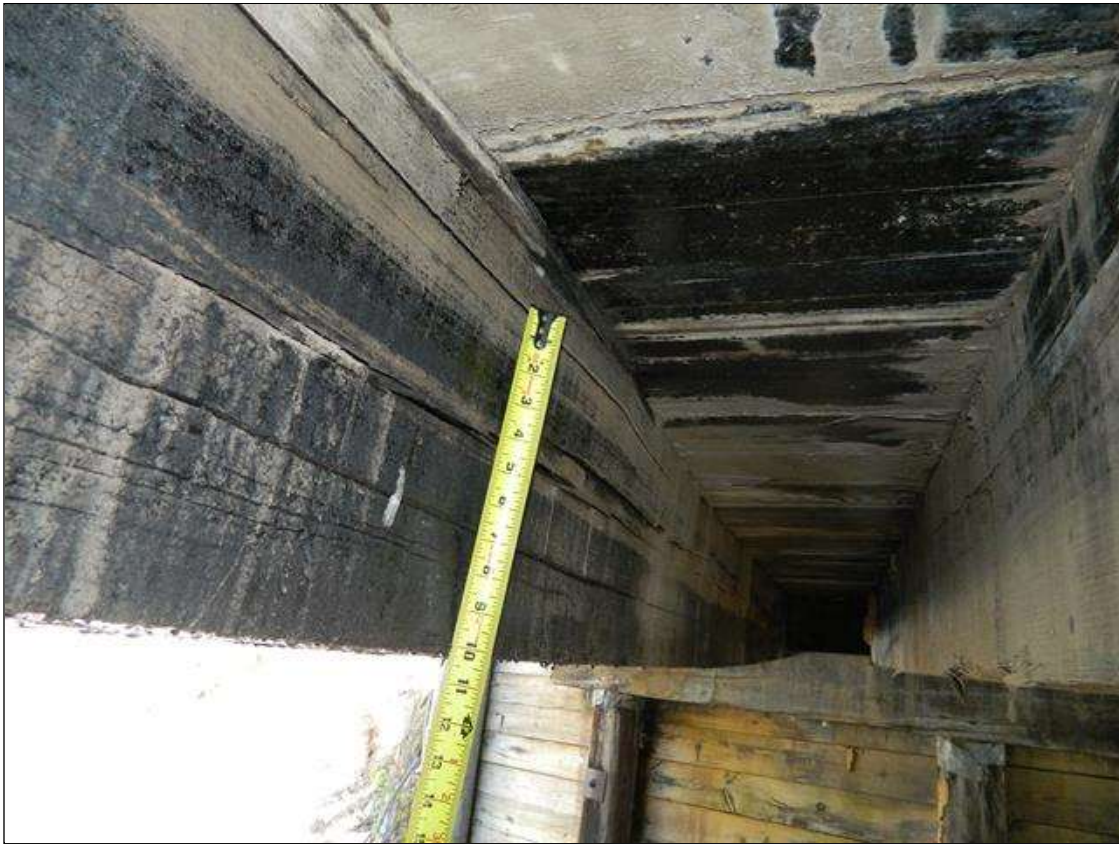
Span 1 Beam 3: 9' LONG X 5" HIGH DELAMINATED AREA AT THE TOP OF THE JOIST, BOTH FACES, BEGINNING AT THE NEAR END OF THE JOIST. THE DELAMINATED AREA IS CRUSHING / BULGING OUT UP TO 1". A PRIORITY MAINTENANCE IS REQUESTED.

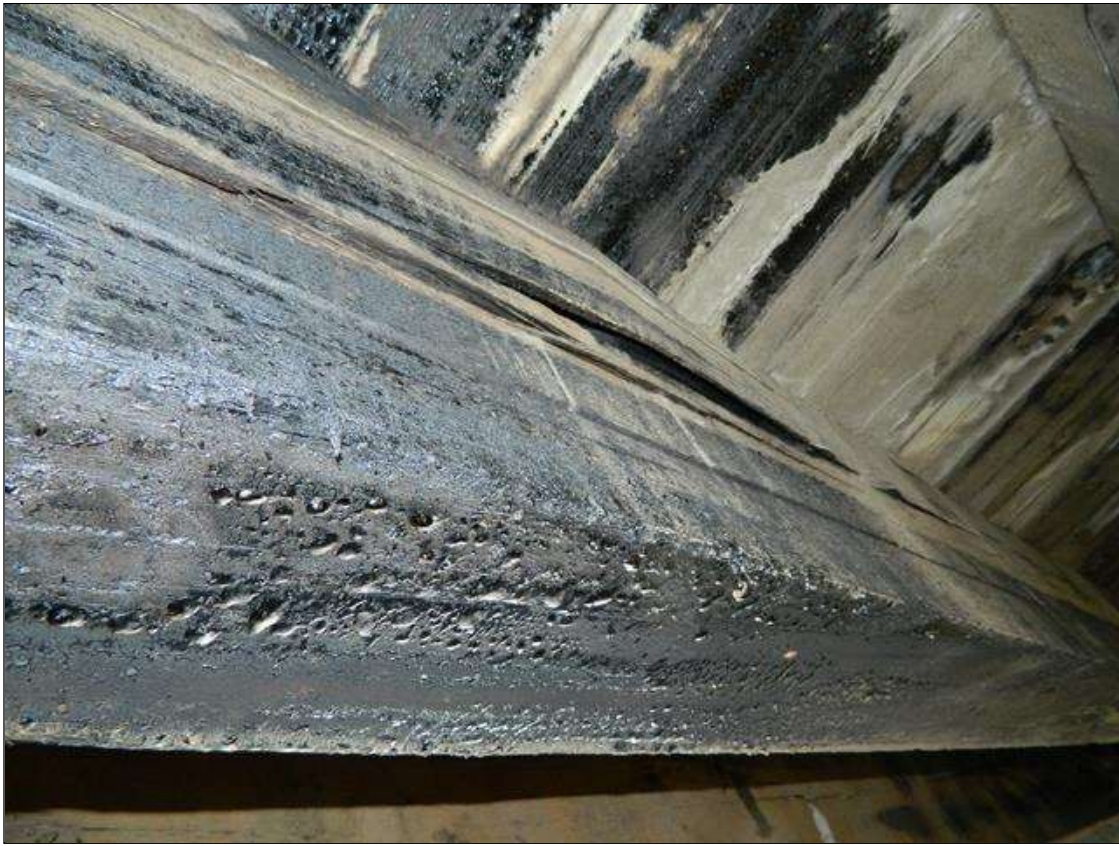
Span 1 Beam 3: 9' LONG X 5" HIGH DELAMINATED AREA AT THE TOP OF THE JOIST, BOTH FACES, BEGINNING AT THE NEAR END OF THE JOIST. THE DELAMINATED AREA IS CRUSHING / BULGING OUT UP TO 1". A PRIORITY MAINTENANCE IS REQUESTED.

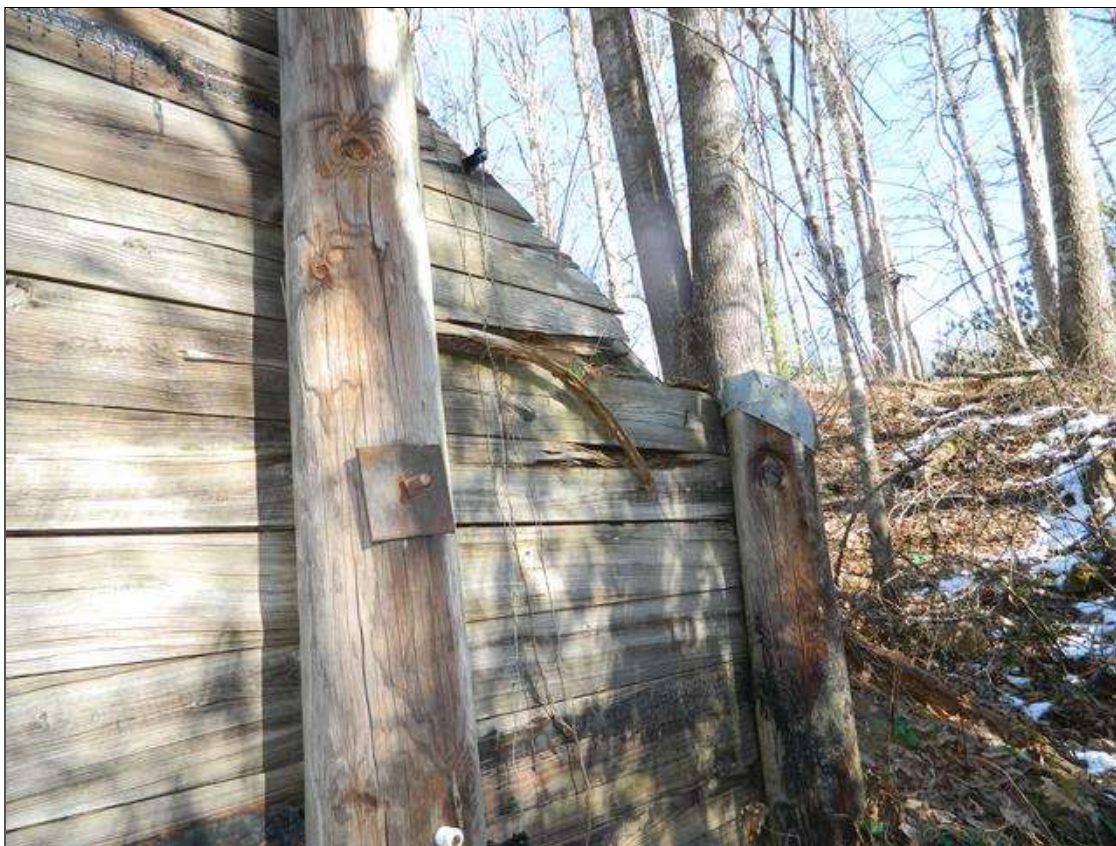
NORTH EAST WINGWALL: TIMBERS ARE SOFT WITH AREAS OF DECAY UP TO 0.5" DEEP. 3' WIDE X 1' LONG  
COMPLETE DECAY AT THE TOP END OF THE WALL.

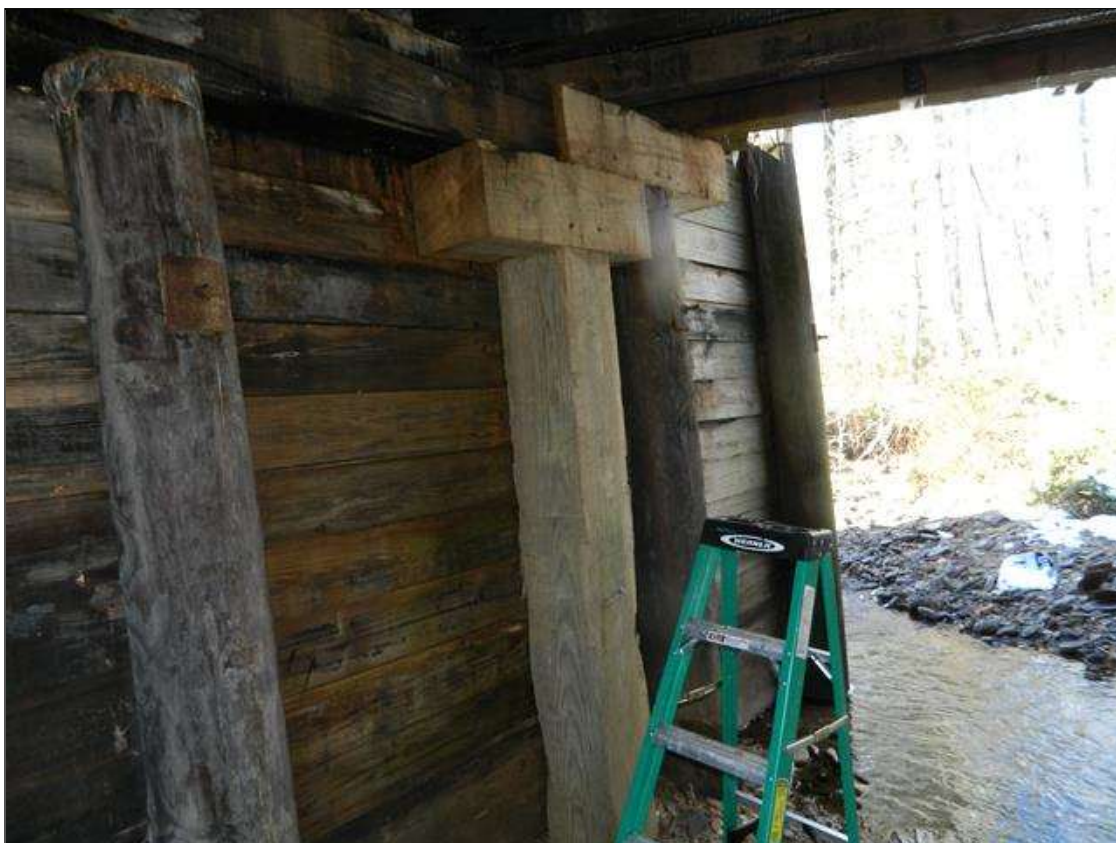
TEMPORARY REPAIR MADE TO END BENT 1.

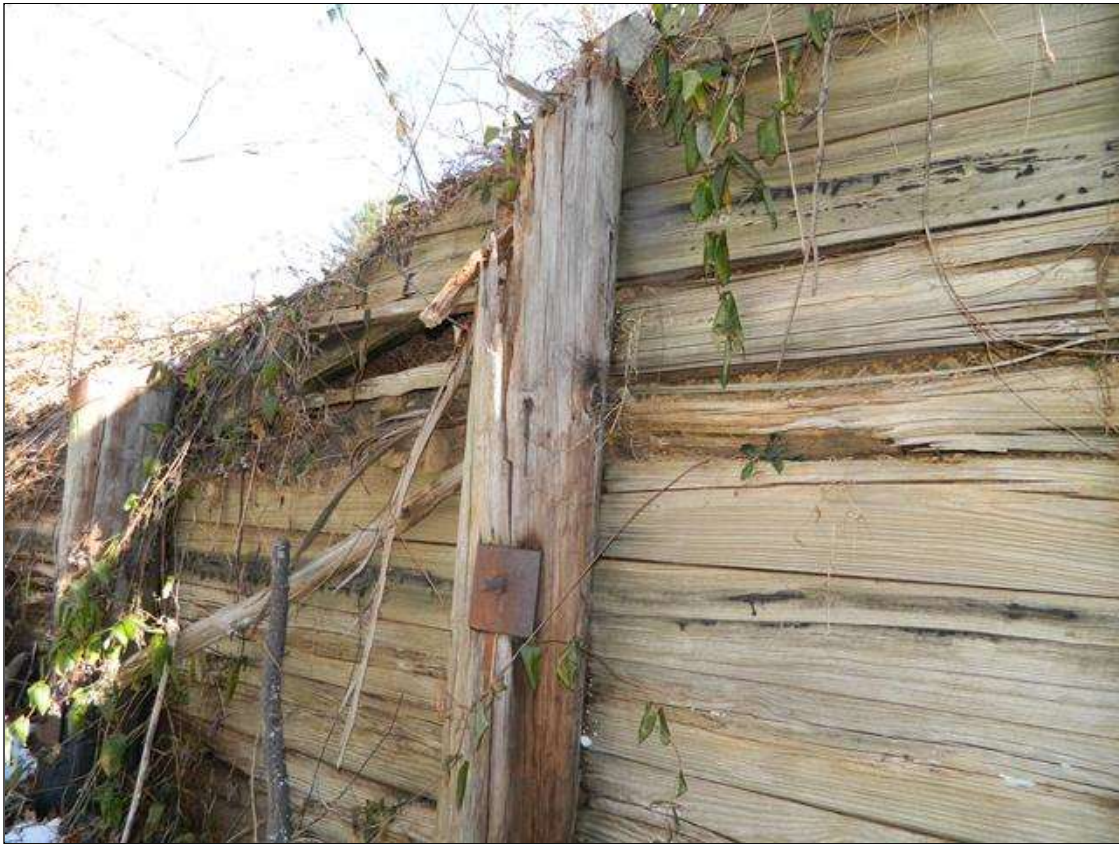
NORTH WEST WINGWALL: TIMBERS ARE SATURATED AND SOFT WITH DECAY UP TO 0.5" DEEP THROUGHOUT. 8' LONG X 3' HIGH COMPLETE DECAY AT 6' FROM THE BOTTOM OF THE WALL. A PRIORITY MAINTENANCE IS REQUESTED.

| MMS Code | Description of Function | Unit | Quantity | Remarks | Est. Cost |
|---|---|---|---|---|---|
| 3346 | Repair / Maintain Timber Wings & Blkhds | SF | 24 | NORTH WEST WINGWALL: TIMBERS ARE SATURATED AND SOFT WITH DECAY UP TO 0.5" DEEP THROUGHOUT. 8' LONG X 3' HIGH COMPLETE DECAY AT 6' FROM THE BOTTOM OF THE WALL. A PRIORITY MAINTENANCE IS REQUESTED. | |

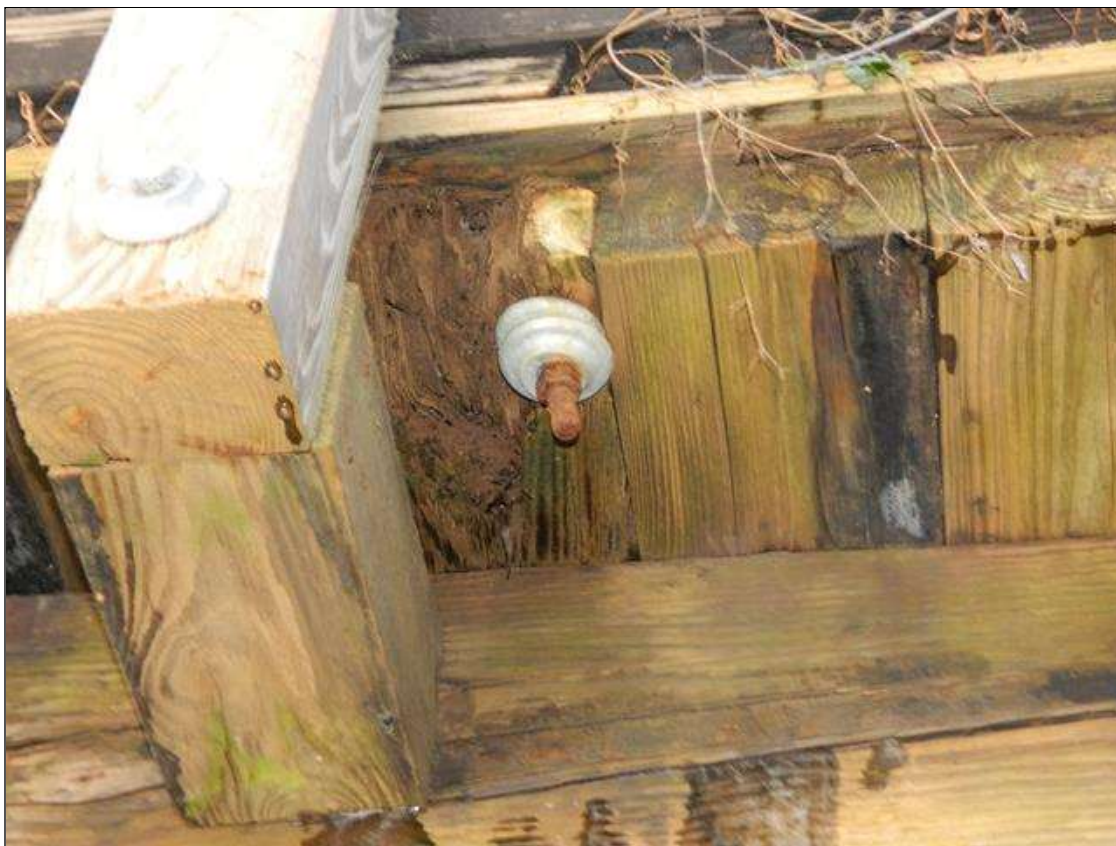
| Element Number | Defect Type | Defect Description | CS | CS Qty | Maint Qty | |
|---|---|---|---|---|---|---|
| 31 | Decay/Section Loss | DECAY IN THE ENDS OF THE FLOORING UP TO 3" DEEP. | 3 | 40 | 40 | Square Feet |

Span 1 Deck: DECAY IN THE ENDS OF THE FLOORING UP TO 3" DEEP.

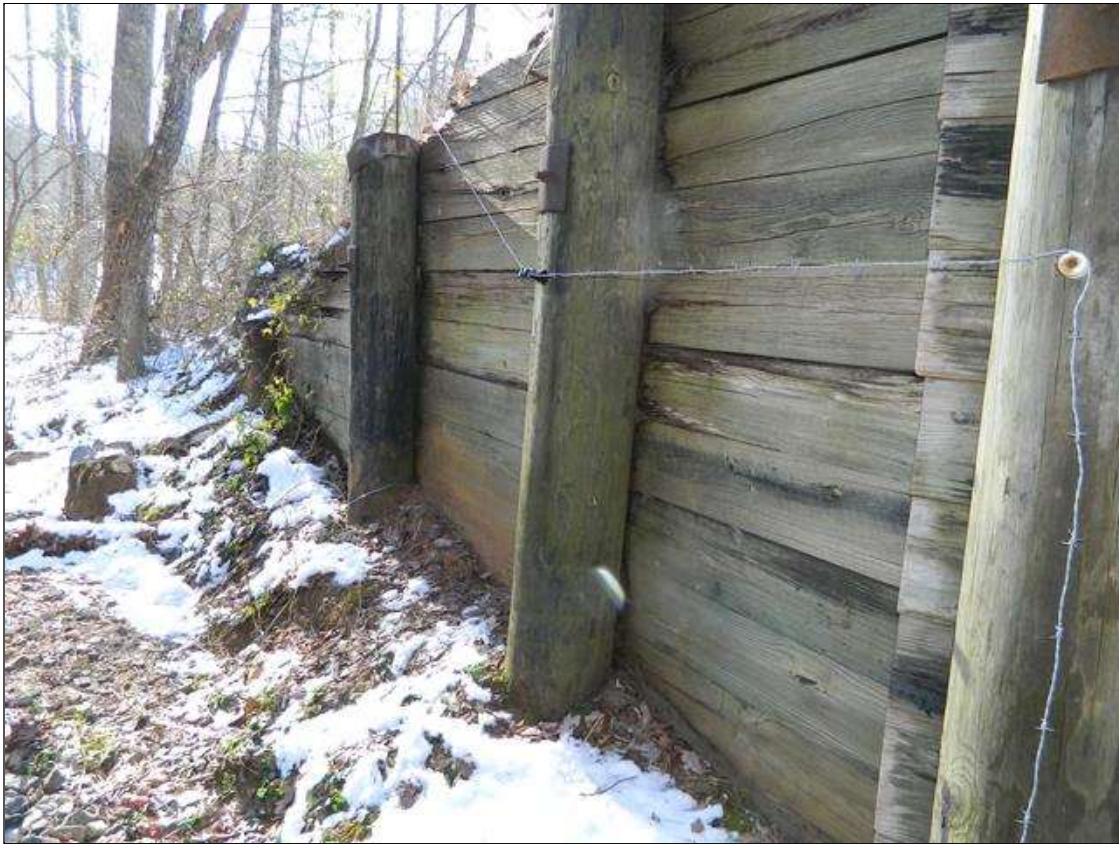
SOUTH EAST WINGWALL: TIMBERS ARE SATURATED AND SOFT, WITH MULTIPLE AREAS OF 0.5" DEEP DECAY. THE SOUTH WEST WINGWALL IS SIMILAR.

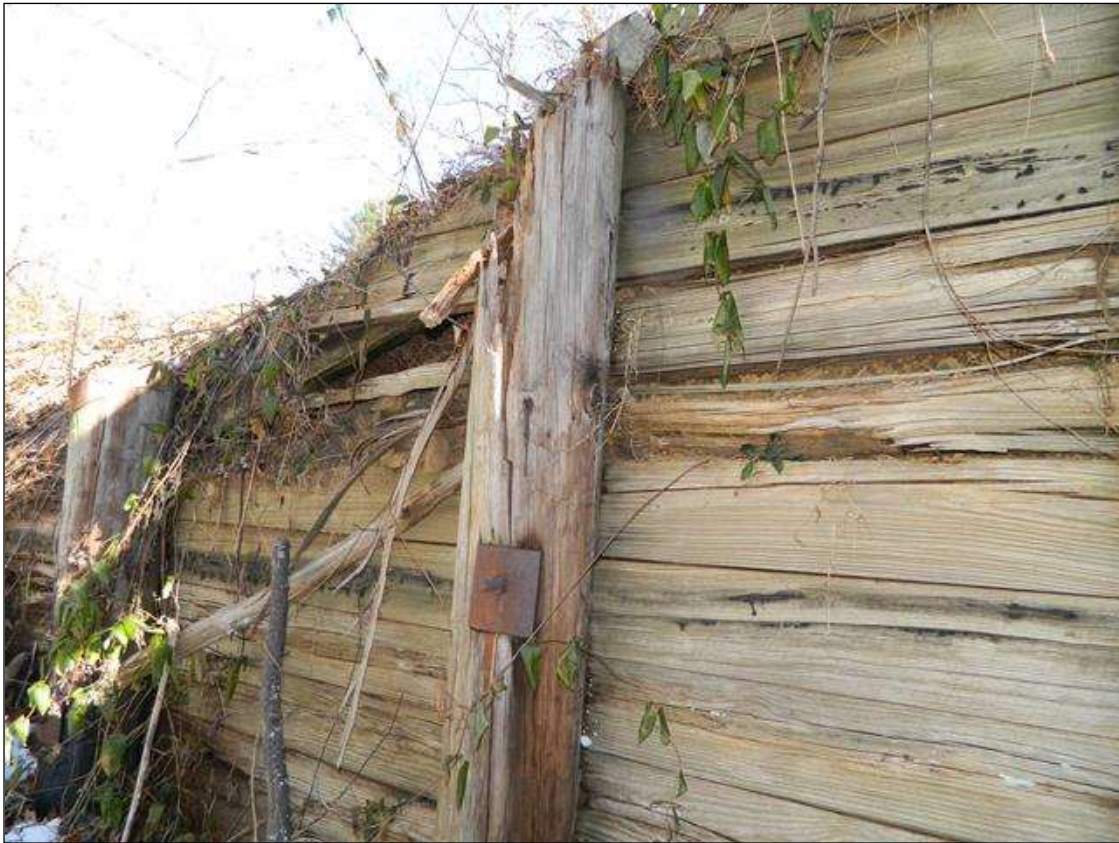
NORTH WEST WINGWALL: TIMBERS ARE SATURATED AND SOFT WITH DECAY UP TO 0.5" DEEP THROUGHOUT. 8' LONG X 3' HIGH COMPLETE DECAY AT 6' FROM THE BOTTOM OF T
