NC DEPARTMENT OF TRANSPORTATION

# Structure Safety Report

## Routine Element Inspection

DIVISION: 13 COUNTY: BUNCOMBE STRUCTURE NUMBER: 100536 FREQUENCY: 24 MONTHS

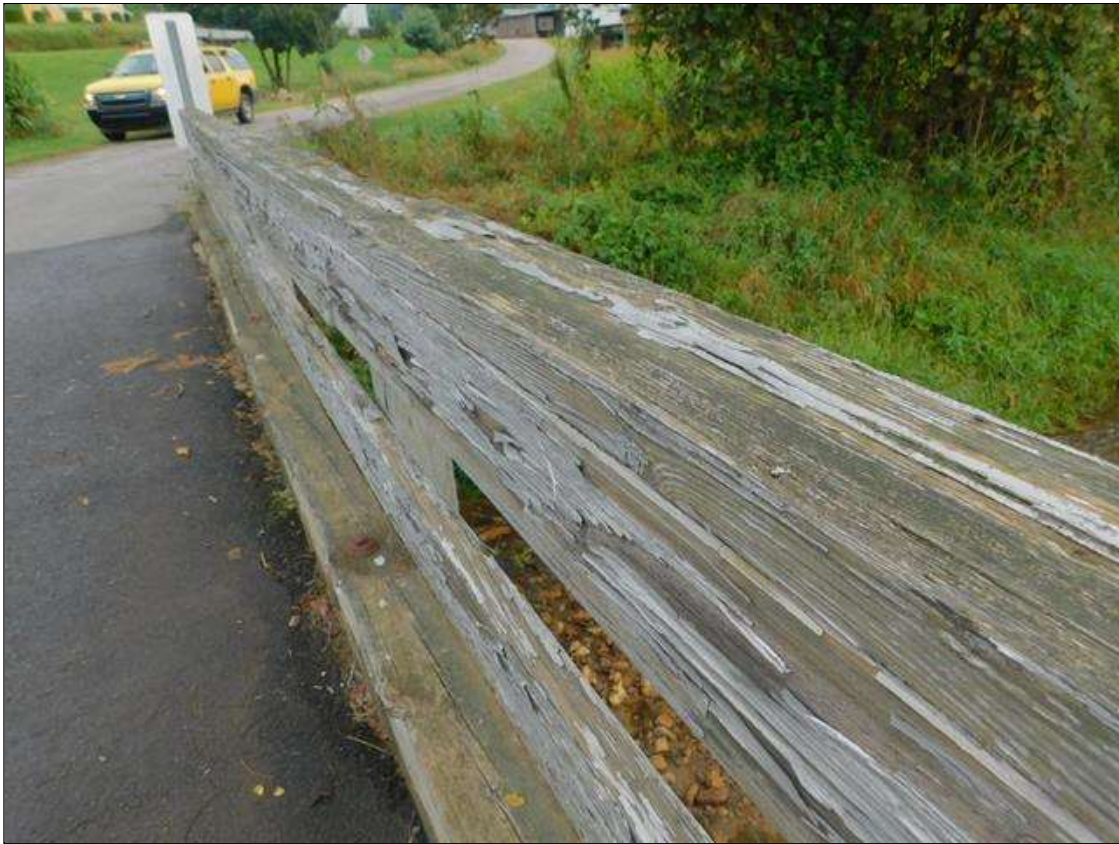
| Element Number | Defect Type | Defect Description | CS | CS Qty | Maint Qty | |
|---|---|---|---|---|---|---|
| 332 | Decay/Section Loss | WEATHERED WITH MULTIPLE CHECKS/SHAKES. DECAY UP TO 0.125" DEEP SCATTERED THROUGHOUT. | 2 | 31 | | Feet |

Span 1 Right Bridge Rail: WEATHERED WITH MULTIPLE CHECKS/SHAKES. DECAY UP TO 0.125" DEEP SCATTERED THROUGHOUT.

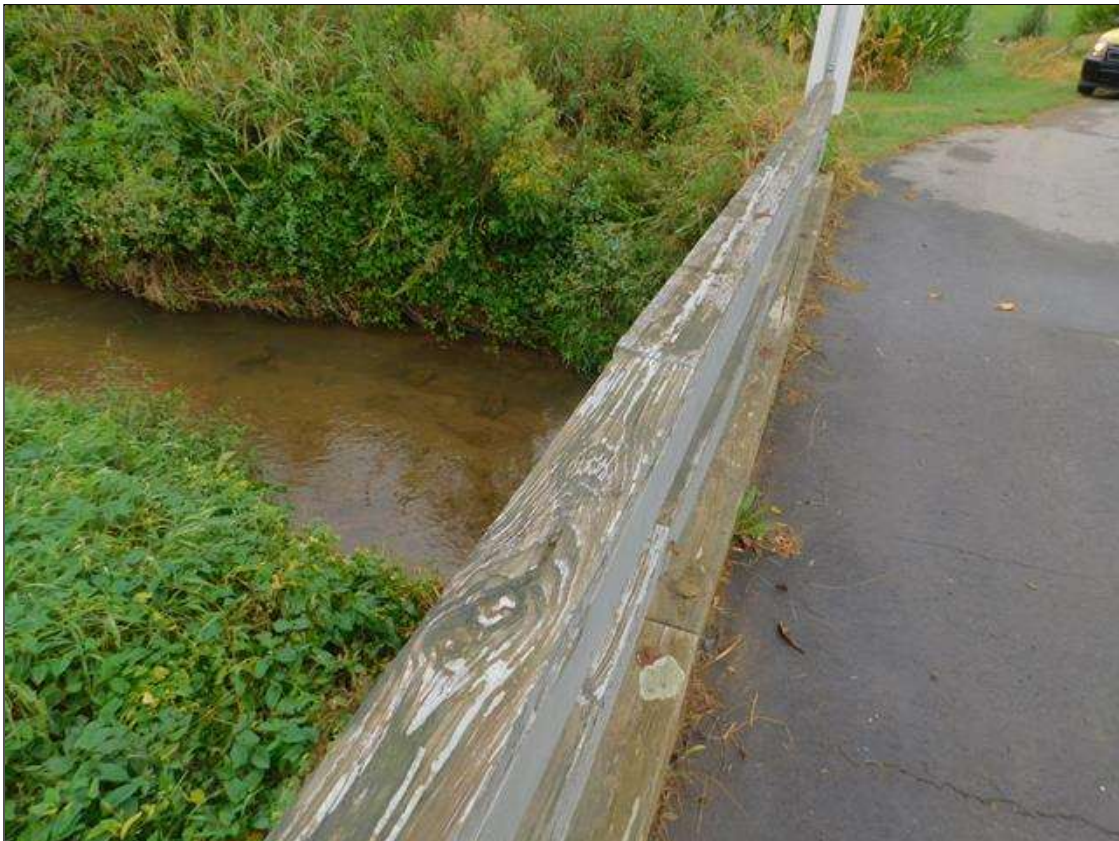
| Element Number | Defect Type | Defect Description | CS | CS Qty | Maint Qty | |
|---|---|---|---|---|---|---|
| 332 | Check/Shake | WEATHERED WITH MULTIPLE CHECKS/SHAKES, ESPECIALLY IN THE TOP RAIL. | 2 | 31 | | Feet |

Span 1 Left Bridge Rail: WEATHERED WITH MULTIPLE CHECKS/SHAKES, ESPECIALLY IN THE TOP RAIL.

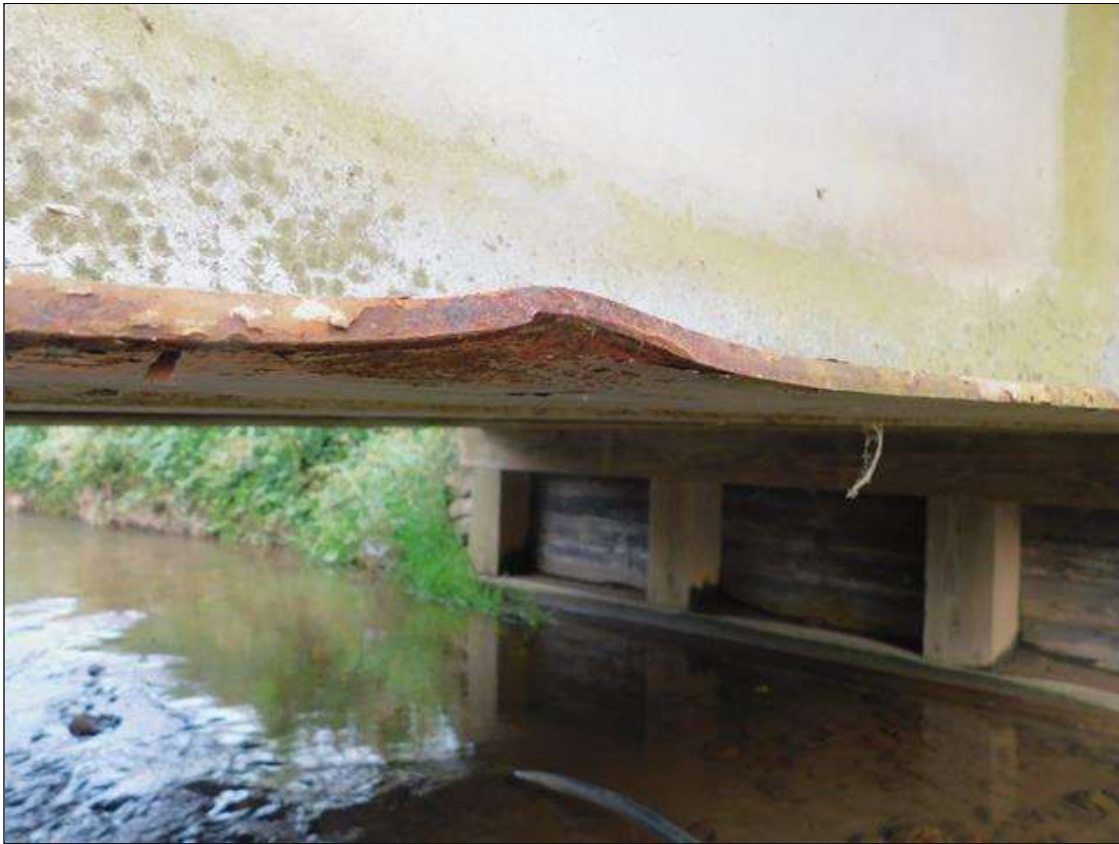
| Element Number | Defect Type | Defect Description | CS | CS Qty | Maint Qty | |
|---|---|---|---|---|---|---|
| 107 | Distortion | 6" WIDE X 0.75" HIGH UPWARD BEND IN THE RIGHT HALF OF THE BOTTOM FLANGE AT MIDSPAN. | 3 | 1 | 1 | Feet |

Span 1 Beam 11: 6" WIDE X 0.75" HIGH UPWARD BEND IN THE RIGHT HALF OF THE BOTTOM FLANGE AT MIDSPAN.

| MMS Code | Element Name | Defect Name | Recommended Quantity |
|---|---|---|---|
| 3314 | Steel Open Girder/Beam | Distortion | 1 Feet |

| Location | MMS Code | Description | Maint Quantity | Total Quantity | Severe Quantity | Poor Quantity | Fair Quantity | Good Quantity |
|---|---|---|---|---|---|---|---|---|
| Beam | 3314 | Maintenance Steel Superstructure Components | 1 | 341 | 0 | 1 | 340 | 0 |

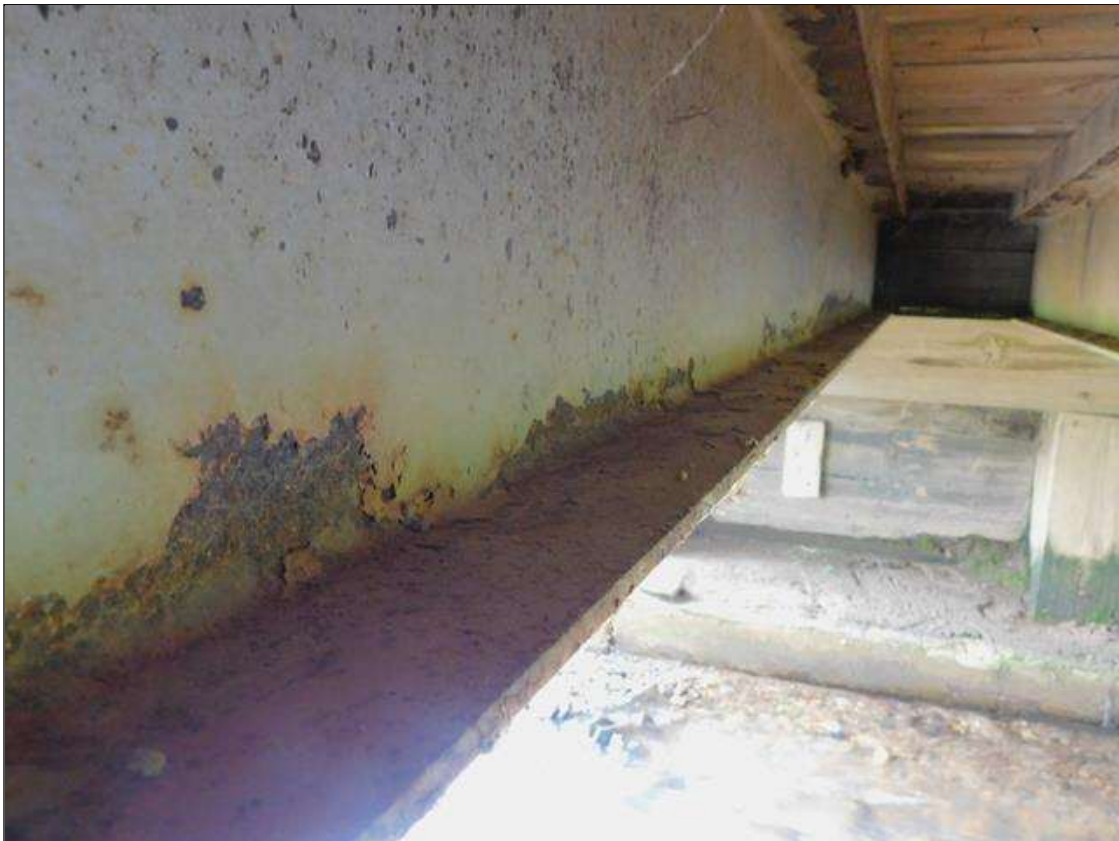
| Element Number | Defect Type | Defect Description | CS | CS Qty | Maint Qty |
|---|---|---|---|---|---|
| 107 | Corrosion | LOSS OF PAINT ALLOWING SURFACE CORROSION MAINLY ALONG THE TOP FLANGE AND SCATTERED ALONG THE EDGES OF THE BOTTOM FLANGE. | 2 | 31 | Feet |
| 515 | Effectiveness (Steel Protective Coatings) | LOSS OF PAINT ALLOWING SURFACE CORROSION MAINLY ALONG THE TOP FLANGE AND SCATTERED ALONG THE EDGES OF THE BOTTOM FLANGE. | 3 | 139 | 139 Square Feet |

Span 1 Beam 2: LOSS OF PAINT ALLOWING SURFACE CORROSION MAINLY ALONG THE TOP FLANGE AND SCATTERED ALONG THE EDGES OF THE BOTTOM FLANGE.

| MMS Code | Element Name | Defect Name | Recommended Quantity |
|---|---|---|---|
| 3342 | Steel Protective Coating | Effectiveness (Steel Protective Coatings) | 1529 Square Feet |

| Location | MMS Code | Description | Maint Quantity | Total Quantity | Severe Quantity | Poor Quantity | Fair Quantity | Good Quantity |
|---|---|---|---|---|---|---|---|---|
| Beam | 3342 | Clean and Paint Steel | 1529 | 1529 | 0 | 1529 | 0 | 0 |

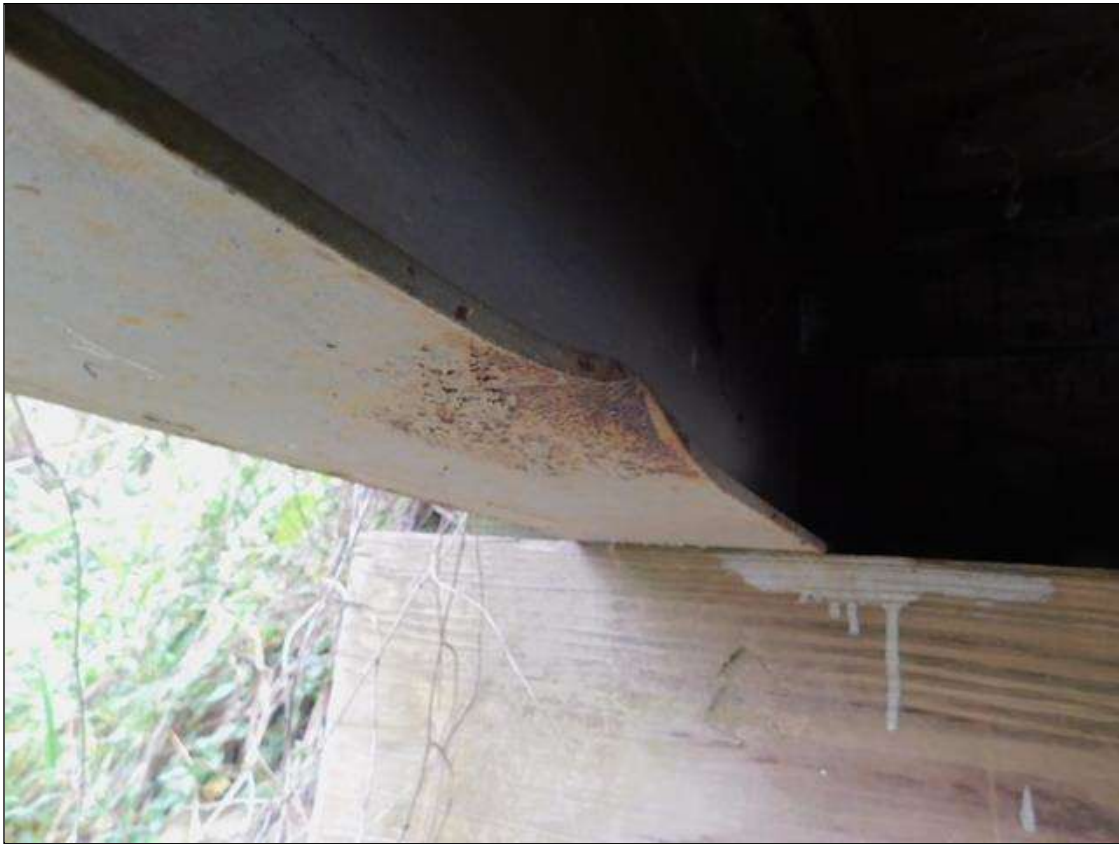
| Element Number | Defect Type | Defect Description | CS | CS Qty | Maint Qty |
|---|---|---|---|---|---|
| 107 | Distortion | RIGHT BOTTOM FLANGE HAS A 2" LONG X 1/2" DEEP UPWARD BEND AT 2' FROM THE END AT END BENT 1. THERE IS A SIMILAR AREA OF DISTORTION IN THE RIGHT BOTTOM FLANGE AT 1' 6" FROM THE END AT END BENT 2. | 2 | 2 | Feet |

Span 1 Beam 1: RIGHT BOTTOM FLANGE HAS A 2" LONG X 1/2" DEEP UPWARD BEND AT 2' FROM THE END AT END BENT 1. THERE IS A SIMILAR AREA OF DISTORTION IN THE RIGHT BOTTOM FLANGE AT 1' 6" FROM THE END AT END BENT 2.

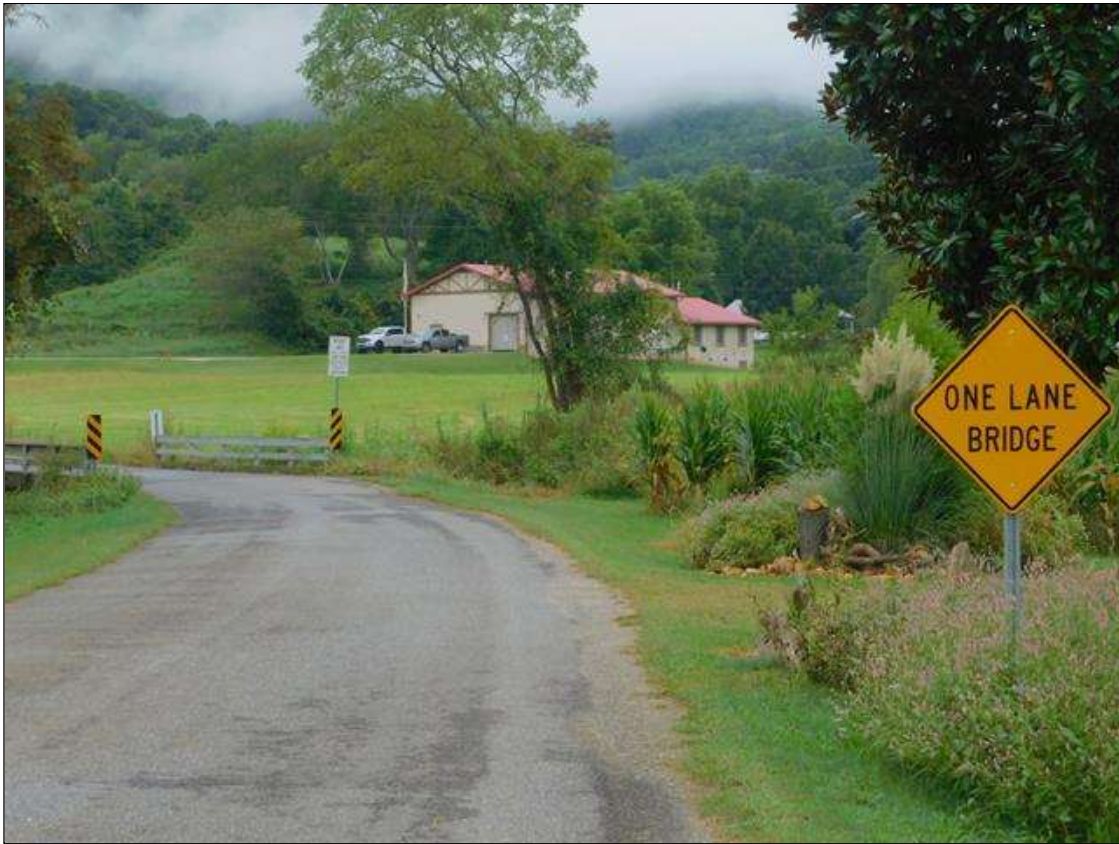
NORTH APPROACH ONE LANE BRIDGE SIGN AT 100' FROM THE BRIDGE END. SOUTH APPROACH SIGN IS AT THE BRIDGE.
