NC DEPARTMENT OF TRANSPORTATION  
DIVISION OF HIGHWAYS  
STRUCTURE MANAGEMENT UNIT

# Structure Safety Report

## Routine Element Inspection

DIVISION: 13 COUNTY: BURKE STRUCTURE NUMBER: 110237 FREQUENCY: 24 MONTHS

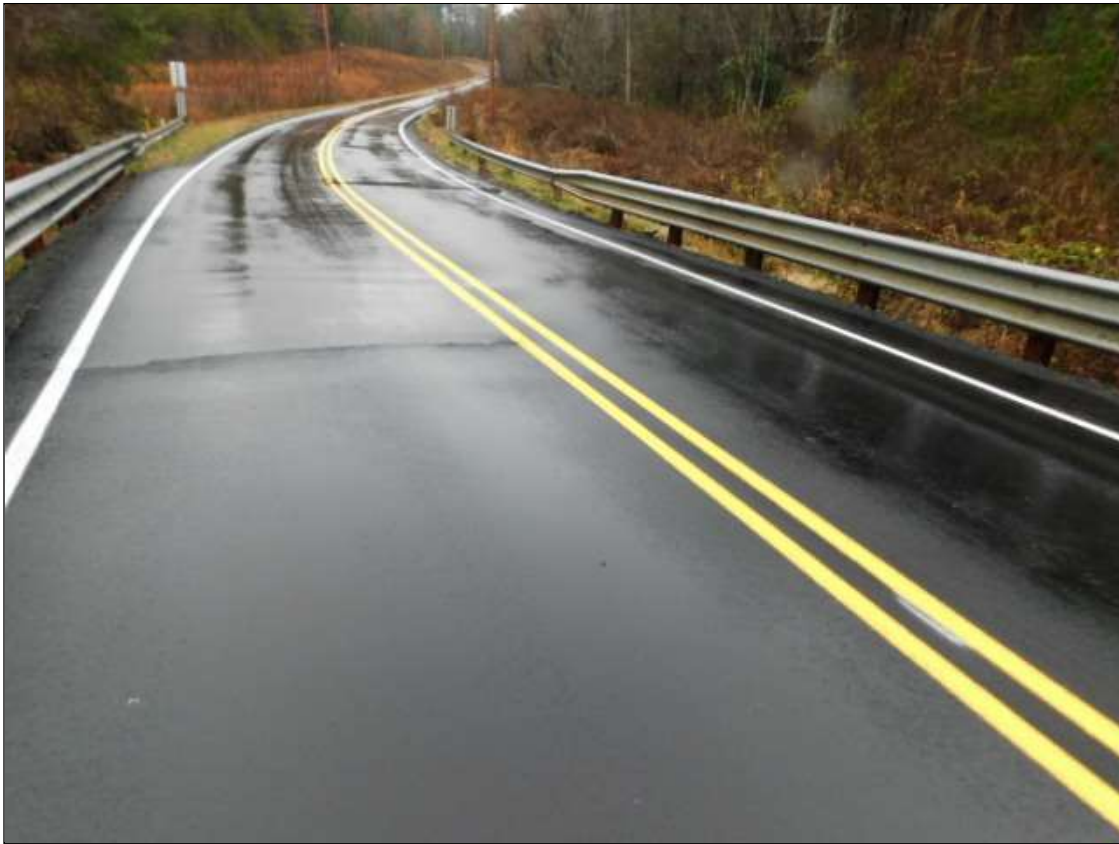
A NEW WEARING SURFACE HAS BEEN LAID SINCE LAST INSPECTION.

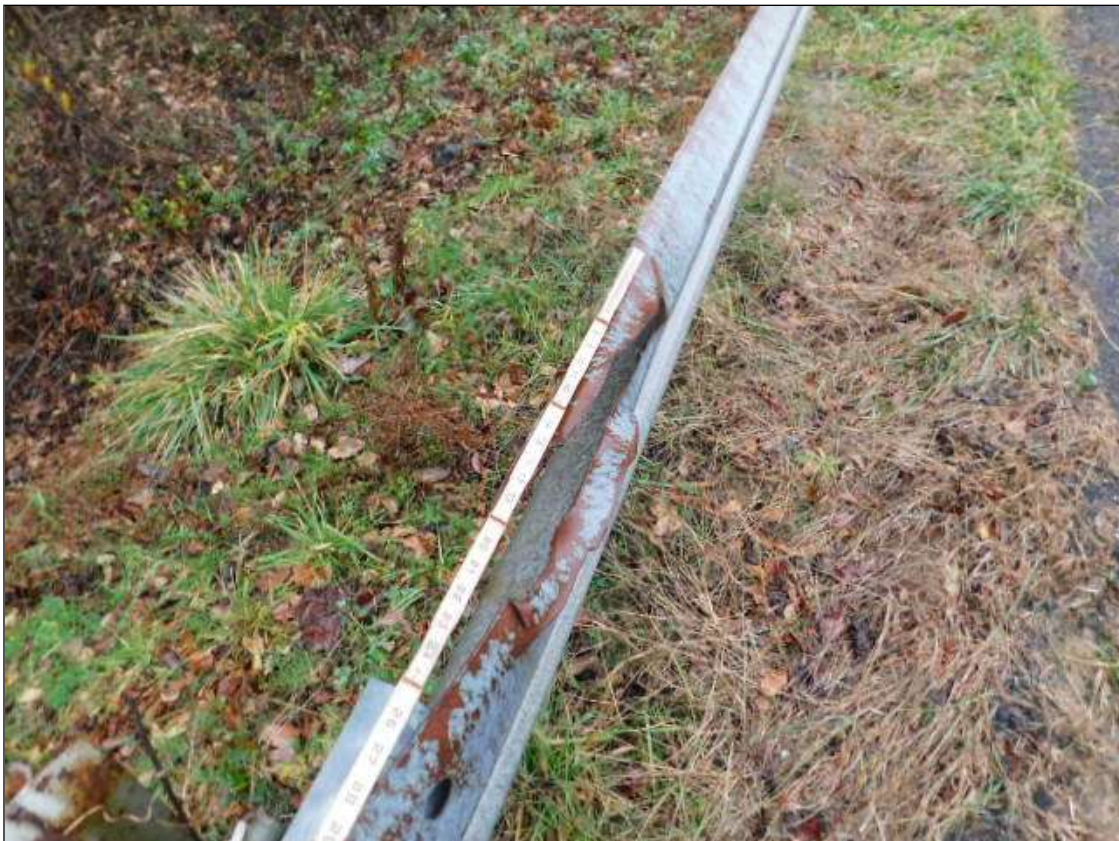
NE GUARDRAIL HAS A 28" LONG x 3" WIDE TEAR IN THE TOP RAIL.

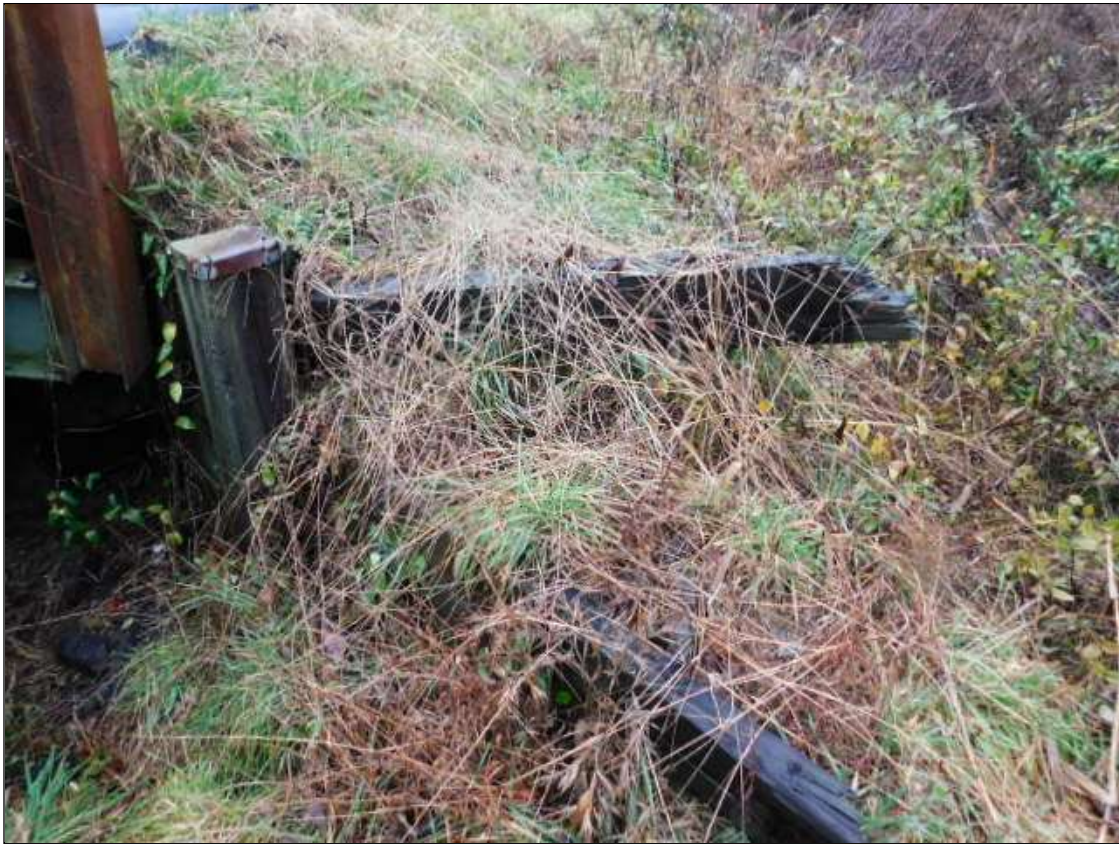
End Bent 2 Abutment/Backwall : TOP BOARD IS BROKEN FOR 4' LONG AT THE RIGHT END OF THE ABUTMENT.  
THERE IS NO FILL BEHIND THE BOARD.

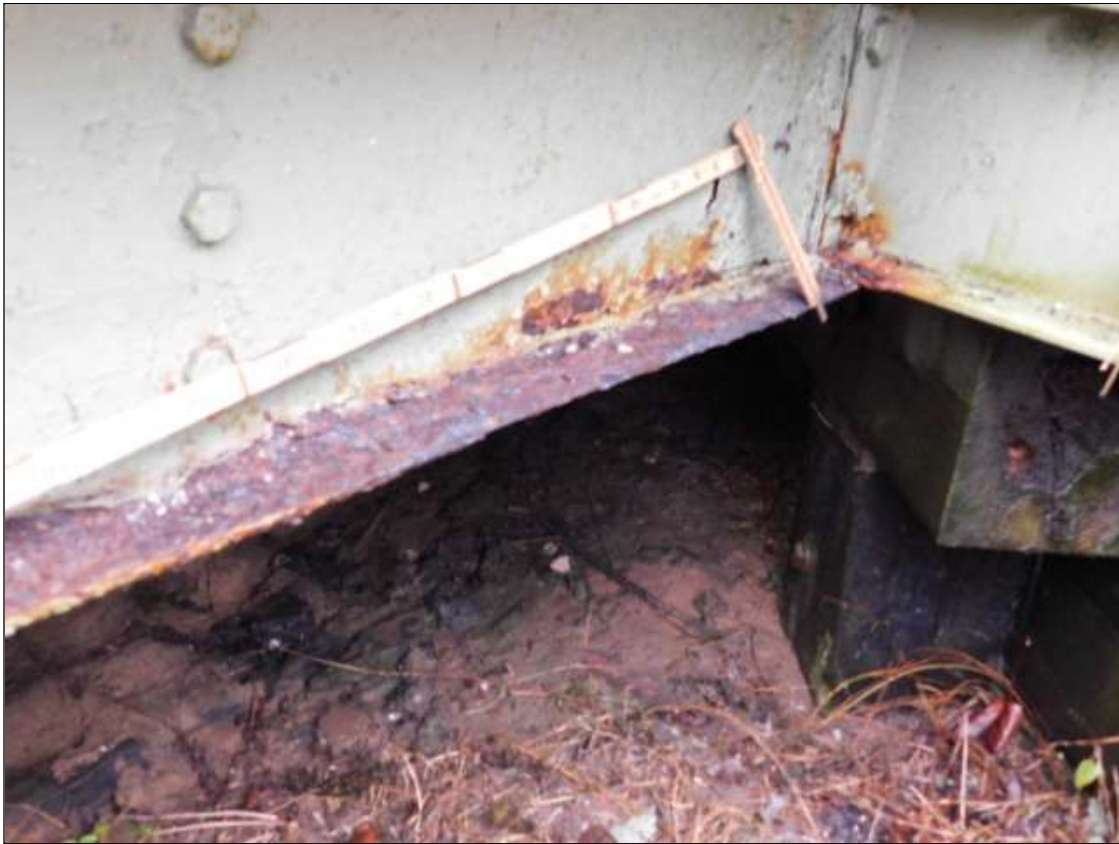
| Priority Level | Defect Type | Quantity | Defect Description |
|---|---|---|---|
| <b>2</b> | Corrosion | 0 | Span 3 Beam 10: RIGHT BOTTOM FLANGE IS DOWN TO 0.188" FROM THE ORIGINAL 0.375" FOR 4' 0" LONG x 1.5" WIDE STARTING AT 2' FROM THE END AT END BENT 2. A PRIORITY ACTION REQUEST IS BEING ISSUED FOR THIS BEAM. |

Span 3 Beam 10: RIGHT BOTTOM FLANGE IS DOWN TO 0.188" FROM THE ORIGINAL 0.375" FOR 4' 0" LONG x 1.5" WIDE STARTING AT 2' FROM THE END AT END BENT 2. A PRIORITY ACTION REQUEST IS BEING ISSUED FOR THIS BEAM.

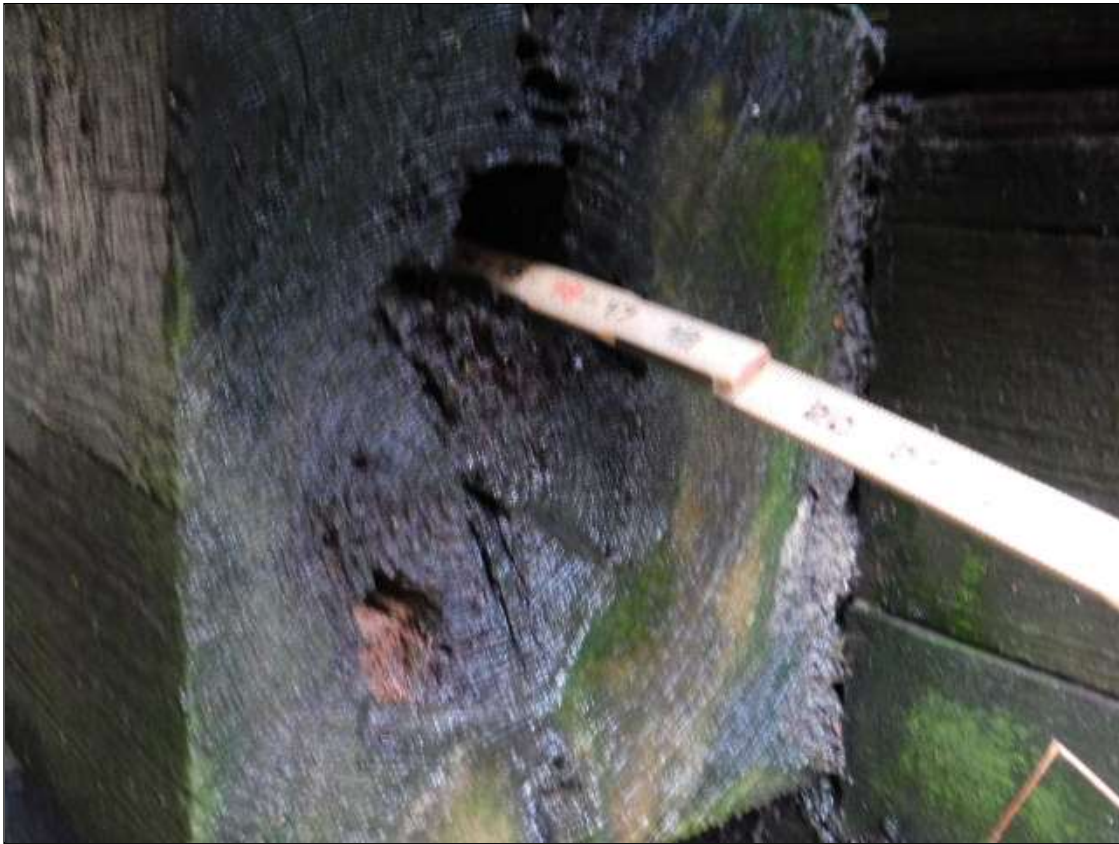
End Bent 2 Cap 2: END BENT 2 CAP: 3" DIAMETER X 16" DEEP DECAY AT RIGHT END OF CAP IN THE CORE.  
THIS DECAY IS NOT YET AFFECTING THE BEARING AREAS.

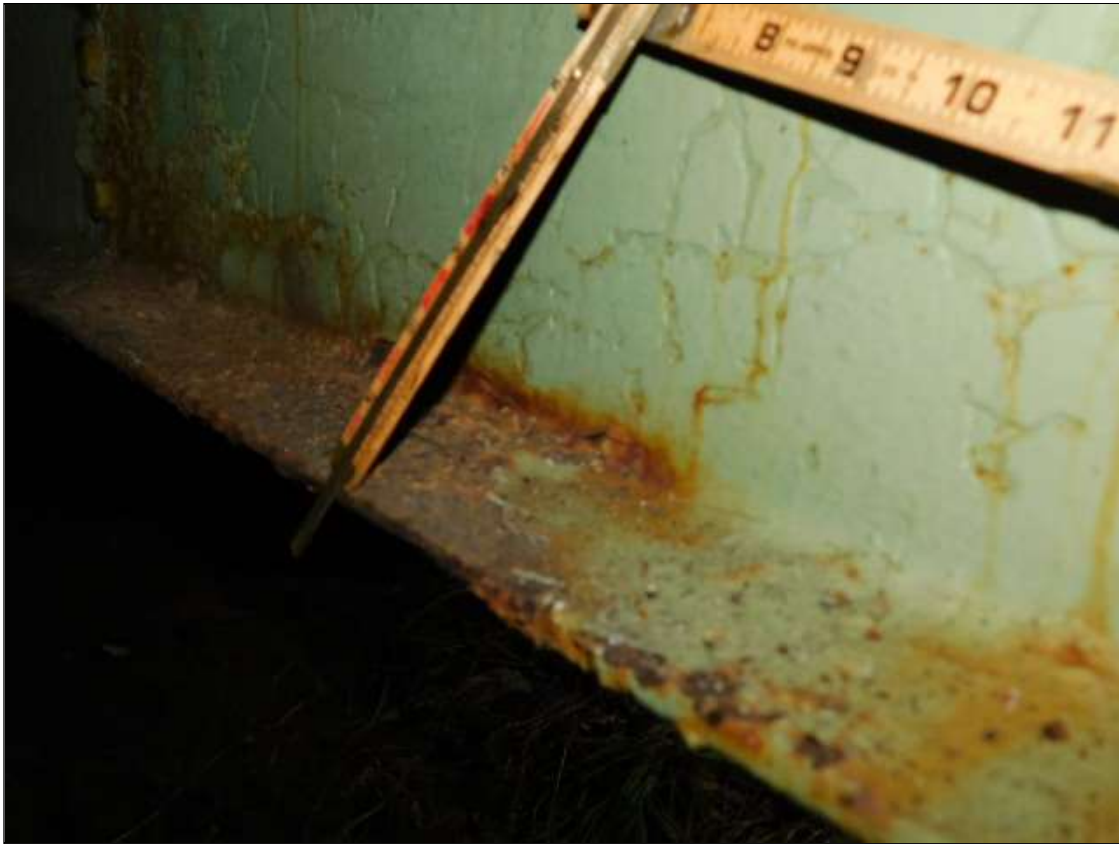
| Priority Level | Defect Type | Quantity | Defect Description |
|---|---|---|---|
| <b>2</b> | Corrosion | 1 | Span 3 Beam 9: LEFT BOTTOM FLANGE IS DOWN TO 0.250" FROM THE ORIGINAL 0.375" FOR 10" LONG x 1.5" WIDE STARTING AT 8' 5" FROM THE END AT END BENT 2. A PRIORITY ACTION REQUEST IS BEING ISSUED FOR THIS BEAM. |

Span 3 Beam 9: LEFT BOTTOM FLANGE IS DOWN TO 0.250" FROM THE ORIGINAL 0.375" FOR 10" LONG x 1.5" WIDE STARTING AT 8' 5" FROM THE END AT END BENT 2. A PRIORITY ACTION REQUEST IS BEING ISSUED FOR THIS BEAM.

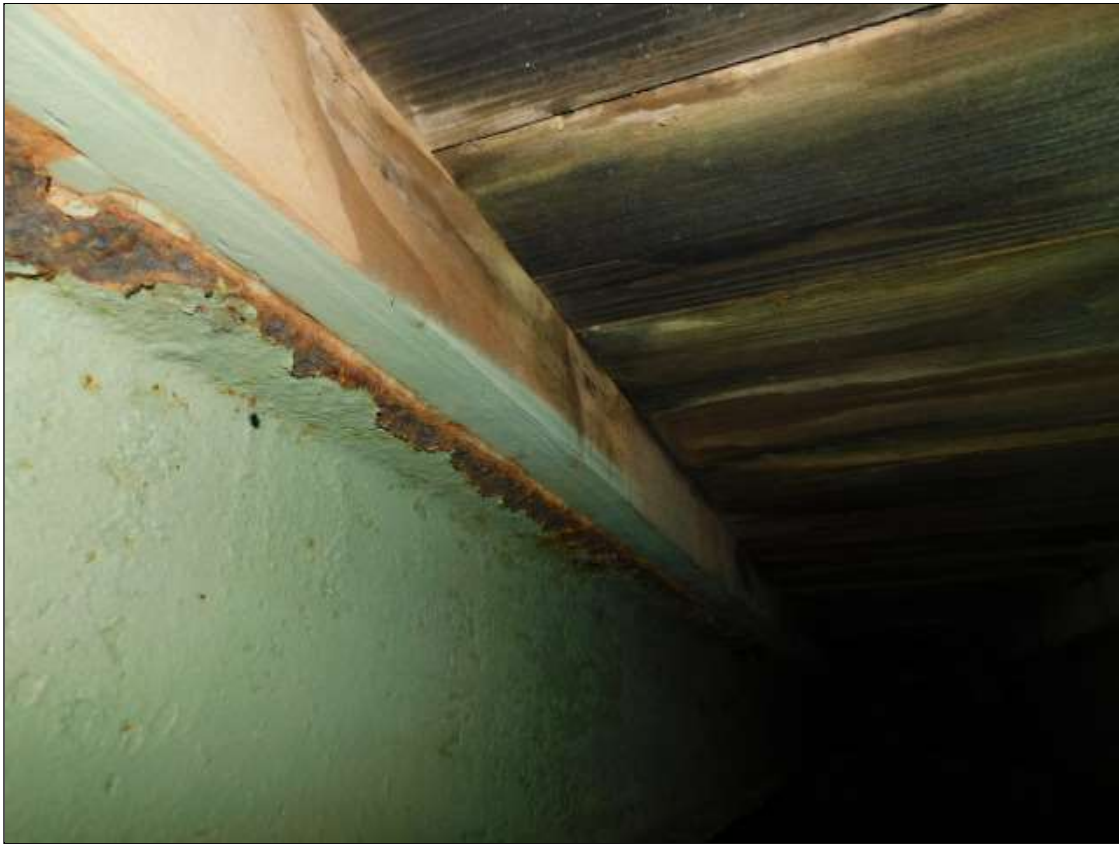
Span 3 Beam 7: 1/32" SECTION LOSS TO TOP AND BOTTOM FLANGES THROUGHOUT SPAN

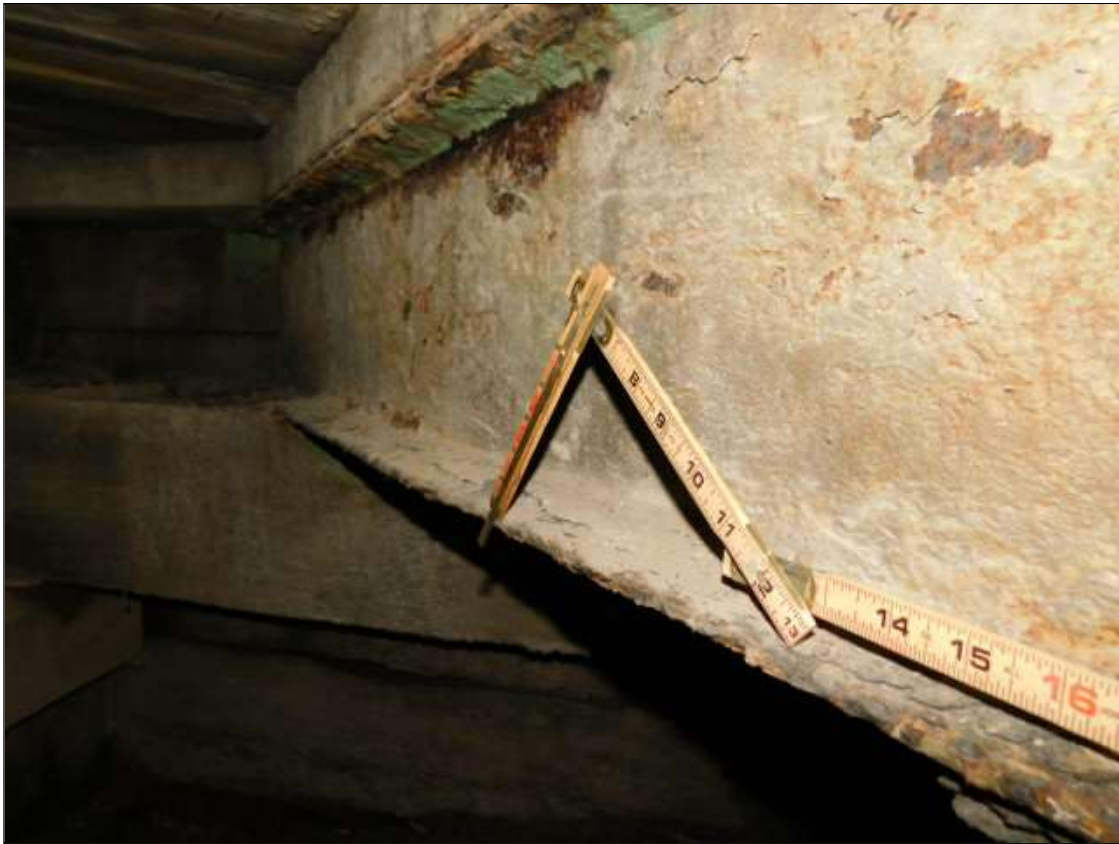
| Priority Level | Defect Type | Quantity | Defect Description |
|---|---|---|---|
| <b>2</b> | Corrosion | 4 | Span 3 Beam 7: LEFT BOTTOM FLANGE IS DOWN TO 0.250" FROM THE ORIGINAL 0.375" FOR 4' 0" LONG x 1.5" WIDE STARTING AT THE END AT END BENT 2. A PRIORITY ACTION REQUEST IS BEING ISSUED FOR THIS BEAM. |

Span 3 Beam 7: LEFT BOTTOM FLANGE IS DOWN TO 0.250" FROM THE ORIGINAL 0.375" FOR 4' 0" LONG x 1.5" WIDE STARTING AT THE END AT END BENT 2. A PRIORITY ACTION REQUEST IS BEING ISSUED FOR THIS BEAM.

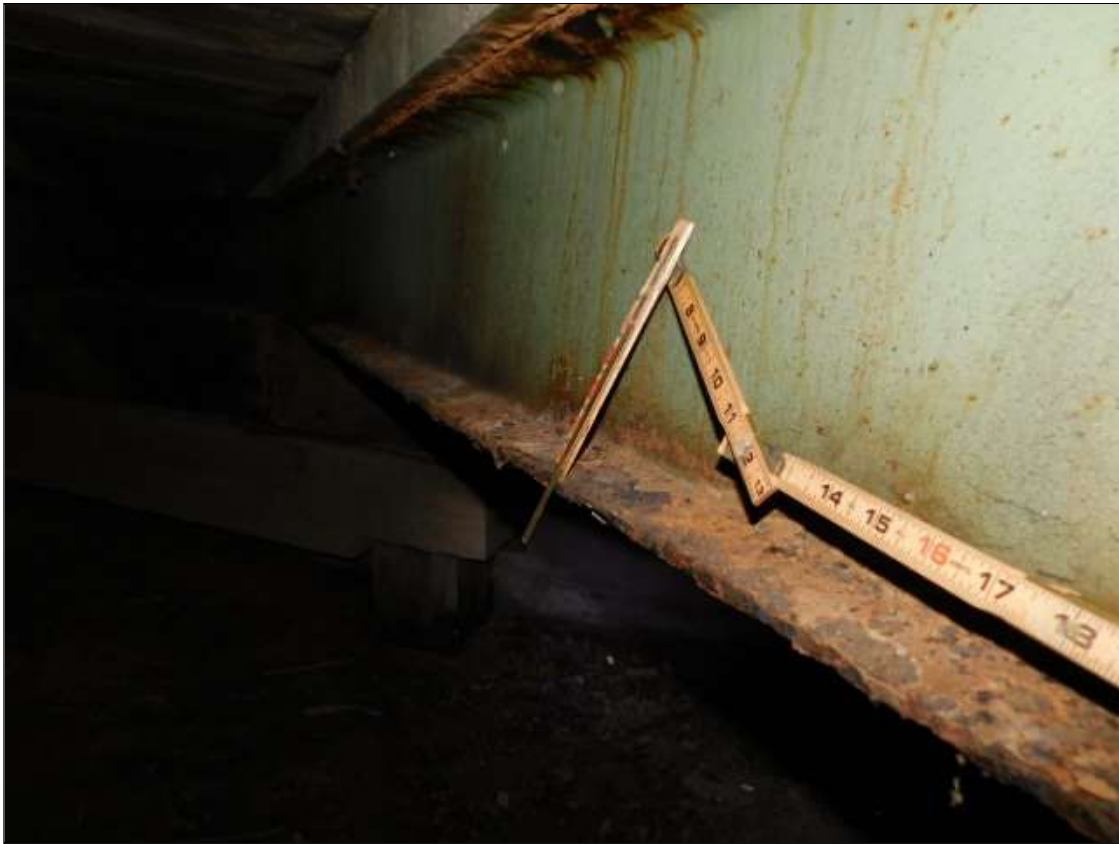
| Priority Level | Defect Type | Quantity | Defect Description |
|---|---|---|---|
| <b>2</b> | Corrosion | 1 | Span 3 Beam 6: LEFT BOTTOM FLANGE IS DOWN TO 0.250" FROM THE ORIGINAL 0.375" FOR 8" LONG x 1.5" WIDE STARTING AT 6' 1" FROM THE END AT END BENT 2. A PRIORITY ACTION REQUEST IS BEING ISSUED FOR THIS BEAM. |

Span 3 Beam 6: LEFT BOTTOM FLANGE IS DOWN TO 0.250" FROM THE ORIGINAL 0.375" FOR 8" LONG x 1.5" WIDE STARTING AT 6' 1" FROM THE END AT END BENT 2. A PRIORITY ACTION REQUEST IS BEING ISSUED FOR THIS BEAM.

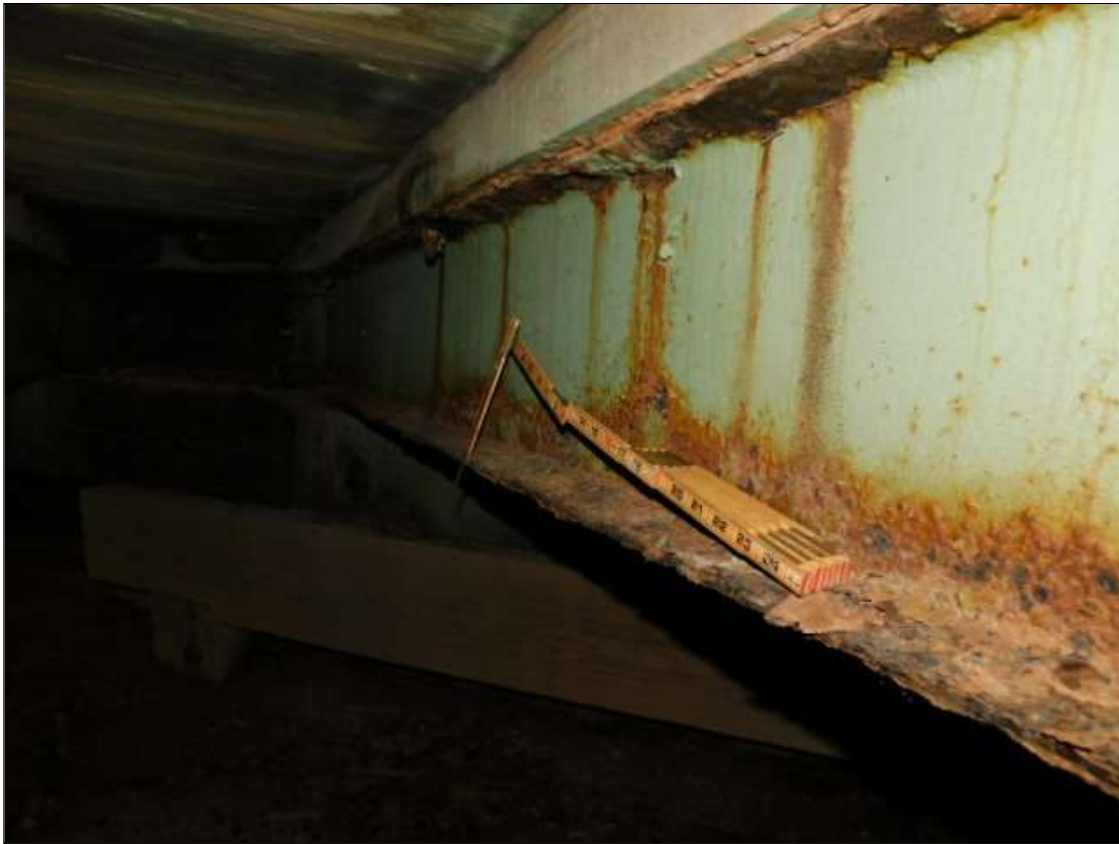
| Priority Level | Defect Type | Quantity | Defect Description |
|---|---|---|---|
| <b>2</b> | Corrosion | 8 | Span 3 Beam 5: LEFT BOTTOM FLANGE IS DOWN TO 0.250" FROM THE ORIGINAL 0.375" FOR 7' 6" LONG x 1.5" WIDE STARTING AT 18' FROM THE END AT END BENT 2. A PRIORITY ACTION REQUEST IS BEING ISSUED FOR THIS BEAM. |

Span 3 Beam 5: LEFT BOTTOM FLANGE IS DOWN TO 0.250" FROM THE ORIGINAL 0.375" FOR 7' 6" LONG x 1.5" WIDE STARTING AT 18' FROM THE END AT END BENT 2. A PRIORITY ACTION REQUEST IS BEING ISSUED FOR THIS BEAM.

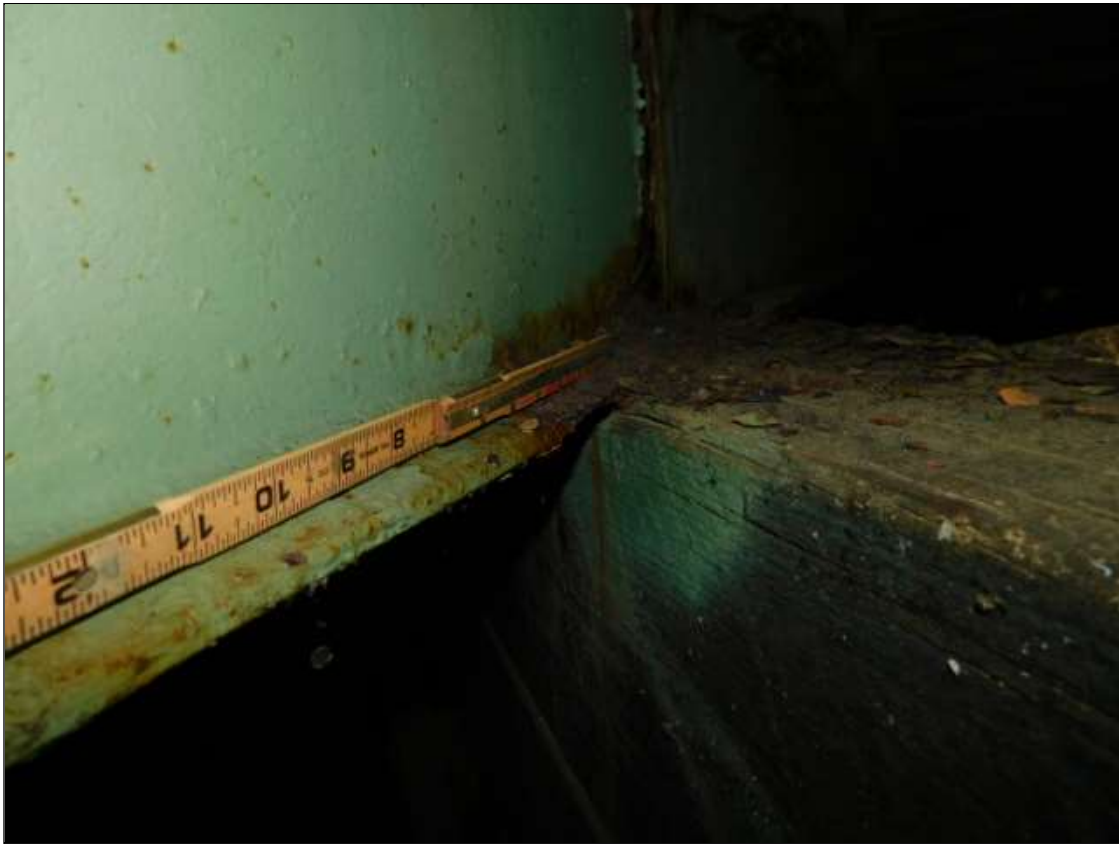
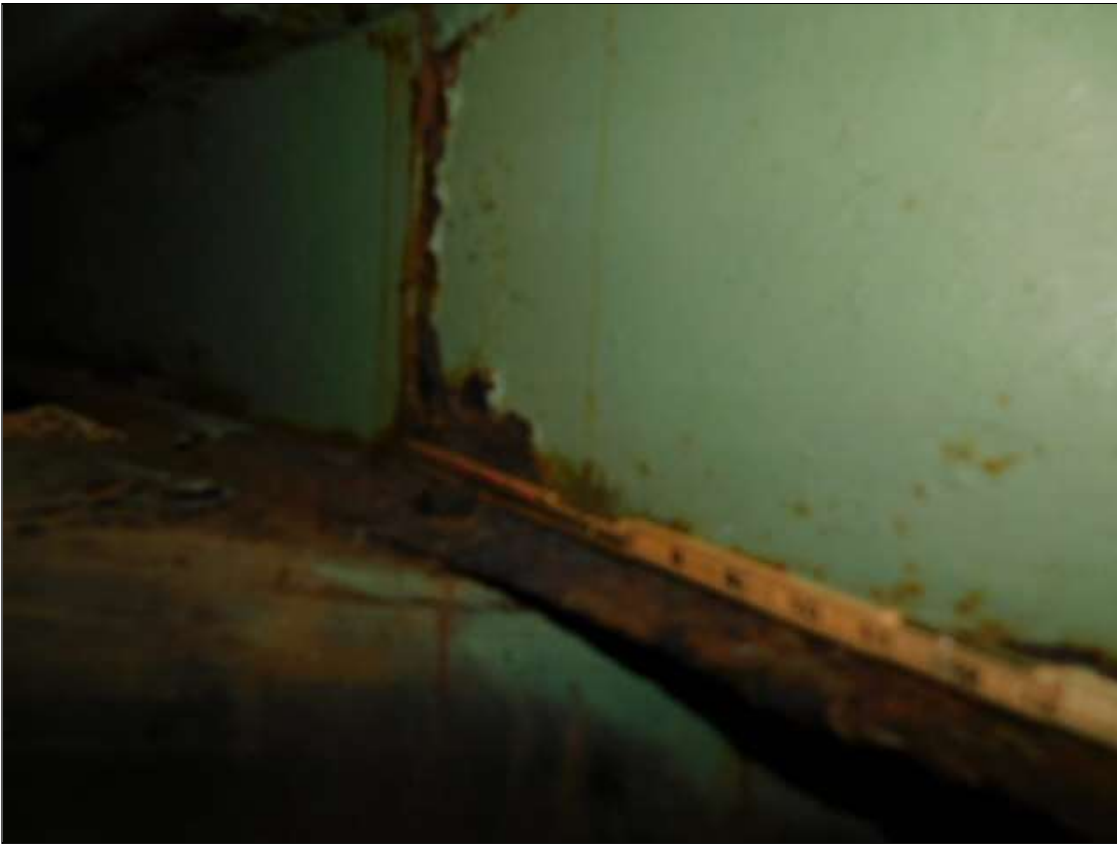
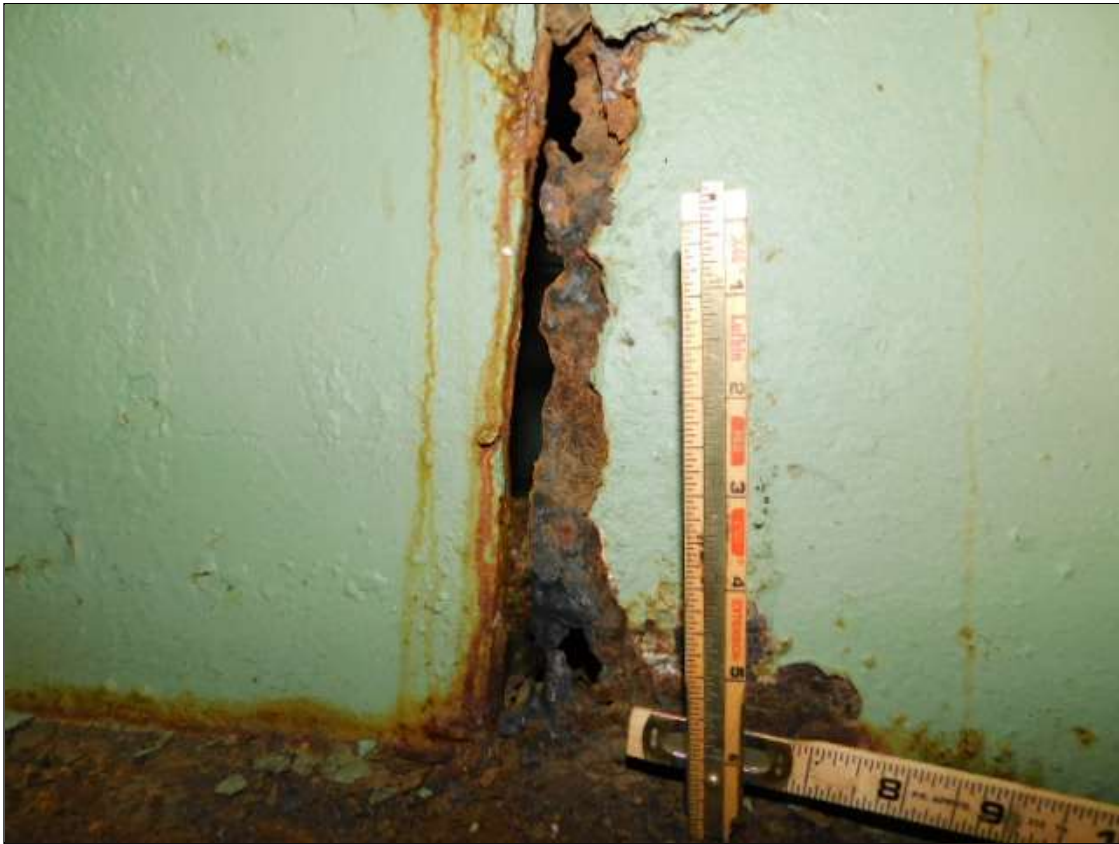
| Priority Level | Defect Type | Quantity | Defect Description |
|---|---|---|---|
| <b>2</b> | Corrosion | 2 | Span 3 Beam 3: RIGHT BOTTOM FLANGE IS DOWN TO A KNIFE EDGE FOR 3" LONG AND 0.250" FOR 13" LONG FROM THE ORIGINAL 0.375" x 1.5" WIDE STARTING AT THE END AT BENT 2. THE LEFT BOTTOM FLANGE IS DOWN TO A KNIFE EDGE FOR 10" LONG x 1" WIDE AND THE END OF THE WEB IS DOWN TO 0.125" FROM THE ORIGINAL 0.375" FOR 1.5" WIDE x FULL HEIGHT AND HAS A 0.5" DIAMETER HOLE AT 1" FROM THE END AND 1.5" ABOVE THE BOTTOM FLANGE IN THIS AREA. A PRIORITY ACTION REQUEST IS BEING |

Span 3 Beam 3: RIGHT BOTTOM FLANGE IS DOWN TO A KNIFE EDGE FOR 3" LONG AND 0.250" FOR 13" LONG FROM THE ORIGINAL 0.375" x 1.5" WIDE STARTING AT THE END AT BENT 2. THE LEFT BOTTOM FLANGE IS DOWN TO A KNIFE EDGE FOR 10" LONG x 1" WIDE AND THE END OF THE WEB IS DOWN TO 0.125" FROM THE ORIGINAL 0.375" FOR 1.5" WIDE x FULL HEIGHT AND HAS A 0.5" DIAMETER HOLE AT 1" FROM THE END AND 1.5" ABOVE THE BOTTOM FLANGE IN THIS AREA. A PRIORITY ACTION REQUEST IS BEING ISSUED FOR THIS BEAM.

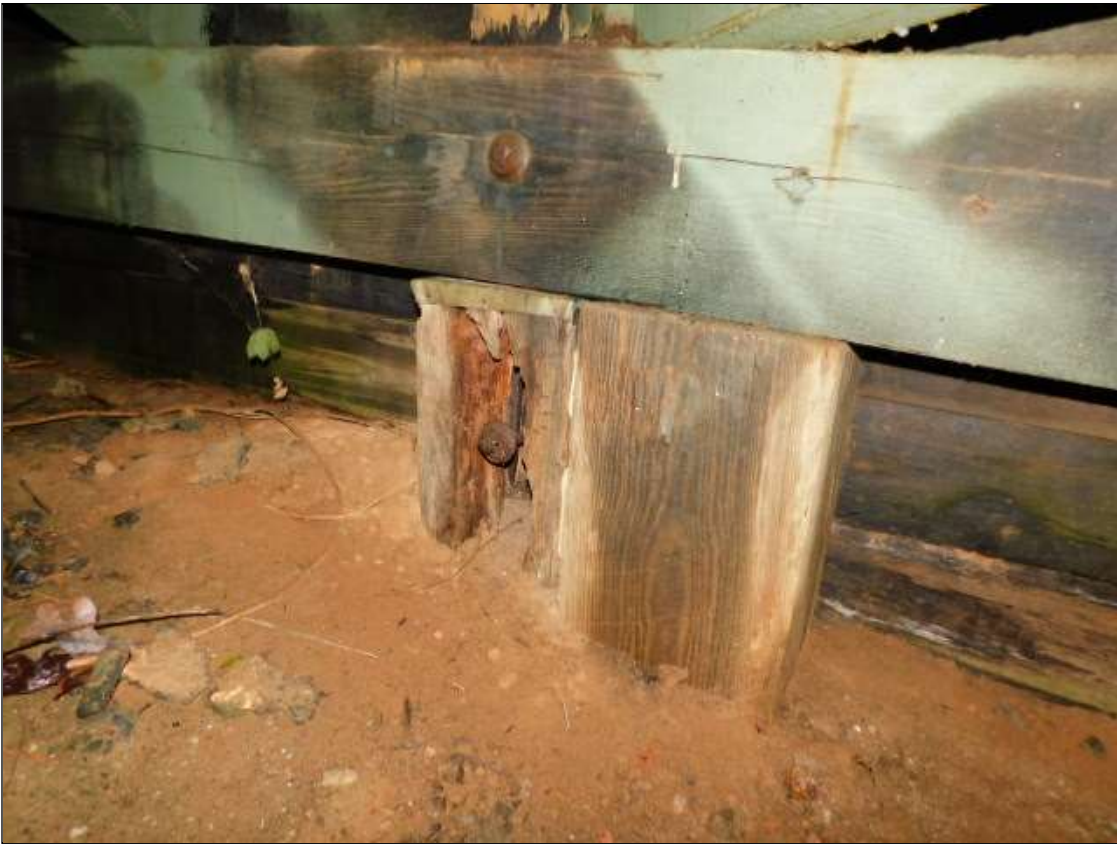
End Bent 2 Pile 2: WEST FACE OF THE POST HAS 6" WIDE x 12" HIGH x 4" DEEP DECAY. THERE IS AN ADJACENT SUPPLEMENT POST.

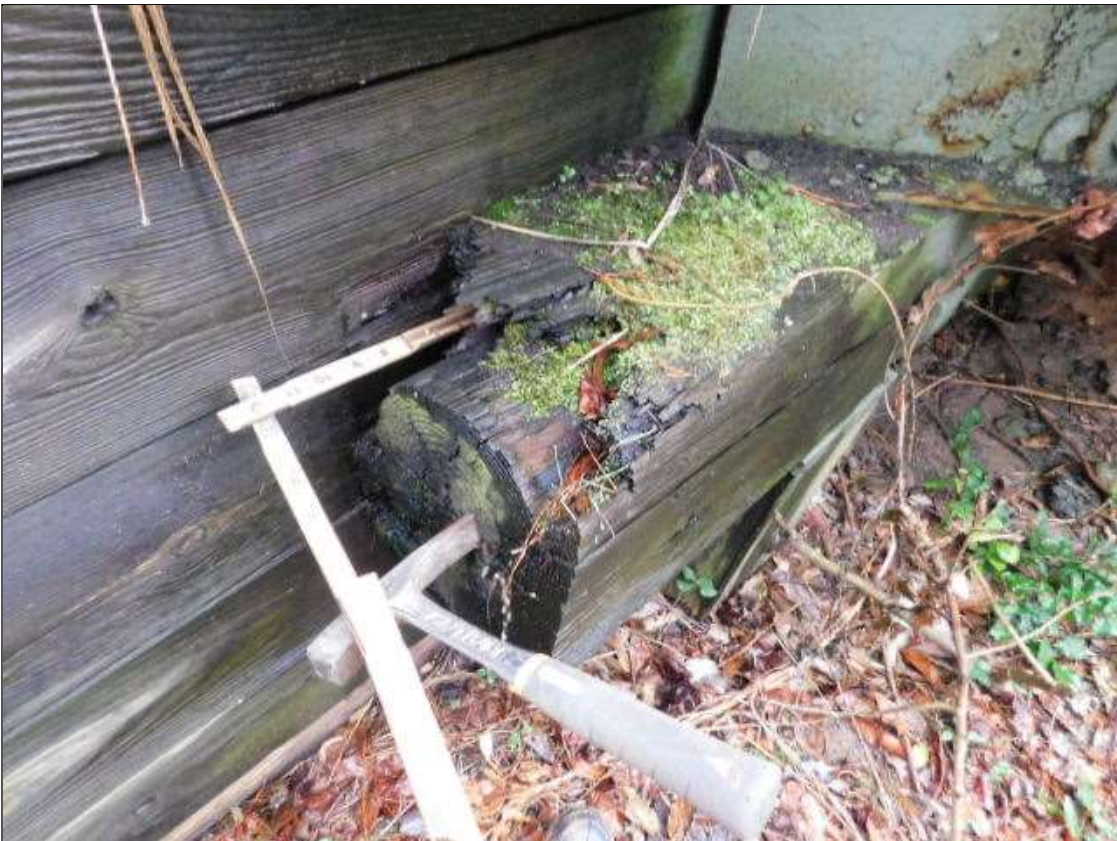
End Bent 2 Cap 1: LEFT END OF THE CAP HAS A 10" WIDE x 7" HIGH x 8" DEEP AREA OF DECAY. THIS DECAY IS NOT YET AFFECTING THE BEARING AREAS.

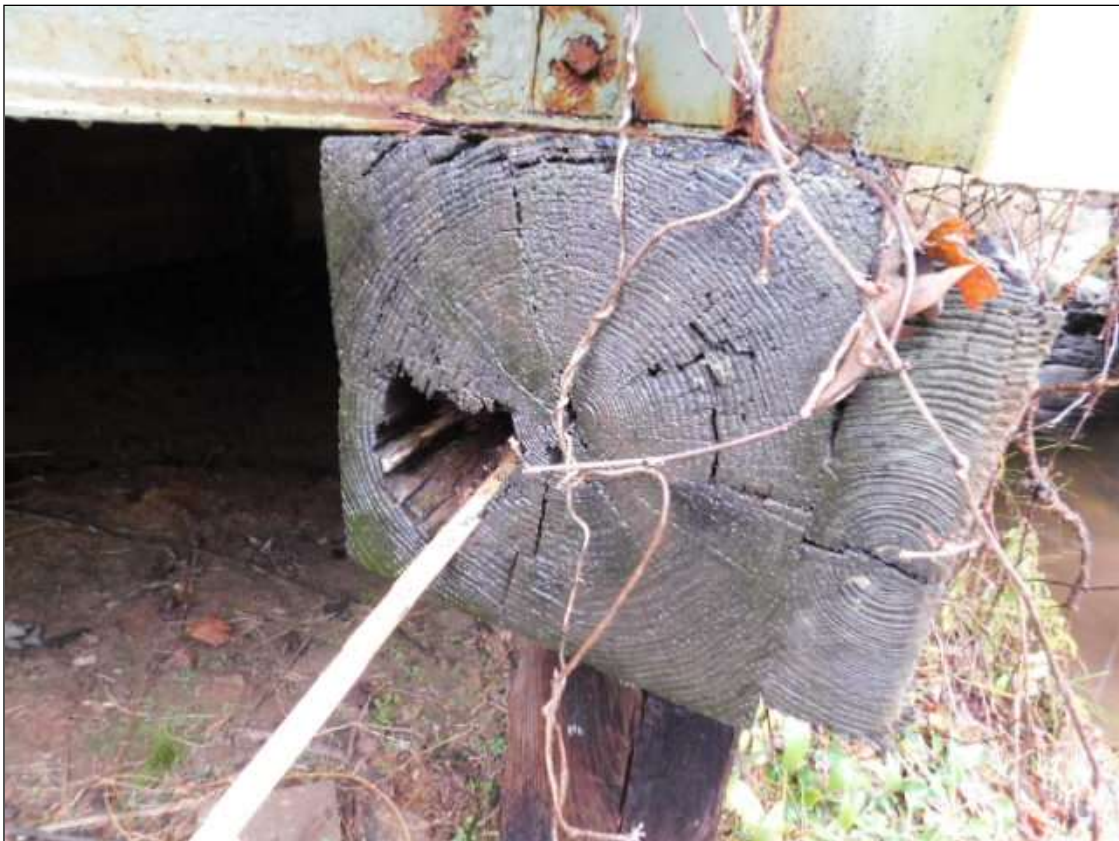
Bent 1 Cap 2: BENT 1 CAP: 5" DIAMETER X 15" DEEP AREA OF DECAY IN SOUTH END. THERE IS NO INDICATION OF THE CAP CRUSHING IN THIS AREA.

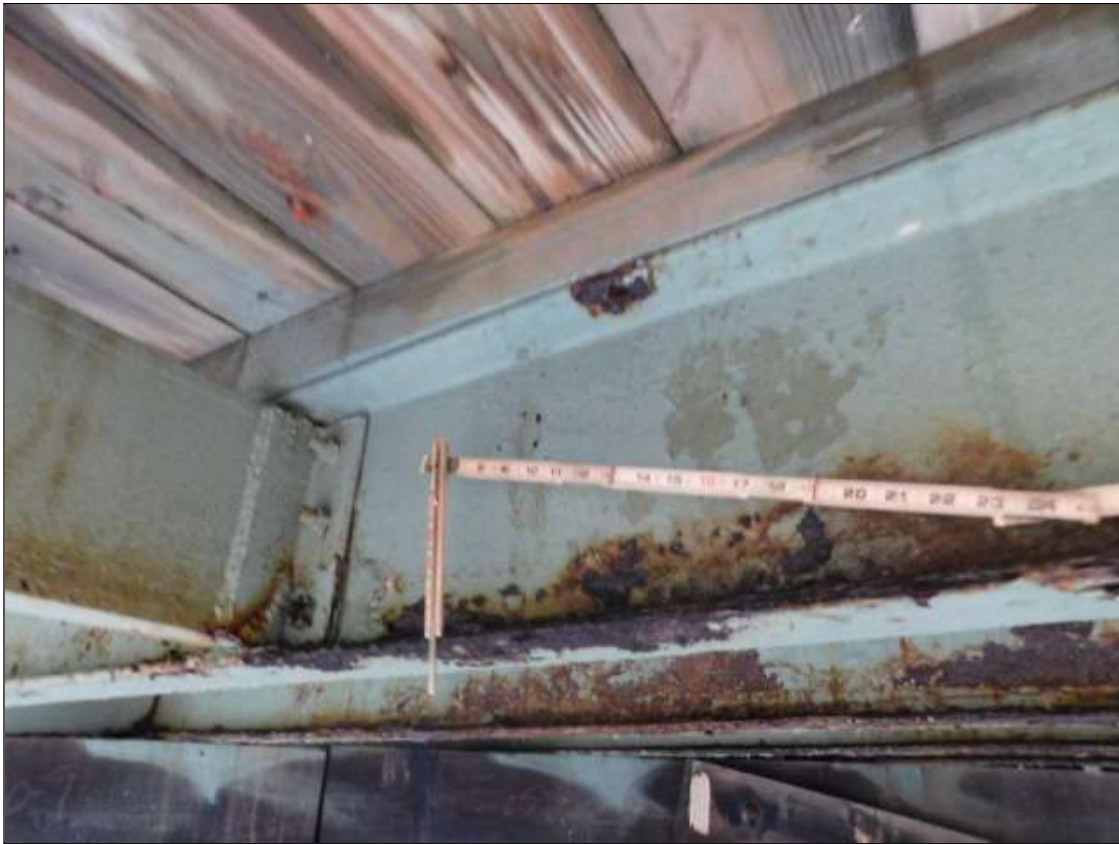
| 2 | Corrosion | 4 | Span 2 Beam 2: LEFT BOTTOM FLANGE IS DOWN TO 0.250" FROM THE ORIGINAL 0.375" FOR 3' 10" LONG x 2" WIDE STARTING AT 8' 5" FROM THE END AT BENT 1. A PRIORITY ACTION REQUEST IS BEING ISSUED FOR THIS BEAM. |

Span 2 Beam 2: LEFT BOTTOM FLANGE IS DOWN TO 0.250" FROM THE ORIGINAL 0.375" FOR 3' 10" LONG x 2" WIDE STARTING AT 8' 5" FROM THE END AT BENT 1. A PRIORITY ACTION REQUEST IS BEING ISSUED FOR THIS BEAM.

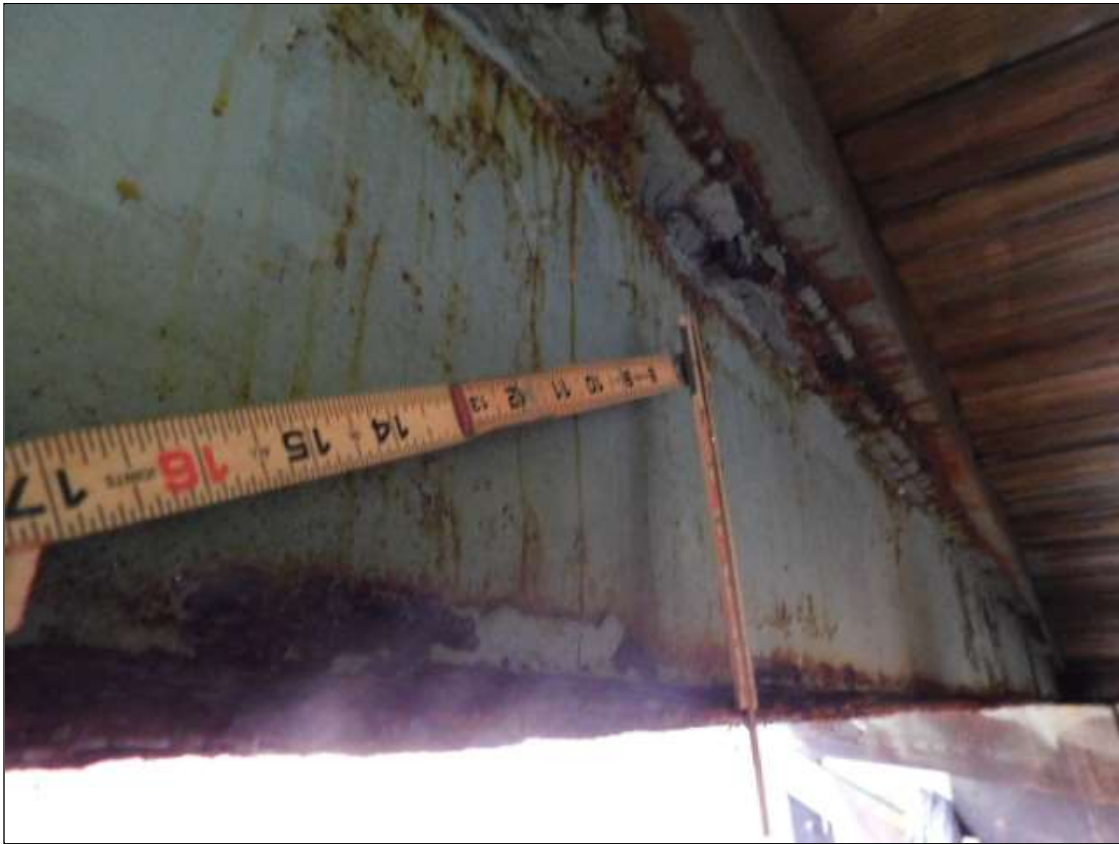
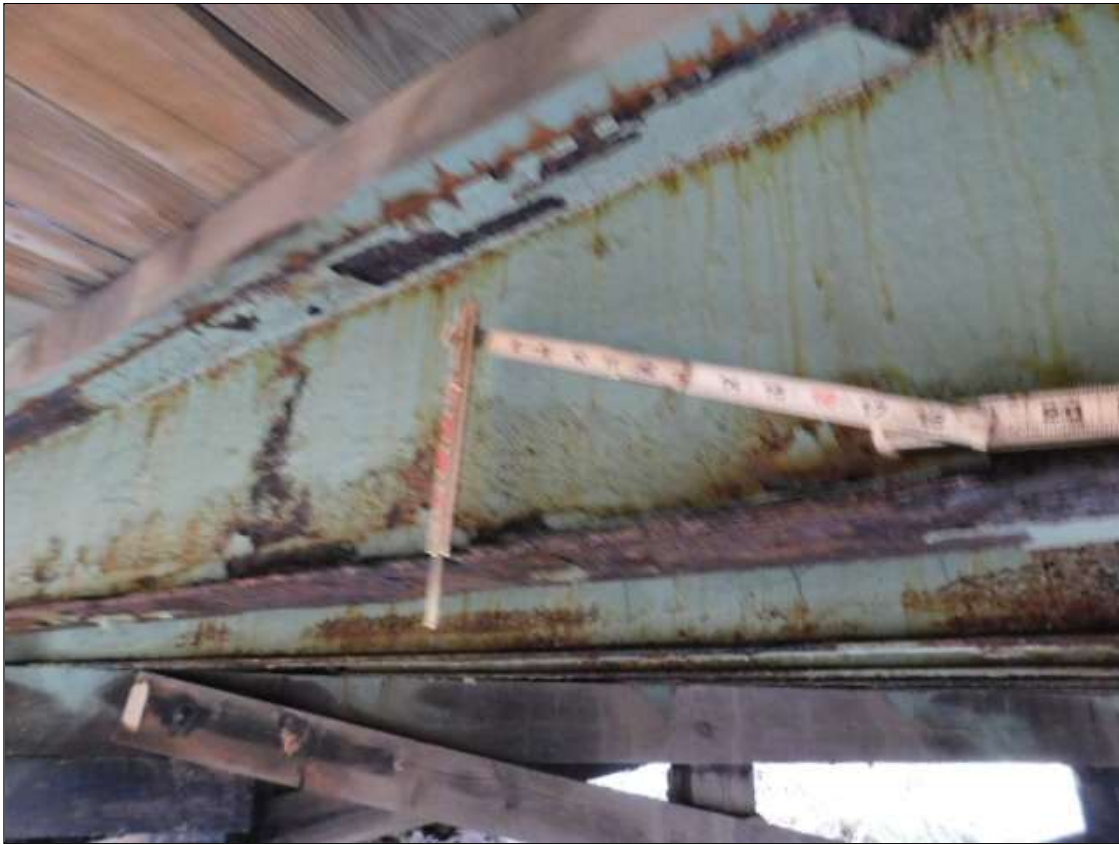
| Priority Level | Defect Type | Quantity | Defect Description |
|---|---|---|---|
| <b>2</b> | Corrosion | 20 | Span 2 Beam 3: LEFT BOTTOM FLANGE IS DOWN TO 0.125" TO 0.250" FROM THE ORIGINAL 0.375" FOR FULL LENGTH x 1.5" WIDE. RIGHT BOTTOM FLANGE IS DOWN TO 0.188" TO 0.250" FOR FULL LENGTH x UP TO 1.5" WIDE. A PRIORITY ACTION REQUEST IS BEING ISSUED FOR THIS BEAM. |

Span 2 Beam 3: LEFT BOTTOM FLANGE IS DOWN TO 0.125" TO 0.250" FROM THE ORIGINAL 0.375" FOR FULL LENGTH x 1.5" WIDE. RIGHT BOTTOM FLANGE IS DOWN TO 0.188" TO 0.250" FOR FULL LENGTH x UP TO 1.5" WIDE. A PRIORITY ACTION REQUEST IS BEING ISSUED FOR THIS BEAM.

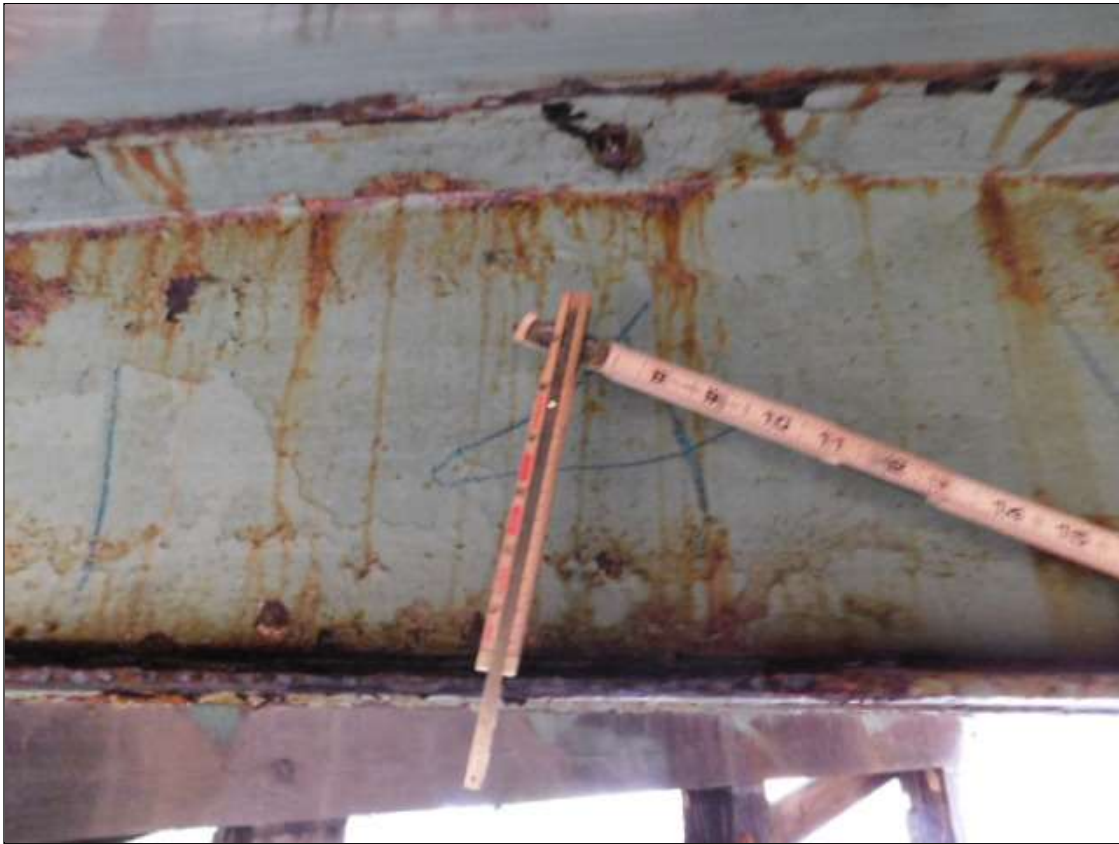
| Priority Level | Defect Type | Quantity | Defect Description |
|---|---|---|---|
| <b>2</b> | Corrosion | 1 | Span 2 Beam 4: LEFT BOTTOM FLANGE IS DOWN TO 0.125" TO 0.250" FROM THE ORIGINAL 0.375" FOR 7" LONG x 1.5" WIDE STARTING AT 10' 4" FROM THE END AT BENT 1. A PRIORITY ACTION REQUEST IS BEING ISSUED FOR THIS BEAM. |

Span 2 Beam 4: LEFT BOTTOM FLANGE IS DOWN TO 0.125" TO 0.250" FROM THE ORIGINAL 0.375" FOR 7" LONG x 1.5" WIDE STARTING AT 10' 4" FROM THE END AT BENT 1. A PRIORITY ACTION REQUEST IS BEING ISSUED FOR THIS BEAM.

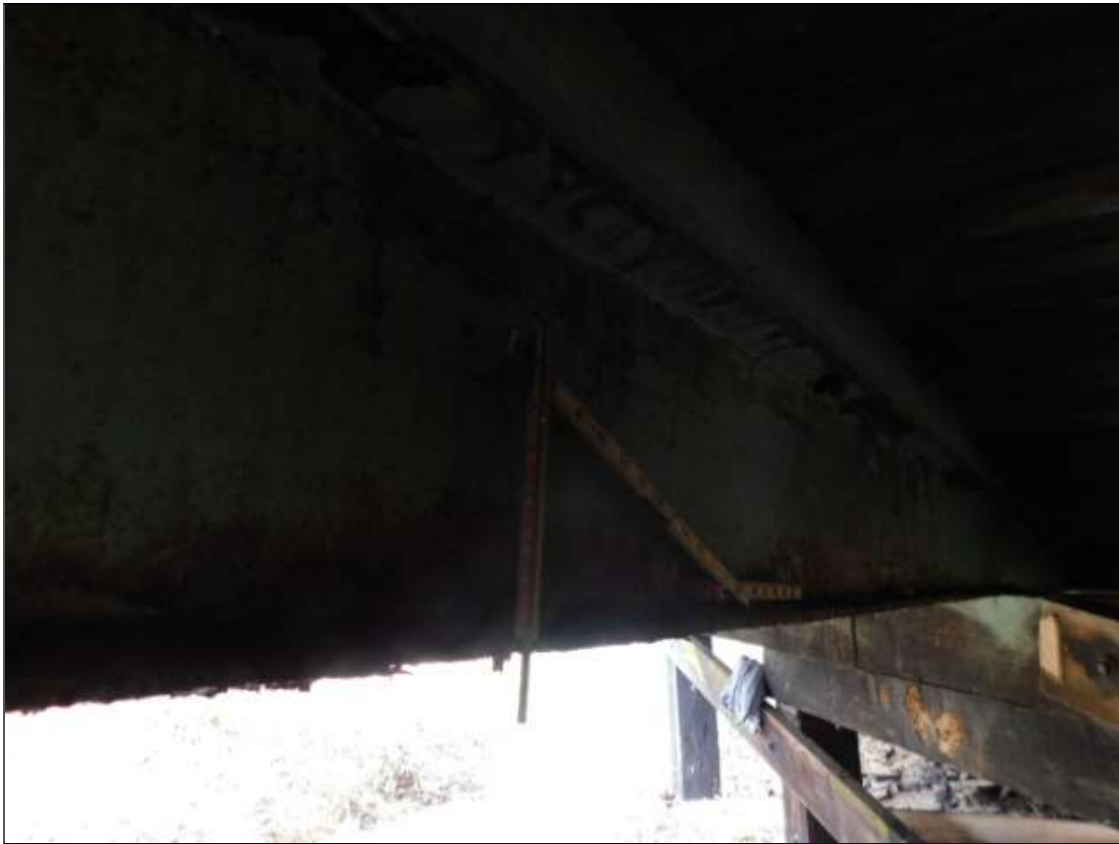
| Priority Level | Defect Type | Quantity | Defect Description |
|---|---|---|---|
| <b>2</b> | Corrosion | 1 | Span 2 Beam 4: RIGHT BOTTOM FLANGE IS DOWN TO 0.250" FROM THE ORIGINAL 0.375" FOR 9" LONG x 1.5" WIDE STARTING AT 11' 5" FROM THE END AT BENT 1. A PRIORITY ACTION REQUEST IS BEING ISSUED FOR THIS BEAM. |

Span 2 Beam 4: RIGHT BOTTOM FLANGE IS DOWN TO 0.250" FROM THE ORIGINAL 0.375" FOR 9" LONG x 1.5" WIDE STARTING AT 11' 5" FROM THE END AT BENT 1. A PRIORITY ACTION REQUEST IS BEING ISSUED FOR THIS BEAM.

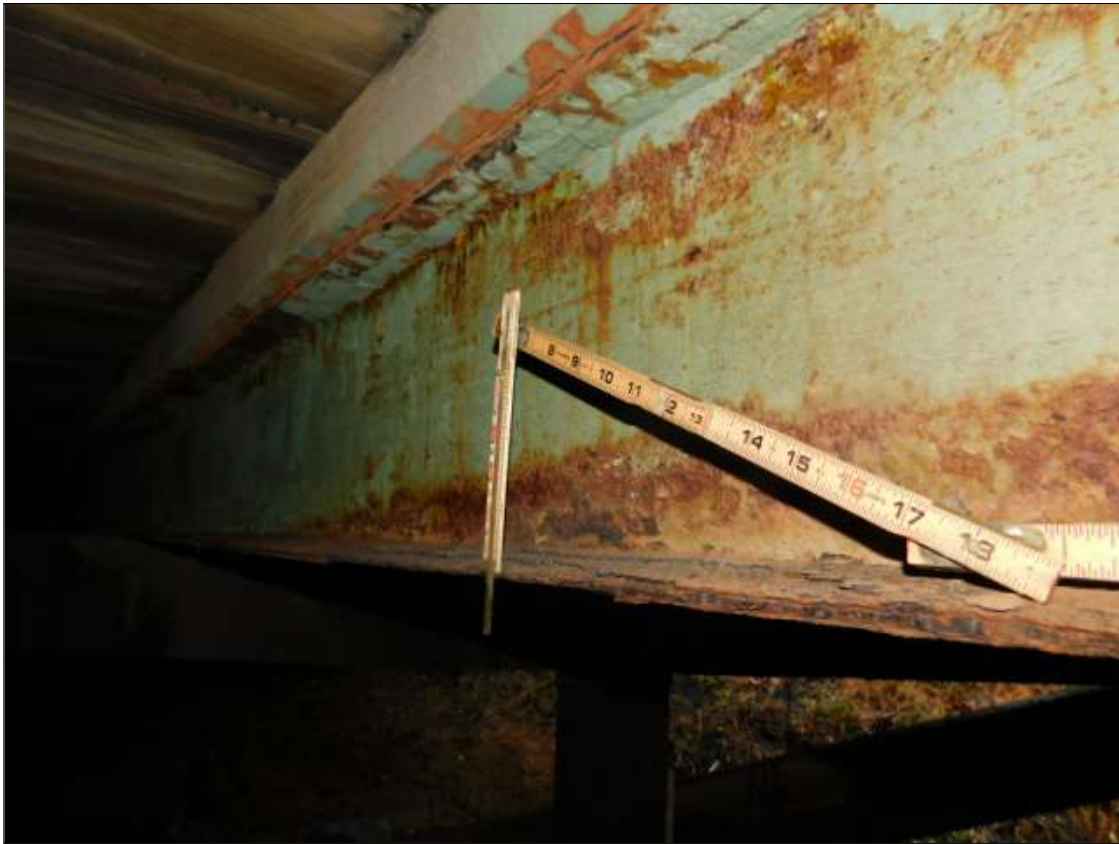
| Priority Level | Defect Type | Quantity | Defect Description |
|---|---|---|---|
| <b>2</b> | Corrosion | 3 | Span 2 Beam 4: RIGHT BOTTOM FLANGE IS DOWN TO 0.250" FROM THE ORIGINAL 0.375" FOR 3' 0" LONG x 1.5" WIDE STARTING AT 5' 3" FROM THE END AT BENT 1. A PRIORITY ACTION REQUEST IS BEING ISSUED FOR THIS BEAM. |

Span 2 Beam 4: RIGHT BOTTOM FLANGE IS DOWN TO 0.250" FROM THE ORIGINAL 0.375" FOR 3' 0" LONG x 1.5" WIDE STARTING AT 5' 3" FROM THE END AT BENT 1. A PRIORITY ACTION REQUEST IS BEING ISSUED FOR THIS BEAM.
