NC DEPARTMENT OF TRANSPORTATION  
DIVISION OF HIGHWAYS  
STRUCTURE MANAGEMENT UNIT

# Structure Safety Report

## Routine Element Inspection

DIVISION: 13 COUNTY: BURKE STRUCTURE NUMBER: 110237 FREQUENCY: 24 MONTHS

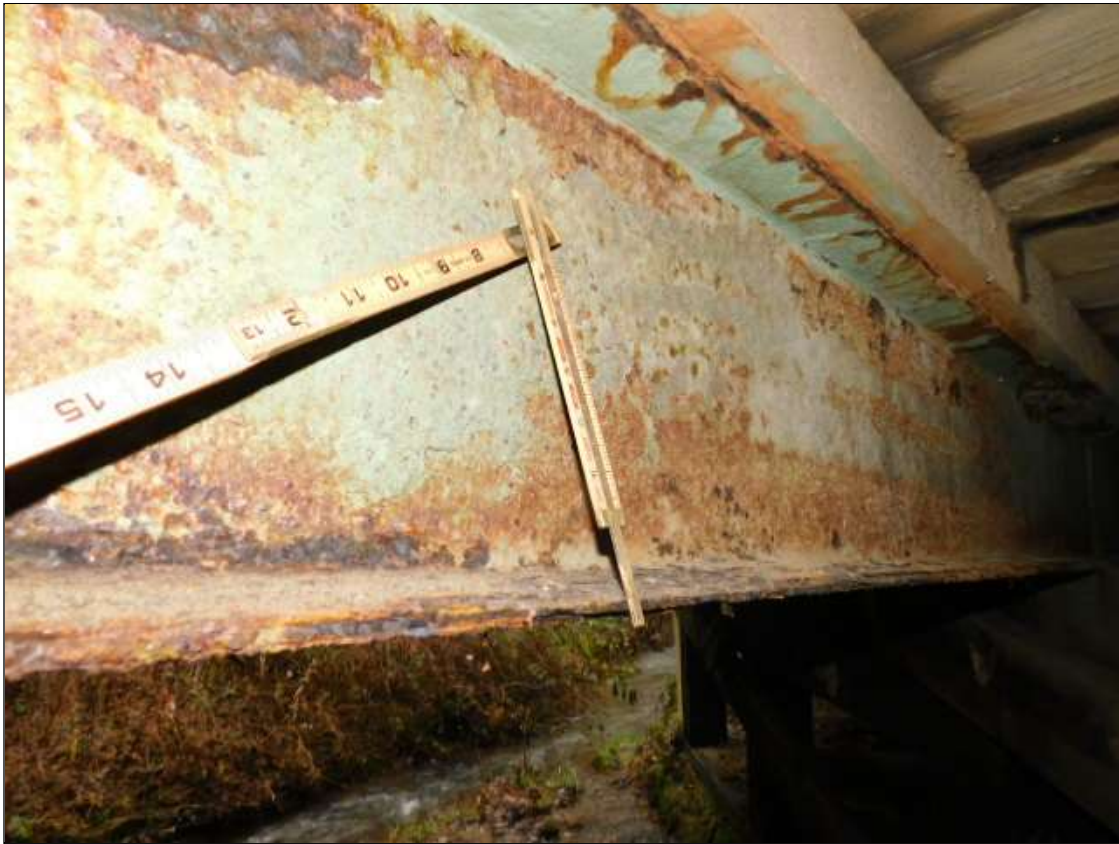
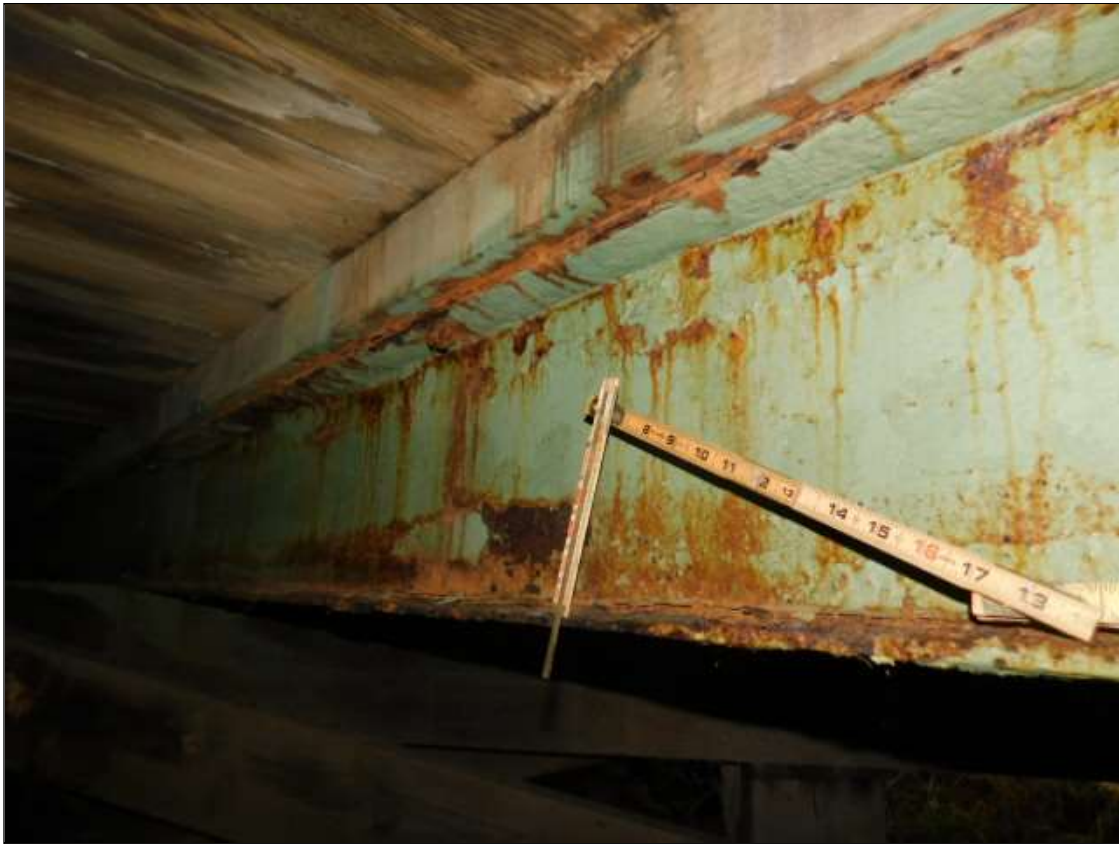
| Priority Level | Defect Type | Quantity | Defect Description |
|---|---|---|---|
| <b>2</b> | Corrosion | 2 | Span 2 Beam 5: LEFT BOTTOM FLANGE IS DOWN TO 0.250" FROM THE ORIGINAL 0.375" FOR 21" LONG x 1.5" WIDE STARTING AT 14' 2" FROM THE END AT BENT 1. RIGHT BOTTOM FLANGE IS DOWN TO 0.250" FROM THE ORIGINAL 0.375" FOR 3' 1" LONG x 1" WIDE STARTING AT 13' 5" FROM THE END AT BENT 1. A PRIORITY ACTION REQUEST IS BEING ISSUED FOR THIS BEAM. |

Span 2 Beam 5: LEFT BOTTOM FLANGE IS DOWN TO 0.250" FROM THE ORIGINAL 0.375" FOR 21" LONG x 1.5" WIDE STARTING AT 14' 2" FROM THE END AT BENT 1. RIGHT BOTTOM FLANGE IS DOWN TO 0.250" FROM THE ORIGINAL 0.375" FOR 3' 1" LONG x 1" WIDE STARTING AT 13' 5" FROM THE END AT BENT 1. A PRIORITY ACTION REQUEST IS BEING ISSUED FOR THIS BEAM.

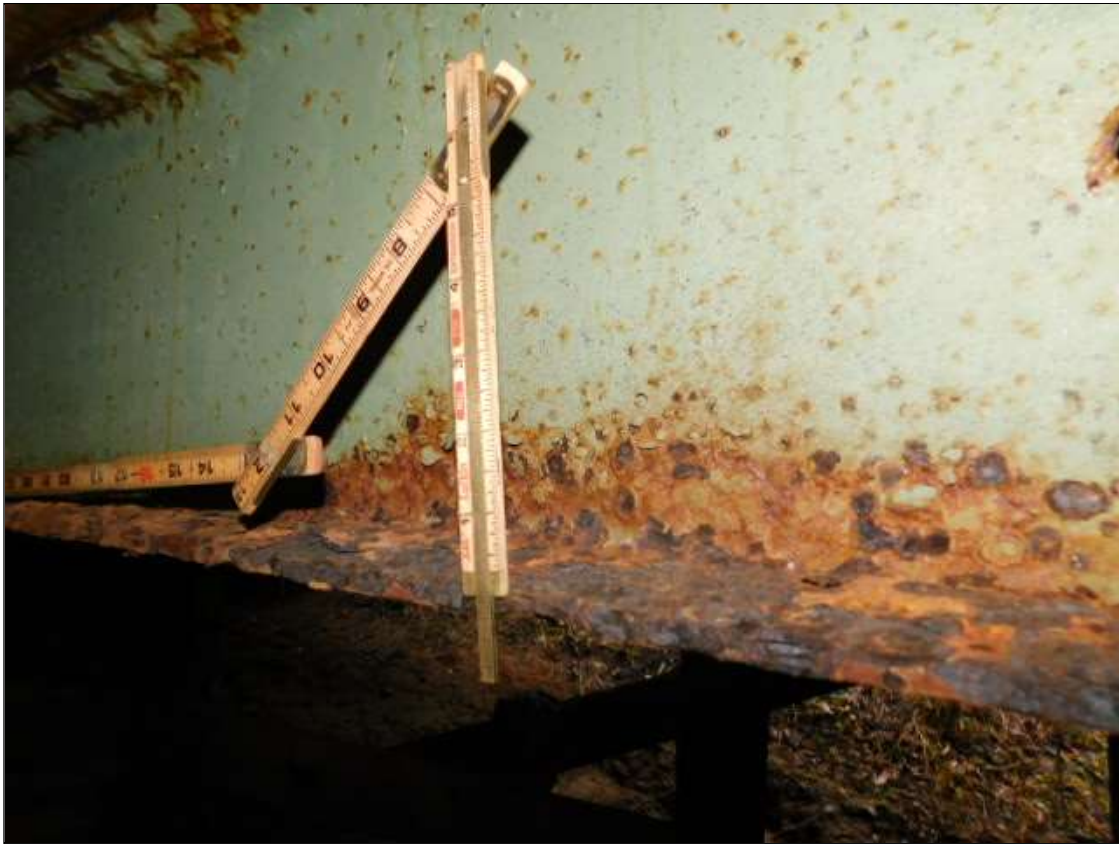
| Priority Level | Defect Type | Quantity | Defect Description |
|---|---|---|---|
| <b>2</b> | Corrosion | 1 | Span 2 Beam 6: RIGHT BOTTOM FLANGE IS DOWN TO 0.188" FROM THE ORIGINAL 0.375" FOR 2" LONG x 1" WIDE STARTING AT 11' 4" FROM THE END AT BENT 2. A PRIORITY ACTION REQUEST IS BEING ISSUED FOR THIS BEAM. |

Span 2 Beam 6: RIGHT BOTTOM FLANGE IS DOWN TO 0.188" FROM THE ORIGINAL 0.375" FOR 2" LONG x 1" WIDE STARTING AT 11' 4" FROM THE END AT END BENT 2. A PRIORITY ACTION REQUEST IS BEING ISSUED FOR THIS BEAM.

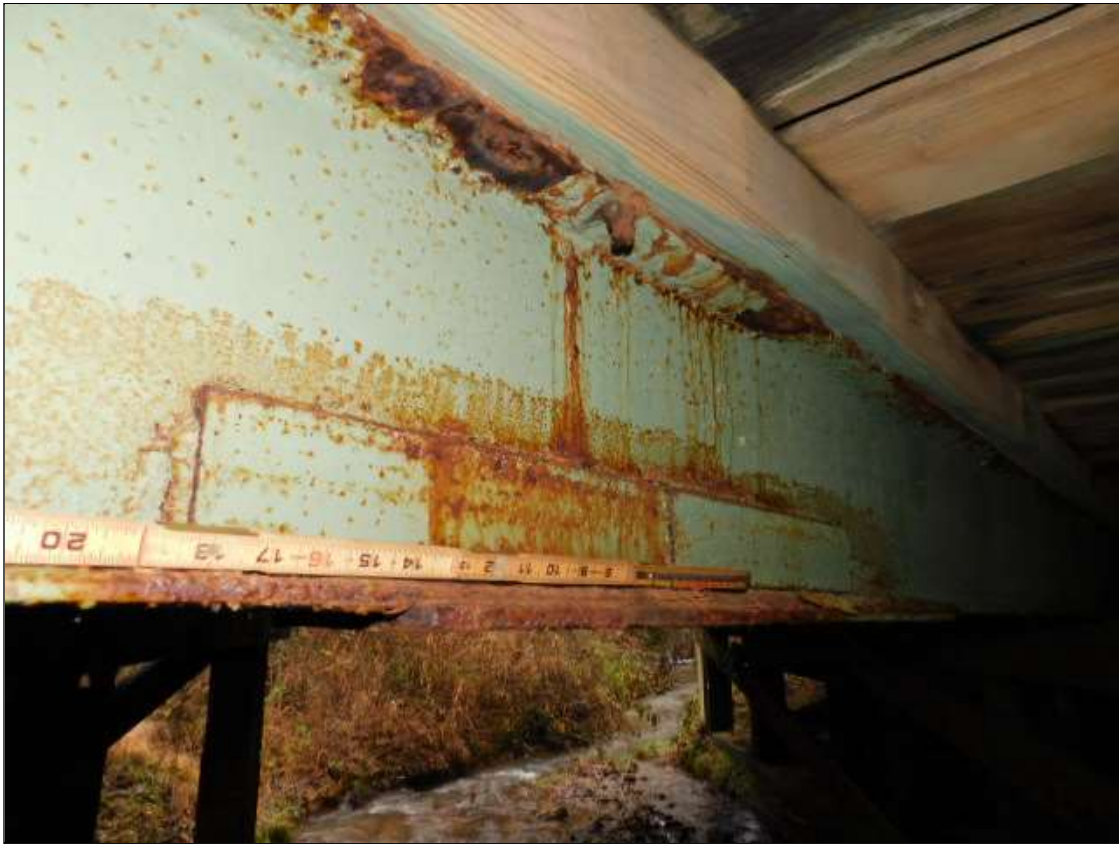
SPAN 2, BEAM 7: 35" LONG x 6" WIDE x 0.438" THICK PLATE WELDED TO THE BOTTOM FLANGE AT 8' 2" FROM THE END AT BENT 1. THE RIGHT FACE OF THE WEB HAS 2 PLATES 15" LONG x 3" HIGH x 0.438" THICK WELDED JUST ABOVE THE BOTTOM FLANGE. THIS REPAIR IS IN GOOD CONDITION.

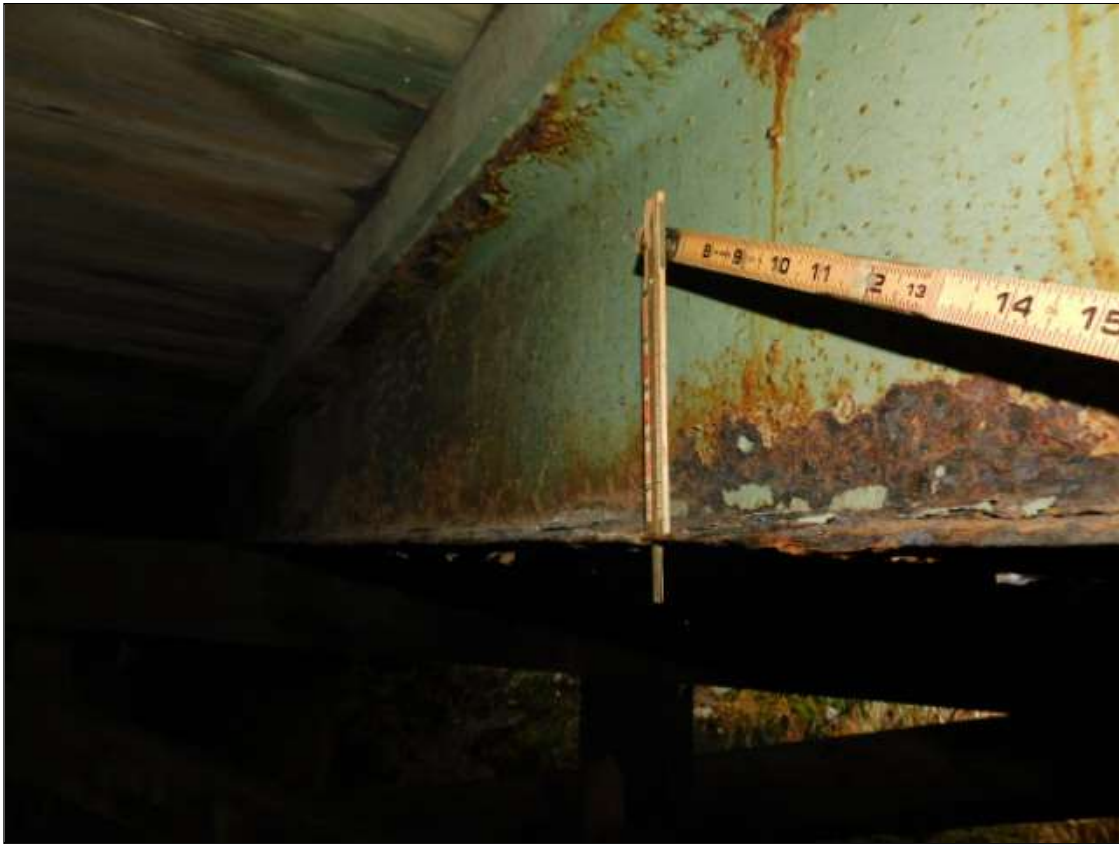
| Priority Level | Defect Type | Quantity | Defect Description |
|---|---|---|---|
| <b>2</b> | Corrosion | 9 | Span 2 Beam 7: LEFT BOTTOM FLANGE IS DOWN TO A KNIFE EDGE TO 0.125" FROM THE ORIGINAL 0.375" FOR 8' 11" LONG x 1.5" WIDE STARTING THE END AT BENT 2. A PRIORITY ACTION REQUEST IS BEING ISSUED FOR THIS BEAM. |

Span 2 Beam 7: LEFT BOTTOM FLANGE IS DOWN TO A KNIFE EDGE TO 0.125" FROM THE ORIGINAL 0.375" FOR 8' 11" LONG x 1.5" WIDE STARTING THE END AT BENT 2. A PRIORITY ACTION REQUEST IS BEING ISSUED FOR THIS BEAM.

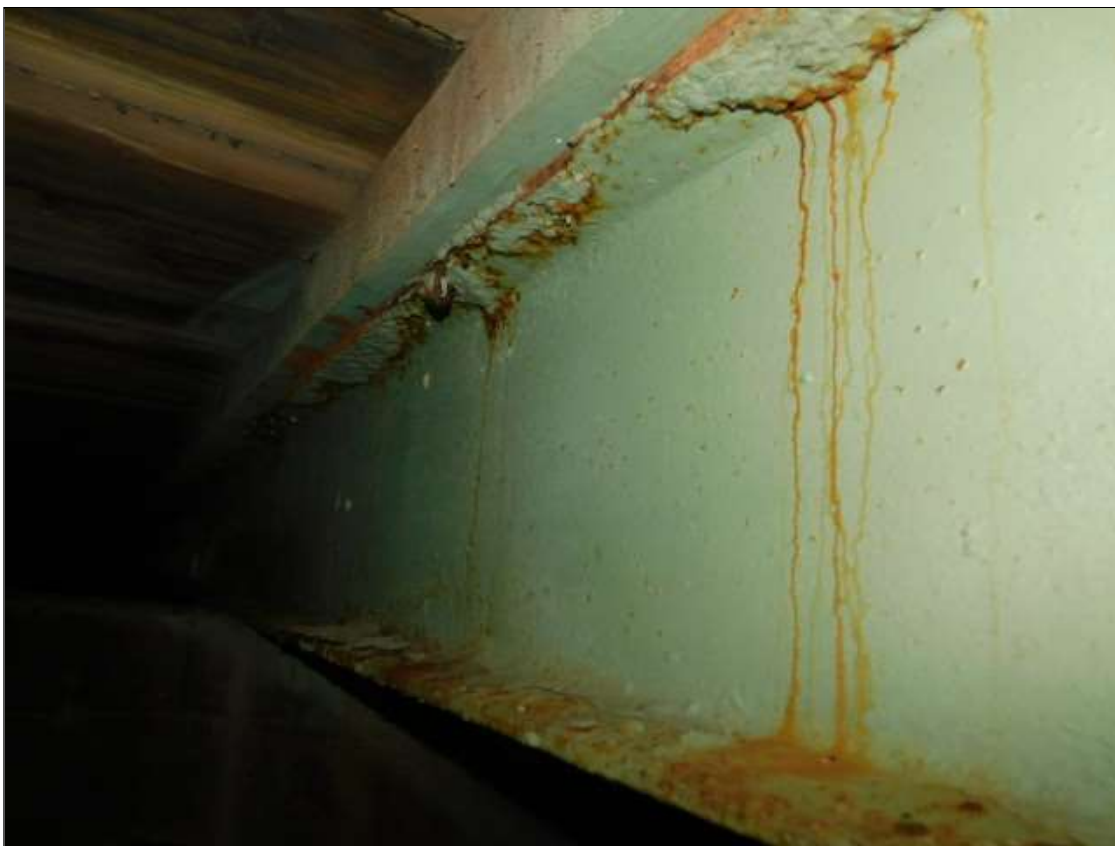
Span 2 Beam 8: 1/32" SECTION LOSS TO TOP FLANGE THROUGHOUT SPAN

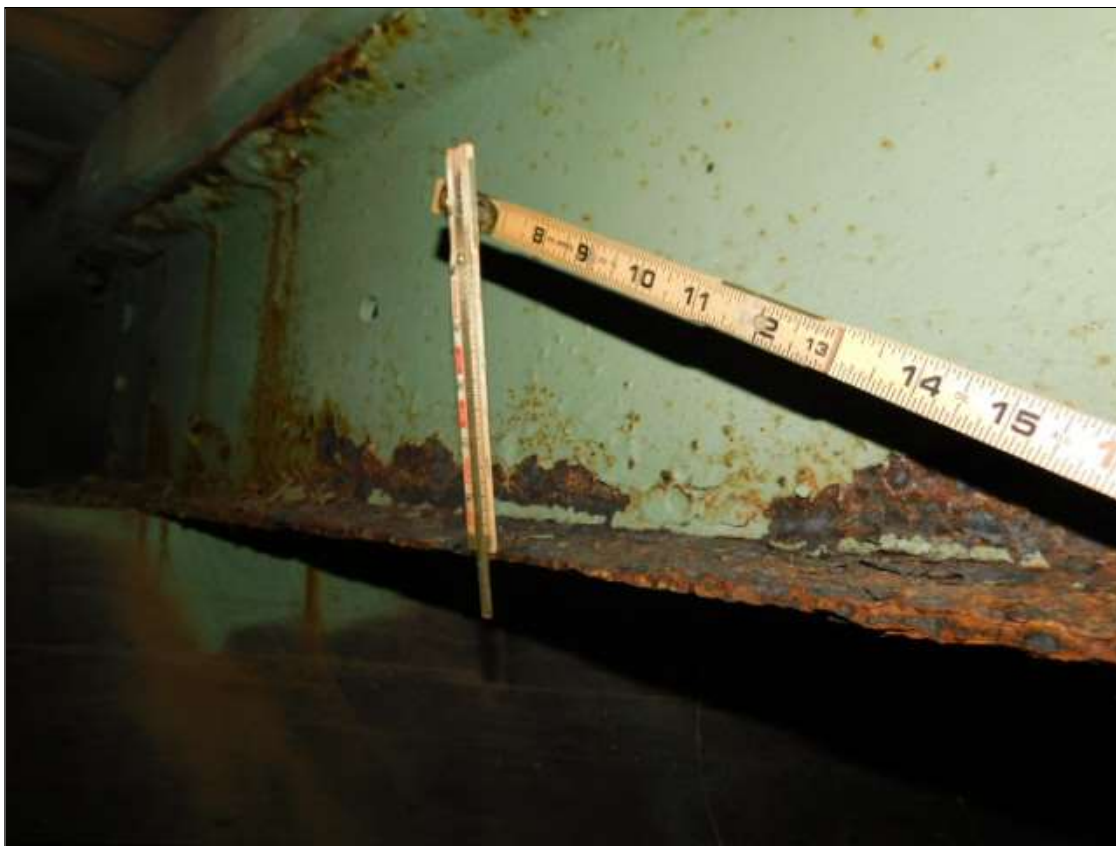
**2** Corrosion 16 Span 2 Beam 9: LEFT BOTTOM FLANGE IS DOWN TO 0.125" TO 0.250" FROM THE ORIGINAL 0.375" FOR 15' 5" LONG x 1.5" WIDE STARTING AT THE END AT BENT 2. A PRIORITY ACTION REQUEST IS BEING ISSUED FOR THIS BEAM.

Span 2 Beam 9: LEFT BOTTOM FLANGE IS DOWN TO 0.125" TO 0.250" FROM THE ORIGINAL 0.375" FOR 15' 5" LONG x 1.5" WIDE STARTING AT THE END AT BENT 2. A PRIORITY ACTION REQUEST IS BEING ISSUED FOR THIS BEAM.

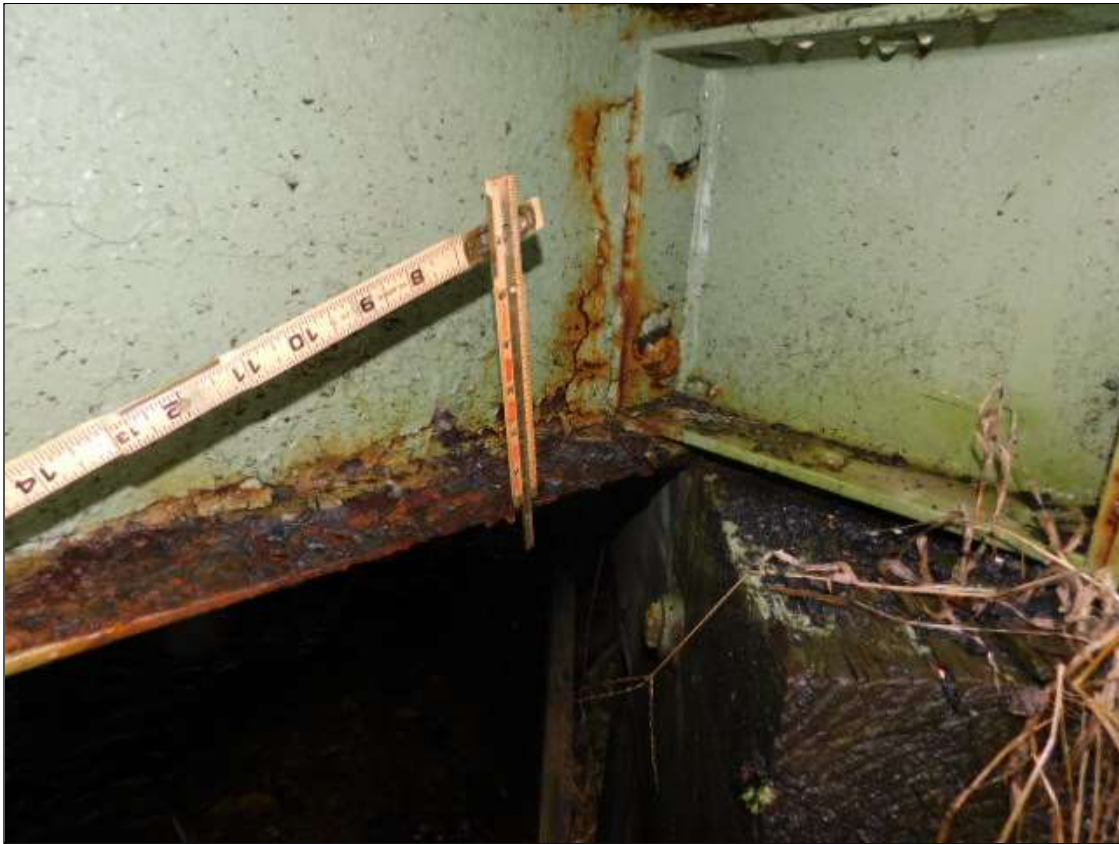
| Priority Level | Defect Type | Quantity | Defect Description |
|---|---|---|---|
| <b>2</b> | Corrosion | 3 | Span 2 Beam 10: RIGHT BOTTOM FLANGE IS DOWN TO 0.125" TO 0.250" FROM THE ORIGINAL 0.375" FOR 26" LONG x 1" WIDE STARTING AT THE END AT BENT 2. A PRIORITY ACTION REQUEST IS BEING ISSUED FOR THIS BEAM. |

Span 2 Beam 10: RIGHT BOTTOM FLANGE IS DOWN TO 0.125" TO 0.250" FROM THE ORIGINAL 0.375" FOR 26" LONG x 1" WIDE STARTING AT THE END AT BENT 2. A PRIORITY ACTION REQUEST IS BEING ISSUED FOR THIS BEAM.

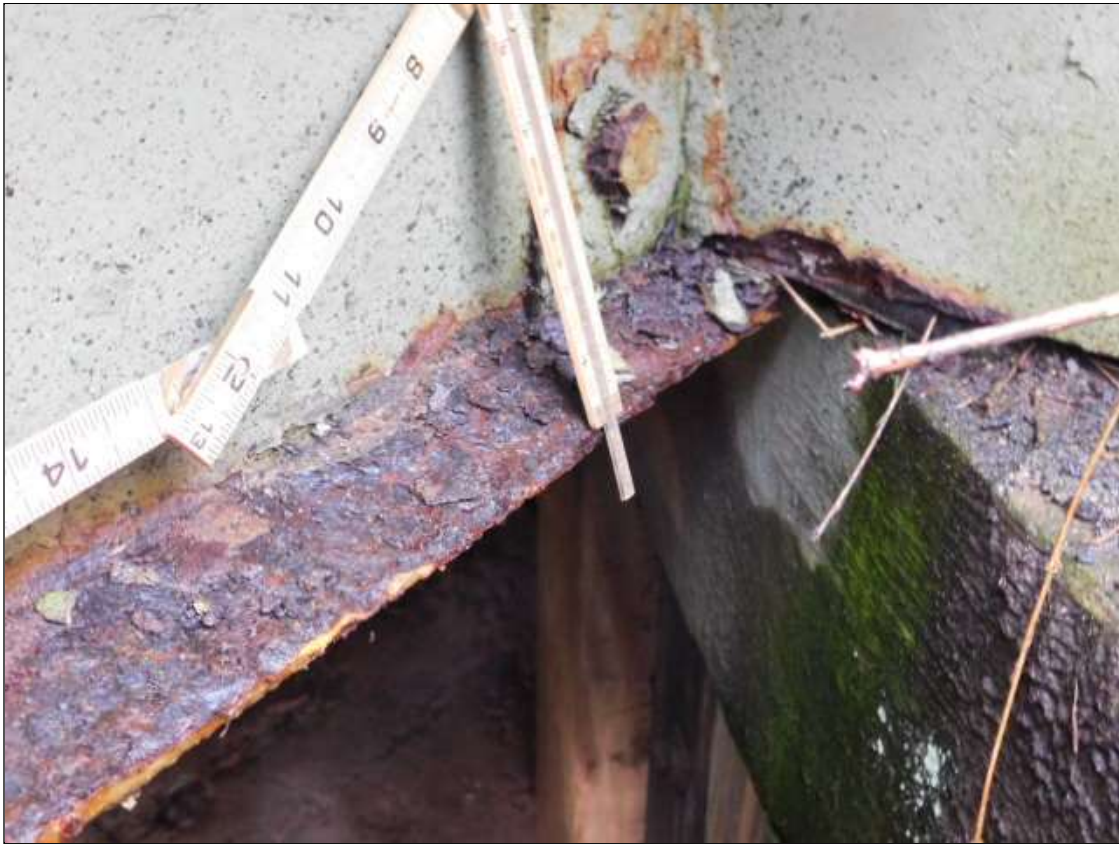
| 2 | Corrosion | 3 | Span 1 Beam 1: LEFT BOTTOM FLANGE IS DOWN TO 0.188" FROM THE ORIGINAL 0.375" FOR 3' 0" LONG x 1" WIDE STARTING AT THE END AT END BENT 1. A PRIORITY ACTION REQUEST IS BEING ISSUED FOR THIS BEAM. |

| Element Number | Defect Type | Defect Description | CS | CS Qty | Maint Qty |
|---|---|---|---|---|---|
| 107 | Corrosion | LEFT BOTTOM FLANGE IS DOWN TO 0.188" FROM THE ORIGINAL 0.375" FOR 3' 0" LONG x 1" WIDE STARTING AT THE END AT END BENT 1. A PRIORITY ACTION REQUEST IS BEING ISSUED FOR THIS BEAM. | 3 | 3 | 3 Feet |

Span 1 Beam 1: LEFT BOTTOM FLANGE IS DOWN TO 0.188" FROM THE ORIGINAL 0.375" FOR 3' 0" LONG x 1" WIDE STARTING AT THE END AT END BENT 1. A PRIORITY ACTION REQUEST IS BEING ISSUED FOR THIS BEAM.

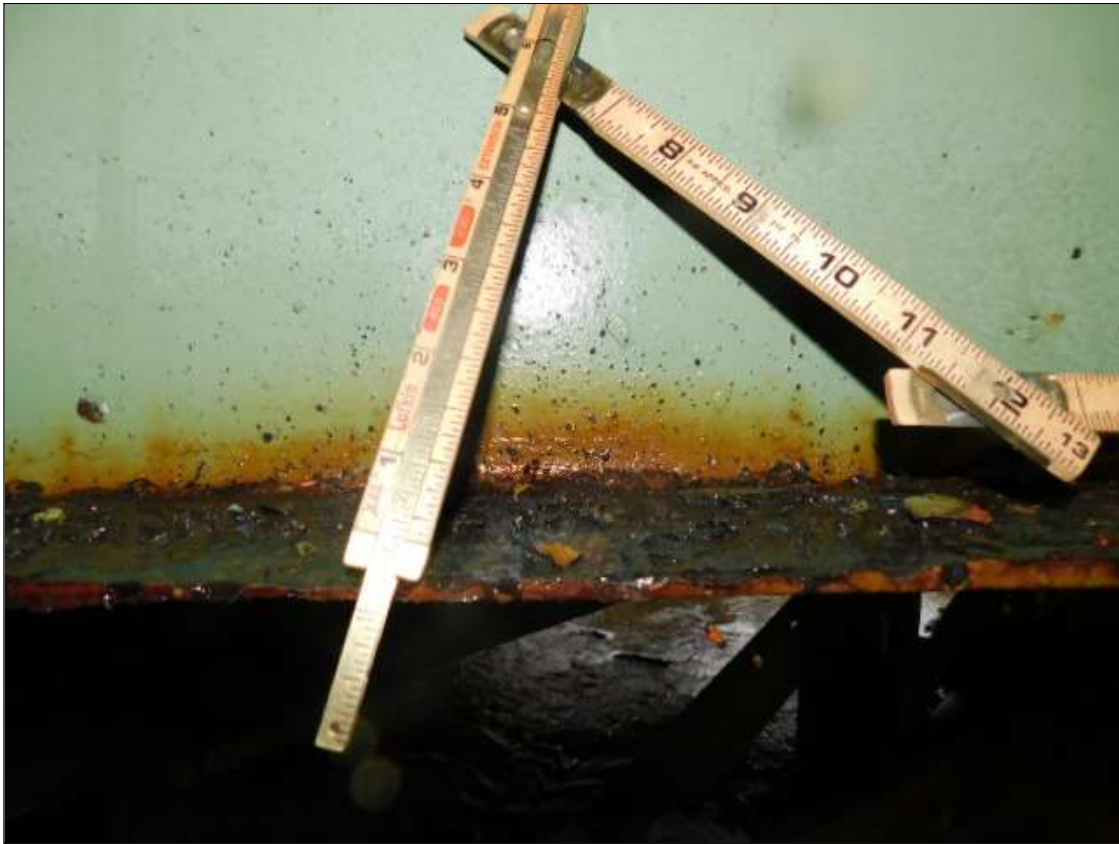
| 2 | Corrosion | 1 | Span 1 Beam 2: LEFT BOTTOM FLANGE IS DOWN TO 0.125" FROM THE ORIGINAL 0.375" FOR 4" LONG x 1" WIDE STARTING AT 3' 0" FROM THE END AT BENT 1. A PRIORITY ACTION REQUEST IS BEING ISSUED FOR THIS BEAM. |

| Element Number | Defect Type | Defect Description | CS | CS Qty | Maint Qty |
|---|---|---|---|---|---|
| 107 | Corrosion | LEFT BOTTOM FLANGE IS DOWN TO 0.125" FROM THE ORIGINAL 0.375" FOR 4" LONG x 1" WIDE STARTING AT 3' 0" FROM THE END AT BENT 1. A PRIORITY ACTION REQUEST IS BEING ISSUED FOR THIS BEAM. | 3 | 1 | 1 Feet |

Span 1 Beam 2: LEFT BOTTOM FLANGE IS DOWN TO 0.125" FROM THE ORIGINAL 0.375" FOR 4" LONG x 1" WIDE STARTING AT 3' 0" FROM THE END AT BENT 1. A PRIORITY ACTION REQUEST IS BEING ISSUED FOR THIS BEAM.

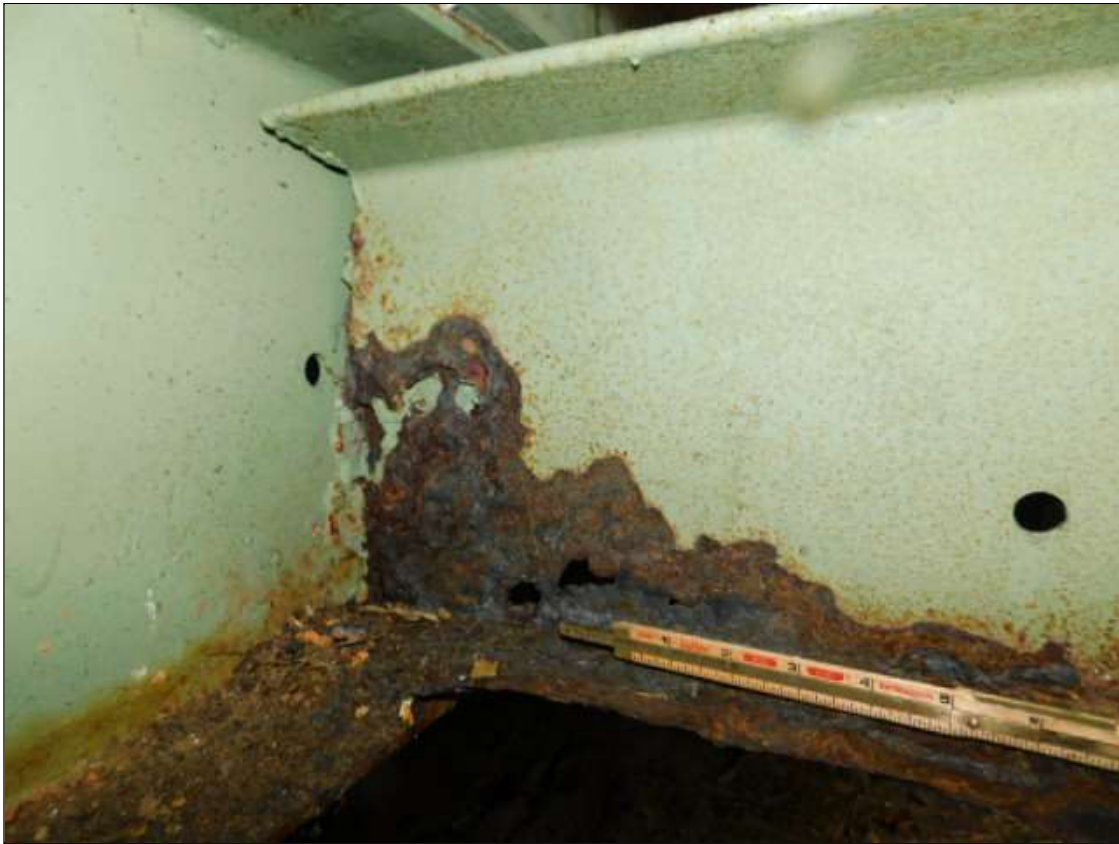
SPAN 1: BAY 1, DIAPHRAGM 2 BOTTOM FLANGE IS DOWN TO A KNIFE EDGE FOR 12" LONG x FULL WIDTH AND THE WEB IS DOWN TO 0.125" THICK FOR 14" LONG x UP TO 4" HIGH WITH 2 HOLES 0.75" DIAMETER NEAR THE BOTTOM FLANGE.

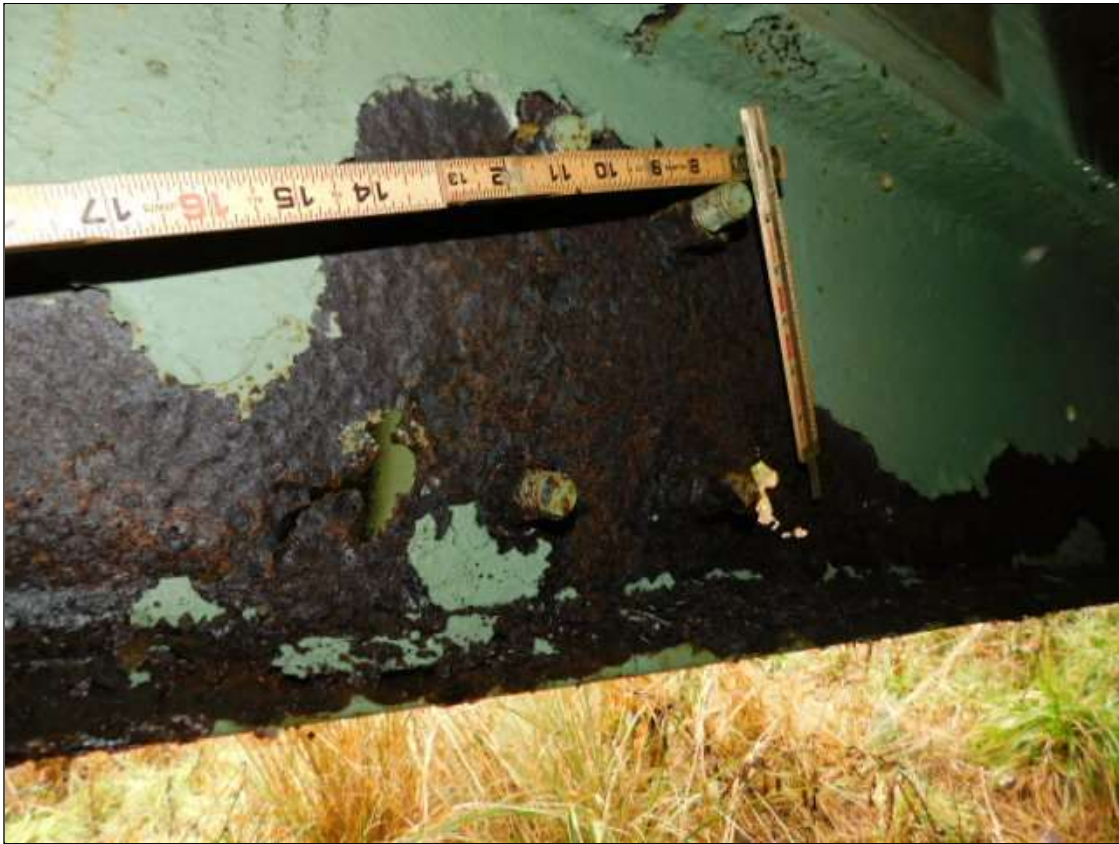
| 3 | Corrosion | 16 | Span 1 Beam 10: LEFT BOTTOM FLANGE IS DOWN TO A KNIFE EDGE TO 0.125" FROM THE ORIGINAL 0.375" FOR 15' 1" LONG x 1.5" WIDE STARTING AT THE END AT END BENT 1. THE WEB AT BRIDGERAIL POST 2 BLOCK HAS HOLES 3" HIGH x 1.25" WIDE AND 3" HIGH x 1" WIDE AT EITHER SIDE OF THE BLOCK. A PRIORITY ACTION REQUEST IS BEING ISSUED FOR THIS BEAM. |

| Element Number | Defect Type | Defect Description | CS | CS Qty | Maint Qty |
|---|---|---|---|---|---|
| 107 | Corrosion | LEFT BOTTOM FLANGE IS DOWN TO A KNIFE EDGE TO 0.125" FROM THE ORIGINAL 0.375" FOR 15' 1" LONG x 1.5" WIDE STARTING AT THE END AT END BENT 1. THE WEB AT BRIDGERAIL POST 2 BLOCK HAS HOLES 3" HIGH x 1.25" WIDE AND 3" HIGH x 1" WIDE AT EITHER SIDE OF THE BLOCK. A PRIORITY ACTION REQUEST IS BEING ISSUED FOR THIS BEAM. | 4 | 16 | 16 Feet |

Span 1 Beam 10: LEFT BOTTOM FLANGE IS DOWN TO A KNIFE EDGE TO 0.125" FROM THE ORIGINAL 0.375" FOR 15' 1" LONG x 1.5" WIDE STARTING AT THE END AT END BENT 1. THE WEB AT BRIDGERAIL POST 2 BLOCK HAS HOLES 3" HIGH x 1.25" WIDE AND 3" HIGH x 1" WIDE AT EITHER SIDE OF THE BLOCK. A PRIORITY ACTION REQUEST IS BEING ISSUED FOR THIS BEAM.

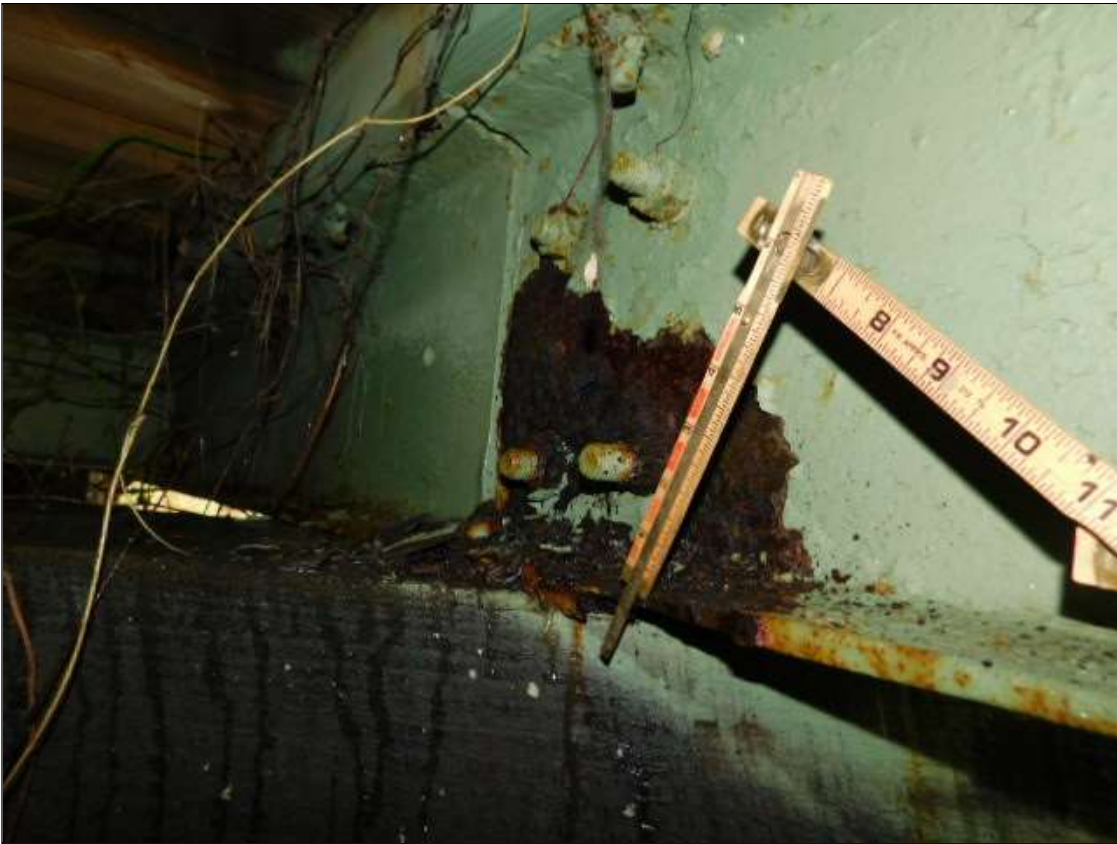
| 2 | Corrosion | 1 | Span 1 Beam 10: BOTH SIDES OF THE BOTTOM FLANGE ARE DOWN TO A KNIFE EDGE 0.125" FROM THE ORIGINAL 0.375" FOR 10" LONG x FULL WIDTH STARTING AT THE END AT BENT 1. THE LOWER WEB IS DOWN TO 0.125" TO 0.250" FROM THE ORIGINAL 0.375" FOR 10" LONG x 8" HIGH IN THIS AREA. A PRIORITY ACTION REQUEST IS BEING ISSUED FOR THIS BEAM. |

| Element Number | Defect Type | Defect Description | CS | CS Qty | Maint Qty |
|---|---|---|---|---|---|
| 107 | Corrosion | BOTH SIDES OF THE BOTTOM FLANGE ARE DOWN TO A KNIFE EDGE 0.125" FROM THE ORIGINAL 0.375" FOR 10" LONG x FULL WIDTH STARTING AT THE END AT BENT 1. THE LOWER WEB IS DOWN TO 0.125" TO 0.250" FROM THE ORIGINAL 0.375" FOR 10" LONG x 8" HIGH IN THIS AREA. A PRIORITY ACTION REQUEST IS BEING ISSUED FOR THIS BEAM. | 4 | 1 | 1 Feet |

Span 1 Beam 10: BOTH SIDES OF THE BOTTOM FLANGE ARE DOWN TO A KNIFE EDGE 0.125" FROM THE ORIGINAL 0.375" FOR 10" LONG x FULL WIDTH STARTING AT THE END AT BENT 1. THE LOWER WEB IS DOWN TO 0.125" TO 0.250" FROM THE ORIGINAL 0.375" FOR 10" LONG x 8" HIGH IN THIS AREA. A PRIORITY ACTION REQUEST IS BEING ISSUED FOR THIS BEAM.

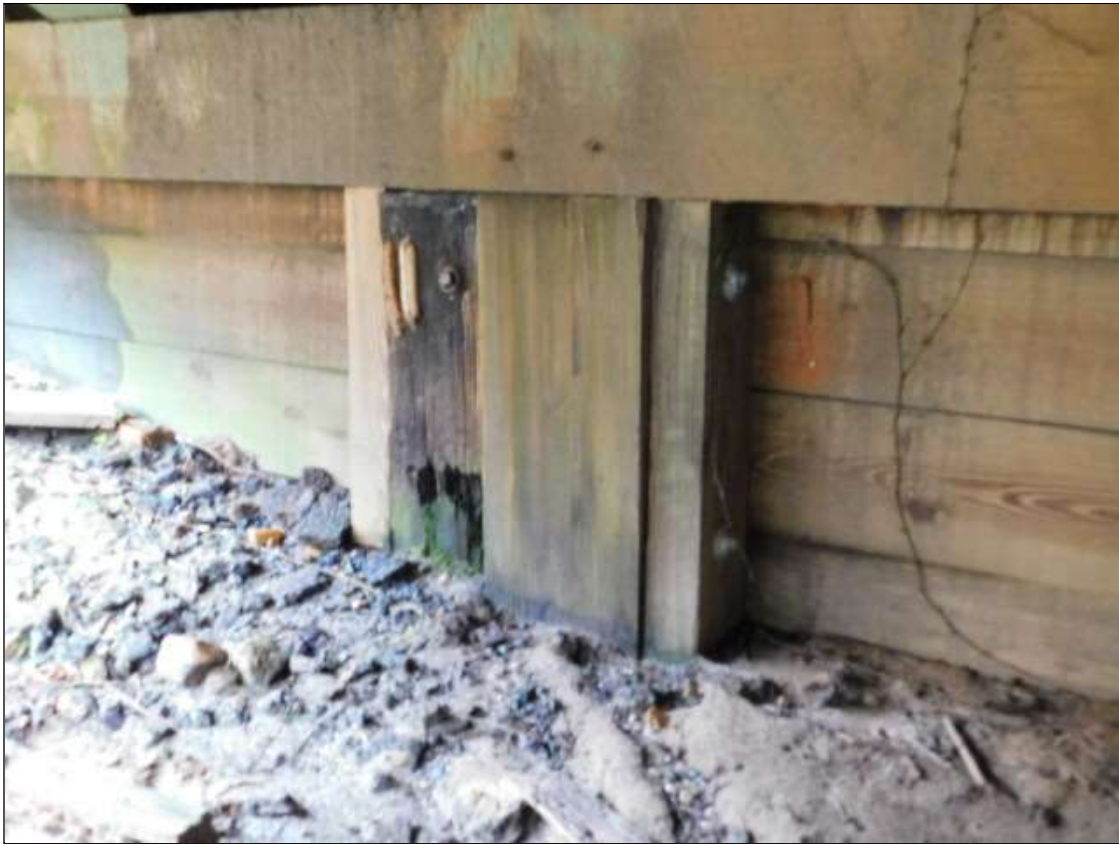
End Bent 1 Pile 7: EAST FACE OF THE POST HAS 8" HIGH x 8" WIDE x 3" DEEP DECAY. THERE IS AN ADJACENT SUPPLEMENT POST.

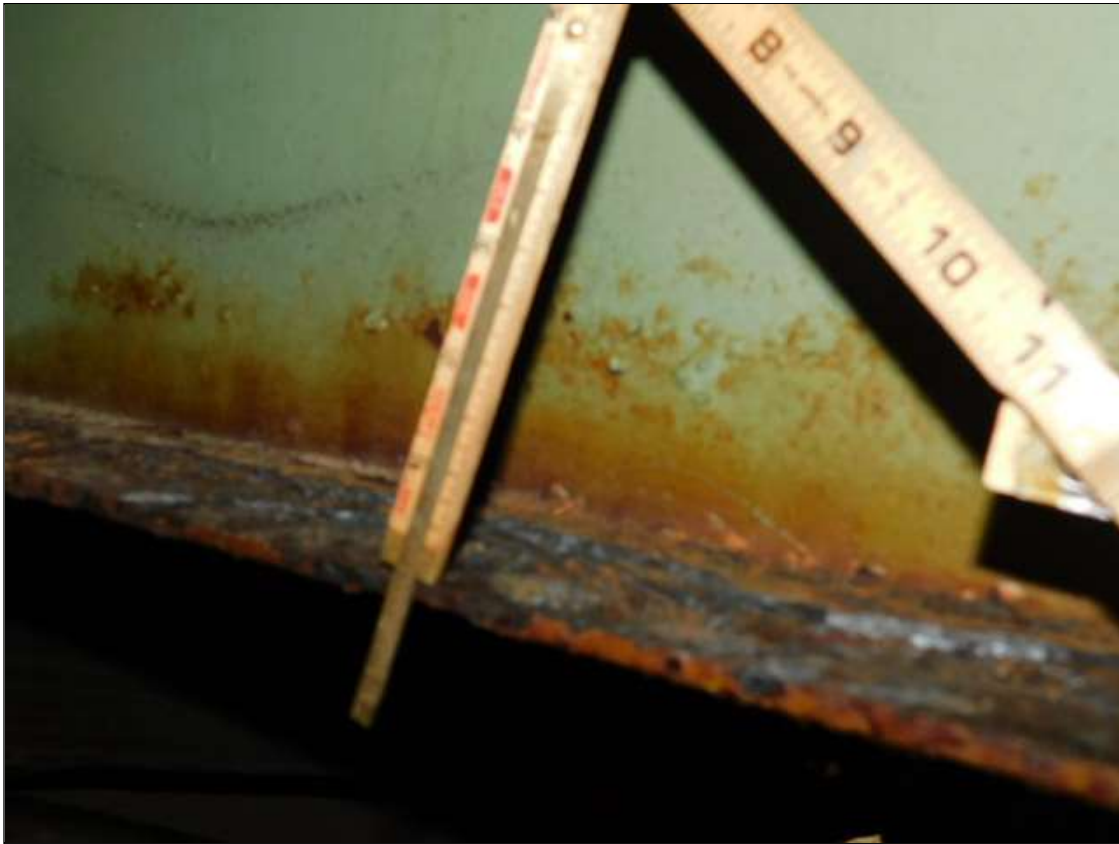
| 2 | Corrosion | 12 | Span 1 Beam 5: LEFT BOTTOM FLANGE IS DOWN TO 0.250" IN SCATTERED AREAS FROM THE ORIGINAL 0.375" FOR 11' 6" LONG x 1" WIDE STARTING AT 6' 2" FROM THE END AT BENT 1. A PRIORITY ACTION REQUEST IS BEING ISSUED FOR THIS BEAM. |

| Element Number | Defect Type | Defect Description | CS | CS Qty | Maint Qty |
|---|---|---|---|---|---|
| 107 | Corrosion | LEFT BOTTOM FLANGE IS DOWN TO 0.250" IN SCATTERED AREAS FROM THE ORIGINAL 0.375" FOR 11' 6" LONG x 1" WIDE STARTING AT 6' 2" FROM THE END AT BENT 1. A PRIORITY ACTION REQUEST IS BEING ISSUED FOR THIS BEAM. | 3 | 12 | 12 Feet |

Span 1 Beam 5: LEFT BOTTOM FLANGE IS DOWN TO 0.250" IN SCATTERED AREAS FROM THE ORIGINAL 0.375" FOR 11' 6" LONG x 1" WIDE STARTING AT 6' 2" FROM THE END AT BENT 1. A PRIORITY ACTION REQUEST IS BEING ISSUED FOR THIS BEAM.

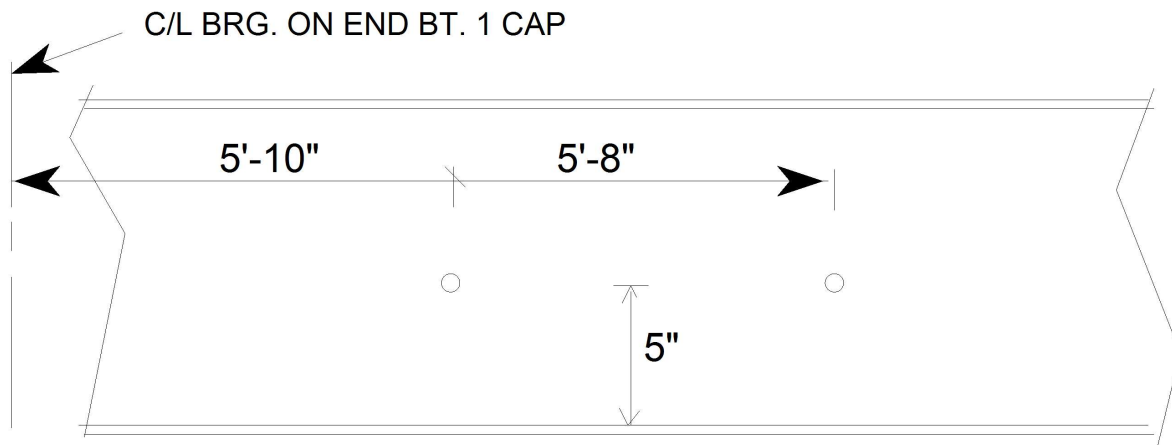
TYP. HOLES IN WEB OF BMS. #2,5 & 10 IN SPAN #1 - (HOLES 11/16" DIAM. DRILLED)

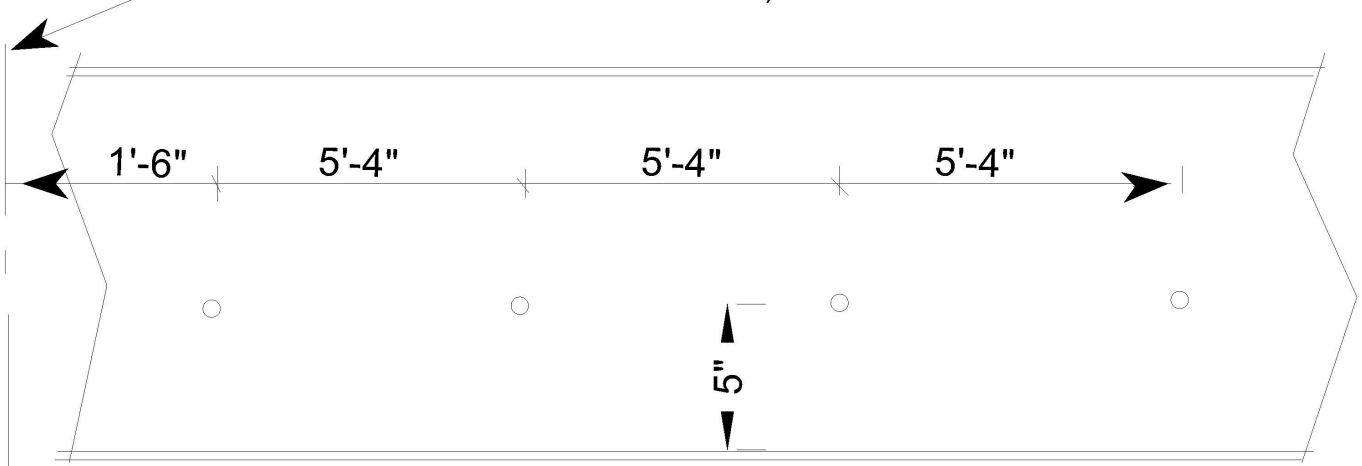
TYP. HOLES IN WEB OF BMS. #6 & 10 IN SP. #2 AND #2,5 & 7 IN SP. #3  
(ALL HOLES 11/16" DIAMETER DRILLED)
