NC DEPARTMENT OF TRANSPORTATION  
DIVISION OF HIGHWAYS  
STRUCTURE MANAGEMENT UNIT

# Structure Safety Report

## Routine Element Inspection - Contract

DIVISION: 11 COUNTY: ALLEGHANY STRUCTURE NUMBER: 020035 FREQUENCY: 24 MONTHS

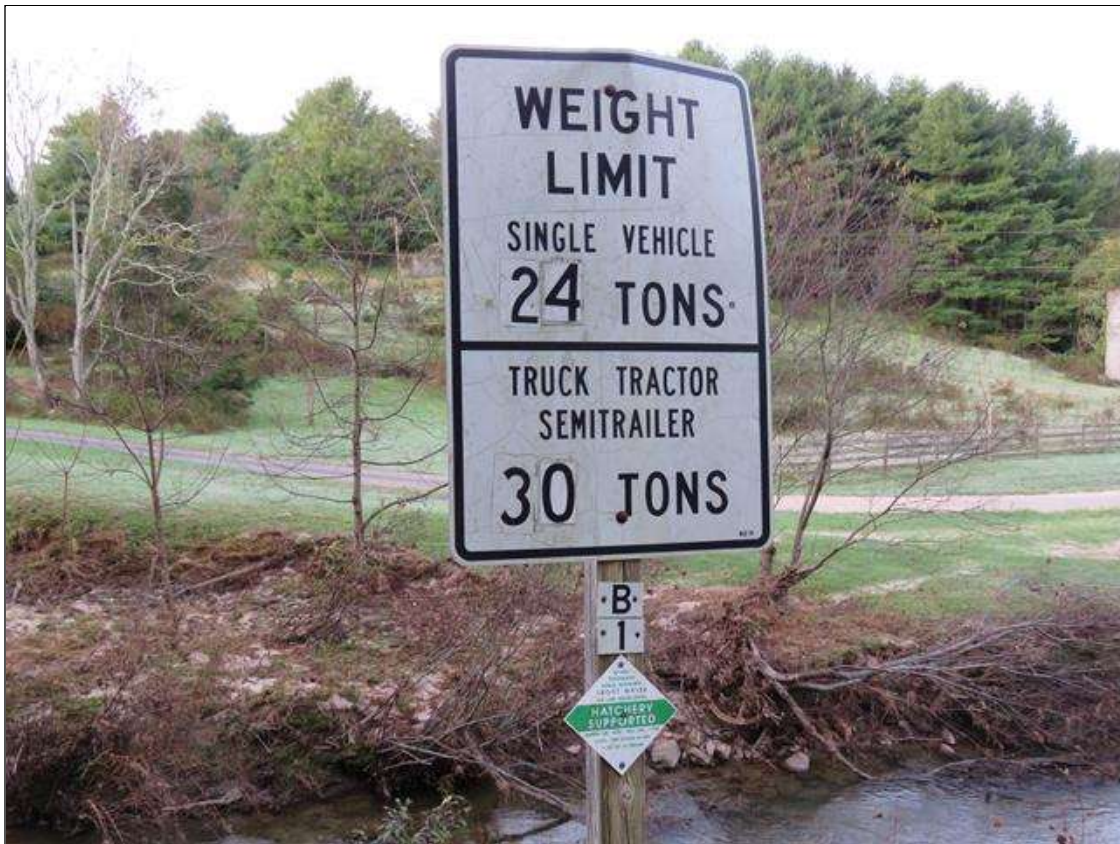
WEIGHT LIMIT FAR LEFT, DOES NOT REFLECT CURRENT POSTING SV: 22 TONS, TTST: 27 TONS (PM PHOTO)

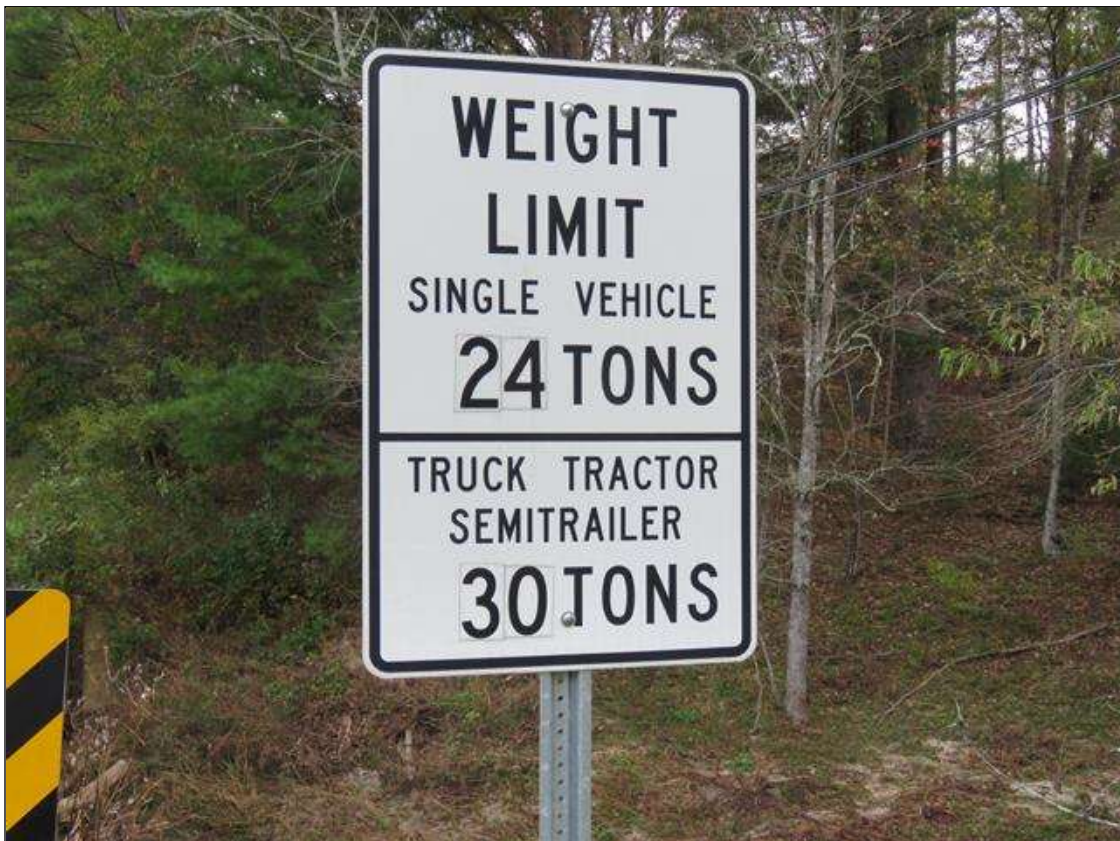
WEIGHT LIMIT NEAR RIGHT, DOES NOT REFLECT CURRENT POSTING SV: 22 TONS, TTST: 27 TONS (PM PHOTO)

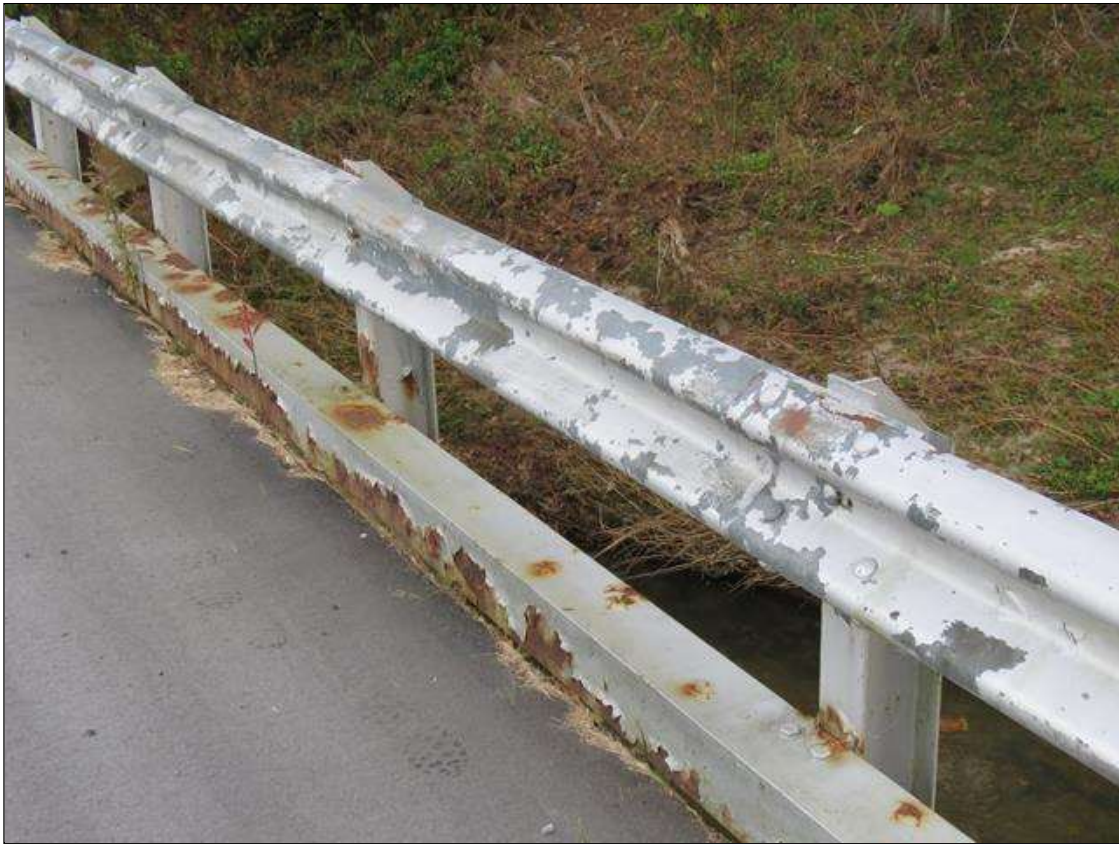
TYPICAL INTERMITTENT PC FLAKING AND PEELING WITH MINOR SURFACE CORROSION THROUGHOUT SPAN 1 RIGHT RAIL

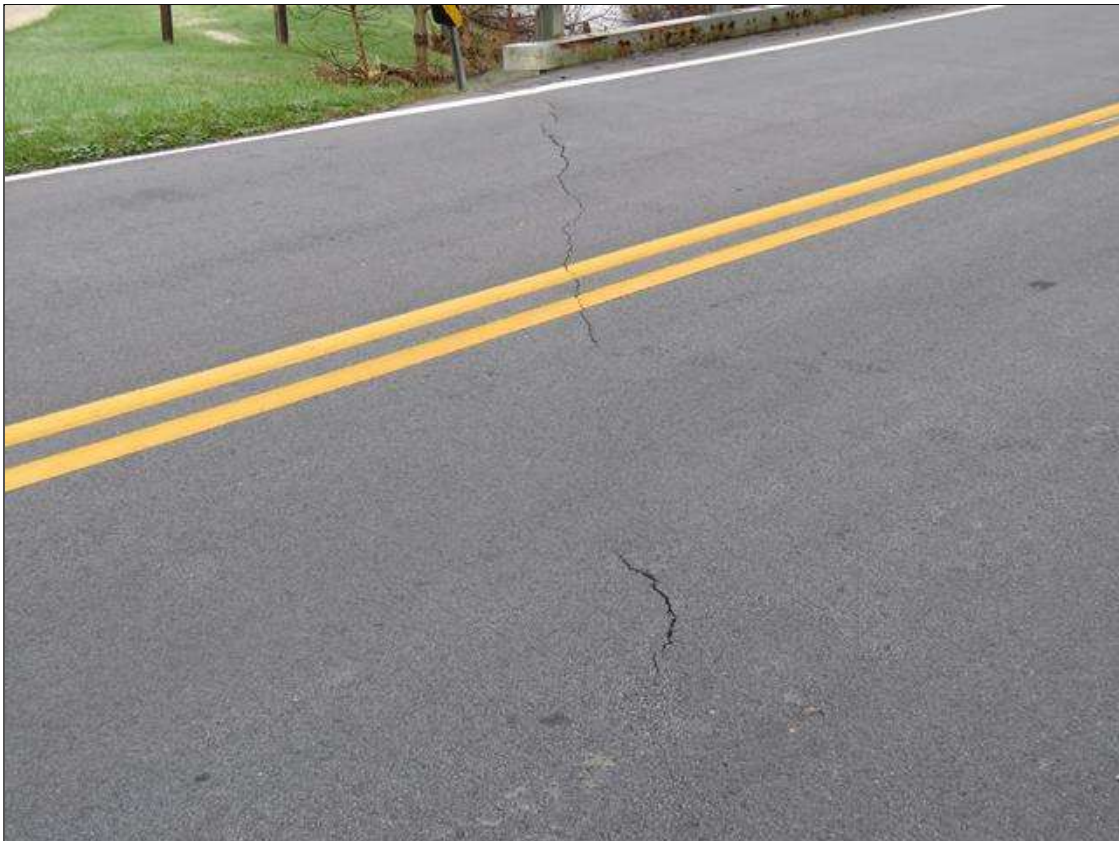
NEAR APPROACH ROADWAY AWS HAIRLINE TO 1/2" FULL WIDTH TRANSVERSE CRACKING

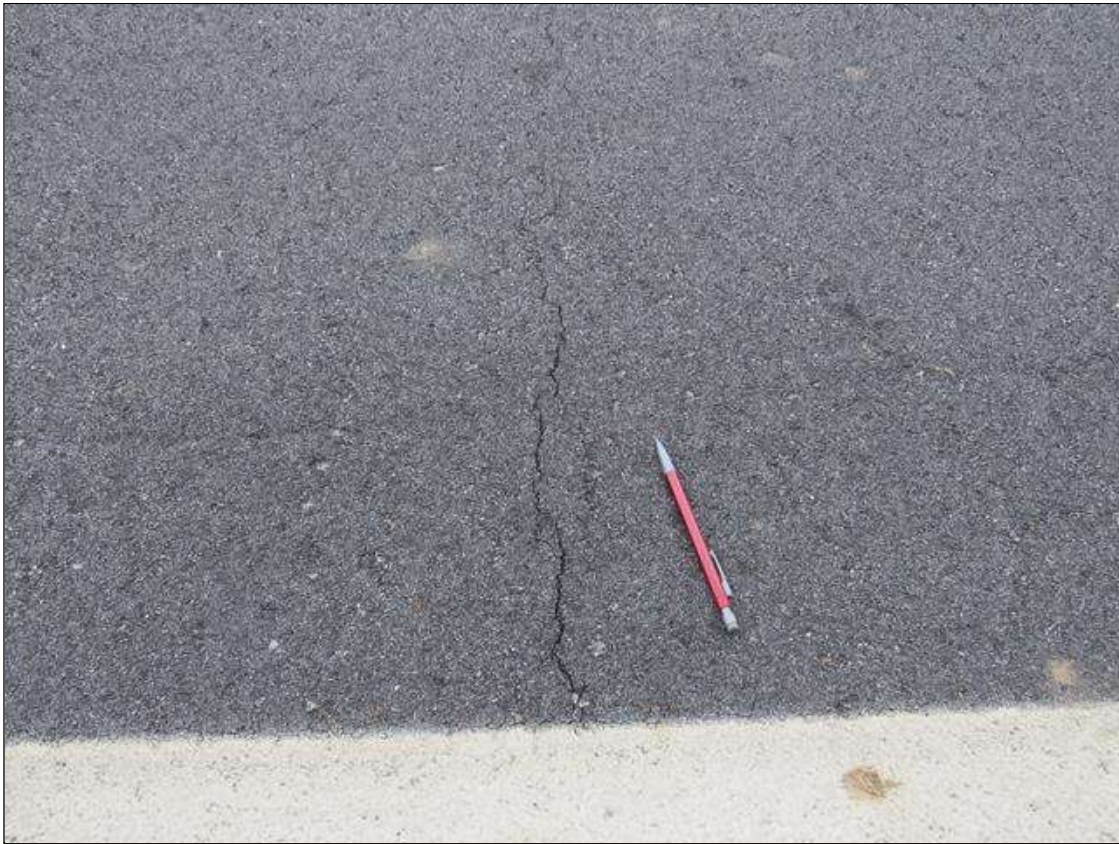
TYPICAL INTERMITTENT HAIRLINE TO 1/8" TRANSVERSE CRACKING, PARTIAL WIDTH (2' TO 6' LENGTH)  
SPACED 2' O.C. FULL LENGTH SPAN 1 AWS RIGHT LANE

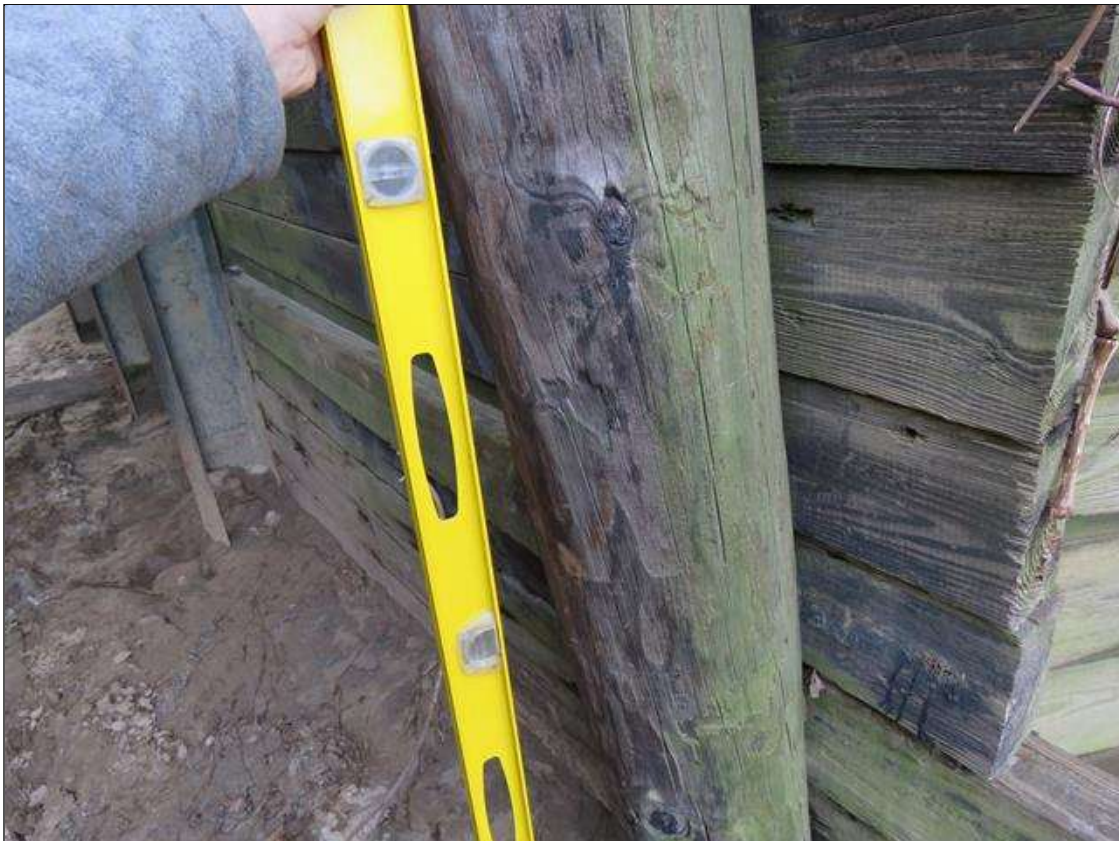
END BENT 1 ABUTMENT LAGGING PILE LEFT END MODERATE ROTATION TOWARDS CHANNEL, MEASURED  
8" OVER 4' HEIGHT (PM PHOTO 1 OF 2)

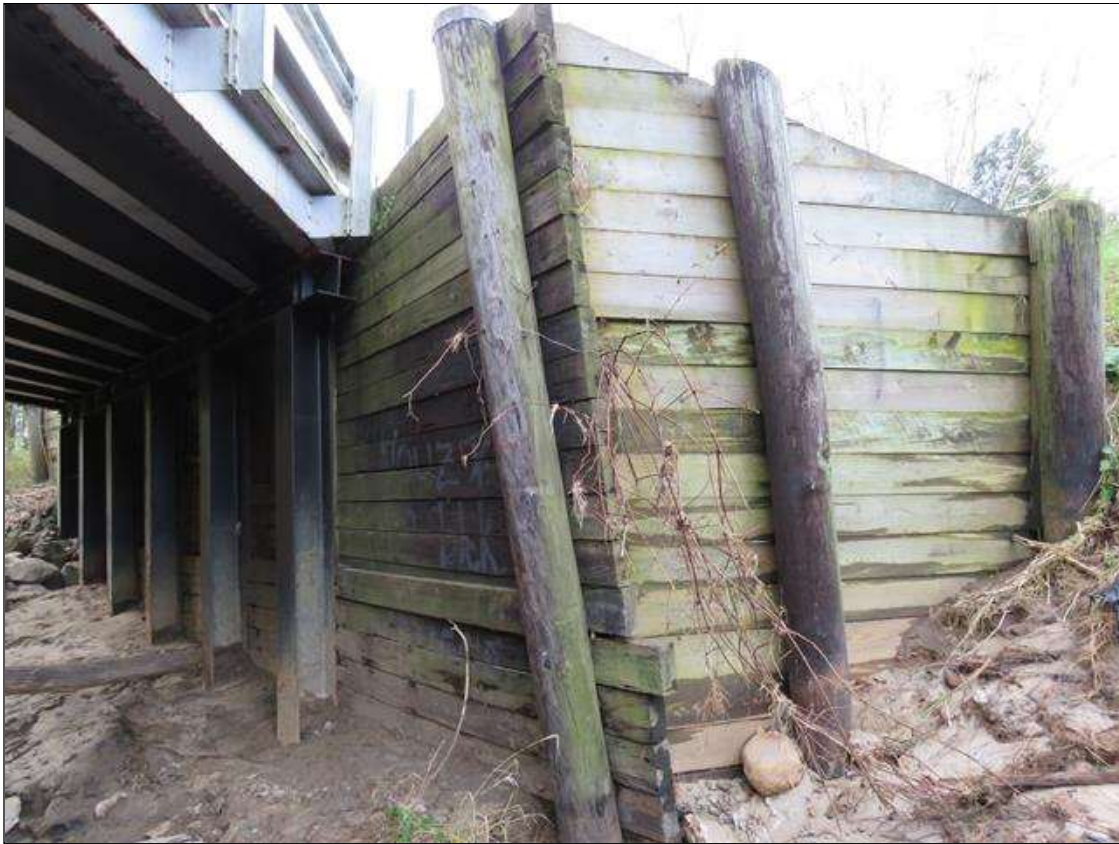
END BENT 1 ABUTMENT LAGGING PILE LEFT END MODERATE ROTATION TOWARDS CHANNEL, MEASURED 8" OVER 4' HEIGHT (PM PHOTO 2 OF 2)

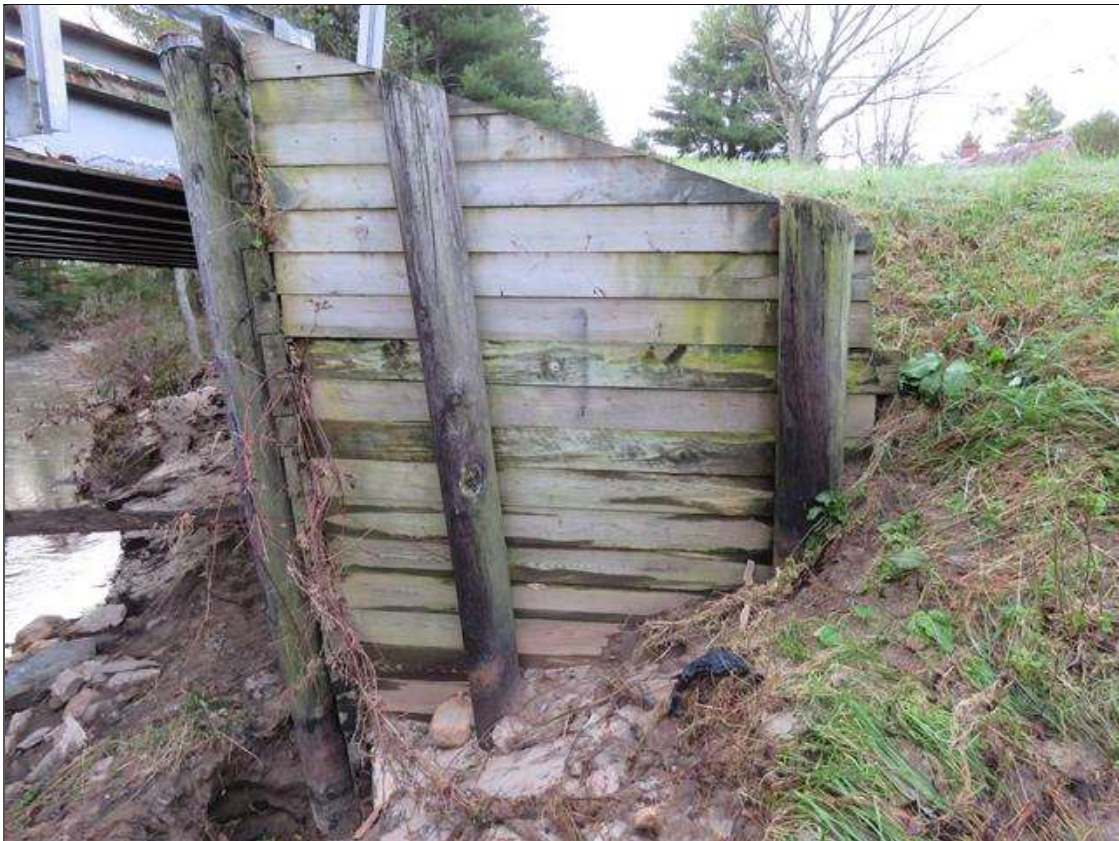
END BENT 1 ABUTMENT LAGGING PILE LEFT END SCOUR HOLE (4'DIAM. x 3' DEPTH) AT BASE OF PILE

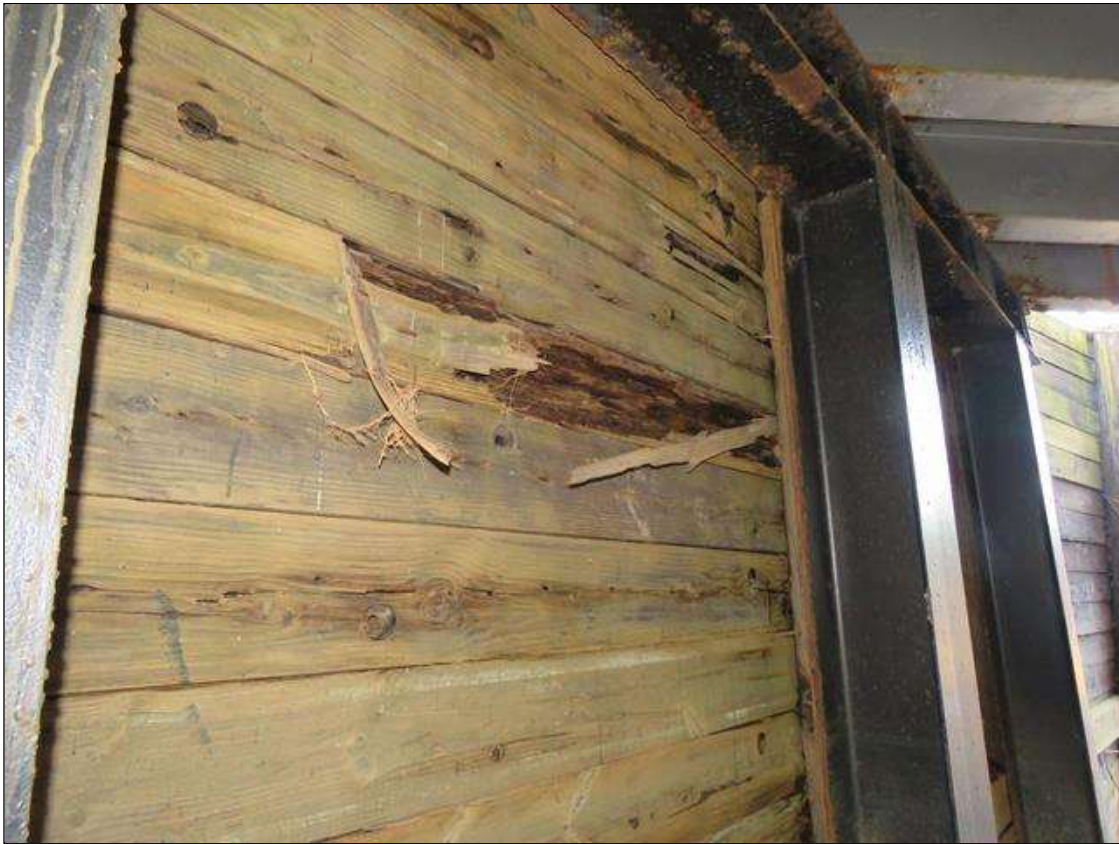
END BENT 1 ABUTMENT MODERATE DECAY WITH UP TO 75% SECTION LOSS OF TIMBER LAGGING, 1" REMAINING OF 4" ORIGINAL THICKNESS, BELOW CAP BETWEEN PILES 2 AND 3 (5'x3'), SIMILAR BETWEEN PILES 3 AND 4 (PM PHOTO)

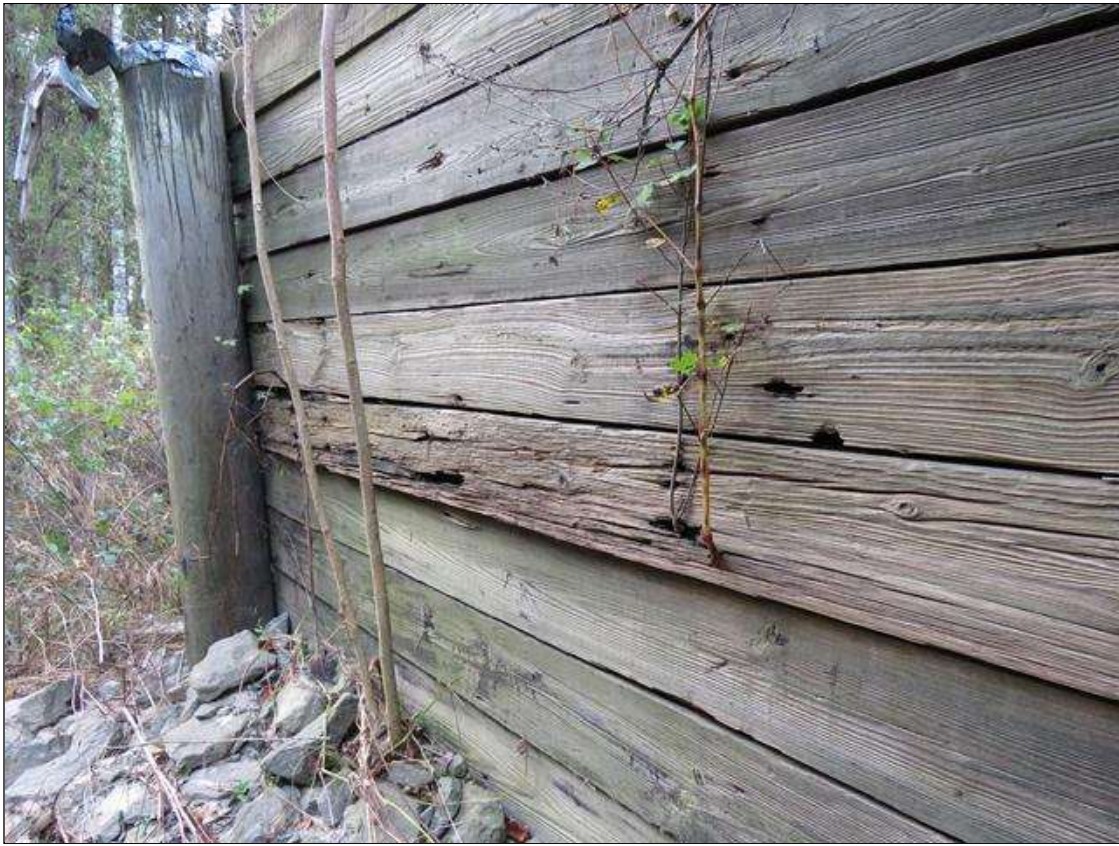
END BENT 1 ABUTMENT RIGHT EXTENSION MINOR TO MODERATE DECAY WITH UP TO 25% SECTION LOSS OF TIMBER LAGGING, 3" REMAINING OF 4" ORIGINAL THICKNESS (10'x8'), MINOR DAMAGE TO TOP OF LAGGING WALL AND END SUPPORT PILE (PM PHOTO)

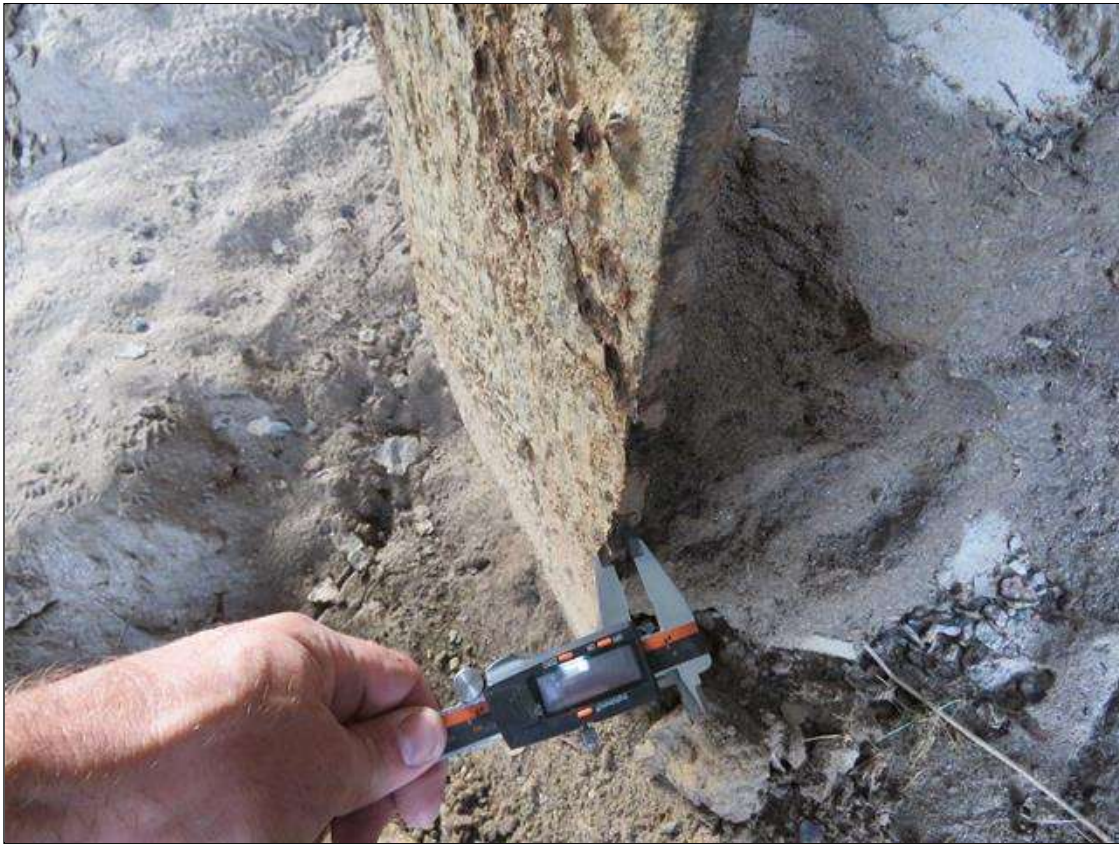
END BENT 1 PILE 1 FAR FACE FLANGE AT GRADE 1.5' HEIGHT x FULL WIDTH MINOR SCALE AND PITTING WITH 1/16" SECTION LOSS (14%), 3/8" REMAINING OF 7/16" ORIGINAL

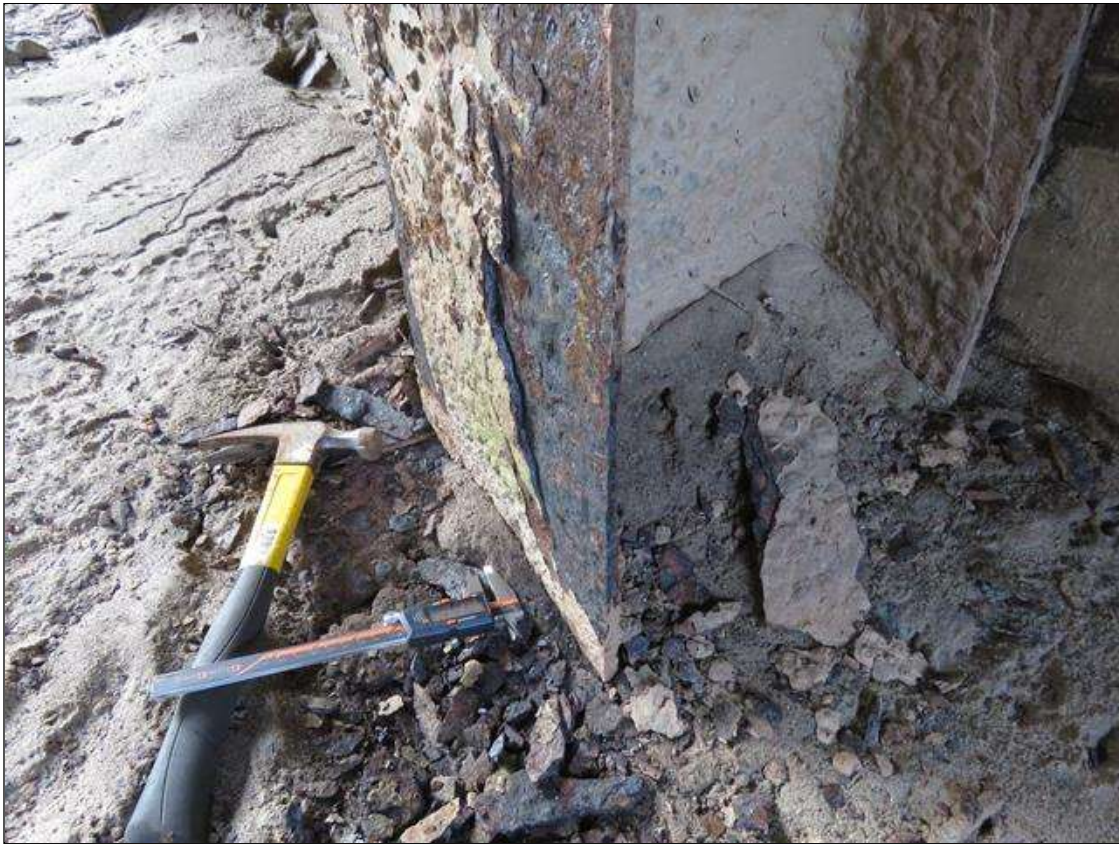
END BENT 1 PILE 3 FAR FACE FLANGE AT GRADE 2' HEIGHT x FULL WIDTH MINOR SCALE AND PITTING WITH 3/16" SECTION LOSS (42%), 1/4" REMAINING OF 7/16" ORIGINAL (PM PHOTO)

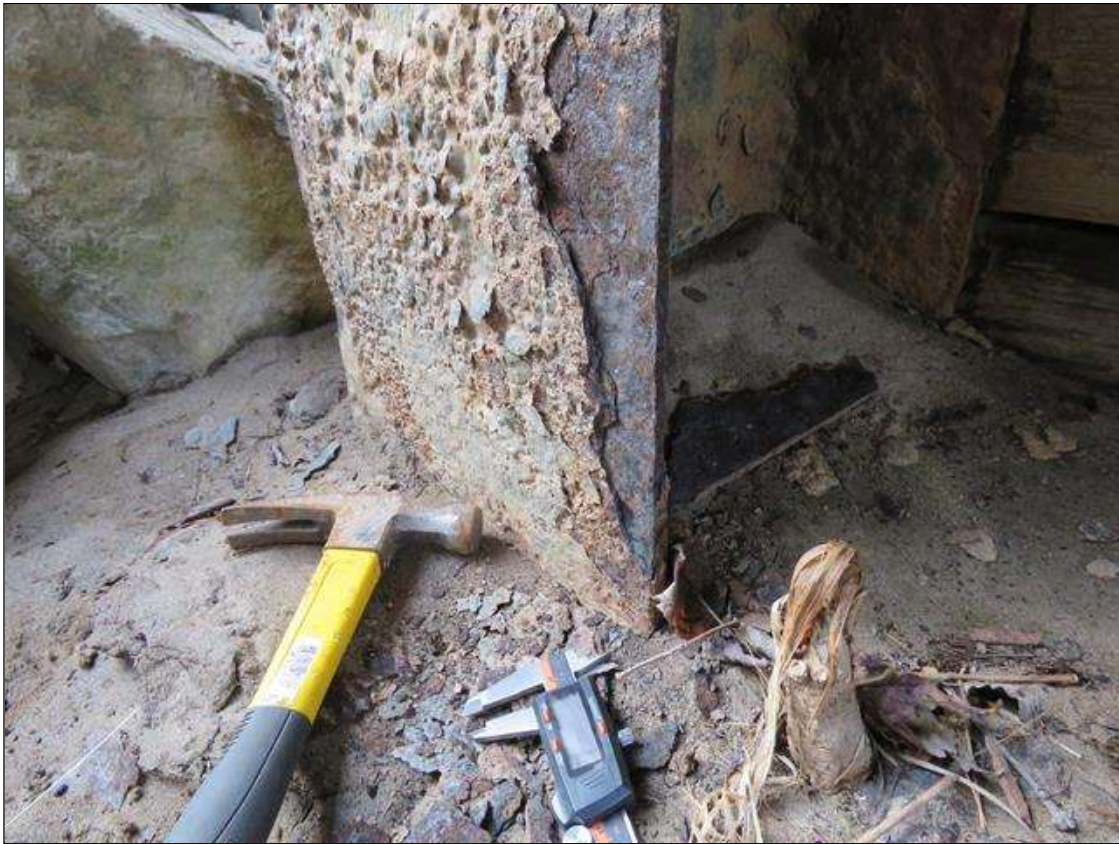
END BENT 1 PILE 5 FAR FACE FLANGE AT GRADE 1.5' HEIGHT x FULL WIDTH MINOR SCALE AND PITTING WITH 1/8" SECTION LOSS (28%), 5/16" REMAINING OF 7/16" ORIGINAL (PM PHOTO)

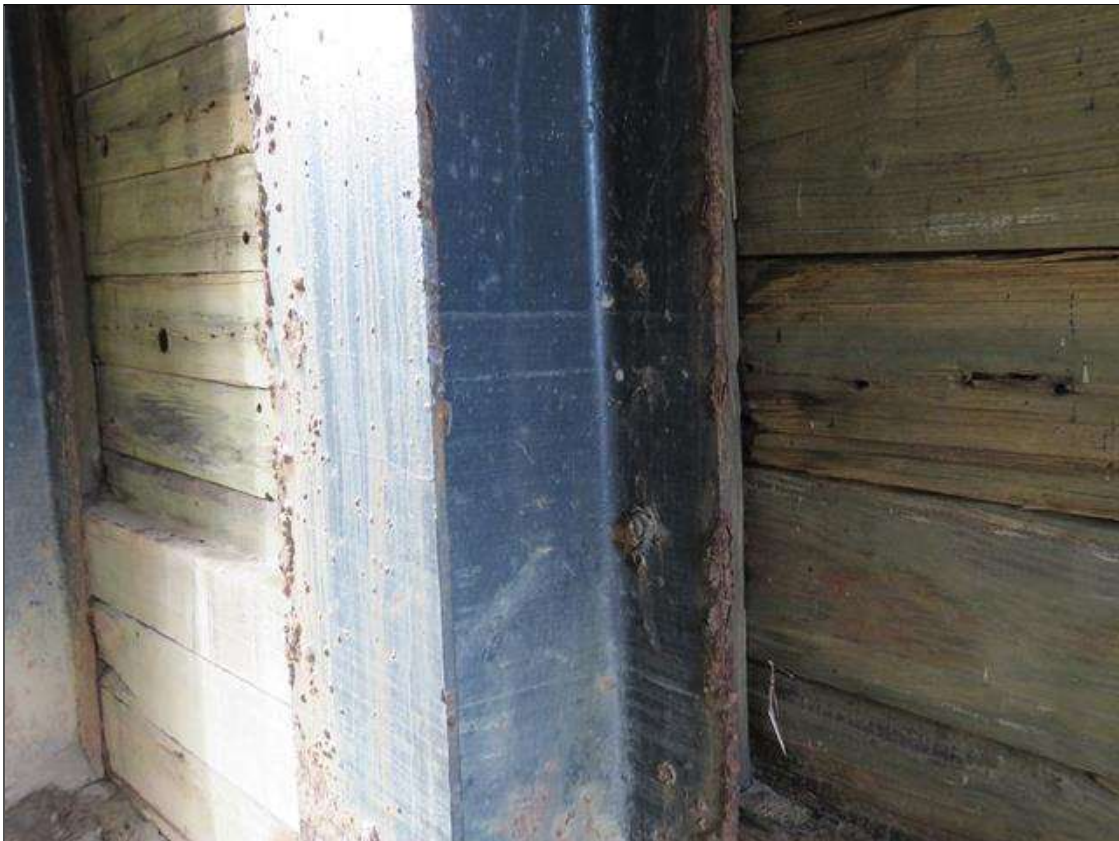
TYPICAL INTERMITTENT PROTECTIVE COATING LOSS AND MINOR CORROSION TO MINOR SCALE WITH NO MEASUREABLE SECTION LOSS END BENT 1 PILE 3

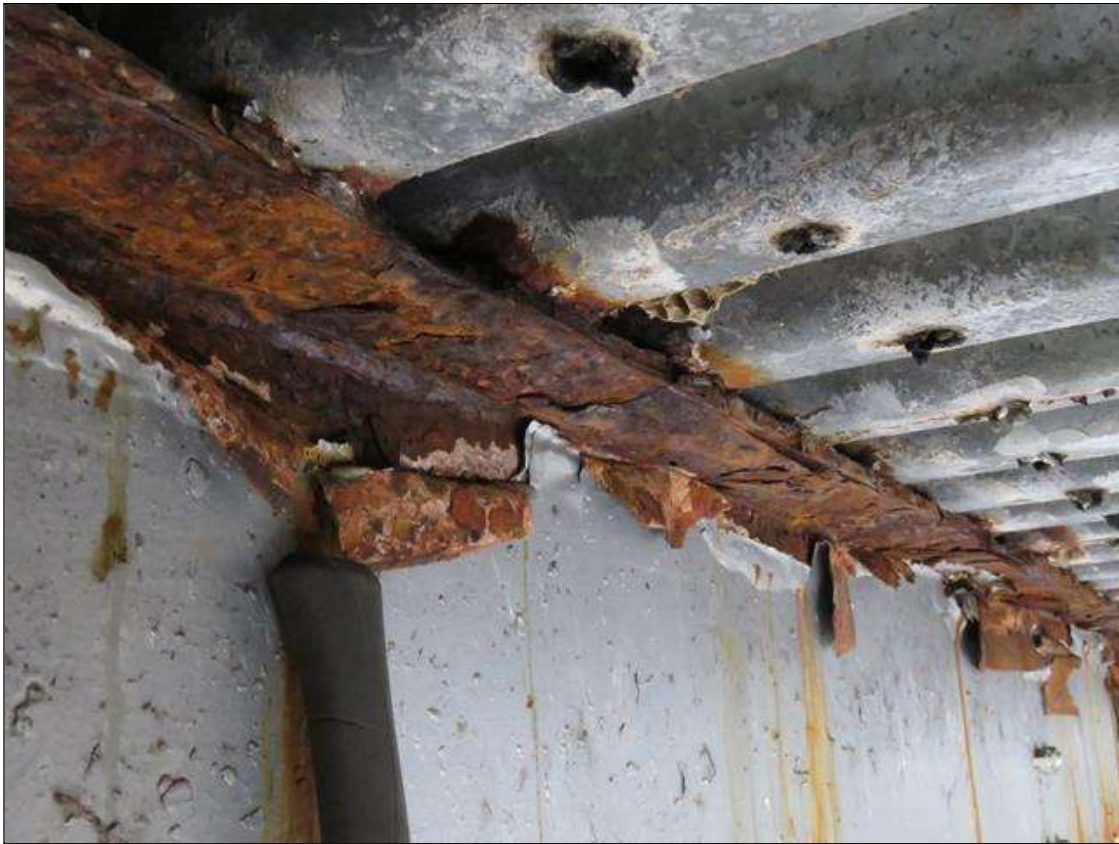
| Element Number | Defect Type | Defect Description | CS | CS Qty | Maint Qty | |
|---|---|---|---|---|---|---|
| 107 | Corrosion | TOP FLANGE RIGHT SIDE ONLY MINOR SCALE WITH TAPERED SECTION LOSS (17% LOSS) 3/8" REMAINING AT EDGE OF 9/16" ORIGINAL FOR FULL LENGTH. BOTTOM FLANGE RIGHT SIDE ONLY MINOR SCALE WITH TAPERED SECTION LOSS (11% LOSS) 7/16" REMAINING AT EDGE OF 9/16" ORIGINAL FOR FULL LENGTH | 3 | 39 | | Feet |

SPAN 1 BEAM 1 TOP FLANGE RIGHT SIDE ONLY MINOR SCALE WITH TAPERED SECTION LOSS (17% LOSS)  
3/8" REMAINING AT EDGE OF 9/16" ORIGINAL FOR FULL LENGTH

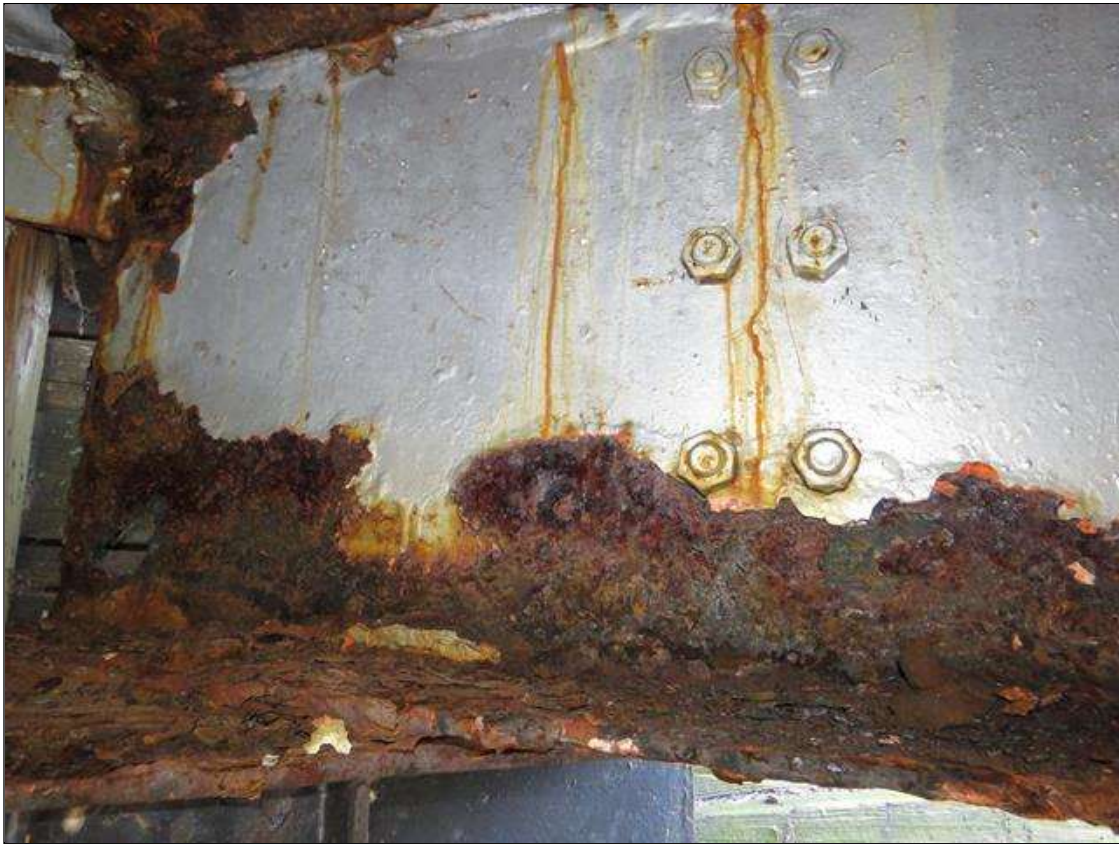
| Element Number | Defect Type | Defect Description | CS | CS Qty | Maint Qty | |
|---|---|---|---|---|---|---|
| 107 | Corrosion | WEB WITH 100% SECTION LOSS FOR 4" HEIGHT x 4" LENGTH AND 3/16" SECTION LOSS (50%) AND 3/16" REMAINING TO 6" HEIGHT x 2' LENGTH AT BASE NEAR END. BOTTOM FLANGE 1/8" SECTION LOSS (22%) 7/16" REMAINING OF ORIGINAL 9/16" FOR FULL WIDTH x 2' NEAR END (PM) | 4 | 2 | 2 | Feet |

SPAN 1 BEAM 1 MODERATE SCALE, WEB WITH 100% SECTION LOSS FOR 4" HEIGHT x 4" LENGTH AND 3/16" SECTION LOSS (50%) AND 3/16" REMAINING TO 6" HEIGHT x 2' LENGTH AT BASE NEAR END. BOTTOM FLANGE 1/8" SECTION LOSS (22%) 7/16" REMAINING OF ORIGINAL 9/16" FOR FULL WIDTH x 2' NEAR END (PM PHOTO)

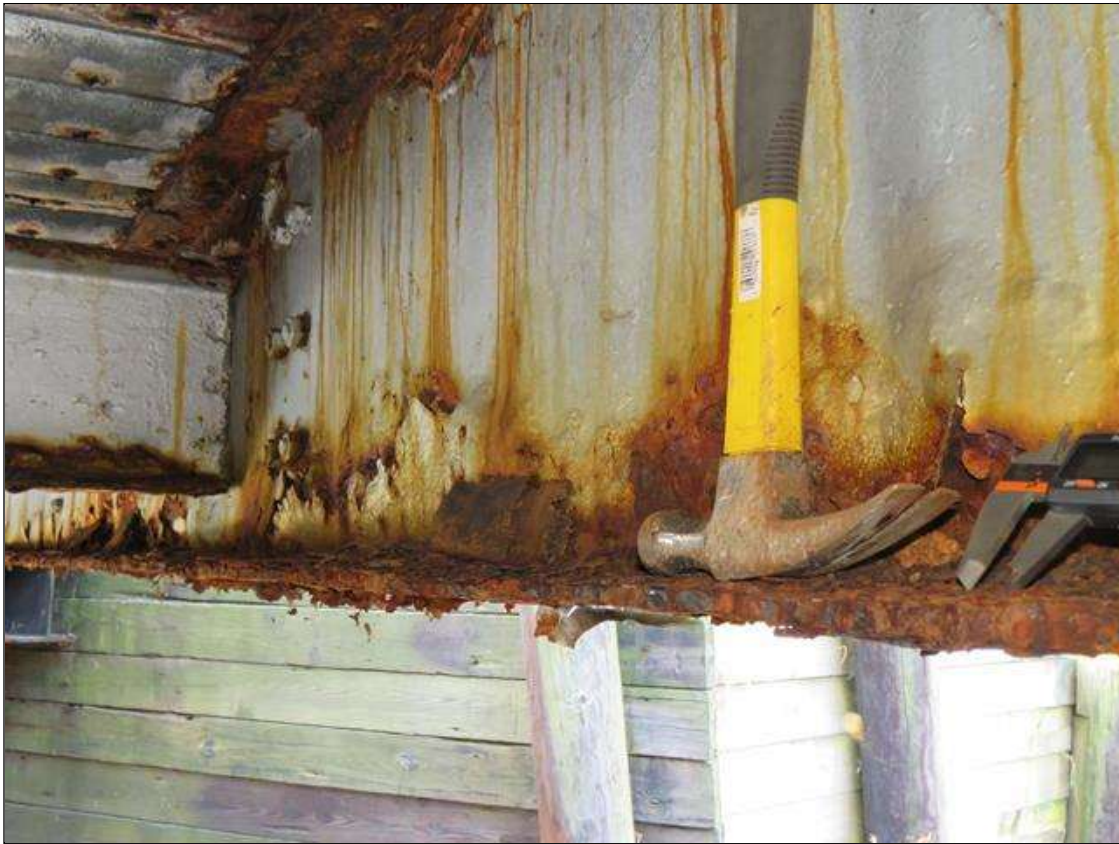
SPAN 1 BEAM 1 BOTTOM FLANGE RIGHT SIDE ONLY MINOR SCALE WITH TAPERED SECTION LOSS (11% LOSS) 7/16" REMAINING AT EDGE OF 9/16" ORIGINAL FOR FULL LENGTH

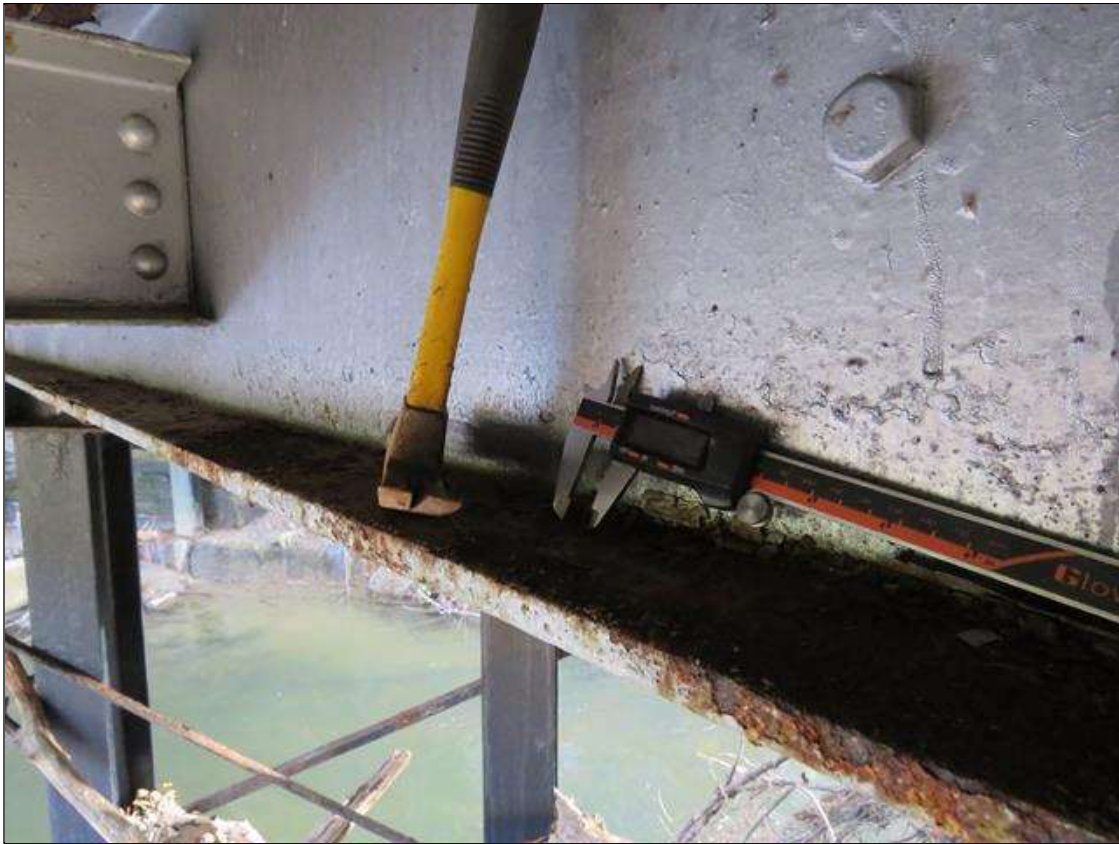
TYPICAL MINOR SCALE THROUGHOUT NO MEASUREABLE SECTION LOSS FOR FULL LENGTH OF BOTTOM FLANGE SPAN 1 BEAM 6

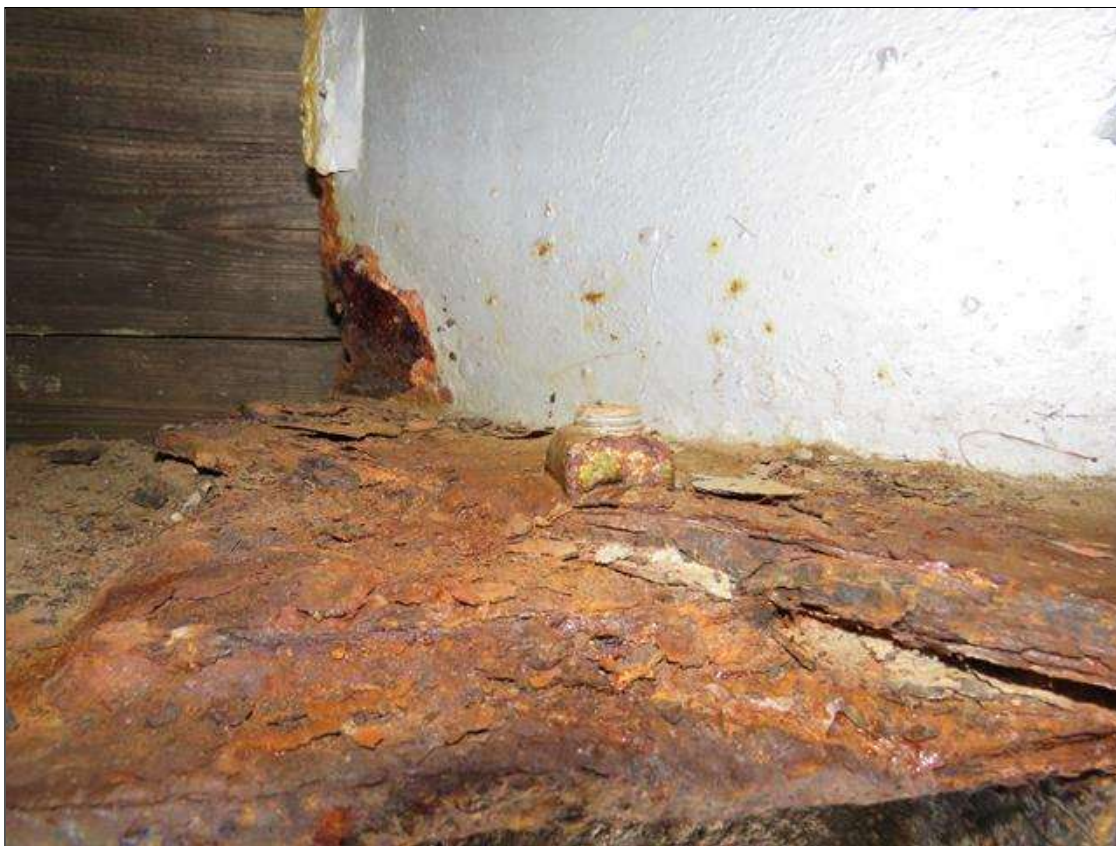
TYPICAL SPAN 1 NEAR BEARING MINOR SCALE WITH 1/16" SECTION LOSS THROUGHOUT BEAM 2

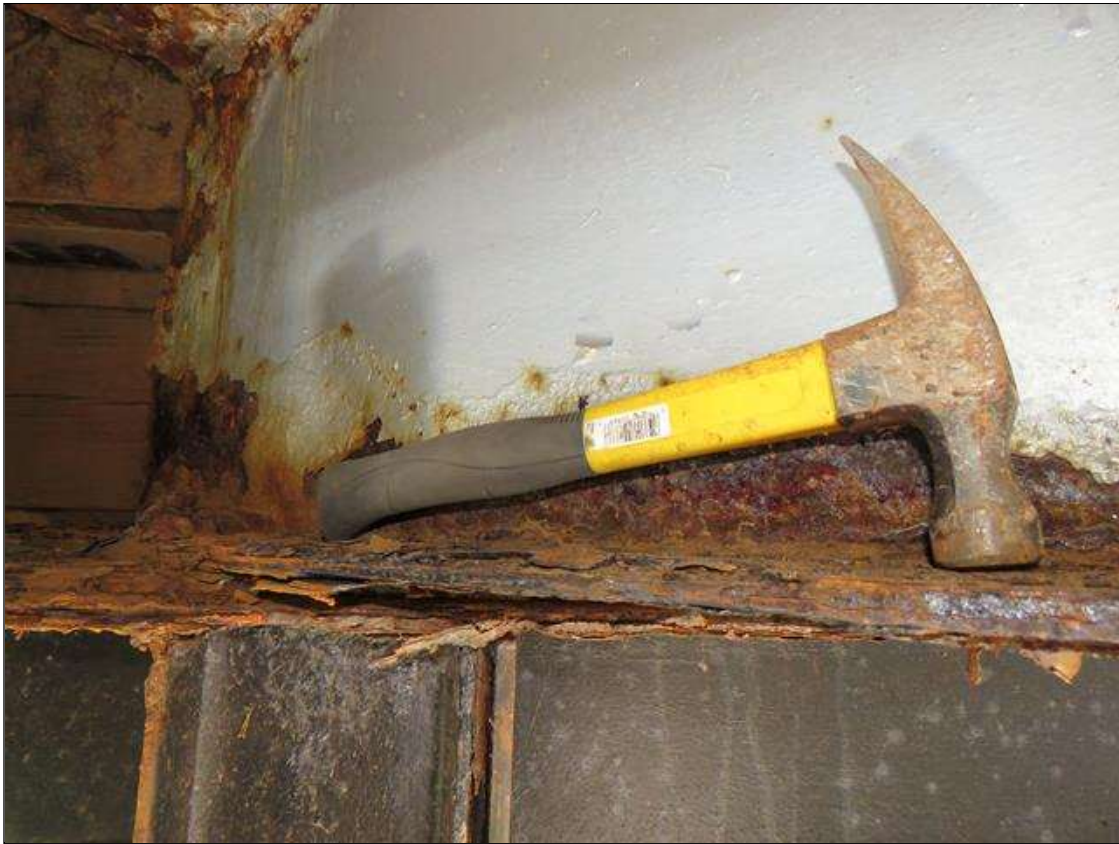
SPAN 1 BEAM 4 MODERATE SCALE, WEB WITH 3/16" SECTION LOSS (50%) AND 3/16" REMAINING TO 6" HEIGHT x 2' LENGTH AT BASE NEAR END. BOTTOM FLANGE 5/16" SECTION LOSS (55%) 1/4" REMAINING OF ORIGINAL 9/16" FOR FULL WIDTH x 2' NEAR END (PM PHOTO)

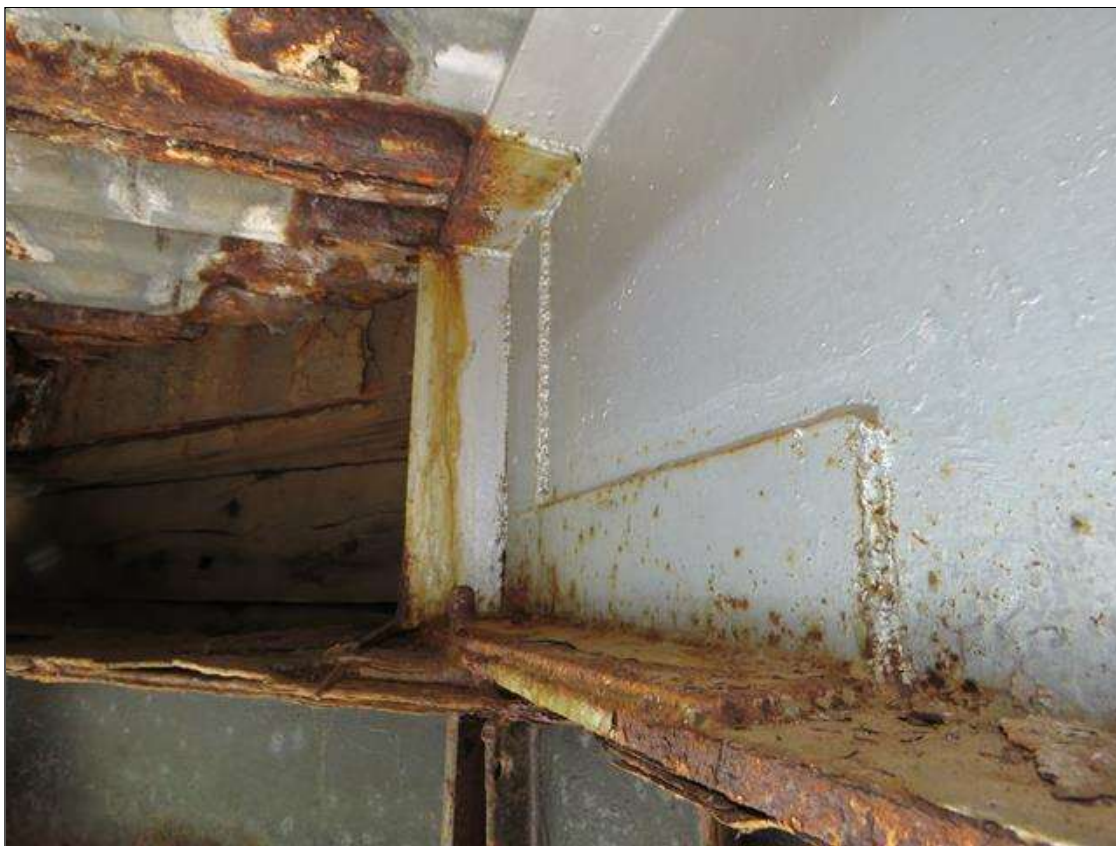
SPAN 1 BEAM 5 RIGHT SIDE TEMPORARY REPAIRS NEAR END, SPAN 1 BEAM 3 SIMILAR AT NEAR END

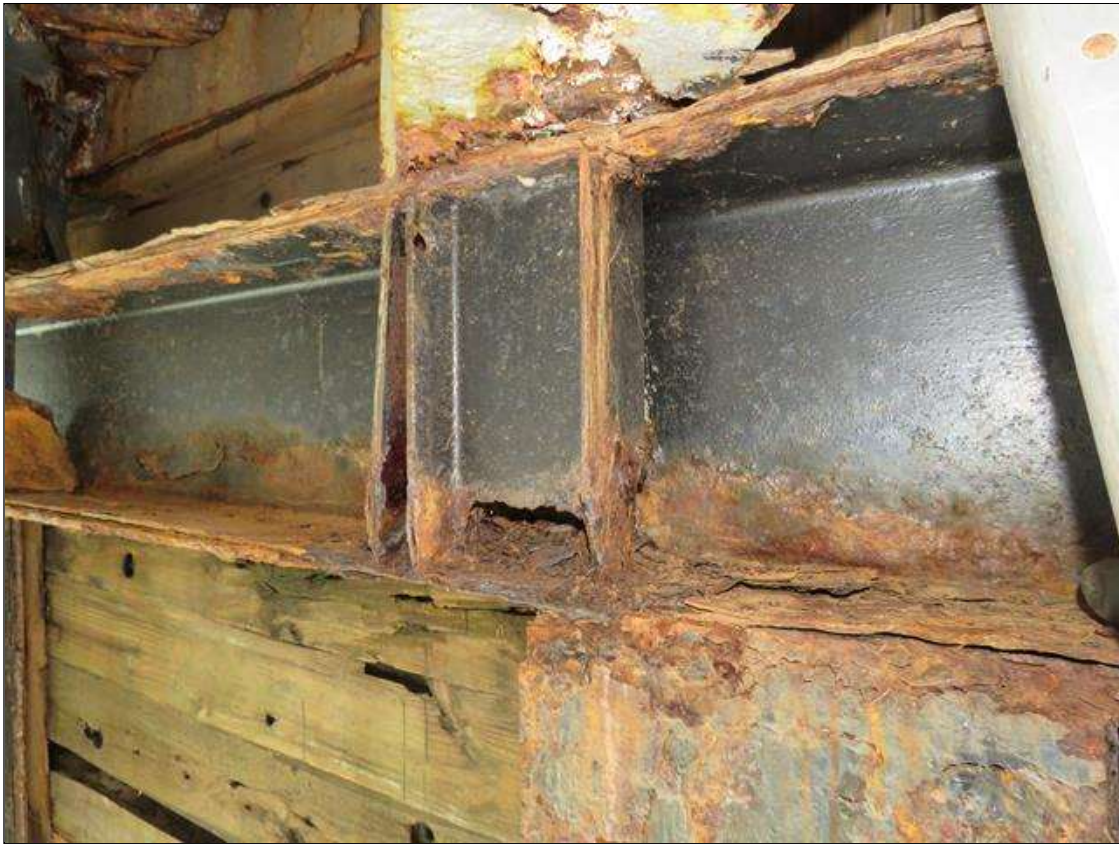
END BENT 1 CAP BOTTOM FLANGE FULL WIDTH MODERATE SCALE WITH TAPERED SECTION LOSS (35% LOSS) 1/8" REMAINING AT EDGE OF 7/16" ORIGINAL FOR 1' LENGTH LEFT AND RIGHT OF BEAM 5. MODERATE SCALE WITH 50% SECTION LOSS AT BASE OF BEARING STIFFENERS BELOW BEAM 5 (PM PHOTO)

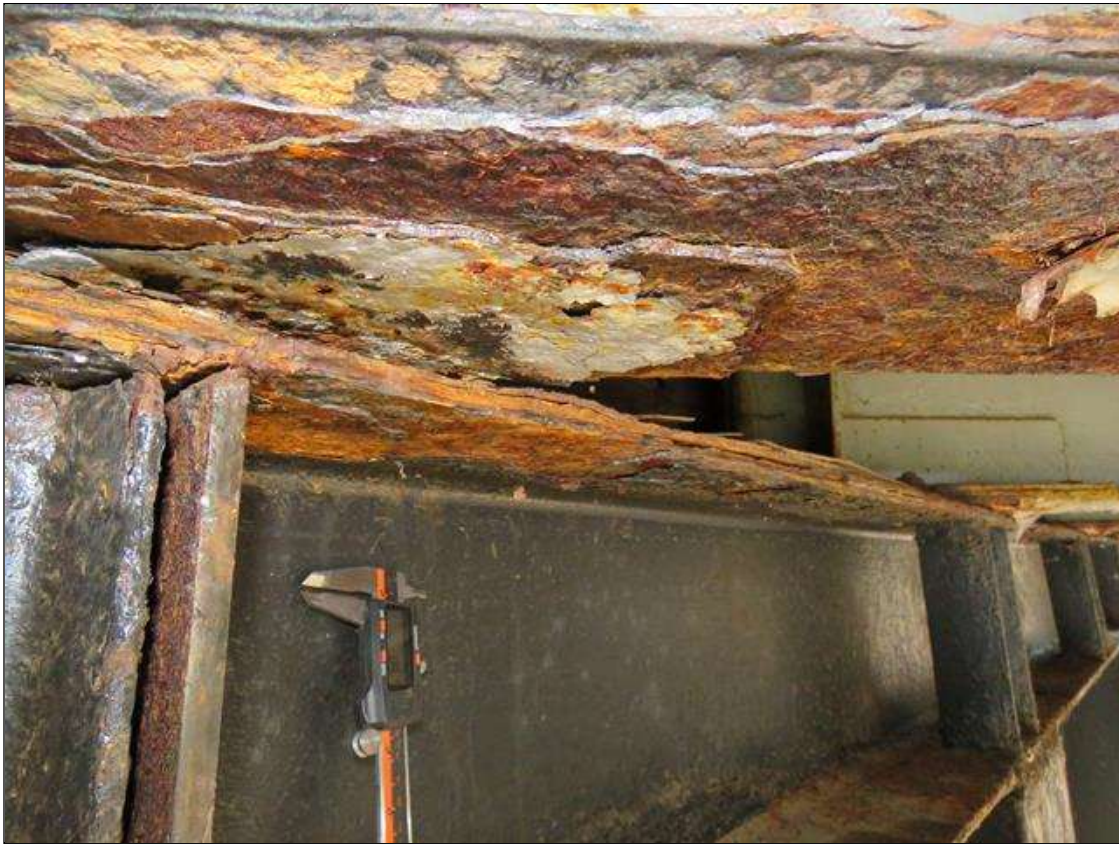
END BENT 1 CAP TOP FLANGE FULL WIDTH MODERATE SCALE WITH TAPERED SECTION LOSS (44% LOSS)  
1/16" REMAINING AT EDGE OF 7/16" ORIGINAL FOR 2' LENGTH BELOW AND LEFT OF BEAM 4 (PM PHOTO)
