NC DEPARTMENT OF TRANSPORTATION  
DIVISION OF HIGHWAYS  
STRUCTURE MANAGEMENT UNIT

# Structure Safety Report

## Routine Element Inspection - Contract

DIVISION: 11 COUNTY: ALLEGHANY STRUCTURE NUMBER: 020035 FREQUENCY: 24 MONTHS

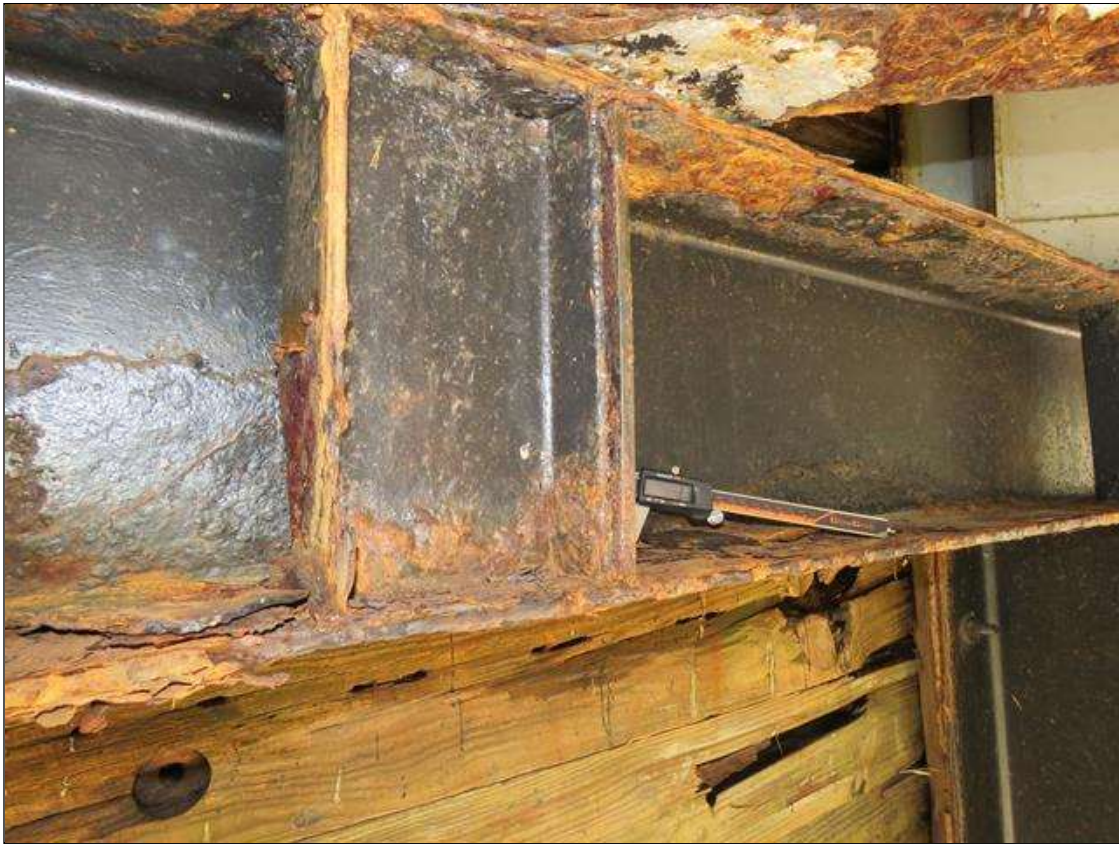
END BENT 1 CAP BOTTOM FLANGE FULL WIDTH MODERATE SCALE WITH TAPERED SECTION LOSS (35% LOSS) 1/8" REMAINING AT EDGE OF 7/16" ORIGINAL FOR 1.5' LENGTH BELOW BEAM 4. MODERATE SCALE WITH 33% SECTION LOSS AT BASE OF BEARING STIFFENERS BELOW BEAM 4 (PM PHOTO)

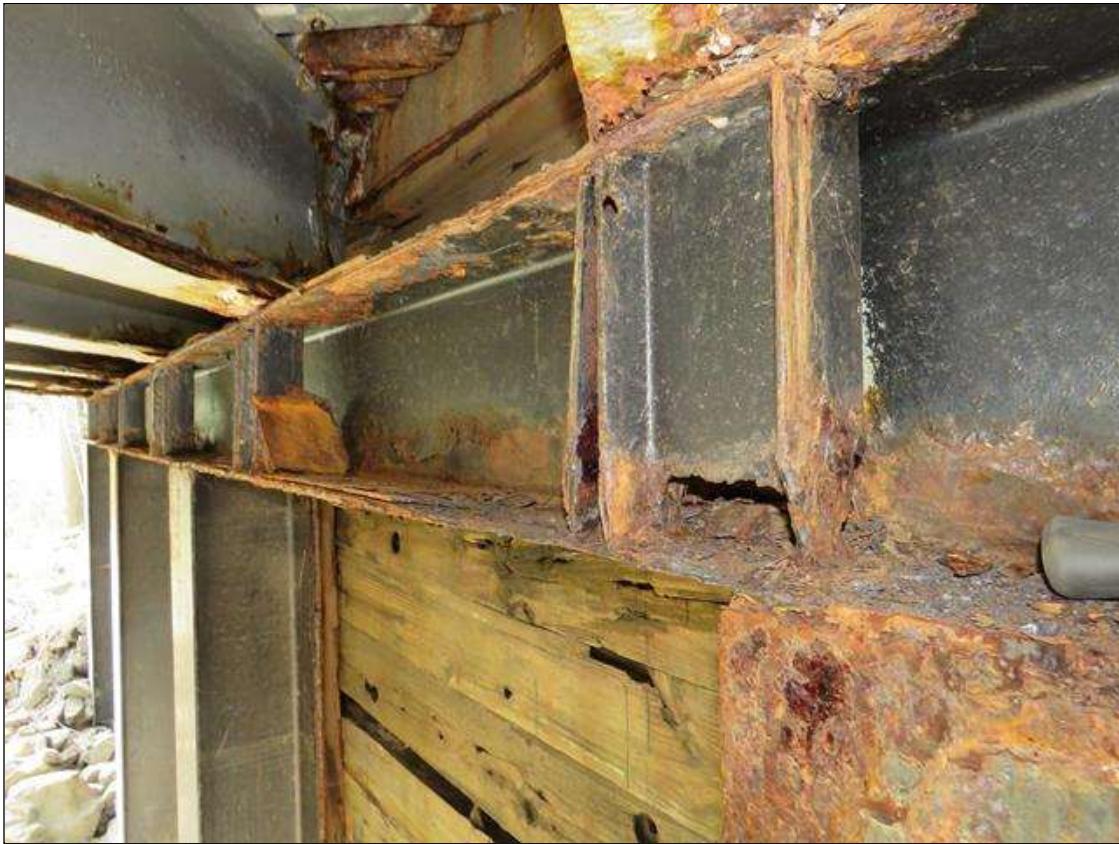
END BENT 1 CAP BOTTOM FLANGE FULL WIDTH MODERATE SCALE WITH TAPERED SECTION LOSS (44% LOSS) 1/16" REMAINING AT EDGE OF 7/16" ORIGINAL FOR 2.5' LENGTH BELOW AND RIGHT OF BEAM 7. MODERATE SCALE WITH 50% SECTION LOSS AT BASE OF BEARING STIFFENERS BELOW BEAM 7 (PM PHOTO)

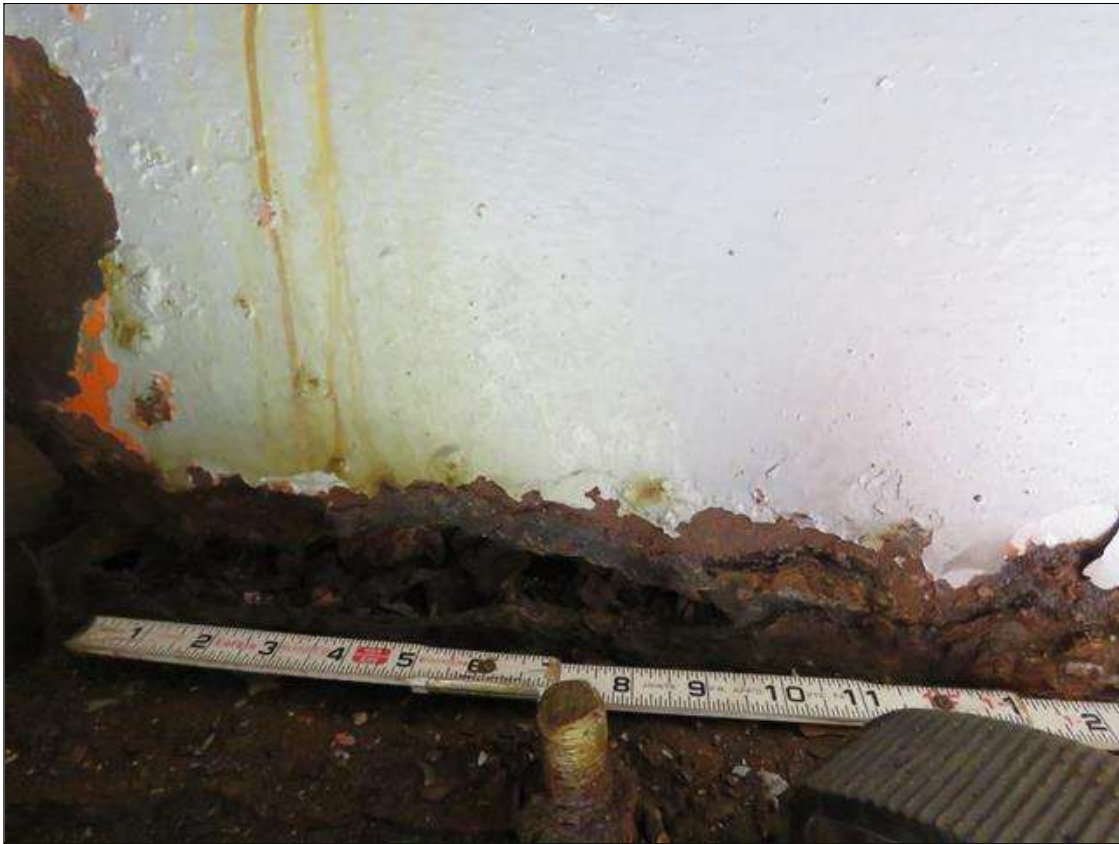
SPAN 1 BEAM 6 MODERATE TO HEAVY SCALE, WEB WITH 100% SECTION LOSS FOR 4" HEIGHT x 14" LENGTH AT BASE NEAR END. BOTTOM FLANGE 1/8" SECTION LOSS (22%) 7/16" REMAINING OF ORIGINAL 9/16" FOR FULL WIDTH x 2' NEAR END (PM PHOTO 1 OF 3)

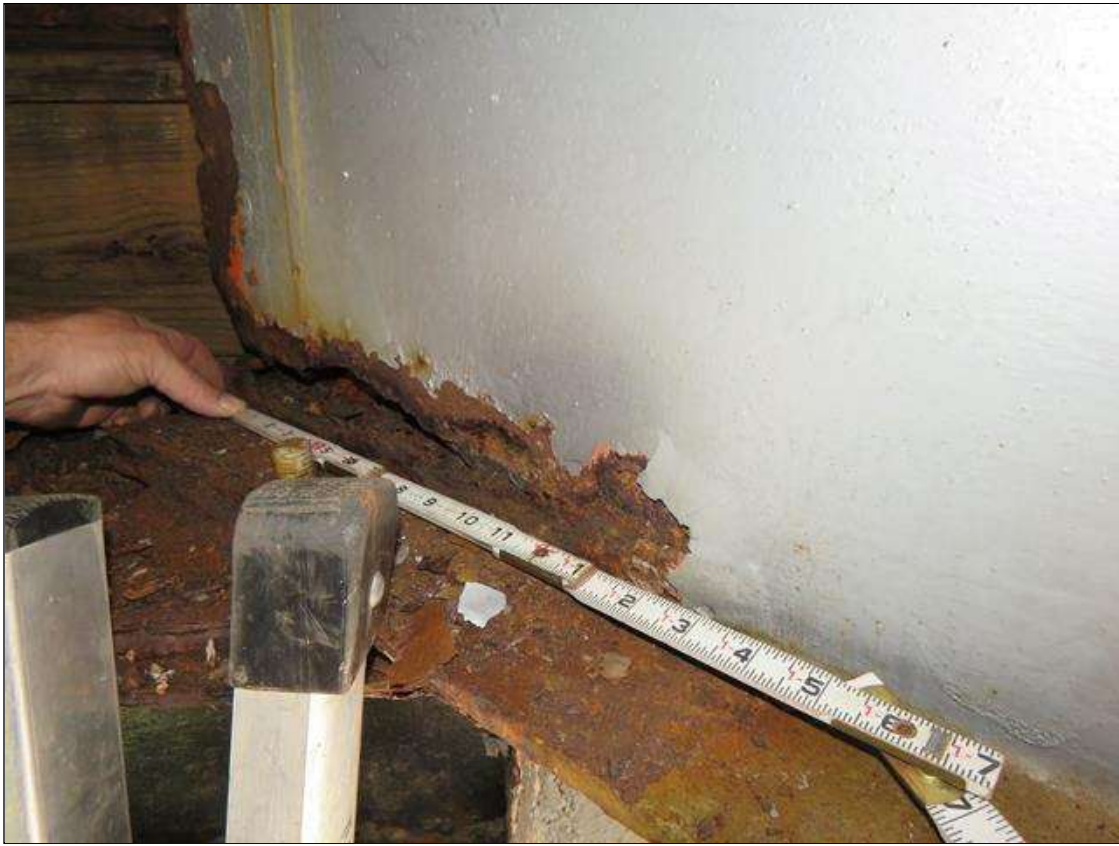
SPAN 1 BEAM 6 MODERATE TO HEAVY SCALE, WEB WITH 100% SECTION LOSS FOR 4" HEIGHT x 14" LENGTH AT BASE NEAR END. BOTTOM FLANGE 1/8" SECTION LOSS (22%) 7/16" REMAINING OF ORIGINAL 9/16" FOR FULL WIDTH x 2' NEAR END (PM PHOTO 2 OF 3)

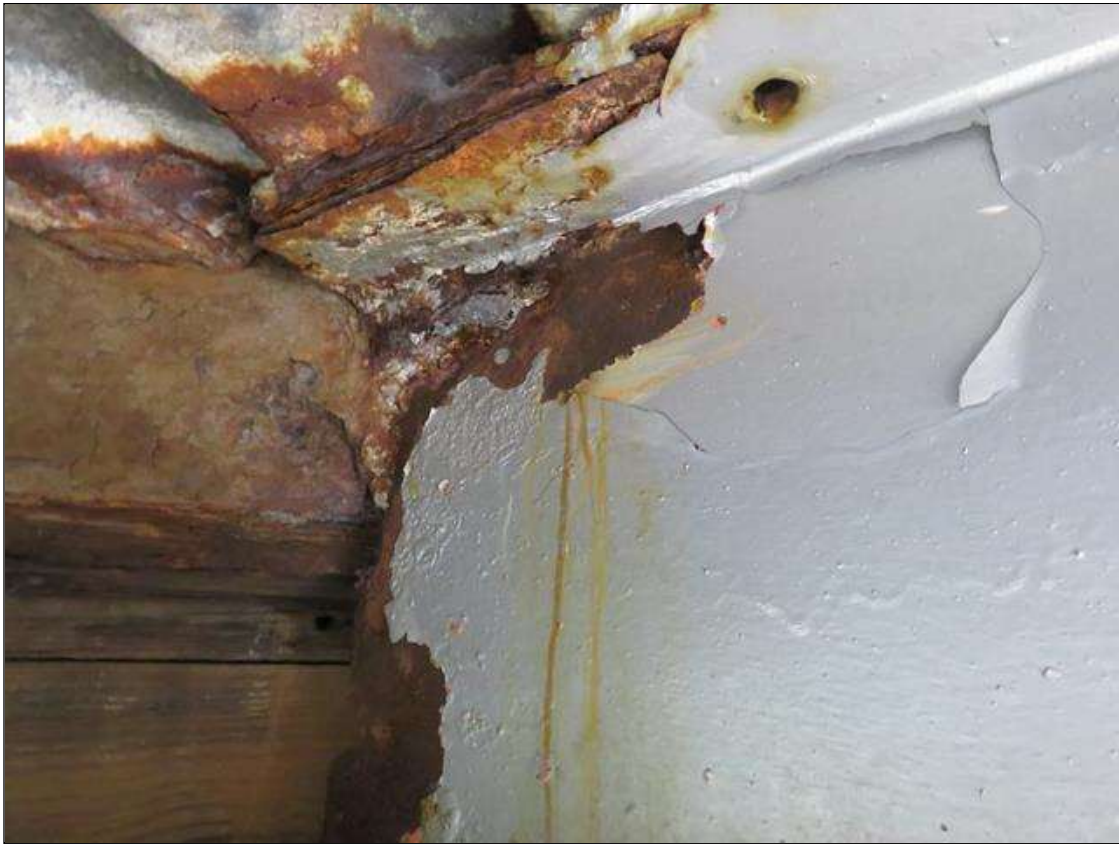
SPAN 1 BEAM 6 MODERATE TO HEAVY SCALE, WEB WITH 100% SECTION LOSS FOR 4" HEIGHT x 6" LENGTH AT TOP OF WEB NEAR END (PM PHOTO 3 OF 3)

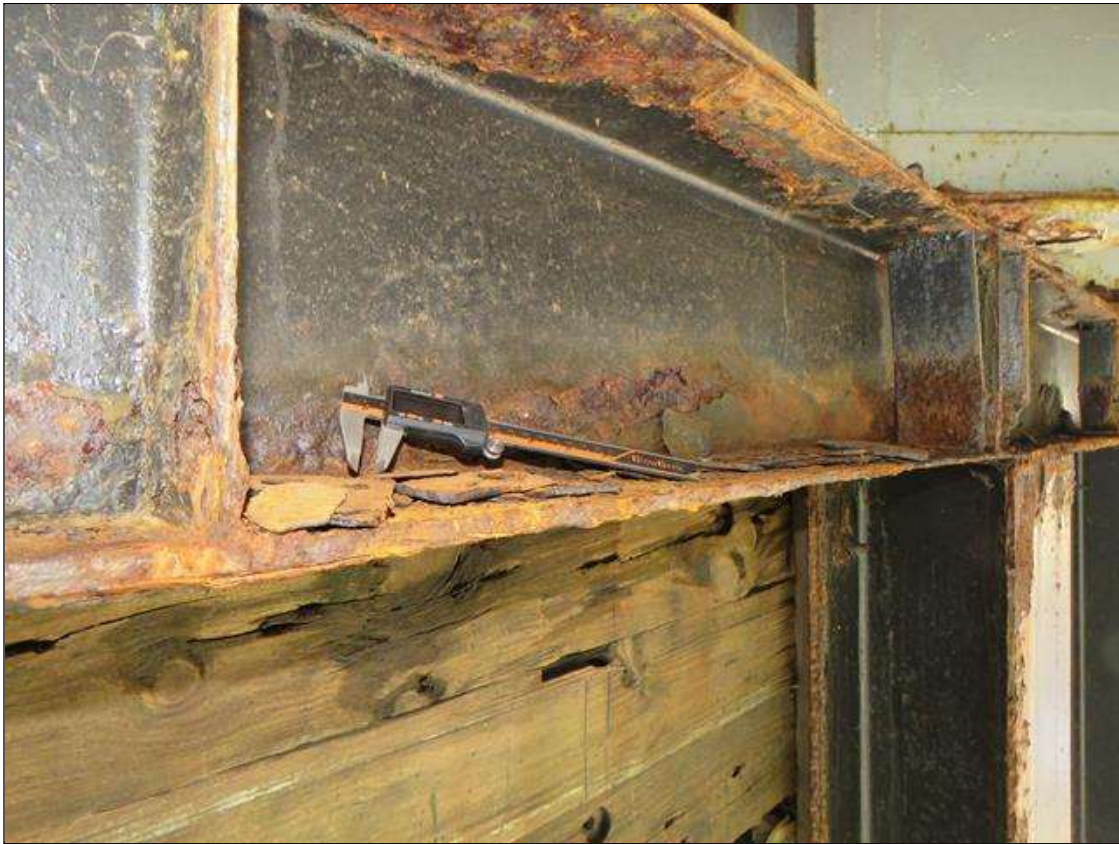
TYPICAL MINOR SCALE NO MEASUREABLE SECTION LOSS BOTTOM 4" TO 6" OF WEB THROUGHOUT END BENT 1 CAP BETWEEN BEAMS 5 AND 6

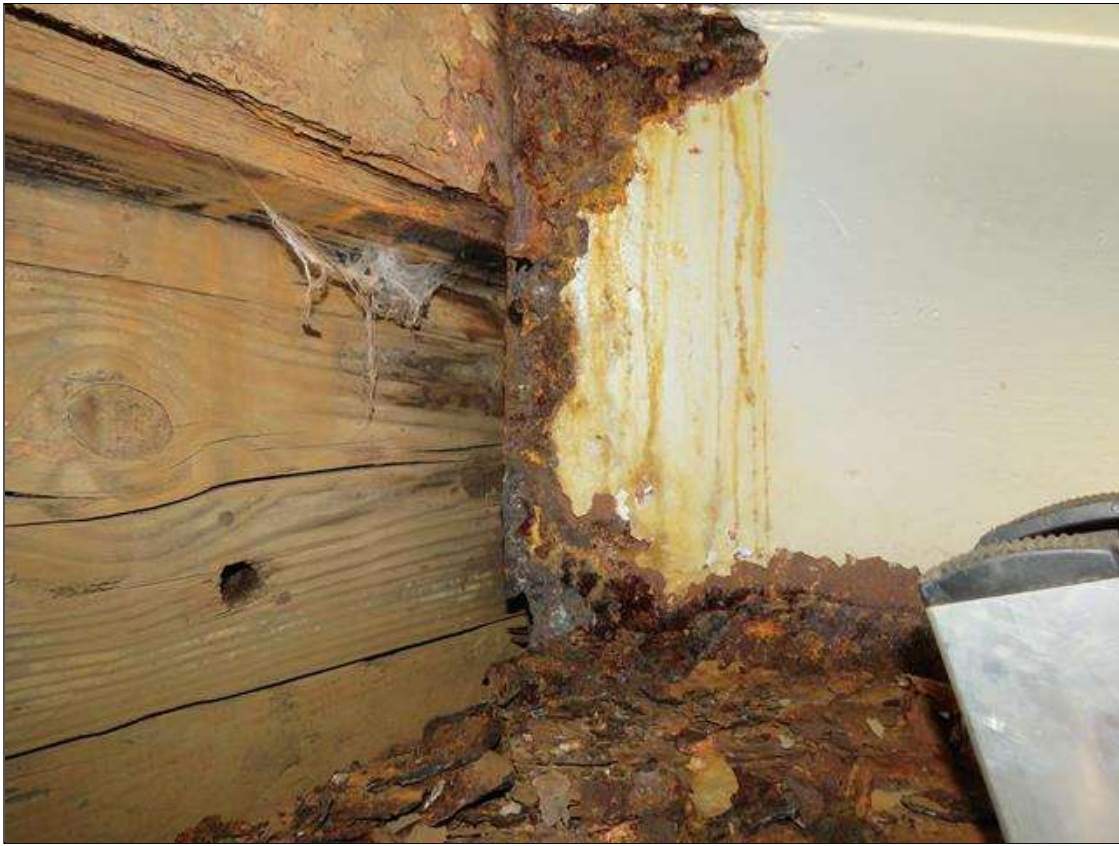
SPAN 1 BEAM 7 MODERATE SCALE, WEB WITH 3/16" SECTION LOSS (50%) AND 3/16" REMAINING TO 6" HEIGHT x 2' LENGTH AT BASE NEAR END AND TO 8" HEIGHT x 1' LENGTH AT TOP OF WEB. BOTTOM FLANGE 5/16" SECTION LOSS (55%) 1/4" REMAINING OF ORIGINAL 9/16" FOR FULL WIDTH x 2' NEAR END (PM PHOTO)

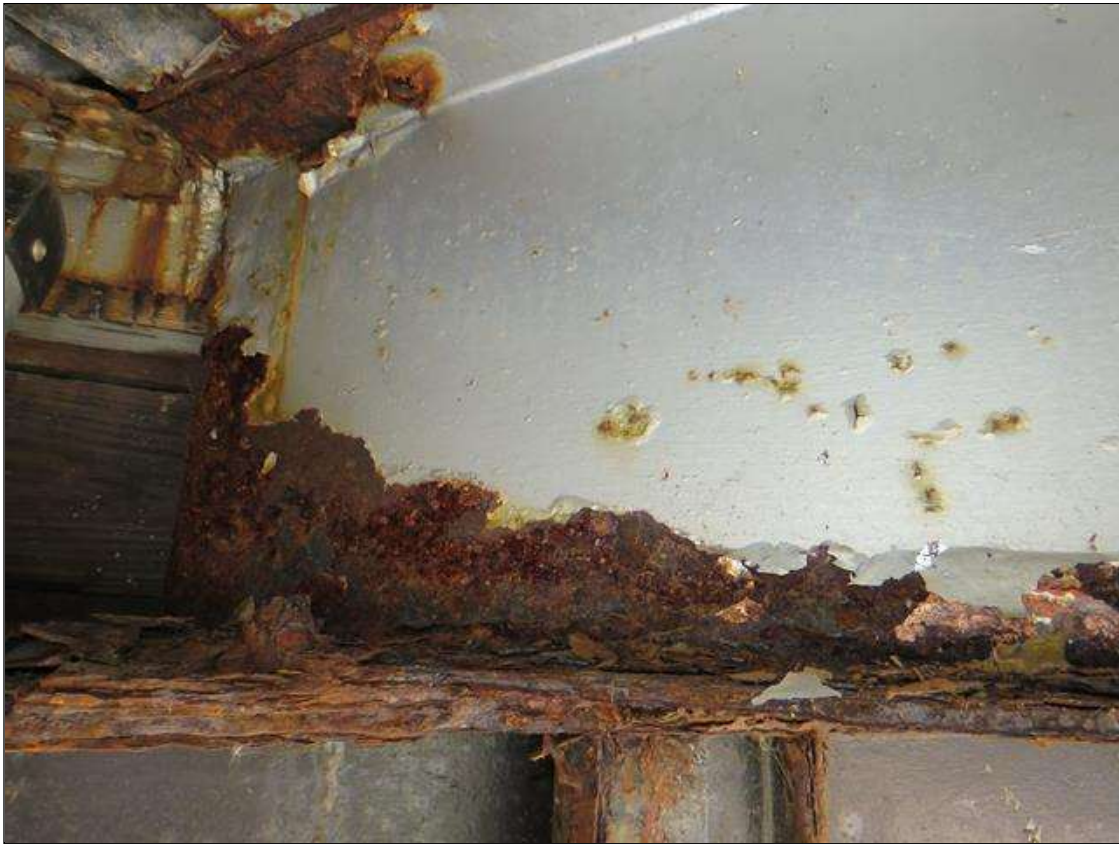
SPAN 1 BEAM 9 MODERATE SCALE, WEB WITH 3/16" SECTION LOSS (50%) AND 3/16" REMAINING TO 6" HEIGHT x 2' LENGTH AT BASE NEAR END. BOTTOM FLANGE 5/16" SECTION LOSS (55%) 1/4" REMAINING OF ORIGINAL 9/16" FOR FULL WIDTH x 2' NEAR END (PM PHOTO)

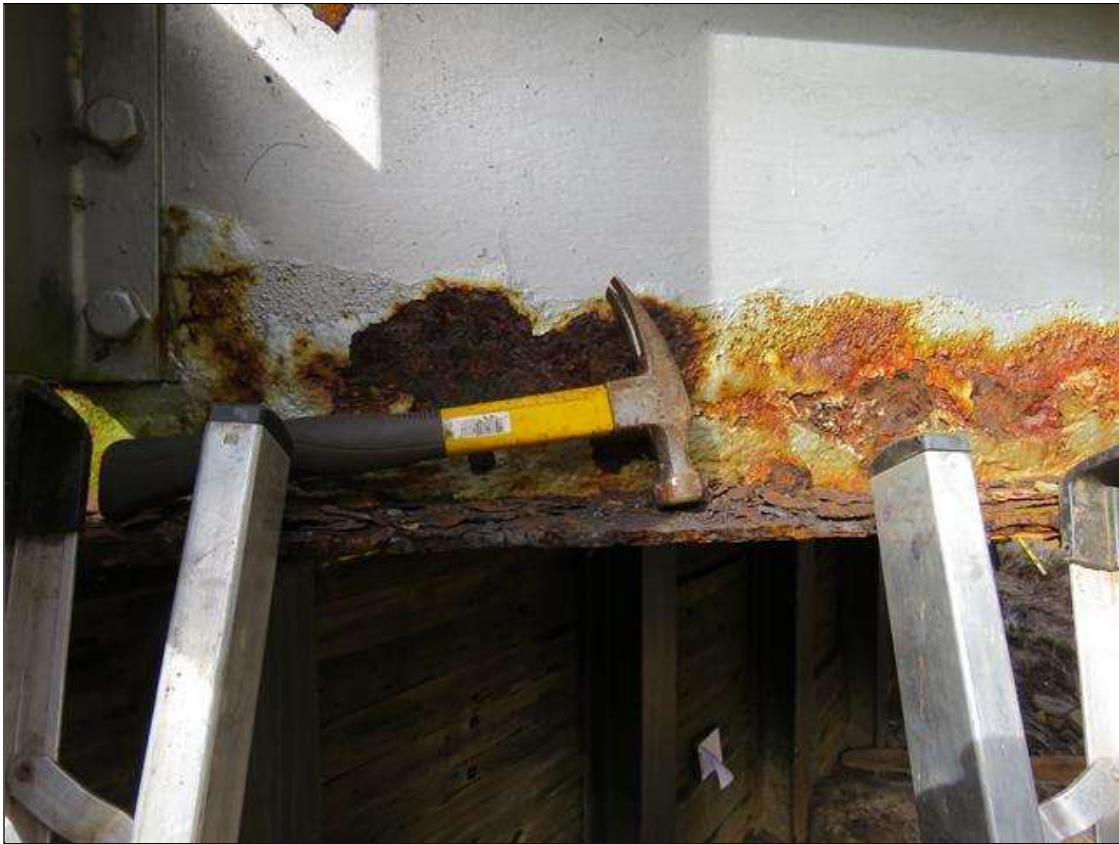
SPAN 1 BEAM 10 MODERATE SCALE, WEB WITH 1/8" SECTION LOSS (33%) AND 1/4" REMAINING OF 3/8" ORIGINAL TO 6" HEIGHT x 3' LENGTH AT BASE NEAR END. BOTTOM FLANGE 5/16" SECTION LOSS (55%) 1/4" REMAINING OF ORIGINAL 9/16" FOR FULL WIDTH x 2' NEAR END (PM PHOTO)

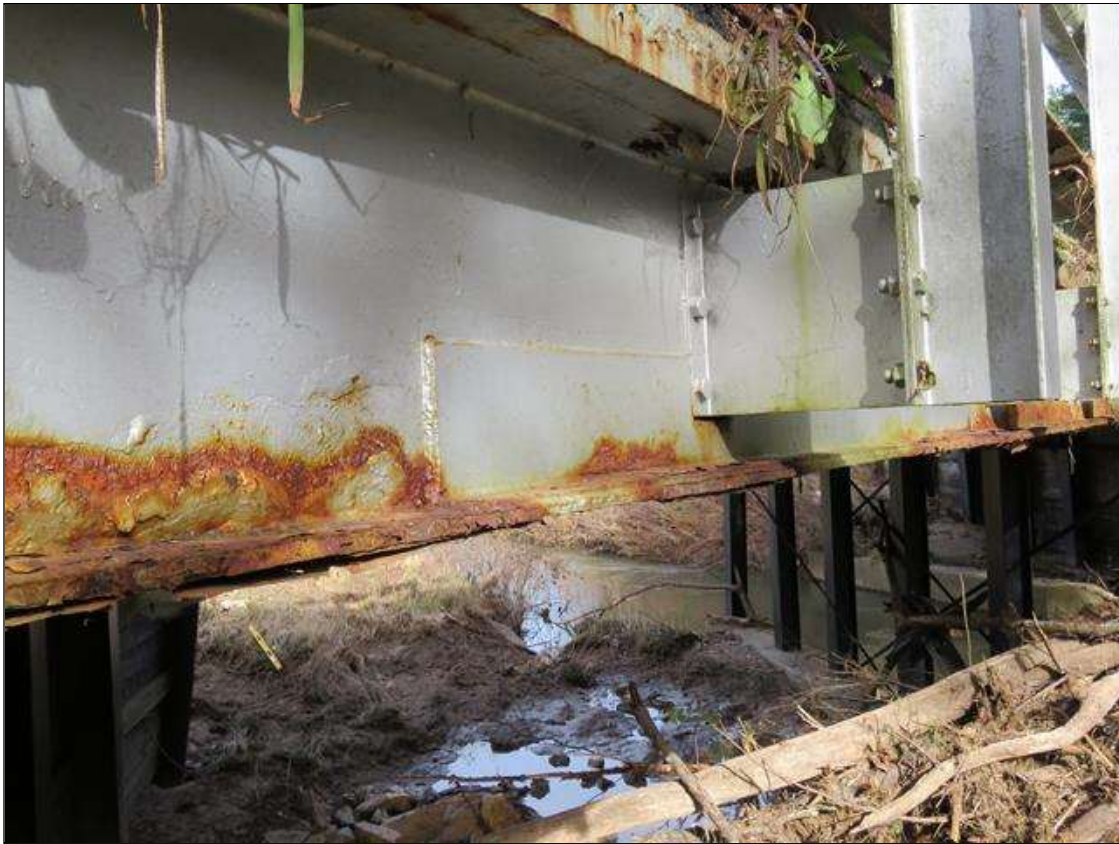
SPAN 1 BEAM 10 RIGHT SIDE TEMPORARY PLATE REPAIRS

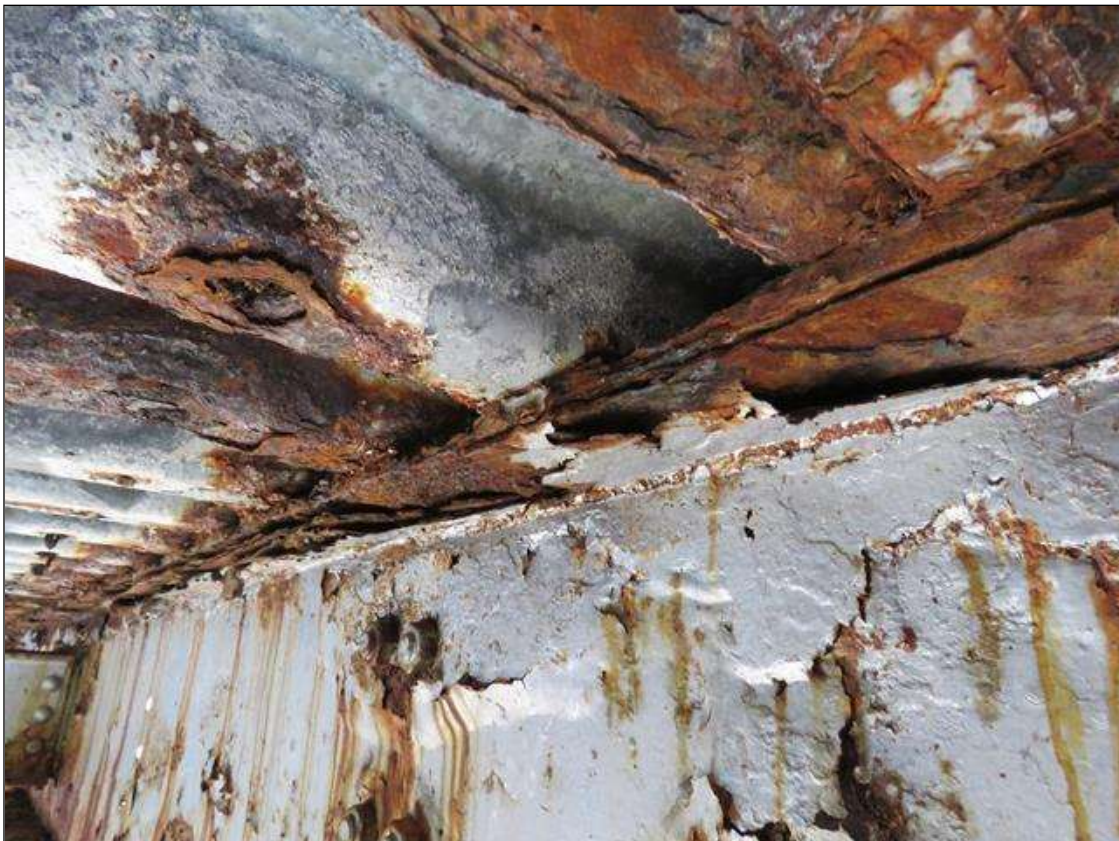
SPAN 1 BEAM 10 TOP FLANGE LEFT SIDE ONLY MINOR TO MODERATE SCALE WITH 1/8" SECTION LOSS (22% LOSS) 7/16" REMAINING AT EDGE OF 9/16" ORIGINAL FOR FULL LENGTH

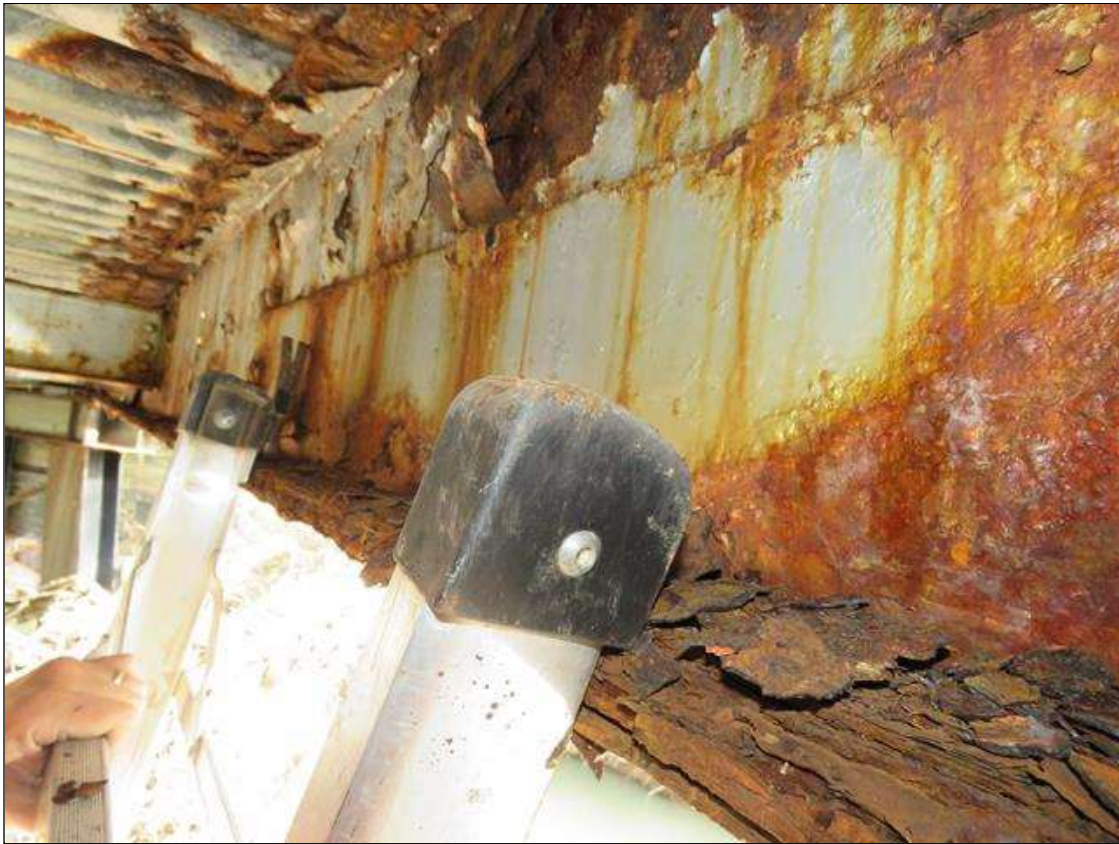
SPAN 1 BEAM 10 LEFT SIDE TEMPORARY PLATE REPAIRS MID SPAN. BOTTOM FLANGE FULL WIDTH MINOR TO MODERATE SCALE WITH TAPERED SECTION LOSS (17% LOSS) 3/8" REMAINING AT EDGE OF 9/16" ORIGINAL FOR FULL LENGTH

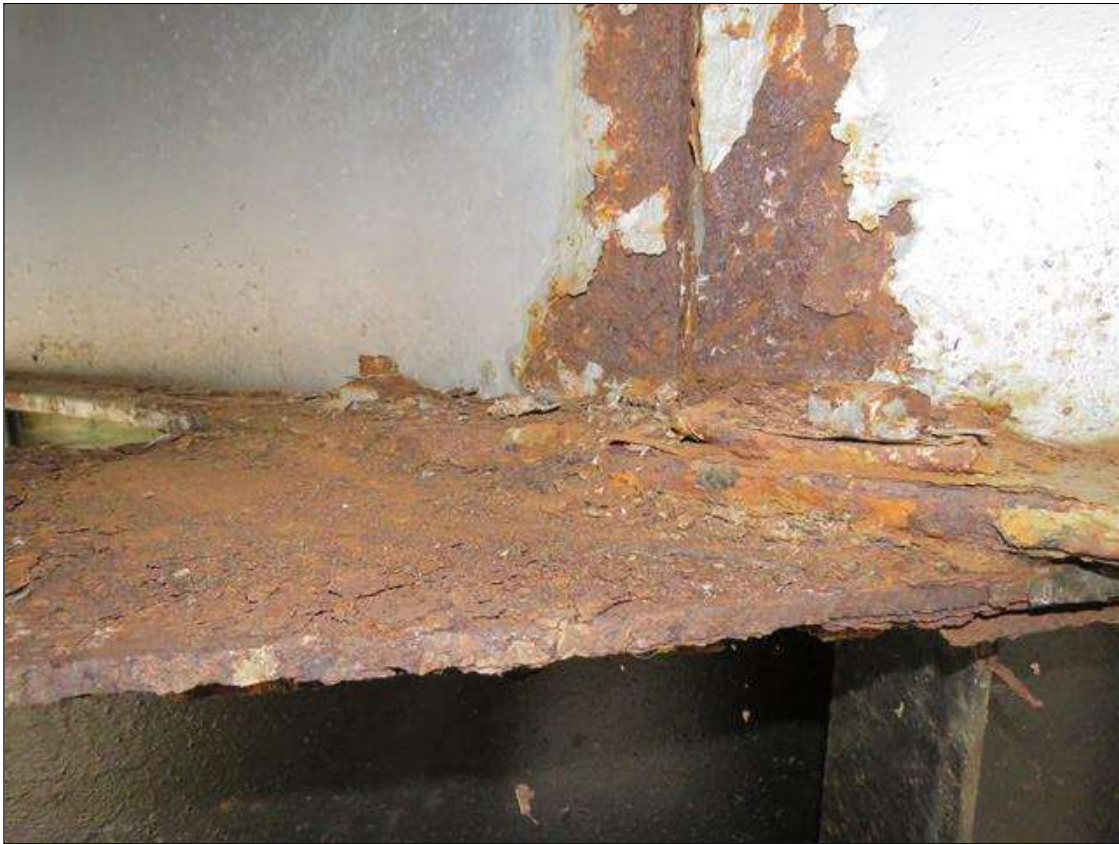
TYPICAL BEARINGS AT BENT 1 MINOR SCALE WITH 1/16" SECTION LOSS THROUGHOUT BEAM 4

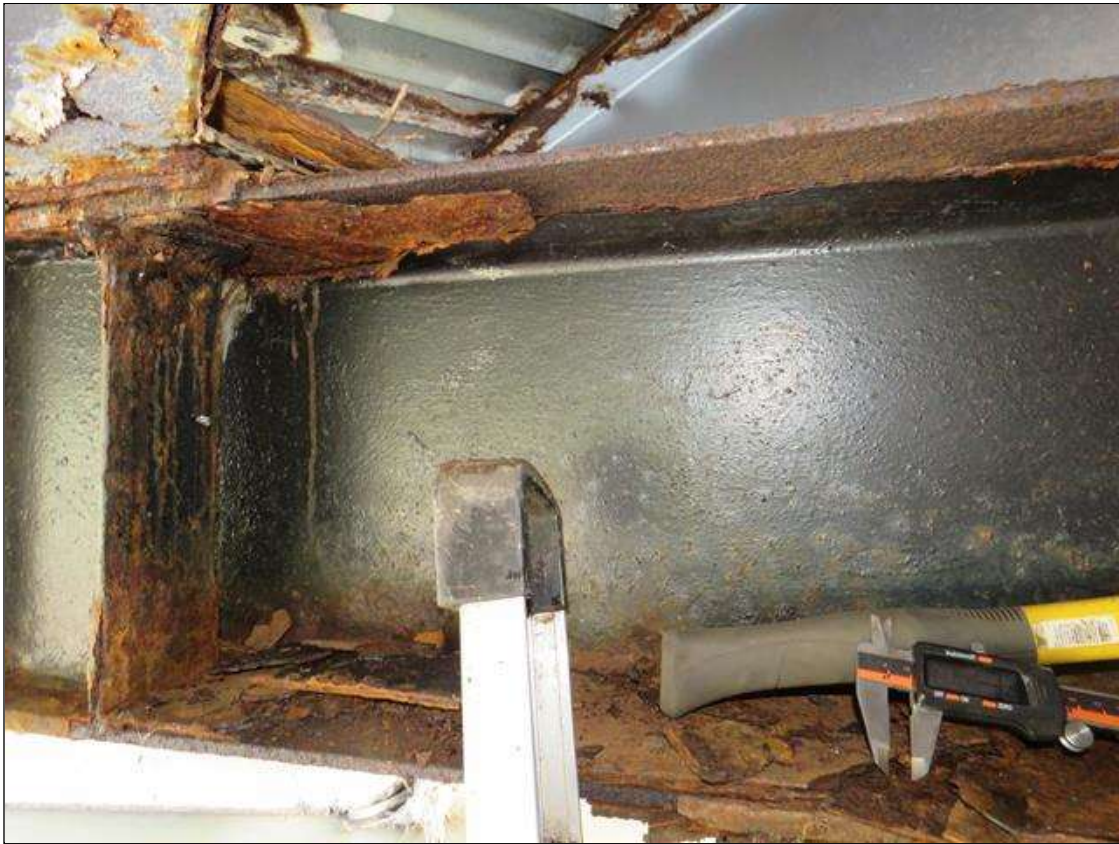
TYPICAL TOP AND BOTTOM FLANGE FULL WIDTH MODERATE SCALE WITH TAPERED SECTION LOSS (7% LOSS) 3/8" REMAINING AT EDGE OF 7/16" ORIGINAL FOR FULL LENGTH, BENT 1 CAP RIGHT OF BEAM 3  
(PHOTO 1 OF 2)

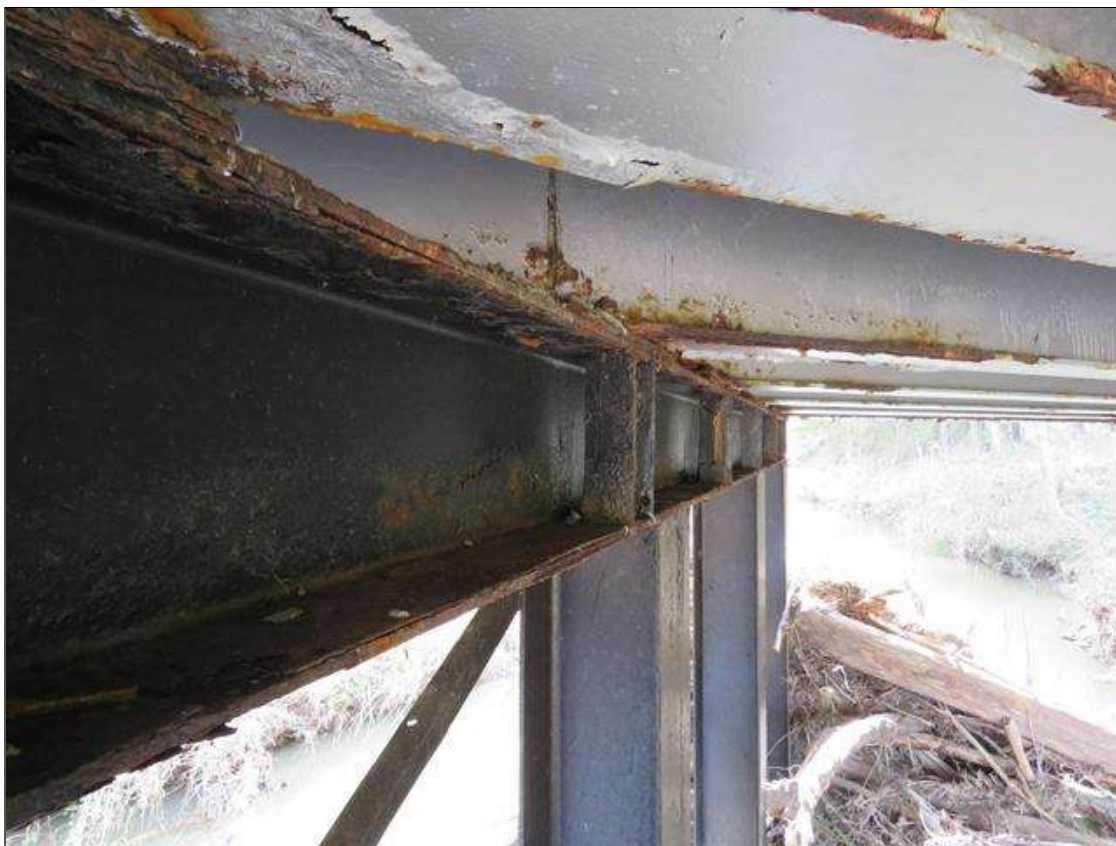
TYPICAL TOP AND BOTTOM FLANGE FULL WIDTH MODERATE SCALE WITH TAPERED SECTION LOSS (7% LOSS) 3/8" REMAINING AT EDGE OF 7/16" ORIGINAL FOR FULL LENGTH, BENT 1 CAP RIGHT OF BEAM 3  
(PHOTO 2 OF 2)

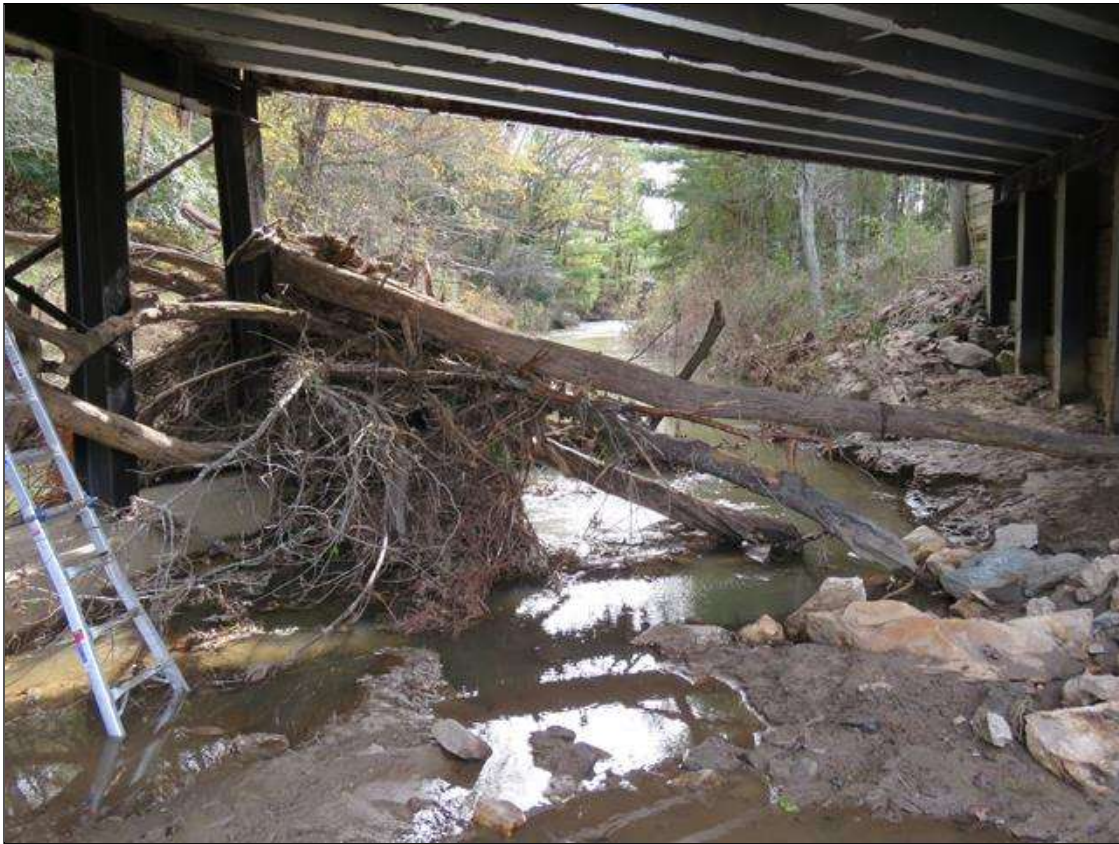
HEAVY AMOUNT OF DRIFT ACCUMULATED AT UPSTREAM FACE OF BENT 1 (16 CY) (PM PHOTO)

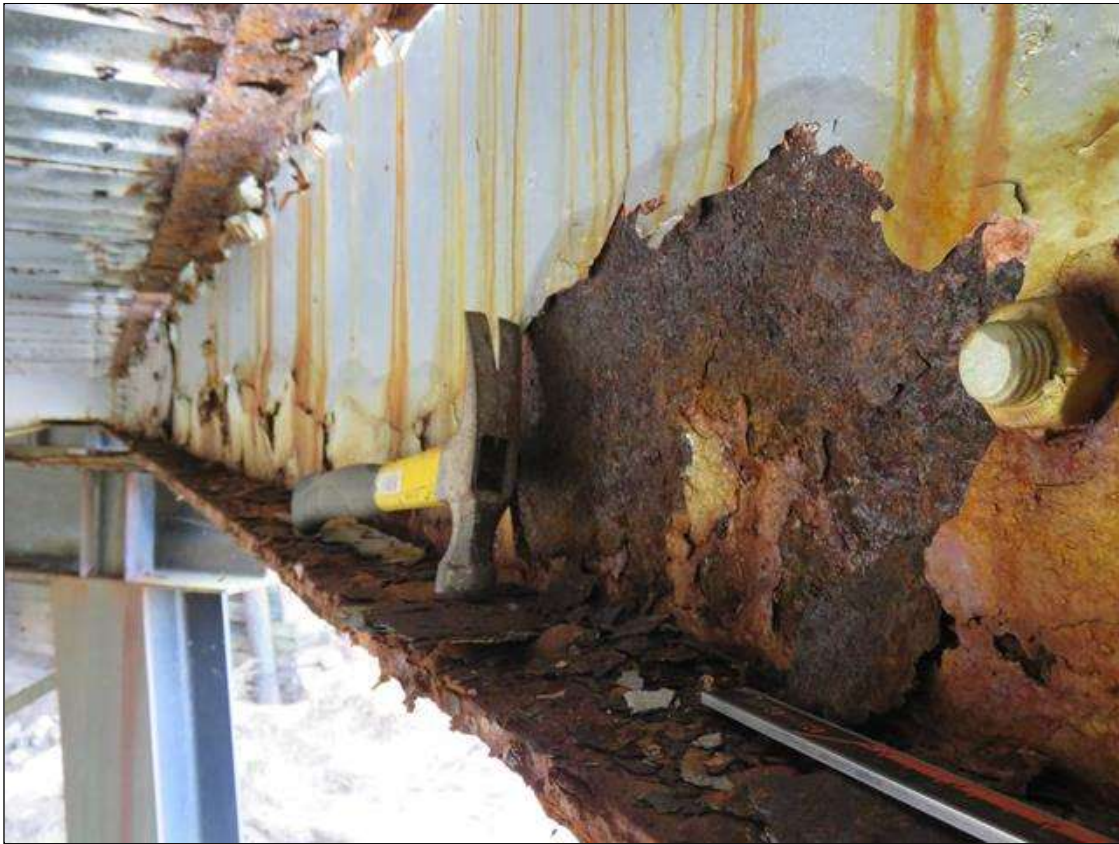
SPAN 2 BEAM 1 MODERATE SCALE, WEB 1/16" SECTION LOSS (17%) AND 5/16" REMAINING TO 6" HEIGHT AT BASE AND 3" HEIGHT AT TOP OF WEB, FOR FULL LENGTH. BOTTOM FLANGE RIGHT SIDE ONLY MINOR SCALE WITH TAPERED SECTION LOSS (11% LOSS) 7/16" REMAINING AT EDGE OF 9/16" ORIGINAL FOR FULL LENGTH. TOP FLANGE RIGHT SIDE ONLY MINOR SCALE WITH TAPERED SECTION LOSS (22% LOSS) 5/16" REMAINING AT EDGE OF 9/16" ORIGINAL FOR FULL LENGTH

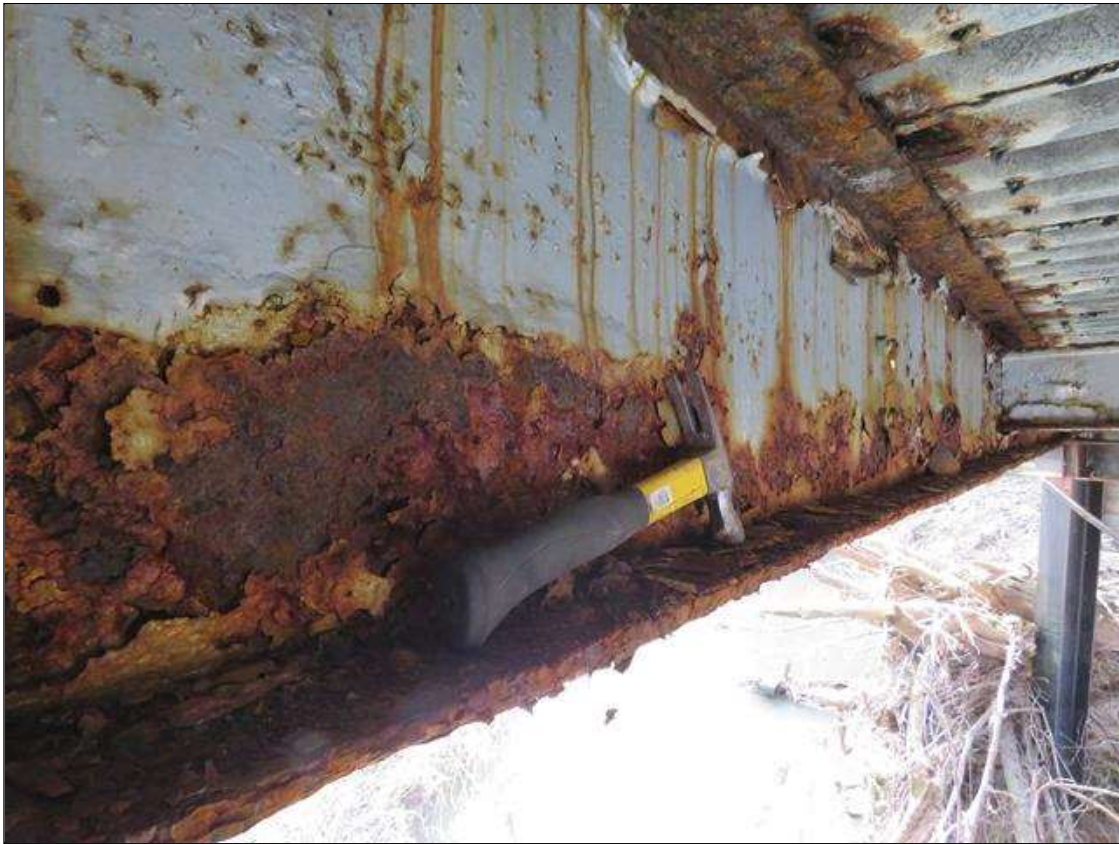
SPAN 2 BEAM 10 MODERATE SCALE, WEB 1/16" SECTION LOSS (17%) AND 5/16" REMAINING TO 8" HEIGHT AT BASE AND 3" HEIGHT AT TOP OF WEB, FOR FULL LENGTH. BOTTOM FLANGE LEFT SIDE ONLY MINOR SCALE WITH TAPERED SECTION LOSS (17% LOSS) 3/8" REMAINING AT EDGE OF 9/16" ORIGINAL FOR FULL LENGTH. TOP FLANGE LEFT SIDE ONLY MINOR SCALE WITH TAPERED SECTION LOSS (33% LOSS) 3/16" REMAINING AT EDGE OF 9/16" ORIGINAL FOR FULL LENGTH (PM PHOTO 1 OF 2)

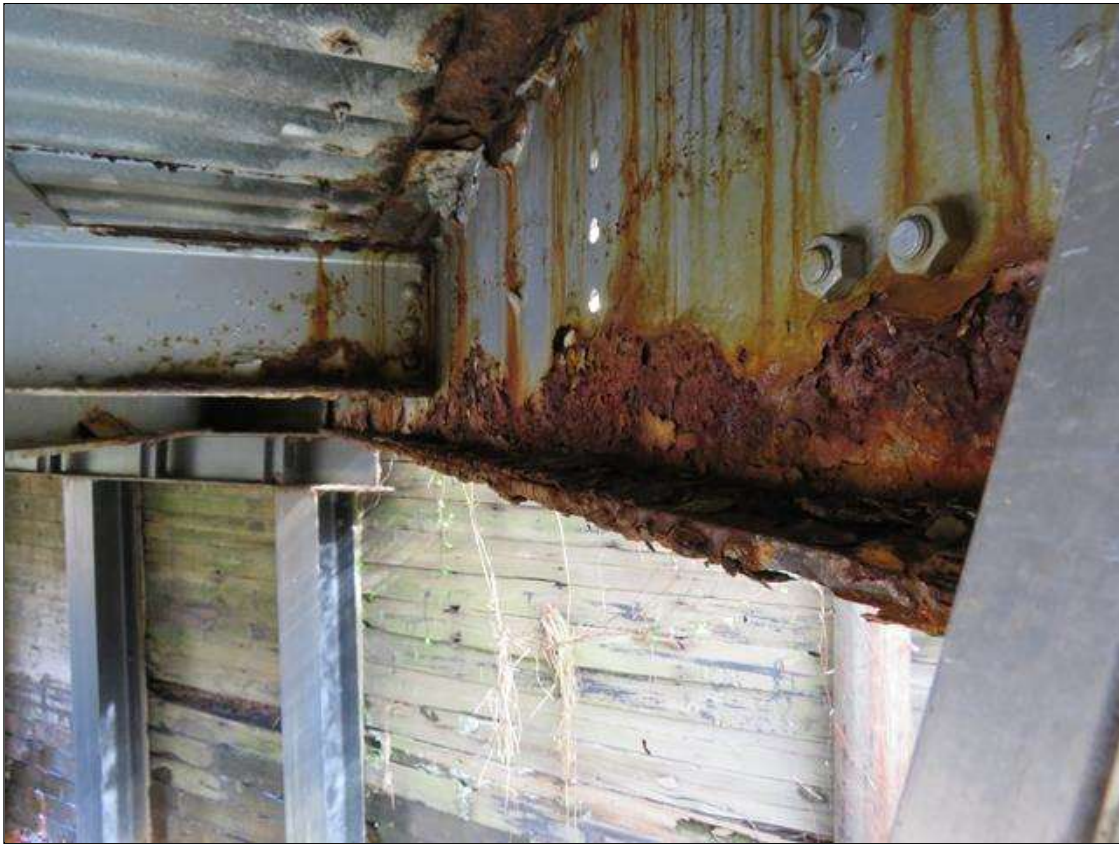
SPAN 2 BEAM 10 MODERATE SCALE, WEB 1/16" SECTION LOSS (17%) AND 5/16" REMAINING TO 8" HEIGHT AT BASE AND 3" HEIGHT AT TOP OF WEB, FOR FULL LENGTH. BOTTOM FLANGE LEFT SIDE ONLY MINOR SCALE WITH TAPERED SECTION LOSS (17% LOSS) 3/8" REMAINING AT EDGE OF 9/16" ORIGINAL FOR FULL LENGTH. TOP FLANGE LEFT SIDE ONLY MINOR SCALE WITH TAPERED SECTION LOSS (33% LOSS) 3/16" REMAINING AT EDGE OF 9/16" ORIGINAL FOR FULL LENGTH (PM PHOTO 2 OF 2)

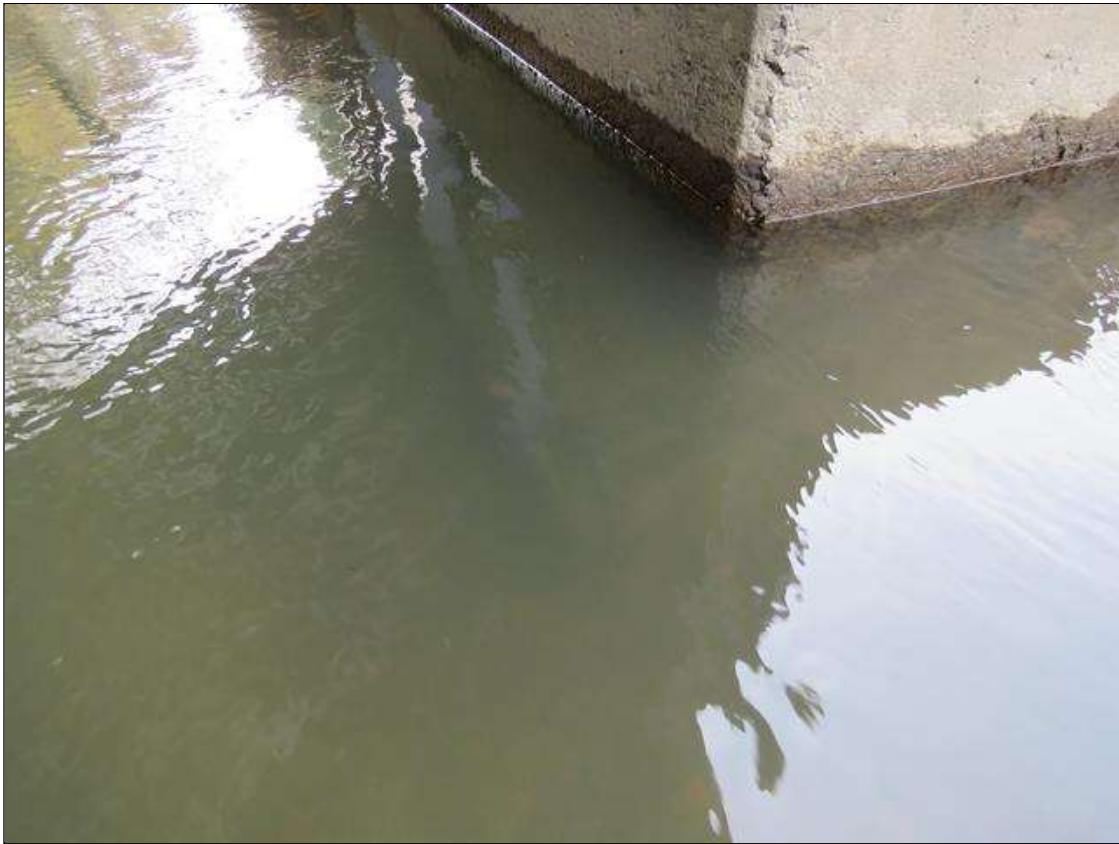
BENT 1 SILL MINOR SCOUR (0.83'x FULL LENGTH) WITH FOOTING EXPOSED NO UNDERMINE (PHOTO 1 OF 2)

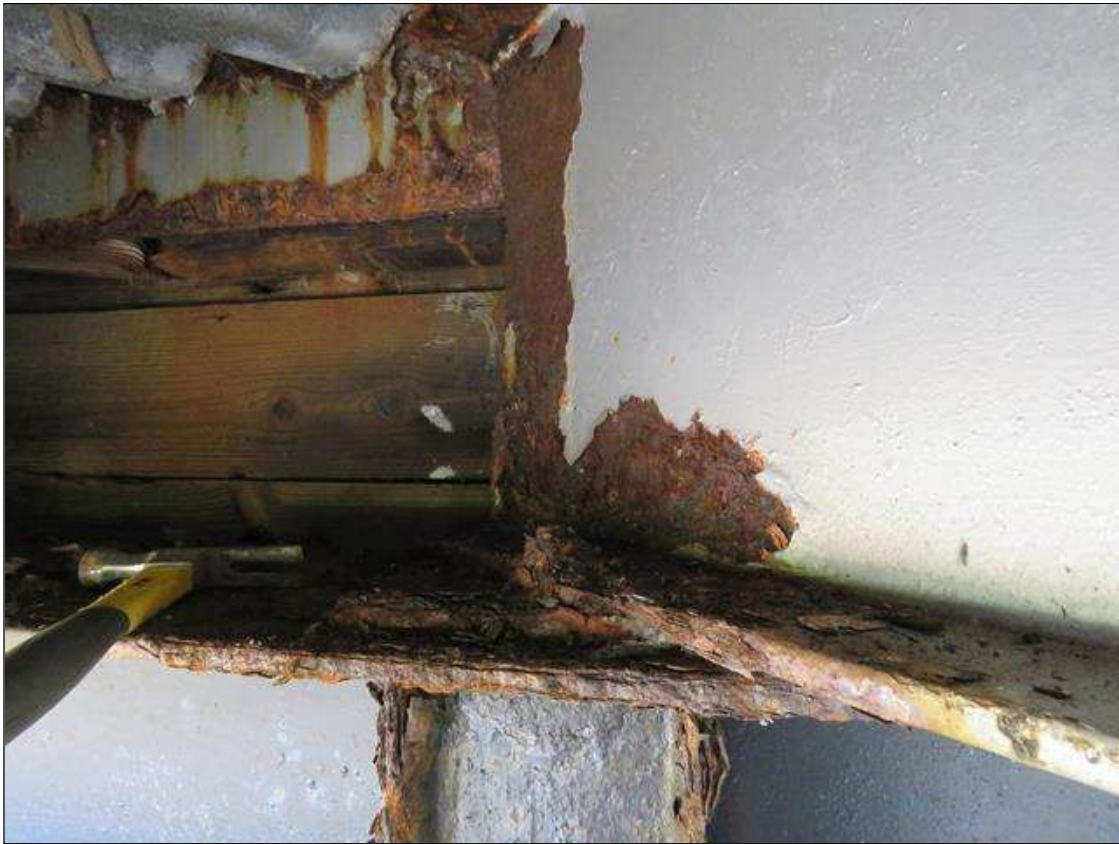
SPAN 2 BEAM 2 MODERATE SCALE, WEB WITH 3/16" SECTION LOSS (50%) AND 3/16" REMAINING TO 6" HEIGHT x 1' LENGTH AT BASE AND 6" LENGTH x FULL HEIGHT, FAR END. BOTTOM FLANGE 5/16" SECTION LOSS (55%) 1/4" REMAINING OF ORIGINAL 9/16" FOR FULL WIDTH x 1.5' FAR END (PM PHOTO)

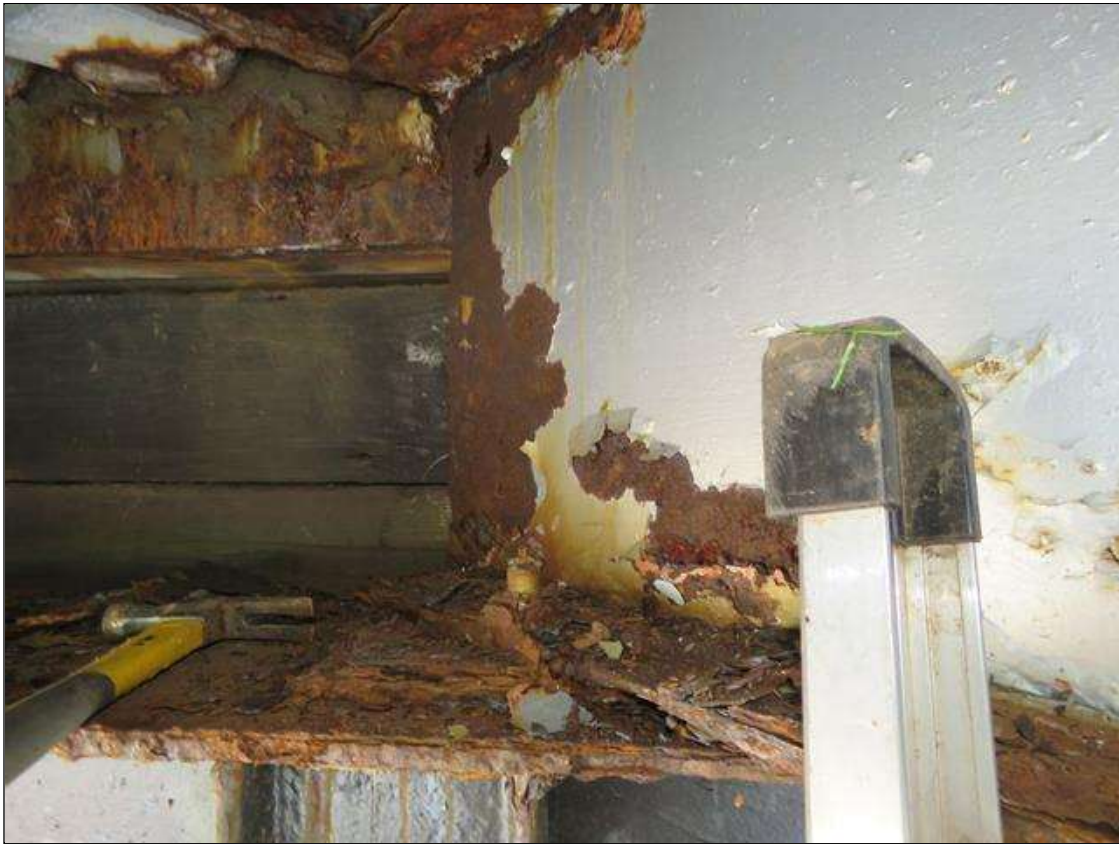
SPAN 2 BEAM 3 MODERATE SCALE, WEB WITH 3/16" SECTION LOSS (50%) AND 3/16" REMAINING TO 1" LENGTH x FULL HEIGHT, FAR END. BOTTOM FLANGE 5/16" SECTION LOSS (55%) 1/4" REMAINING OF ORIGINAL 9/16" FOR FULL WIDTH x 1.5' FAR END (PM PHOTO)

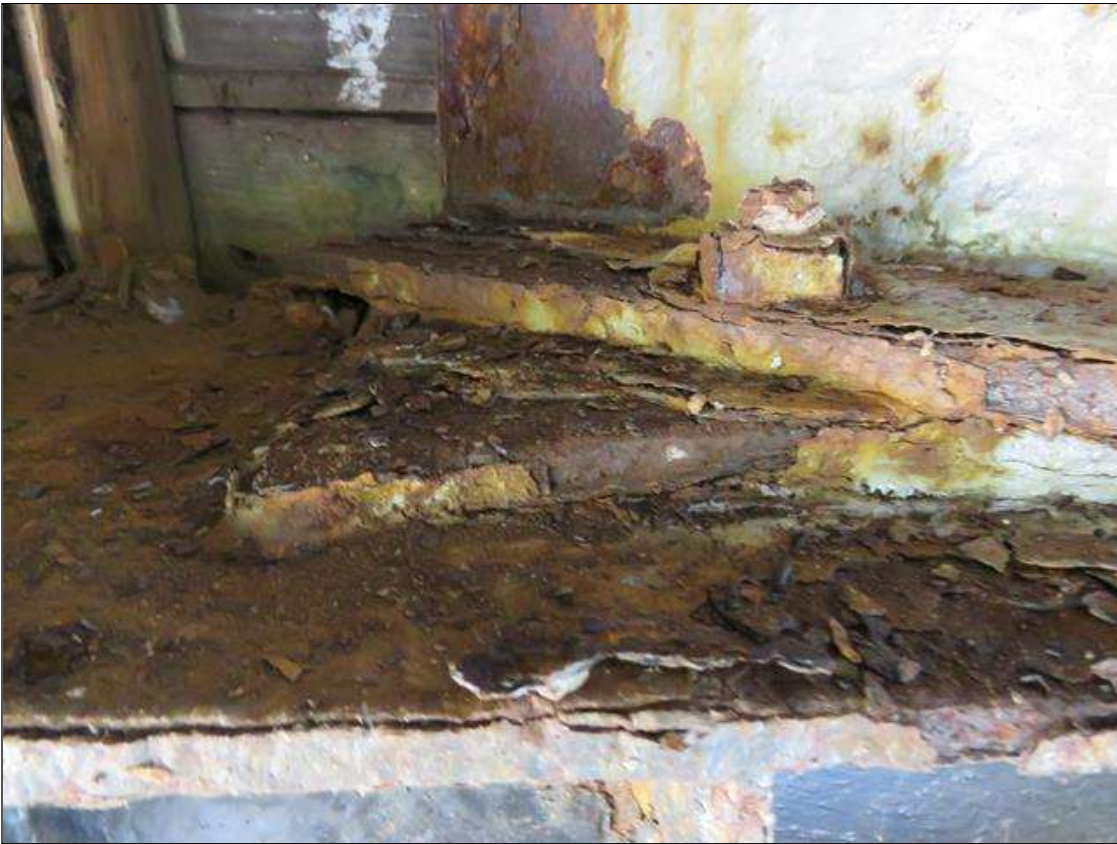
TYPICAL SPAN 2 FAR BEARINGS AT END BENT 2 MINOR SCALE WITH 1/16" SECTION LOSS THROUGHOUT BEAM 4
