NC DEPARTMENT OF TRANSPORTATION  
DIVISION OF HIGHWAYS  
STRUCTURE MANAGEMENT UNIT

# Structure Safety Report

## Routine Element Inspection - Contract

DIVISION: 11 COUNTY: ALLEGHANY STRUCTURE NUMBER: 020035 FREQUENCY: 24 MONTHS

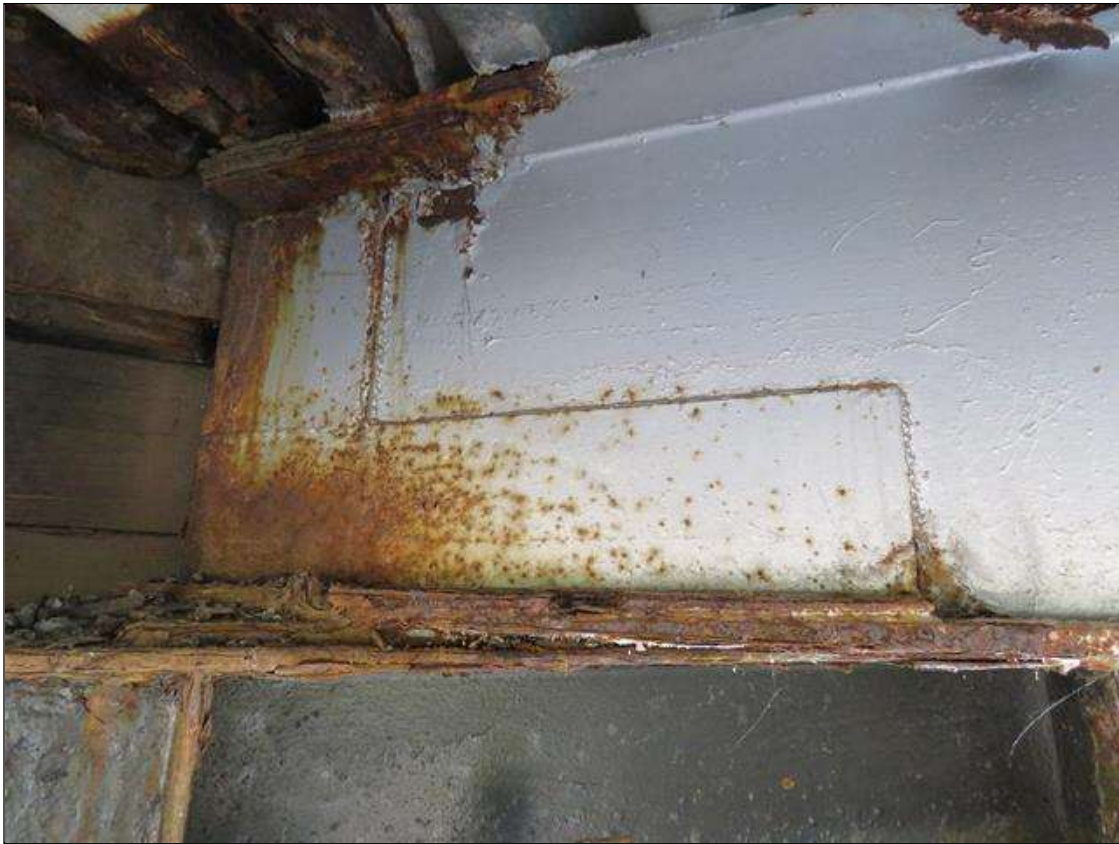
SPAN 2 BEAM 5 TEMPORARY PLATE REPAIR (3') FAR END

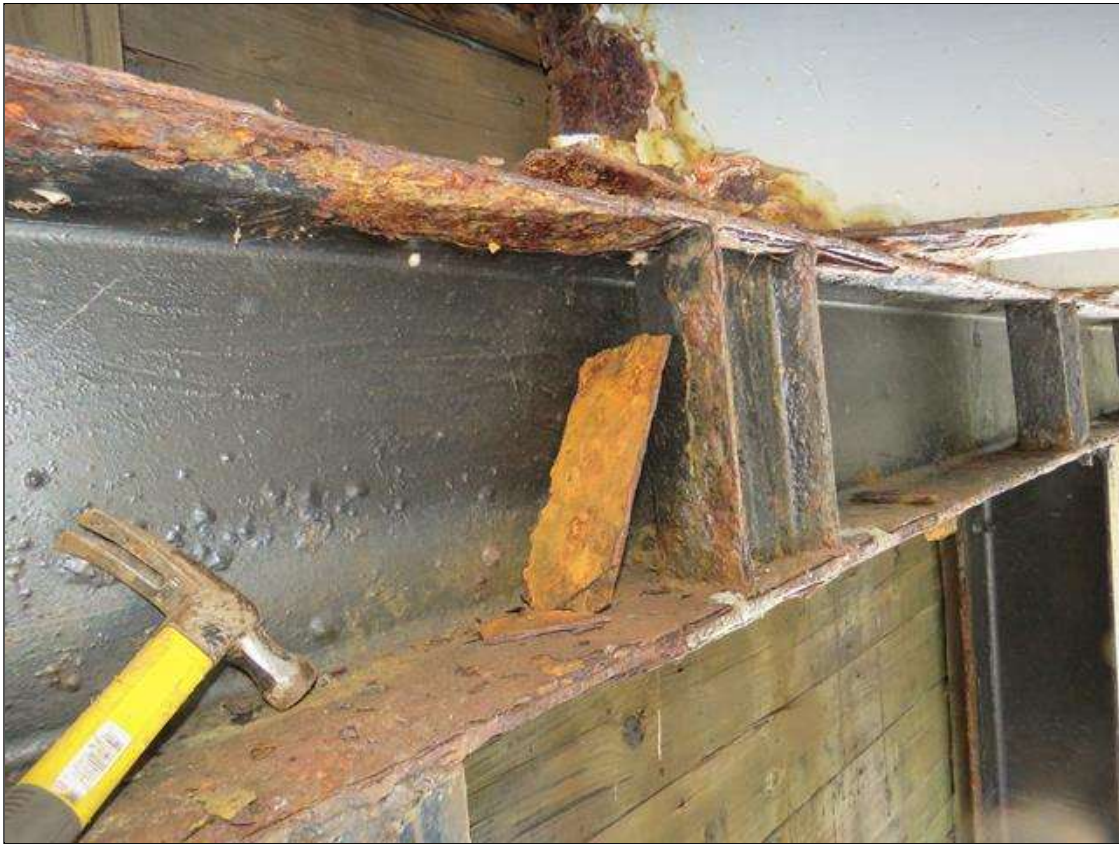
TYPICAL TOP AND BOTTOM FLANGE FULL WIDTH MODERATE SCALE WITH TAPERED SECTION LOSS (14% LOSS) 5/16" REMAINING AT EDGE OF 7/16" ORIGINAL FOR FULL LENGTH, END BENT 2 CAP RIGHT OF BEAM

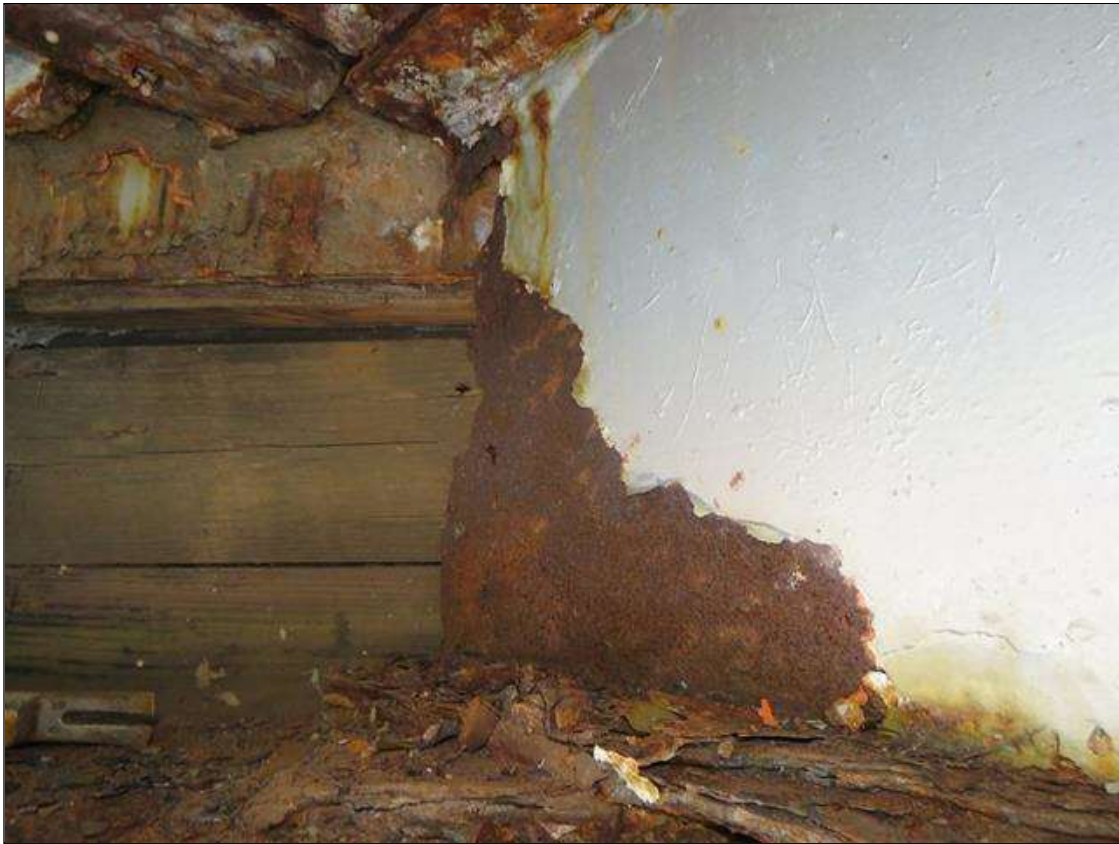
SPAN 2 BEAM 7 MODERATE SCALE, WEB WITH 3/16" SECTION LOSS (50%) AND 3/16" REMAINING TO 8" HEIGHT x 1' LENGTH AT BASE AND 6" LENGTH x FULL HEIGHT, FAR END. BOTTOM FLANGE 5/16" SECTION LOSS (55%) 1/4" REMAINING OF ORIGINAL 9/16" FOR FULL WIDTH x 1.5' FAR END (PM PHOTO)

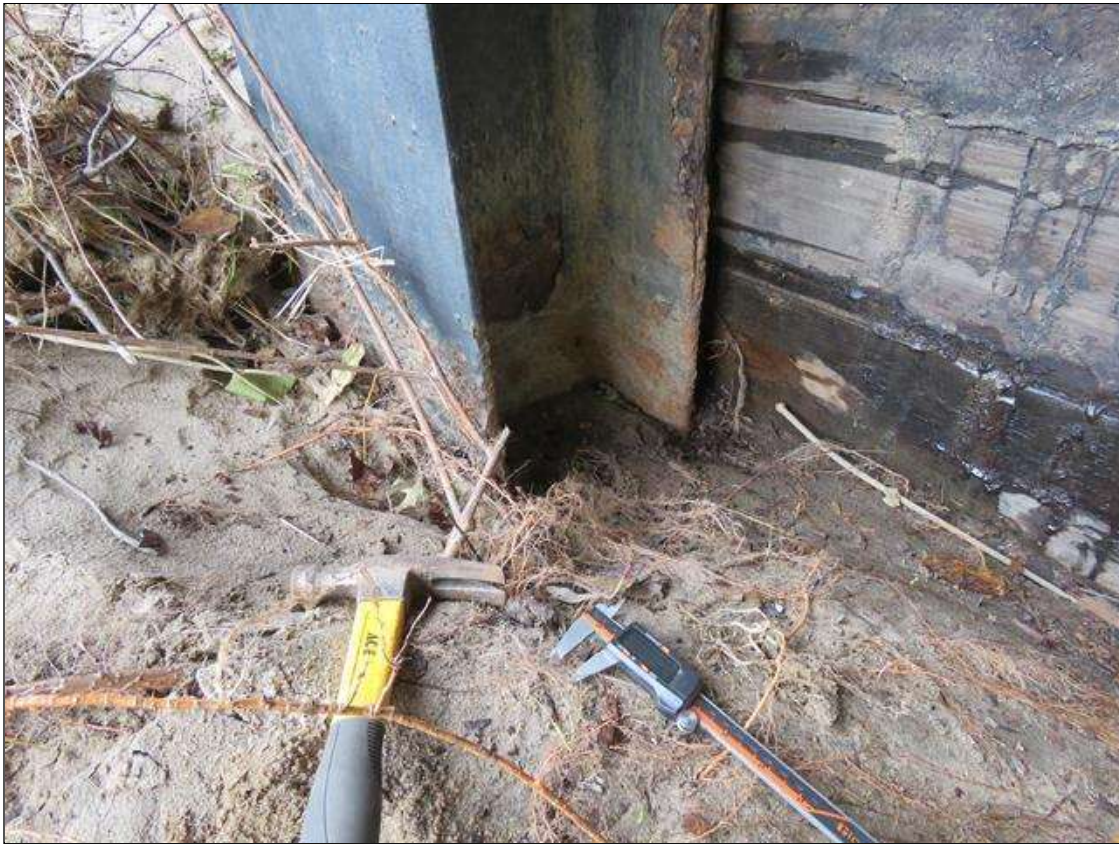
END BENT 2 PILE 2 NEAR AND FAR FACE FLANGE AT GRADE 1.5' HEIGHT x FULL WIDTH MINOR SCALE AND PITTING WITH 1/8" SECTION LOSS (28%), 5/16" REMAINING OF 7/16" ORIGINAL (PM PHOTO)

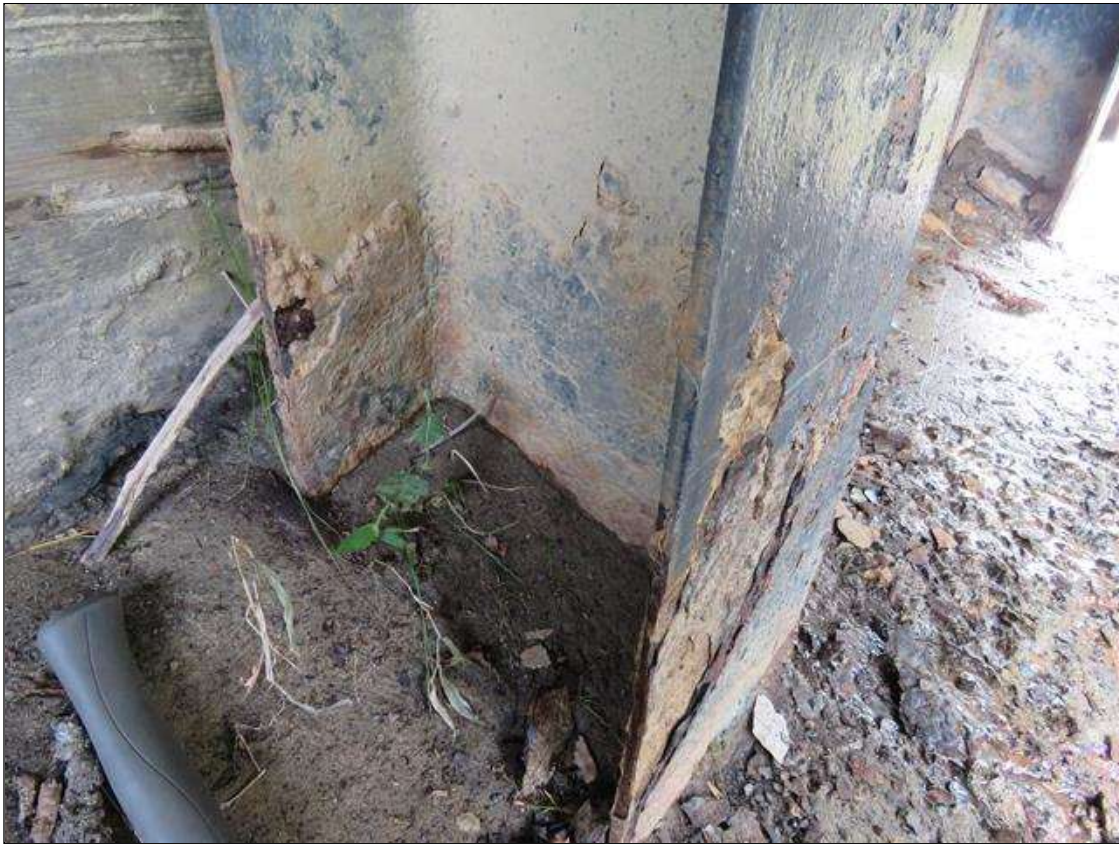
END BENT 2 PILE 4 NEAR AND FAR FACE FLANGES AT GRADE 1' HEIGHT x FULL WIDTH MINOR SCALE AND PITTING WITH 3/16" SECTION LOSS (42%), 1/4" REMAINING OF 7/16" ORIGINAL (PM PHOTO)

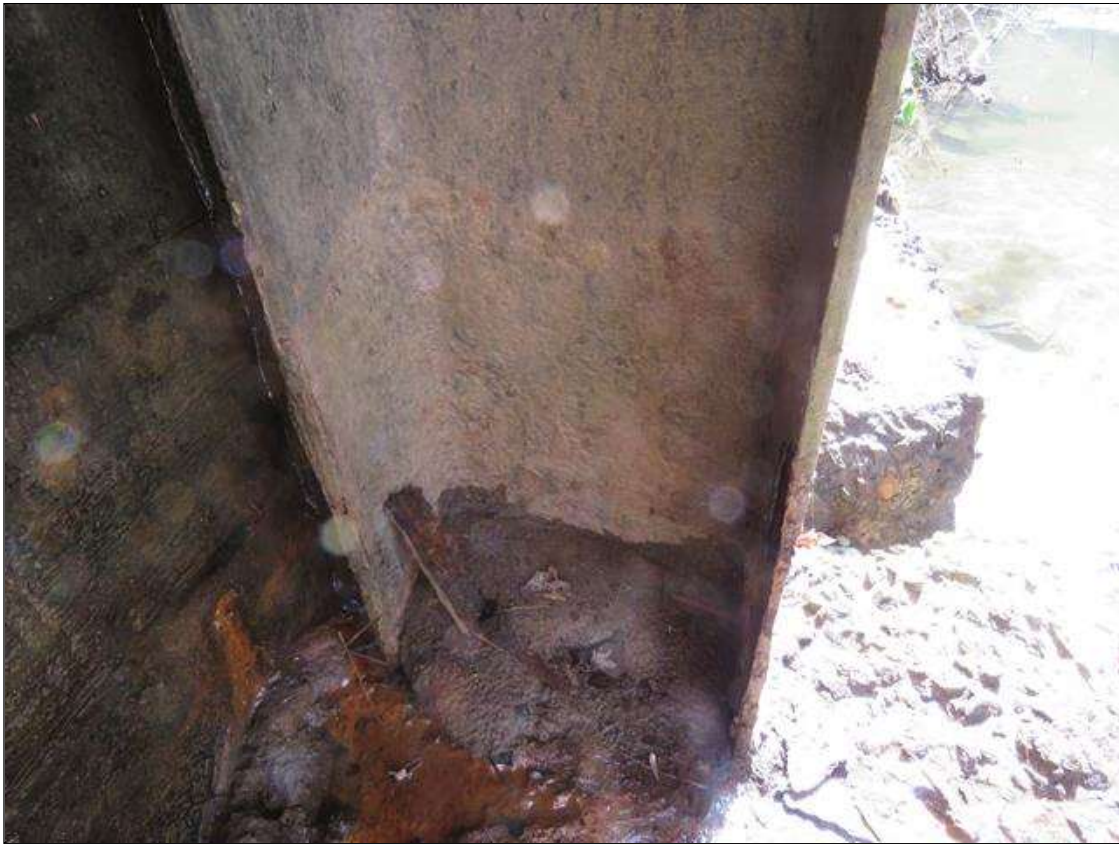
END BENT 2 PILE 6 NEAR AND FAR FACE FLANGES AT GRADE 1' HEIGHT x FULL WIDTH MINOR SCALE AND PITTING WITH 1/8" SECTION LOSS (28%), 5/16" REMAINING OF 7/16" ORIGINAL (PM PHOTO)

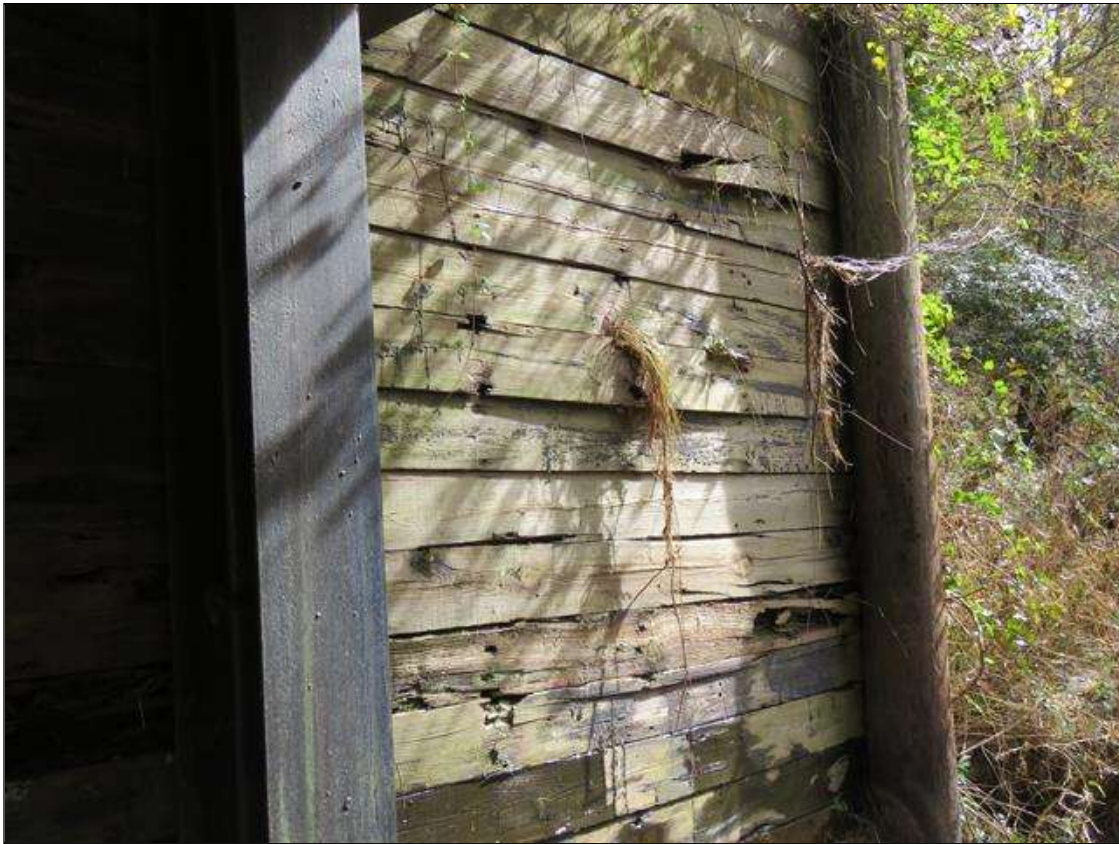
END BENT 2 ABUTMENT RIGHT EXTENSION MINOR TO MODERATE DECAY SPOTS WITH UP TO 50% SECTION LOSS OF TIMBER LAGGING, 2" REMAINING OF 4" ORIGINAL THICKNESS (40 SF), THROUGHOUT RIGHT OF PILE 7 TO RIGHT END EXTENSION TIMBER PILE (PM PHOTO)

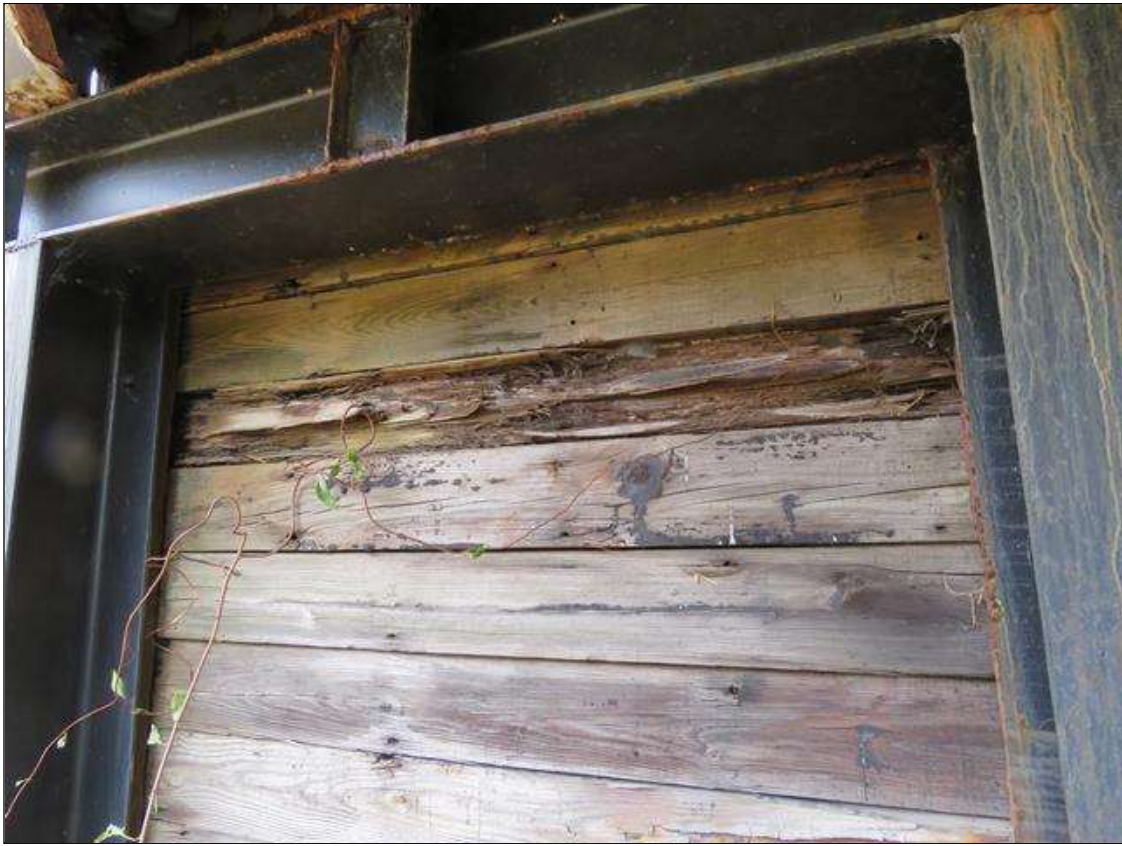
END BENT 2 ABUTMENT MINOR TO MODERATE DECAY SPOTS WITH UP TO 50% SECTION LOSS OF TIMBER LAGGING, 2" REMAINING OF 4" ORIGINAL THICKNESS (8 SF), 1' BELOW CAP BETWEEN PILES 1 AND 2, SIMILAR BETWEEN PILES 5 AND 6 (PM PHOTO)

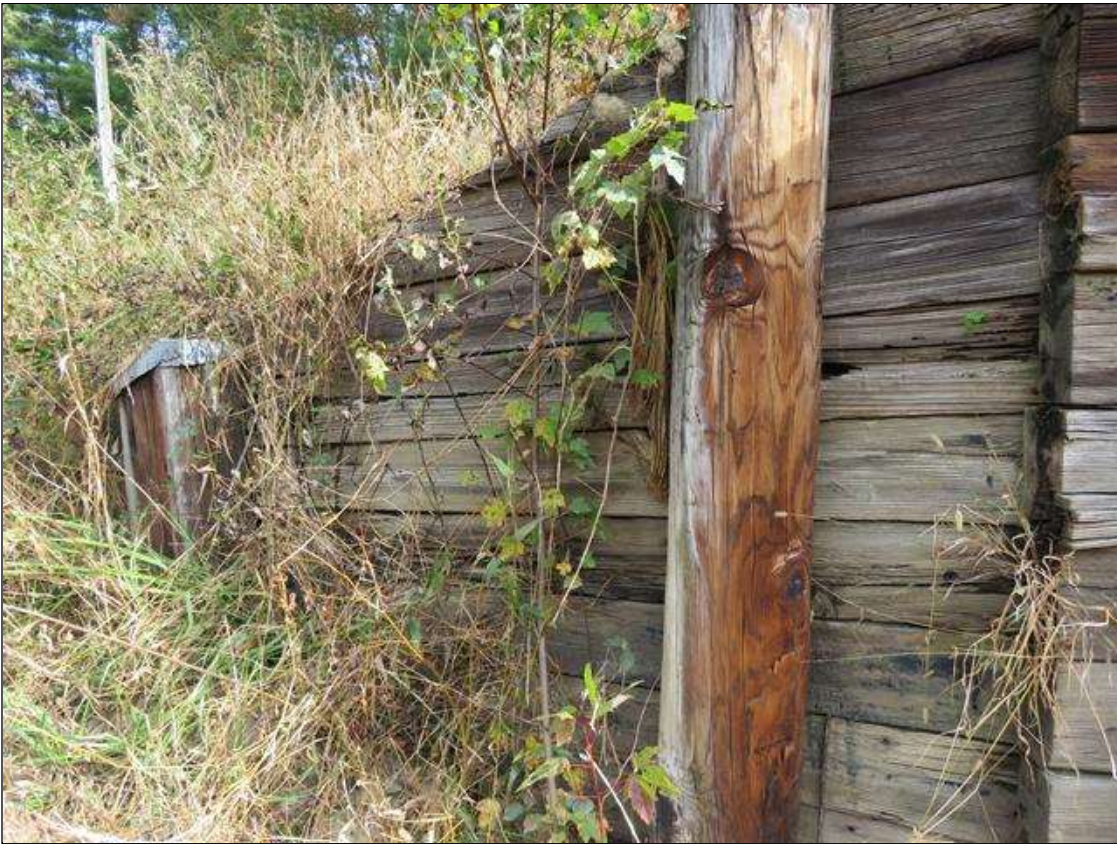
FAR LEFT WING WALL MINOR DECAY SPOTS WITH UP TO 10% SECTION LOSS OF TIMBER LAGGING, 3.5" REMAINING OF 4" ORIGINAL THICKNESS (20 SF) THROUGHOUT

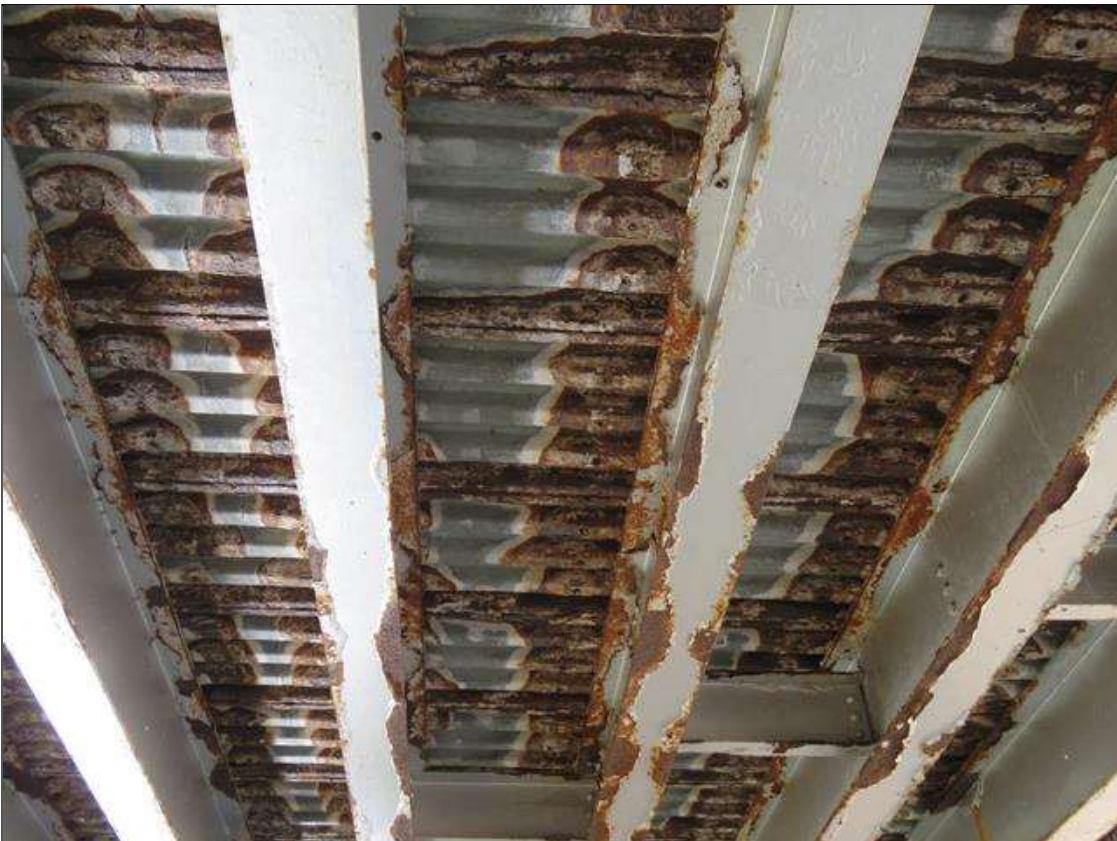
| Element Number | Defect Type | Defect Description | CS | CS Qty | Maint Qty | |
|---|---|---|---|---|---|---|
| 30 | Corrosion | UNDERSIDE CORRUGATED PANS INTERMITTENT MODERATE SCALE WITH UP TO 30% SECTION LOSS THROUGHOUT (PM) | 3 | 970 | 970 | Square Feet |

SPAN 2 DECK UNDERSIDE CORRUGATED PANS INTERMITTENT MODERATE SCALE WITH UP TO 30% SECTION LOSS BAYS 4 THROUGH 6 (PM PHOTO)

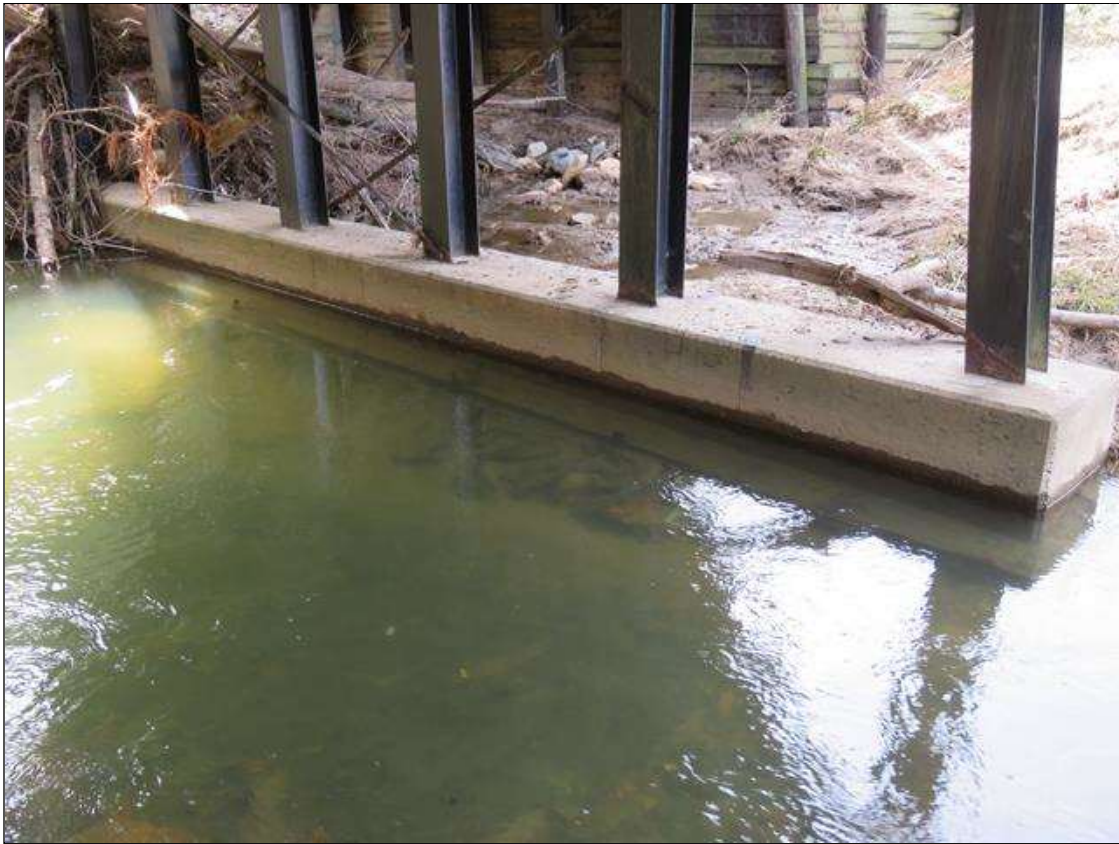
BENT 1 SILL MINOR SCOUR (0.83'x FULL LENGTH) WITH FOOTING EXPOSED NO UNDERMINE (PHOTO 2 OF 2)
