NC DEPARTMENT OF TRANSPORTATION  
DIVISION OF HIGHWAYS  
STRUCTURE MANAGEMENT UNIT

# Structure Safety Report

## 2 Year Complete Topside and Underwater Element Inspection

DIVISION: 11 COUNTY: ALLEGHANY STRUCTURE NUMBER: 020133 FREQUENCY: 24 MONTHS

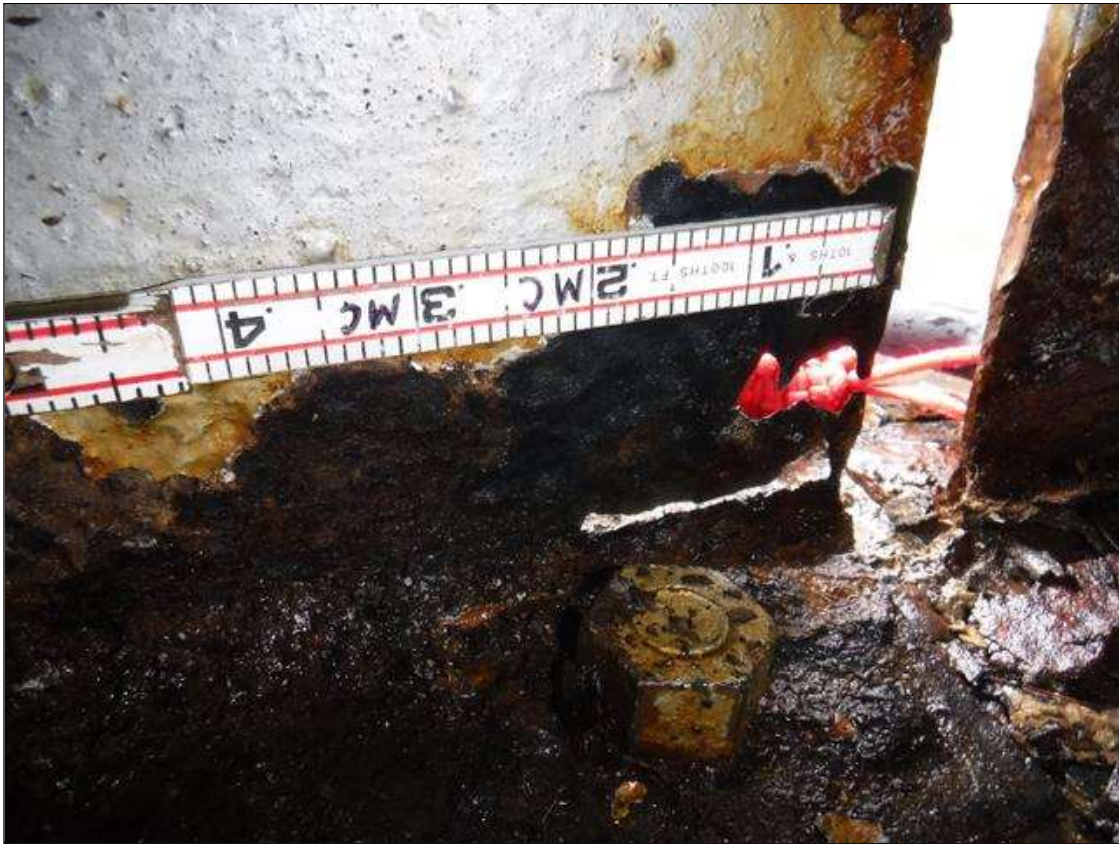
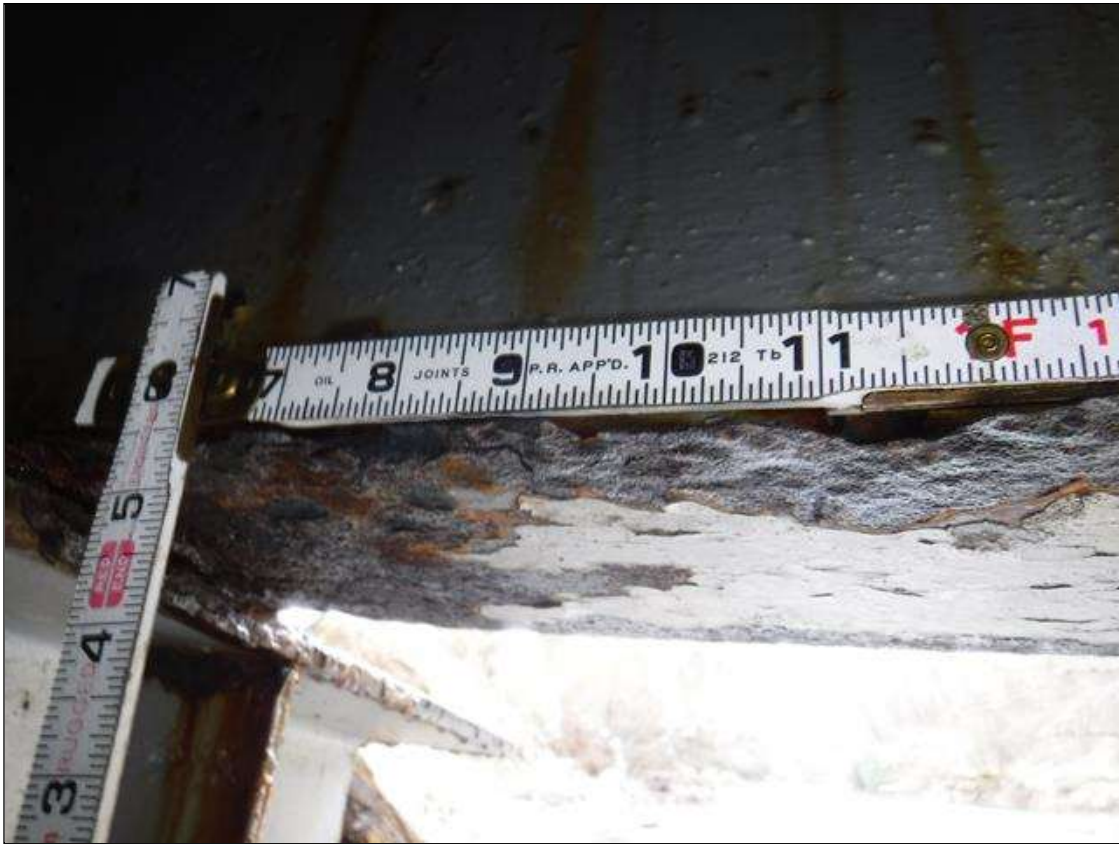
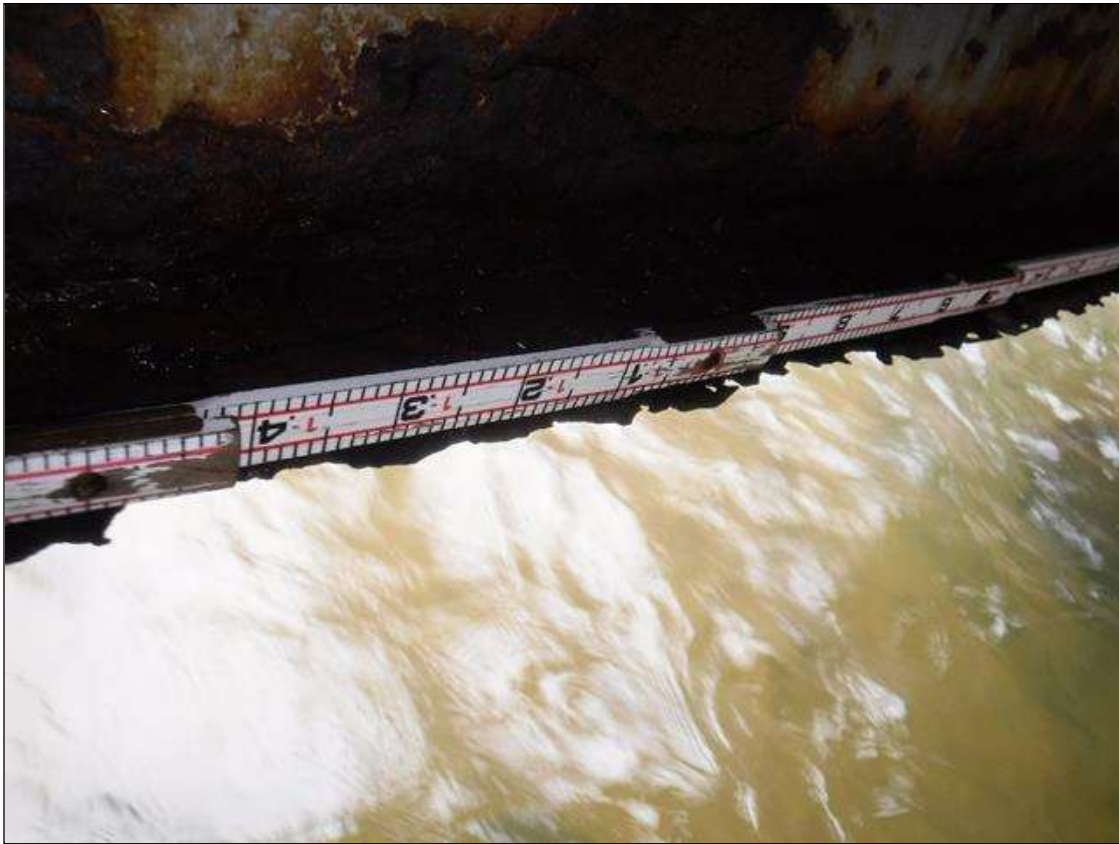
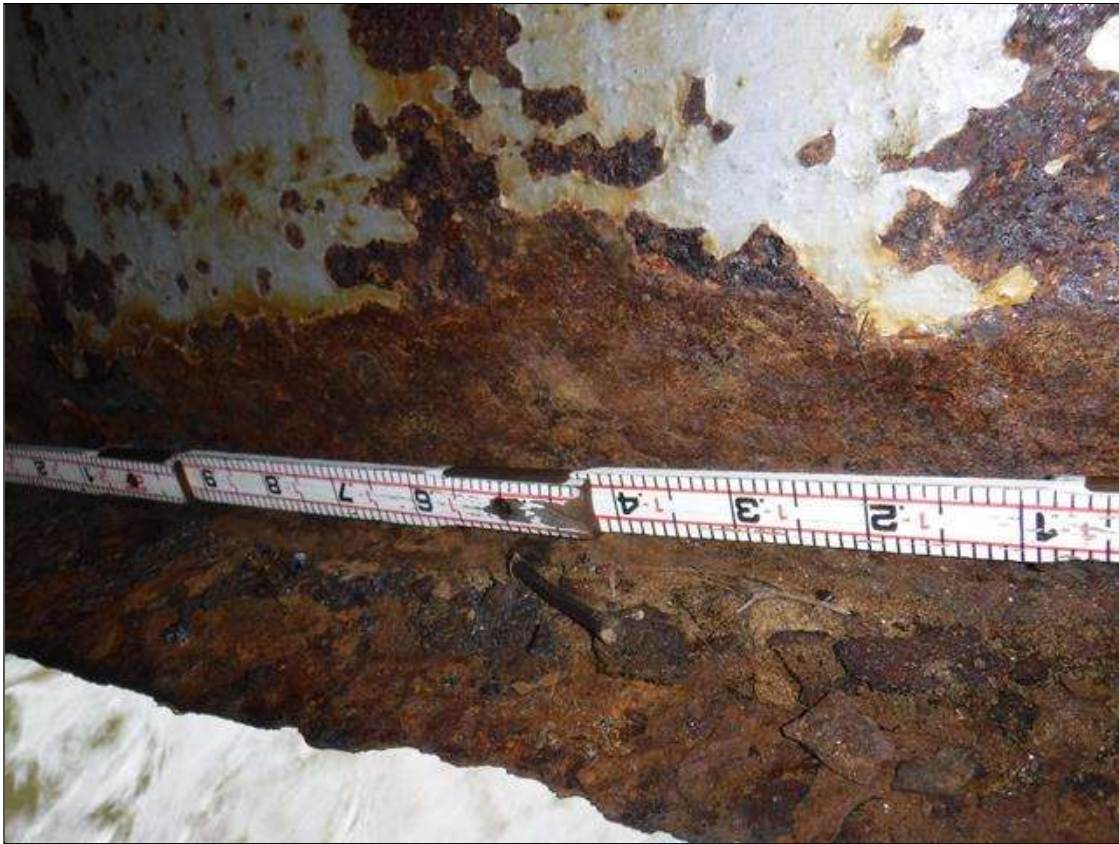
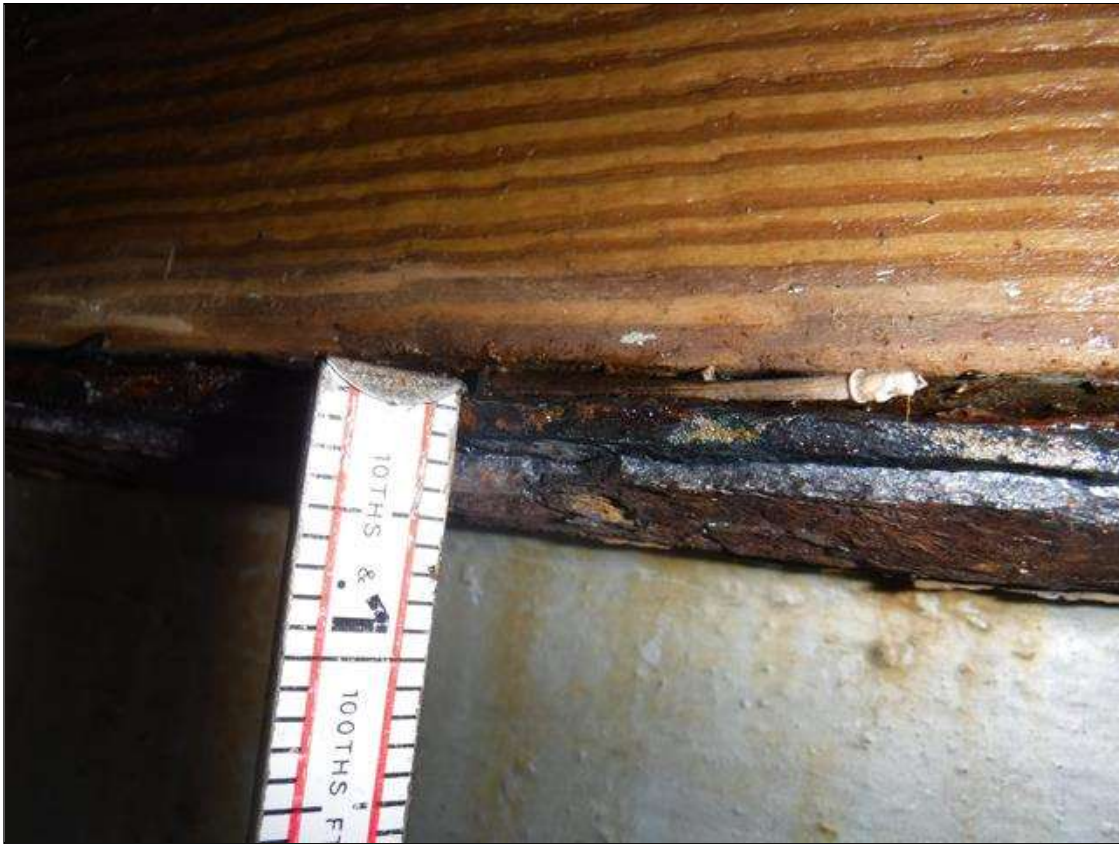
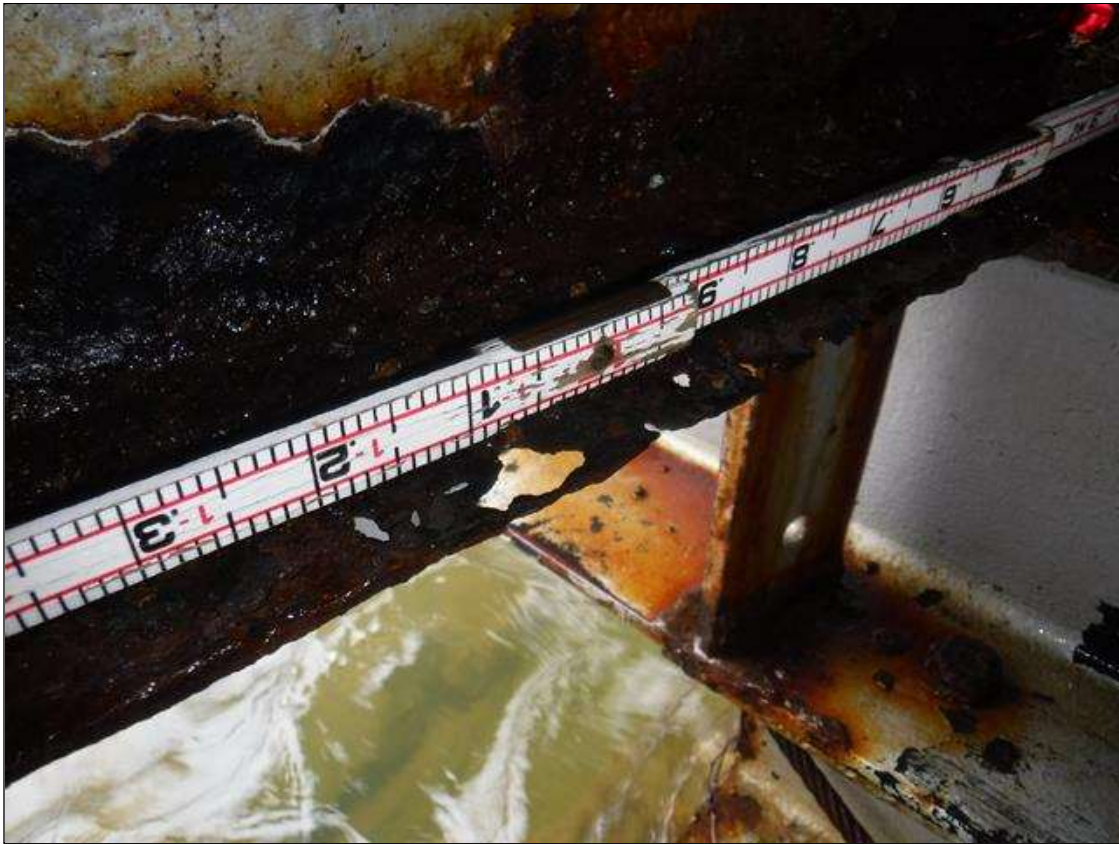
| Element Number | Defect Type | Defect Description | CS | CS Qty | Maint Qty | |
|---|---|---|---|---|---|---|
| 107 | Corrosion | BOTTOM FLANGE FULL LENGTH SCALING RUST DOWN TO KNIFE EDGE WITH HOLES. TOP FLANGE FULL LENGTH SCALING RUST WITH 1/8" REMAINING STEEL. WEB SCALING RUST WITH SECTION LOSS WITH HOLES AT ABUTMENT 1 END AND BENT 1 END. | 4 | 31 | 31 | Feet |

Span 1 Beam 1: BOTTOM FLANGE FULL LENGTH SCALING RUST DOWN TO KNIFE EDGE WITH HOLES. TOP FLANGE FULL LENGTH SCALING RUST WITH 1/8" REMAINING STEEL. WEB SCALING RUST WITH SECTION LOSS WITH HOLES AT ABUTMENT 1 END AND BENT 1 END.

| MMS Code | Description of Function | Unit | Quantity | Remarks | Est. Cost |
|---|---|---|---|---|---|
| 3314 | Maintain Steel Superstructure Components | LF | 31 | Span 1 Beam 1: BOTTOM FLANGE FULL LENGTH SCALING RUST DOWN TO KNIFE EDGE WITH HOLES. TOP FLANGE FULL LENGTH SCALING RUST WITH 1/8" REMAINING STEEL. WEB SCALING RUST WITH SECTION LOSS WITH HOLES AT ABUTMENT 1 END AND BENT 1 END. | |

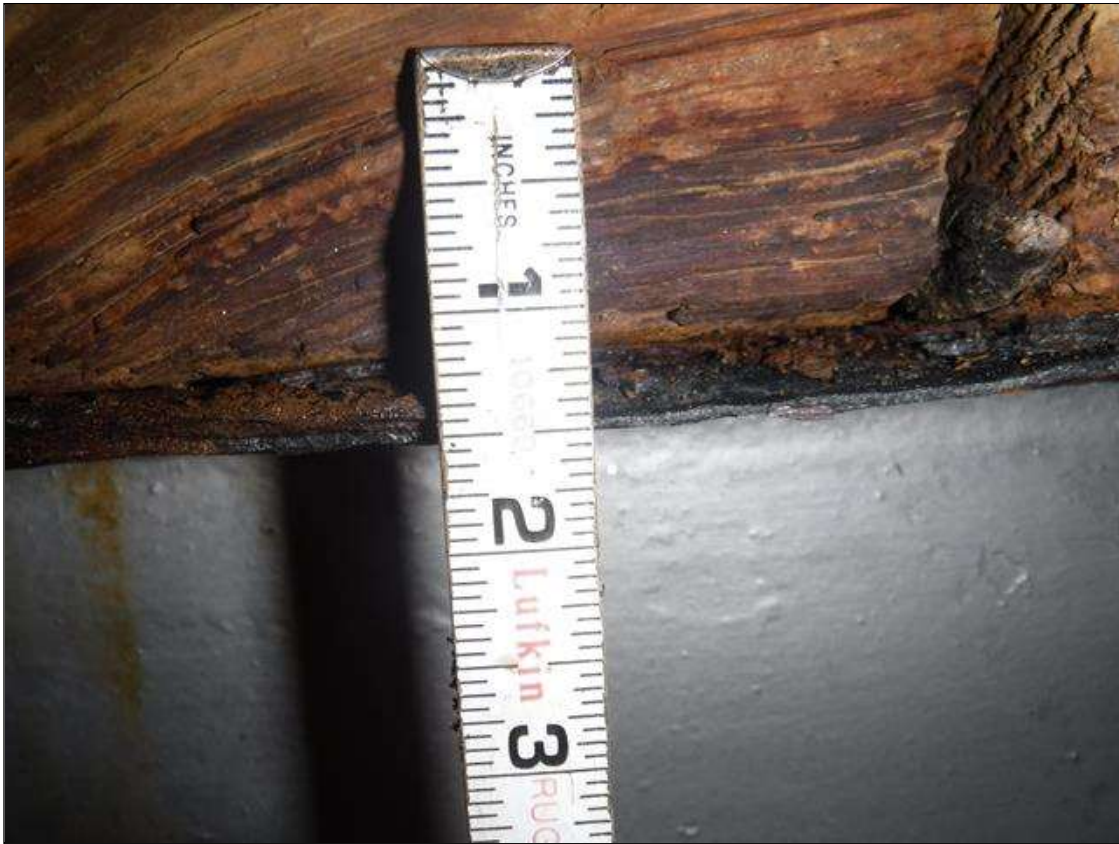
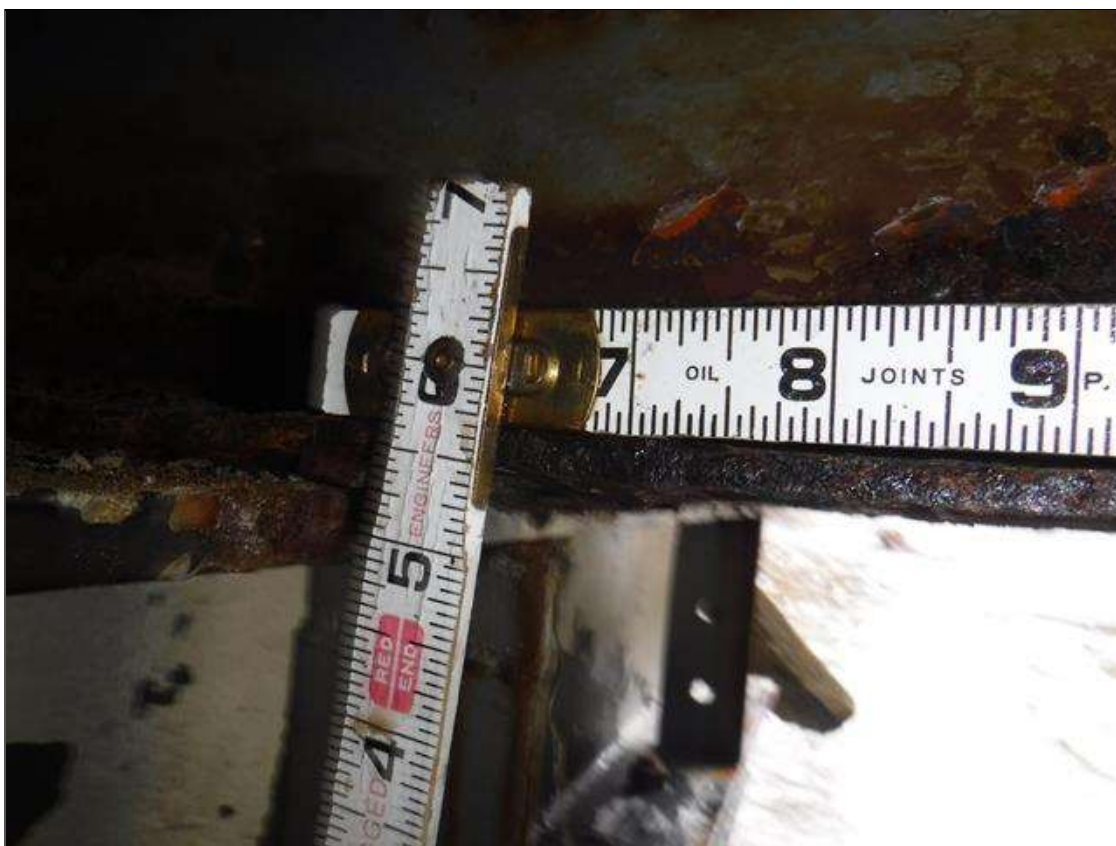
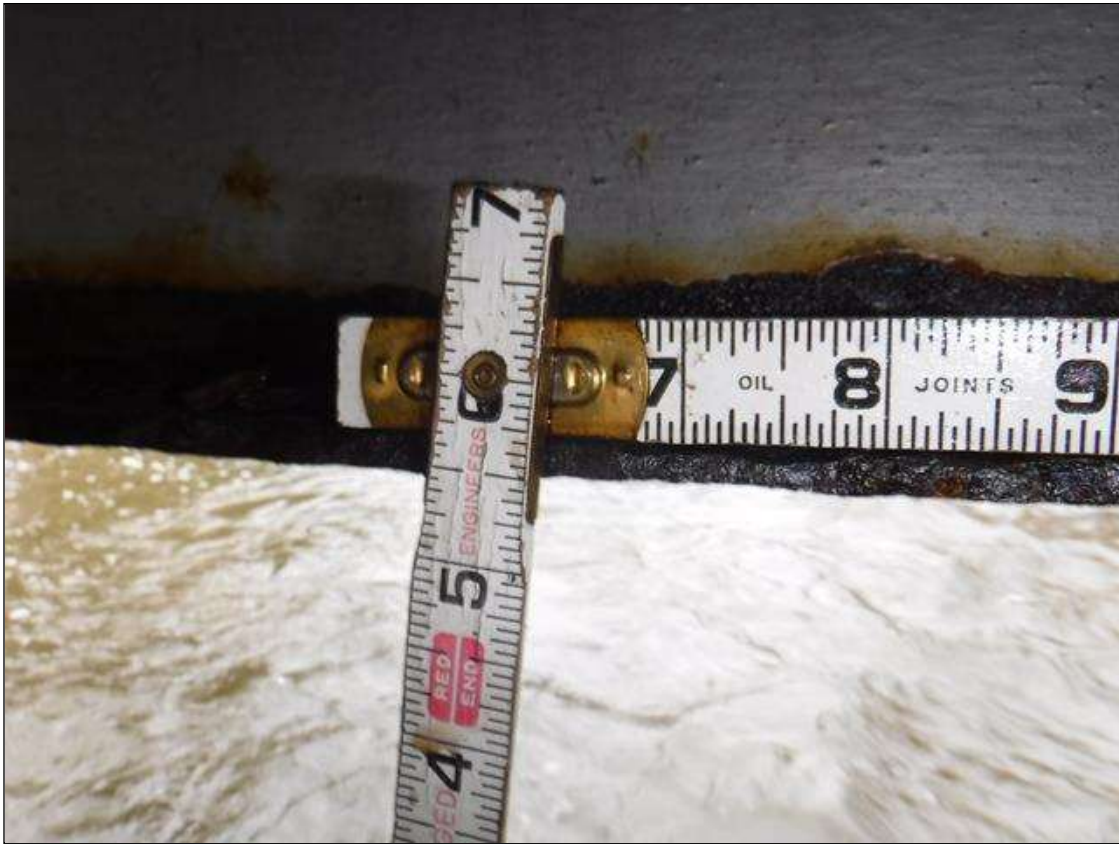
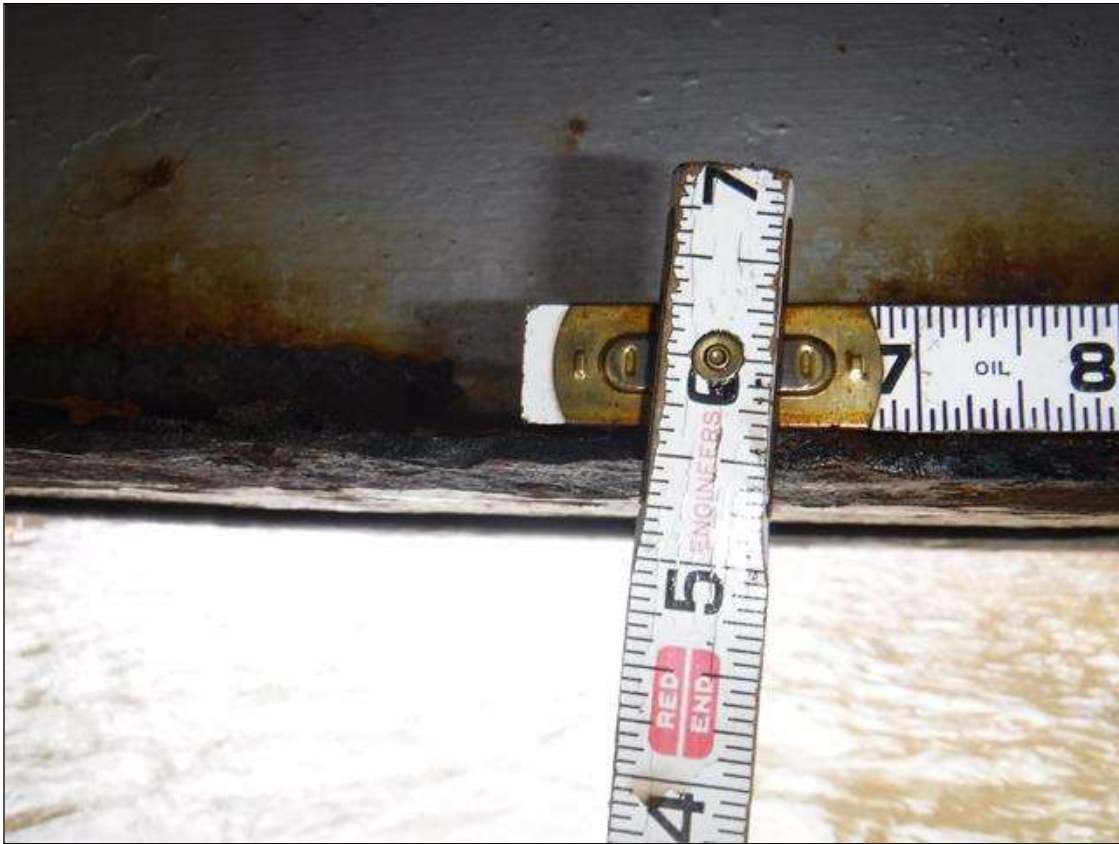
| Element Number | Defect Type | Defect Description | CS | CS Qty | Maint Qty | |
|---|---|---|---|---|---|---|
| 107 | Corrosion | FROM ABUTMENT 1 OUT 17' BOTTOM FLANGE SCALING RUST WITH 1/8" TO 3/16" REMAINING STEEL. TOP FLANGE SCALING RUST WITH 1/16" REMAINING STEEL. WEB SCALING RUST WITH SECTION LOSS. | 4 | 17 | 17 | Feet |

Span 1 Beam 2: FROM ABUTMENT 1 OUT 17' BOTTOM FLANGE SCALING RUST WITH 1/8" TO 3/16" REMAINING STEEL. TOP FLANGE SCALING RUST WITH 1/16" REMAINING STEEL. WEB SCALING RUST WITH SECTION LOSS.

| MMS Code | Description of Function | Unit | Quantity | Remarks | Est. Cost |
|---|---|---|---|---|---|
| 3314 | Maintain Steel Superstructure Components | LF | 17 | Span 1 Beam 2: FROM ABUTMENT 1 OUT 17' BOTTOM FLANGE SCALING RUST WITH 1/8" TO 3/16" REMAINING STEEL. TOP FLANGE SCALING RUST WITH 1/16" REMAINING STEEL. WEB SCALING RUST WITH SECTION LOSS. | |

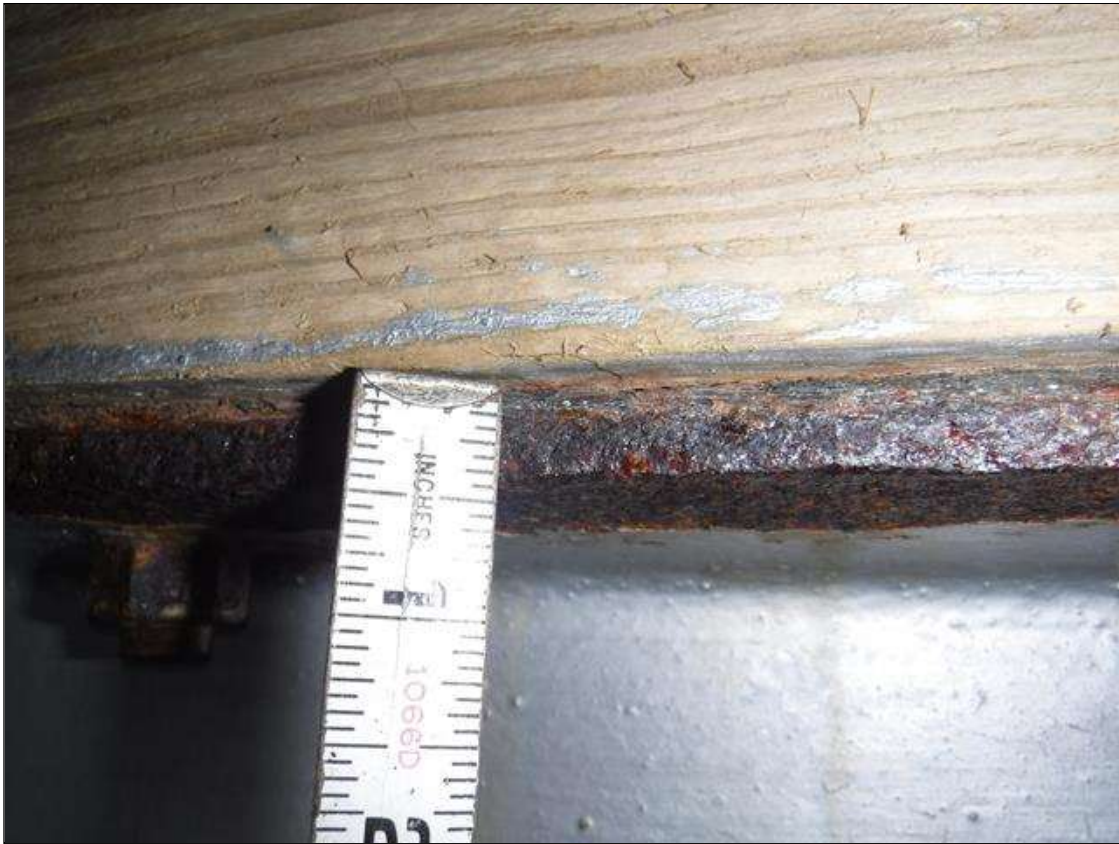
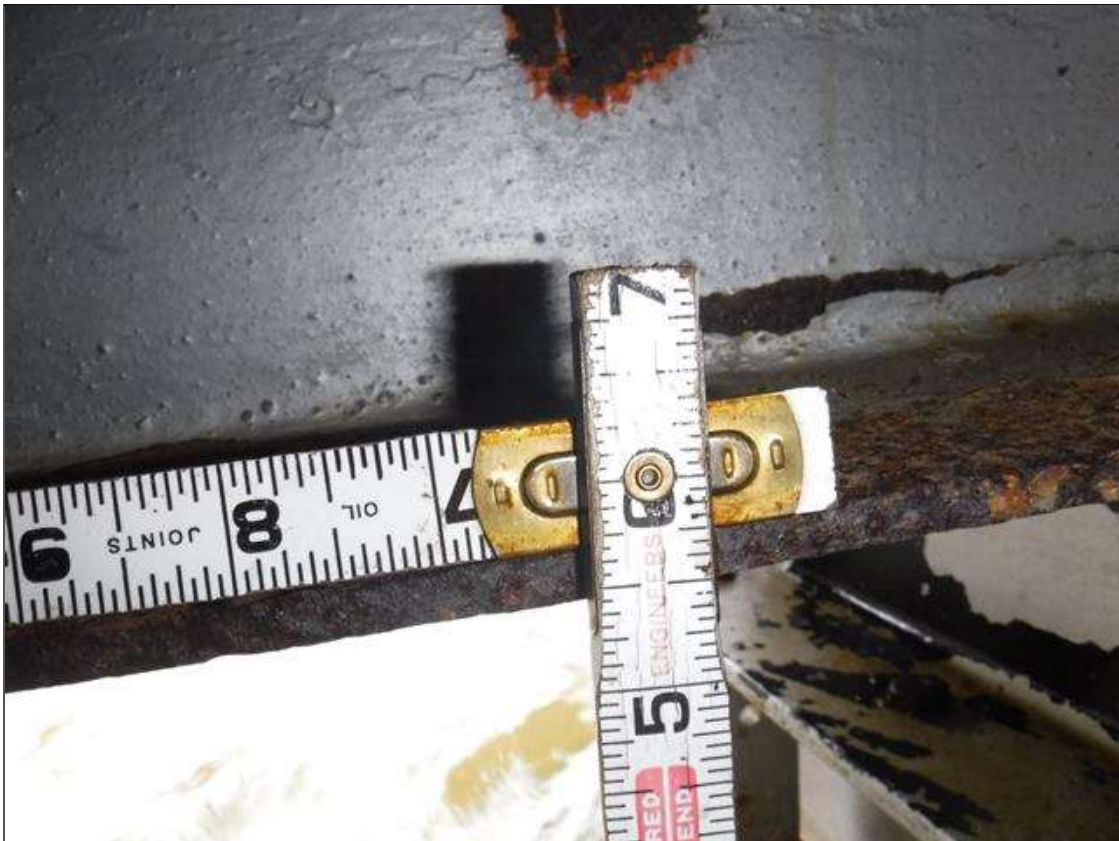
| Element Number | Defect Type | Defect Description | CS | CS Qty | Maint Qty | |
|---|---|---|---|---|---|---|
| 107 | Corrosion | BOTTOM FLANGE SCALING RUST WITH 1/4" REMAINING STEEL. TOP FLANGE SCALING RUST WITH 1/4" REMAINING STEEL. WEB SCATTERED SURFACE RUST WITH RANDOM PITTING TO 1/16". | 3 | 14 | 14 | Feet |

Span 1 Beam 2: BOTTOM FLANGE SCALING RUST WITH 1/4" REMAINING STEEL. TOP FLANGE SCALING RUST WITH 1/4" REMAINING STEEL. WEB SCATTERED SURFACE RUST WITH RANDOM PITTING TO 1/16".

| MMS Code | Description of Function | Unit | Quantity | Remarks | Est. Cost |
|---|---|---|---|---|---|
| 3314 | Maintain Steel Superstructure Components | LF | 14 | Span 1 Beam 2: BOTTOM FLANGE SCALING RUST WITH 1/4" REMAINING STEEL. TOP FLANGE SCALING RUST WITH 1/4" REMAINING STEEL. WEB SCATTERED SURFACE RUST WITH RANDOM PITTING TO 1/16". | |

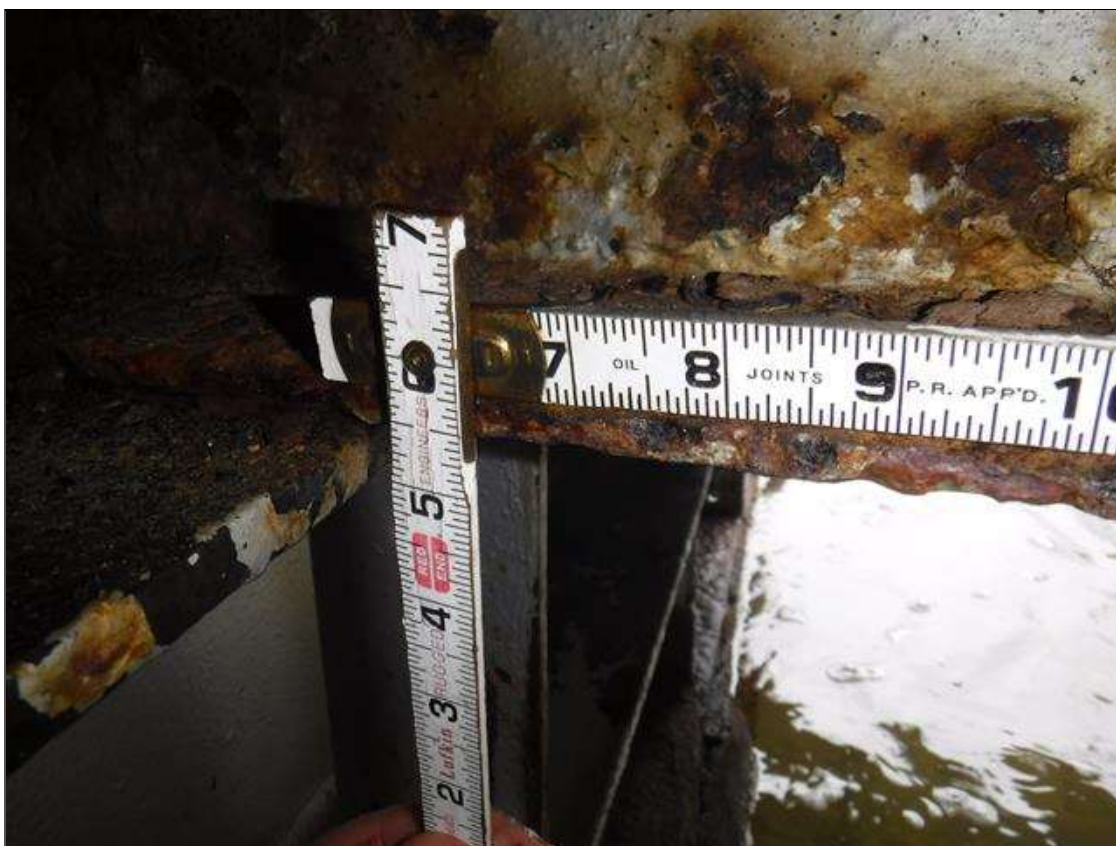
| Element Number | Defect Type | Defect Description | CS | CS Qty | Maint Qty | |
|---|---|---|---|---|---|---|
| 107 | Corrosion | AT ABUTMENT 1 END 3' IN LENGTH TOP AND BOTTOM FLANGE SCALING RUST WITH 1/4" REMAINING STEEL. WEB SCALING RUST WITH PITTING TO 1/16". | 3 | 3 | 3 | Feet |

Span 1 Beam 3: AT ABUTMENT 1 END 3' IN LENGTH TOP AND BOTTOM FLANGE SCALING RUST WITH 1/4" REMAINING STEEL. WEB SCALING RUST WITH PITTING TO 1/16".

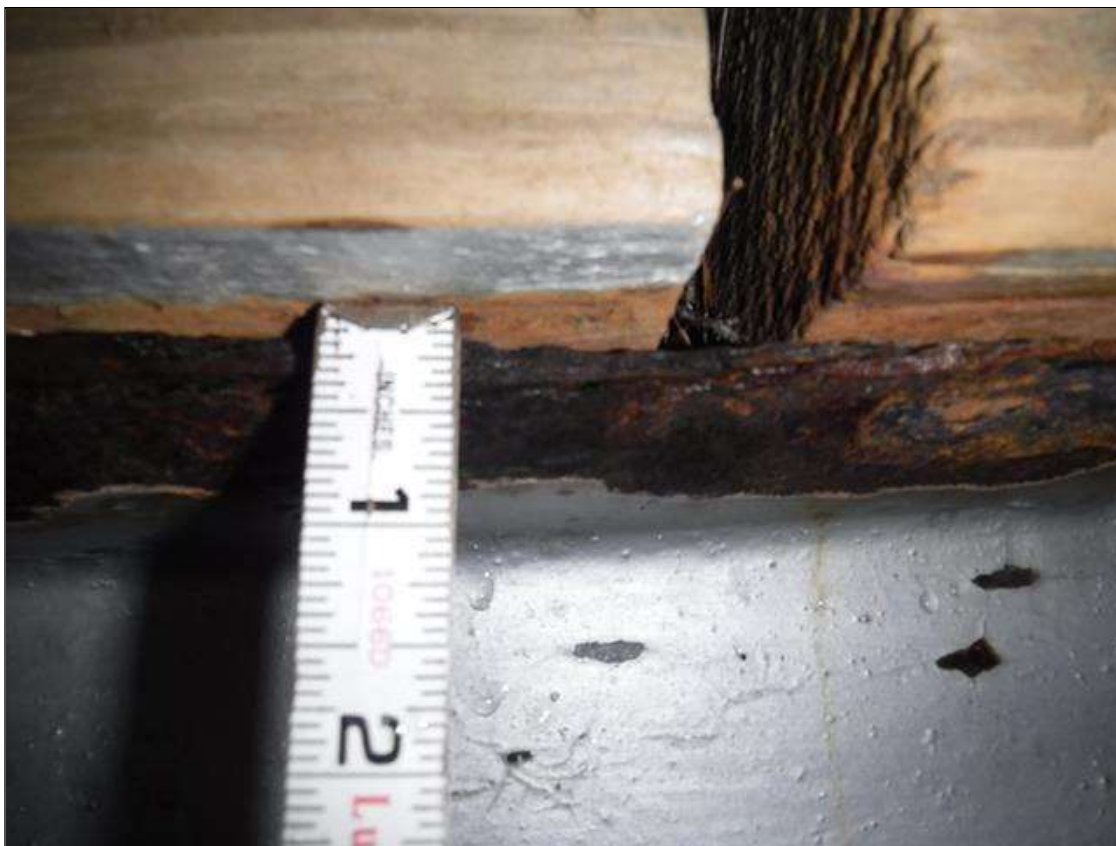
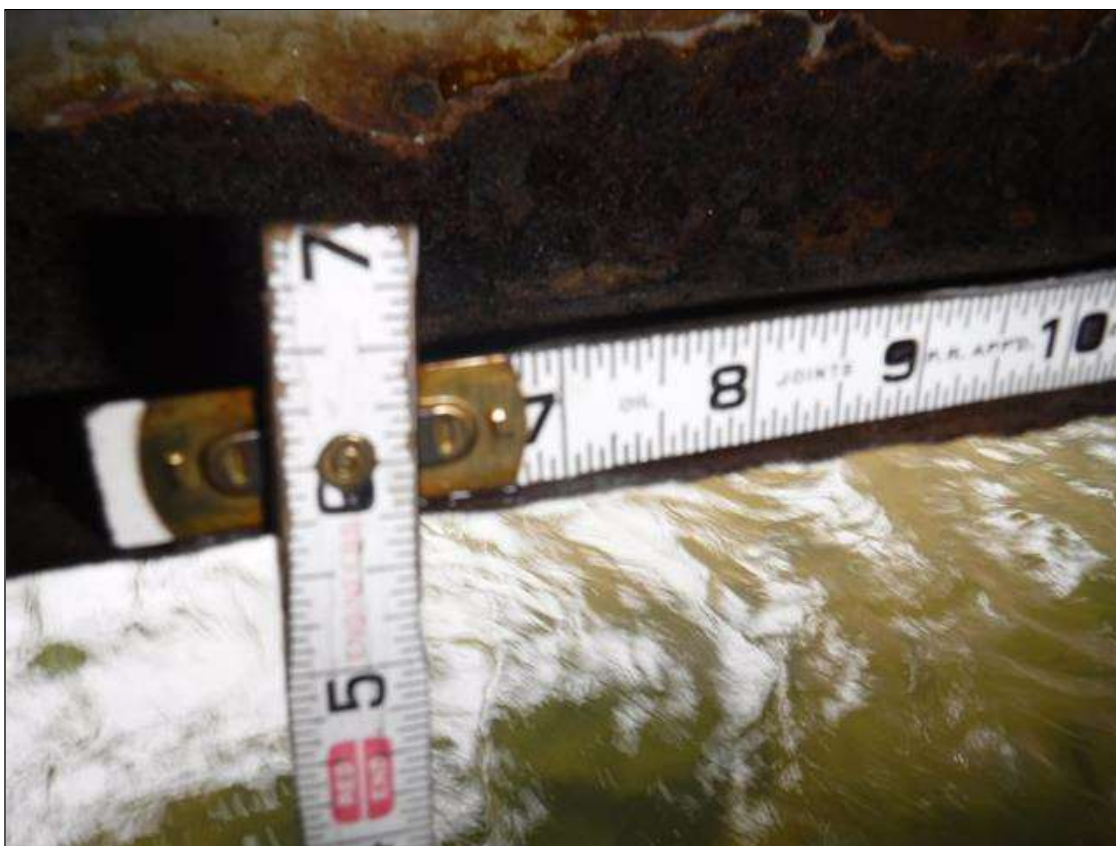
| Element Number | Defect Type | Defect Description | CS | CS Qty | Maint Qty | |
|---|---|---|---|---|---|---|
| 107 | Corrosion | 10' FROM ABUTMENT 1 END BOTTOM FLANGE SCALING RUST WITH 1/16" REMAINING STEEL. TOP FLANGE SCALING RUST WITH 1/16" TO 1/8" REMAINING STEEL. WEB SCALING RUST WITH SECTION LOSS. | 4 | 4 | 4 | Feet |

Span 1 Beam 3: 10' FROM ABUTMENT 1 END BOTTOM FLANGE SCLAING RUST WITH 1/16" REMAINING STEEL. TOP FLANGE SCALING RUST WITH 1/16" TO 1/8" REMAINING STEEL. WEB SCALING RUST WITH SECTION LOSS.

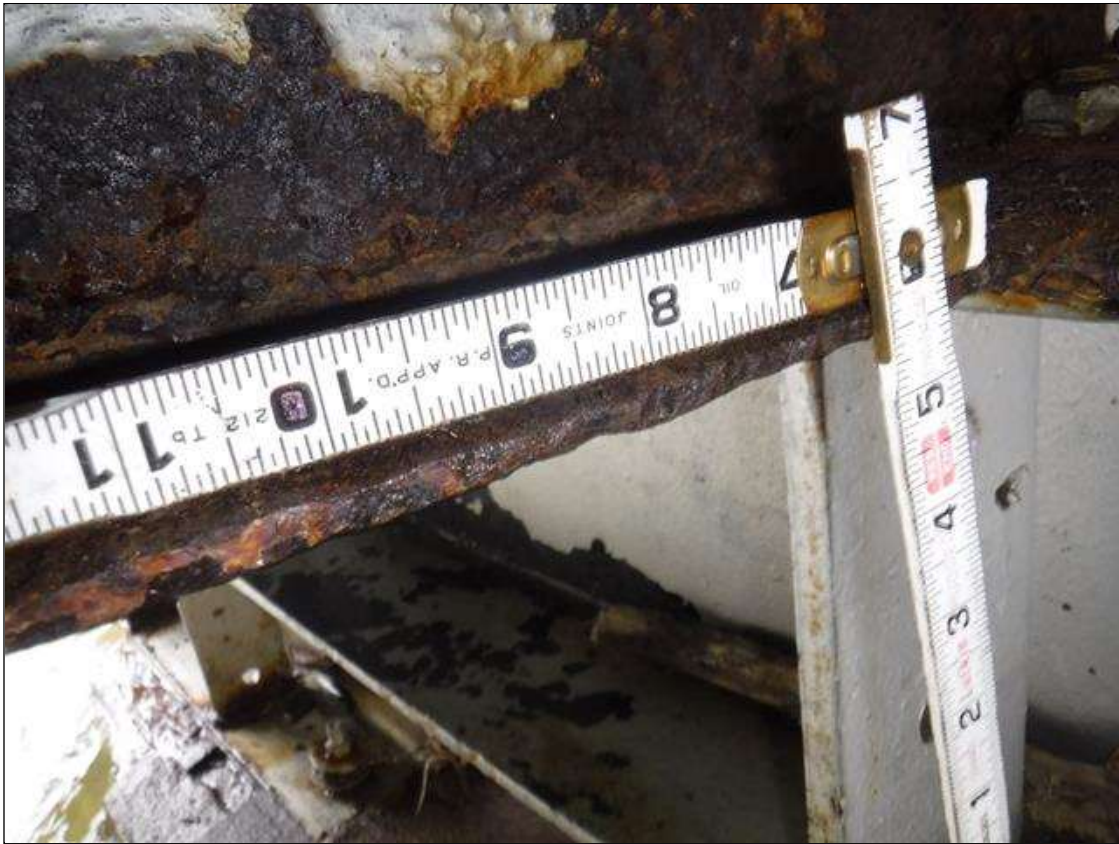
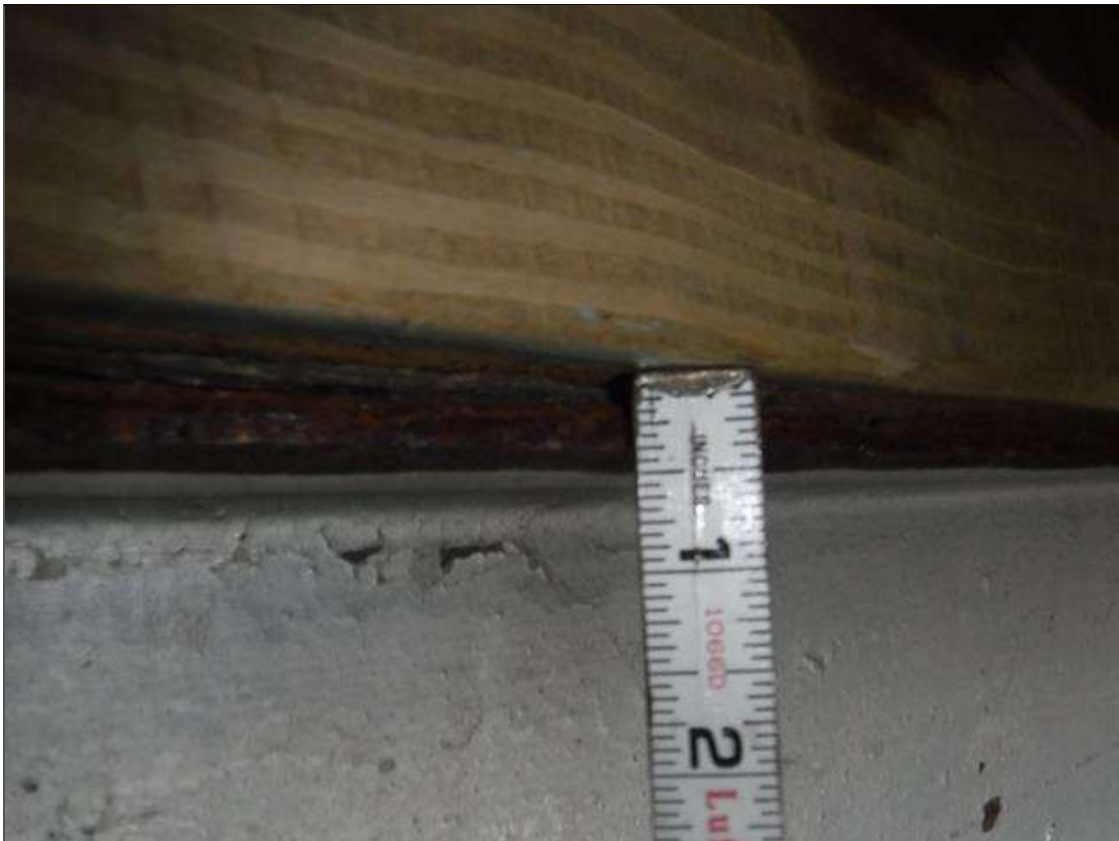
| Element Number | Defect Type | Defect Description | CS | CS Qty | Maint Qty | |
|---|---|---|---|---|---|---|
| 107 | Corrosion | AT BENT 1 END BOTTOM FLANGE SCALING RUST WITH 3/16" REMAINING STEEL. TOP FLANGE SCALING RUST WITH 3/16" TO 1/4" REMAINING STEEL. WEB SCALING RUST WITH SECTION LOSS. | 3 | 2 | 2 | Feet |

Span 1 Beam 3: AT BENT 1 END BOTTOM FLANGE SCALING RUST WITH 3/16" REMAINING STEEL. TOP FLANGE SCALING RUST WITH 3/16" TO 1/4" REMAINING STEEL. WEB SCALING RUST WITH SECTION LOSS.

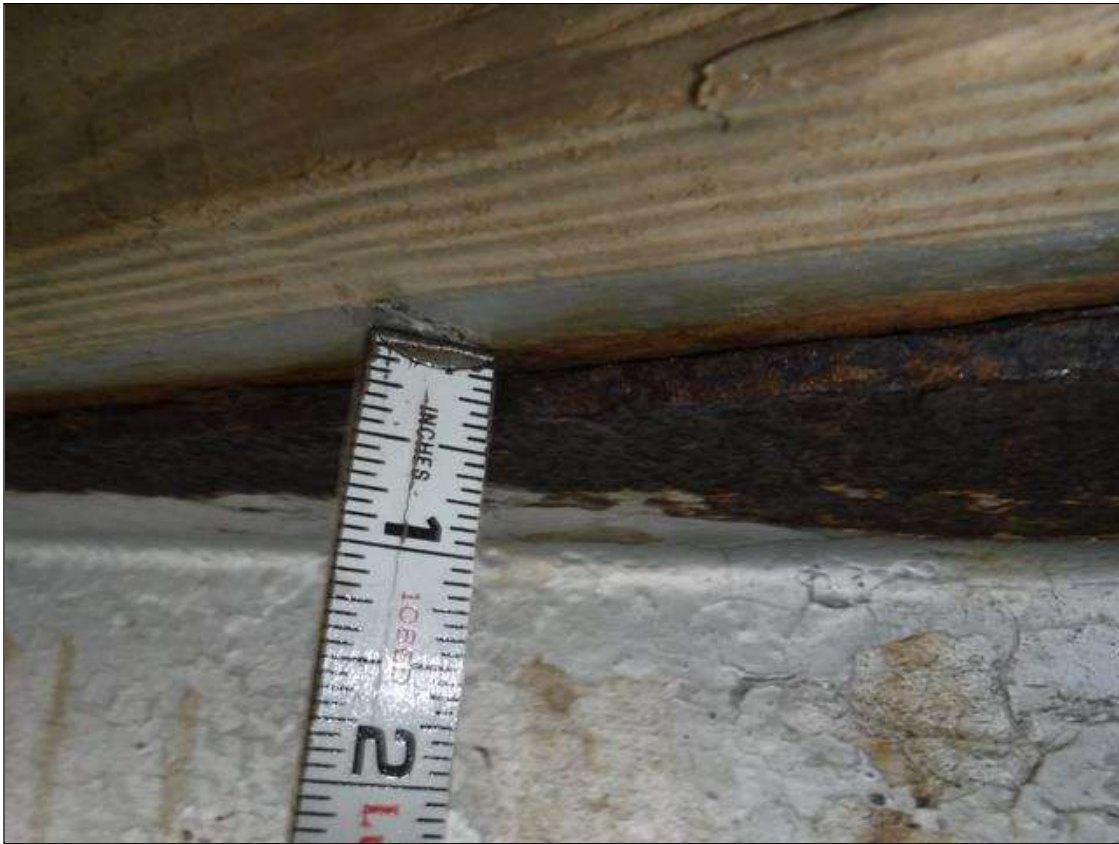
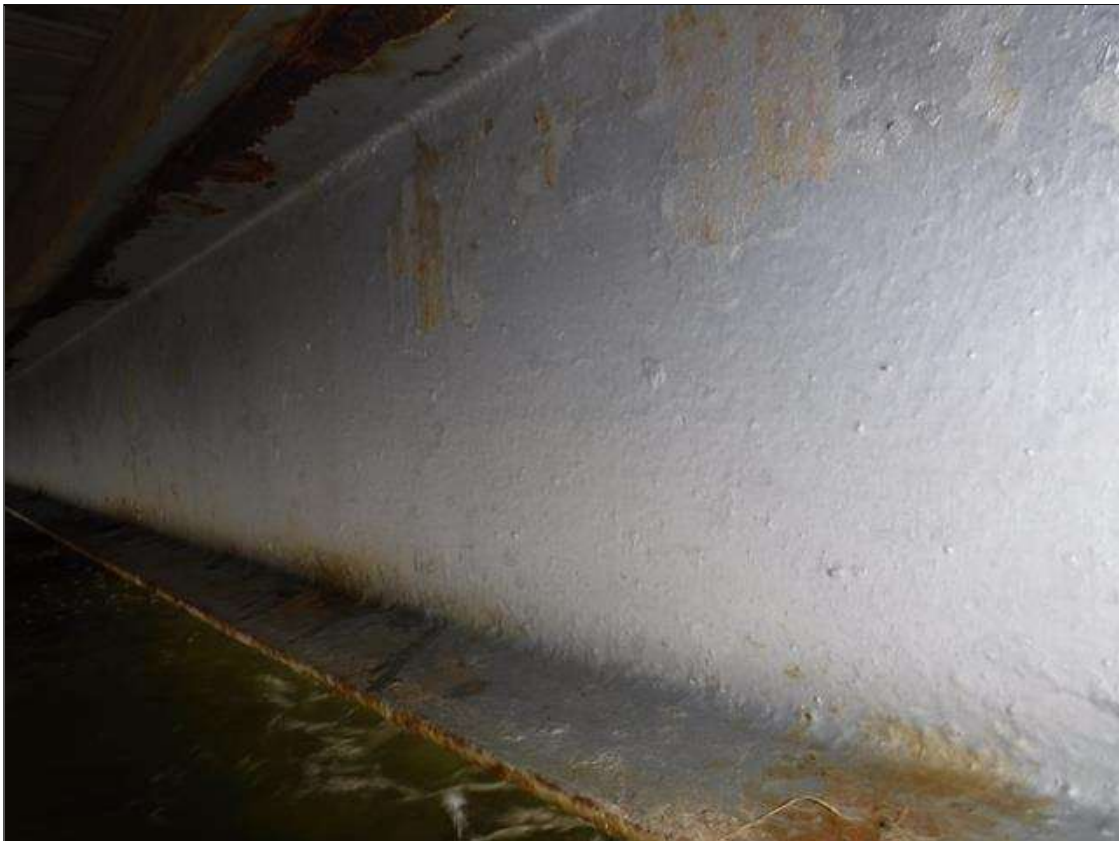
| Element Number | Defect Type | Defect Description | CS | CS Qty | Maint Qty | |
|---|---|---|---|---|---|---|
| 107 | Corrosion | FULL LENGTH OF BEAM TOP FLANGE SCALING RUST WITH 1/4" REMAINING STEEL. BOTTOM FLANGE AND WEB HAVE SURFACE RUST WITH NO MEASUREABLE LOSS. | 3 | 31 | 31 | Feet |

Span 1 Beam 4: FULL LENGTH OF BEAM TOP FLANGE SCALING RUST WITH 1/4" REMAINING STEEL. BOTTOM FLANGE AND WEB HAVE SURFACE RUST WITH NO MEASUREABLE LOSS.

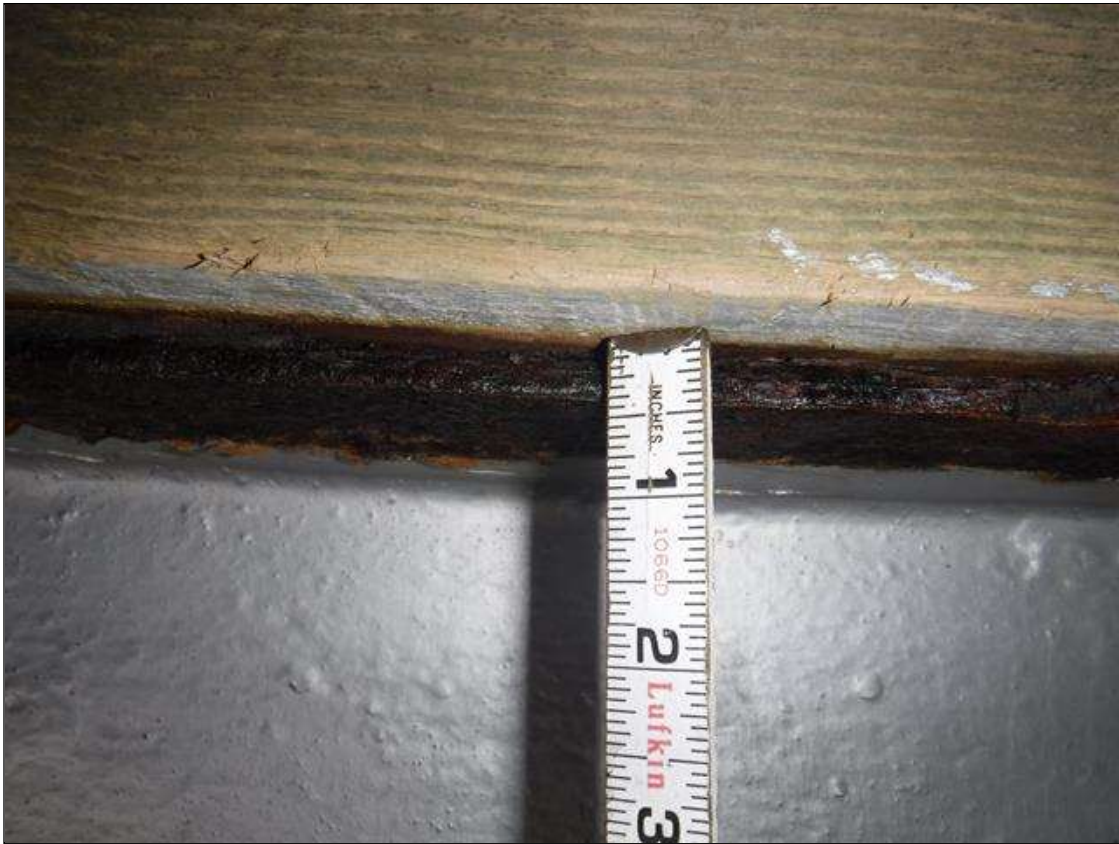
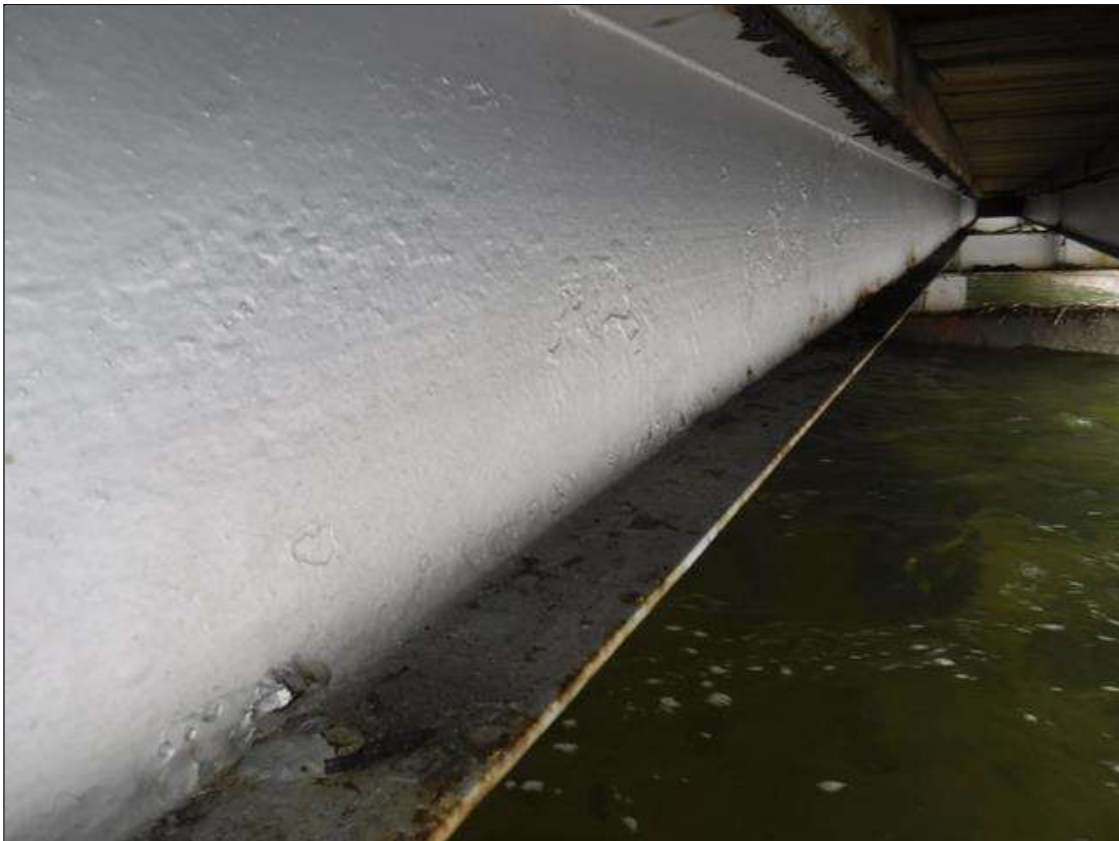
Span 1 Beam 5: FULL LENGTH TOP FLANGE SCALING RUST WITH 3/16" REMAINING STEEL. BOTTOM FLANGE AND WEB RANDOM SURFACE RUST WITH NO MEASUREABLE LOSS.

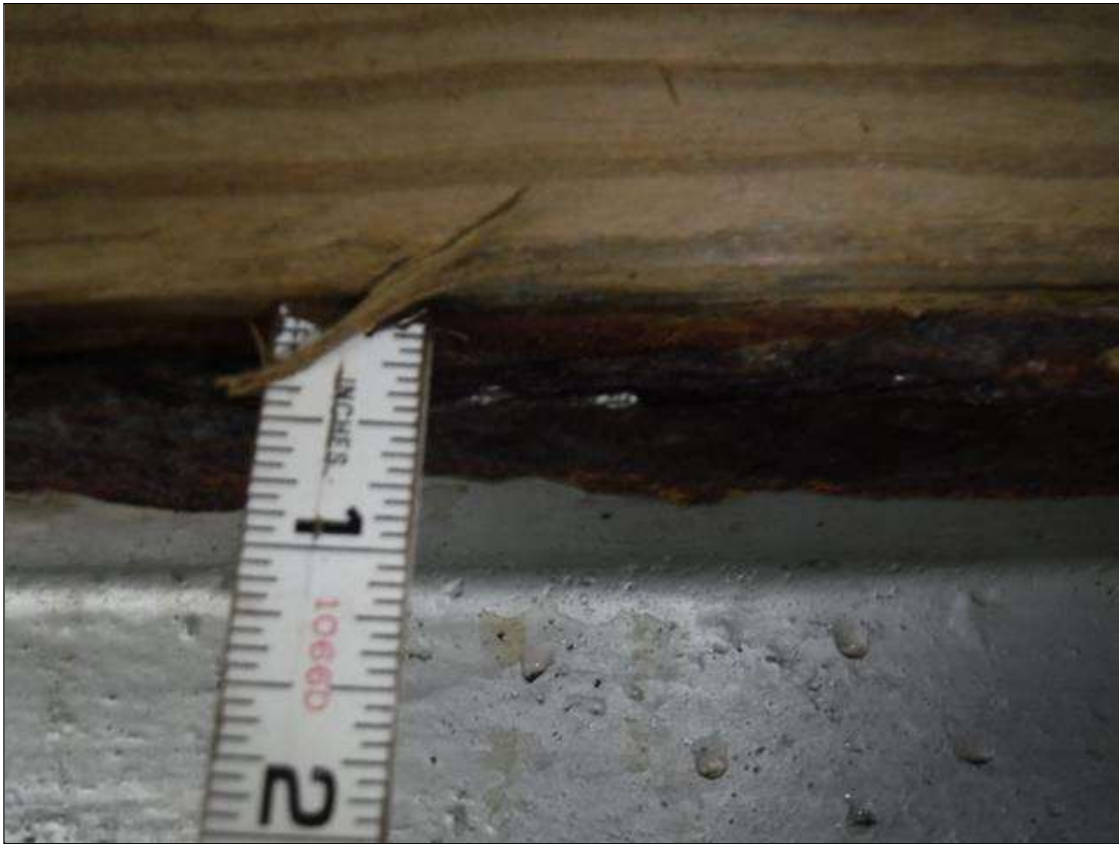
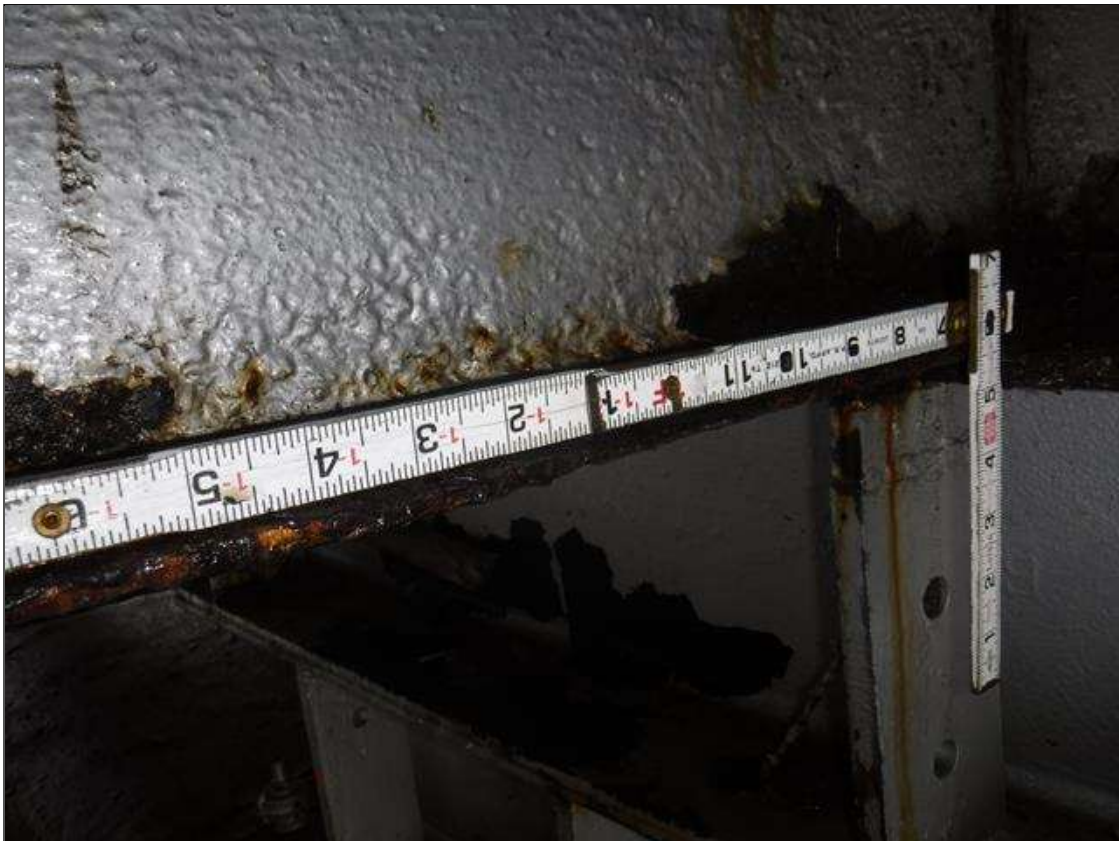
Span 1 Beam 5: AT BENT 1 END TOP AND BOTTOM FLANGE SCALING RUST WITH 3/16" REMAINING STEEL.  
WEB SCALING RUST WITH SECTION LOSS.
