NC DEPARTMENT OF TRANSPORTATION  
DIVISION OF HIGHWAYS  
STRUCTURE MANAGEMENT UNIT

# Structure Safety Report

## 2 Year Complete Topside and Underwater Element Inspection

DIVISION: 11 COUNTY: ALLEGHANY STRUCTURE NUMBER: 020133 FREQUENCY: 24 MONTHS

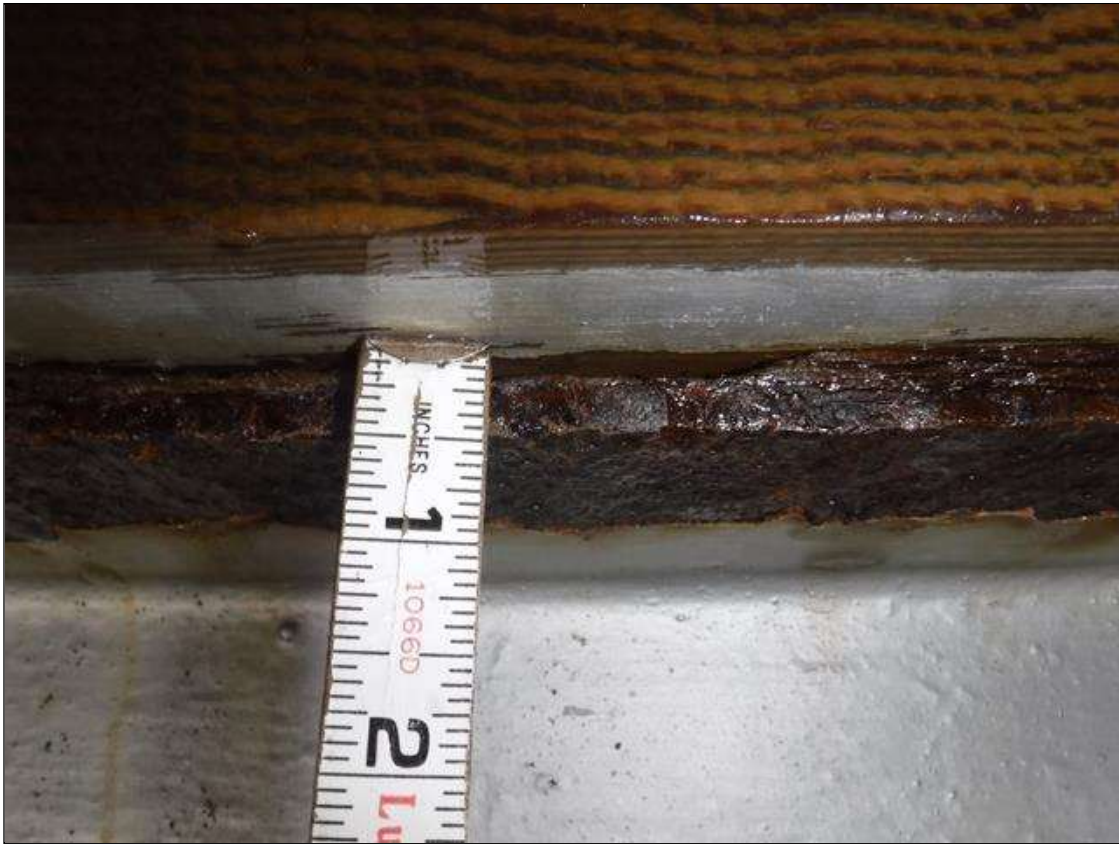
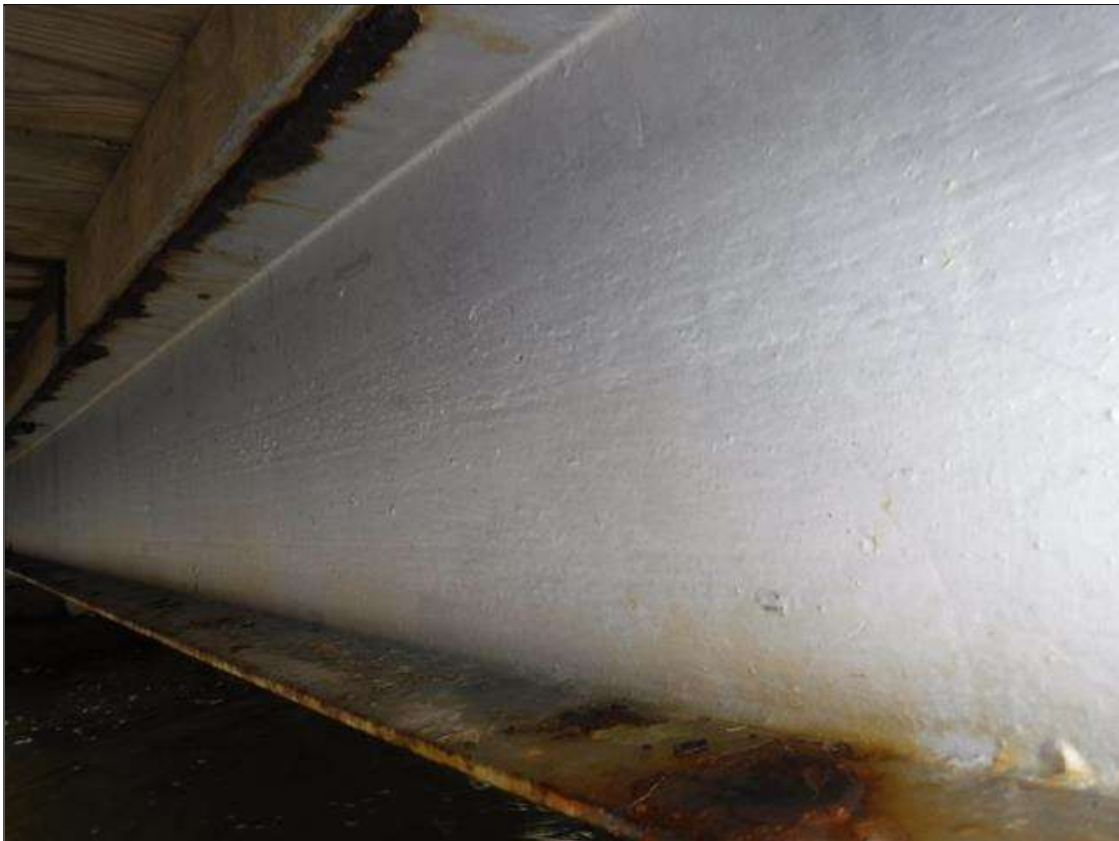
Span 1 Beam 6: FROM ABUTMENT 1 END OUT 27' TOP FLANGE SCALING RUST WITH 1/4" REMAINING STEEL.  
BOTTOM FLANGE AND WEB RANDOM SURFACE RUST WITH NO MEASUREABLE LOSS.

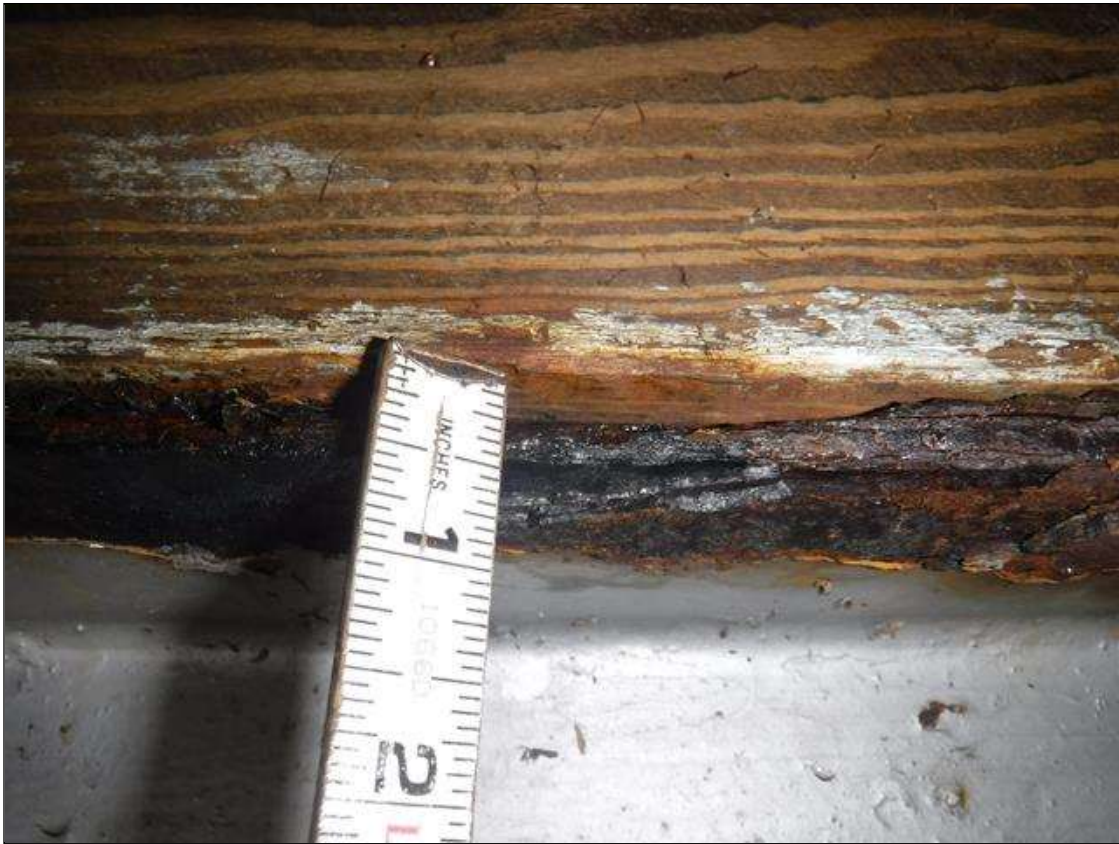
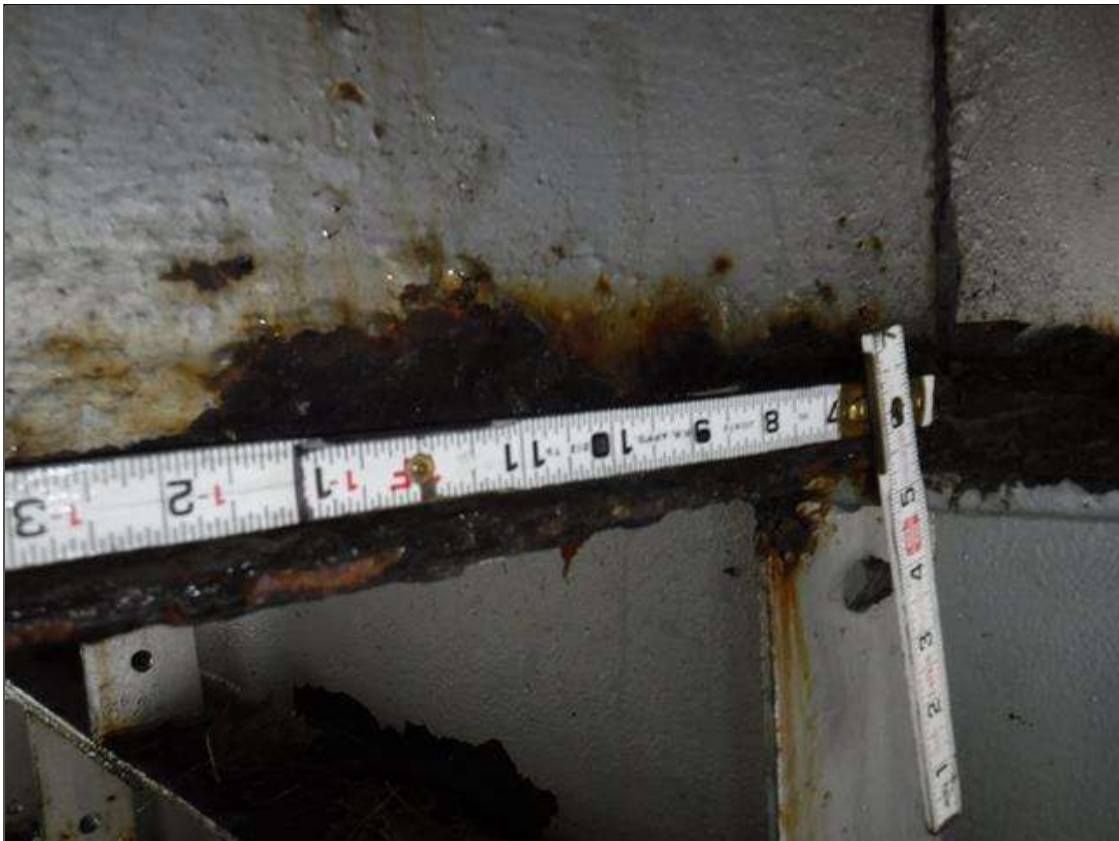
Span 1 Beam 6: AT BENT 1 END TOP FLANGE SCALING RUST WITH 3/16" REMAINING STEEL. BOTTOM FLANGE SCALING RUST WITH 1/4" REMAINING STEEL.

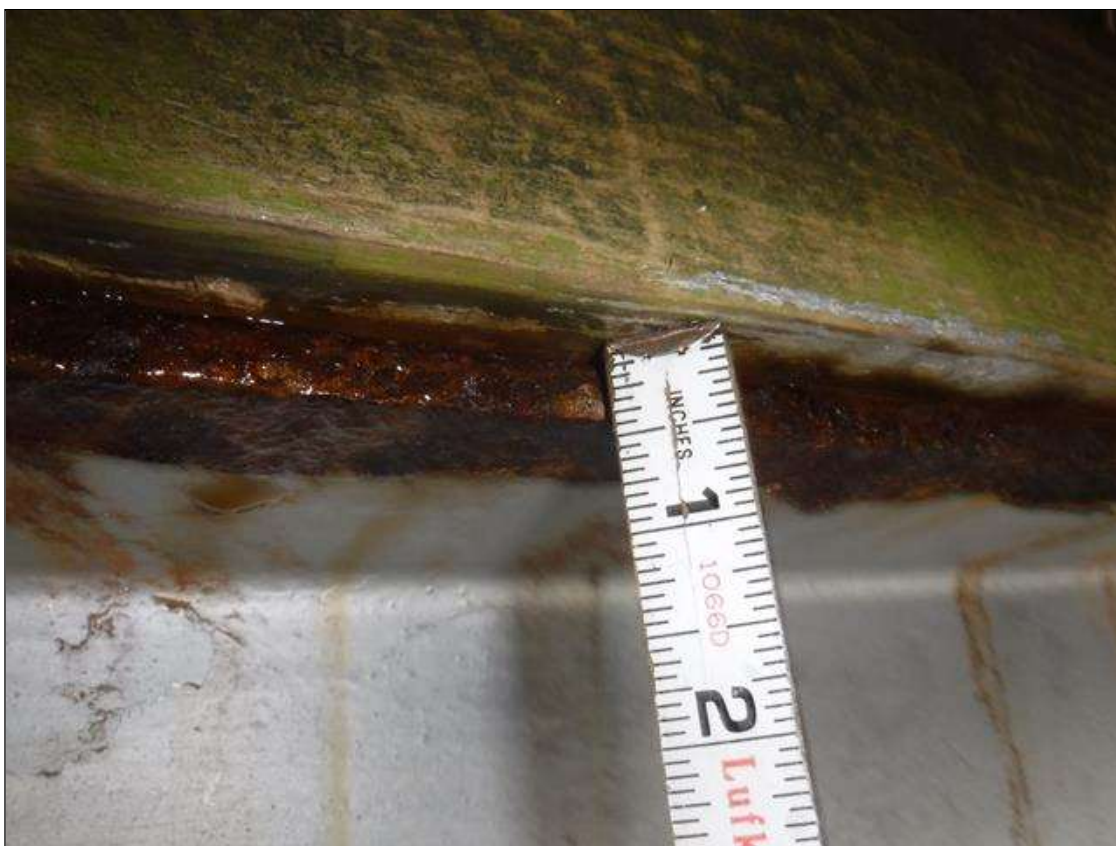
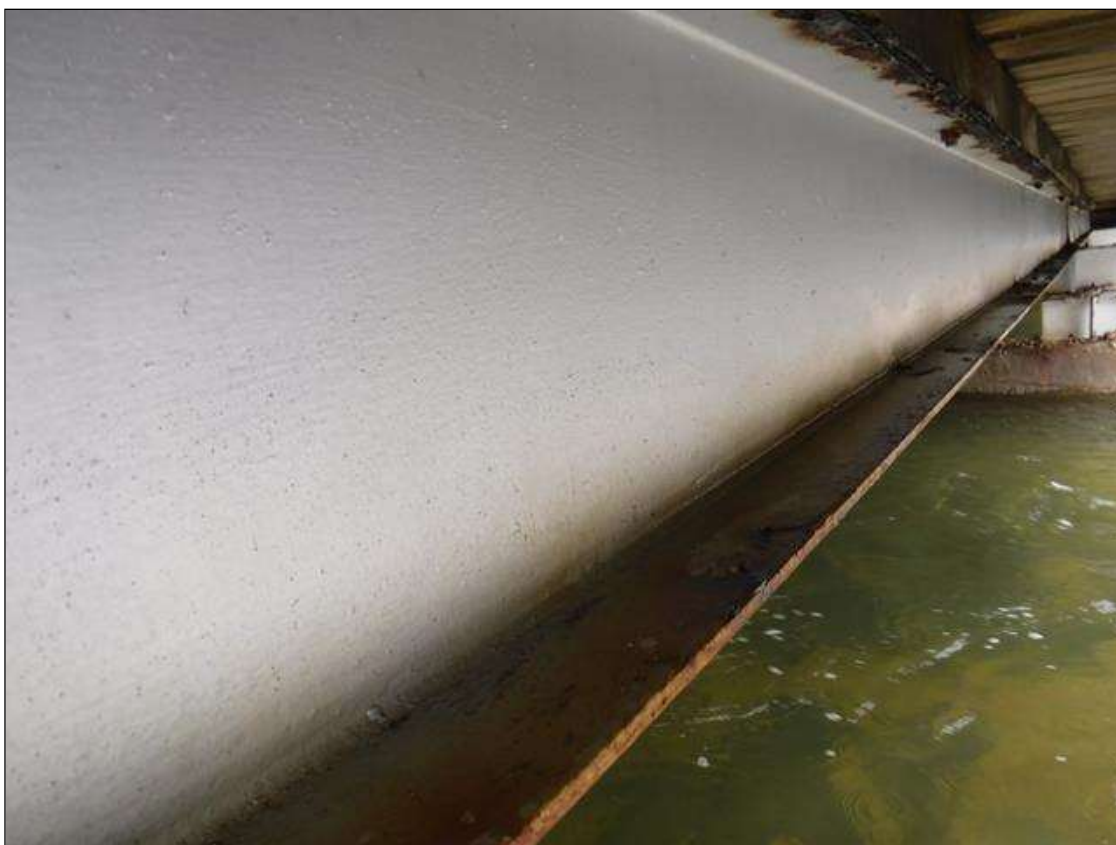
Span 1 Beam 7: SURFACE RUST WITH NO MEASUREABLE LOSS.

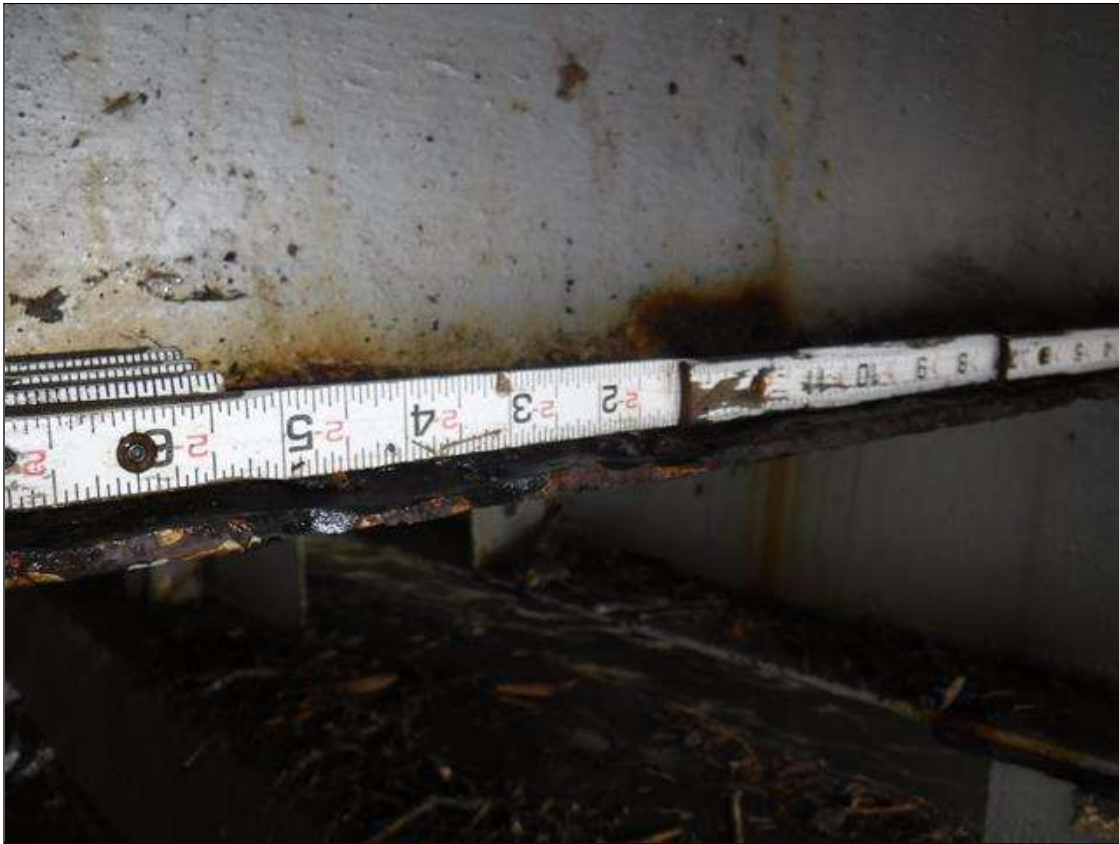
Span 1 Beam 7: AT BENT 1 END BOTTOM FLANGE SCALING RUST WITH 1/4" REMAINING STEEL WITH 1/8" TO 3/16" PITTING.

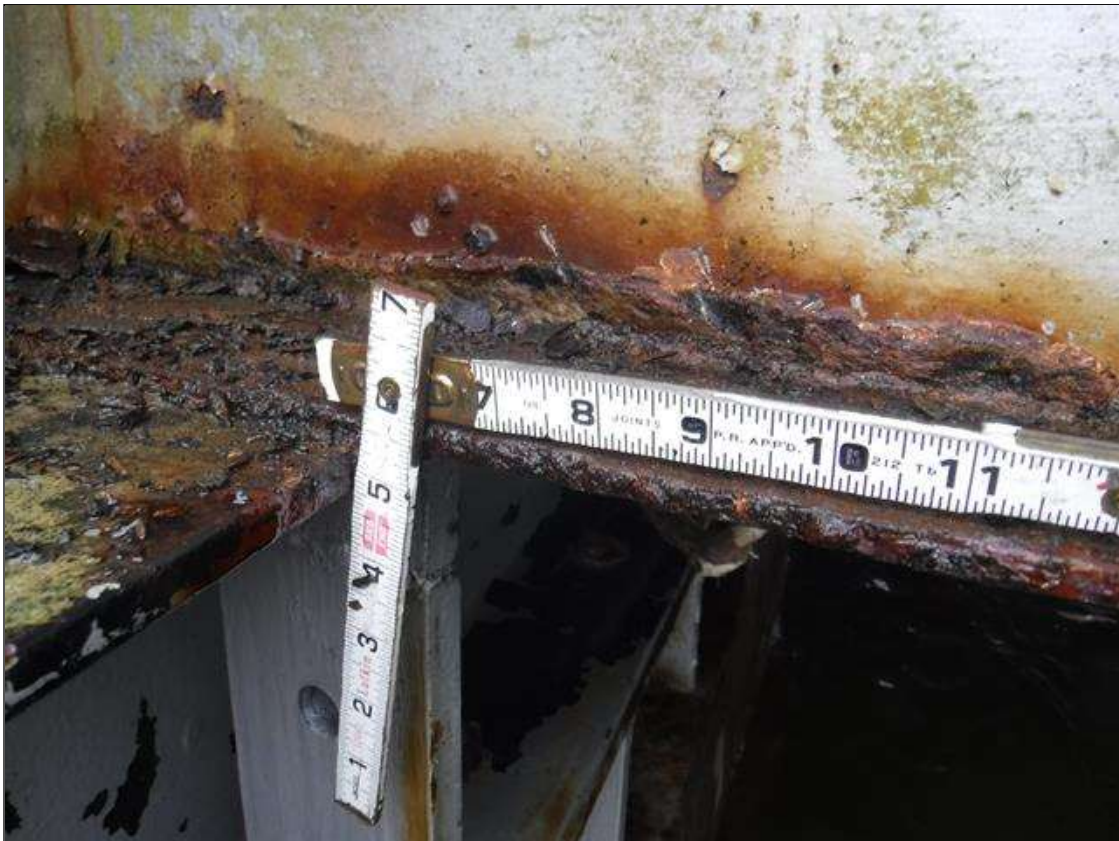
Span 1 Beam 8: ABUTMENT 1 END BOTTOM FLANGE SCALING RUST WITH 5/16" REMAINING STEEL. WEB SCALING RUST WITH SECTION LOSS.

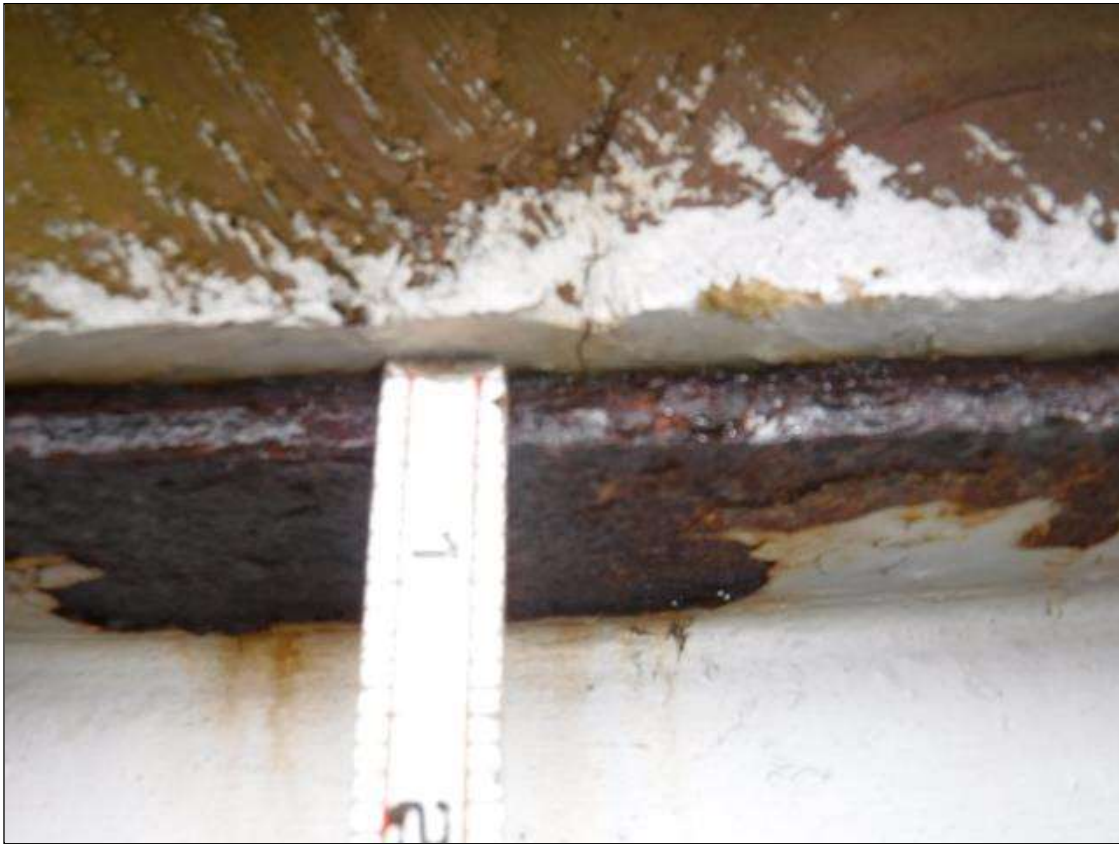
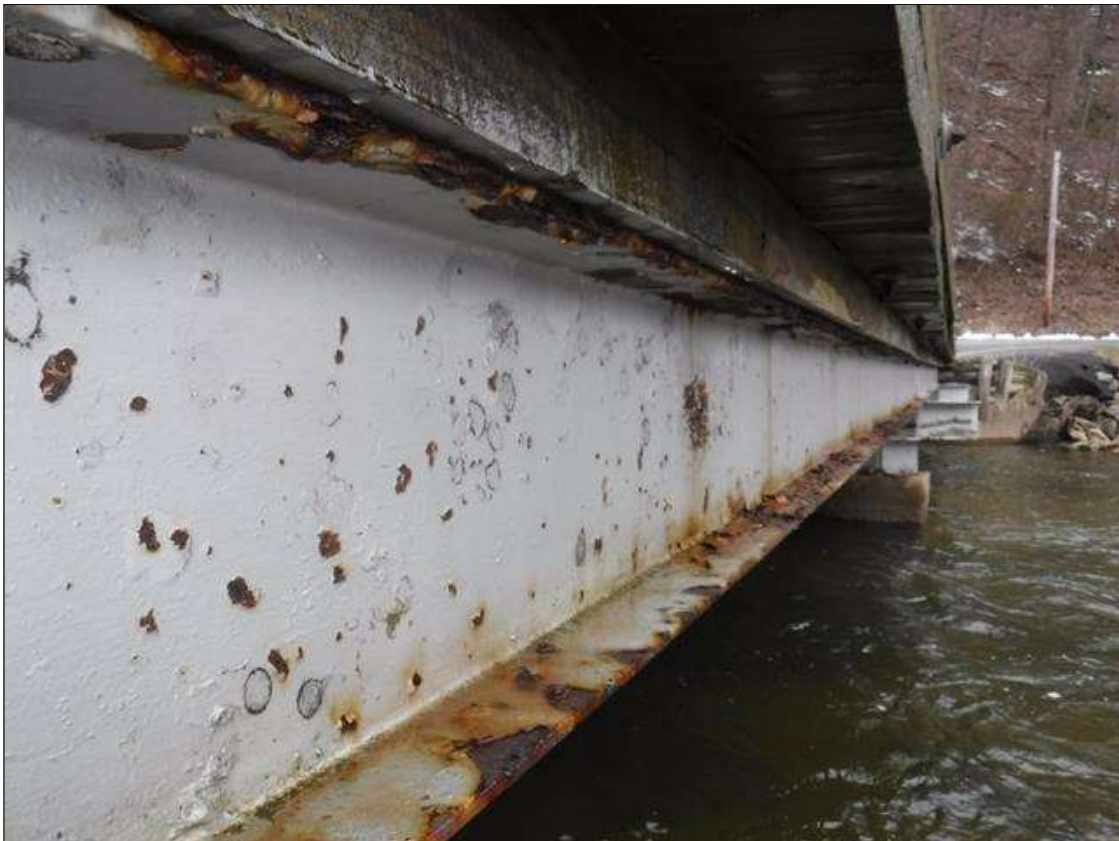
Span 1 Beam 8: TOP FLANGE SCALING RUST WITH 1/4" REMINING STEEL. BOTTOM FLANGE AND WEB SURFACE RUST WITH PITTING TO 1/16".

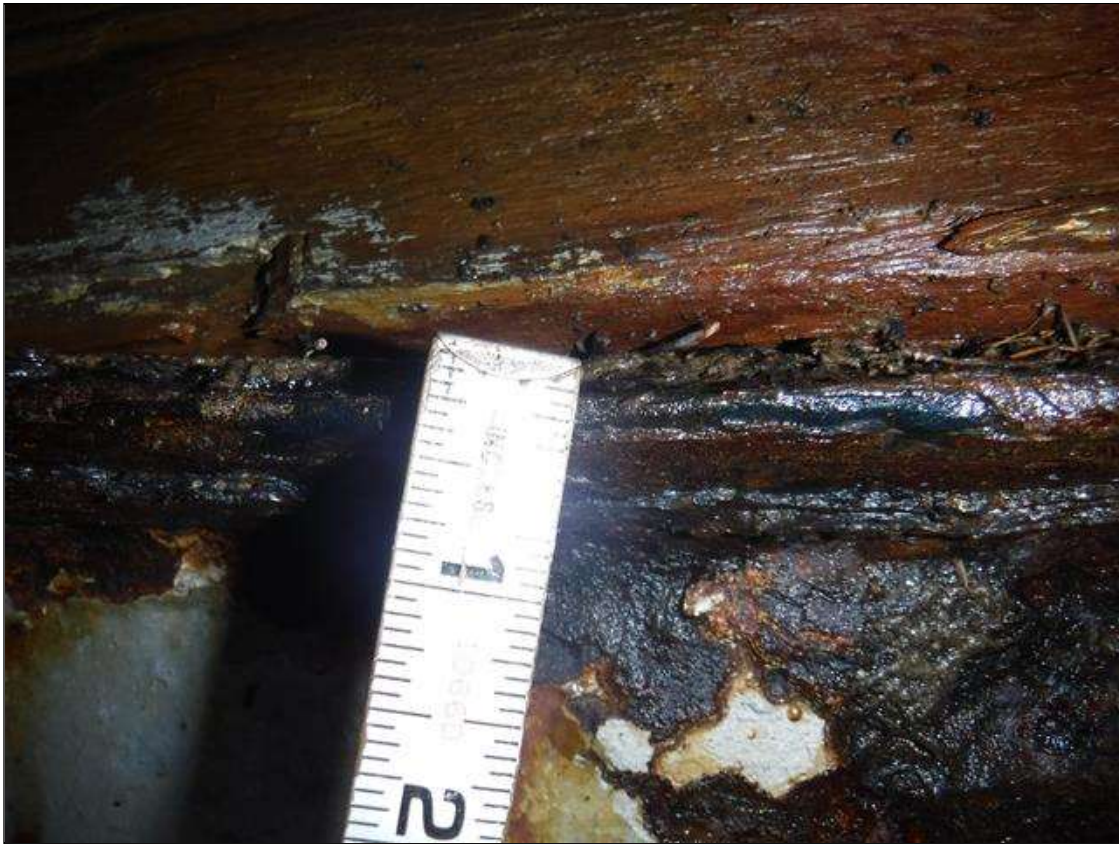
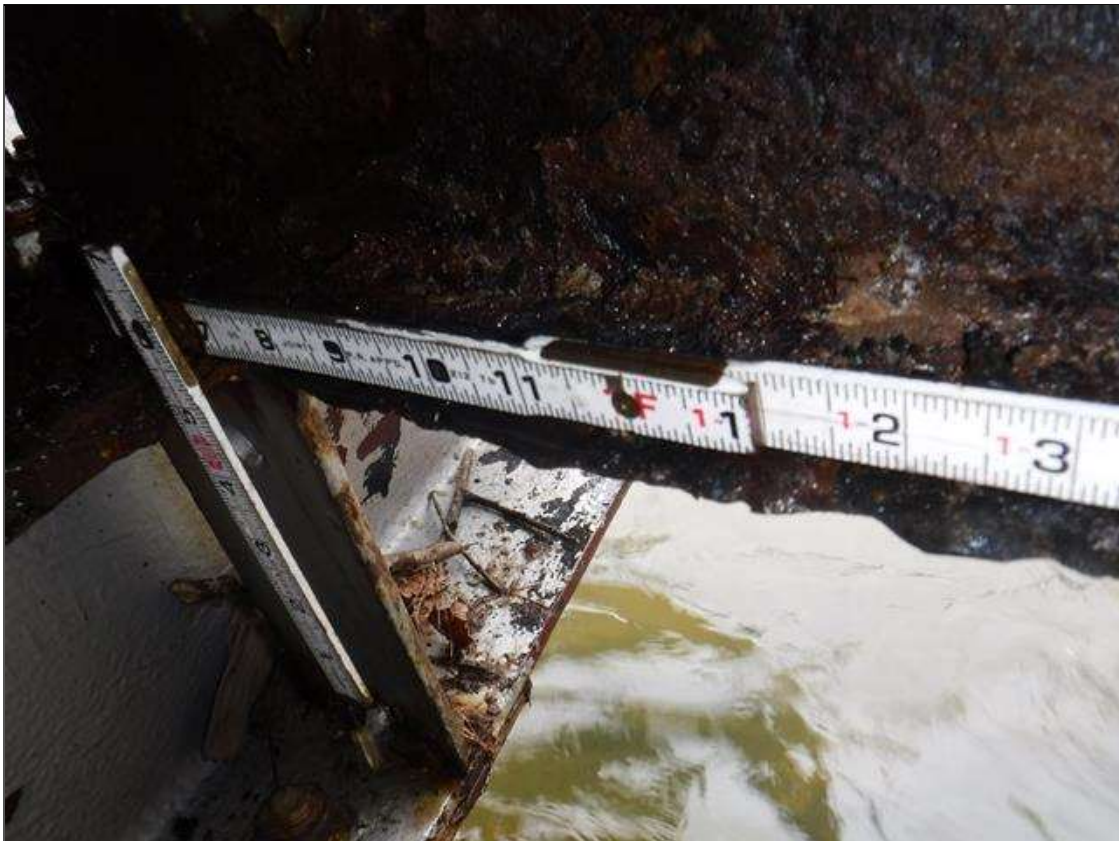
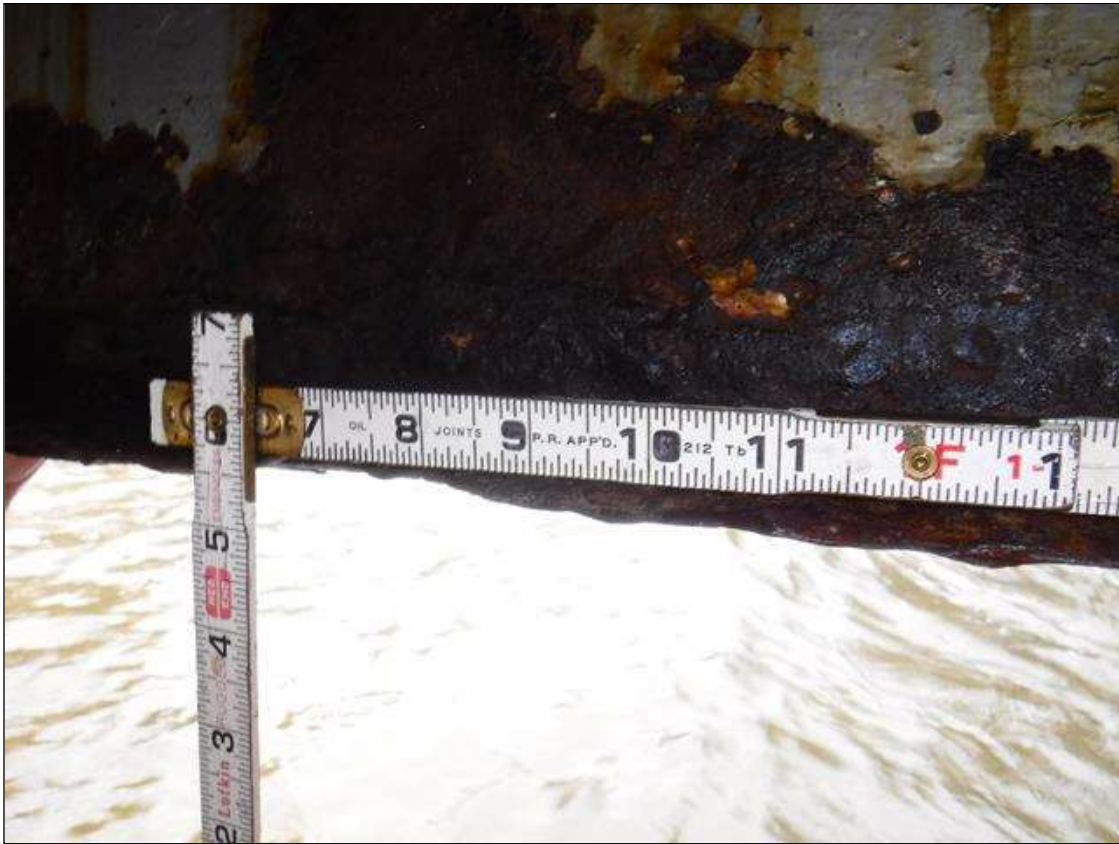
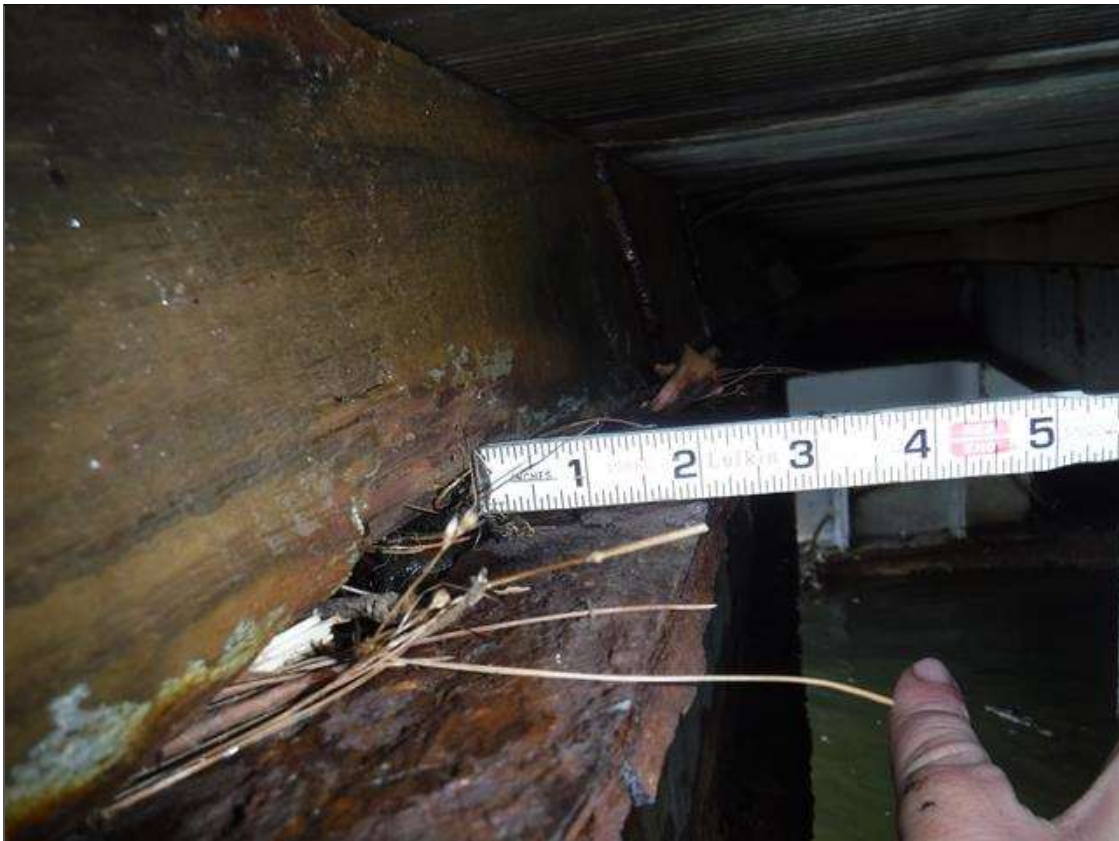
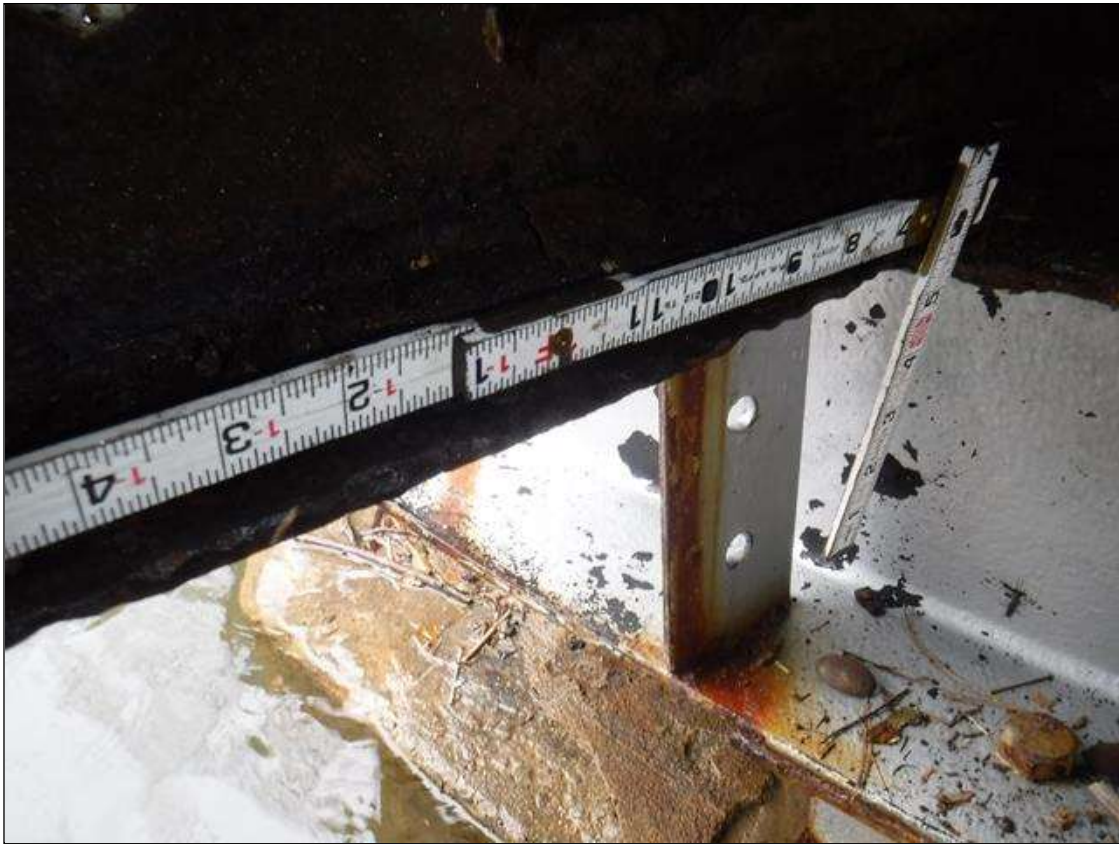
| Element Number | Element Name | Total Qty | CS1 Qty | CS2 Qty | CS3 Qty | CS4 Qty | |
|---|---|---|---|---|---|---|---|
| 107 | Corrosion | FULL LENGTH OF BEAM TOP AND BOTTOM FLANGES SCALING RUST DOWN TO KNIFE EDGE. WEB SCALING RUST WITH SECTION LOSS. | 4 | 31 | 31 | | Feet |

Span 2 Beam 1: FULL LENGTH OF BEAM TOP AND BOTTOM FLANGES SCALING RUST DOWN TO KNIFE EDGE. WEB SCALING RUST WITH SECTION LOSS.

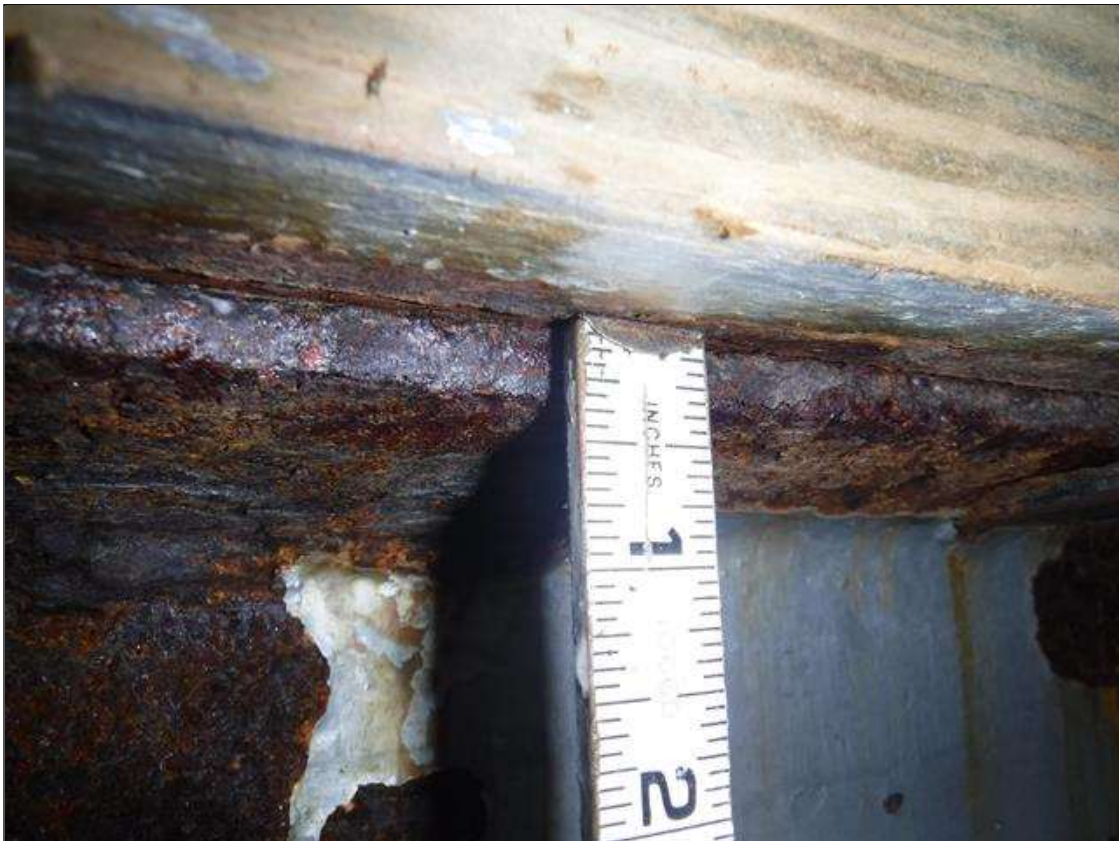
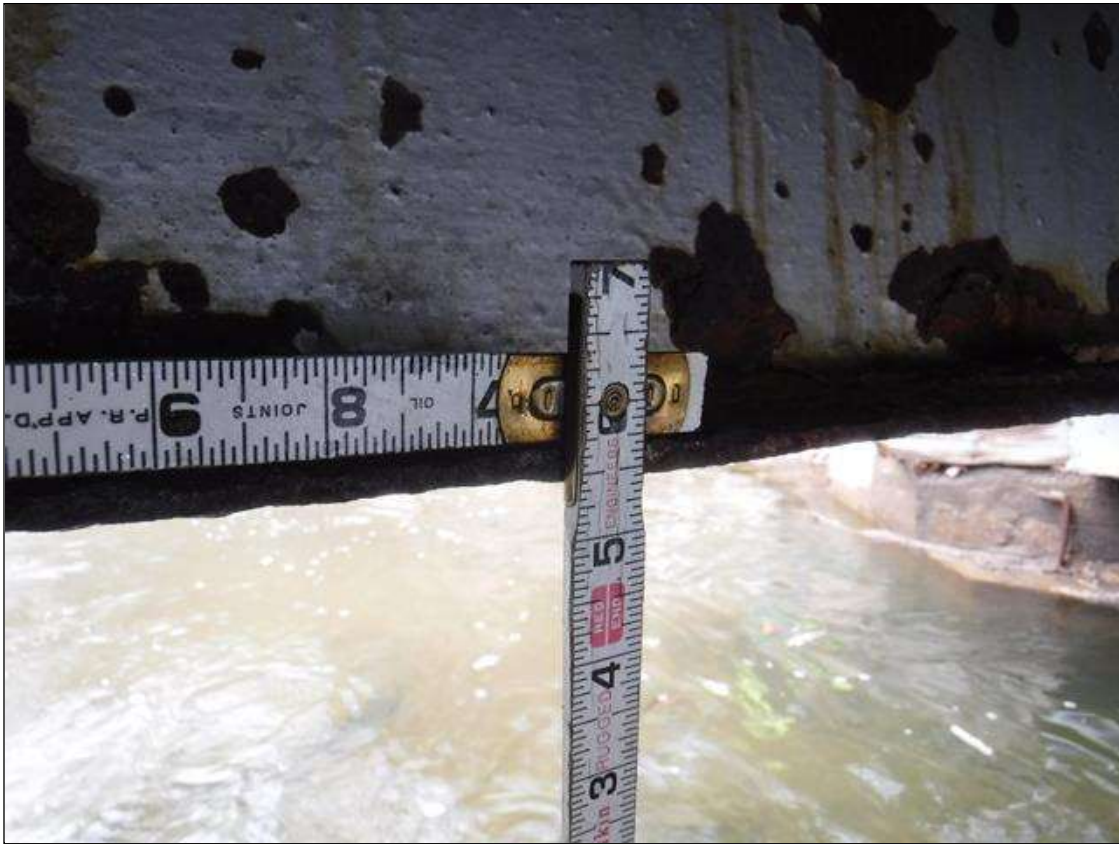
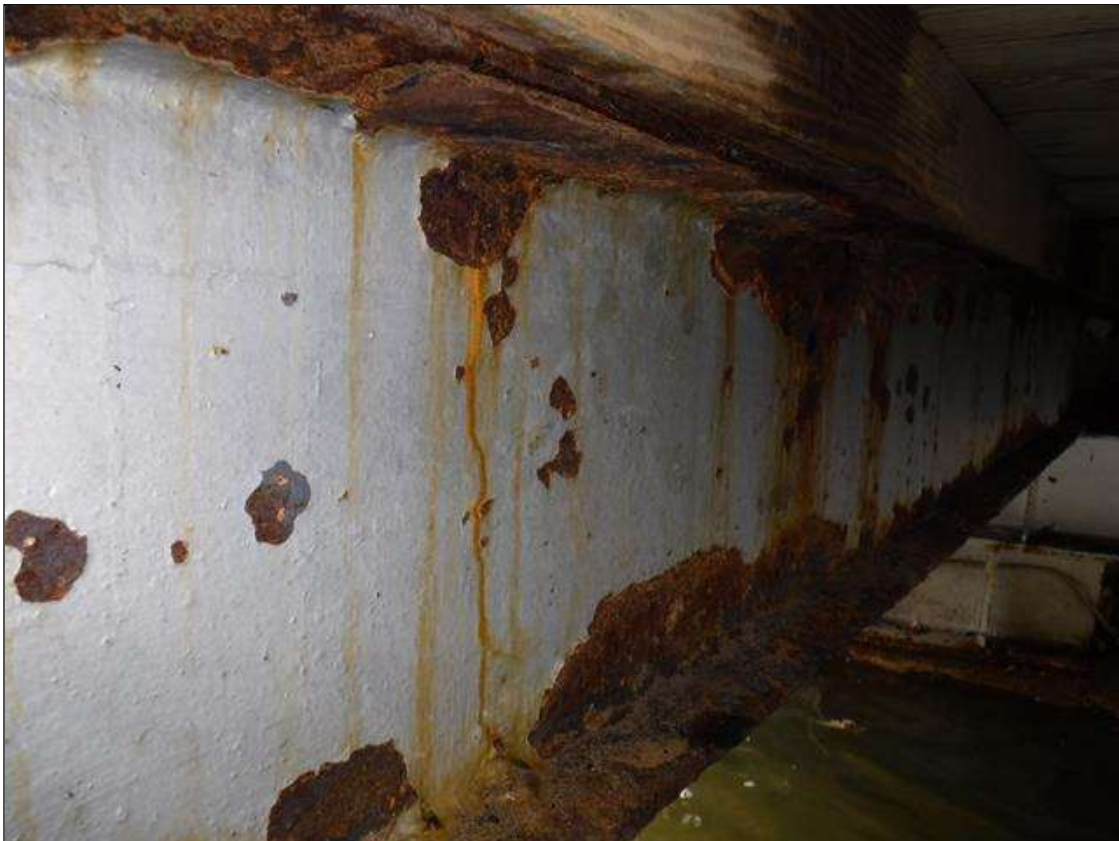
| Element Number | Element Name | Total Qty | CS1 Qty | CS2 Qty | CS3 Qty | CS4 Qty | |
|---|---|---|---|---|---|---|---|
| 107 | Corrosion | FROM ABUTMENT 2 OUT 16' TOP AND BOTTOM FLANGES SCALING RUST WITH 1/4" REMAINING STEEL. WEB SCALING RUST WITH SECTION LOSS. | 3 | 16 | 16 | | Feet |

Span 2 Beam 2: FROM ABUTMENT 2 OUT 16' TOP AND BOTTOM FLANGES SCALING RUST WITH 1/4" REMAINING STEEL. WEB SCALING RUST WITH SECTION LOSS.

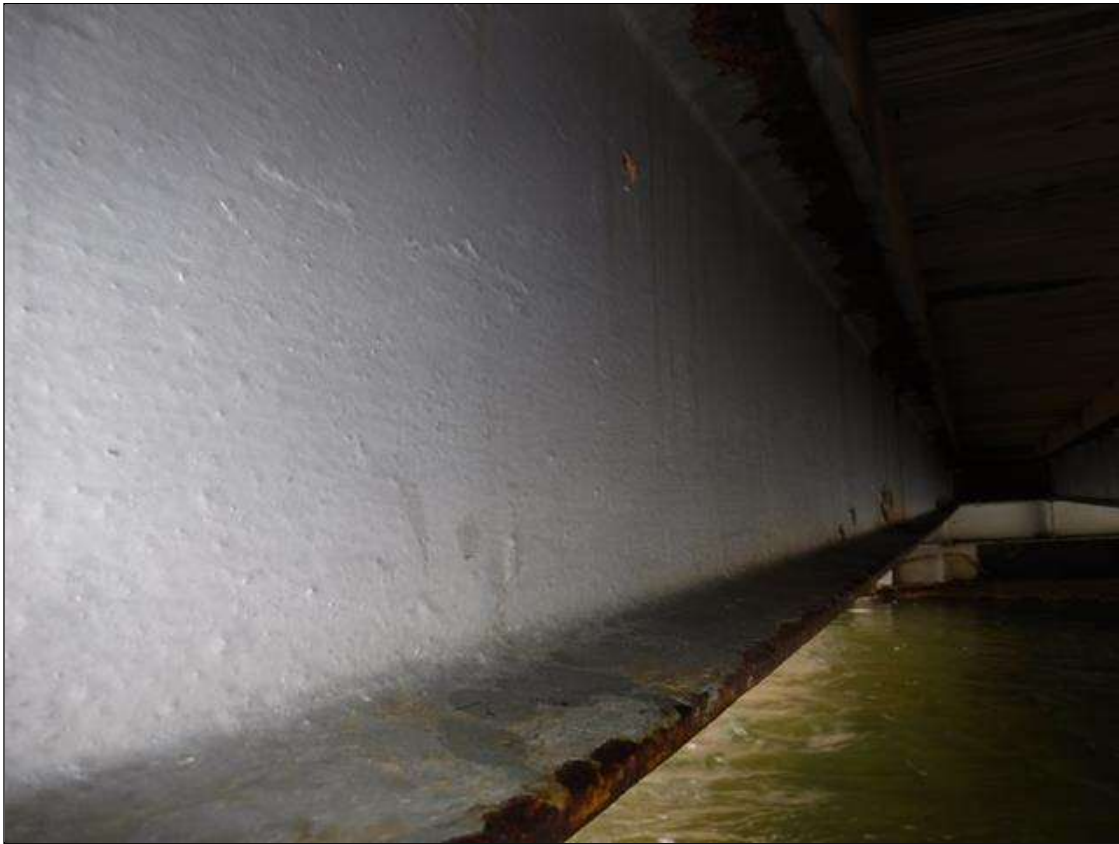
| Element Number | Element Name | Total Qty | CS1 Qty | CS2 Qty | CS3 Qty | CS4 Qty | |
|---|---|---|---|---|---|---|---|
| 107 | Corrosion | FROM BENT 1 OUT 15' SURFACE RUST WITH NO MEASUREABLE LOSS. | 2 | 15 | | | Feet |

Span 2 Beam 2: FROM BENT 1 OUT 15' SURFACE RUST WITH NO MEASUREABLE LOSS.

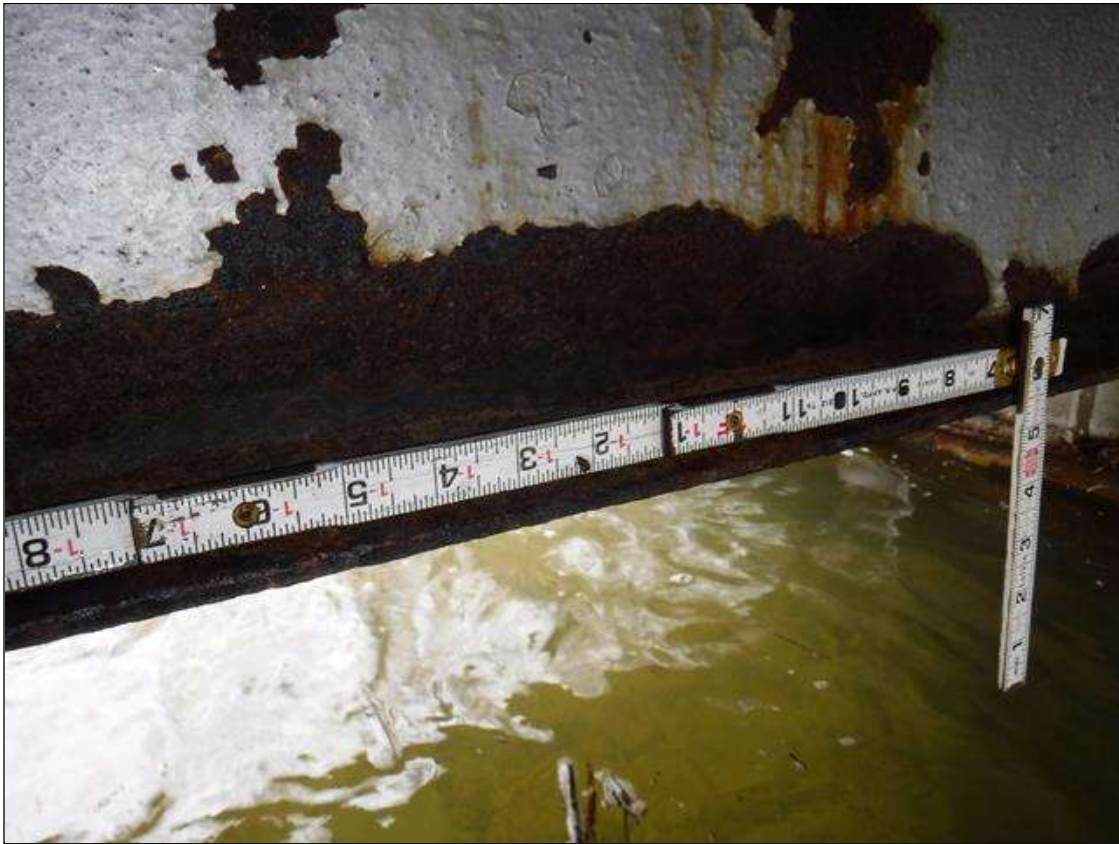
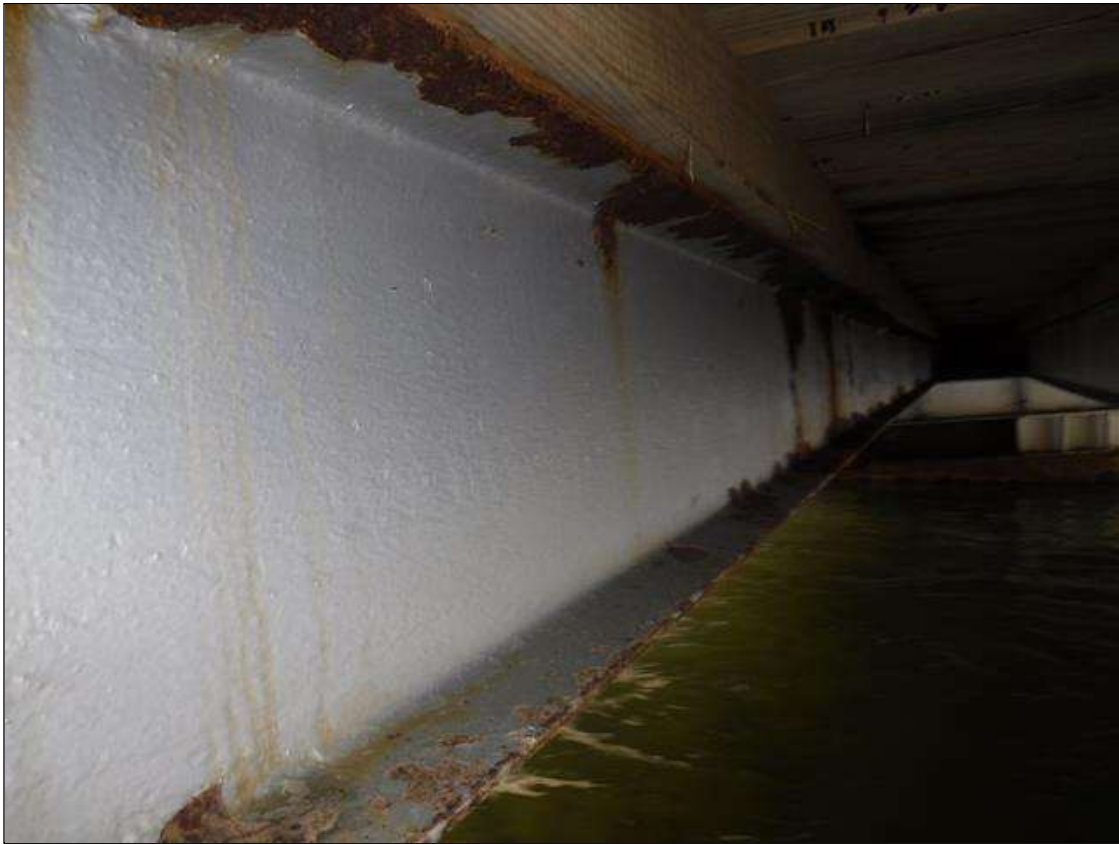
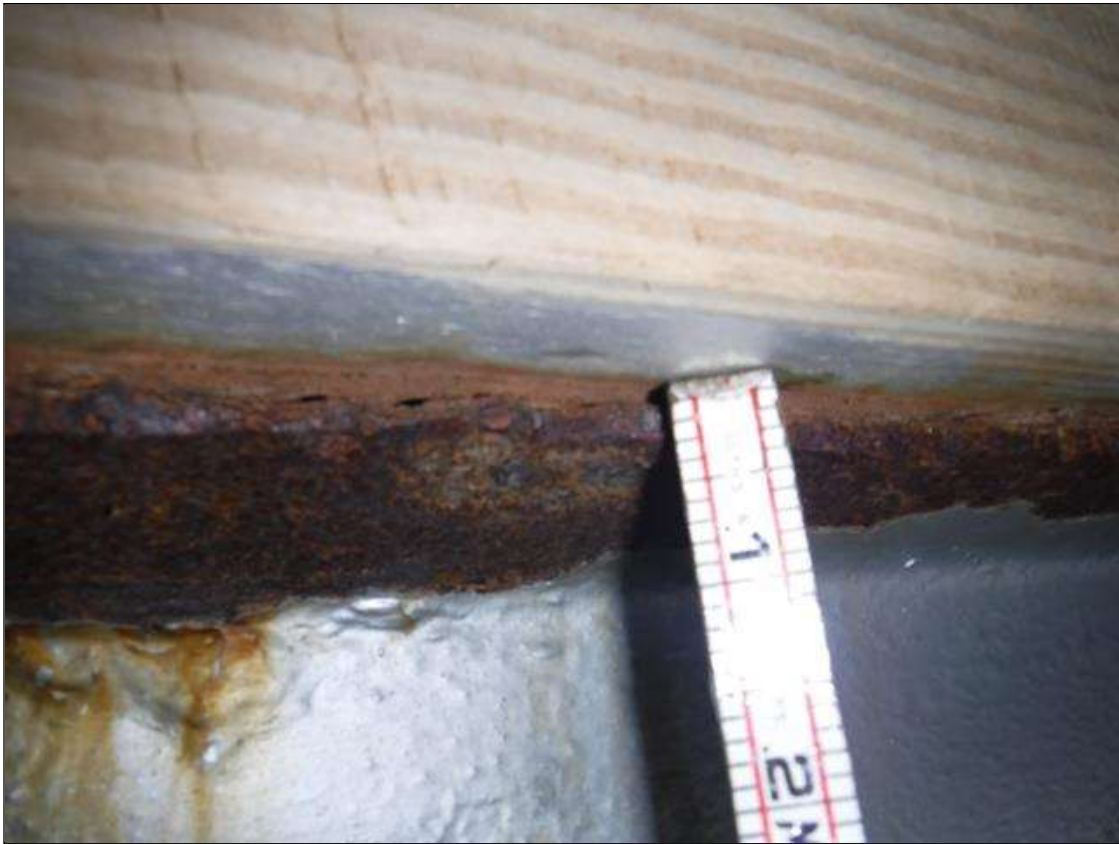
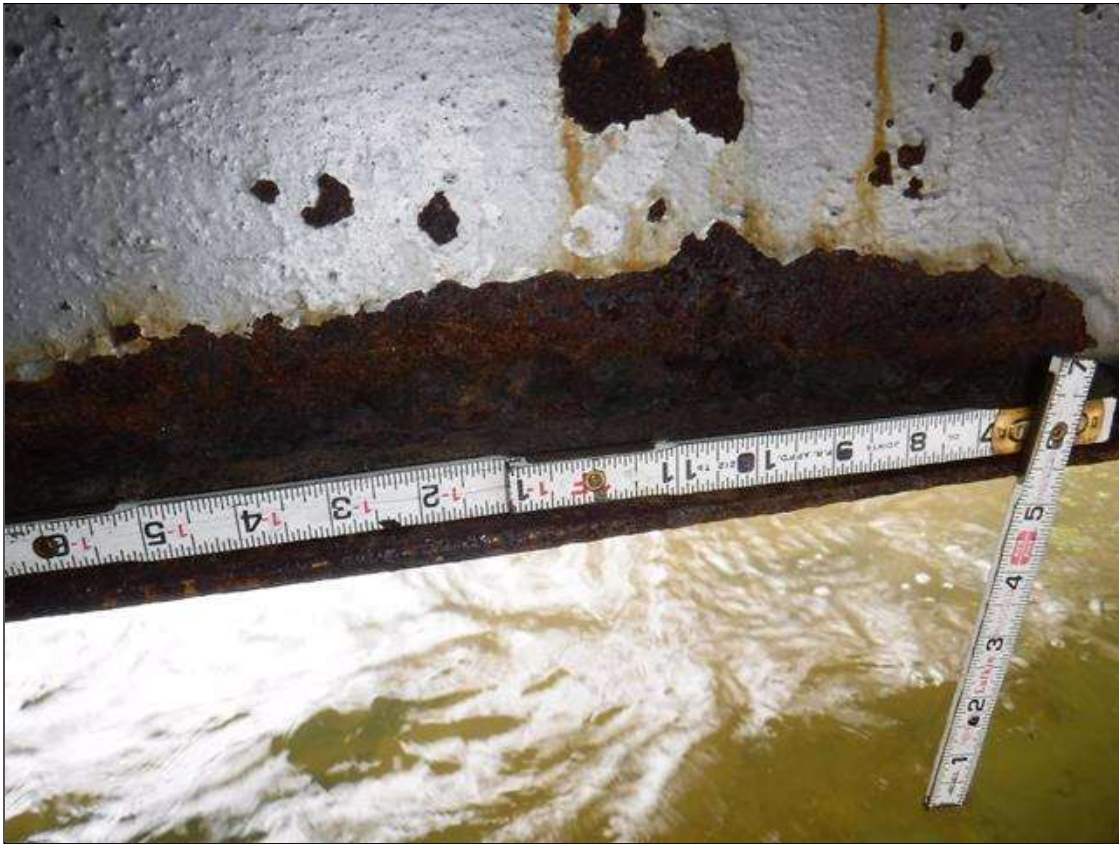
| Element Number | Element Name | Total Qty | CS1 Qty | CS2 Qty | CS3 Qty | CS4 Qty | |
|---|---|---|---|---|---|---|---|
| 107 | Corrosion | FULL LENGTH OF BEAM TOP FLANGE SCALING RUST WITH 1/8" REMAINING STEEL. BOTTOM FLANGE SCALING | 3 | 31 | 31 | | Feet |

RUST WITH 1/4" REMAINING STEEL. WEB RANDOM AREAS  
SCALING RUST WITH SECTION LOSS.

Span 2 Beam 3: FULL LENGTH OF BEAM TOP FLANGE SCALING RUST WITH 1/8" REMAINING STEEL. BOTTOM FLANGE SCALING RUST WITH 1/4" REMAINING STEEL. WEB RANDOM AREAS SCALING RUST WITH SECTION LOSS.
