NC DEPARTMENT OF TRANSPORTATION  
DIVISION OF HIGHWAYS  
STRUCTURE MANAGEMENT UNIT

# Structure Safety Report

## 2 Year Complete Topside and Underwater Element Inspection

DIVISION: 11 COUNTY: ALLEGHANY STRUCTURE NUMBER: 020133 FREQUENCY: 24 MONTHS

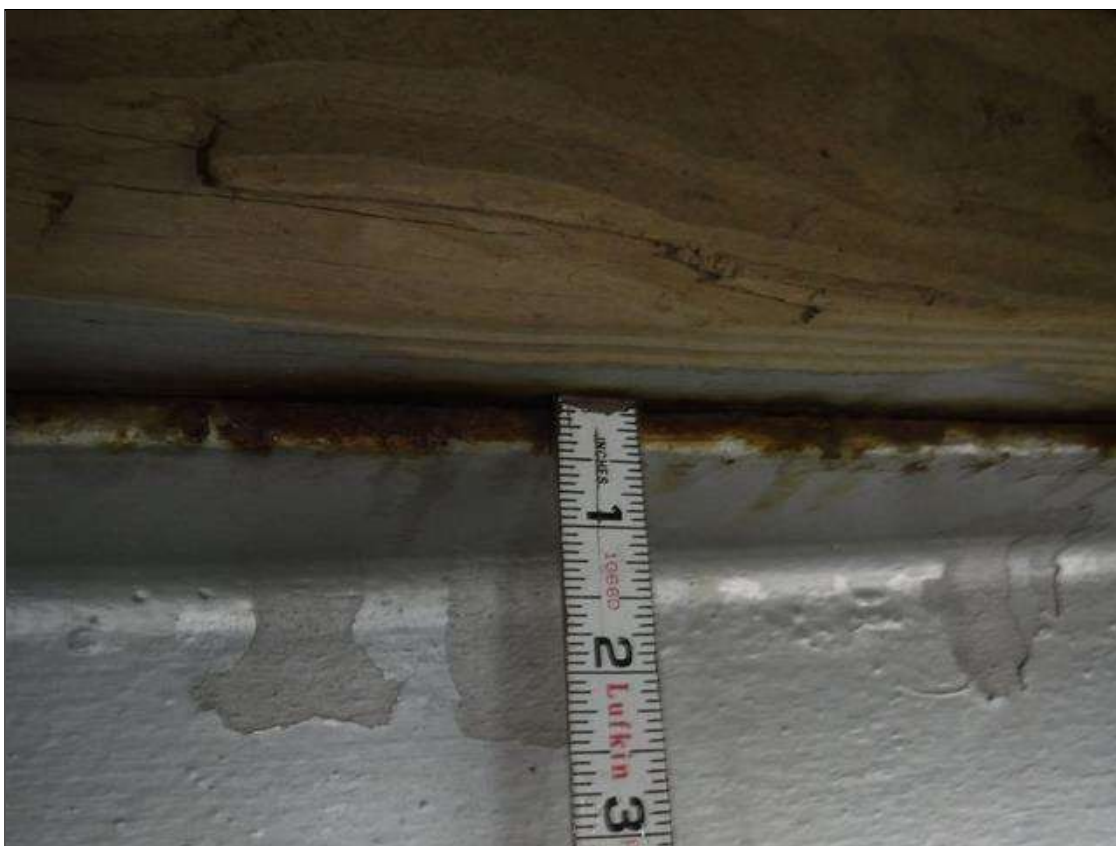
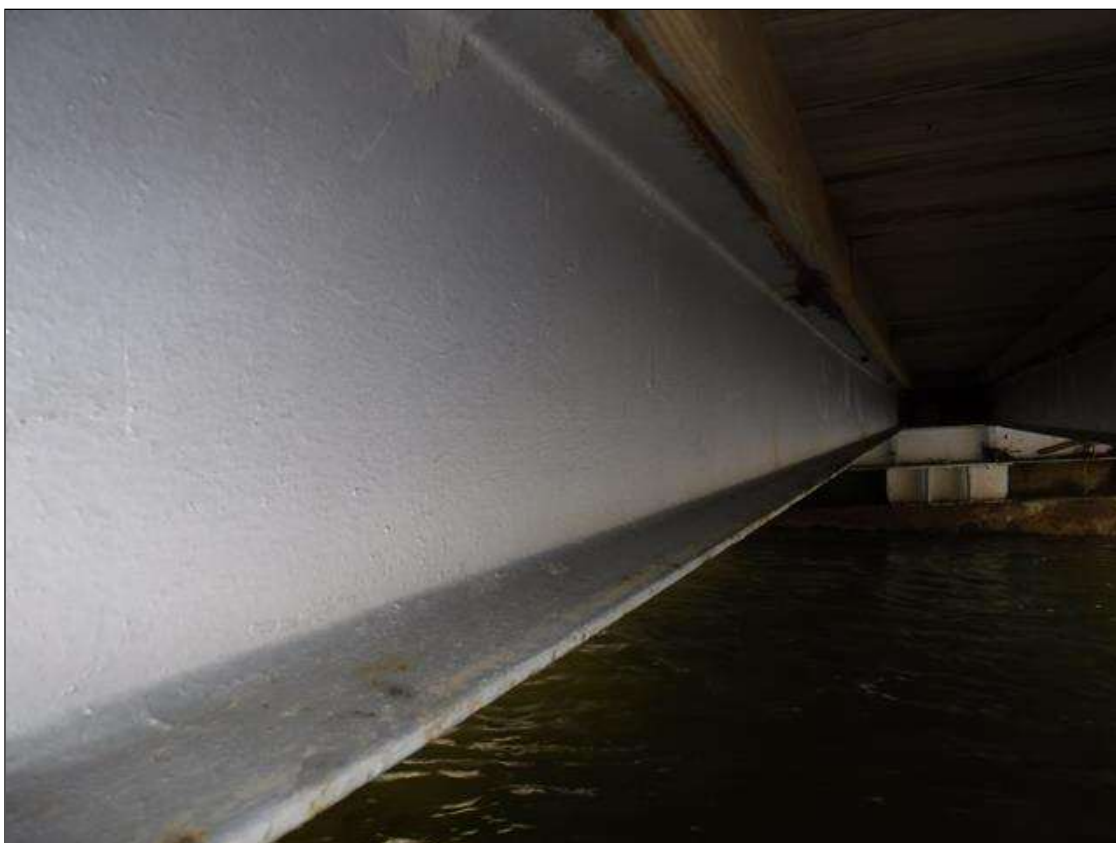
| Element Number | Defect Type | Defect Description | CS | CS Qty | Maint Qty | |
|---|---|---|---|---|---|---|
| 107 | Corrosion | RANDOM AREAS OF SURFACE RUST WITH NO MEASUREABLE LOSS. | 2 | 31 | | Feet |

Span 2 Beam 4: RANDOM AREAS OF SURFACE RUST WITH NO MEASUREABLE LOSS.

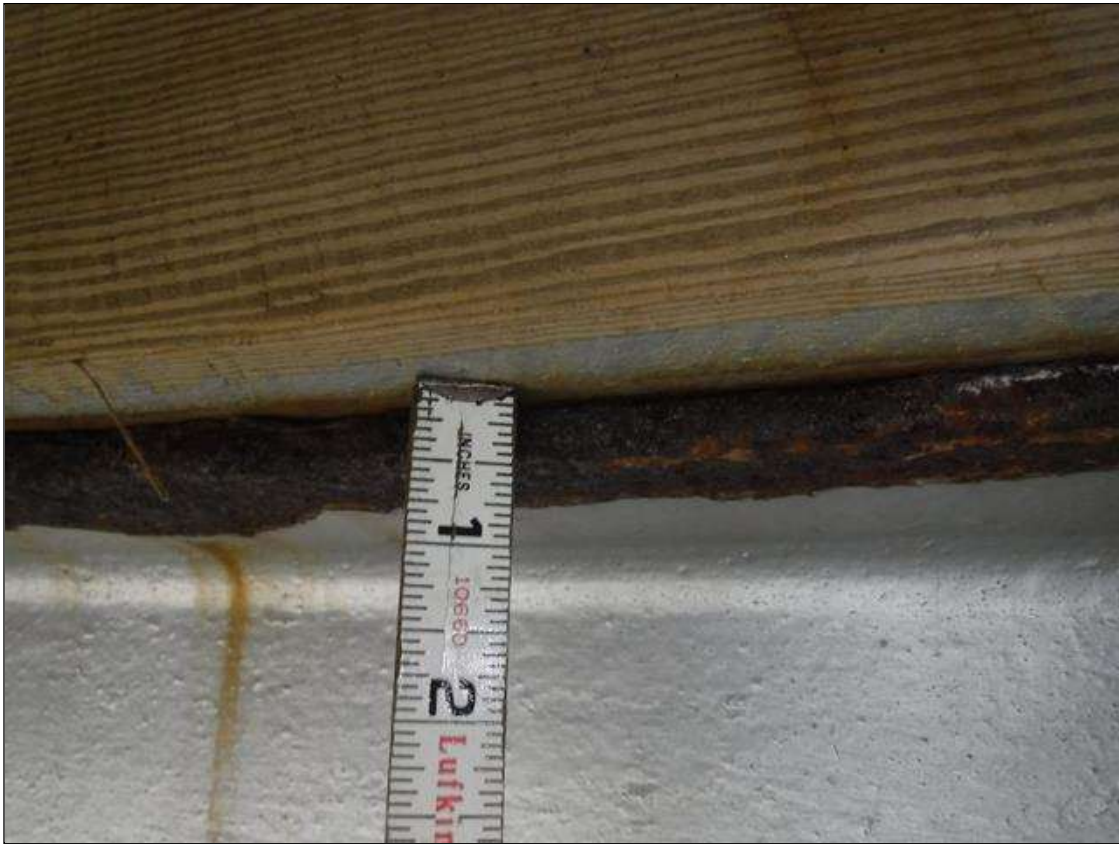
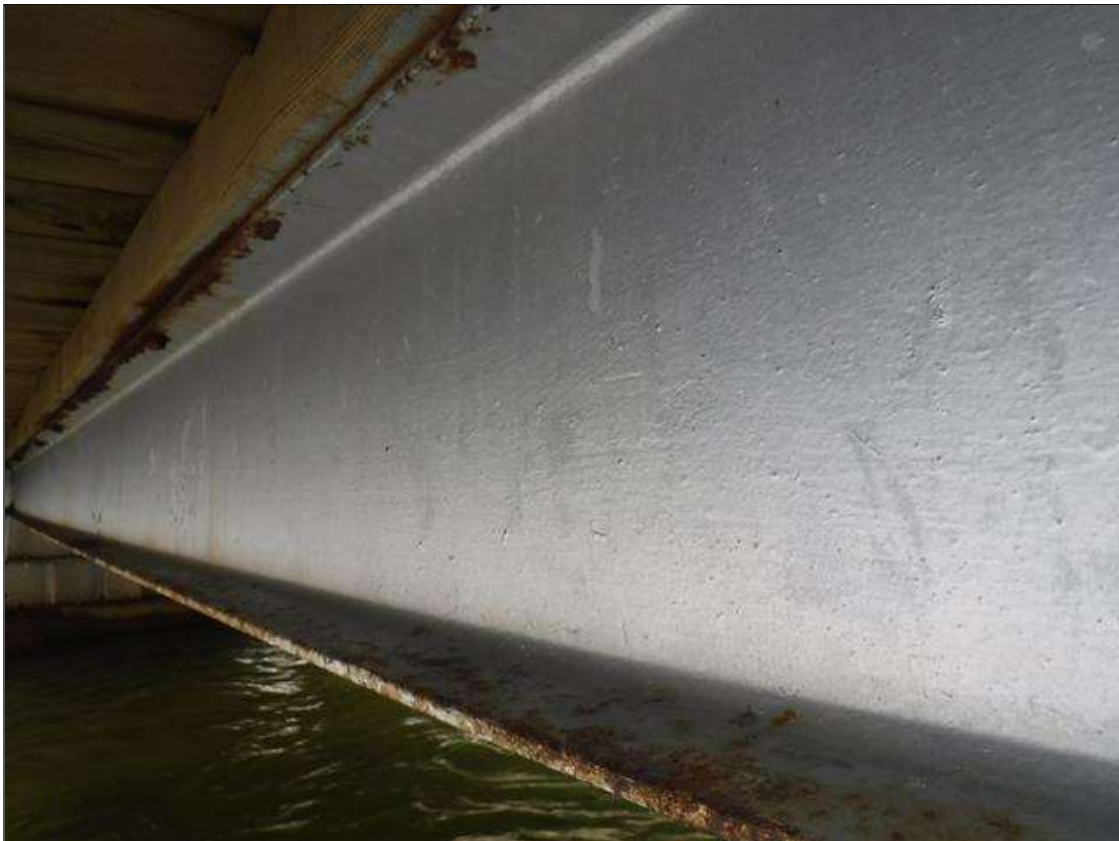
| Element Number | Defect Type | Defect Description | CS | CS Qty | Maint Qty | |
|---|---|---|---|---|---|---|
| 107 | Corrosion | SURFACE RUST ALONG TOP FLANGE WITH PITTING TO 1/16". BOTTOM FLANGE AND WEB RANDOM SURFACE RUST WITH NO MEASUREABLE LOSS. | 2 | 31 | | Feet |

Span 2 Beam 5: SURFACE RUST ALONG TOP FLANGE WITH PITTING TO 1/16". BOTTOM FLANGE AND WEB RANDOM SURFACE RUST WITH NO MEASUREABLE LOSS.

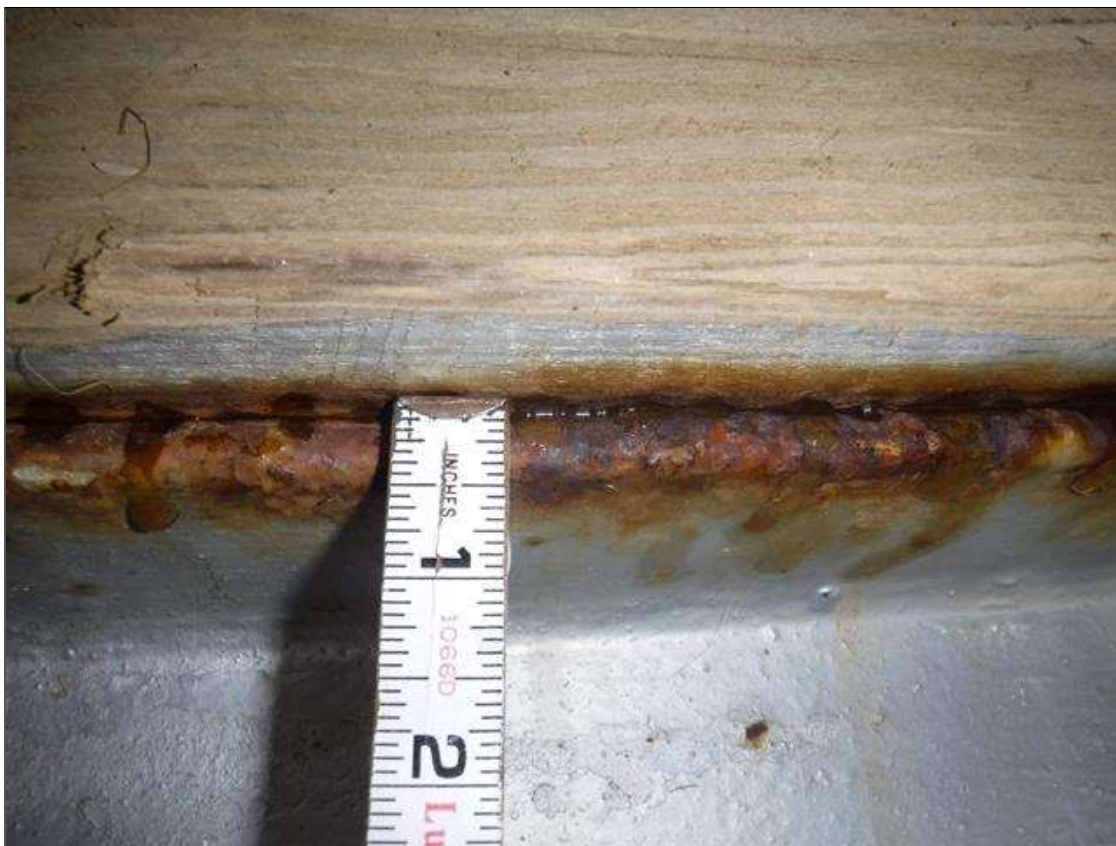
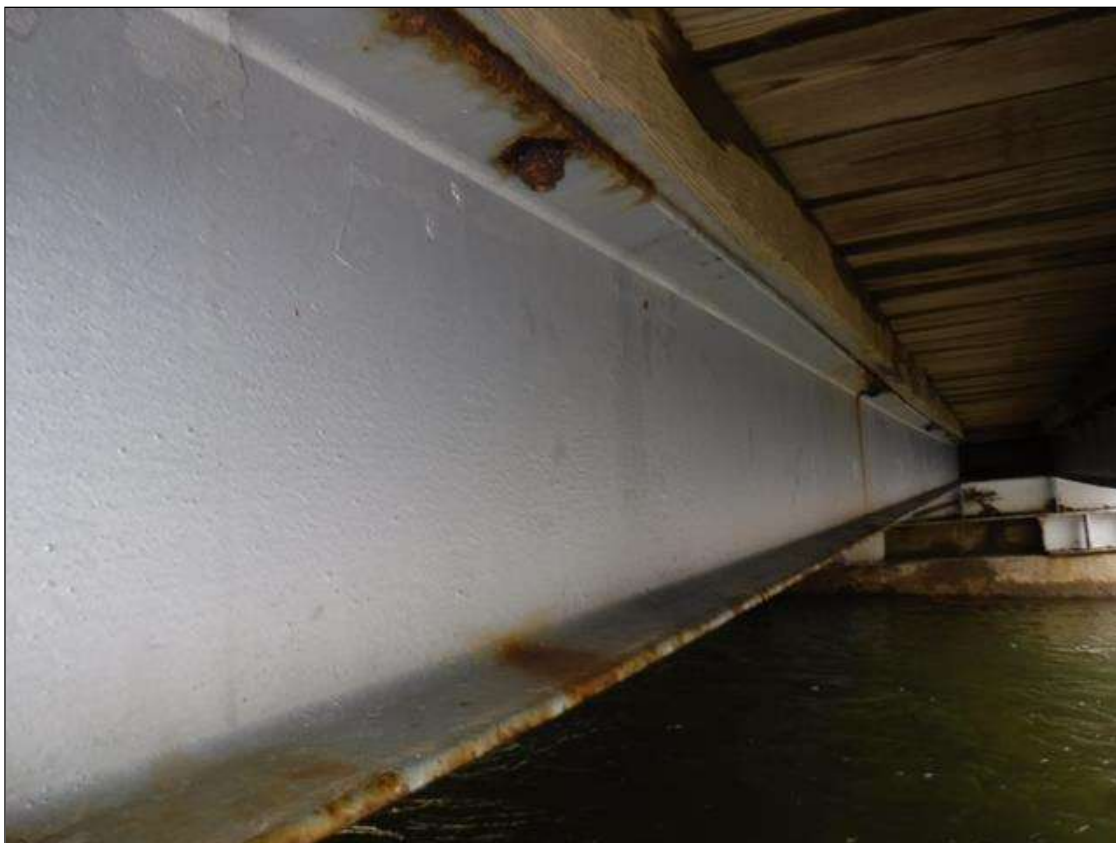
| Element Number | Defect Type | Defect Description | CS | CS Qty | Maint Qty | |
|---|---|---|---|---|---|---|
| 107 | Corrosion | RANDOM AREAS OF SURFACE RUST WITH NO MEASUREABLE LOSS. | 2 | 31 | | Feet |

Span 2 Beam 6: RANDOM AREAS OF SURFACE RUST WITH NO MEASUREABLE LOSS.

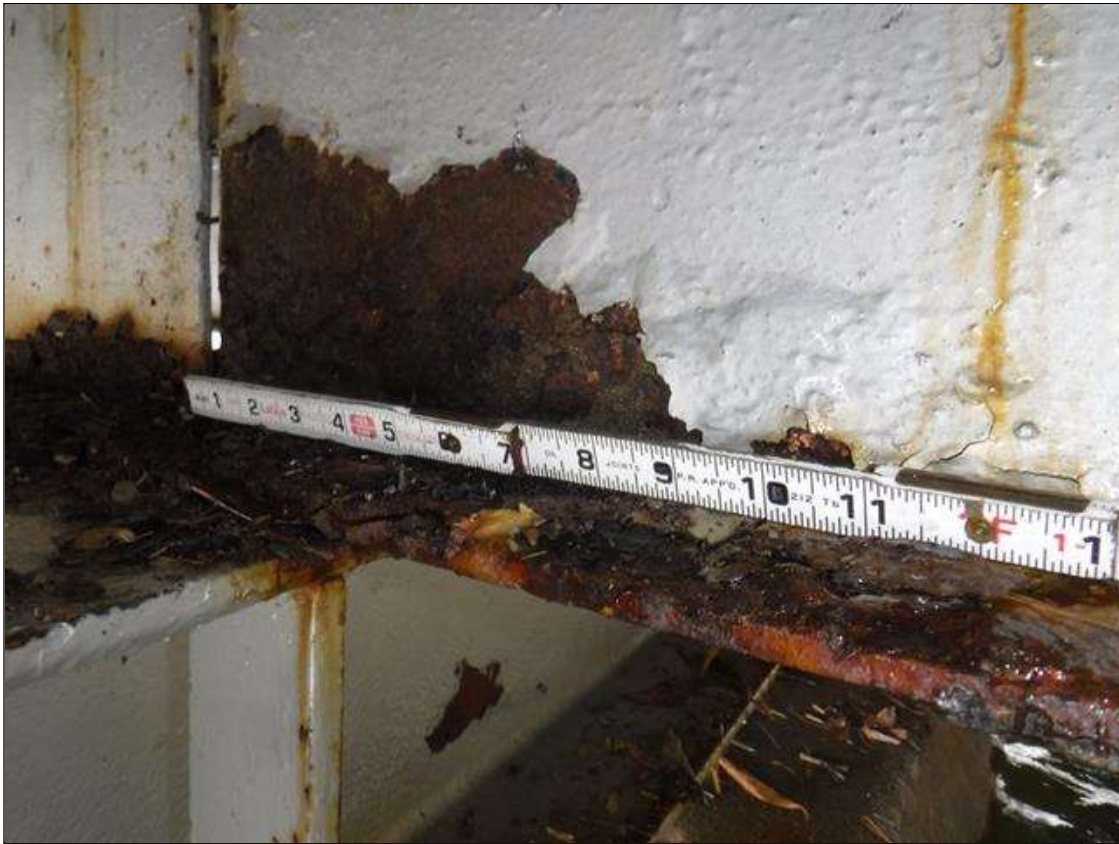
Span 2 Beam 7: BENT 1 END BOTTOM FLANGE SCALING RUST WITH 1/8" PITTING. WEB SCALING RUST WITH SECTION LOSS.

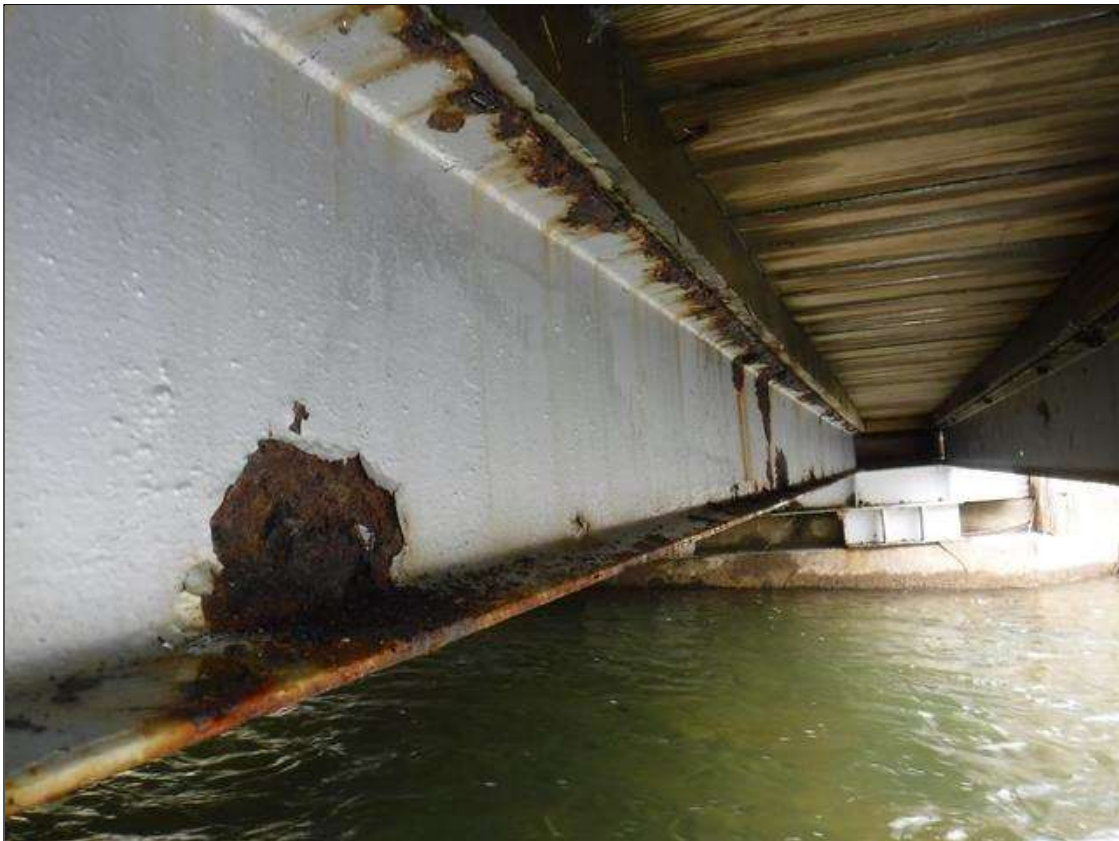
Span 2 Beam 7: RANDOM AREAS OF SCALING RUST TO TOP FLANGE AND WEB WITH UP TO 1/16" PITTING AND /OR LOSS.

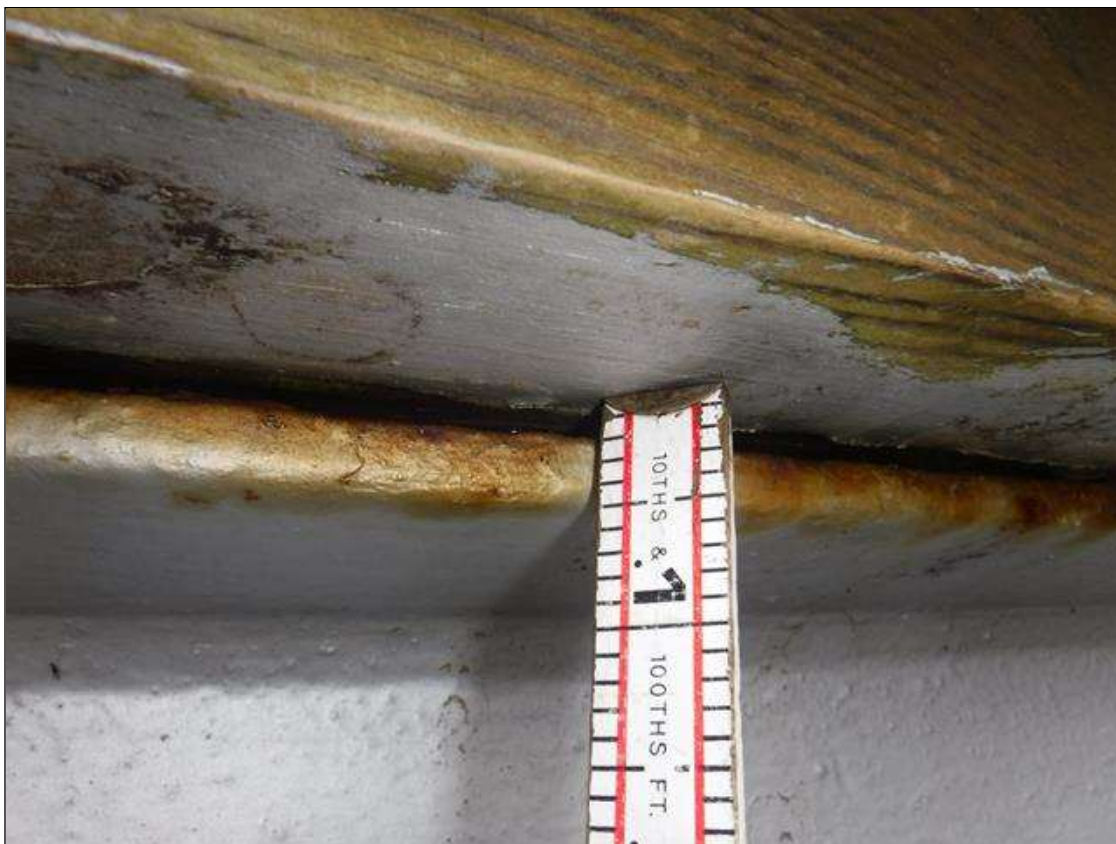
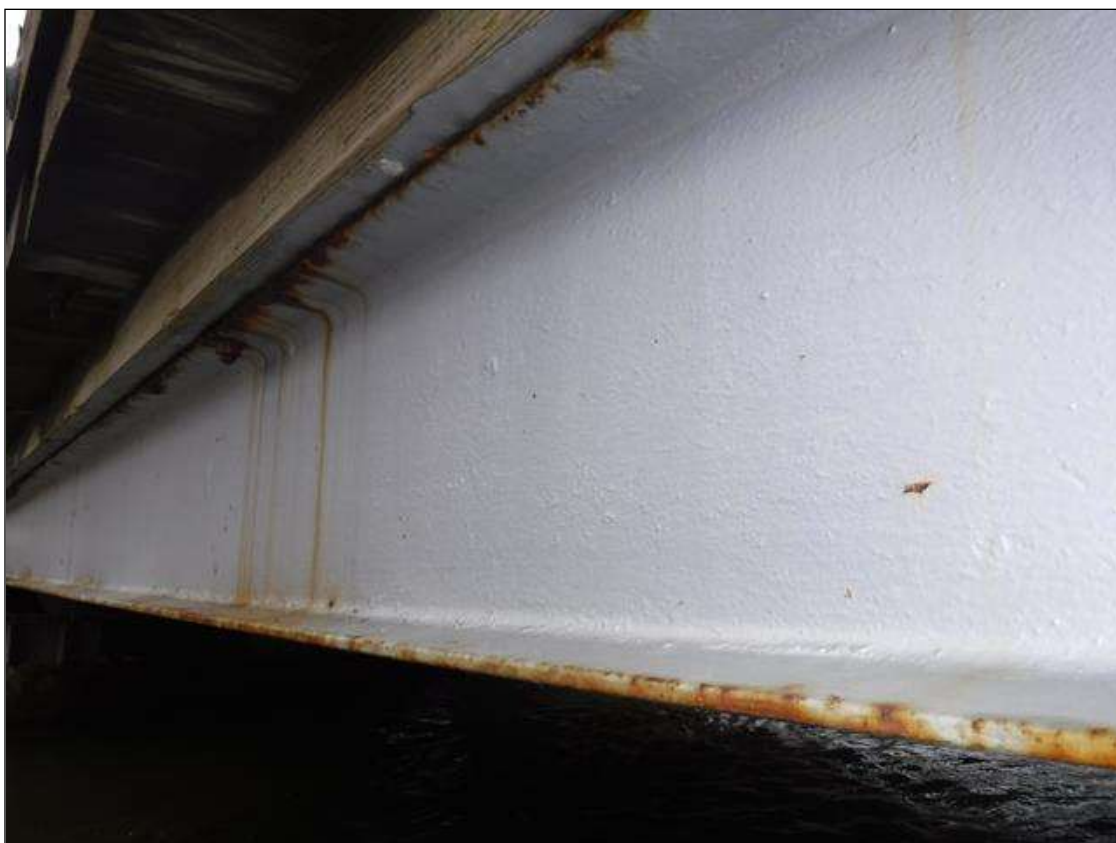
Span 2 Beam 8: RANDOM AREAS OF SURFACE RUST WITH NO MEASUREABLE LOSS.

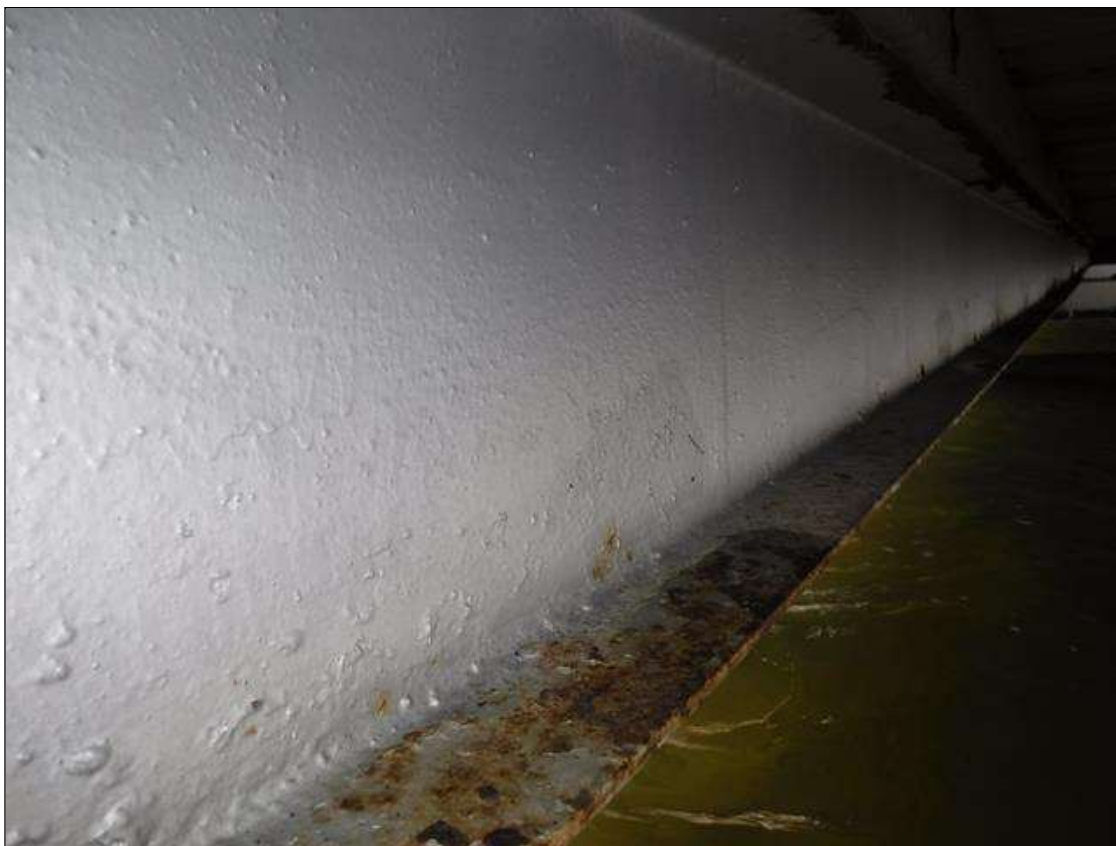
| Element Number | Defect Type | Defect Description | CS | CS Qty | Maint Qty | |
|---|---|---|---|---|---|---|
| 107 | Corrosion | SURFACE RUST ONLY WITH NO MEASURABLE LOSS | 2 | 22 | | Feet |

Span 1 Beam 3: SURFACE RUST ONLY WITH NO MEASURABLE LOSS

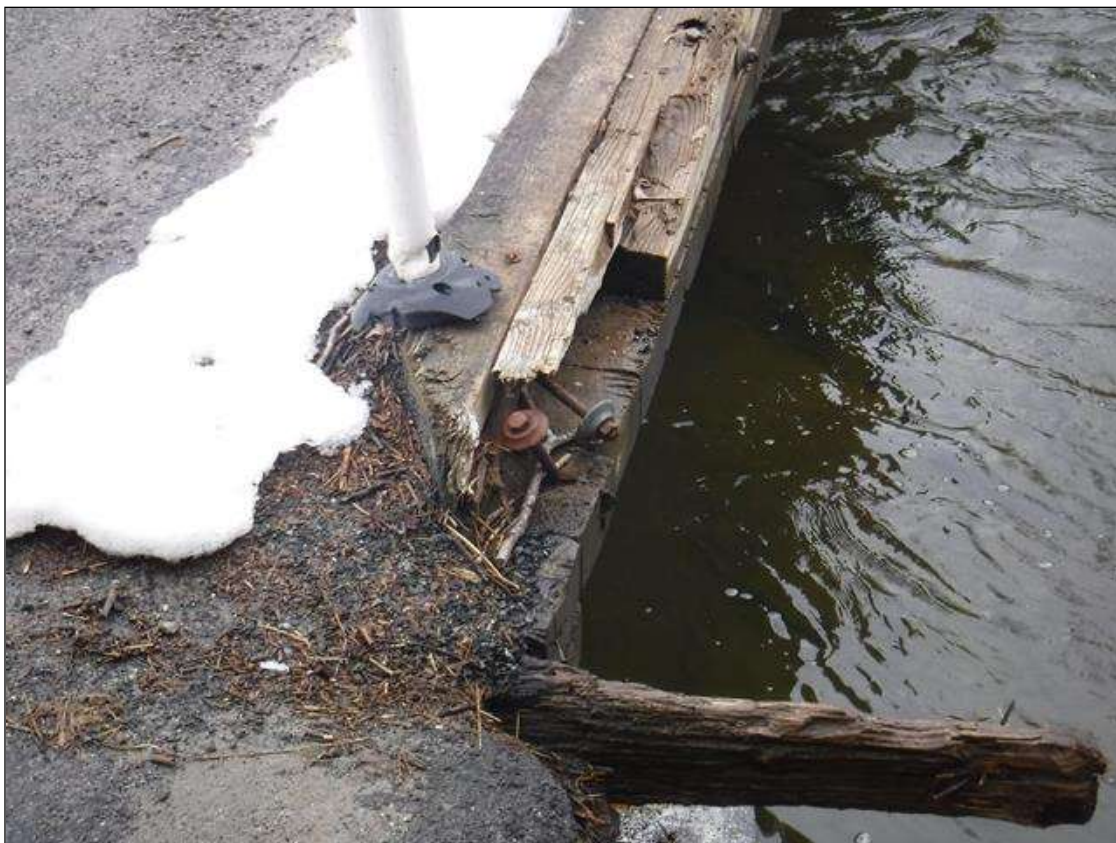
| Span 2 | | Left Bridge Rail | | | | | |
|---|---|---|---|---|---|---|---|
| 332 | Damage | OUTER WHEELGUARD BROKEN OFF AT NORTH END. | 3 | 2 | 2 | Feet | |

Span 2 Left Bridge Rail: OUTER WHEELGUARD BROKEN OFF AT NORTH END.

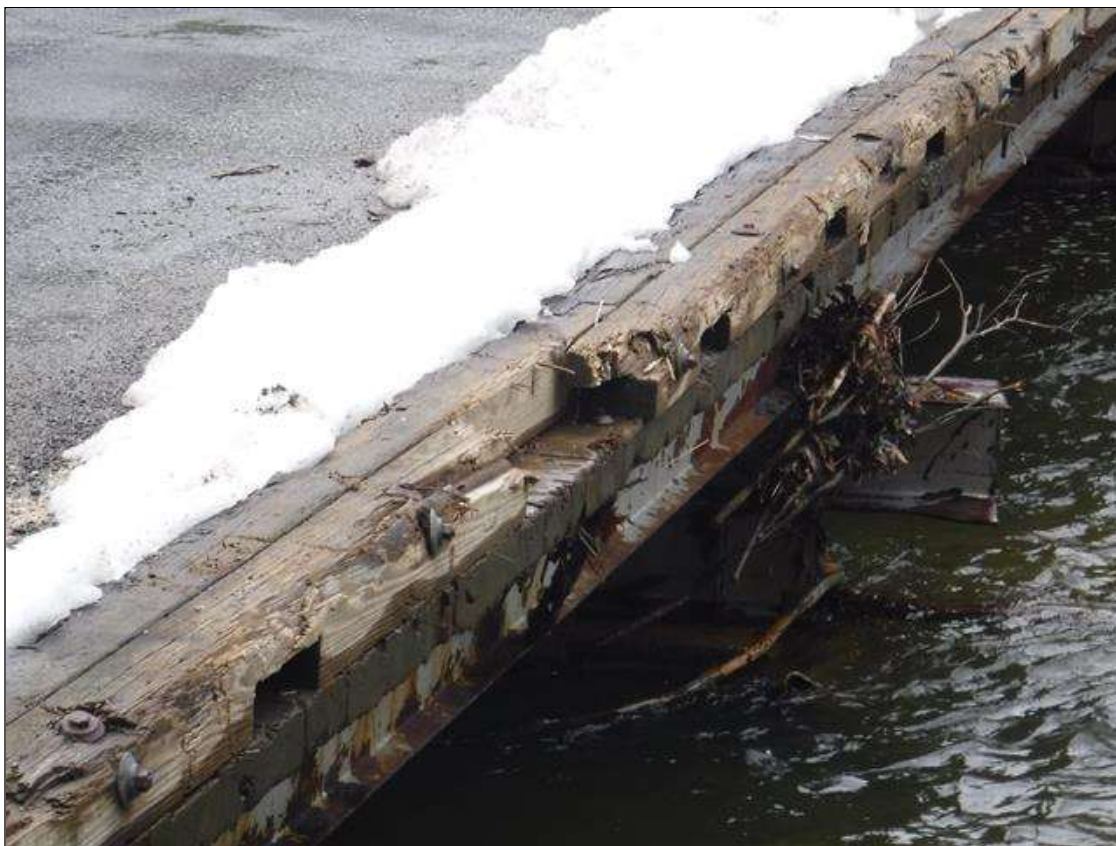
| Span 2 | | Left Bridge Rail | | | | | |
|---|---|---|---|---|---|---|---|
| 332 | Damage | OUTER WHEELGUARD BROKEN OFF MID SPAN. | 3 | 2 | 2 | Feet | |

Span 2 Left Bridge Rail: OUTER WHEELGUARD BROKEN OFF MID SPAN.

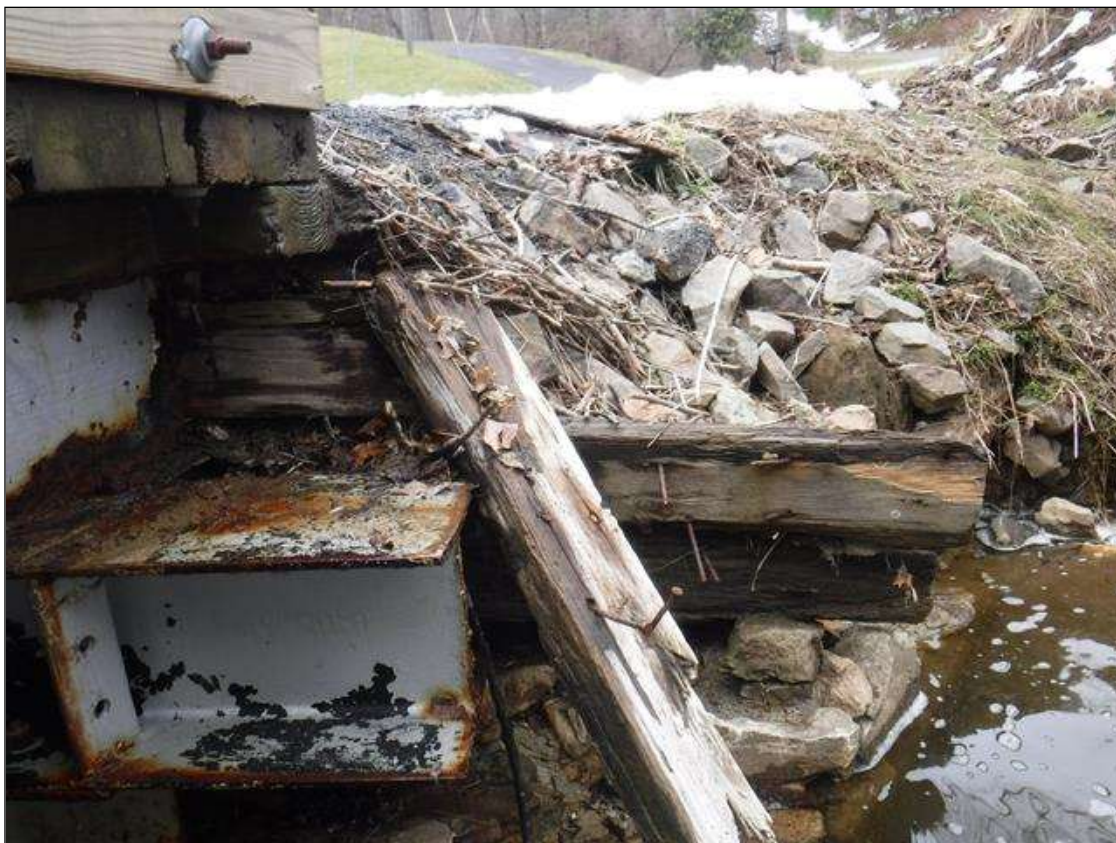
SOUTHWEST WING DAMAGE

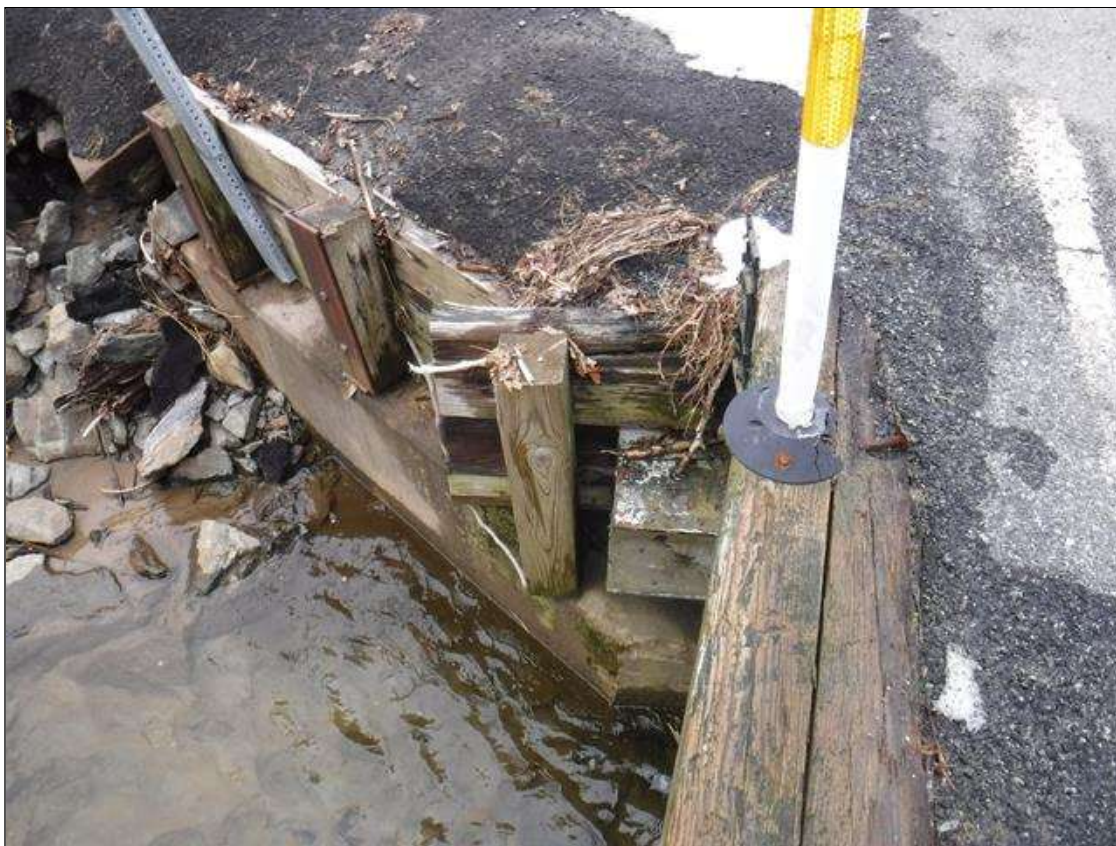
SOUTHEAST WING DAMAGE

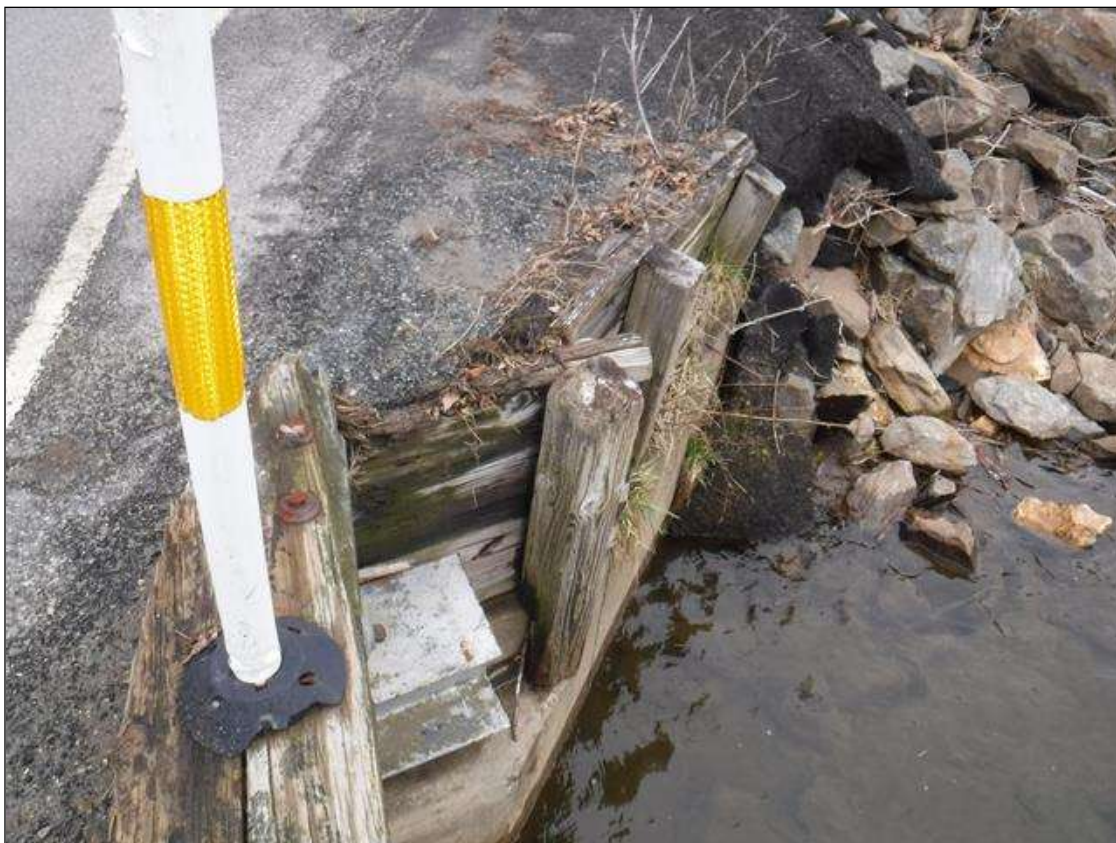
NORTHEAST WING DAMAGE

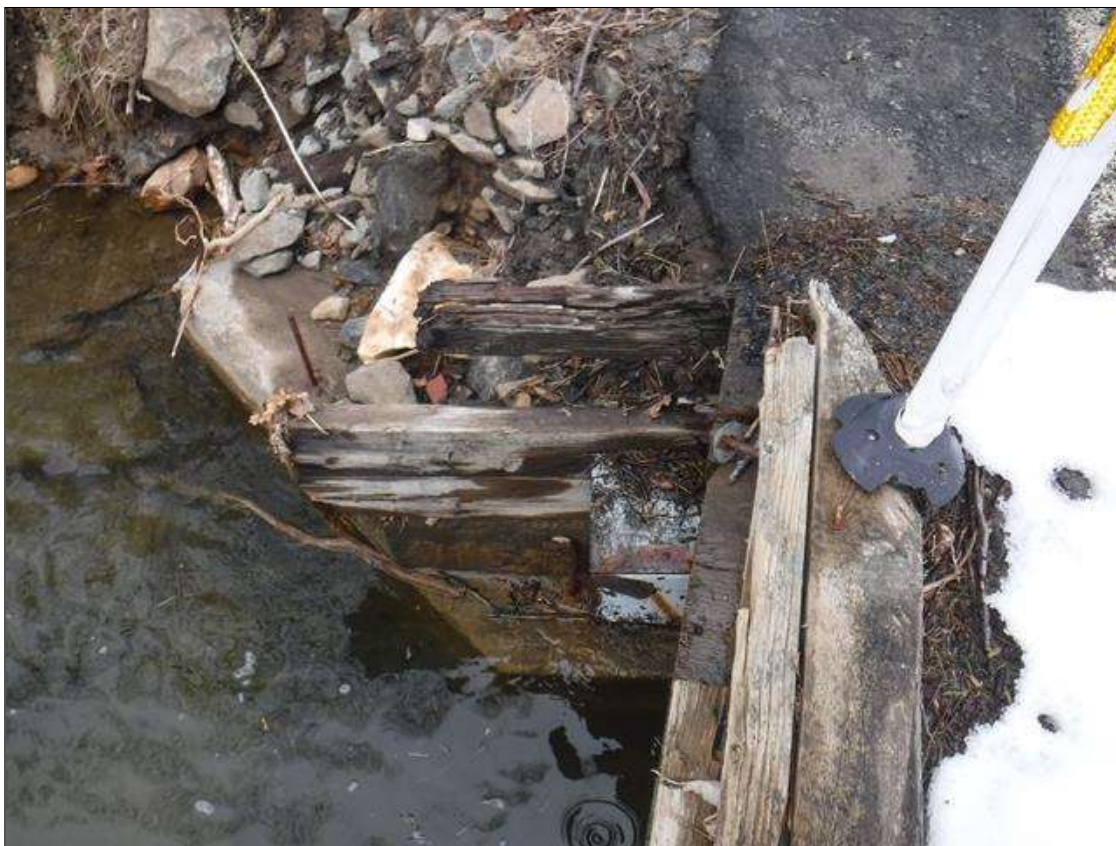
NORTHWEST WING DAMAGE
