NC DEPARTMENT OF TRANSPORTATION  
DIVISION OF HIGHWAYS  
STRUCTURE MANAGEMENT UNIT

## Structure Safety Report

### Routine Element Inspection - Contract

DIVISION: 11 COUNTY: WILKES STRUCTURE NUMBER: 960733 FREQUENCY: 24 MONTHS

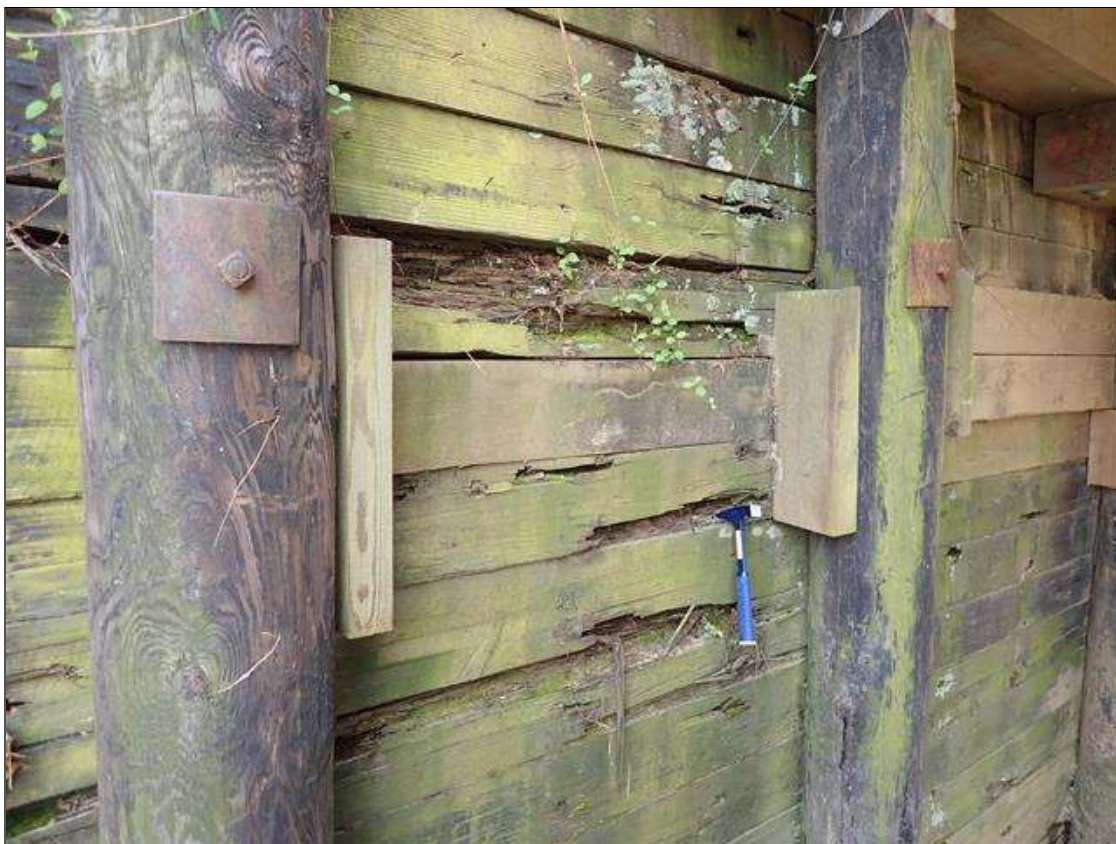
| 3346 | Abutment | Timber Abutment | |
|---|---|---|---|
| 2 | Decay/Section Loss | 15 | End Bent 2 Abutment/Backwall : 4' X 3.5' X UP TO 2" DEEP DECAY AT NORTH END (PAR) |

| Element Number | Defect Type | Defect Description | CS | CS Qty | Maint Qty |
|---|---|---|---|---|---|
| 216 | Decay/Section Loss | 4' X 3.5' X UP TO 2" DEEP DECAY AT NORTH END (PAR) | 3 | 4 | 15 Feet |

End Bent 2 Abutment/Backwall : 4' X 3.5' X UP TO 2" DEEP DECAY AT NORTH END (PAR)

| MMS Code | Description of Function | Unit | Quantity | Remarks | Est. Cost |
|---|---|---|---|---|---|
| 3346 | Repair / Maintain Timber Wings & Blkhds | SF | 15 | End Bent 2 Abutment/Backwall : 4' X 3.5' X UP TO 2" DEEP DECAY AT NORTH END (PAR) | |

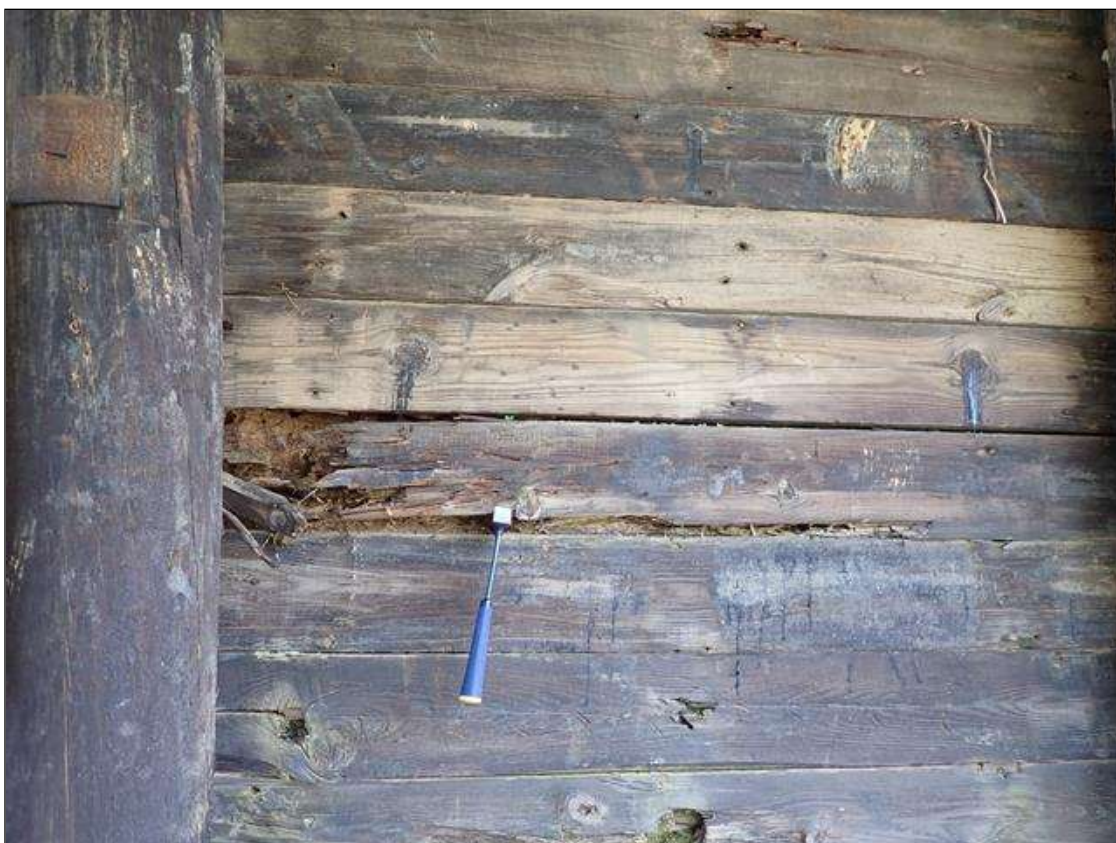
| 3346 | Abutment | Timber Abutment | |
|---|---|---|---|
| 2 | Decay/Section Loss | 6 | End Bent 2 Abutment/Backwall : 3' X 1' AREA OF 100% DECAY BETWEEN PILES 3 AND 4 (PAR) |

| Element Number | Defect Type | Defect Description | CS | CS Qty | Maint Qty |
|---|---|---|---|---|---|
| 216 | Decay/Section Loss | 5' X 1' AREA OF 100% DECAY BETWEEN PILES 3 AND 4 (PAR) | 4 | 5 | 6 Feet |

End Bent 2 Abutment/Backwall : 5' X 1' AREA OF 100% DECAY BETWEEN PILES 3 AND 4 (PAR)

| MMS Code | Description of Function | Unit | Quantity | Remarks | Est. Cost |
|---|---|---|---|---|---|
| 3346 | Repair / Maintain Timber Wings & Blkhds | SF | 6 | End Bent 2 Abutment/Backwall : 3' X 1' AREA OF 100% DECAY BETWEEN PILES 3 AND 4 (PAR) | |

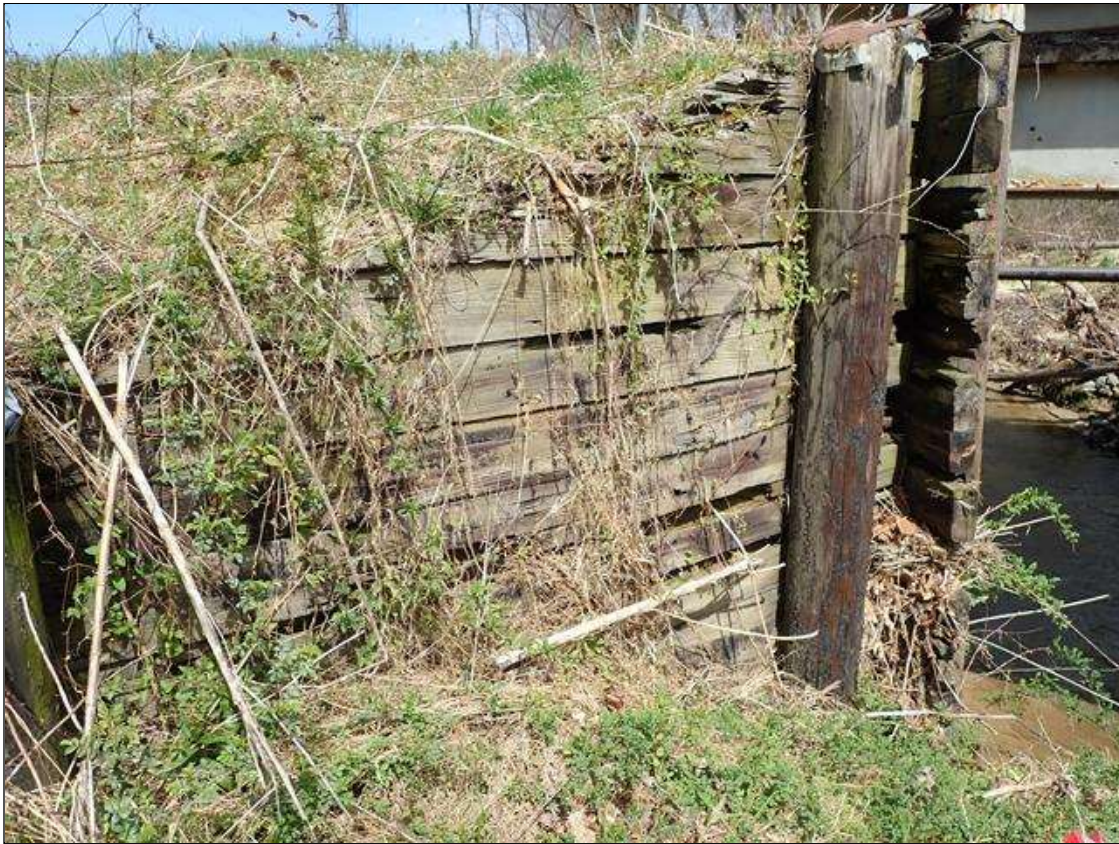
| 3346 | Abutment | Timber Abutment | |
|---|---|---|---|
| 1 | Decay/Section Loss | 25 | End Bent 1 Abutment/Backwall : HEAVY DETERIORATION TO SOUTHWEST WINGWALL WITH GAPS UP TO 2" BETWEEN BOARDS (PAR) |

| Element Number | Defect Type | Defect Description | CS | CS Qty | Maint Qty | |
|---|---|---|---|---|---|---|
| 216 | Decay/Section Loss | HEAVY DETERIORATION TO SOUTHWEST WINGWALL WITH GAPS UP TO 2" BETWEEN BOARDS (PAR) | 3 | 10 | 25 | Feet |

End Bent 1 Abutment/Backwall : HEAVY DETERIORATION TO SOUTHWEST WINGWALL WITH GAPS UP TO 2" BETWEEN BOARDS (PAR)

| MMS Code | Description of Function | Unit | Quantity | Remarks | Est. Cost |
|---|---|---|---|---|---|
| 3346 | Repair / Maintain Timber Wings & Blkhds | SF | 25 | End Bent 1 Abutment/Backwall : HEAVY DETERIORATION TO SOUTHWEST WINGWALL WITH GAPS UP TO 2" BETWEEN BOARDS (PAR) | |

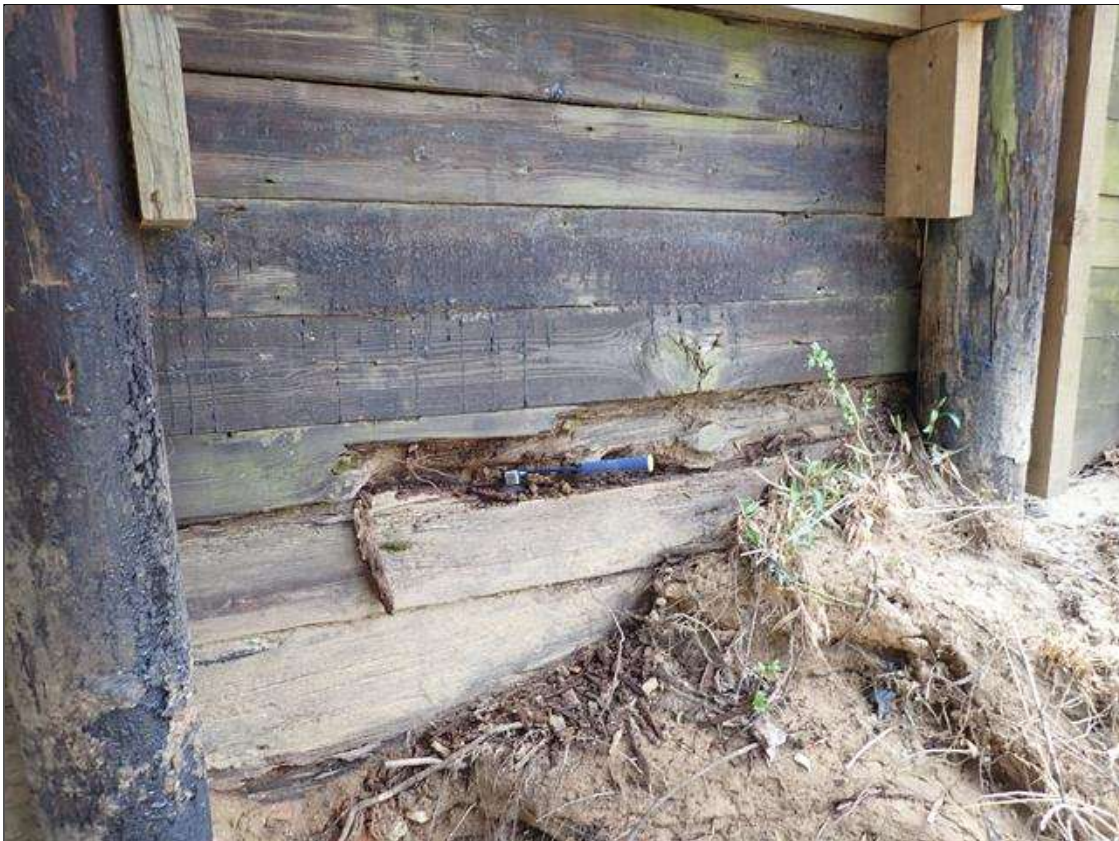
| 3346 | Abutment | Timber Abutment | |
|---|---|---|---|
| 2 | Decay/Section Loss | 6 | End Bent 2 Abutment/Backwall : 3' X 1' AREA OF 100% DECAY BETWEEN PILES 4 AND 5 (PAR) |

| Element Number | Defect Type | Defect Description | CS | CS Qty | Maint Qty |
|---|---|---|---|---|---|
| 216 | Decay/Section Loss | 5' X 1' AREA OF 100% DECAY BETWEEN PILES 4 AND 5 (PAR) | 4 | 5 | 6 Feet |

End Bent 2 Abutment/Backwall : 5' X 1' AREA OF 100% DECAY BETWEEN PILES 4 AND 5 (PAR)

| MMS Code | Description of Function | Unit | Quantity | Remarks | Est. Cost |
|---|---|---|---|---|---|
| 3346 | Repair / Maintain Timber Wings & Blkhds | SF | 6 | End Bent 2 Abutment/Backwall : 3' X 1' AREA OF 100% DECAY BETWEEN PILES 4 AND 5 (PAR) | |

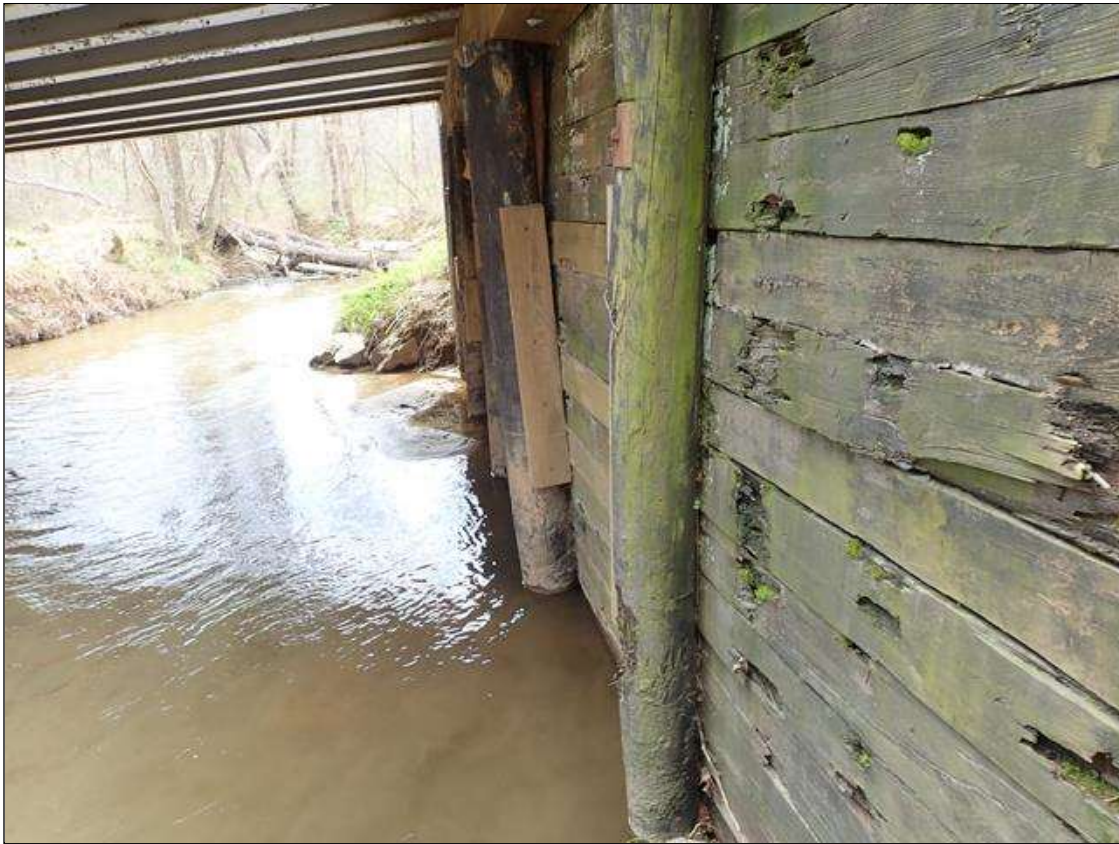
| 3344 | Pile 1 | Timber Pile | |
|---|---|---|---|
| 2 | Decay/Section Loss | 1 | End Bent 1 Pile 1: BOWED OUTWARDS APPROXIMATELY 4" AT MIDDLE WITH FIBERS TEARING AT BEND (PAR) |

| Element Number | Defect Type | Defect Description | CS | CS Qty | Maint Qty | |
|---|---|---|---|---|---|---|
| 228 | Decay/Section Loss | BOWED OUTWARDS APPROXIMATELY 4" AT MIDDLE WITH FIBERS TEARING AT BEND (PAR) | 4 | 1 | 1 | Each |

End Bent 1 Pile 1: BOWED OUTWARDS APPROXIMATELY 4" AT MIDDLE WITH FIBERS TEARING AT BEND (PAR)

| MMS Code | Description of Function | Unit | Quantity | Remarks | Est. Cost |
|---|---|---|---|---|---|
| 3344 | Repair / Replace Timber Substructure Components | LF | 1 | End Bent 1 Pile 1: BOWED OUTWARDS APPROXIMATELY 4" AT MIDDLE WITH FIBERS TEARING AT BEND (PAR) | |

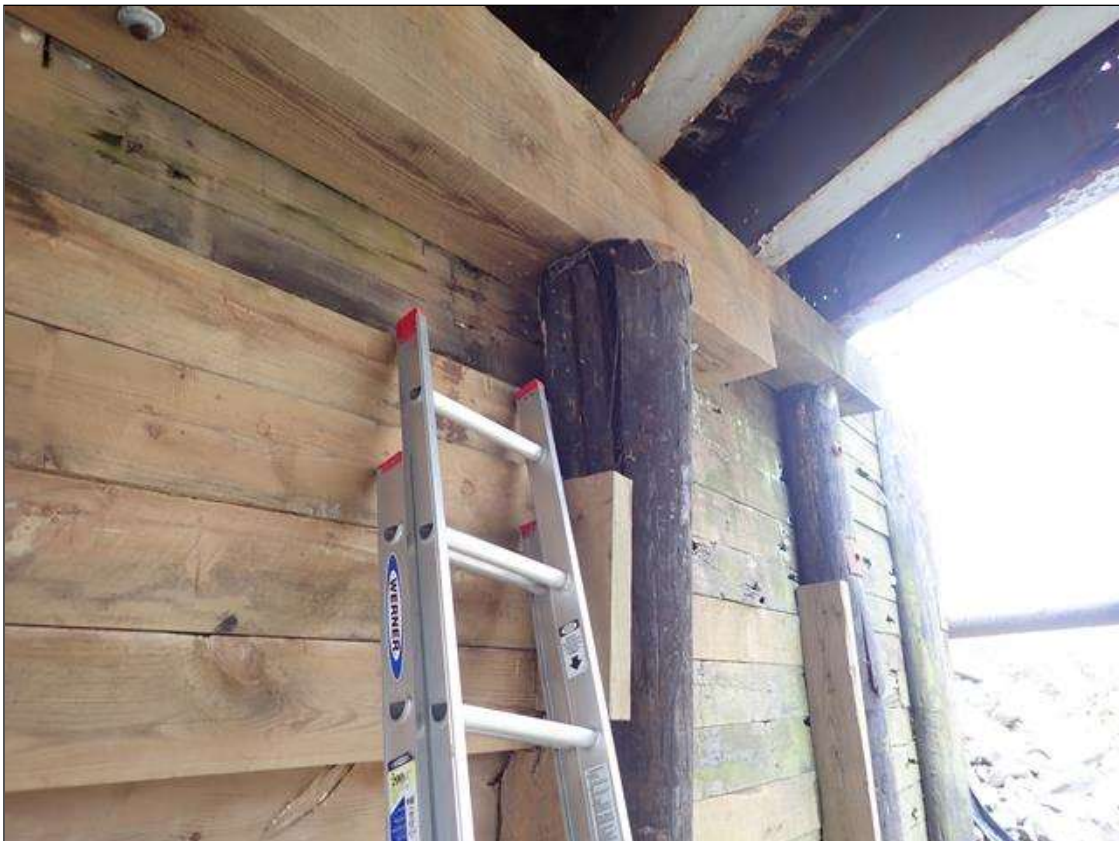
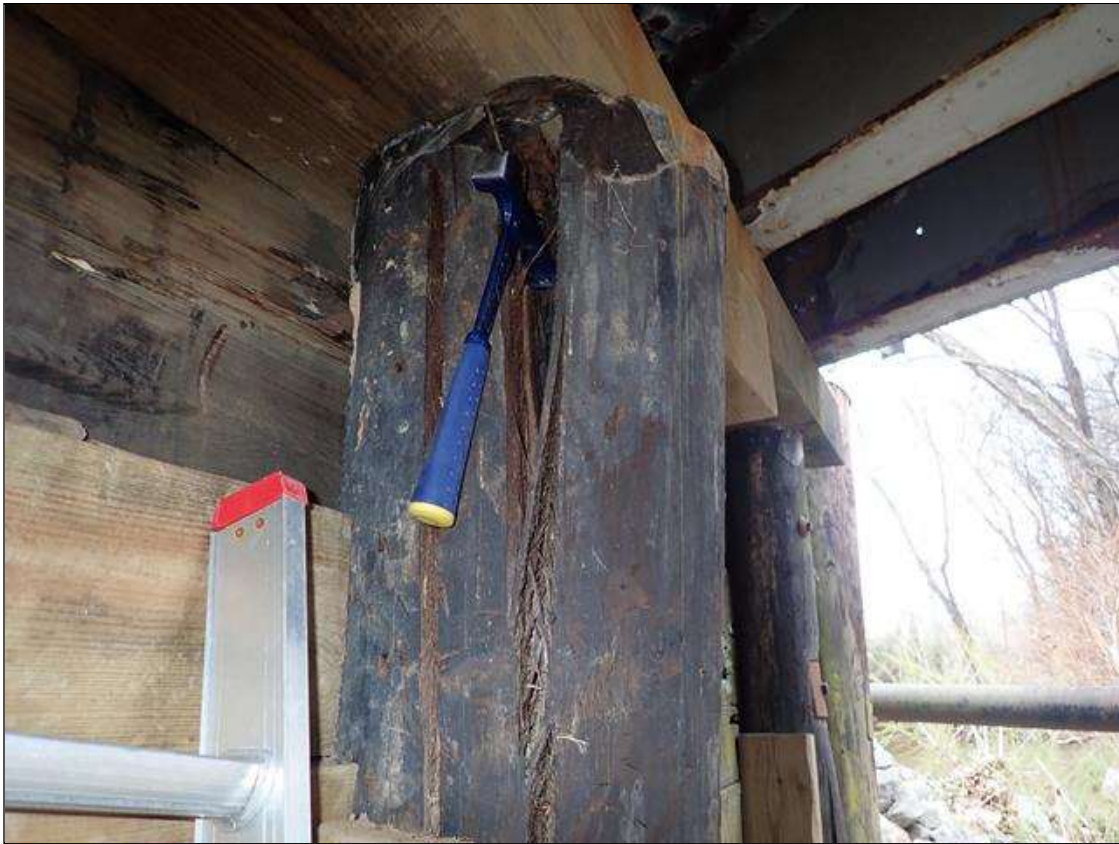
| 3344 | Pile 2 | Timber Pile | |
|---|---|---|---|
| 2 | Decay/Section Loss | 1 | End Bent 1 Pile 2: PILE COMPLETELY DECAYED AND MUSHROOMED FOR 3' AT TOP (CRITICAL FIND) |

| Element Number | Defect Type | Defect Description | CS | CS Qty | Maint Qty | |
|---|---|---|---|---|---|---|
| 228 | Decay/Section Loss | PILE COMPLETELY DECAYED AND MUSHROOMED FOR 3' AT TOP (CRITICAL FIND) | 4 | 1 | 1 | Each |

| Details | GRADE GIVEN DUE TO:<br>SIGNIFICANT DECAY TO BACKWALLS<br>PILES AT END BENT 1 LEANING<br>MUSHROOMING PILE 2 AT END BENT 1 (CRITICAL FIND) |

End Bent 1 Pile 2: PILE COMPLETELY DECAYED AND MUSHROOMED FOR 3' AT TOP (CRITICAL FIND)

| MMS Code | Description of Function | Unit | Quantity | Remarks | Est. Cost |
|---|---|---|---|---|---|
| 3344 | Repair / Replace Timber Substructure Components | LF | 1 | End Bent 1 Pile 2: PILE COMPLETELY DECAYED AND MUSHROOMED FOR 3' AT TOP (CRITICAL FIND) | |

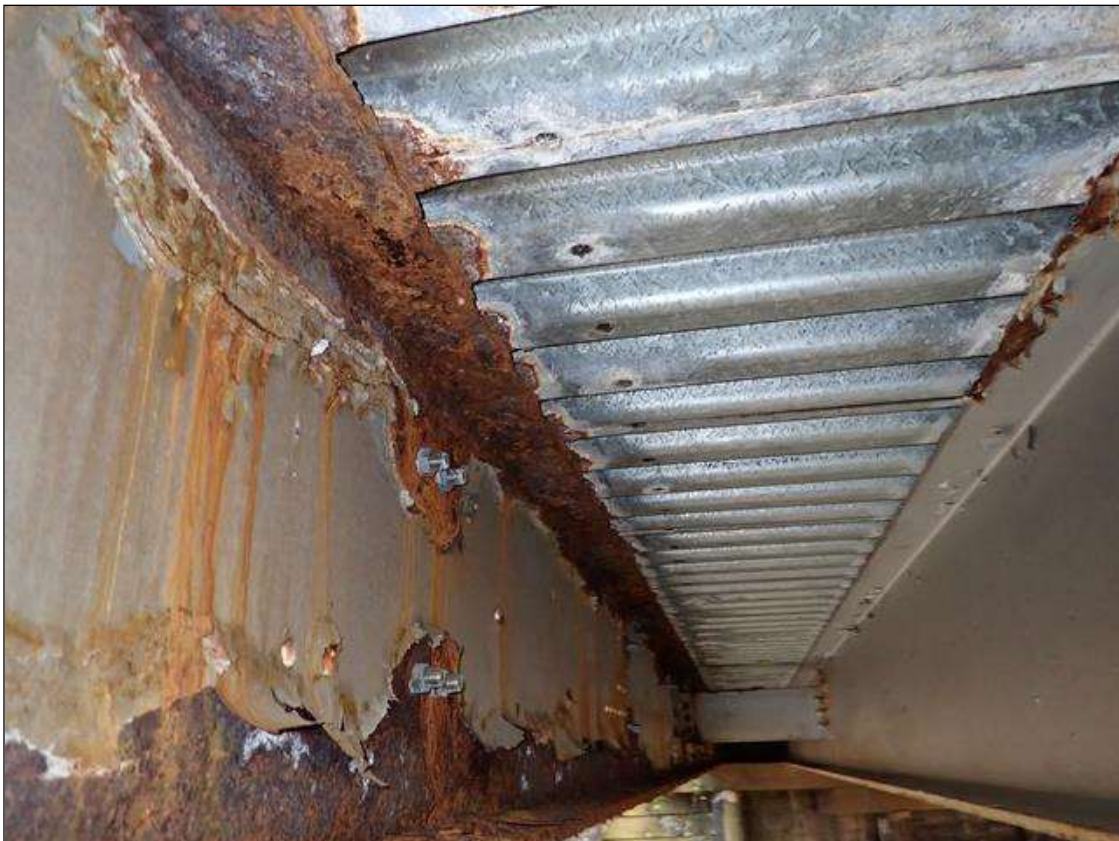
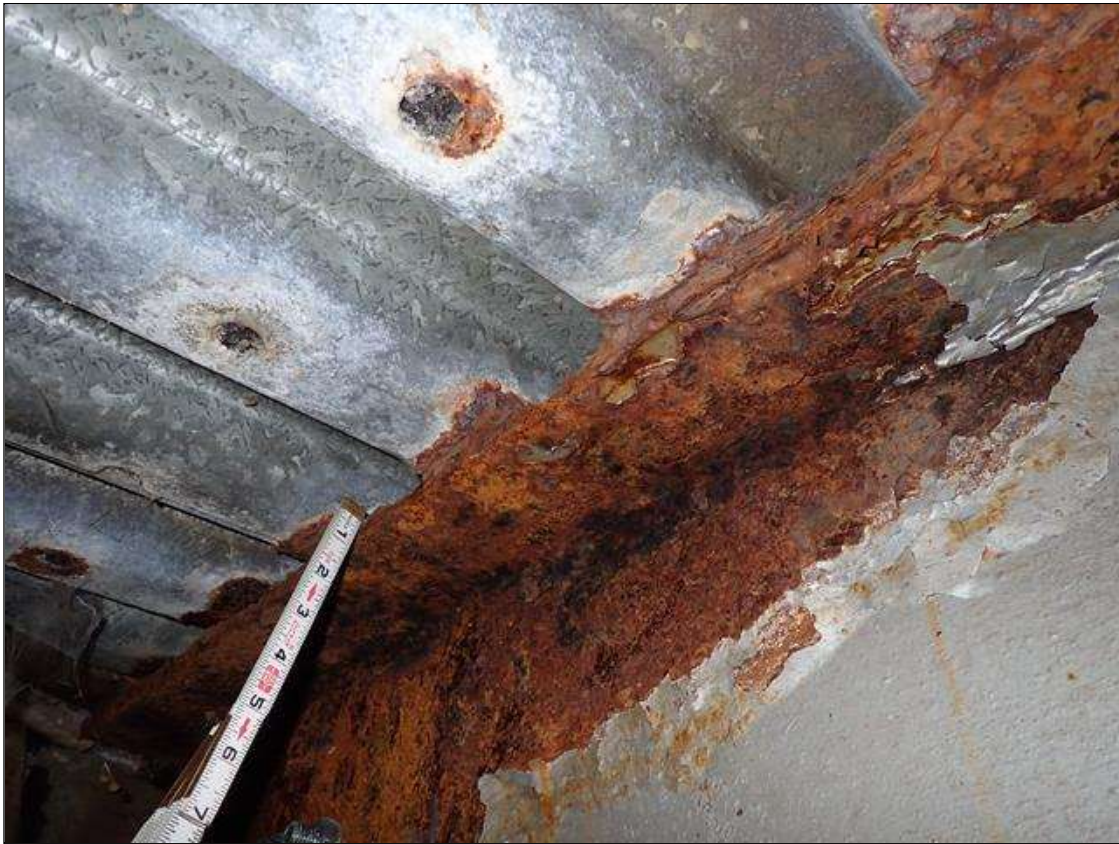
| 3314 | Beam 1 | Plate Girder | |
|---|---|---|---|
| 2 | Corrosion | 36 | Span 1 Beam 1: SECTION LOSS THROUGHOUT TOP FLANGE WITH 1/4" REMAINING (PAR) |

| Element Number | Defect Type | Defect Description | CS | CS Qty | Maint Qty | |
|---|---|---|---|---|---|---|
| 107 | Corrosion | SECTION LOSS THROUGHOUT TOP FLANGE WITH 1/4" REMAINING (PAR) | 4 | 36 | 36 | Feet |

Span 1 Beam 1: SECTION LOSS THROUGHOUT TOP FLANGE WITH 1/4" REMAINING (PAR)

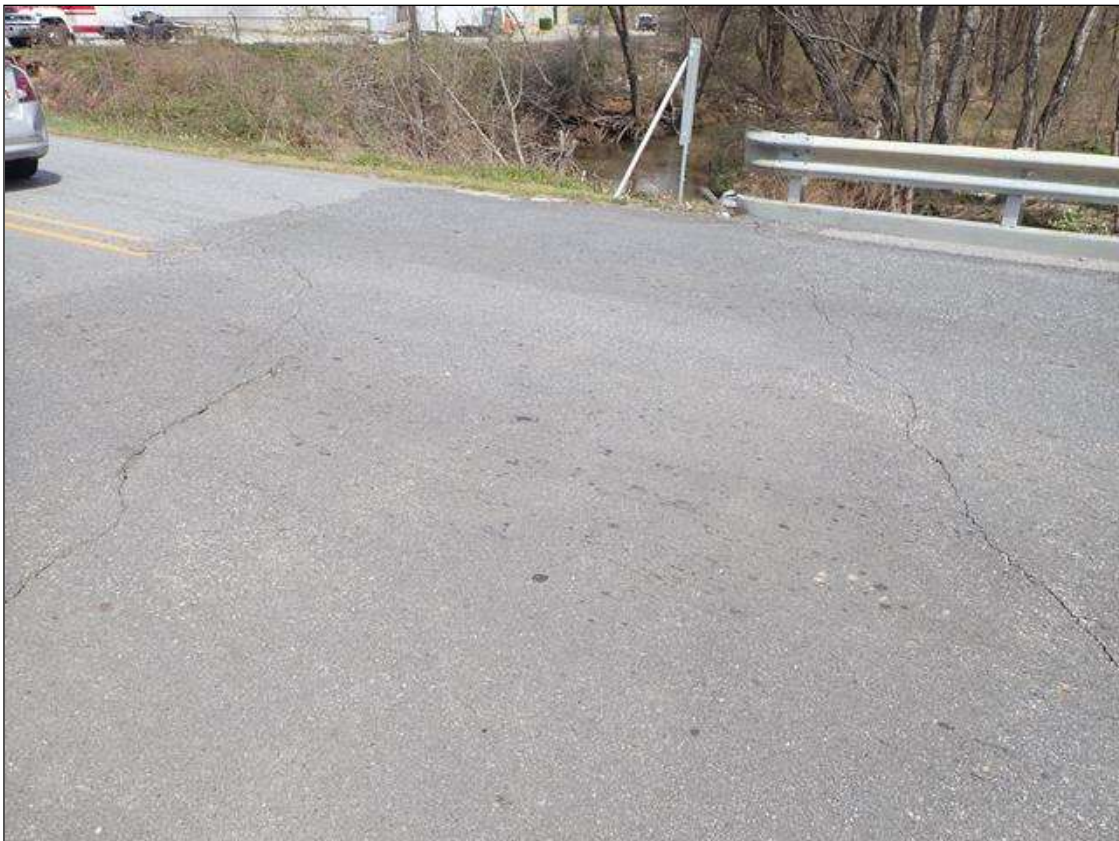
| Details | UP TO 1/4" CRACKING AND 1.5" SETTLEMENT IN WEST APPROACH |

UP TO 1/4" CRACKING AND 1.5" SETTLEMENT IN WEST APPROACH

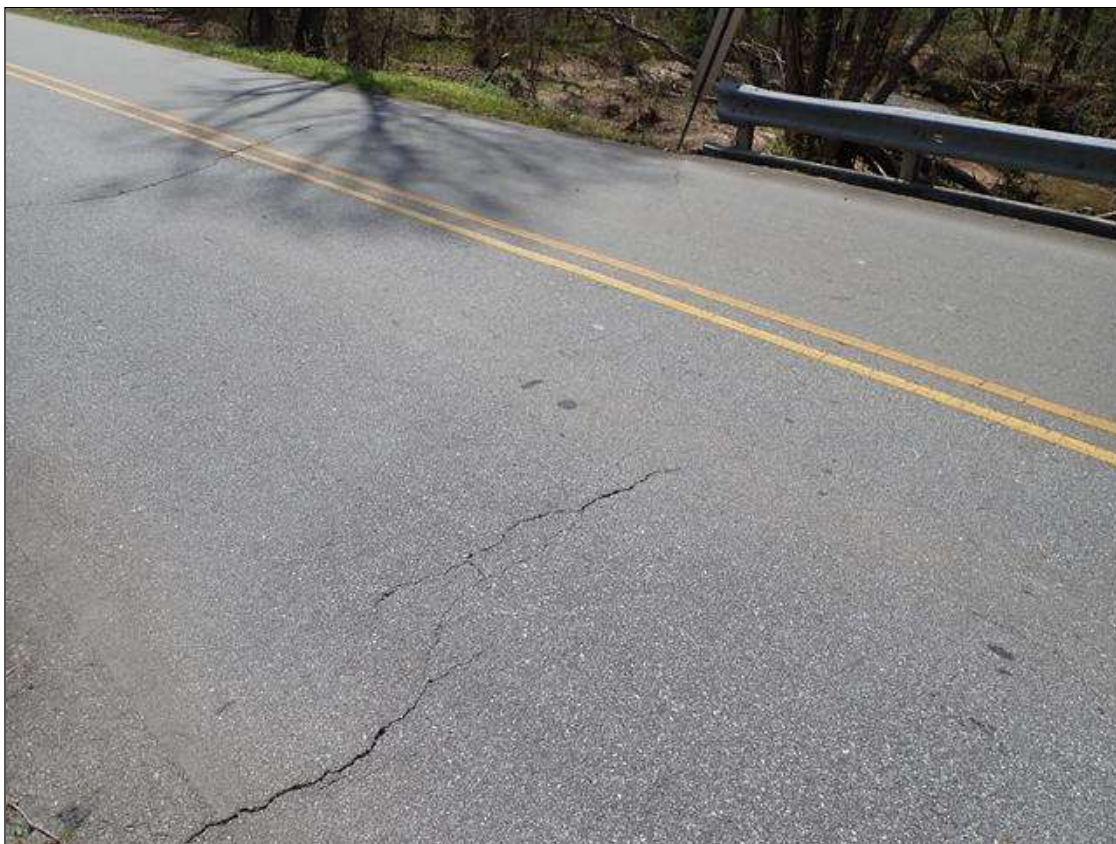
| Element Number | Defect Type | Defect Description | CS | CS Qty | Maint Qty | |
|---|---|---|---|---|---|---|
| 510 | Crack (Wearing Surface) | UP TO 1/4" TRANSVERSE CRACKING OVER END BENT 2 | 3 | 10 | 10 | Square Feet |

Span 1 Wearing Surface: UP TO 1/4" TRANSVERSE CRACKING OVER END BENT 2

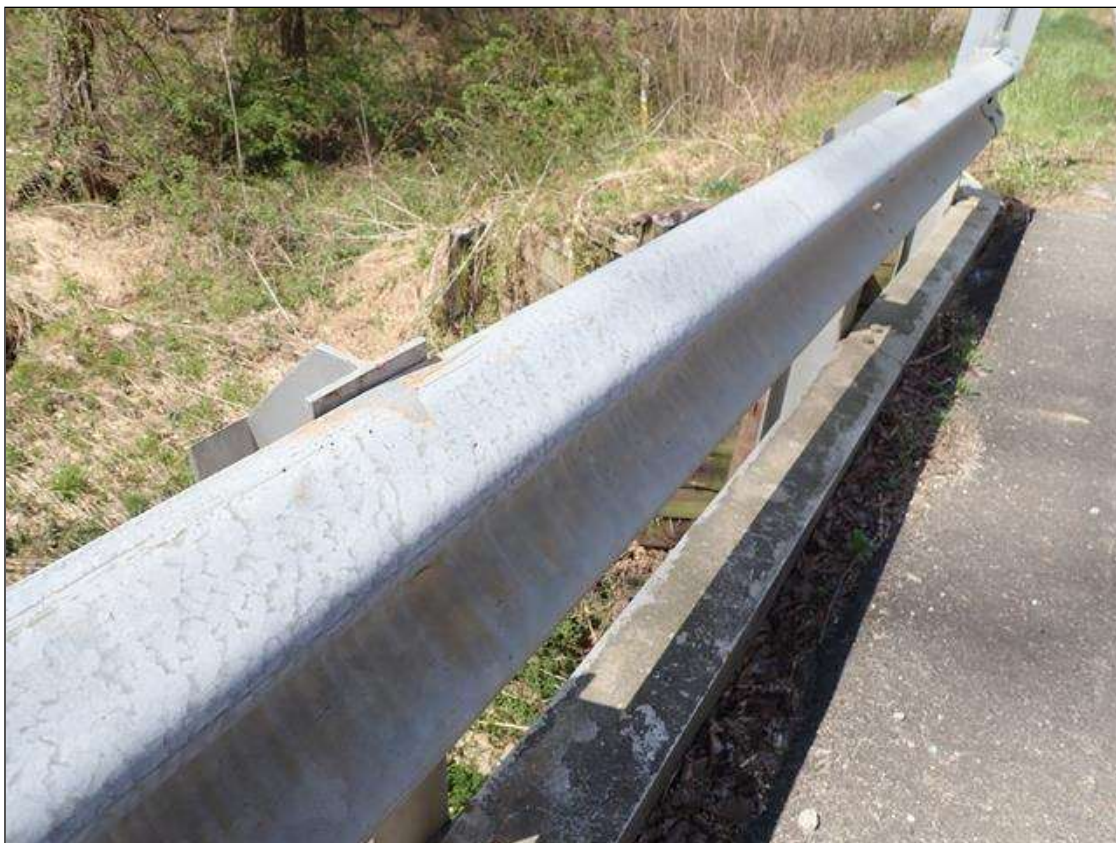
SCATTERED AREAS OF SURFACE RUST THROUGHOUT BOTH RAILS

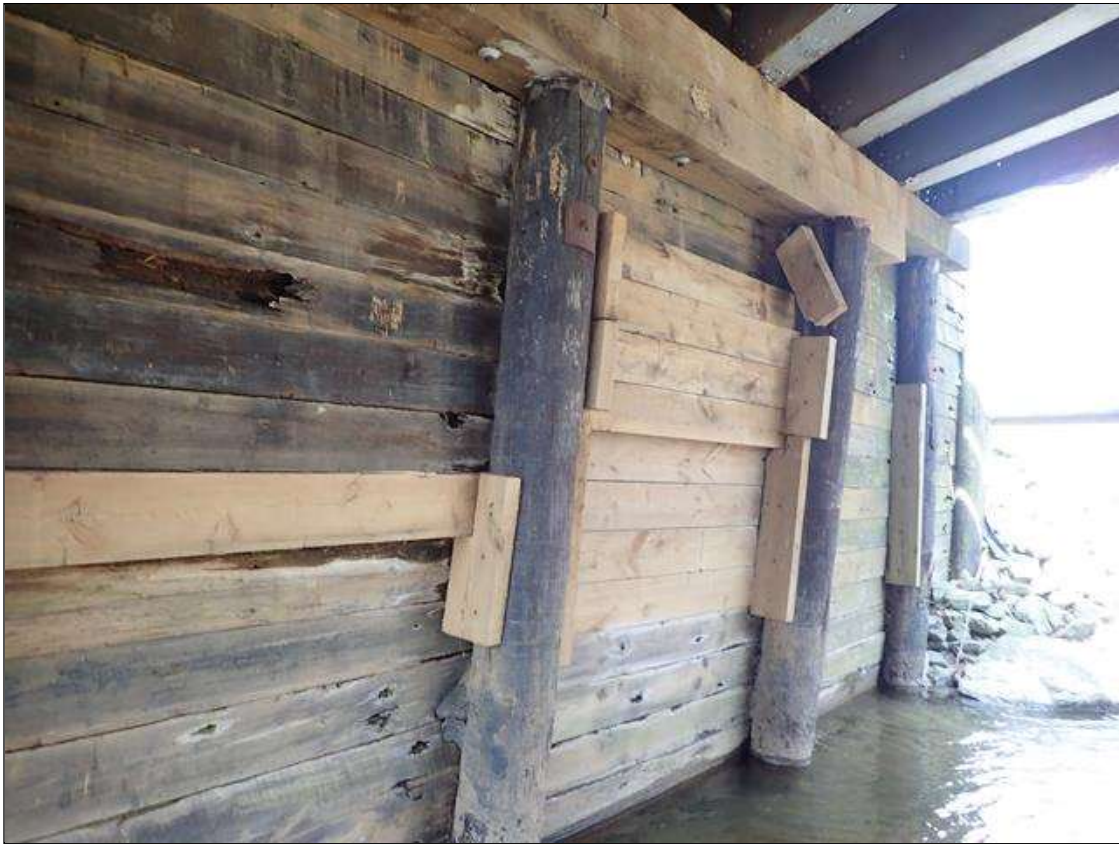
END BENT 1 BACKWALL PAR REPAIRS

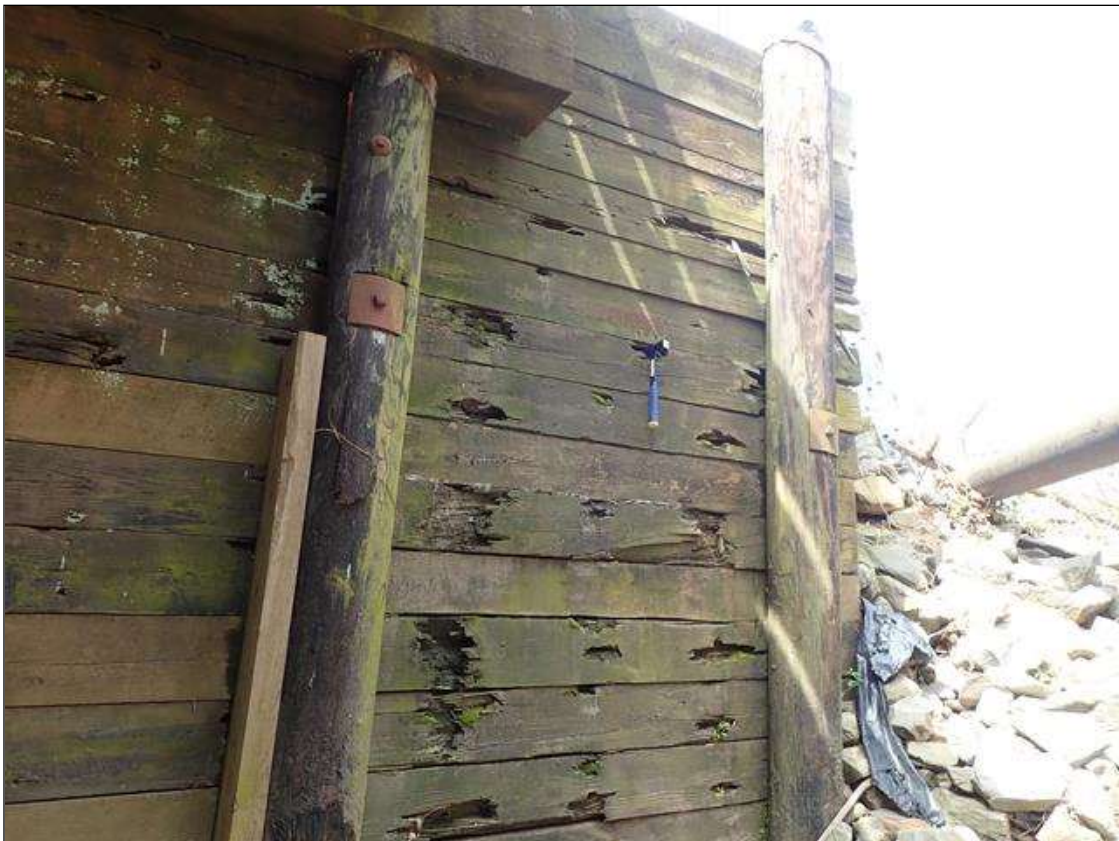
| Element Number | Defect Type | Defect Description | CS | CS Qty | Maint Qty | |
|---|---|---|---|---|---|---|
| 216 | Decay/Section Loss | 5' WIDE X 10' HIGH AREA OF UP TO 3" DECAY AT NORTH END | 3 | 5 | 50 | Feet |

End Bent 1 Abutment/Backwall : 5' WIDE X 10' HIGH AREA OF UP TO 3" DECAY AT NORTH END

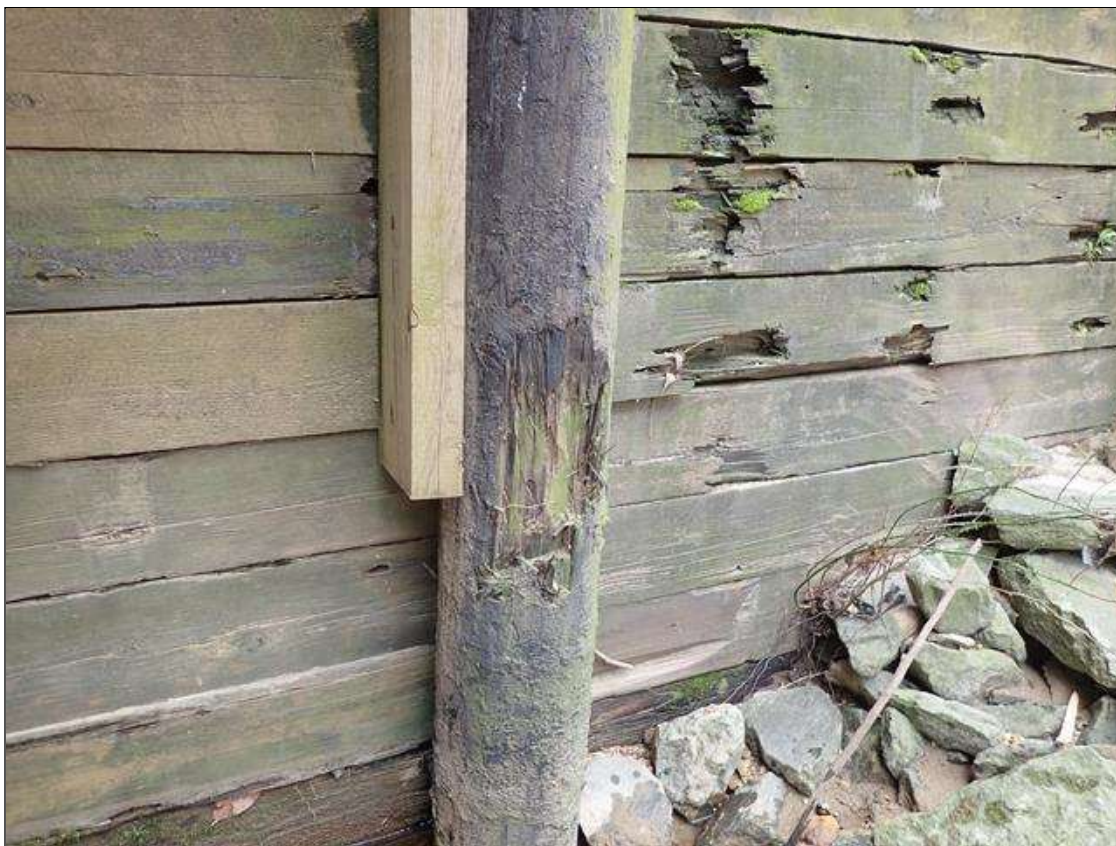
| Element Number | Defect Type | Defect Description | CS | CS Qty | Maint Qty | |
|---|---|---|---|---|---|---|
| 228 | Decay/Section Loss | 6" X 13" X 1" DEEP DECAY NEAR GROUNDLINE | 2 | | | Each |

End Bent 1 Pile 1: 6" X 13" X 1" DEEP DECAY NEAR GROUNDLINE

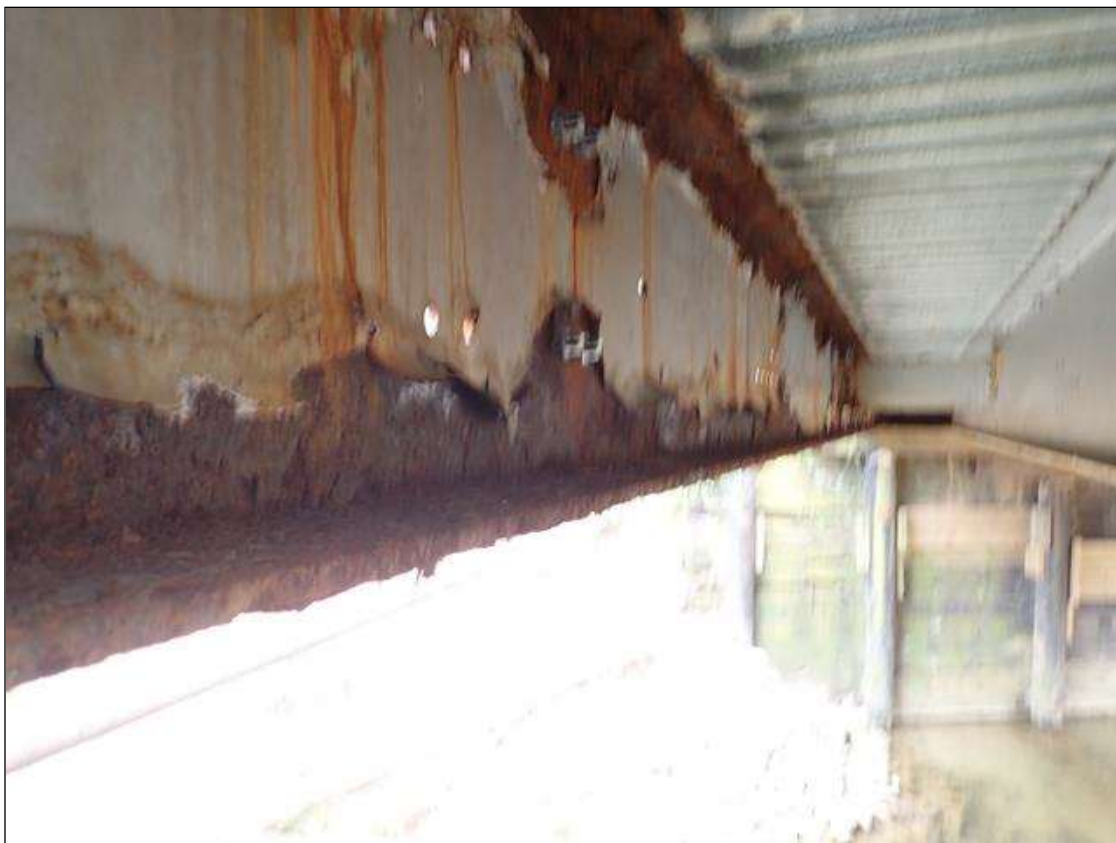
| Element Number | Defect Type | Defect Description | CS | CS Qty | Maint Qty | |
|---|---|---|---|---|---|---|
| 107 | Corrosion | SURFACE RUST WITH PEELING PAINT THROUGHOUT | 3 | | 36 | Feet |

Span 1 Beam 1: SURFACE RUST WITH PEELING PAINT THROUGHOUT

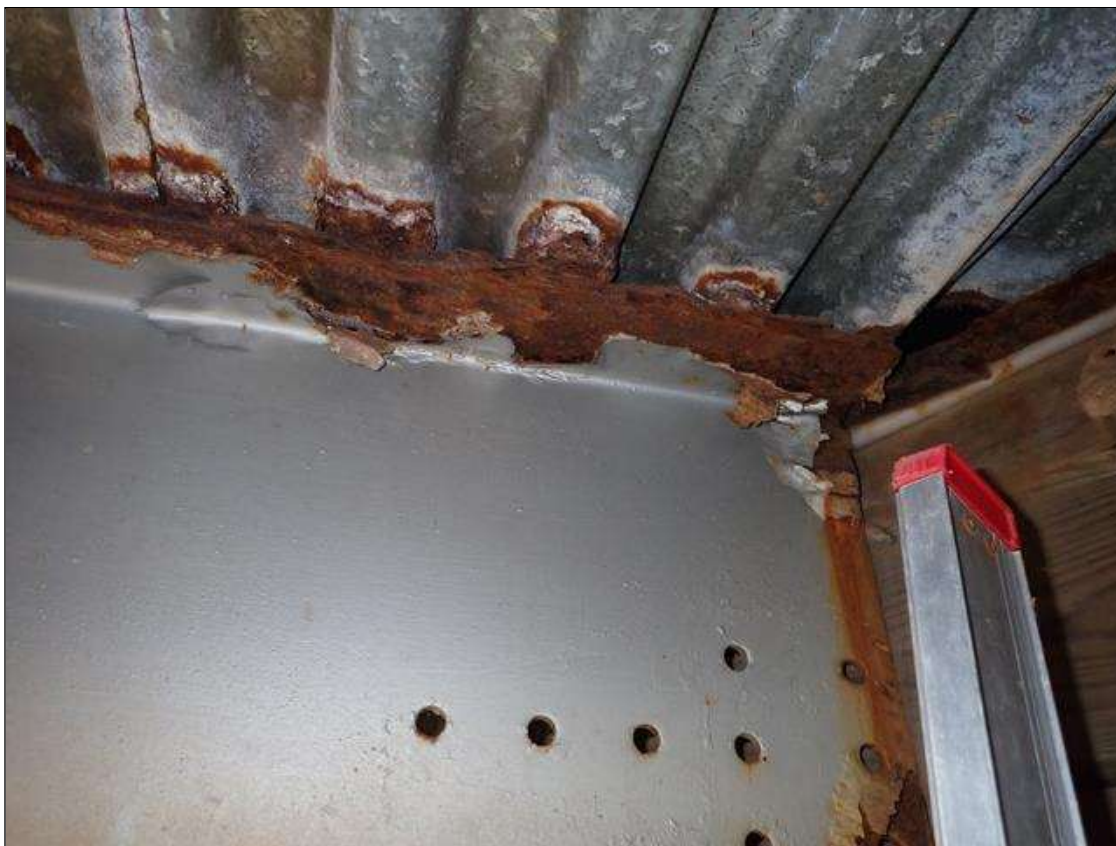
Span 1 Beam 2: 2' FLAKING RUST WITH PEELING PAINT TO TOP FLANGE EDGES AT END BENT 1 (ALL BEAMS AT BOTH END BENTS SIMILAR)

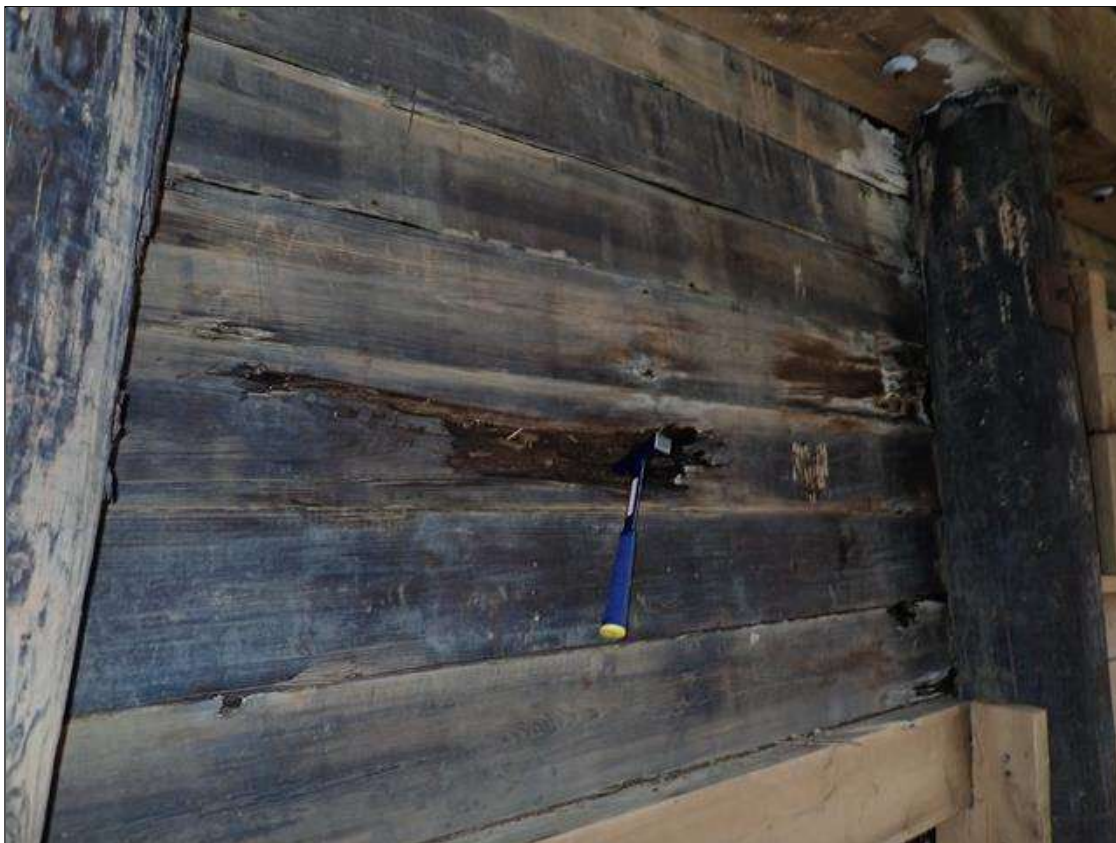
| 216 | Decay/Section Loss | 4' X 8" X 2" DEEP AREA OF DECAY BETWEEN PILES 3 AND 4 | 2 | 4 | Feet |

End Bent 1 Abutment/Backwall : 4' X 8" X 2" DEEP AREA OF DECAY BETWEEN PILES 3 AND 4

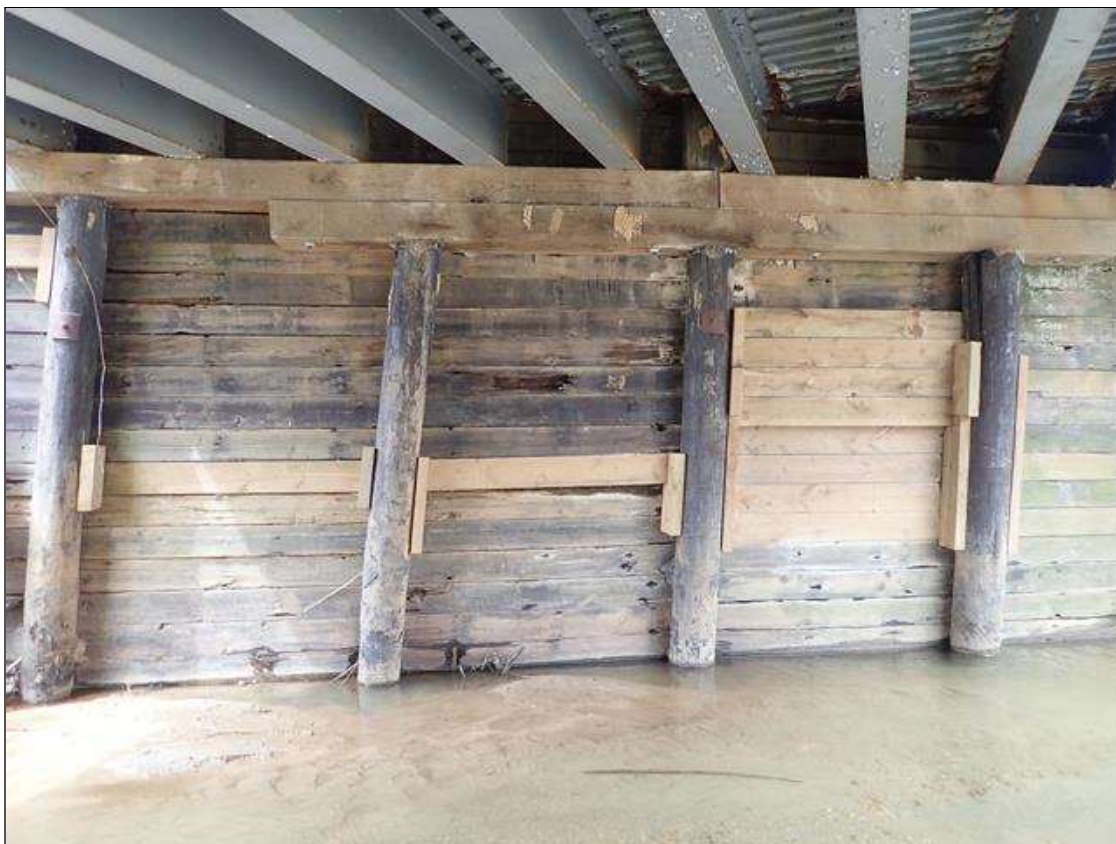
ALL PILES AT END BENT 1 LEANING UP TO 6" TO THE NORTH

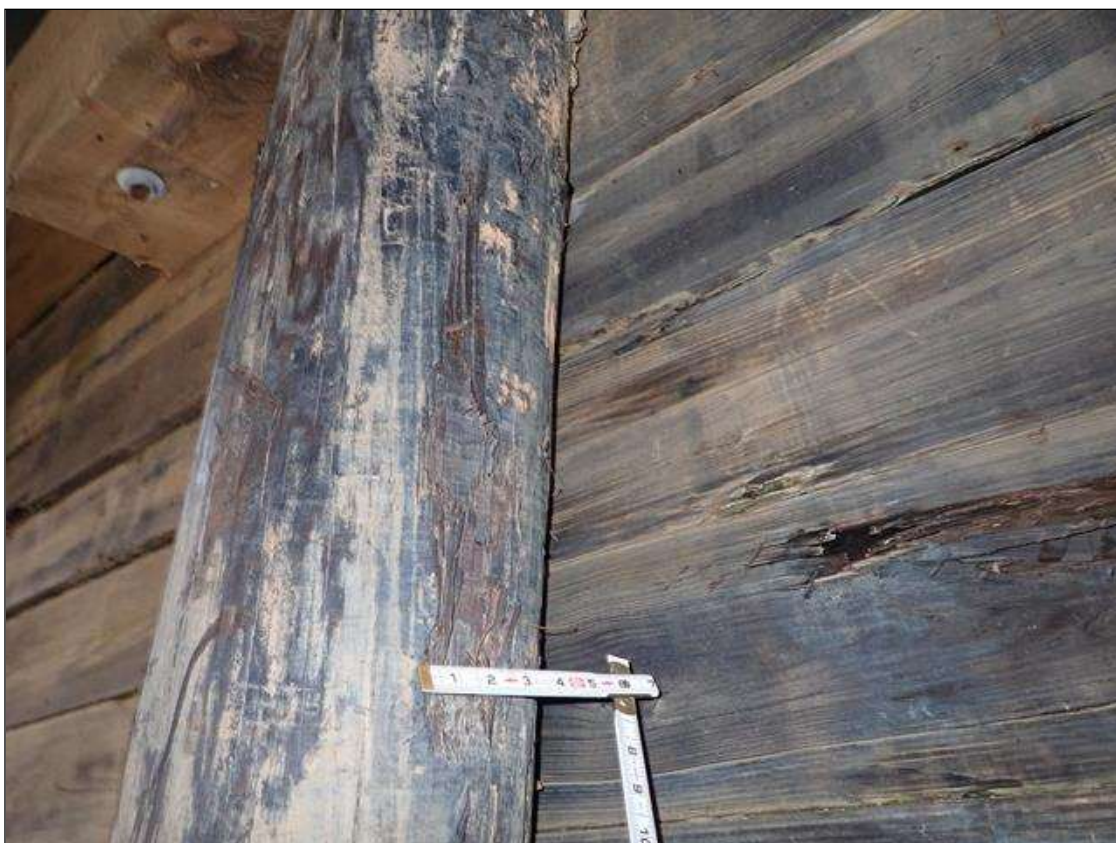
| Element Number | Defect Type | Defect Description | CS | CS Qty | Maint Qty | |
|---|---|---|---|---|---|---|
| 228 | Decay/Section Loss | 16" X 3" X 1/2" AREA OF DECAY TO NORTH FACE (AT PILE 2 IN PREVIOUS REPORT) | 2 | | | Each |

End Bent 1 Pile 4: 16" X 3" X 1/2" AREA OF DECAY TO NORTH FACE (AT PILE 2 IN PREVIOUS REPORT)

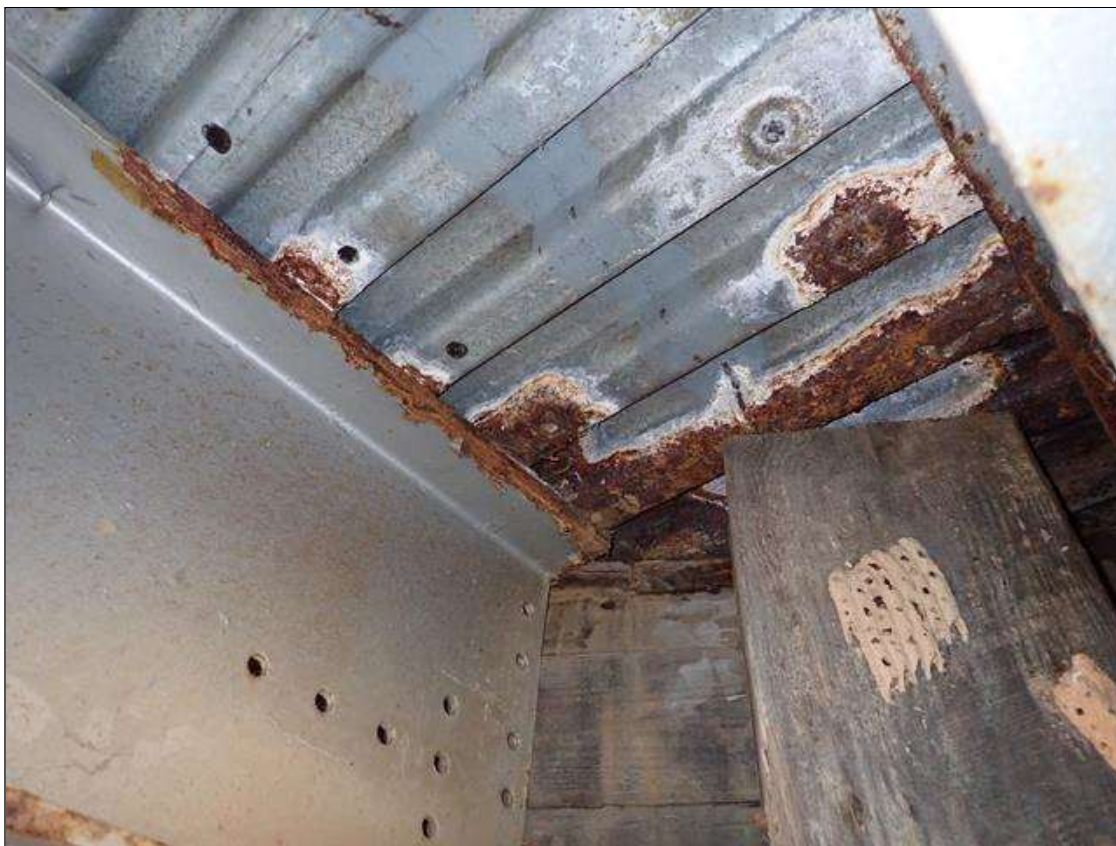
| Element Number | Defect Type | Defect Description | CS | CS Qty | Maint Qty | |
|---|---|---|---|---|---|---|
| 30 | Corrosion | SCATTERED AREAS OF SURFACE RUST | 3 | 60 | 60 | Square Feet |

Span 1 Deck: SCATTERED AREAS OF SURFACE RUST

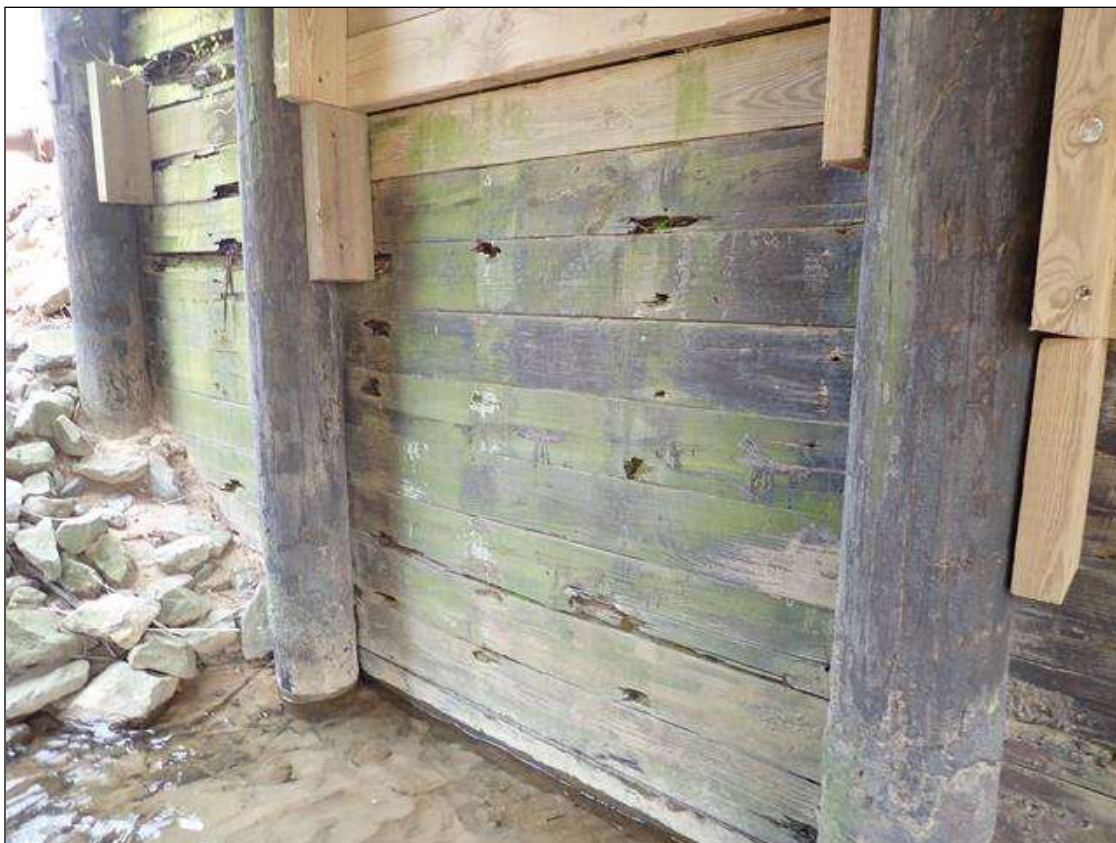
END BENT 2 BACKWALL: AREAS OF 4" DIAMETER X UP TO 2" DEEP DECAY THROUGHOUT
