NC DEPARTMENT OF TRANSPORTATION  
DIVISION OF HIGHWAYS  
STRUCTURE MANAGEMENT UNIT

## Structure Safety Report

### Routine Element Inspection - Contract

DIVISION: 11 COUNTY: WILKES STRUCTURE NUMBER: 960733 FREQUENCY: 24 MONTHS

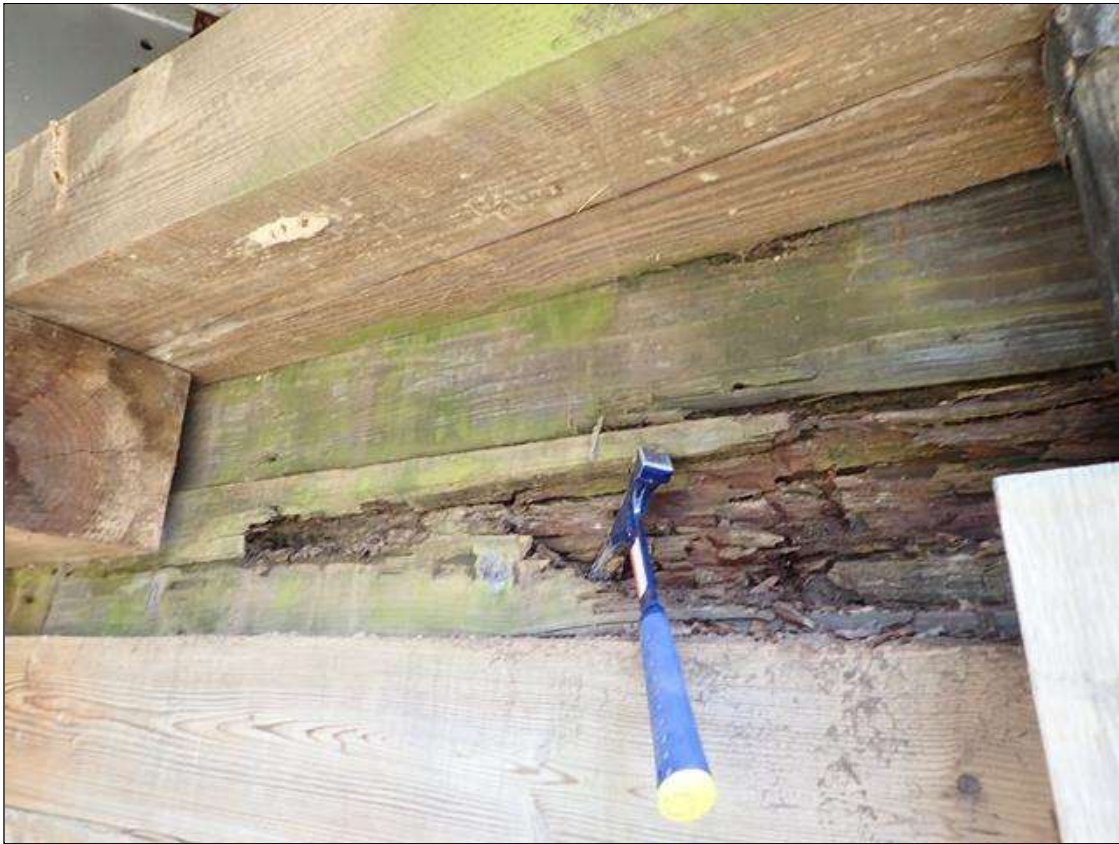
| Element Number | Defect Type | Defect Description | CS | CS Qty | Maint Qty |
|---|---|---|---|---|---|
| 216 | Decay/Section Loss | 3' X 1' X 2" AREA OF DECAY BETWEEN PILES 4 AND 5 | 3 | | 3 Feet |

End Bent 2 Abutment/Backwall : 3' X 1' X 2" AREA OF DECAY BETWEEN PILES 4 AND 5

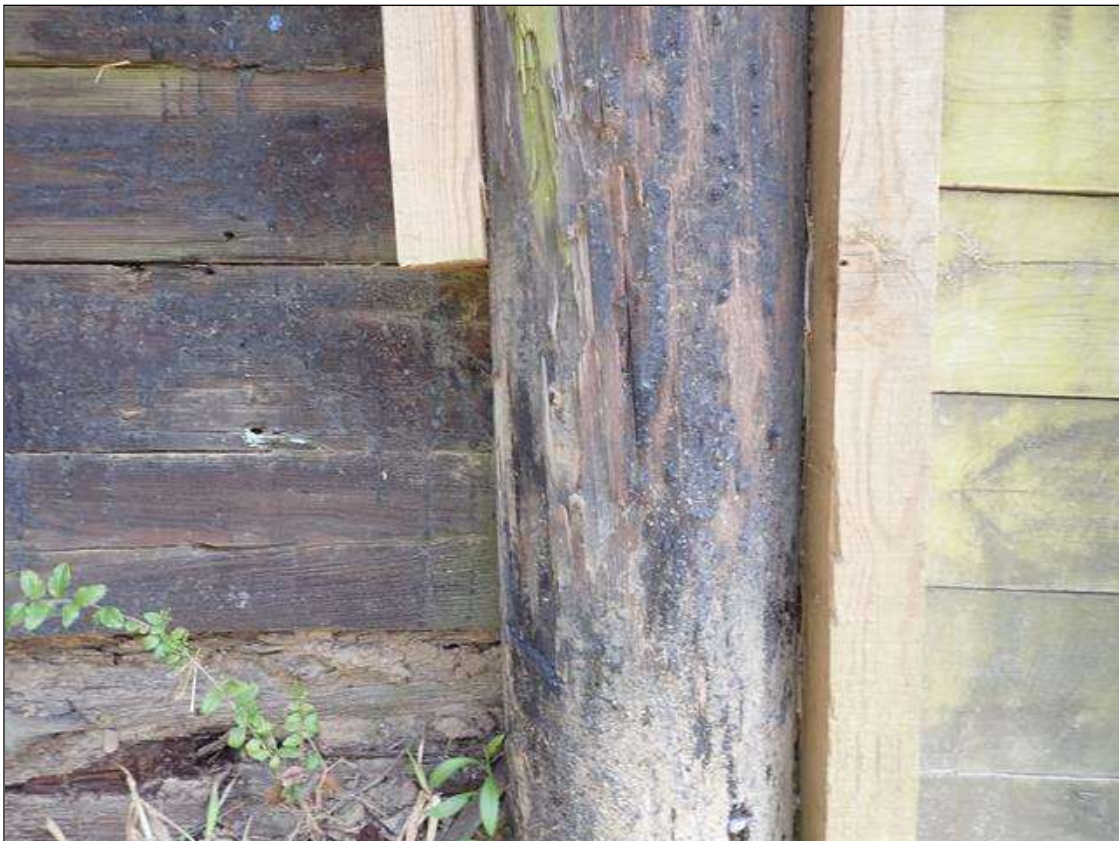
| Element Number | Defect Type | Defect Description | CS | CS Qty | Maint Qty |
|---|---|---|---|---|---|
| 228 | Decay/Section Loss | 23" X 6" X 1/2" DEEP AREA OF DECAY ON SPAN 1 FACE | 2 | 1 | Each |

End Bent 2 Pile 5: 23" X 6" X 1/2" DEEP AREA OF DECAY ON SPAN 1 FACE

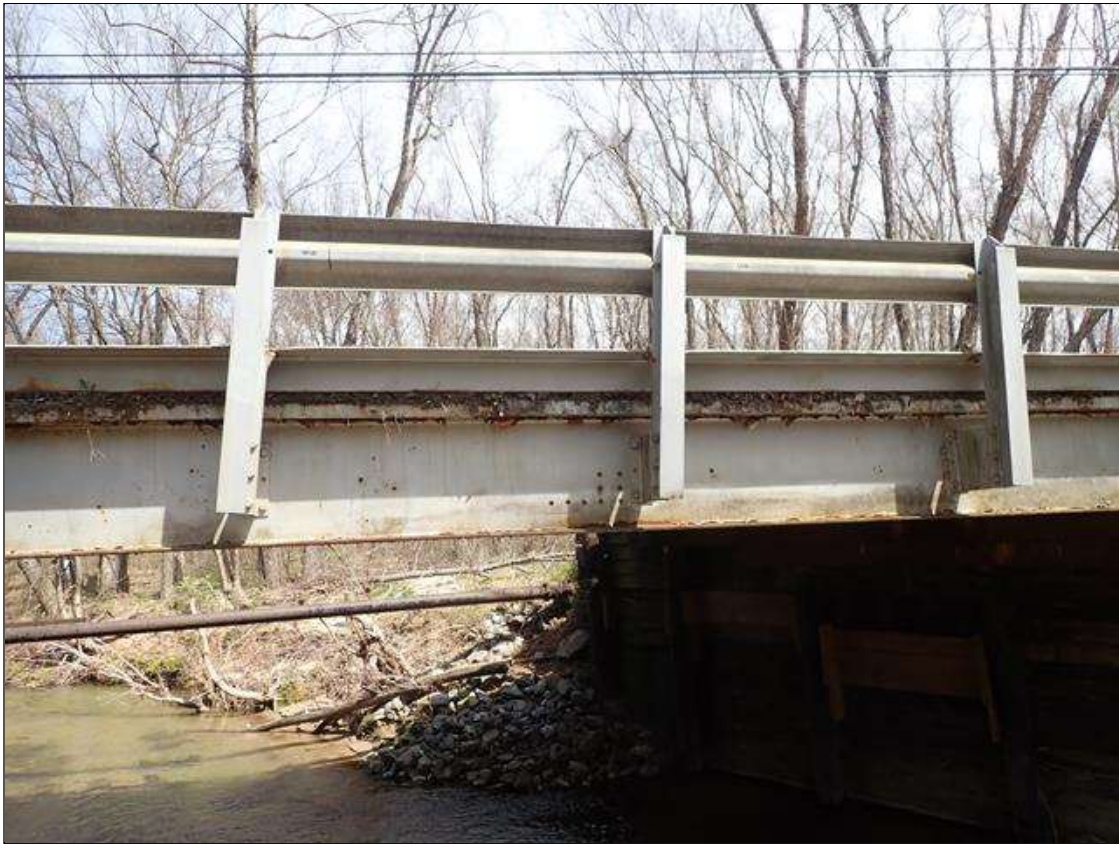
Span 1 Right Bridge Rail: POSTS THROUGHOUT STRUCTURE ARE TWISTED UP TO 3" TO THE EAST WITH DEFORMATIONS TO CURB AT CONNECTIONS

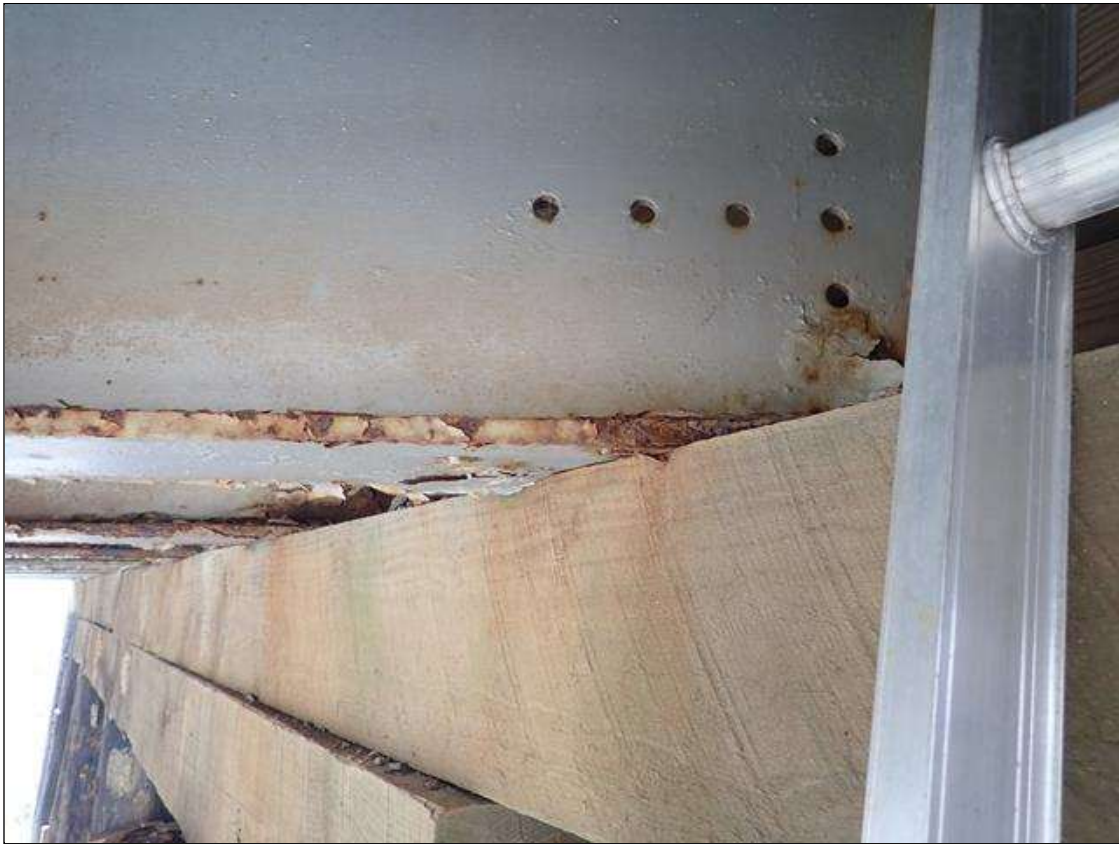
BEAMS BEARING DIRECTLY ON CAP

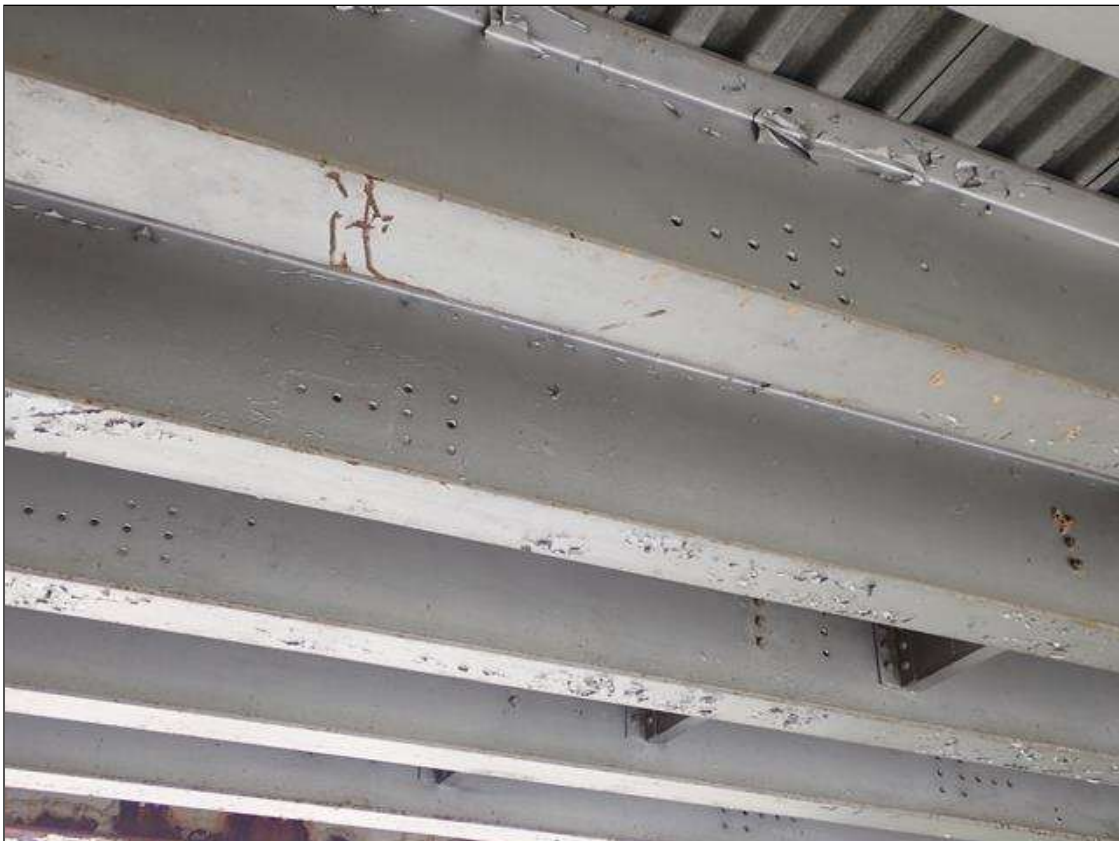
BEAMS THROUGHOUT STRUCTURE HAVE AREAS OF PEELING PAINT AND FRECKLED RUST
