NC DEPARTMENT OF TRANSPORTATION  
DIVISION OF HIGHWAYS  
BRIDGE MANAGEMENT UNIT

# BRIDGE INSPECTION REPORT

INSPECTION TYPE: Routine Inspection

COUNTY ALEXANDER BRIDGE NUMBER 010137 INSPECTION CYCLE 2 YRS  
ROUTE SR1608 ACROSS GLADE CREEK M.P. 0

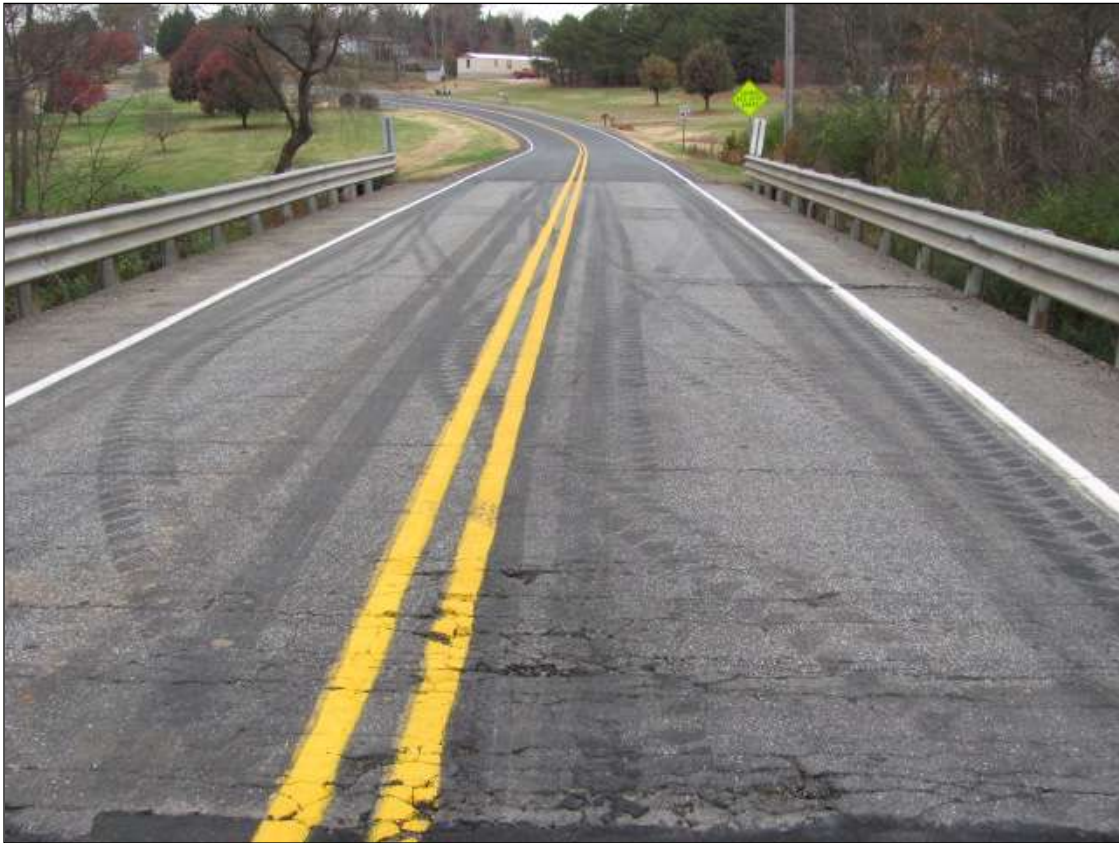
| 1 | 4 | A.W.S.. PAVEMENT IS BROKEN ALONG SOUTH APPROACH, AND OVER PIER 1. TRANSVERSE CRACKS THROUGHOUT. PAVEMENT IS UNEVEN. | |

A.W.S.. PAVEMENT IS BROKEN ALONG SOUTH APPROACH, AND OVER PIER 1. TRANSVERSE CRACKS THROUGHOUT. PAVEMENT IS UNEVEN.

| MMS Code | Description of Function | Unit | Quantity | Remarks | Est. Cost |
|---|---|---|---|---|---|
| 2816 | Asphalt Surface Repair or Replacement | SY | 320 | A.W.S.. PAVEMENT IS BROKEN ALONG SOUTH APPROACH, AND OVER PIER 1. TRANSVERSE CRACKS THROUGHOUT. PAVEMENT IS UNEVEN. | |

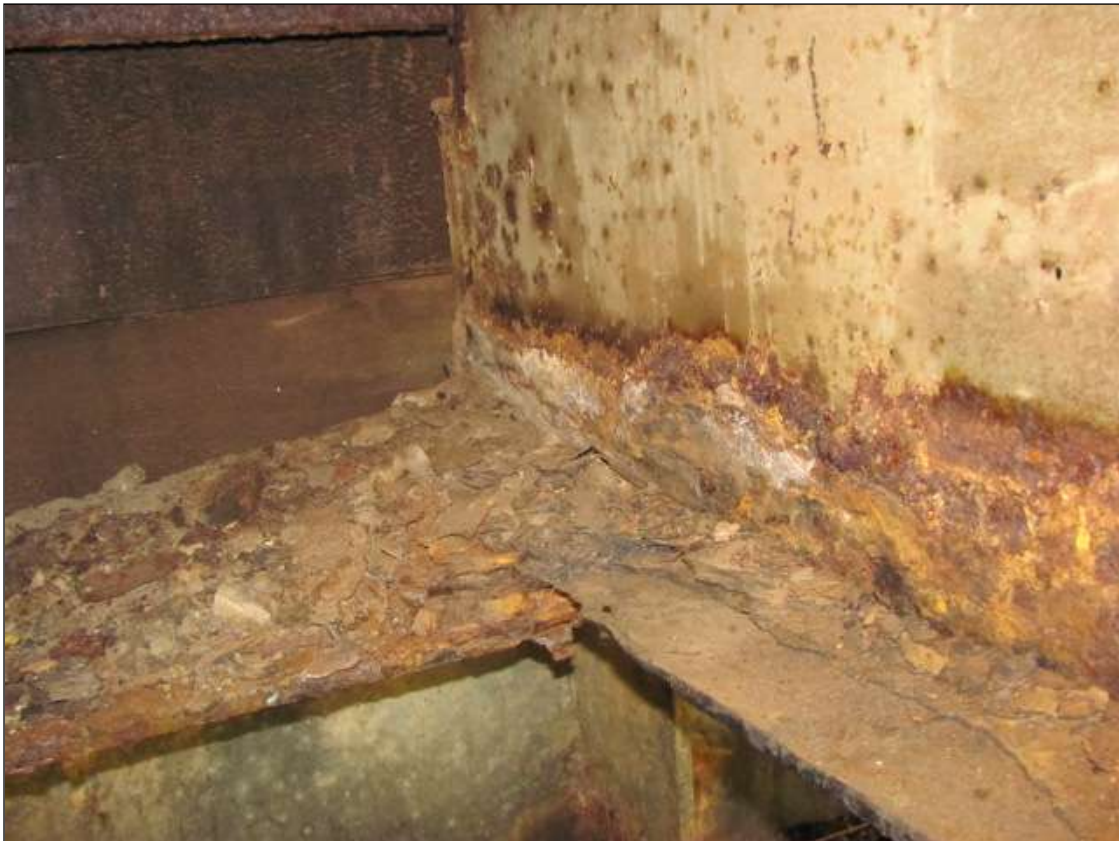
SECTION LOSS; END OF BEAM 2 AT ABUT. A

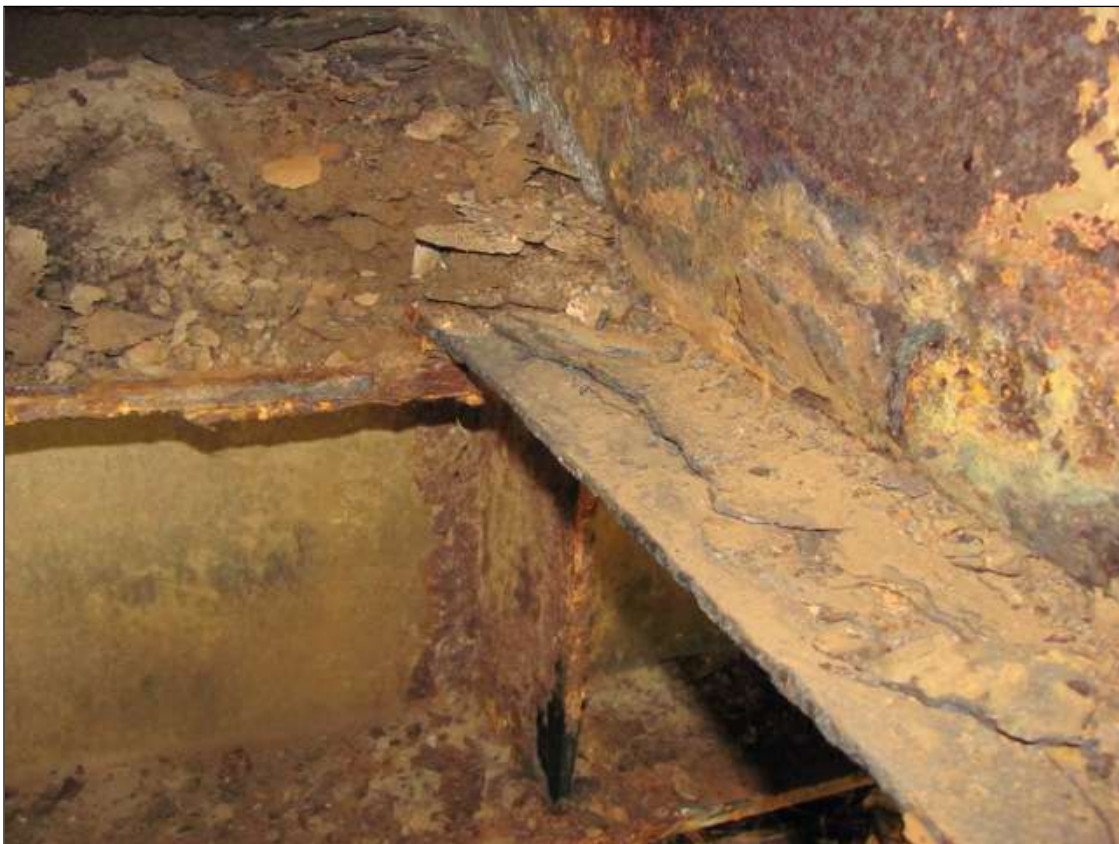
SECTION LOSS; END OF BEAM 3 AT ABUT. A

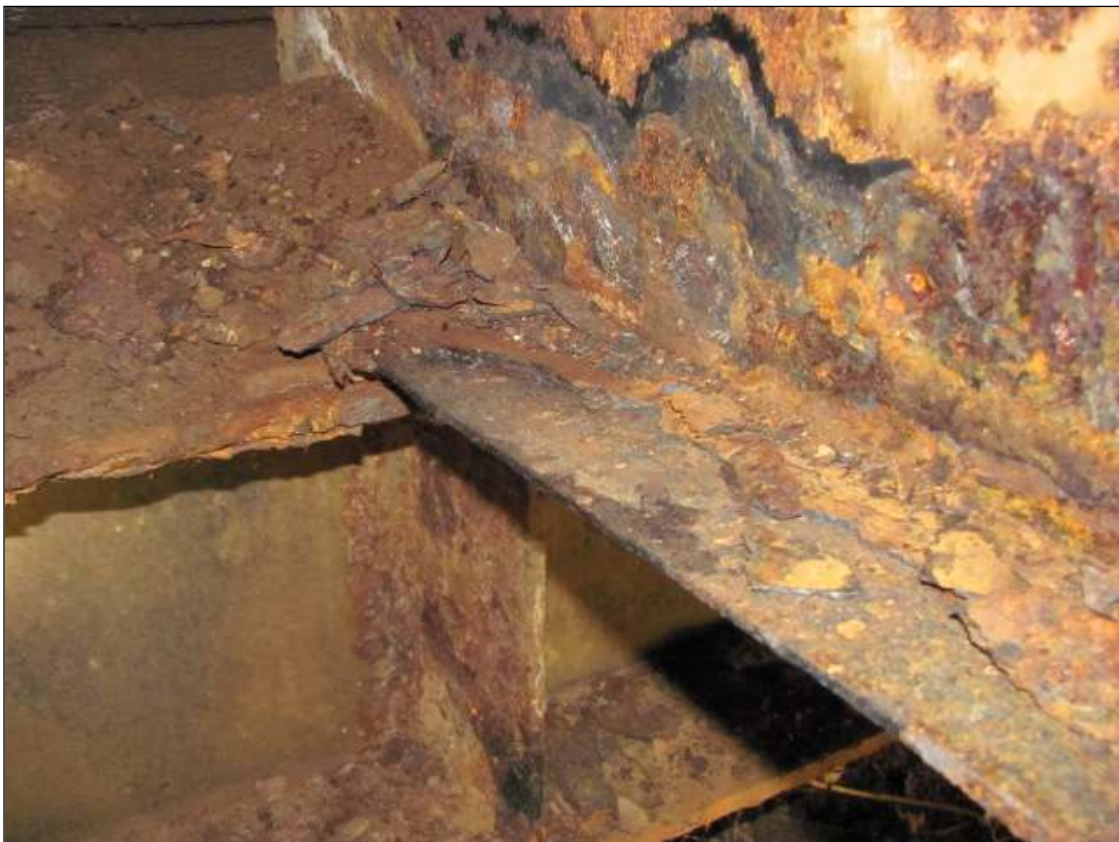
SECTION LOSS; END OF BEAM 4 AT ABUT. A

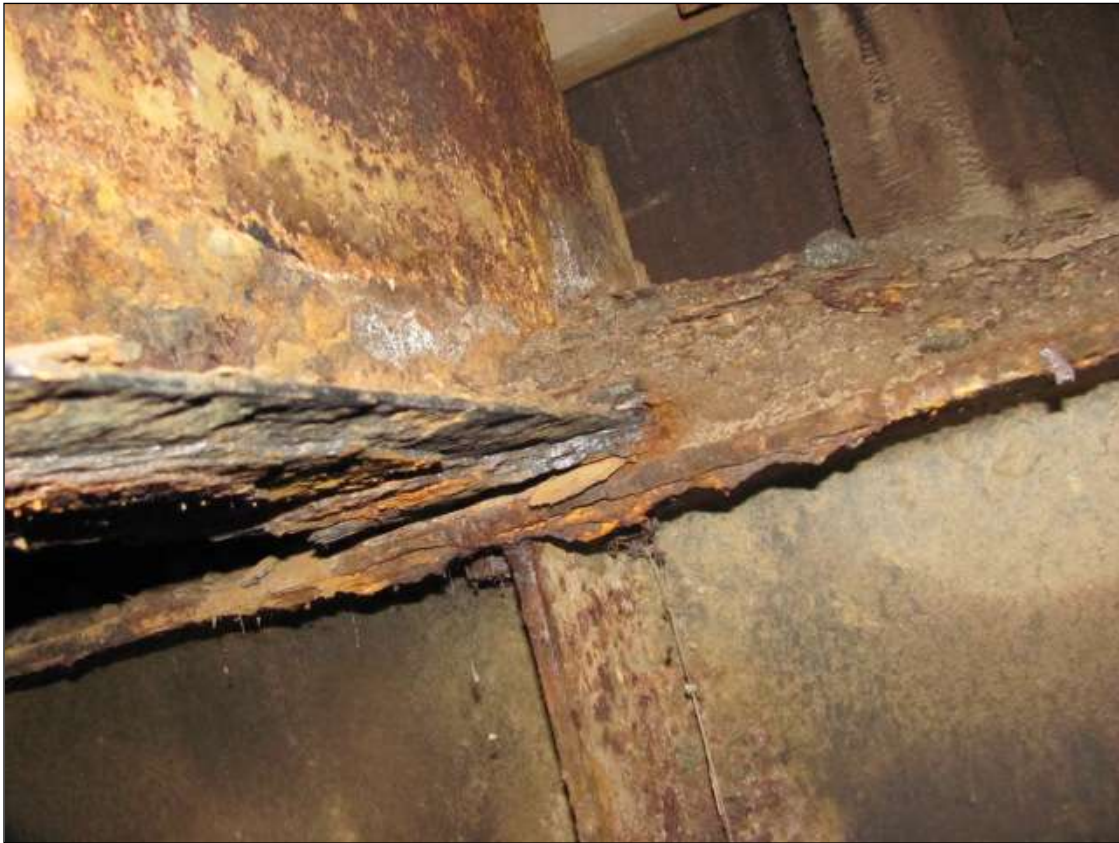
SECTION LOSS; END OF BEAM 5 AT ABUT. A

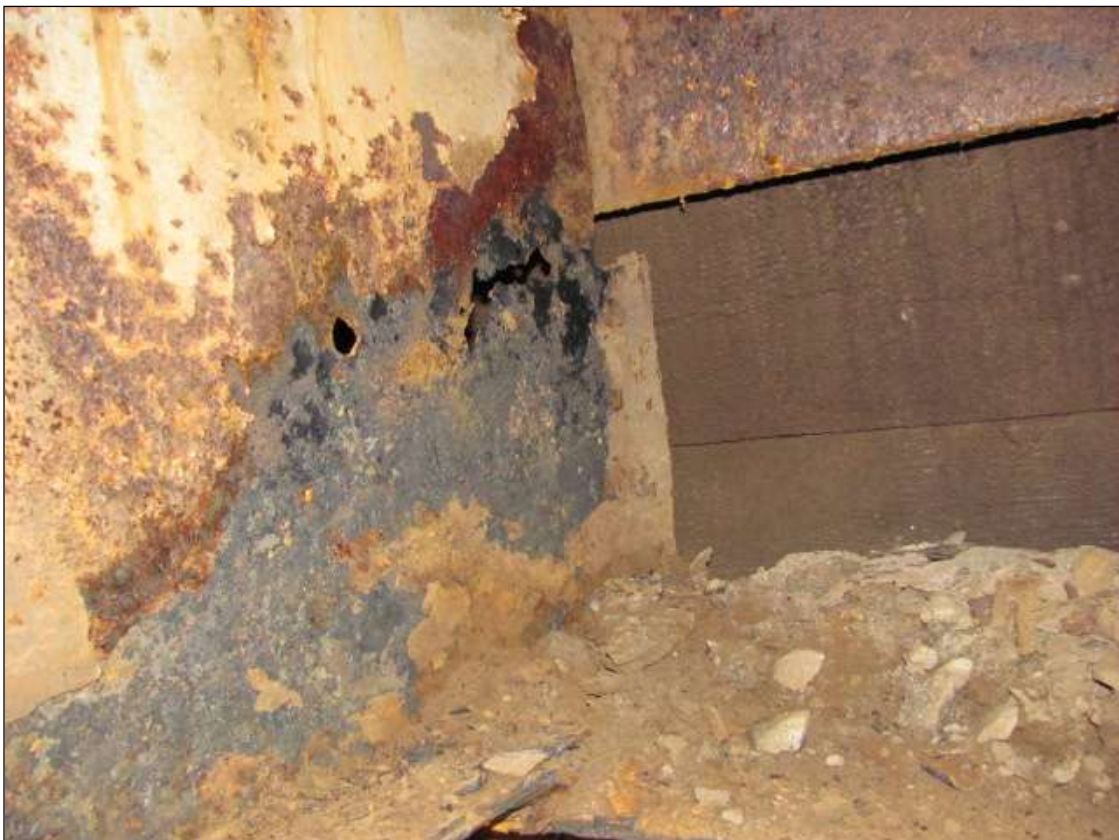
SECTION LOSS; END OF BEAM 6 AT ABUT. A (AREA OF COMPLETE LOSS IN WEB)

| MMS Code | Description of Function | Unit | Quantity | Remarks | Est. Cost |
|---|---|---|---|---|---|
| 3314 | Maintain Steel Superstructure Components | LF | 3 | SECTION LOSS; END OF BEAM 6 AT ABUT. A (AREA OF COMPLETE LOSS IN WEB)<br><br>SEE ATTACHED SKETCH FOR DETAILS... | |

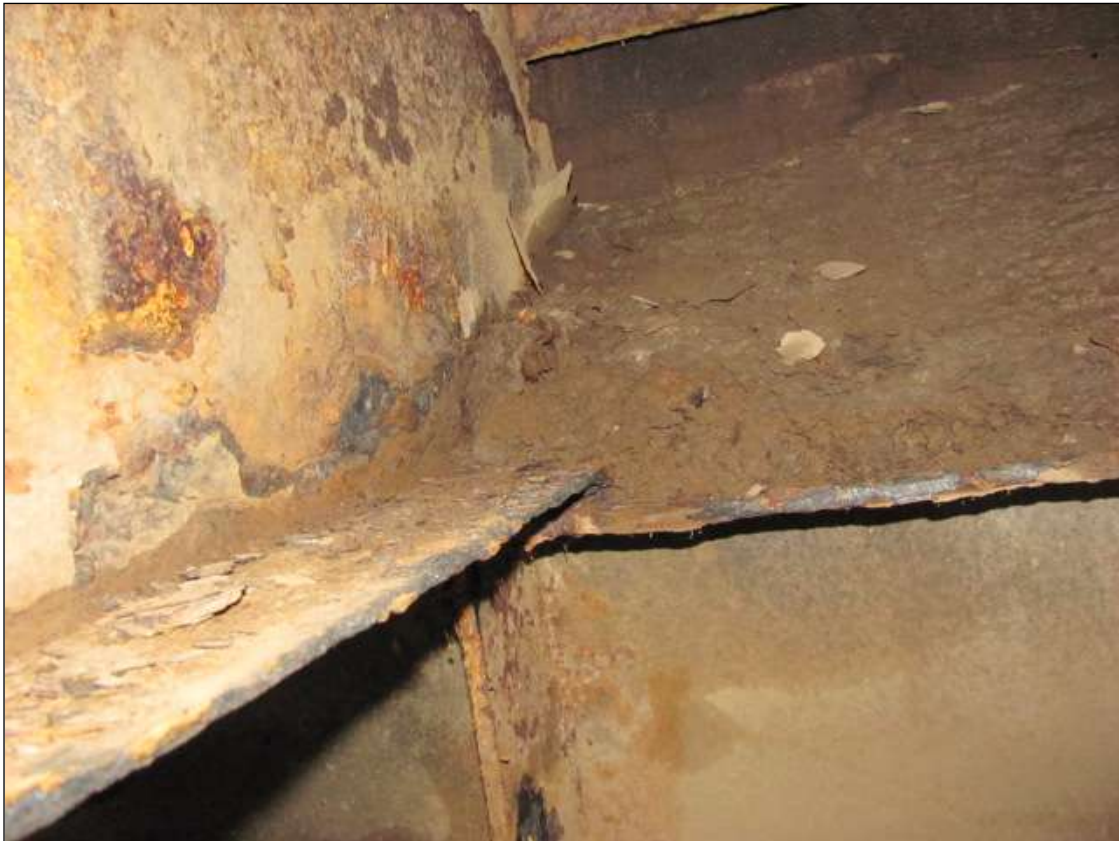
SECTION LOSS; END OF BEAM 8 AT ABUT. A

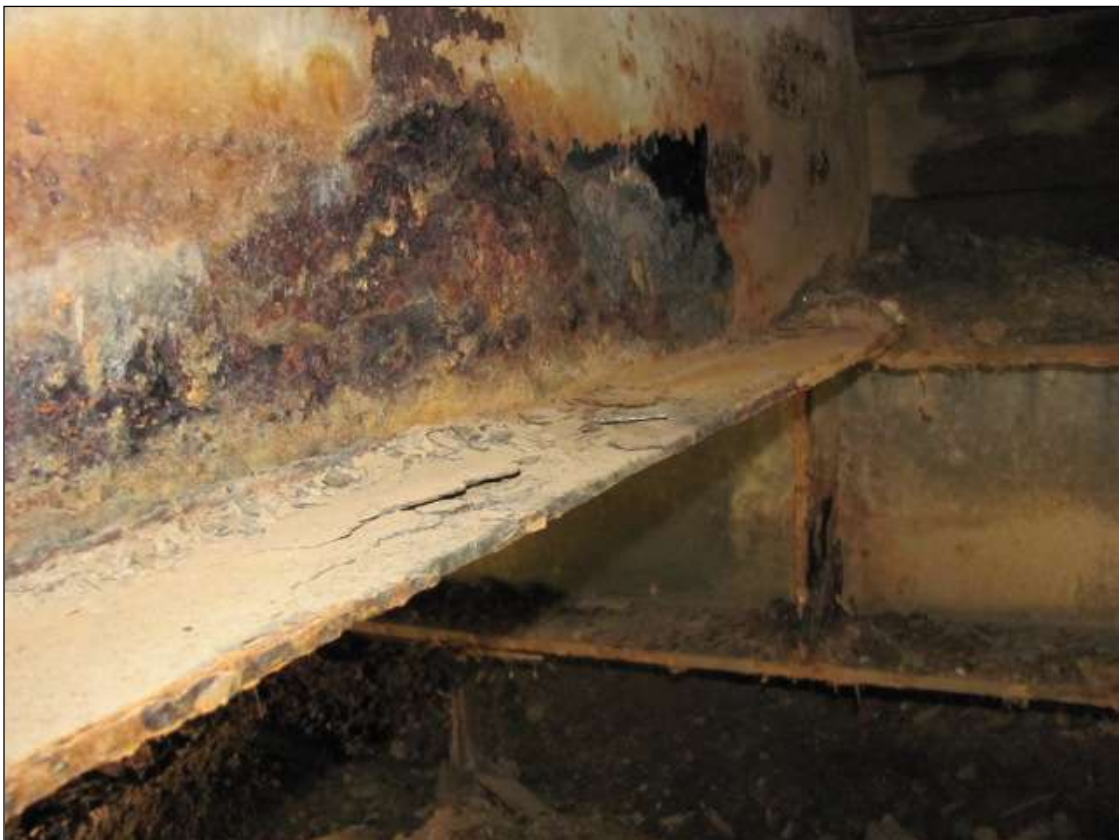
SECTION LOSS; END OF BEAM 9 AT ABUT. A

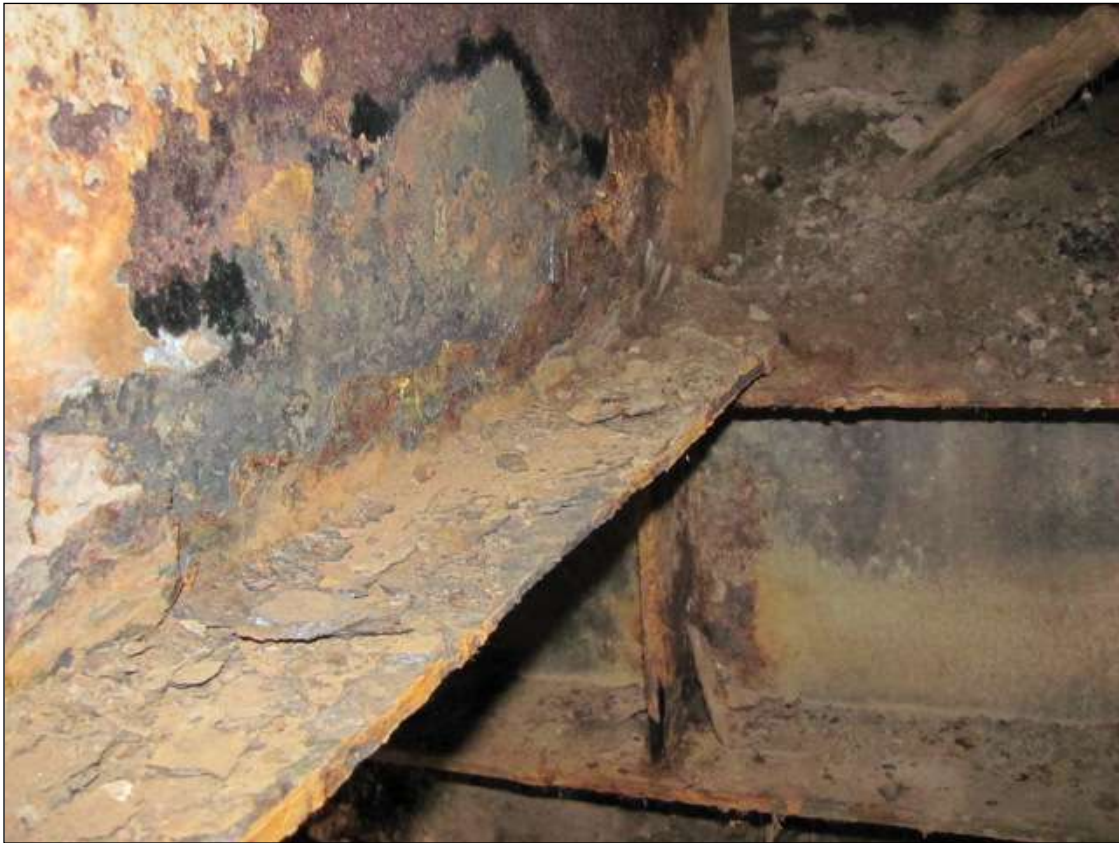
SECTION LOSS; END OF BEAM 10 AT ABUT. A

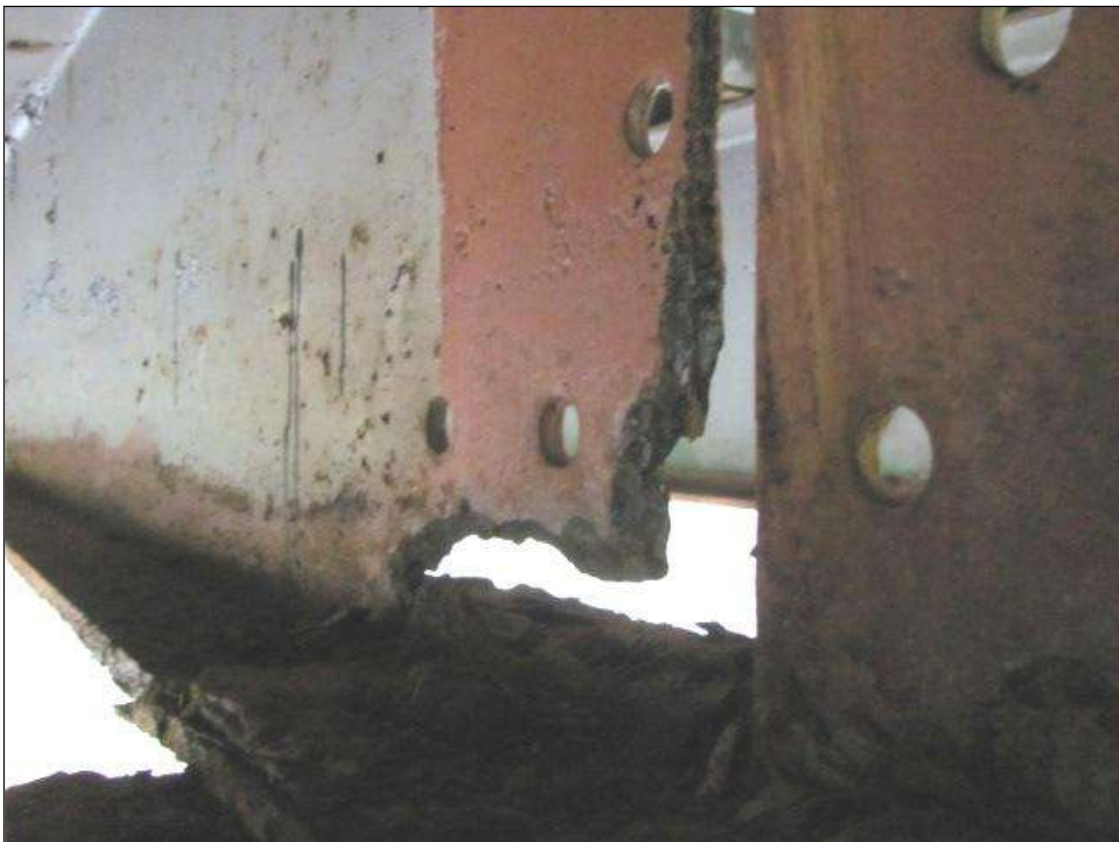
COMPLETE LOSS OF SECTION, WEB; END OF BEAM 2, SPAN B AT PIER 2

| MMS Code | Description of Function | Unit | Quantity | Remarks | Est. Cost |
|---|---|---|---|---|---|
| 3314 | Maintain Steel Superstructure Components | LF | 2 | COMPLETE LOSS OF SECTION, WEB; END OF BEAM 2, SPAN B AT PIER 2<br><br>SEE ATTACHED SKETCH FOR DETAILS... | |

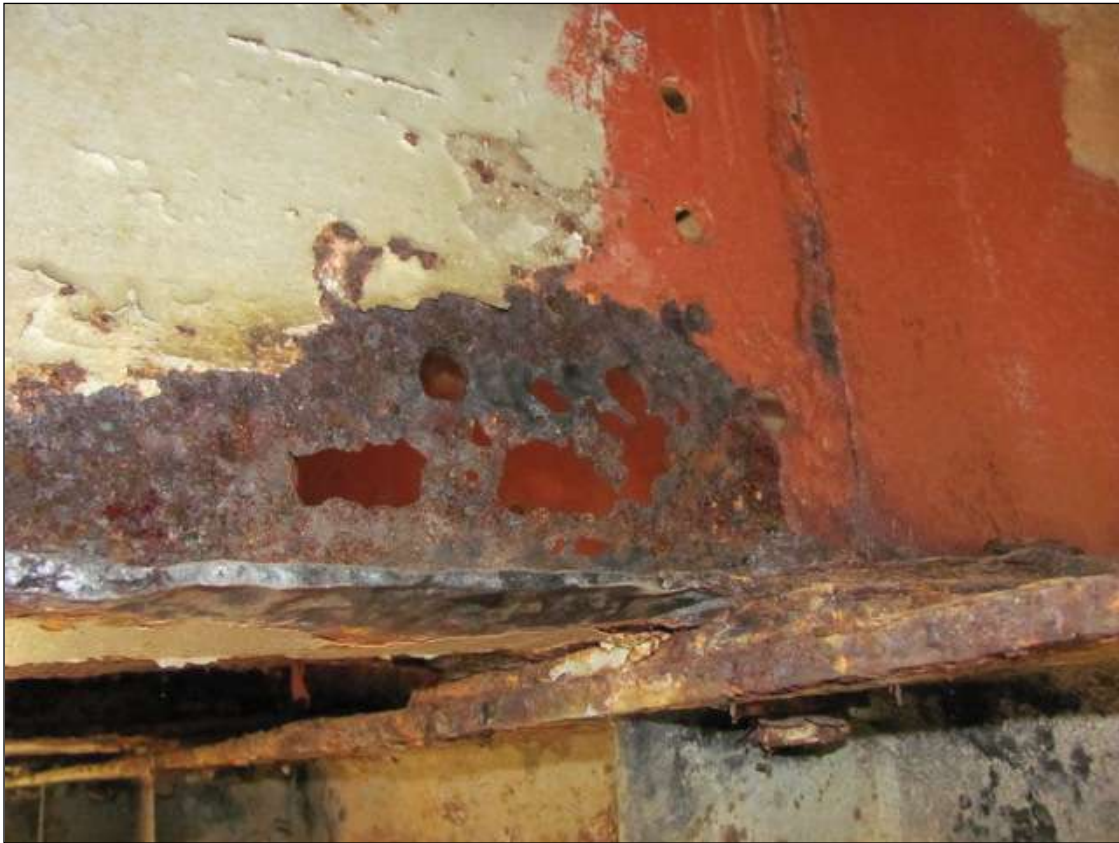
COMPLETE LOSS OF SECTION, WEB; END OF BEAM 9, SPAN C AT PIER 2

| MMS Code | Description of Function | Unit | Quantity | Remarks | Est. Cost |
|---|---|---|---|---|---|
| 3314 | Maintain Steel Superstructure Components | LF | 2 | COMPLETE LOSS OF SECTION, WEB; END OF BEAM 9, SPAN C AT PIER 2<br><br>SEE ATTACHED SKETCH FOR DETAILS... | |

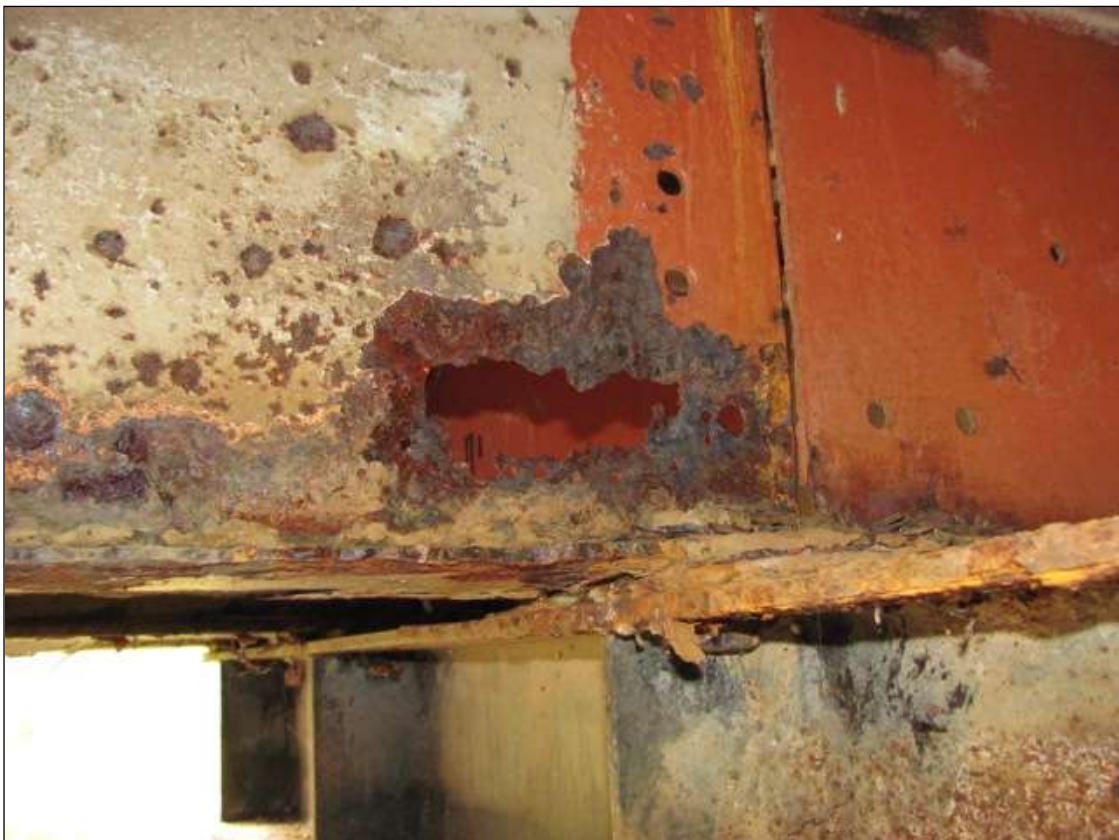
COMPLETE LOSS OF SECTION, WEB; END OF BEAM 10, SPAN C AT PIER 2

| MMS Code | Description of Function | Unit | Quantity | Remarks | Est. Cost |
|---|---|---|---|---|---|
| 3314 | Maintain Steel Superstructure Components | LF | 3 | COMPLETE LOSS OF SECTION, WEB; END OF BEAM 10, SPAN C AT PIER 2<br><br>SEE ATTACHED SKETCH FOR DETAILS... | |

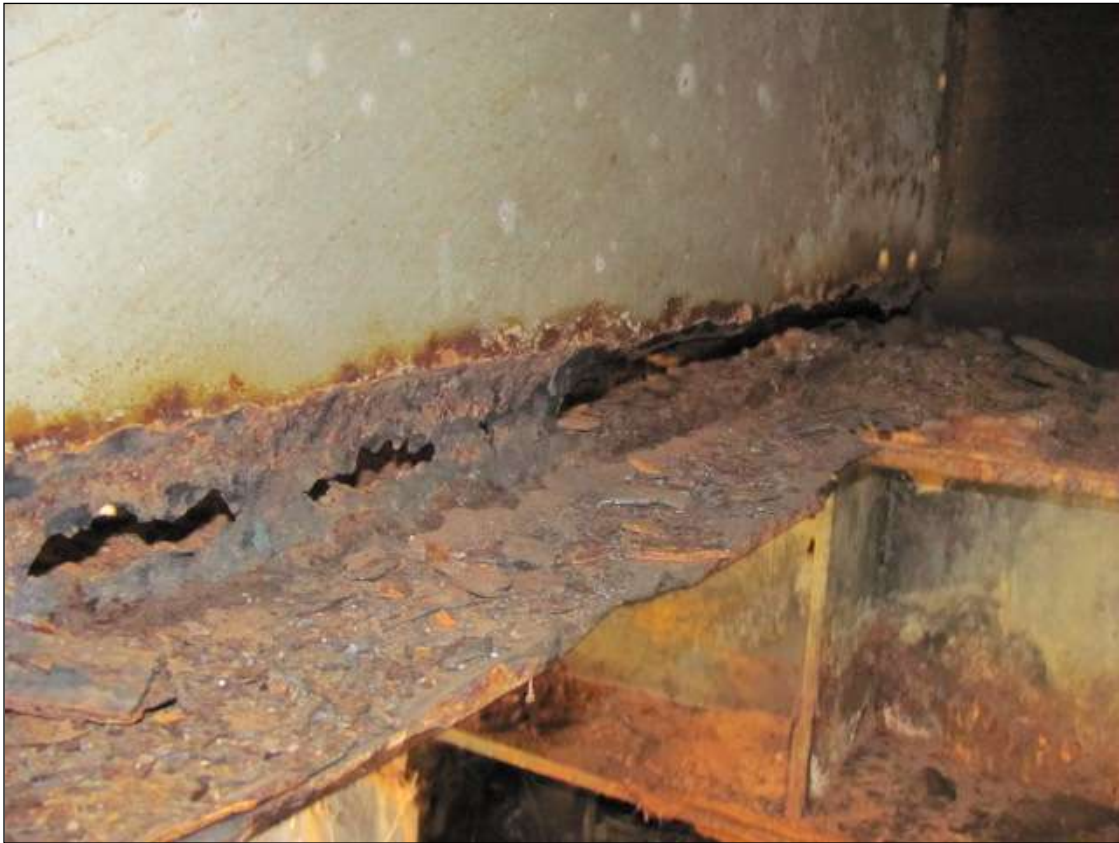
COMPLETE LOSS OF SECTION TO WEB AND BOTTM FLANGE; BEAM 2, SPAN C AT ABUT. B

| MMS Code | Description of Function | Unit | Quantity | Remarks | Est. Cost |
|---|---|---|---|---|---|
| 3314 | Maintain Steel Superstructure Components | LF | 4 | COMPLETE LOSS OF SECTION TO WEB AND BOTTOM FLANGE; BEAM 2, SPAN C AT ABUT. B<br><br>SEE ATTACHED SKETCH FOR DETAILS... | |

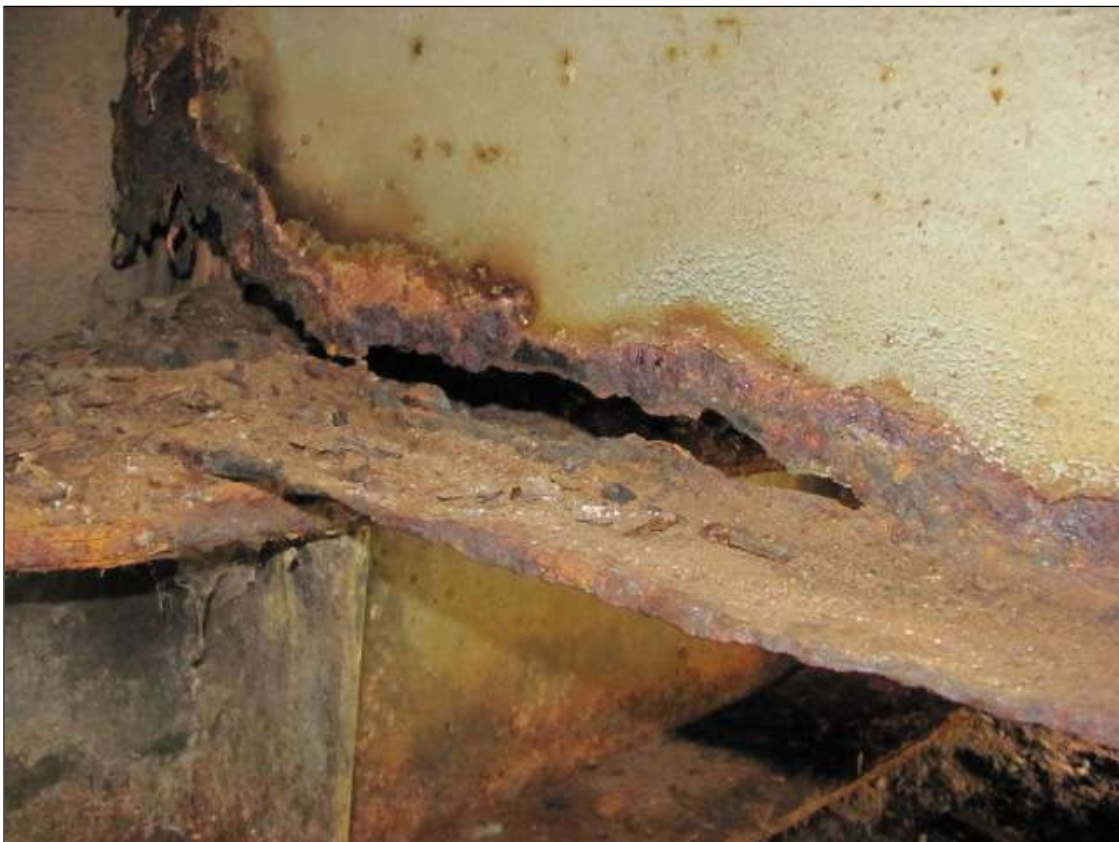
COMPLETE LOSS OF SECTION TO WEB AND BOTTOM FLANGE; BEAM 8, SPAN C AT ABUT. B

| MMS Code | Description of Function | Unit | Quantity | Remarks | Est. Cost |
|---|---|---|---|---|---|
| 3314 | Maintain Steel Superstructure Components | LF | 2 | COMPLETE LOSS OF SECTION TO WEB AND BOTTOM FLANGE; BEAM 8, SPAN C AT ABUT. B<br><br>SEE ATTACHED SKETCH FOR DETAILS... | |

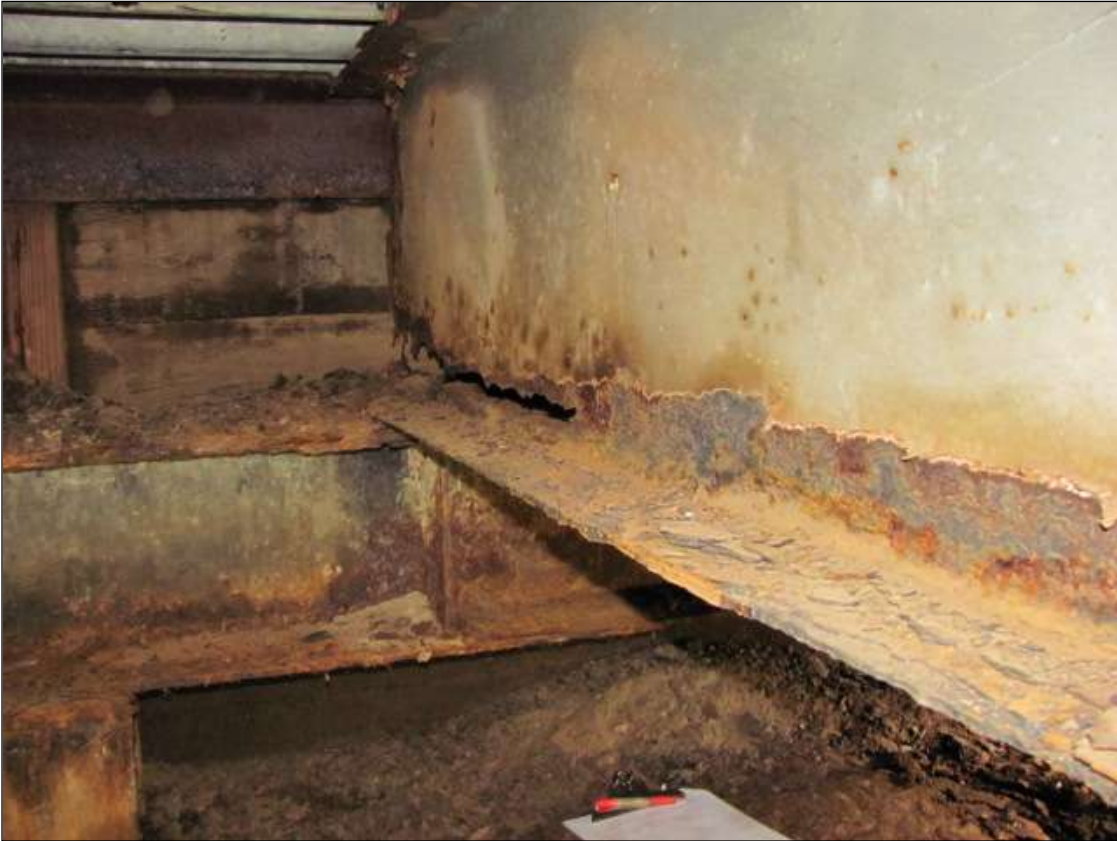
COMPLETE LOSS OF SECTION TO WEB AND BOTTOM FLANGR; BEAM 9, SPAN C AT ABUT. B

| MMS Code | Description of Function | Unit | Quantity | Remarks | Est. Cost |
|---|---|---|---|---|---|
| 3314 | Maintain Steel Superstructure Components | LF | 5 | COMPLETE LOSS OF SECTION TO WEB AND BOTTOM FLANGR; BEAM 9, SPAN C AT ABUT. B | |

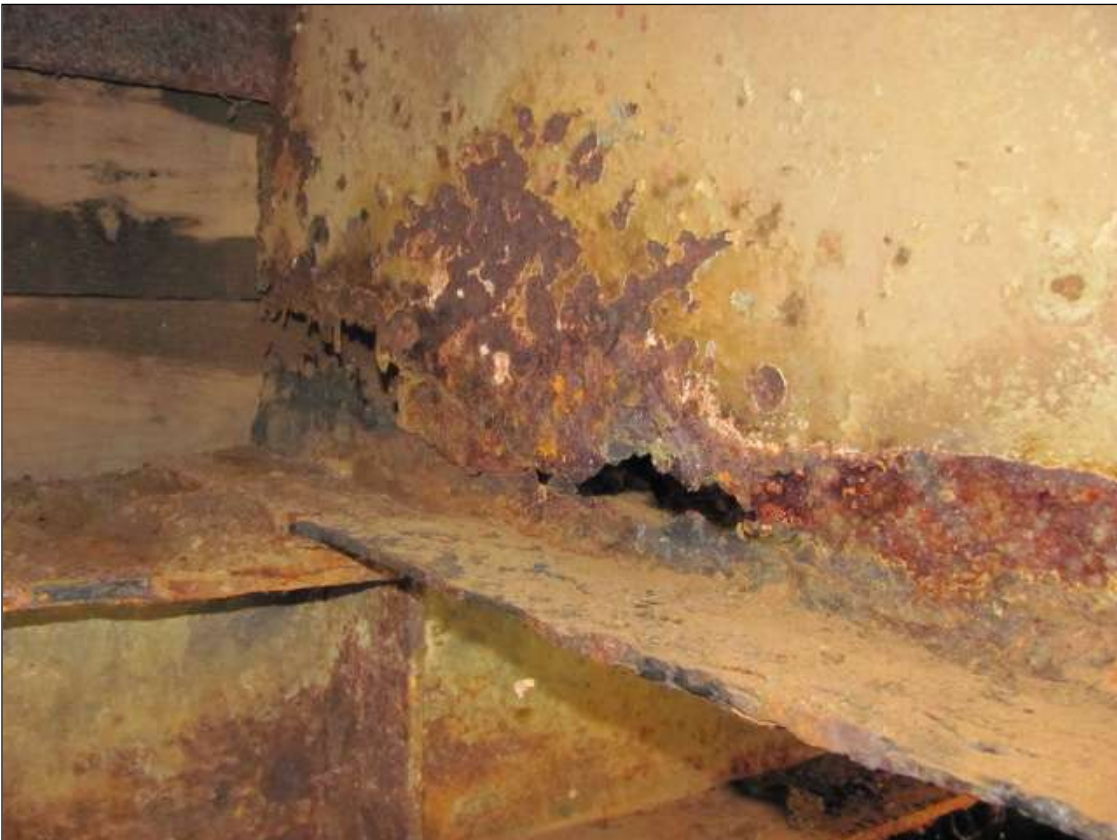
COMPLETE LOSS OF SECTION TO WEB AND BOTTOM FLANGE; BEAM 10, SPAN C AT ABUT. B

| MMS Code | Description of Function | Unit | Quantity | Remarks | Est. Cost |
|---|---|---|---|---|---|
| 3314 | Maintain Steel Superstructure Components | LF | 3 | COMPLETE LOSS OF SECTION TO WEB AND BOTTOM FLANGE; BEAM 10, SPAN C AT ABUT. B<br><br>SEE ATTACHED SKETCH FOR DETAILS... | |

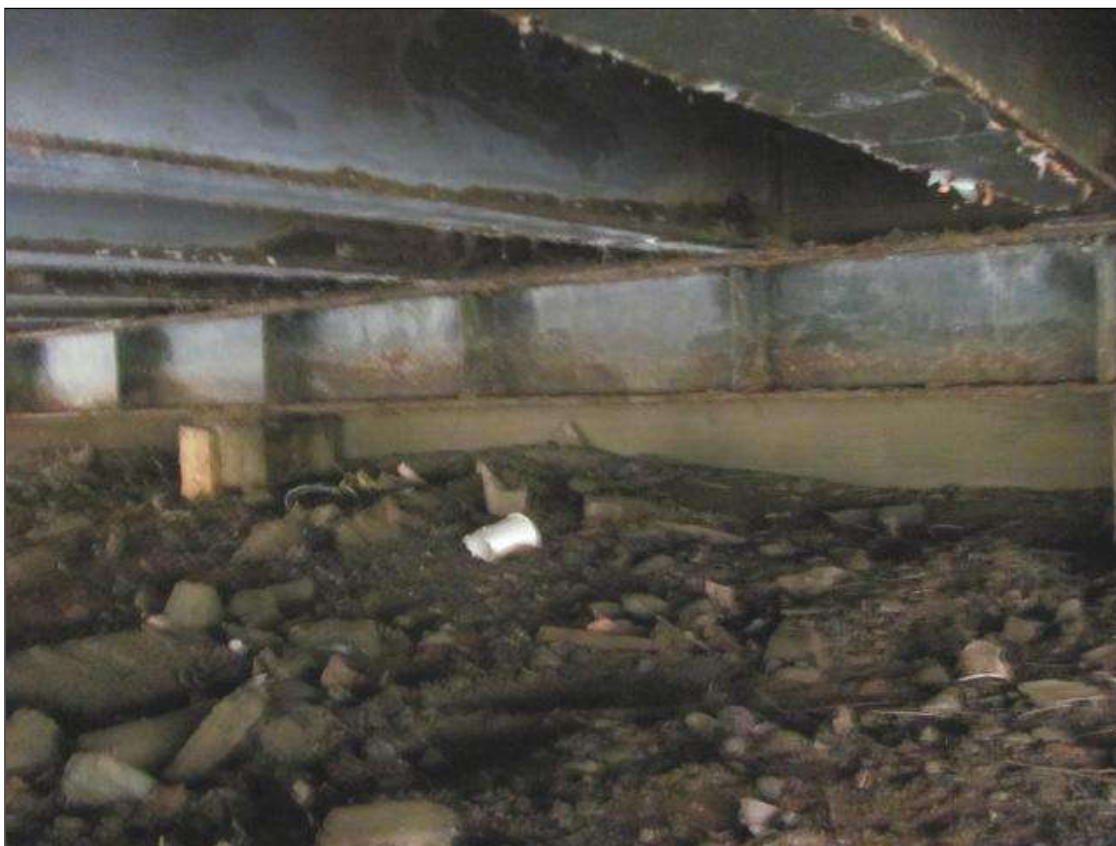
| 37a | 5 | RUST, SCALE, AND AREAS OF 1/16 TO 1/8 INCH LOSS FROM THE LEADING EDGE, BACK APPROX. 1 INCH. STIFFENERS ARE DETERIORATED WITH AREAS OF 25 TO 70 PERCENT LOSS OF SECTION. SEE SKETCH | |

RUST, SCALE, AND AREAS OF 1/16 TO 1/8 INCH LOSS FROM THE LEADING EDGE, BACK APPROX. 1 INCH.  
STIFFENERS ARE DETERIORATED WITH AREAS OF 25 TO 70 PERCENT

| MMS Code | Description of Function | Unit | Quantity | Remarks | Est. Cost |
|---|---|---|---|---|---|
| 3354 | Maintain Steel Substructure Components | LF | 56 | LOSS OF SECTION ALONG LEADING EDGE OF BOTH FLANGES OF BOTH ABUTMENT CAPS. STIFFENERS ARE DETERIORATED. SEE SKETCH. | |

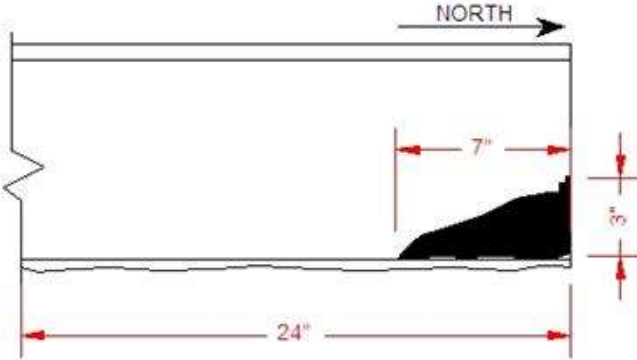
| Bridge Inspection Field Sketch | | | |
|---|---|---|---|
| Title<br>SECT. LOSS 3 | | Description<br>BM. # 2, SPAN # 2 @ PIER # 2 | |

| Bridge Inspection Field Sketch | | | |
|---|---|---|---|
| WEB HOLE IN BM. # 2, SPAN # 2 @ PIER # 2<br>BOTH BOTT. FLANGES 5/16" FROM END OF BM. BACK APPROX. 2' | | | |

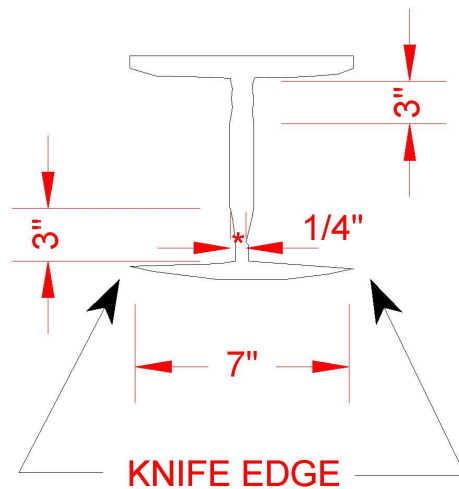
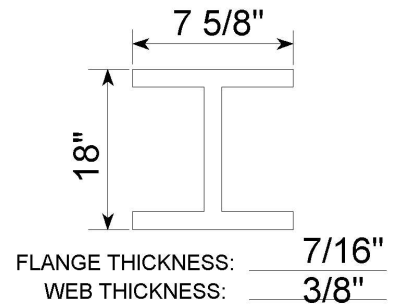
TOP FL. LOSS EXTENDS FROM END OF BM. BACK APPROX. 5'

BOTT. FL. LOSS EXTENDS FROM END OF BM. BACK APPROX. 2'

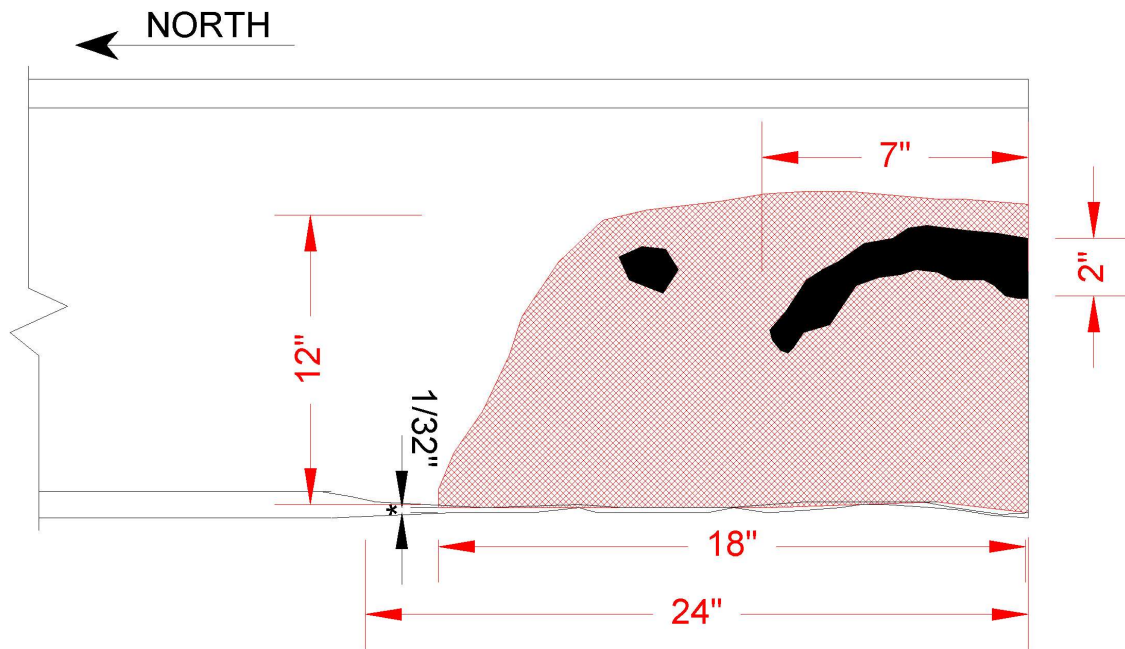
WEB HOLE IN BM. # 6 @ ABUT. # 1

BOTH BOTT. FLANGES KNIFE EDGE FROM END OF BM. BACK APPROX. 2'  
WEB THICKNESS APPROX. 1/32" IN SHADED AREA

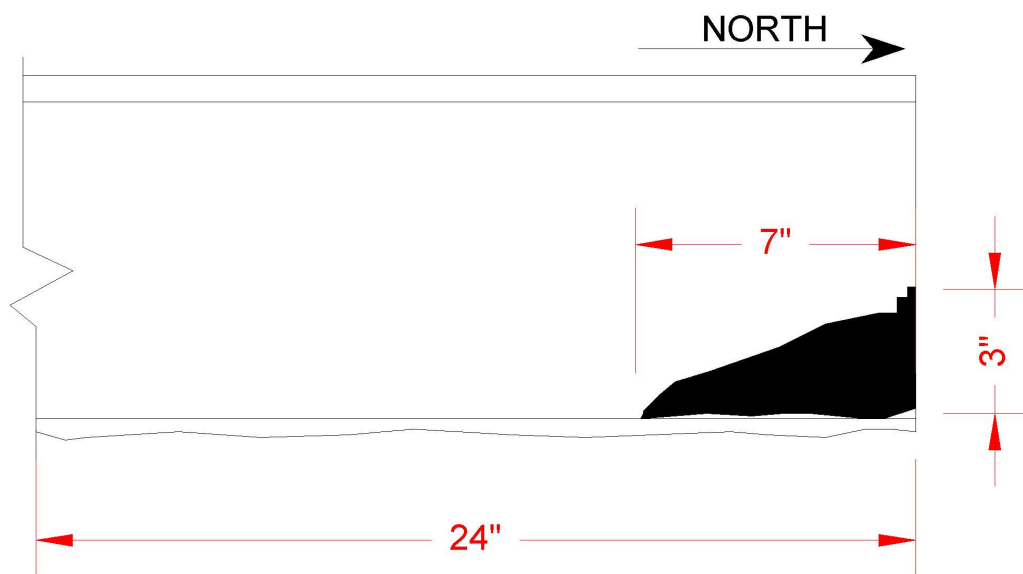
| <b>Title</b><br>SECT. LOSS 3 | | <b>Description</b><br>BM. # 2, SPAN # 2 @ PIER # 2 | |

WEB HOLE IN BM. # 2, SPAN # 2 @ PIER # 2  
BOTH BOTT. FLANGES 5/16" FROM END OF BM. BACK APPROX. 2'

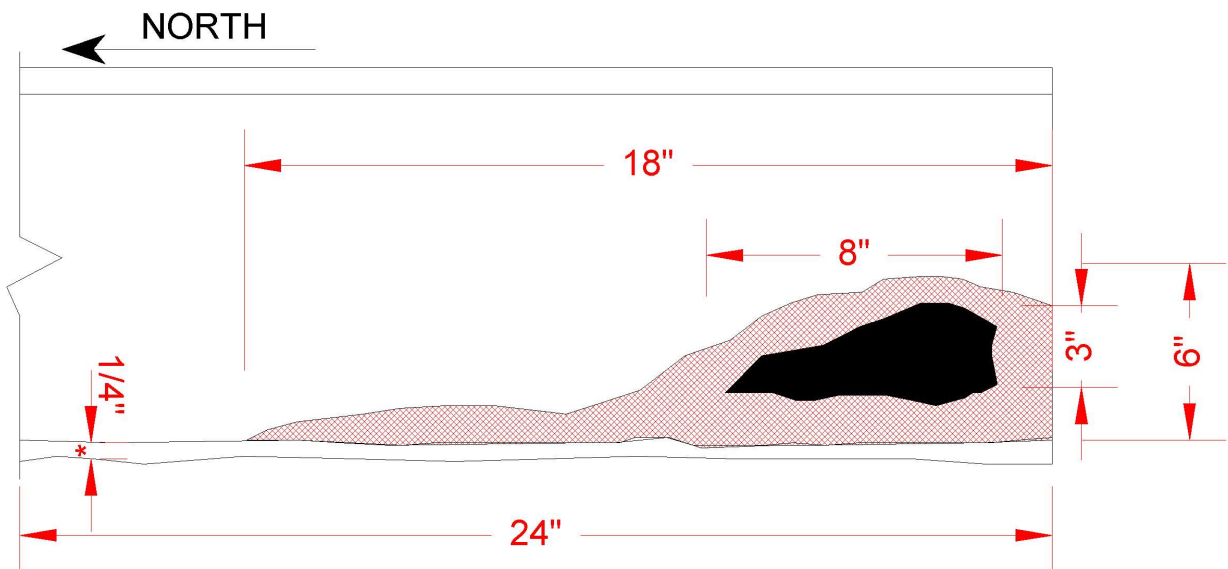
WEB DOWN TO 1/16" IN SHADED AREA

BOTH BOTT. FLANGES 1/4" FROM END OF BM. BACK APPROX. 2'

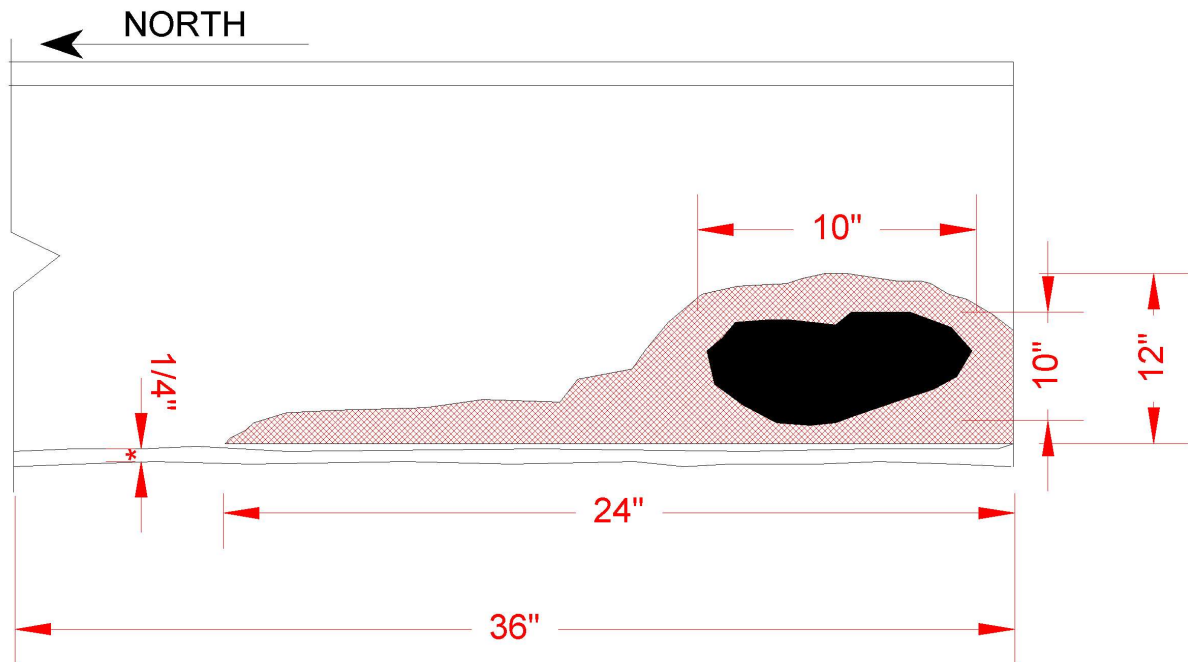
WEB IS DOWN TO 1/16" IN SHADED AREA

BOTH BOTT. FLANGES APPROX. 1/4" FROM END OF BM. BACK APPROX. 3'

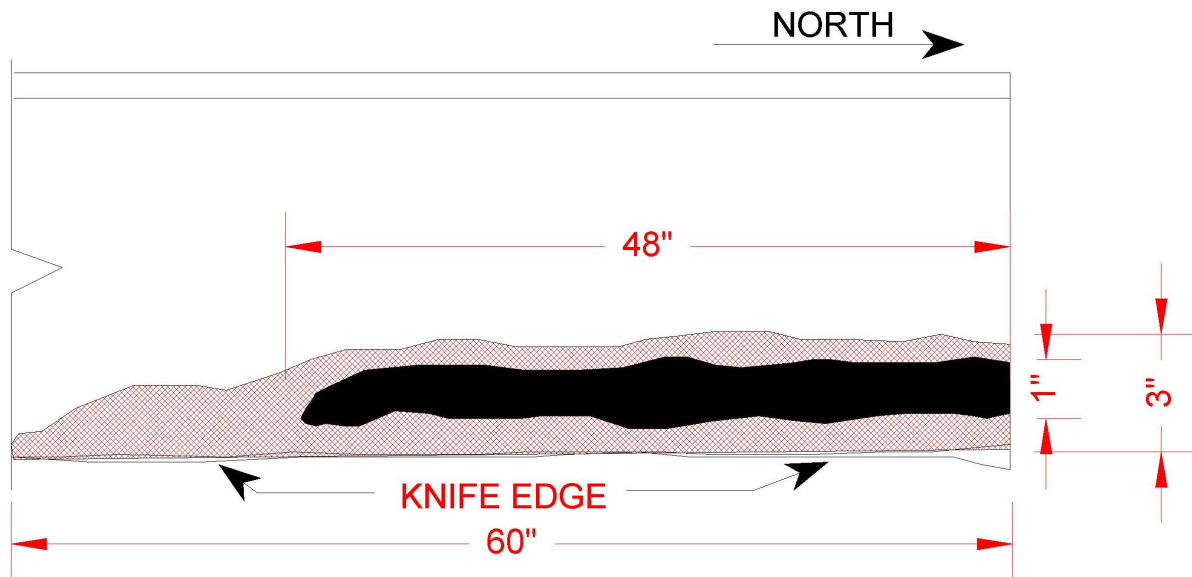
| <b>Title</b><br>SECT. LOSS 6 | | <b>Description</b><br>WEB HOLE IN BM. # 2 @ ABUT. # 2 | |

WEB HOLE IN BM. # 2 @ ABUT. # 2

BOTH BOTT. FLANGES KNIFE EDGE FROM END OF BM. BACK APPROX. 5'  
WEB DOWN TO 1/32" IN SHADED AREA

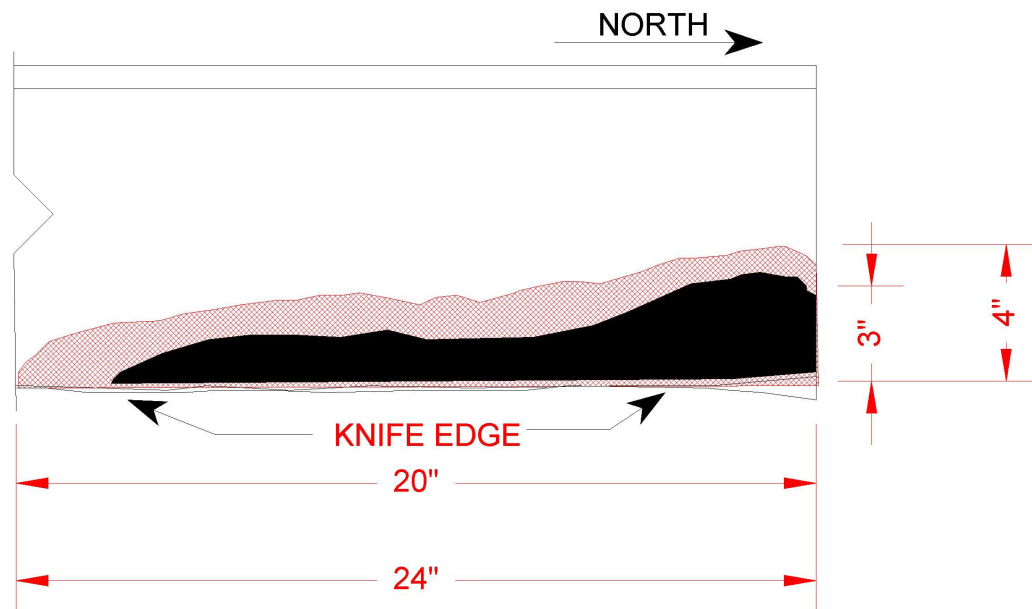
WEB IS DOWN TO 1/32" IN SHADED AREA

BOTH BOTT FLANGES KNIFE EDGE FROM END OF BM. BACK APPROX. 2'

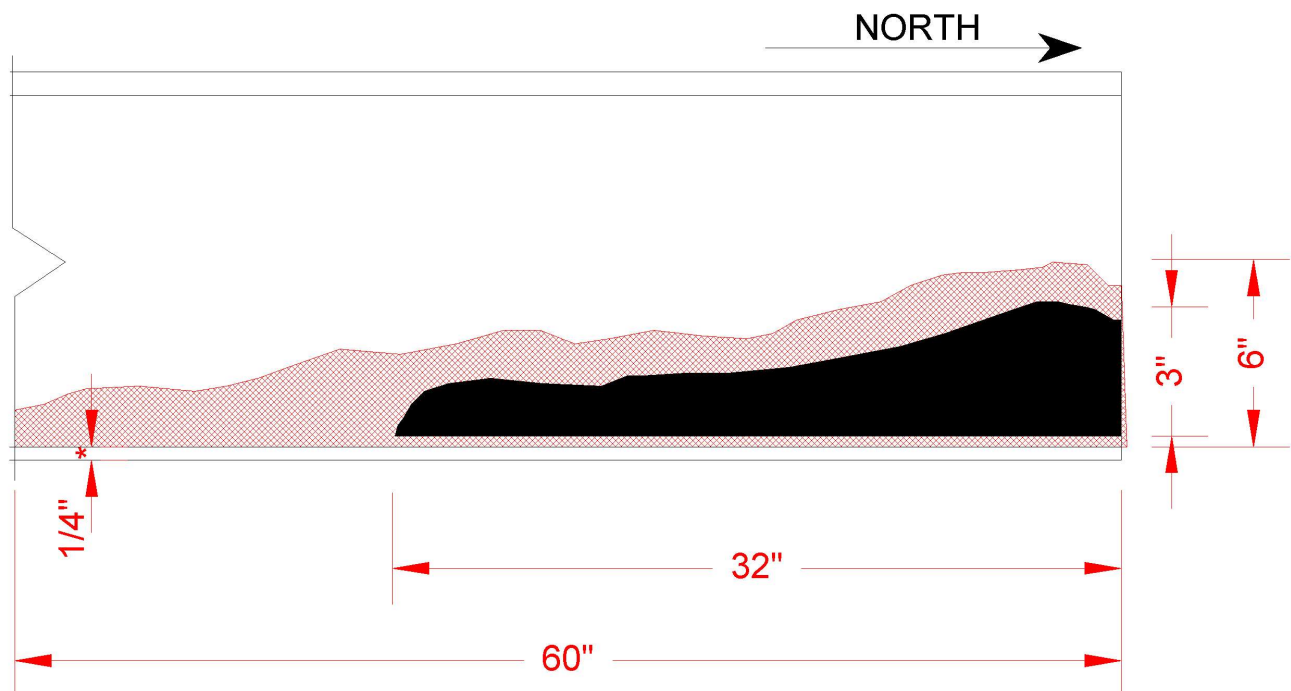
WEB IS DOWN TO 1/32" IN SHADED AREA

BOTH BOTT. FLANGES 1/4" FROM END OF BM. BACK APPROX. 5'
