NC DEPARTMENT OF TRANSPORTATION  
DIVISION OF HIGHWAYS  
BRIDGE MANAGEMENT UNIT

# BRIDGE INSPECTION REPORT

INSPECTION TYPE: Routine Inspection

COUNTY ALEXANDER BRIDGE NUMBER 010137 INSPECTION CYCLE 2 YRS  
ROUTE SR1608 ACROSS GLADE CREEK M.P. 0

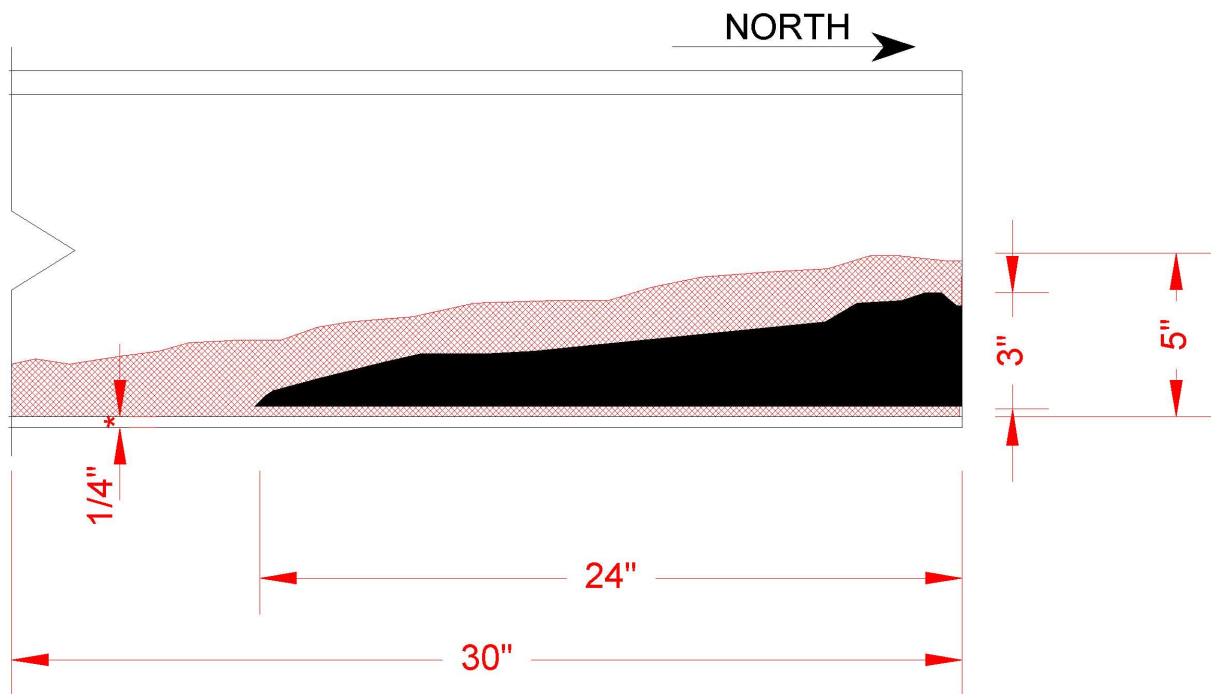
WEB IS DOWN TO 1/32" IN SHADED AREA

BOTH BOTT. FLANGES 1/4" FROM END OF BM. BACK APPROX. 30"

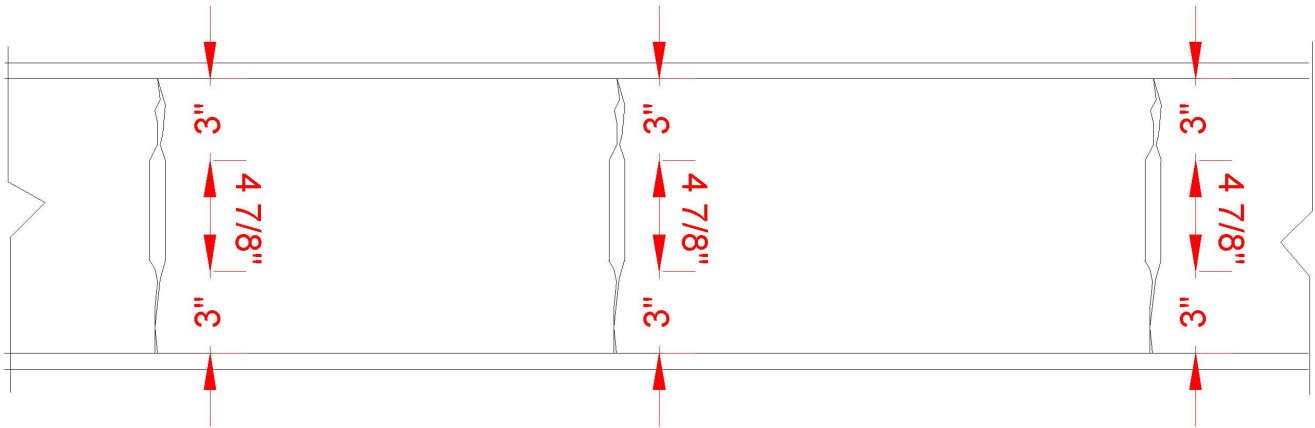
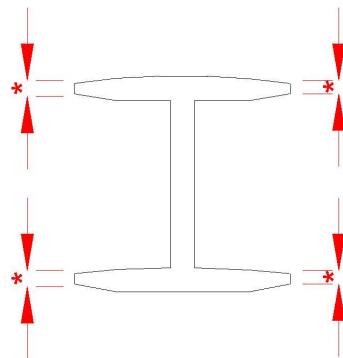
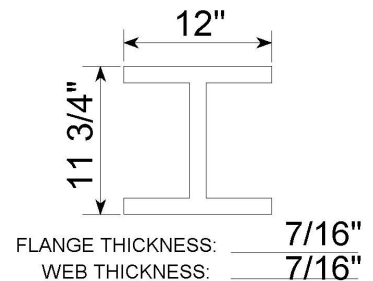
| Title | | Description | |
|---|---|---|---|
| SECT. LOSS 10 | | CAPS | |

TOP & BOTT. 3" OF STIFFENERS DOWN TO KNIFE EDGE

UP TO 1/8" SECT. LOSS ON LEADING EDGE OF CAP FLANGES

\* LEADING EDGE OF CAP FLANGES DOWN TO 5/16"
