NC DEPARTMENT OF TRANSPORTATION  
DIVISION OF HIGHWAYS  
STRUCTURE MANAGEMENT UNIT

## Structure Safety Report

### Routine Element Inspection - Contract

DIVISION: 14 COUNTY: HAYWOOD STRUCTURE NUMBER: 430057 FREQUENCY: 24 MONTHS

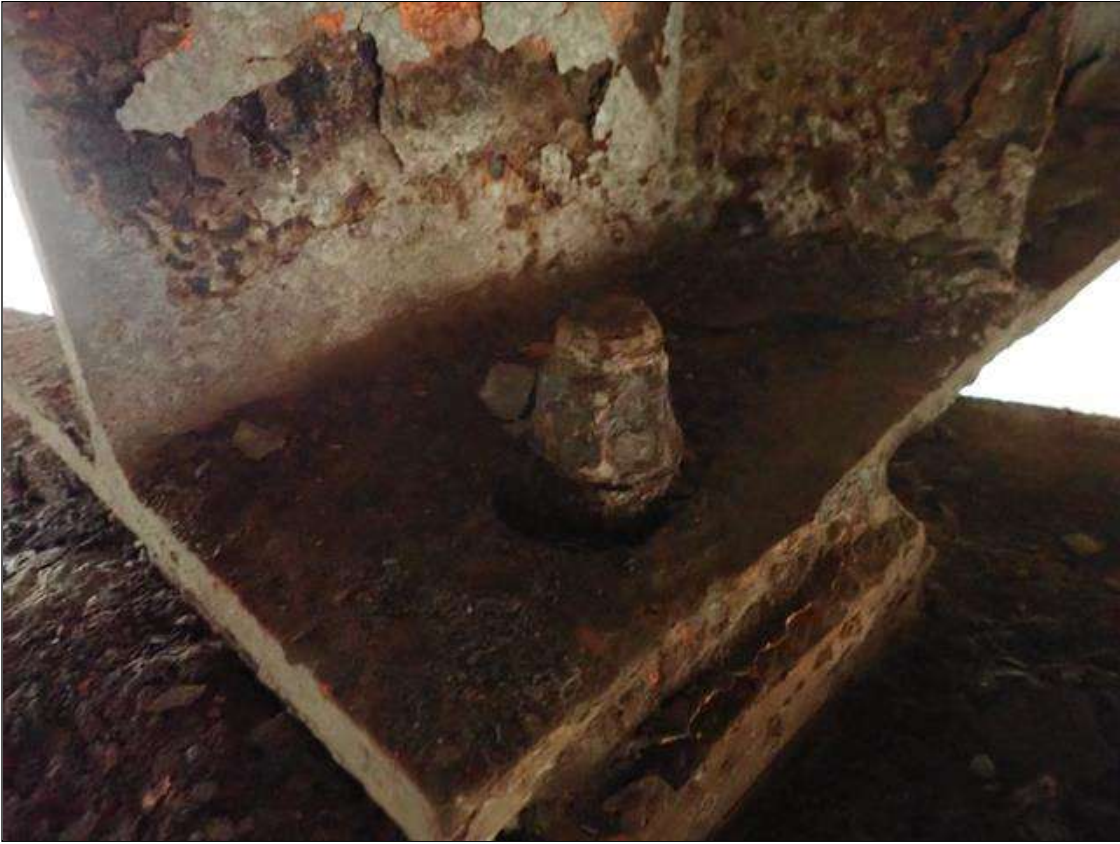
Span 4 Beam 2 Near Bearing: ANCHOR BOLT NUT CORRODED AWAY, GIRDER BOTTOM FLANGE NOT SECURE, PM

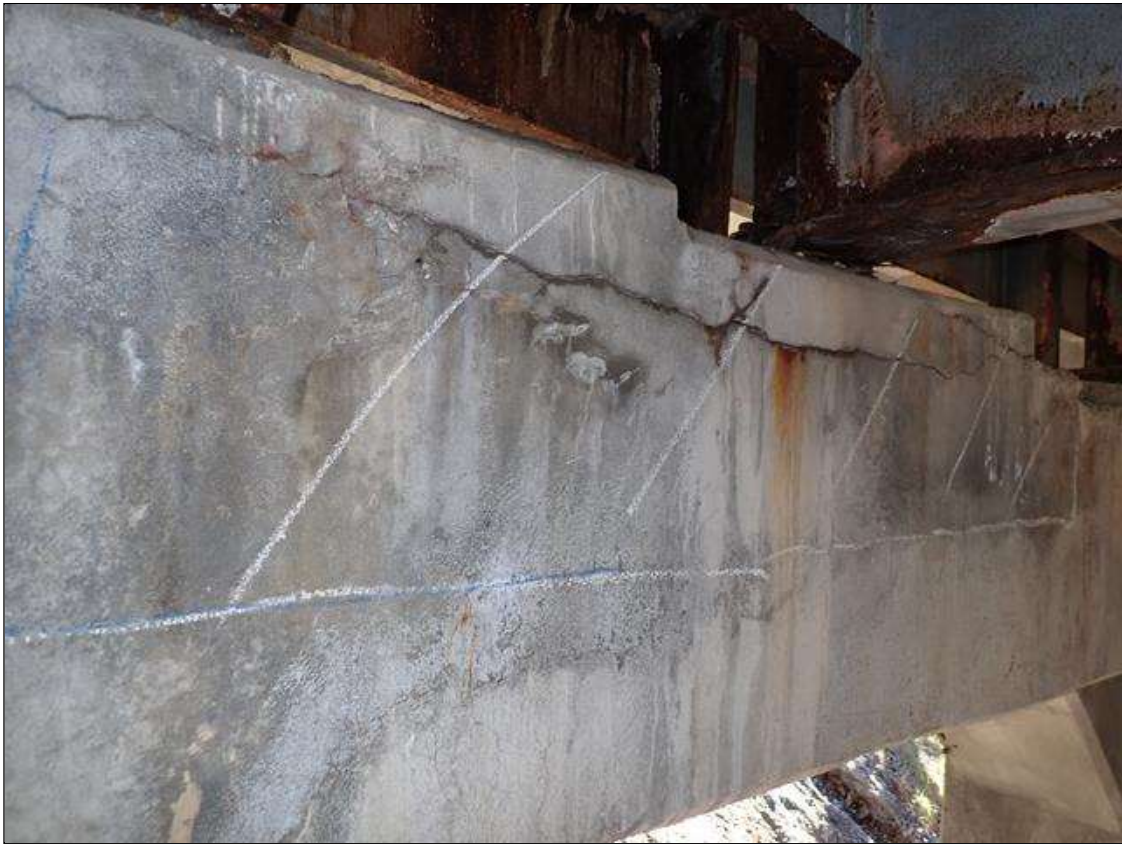
Span 3 Beam 6: 3 FT. OF CORROSION WITH 1/2" REMAINING SECTION IN BOTTOM FLANGE AND 2.5" X 1" HOLE IN BEARING STIFFENER AT BENT 2 (PRIORITY MAINTENANCE ISSUED)

Bent 2 Cap 1: 10 FT X 20" HIGH DELAMINATION IN WEST FACE UNDER BAYS 4 TO 6 (PRIORITY MAINTENANCE ISSUED)

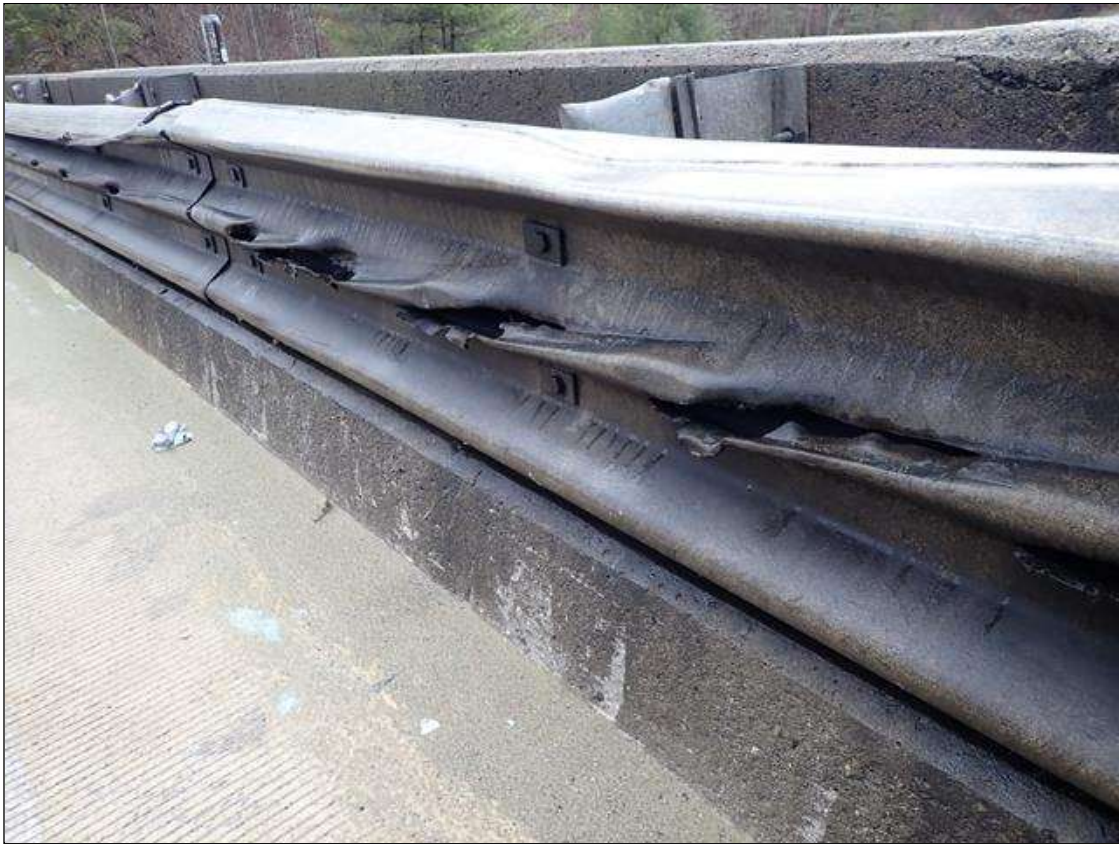
Span 3 Beam 5: 6 FT. OF CORROSION WITH 0.4" REMAINING THICKNESS IN STIFFNER AND 3/4" REMAINING SECTION IN BOTTOM FLANGE AT BENT 2 (PRIORITY MAINTENANCE ISSUED)

Span 3 Right Bridge Rail: IMPACT DAMAGE TO RIGHT GUARDRAIL FOR FULL LENGTH OF SPAN 3, CONCRETE BARRIER RAIL BEHIND IS FULLY FUNCTIONING

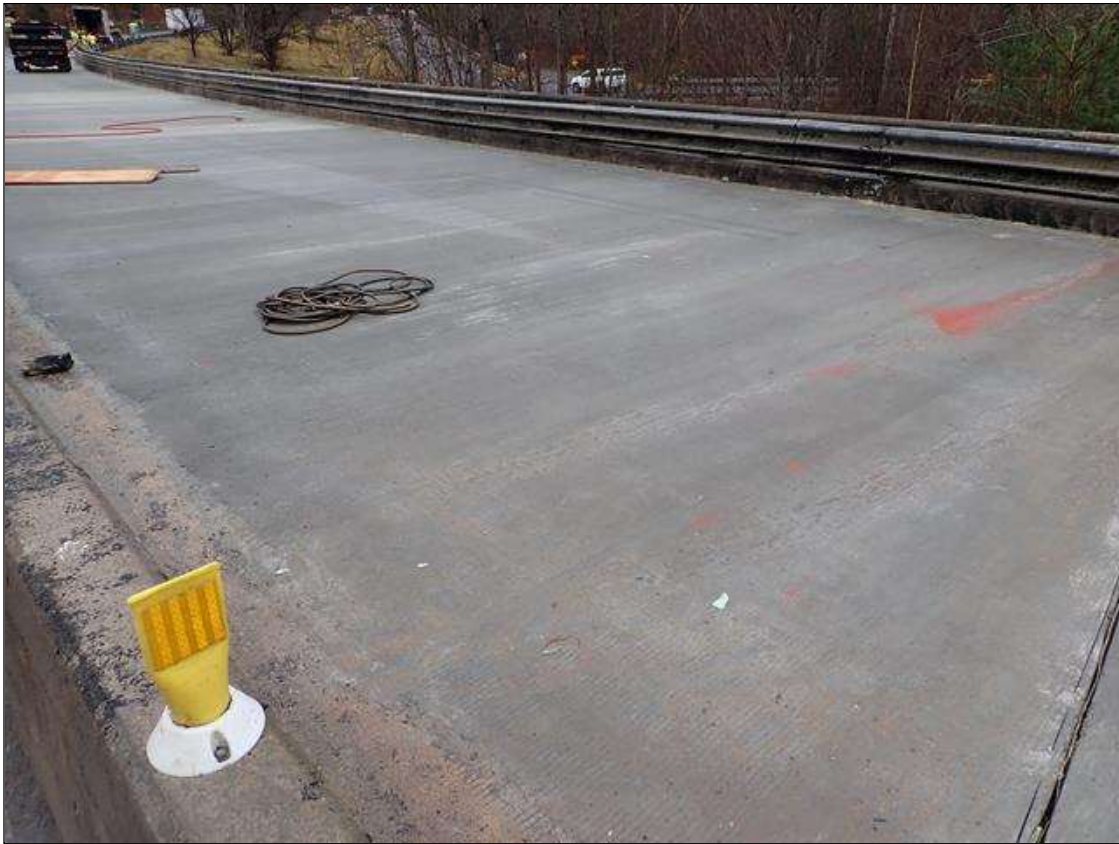
Expansion Joint : JOINT REPAIR AT END BENT 1 ALONG FULL LENGTH OF EAST BOUND LANE

Span 1 Deck: SPAN 1 DECK REPAIR IN EAST BOUND LANES

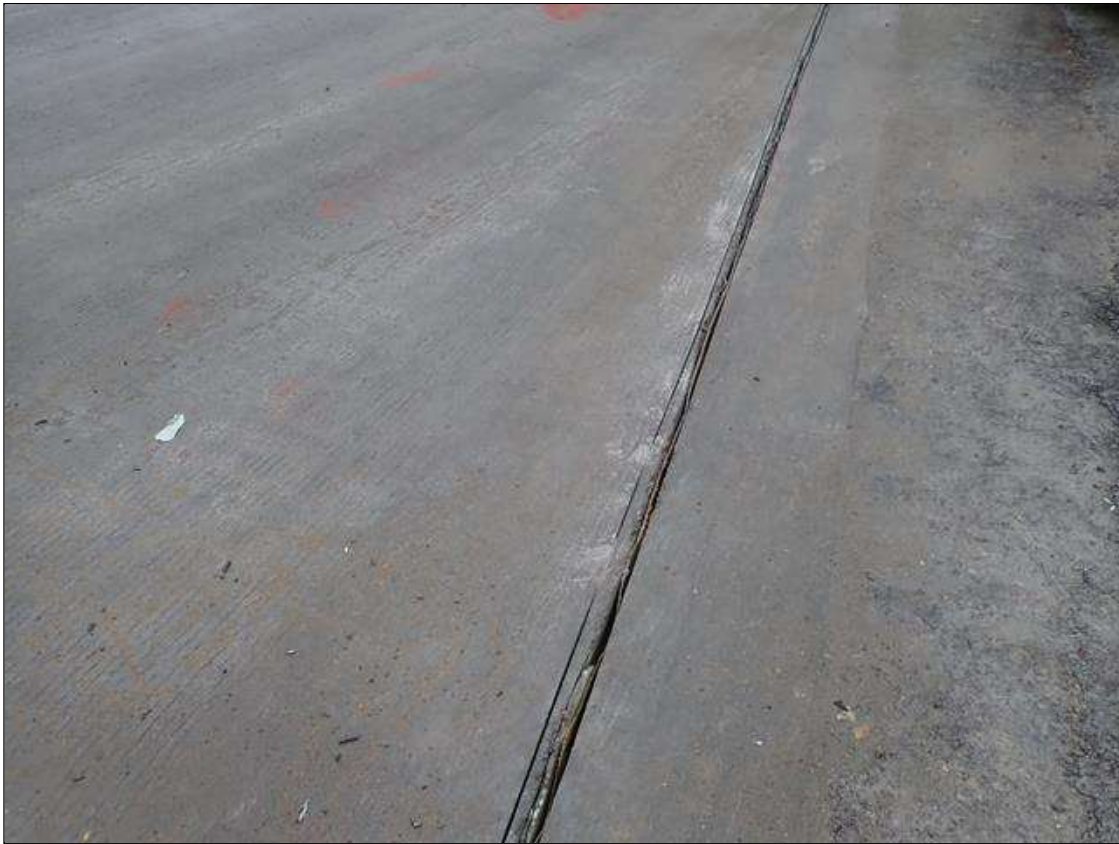
Expansion Joint : 15 FT OF JOINT REPAIR IN WEST BOUND LANES

Expansion Joint : EAST BOUND LANE UNDER REPAIR

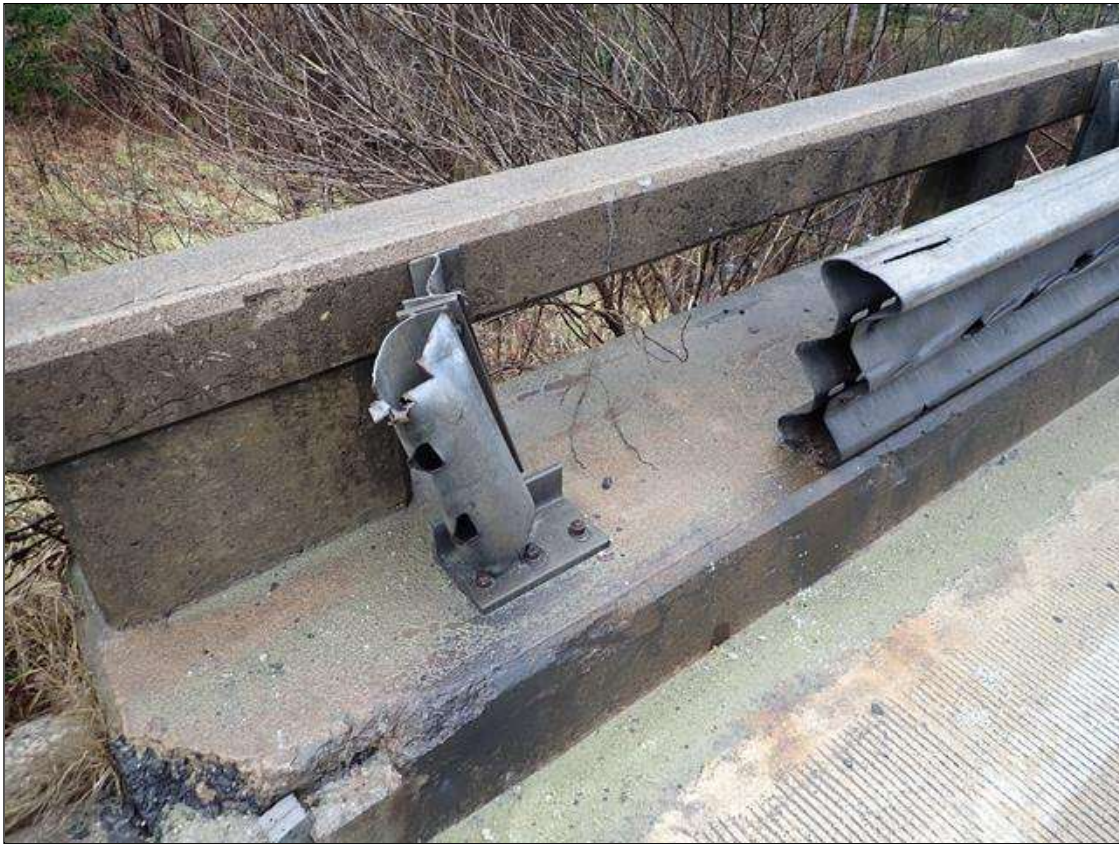
Span 1 Left Bridge Rail: 17 FT. OF HORIZONTAL CRACKS IN TOP OF RAIL, UP TO 1/8" WIDE AT END BENT 1

Span 1 Left Bridge Rail: 5 FT OF MISSING GUARDRAIL AT END BENT 1 IN LEFT BARRIER RAIL

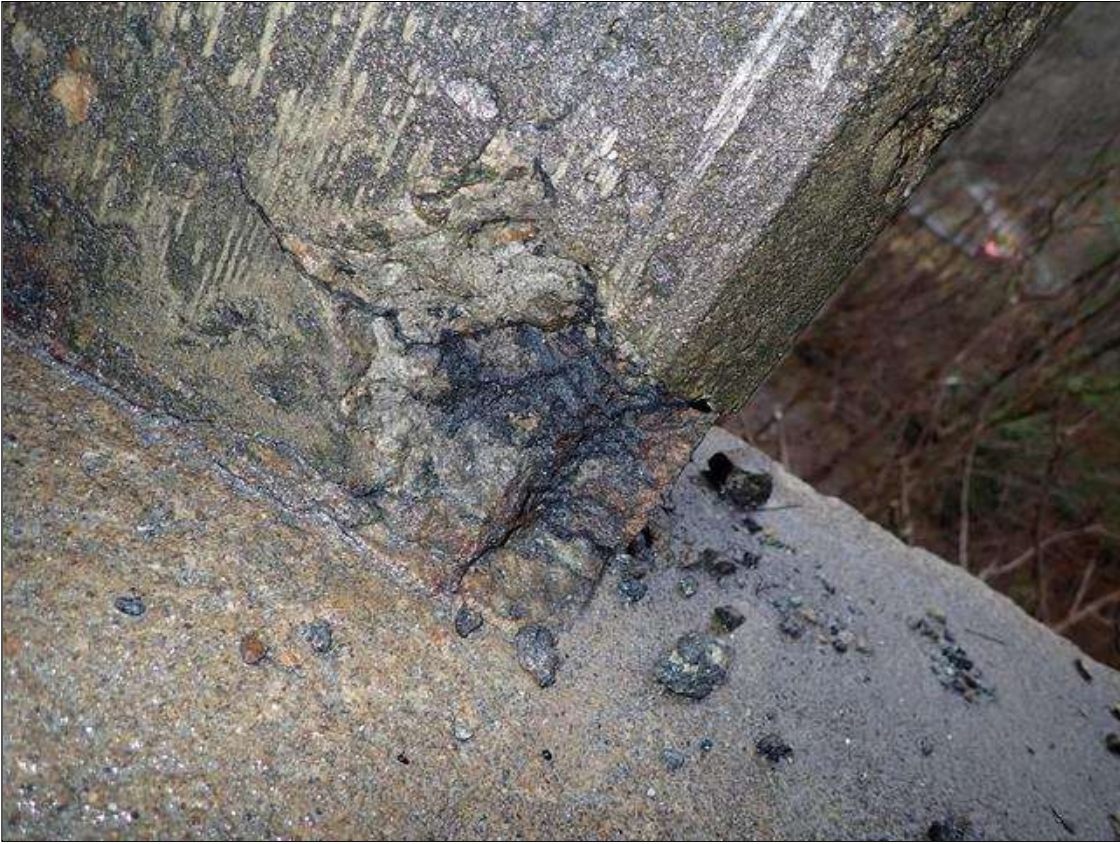
Span 1 Left Bridge Rail: 4 FT DELAMINATION IN UNSOUND PATCH IN OVERHANG AT MIDSPAN OF LEFT BARRIER RAIL

Span 1 Left Bridge Rail: 5" X 5" X 2" SPALL IN BASE OF POST #6 WITH REBAR EXPOSED, NO SECTION LOSS

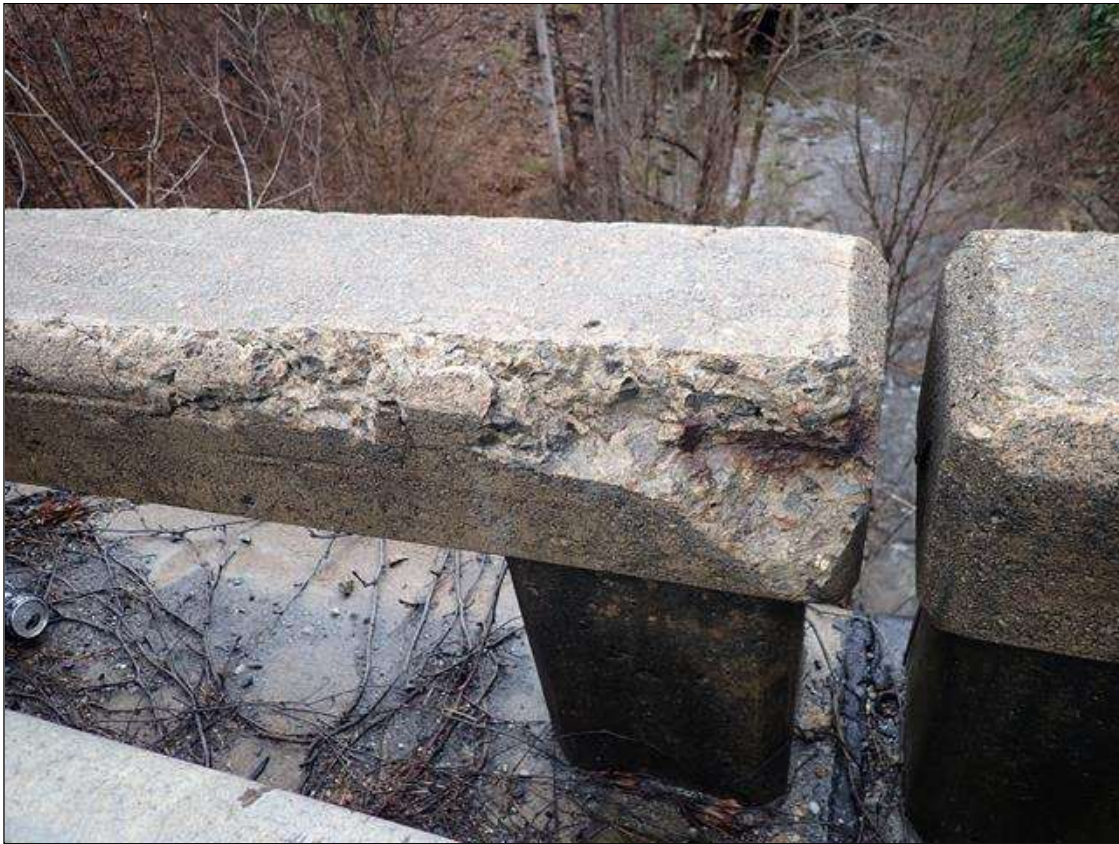
Span 1 Left Bridge Rail: 4 FT OF DELAMINATION AND SPALL WITH EXPOSED REBAR IN THE OUTSIDE FACE OF POST #6

Span 1 Left Bridge Rail: 15" X 6" X 3" SPALL WITH EXPOSED REBAR AT BENT 1

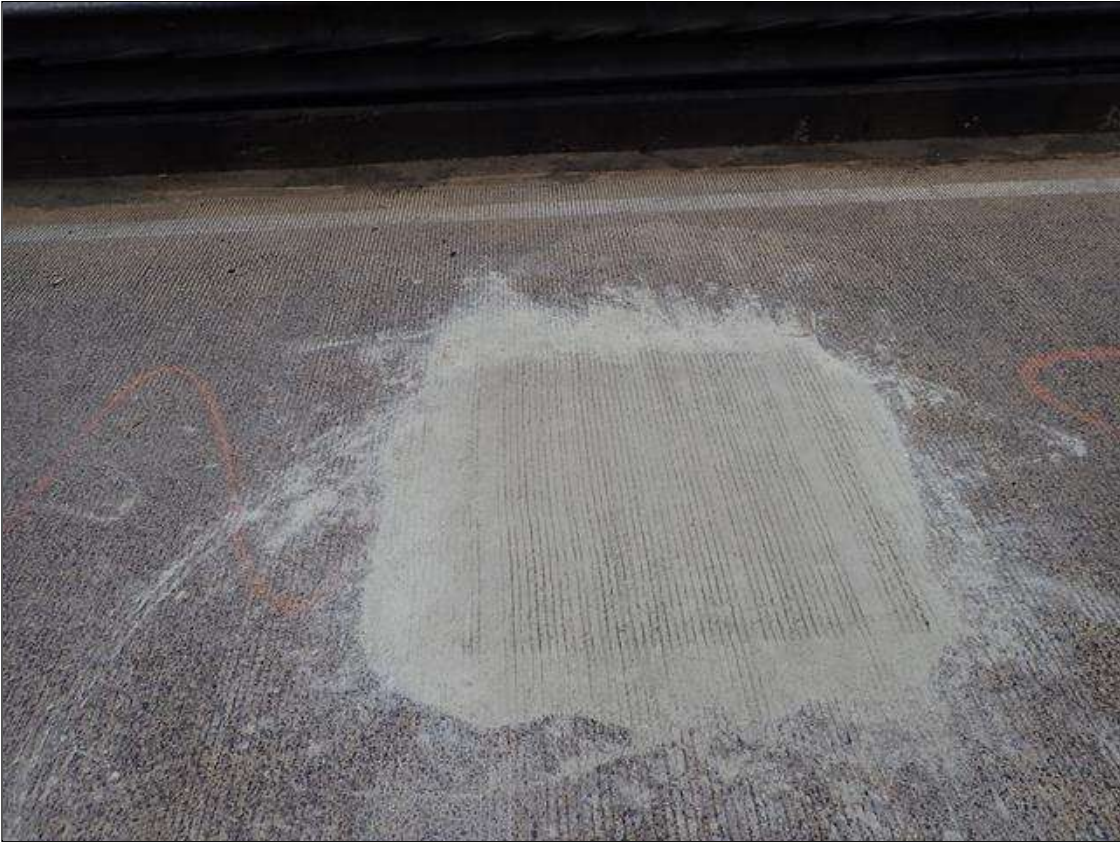
Span 1 Left Bridge Rail: 10 FT OF IMPACT DAMAGE AT 8 FT FROM BENT 1, UP TO 5" OF DEFLECTION

Span 1 Deck: 4 FT BY 4 FT OF SOUND REPAIR IN TOP OF DECK IN WEST BOUND LANES AT 20 FT FROM END BENT 1

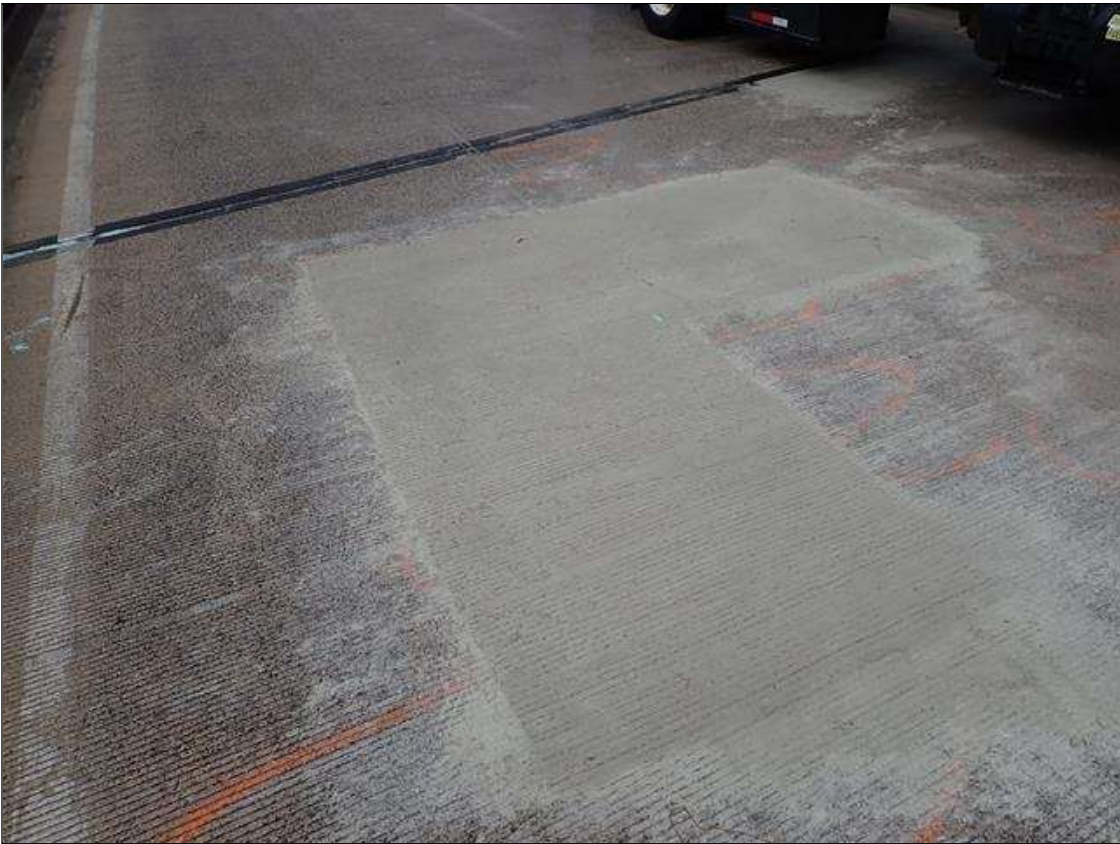
Span 1 Deck: 4 FT BY 5 FT REPAIR IN TOP OF DECK IN WEST BOUND LANES AT 40 FT FROM END BENT 1 IN NORTH LANE.

Span 1 Deck: 9 FT BY 10 FT REPAIR IN TOP OF DECK IN WEST BOUND LANES AT 50 FT FROM END BENT 1 IN NORTH FACE

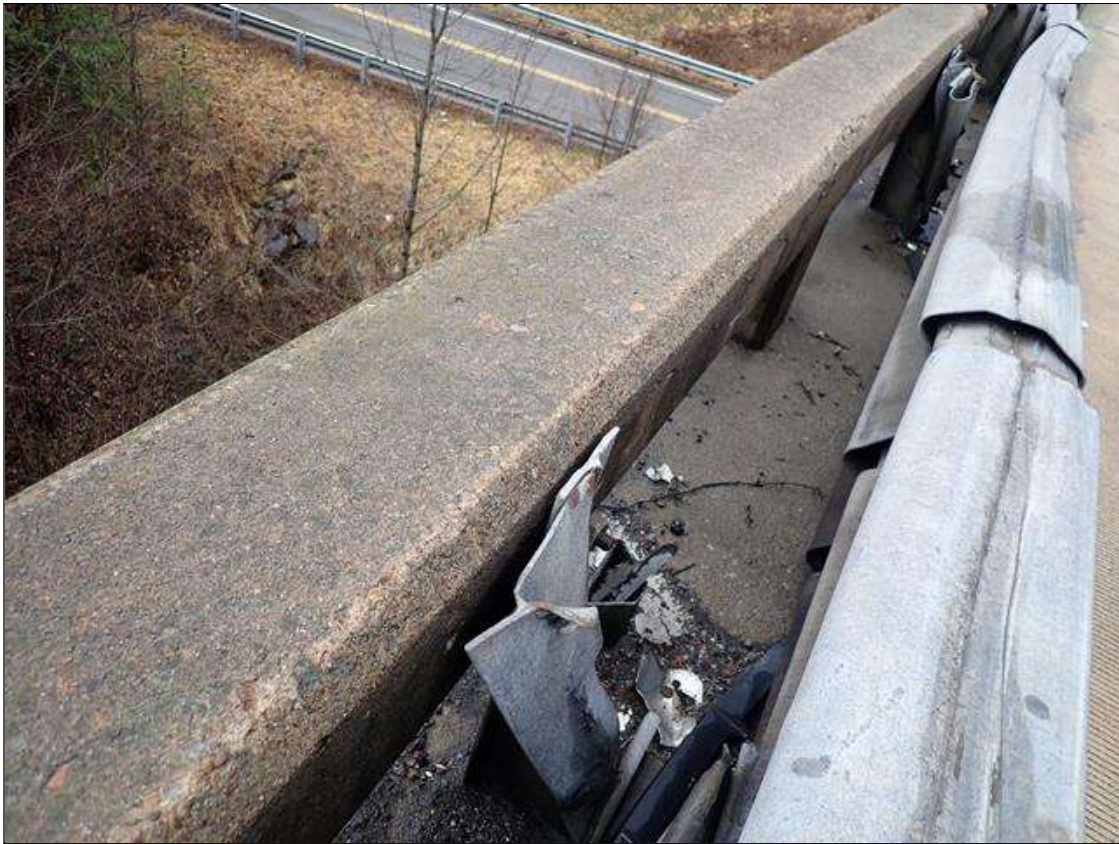
Expansion Joint : 5.5 FT SOUND REPAIR AT JOINT OVER BENT 1

Span 2 Left Bridge Rail: FULL LENGTH OF IMPACT DAMAGE ON GUARDRAIL ATTACHMENT, BROKEN AND INNEFFECTIVE

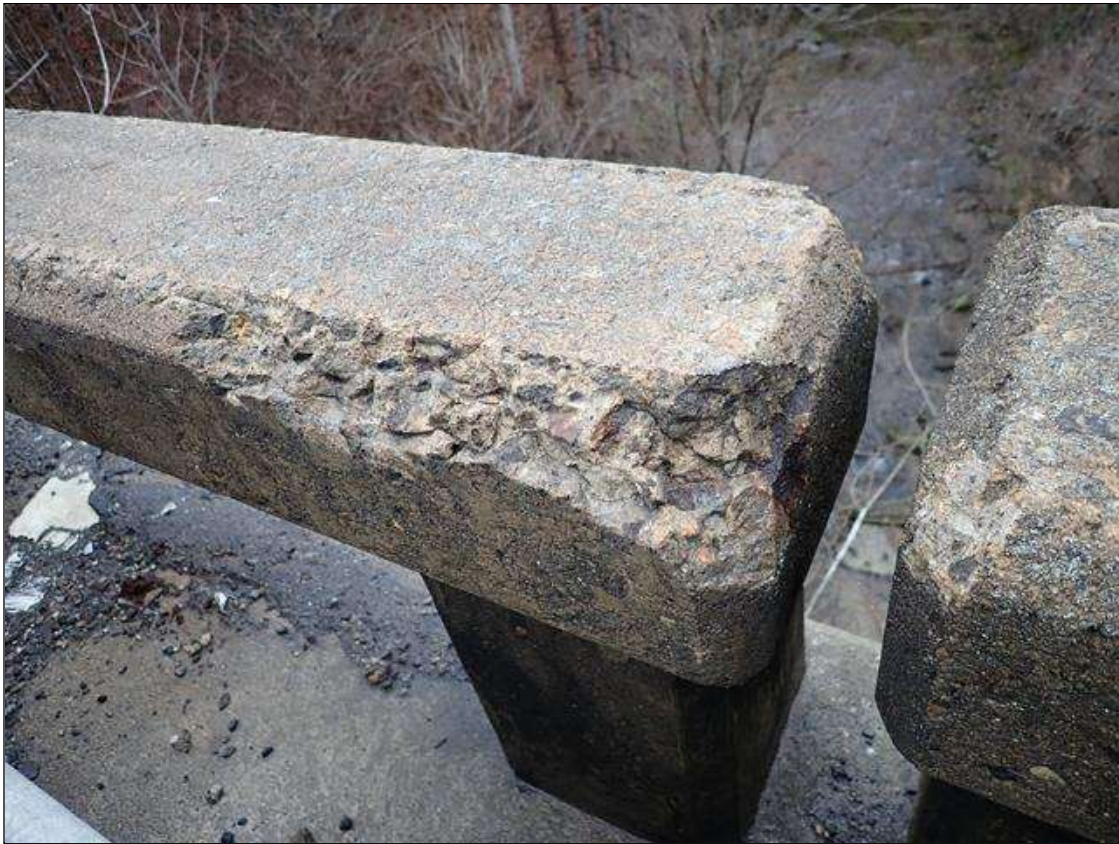
Span 2 Left Bridge Rail: 33 FT LONGITUDINAL CRACK IN TOP FACE OF RAIL UP TO 1/8" WIDE AT BENT 1 AND 8 FT FROM BENT 2

Span 2 Left Bridge Rail: SCATTERED SPALLS UP TO 14" X 5" X 4" WITH EXPOSED REBARS AT 16 FT AND 33 FT FROM BENT 1 IN TOP OF RAIL

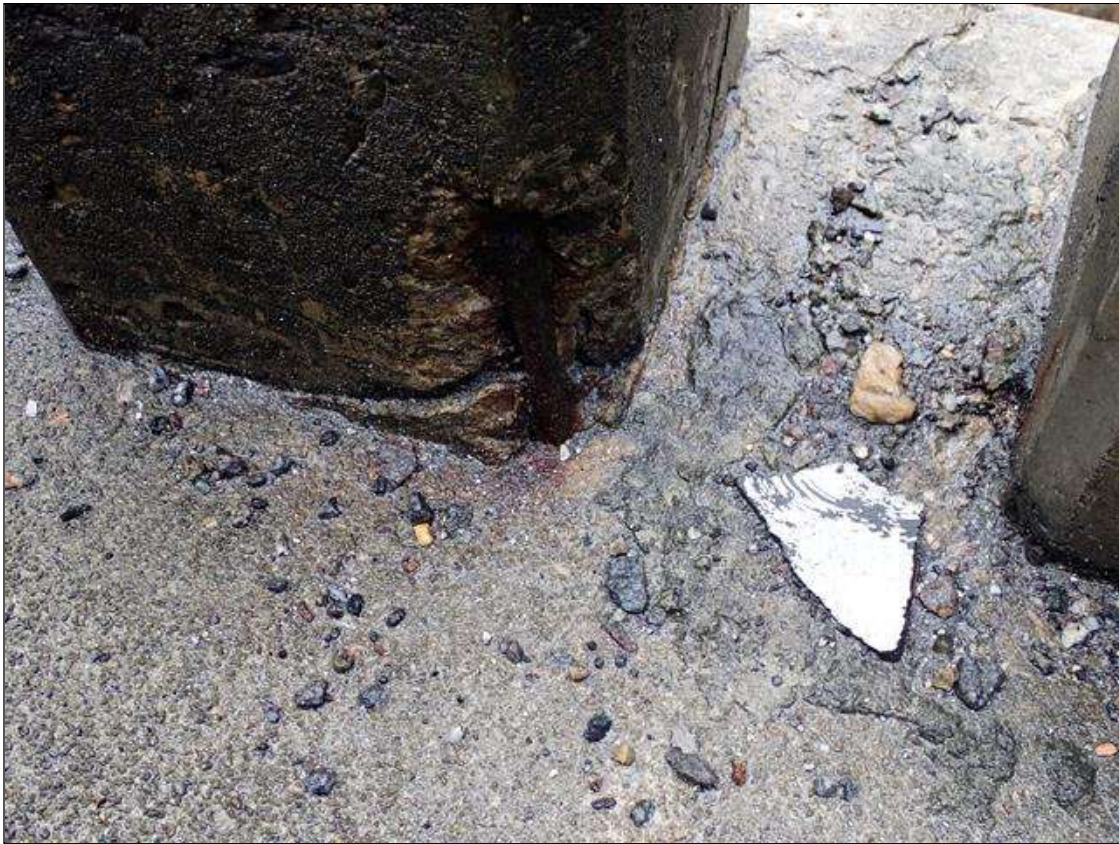
Span 2 Left Bridge Rail: RAIL POSTS CRACKED ALONG FULL HEIGHT UP TO 1/16"

Span 2 Left Bridge Rail: 7" X 2" X 2" SPALL WITH EXPOSED REBAR IN RAIL POST

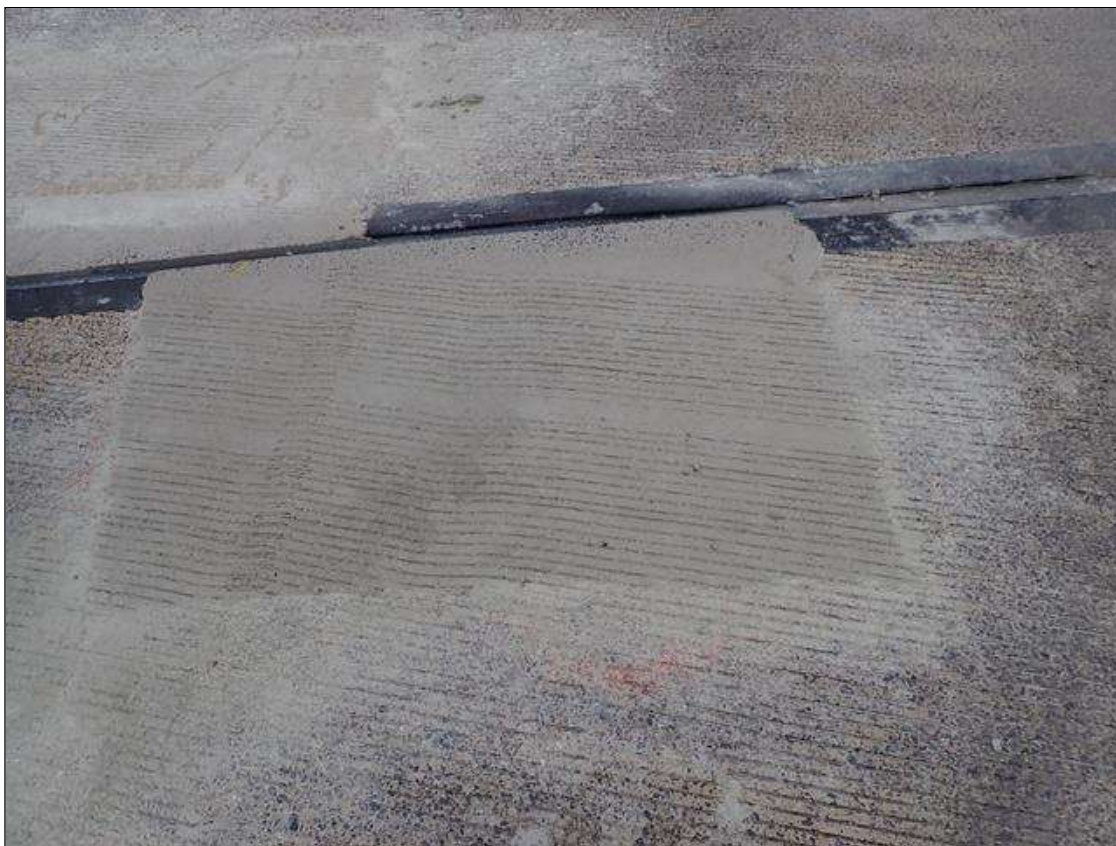
Span 2 Wearing Surface: 9 FT BY 1 FT AREA OF GOUGES IN DECK NEAR BENT 1 IN TOP OF DECK IN WEST BOUND LANES

Span 2 Wearing Surface: 3 FT BY 4.5 FT OF SOUND REPAIR AT BENT 2 IN TOP OF DECK IN WEST BOUND LANE

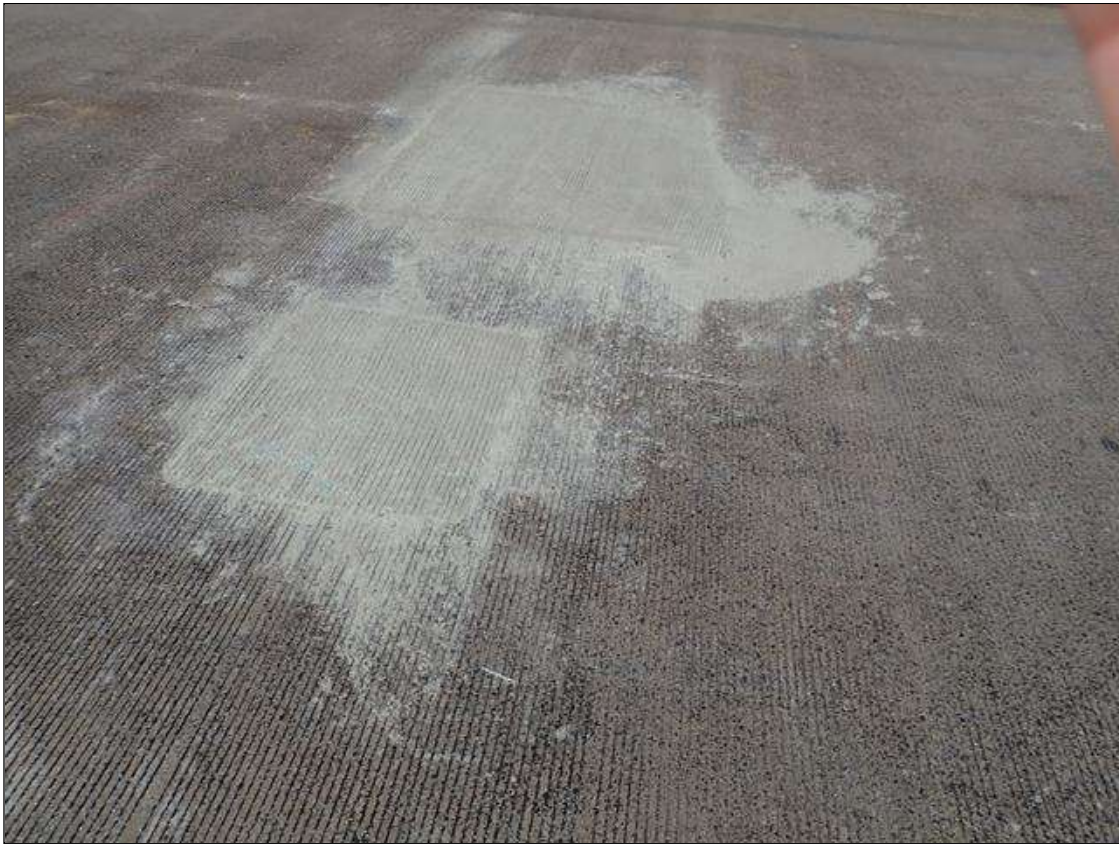
Span 3 Wearing Surface: 6 FT BY 5 FT REPAIR AND, 2 FT BY 6 FT REPAIR AT BENT 2

Span 3 Wearing Surface: 3 FT BY 3 FT SOUND REPAIR AT MIDSPAN IN TOP OF DECK IN WEST BOUND LANES AT NORTH LANE

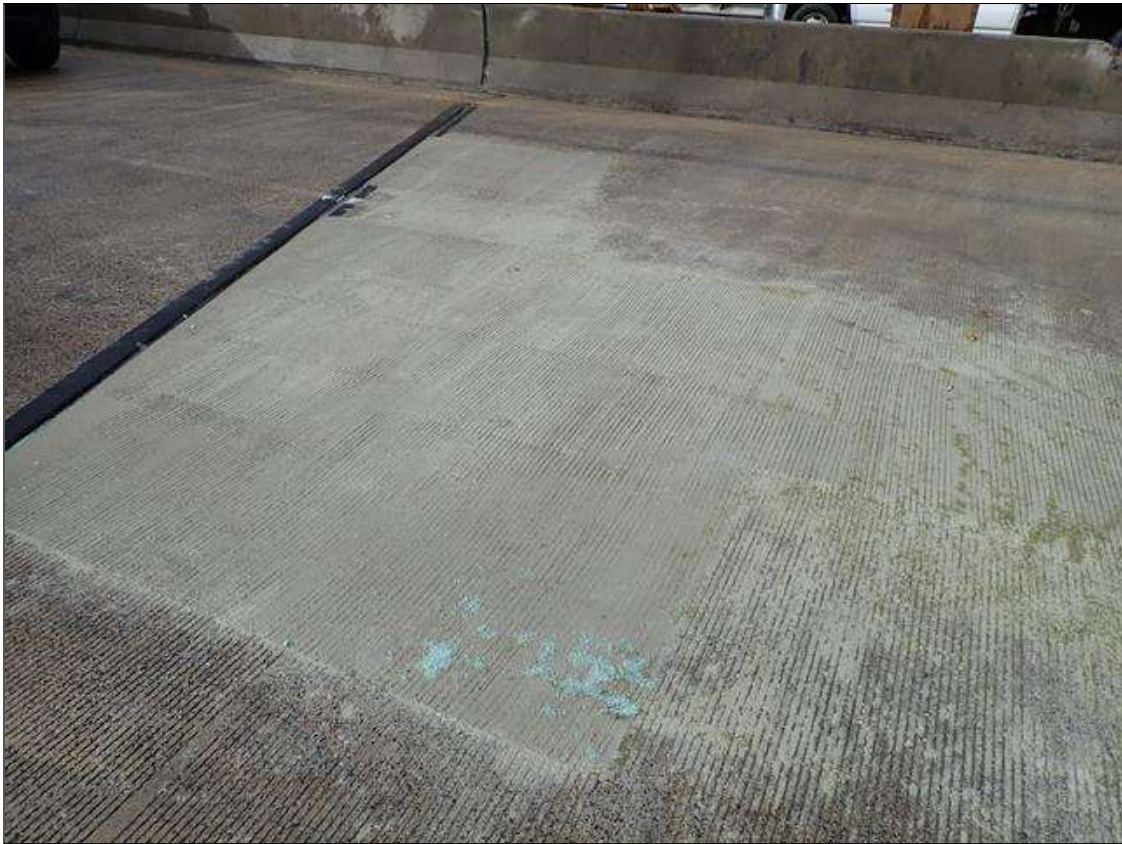
Span 3 Wearing Surface: 3 FT BY 4 FT SOUND REPAIR AND 3 FT BY 3 FT SOUND REPAIR AT 49 FT FROM BENT 2 IN TOP OF DECK IN WEST BOUND LANES IN NORTH LANE

Span 3 Wearing Surface: 14 FT BY 9 FT OF SOUND REPAIR AND 4 FT BY 3 FT AREA OF SOUND REPAIR AT BENT 3 IN NORTH LANE IN TOP OF DECK IN WEST BOUND LANES

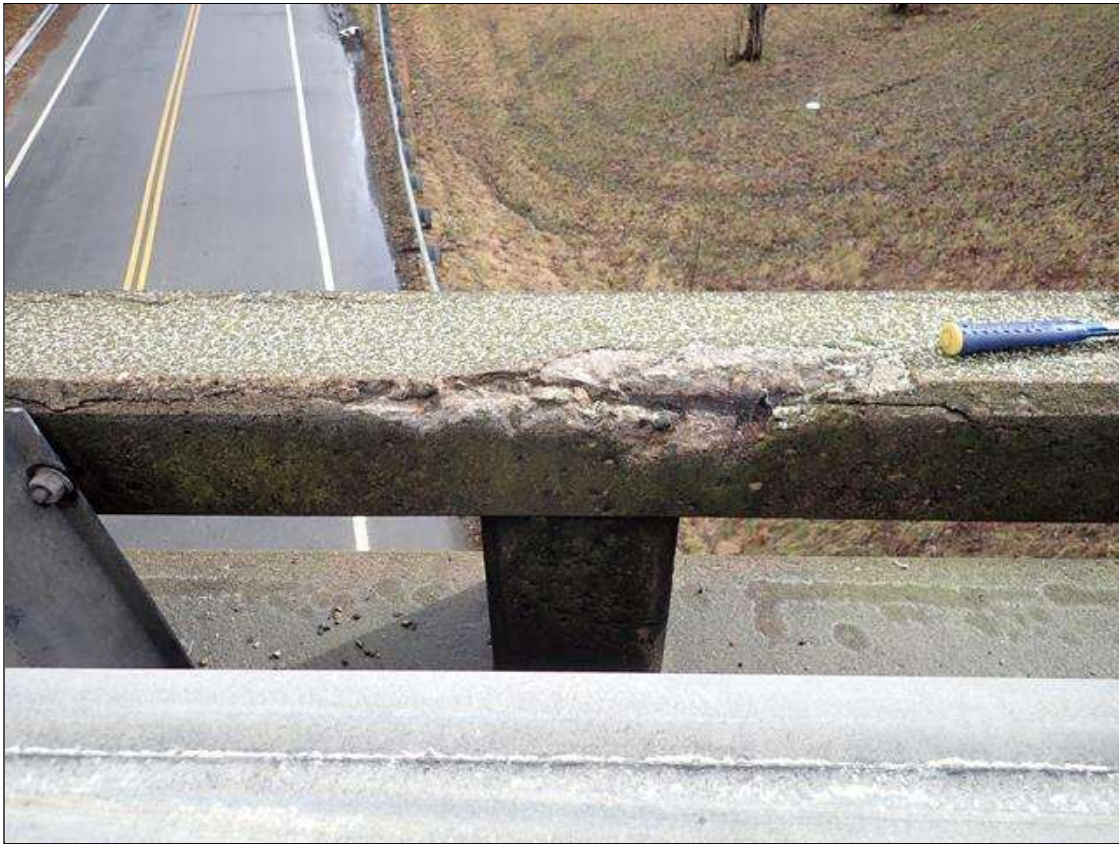
Span 3 Median Rail: 3 FT X 1.5 FT TALL X 6" DEEP SPALL IN TOP OF BARRIER RAIL WITH EXPOSED REBAR IN MIDSPAN 3

Span 3 Left Bridge Rail: 18" X 4" X 1 1/2" DEEP SPALL WITH EXPOSED REBAR AT 8 FT FROM BENT 3 WITH 4 FT HORIZONTAL CRACK UP TO 1/8" WIDE

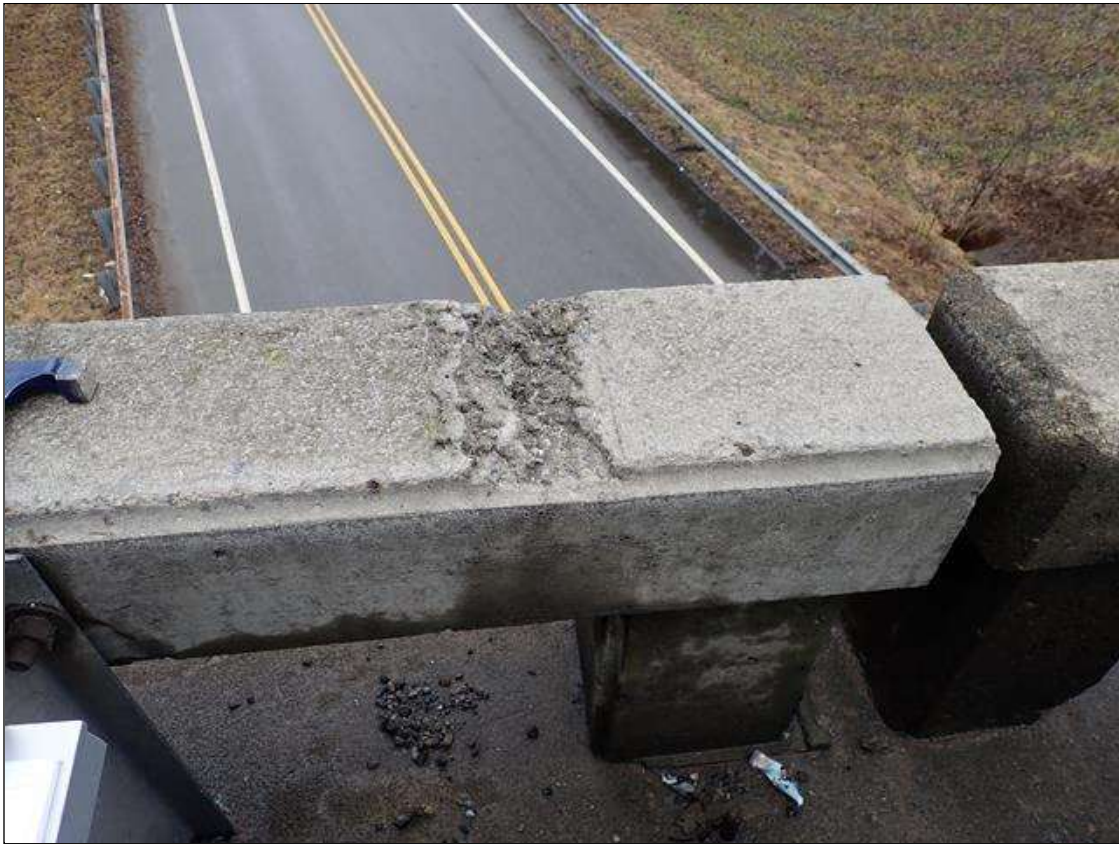
Span 3 Left Bridge Rail: 18" X 6" SPALL IN TOP OF RAIL AT 7 FT FROM BENT 2 WHERE POST MEETS

Span 3 Left Bridge Rail: 10" X 5" X 1" SPALL IN TOP OF RAIL AT MIDSPAN, NO EXPOSED REBAR

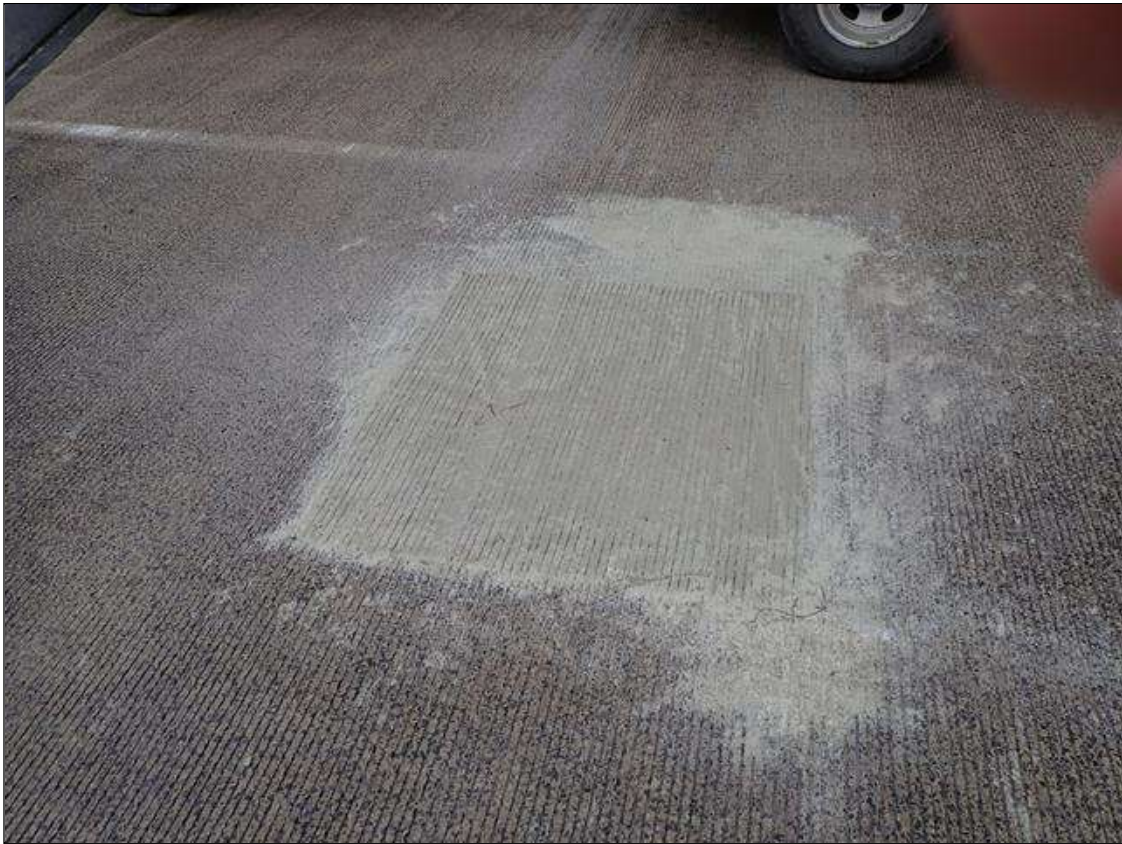
Span 3 Left Bridge Rail: 5 FT X 5" WIDE X 1" DEEP SPALL IN CURB AT 15 FT FROM BENT 2

Span 4 Wearing Surface: 4 FT BY 4 FT REPAIR IN TOP OF DECK IN WEST BOUND LANES AT 8 FT FROM END BENT 2

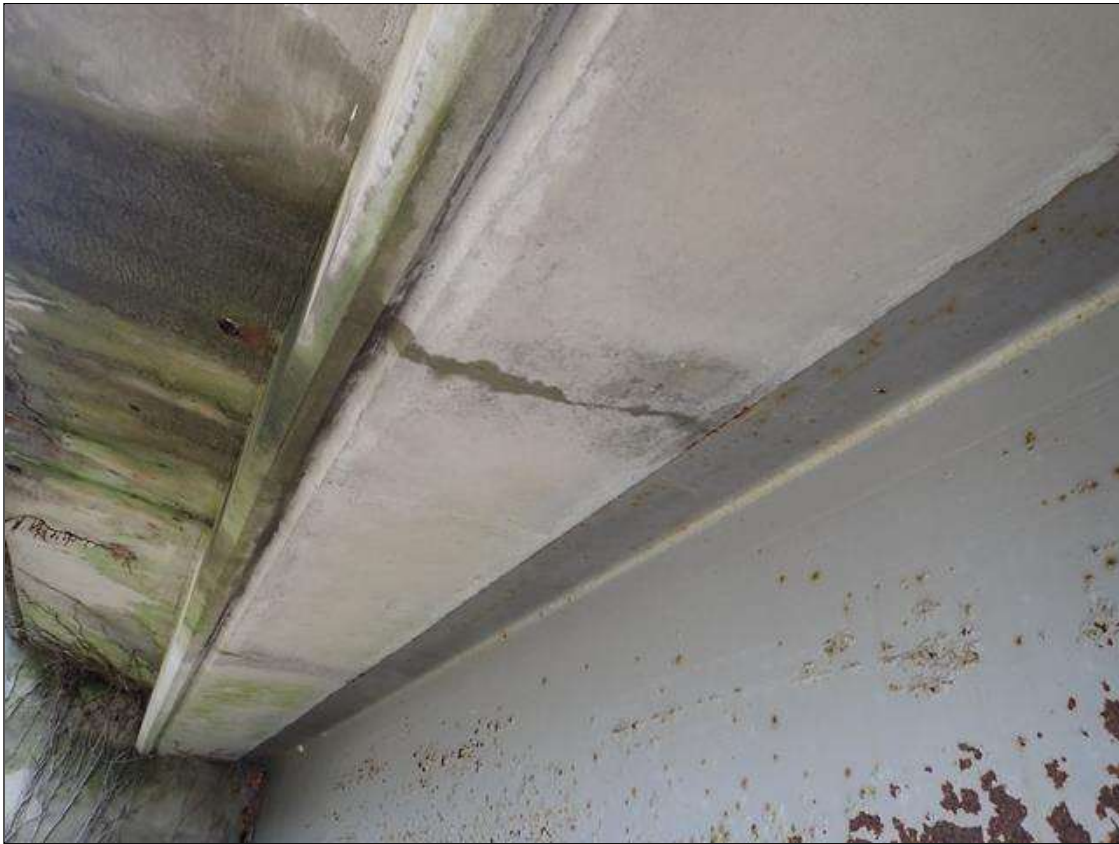
Span 4 Beam 1: 46 FT. OF SURFACE CORROSION ON TOP AND BOTTOM FACES OF BOTTOM FLANGE, ON FULL HEIGHT OF OUTSIDE FACE OF WEB.

Span 4 Deck: TRANSVERSE HAIRLINE CRACKS IN UNDERSIDE OF NORTH OVERHANG SPACED AT 4 FT ALONG FULL LENGTH OF SPAN

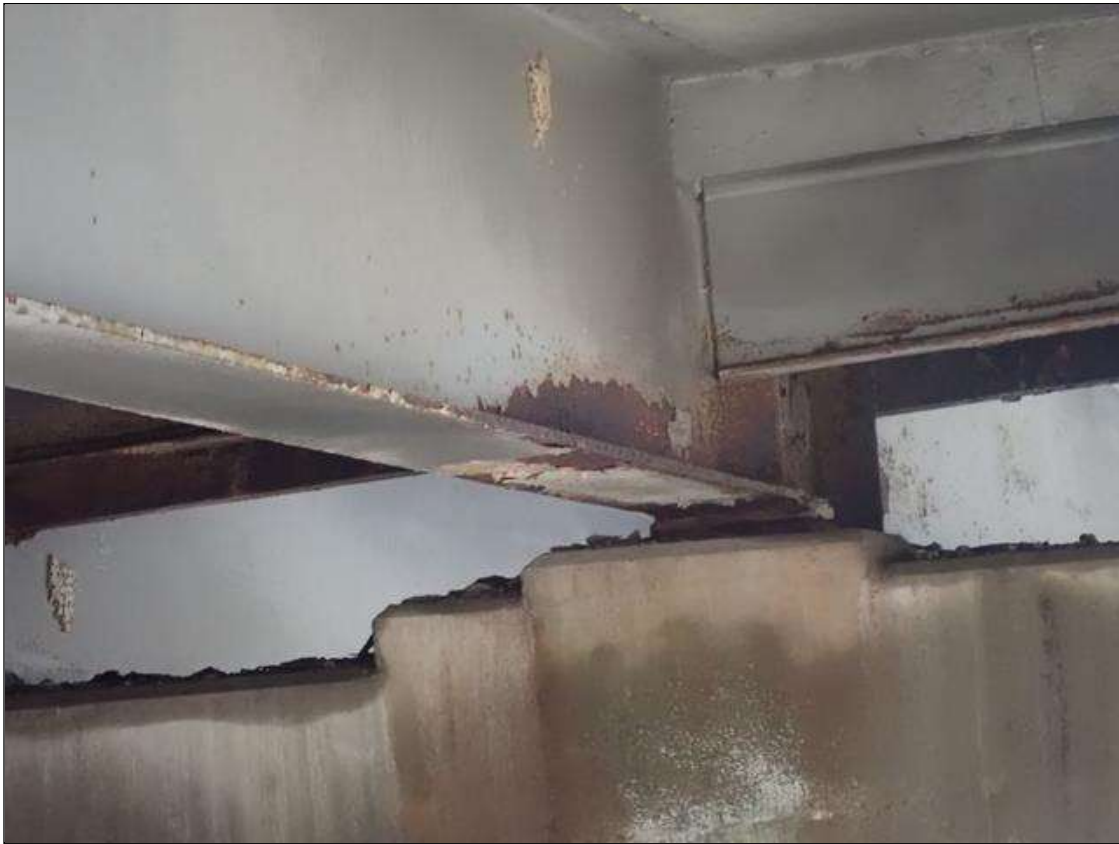
Span 4 Deck: PACTH REPAIR UNDERSIDE OF OVERHANG AT MIDSPAN

Span 4 Beam 2: 3 FT LONG SURFACE CORROSION ON BOTH SIDES OF BOTTOM FLANGE AND 8" OF LOWER WEB AT BENT 3, 1/2" THICK SECTION REMAINS

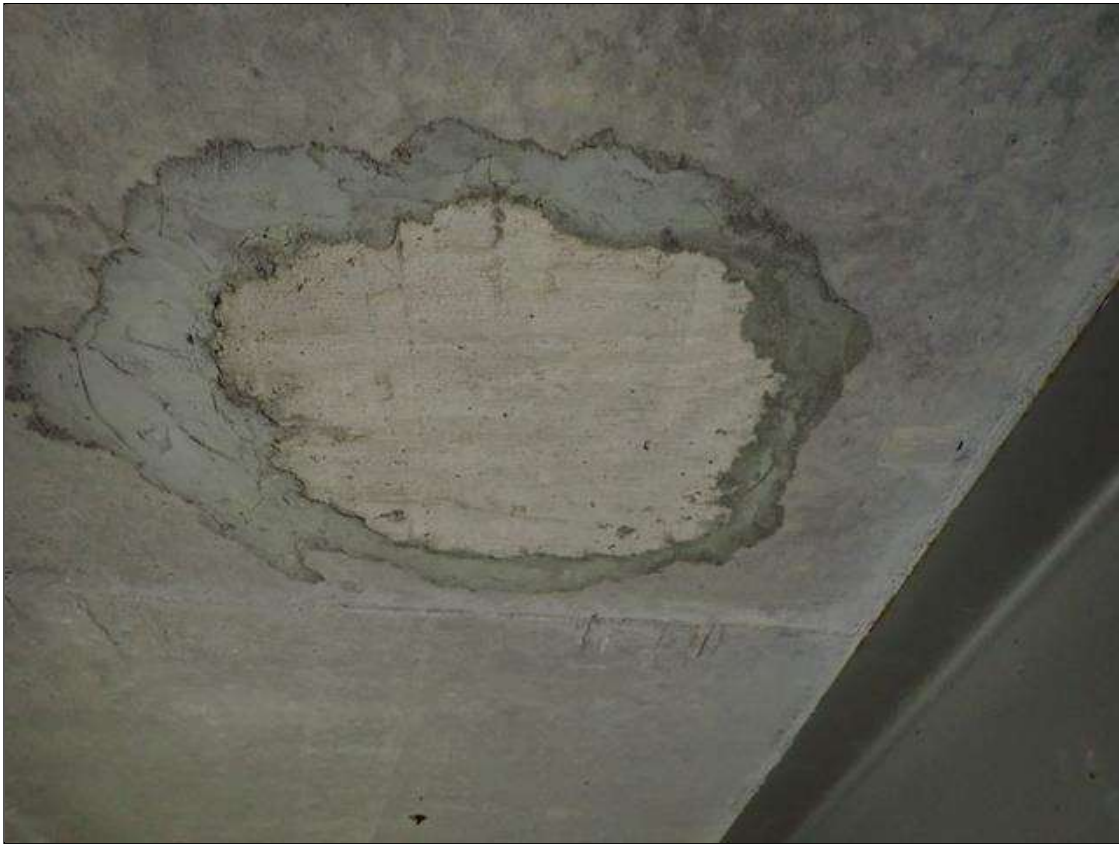
Span 4 Beam 2: SURFACE CORROSION ON BOTTOM FLANGE FOR FULL LENGTH ON BOTH SIDES

Span 4 Deck: 20" DIAMETER SOUND PATCH IN UNDERSIDE OF DECK IN BAY 1 WITH HAIRLINE CRACKS AROUND PERIMETER AT 12 FT FROM END BENT 2

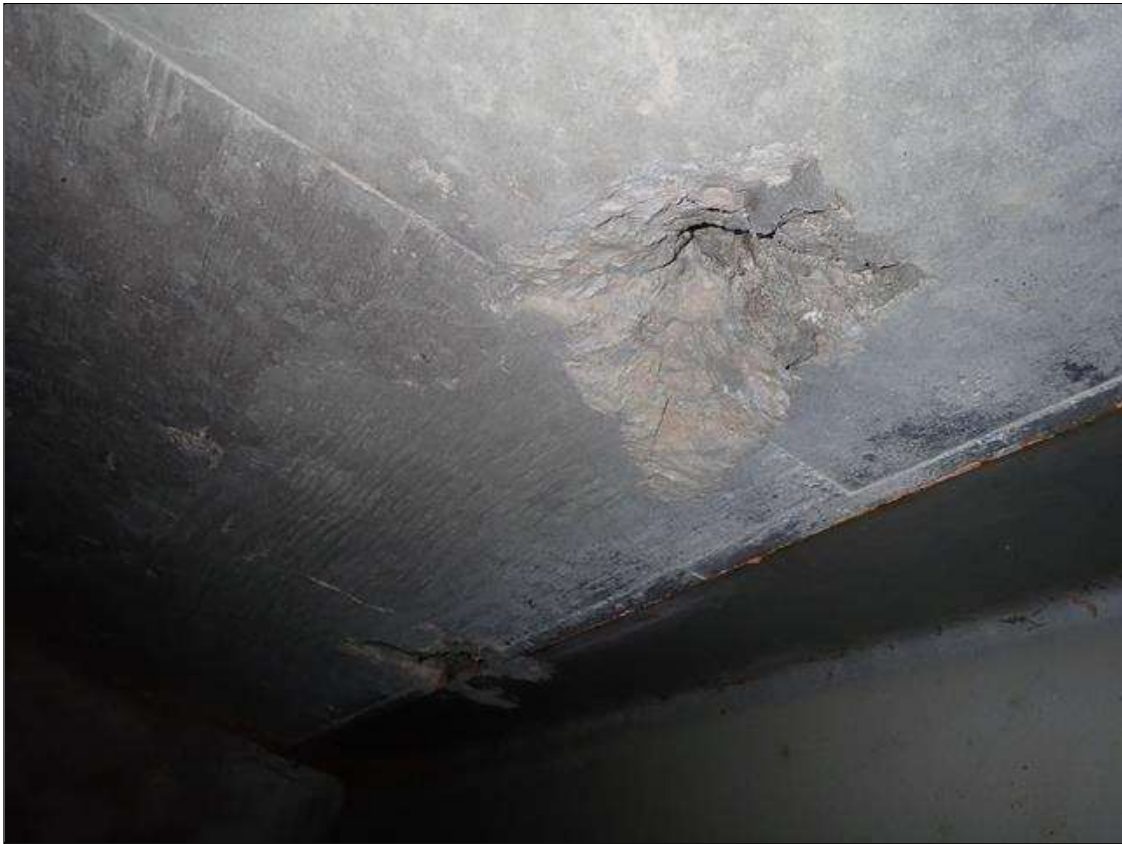
Span 4 Deck: 2 - 7" DIAMETER DELAMINATIONS NEXT TO GIRDER 5 IN BAY 4 IN UNDERSIDE OF DECK AT 7 FT FROM END BENT 2

Span 4 Deck: 2 - 6" DIAMETER x 2" DEEP SPALLS, NO EXPOSED REBAR, IN BAY 4 UNDERSIDE OF DECK NEAR GIRDER 5 AT 3 FT FROM END BENT 2
