NC DEPARTMENT OF TRANSPORTATION  
DIVISION OF HIGHWAYS  
STRUCTURE MANAGEMENT UNIT

## Structure Safety Report

### Routine Element Inspection - Contract

DIVISION: 14 COUNTY: HAYWOOD STRUCTURE NUMBER: 430057 FREQUENCY: 24 MONTHS

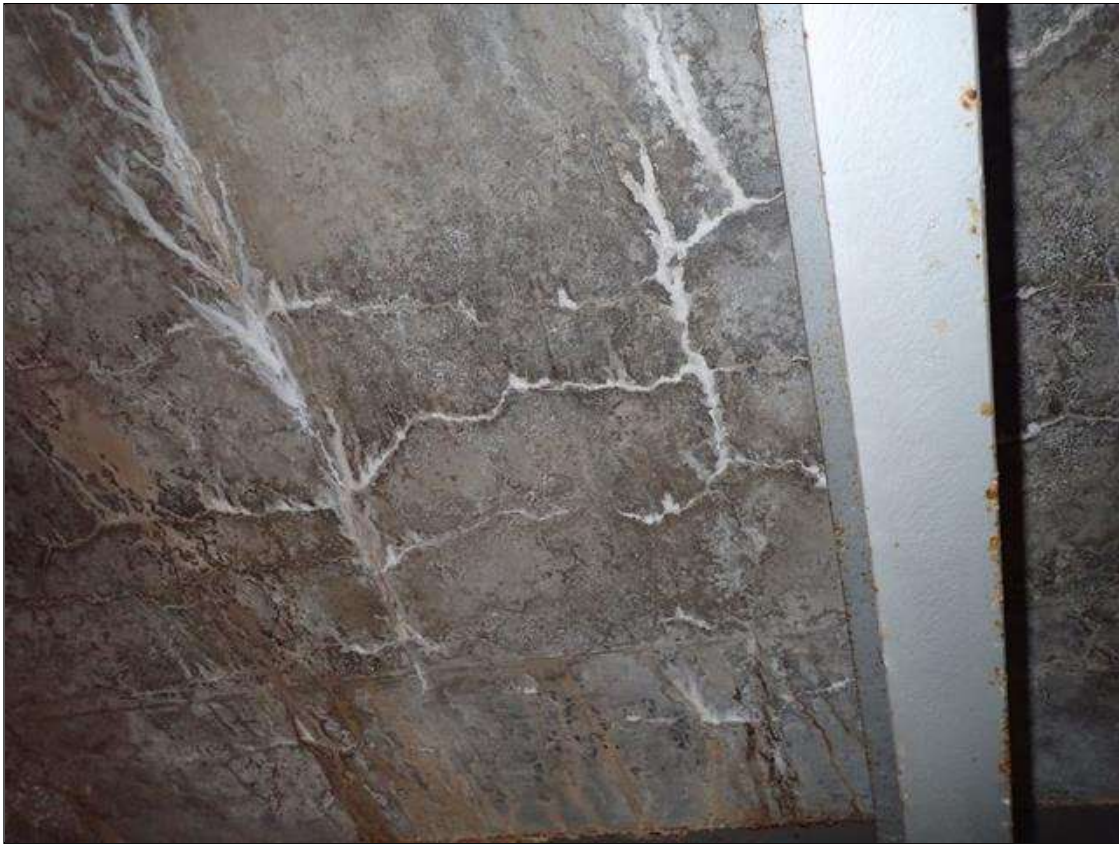
Span 4 Deck: CRACKED DELAMINATION 3 FT x 4 FT LONG, AT END BENT 2 IN BAY 8 UNDERSIDE OF DECK

Span 4 Deck: 7 FT x 6 FT AREA OF 1/16" WIDE MAP CRACKING IN UNDERSIDE OF DECK IN BAY 8 WITH EFFLORESCENCE AT MIDSPAN

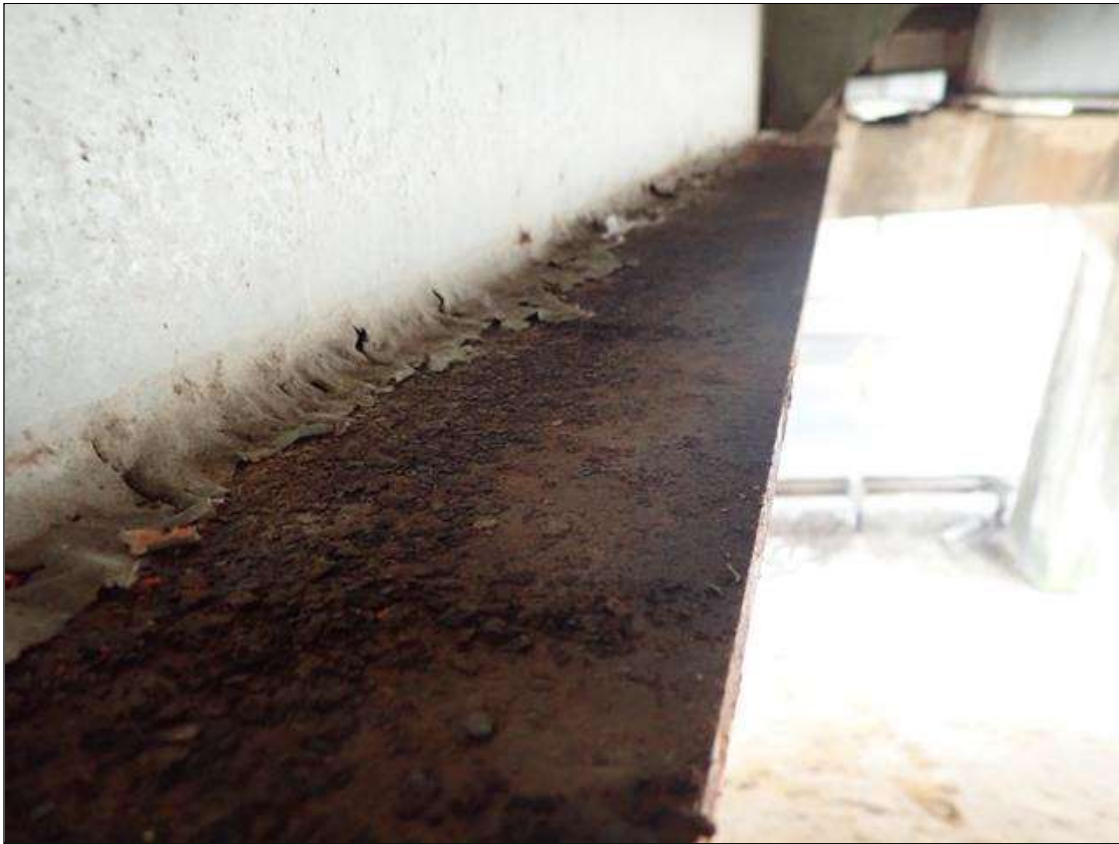
Span 4 Deck: 4 FT x 6 FT PLYWOOD ATTACHED TO BOTTOM DECK IN BAY 8 AT 17 FT FROM BENT 3

Span 4 Beam 6: SURFACE CORROSION SCATTERED THROUGHOUT FULL LENGTH OF BOTTOM FLANGE, NO MEASURABLE SECTION LOSS

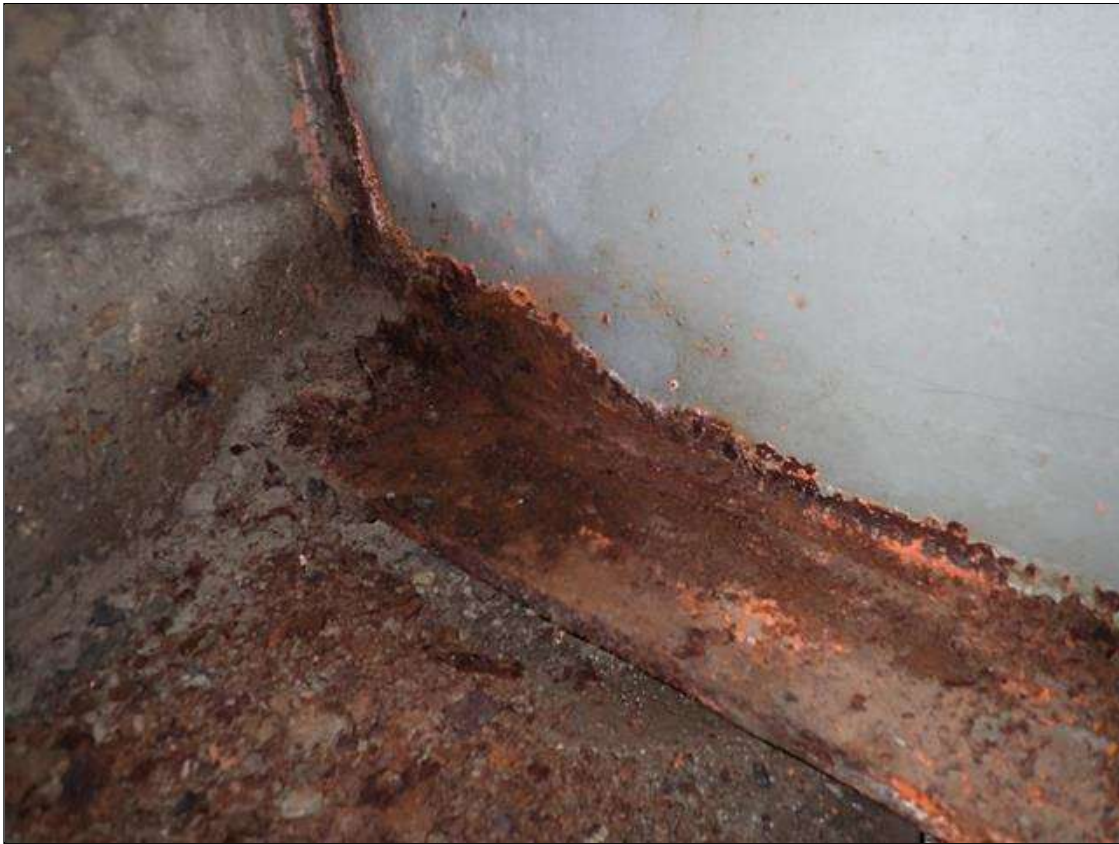
Span 4 Beam 7: SURFACE CORROSION ON BOTTOM FLANGE THROUGHOUT FULL LENGTH ON BOTH SIDES

Span 4 Beam 10: 2 FT x 6" OF SURFACE CORROSION IN LOWER 6" OF WEB AT END BENT 2 ON BOTH SIDES,  
NO MEASURABLE SECTION LOSS

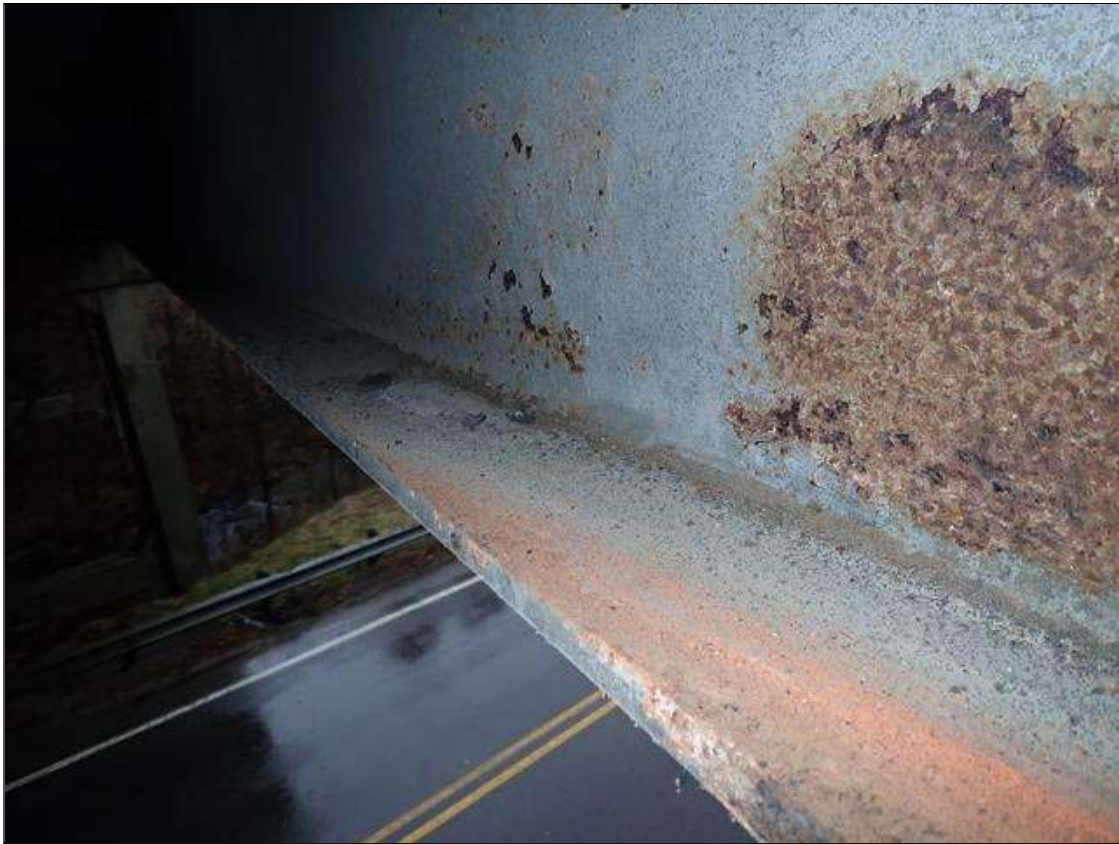
Span 4 Beam 10: SURFACE CORROSION ON BOTH SIDE OF BOTTOM FLANGES THROUGHOUT FULL LENGTH  
OF SPAN, NO MEASURABLE SECTION LOSS

Span 3 Beam 1: SCATTERED SURFACE CORROSION ON BOTTOM FLANGE THROUGHOUT FULL LENGTH OF SPAN

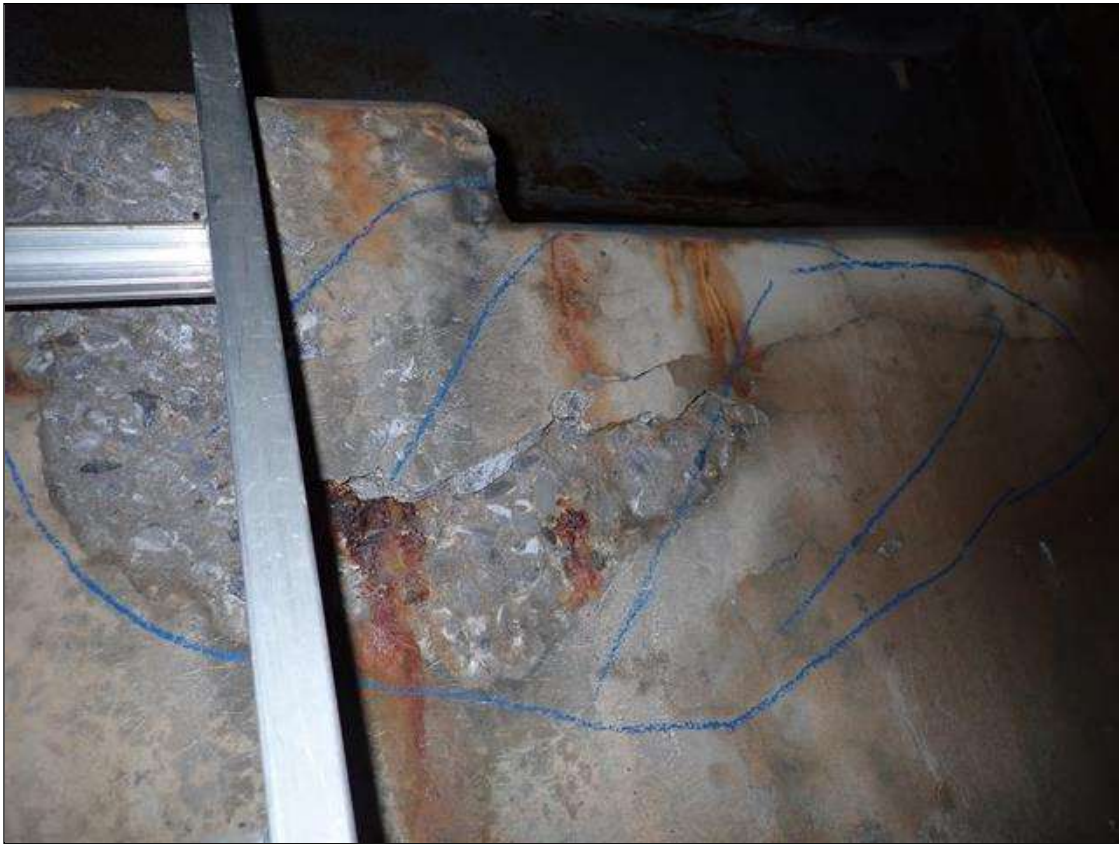
Span 4 Beam 1: 1.5 FT. OF SURFACE CORROSION WITH 1/2" THICKNESS REMAINING SECTION IN BOTTOM FLANGE AT BENT 3

Bent 3 Cap 1: 3 FT X 20" DELAMINATION WITH EXPOSED REBAR IN WEST FACE UNDER BAY 1

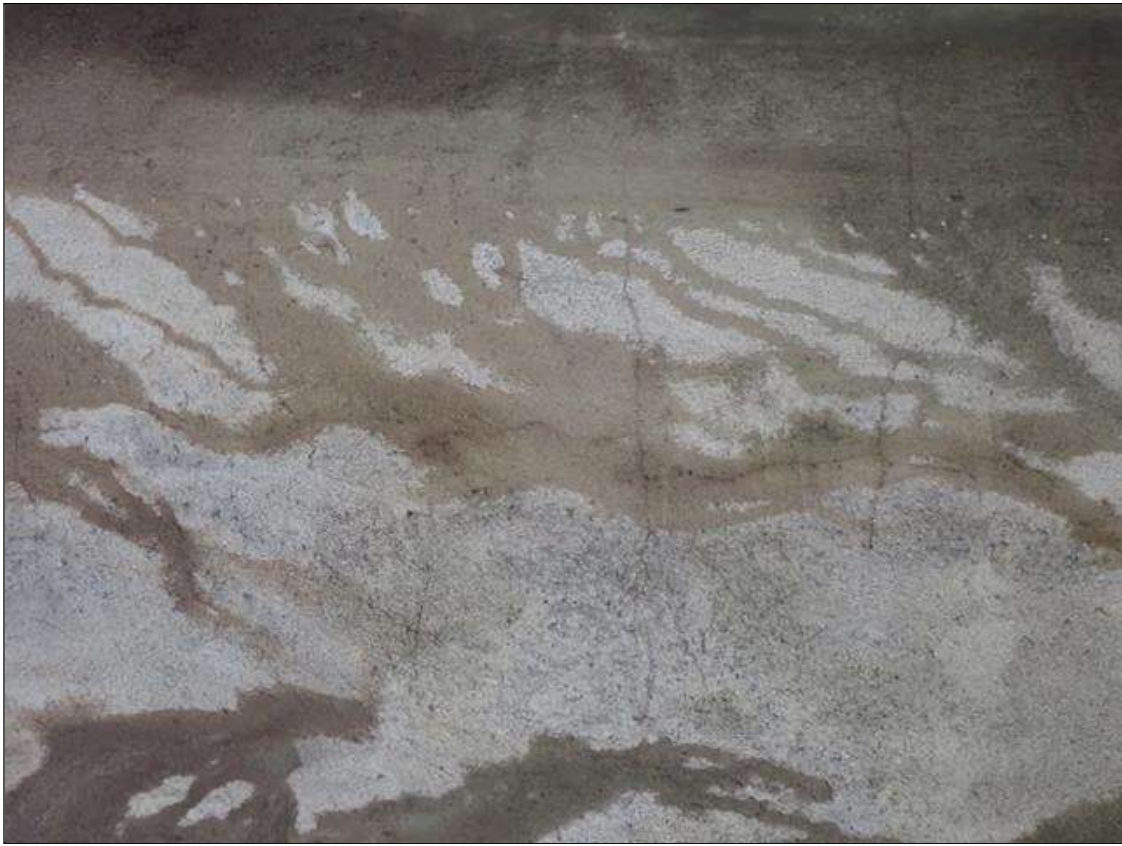
Bent 3 Cap 1: 26" X 4" AREA OF DELAMINATION IN WEST FACE OF BOTTOM CAP UNDER BAY 1

Bent 3 Cap 1: 2 FT x 2 FT x 1 FT HAIRLINE MAP CRACKING AREA ON BOTTOM OF CAP UNDER BAY 2

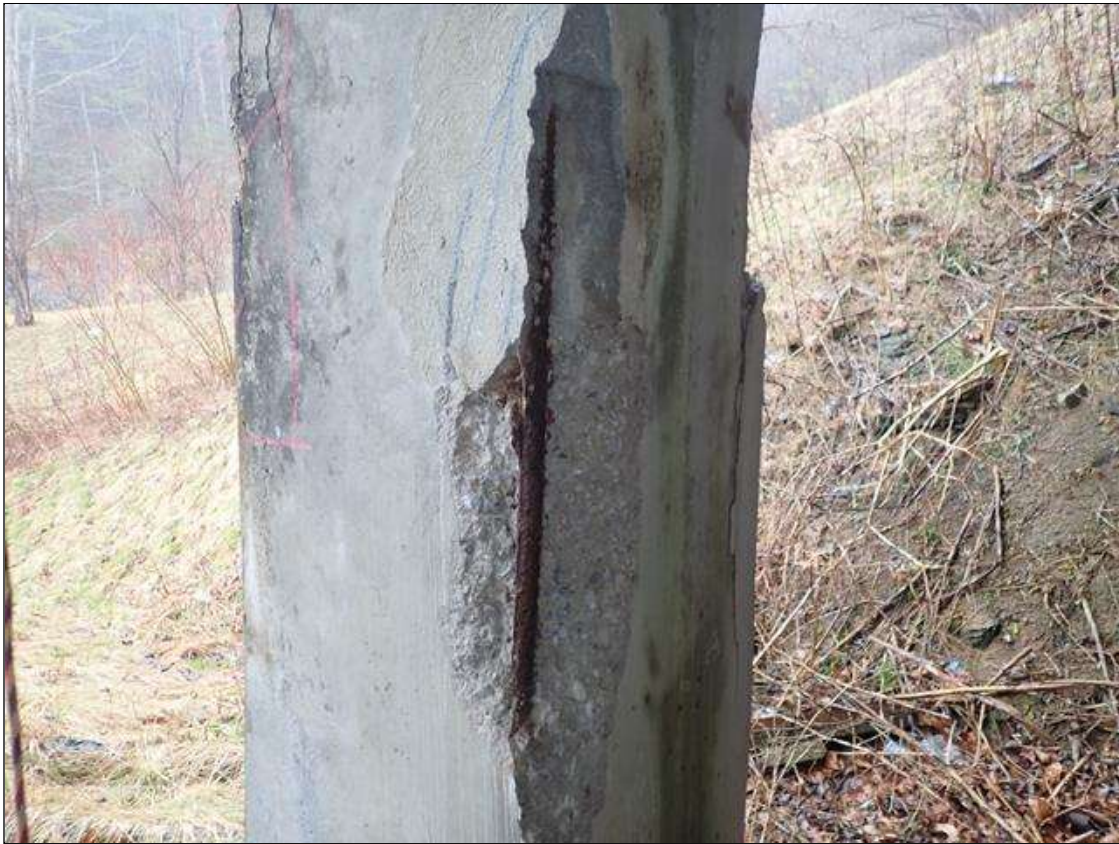
Bent 3 Cap 1: 6 FT x 9" TALL DELAMINATION UNDER BAY 3 IN WEST FACE OF CAP

Bent 3 Pile 1: 8 FT. X 10" X 9" DEEP SPALL WITH EXPOSED MAIN REBAR WITH 1 1/2" REMAINING SECTION IN SOUTHWEST CORNER

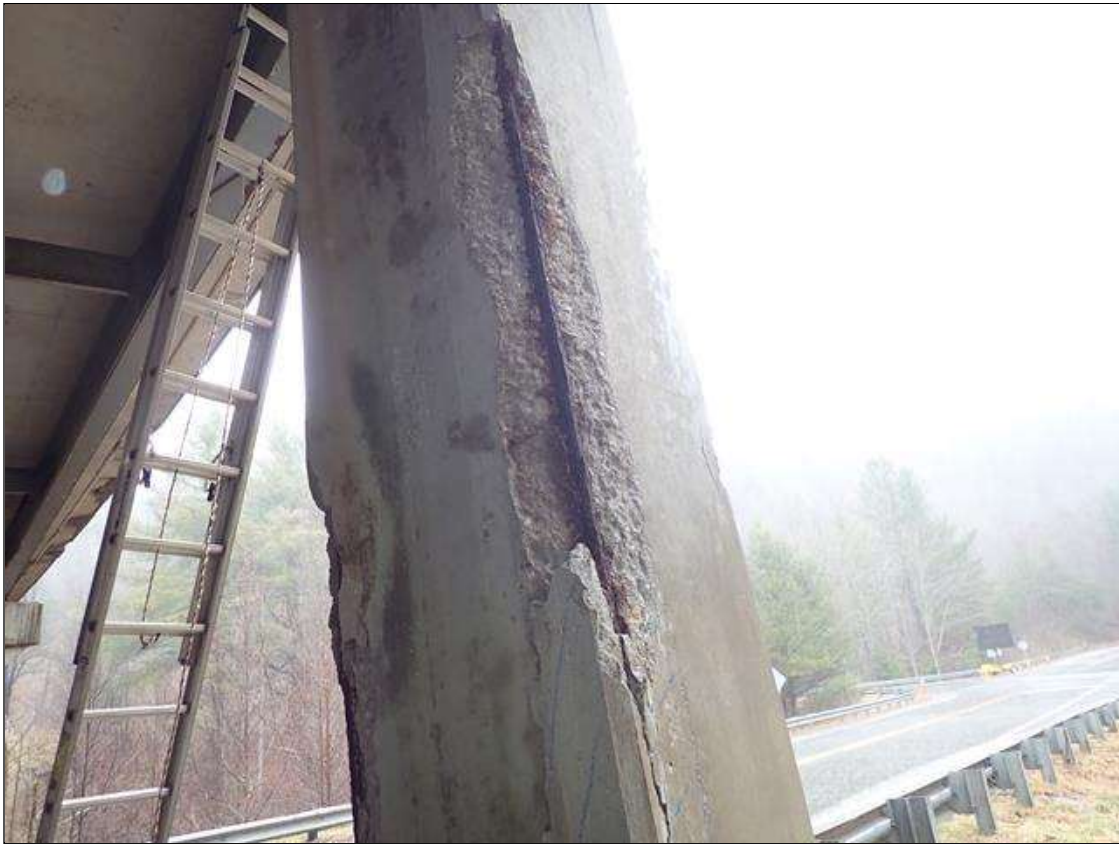
Bent 3 Pile 1: 18" X 6" X 2" DEEP SPALL IN NORTHEAST CORNER

Bent 3 Pile 1: 8.5 FT. X 8" X 10" DEEP SPALL WITH EXPOSED REBAR WITH 1 1/2" REMAINING SECTION IN SOUTHEAST CORNER

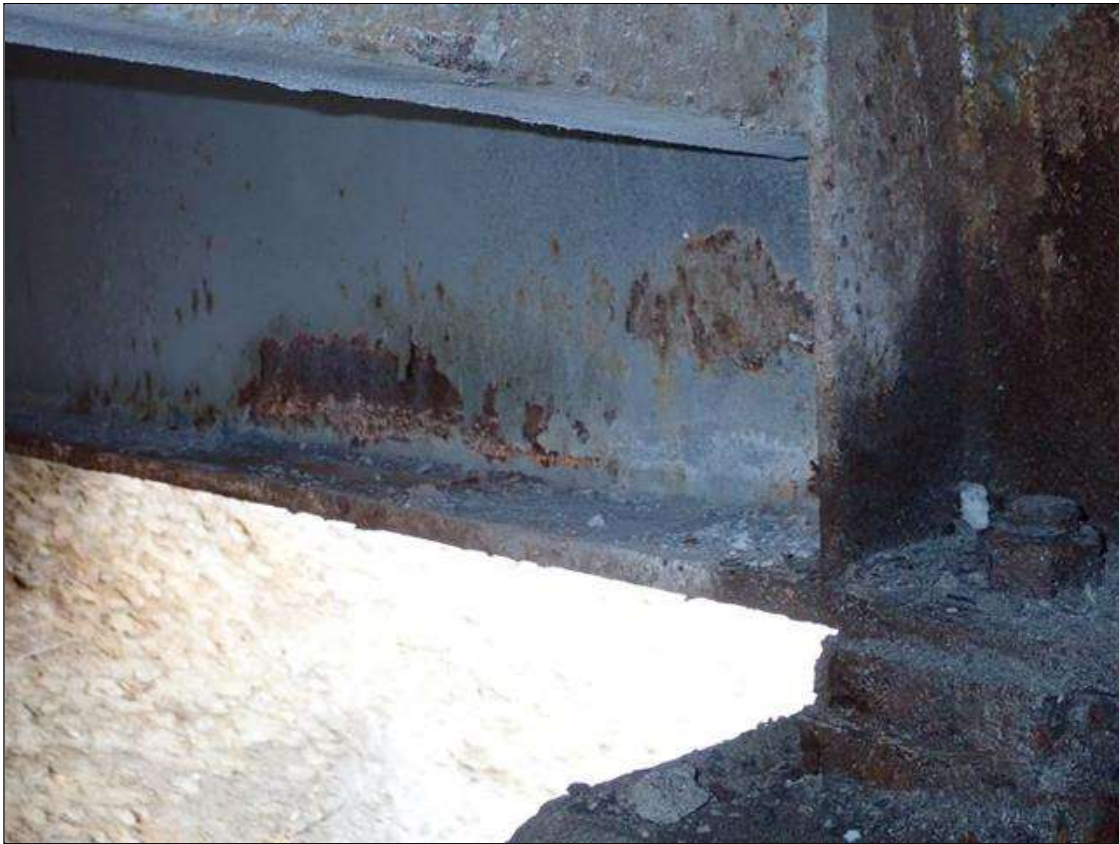
Span 4 Beam 10: SURFACE CORROSION AT BENT 3, 4 FT LONG x FULL HEIGHT OF WEB ON OUTSIDE FACE OF BEAM 10

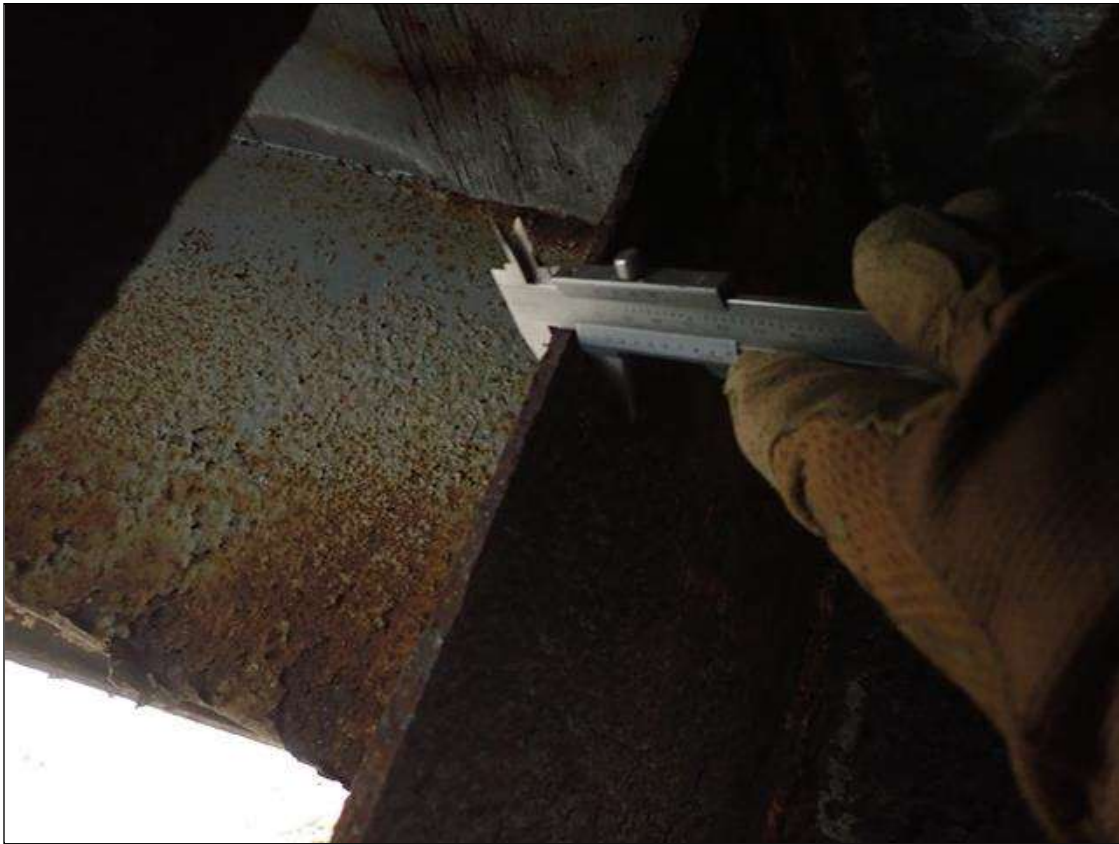
Span 4 Beam 8: 3 FT x 1 FT TALL SURFACE CORROSION ON WEB AT BENT 3

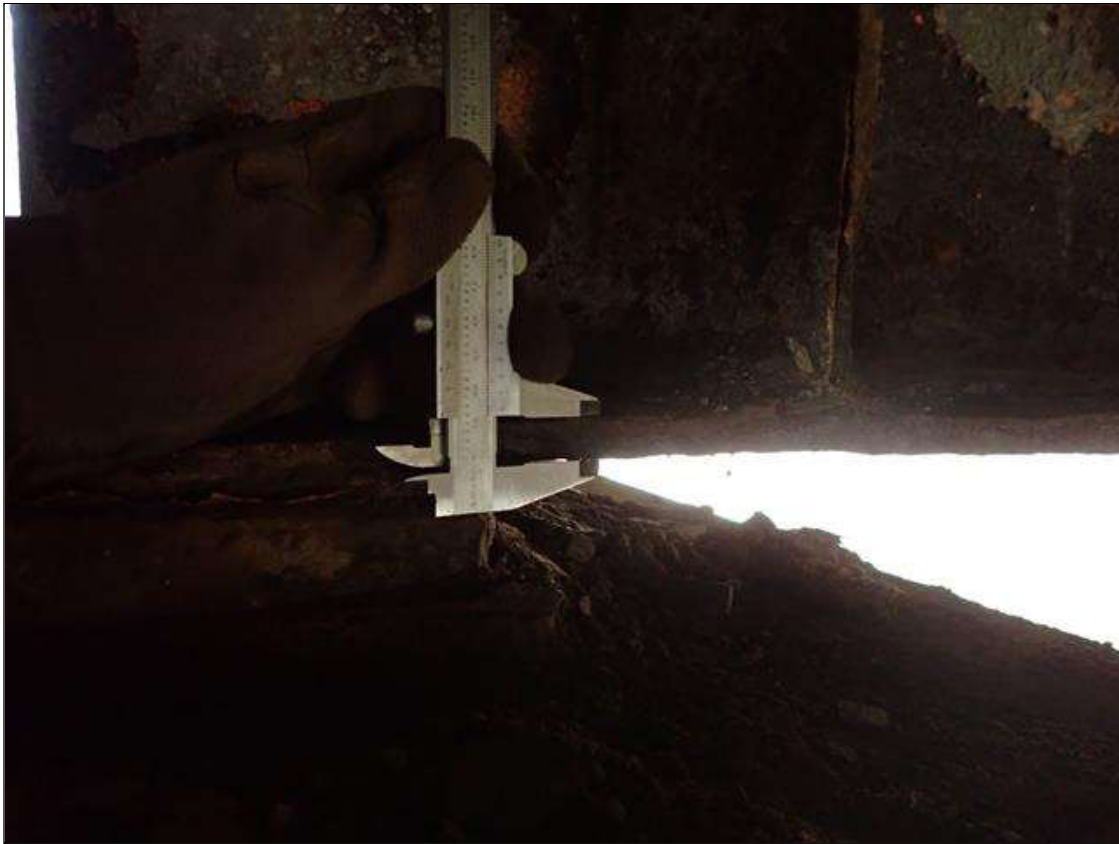
Span 4 Beam 5: 10" LONG x FULL HEIGHT OF SURFACE CORROSION WITH 0.3" REMAINING THICKNESS IN LOWER WEB AND 5/8" REMAINING SECTION IN BOTTOM FLANGE AT BENT 3 (PRIORITY MAINTENANCE ISSUED)

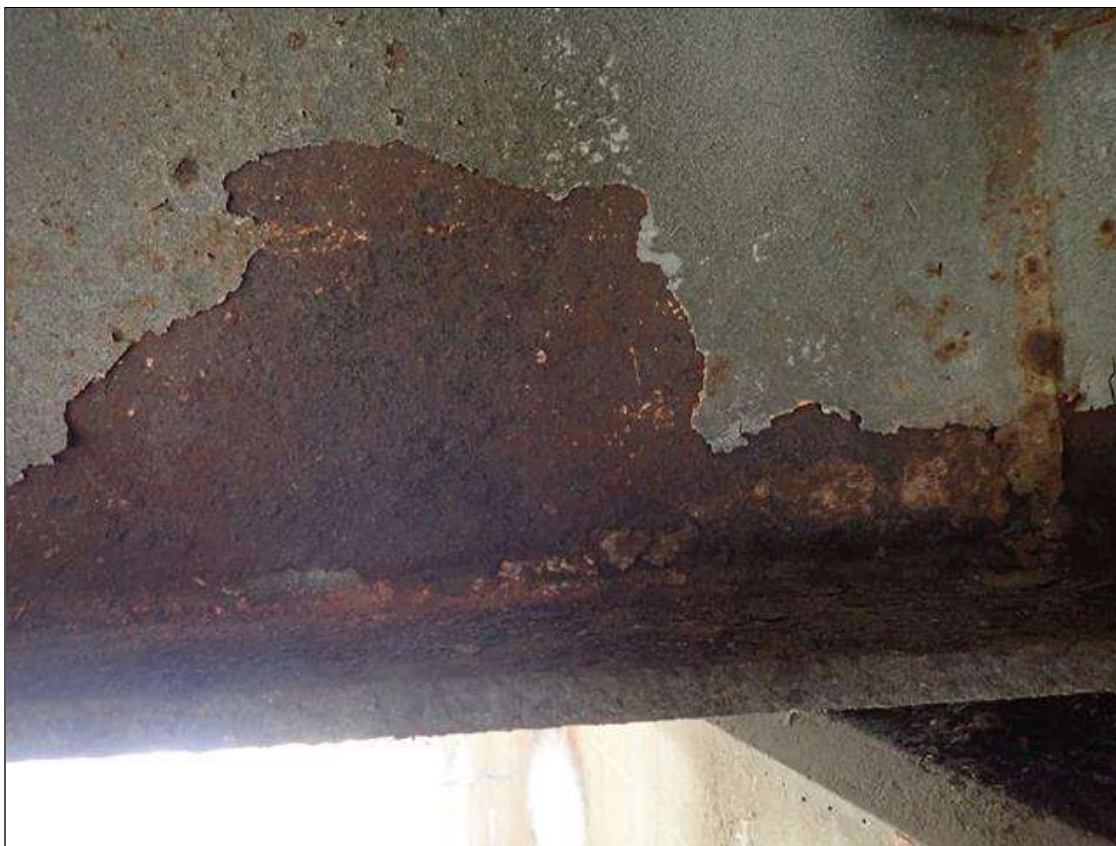
Span 4 Beam 2: 1 FT LONG SECTION LOSS IN BOTTOM FLANGE AT BENT 3, 0.4" THICK SECTION REMAINS, PRIORITY MAINTENANCE ISSUED

Span 3 Beam 2: 1 FT LONG SURFACE CORROSION ON BOTTOM FLANGE AT BENT 3, 0.5" REMAINING THICKNESS IN BOTTOM FLANGE

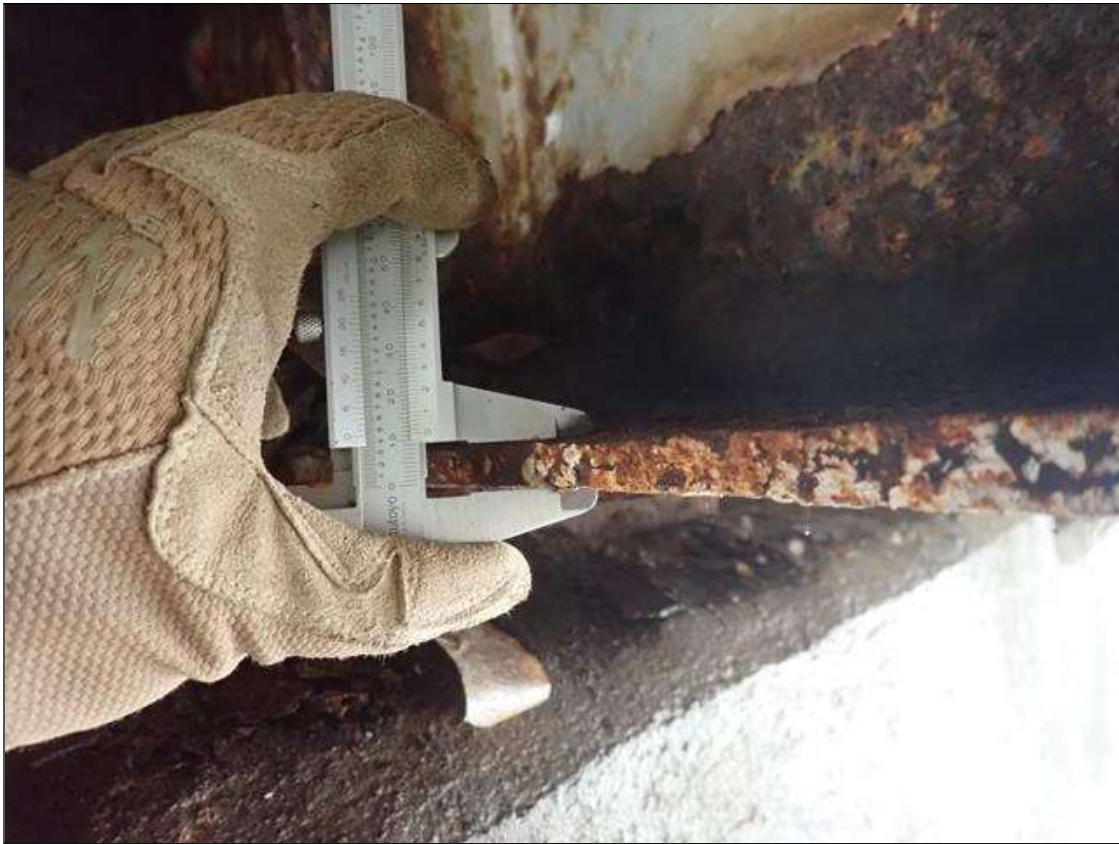
Span 3 Beam 2: 4 FT. x 10" TALL SURFACE CORROSION IN LOWER WEB AT BENT 3, NO MEASURABLE SECTION LOSS

Span 3 Beam 3: SCATTERED SURFACE CORROSION ON BOTTOM FLANGE THROUGHOUT FULL LENGTH

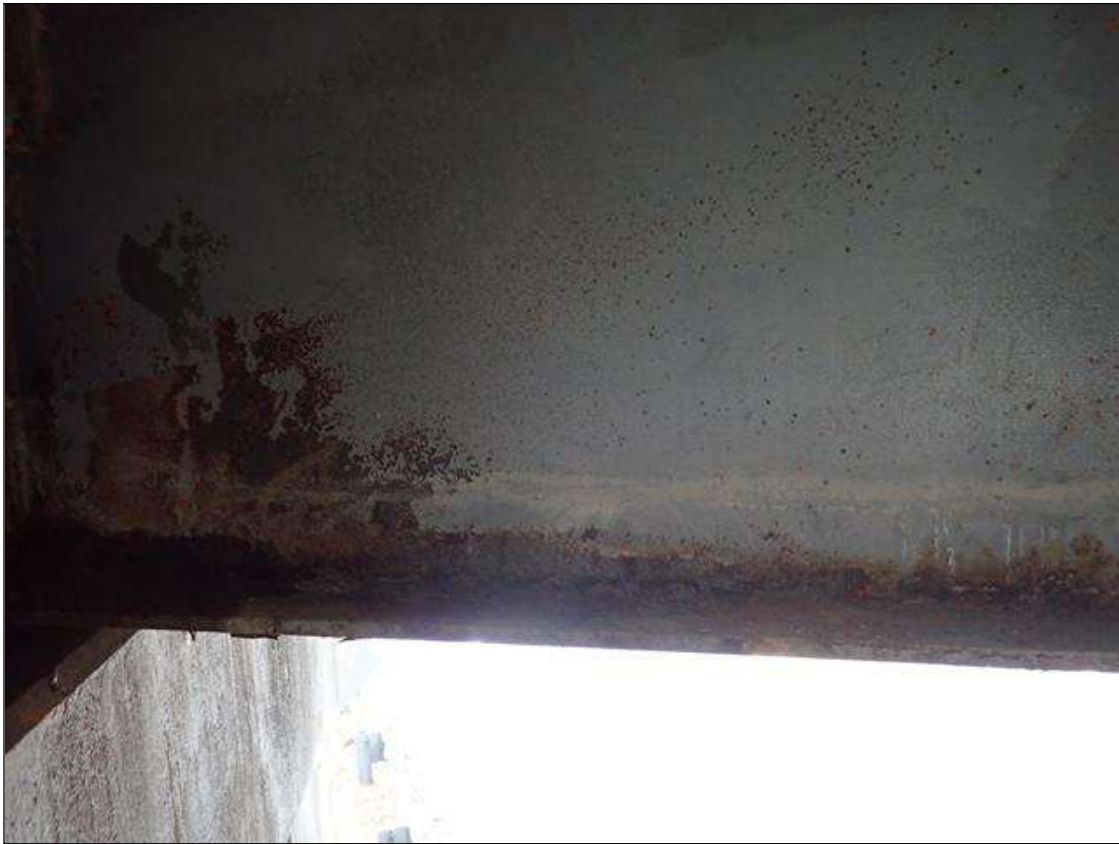
Span 3 Beam 6: 2 FT. OF SURFACE CORROSION, 0.45" REMAINING THICKNESS IN BOTTOM FLANGE AT BENT 3 (PRIORITY MAINTENANCE ISSUED)

Span 3 Beam 7: 1 FT. OF CORROSION WITH 0.65" REMAINING THICKNESS IN BOTTOM FLANGE AT BENT 3

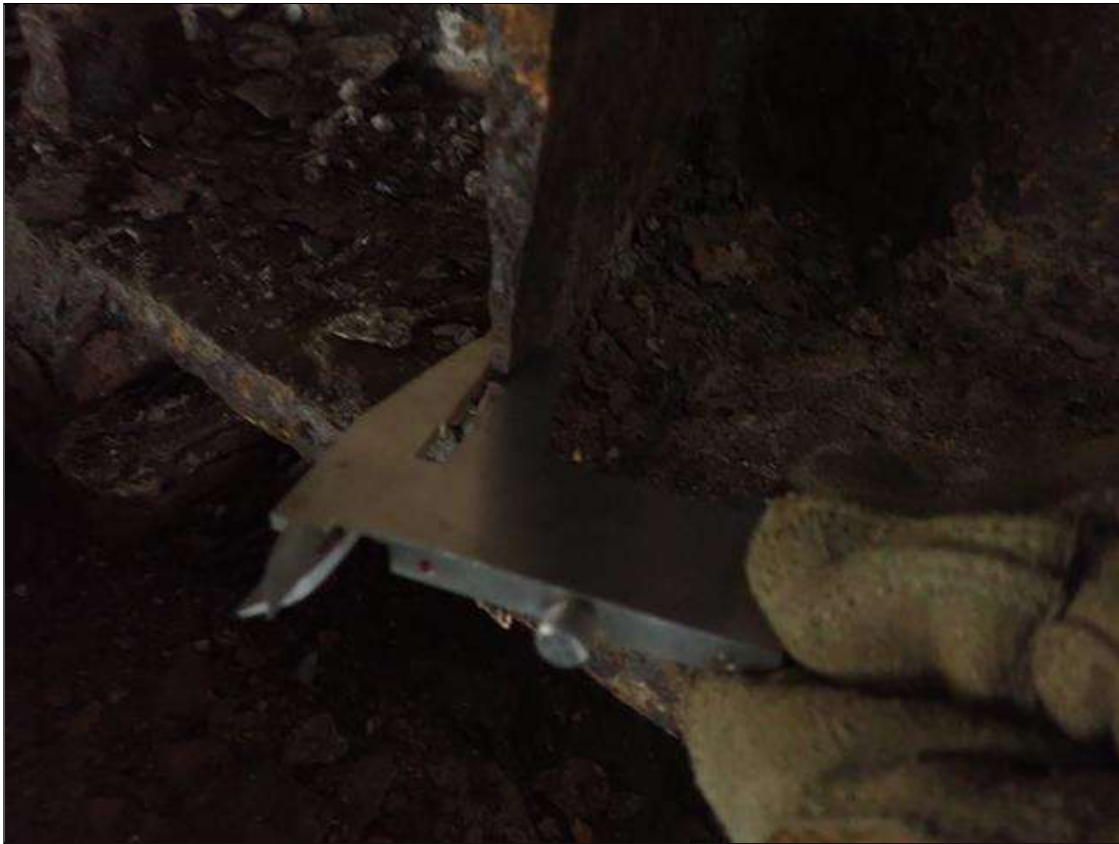
Span 3 Beam 9: 3 FT. OF SURFACE CORROSION IN WEB FOR 15" TALL DOWN TO 4" TALL UNTIL MIDSPAN

Span 3 Beam 5: 2 FT CORROSION WITH SECTION LOSS ON BOTTOM FLANGE, 0.6" THICKNESS REMAINS AT BENT 3

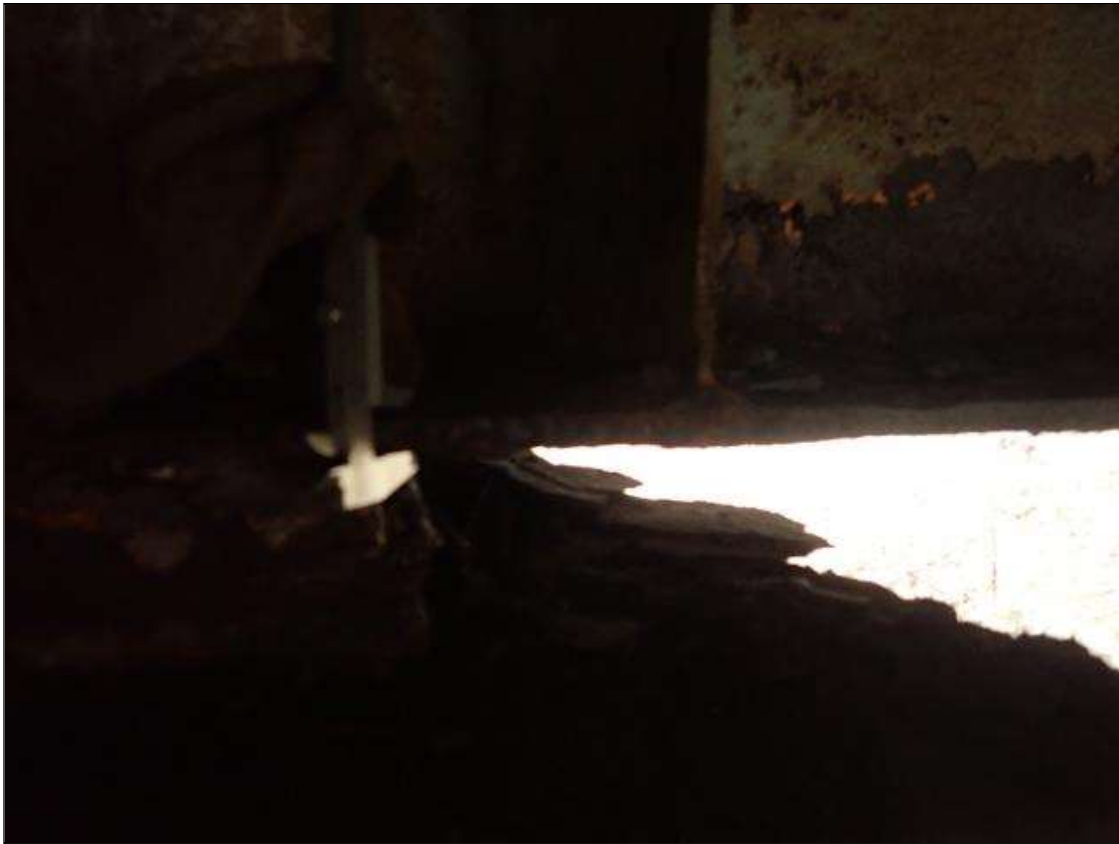
Span 3 Beam 5: BEARING STIFFNER HAS SECTION LOSS FOR 5" TALL x FULL WIDTH, 0.1" THICKNESS REMAINS AT BENT 3. PRIORITY MAINTENANCE ISSUED

Span 3 Beam 5: 10.5 FT x 1 FT CORROSION IN LOWER PART OF WEB AT BENT 3, NO MEASURABLE SECTION LOSS.

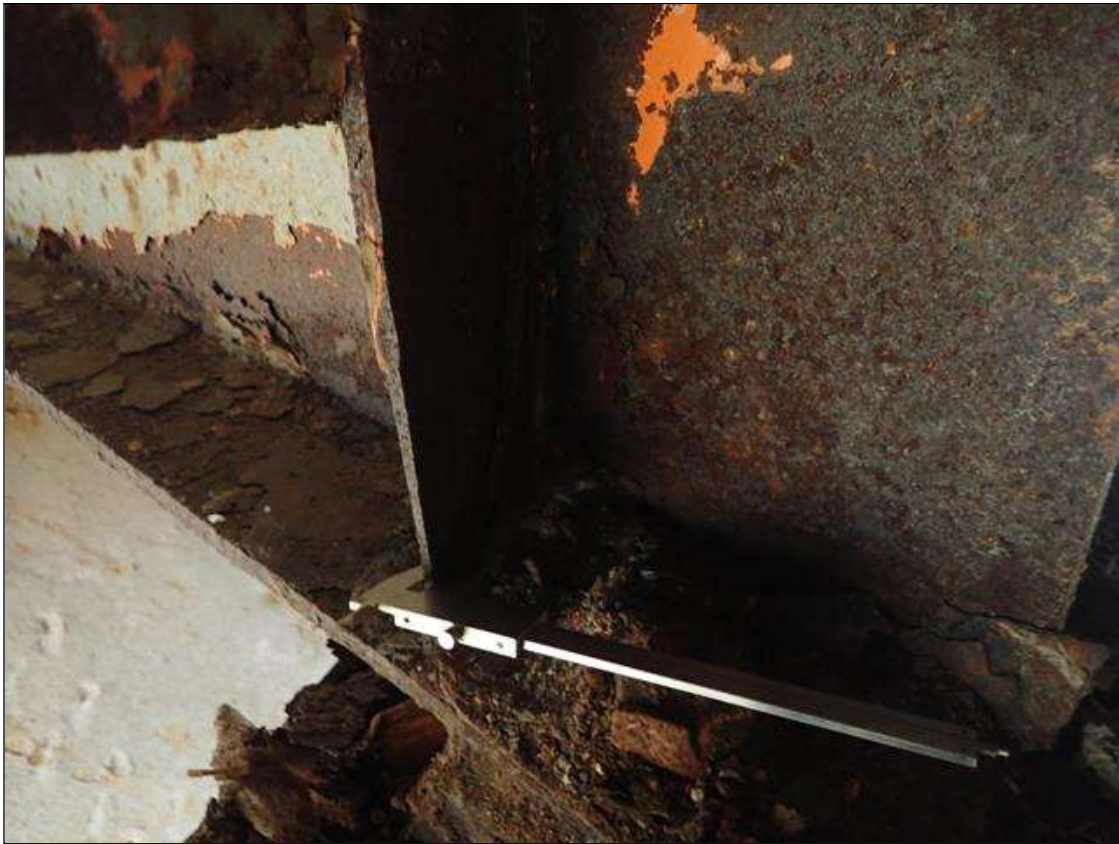
Span 4 Beam 3: 1 FT. OF CORROSION WITH 0.4" REMAINING THICKNESS IN BOTTOM FLANGE AT BENT 3  
(PRIORITY MAINTENANCE ISSUED)

Span 4 Beam 4: 1 FT. OF CORROSION WITH 0.4" REMAINING THICKNESS IN BOTTOM FLANGE AT BENT 3  
(PRIORITY MAINTENANCE ISSUED)

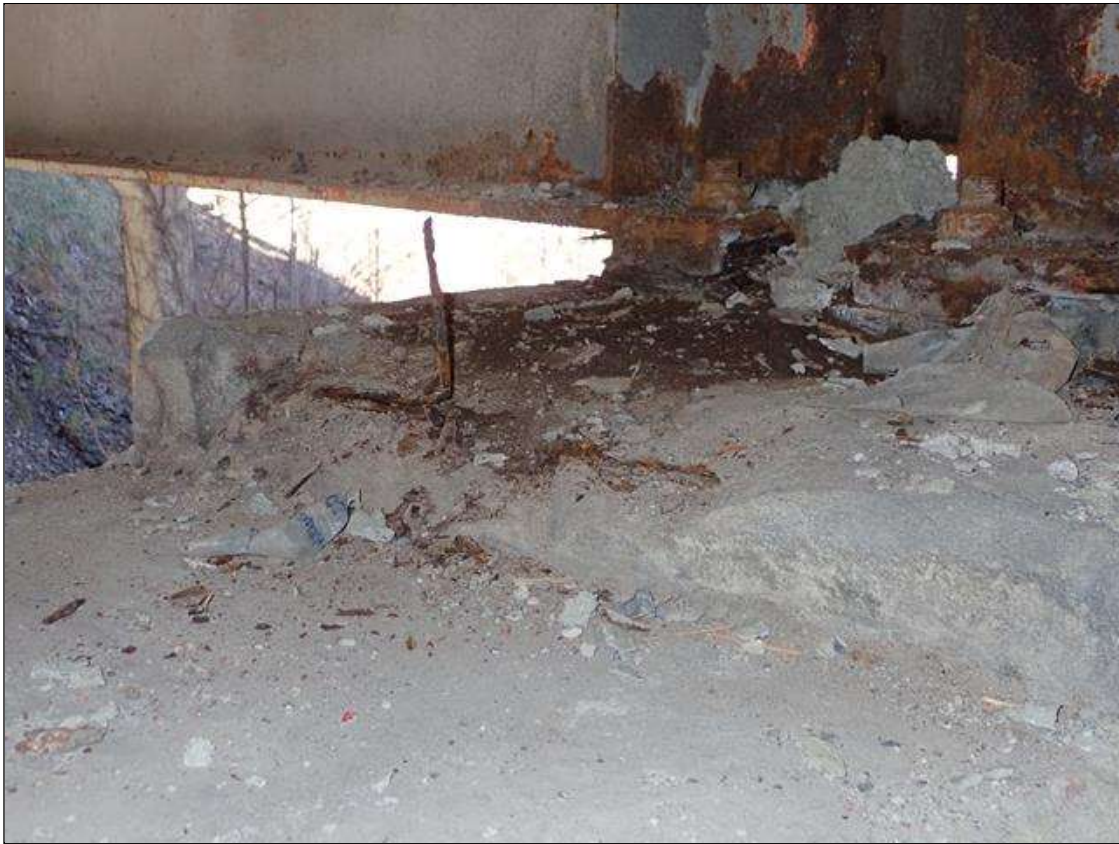
Span 4 Beam 4: CORROSION WITH SECTION LOSS ON BEARING STIFFNER FOR 11" HIGH, 0.15" THICKNESS REMAINS, PRIORITY MAINTENANCE ISSUED

Bent 2 Cap 1: 3 FT x 2 FT DELAMINATION AREA IN END OF CAP NEAR GIRDER 10

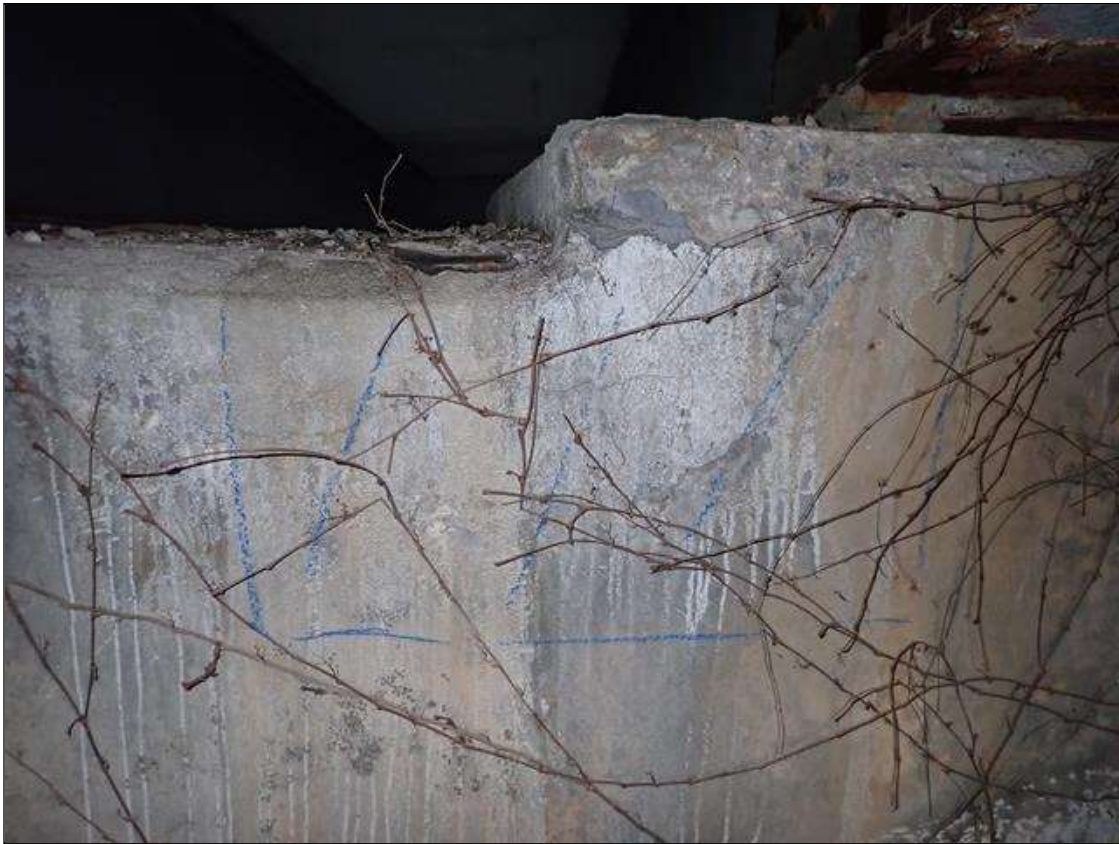
Bent 1 Cap 1: 2.5 FT x 1 FT AREA OF DELAMINATION/SPALL UNDER BAY 4 IN EAST FACE OF CAP AT THE STEP

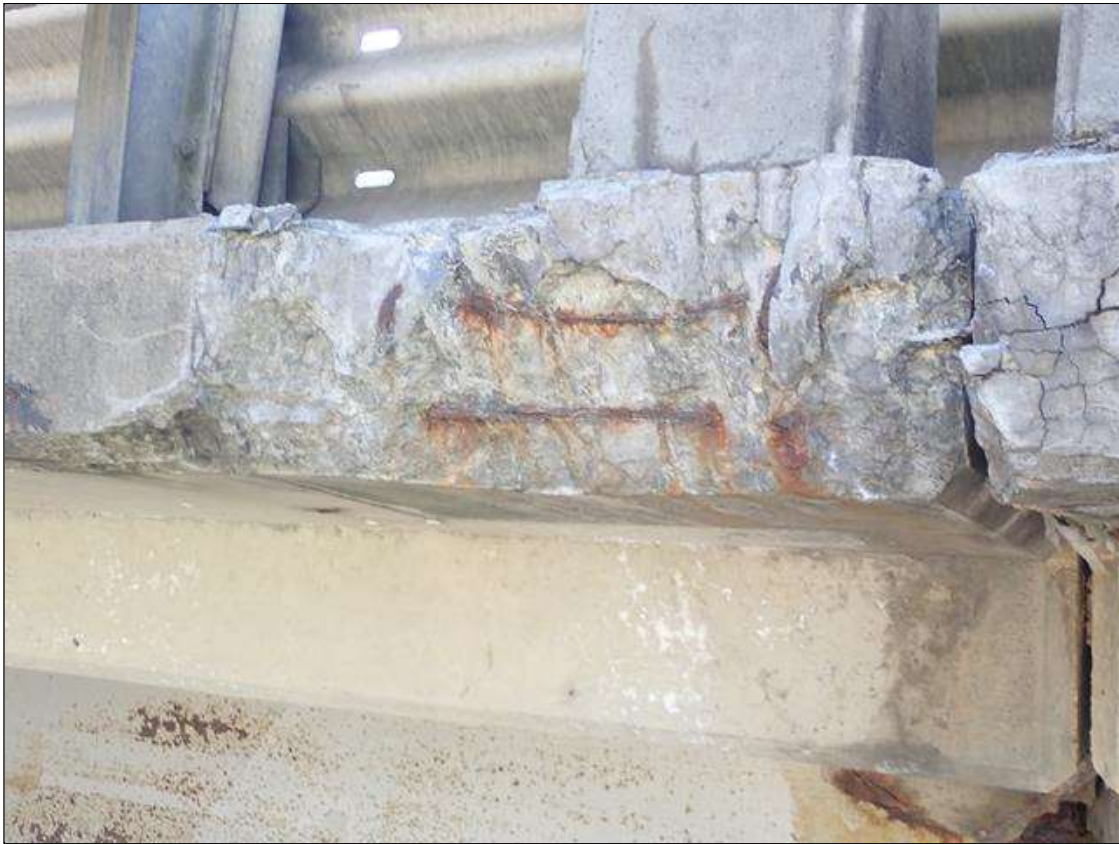
Span 3 Deck: 2.5 FT x 10" x 6" SPALL IN UNDERSIDE OF DECK NEAR GIRDER 1 AT BENT 2 WITH EXPOSED REBAR, NO MEASURABLE SECTION LOSS

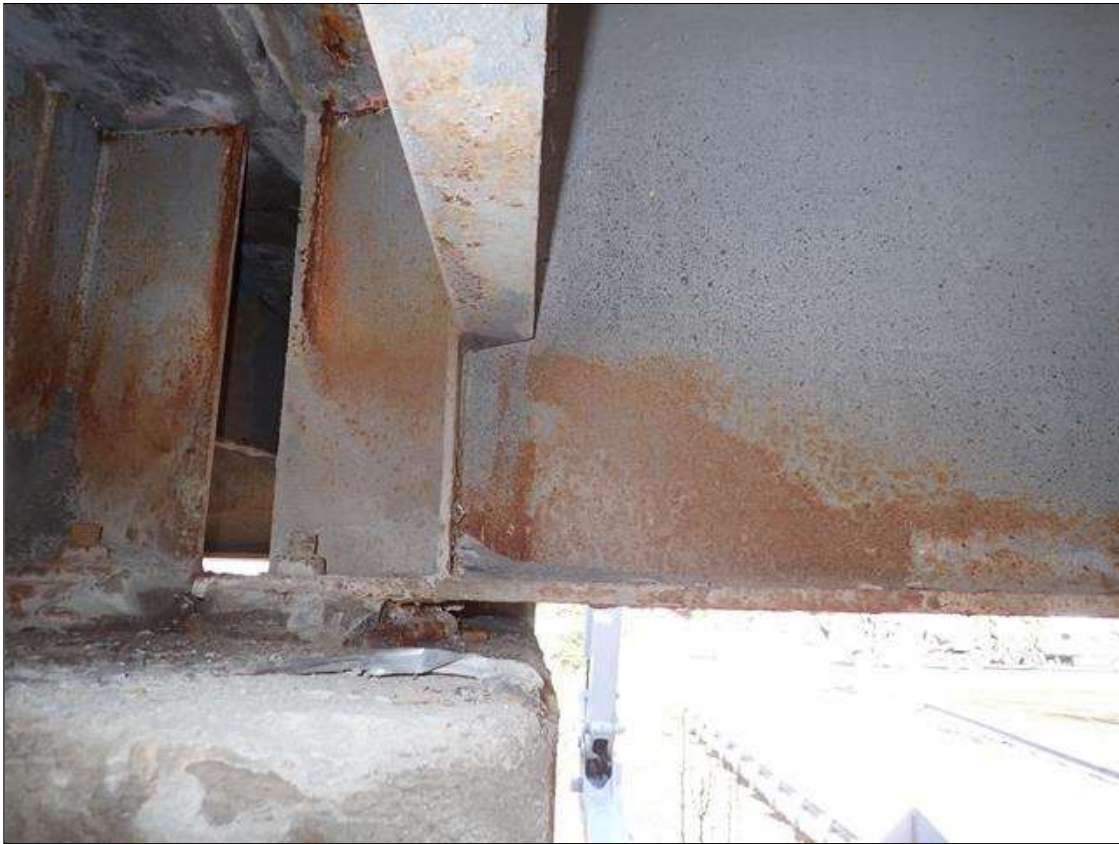
Span 3 Beam 3: 3 FT LONG x 18" HIGH AREA OF SURFACE CORROSION ON WEB AT BENT 2 ON BOTH FACES

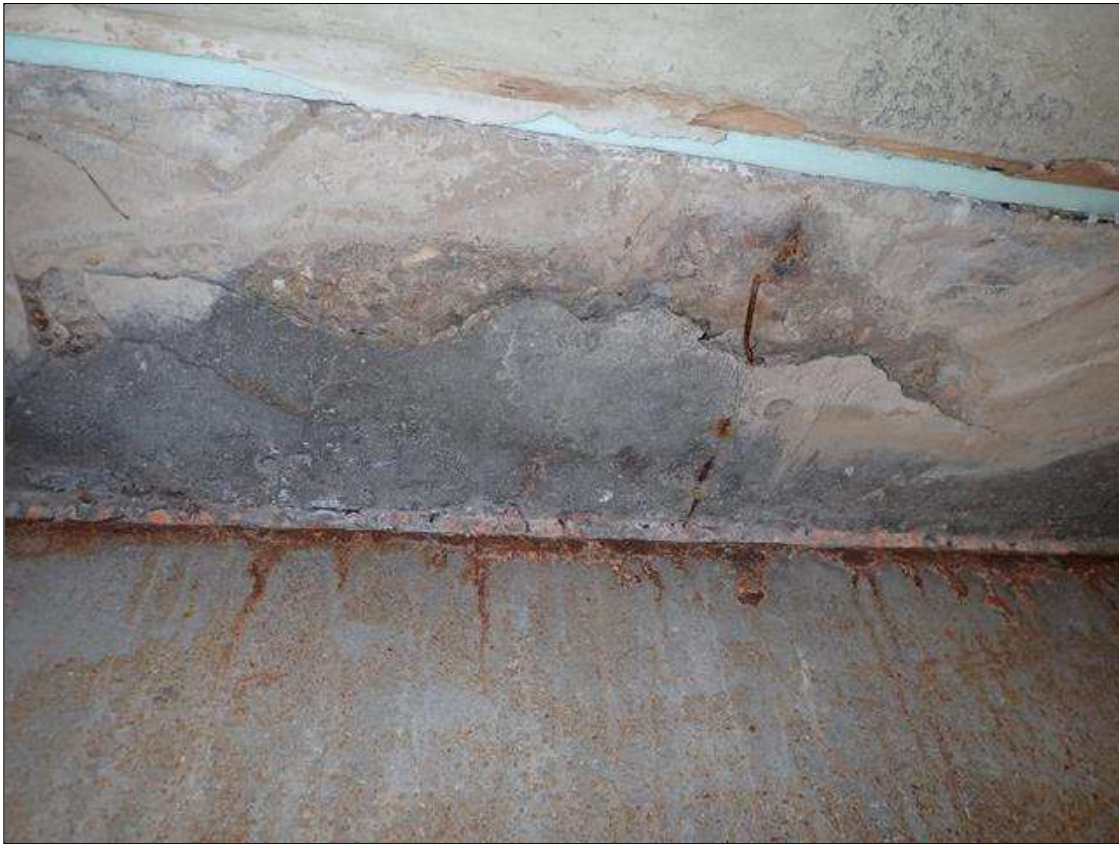
Span 3 Deck: 2 SPALLS IN UNDERSIDE OF DECK NEAR GIRDER 8 AT BENT 2, ONE IS 18" x 10" x 2.5" DEEP WITH EXPOSED REBAR AND NO MEASURABLE SECTION LOSS. SECOND SPALL IS 2 FT x 3" x 1" DEEP WITH NO EXPOSED REBAR.

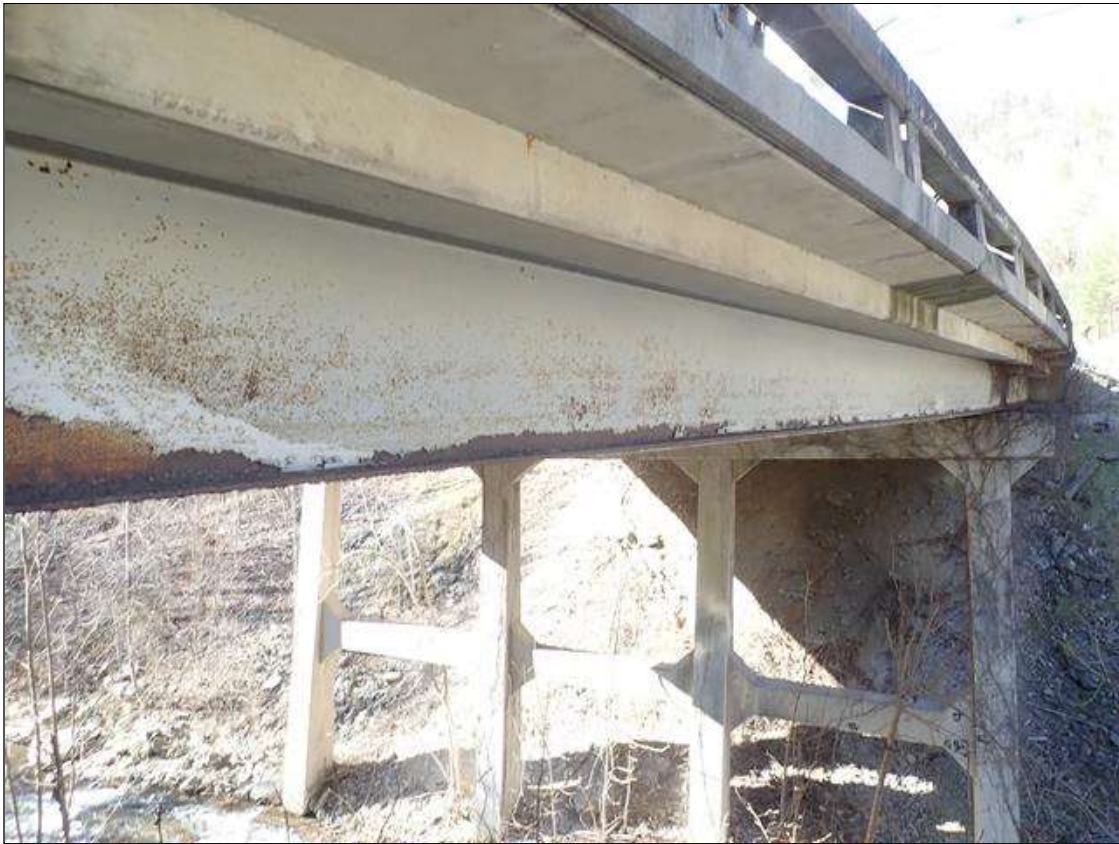
Span 2 Beam 1: SURFACE CORROSION ON BOTTOM FLANGE ALONG FULL LENGTH
