NC DEPARTMENT OF TRANSPORTATION  
DIVISION OF HIGHWAYS  
STRUCTURE MANAGEMENT UNIT

## Structure Safety Report

### Routine Element Inspection - Contract

DIVISION: 14 COUNTY: HAYWOOD STRUCTURE NUMBER: 430057 FREQUENCY: 24 MONTHS

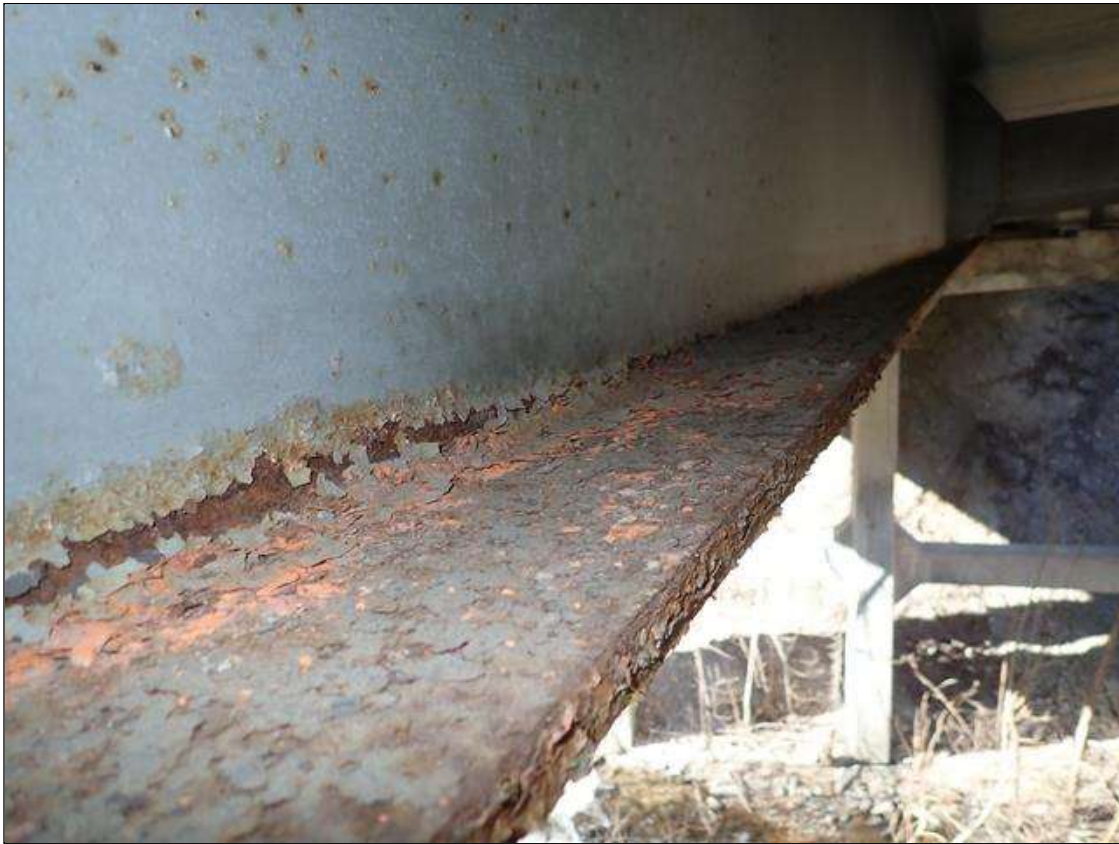
Span 2 Beam 3: SCATTERED SURFACE CORROSION ON BOTTOM FLANGE THROUGHOUT FULL SPAN LENGTH. SCATTERED FRECKLED SURFACE CORROSION IN LOWER 18" OF WEB FOR 6 FT LONG AT BENT 2.

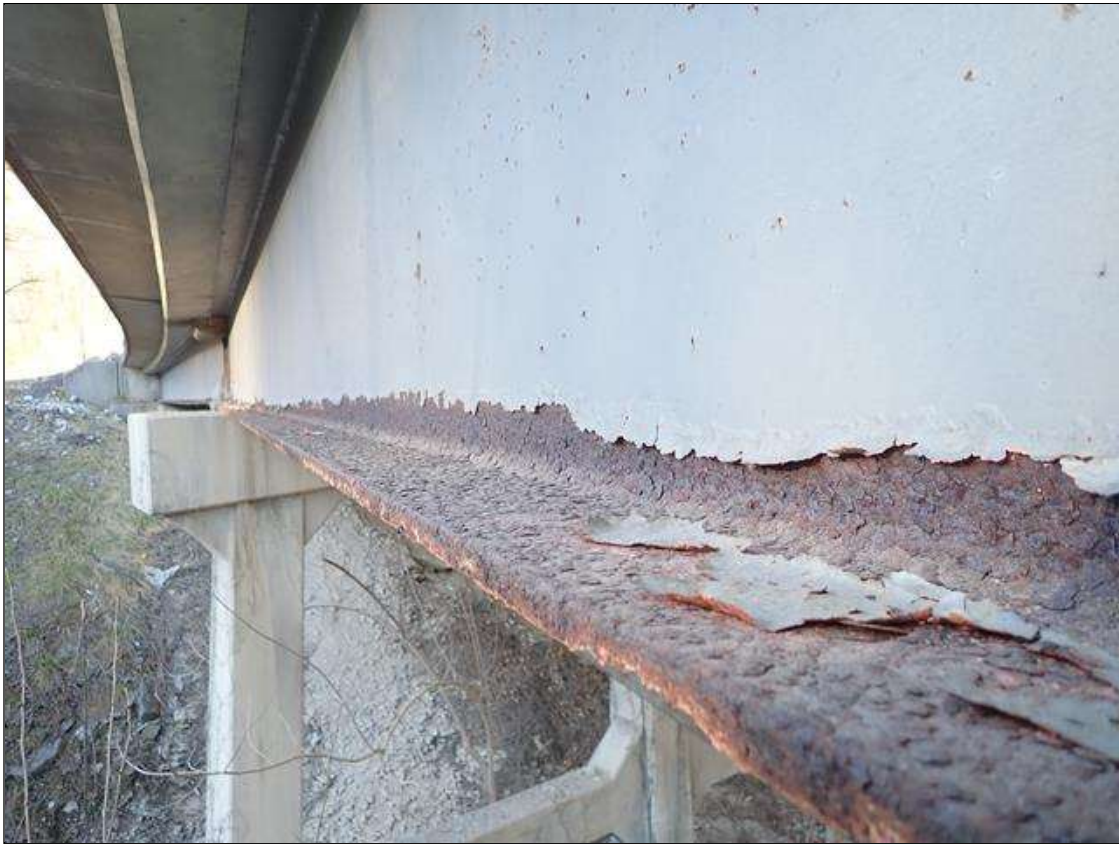
Span 2 Beam 10: SCATTERED SURFACE CORROSION ON BOTTOM FLANGE AND LOWER 6" OF WEB THROUGHOUT FULL SPAN LENGTH WITH NO MEASURABLE SECTION LOSS.

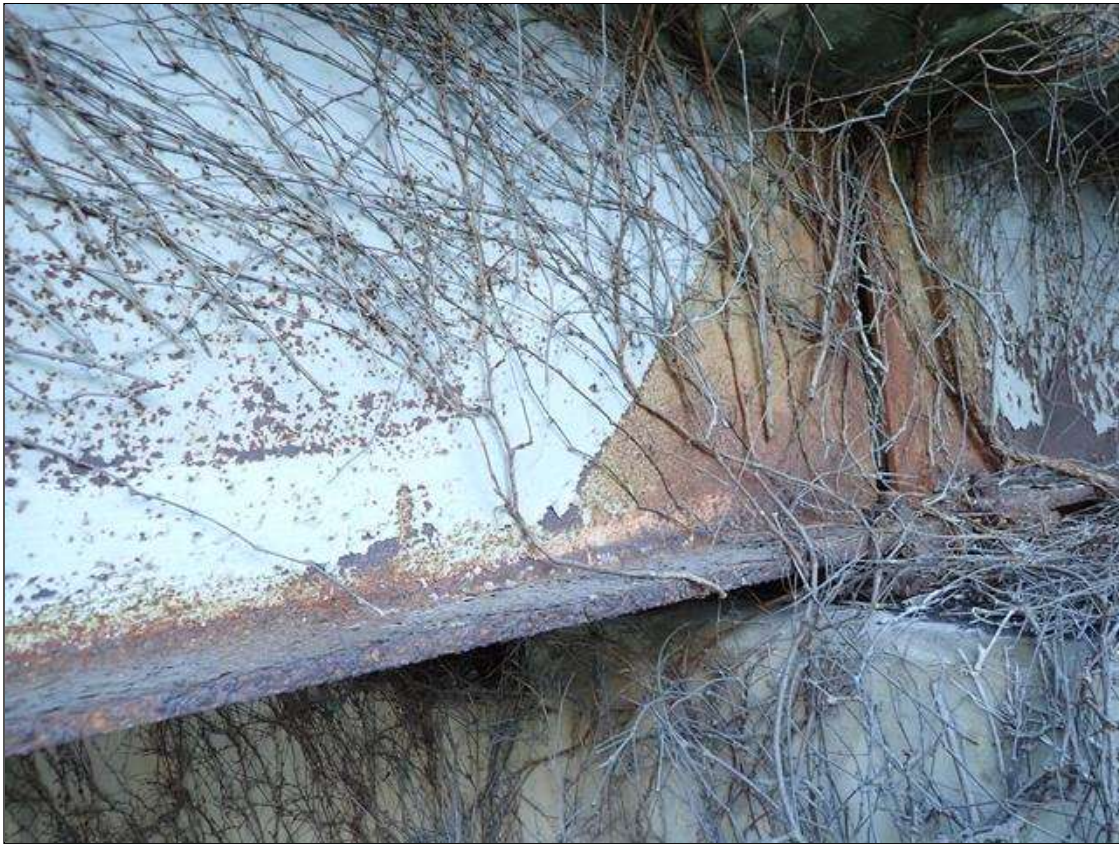
Span 2 Beam 1: SURFACE CORROSION ON FULL HEIGHT OF WEB FOR 30" LONG AT BENT 1 WITH NO MEASURABLE SECTION LOSS. SURFACE CORROSION ON BOTTOM FLANGE AND LOWER 6" OF WEB THROUGHOUT FULL SPAN LENGTH ON OUTSIDE GIRDER FACE

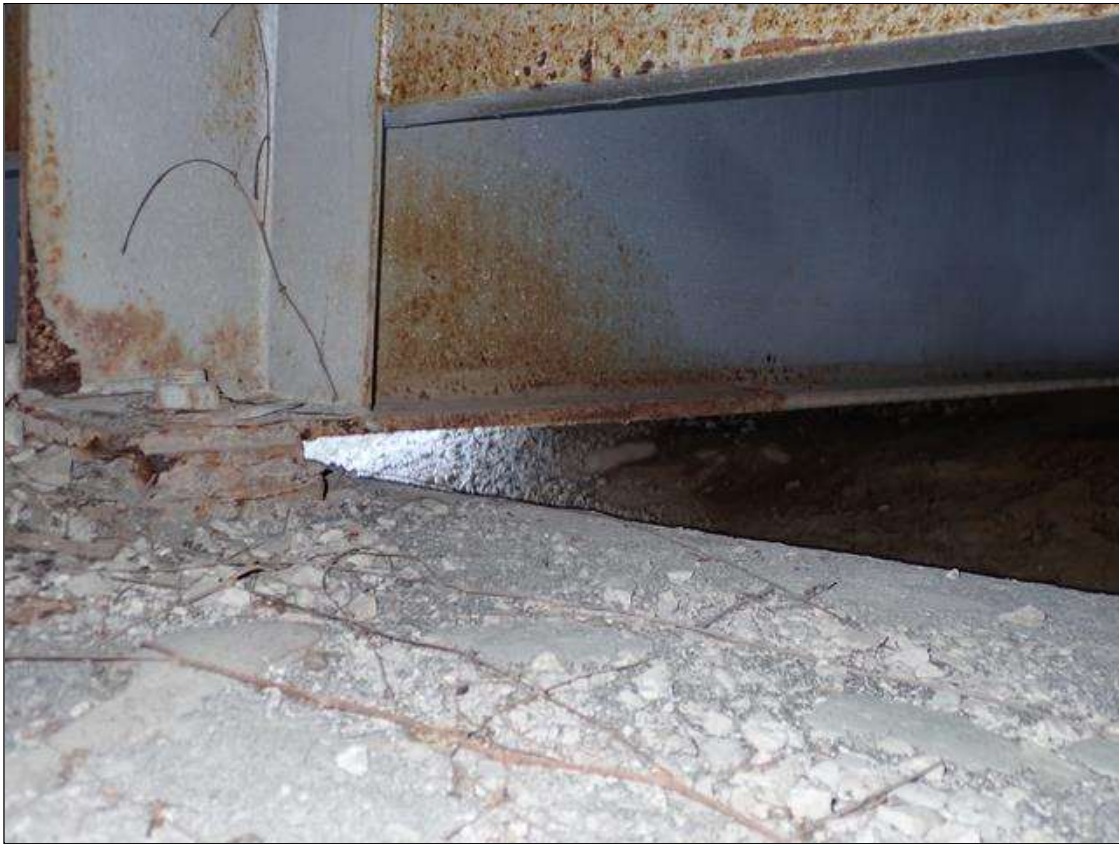
Span 2 Beam 2: SURFACE CORROSION ON BOTTOM FLANGE FOR 4 FT LONG AT BENT 1 WITH NO MEASURABLE SECTION LOSS

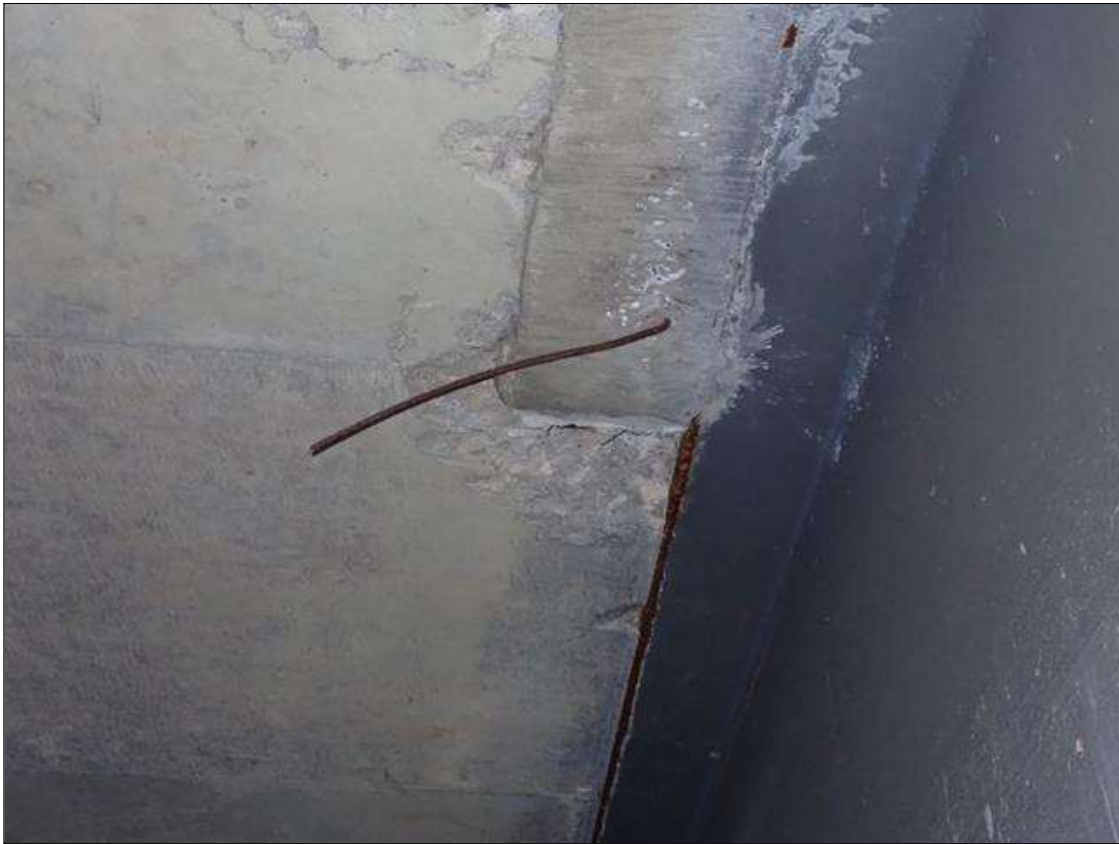
Span 2 Beam 5: SURFACE CORROSION ON TOP FLANGE FOR 15 FT LONG AT MIDSPAN EDGE WITH NO MEASURABLE SECTION LOSS

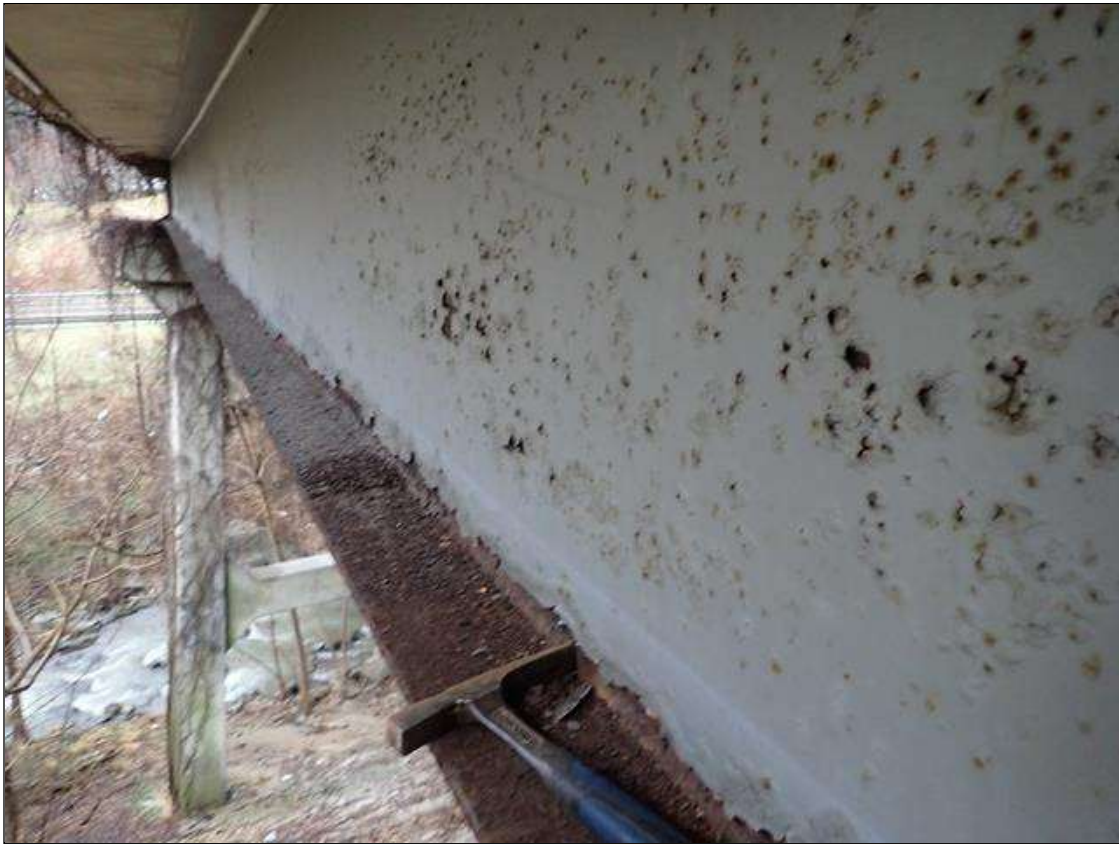
Span 1 Beam 1: SURFACE CORROSION THROUGHOUT FULL LENGTH OF BOTTOM FLANGE AND SCATTERED FRECKLED RUST THROUGHOUT FULL HEIGHT OF WEB x FULL SPAN LENGTH WITH NO MEASURABLE SECTION LOSS

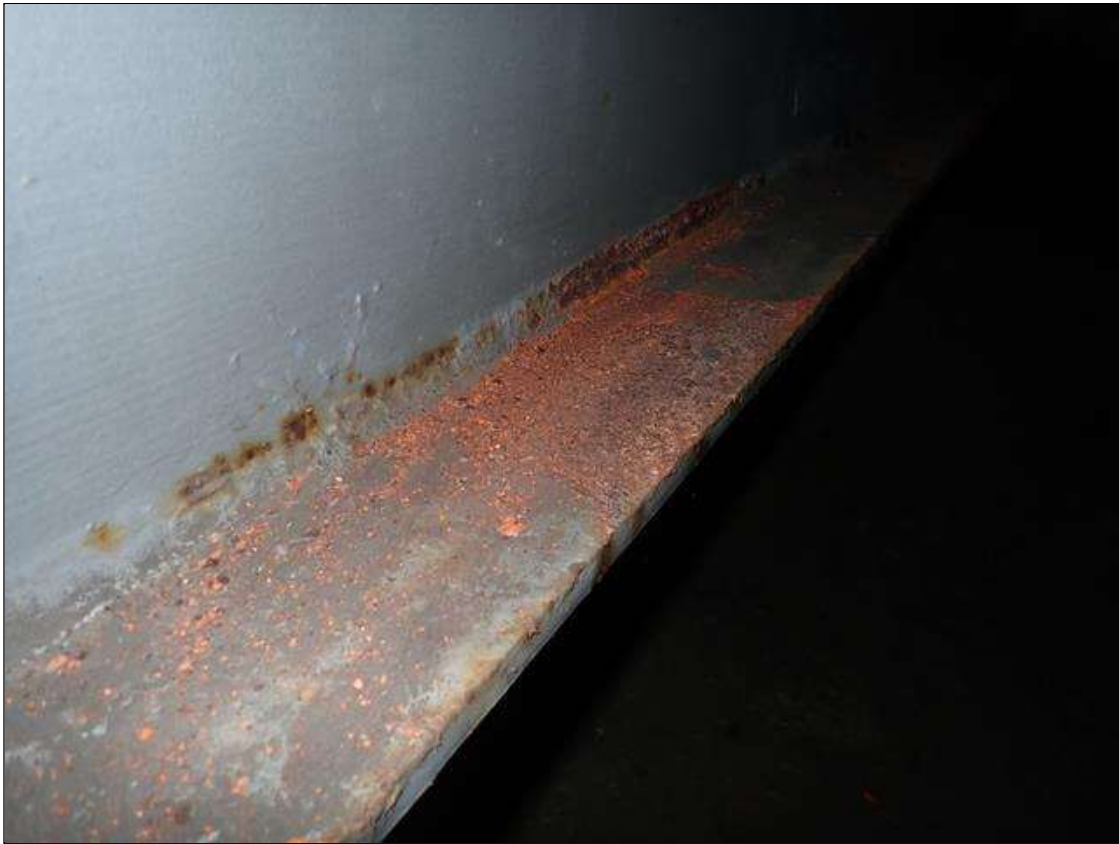
Span 1 Beam 3: SCATTERED SURFACE CORROSION THROUGHOUT FULL LENGTH OF BOTTOM FLANGE AND  
SCATTERED SURFACE CORROSION THROUGHOUT LOWER 2" OF WEB x FULL SPAN LENGTH WITH NO  
MEASURABLE SECTION LOSS

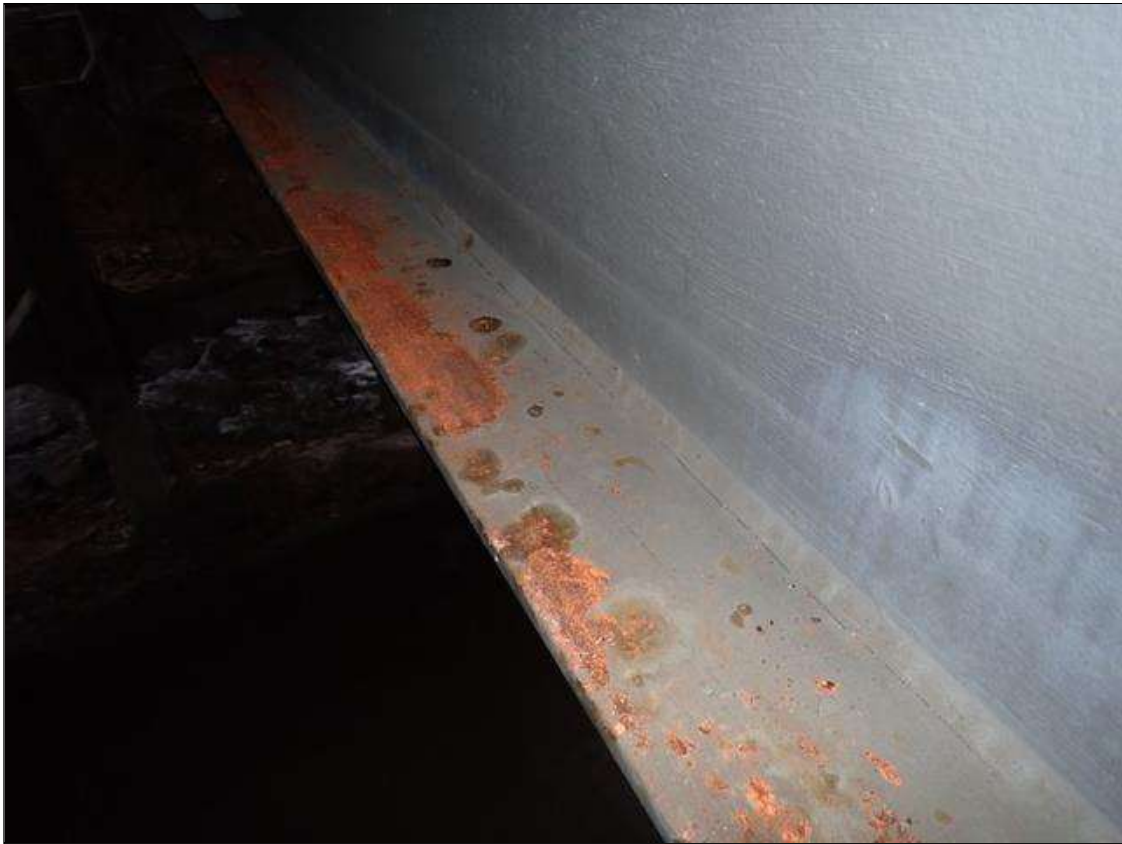
Span 1 Beam 5: SCATTERED SURFACE CORROSION THROUGHOUT FULL LENGTH OF BOTTOM FLANGE  
WITH NO MEASURABLE SECTION LOSS

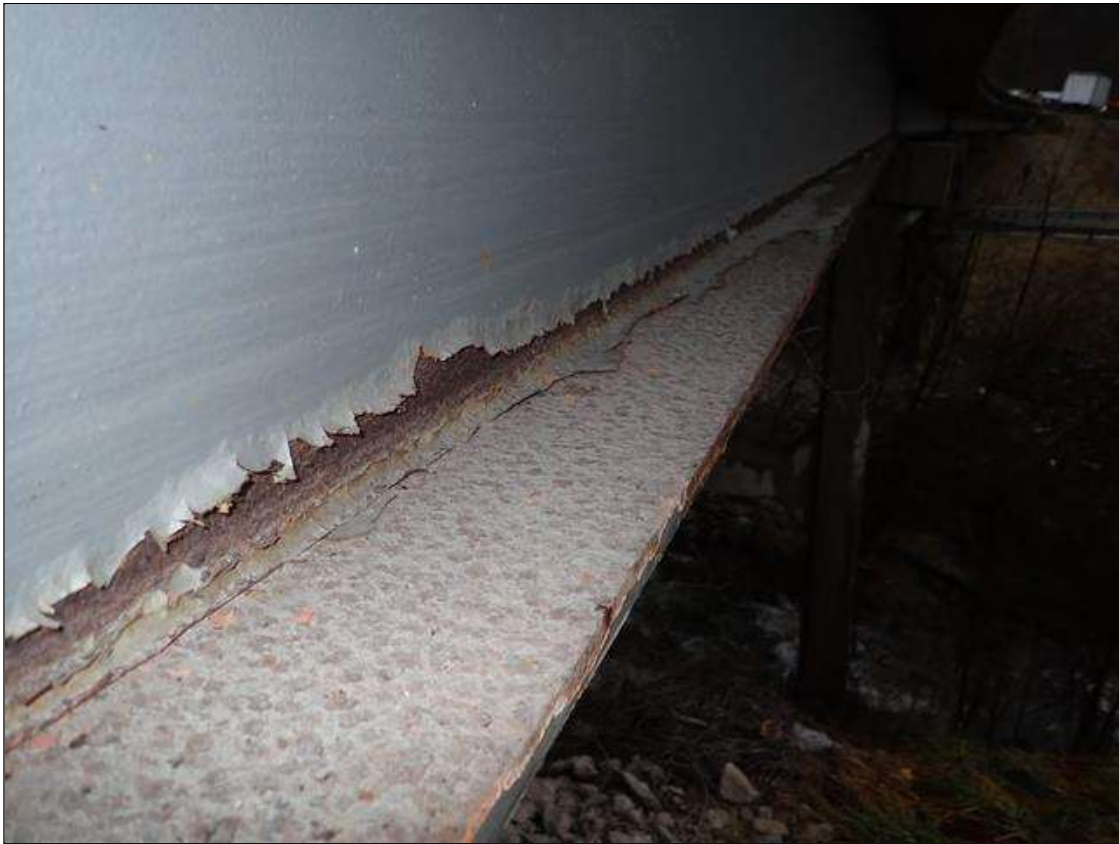
Span 1 Beam 10: SURFACE CORROSION THROUGHOUT FULL LENGTH OF BOTTOM FLANGE AND SURFACE CORROSION THROUGHOUT LOWER 2" OF WEB x FULL SPAN LENGTH WITH NO MEASURABLE SECTION LOSS

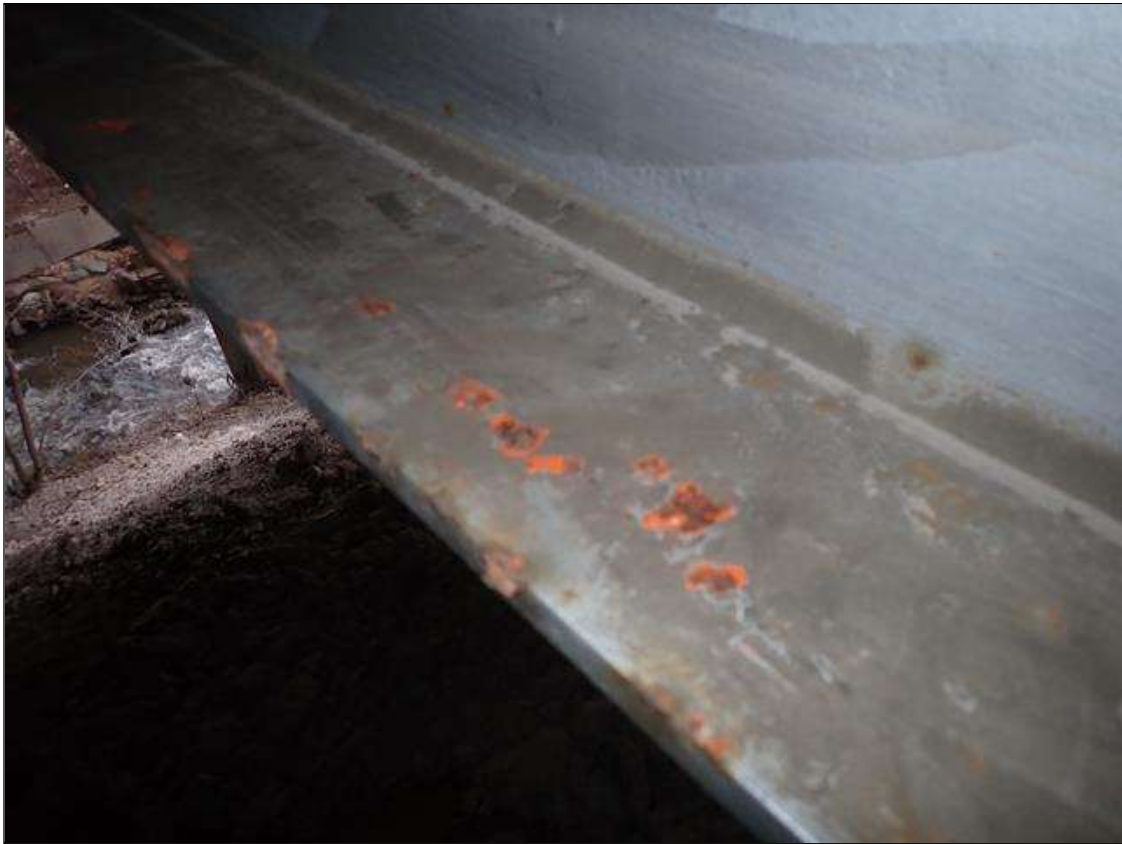
Span 1 Beam 8: SCATTERED FRECKLED CORROSION THROUGHOUT FULL LENGTH OF BOTTOM FLANGE  
WITH NO MEASURABLE SECTION LOSS

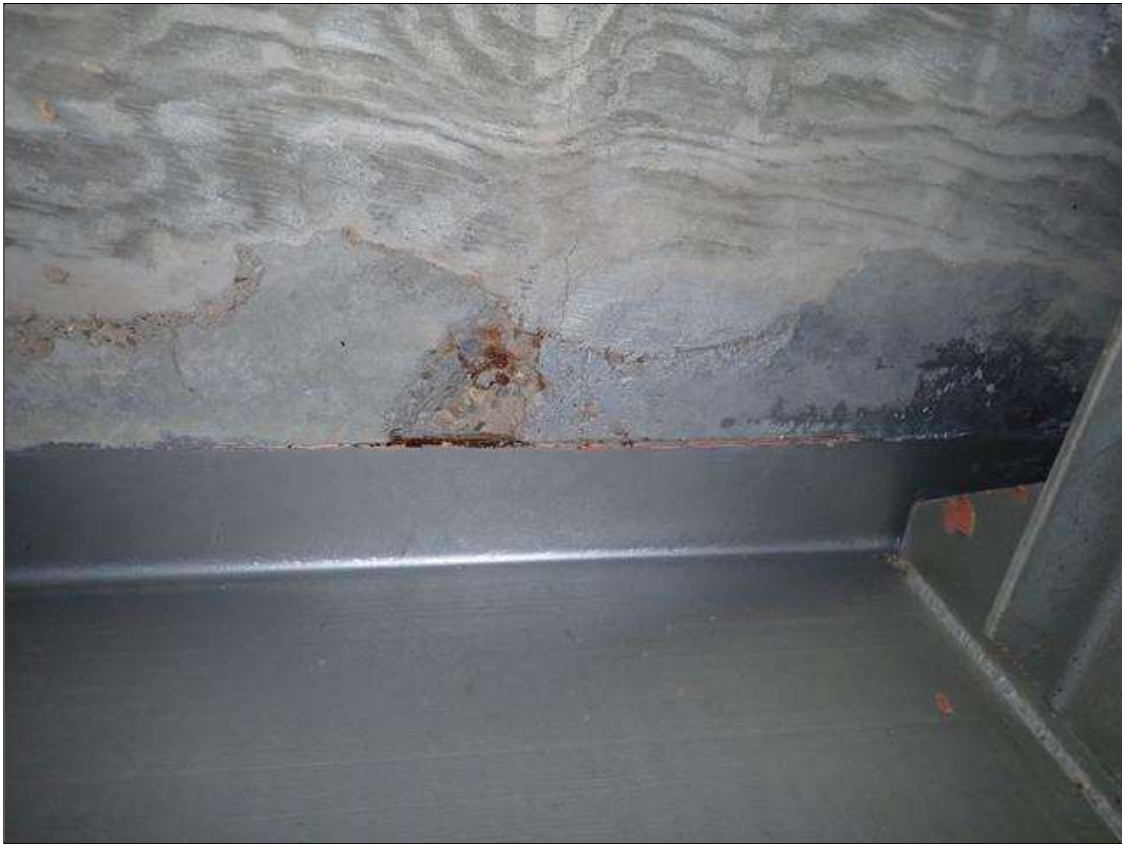
Span 1 Deck: 6" x 6" x 1" SPALL AT MIDSPAN WITH EXPOSED REBAR, NO MEASURABLE SECTION LOSS, AT MIDSPAN IN BAY 7 IN UNDERSIDE OF DECK

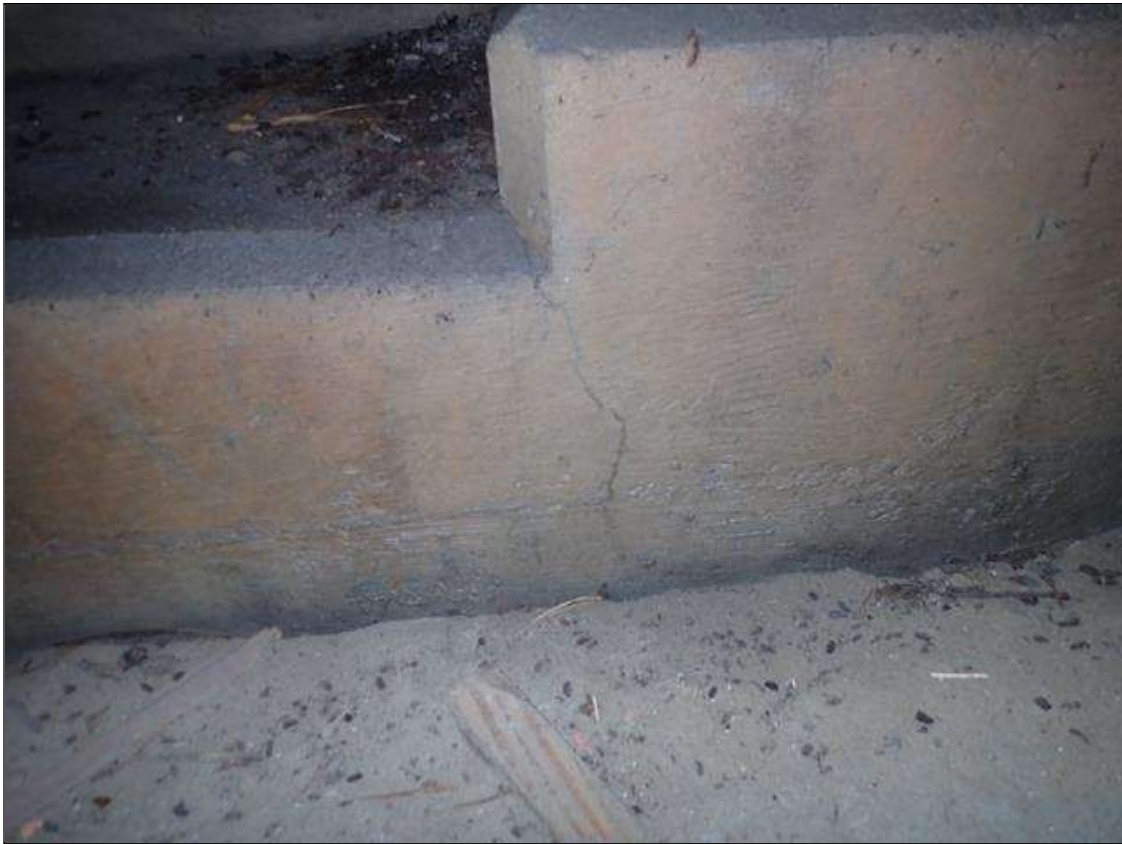
End Bent 1 Cap 1: 1 FT VERTICAL HAIRLINE CRACK UNDER BAY 3 IN CAP

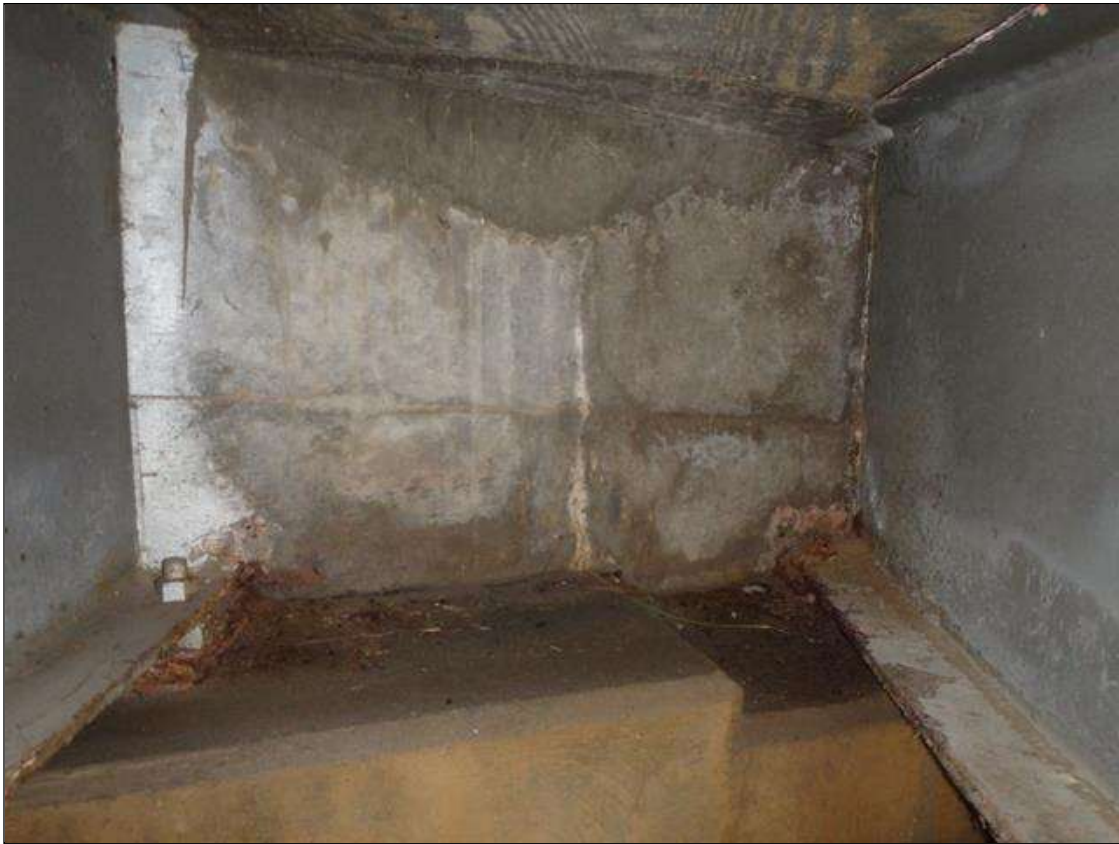
End Bent 2 Abutment/Backwall : 3 - 12" LONG VERTICAL HAIRLINE CRACKS IN CAP IN BAY 4, 1 SIMILAR IN BAY 5

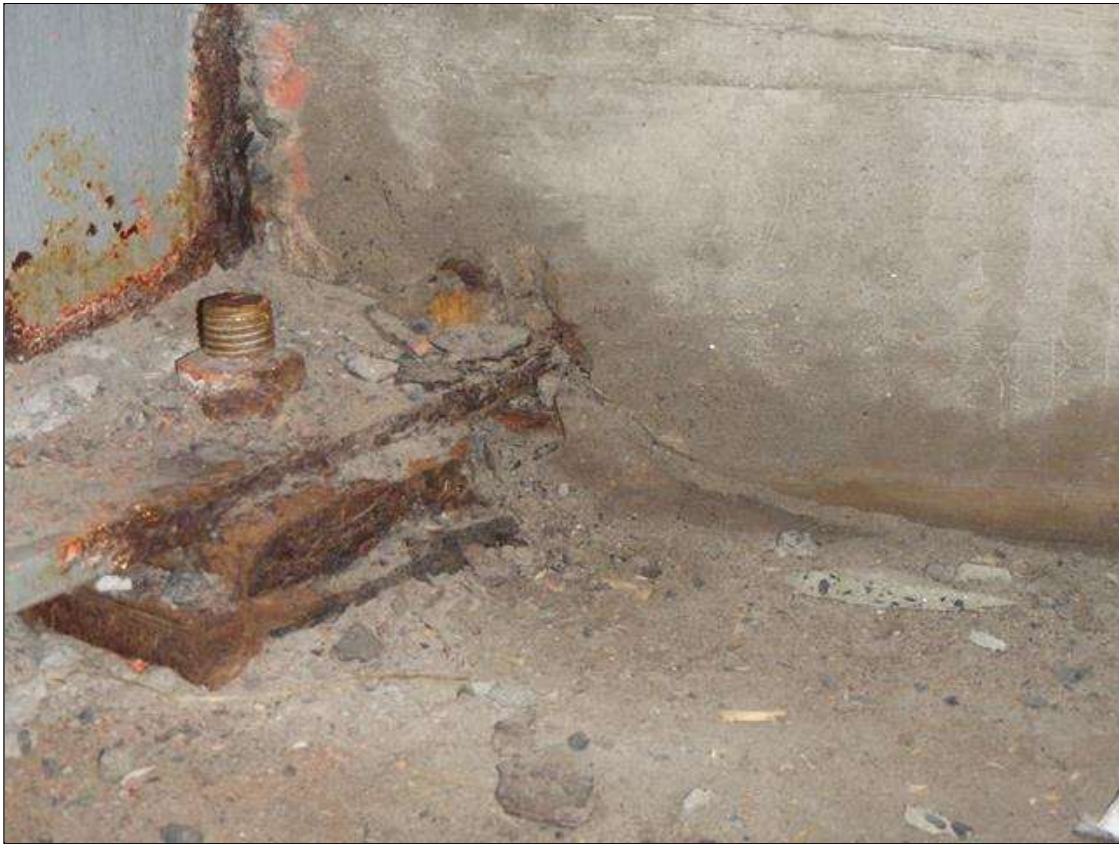
End Bent 2 Abutment/Backwall : 3" x 3" x 1/2" SPALL IN BACKWALL IN BAY 8 NEAR GIRDER 8

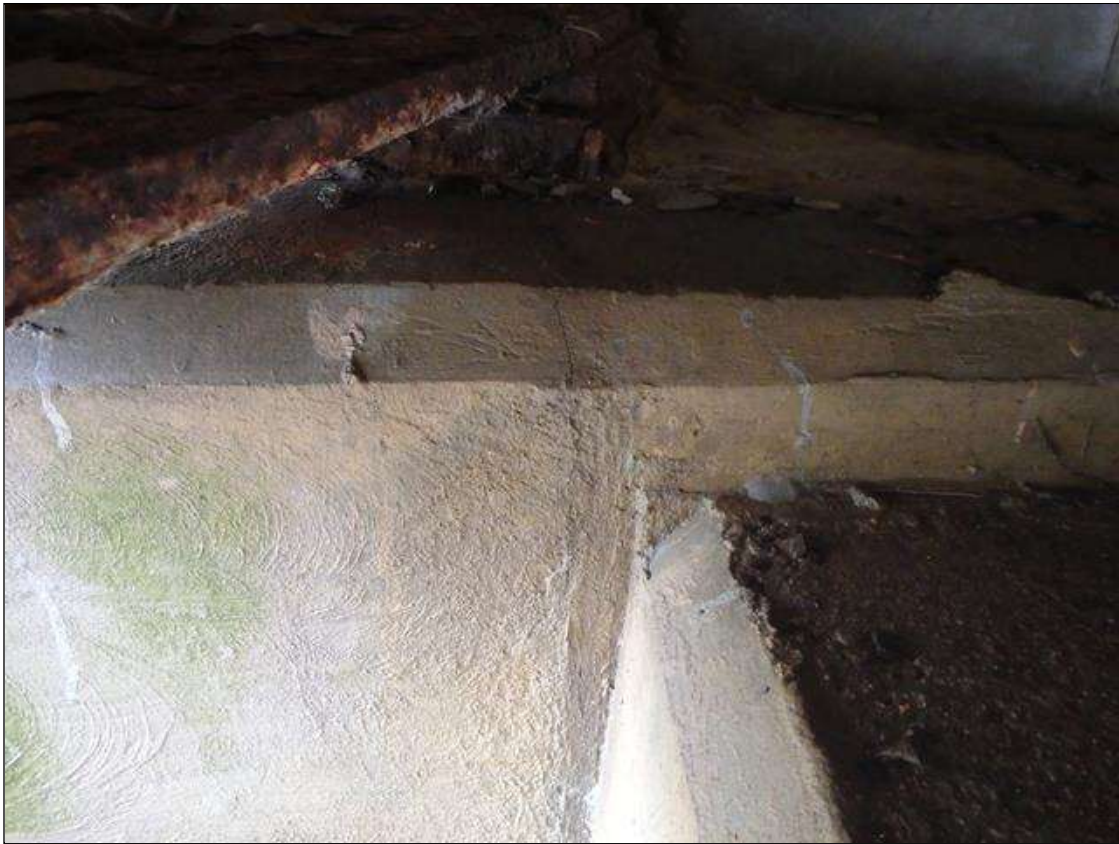
End Bent 2 Cap 1: 12" VERTICAL HAIRLINE CRACK IN CAP, 1 AT GIRDER 1 BEARING, 1 IN CAP UNDER BAY 1 AND 1 IN CAP AT BEARING OF GIRDER 2.

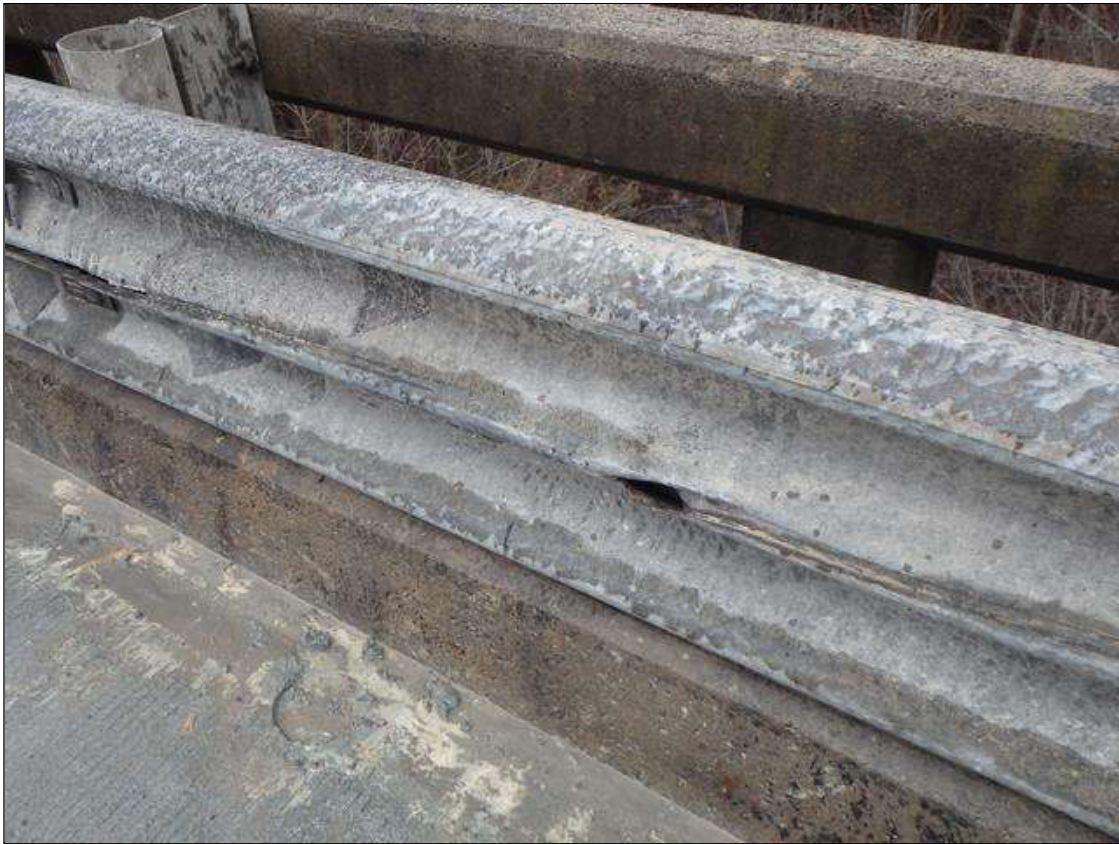
Span 1 Right Bridge Rail: 25 FT OF IMPACT DAMAGE IN RAIL AT BENT 1

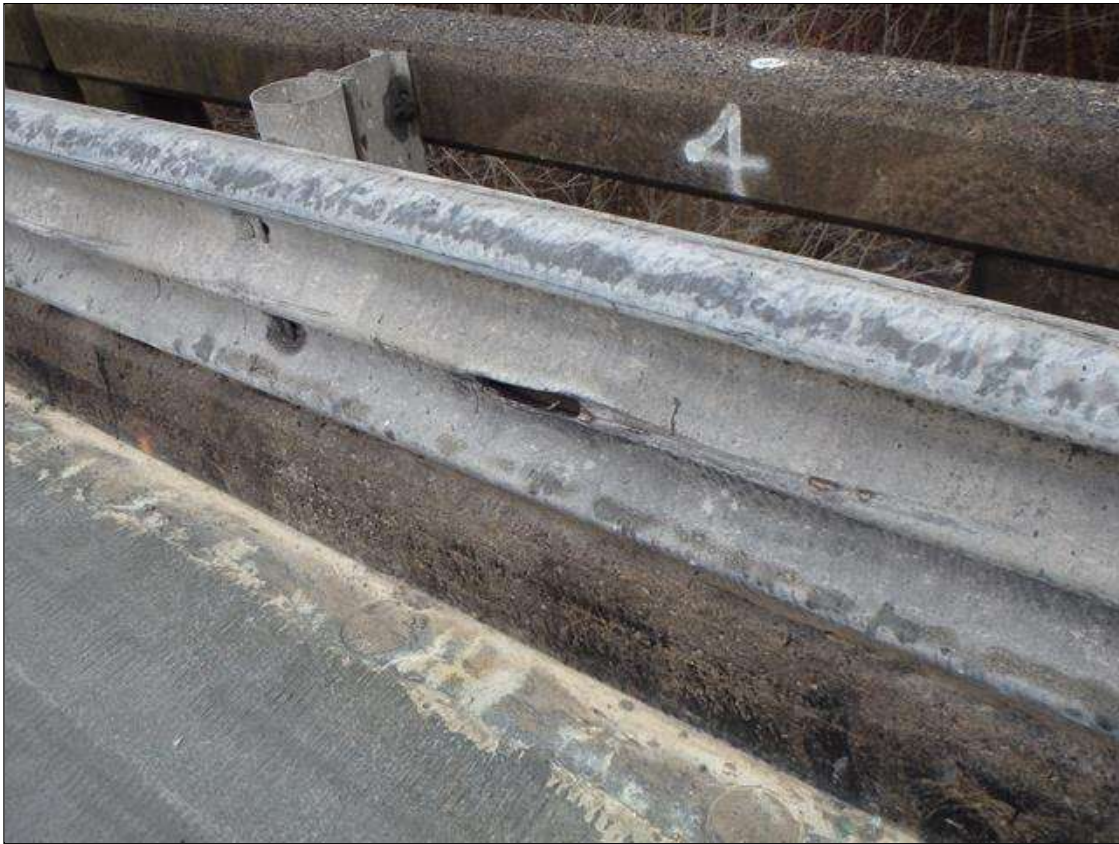
Span 2 Right Bridge Rail: 4 FT LONG IMPACT DAMAGE AT 6 FT FROM BENT 1

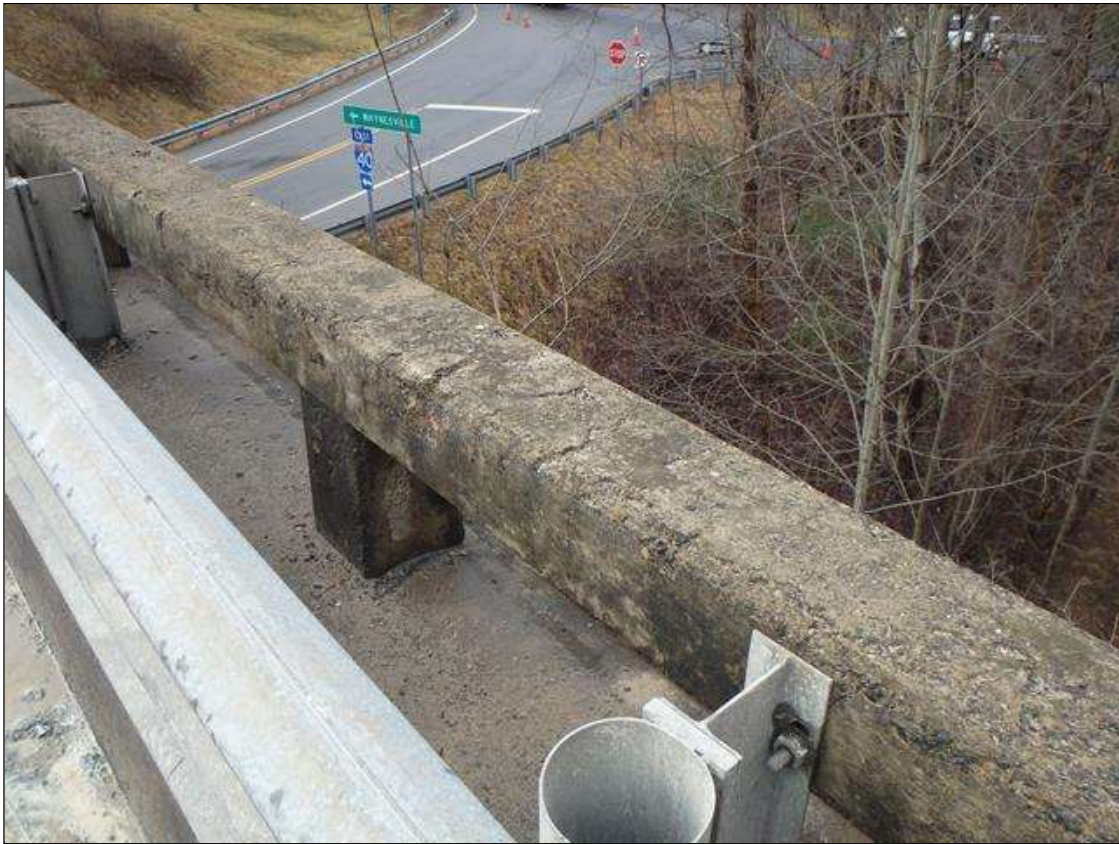
Span 2 Right Bridge Rail: 17 FT OF RAIL WITH SCATTERED SPALLS UP TO 4" x 4" x 3/4" WITH EXPOSED REBARS BUT NO SECTION LOSS AT 49 FT FROM END BENT 1

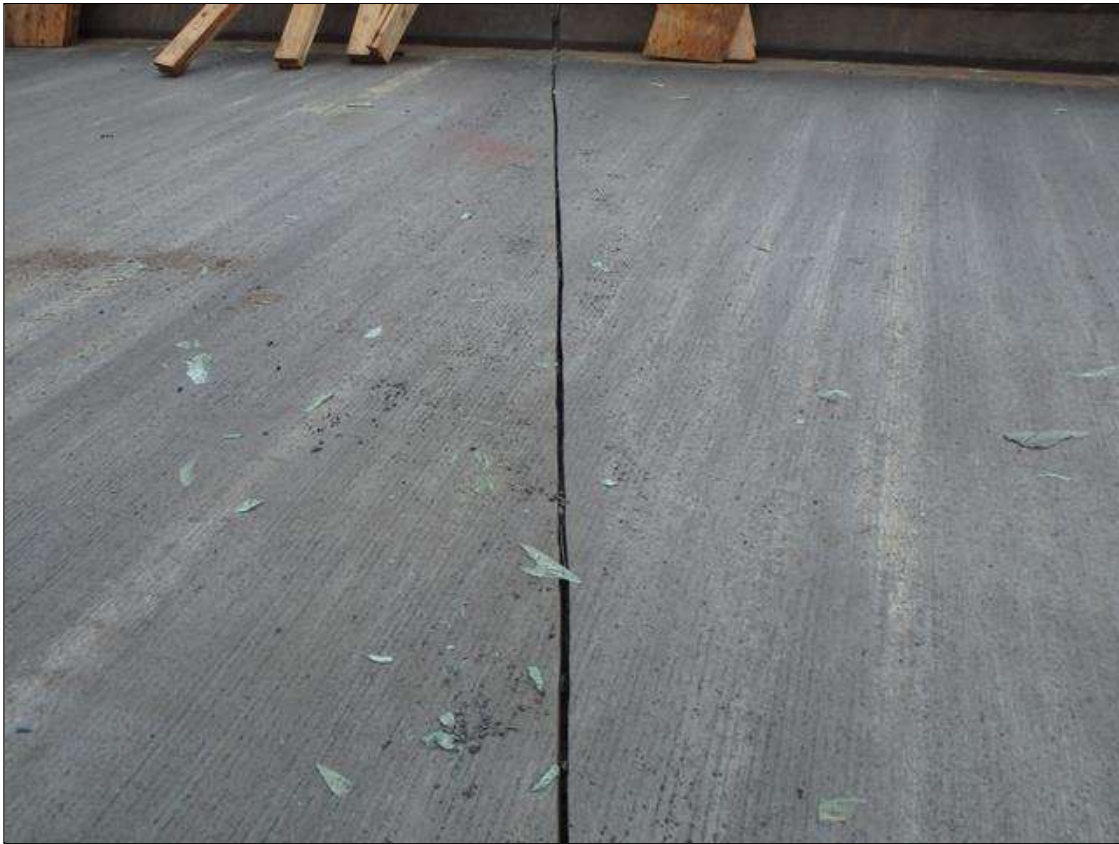
Expansion Joint : JOINT AT BENT 3 EASTBOUND LANES UNDER REPAIR

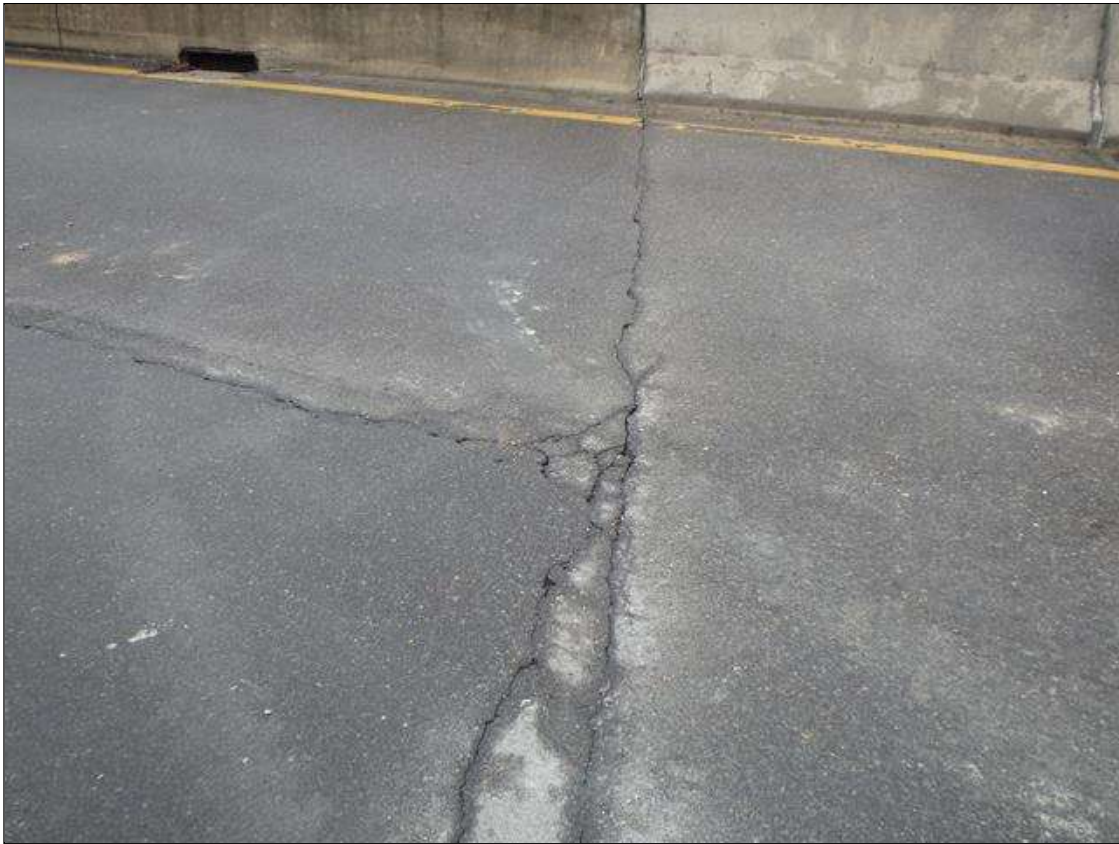
Approach 2: ASPHALT WEARING SURFACE CRACKED AT END OF BRIDGE, FULL WIDTH x UP TO 1/8" WIDE  
WITH 1/2" DIVOTS

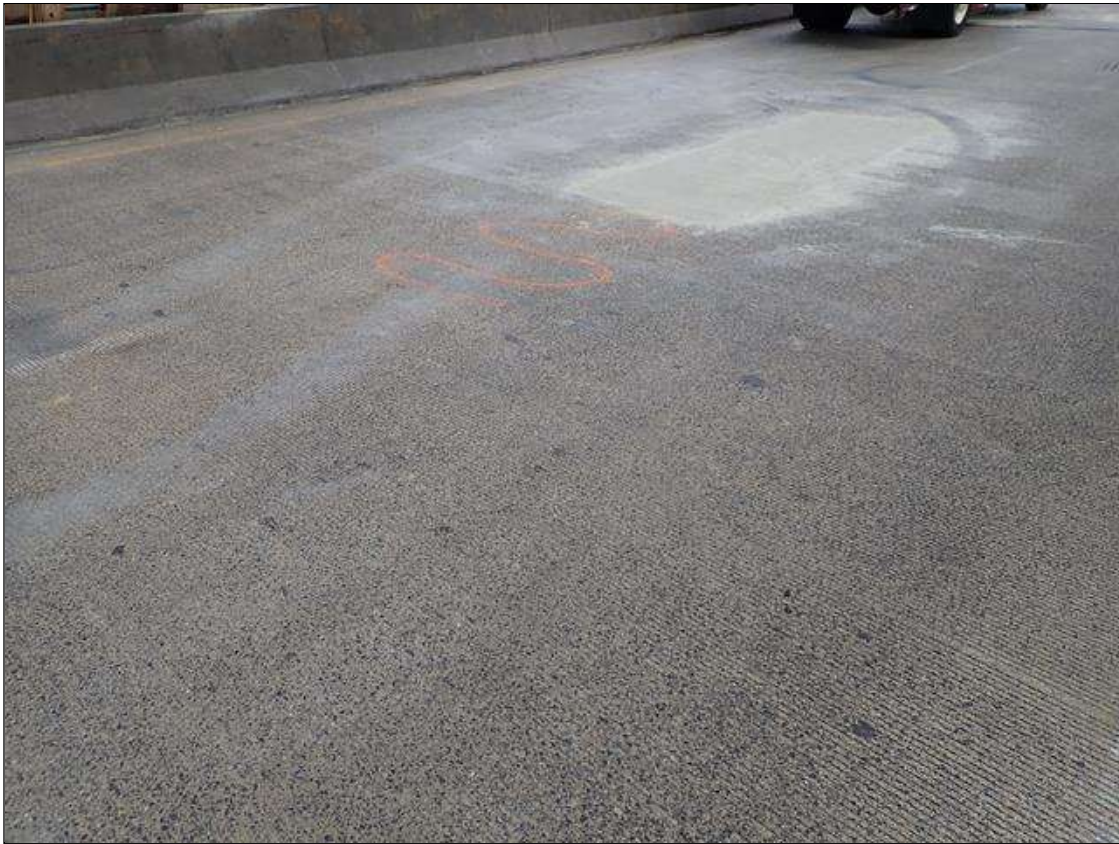
ASPHALT WEARING SURFACE SPAN 2, TYPICAL
