NC DEPARTMENT OF TRANSPORTATION  
DIVISION OF HIGHWAYS  
STRUCTURE MANAGEMENT UNIT

## Structure Safety Report

### Routine Element Inspection - Contract

DIVISION: 14 COUNTY: HAYWOOD STRUCTURE NUMBER: 430124 FREQUENCY: 24 MONTHS

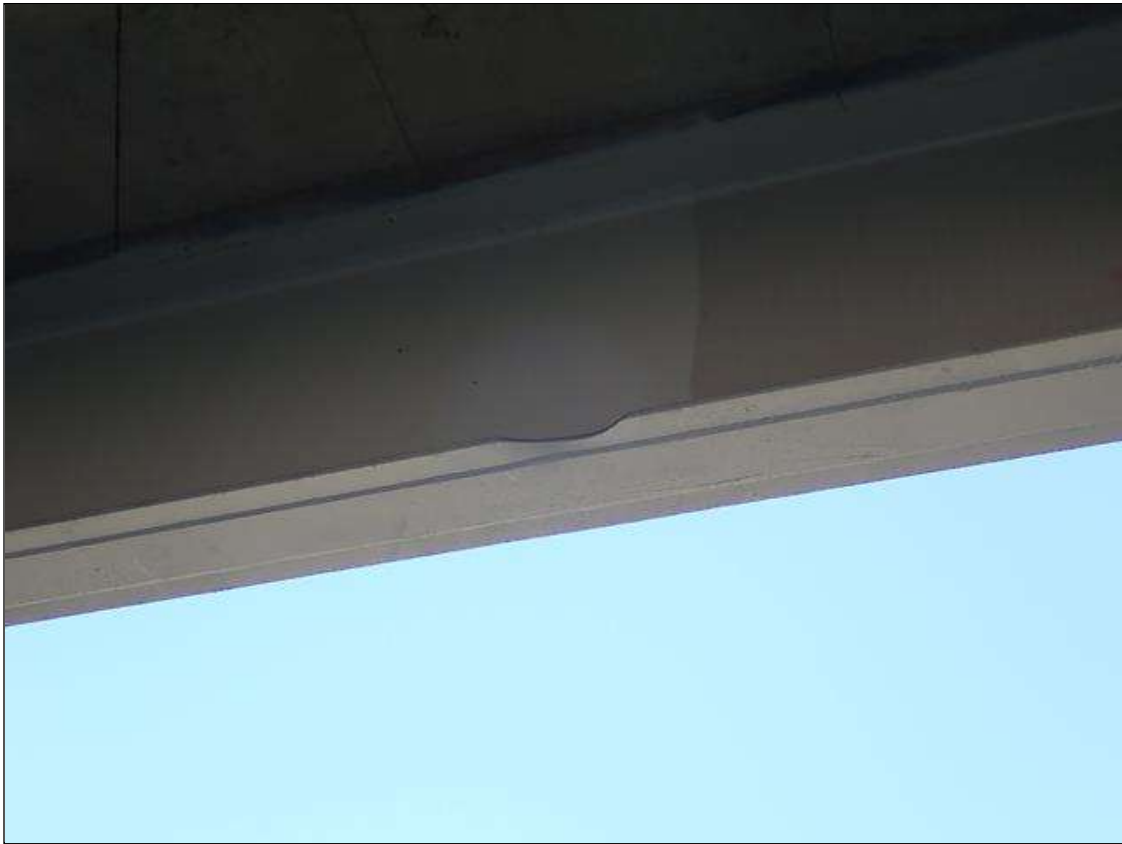
Span 2 Beam 1: BOTTOM FLANGE HAS MISSING SECTION OUT OF BOTTOM FLANGE OVER NORTHBOUND LANES FOR 15" LONG X 2" WIDE FOR FULL FLANGE DEPTH. (PRIORITY MAINTENANCE)

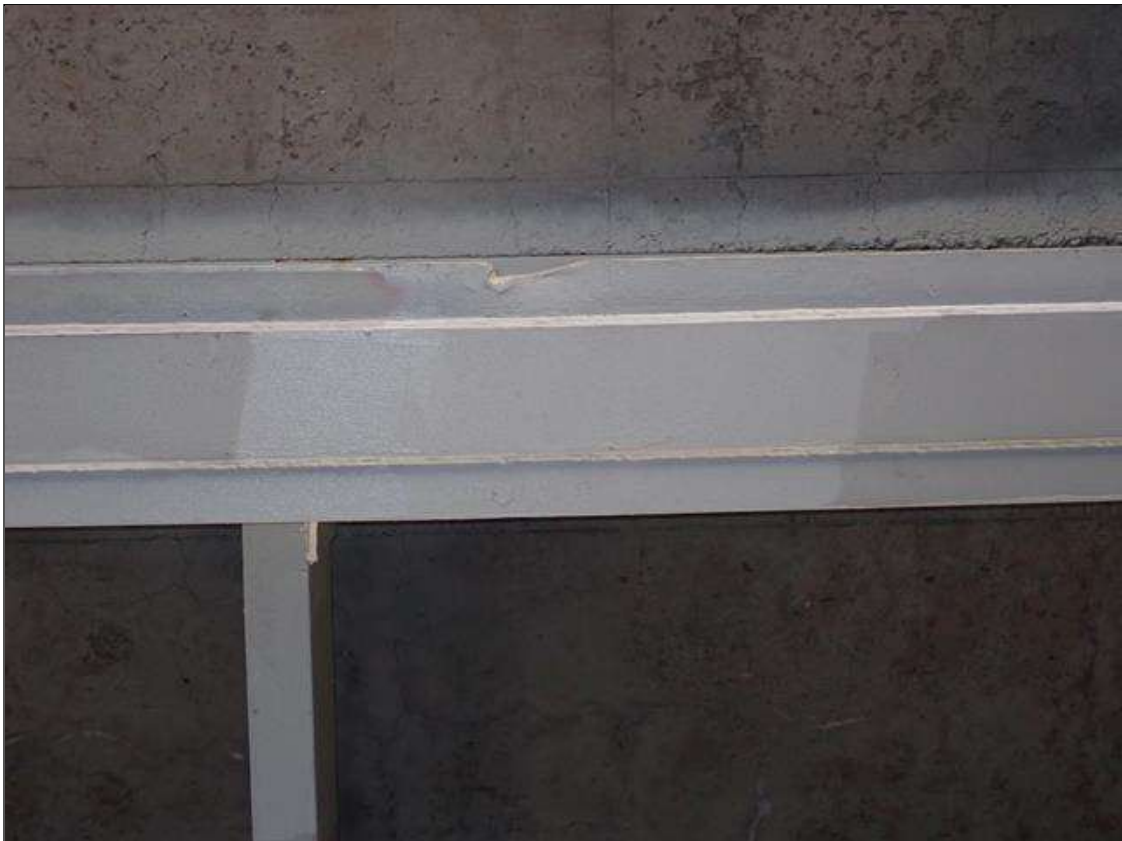
Span 2 Beam 1: BOTTOM FLANGE HAS MISSING SECTION OUT OF BOTTOM FLANGE OVER NORTHBOUND LANES FOR 15" LONG X 2" WIDE FOR FULL FLANGE DEPTH. (PRIORITY MAINTENANCE)

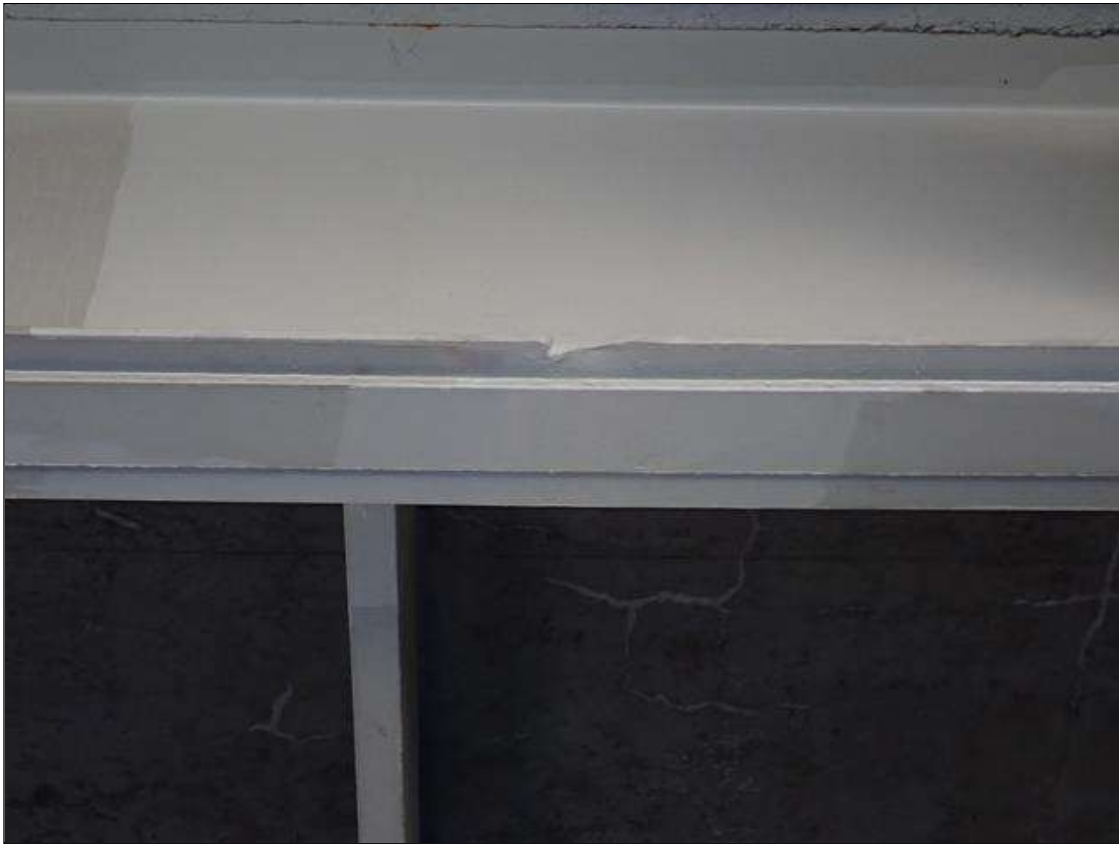
Span 2 Beam 3: BOTTOM FLANGE OVER SOUTHBOUND LANES HAS MISSING SECTION FOR 6" LONG X UP TO 1" WIDE FOR FULL DEPTH OF BOTTOM FLANGE (PRIORITY MAINTENANCE)

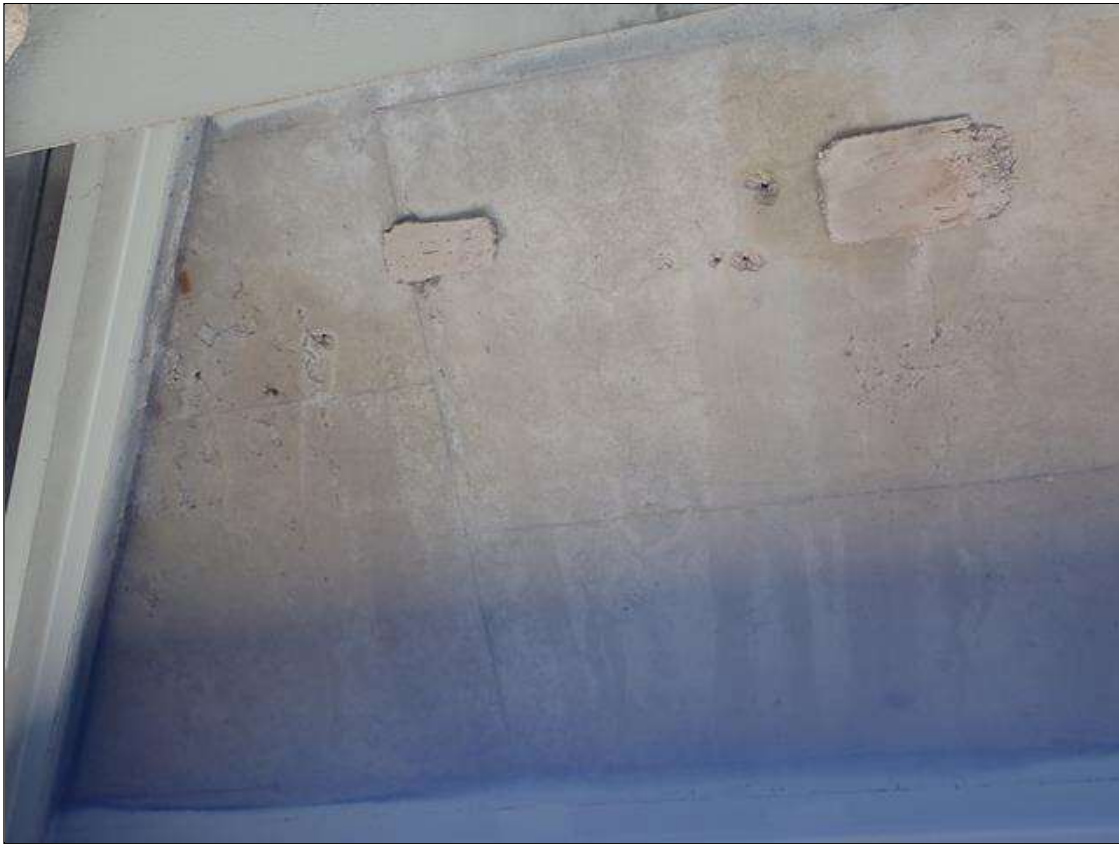
Span 2 Deck: SPALL IN UNDERSIDE OF DECK, 2 FT X 1 FT X 2-1/2" DEEP AT BAY 1, 12' FROM BENT 1 END.

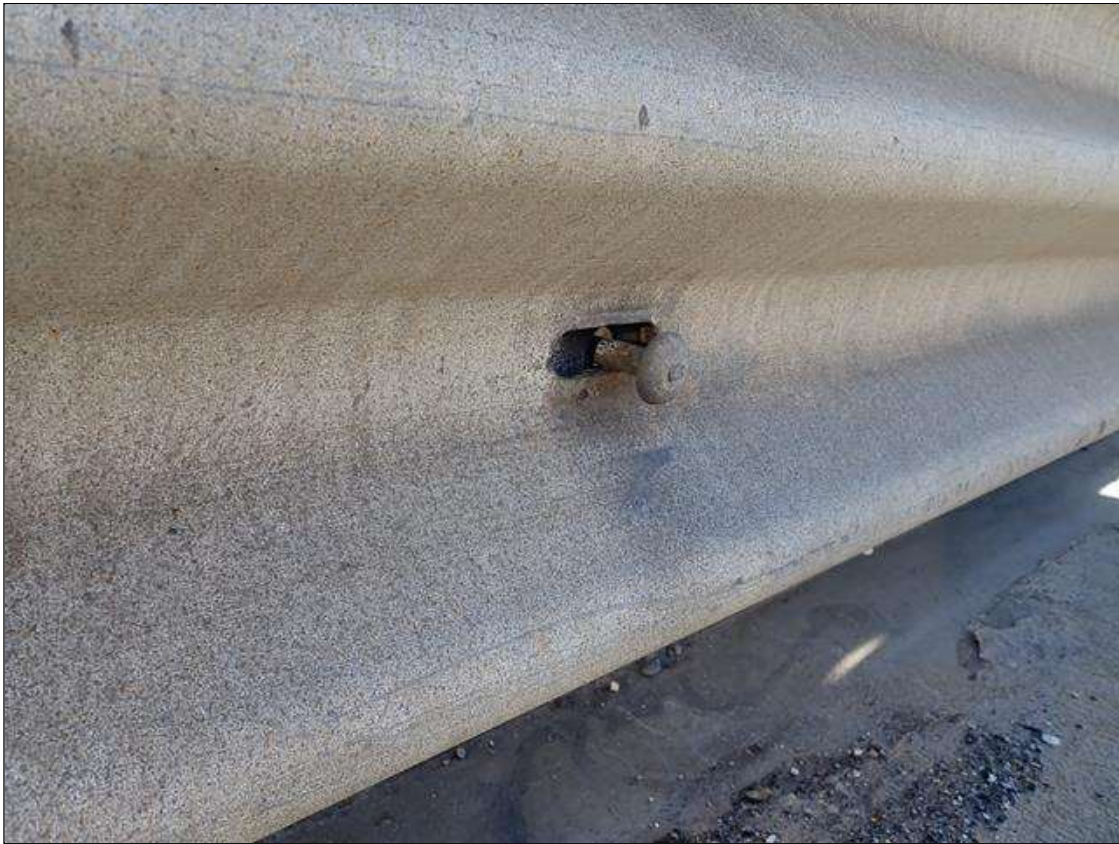
Span 2 Left Bridge Rail: FOURTH POST IN SPAN HAS LOOSE ATTACHMENT FROM GUARDRAIL TO TUBE

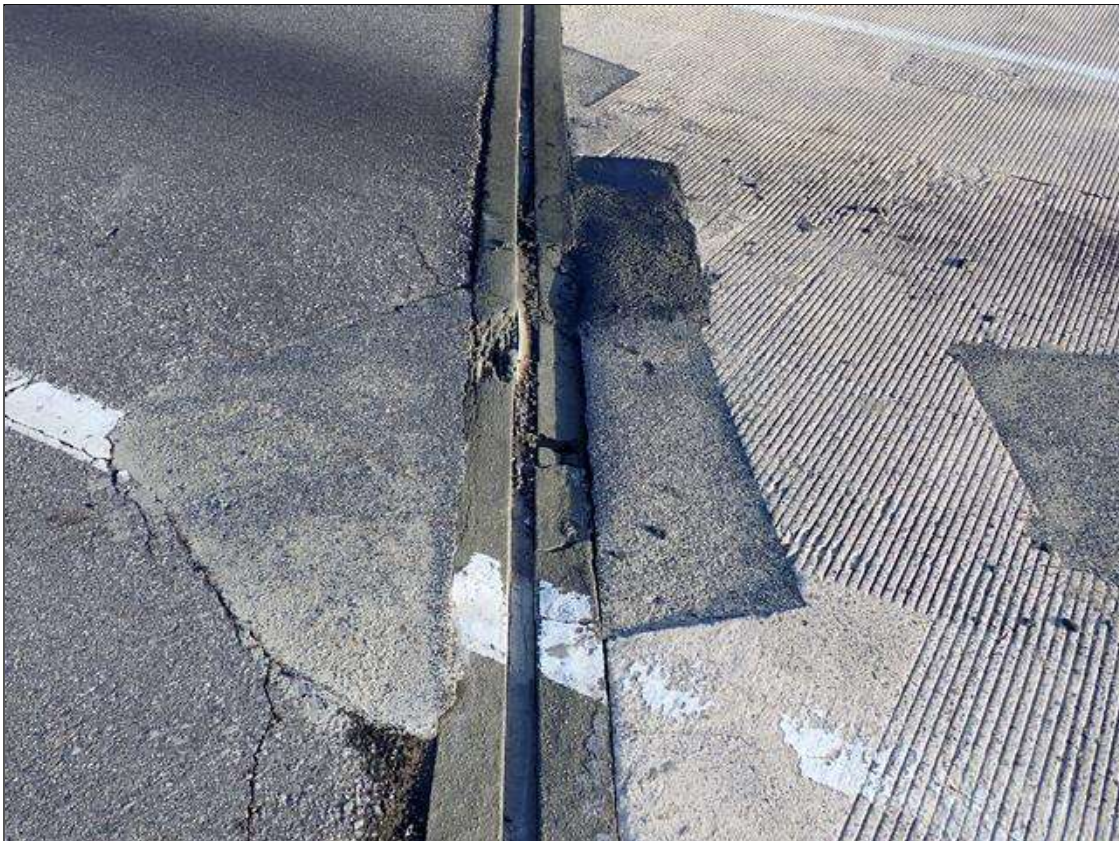
End Bent 1 Expansion Joint : 6 FT OF DEBRIS IMPACTION IN RIGHT SHOULDER OF EASTBOUND LANES, JOINT MOVEMENT UNAFFECTED.

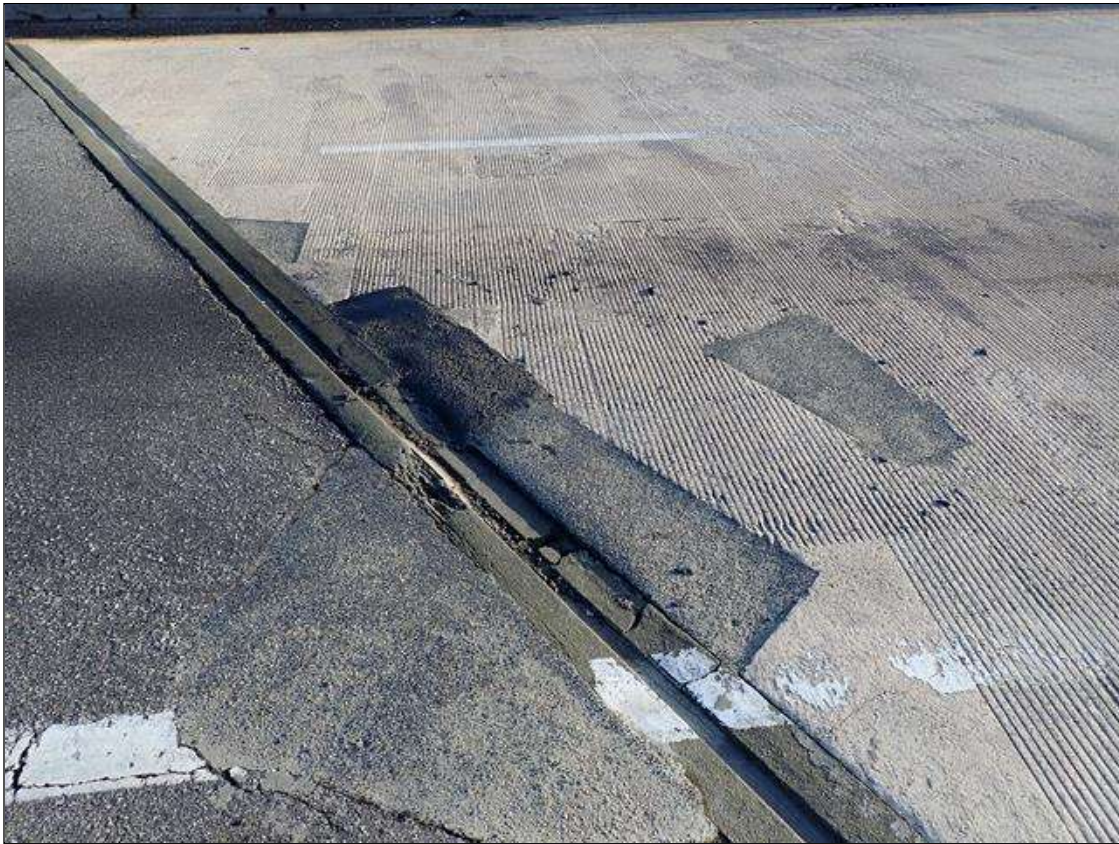
End Bent 1 Expansion Joint : SPALLED/DEPRESSED HEADER IN RIGHT LANE OF EASTBOUND LANES, 3 FT X 6" X 2" DEEP, NO EXPOSED REINFORCEMENT.

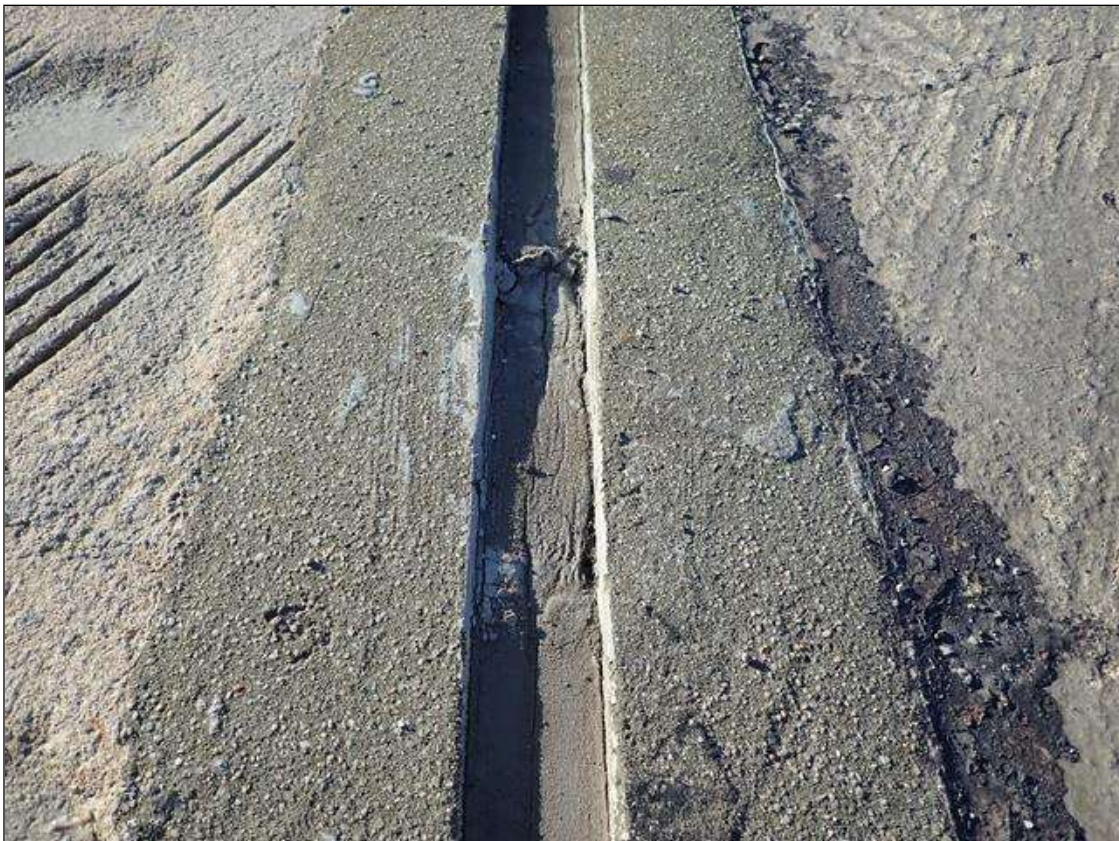
End Bent 1 Expansion Joint : 4" X 1" TEAR IN JOINT MATERIAL IN WESTBOUND LANES AT RIGHT SHOULDER.

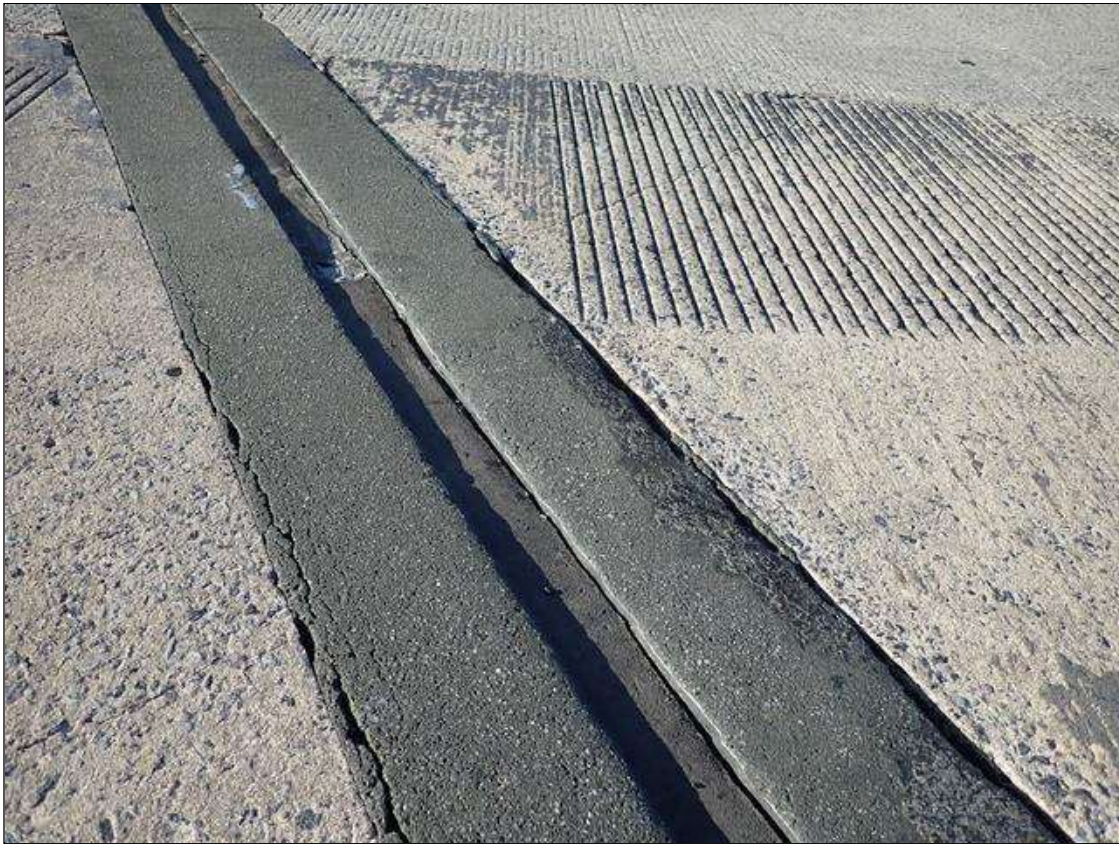
Bent 2 Expansion Joint : CRACKS IN JOINT SEAL AT RIGHT SHOULDER OF WESTBOUND TRAVEL LANES.

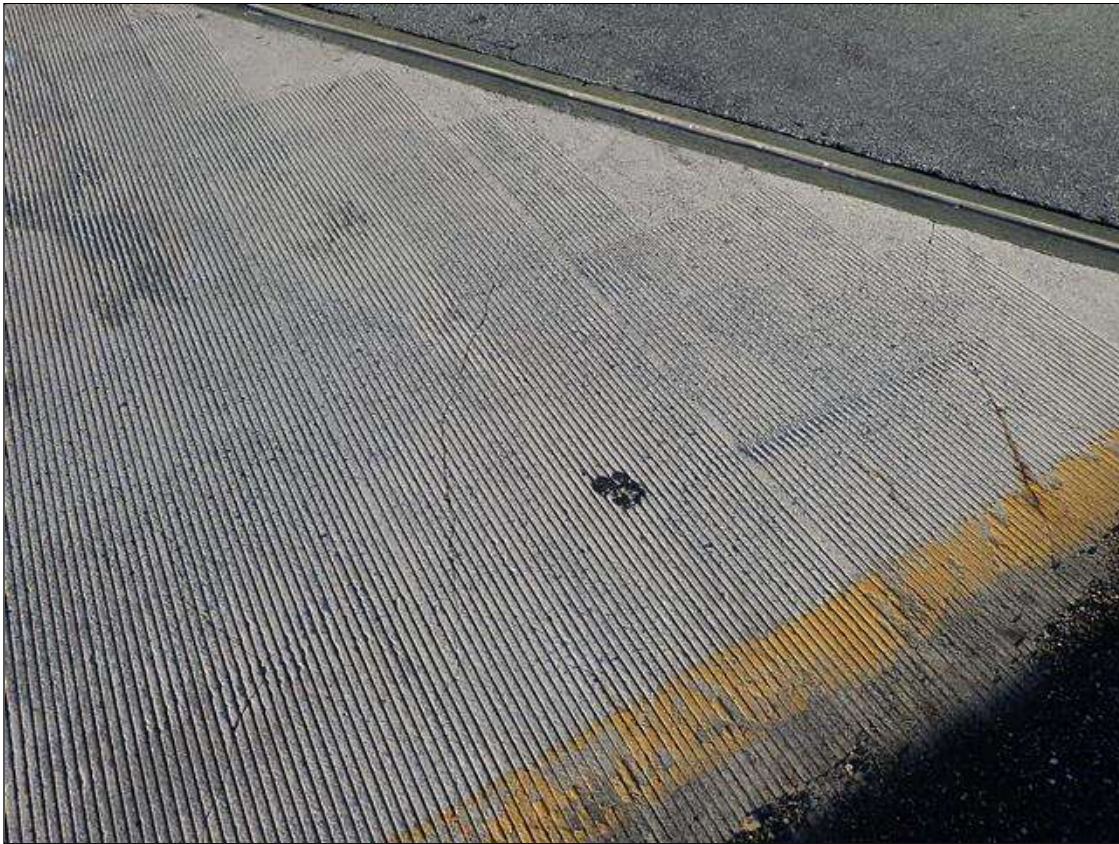
End Bent 2 Expansion Joint : 10 FT OF SOUND PATCHES IN ADJACENT CONCRETE HEADER IN WESTBOUND TRAVEL LANES.

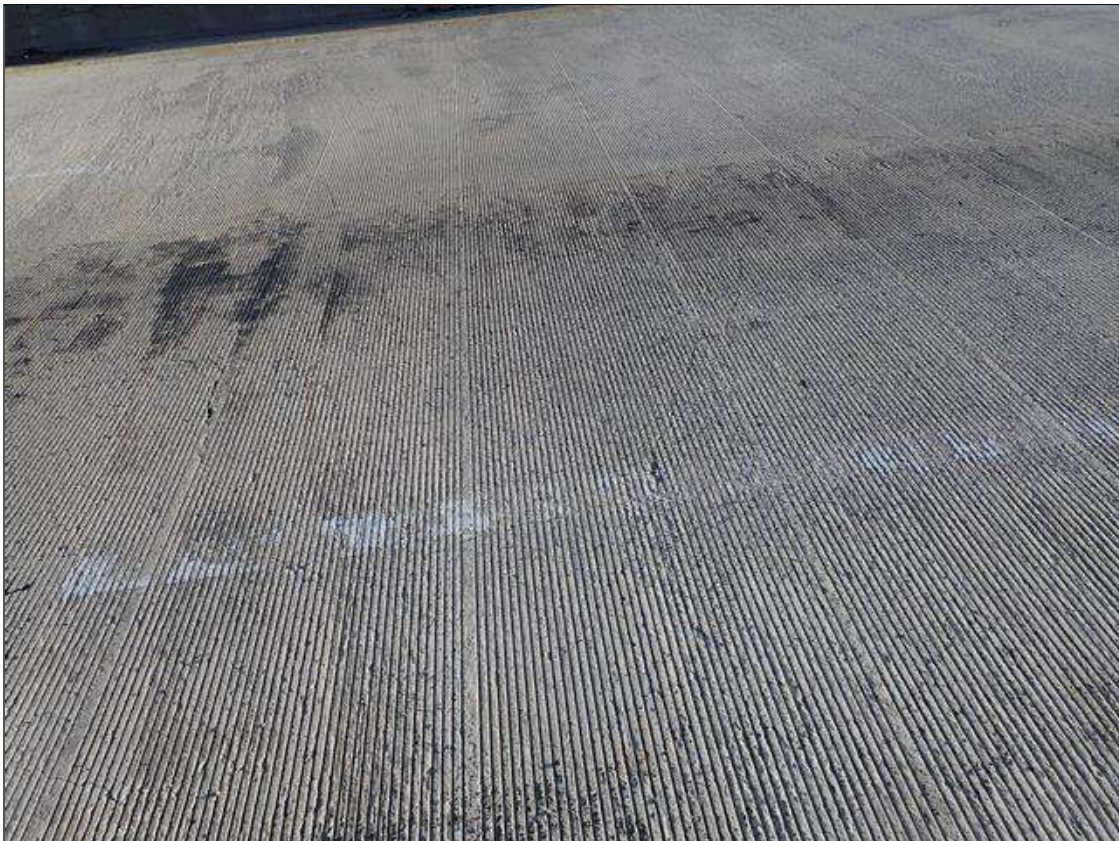
Span 1 Deck: DIAGONAL CRACKING UP TO 10 FT LONG, 1/16" WIDE, IN TOP OF DECK AT NORTHWEST CORNER NEAR END BENT 1.

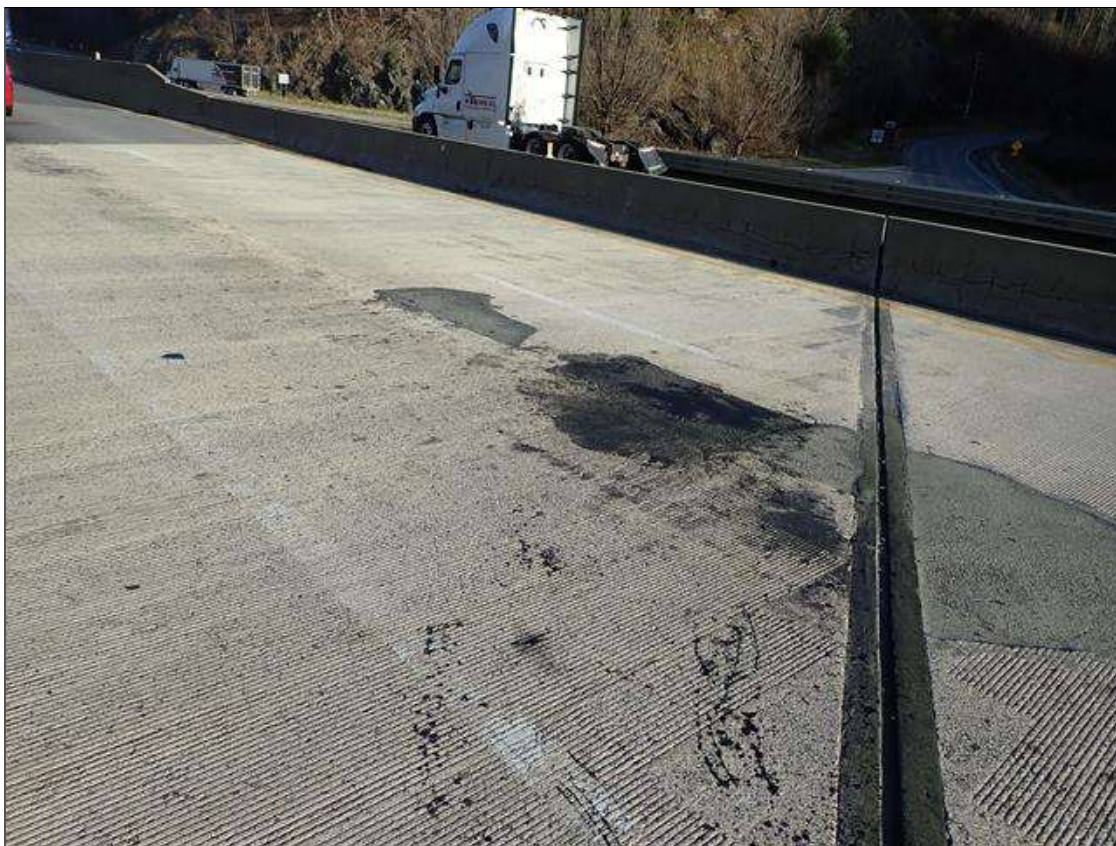
Span 1 Deck: SCATTERED TRANSVERSE CRACKS UP TO 1/16" WIDE, SCATTERED THROUGHOUT EASTBOUND AND WESTBOUND LANES.

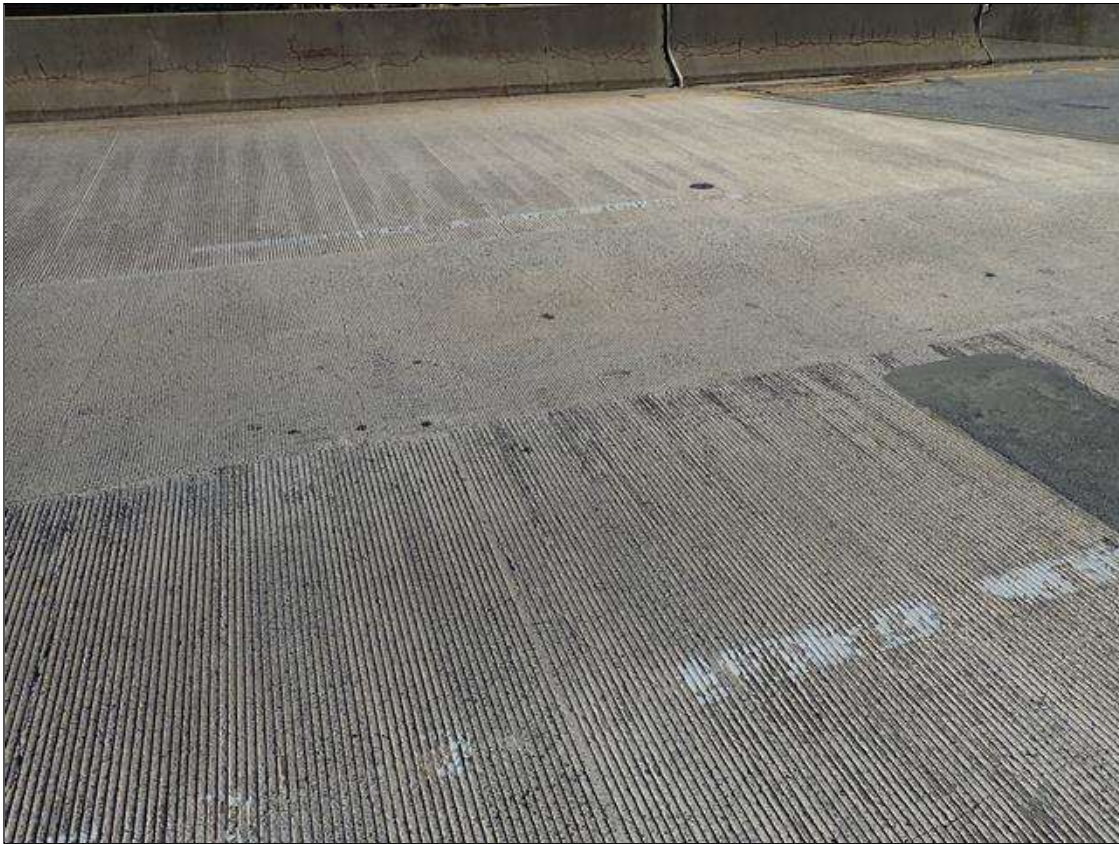
Span 1 Deck: PATCHED AREA 4' WIDE X 2' LONG IN LEFT WEST BOUND LANE 16' FROM END BENT 1 END.

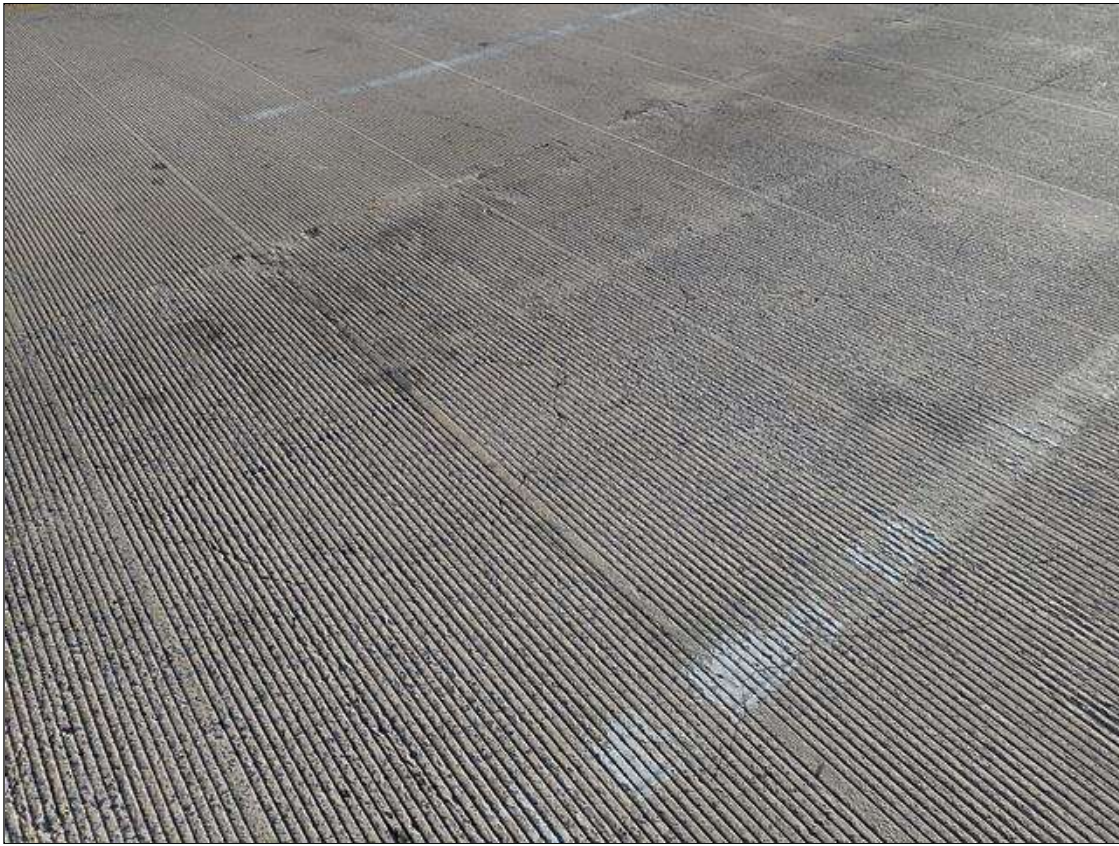
Span 1 Deck: SCATTERED TRANSVERSE CRACKS UP TO 1/16" WIDE, SCATTERED THROUGHOUT EASTBOUND AND WESTBOUND LANES.

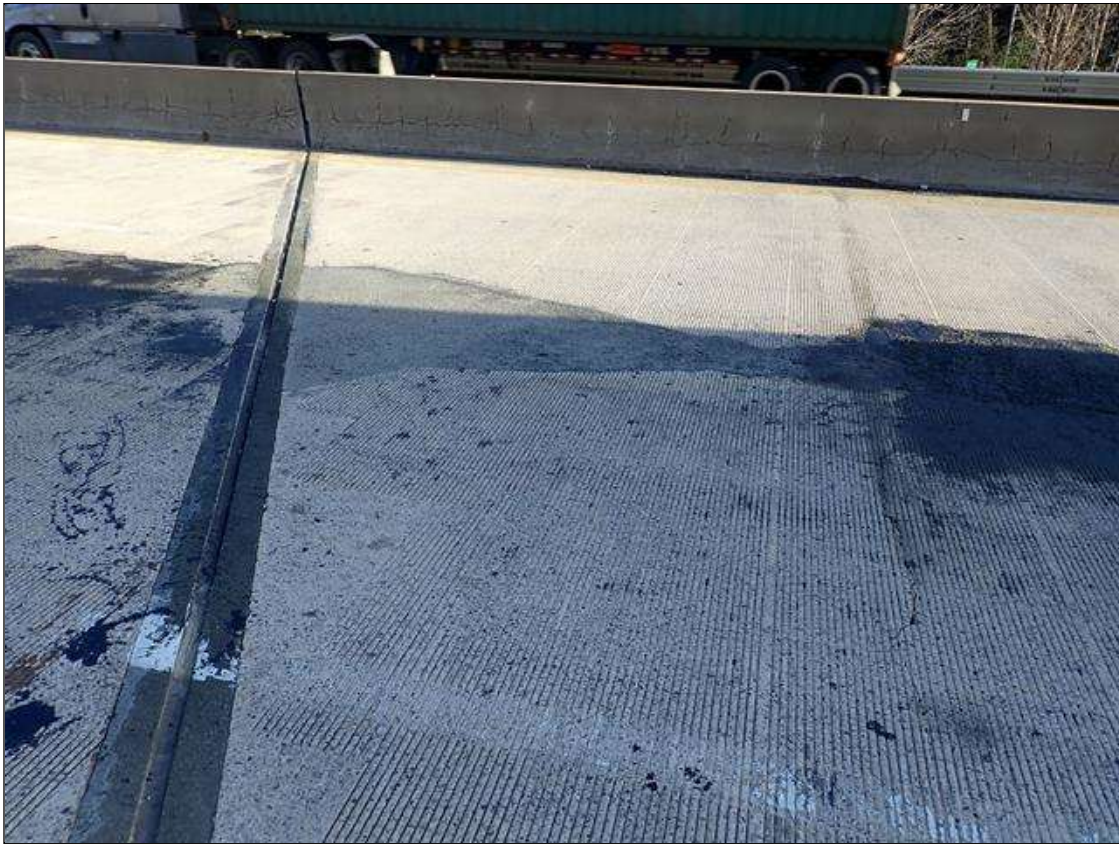
Span 2 Deck: TOP OF DECK, SCATTERED DIAGONAL AND TRANSVERSE CRACKS UP TO 1/32" WIDE, UP TO FULL WIDTH OF LANES, SPACED AT APPROXIMATELY 3 TO 6 FT CENTERS THROUGHOUT FULL LENGTH OF SPAN.

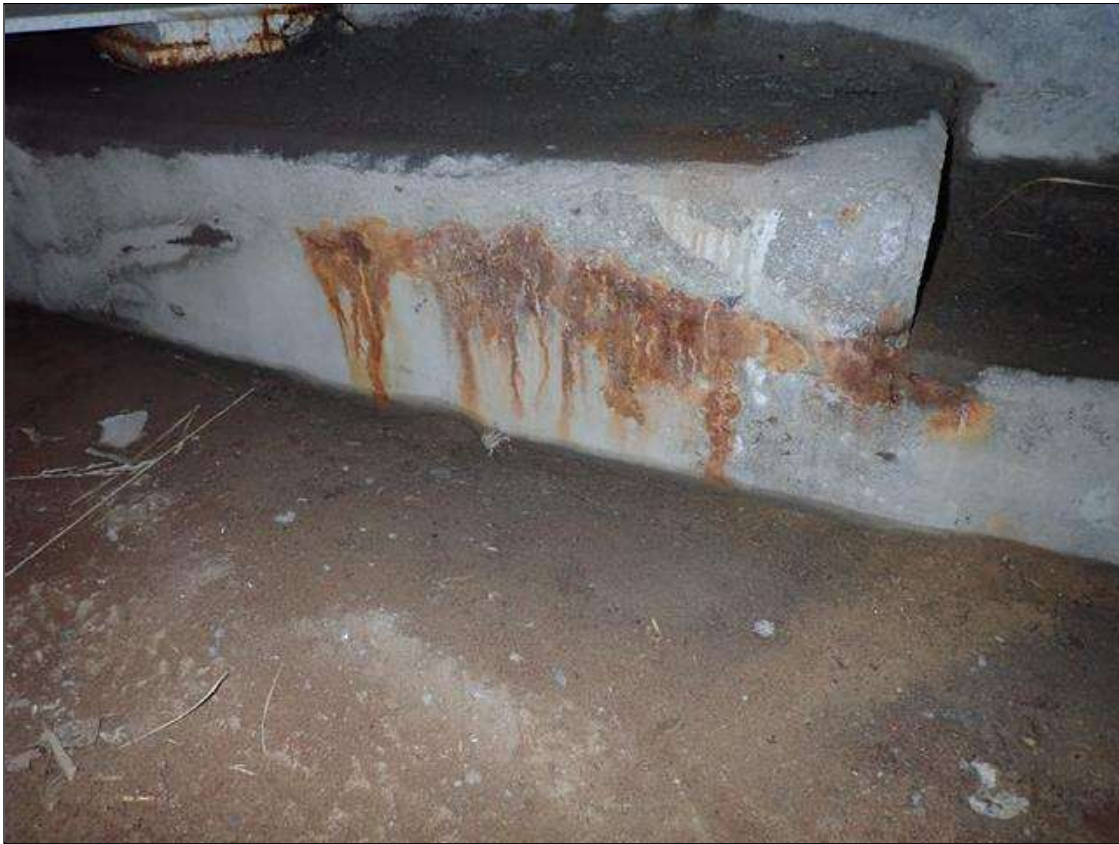
End Bent 1 Cap 1: 6" X 18" X 6" DELAMINATION IN TOP AND FRONT FACE OF CAP AT STEP BELOW BAY 1.

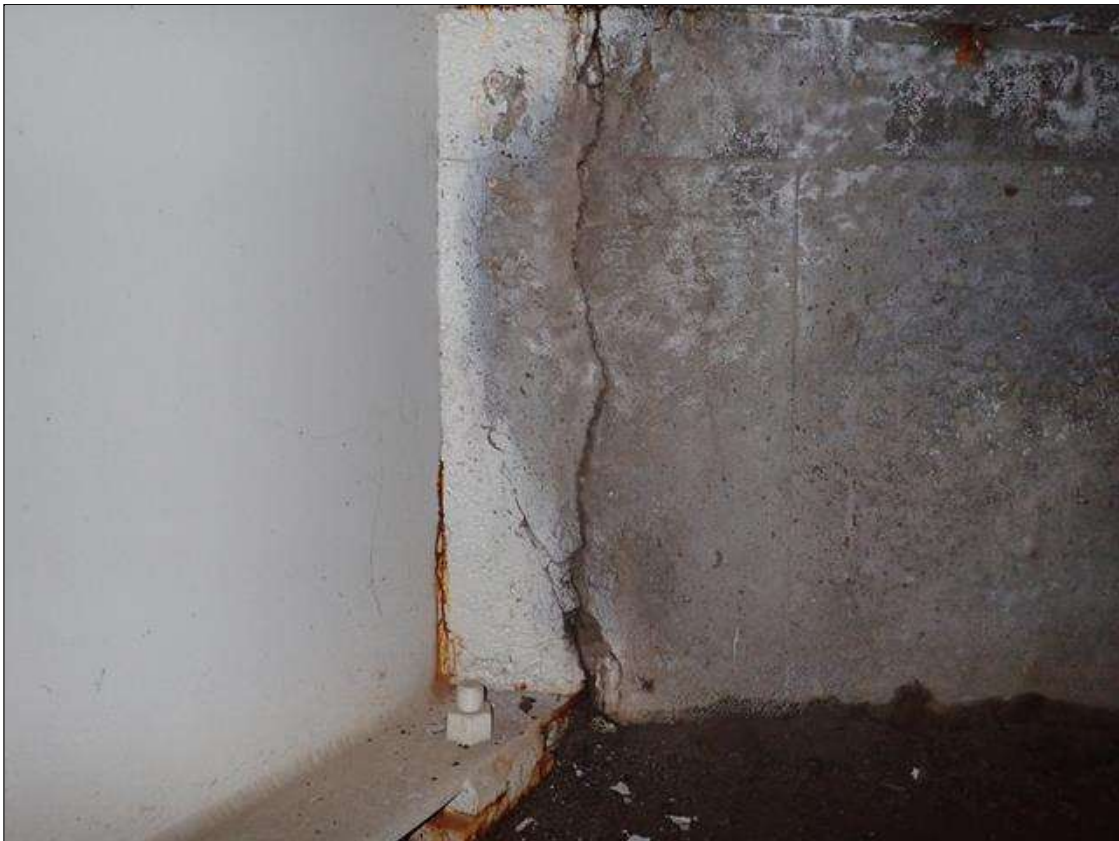
End Bent 1 Cap 1: 3 FT LONG HORIZONTAL HAIRLINE CRACK WITH RUST STAINING IN FRONT FACE OF CAP BELOW BAY 2.

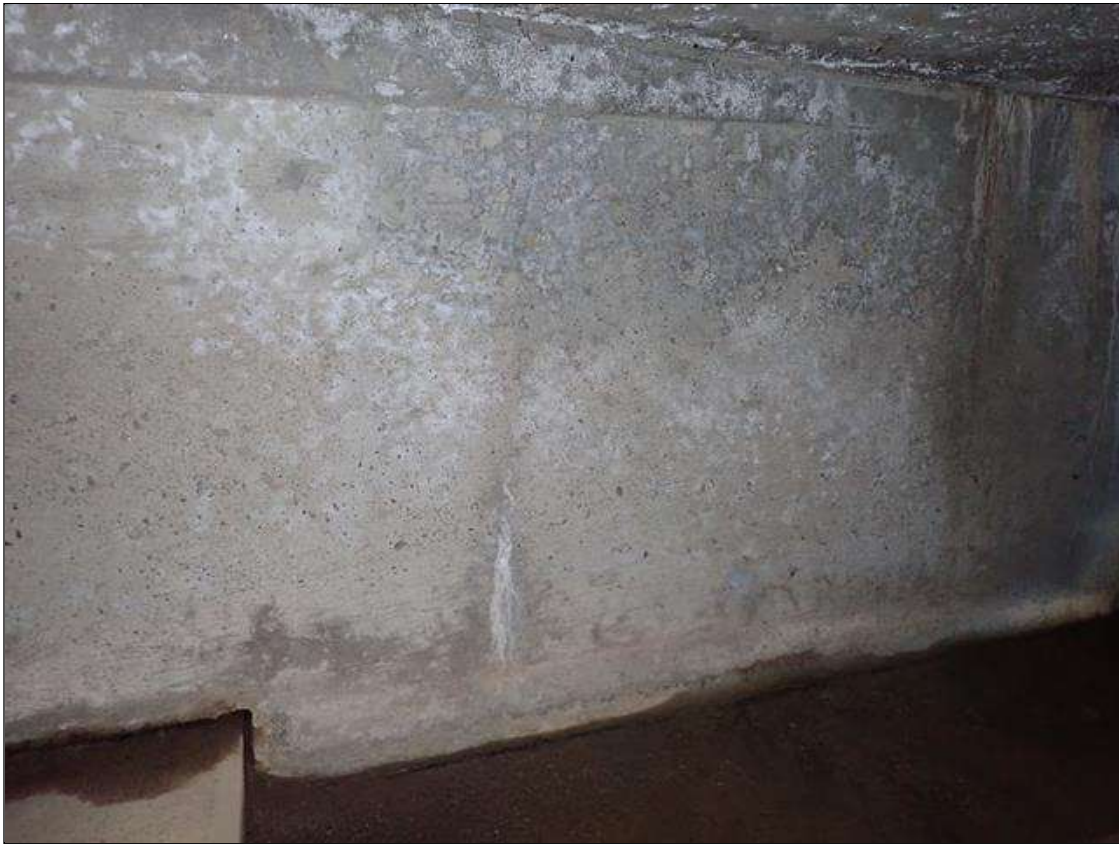
End Bent 1 Abutment/Backwall : FULL HEIGHT VERTICAL CRACK UP TO 1/16" WIDE IN BACKWALL OF BAY 2 AT GIRDER 3.

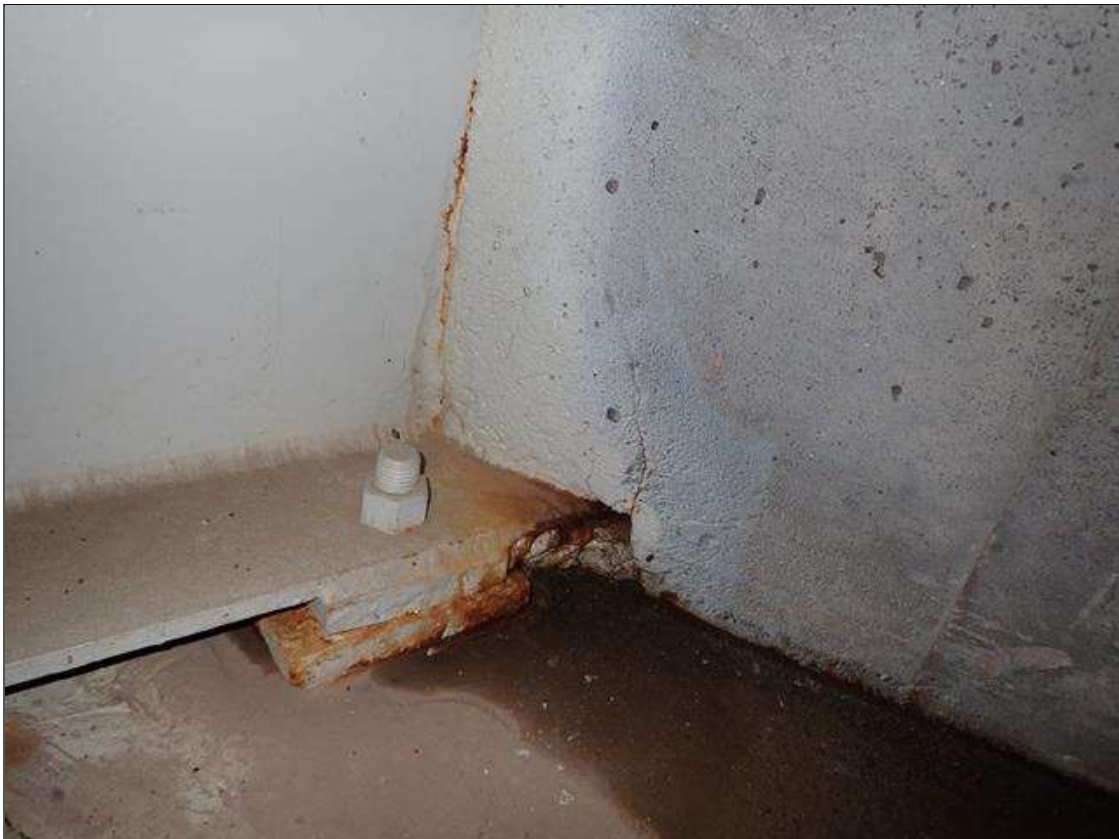
End Bent 1 Abutment/Backwall : FULL HEIGHT VERTICAL HAIRLINE CRACK WITH EFFLORESCENCE IN BACKWALL OF BAY 3.

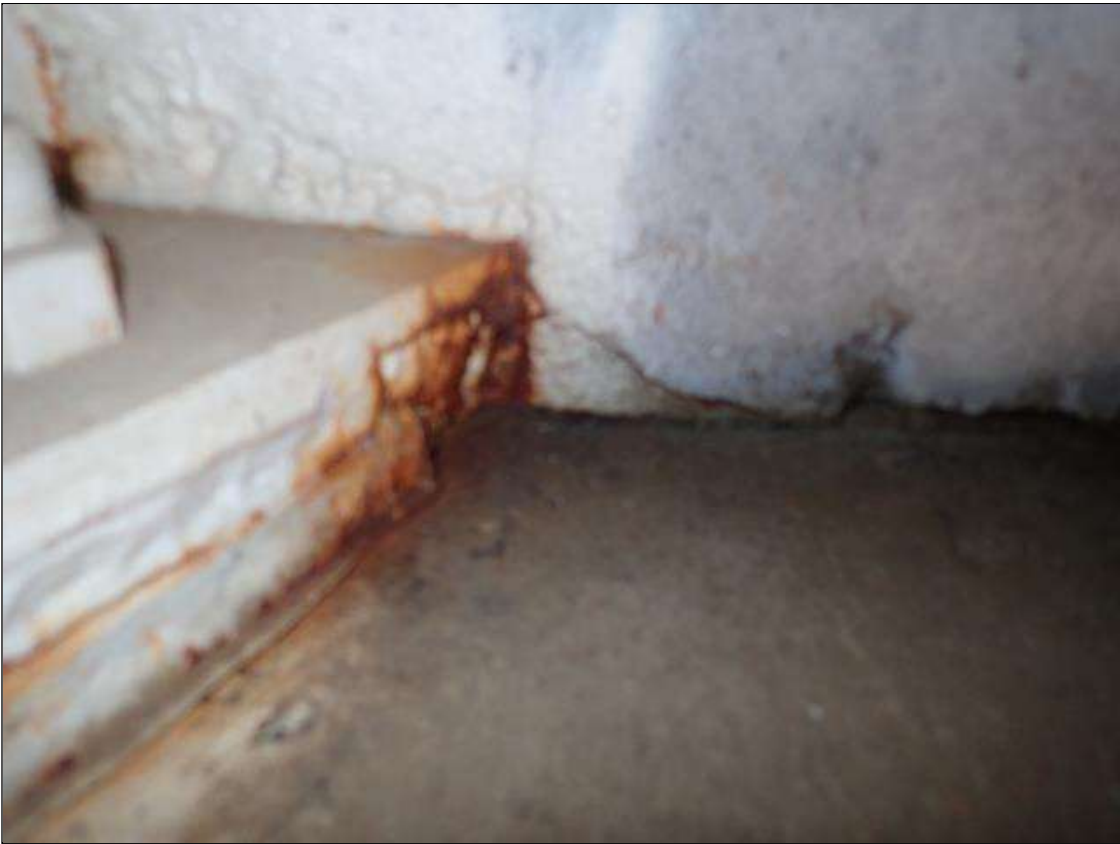
End Bent 1 Abutment/Backwall : 1 FT HAIRLINE DIAGONAL CRACK IN BACKWALL AT GIRDER 4 BOTTOM FLANGE.

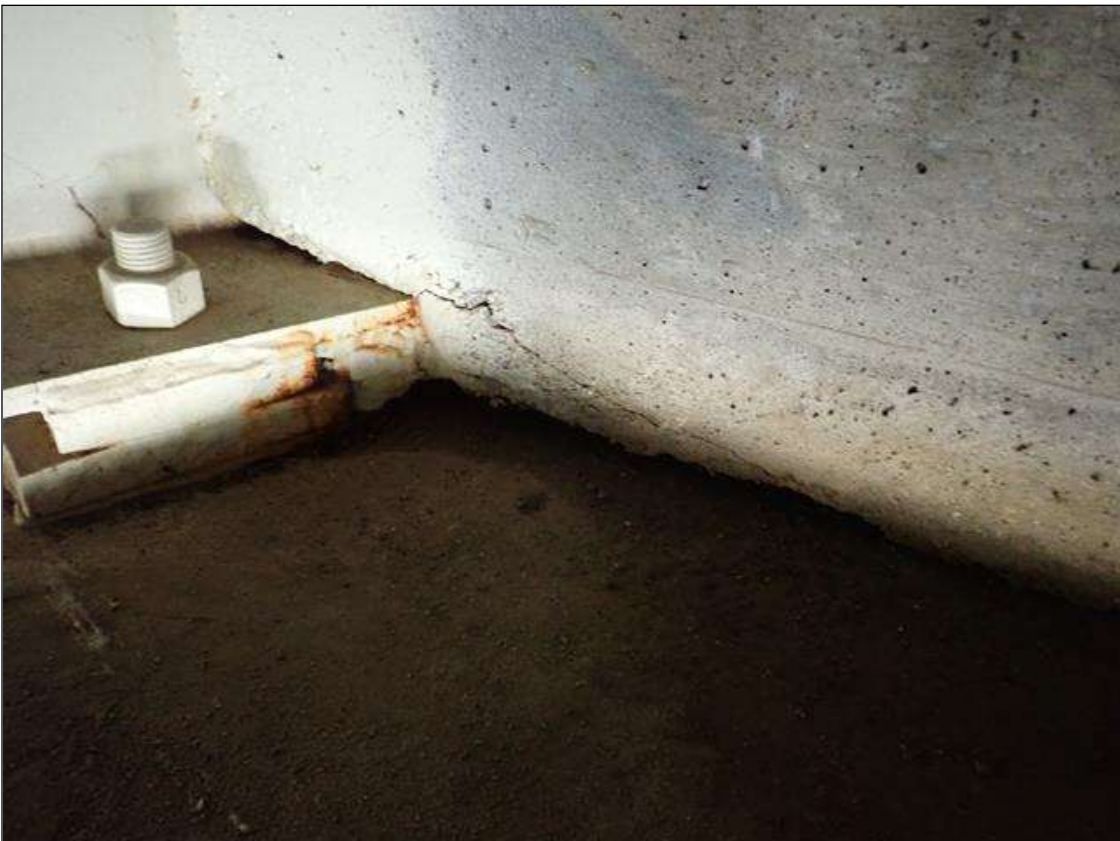
End Bent 1 Abutment/Backwall : 2" X 2" DELAMINATION IN BACKWALL AT GIRDER 5 BOTTOM FLANGE IN BAY 4.

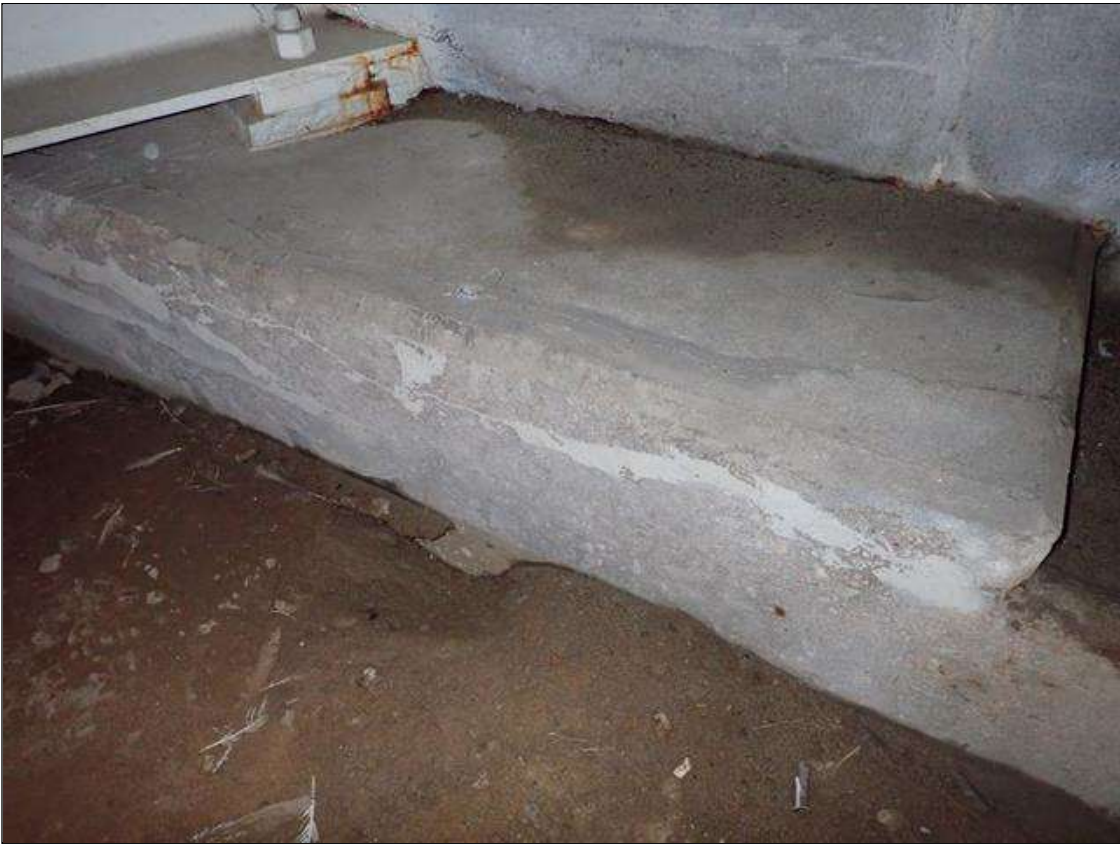
End Bent 1 Abutment/Backwall : 15" DIAGONAL HAIRLINE CRACK IN BACKWALL AT BOTTOM FLANGE OF GIRDER 6 IN BAY 5. SIMILAR IN BAY 6 AT GIRDER 7, BAY 8 AT GIRDER 9, BAY 9 AT GIRDER 10.

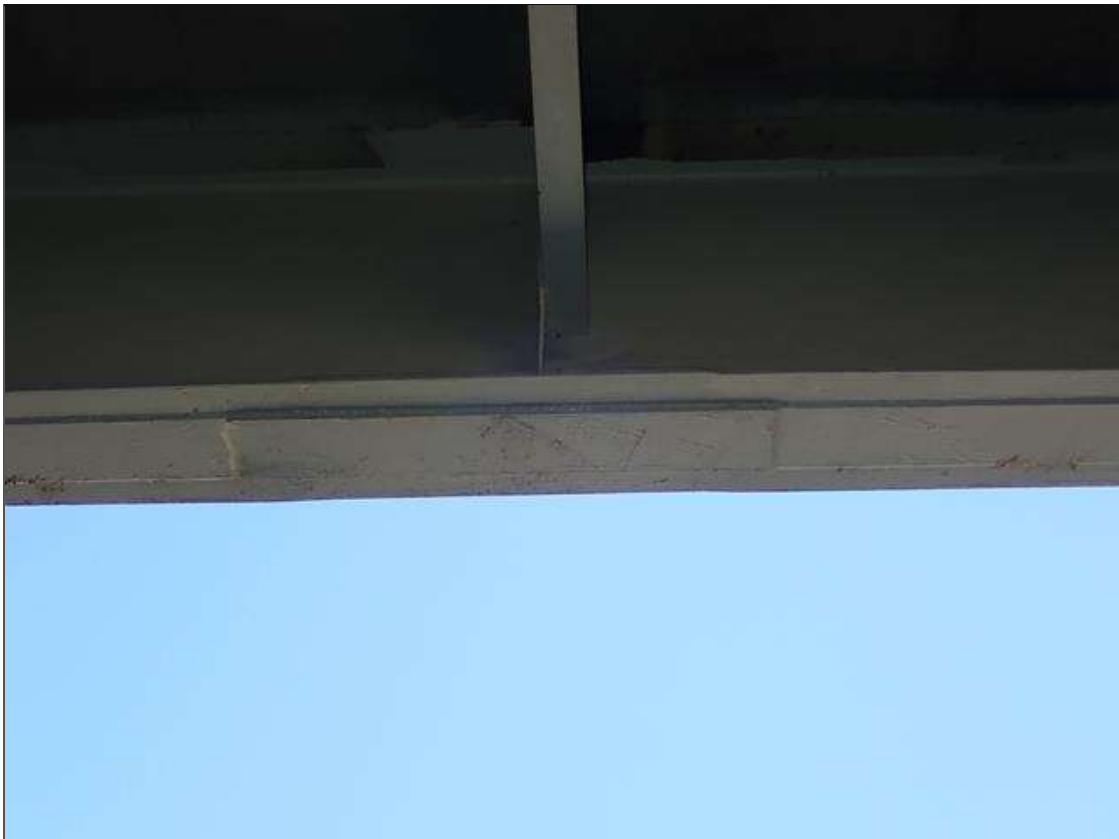
Span 1 Beam 1: TOP FLANGE (EXTERIOR) HAS PITTING UP TO .06" DEEP, HOWEVER BEAM HAS BEEN RECENTLY CLEANED AND PAINTED WITH CORROSION ARRESTED.
