NC DEPARTMENT OF TRANSPORTATION  
DIVISION OF HIGHWAYS  
STRUCTURE MANAGEMENT UNIT

## Structure Safety Report

### Routine Element Inspection - Contract

DIVISION: 14 COUNTY: HAYWOOD STRUCTURE NUMBER: 430124 FREQUENCY: 24 MONTHS

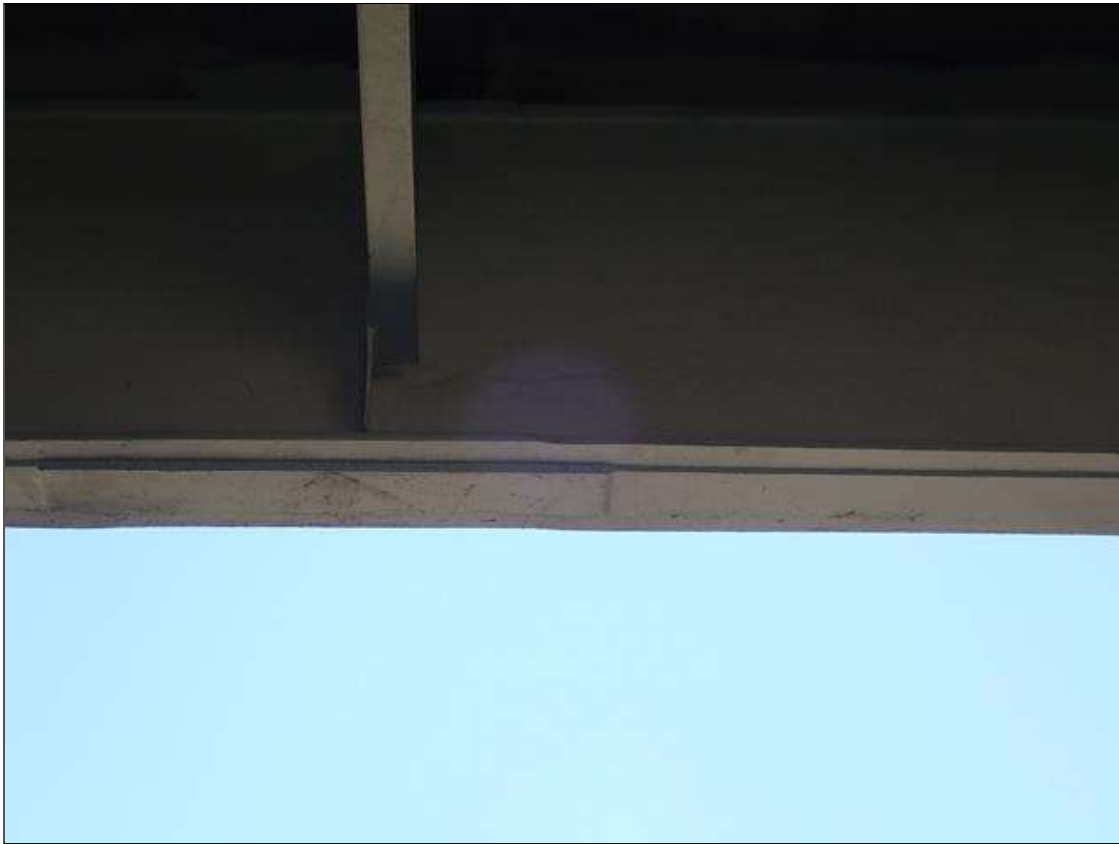
Span 2 Beam 1: 5 FT REPAIR TO COVER PLATE ON BOTTOM FLANGE AT DIAPHRAGM 1

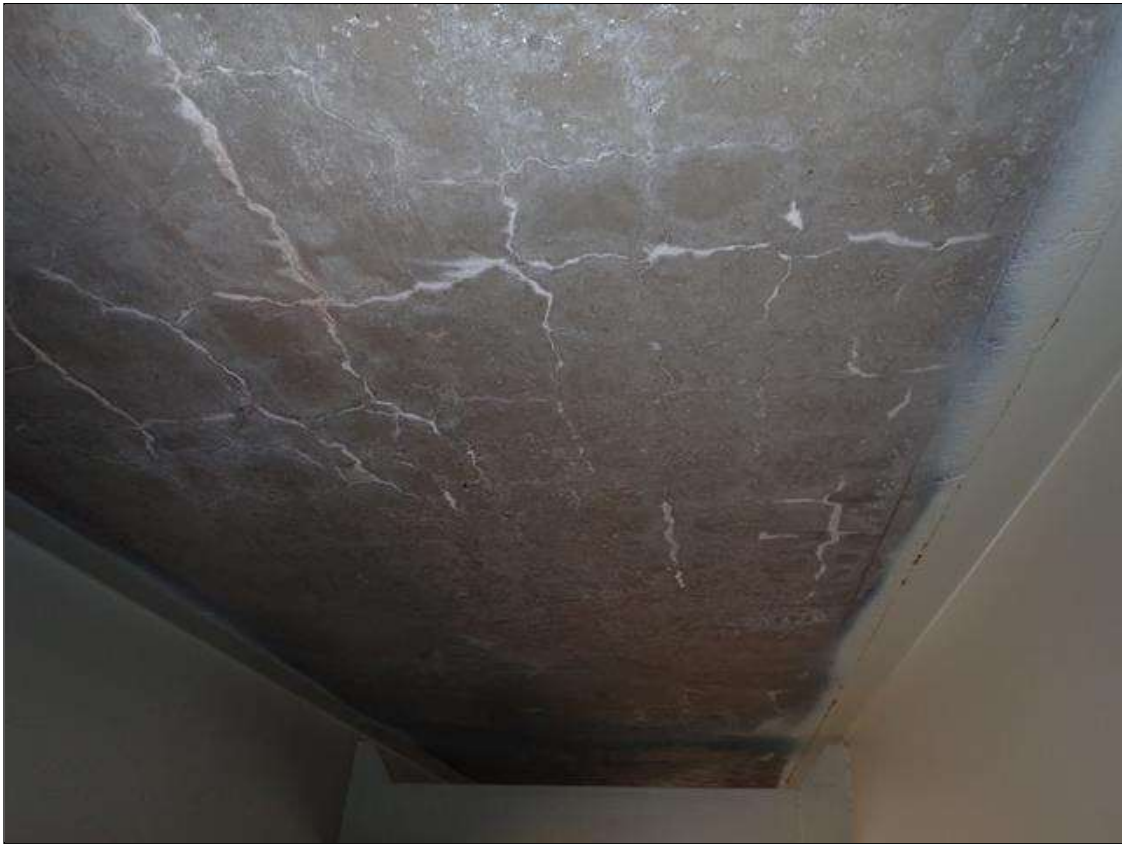
Span 1 Deck: 3 DIAGONAL HAIRLINE CRACKS UP TO 4 FT LONG WITH EFFLORESCENCE IN THE UNDERSIDE OF DECK IN BAY 1 NEAR GIRDER 2 AT END BENT 1

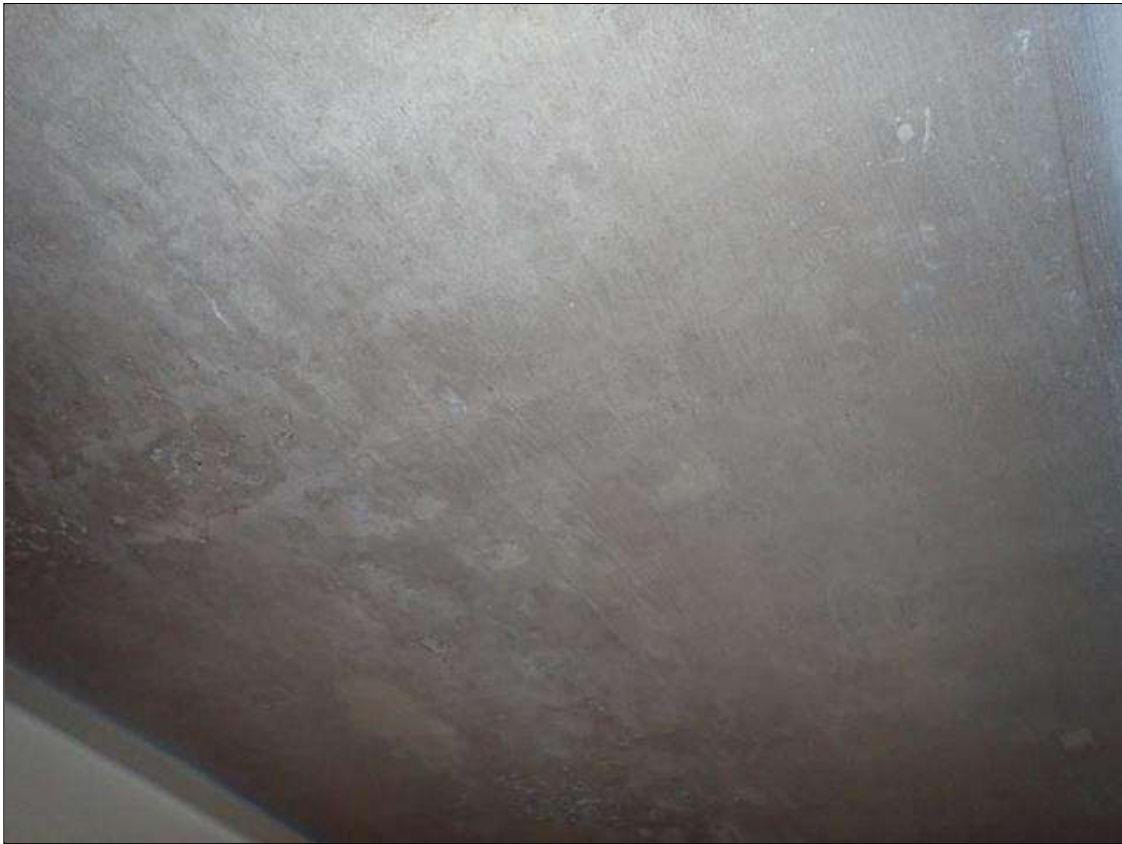
Span 1 Deck: 2.5 FT X 1 FT X 1" DEEP DELAMINATION/SPALL WITH EXPOSED REBAR NO MEASUREABLE SECTION LOSS, IN THE UNDERSIDE OF DECK IN BAY 4 NEAR DIAPHRAGM 1

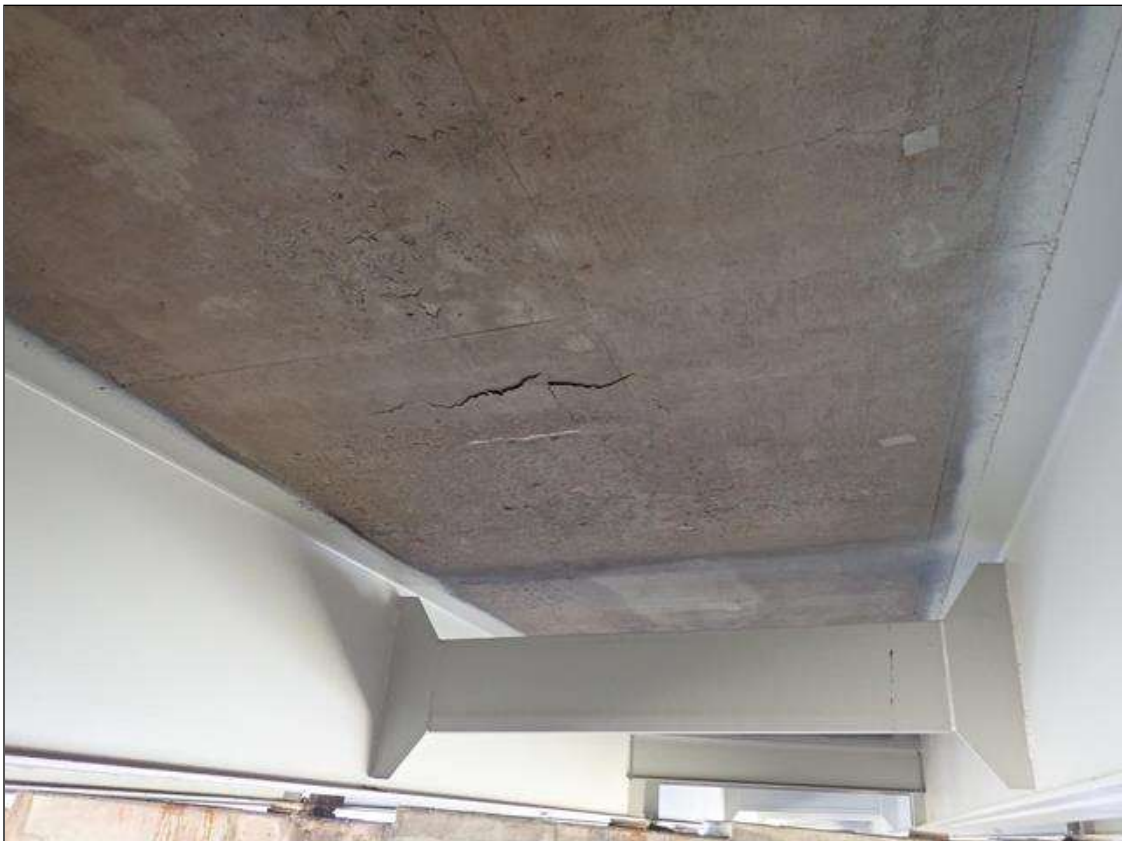
Span 1 Deck: 2 FULL WIDTH TRANSVERSE CRACKS UP TO 1/16" IN UNDERSIDE OF DECK NEAR MIDSPAN

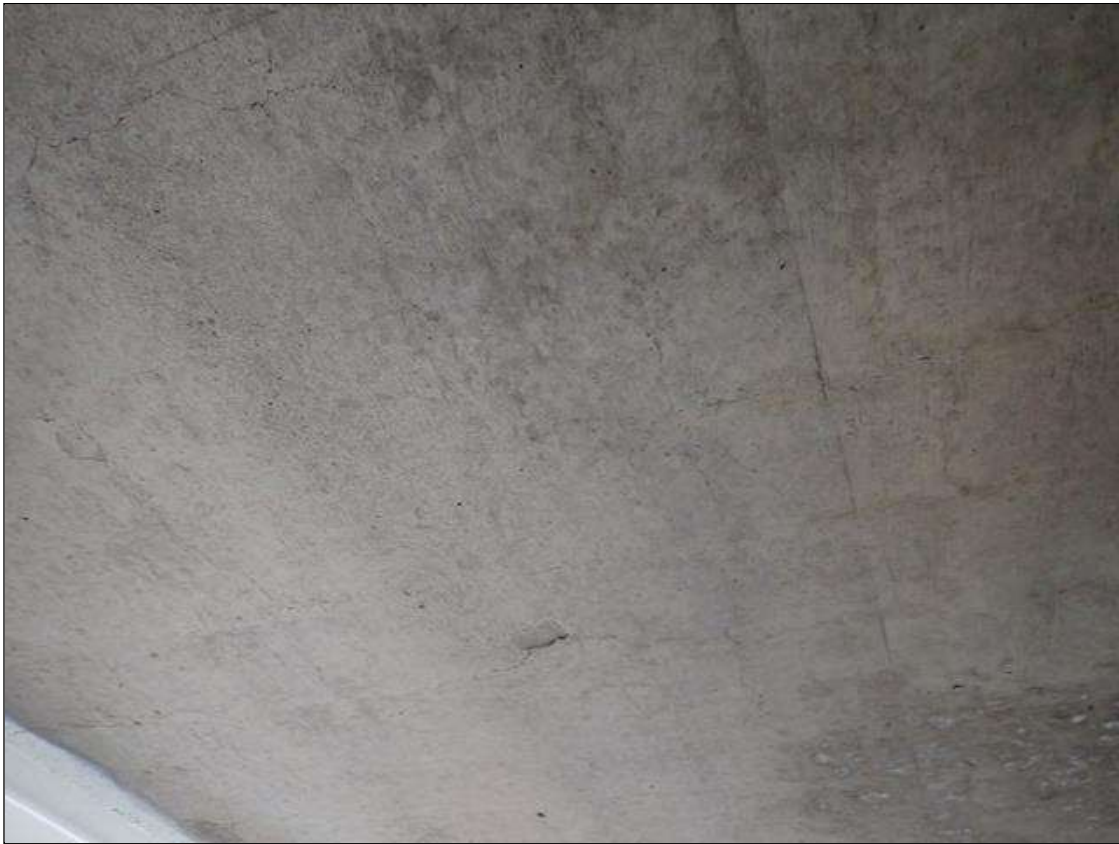
Span 1 Deck: 2 FT X 1 FT DELAMINATION IN UNDERSIDE OF DECK IN BAY 4 NEAR DIAPHRAGM 2

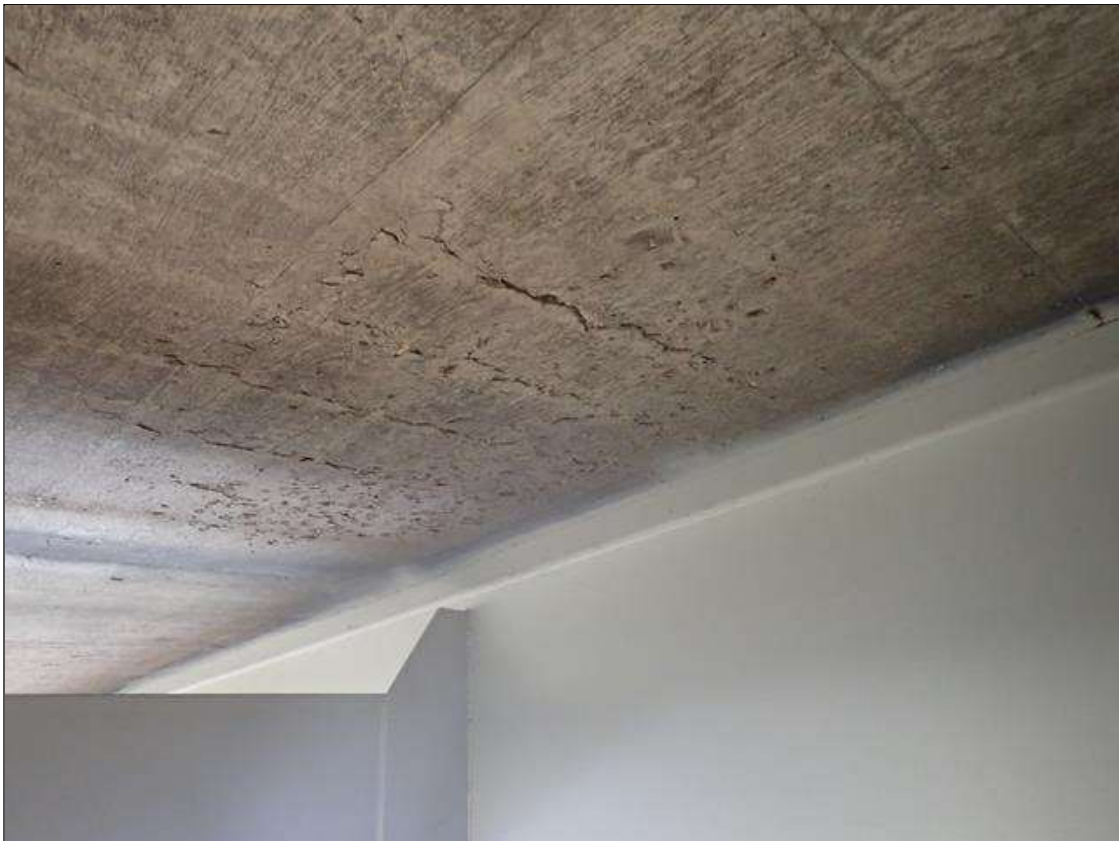
Span 1 Deck: DECK UNDERSIDE, MAP CRACKING UP TO .03" OPEN WITH EFFLORESCENCE AT BAY 8 NEAR END BENT 1. SIMILAR IN BAY 6 AND 7

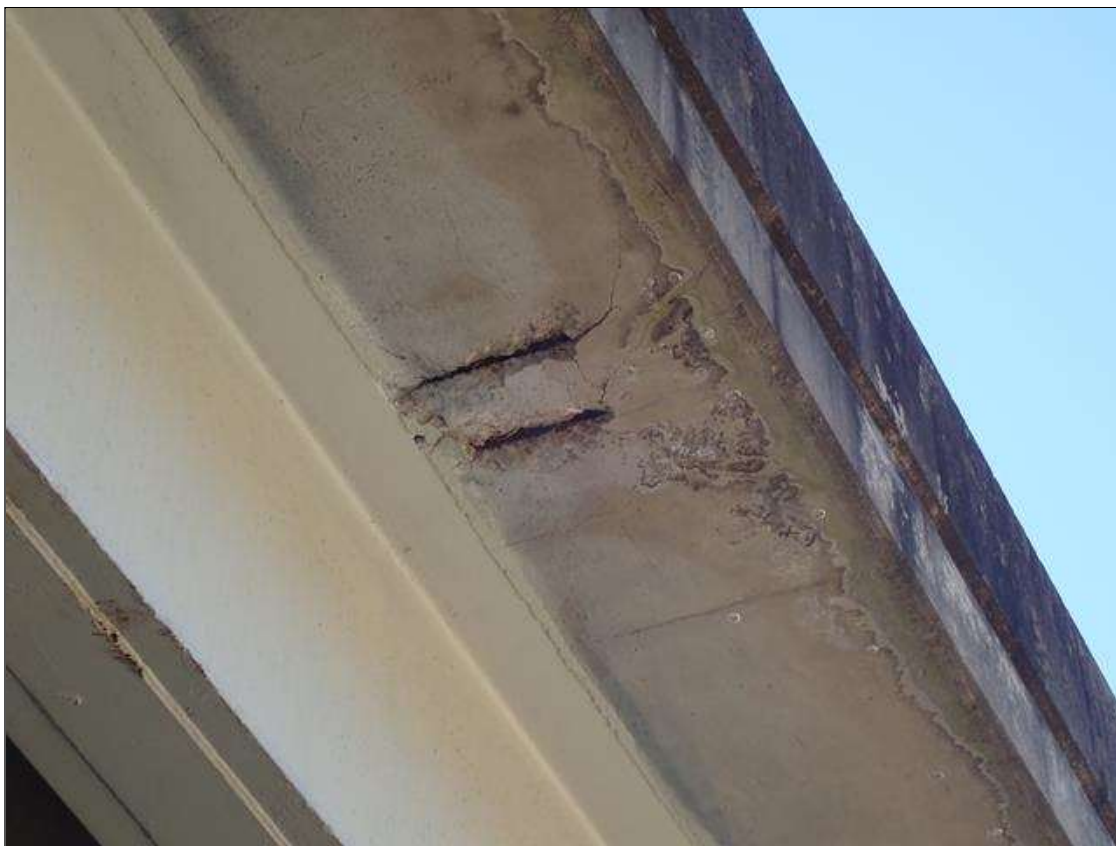
Span 1 Deck: 6 FT X 2 FT PATCH, SOUND, IN UNDERSIDE OF RIGHT OVERHANG NEAR END BENT 1

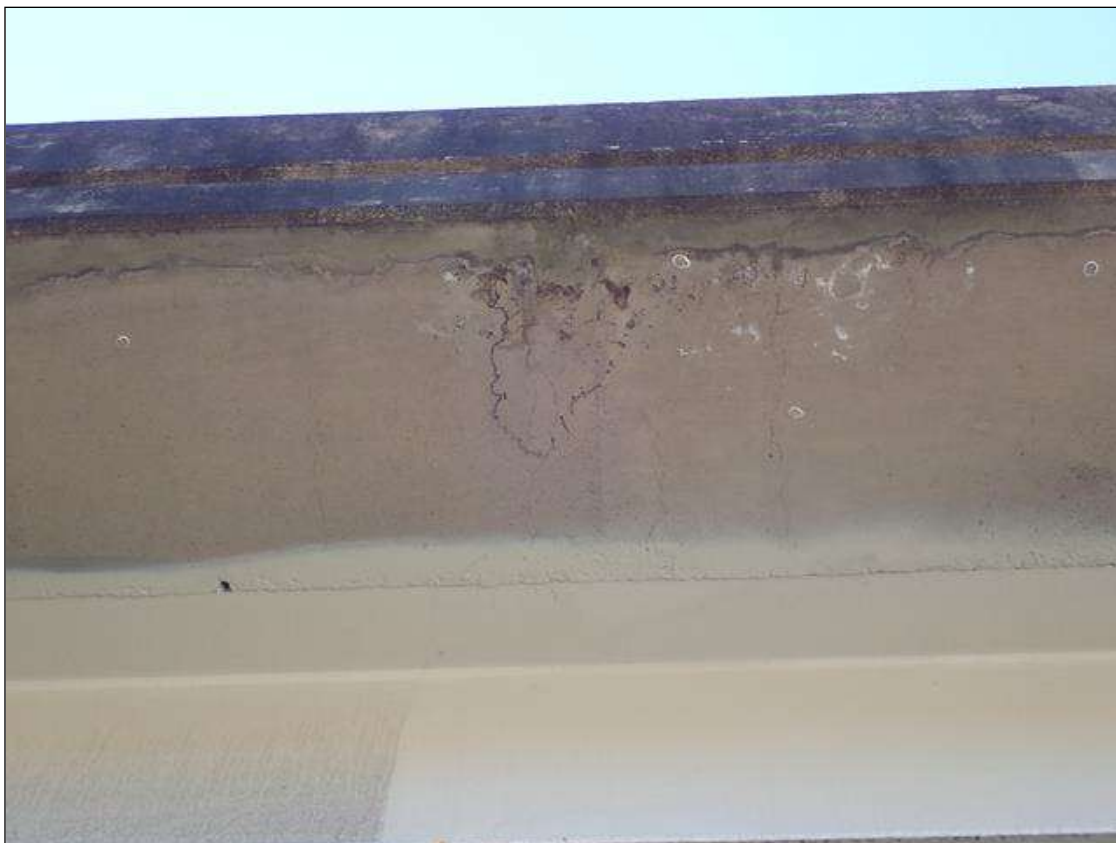
Span 2 Deck: SPALL 12" X 12" X 2" DEEP IN LEFT OVERHANG 12' FROM BENT 1 END.

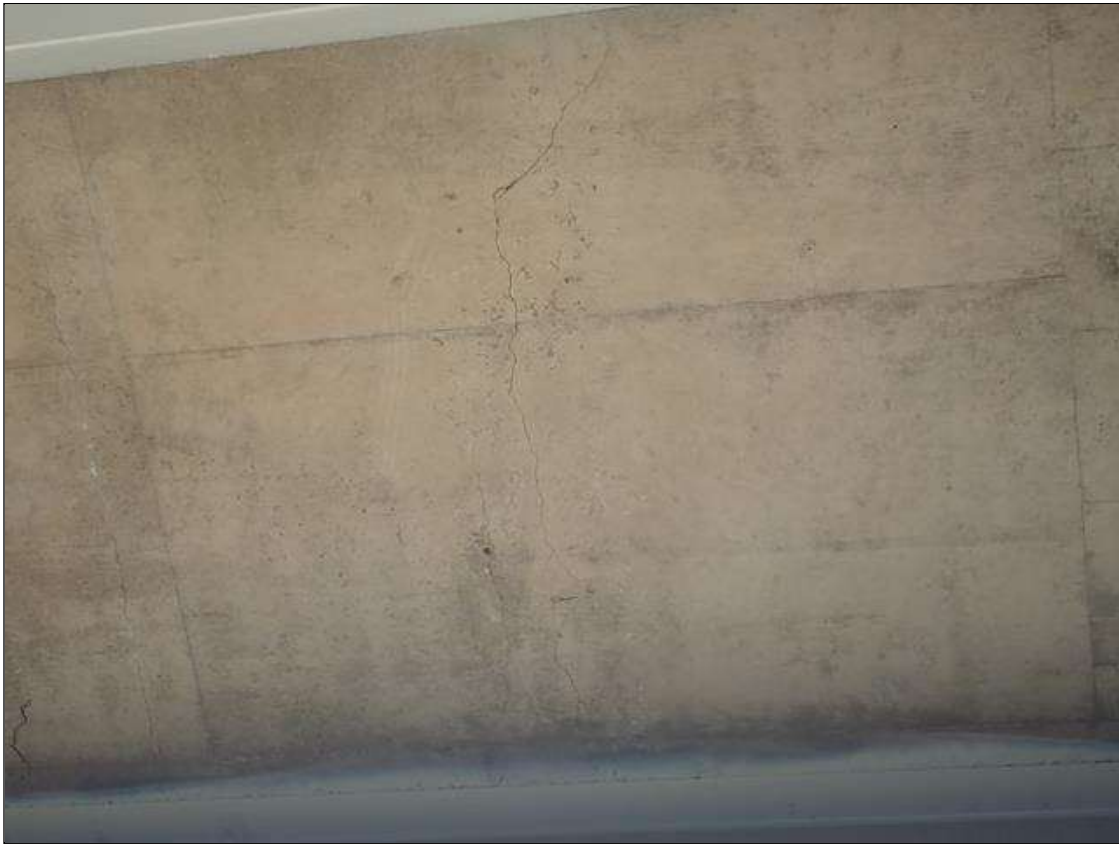
Span 2 Deck: 8 PATCHES UP TO 2" X 1" SOUND, IN UNDERSIDE OF DECK SCATTERED THROUGHOUT BAY 7, 8, 9, AND 6

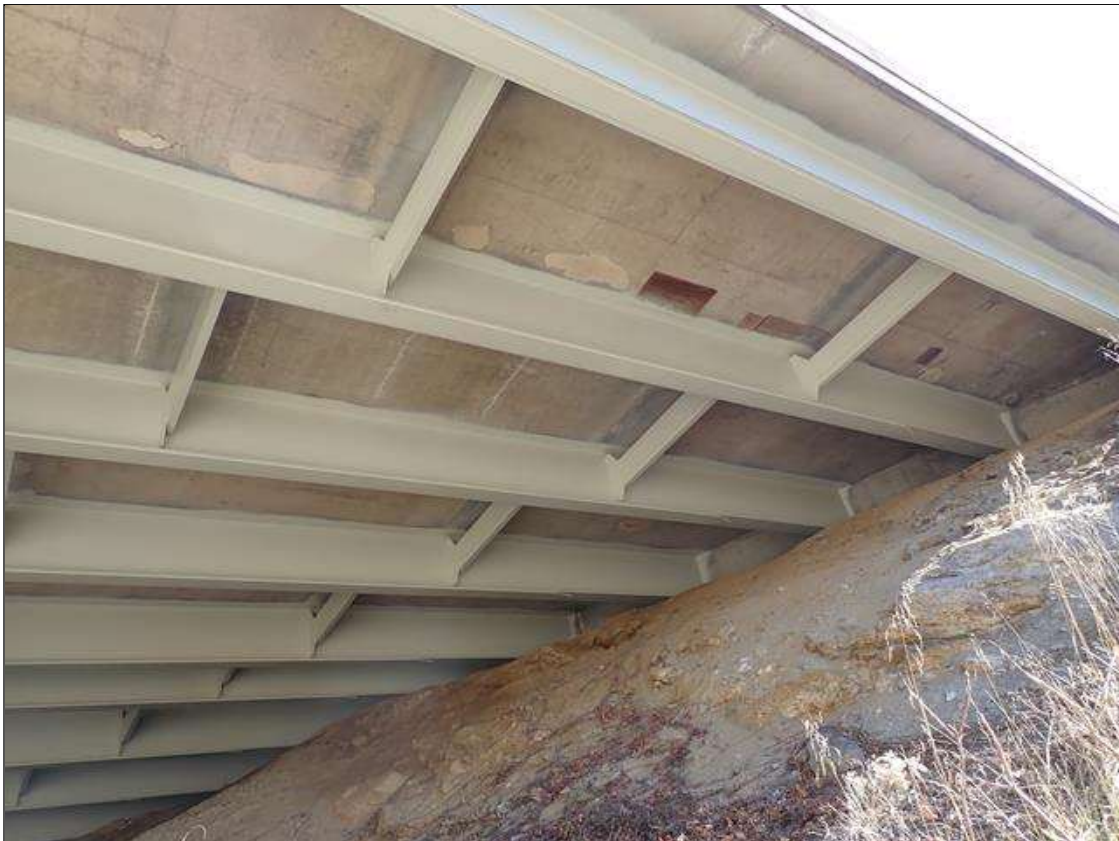
Span 2 Deck: FULL WIDTH TRANSVERSE CRACK UP TO 1/16" IN THE UNDERSIDE OF DECK, BAY 9, NEAR BENT 1

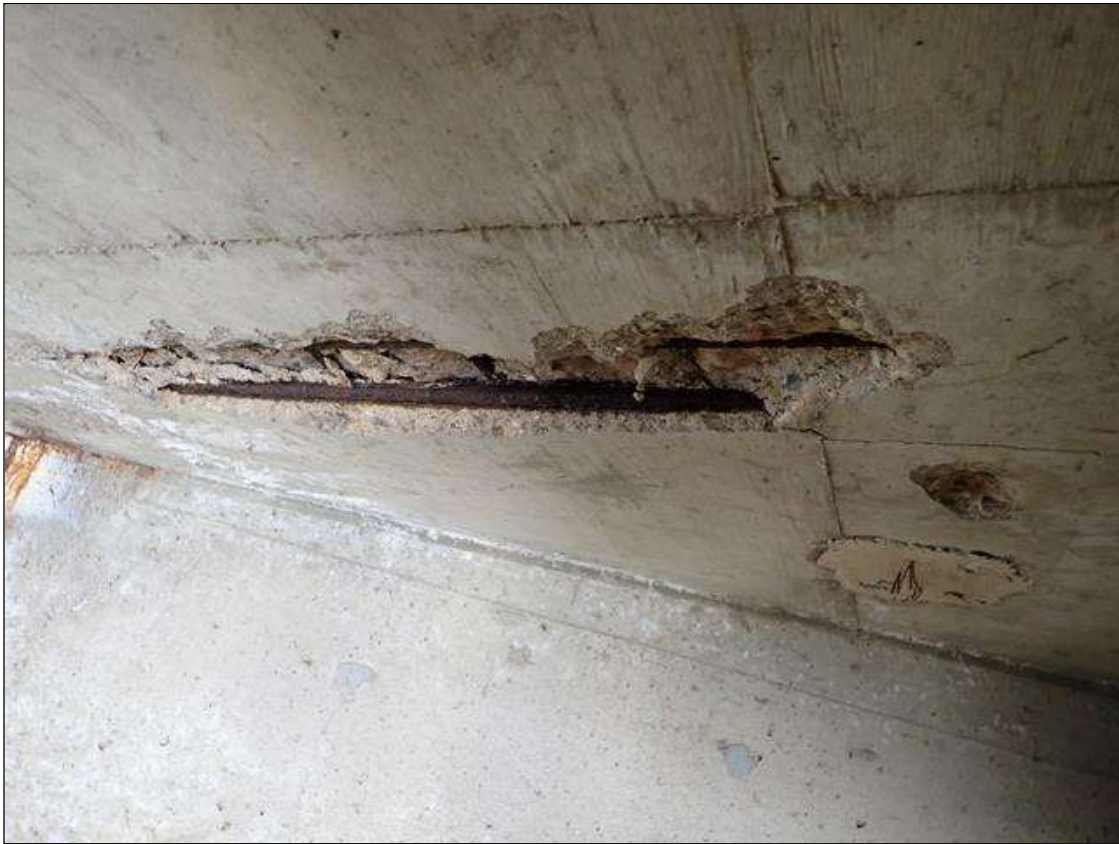
Span 3 Deck: PATCHED AREAS: (3) 10" X 10", 10" WIDE X 14" LONG AND 8" DIAMETER IN BAY 9 NEAR END BENT 2 END.

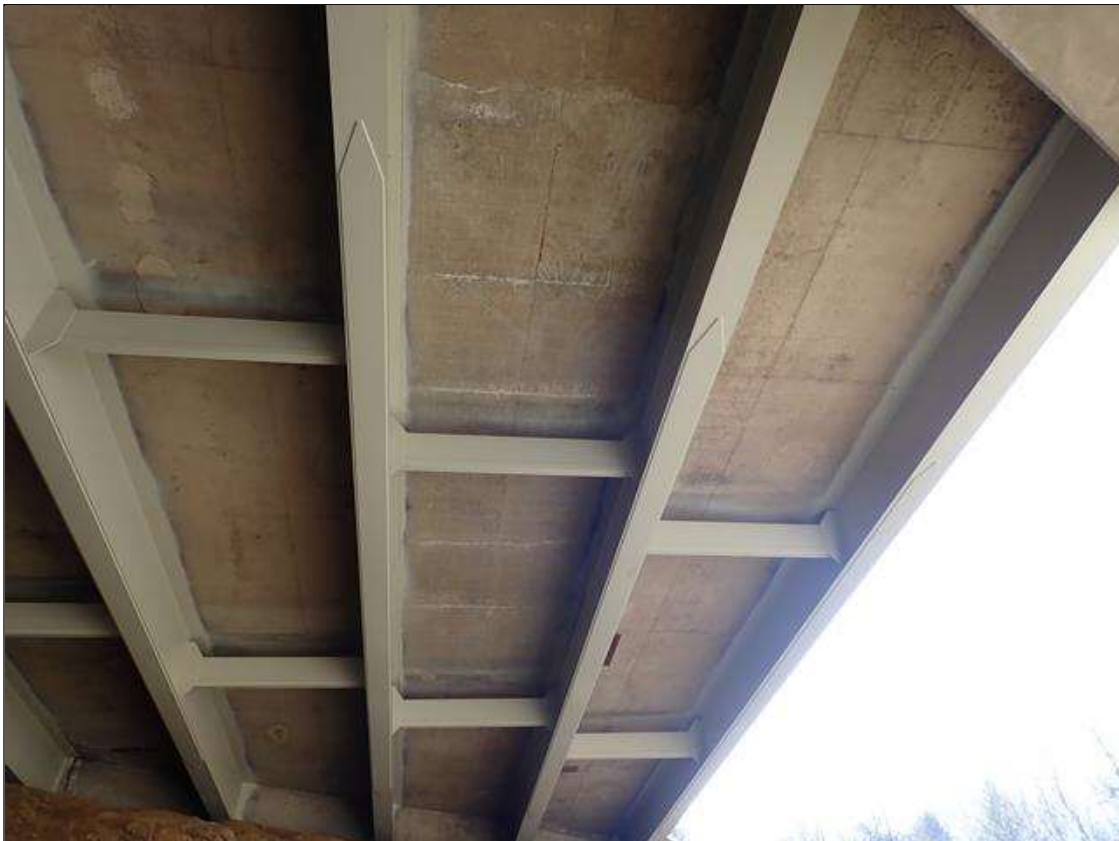
Span 3 Deck: SPALL 1 FT LONG X 4 FT WIDE X 3" DEEP WITH 2 REBARS EXPOSED AND 12" X 12" PATCH AT BAY 6, NO MEASURABLE SECTION LOSS

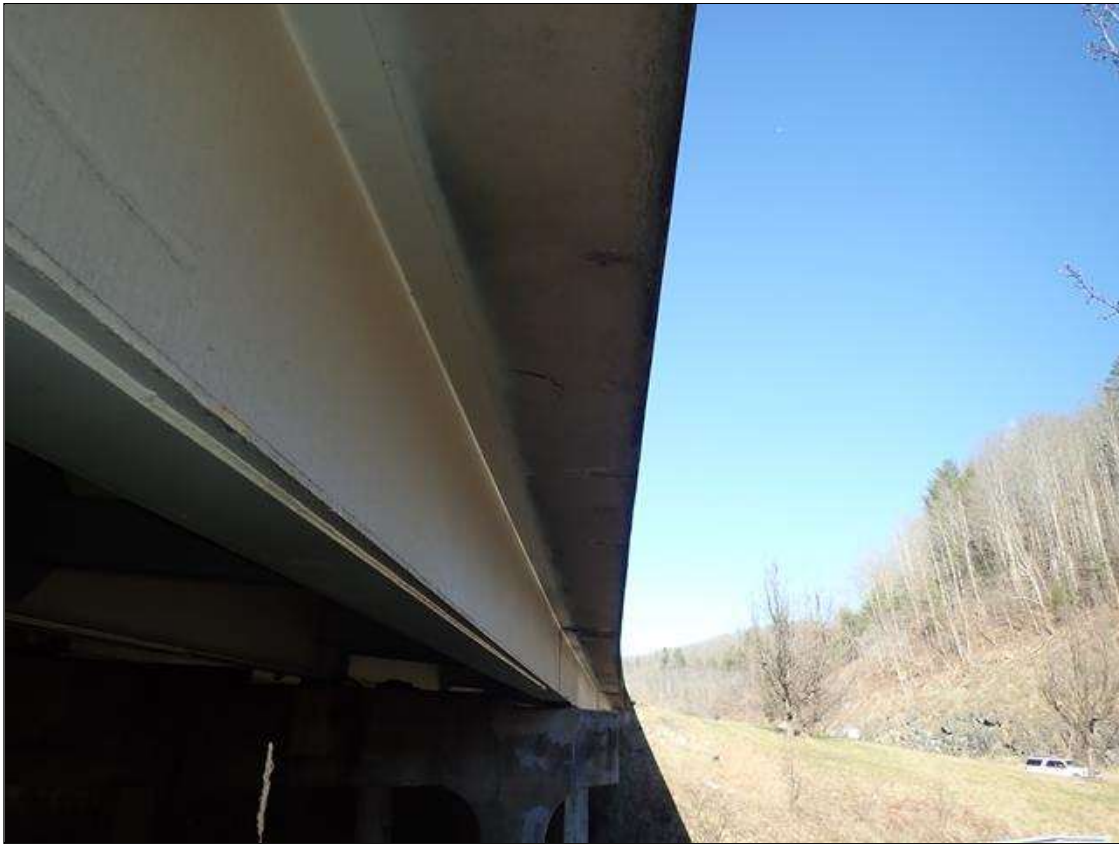
Span 3 Deck: 7 FULL WIDTH HAIRLINE TRANSVERSE CRACKS SCATTERED IN BAY 8 WITH EFFLORESCENCE IN UNDERSIDE OF DECK AND 5 SOUTH FACE SOUND PATCHES.

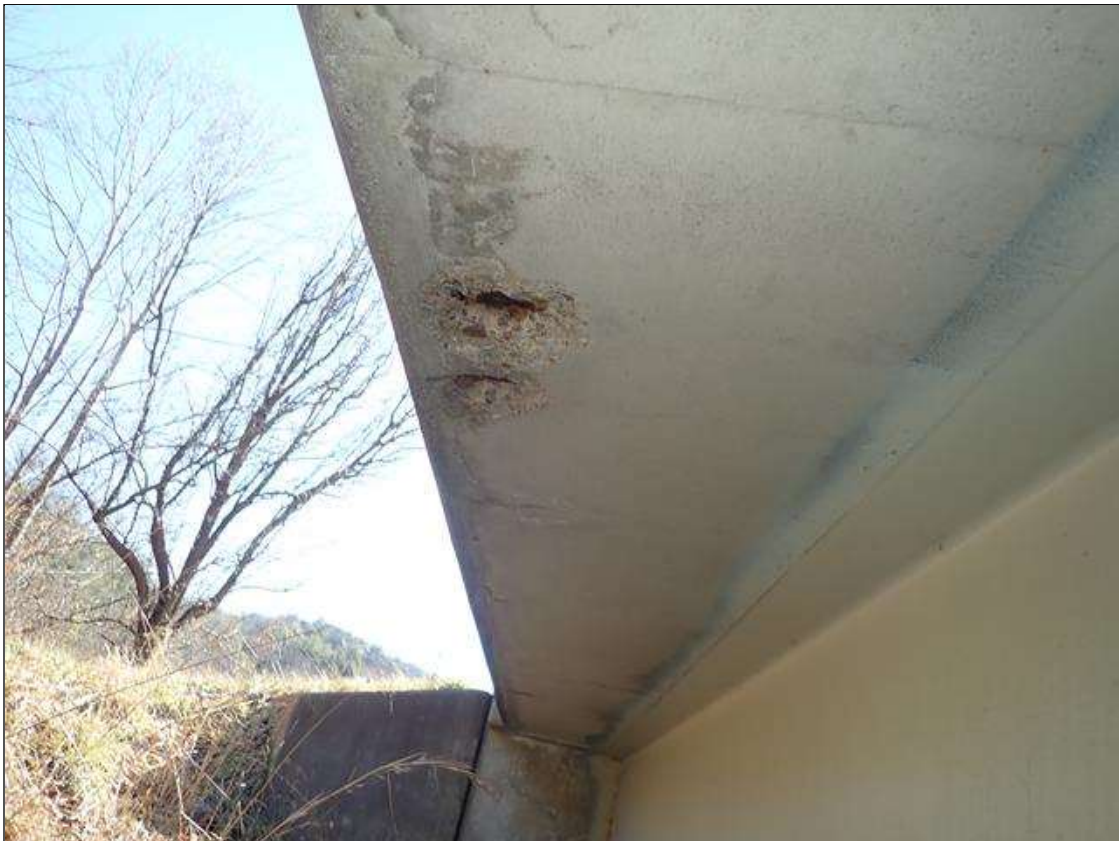
Span 3 Deck: SCATTERED DELAMINATIONS UP TO 6" DIAMETER SPACED AT 4 FT CENTER IN NORTH OVERHANG IN UNDERSIDE OF DECK.

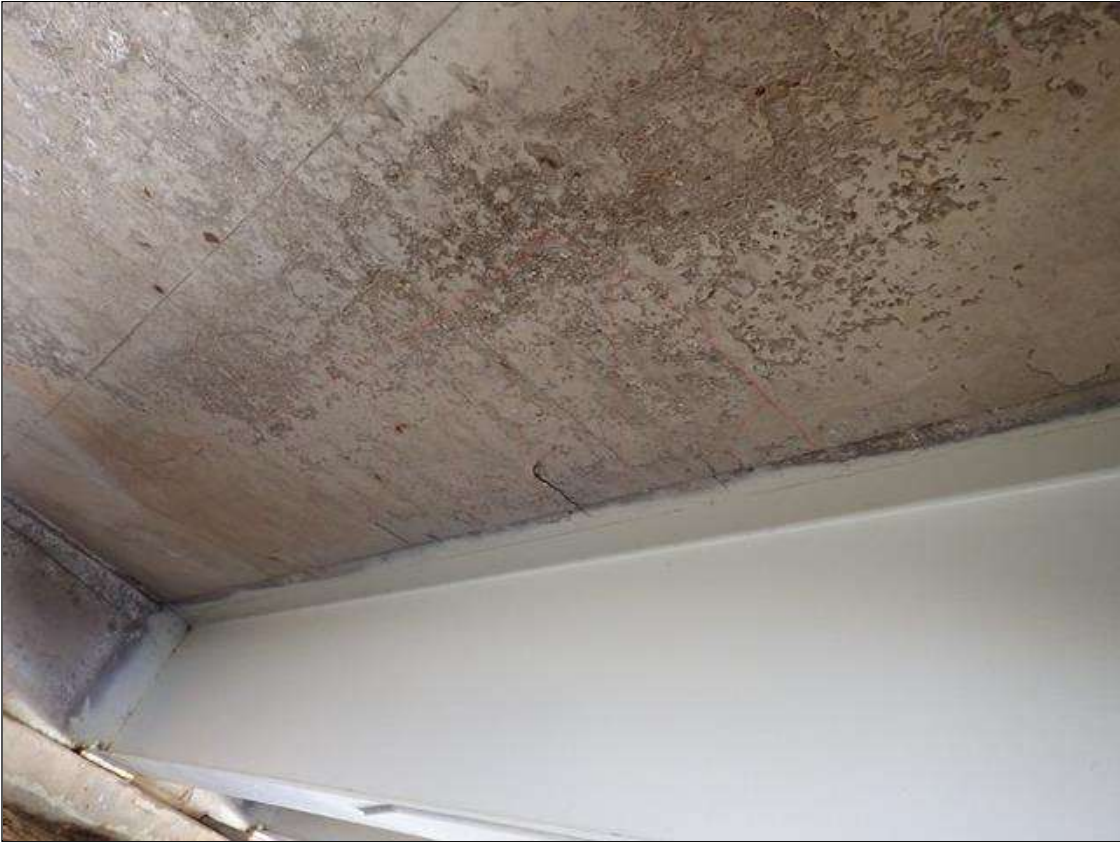
Span 3 Deck: 2 - 6" DIAMETER x 1" DEEP SPALLS WITH EXPOSED REBAR IN NORTH OVERHANG IN UNDERSIDE OF DECK, NO MEASURABLE SECTION LOSS.

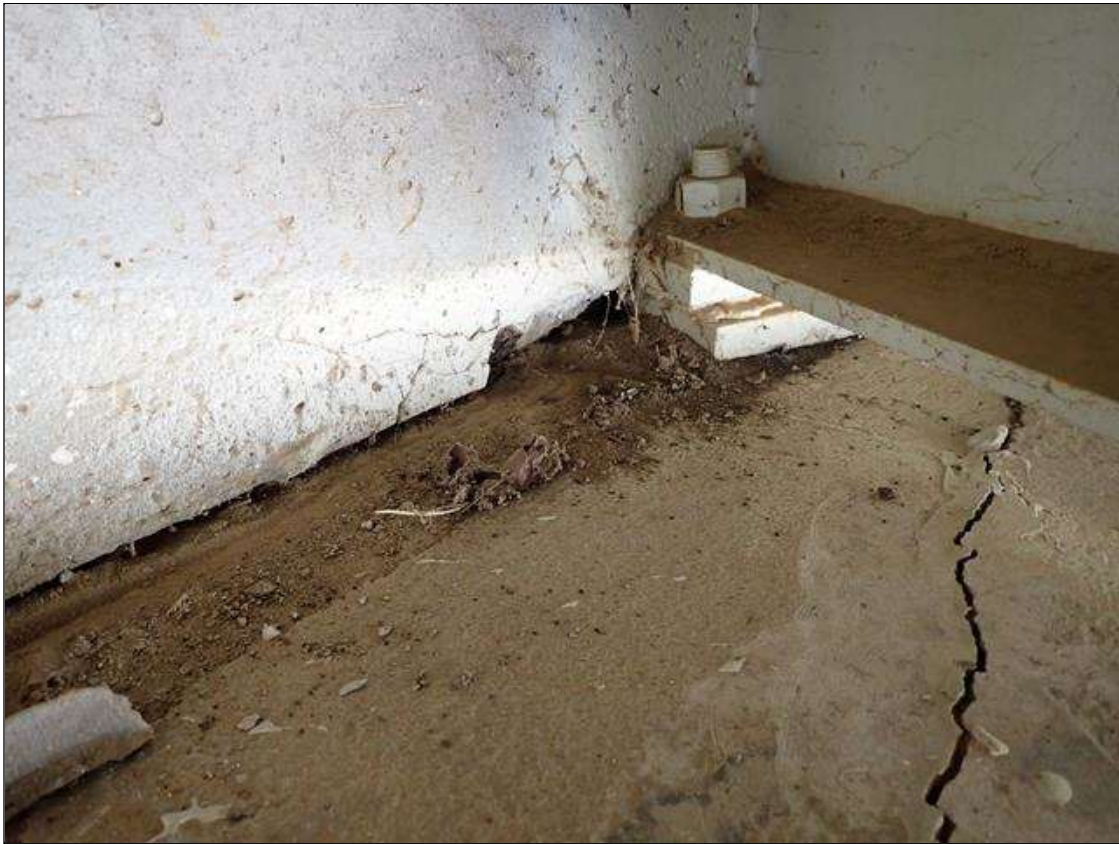
End Bent 2 Abutment/Backwall : 6" WIDE x 3" HIGH DELAMINATION AT GIRDER 6 NEAR BOTTOM FLANGE IN BACKWALL UNDER BAY 6

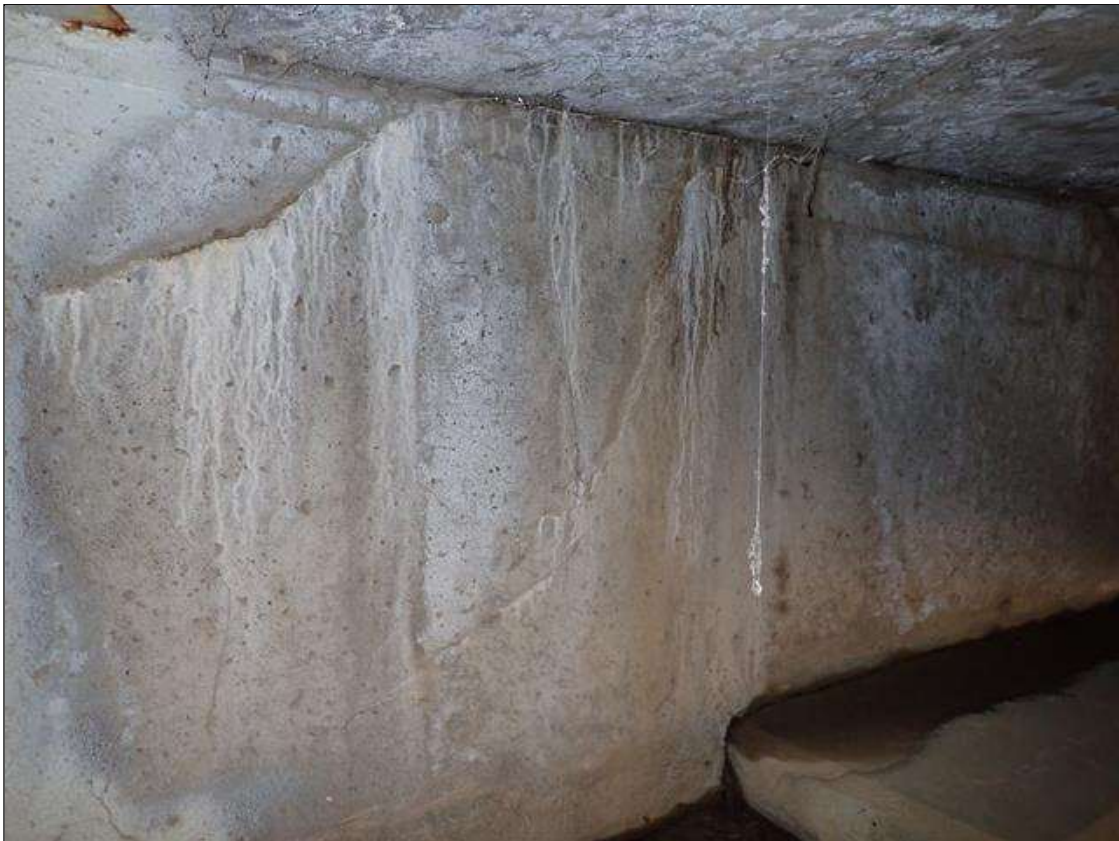
End Bent 2 Abutment/Backwall : 8" WIDE x 2" HIGH x 1" DEEP SPALL NEAR BOTTOM FLANGE OF GIRDER 8 IN BACKWALL UNDER BAY 8

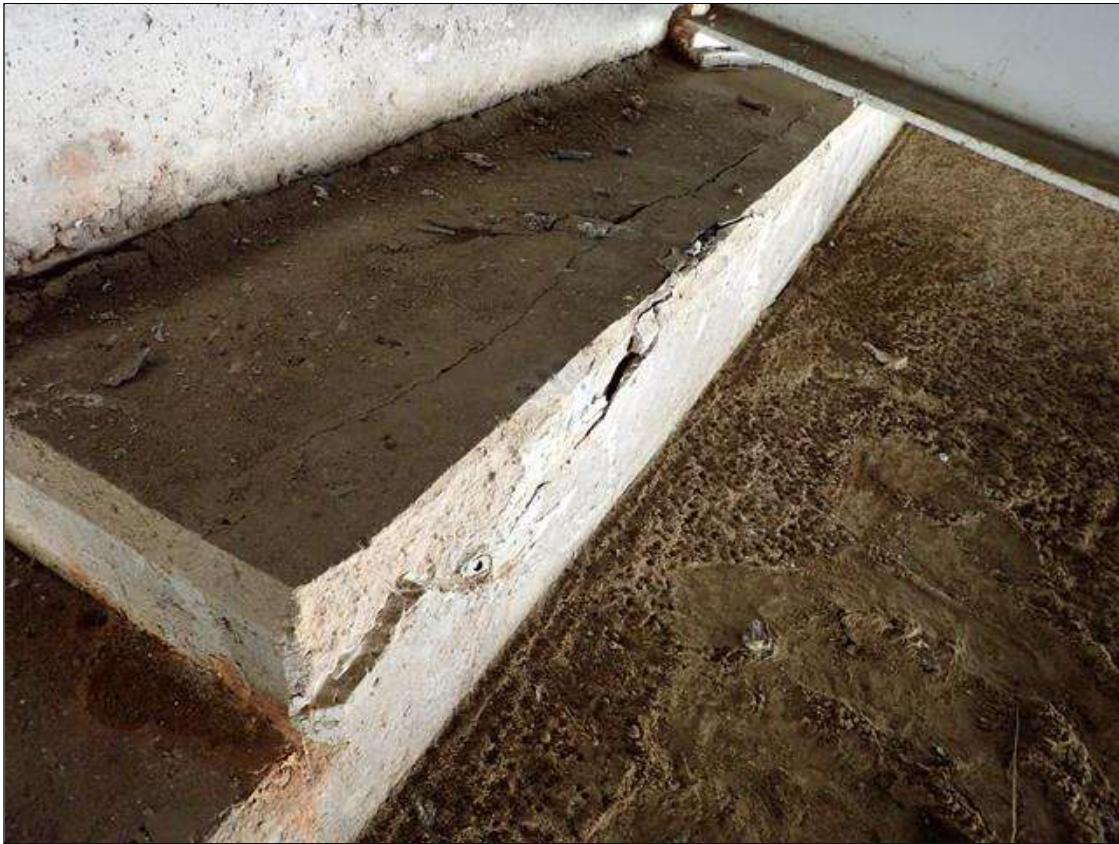
End Bent 2 Abutment/Backwall : 2 DIAGONAL CRACKS NEAR GIRDER 1 WITH EFFLORESCENCE IN BACKWALL IN BAY 1

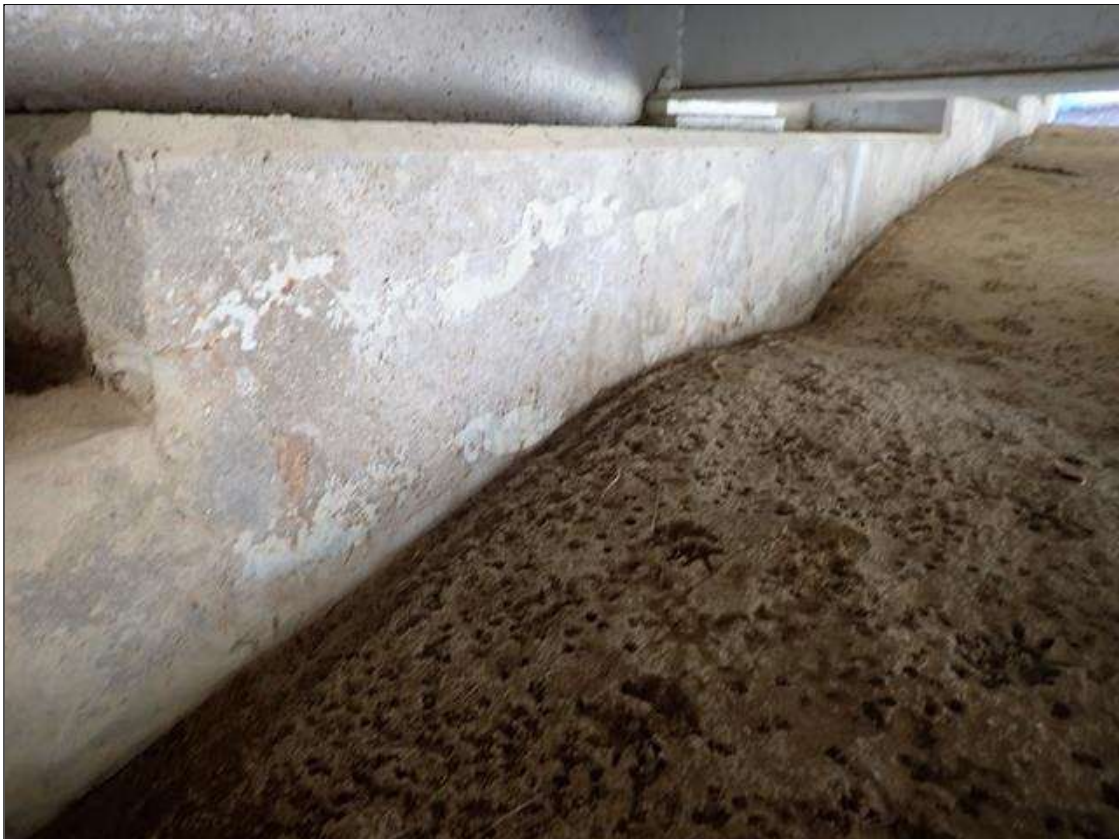
End Bent 2 Cap 1: 9 FT x FULL HEIGHT OF CAP DELAMINATION UNDER BAY 2 WITH HORIZONTAL CRACK GOING THROUGH

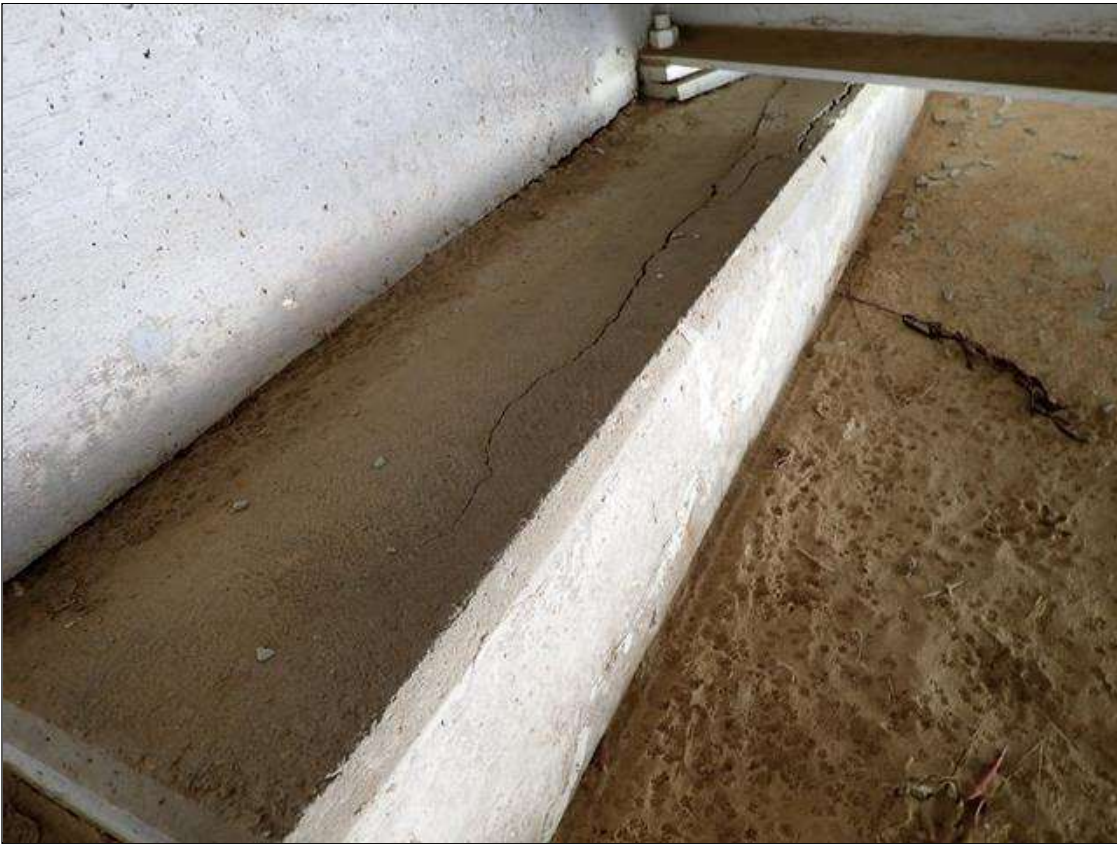
End Bent 2 Cap 1: SCATTERED CRACK REPAIRS THROUGHOUT END BENT CAP

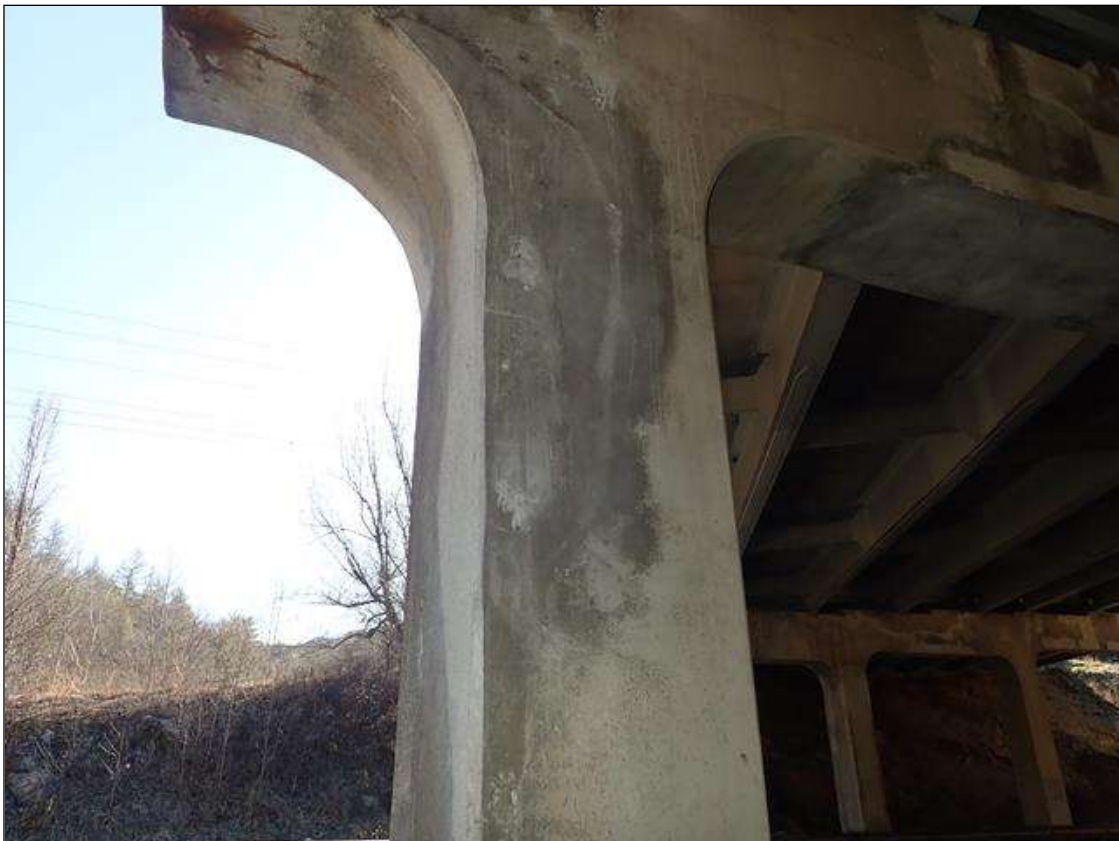
Bent 1 Pile 1: 4 FT HORIZONTAL HAIRLINE CRACKS IN NORTH FACE OF COLUMN NEAR TOP OF CAP

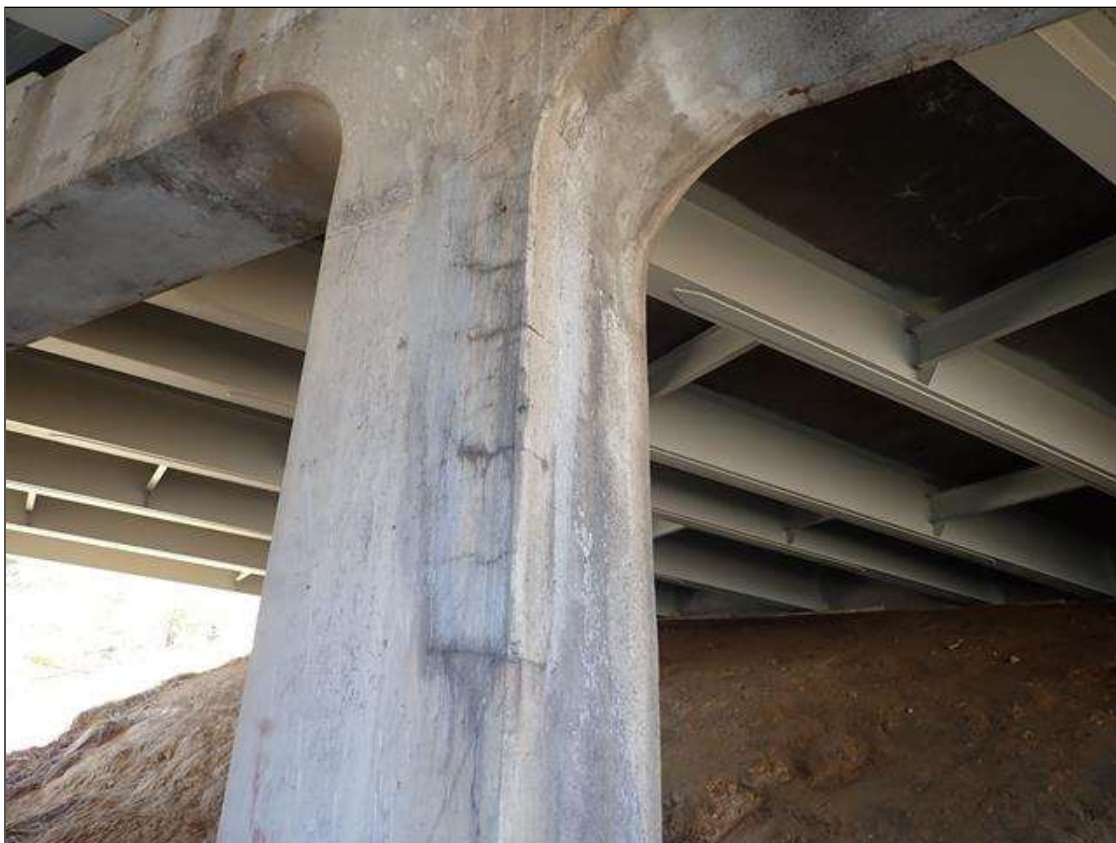
Bent 1 Pile 1: 8 FT x 2 FT WIDE SOUND PATCH IN EAST FACE OF COLUMN

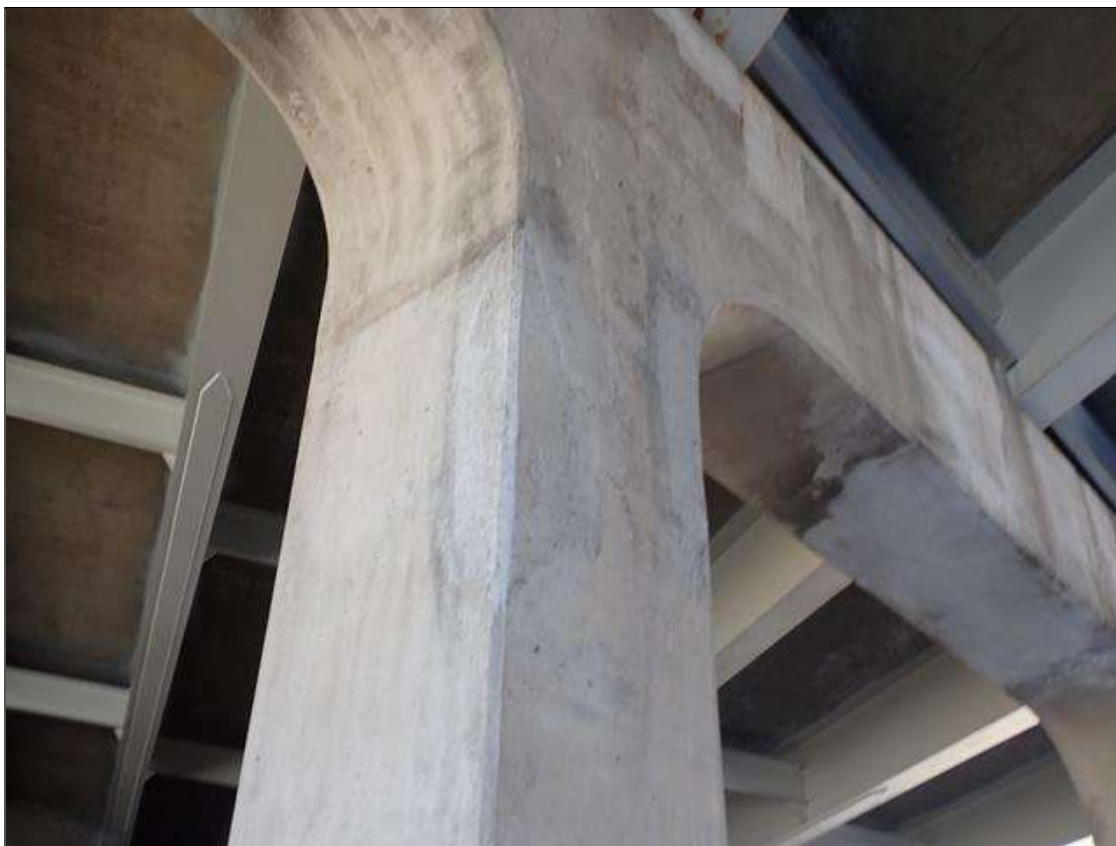
Bent 1 Pile 2: PATCHED AREA 6" WIDE x 1 FT WIDE X 5' HIGH IN NORTHEAST CORNER WITH 5 - 2 FT HIGH VERTICAL HAIRLINE CRACKS 6" TO 1' APART.
