NC DEPARTMENT OF TRANSPORTATION  
DIVISION OF HIGHWAYS  
STRUCTURE MANAGEMENT UNIT

## Structure Safety Report

### Routine Element Inspection - Contract

DIVISION: 14 COUNTY: HAYWOOD STRUCTURE NUMBER: 430124 FREQUENCY: 24 MONTHS

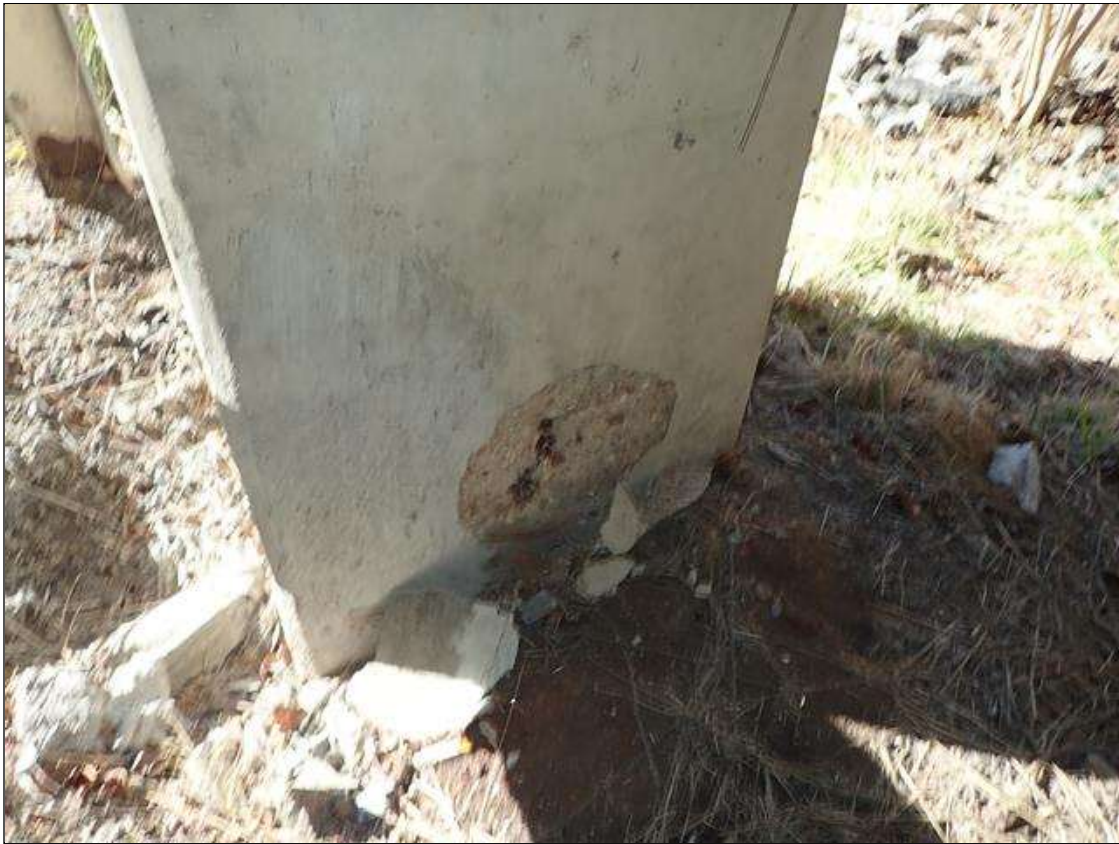
Bent 1 Pile 4: PATCHWORK 4 FT HIGH x FULL WIDTH OF COLUMN ON SOUTHWEST FACE NEAR BOTTOM OF CAP

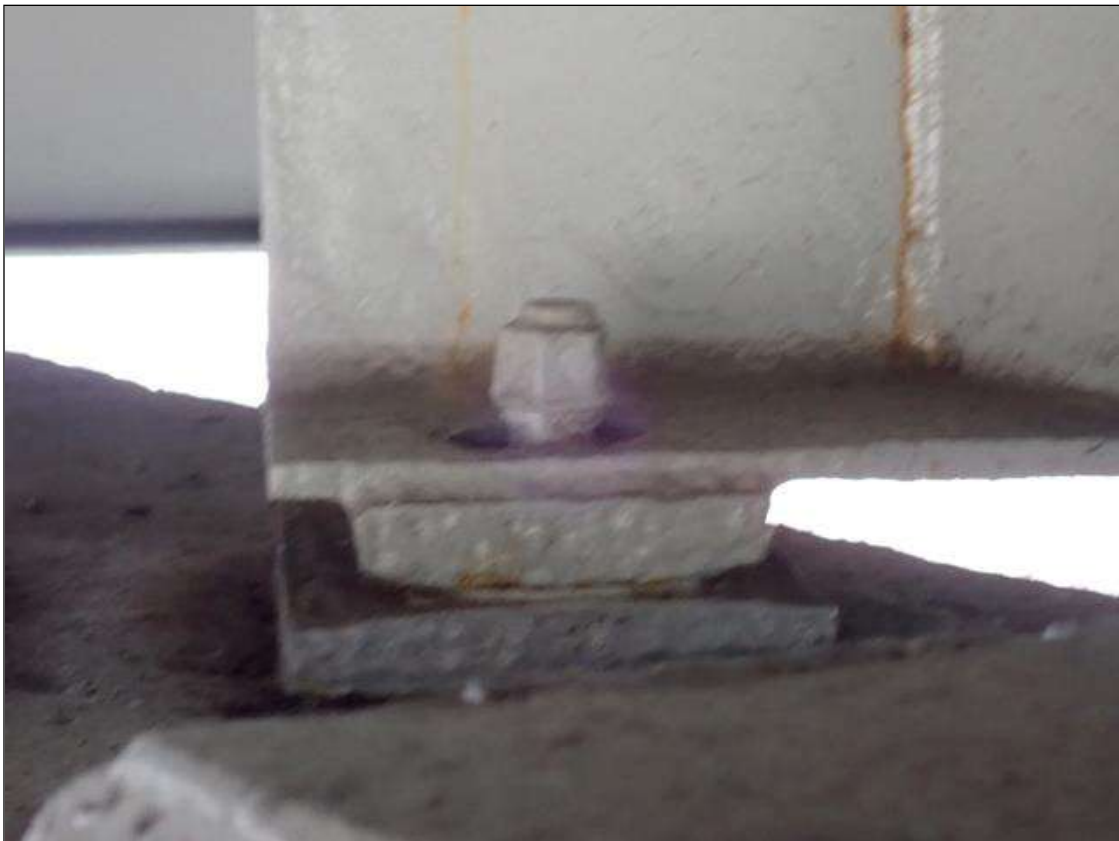
Span 3 Beam 1 Far Bearing: PACK RUST COMING THROUGH COATING
