NC DEPARTMENT OF TRANSPORTATION  
DIVISION OF HIGHWAYS  
STRUCTURE MANAGEMENT UNIT

## Structure Safety Report

### Routine Element Inspection - Contract

DIVISION: 14 COUNTY: HAYWOOD STRUCTURE NUMBER: 430142 FREQUENCY: 24 MONTHS

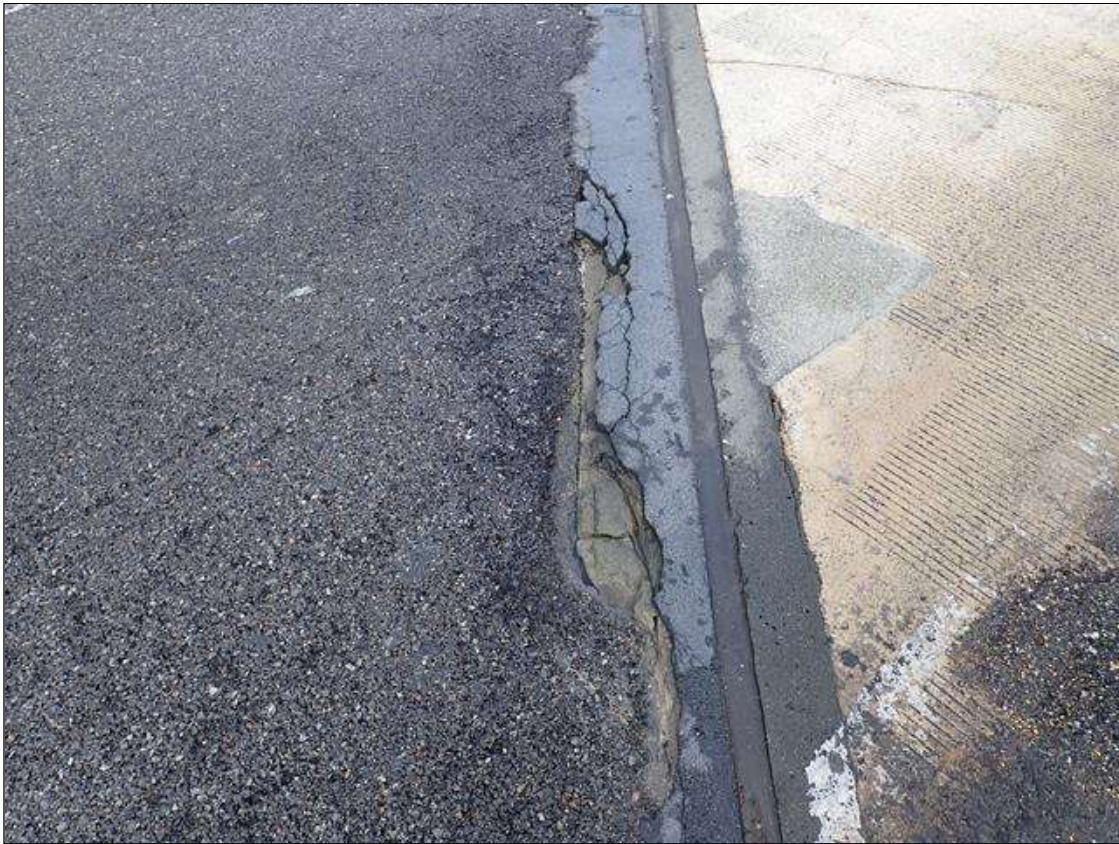
Expansion Joint At End Bent 2: UNSOUND PATCH IN THE ADJACENT HEAD IN THE WEST APPROACH IN THE LEFT WESTBOUND LANE IN THE LEFT WHEEL PATH WITH A 4 FT X 10" X 2" DEEP SPALL WITH NO EXPOSED REBAR

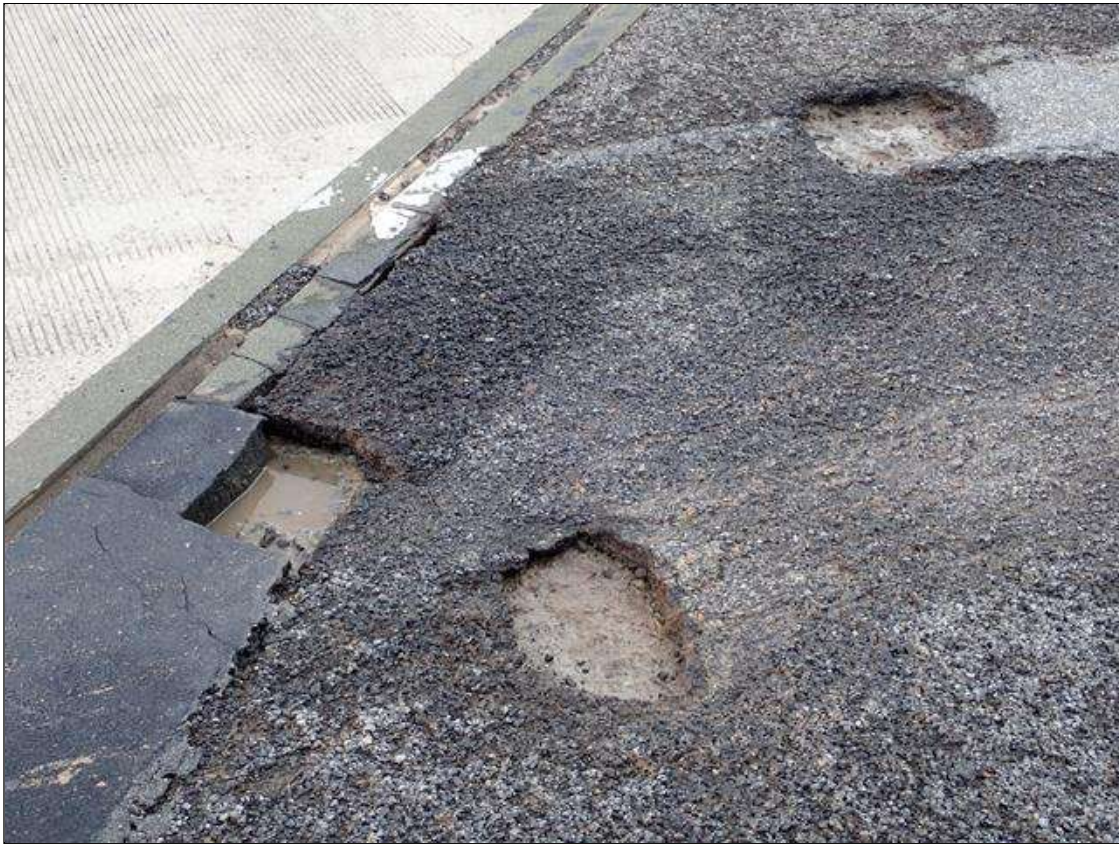
WEST APPROACH ROADWAY HAS THREE POTHOLES UP TO 2 FT DIAMETER X 3" DEEP SCATTERED IN THE EASTBOUND LANES NEAR THE JOINT

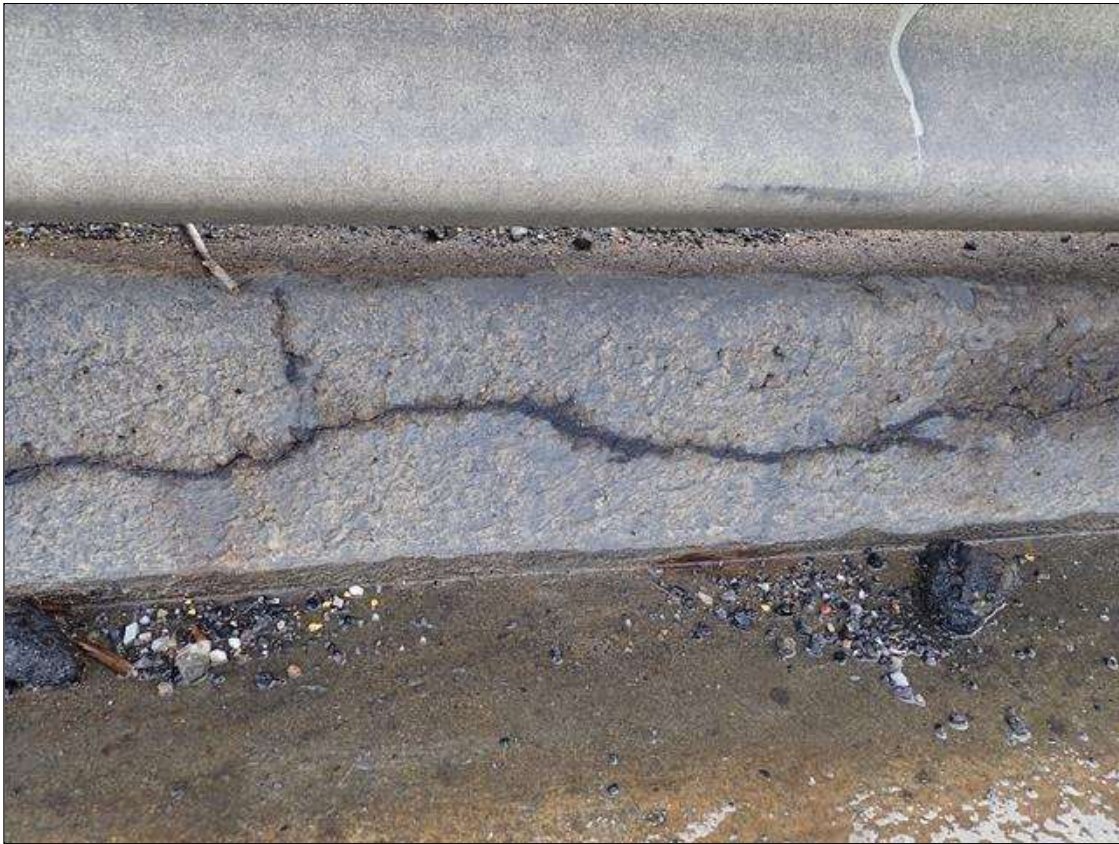
Span 5 Left Bridge Rail: CONCRETE CURB HAS SCATTERED HORIZONTAL CRACKS UP TO 1/16" WIDE THROUGHOUT

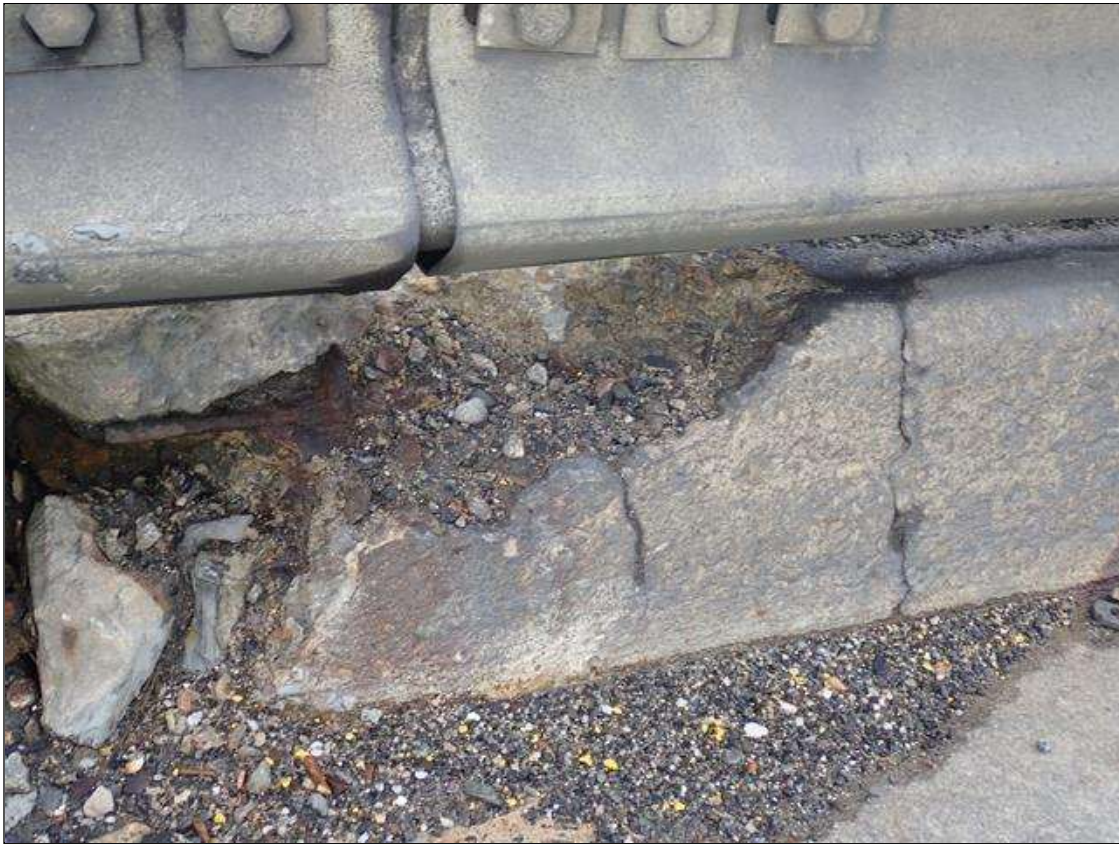
Span 4 Left Bridge Rail: SPAN 4, LEFT CURB AT BENT 3 HAS A SPALL, 18" LONG X 10" HIGH X 8" DEEP WITH EXPOSED REBAR, NO SECTION LOSS

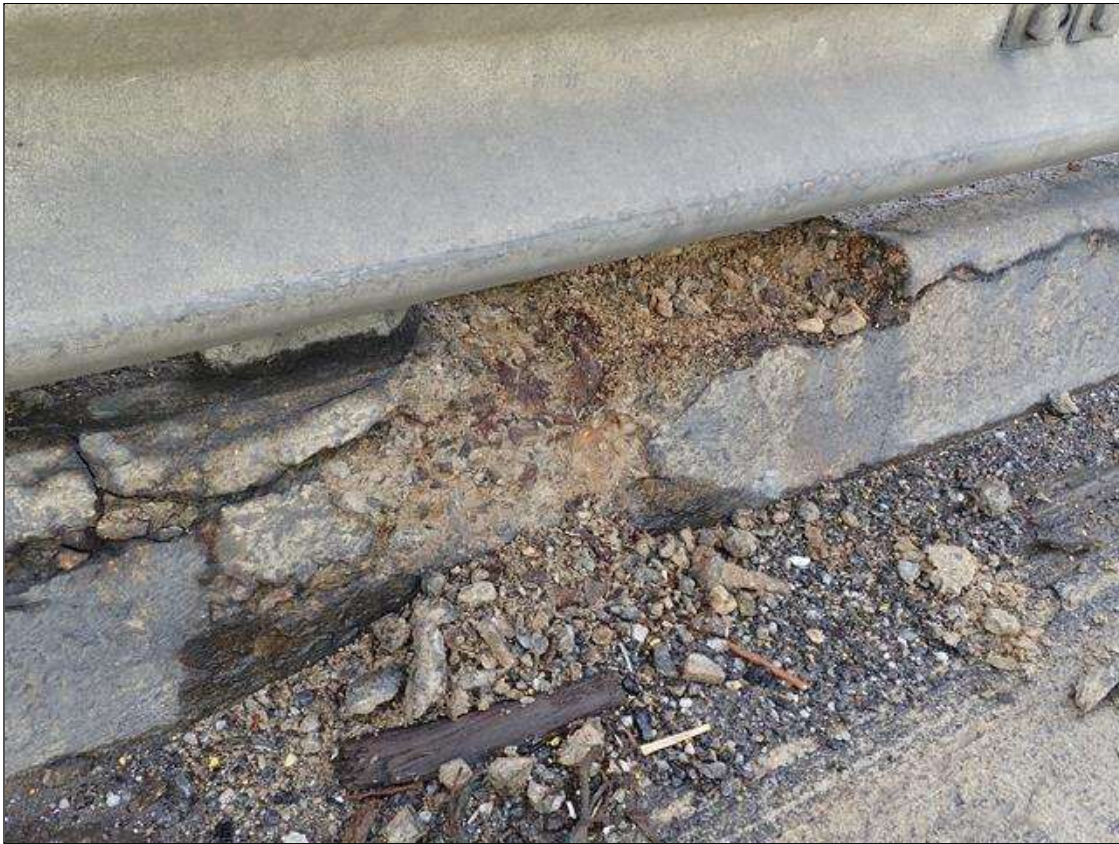
Span 2 Left Bridge Rail: CONCRETE CURB HAS A 4 FT X 9" X 8" SPALL, NO EXPOSED REBAR, 23 FT FROM BENT 2

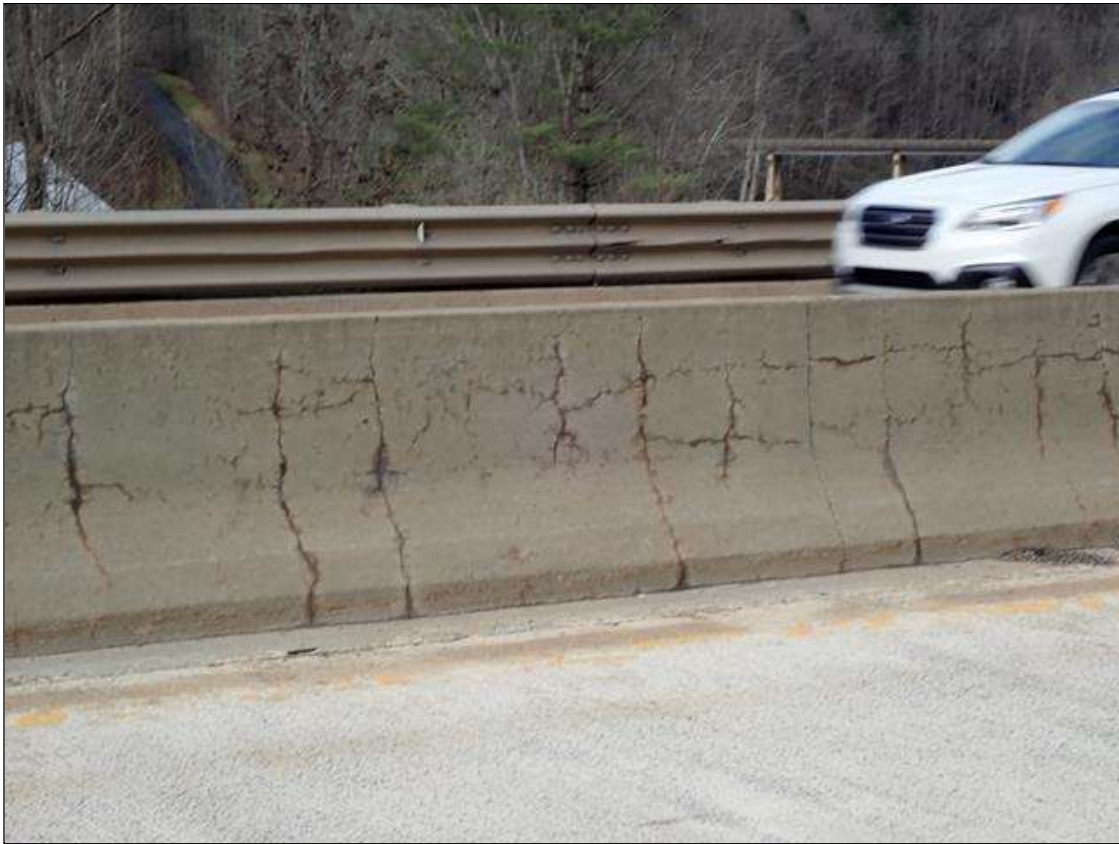
Span 2 Median Rail: MAP CRACKING UP TO 1/16" WIDE THROUGHOUT BOTH FACES

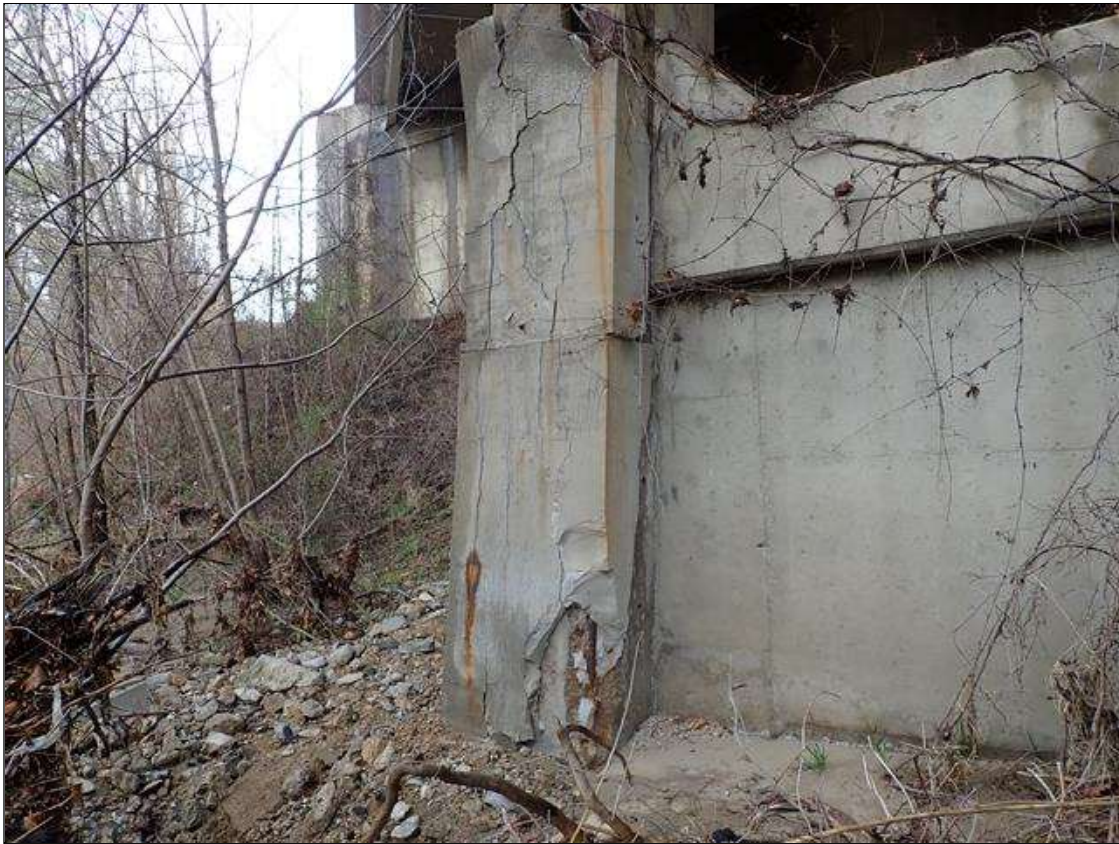
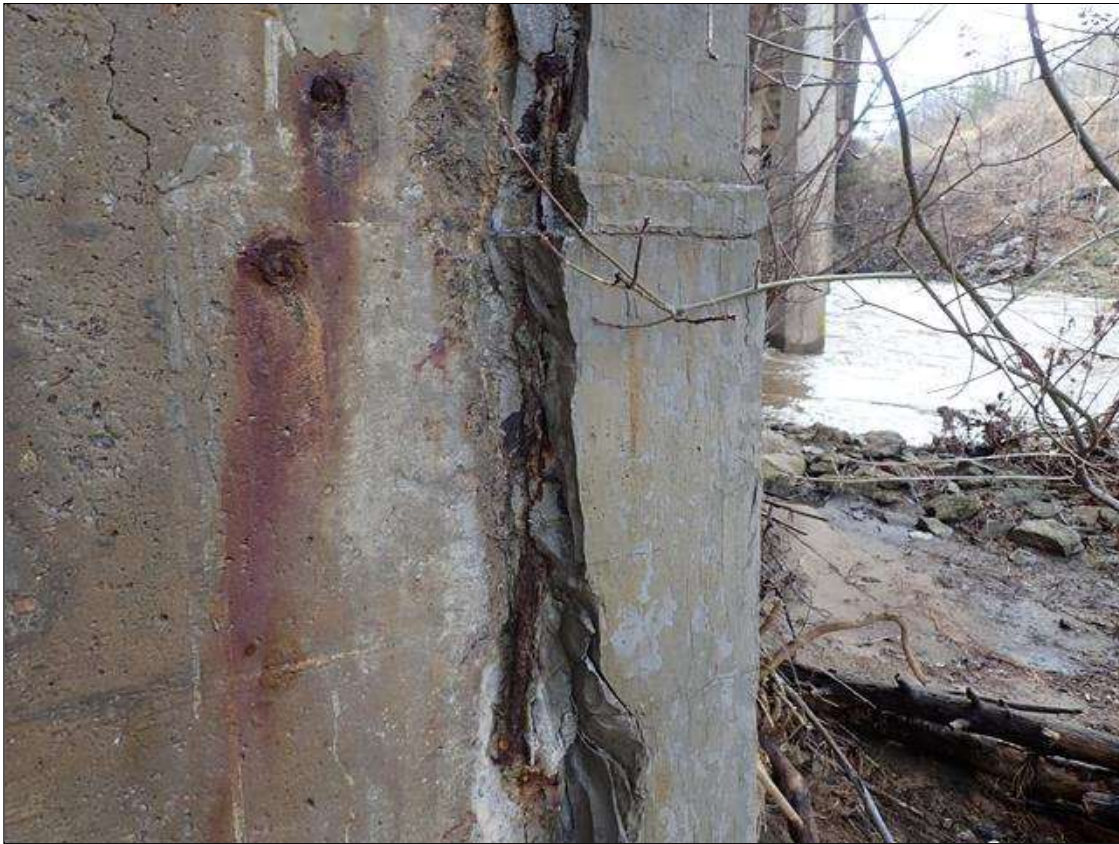
Bent 1 Pile 5: 10 FT X FULL WIDTH UNSOUND PATCH IN THE EAST FACE AT THE GROUND LINE THAT EXTENDS 12" INTO THE SOUTH FACE WITH DELAMINATION AND SPALLING THROUGHOUT. SPALLS HAVE EXPOSED MAIN REINFORCING STEEL AND SPLICE, WITH UP TO 10% SECTION LOSS. PM

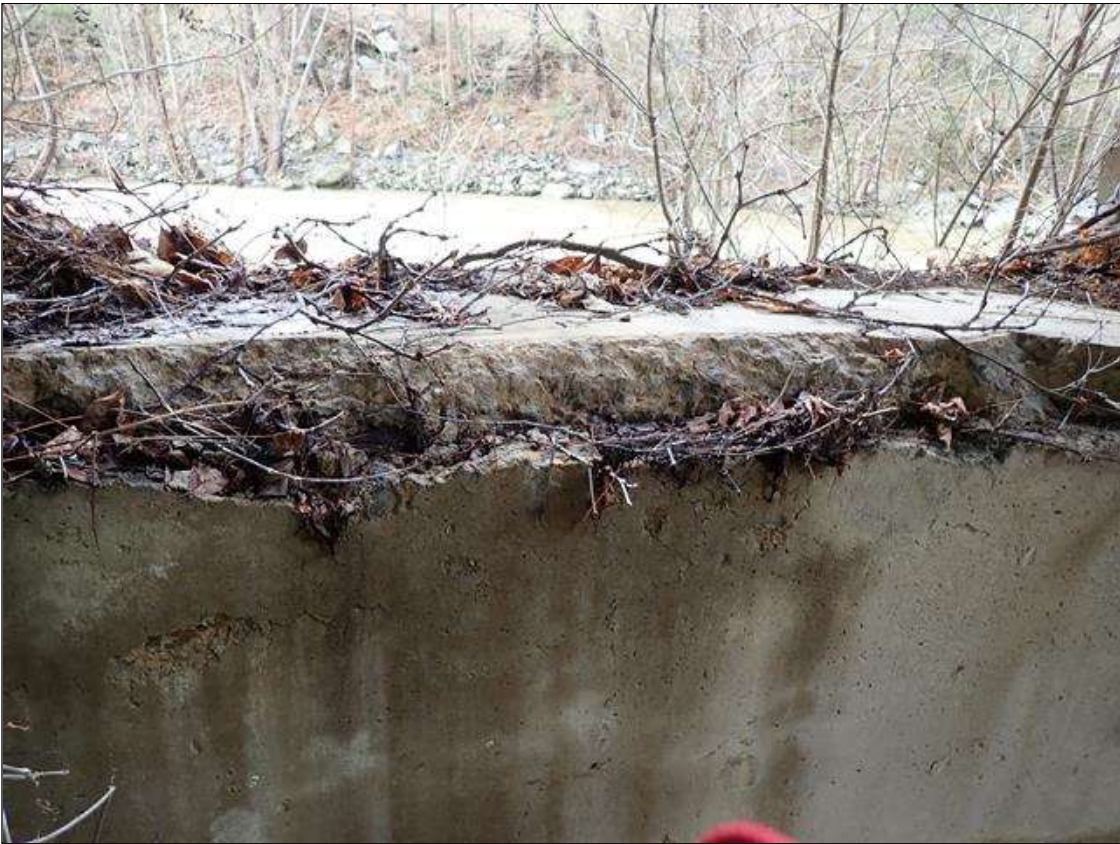
Bent 1 Pile 4: STRUT BETWEEN COLUMNS 4 AND 5 HAS A FULL WIDTH X 7" X 18" SPALL WITH EXPOSED REBAR, NO SECTION LOSS

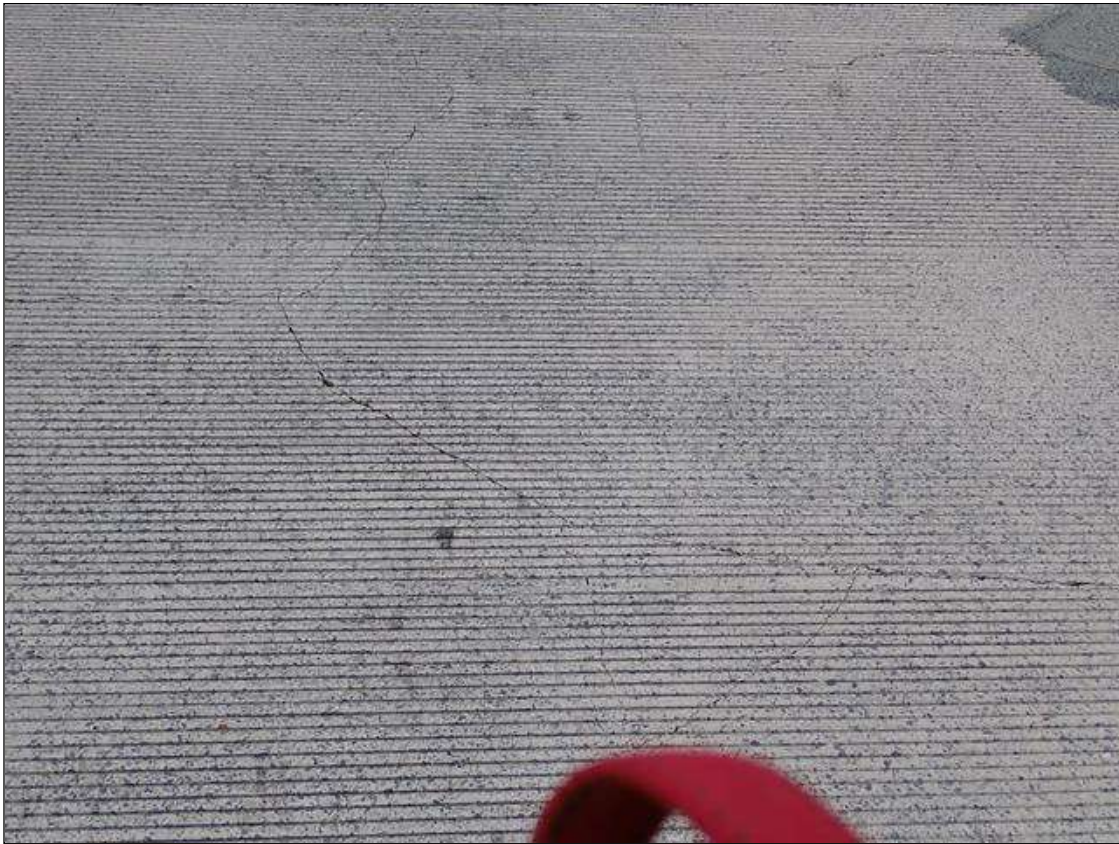
Span 2 Deck: HAIRLINE MAP CRACKING SCATTERED THROUGHOUT TOP OF DECK.

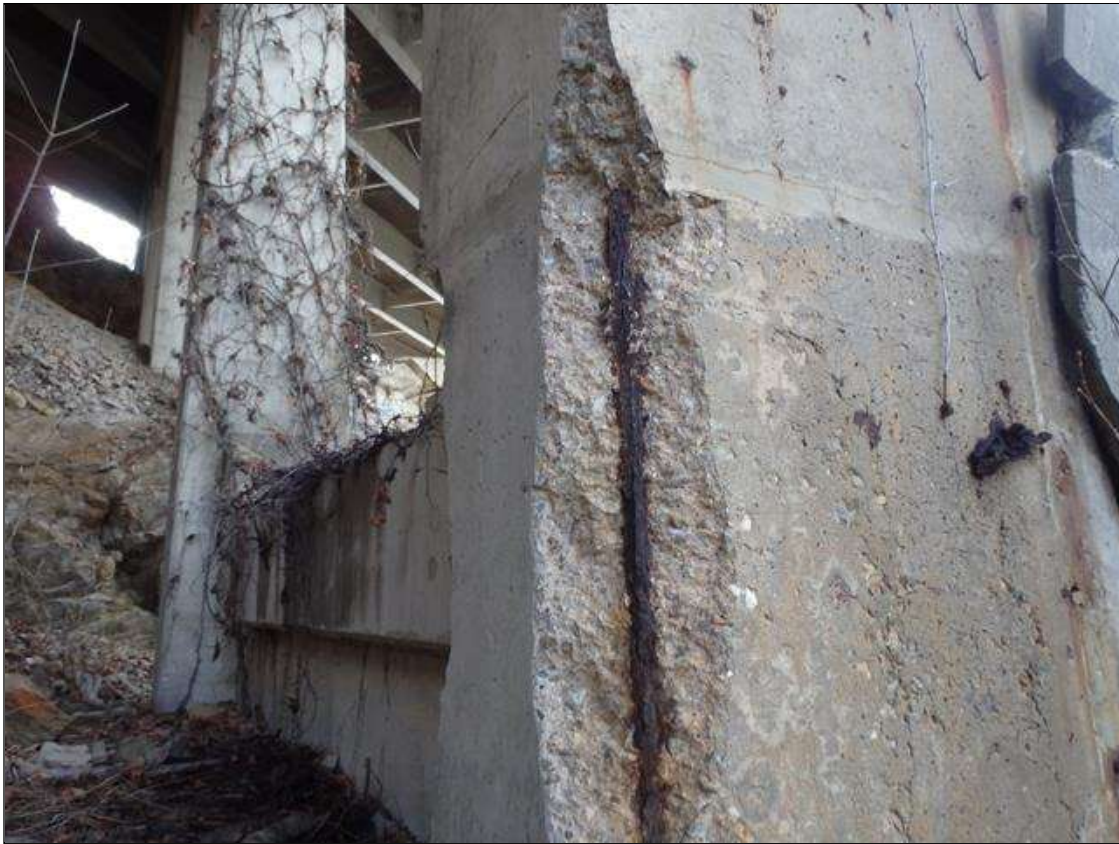
Bent 1 Pile 5: 5 FT HIGH X 10" X 8" X UP TO 3" DEEP SPALL WITH EXPOSED REINFORCEMENT IN SOUTHWEST CORNER BEGINNING AT GROUNDLINE, 90% SECTION REMAINING OF EXPOSED REINFORCEMENT.  
(PRIORITY MAINTENANCE)

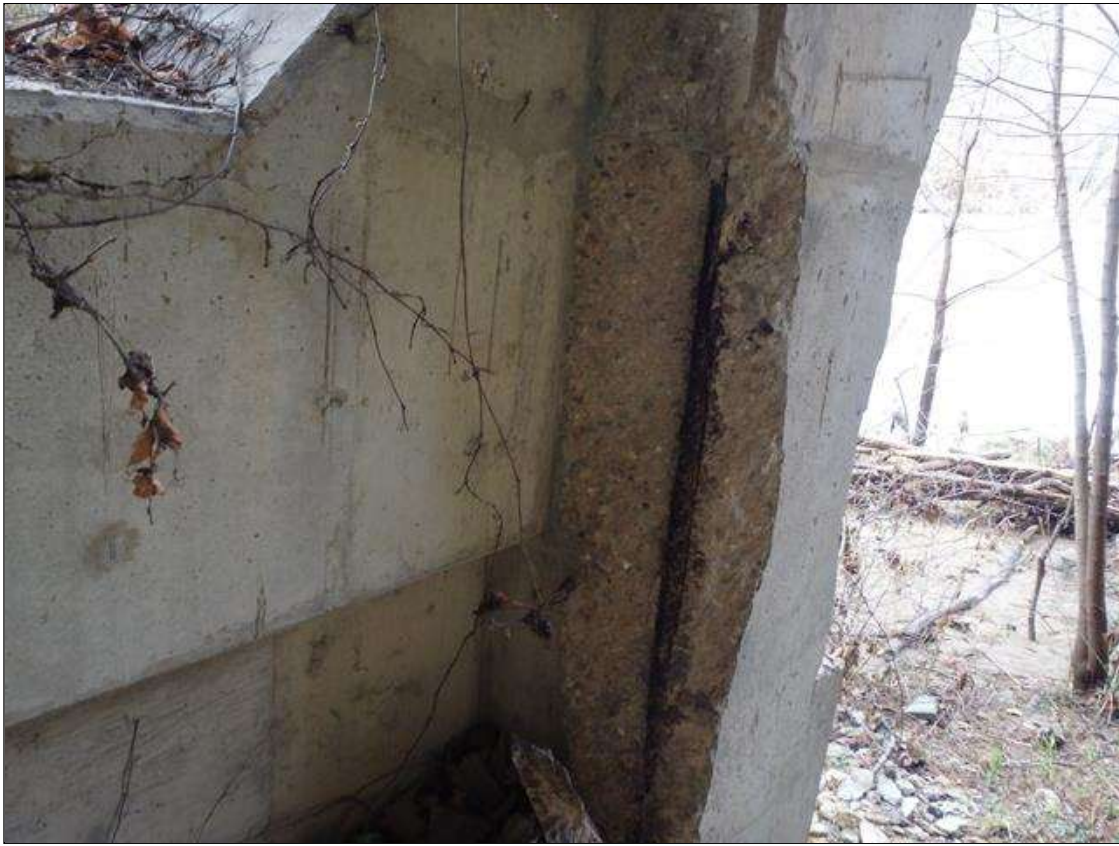
Bent 1 Pile 5: 6 FT HIGH X 13" X 9" X UP TO 3" DEEP SPALL WITH EXPOSED REINFORCEMENT IN NORTHWEST CORNER BEGINNING AT GROUNDLINE, NO MEASURABLE SECTION LOSS OF EXPOSED REINFORCEMENT. (PRIORITY MAINTENANCE)

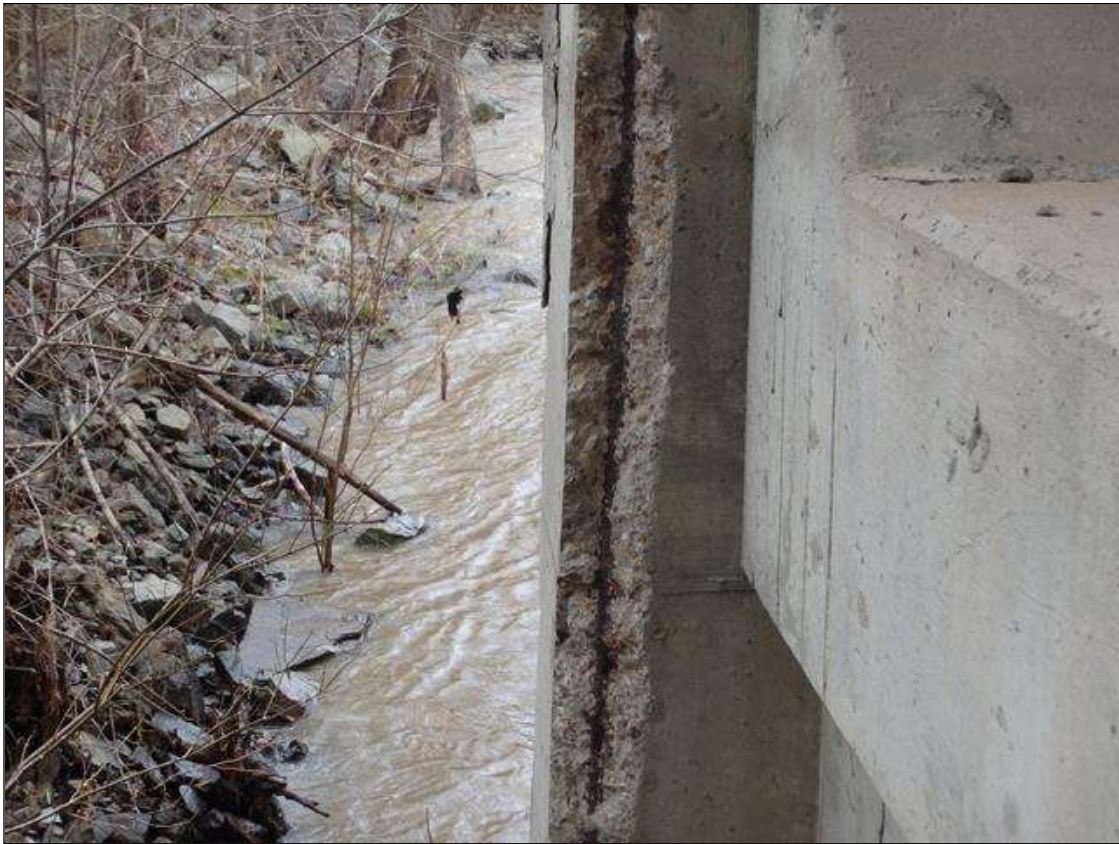
Bent 4 Pile 5: 9 FT HIGH X 5" X 5" X UP TO 3" DEEP SPALL WITH EXPOSED REINFORCEMENT IN NORTHEAST CORNER OF COLUMN, BEGINNING AT GROUNDLINE. NO MEASURABLE SECTION LOSS OF EXPOSED REINFORCEMENT. (PRIORITY MAINTENANCE)

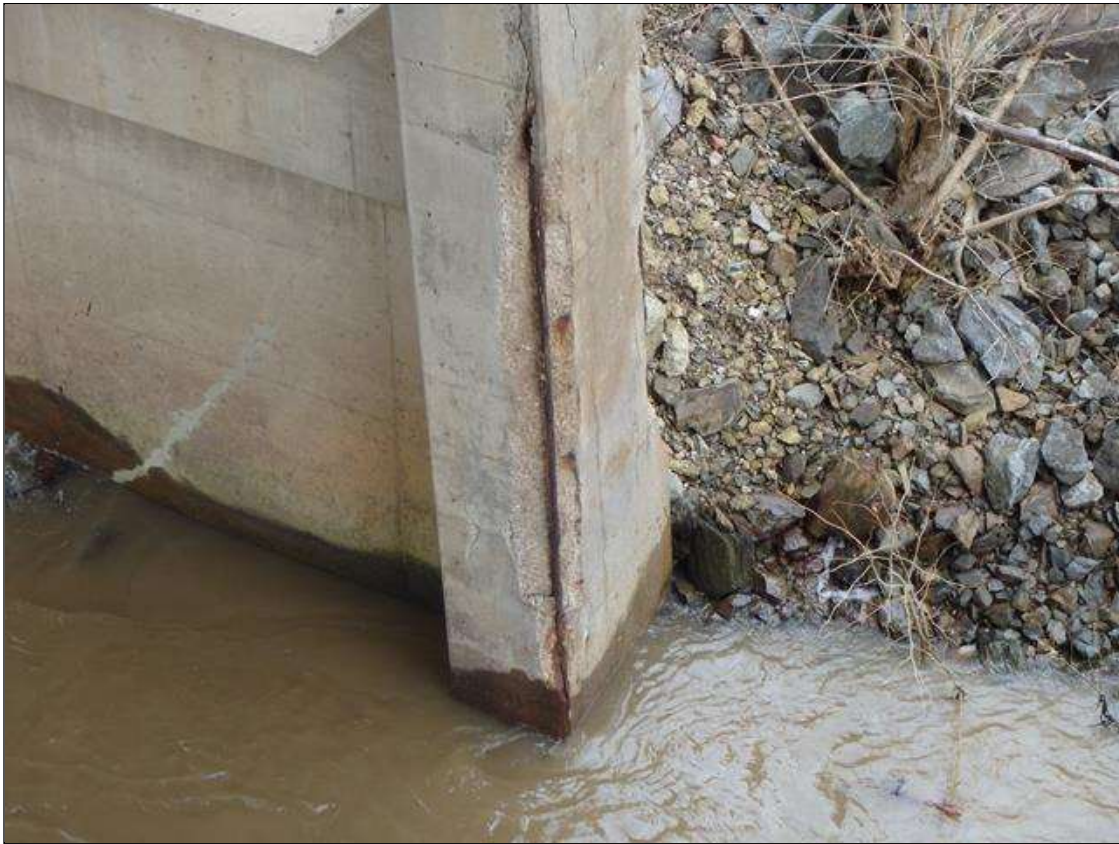
Bent 4 Pile 5: 13 FT HIGH X 19" X 12" X UP TO 5" DEEP SPALL WITH EXPOSED REINFORCEMENT IN SOUTHWEST CORNER OF COLUMN, BEGINNING AT WATERLINE, APPROXIMATELY 90% SECTION REMAINING IN EXPOSED REINFORCEMENT. (PRIORITY MAINTENANCE)

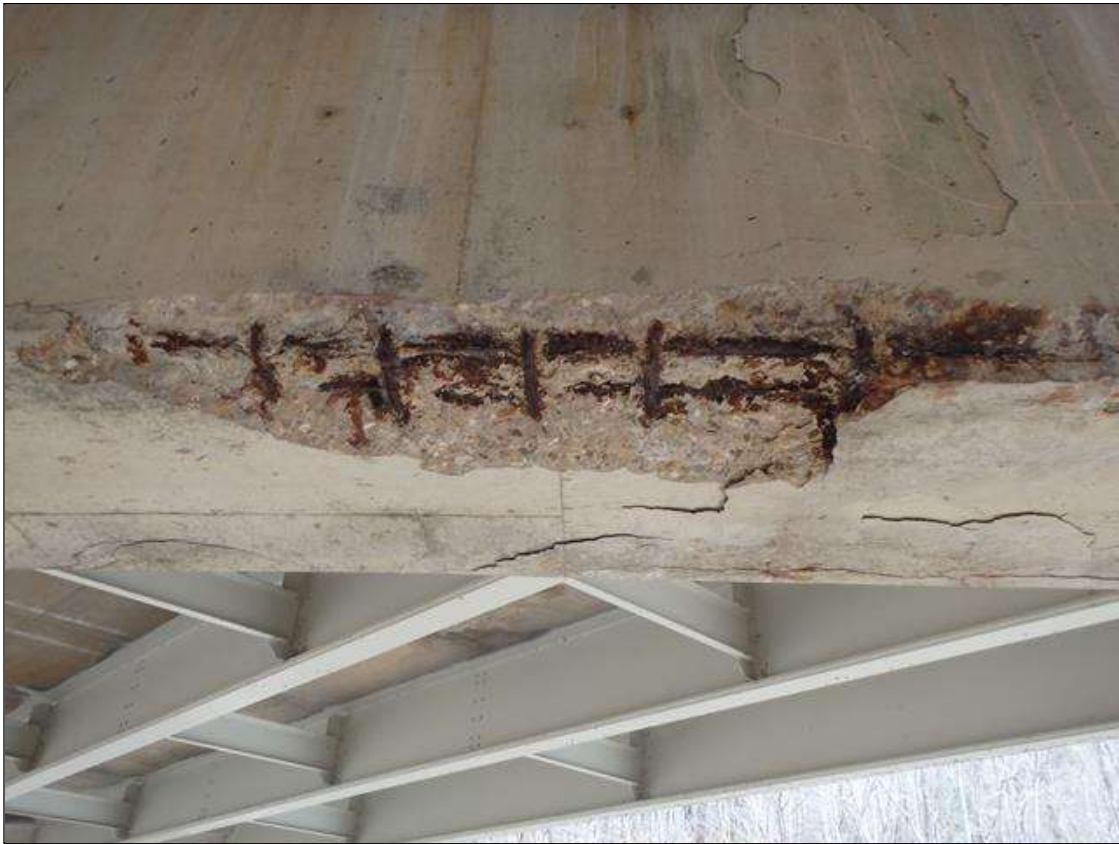
Bent 3 Cap 1: SPALL IN BOTTOM CORNER OF CAP, SPAN 4 FACE AND UNDERSIDE BETWEEN COLUMNS 2 AND 3, 7 FT X 2 FT ACROSS UNDERSIDE OF CAP X 8" UP FACE OF CAP, UP TO 2" DEEP WITH EXPOSED MAIN REINFORCEMENT, APPROXIMATELY 85% SECTION REMAINING. (PRIORITY MAINTENANCE)

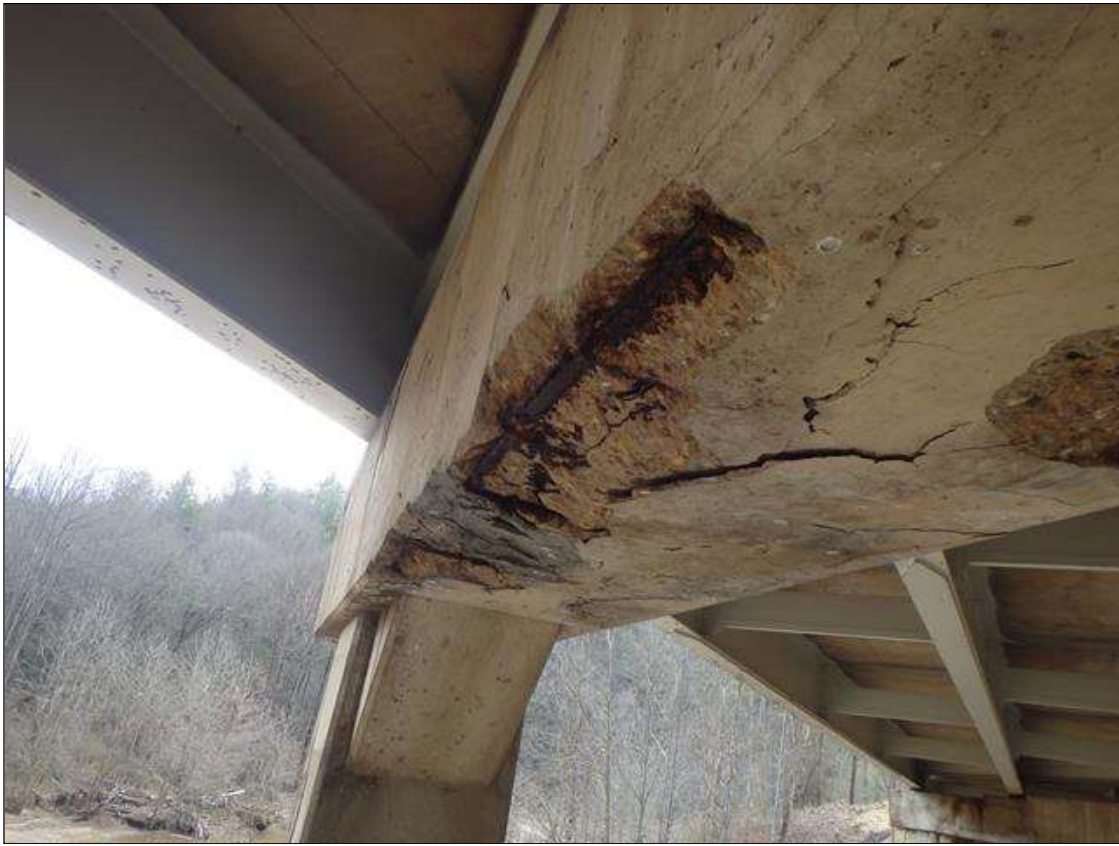
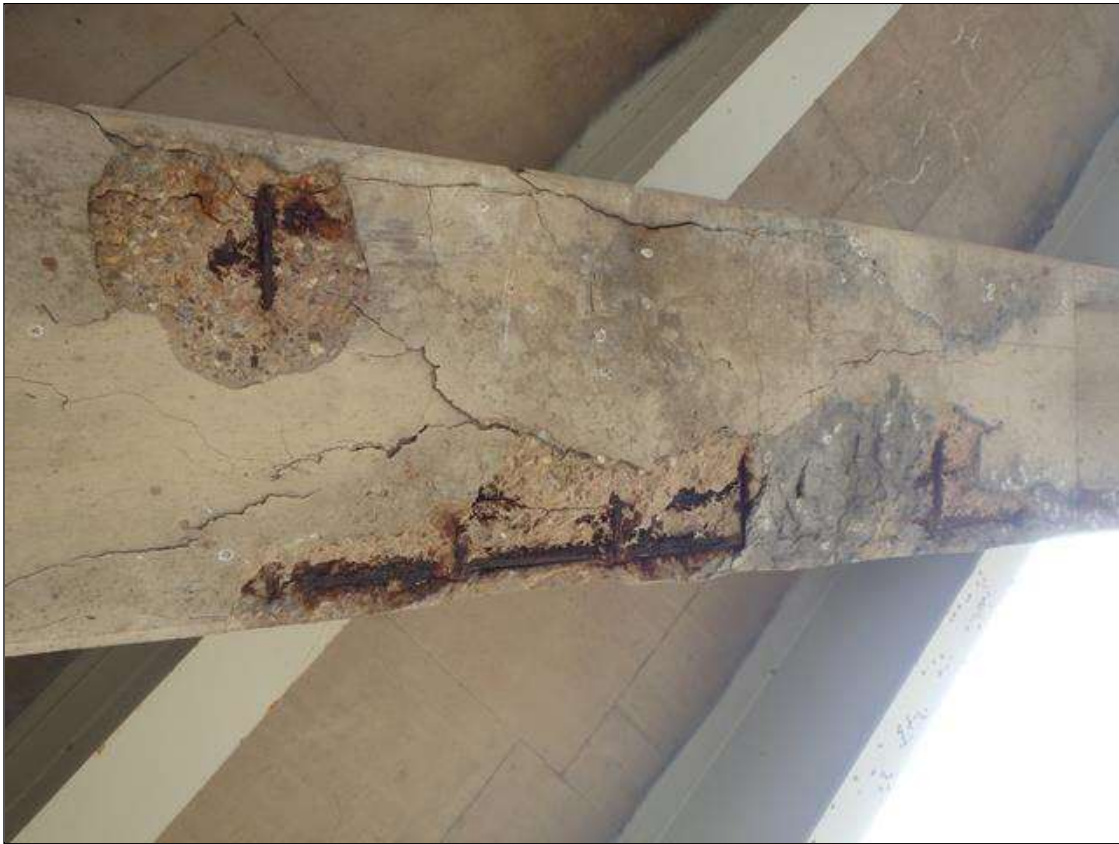
Bent 3 Cap 1: SPALLING AND DELAMINATION IN UNDERSIDE OF CAP BETWEEN COLUMNS 1 AND 2. SPALL IS 7 FT LONG X UP TO 18" WIDE X 3" DEEP WITH AREA OF UNSOUND PATCHING AND EXPOSED REINFORCEMENT. APPROXIMATELY 90% SECTION REMAINING OF EXPOSED REINFORCEMENT. ENTIRE CAP UNDERSIDE BETWEEN COLUMNS 1 AND 2 IS DELAMINATED. (PRIORITY MAINTENANCE)

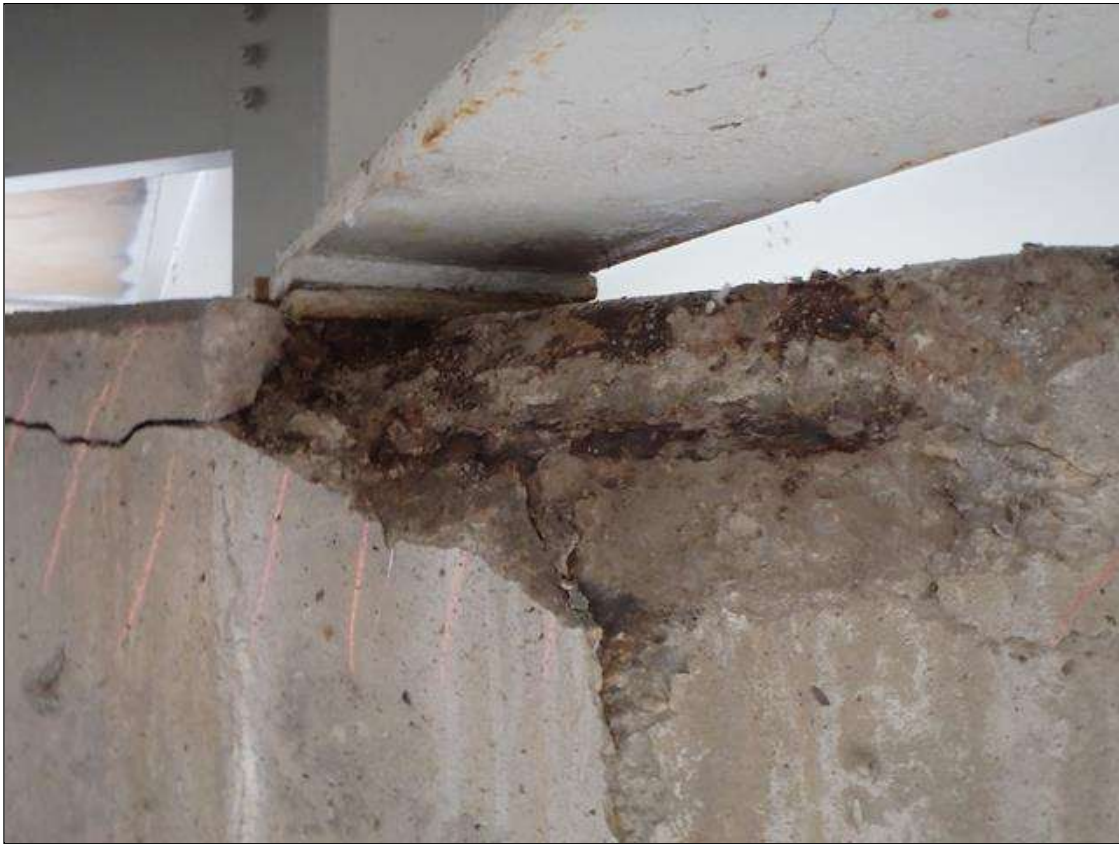
Bent 4 Cap 1: SPALL WITH EXPOSED REINFORCEMENT IN FACE OF CAP, SPAN 5 SIDE BELOW BEAM 3. 2 FT LONG X 10" HIGH X UP TO 2" DEEP, NO MEASURABLE SECTION LOSS OF REINFORCEMENT. BEAM BEARING AREA IS BEGINNING TO BE AFFECTED. (PRIORITY MAINTENANCE)

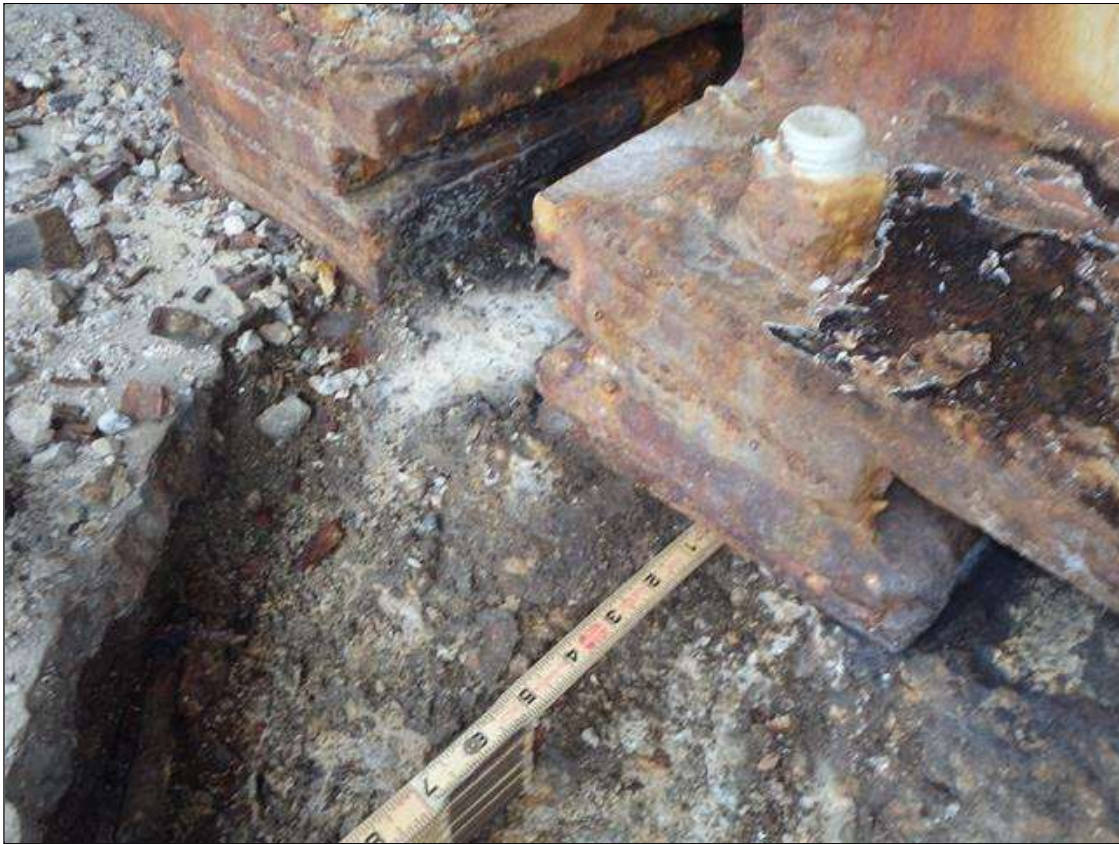
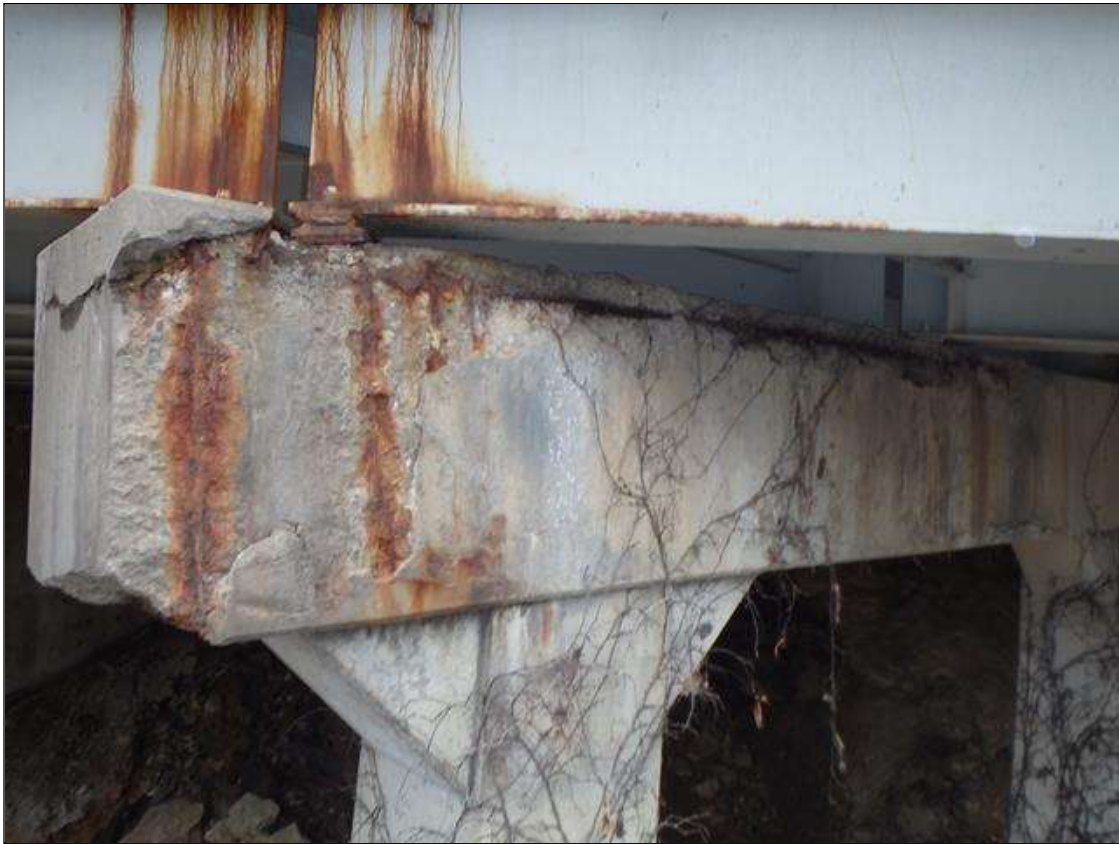
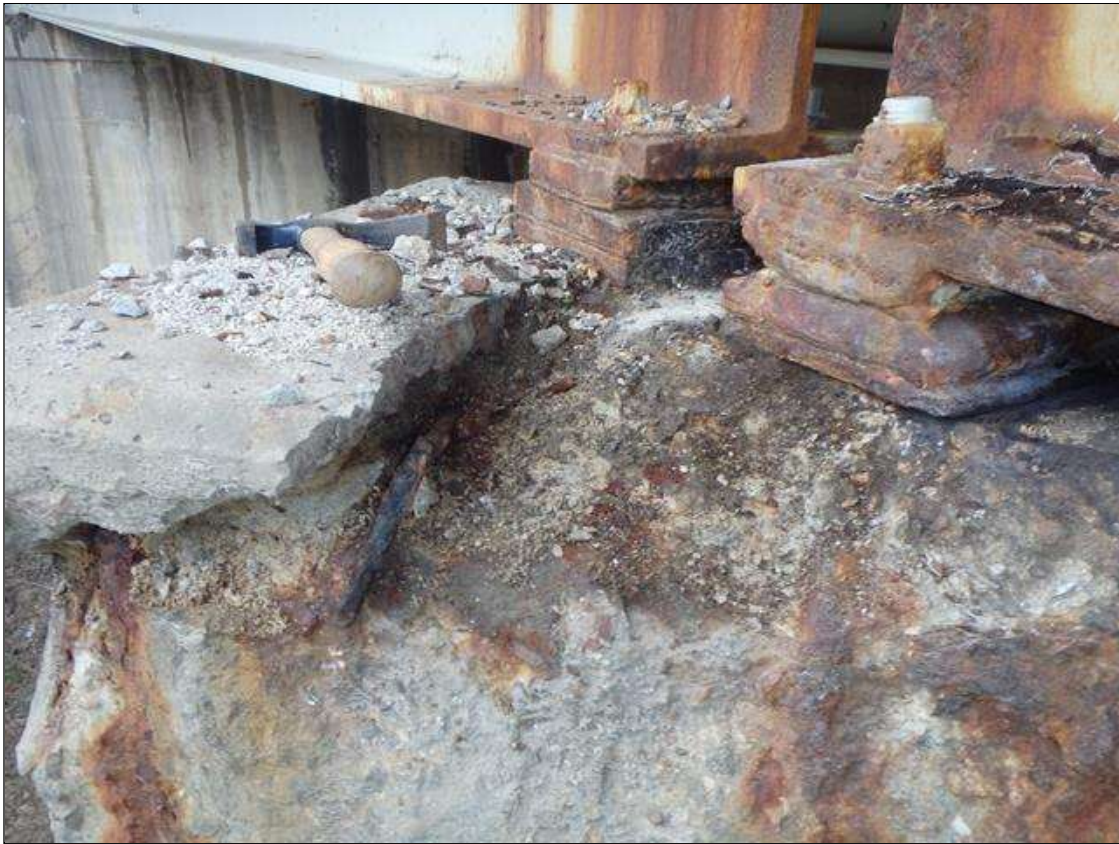
Bent 1 Cap 1: SPALL ON FACE OF CAP, SPAN 2 SIDE BELOW BEAM 8. SPALL IS FULL HEIGHT OF CAP X 3 FT WIDE X UP TO 12" INTO TOP OF CAP X UP TO 3" DEEP WITH EXPOSED REINFORCEMENT. EXPOSED CONFINING STEEL IS BROKEN WITH APPROXIMATELY 50% SECTION REMAINING. BEARING OF BEAM 8 IN SPAN 2 IS BEGINNING TO BE AFFECTED, UP TO 1/2" UNDERMINING. EXPOSED CONCRETE IS DETERIORATING. (PRIORITY MAINTENANCE)

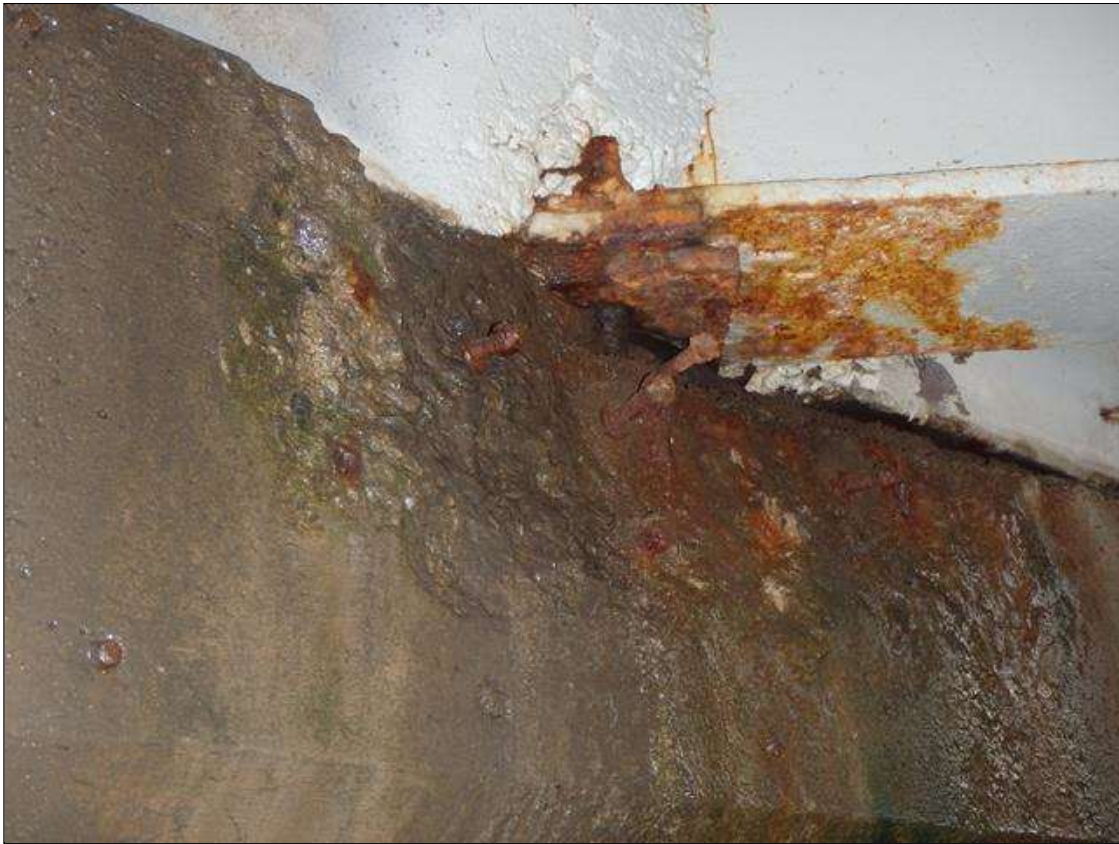
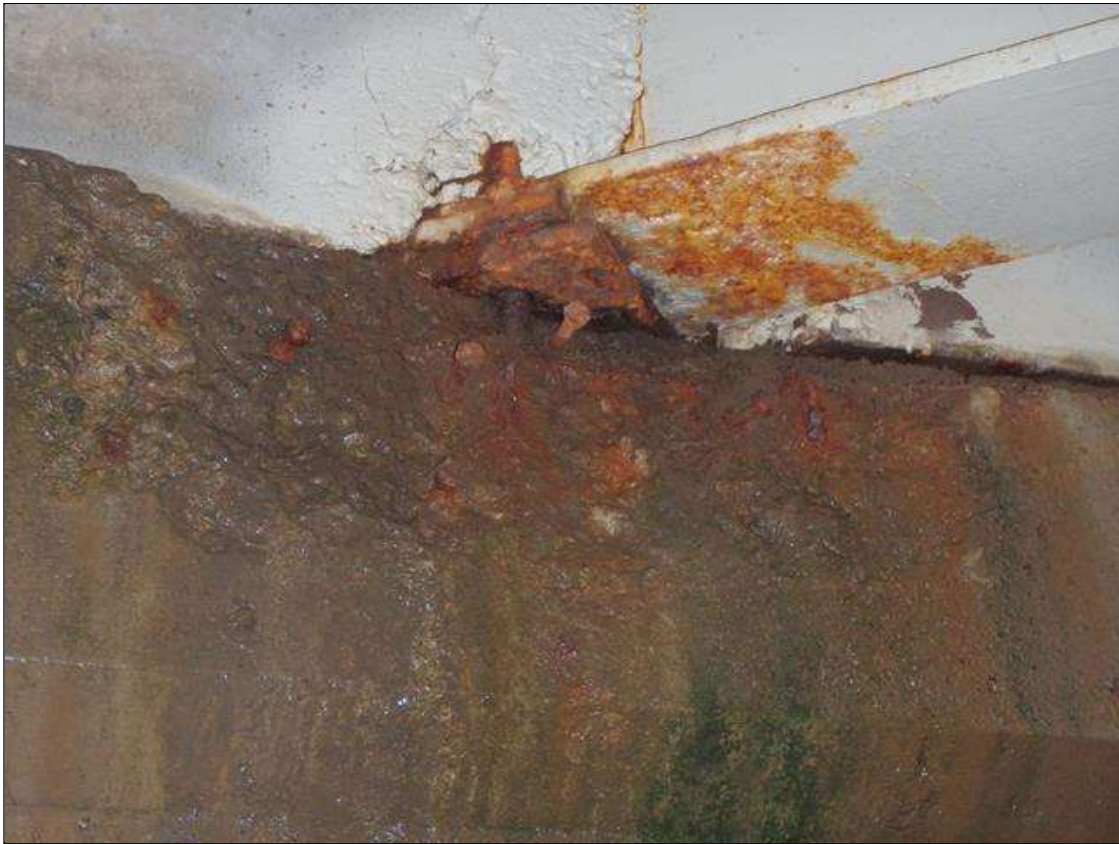
End Bent 1 Abutment/Backwall : SPALL WITH EXPOSED ANCHOR BOLT BELOW BEAM 1 BEARING. 4 FT X 18" HIGH X 7" DEEP WITH APPROXIMATELY 30% UNDERMINING OF BEARING. NO MEASURABLE SECTION LOSS OF EXPOSED ANCHOR BOLT. EXPOSED CONCRETE IS DETERIORATING, ACTIVE LEAKAGE THROUGH BEARING. (PRIORITY MAINTENANCE)
