NC DEPARTMENT OF TRANSPORTATION  
DIVISION OF HIGHWAYS  
STRUCTURE MANAGEMENT UNIT

## Structure Safety Report

### Routine Element Inspection - Contract

DIVISION: 14 COUNTY: HAYWOOD STRUCTURE NUMBER: 430142 FREQUENCY: 24 MONTHS

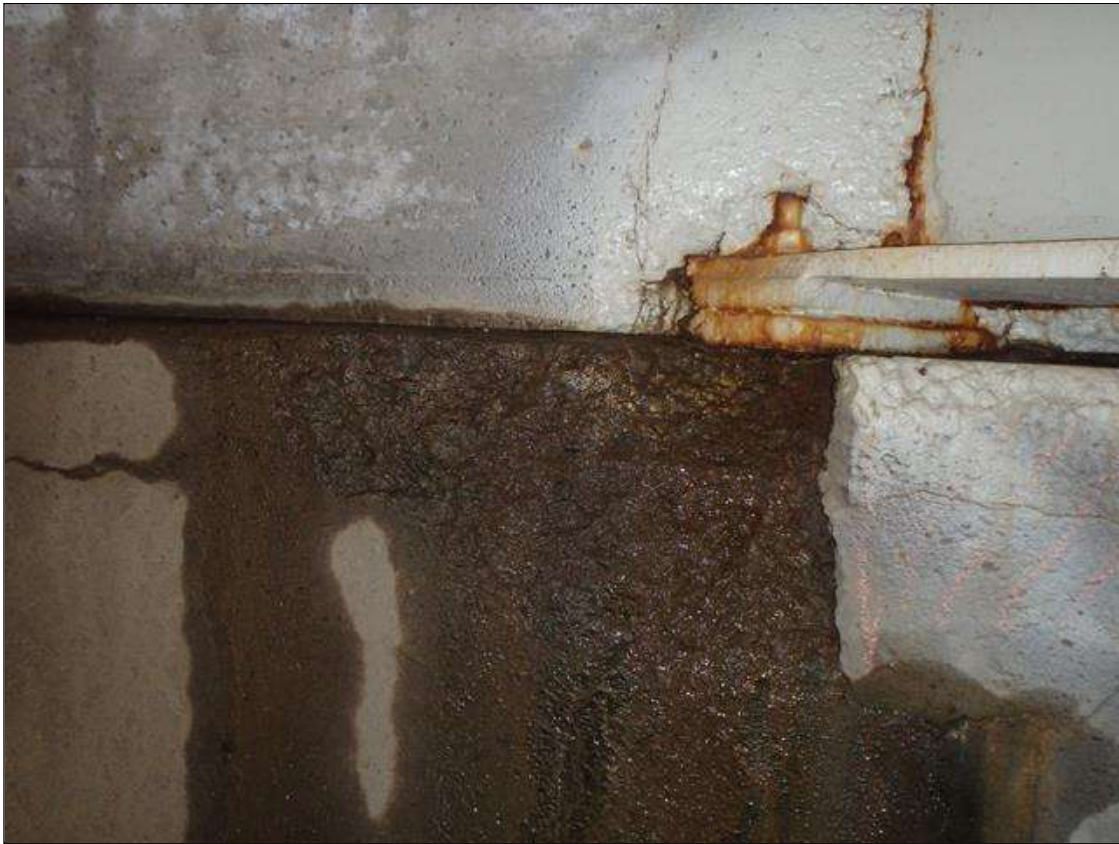
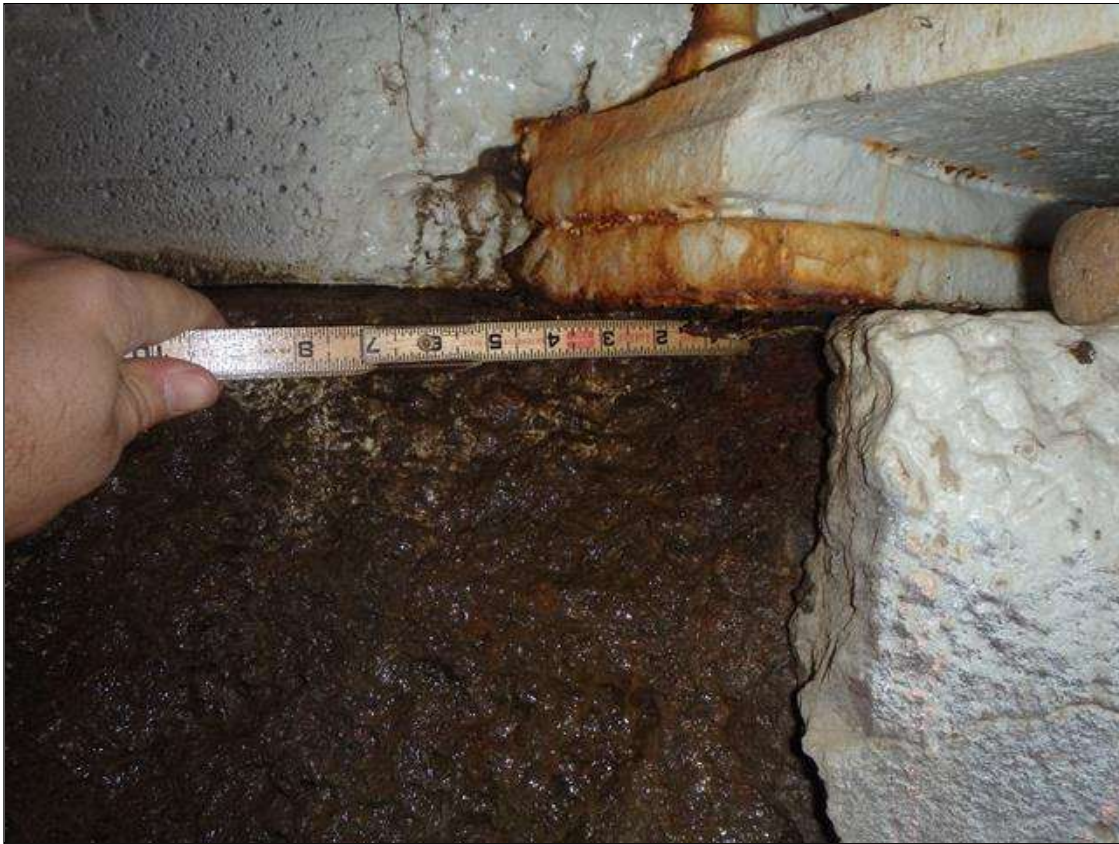
End Bent 1 Abutment/Backwall : SPALL BELOW BEAM 5 BEARING AT END BENT 1. 2 FT X 12" HIGH X UP TO 6" DEEP SPALL WITH APPROXIMATELY 10% OF BEARING UNDERMINED, UP TO 3". ADJACENT DELAMINATION IN TOP OF ABUTMENT BELOW BEAM 5 IS 12" X 12", NO EXPOSED REINFORCEMENT OR ANCHOR BOLTS. ACTIVE LEAKAGE THROUGH BEARING. (PRIORITY MAINTENANCE)

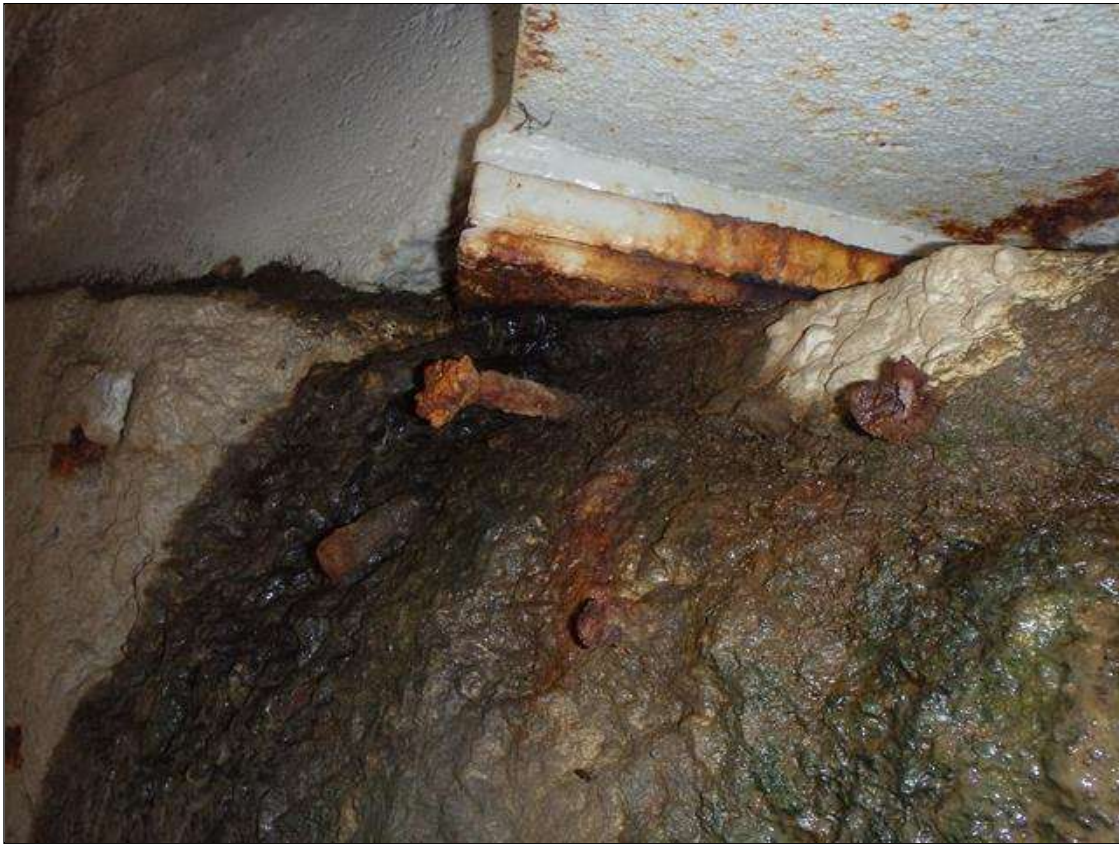
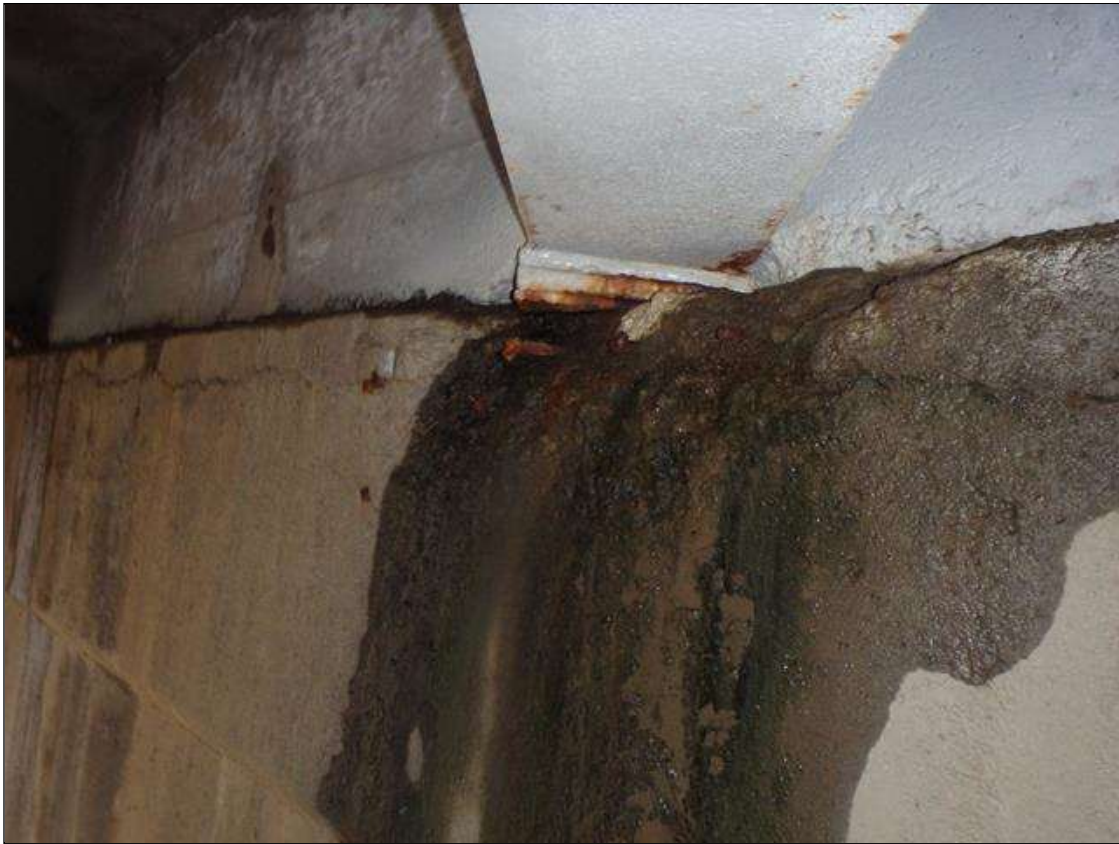
End Bent 1 Abutment/Backwall : SPALL BELOW BEAM 6 BEARING, 3 FT X 14" HIGH X UP TO 6" DEEP WITH APPROXIMATELY 10% OF BEARING AREA UNDERMINED., UP TO 3". NO EXPOSED REINFORCEMENT OR ANCHOR BOLTS, ACTIVE LEAKAGE THROUGH BEARING. (PRIORITY MAINTENANCE)

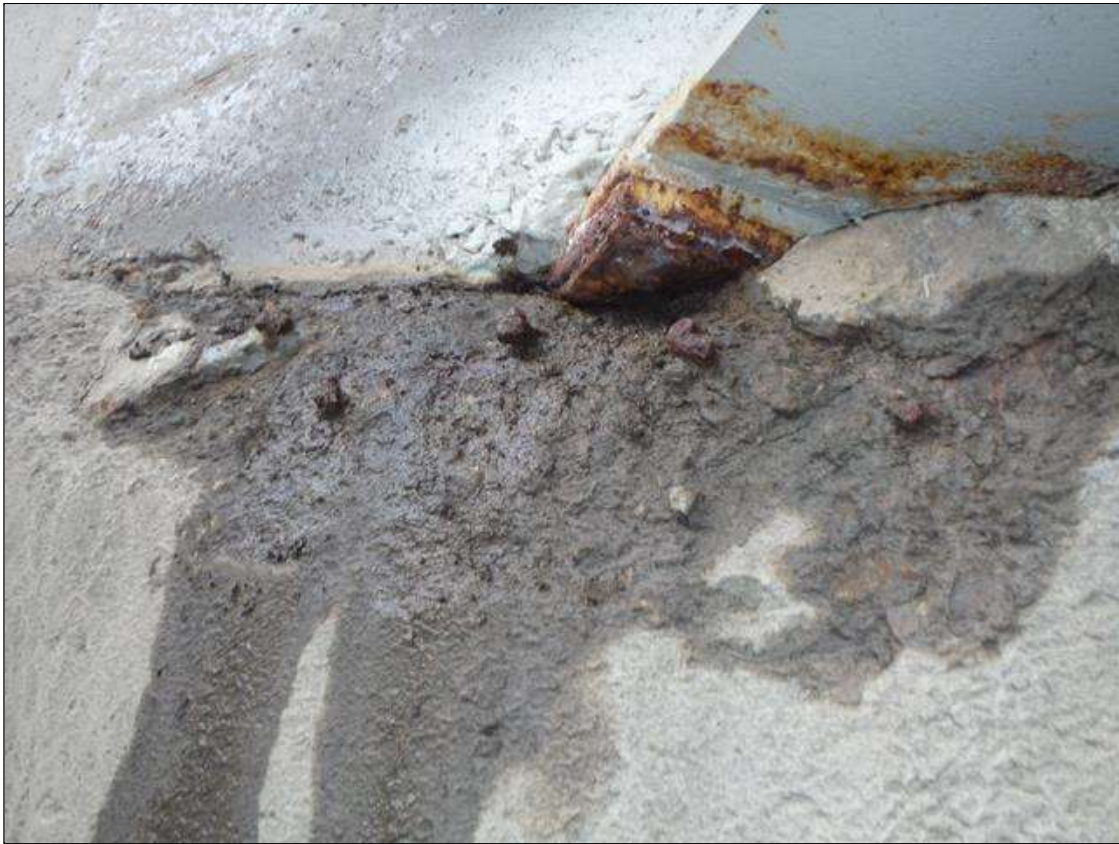
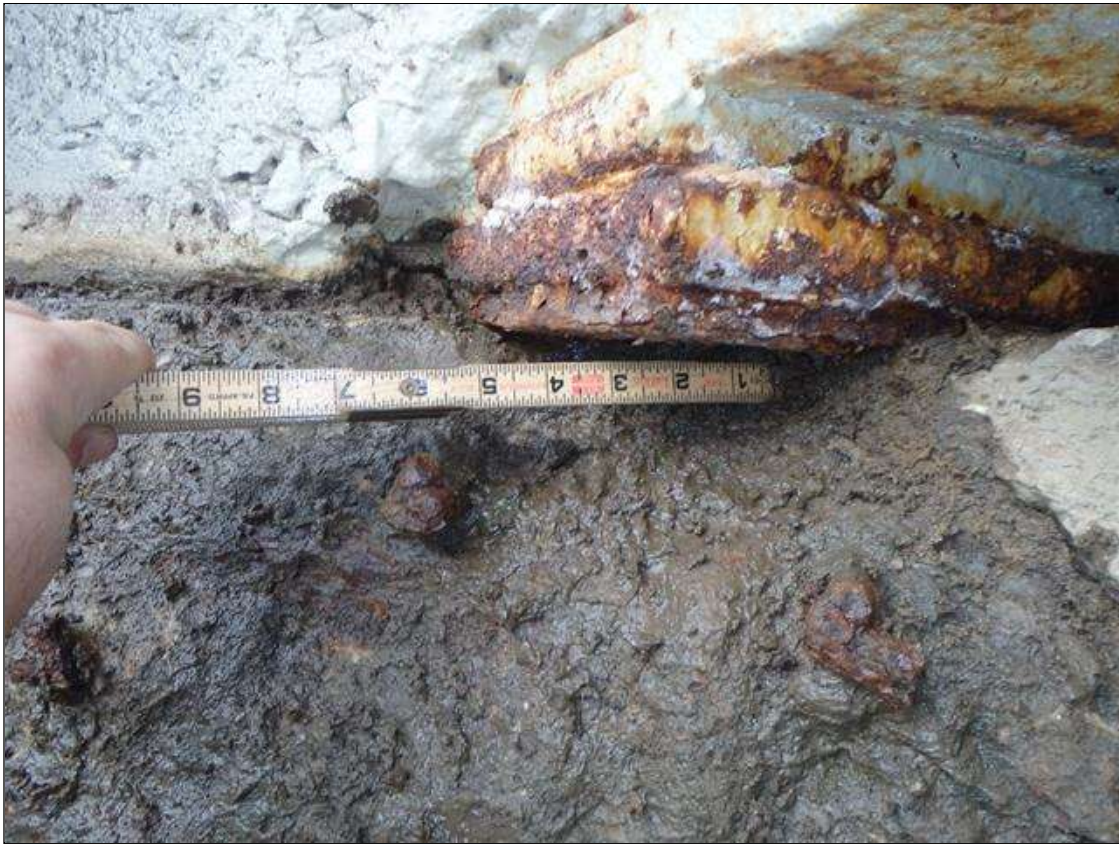
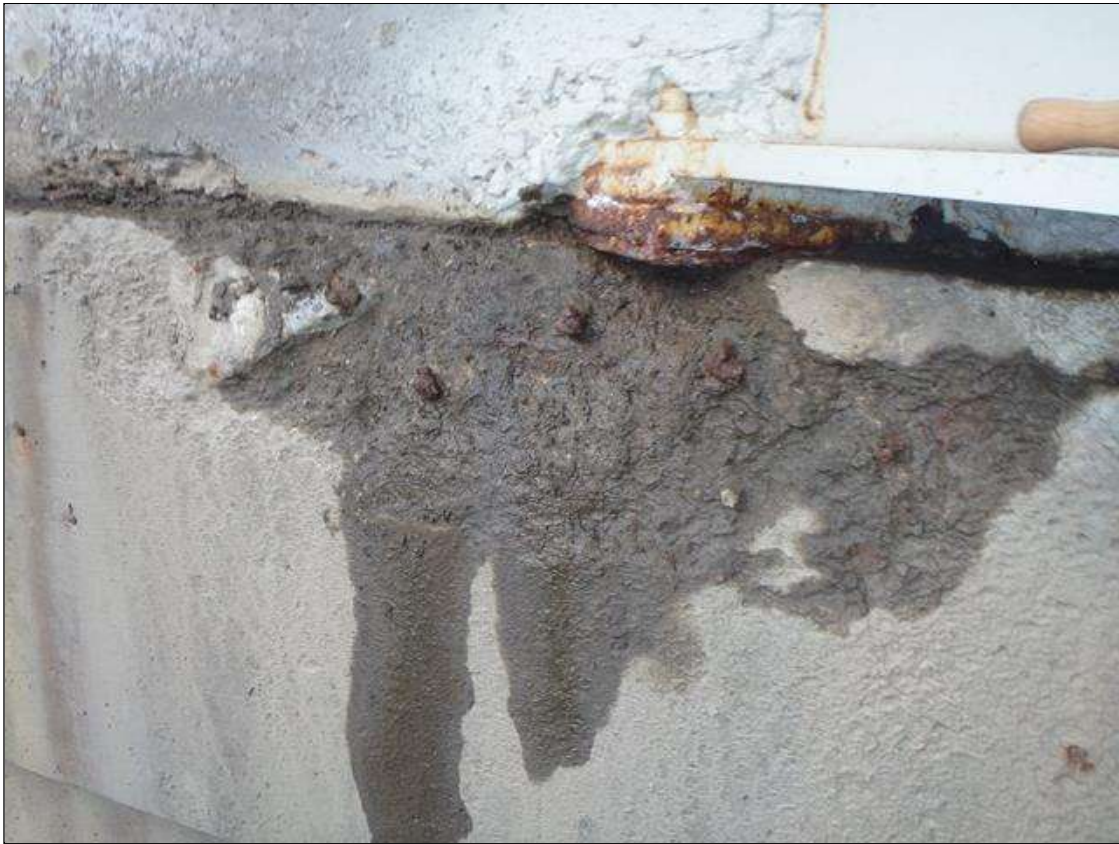
End Bent 1 Abutment/Backwall : SPALL BELOW BEAM 8, 4 FT X UP TO 16" HIGH X UP TO 6" DEEP. APPROXIMATELY 20% OF BEARING AREA UNDERMINED, UP TO 4". NO EXPOSED REINFORCEMENT OR ANCHOR BOLTS, ACTIVE LEAKAGE THROUGH BEARING. (PRIORITY MAINTENANCE)

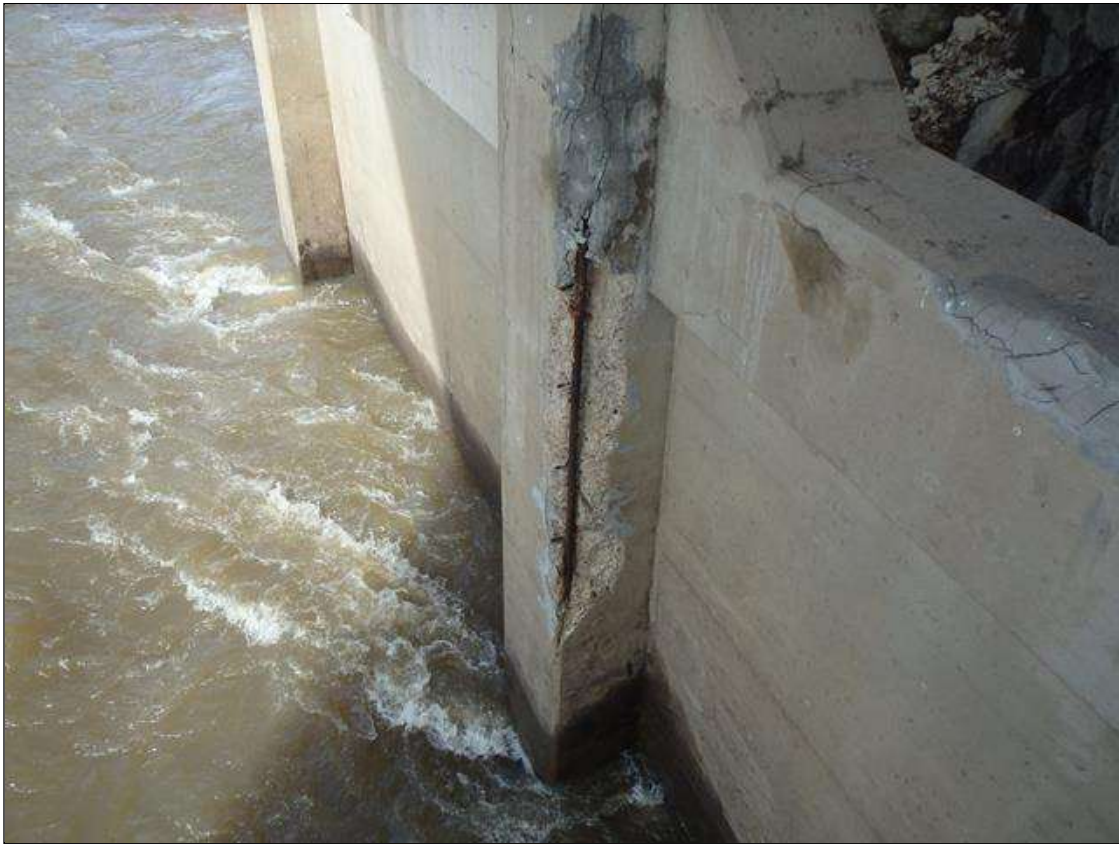
Bent 2 Pile 4: SPALL WITH EXPOSED REINFORCEMENT IN NORTHEAST CORNER, 12 FT HIGH X 1 FT X 1 FT X UP TO 4" DEEP WITH 3 FT X 1 FT X 1 FT UNSOUND PATCH, BEGINNING AT STRUT, NO MEASURABLE SECTION LOSS. (PRIORITY MAINTENANCE)

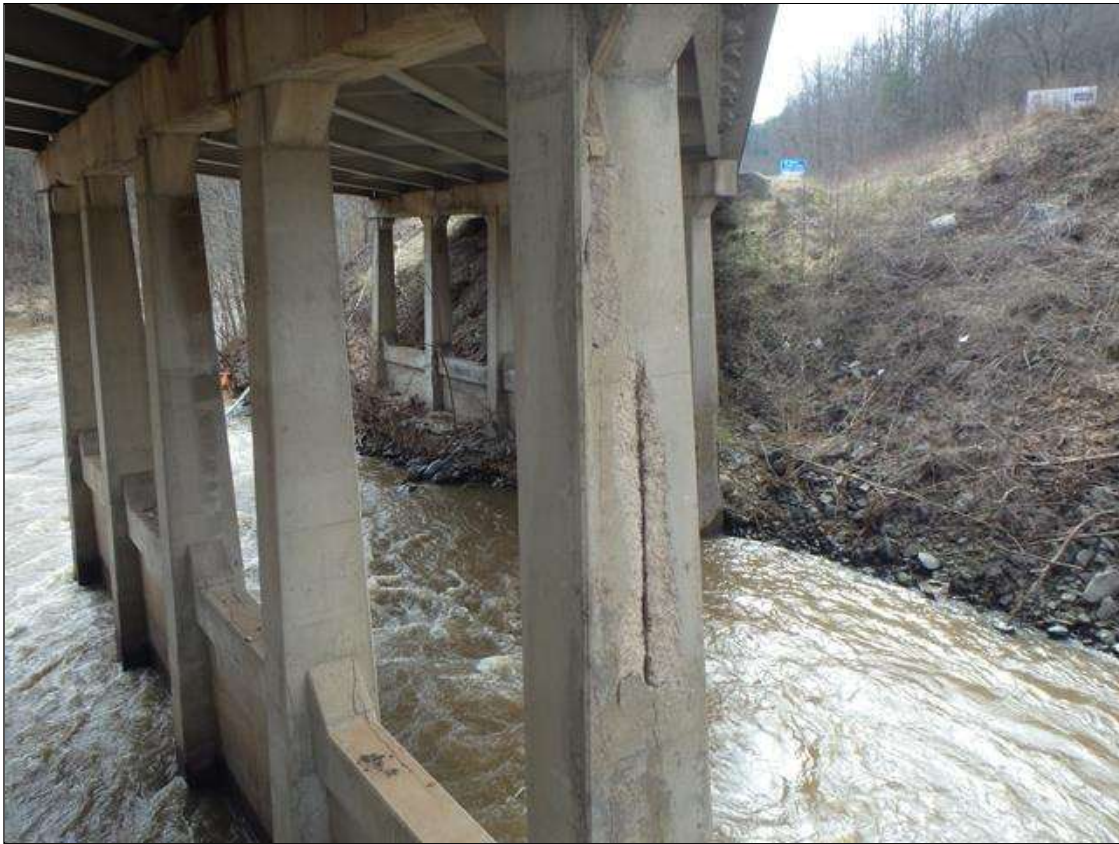
Bent 3 Pile 5: DELAMINATION AND SPALLING ON SOUTH AND WEST FACES OF COLUMN. ENTIRE HEIGHT OF COLUMN X UP TO 2 FT ON EACH FACE IS DELAMINATED WITH SPALLING UP TO 12 FT HIGH X 14" WIDE X UP TO 2" DEEP WITH EXPOSED REINFORCEMENT, NO MEASURABLE SECTION LOSS OF EXPOSED REINFORCEMENT, DELAMINATIONS HAVE UP TO 1/2 INCH SEPARATION. (PRIORITY MAINTENANCE)

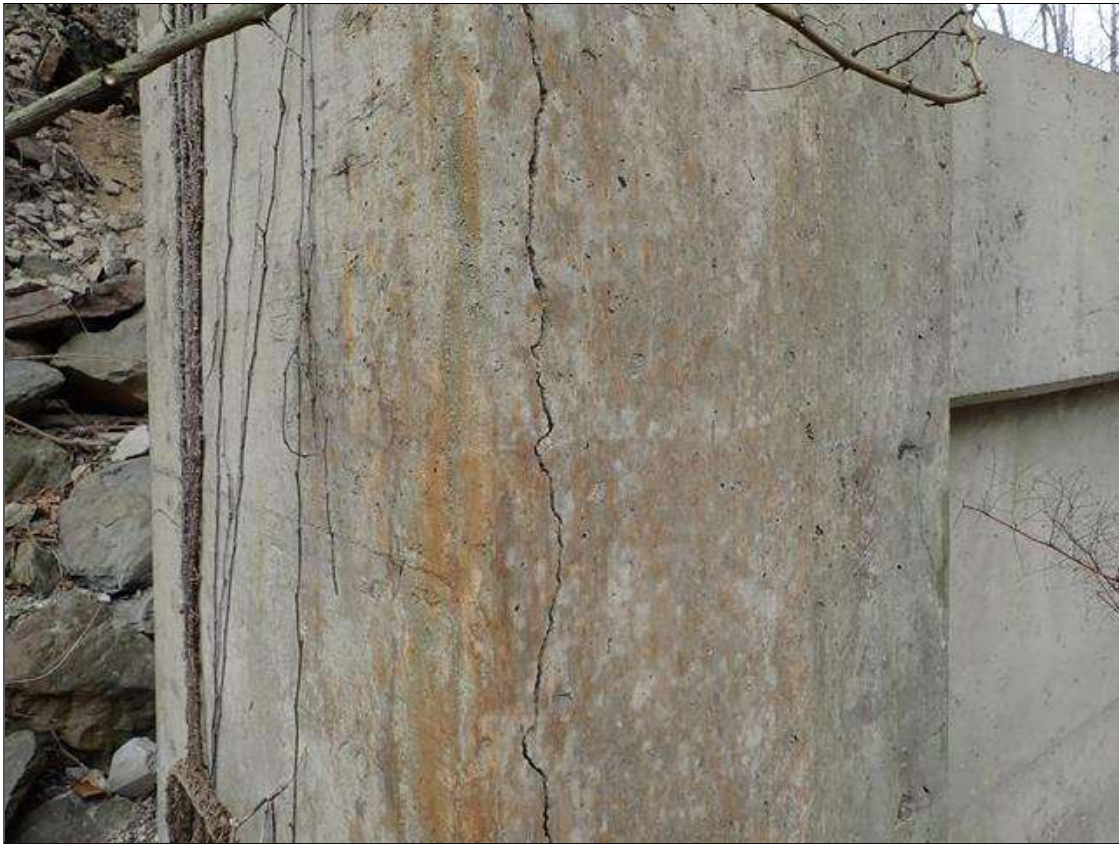
Bent 4 Pile 1: 9 FT HIGH X 4" X 8" DELAMINATION WITH RUST STAINING ON NORTHWEST CORNER AT BOTTOM OF COLUMN.

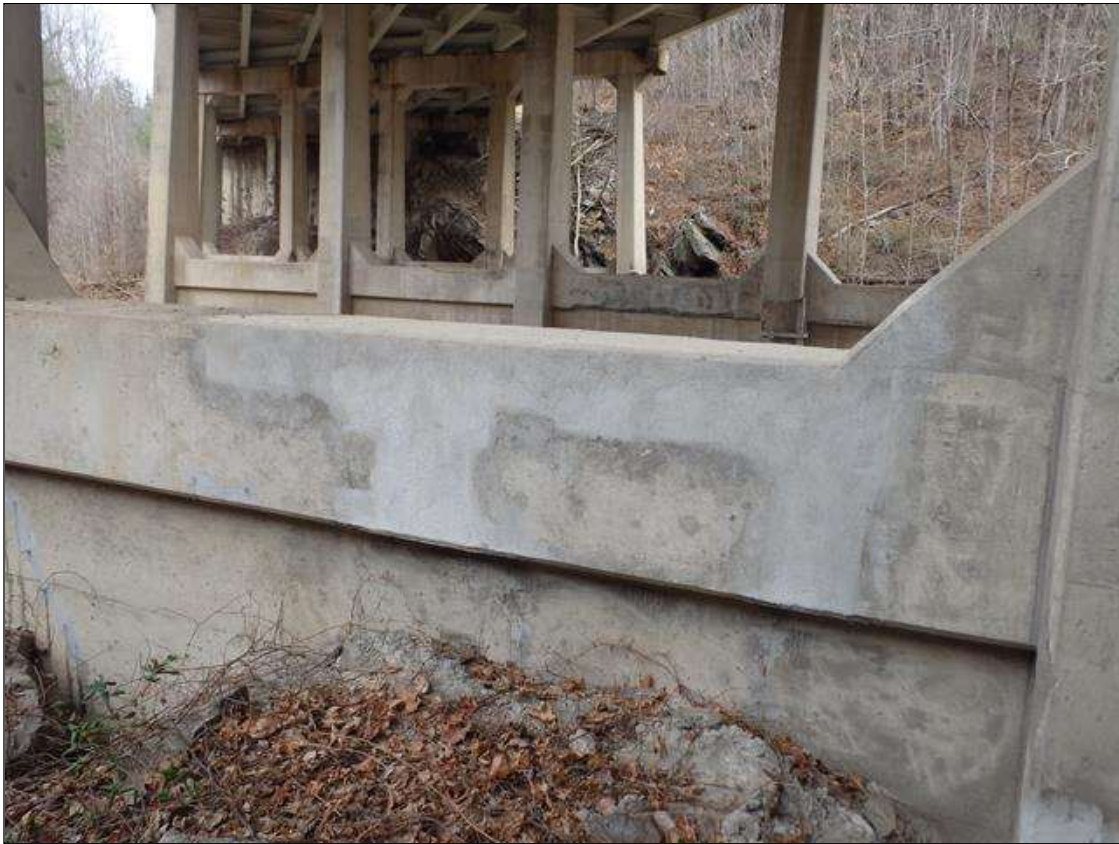
Bent 4 Pile 4: SOUND PATCH ON STRUT BETWEEN COLUMNS 4 AND 5. APPROXIMATELY 15 FT LONG X FULL WIDTH OF STRUT X UP TO FULL DEPTH OF STRUT.

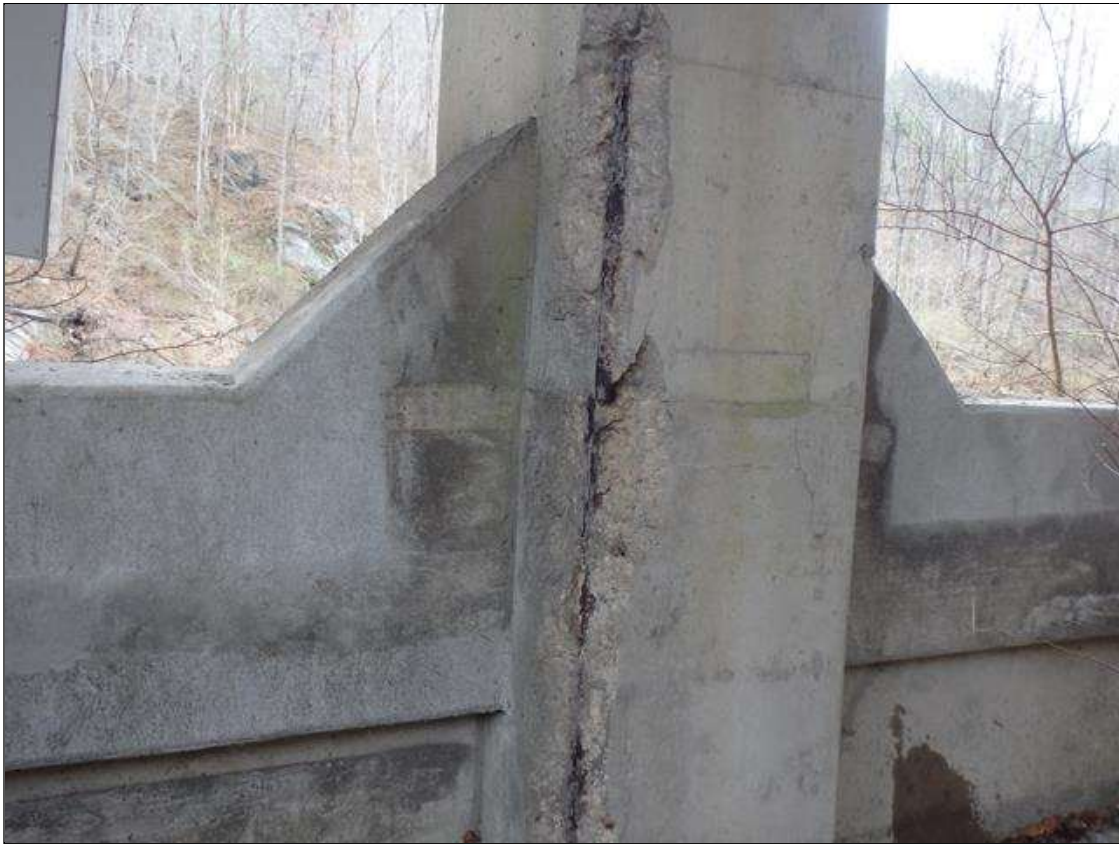
Bent 4 Pile 3: 9 FT HIGH X 8" X 8" X UP TO 4" DEEP SPALL WITH EXPOSED REINFORCEMENT IN SOUTHEAST CORNER OF COLUMN WITH 90% SECTION REMAINING OF EXPOSED REINFORCEMENT, AT HEIGHT OF STRUT. (PRIORITY MAINTENANCE).

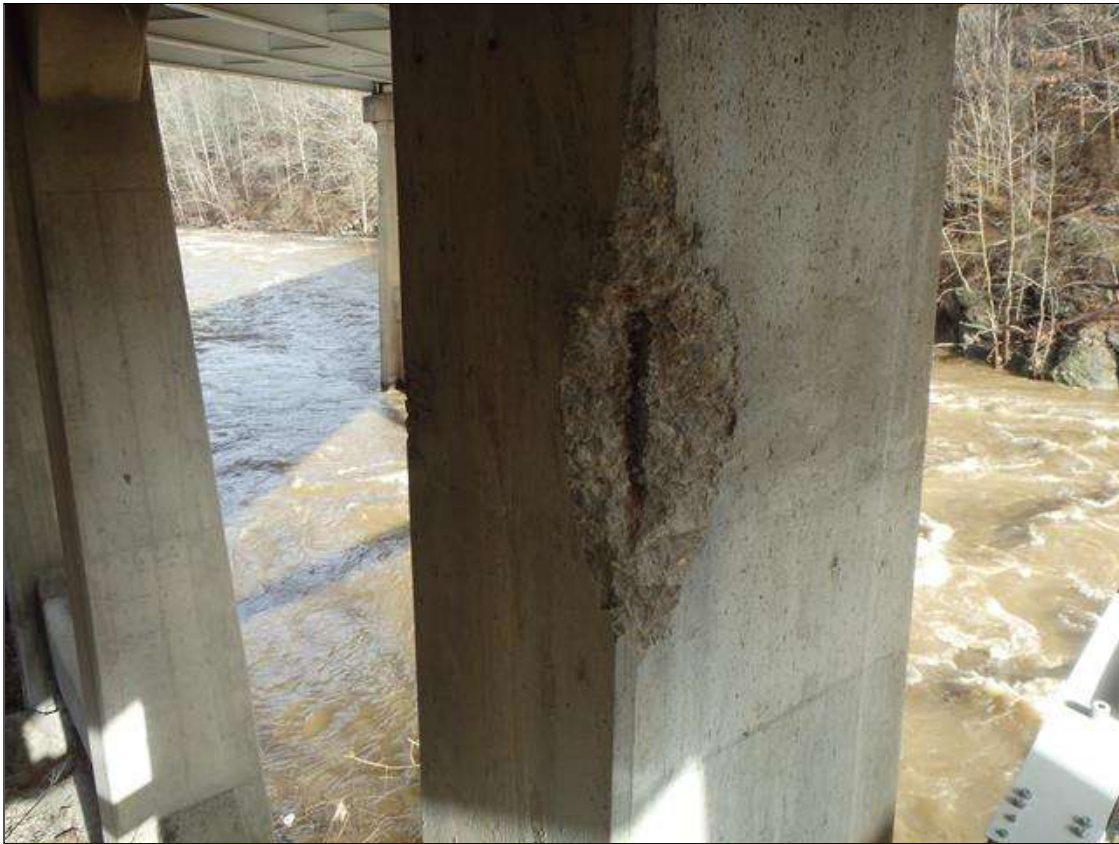
Bent 4 Pile 1: 3 FT HIGH X 1 FT WIDE X 3" DEEP CORNER SPALL WITH EXPOSED REINFORCEMENT, 5 FT BELOW CAP, NO SECTION LOSS OF REINFORCEMENT.

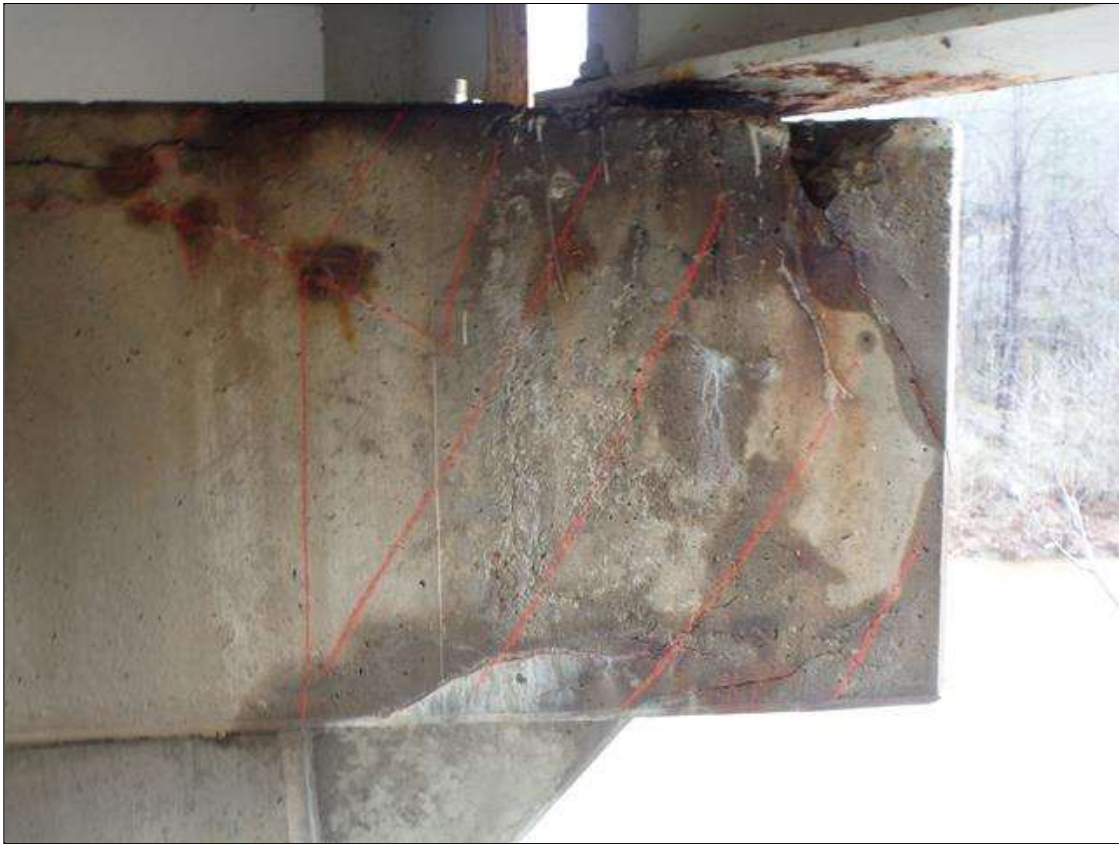
Bent 4 Cap 1: DELAMINATION WITH HAIRLINE MAP CRACKING, EFFLORESCENCE, AND RUST STAINING IN THE FACE OF THE CAP, SPAN 5 SIDE, UNDER BEAM 1, DELAMINATION IS 42" X FULL DEPTH OF CAP X 8 INCHES ACROSS THE TOP OF THE CAP WITH 7" X 6" X 3" SPALL BELOW BEAM 1 BEARING, BEAM 1 BEARING IS NOT AFFECTED, NO EXPOSED REINFORCEMENT.

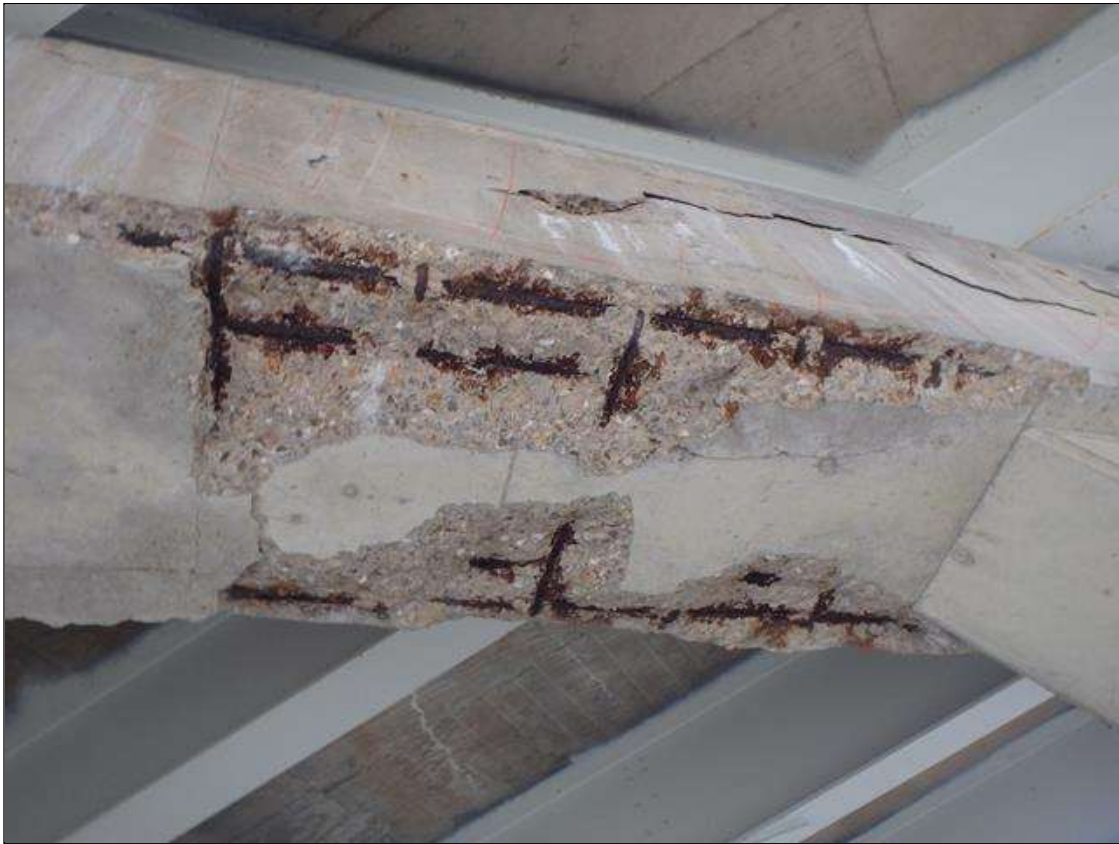
Bent 4 Cap 1: SPALL WITH EXPOSED REINFORCEMENT IN UNDERSIDE OF CAP BETWEEN COLUMNS 3 AND 4, 7 FT LONG X 3 FT WIDE X UP TO 3 INCHES DEEP WITH EXPOSED REINFORCEMENT, APPROXIMATELY 90% SECTION REMAINING OF EXPOSED REINFORCEMENT. (PRIORITY MAINTENANCE)

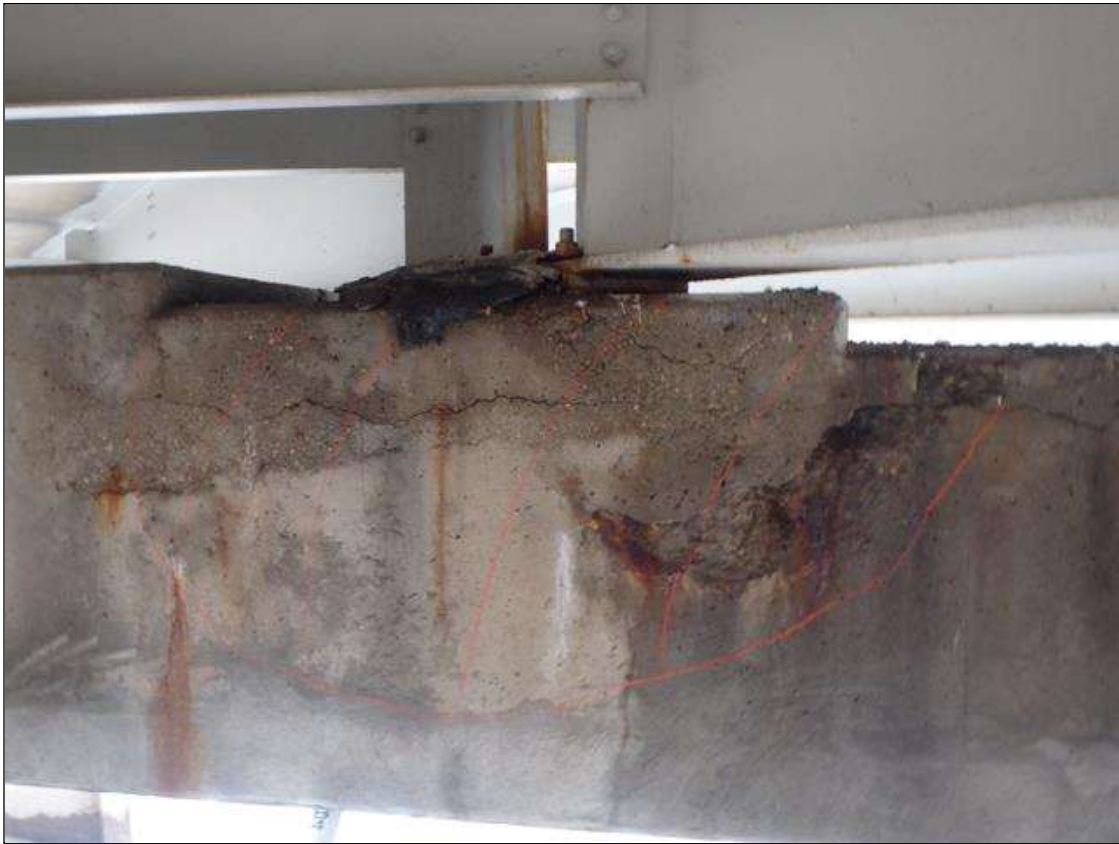
Bent 4 Cap 1: DELAMINATION ON SPAN 5 FACE OF CAP, BELOW BEAM 2. DELAMINATION IS 6 FT LONG X UP TO 3 FT HIGH WITH 2 FT X 6" X UP TO 1.5" DEEP SPALL WITH RUST STAINING, NO EXPOSED REINFORCEMENT.

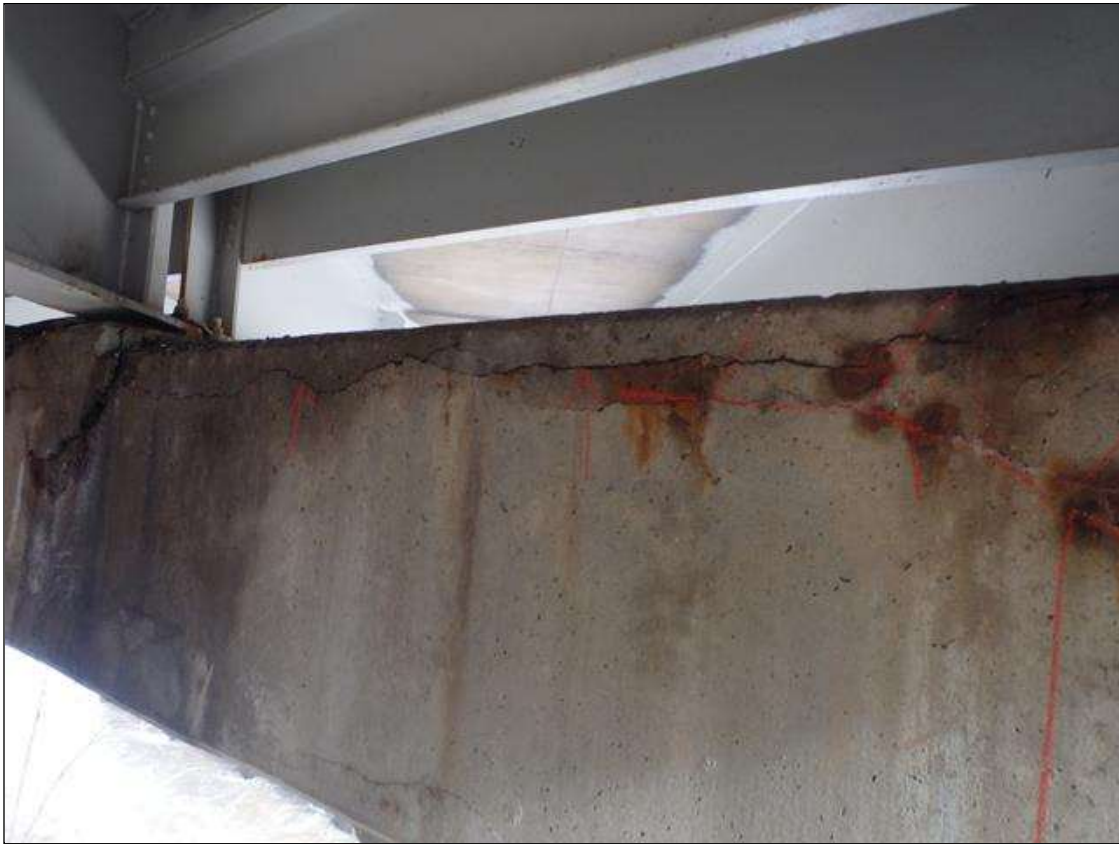
Bent 4 Cap 1: HORIZONTAL CRACK IN SPAN 5 FACE, UP TO 1/16" WIDE, BEGINNING IN BAY 1 AND ENDING IN BAY 2, APPROXIMATELY 6" DOWN FROM TOP OF CAP.

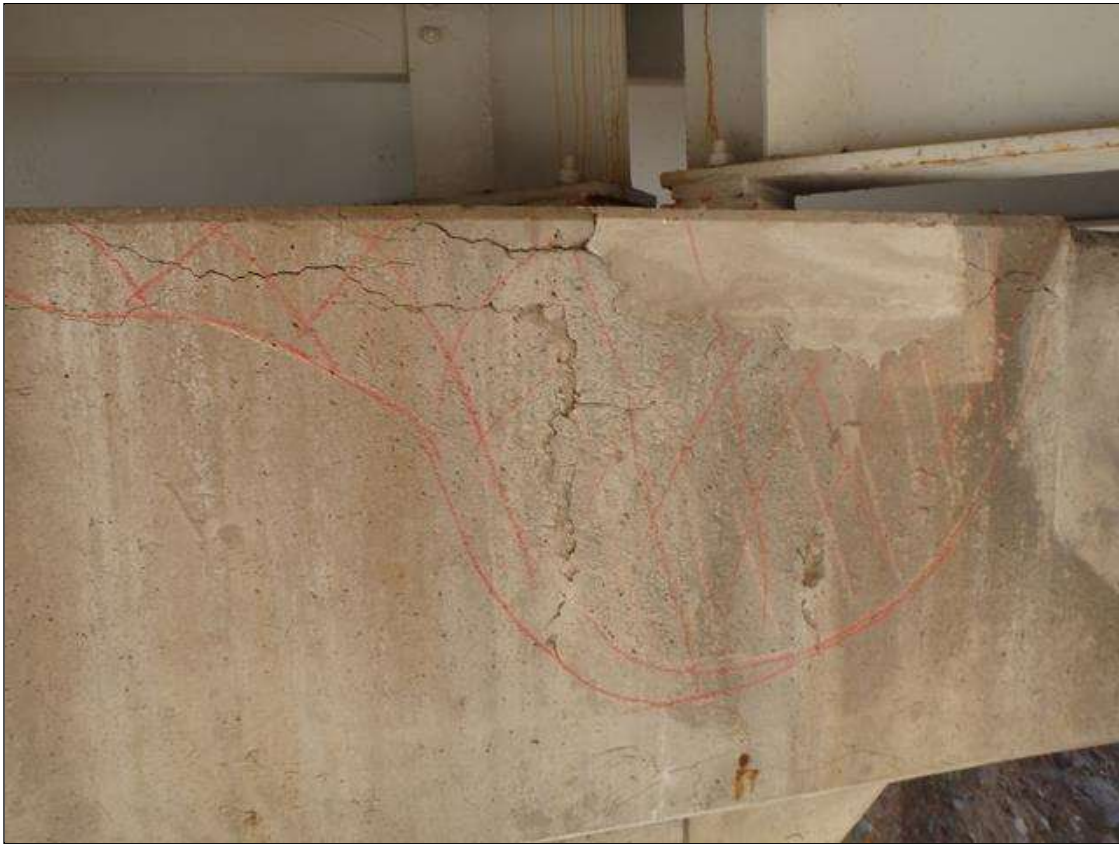
Bent 4 Cap 1: DELAMINATION IN THE FACE OF THE CAP, SPAN 4 SIDE, BAY 2 AND BELOW BEAM 3, DELAMINATION IS 5 FT LONG X UP TO X 30" HIGH WITH 1/8 INCH SEPARATION X 3 INCHES ACROSS THE TOP, ADJACENT PATCH BELOW BEAM 3 IS SOUND.

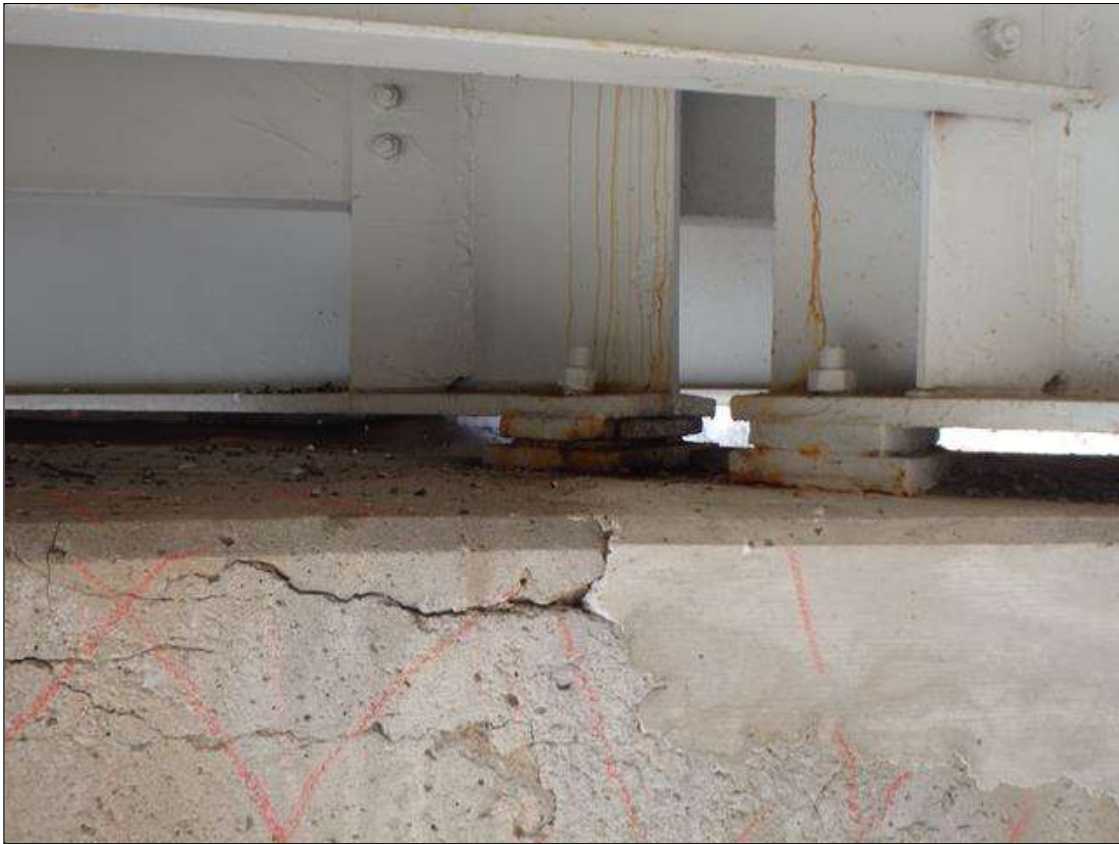
Span 5 Beam 3 Near Bearing: BEARING HAS SURFACE CORROSION, NO SECTION LOSS.

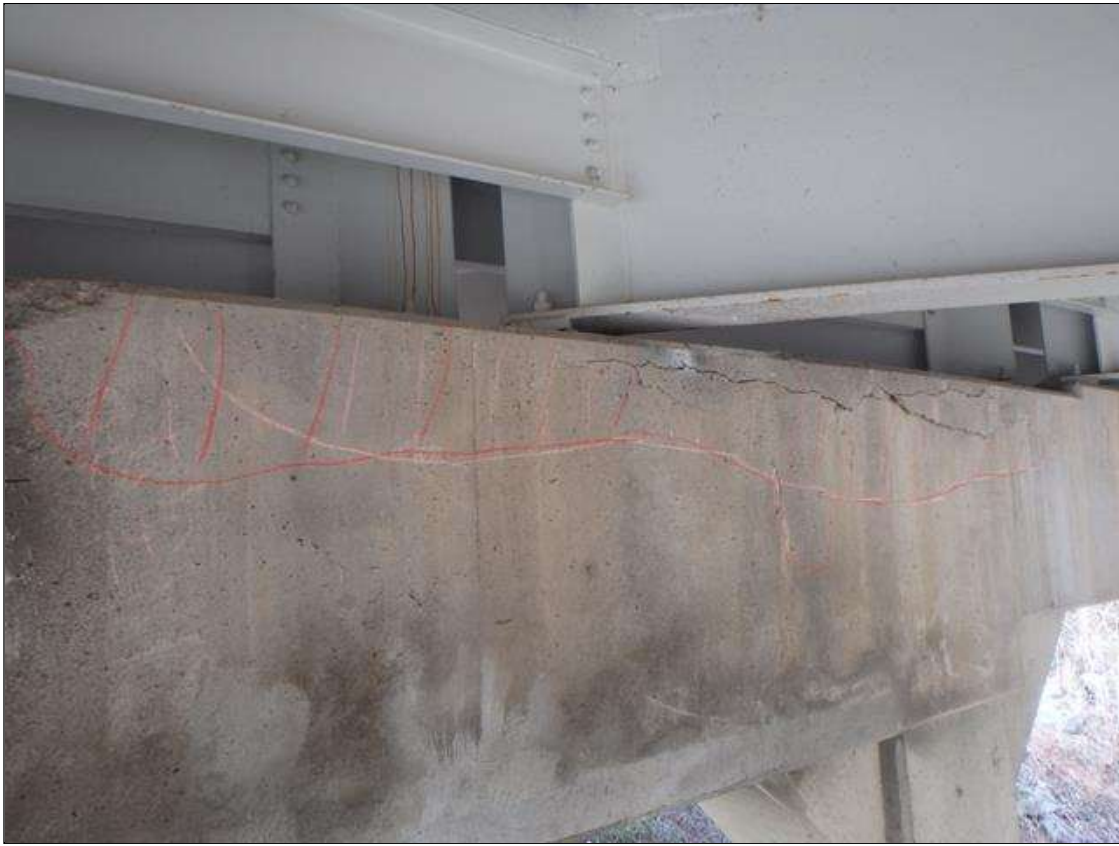
Bent 4 Cap 1: DELAMINATION ON TOP CORNER OF CAP, SPAN 4 SIDE, BELOW BAYS 3 AND 4. DELAMINATION IS 18 FT LONG X UP TO 2 FT HIGH X UP TO 12" INTO TOP FACE OF CAP, WITH SEPARATION UP TO 1/8" AND HORIZONTAL CRACKING UP TO 8 FT LONG AND UP TO 1/4" WIDE

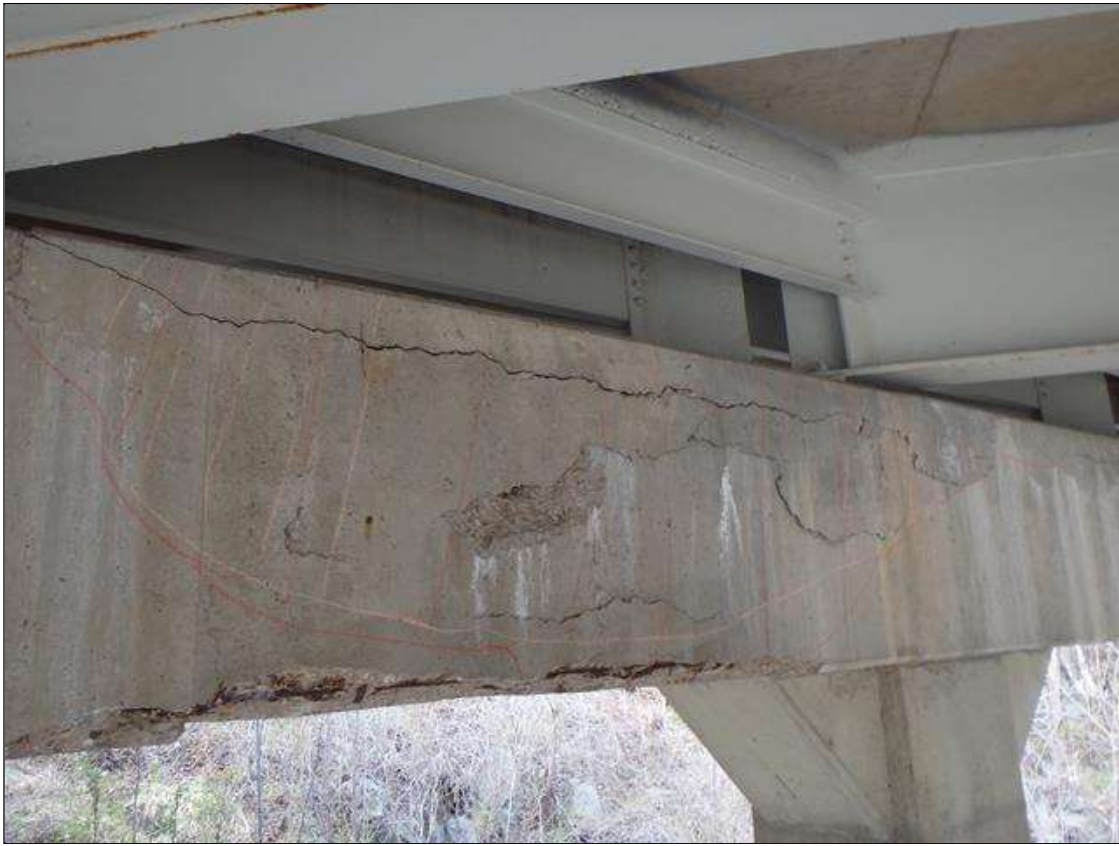
Bent 4 Cap 1: DELAMINATION IN THE FACE OF THE CAP, SPAN 4 SIDE, FROM BEAM 5 TO BEAM 6, 10 FT. LONG X UP TO FULL HEIGHT OF CAP X 5 INCHES ACROSS THE TOP WITH 2 FT X 6" X 1" DEEP SPALL, NO EXPOSED REINFORCEMENT AND CRACKING WITHIN DELAMINATED AREA UP TO 1/4" WIDE. BEARING AREAS ARE SOUND.

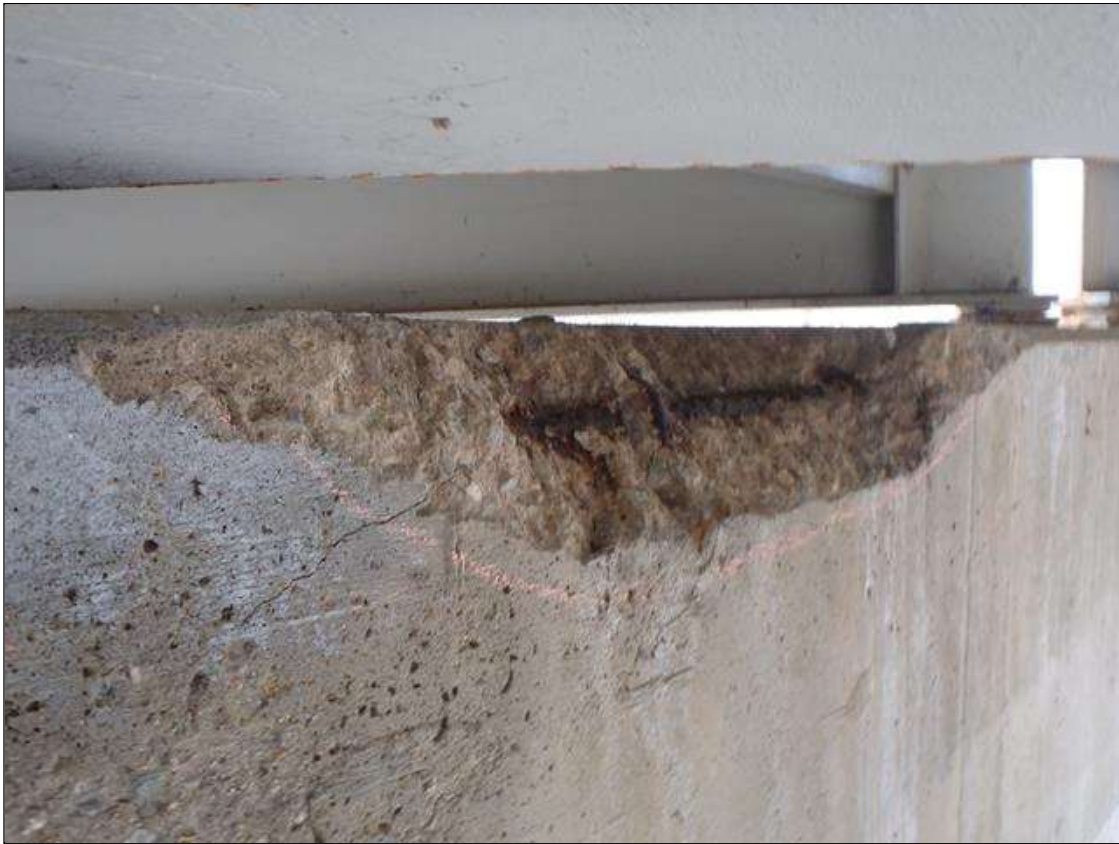
Bent 4 Cap 1: SPALL WITH EXPOSED REINFORCEMENT IN TOP CORNER OF CAP, SPAN 4 FACE, BAY 7, 4 FT LONG X 1 FT WIDE X UP TO 3" DEEP, NO MEASURABLE SECTION LOSS IN EXPOSED REINFORCEMENT.

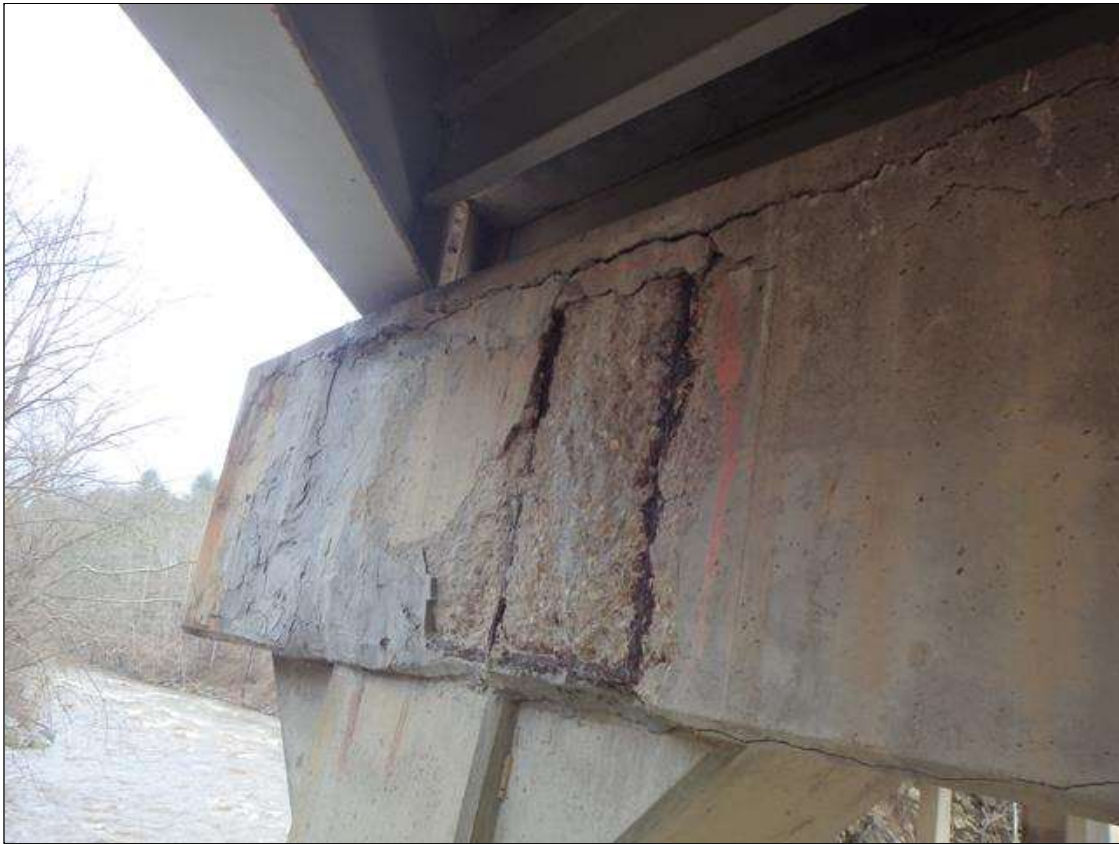
Bent 4 Cap 1: SPALL ON THE FACE OF THE CAP IN BAY 7, SPAN 5 SIDE, 30 INCHES LONG X UP TO FULL HEIGHT OF CAP X 1.5 INCHES DEEP WITH EXPOSED REINFORCEMENT, NO MEASURABLE SECTION LOSS OF EXPOSED REINFORCEMENT.
