NC DEPARTMENT OF TRANSPORTATION  
DIVISION OF HIGHWAYS  
STRUCTURE MANAGEMENT UNIT

## Structure Safety Report

### Routine Element Inspection - Contract

DIVISION: 14 COUNTY: HAYWOOD STRUCTURE NUMBER: 430142 FREQUENCY: 24 MONTHS

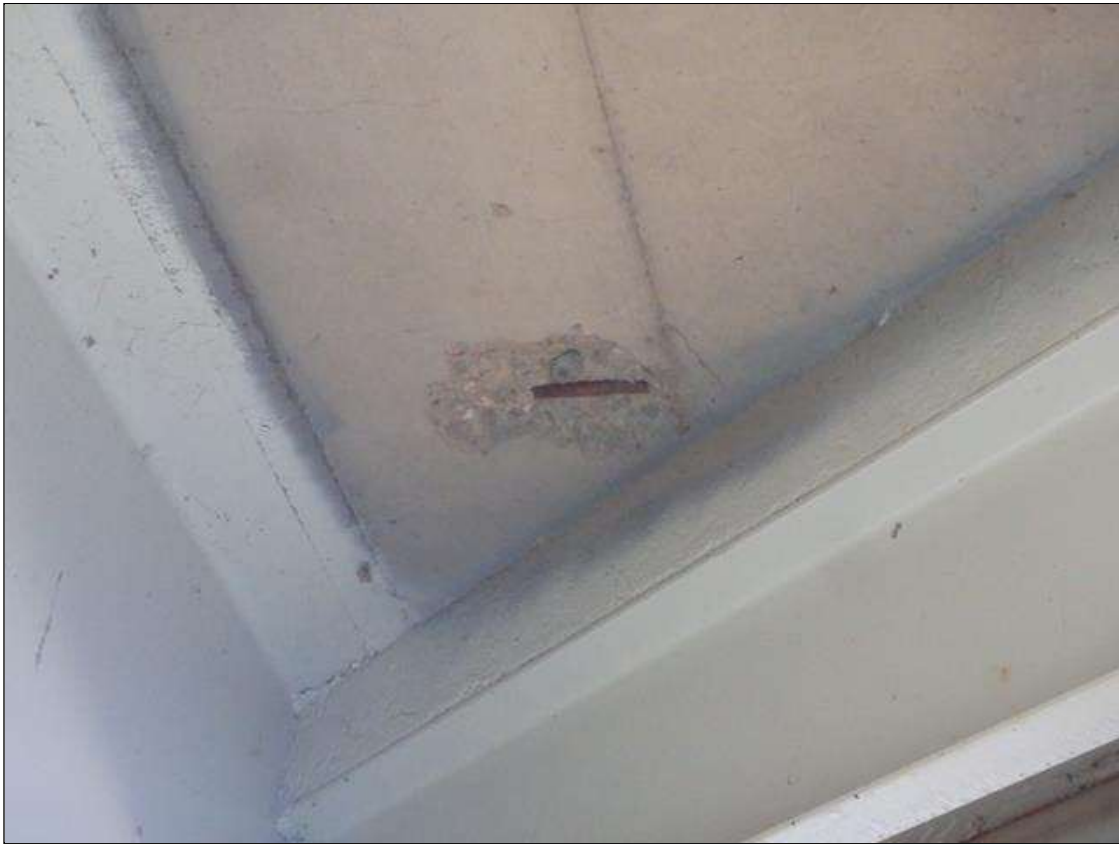
Span 5 Deck: 1 FT DIAMETER X 3" DEEP SPALL WITH EXPOSED REINFORCEMENT IN UNDERSIDE OF DECK IN BAY 7 NEAR BEAM 8 AT BENT 4, NO SECTION LOSS OF EXPOSED REINFORCEMENT.

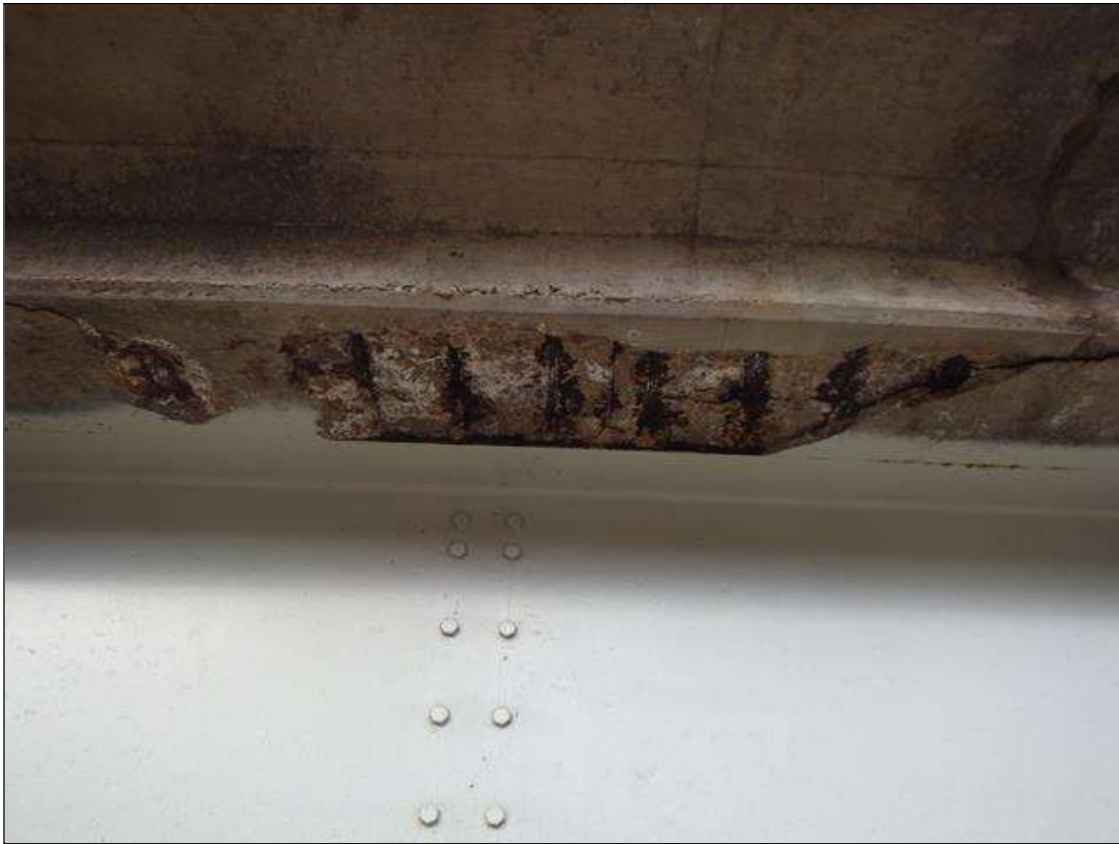
Span 5 Deck: SPALL WITH EXPOSED REINFORCEMENT IN UNDERSIDE OF LEFT OVERHANG NEAR MIDSPAN.  
4 FT LONG X 14" WIDE X UP TO 2" DEEP WITH UP TO 80% SECTION REMAINING IN EXPOSED  
REINFORCEMENT.

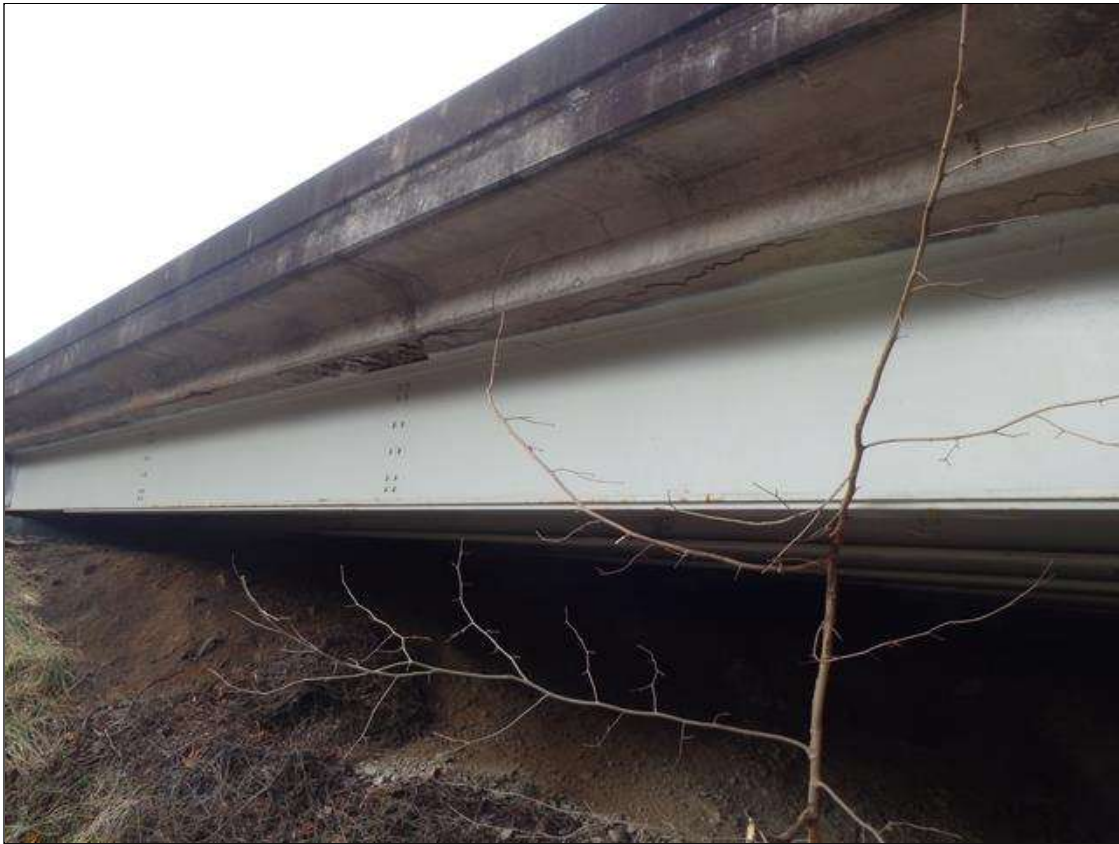
Span 5 Deck: SCATTERED DELAMINATION AND CRACKING UP TO 1/4" WIDE WITH RUST STAINING IN UNDERSIDE OF OF BOTH OVERHANGS.

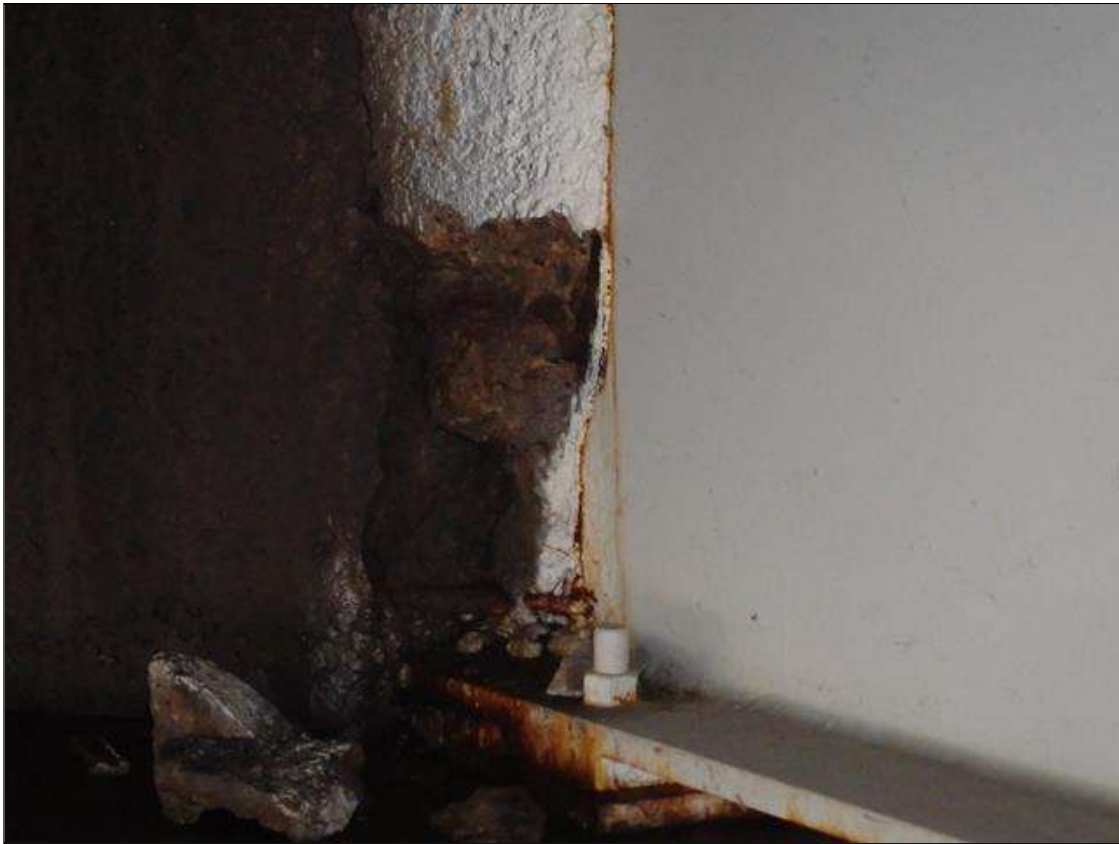
End Bent 2 Abutment/Backwall : 10" WIDE X 2 FT HIGH X UP TO 4" DEEP SPALL WITH EXPOSED REINFORCEMENT IN BACKWALL ADJACENT TO THE LEFT SIDE OF BEAM 3, NO SECTION LOSS OF EXPOSED REINFORCEMENT.

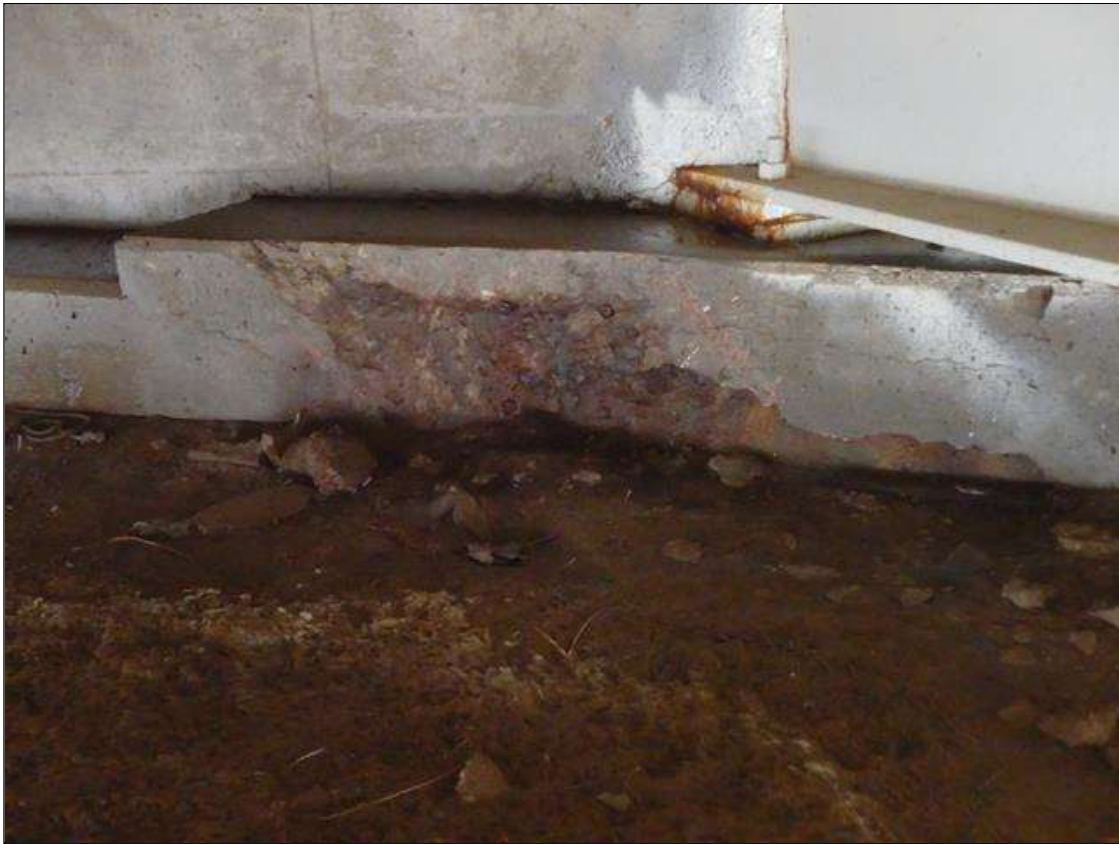
End Bent 2 Cap 1: 5 FT X UP TO 18" HIGH X UP TO 2" DEEP SPALL IN FACE OF CAP IN BAY 3, NO EXPOSED REINFORCEMENT.

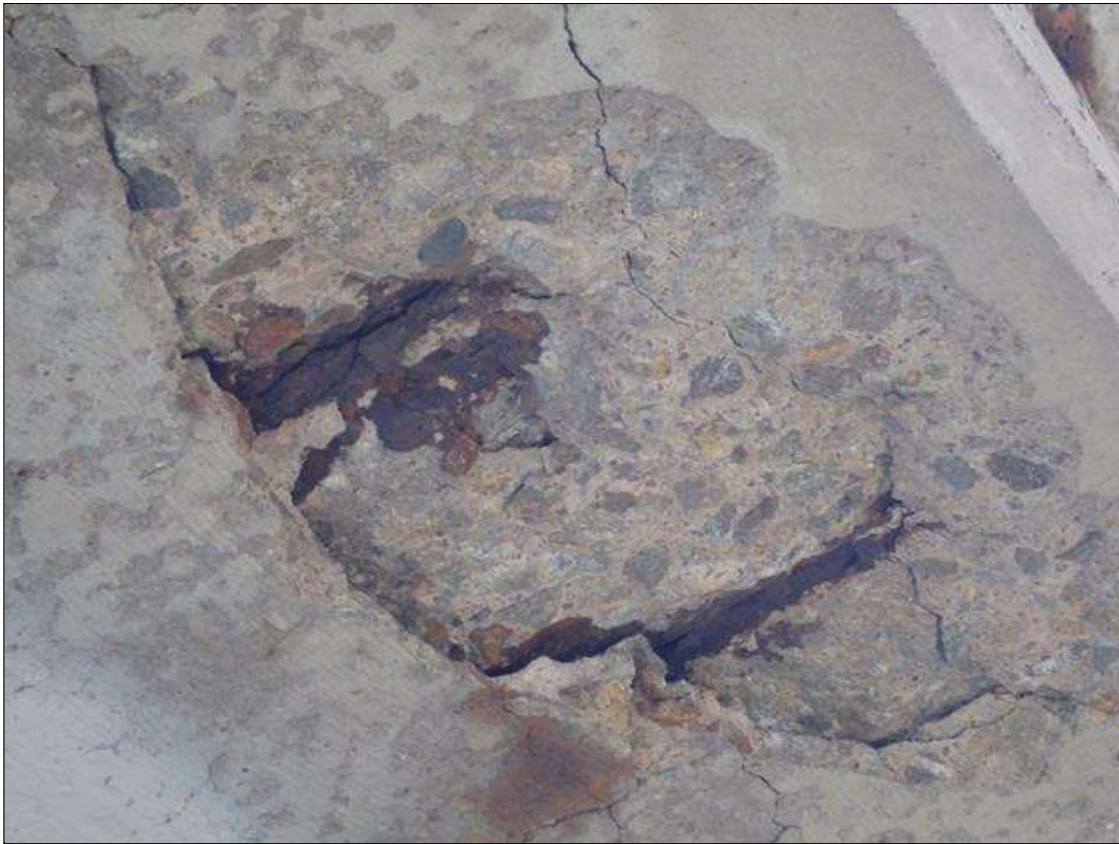
Span 5 Deck: 16" X 9" X 1" DEEP SPALL WITH EXPOSED REINFORCEMENT IN UNDERSIDE OF RIGHT OVERHANG, 10 FT FROM END BENT 2, 95% SECTION REMAINING.

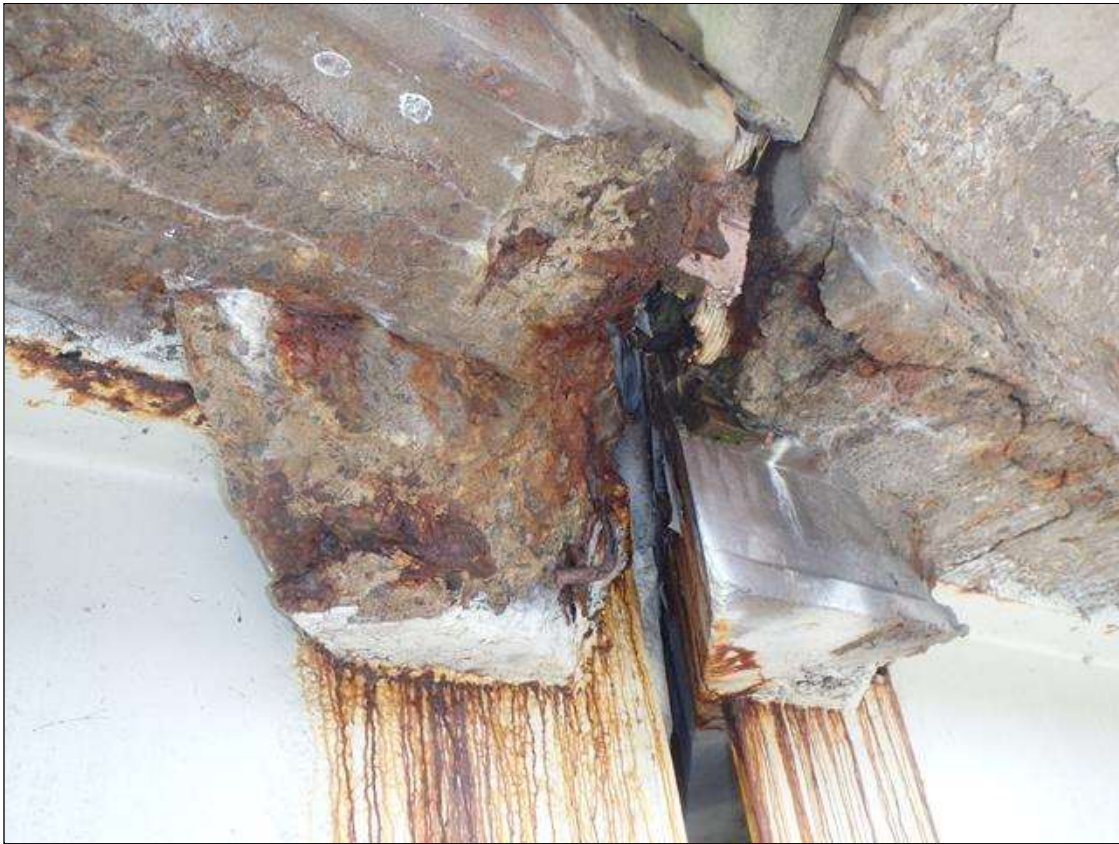
Span 4 Deck: (2) SPALLS WITH EXPOSED REINFORCEMENT IN UNDERSIDE OF LEFT OVERHANG AT BENT 3, UP TO 18" X 8" X UP TO 4" DEEP WITH RUST STAINING ONTO BEAM BELOW, UP TO 30% SECTION REMAINING OF EXPOSED REINFORCEMENT.

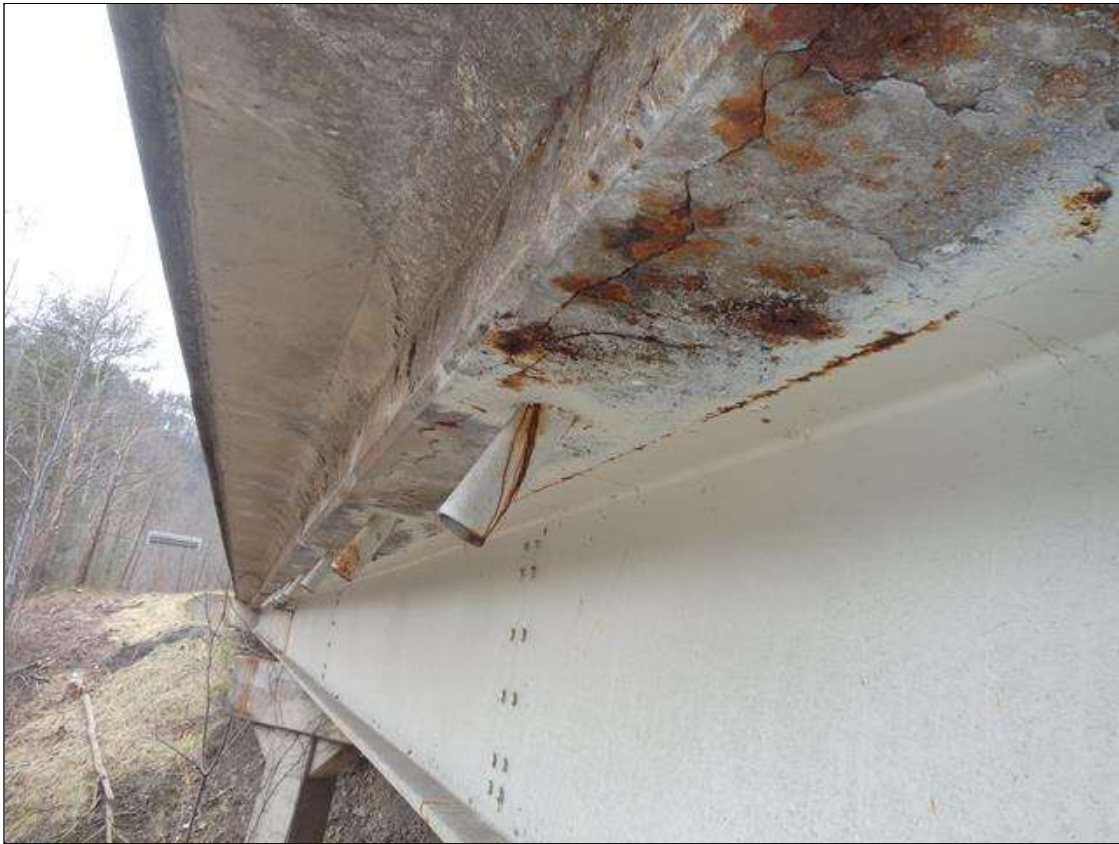
Span 4 Deck: SCATTERED DELAMINATION AND CRACKING UP TO 1/4" WIDE WITH RUST STAINING IN UNDERSIDE OF OF BOTH OVERHANGS.

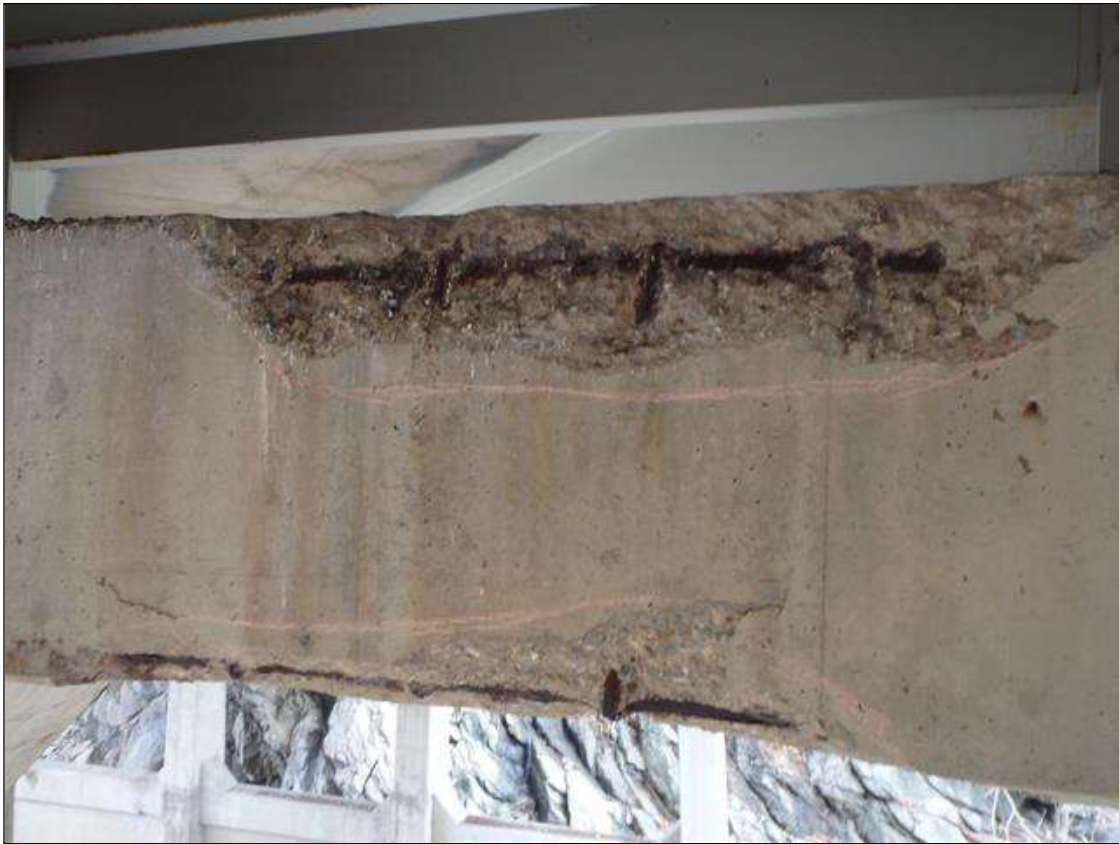
Bent 3 Cap 1: SPALLS WITH EXPOSED REINFORCEMENT IN TOP AND BOTTOM CORNER OF CAP, SPAN 4 SIDE, BAY 5. TOP CORNER SPALL IS 6 FT LONG X 12" HIGH X 10" INTO TOP OF CAP X UP TO 3" DEEP. BOTTOM CORNER SPALL IS 5 FT LONG X 10" X 10" UP TO 2" DEEP. NO MEASURABLE SECTION LOSS OF EXPOSED REINFORCEMENT.

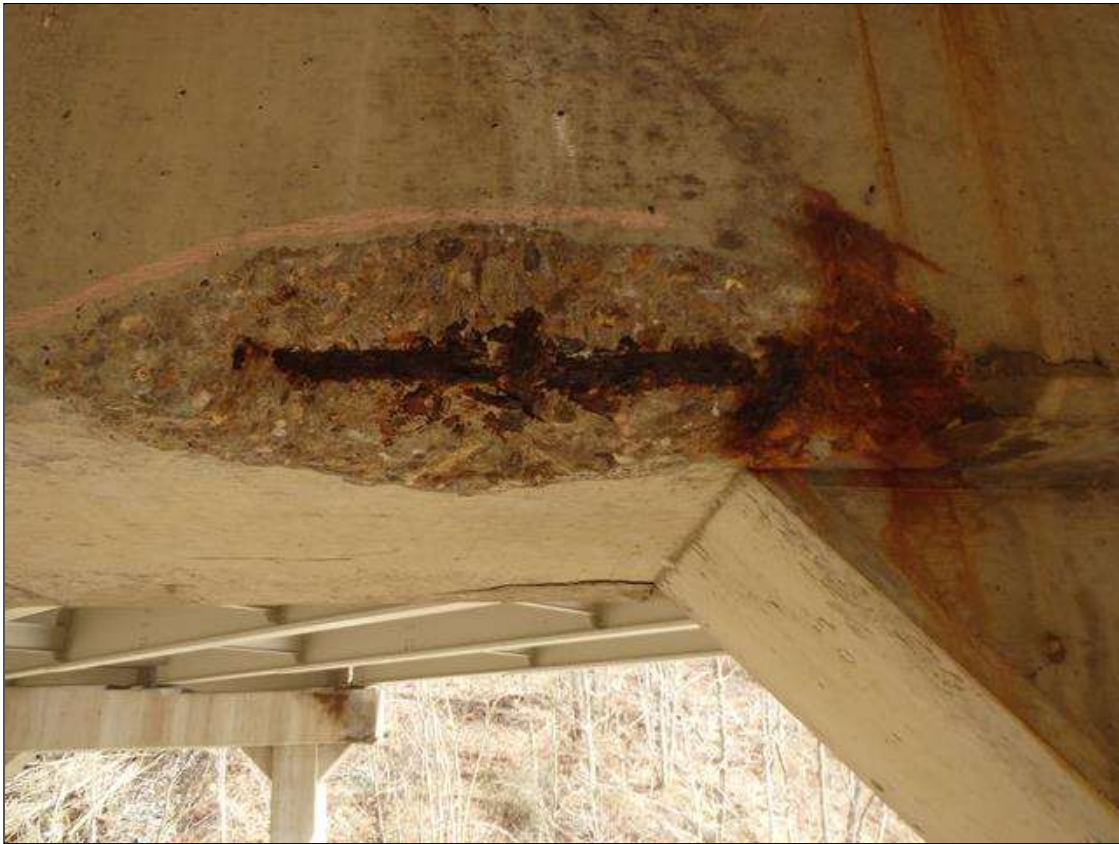
Bent 3 Cap 1: SPALL WITH EXPOSED REINFORCEMENT IN BOTTOM CORNER OF CAP, SPAN 4 FACE BELOW BEAM 5. 2 FT X 8" X 8" X UP TO 2" DEEP, NO MEASURABLE SECTION LOSS OF EXPOSED REINFORCEMENT.

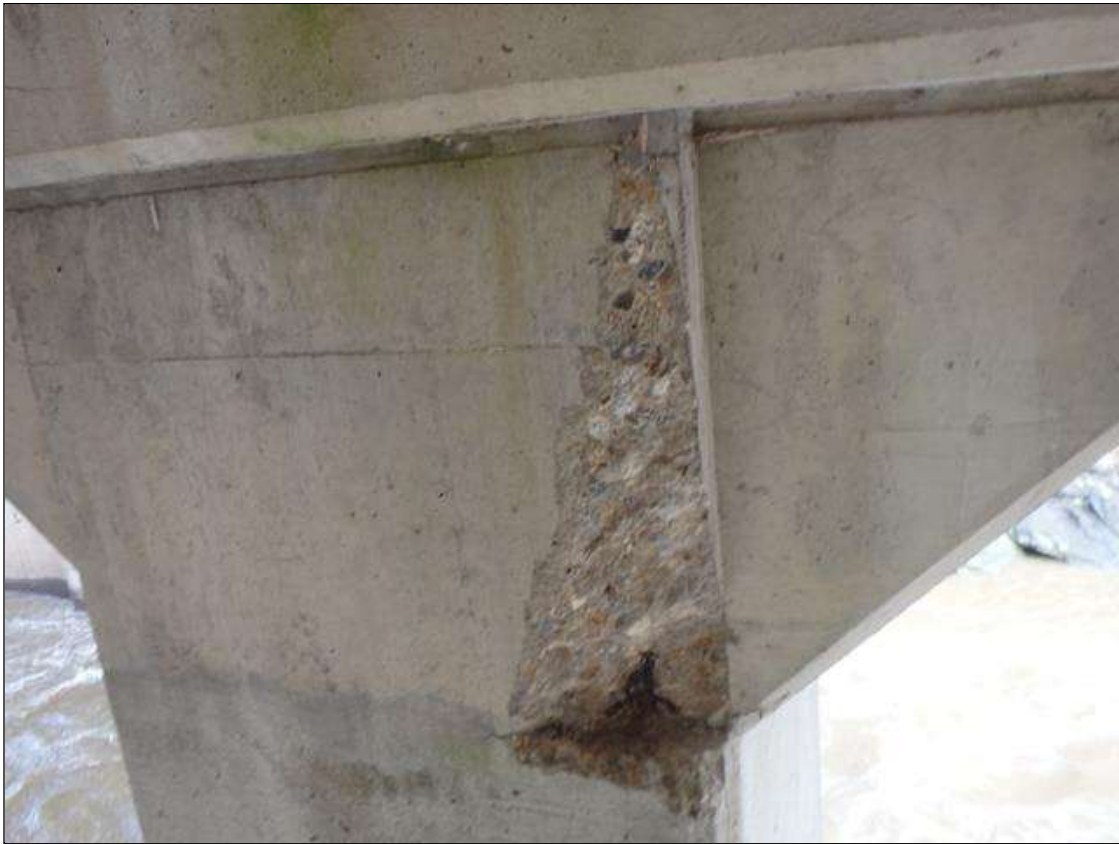
Bent 3 Pile 2: 2 FT X 8" X UP TO 3" DEEP SPALL WITH EXPOSED REINFORCEMENT IN SPAN 3 FACE OF COLUMN, DIRECTLY BELOW CAP, NO MEASURABLE SECTION LOSS OF EXPOSED REINFORCEMENT.

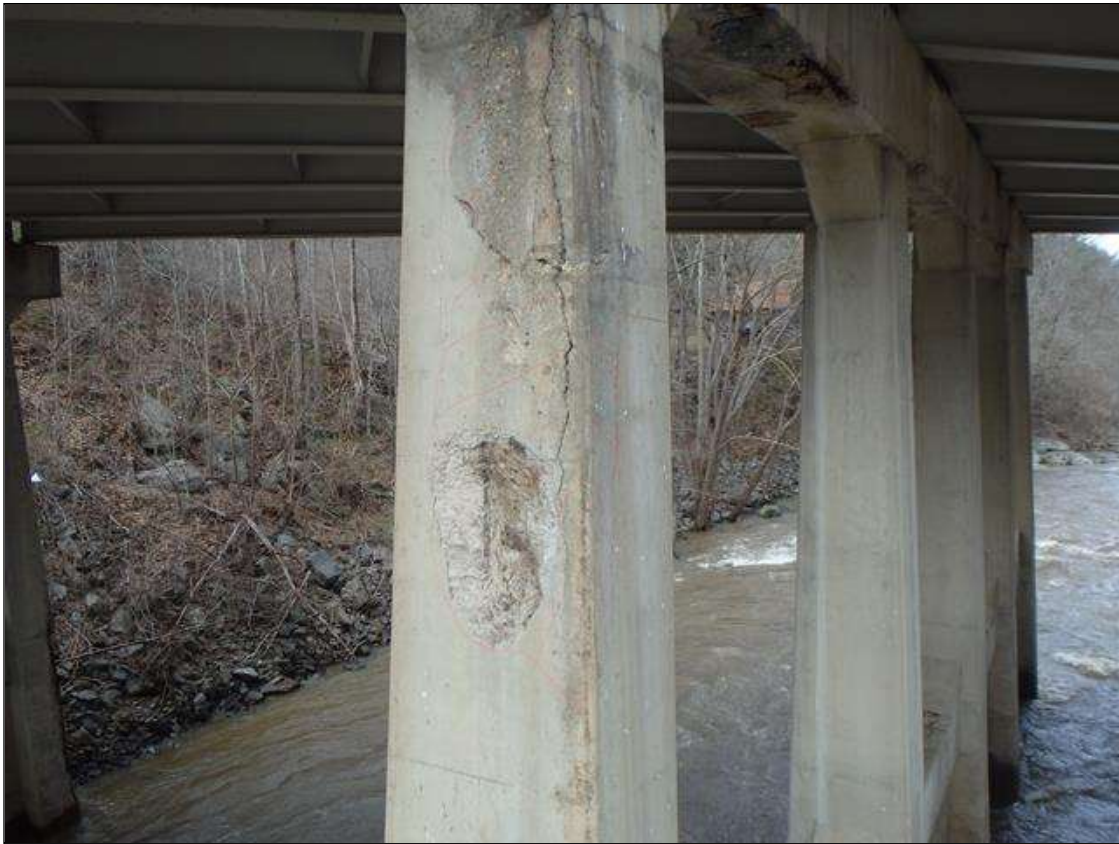
Bent 3 Pile 1: DELAMINATION ON THE NORTHWEST CORNER OF COLUMN, 34" X 1 FT X 8 FT TALL, STARTING AT THE BOTTOM OF THE CAP, WITH UP TO 1 INCH SEPARATION

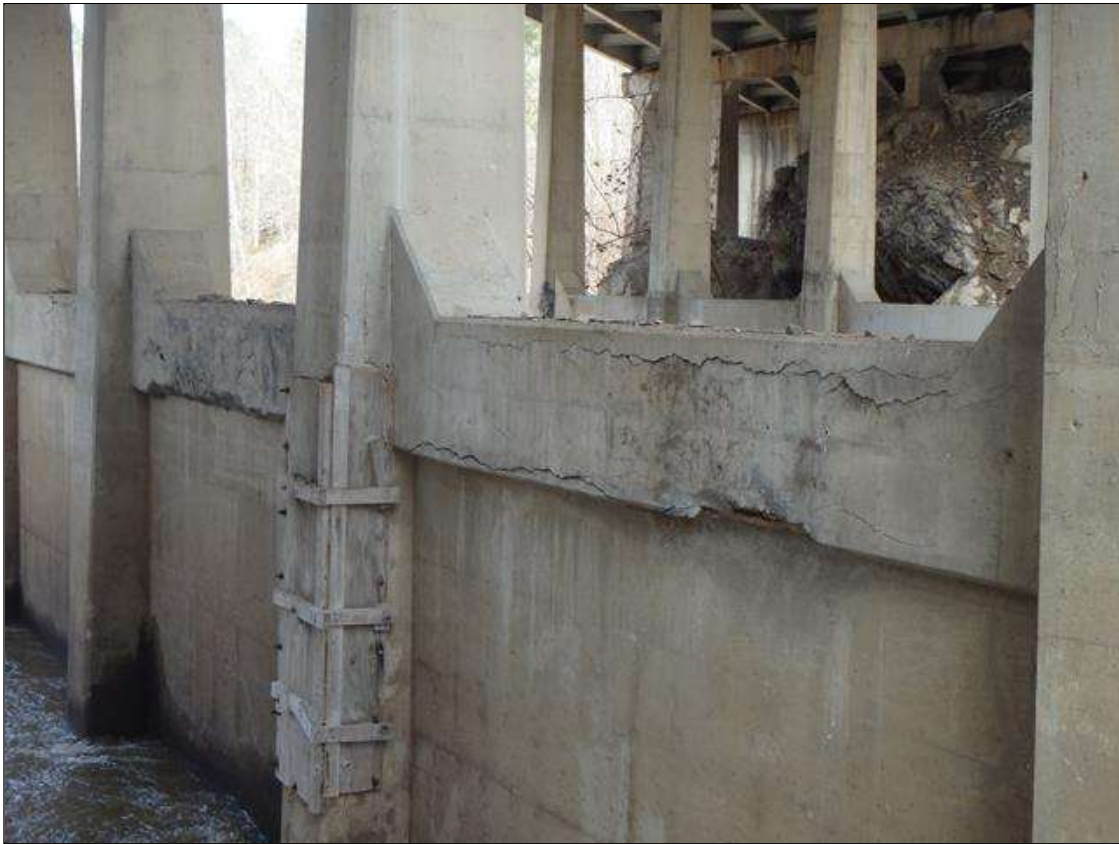
Bent 3 Pile 1: DELAMINATION WITH SPALLING WITH EXPOSED REINFORCEMENT UP TO 2" DEEP FOR UP TO 10" HIGH TOP AND BOTTOM CORNERS OF EAST FACE OF STRUT FOR FULL LENGTH OF STRUT 1, NO SECTION LOSS OF EXPOSED REINFORCEMENT.

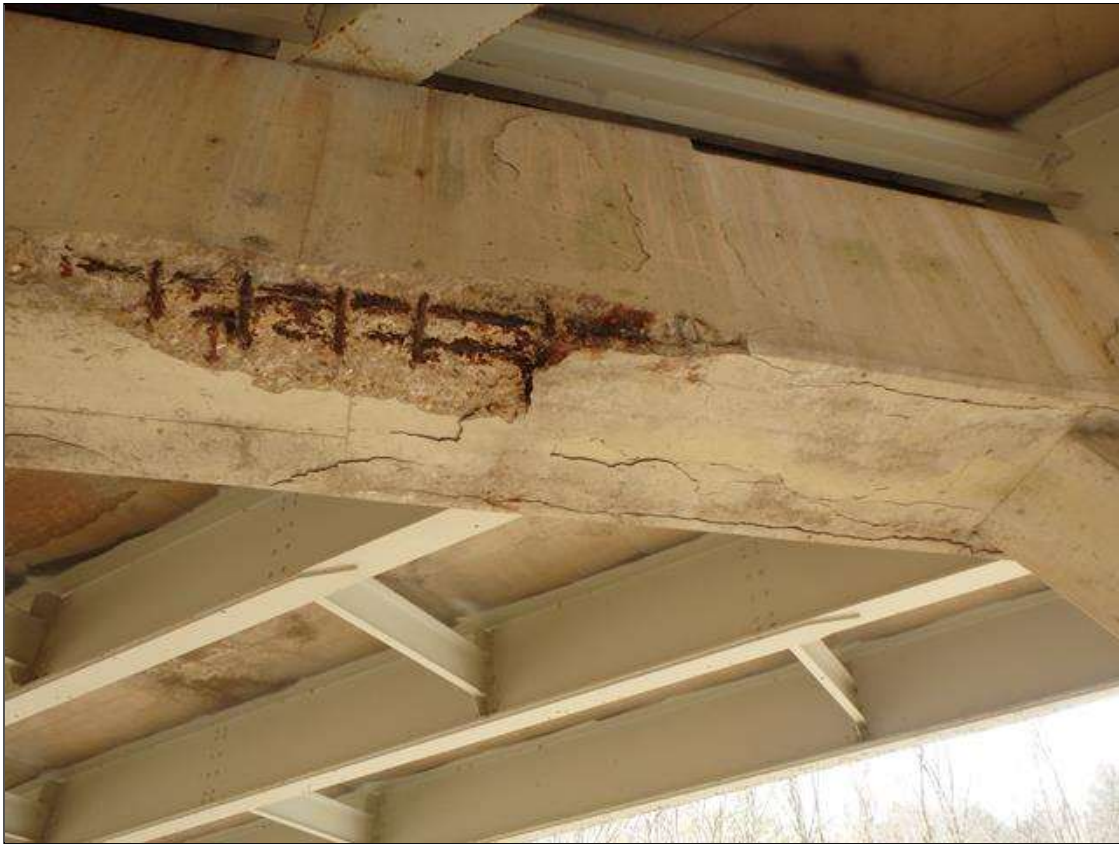
Bent 3 Cap 1: DELAMINATION AND SPALLING WITH EXPOSED REINFORCEMENT IN UNDERSIDE OF CAP BETWEEN COLUMNS 2 AND 3. SPALLING UP TO UP TO 5 FT LONG X 14" WIDE X 2" DEEP, NO MEASURABLE SECTION LOSS OF EXPOSED REINFORCEMENT. DELAMINATION TRAVELS UP BOTH FACES OF CAP FOR UP TO 6".

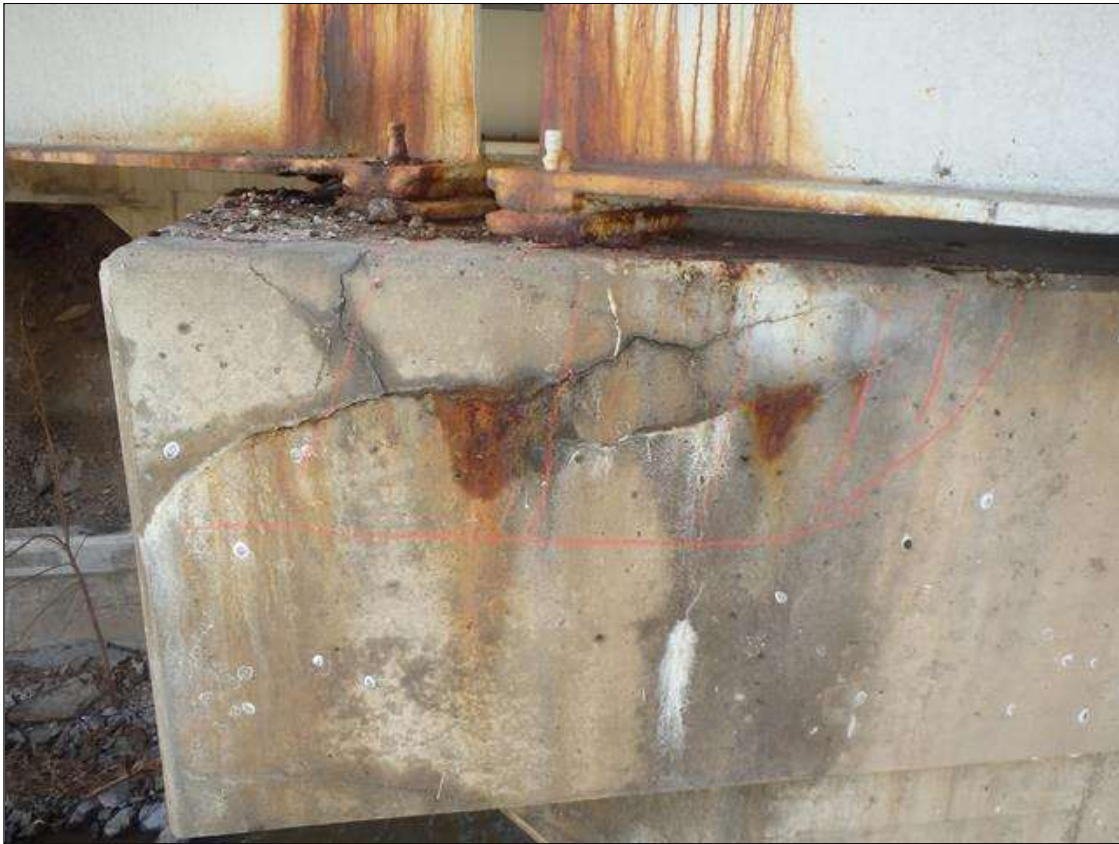
Bent 3 Cap 1: DELAMINATION WITH MAP CRACKING UP TO 1/32" WIDE AND RUST STAINING AND EFFLORESCENCE IN FACE OF CAP BELOW BEAM 1, SPAN 3 SIDE. DELAMINATION IS 5 FT LONG X 18" HIGH X UP TO 6" INTO TOP OF CAP.

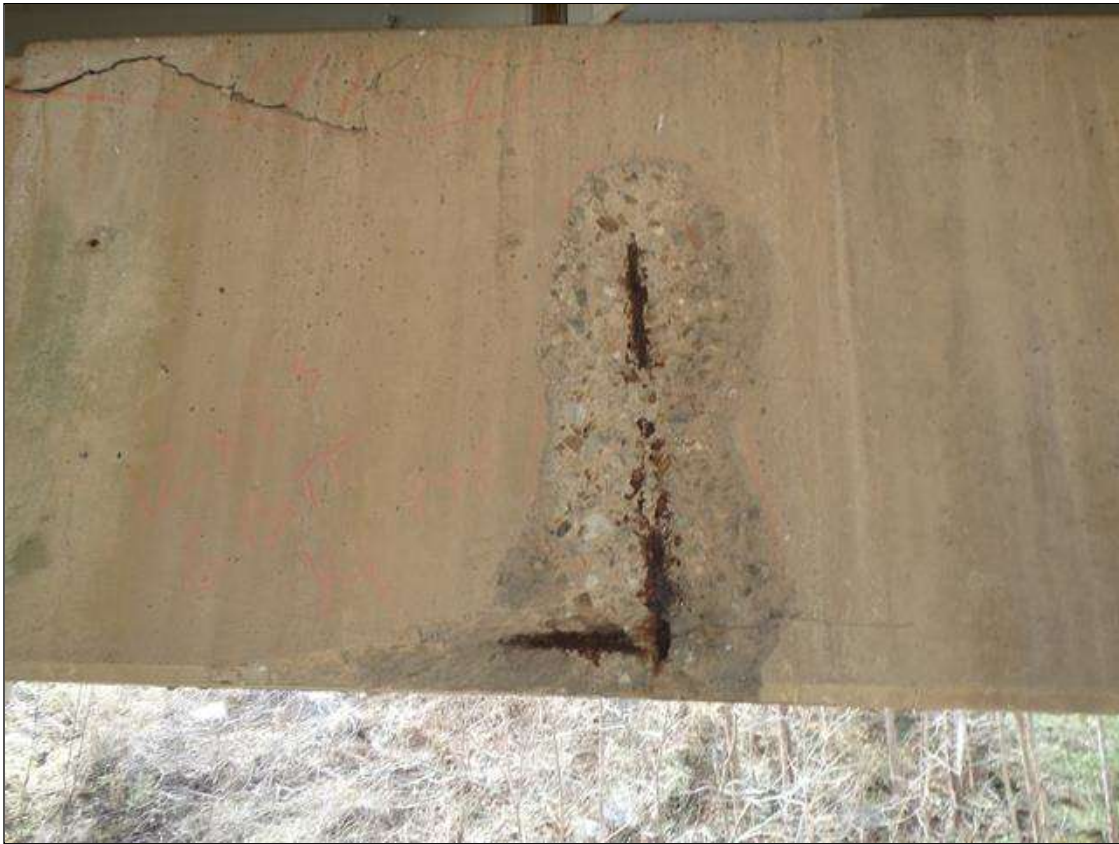
Bent 3 Cap 1: 2 FT HIGH X 1 FT WIDE X UP TO 2" DEEP SPALL WITH EXPOSED REINFORCEMENT IN SPAN 3 SIDE OF CAP BELOW BEAM 7, NO SECTION LOSS OF EXPOSED REINFORCEMENT.

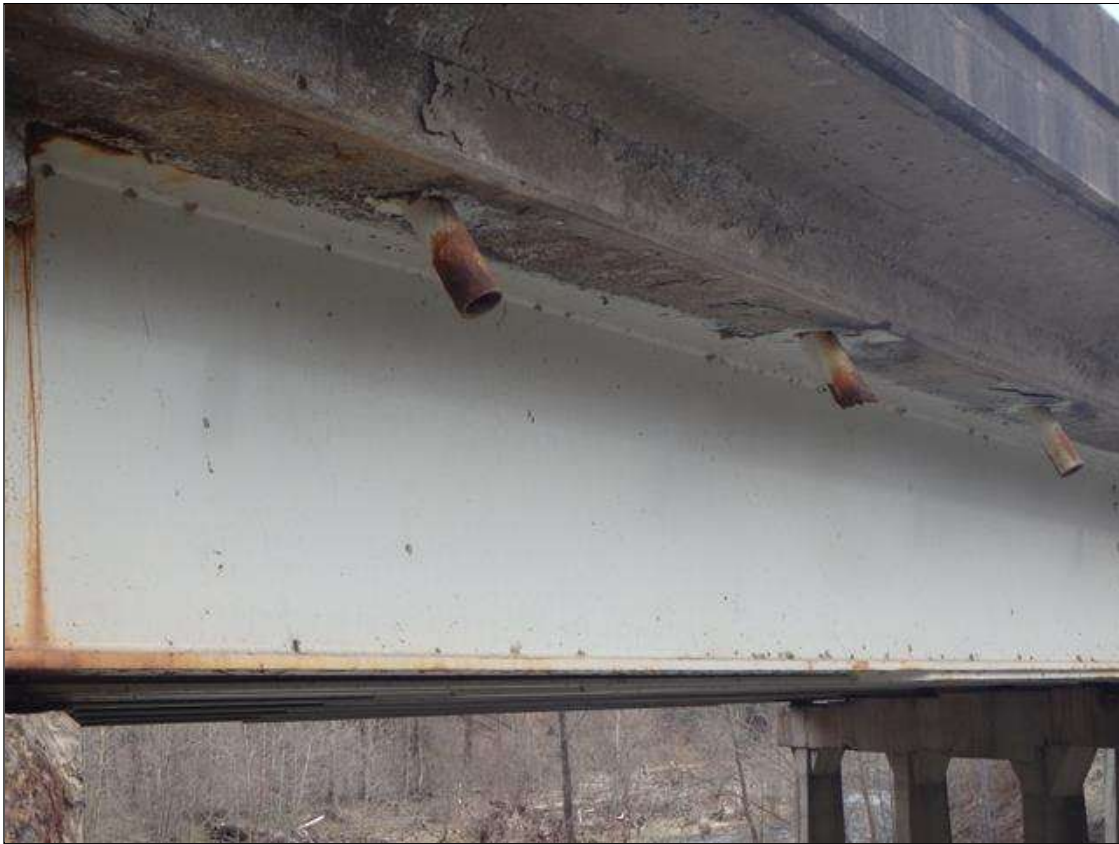
SURFACE CORROSION IN DECK DRAINS SCATTERED THROUGHOUT ALL SPANS, NO MEASURABLE SECTION LOSS.
