NC DEPARTMENT OF TRANSPORTATION  
DIVISION OF HIGHWAYS  
STRUCTURE MANAGEMENT UNIT

## Structure Safety Report

### Routine Element Inspection - Contract

DIVISION: 14 COUNTY: HAYWOOD STRUCTURE NUMBER: 430159 FREQUENCY: 24 MONTHS

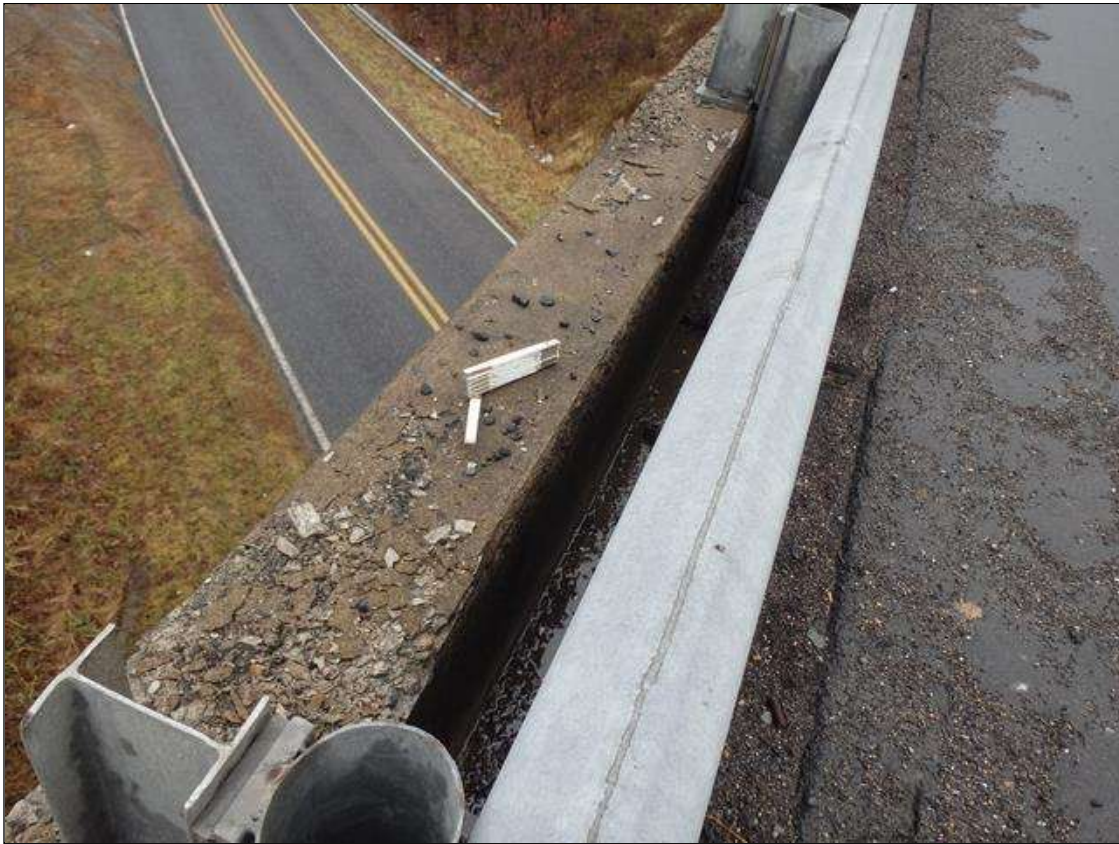
Span 2 Left Bridge Rail: DISINTEGRATING CONCRETE ON ORIGINAL BARRIER RAIL FOR FULL WIDTH X 4" DEEP FOR 50% OF THE SPAN, CONCRETE IS FALLING ONTO TRAFFIC BELOW, PM

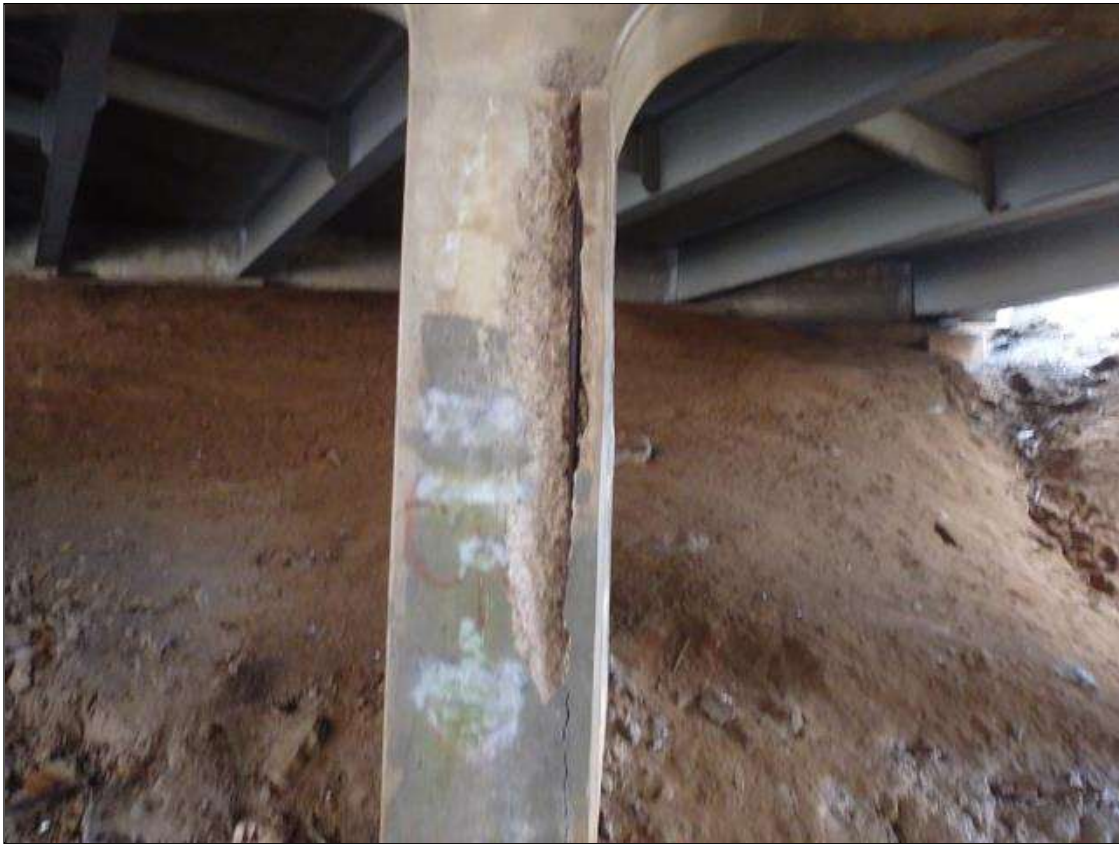
Bent 1 Pile 3: SPALL/DELAMINATED AREA ON NORTHEAST CORNER OF COLUMN, FULL HEIGHT DELAMINATION X 1 FT WIDE X 6" WITH A SPALL THAT IS 8 FT HIGH X 18" WIDE X 3.5" DEEP WITH EXPOSED REBAR, NO MEASUREABLE SECTION LOSS, PM

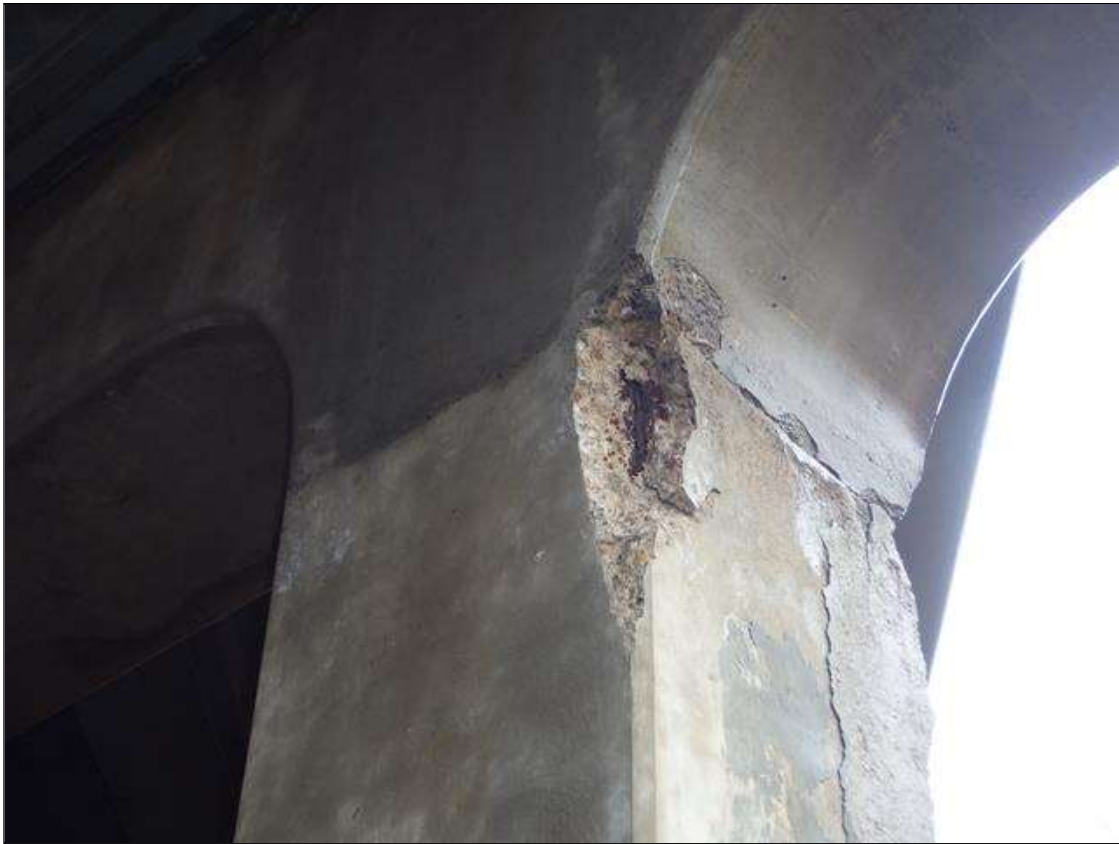
Bent 1 Pile 1: SPALL, 2 FT X 6" X 6", ON NORTHEAST CORNER OF COLUMN AT TOP WITH EXPOSED REBAR WITH SECTION LOSS UP TO 10% OF ONE MAIN REINFORCING BAR, PM

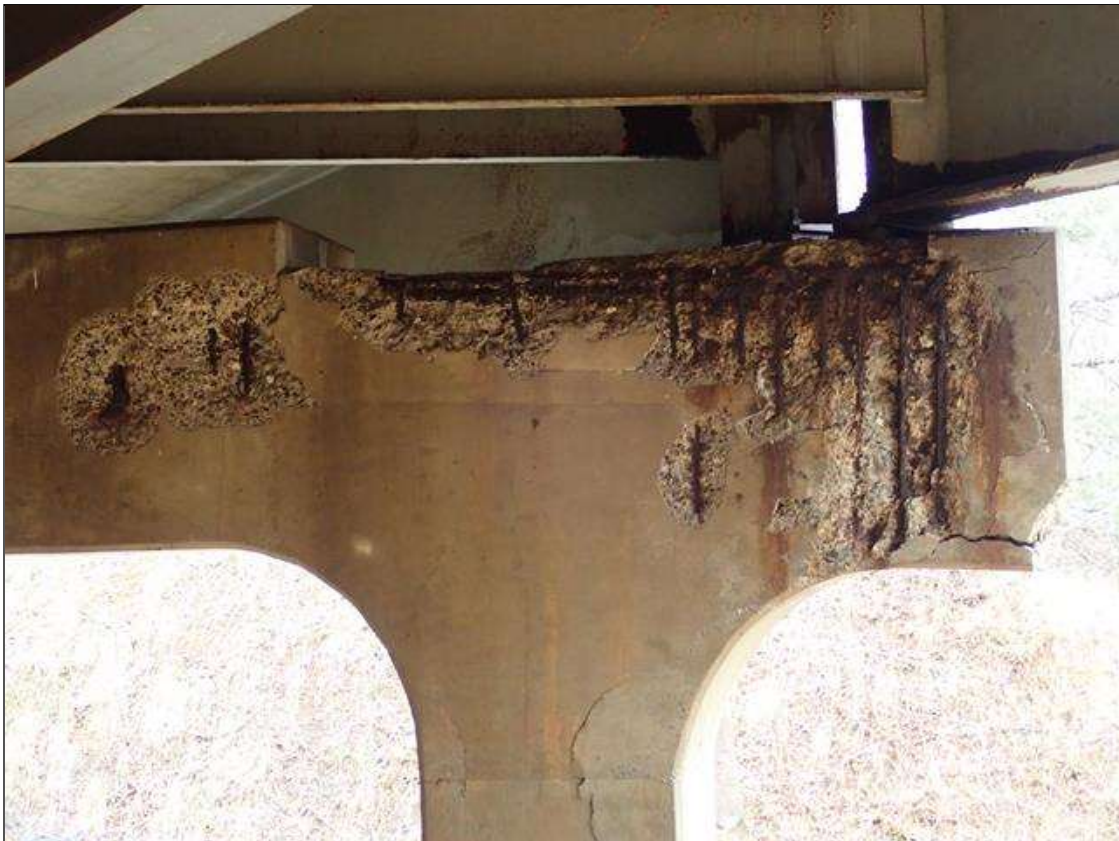
Bent 2 Cap 1: SPALL, FULL HEIGHT X 9 FT X 2" DEEP, ON SPAN 3 SIDE OF CAP UNDER BEAM 1 AND BAY 1 WITH EXPOSED MAIN REINFORCING AND SHEAR REINFORCING WITH SECTION LOSS UP TO 25%, PM

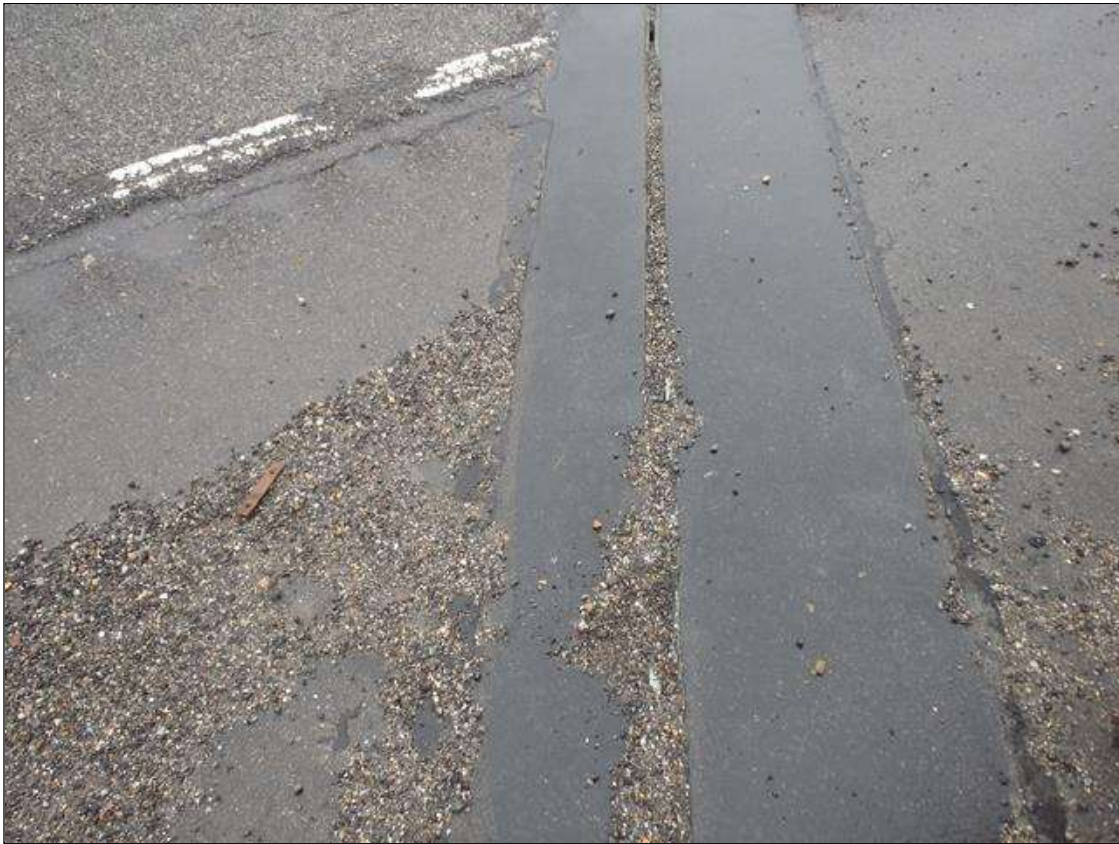
Expansion Joint At End Bent 2: JOINT MATERIAL MISSING FOR FULL LENGTH OF JOINT WITH DEBRIS IN JOINT THROUGHOUT THE OUTSIDE SHOULDERS

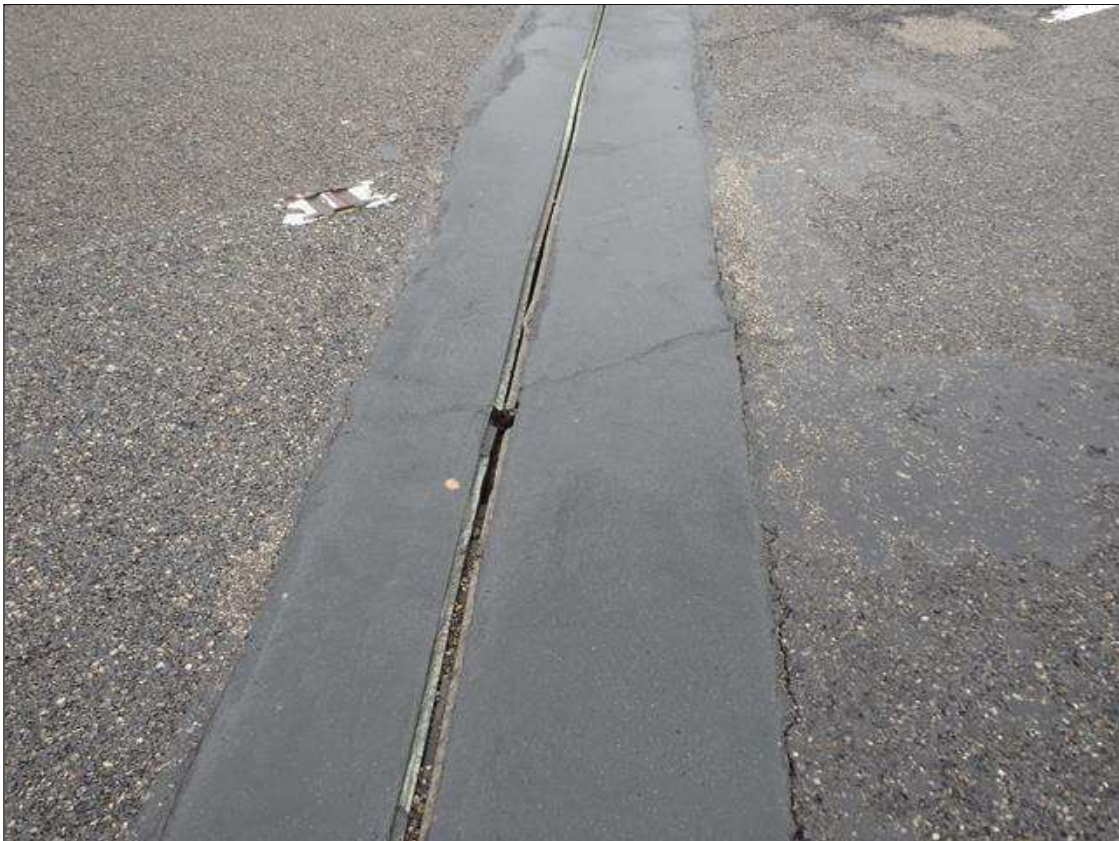
Expansion Joint At End Bent 1: JOINT MATERIAL MISSING FOR FULL LENGTH OF JOINT WITH DEBRIS IN JOINT THROUGHOUT THE OUTSIDE SHOULDERS

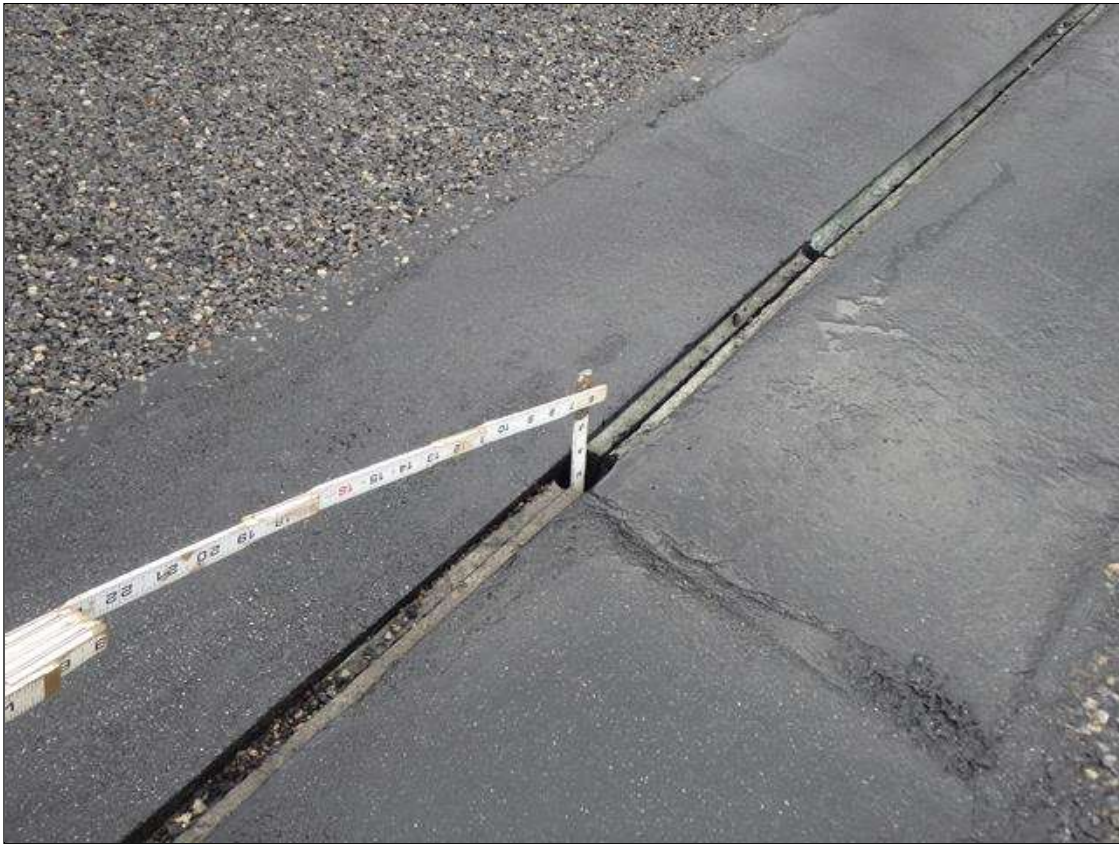
Expansion Joint At Bent 1: GAPS IN THE JOINT MATERIAL SCATTERED THROUGHOUT JOINT LESS THAN 2" WIDE

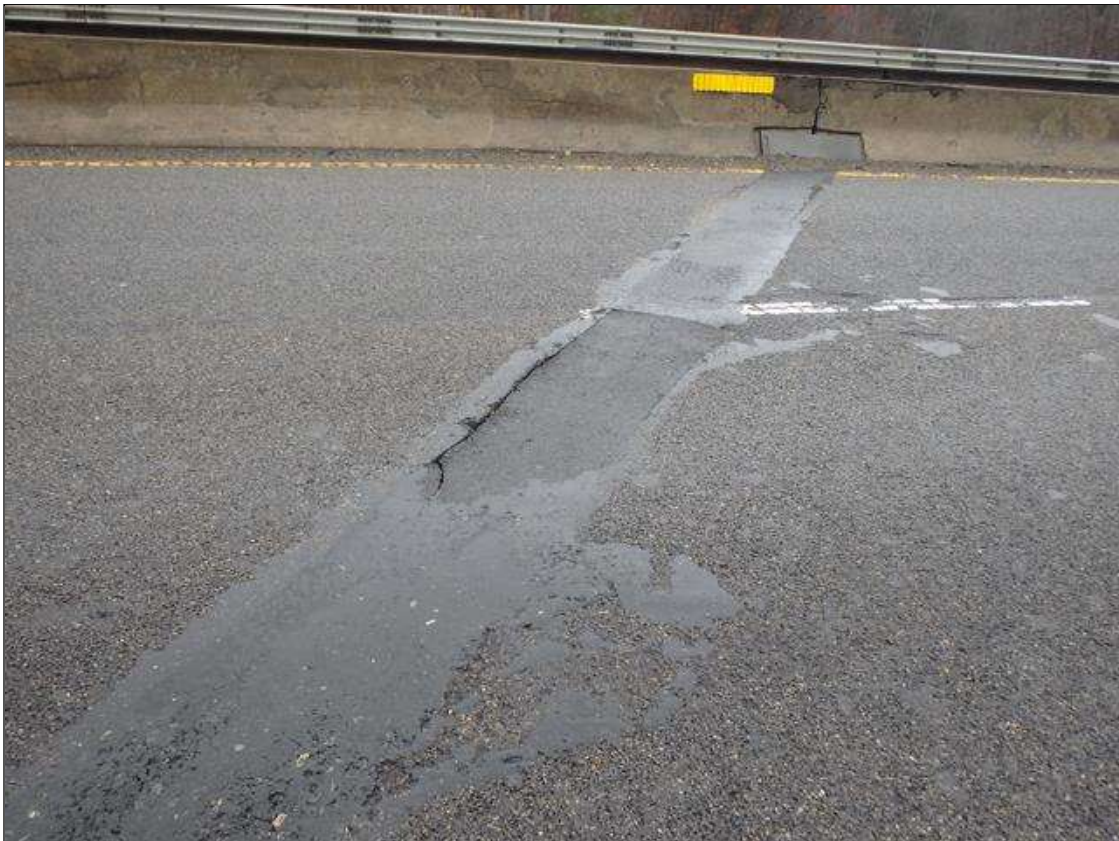
Span 1 Wearing Surface: SOUND PATCH, 5 FT LONG X 2 FT WIDE IN WEST BOUND LANES OVER BENT 1

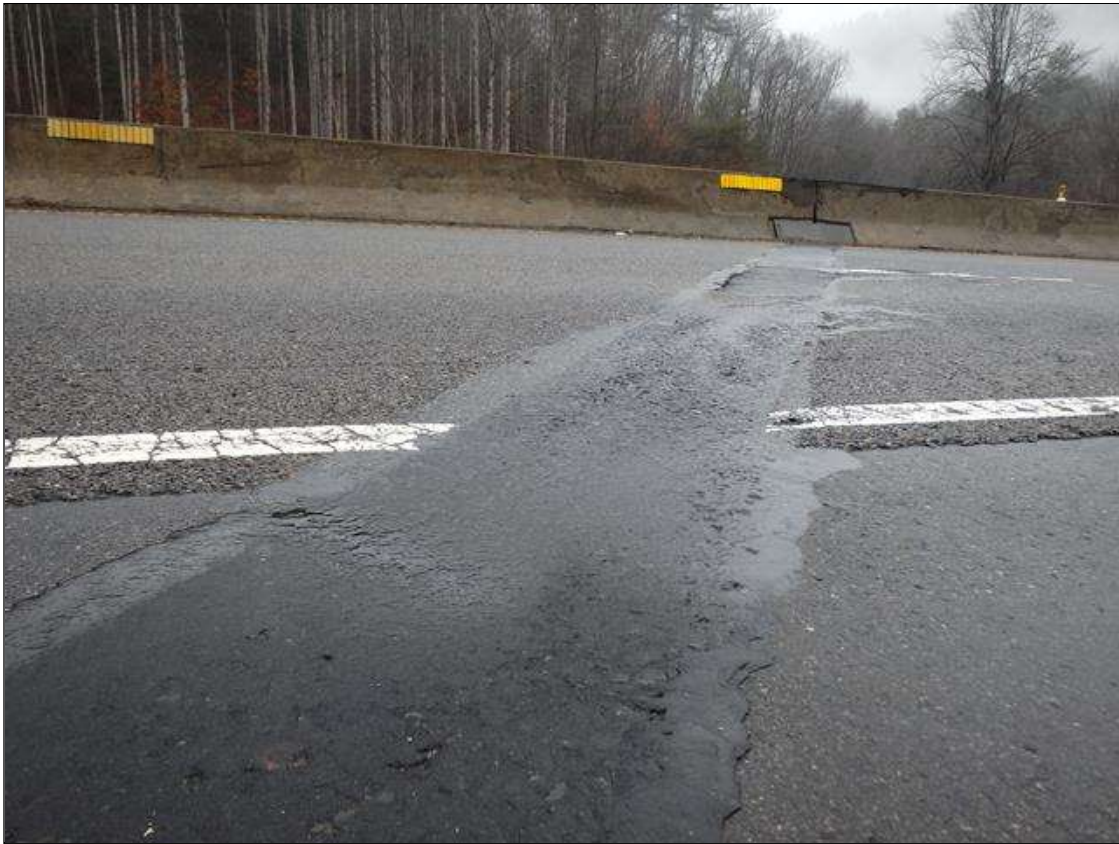
Span 2 Wearing Surface: WEARING SURFACE DEPRESSIONS, 5 FT X 2 FT UP TO 3/4" DEEP IN RIGHT WHEEL LINE IN WEST BOUND RIGHT LANE OVER BENT 1

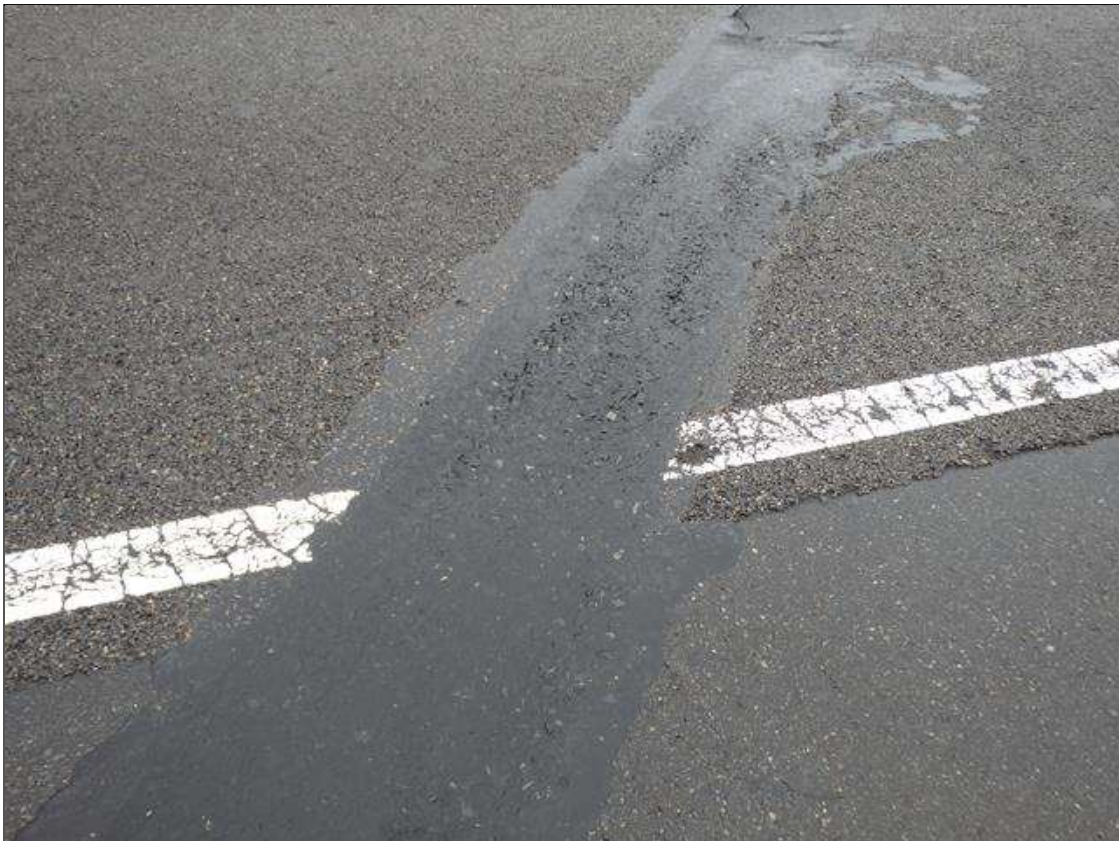
Span 2 Wearing Surface: WEARING SURFACE DEPRESSIONS, 5 FT X 2 FT UP TO 3/4" DEEP IN RIGHT WHEEL LINE IN WEST BOUND RIGHT LANE OVER BENT 1

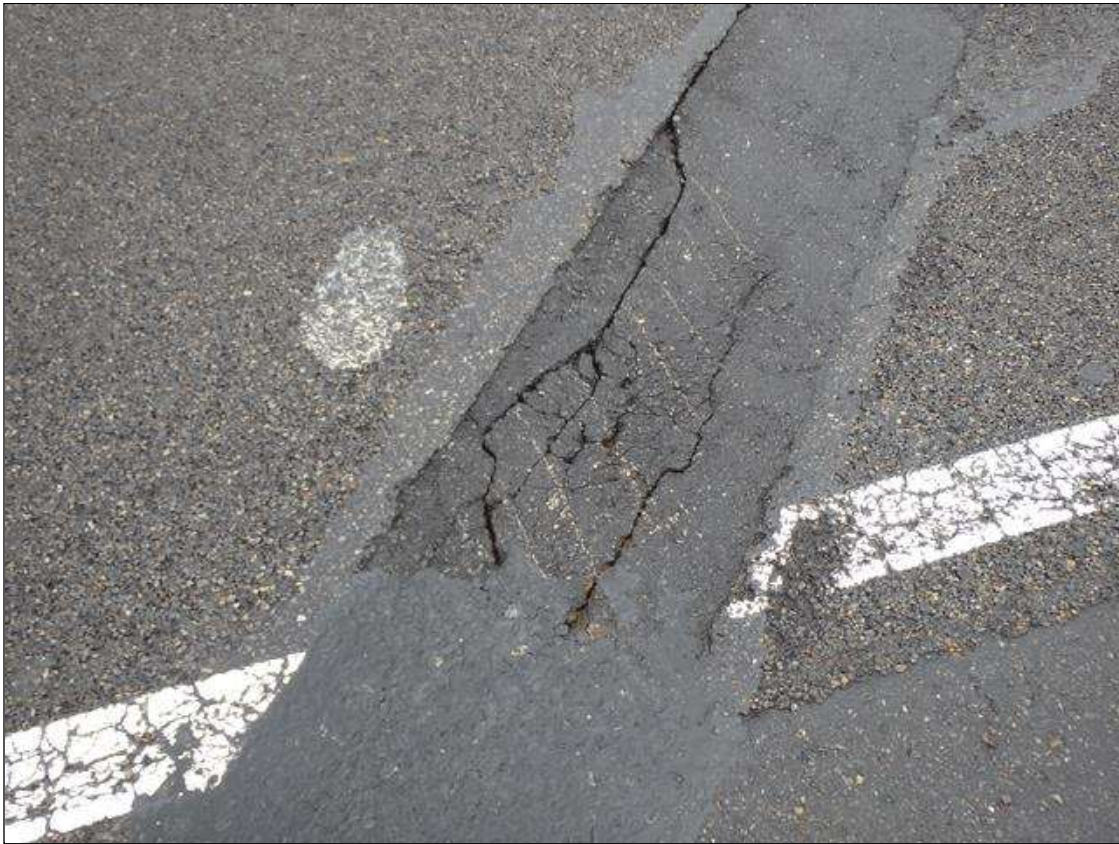
Span 2 Wearing Surface: DELAMINATION, 3 FT X 1 FT IN RIGHT LANE IN RIGHT WHEEL PATH OVER BENT 2  
WITH CRACKS UP TO 5/8" WIDE

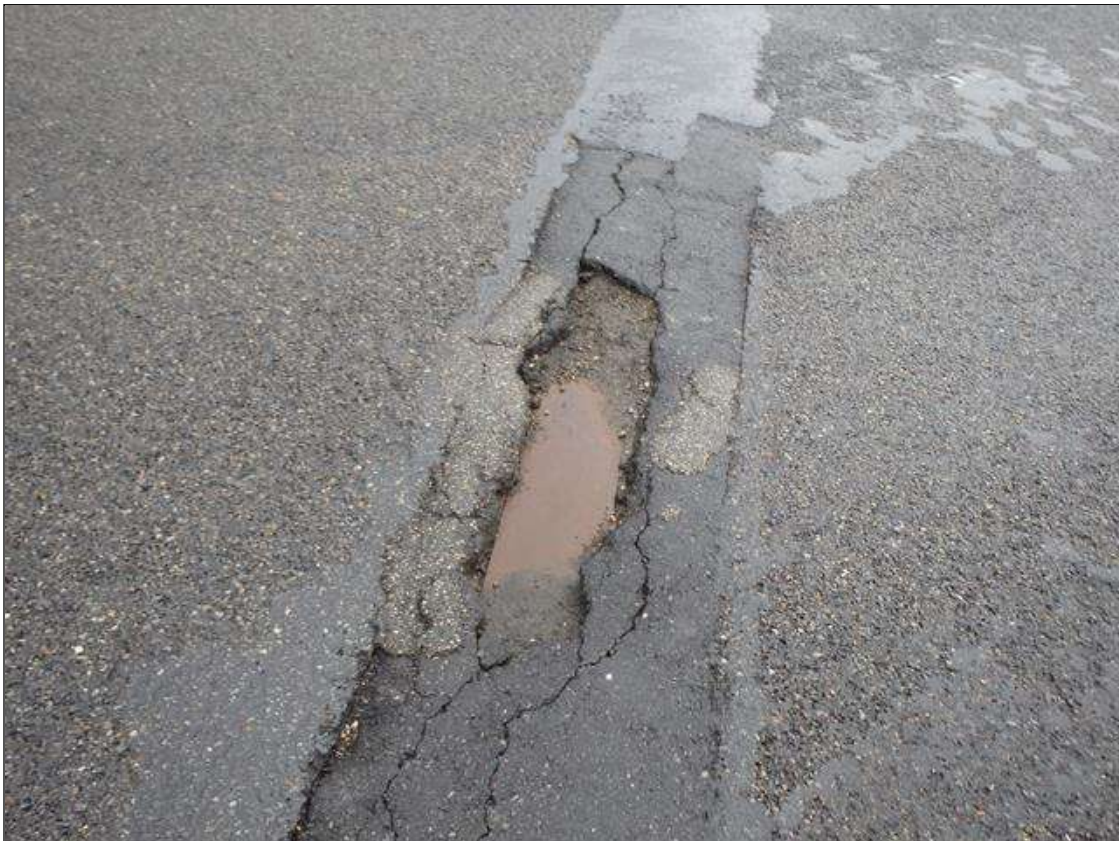
Span 2 Wearing Surface: DELAMINATED AREA, 5 FT X 1 FT WITH POT HOLE, 3 FT X 1 FT IN RIGHT WEST  
BOUND TRAVEL LANE IN LEFT WHEEL LINE

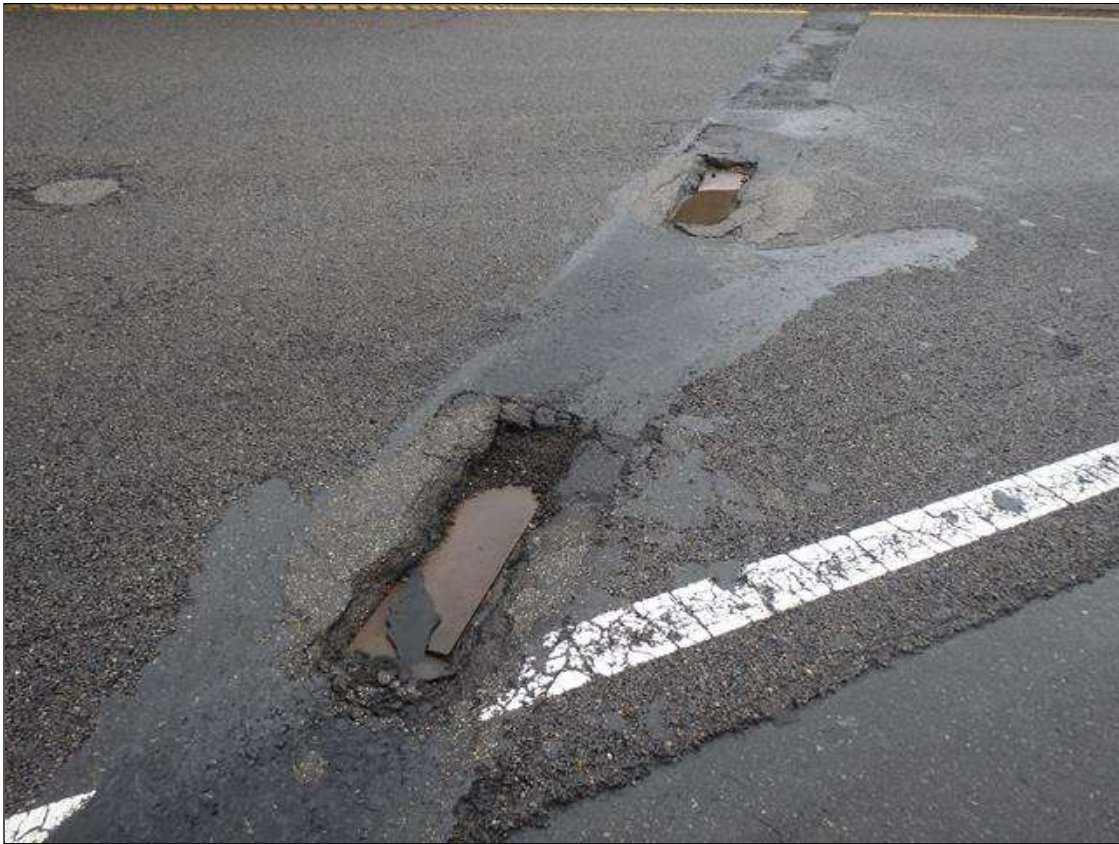
Span 3 Wearing Surface: TWO POT HOLES UP TO 3 FT X 1 FT X 3" DEEP IN LEFT AND RIGHT WHEEL PATHS IN RIGHT TRAVEL LANE WITH EXPOSED STEEL PLATES COVERING JOINTS

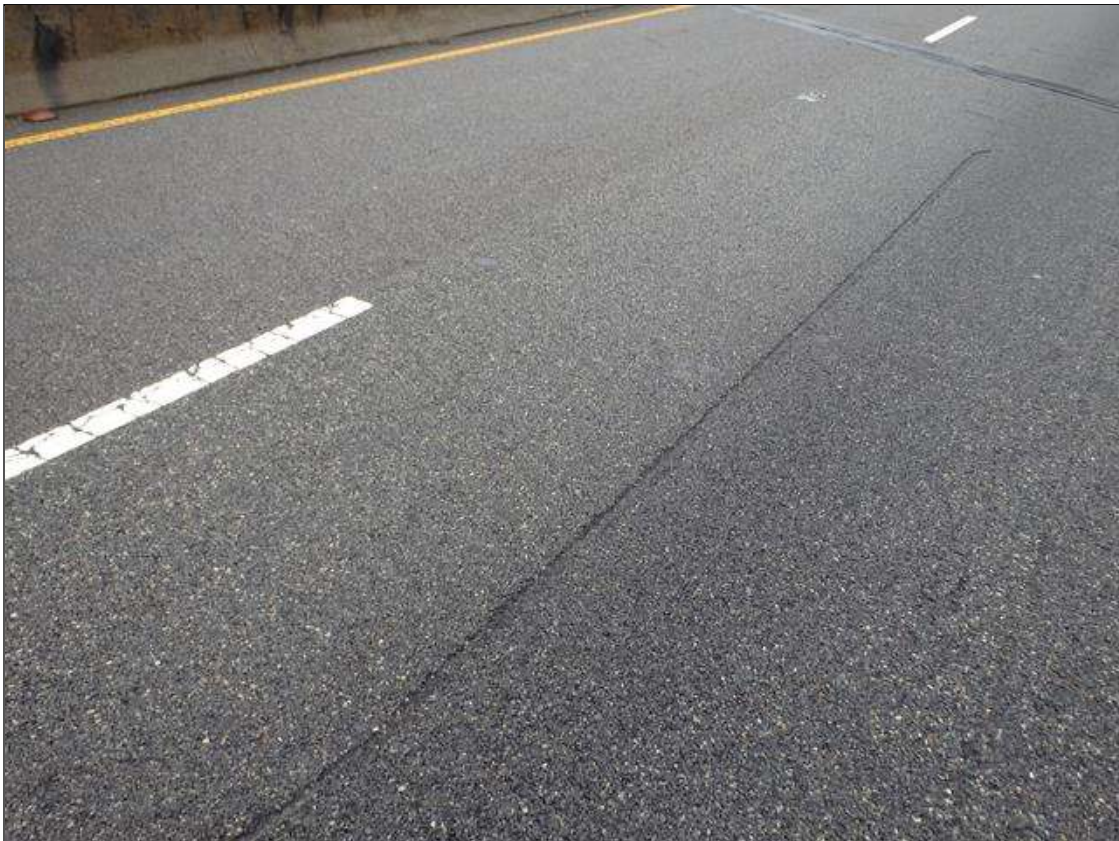
Span 2 Wearing Surface: GOUGE IN ASPHALT WEARING SURFACE IN RIGHT EAST BOUND TRAVEL LANES, 20 FT X 1" WIDE X 1/2" DEEP

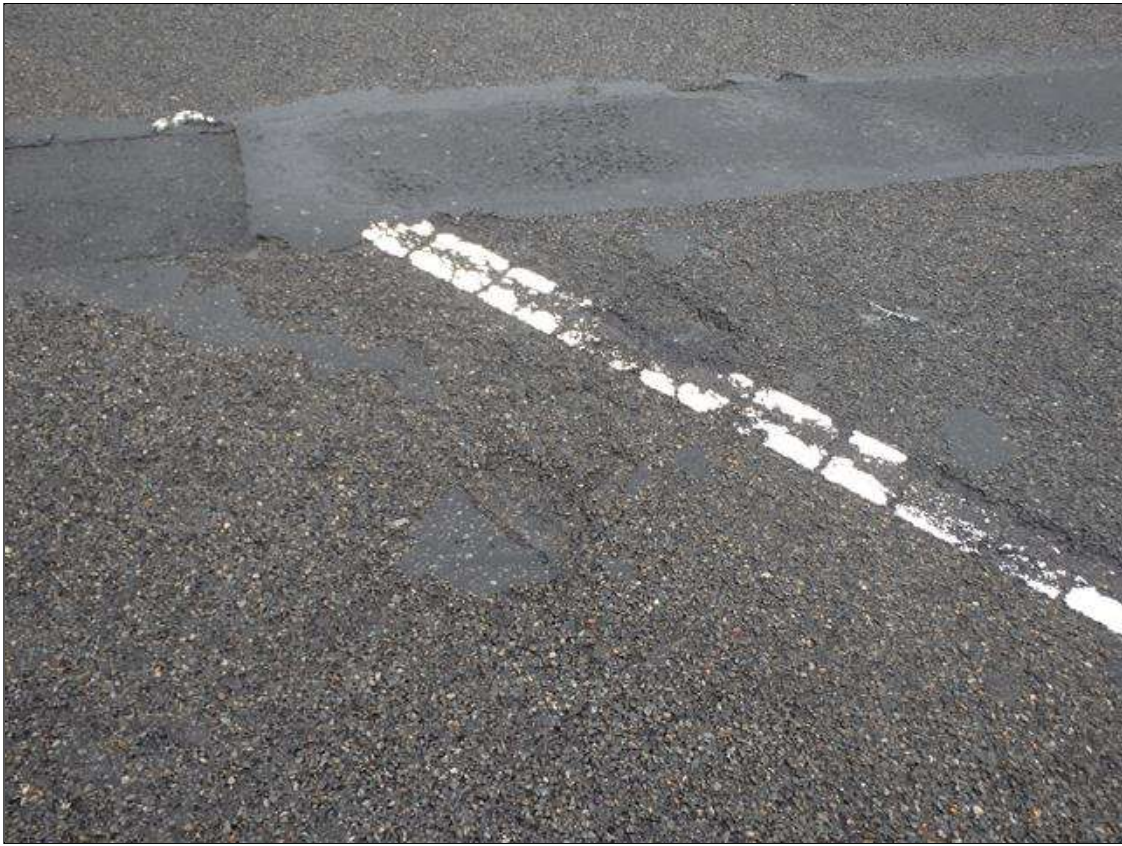
Span 1 Wearing Surface: TWO SPALLS, UP TO 6" X 4" X 1/2" DEEP IN CENTERLINE OF ROADWAY AT BENT 1

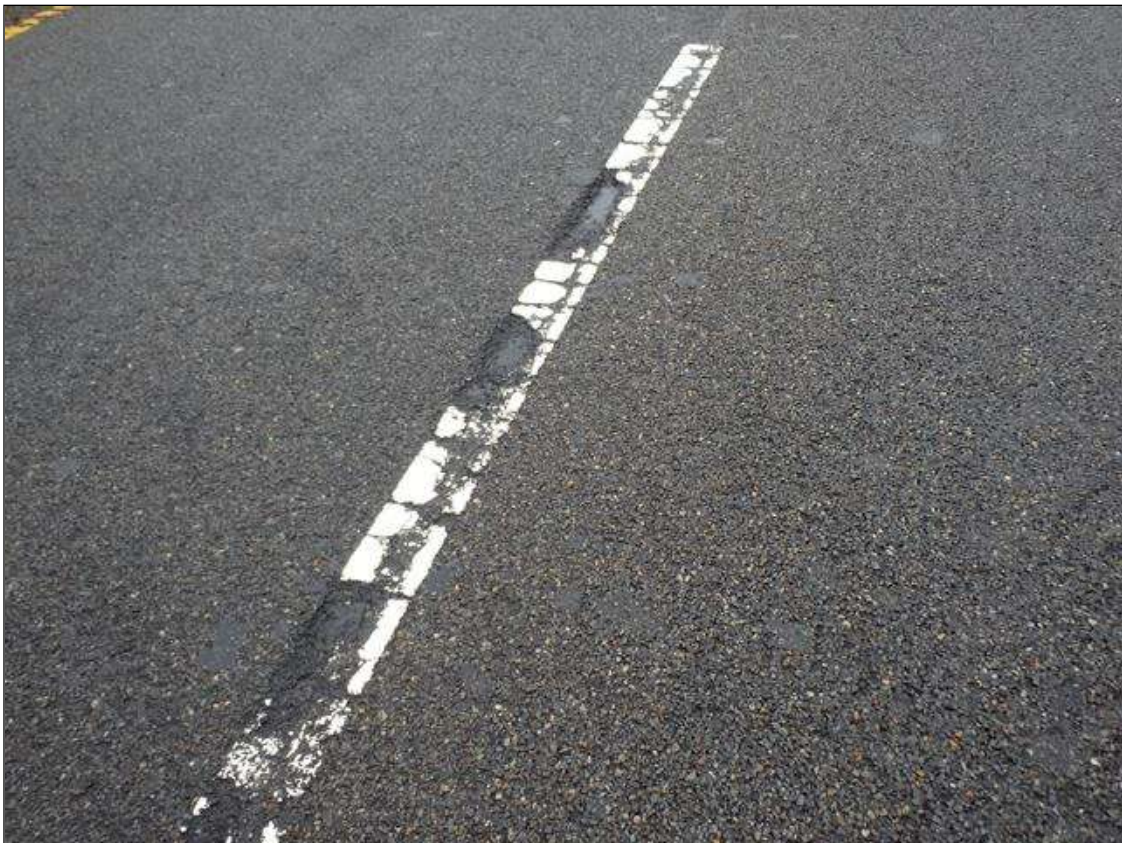
Span 2 Wearing Surface: THREE POT HOLES UP TO 1 FT X 3" X 1" DEEP AT CENTERLINE OF ROADWAY  
SCATTERED ALONG DECK

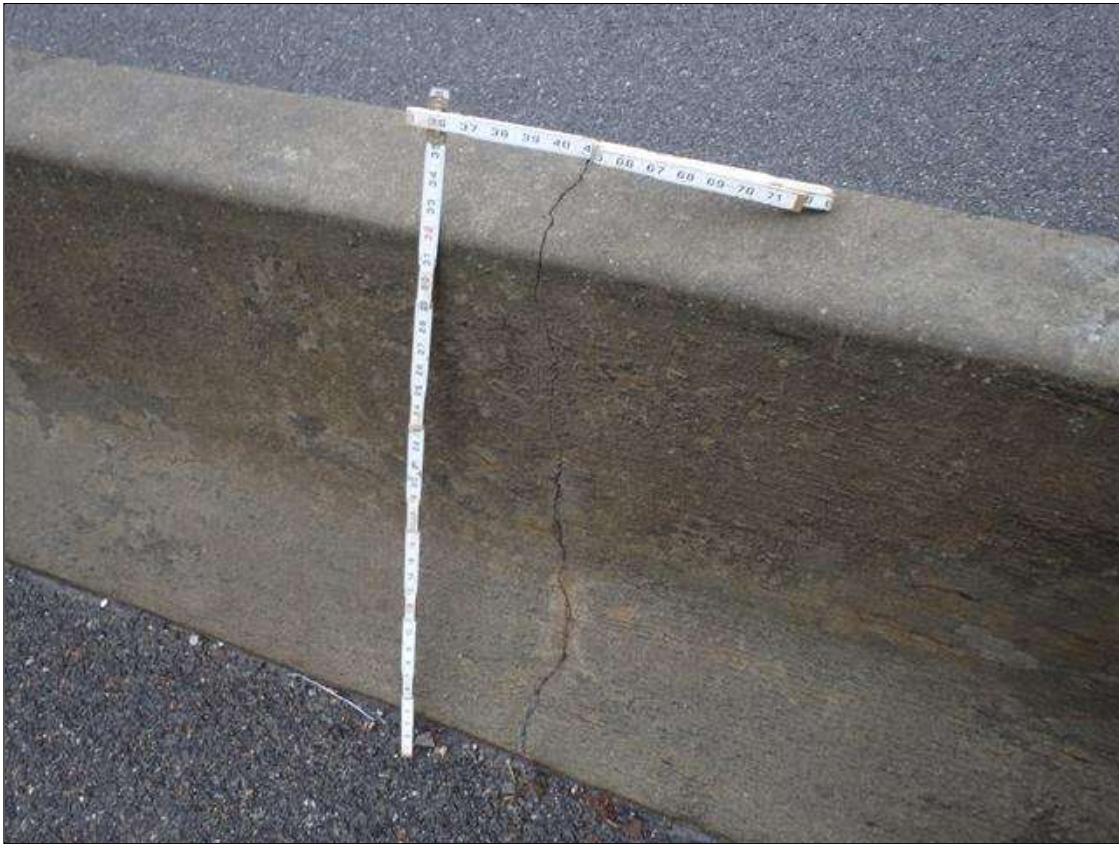
Span 3 Median Rail: 19 - FULL HEIGHT VERTICAL CRACKS UP TO 1/16" WIDE ON NORTH AND SOUTH FACE

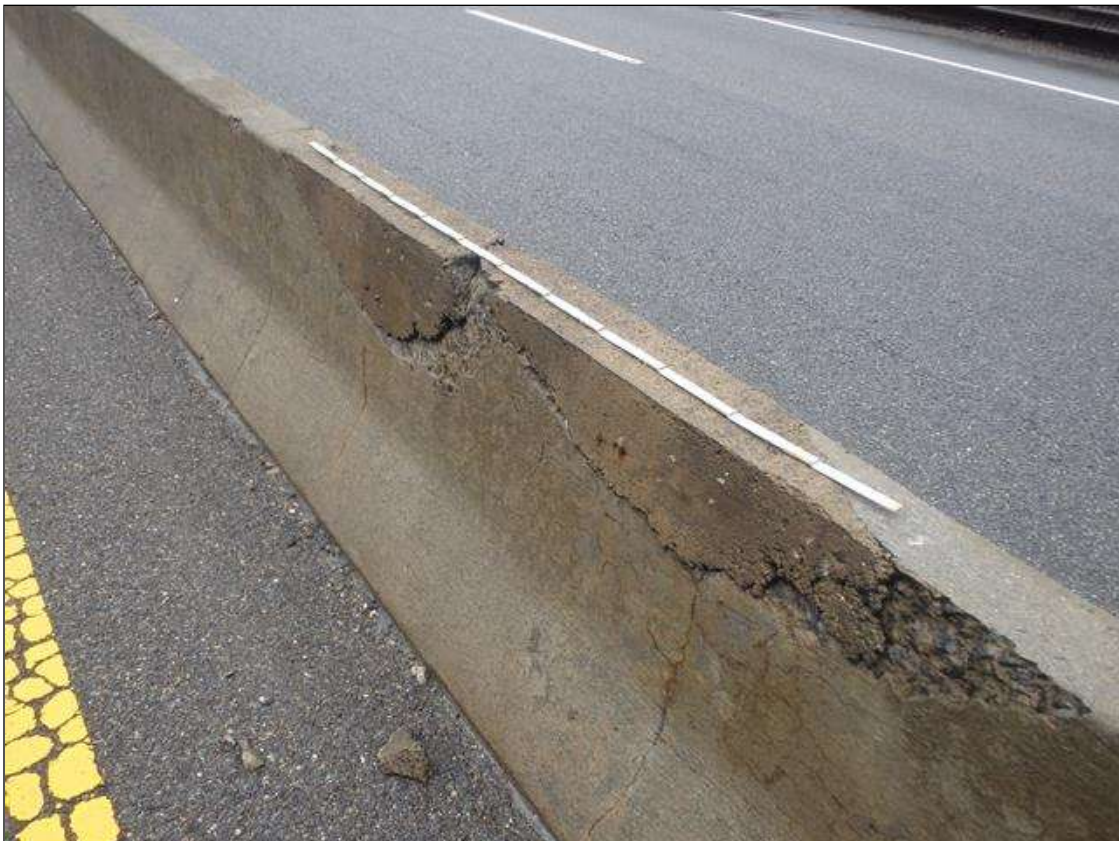
Span 3 Median Rail: UNSOUND PATCH/DELAMINATED, 6 FT X 1 FT WITH SPALLING UP TO 1" DEEP AROUND EDGES OF SPALL, 15 FT FROM END BENT 2

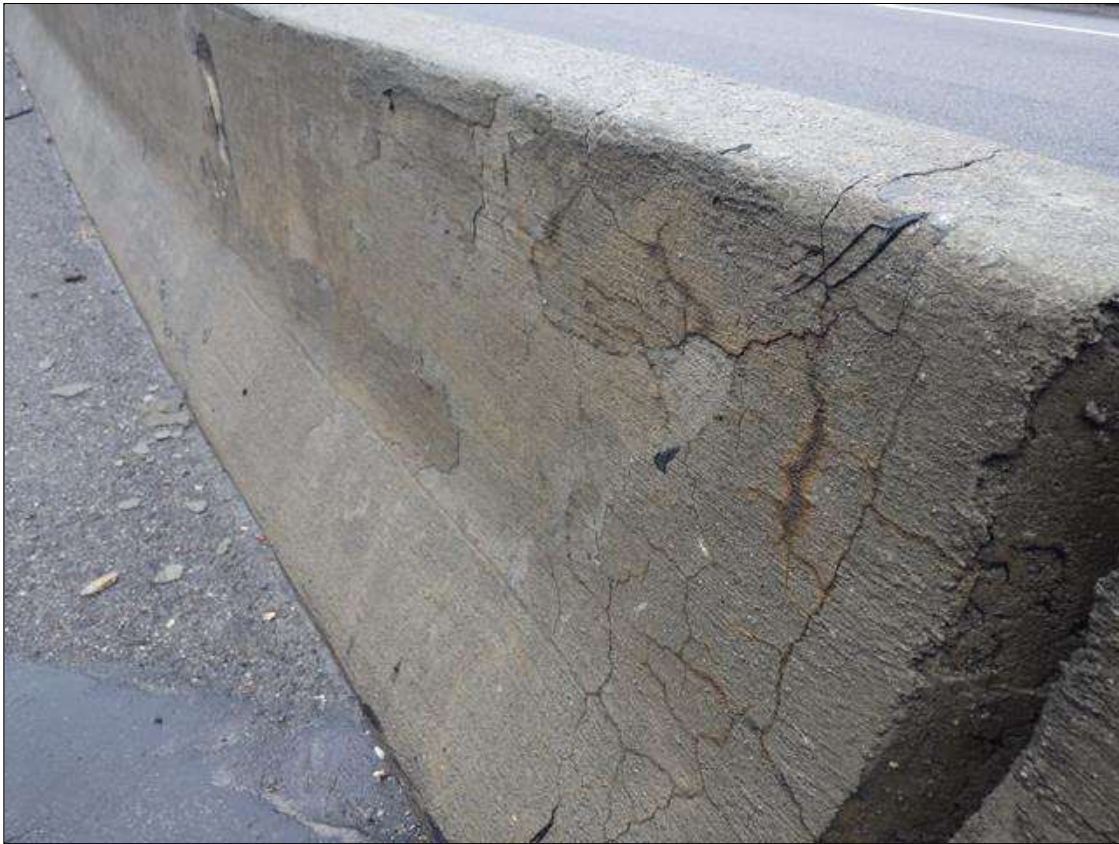
Span 3 Median Rail: 12 FT OF HAIRLINE MAP CRACKING ON SOUTH FACE BEGINNING AT END BENT 2

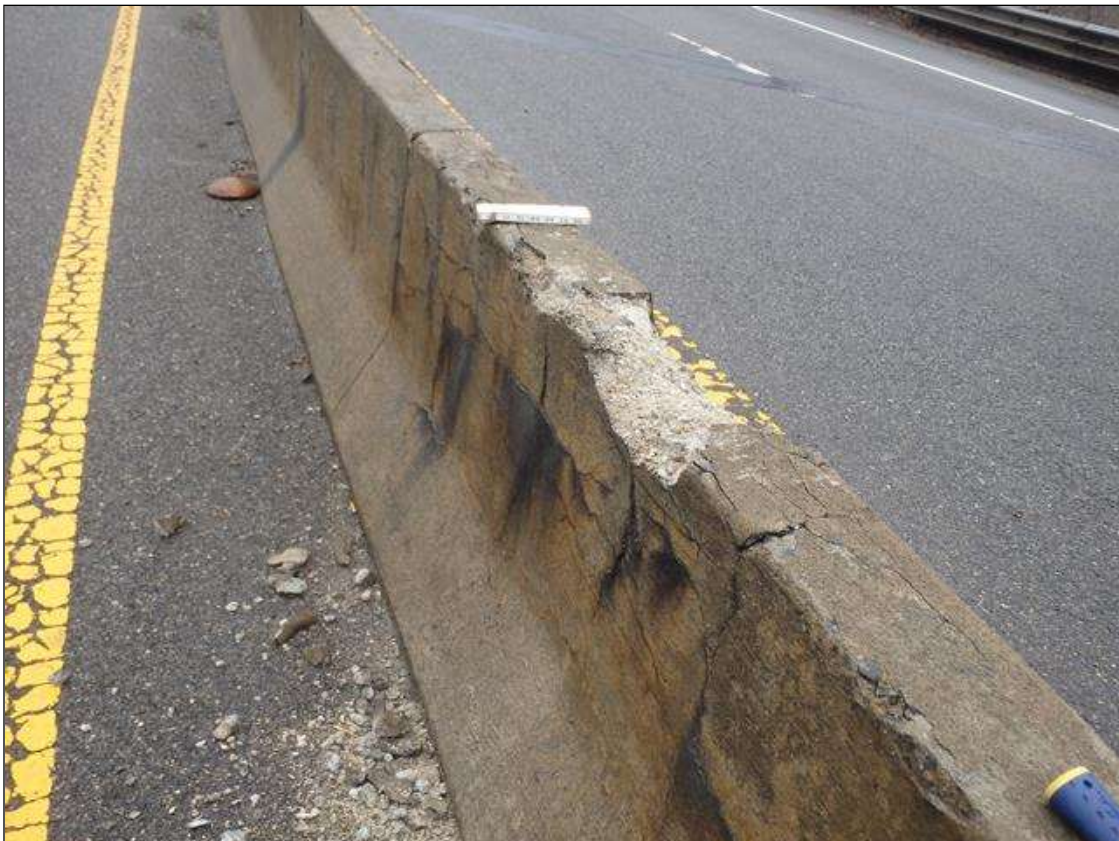
Span 2 Median Rail: DELAMINATION/SPALLED AREA ON TOP FACE, 2 FT X 1 FT HIGH X 6" WIDE AREA NEAR MIDSPAN WITH POSSIBLE ASR, CONCRETE IS POWDERY

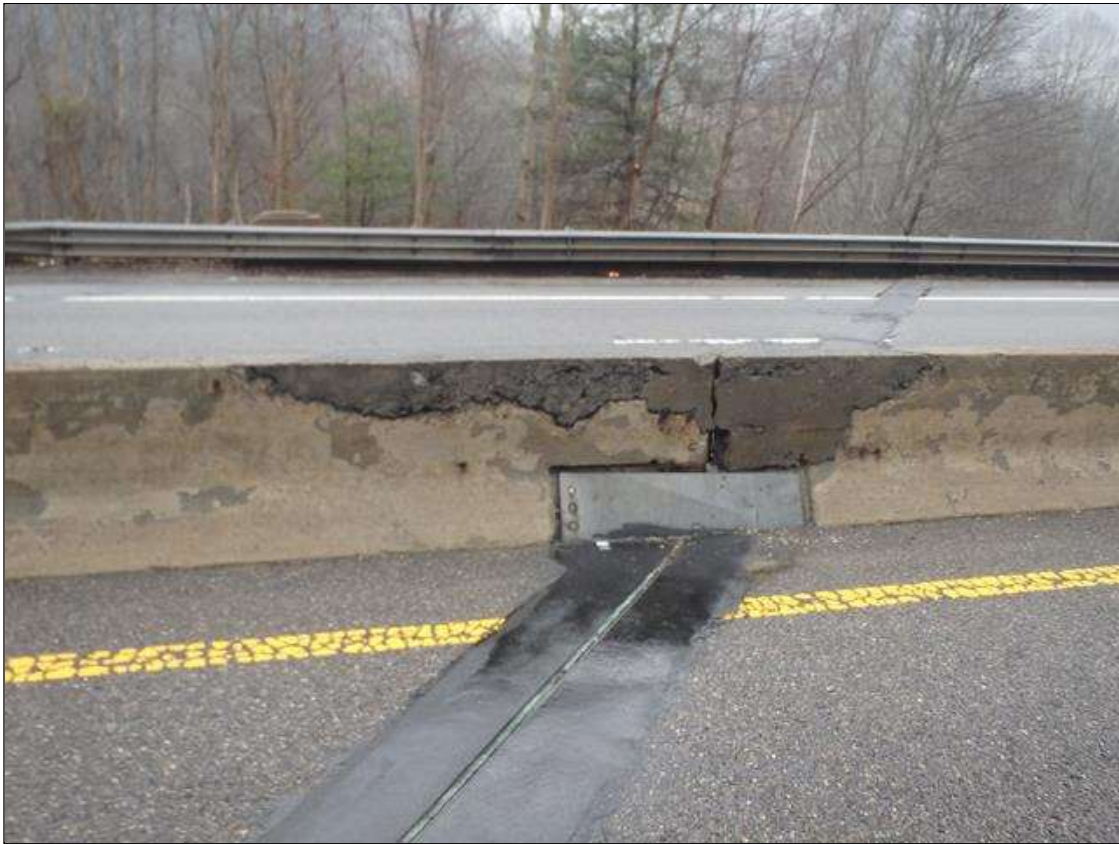
Span 2 Median Rail: UNSOUND PATCH, HONEYCOMBING 3 FT X 2 FT HIGH IN RAIL AT BENT 1

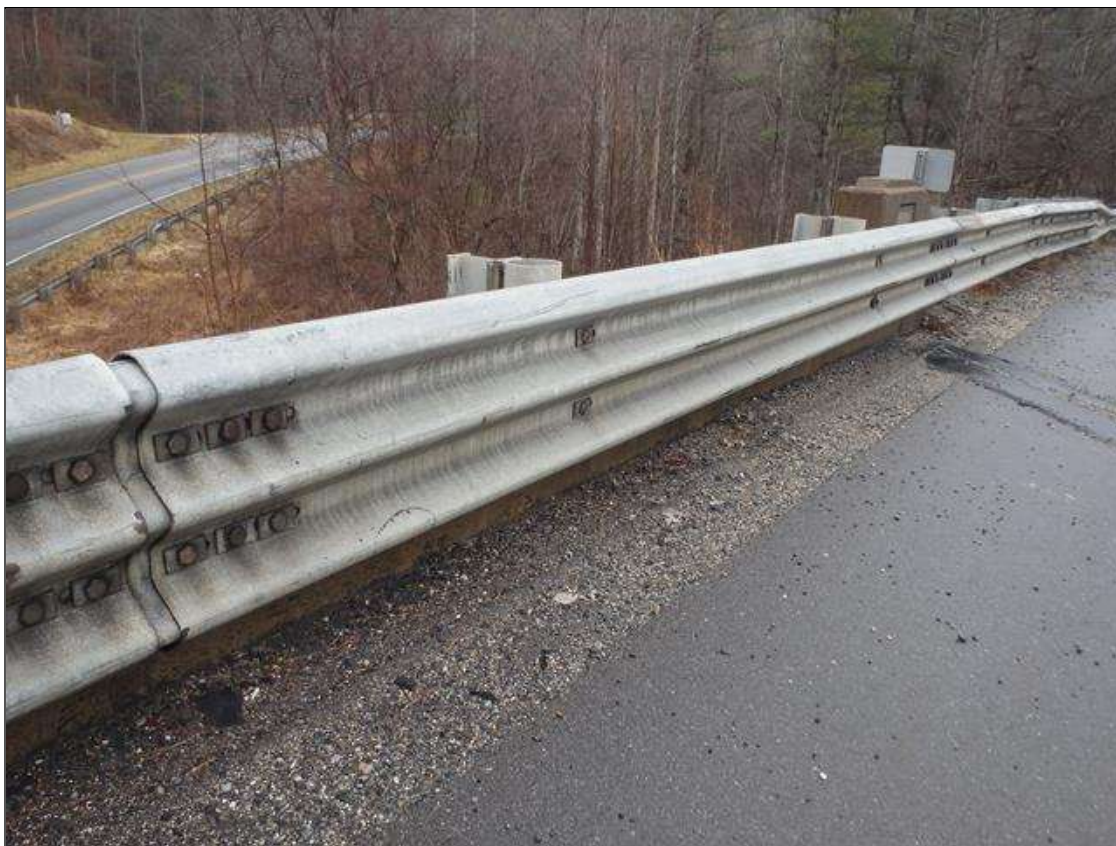
Span 1 Right Bridge Rail: 15 FT OF SCRAPING ON METAL RAIL AT END BENT 1, RAIL STILL FUNCTIONAL

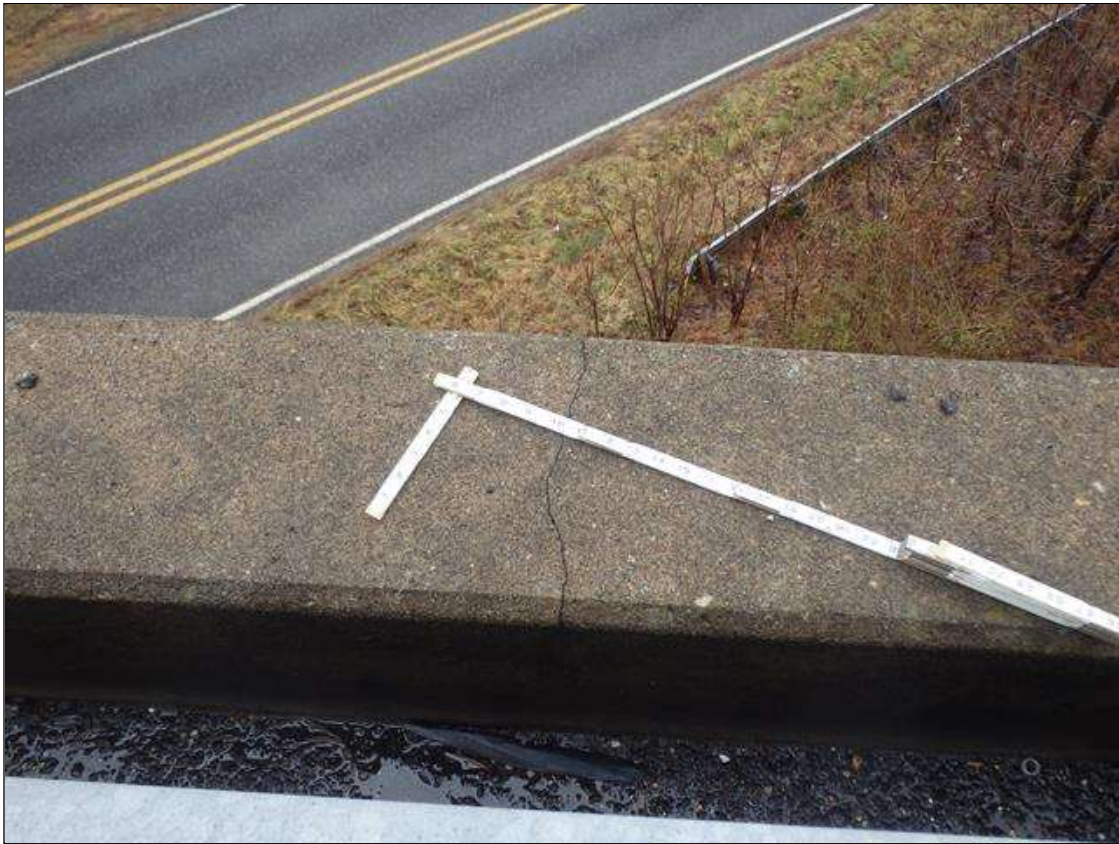
Span 3 Left Bridge Rail: 3 - FULL HEIGHT VERTICAL CRACKS UP TO 1/16" WIDE IN FACE OF RAIL SCATTERED THROUGHOUT
