NC DEPARTMENT OF TRANSPORTATION  
DIVISION OF HIGHWAYS  
STRUCTURE MANAGEMENT UNIT

## Structure Safety Report

### Routine Element Inspection - Contract

DIVISION: 14 COUNTY: HAYWOOD STRUCTURE NUMBER: 430159 FREQUENCY: 24 MONTHS

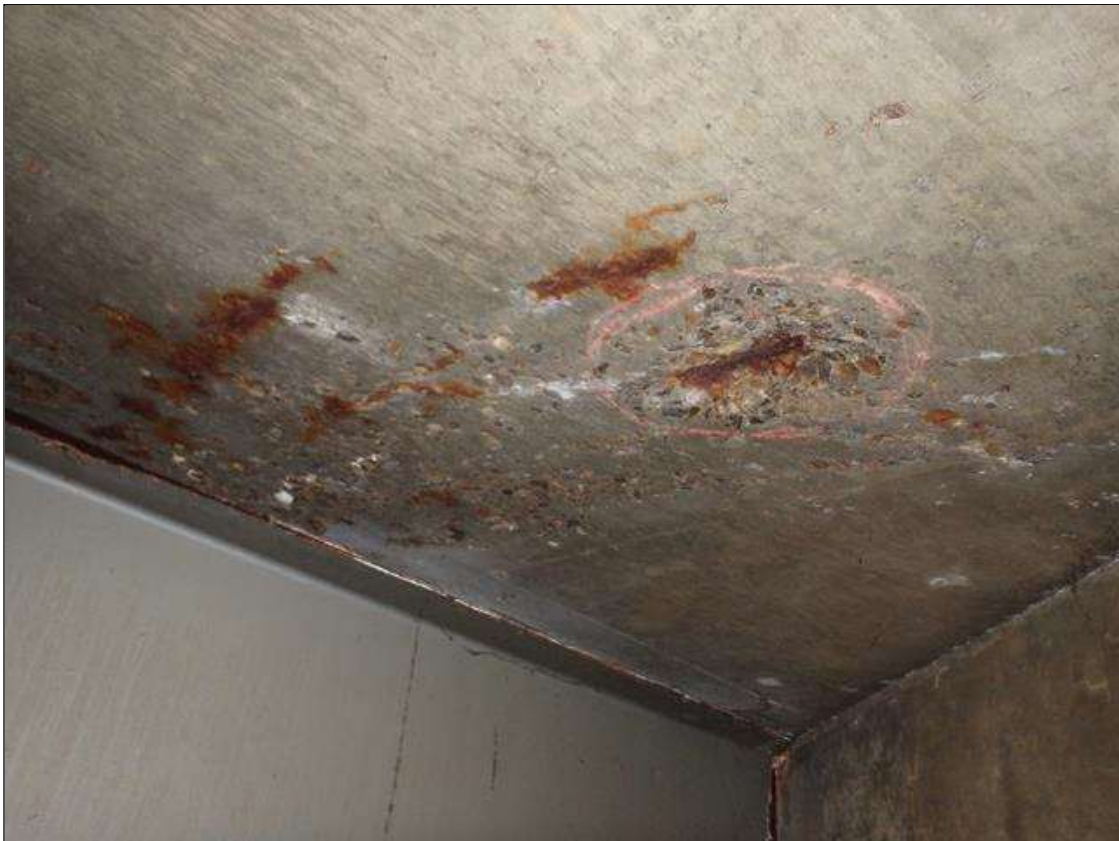
| Element Number | Defect Type | Defect Description | CS | CS Qty | Maint Qty | |
|---|---|---|---|---|---|---|
| 12 | Delamination/Spall | SPALL/DELAMINATED AREA, 5 FT X 3 FT ON UNDERSIDE OF DECK WITH SPALL 1 FT DIAMETER X 1.5" DEEP IN BAY 4 ADJACENT TO GIRDER 5 WITH EXPOSED REBAR, NO SECTION LOSS | 3 | 15 | 15 | Square Feet |

Span 1 Deck: SPALL/DELAMINATED AREA, 5 FT X 3 FT ON UNDERSIDE OF DECK WITH SPALL 1 FT DIAMETER X 1.5" DEEP IN BAY 4 ADJACENT TO GIRDER 5 WITH EXPOSED REBAR, NO SECTION LOSS

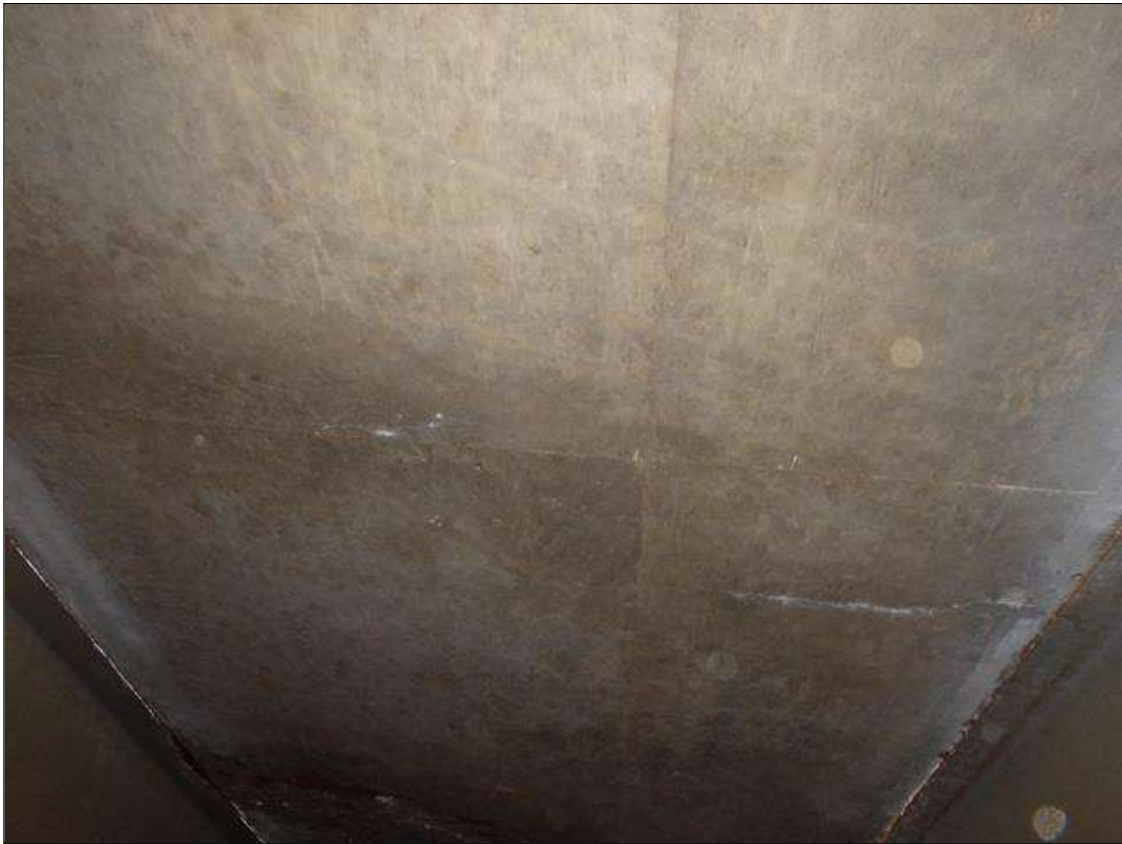
| Element Number | Defect Type | Defect Description | CS | CS Qty | Maint Qty | |
|---|---|---|---|---|---|---|
| 12 | Cracking (RC and Other) | TWO TRANSVERSE HAIRLINE CRACKS IN UNDERSIDE OF DECK IN BAY 4 UP TO 3 FT LONG WITH EFFLORESCENCE NEAR END BENT 1 | 2 | 6 | | Square Feet |

Span 1 Deck: TWO TRANSVERSE HAIRLINE CRACKS IN UNDERSIDE OF DECK IN BAY 4 UP TO 3 FT LONG  
WITH EFFLORESCENCE NEAR END BENT 1

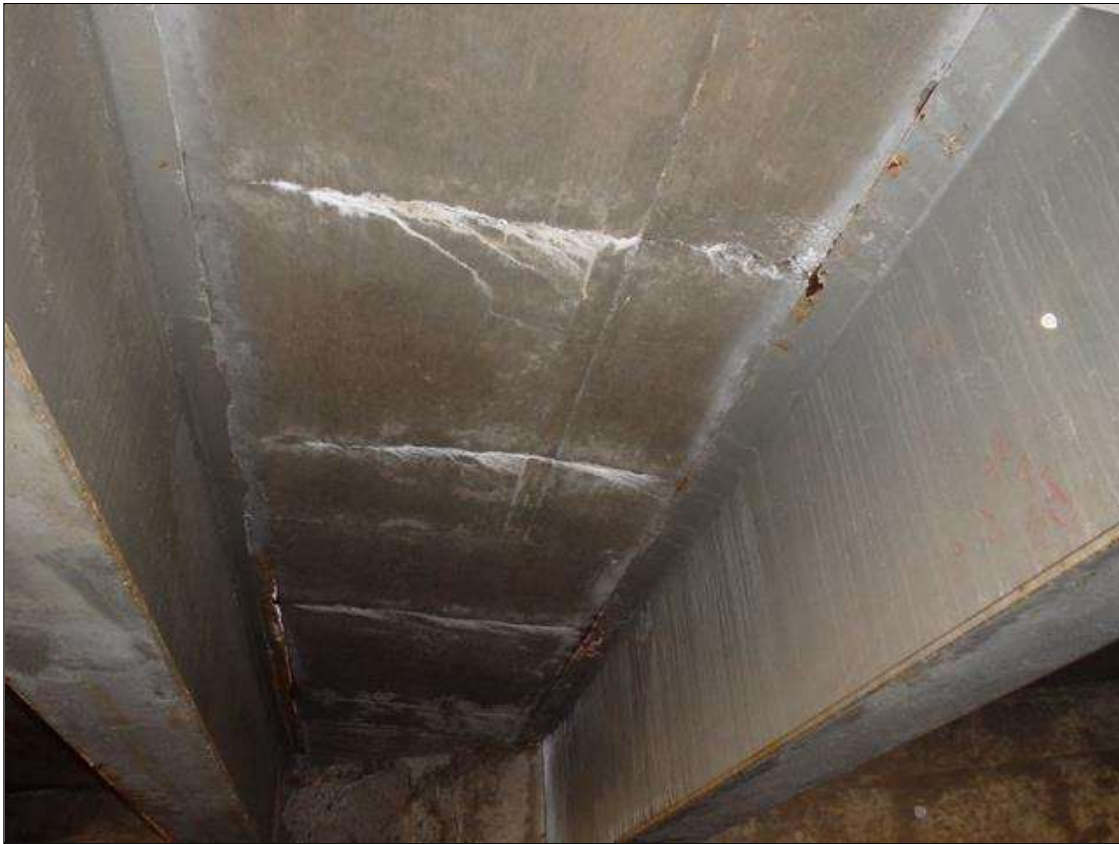
| Element Number | Defect Type | Defect Description | CS | CS Qty | Maint Qty | |
|---|---|---|---|---|---|---|
| 12 | Cracking (RC and Other) | 8 - FULL WIDTH HAIRLINE TRANSVERSE CRACKS IN UNDERSIDE OF DECK IN BAY 5 SCATTERED THROUGHOUT SPAN WITH EFFLORESCENCE, 3 SIMILAR IN BAY 6 AND 2 SIMILAR IN BAYS 8 AND 9 | 2 | 120 | | Square Feet |

Span 1 Deck: 8 - FULL WIDTH HAIRLINE TRANSVERSE CRACKS IN UNDERSIDE OF DECK IN BAY 5  
SCATTERED THROUGHOUT SPAN WITH EFFLORESCENCE, 3 SIMILAR IN BAY 6 AND 2 SIMILAR IN BAYS 8  
AND 9

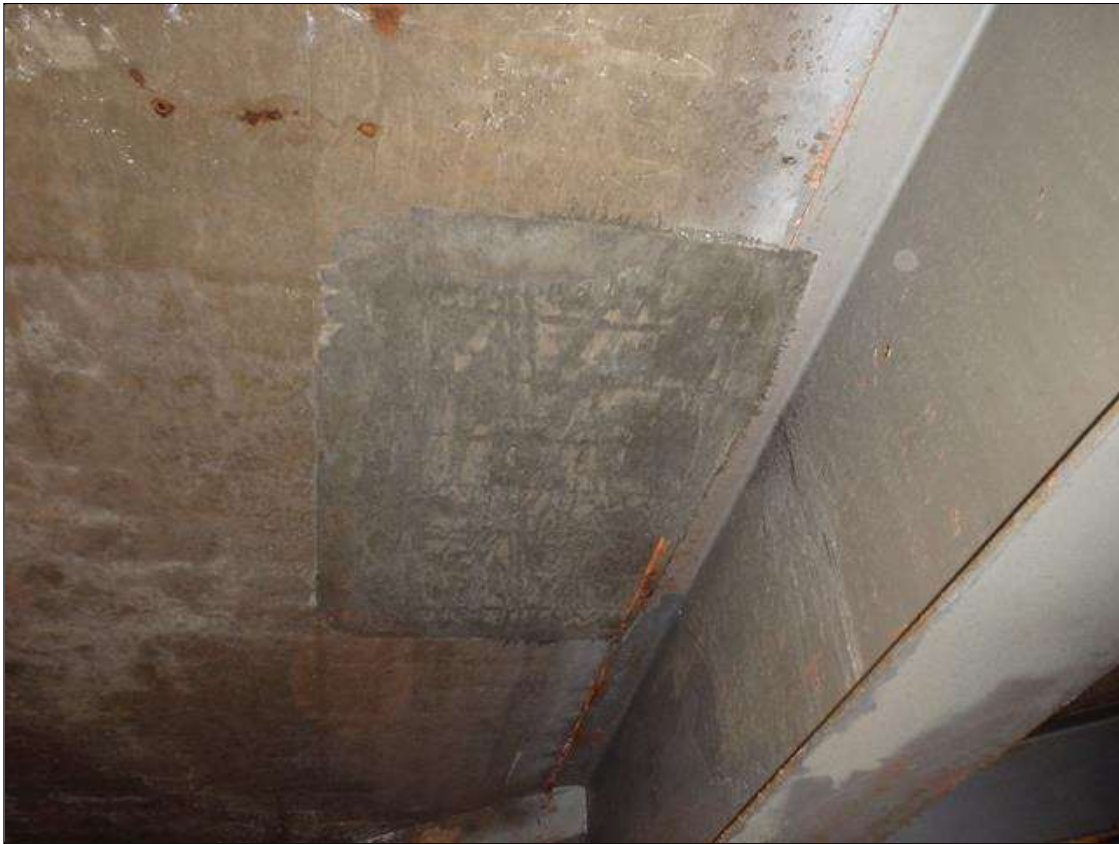
Span 1 Deck: SOUND PATCH, 3 FT X 5 FT ON UNDERSIDE OF DECK IN BAY 6, 4 FT FROM BENT 1

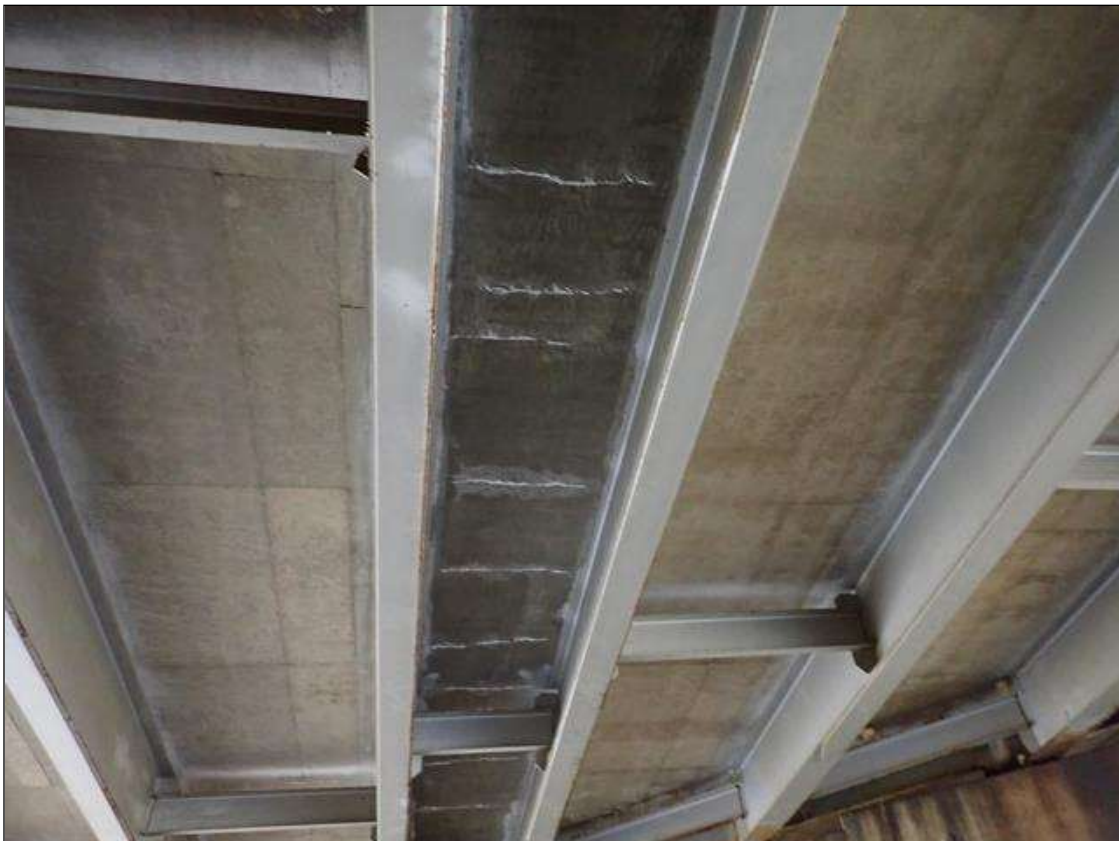
Span 2 Deck: FULL WIDTH HAIRLINE TRANSVERSE CRACKS IN UNDERSIDE OF DECK WITH EFFLORESCENCE SCATTERED THROUGHOUT ALL BAYS, BAY 5 SHOWN HERE

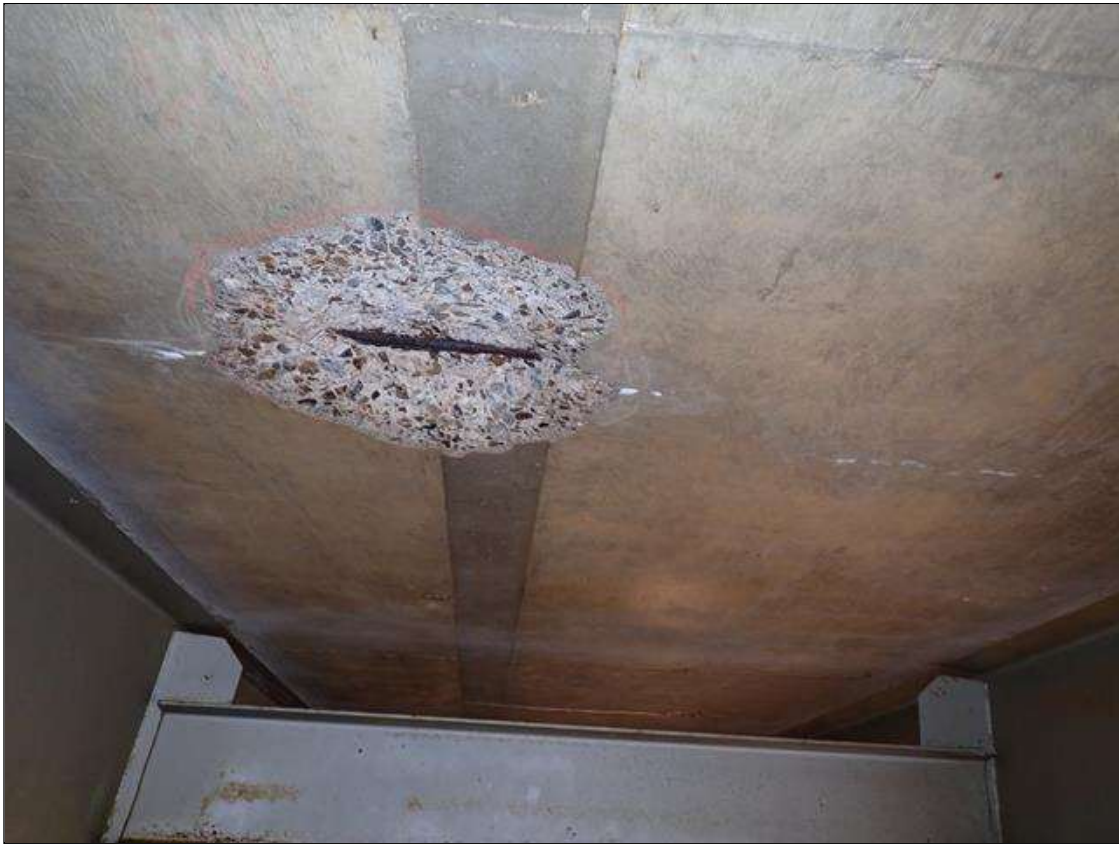
Span 3 Deck: SPAN 3 BOTTOM OF BAY 9 DECK HAS A SPALL, 22 INCHES IN DIAMETER X 1.5 INCHES DEEP WITH EXPOSED REBAR AT 2/3 POINT

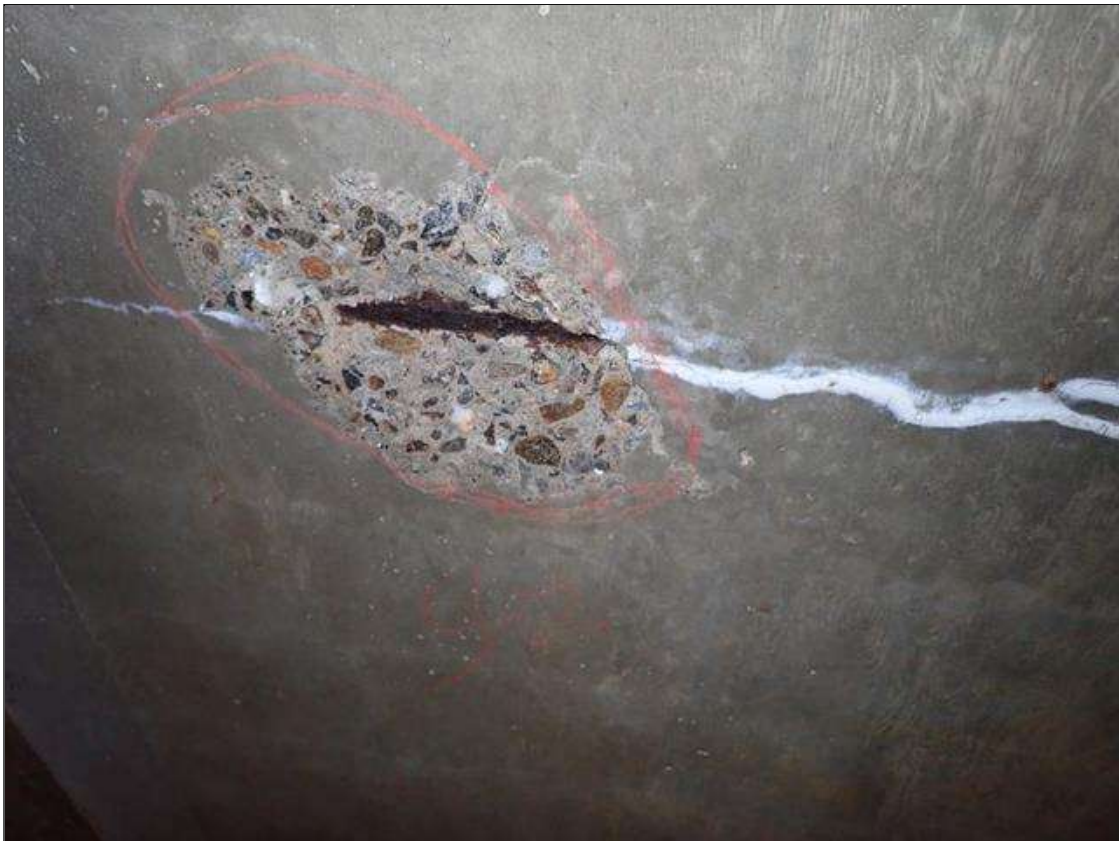
Span 3 Deck: SPAN 3 BOTTOM OF BAY 9 DECK HAS A SPALL, 8 INCHES X 11 INCHES X 1 INCH DEEP WITH EXPOSED REBAR , 16 FT. FROM END BENT 2, NO SECTION LOSS

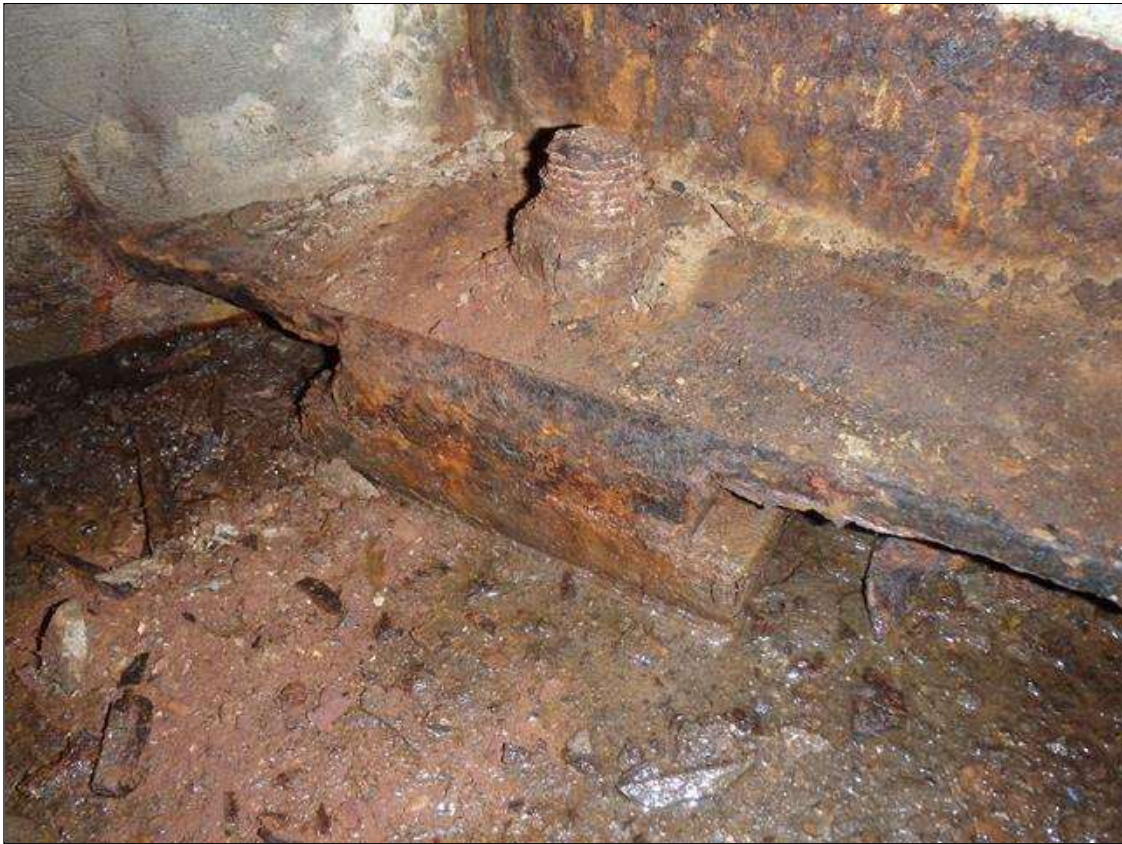
Span 1 Beam 1 Near Bearing: PACK RUST PRESENT ON BEARING PLATES

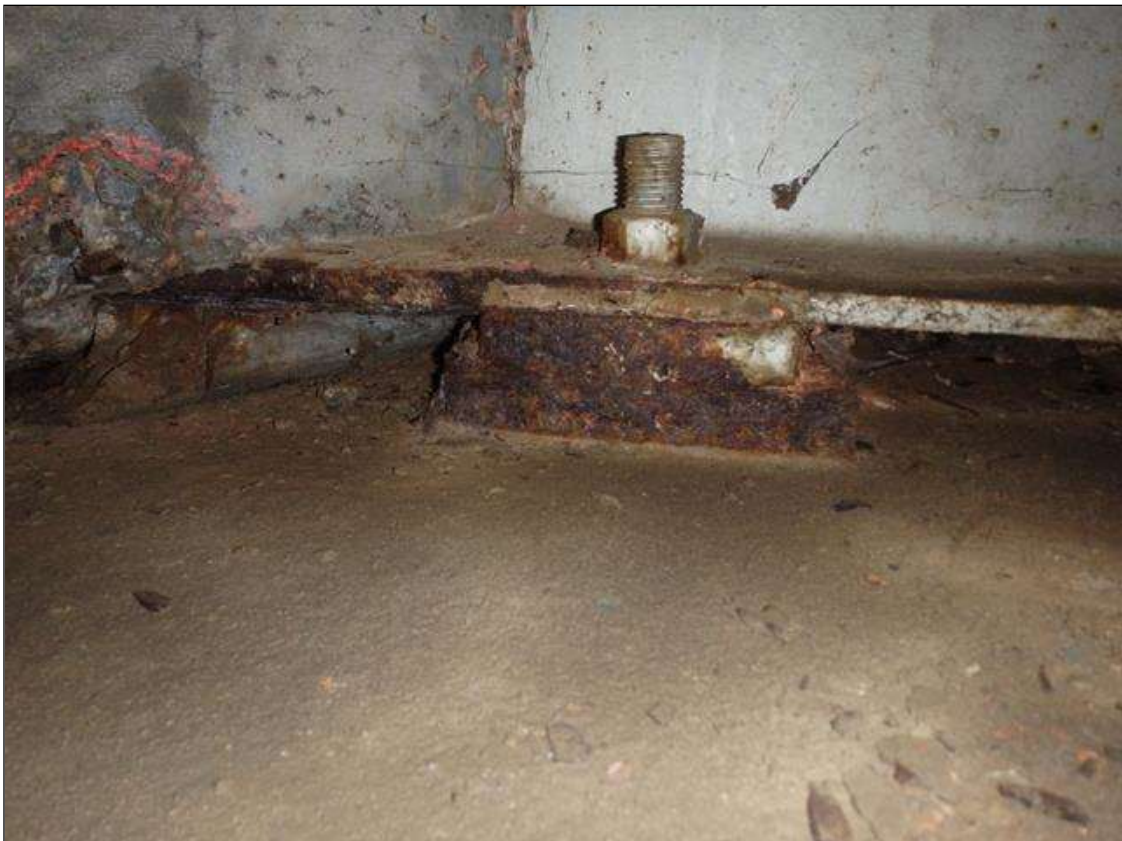
Span 1 Beam 2 Near Bearing: PACK RUST PRESENT ON BEARING PLATES

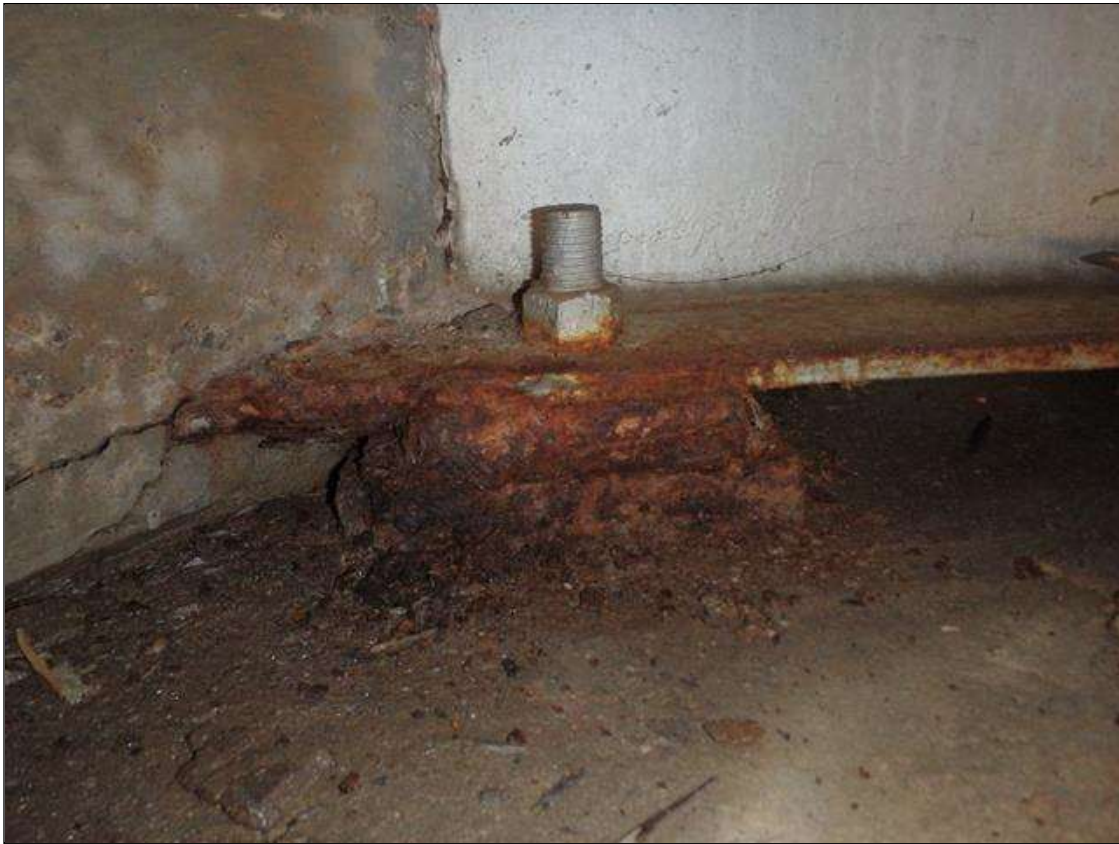
Span 1 Beam 5 Near Bearing: PACK RUST PRESENT ON BEARING PLATES

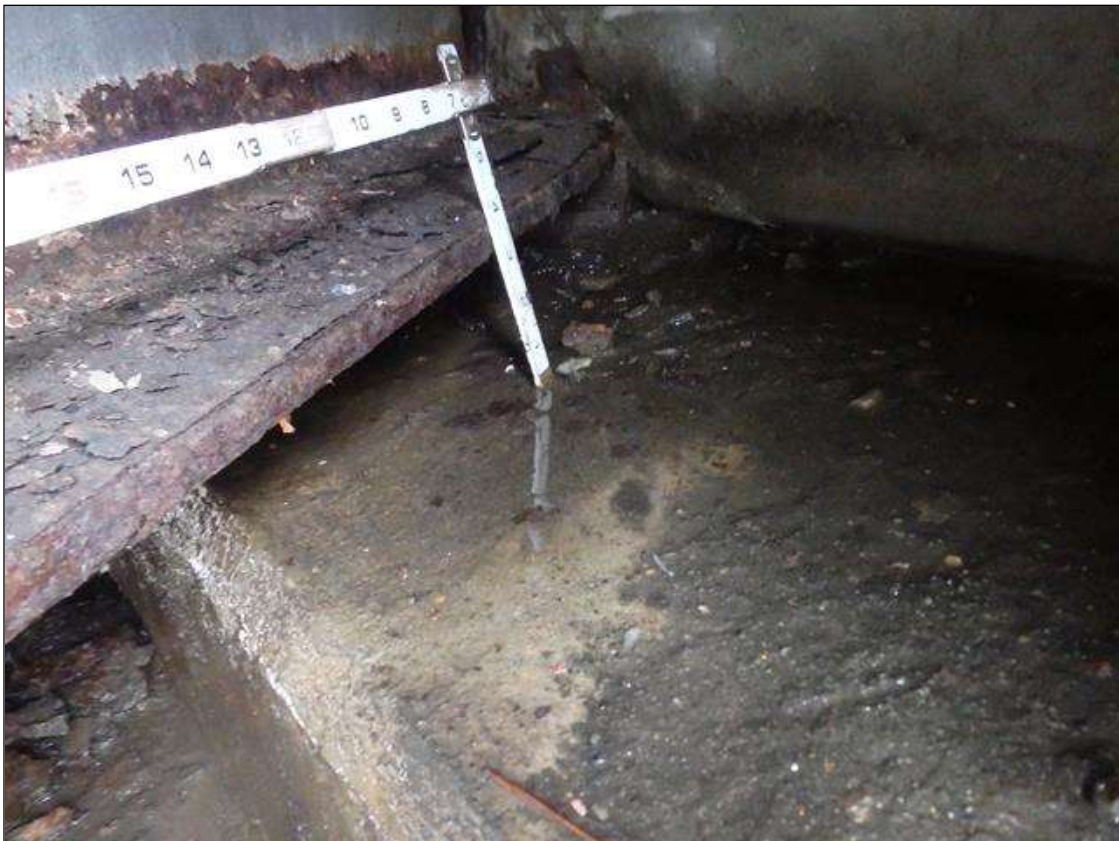
End Bent 1 Cap 1: 1/16" STANDING WATER ON TOP OF CAP OUTSIDE GIRDER 1

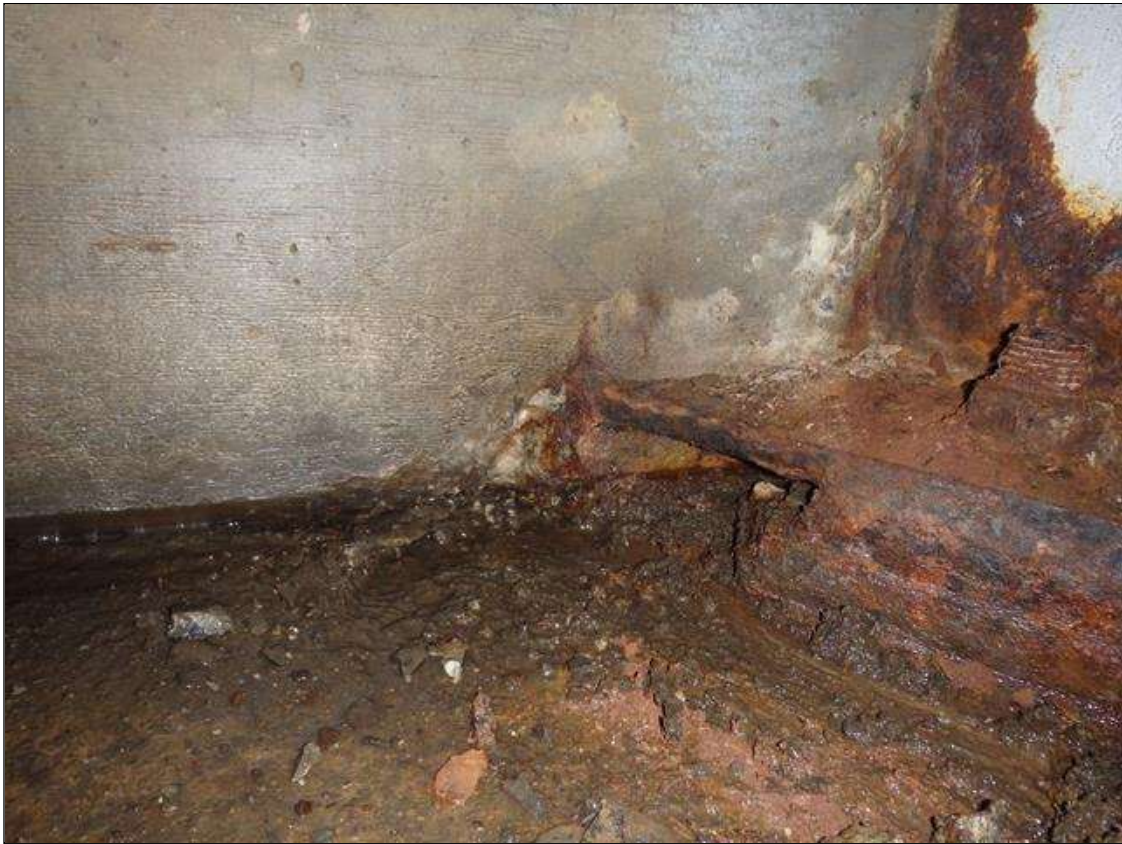
End Bent 1 Abutment/Backwall : SPALL, 6" X 4" X 1.5" DEEP ON BACKWALL ADJACENT TO GIRDER 1 BOTTOM FLANGE, NO EXPOSED REBAR

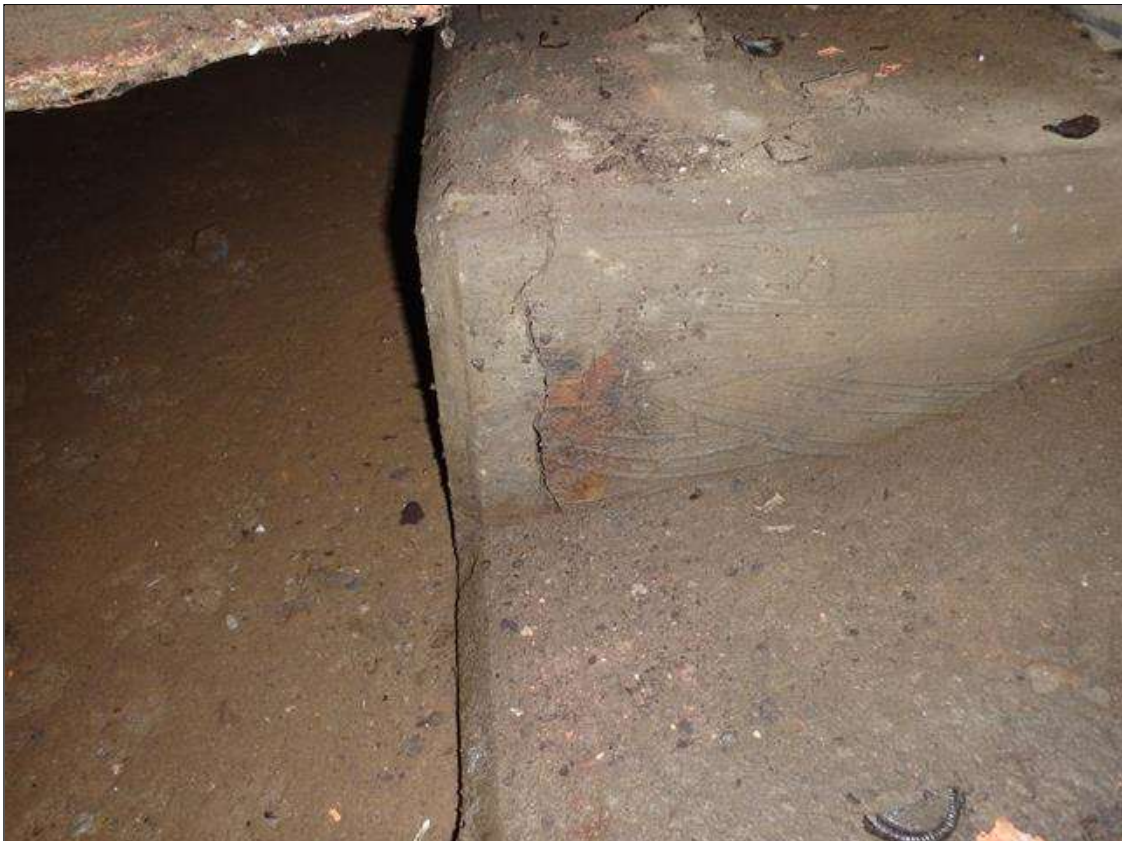
End Bent 1 Cap 1: FULL HEIGHT VERTICAL CRACK ON NORTH FACE OF CAP UNDER GIRDER 2 UP TO 1/8" WIDE FOR 1 FT IN TOP OF CAP

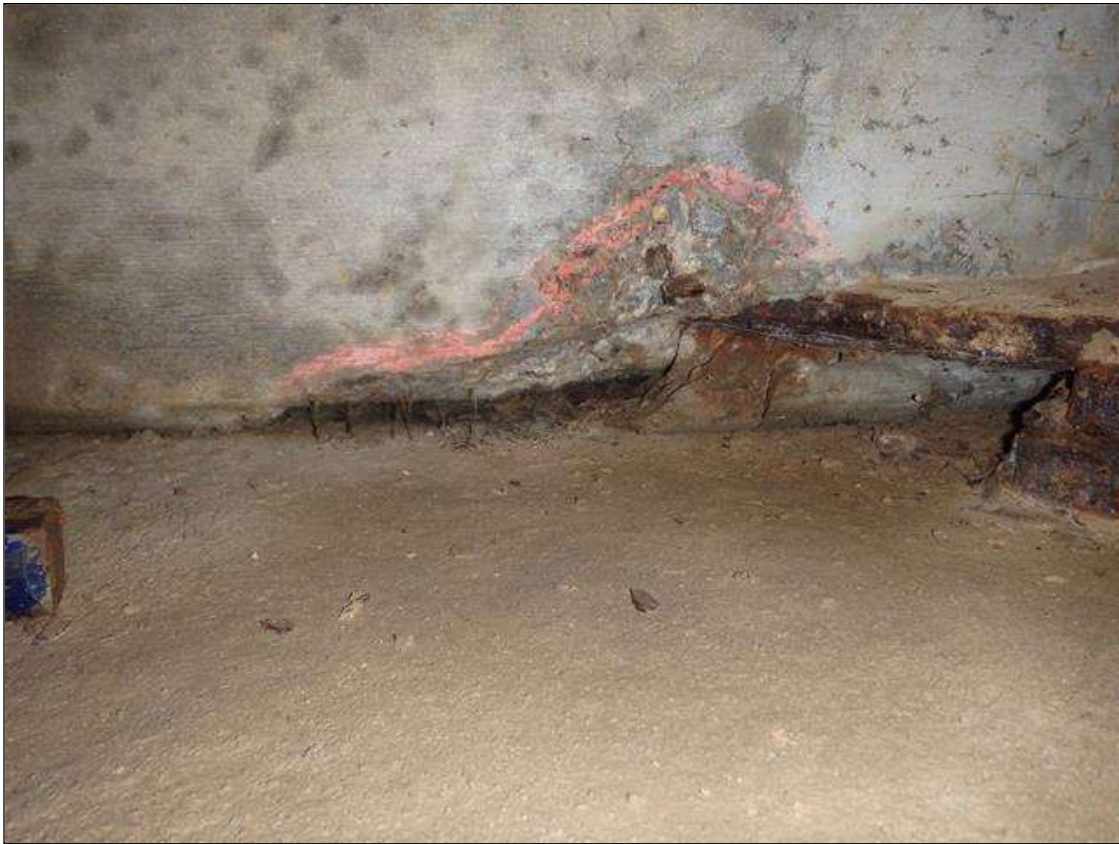
End Bent 1 Cap 1: SPALL, 1 FT X 5" X 1" DEEP ON BACKWALL OF BAY 2 ADJACENT TO GIRDER 2 WITH NO EXPOSED REBAR

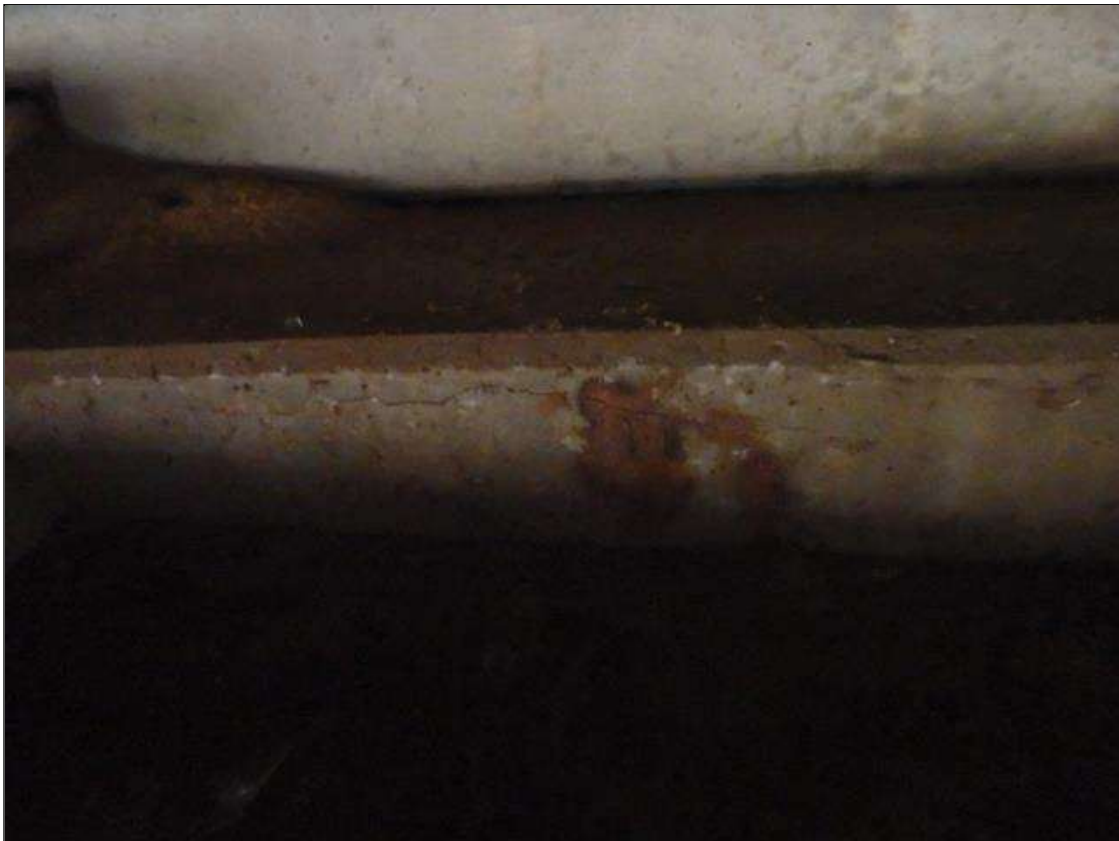
End Bent 1 Cap 1: DELAMINATION, 3 FT X 2" ON FACE OF CAP UNDER BAY 2

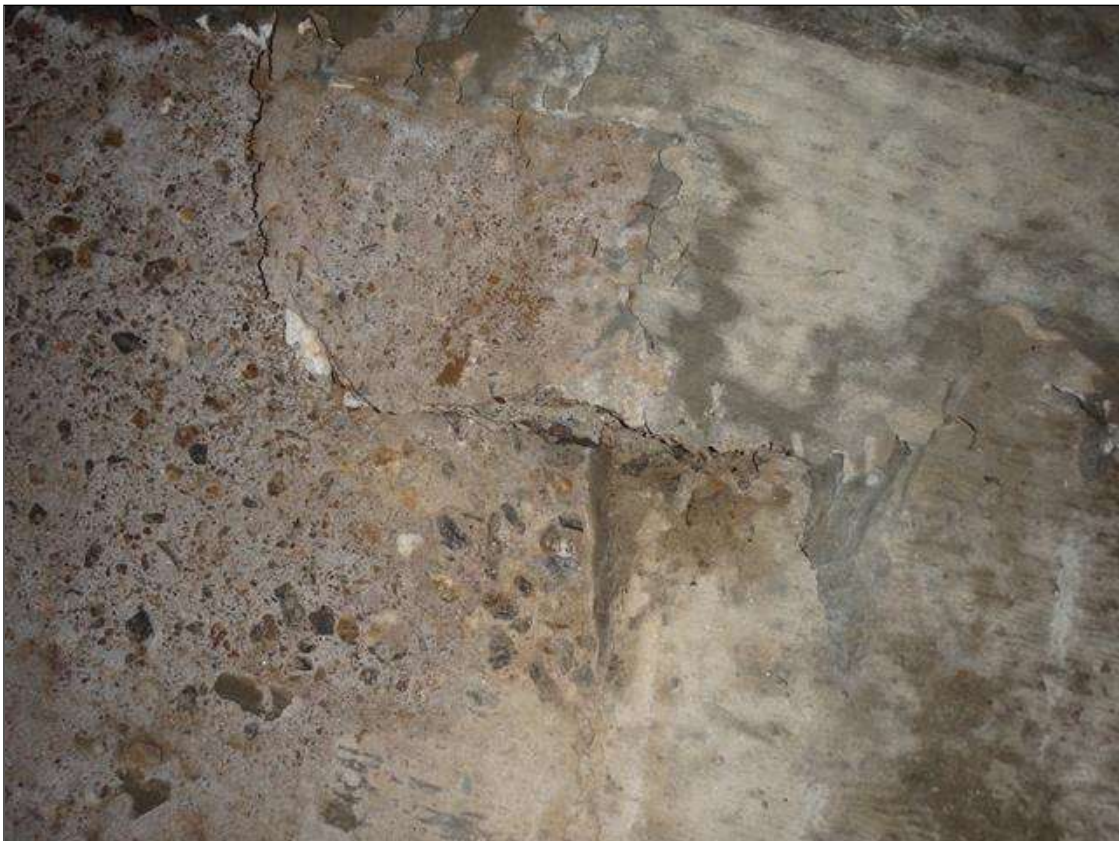
End Bent 1 Abutment/Backwall : SPALL, 1 FT X 6" X 2" DEEP ON BACKWALL AT TOP IN BAY 5 WITH EXPOSED REBAR, NO SECTION LOSS

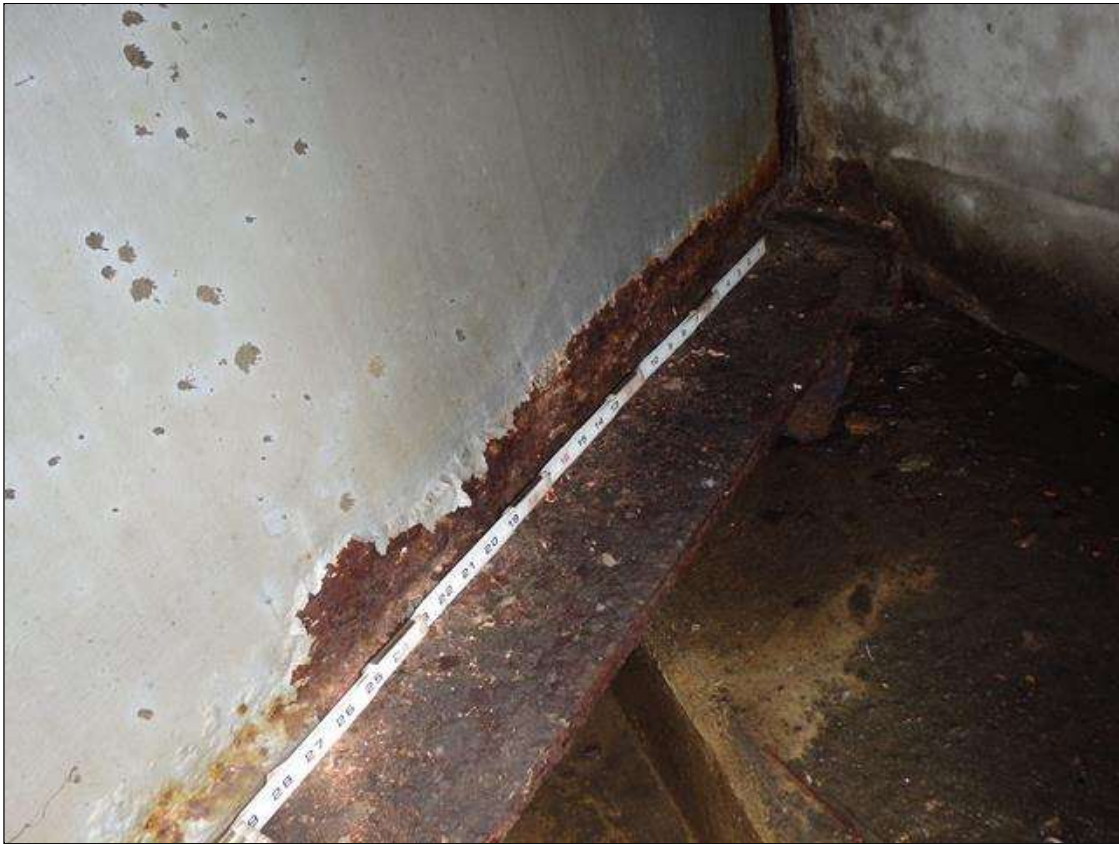
Span 1 Beam 1: SPAN 1 BEAM 1 AT END BENT 1 HAS SECTION LOSS ON THE BOTTOM FLANGES FROM THE BEAM END OUT 3 FT. X FULL WIDTH WITH  $\frac{3}{4}$ " REMAINING AND SECTION LOSS IN THE LOWER WEB FROM THE BEAM END OUT 2 FT. X 4" HIGH WITH  $\frac{11}{16}$ " REMAINING

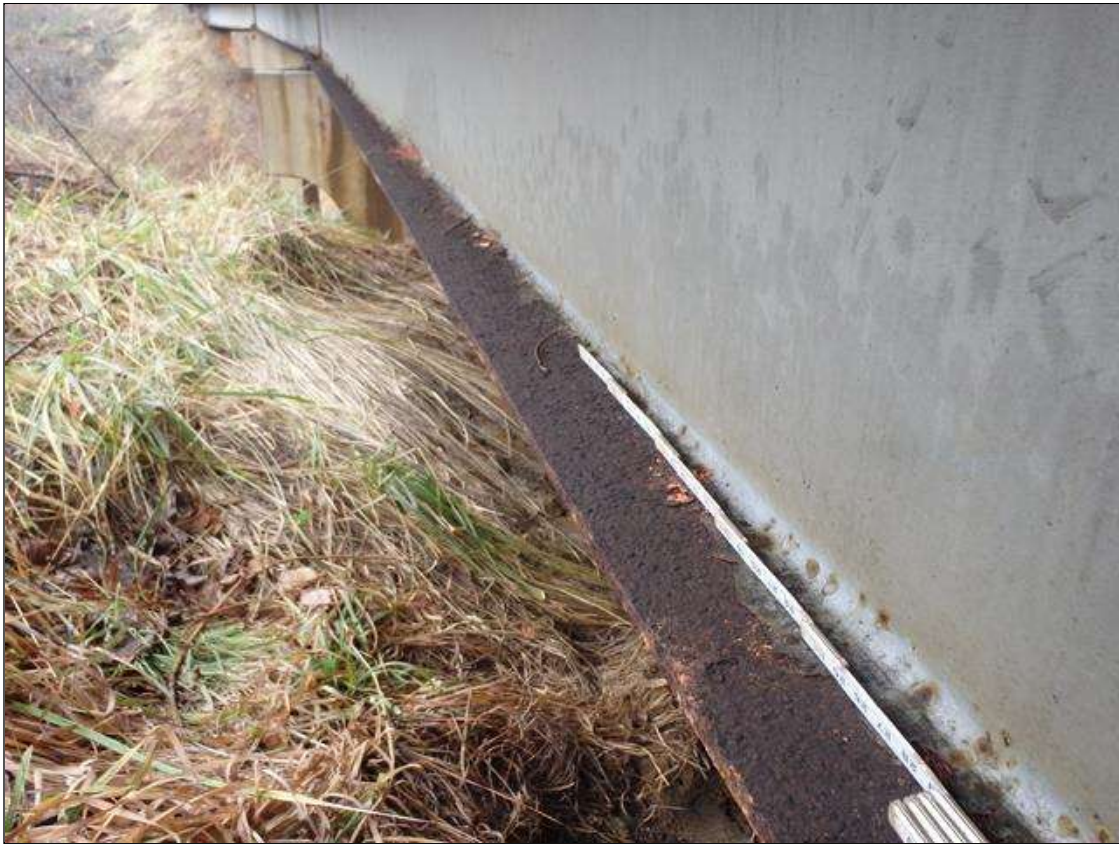
Span 1 Beam 1: OUTSIDE TOP OF BOTTOM FLANGE HAS SURFACE CORROSION THROUGHOUT THE SPAN,  
NO MEASUREABLE SECTION LOSS

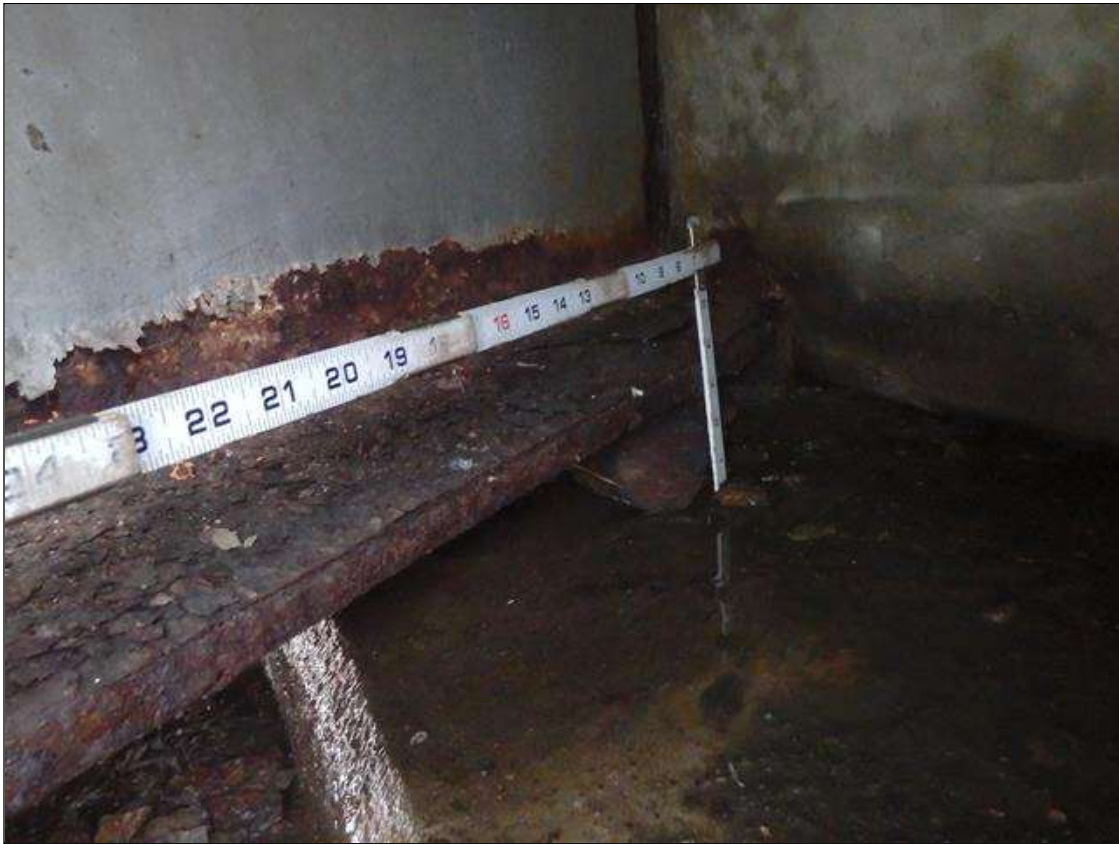
Span 1 Beam 1: SPAN 1 BEAM 1 AT END BENT 1 HAS SECTION LOSS ON THE BOTTOM FLANGES FROM THE BEAM END OUT 3 FT. X FULL WIDTH WITH  $\frac{3}{4}$ " REMAINING AND SECTION LOSS IN THE LOWER WEB FROM THE BEAM END OUT 2 FT. X 4" HIGH WITH  $\frac{11}{16}$ " REMAINING

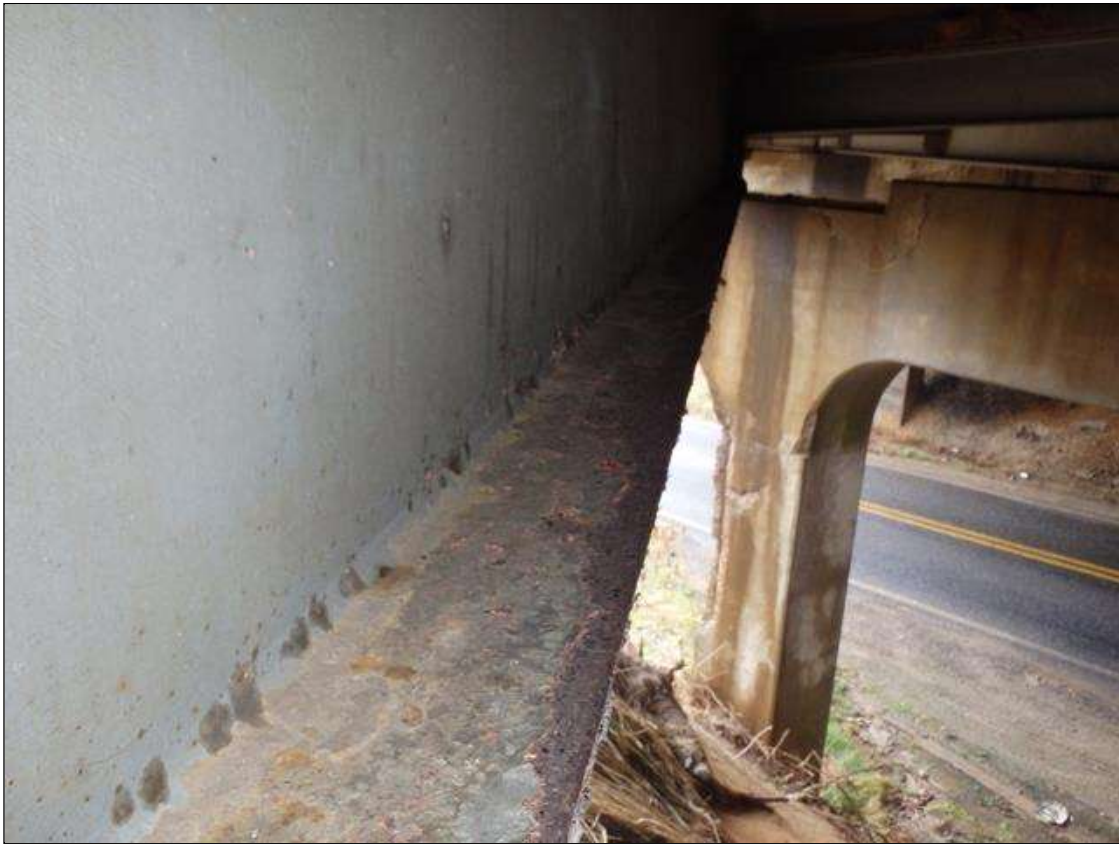
Span 1 Beam 1: PROTECTIVE COATING HAS STARTED TO FAIL DUE TO RUST

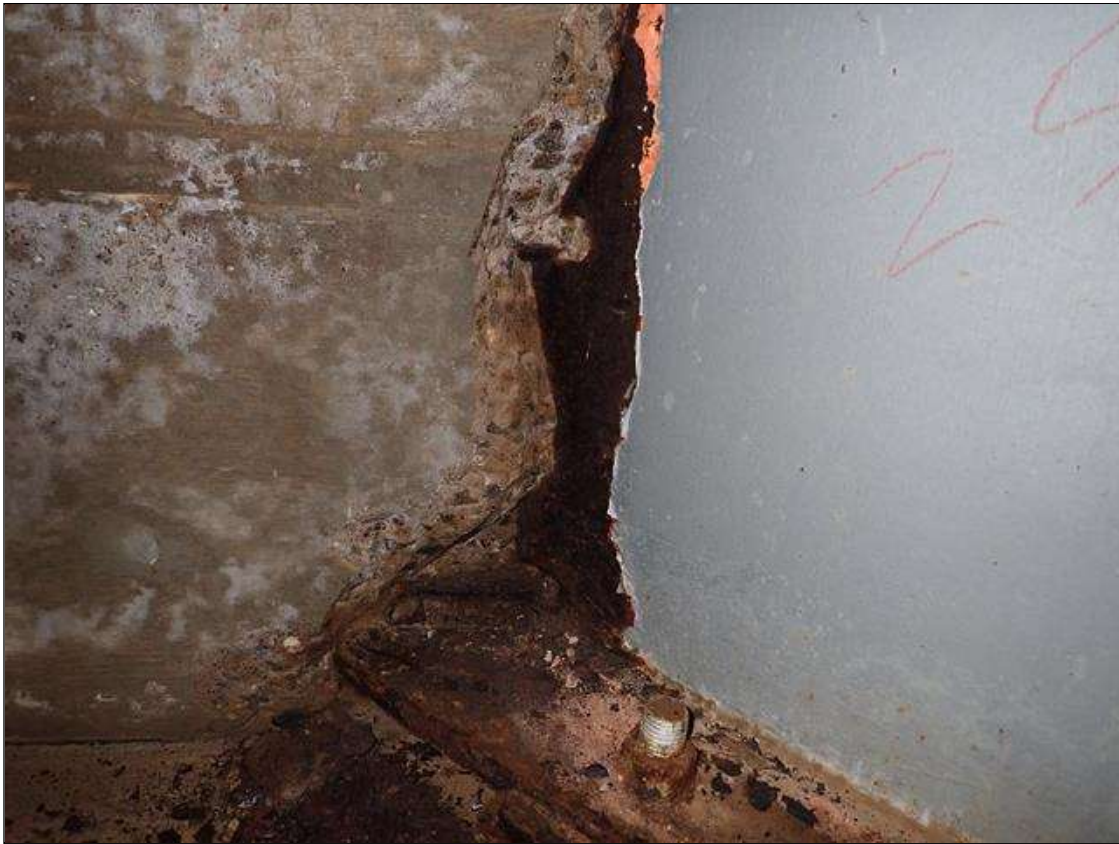
End Bent 2 Abutment/Backwall : SPALL, 18" X 6" X 2.5" DEEP ON BACKWALL IN BAY 2 ADJACENT TO GIRDER 3  
WITH EXPOSED REBAR, NO SECTION LOSS

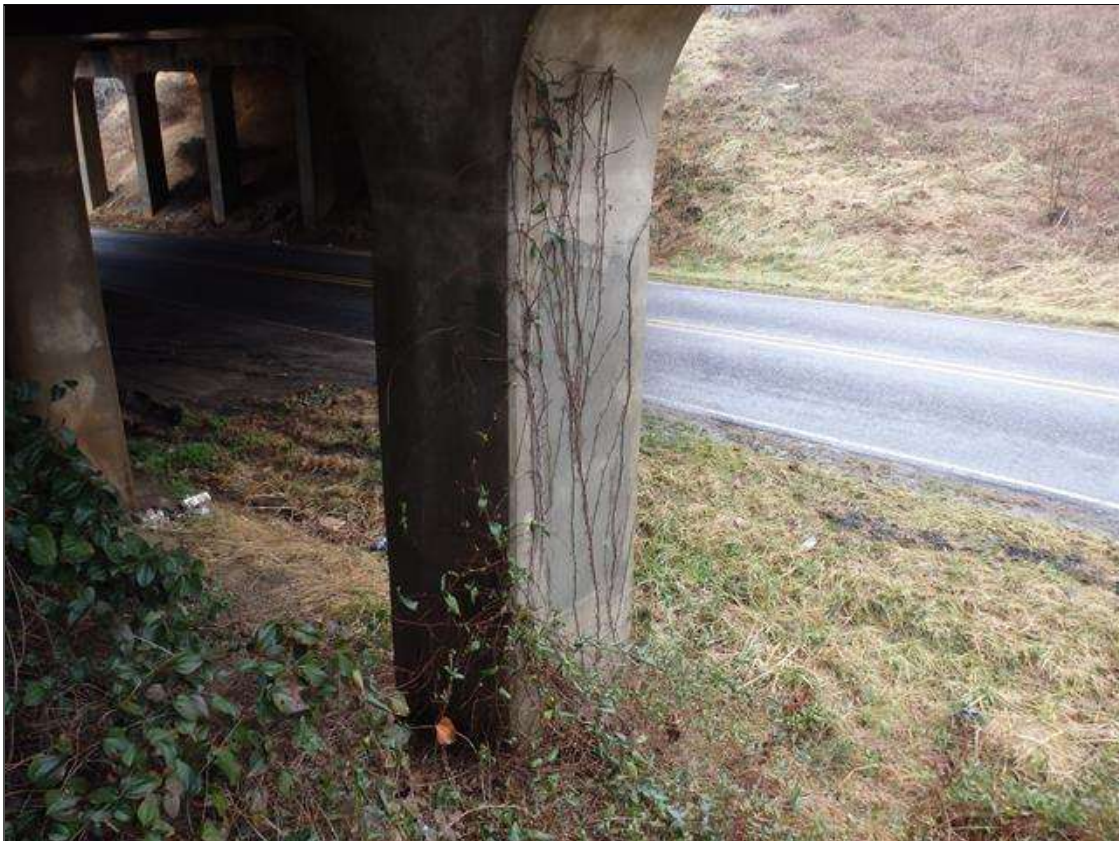
VEGETATION GROWTH FOR FULL HEIGHT OF COLUMN 6 ON BENT 1 SOUTH AND EAST FACE

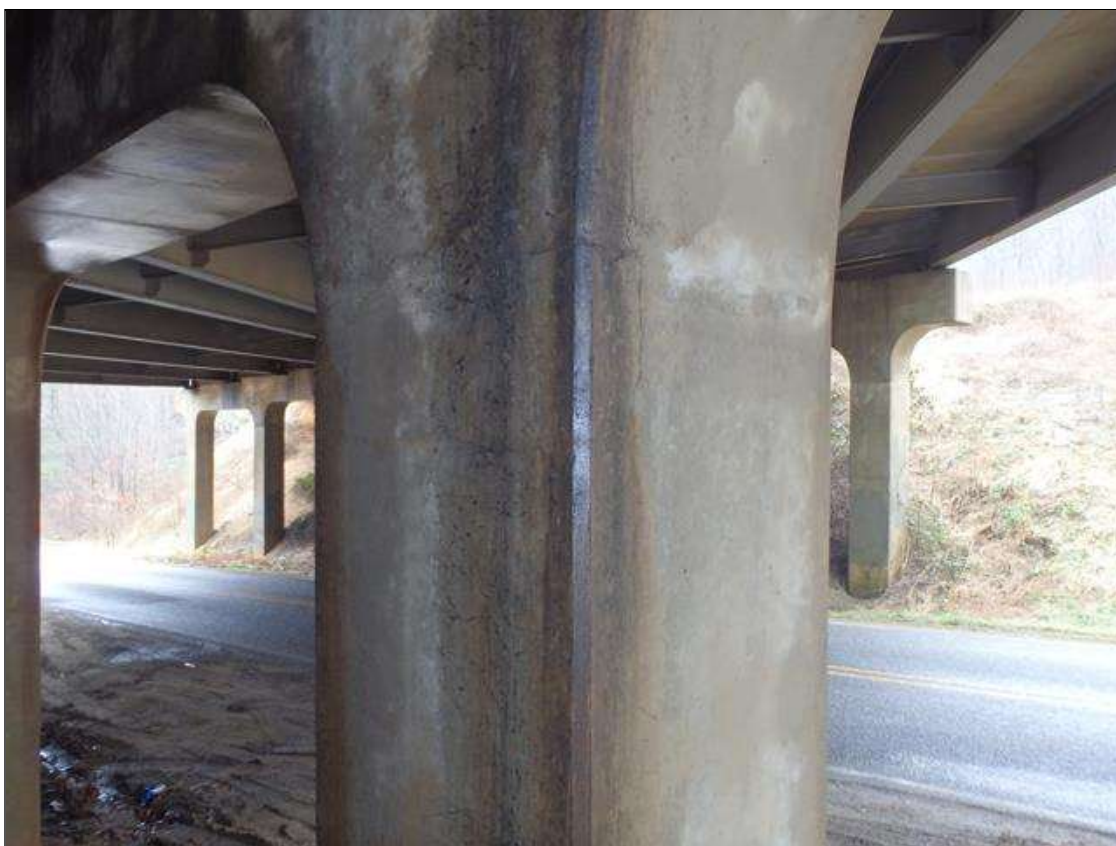
Bent 1 Pile 5: DELAMINATION, 2 FT X 4" X 2 FT ON SOUTHWEST CORNER WITH TWO VERTICAL CRACKS UP TO 1/16" WIDE ON NORTH AND WEST FACES
