NC DEPARTMENT OF TRANSPORTATION  
DIVISION OF HIGHWAYS  
STRUCTURE MANAGEMENT UNIT

## Structure Safety Report

### Routine Element Inspection - Contract

DIVISION: 14 COUNTY: HAYWOOD STRUCTURE NUMBER: 430159 FREQUENCY: 24 MONTHS

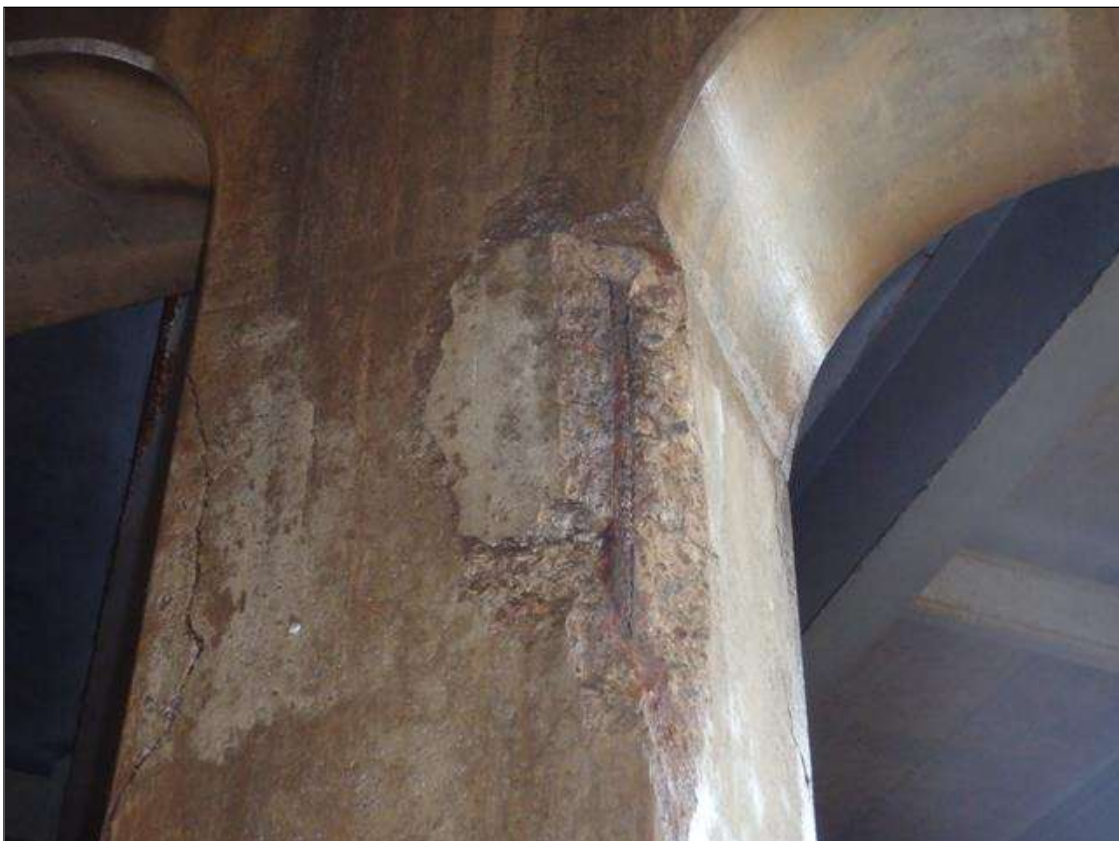
Bent 1 Pile 2: SPALL, 3 FT X 15" X 3.5" ON NORTHEAST CORNER WITH EXPOSED REBAR, NO SECTION LOSS  
ADJACENT TO DELAMINATION, 2 FT X 1 FT ON EAST FACE, TOP OF COLUMN

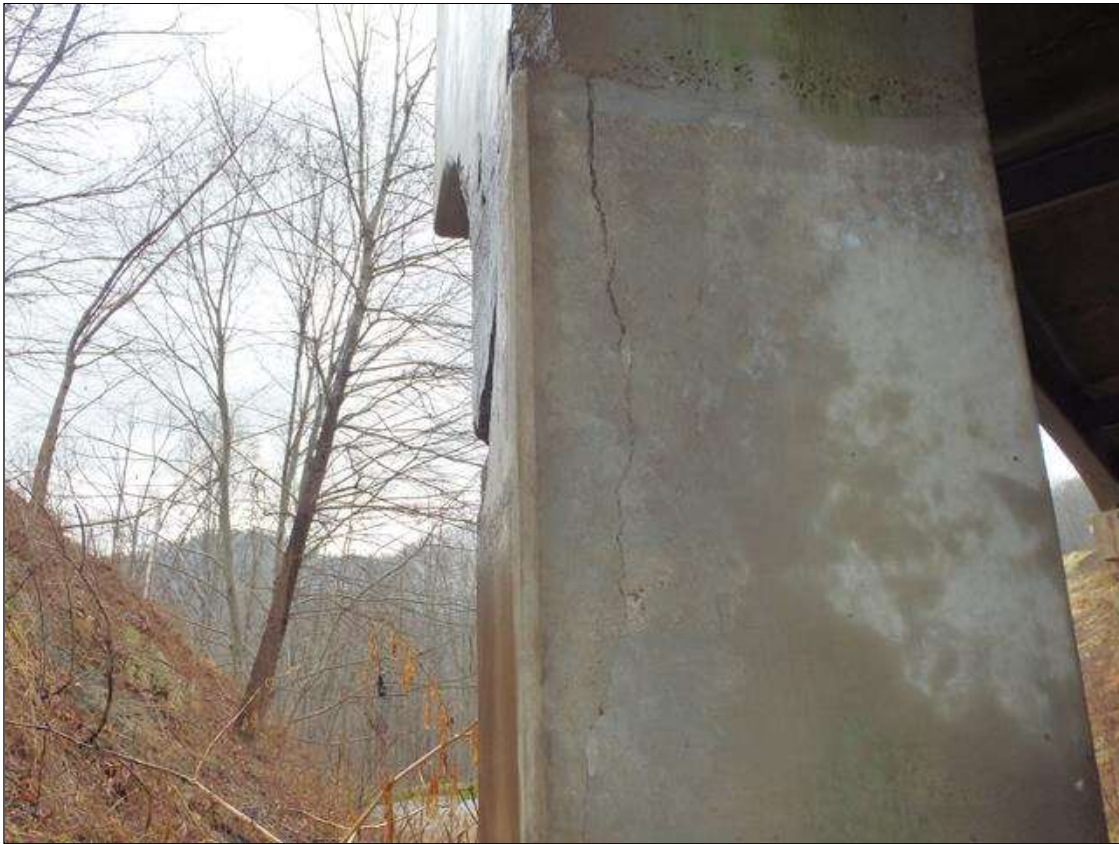
Bent 1 Pile 1: DELAMINATION, 4.5 FT X 1 FT X 6" ON SOUTHWEST CORNER WITH CRACKING UP TO 1/4" WIDE, TOP OF COLUMN

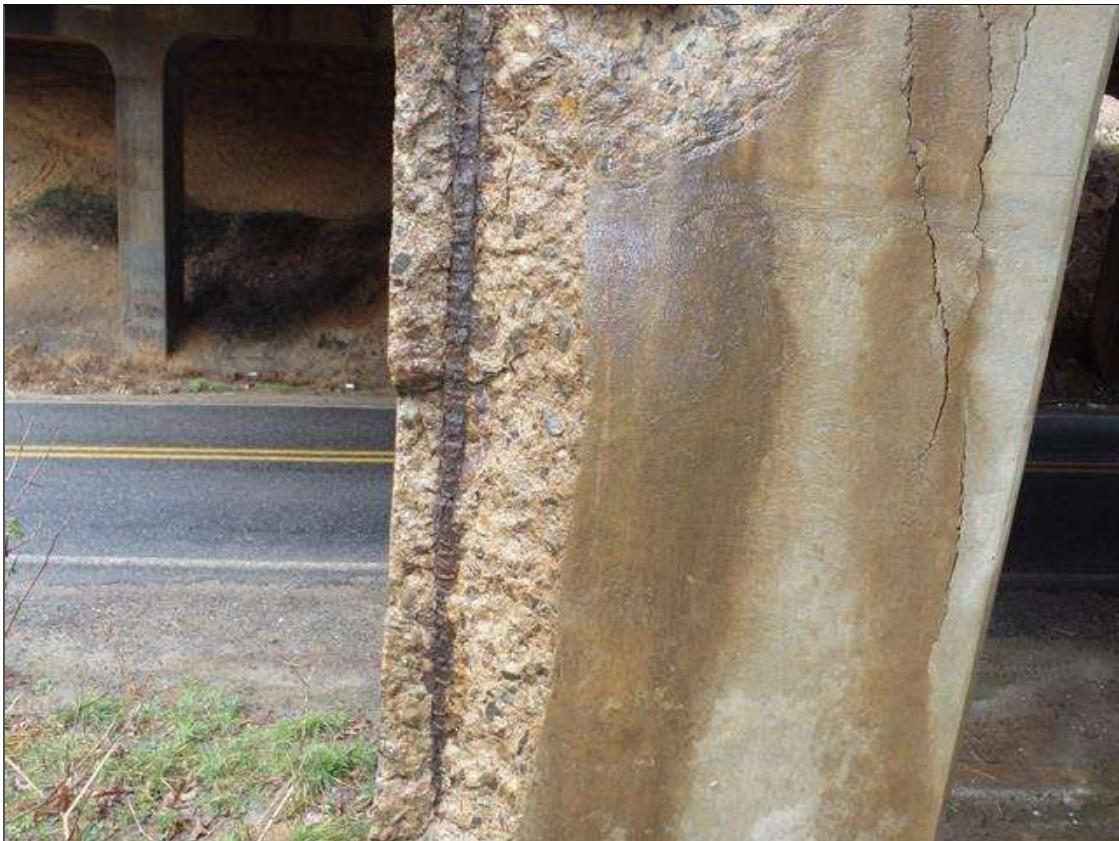
Bent 1 Pile 1: SPALL/DELAMINATED AREA, 8 FT X 1 FT X 6" WITH SPALL, 6 FT X 1 FT X 6" ON NORTHEAST CORNER WITH EXPOSED REBAR, NO SECTION LOSS, TOP OF COLUMN. PAR

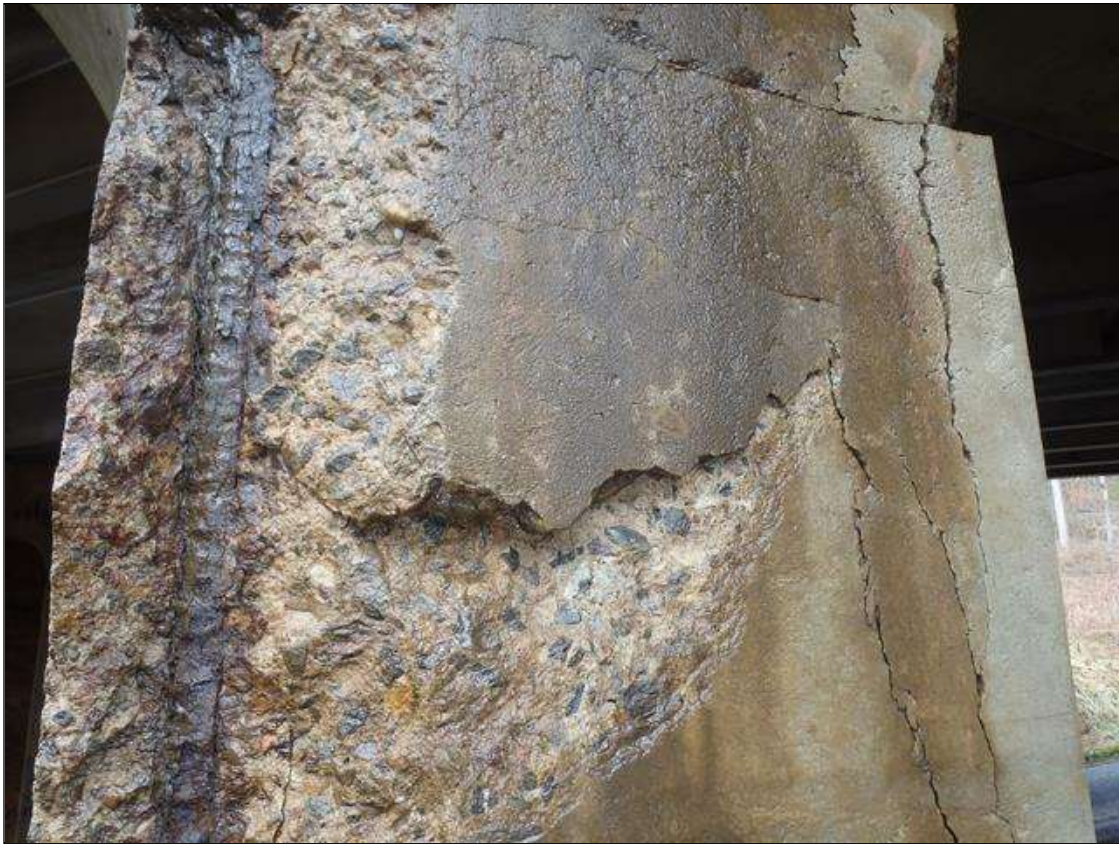
Bent 1 Pile 1: DELAMINATION, 1.5 FT X 1.5 FT ON WEST FACE MIDHEIGHT OF COLUMN. PAR

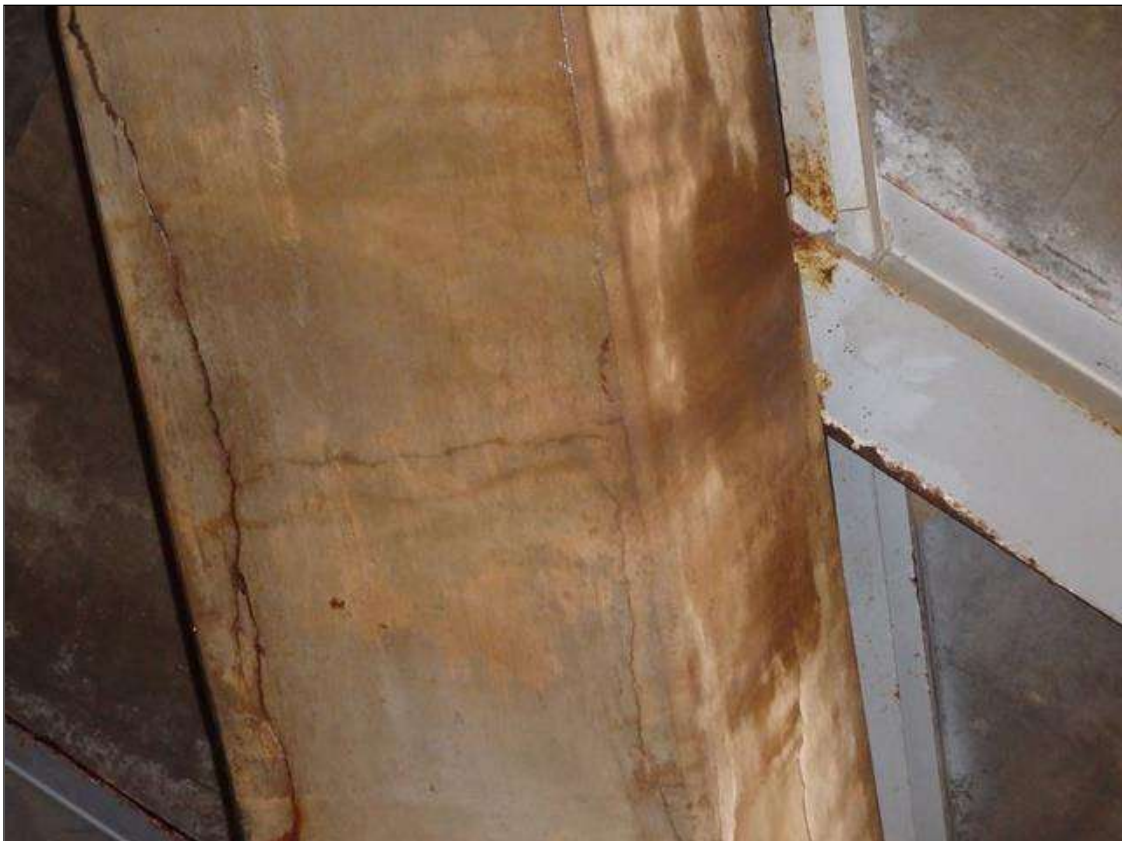
Bent 1 Cap 1: DELAMINATION, 6 FT X 6" X 1 FT ON UNDERSIDE OF CAP AND WEST FACE WITH 1/4" CRACK RUNNING THROUGH

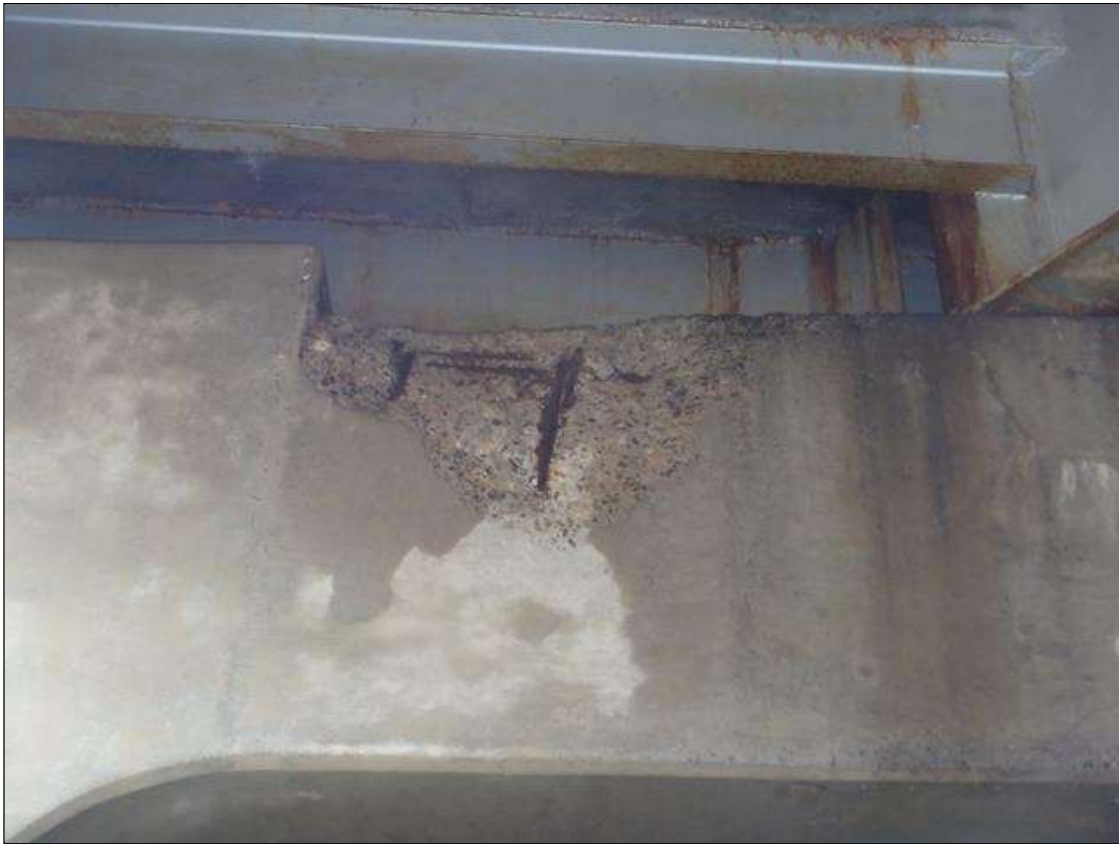
Bent 1 Cap 1: SPALL, 4 FT X 2.5 FT X 3" DEEP ON EAST FACE BELOW BAY 9 WITH EXPOSED REBAR, NO MEASUREABLE SECTION LOSS. PAR

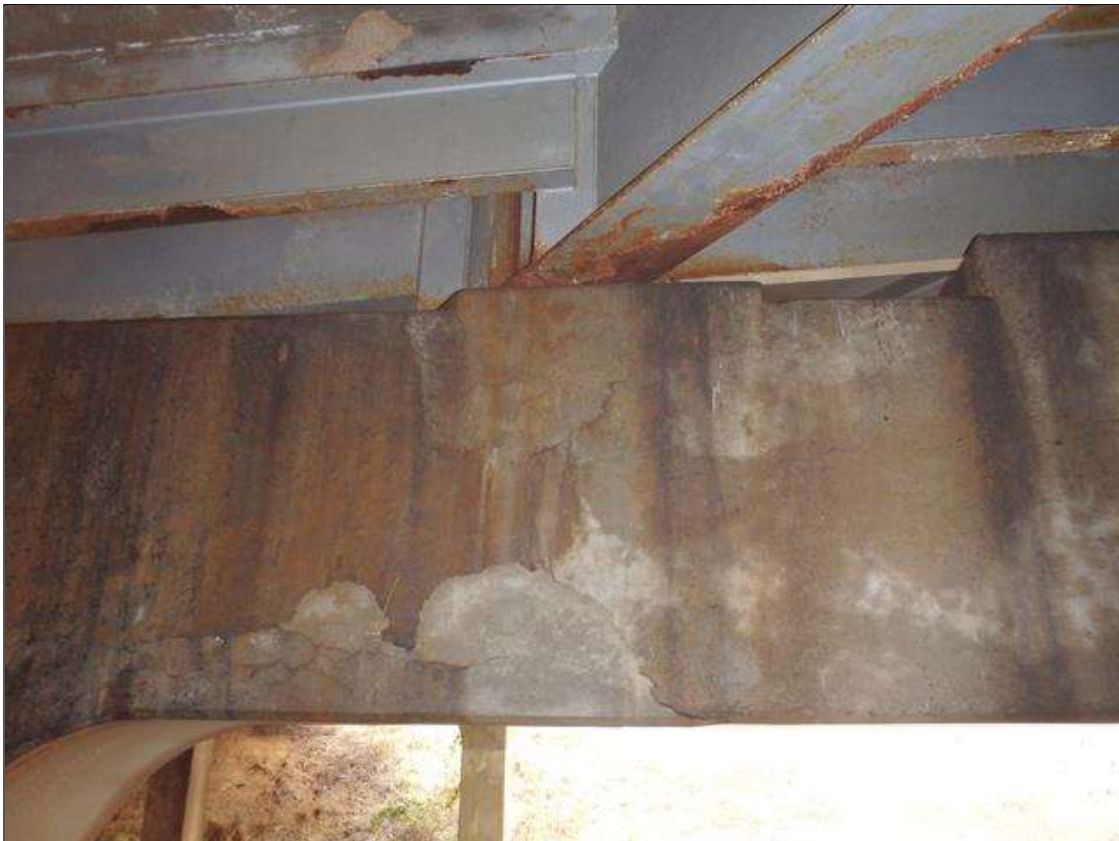
Bent 1 Cap 1: DELAMINATION, 2 FT DIAMETER ON WEST FACE UNDER GIRDER 7

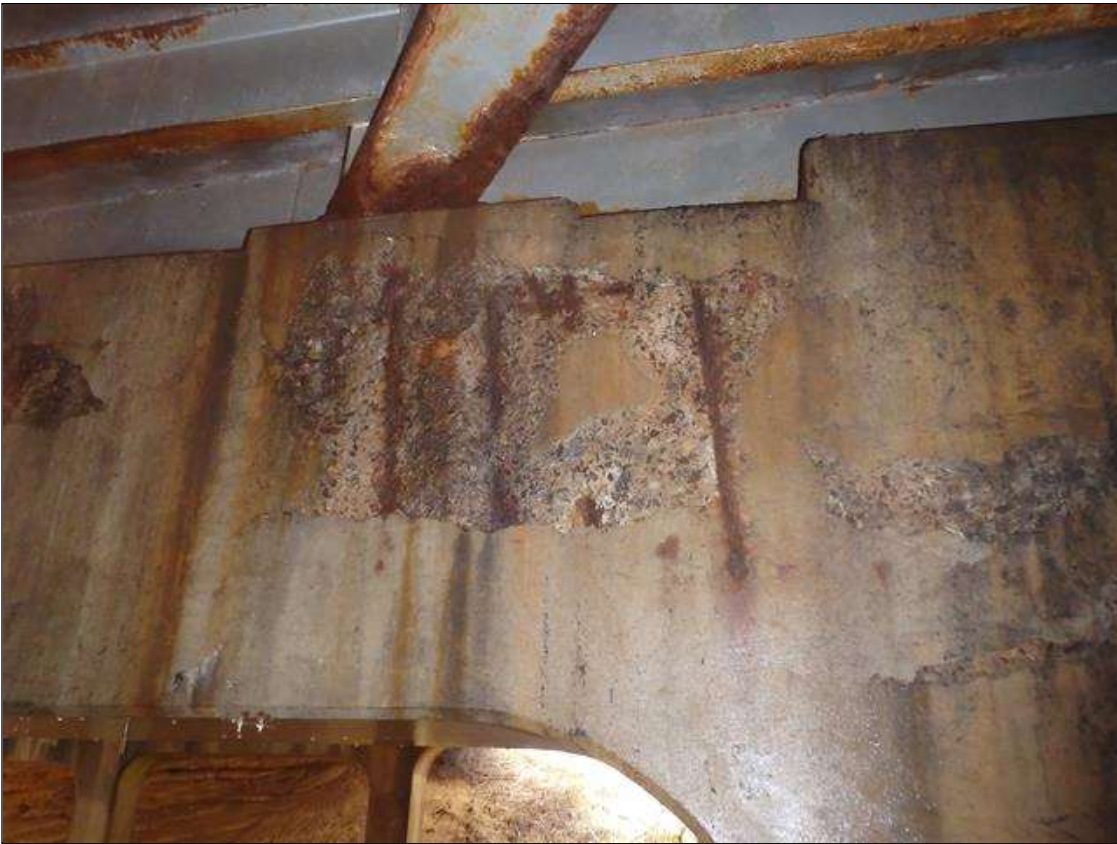
Bent 1 Cap 1: SPALL, 4 FT X 2 FT X 2.5" DEEP ON WEST FACE UNDER GIRDER 3 WITH EXPOSED REBAR, NO SECTION LOSS

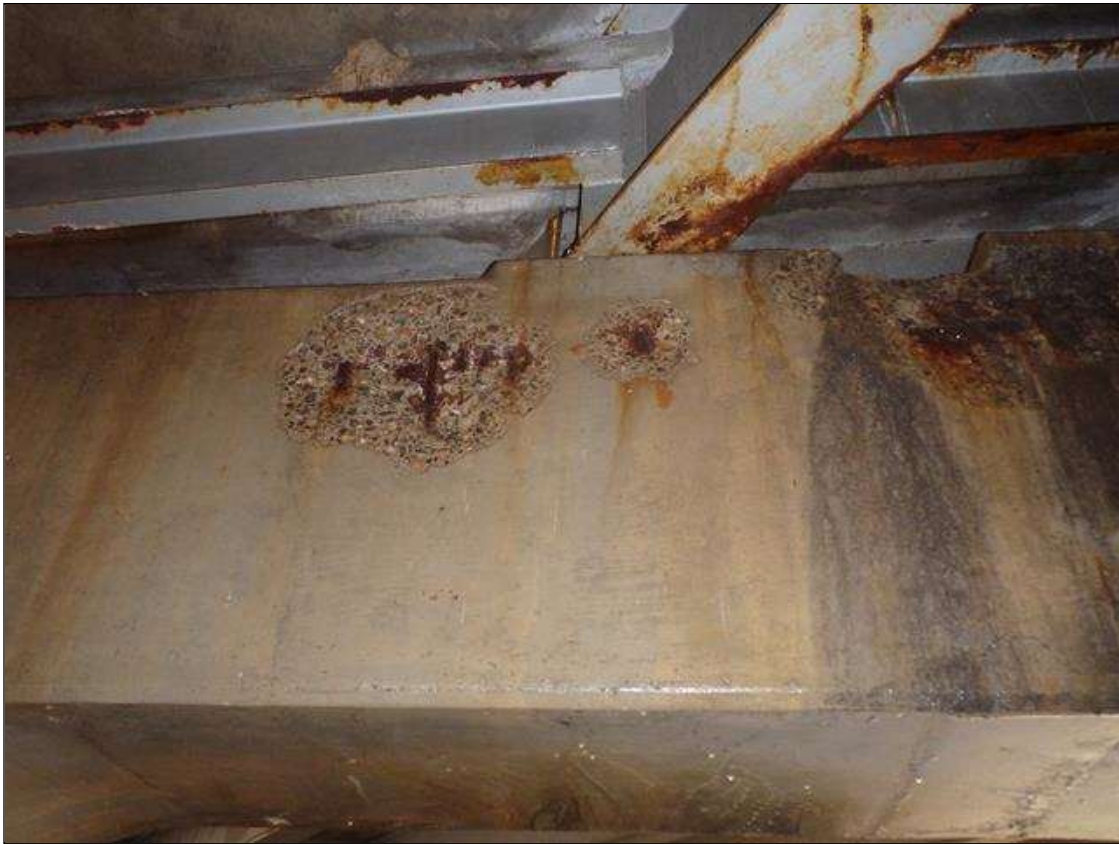
Bent 1 Cap 1: 2 SPALLS, 1 FT DIAMETER X 1/2" DEEP AND 2 FT DIAMETER X 1" DEEP ON WEST FACE OF CAP BELOW GIRDER 5 AND NO MEASUREABLE SECTION LOSS

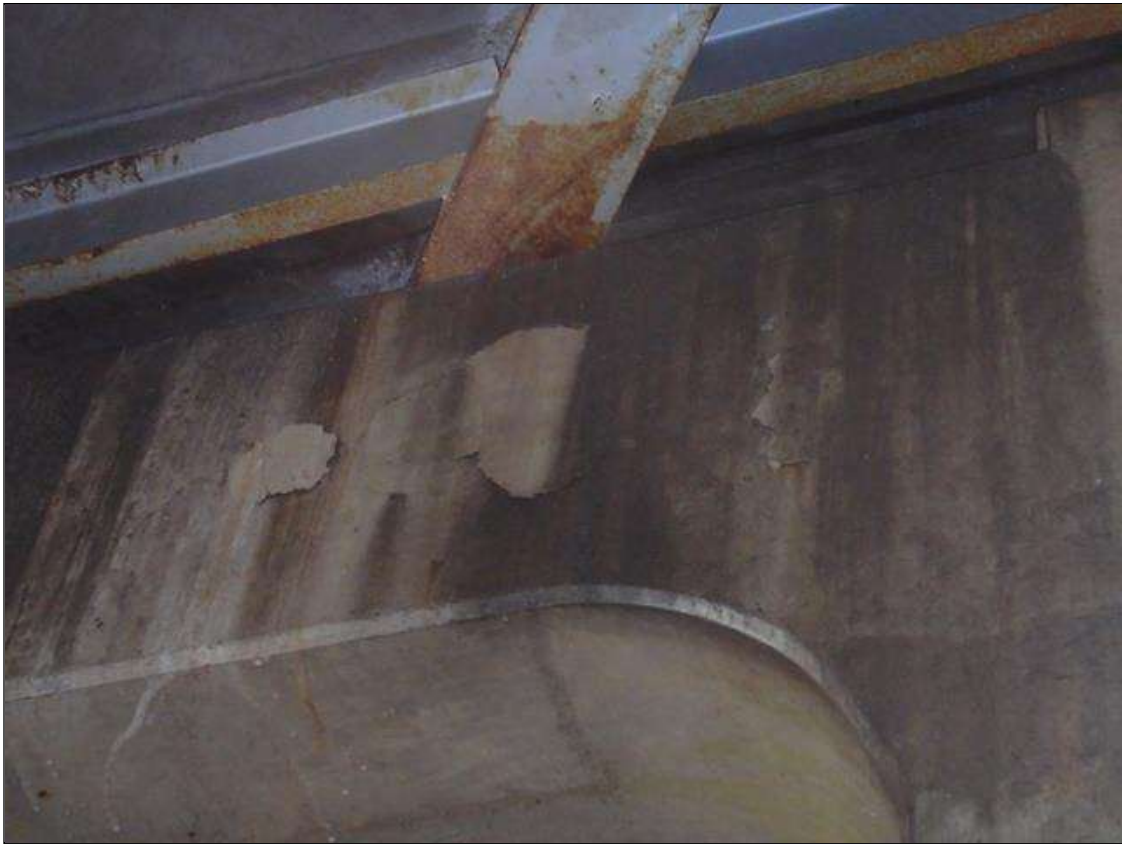
Bent 2 Cap 1: THREE DELAMINATIONS, UP TO 2 FT X 18" ON WEST FACE OF CAP BELOW GIRDER 6

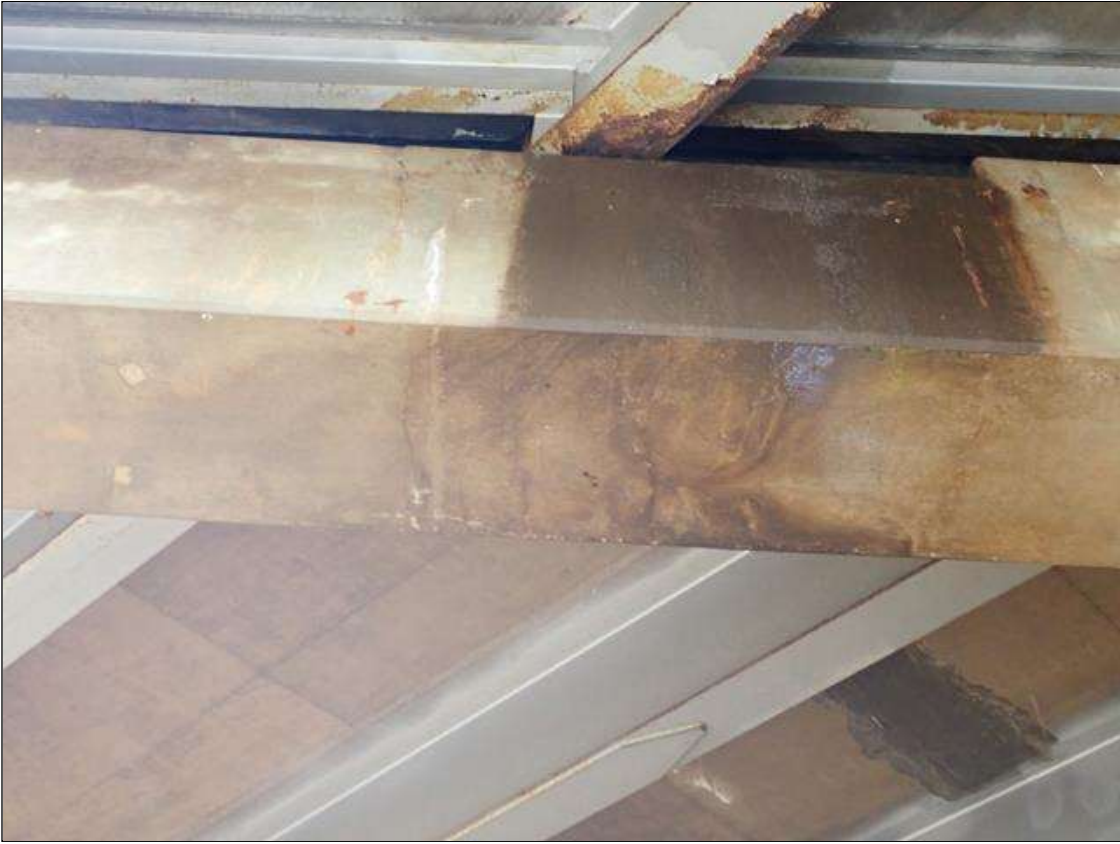
Bent 2 Cap 1: TWO FULL WIDTH HAIRLINE CRACKS IN UNDERSIDE OF CAP BETWEEN COLUMNS 1 AND 2

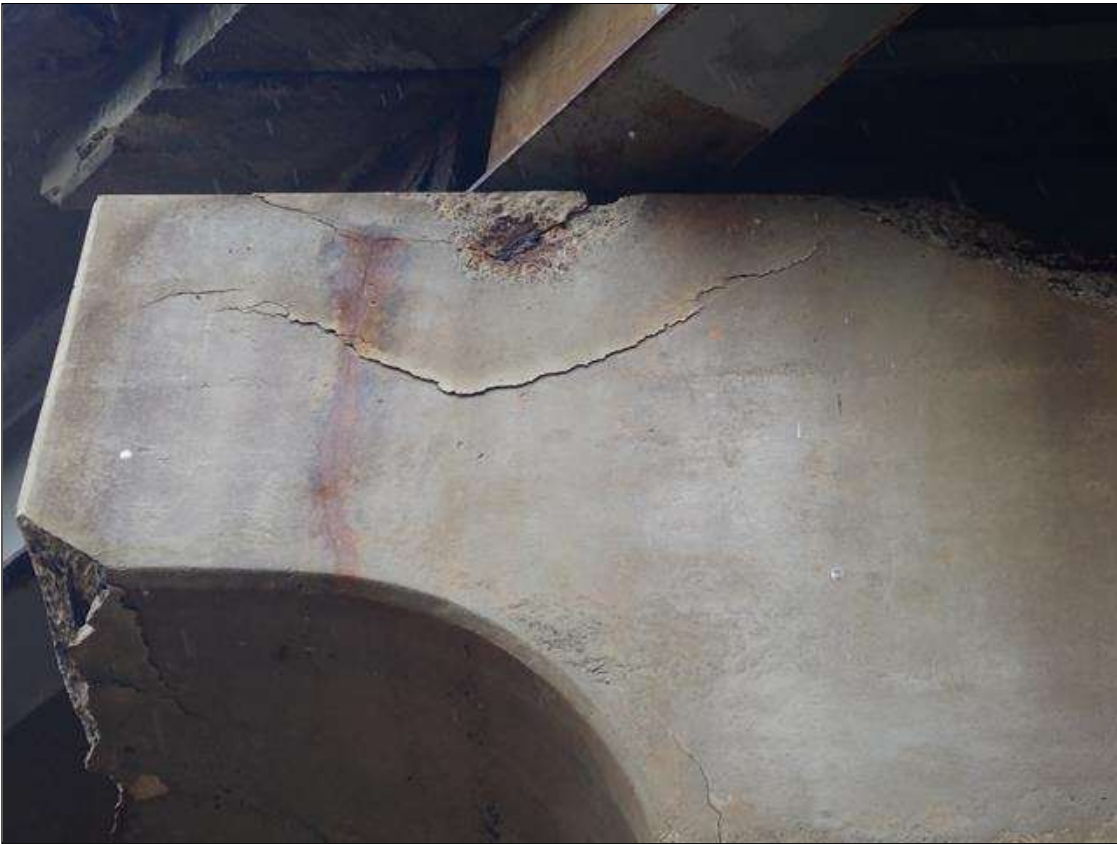
Bent 2 Cap 1: DELAMINATION, 4 FT X 2 FT ON WEST FACE BELOW GIRDER 1 WITH A SPALL, 18" X 1 FT X 2" DEEP WITH EXPOSED REBAR, NO SECTION LOSS

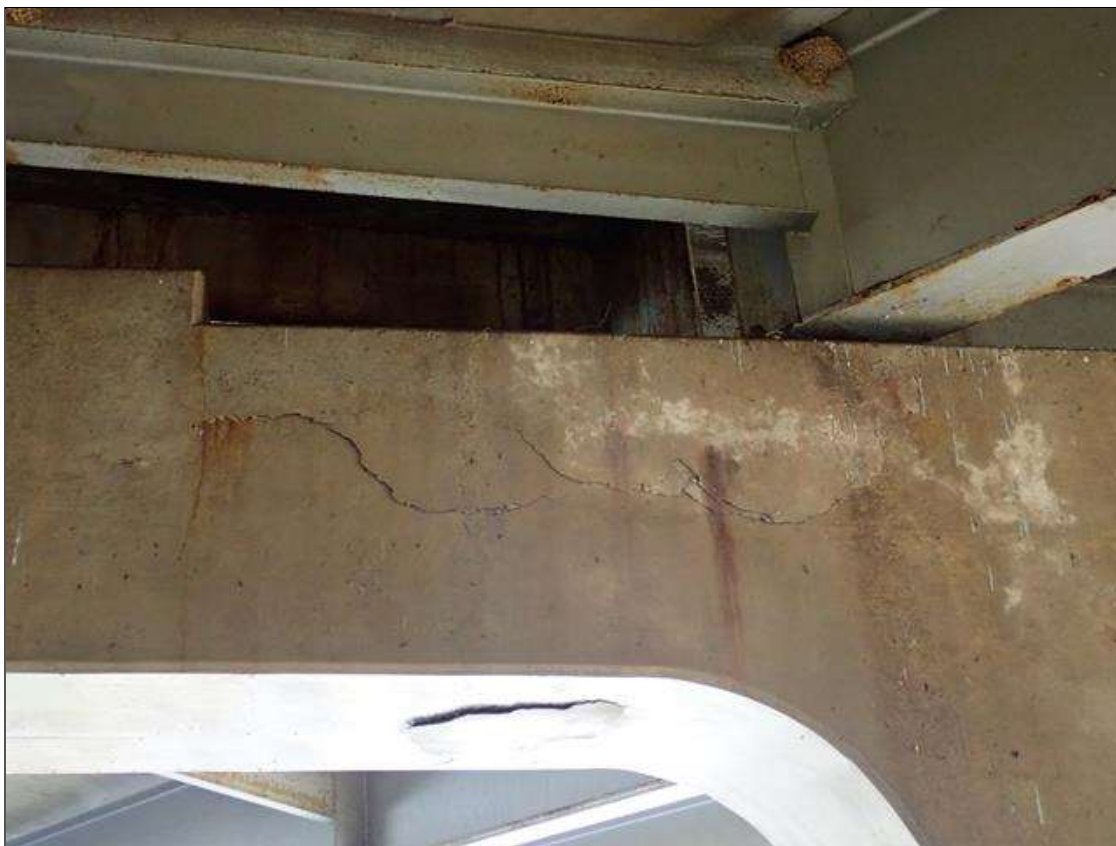
Bent 2 Cap 1: DELAMINATION, 6 FT X 3 FT ON EAST FACE BELOW BAY 3

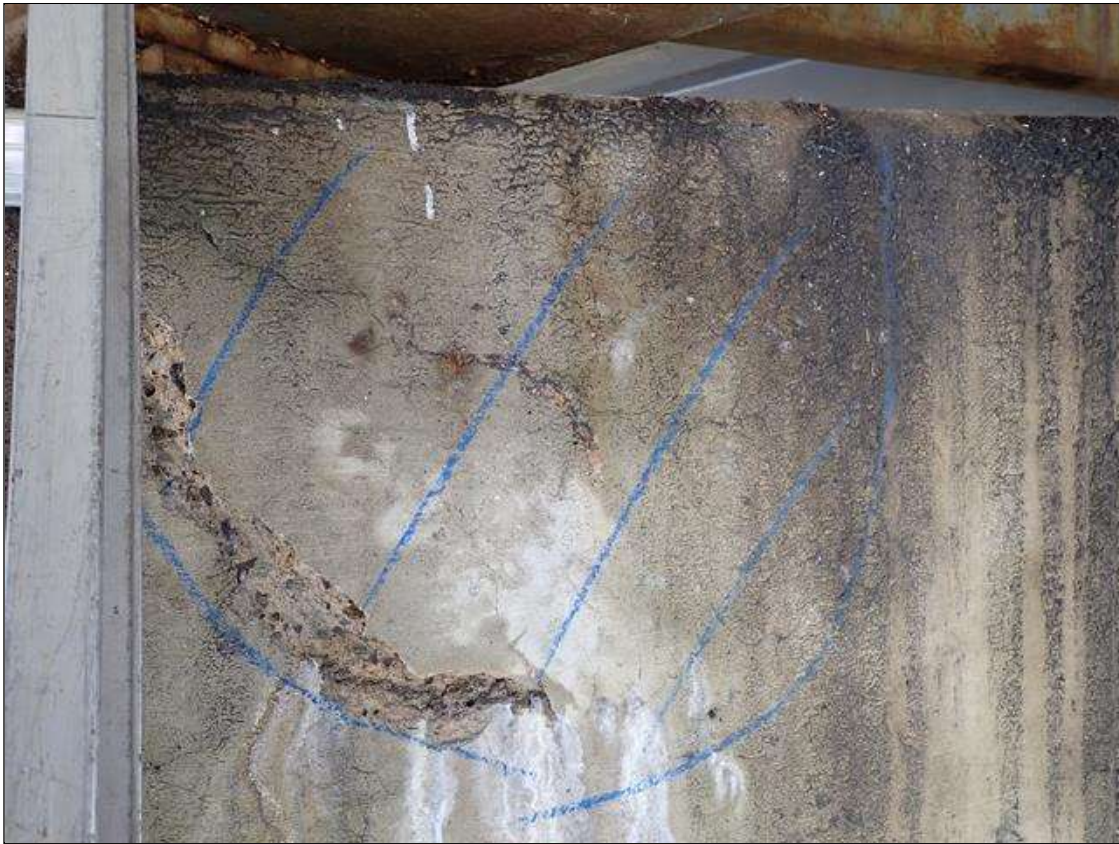
Bent 1 Cap 1: DELAMINATION, 20" X 19" ON EAST FACE UNDER GIRDER 9

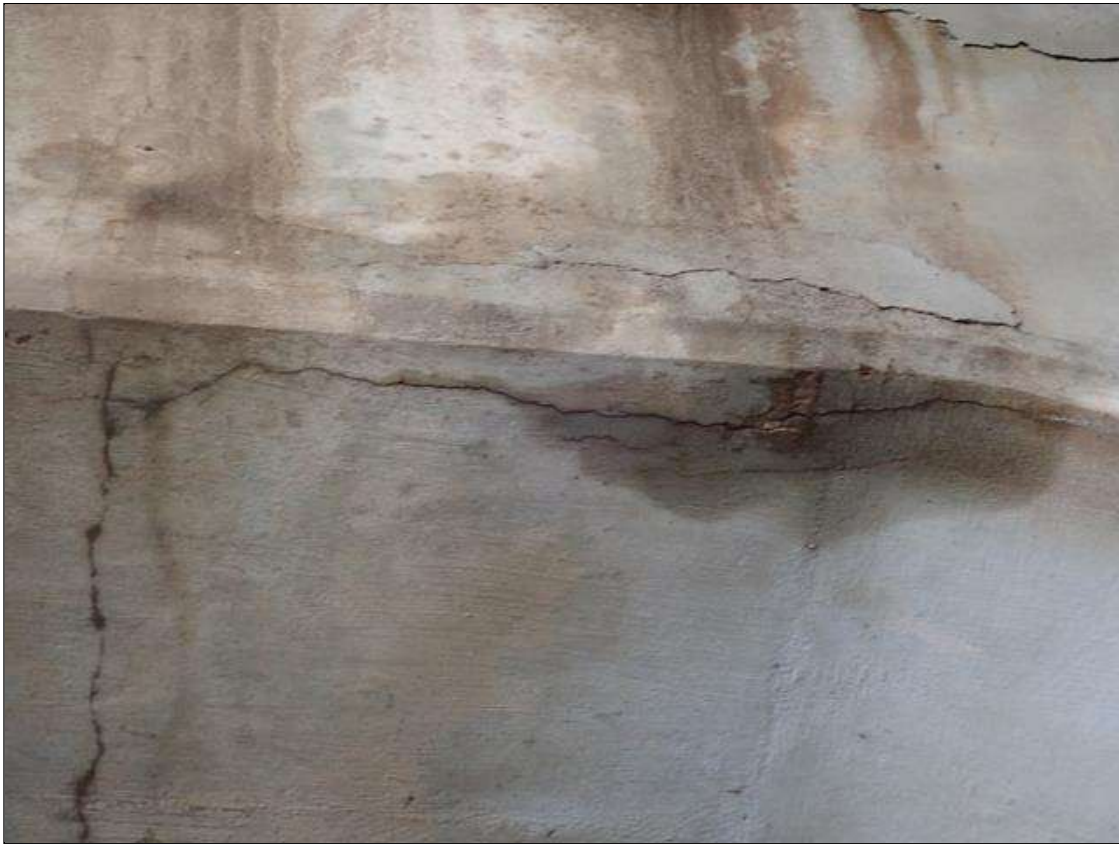
Bent 1 Cap 1: BENT 1 CAP, SPAN 2 SIDE HAS AN AREA OF DELAMINATION AT THE TOP EDGE UNDER BEAM 6, 28 INCHES LONG X 9 INCHES HIGH ON THE FACE X 5 INCHES ACROSS THE TOP WITH 1/8 INCH SEPARATION, CRACK ON TOP RUNS ADJACENT TO BEARING AT THIS BEAM

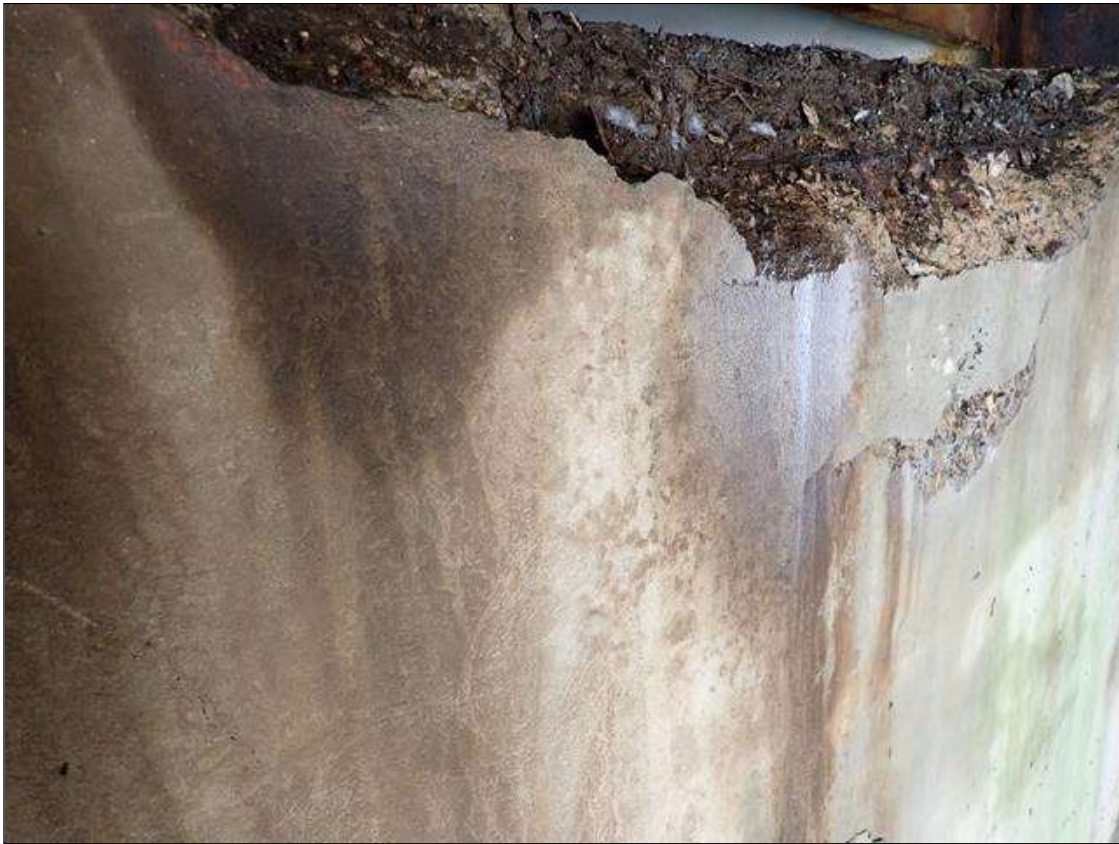
Bent 1 Cap 1: SPALL, 4.5 FT X 20" X 5" ON EAST FACE OF CAP ON UNDER GIRDER 6 WITH EXPOSED REBAR WITH UP TO 5% SECTION LOSS, PM

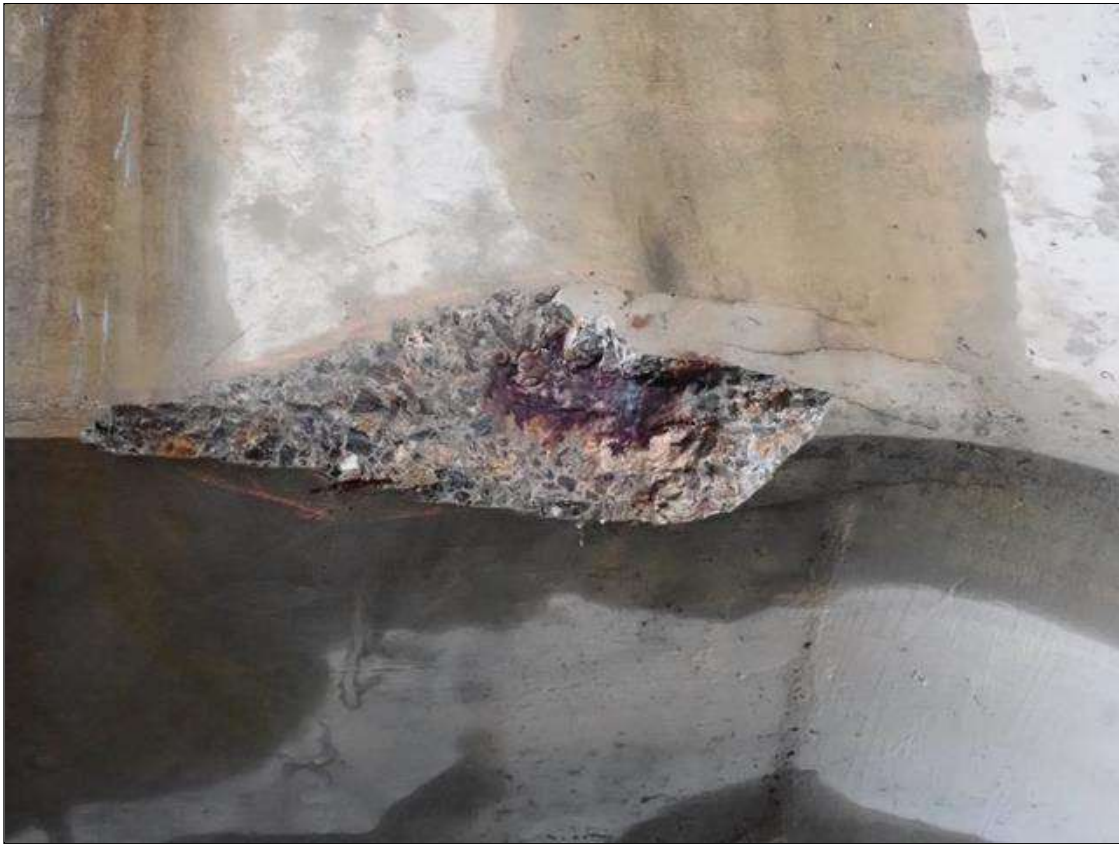
Bent 1 Cap 1: SPALL, 24" X 8" X 6" ON BOTTOM OF EAST FACE OF CAP BELOW GIRDER 5 WITH EXPOSED REBAR, NO SECTION LOSS

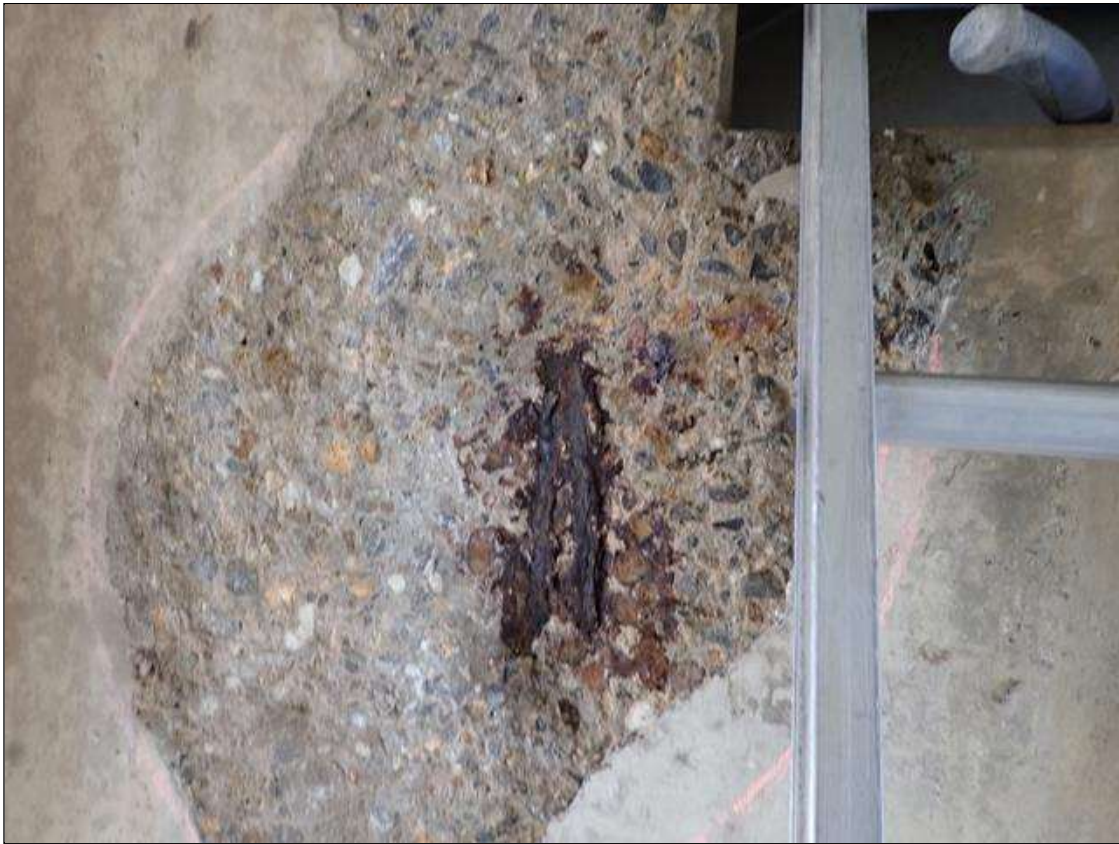
Bent 1 Cap 1: SPALL, 29" X 32" X 2.5" DEEP ON EAST FACE OF CAP UNDER BAY 3 WITH EXPOSED REBAR, NO SECTION LOSS

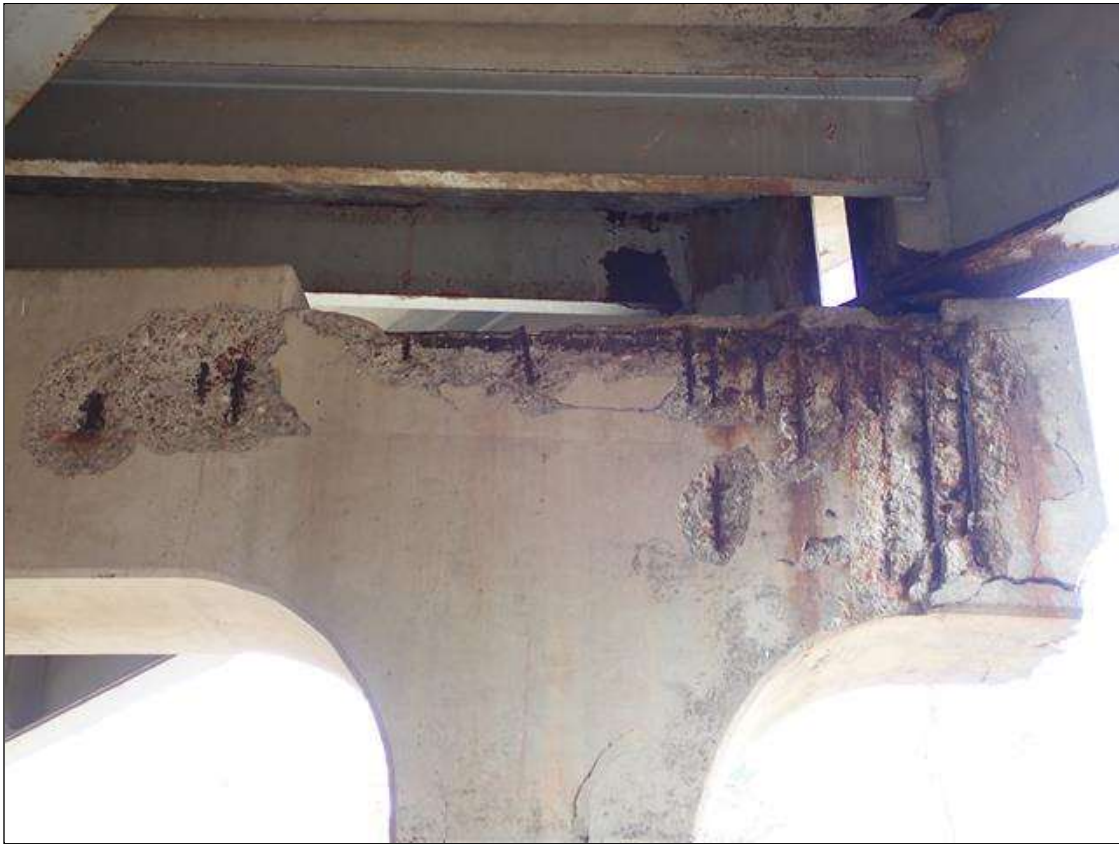
**Details** ISSUED FOR SPALLS ON BENTS AND LOSS OF BEARING AREA UNDER GIRDER AT BENT

Bent 2 Cap 1: SPALL, FULL HEIGHT X 9 FT X 2" DEEP, ON SPAN 3 SIDE OF CAP UNDER BEAM 1 AND BAY 1 WITH EXPOSED MAIN REINFORCING AND SHEAR REINFORCING WITH SECTION LOSS UP TO 25%, PM

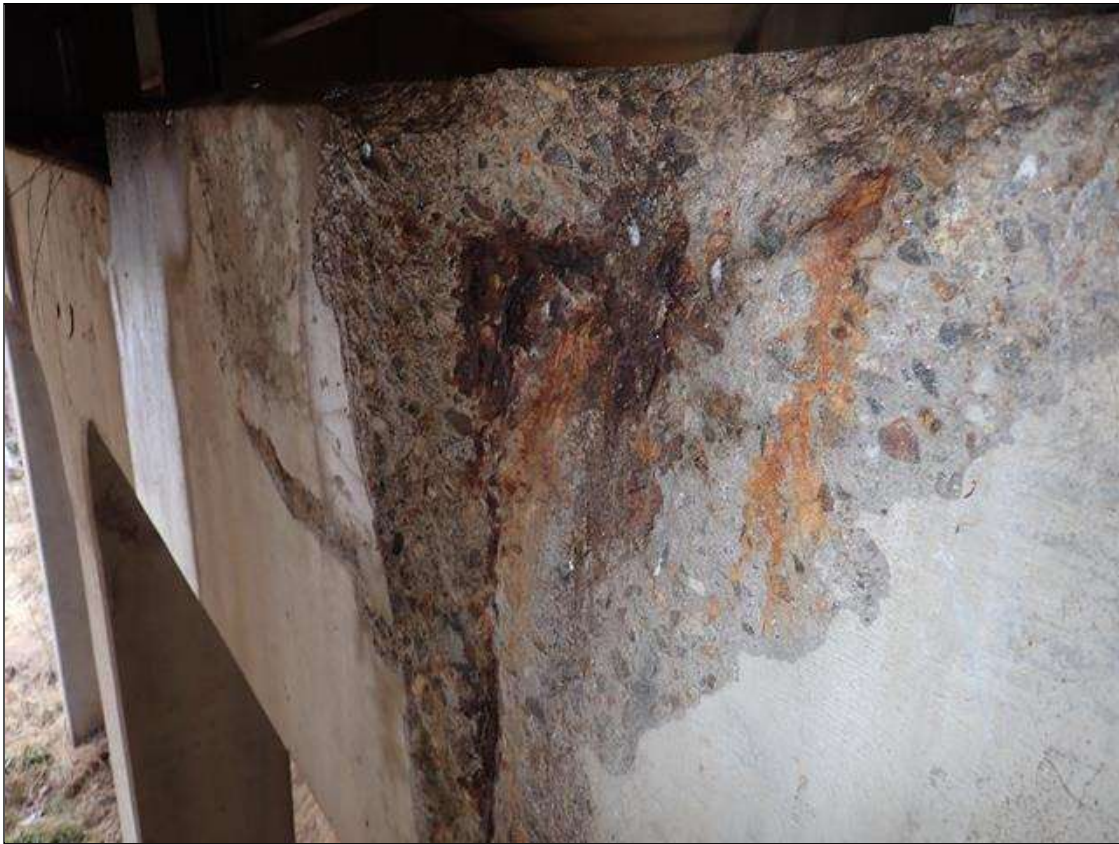
Bent 2 Cap 1: SPALL/DELAMINATED AREA, 8 FT X FULL HEIGHT X 3" DEEP ON WEST FACE OF CAP UNDER BAY 3 WITH EXPOSED SECTION LOSS WITH UP TO 5% SECTION REMAINING ON REBAR, PM

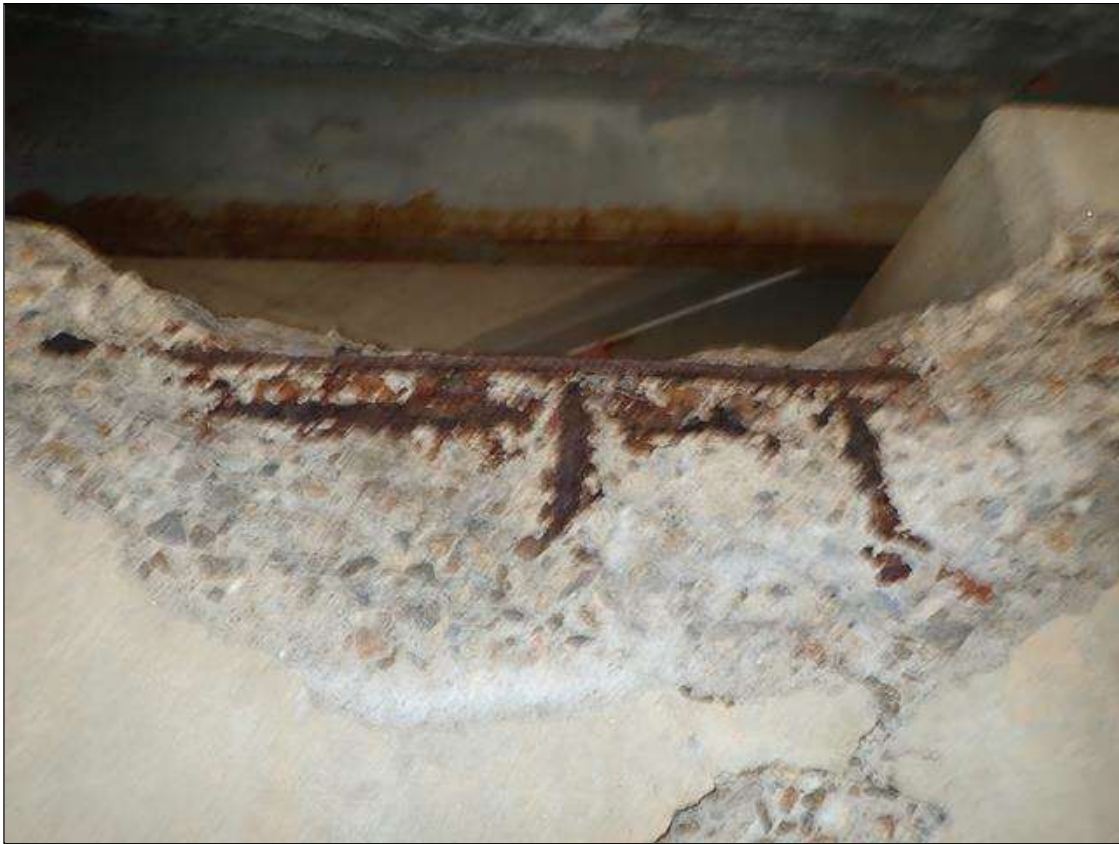
Bent 2 Cap 1: SPALL, FULL HEIGHT X 9 FT X 2" DEEP, ON SPAN 3 SIDE OF CAP UNDER BEAM 1 AND BAY 1 WITH EXPOSED MAIN REINFORCING AND SHEAR REINFORCING WITH SECTION LOSS UP TO 25% WITH A POTENTIAL LOSS OF BEARING AREA, PM

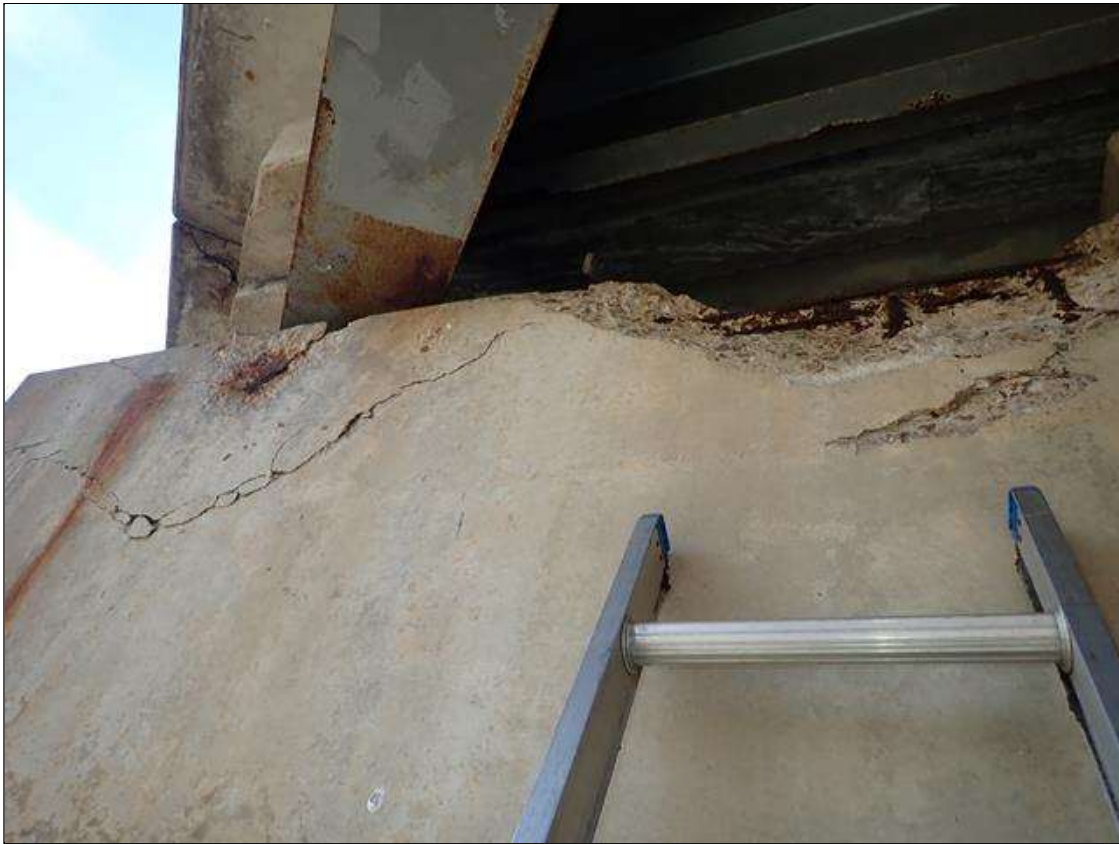
Bent 2 Cap 1: SPALL, FULL HEIGHT X 9 FT X 2" DEEP, ON SPAN 3 SIDE OF CAP UNDER BEAM 1 AND BAY 1 WITH EXPOSED MAIN REINFORCING AND SHEAR REINFORCING WITH SECTION LOSS UP TO 25% WITH A POTENTIAL LOSS OF BEARING AREA, PM

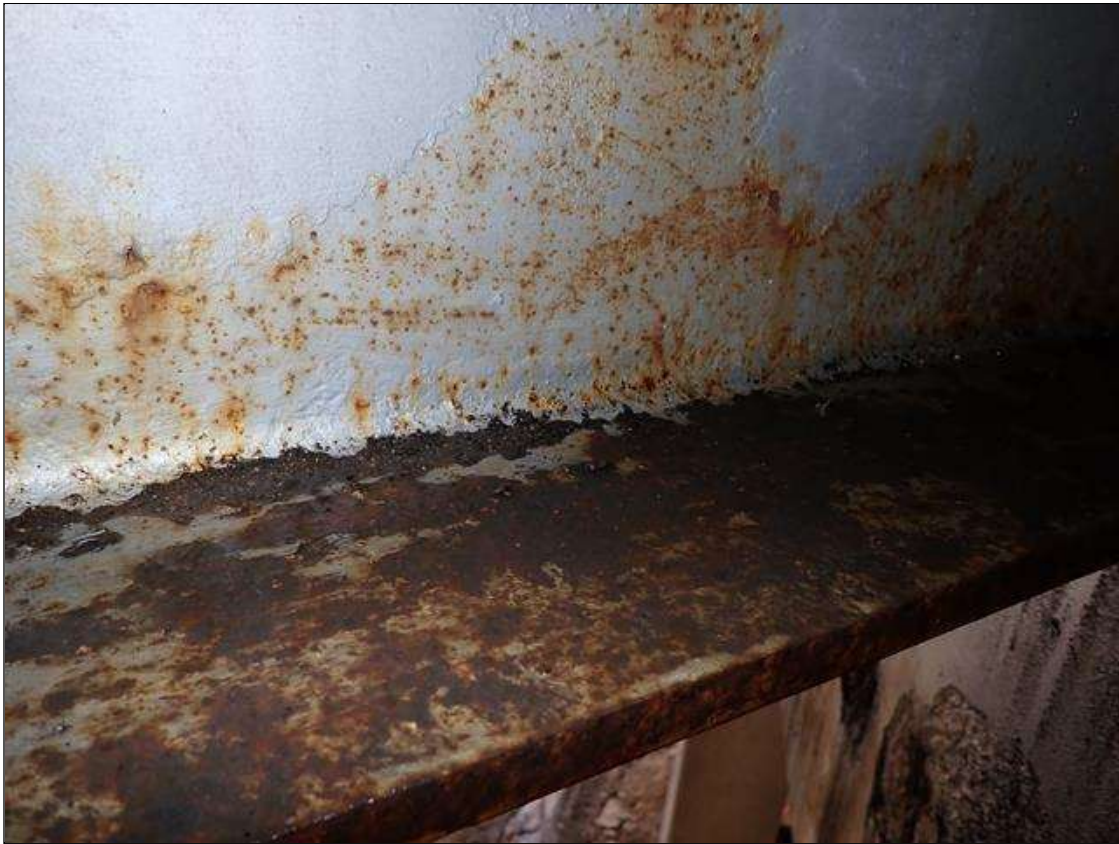
WATER SITTING ON TOP OF BOTTOM FLANGE FOR 20 FT AT BENT 2
