NC DEPARTMENT OF TRANSPORTATION  
DIVISION OF HIGHWAYS  
STRUCTURE MANAGEMENT UNIT

## Structure Safety Report

### Routine Element Inspection - Contract

COUNTY: HAYWOOD STRUCTURE NUMBER: 430057 FREQUENCY: 24 MONTHS

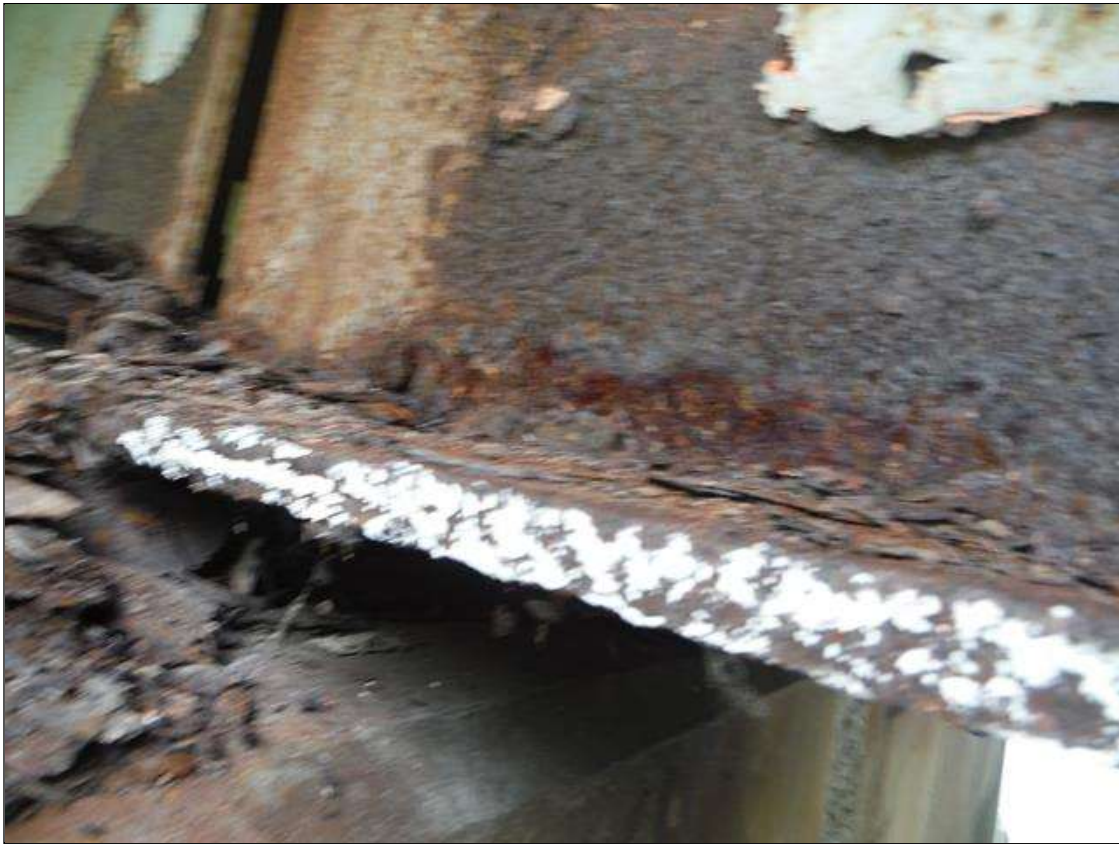
Span 3 Beam 1: 3 FT. OF CORROSION WITH 9/16" REMAINING SECTION IN LOWER WEB AND 5/8" REMAINING SECTION IN BOTTOM FLANGE AT BENT 3 (PM)

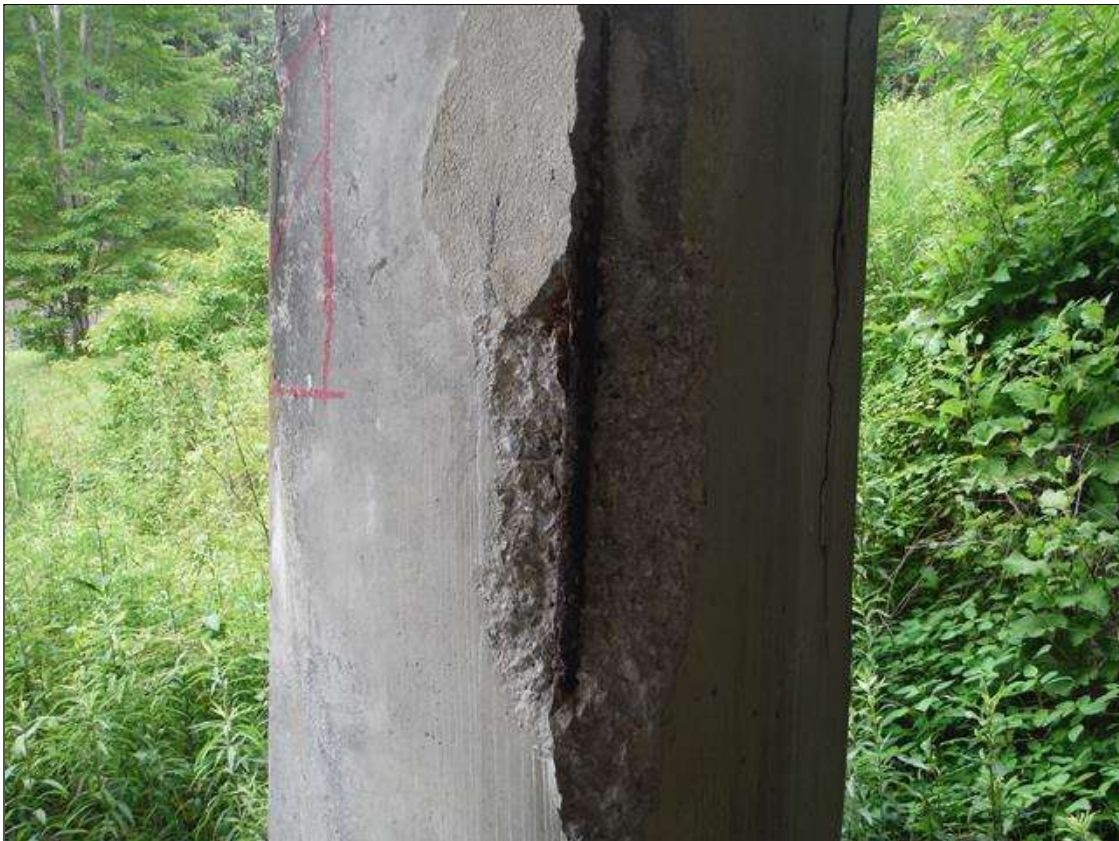
Bent 3 Pile 1: 5 FT. X 10" X 4" DEEP SPALL WITH EXPOSED REBAR WITH 1 1/2" REMAINING SECTION IN SOUTHWEST CORNER (PM)

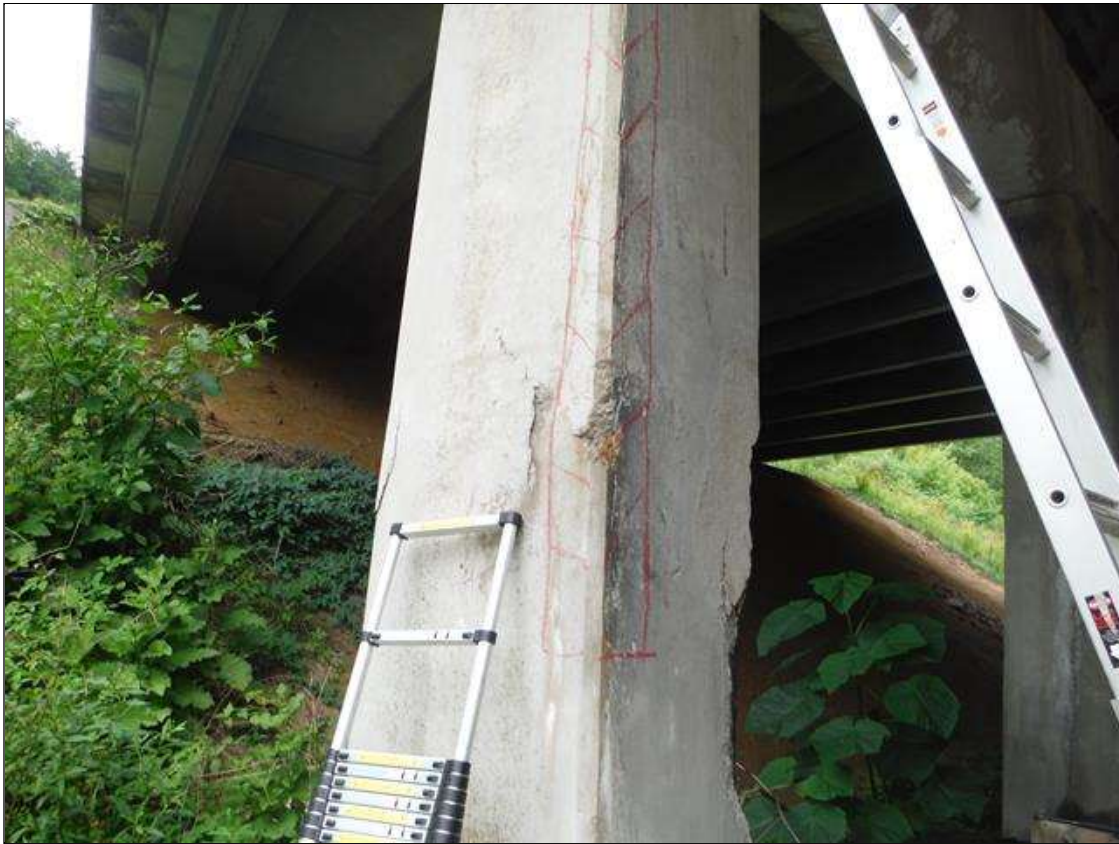
Bent 3 Pile 1: 82" X 13" AREA OF DELAMINATION ON NORTHWEST CORNER

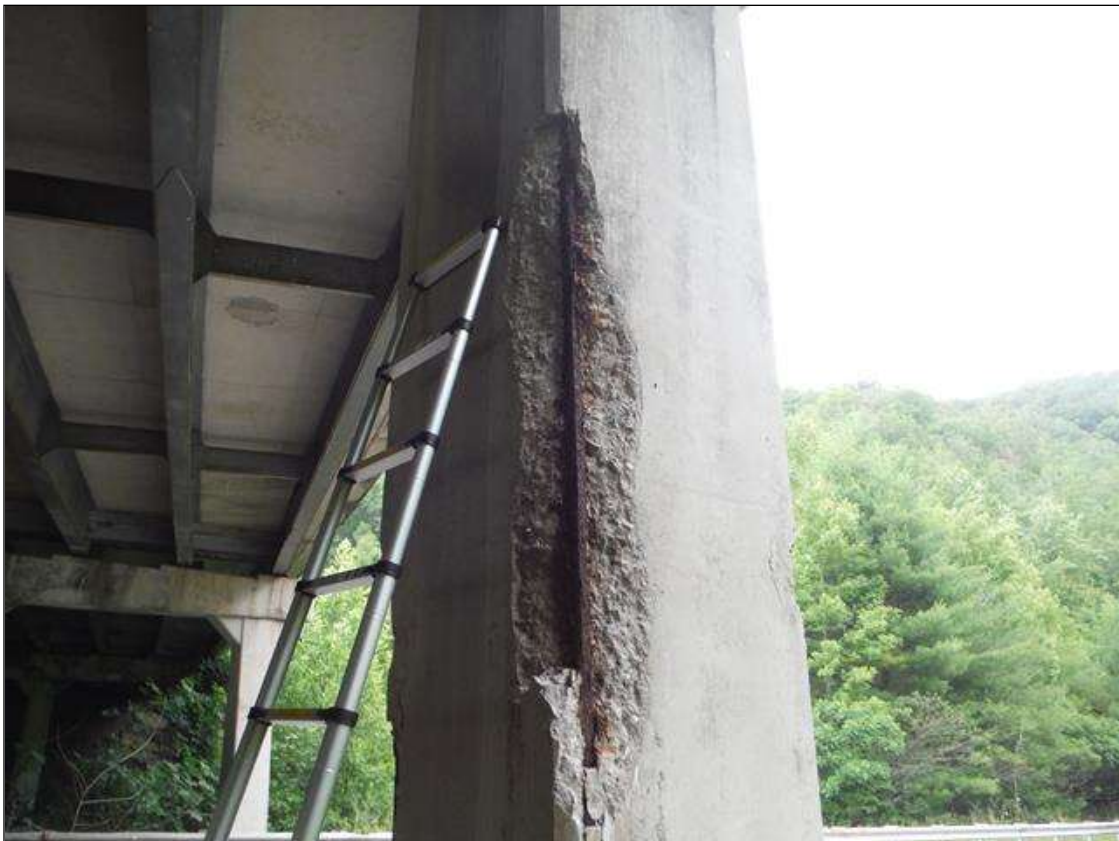
Bent 3 Pile 1: 8 FT. X 12" X 4" DEEP SPALL WITH EXPOSED REBAR WITH 1 1/2" REMAINING SECTION IN SOUTHEAST CORNER (PM)

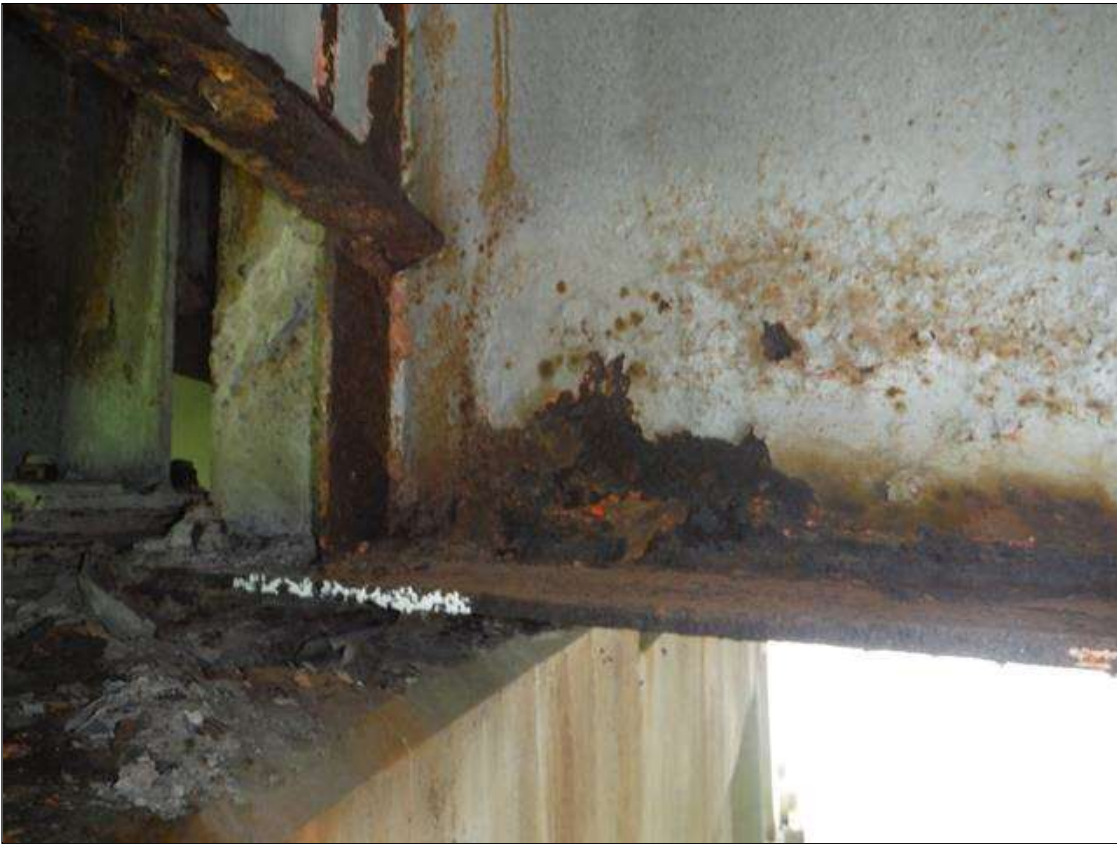
Span 3 Beam 2: 3 FT. OF CORROSION WITH 9/16" REMAINING SECTION IN LOWER WEB AND 1/2" REMAINING SECTION IN BOTTOM FLANGE AT BENT 3 (PM)

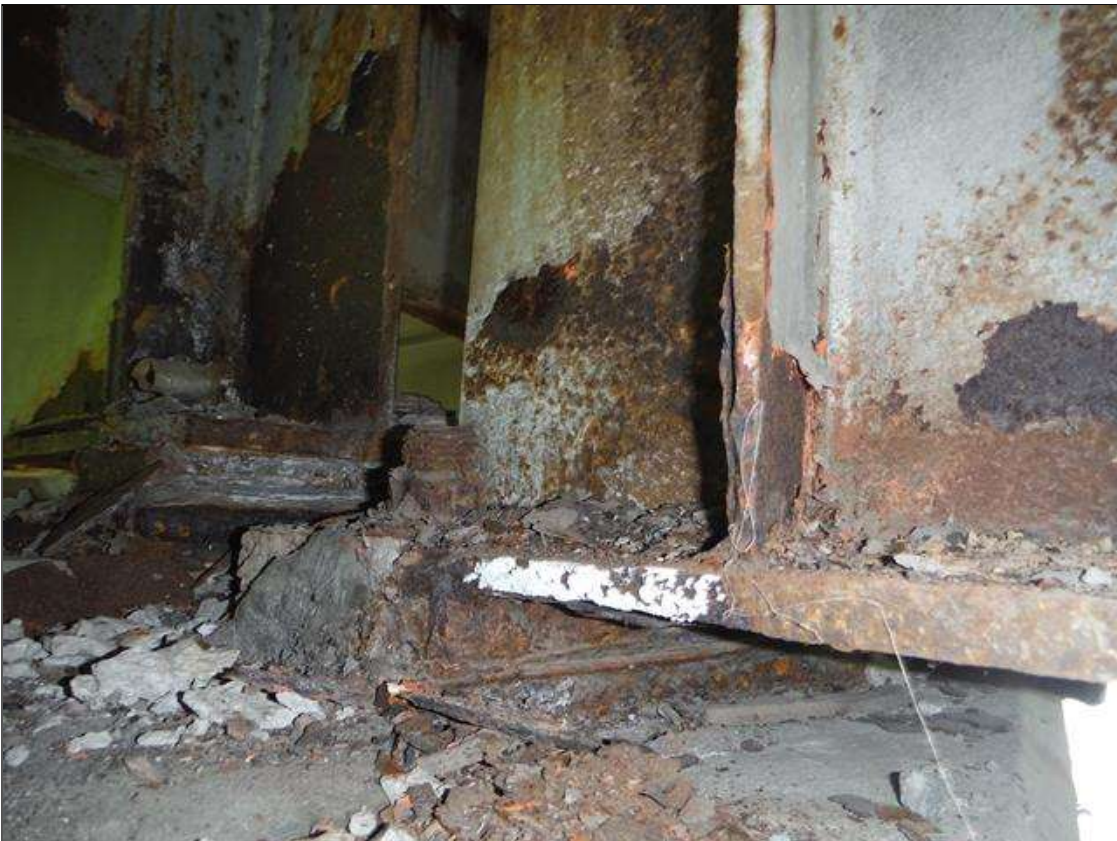
Span 3 Beam 3: 1 FT. OF CORROSION WITH 1/2" REMAINING SECTION IN BOTTOM FLANGE AT BENT 3 (PM)

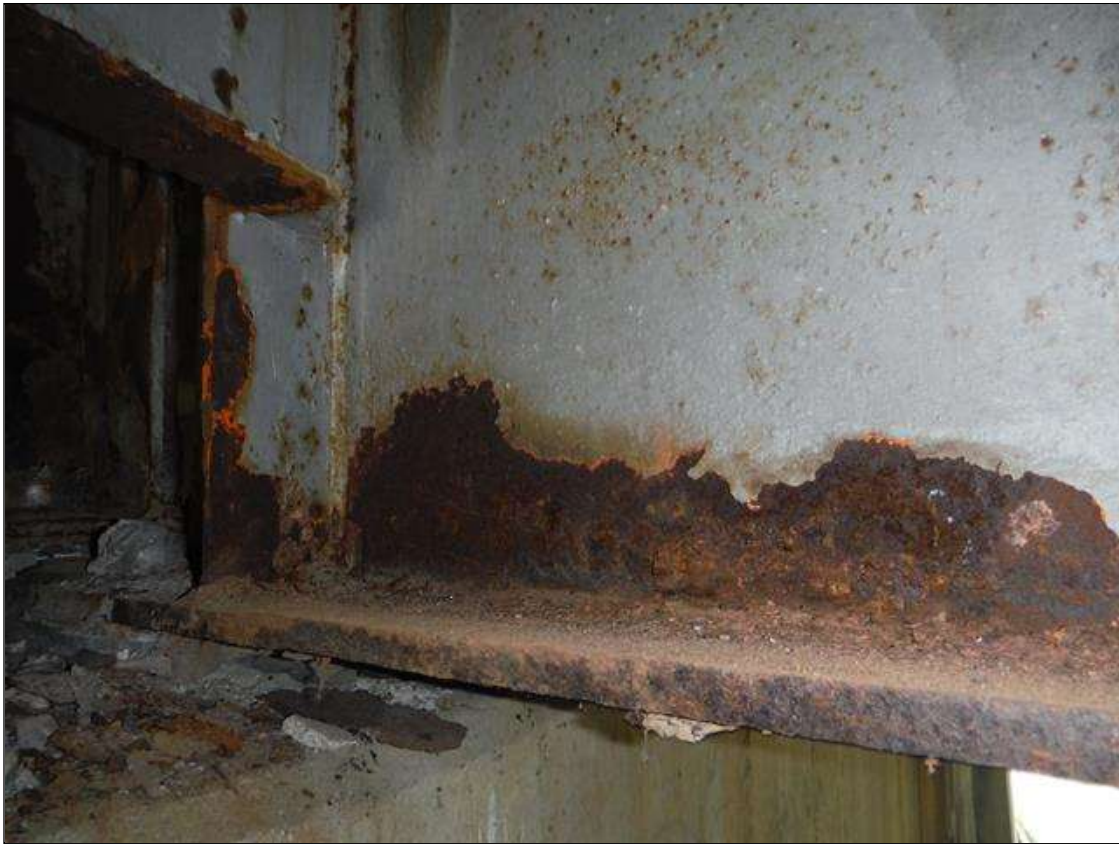
Span 3 Beam 4: 4 FT. OF CORROSION WITH 9/16" REMAINING SECTION IN LOWER WEB AND 11/16" REMAINING SECTION IN BOTTOM FLANGE AT BENT 3 (PM)

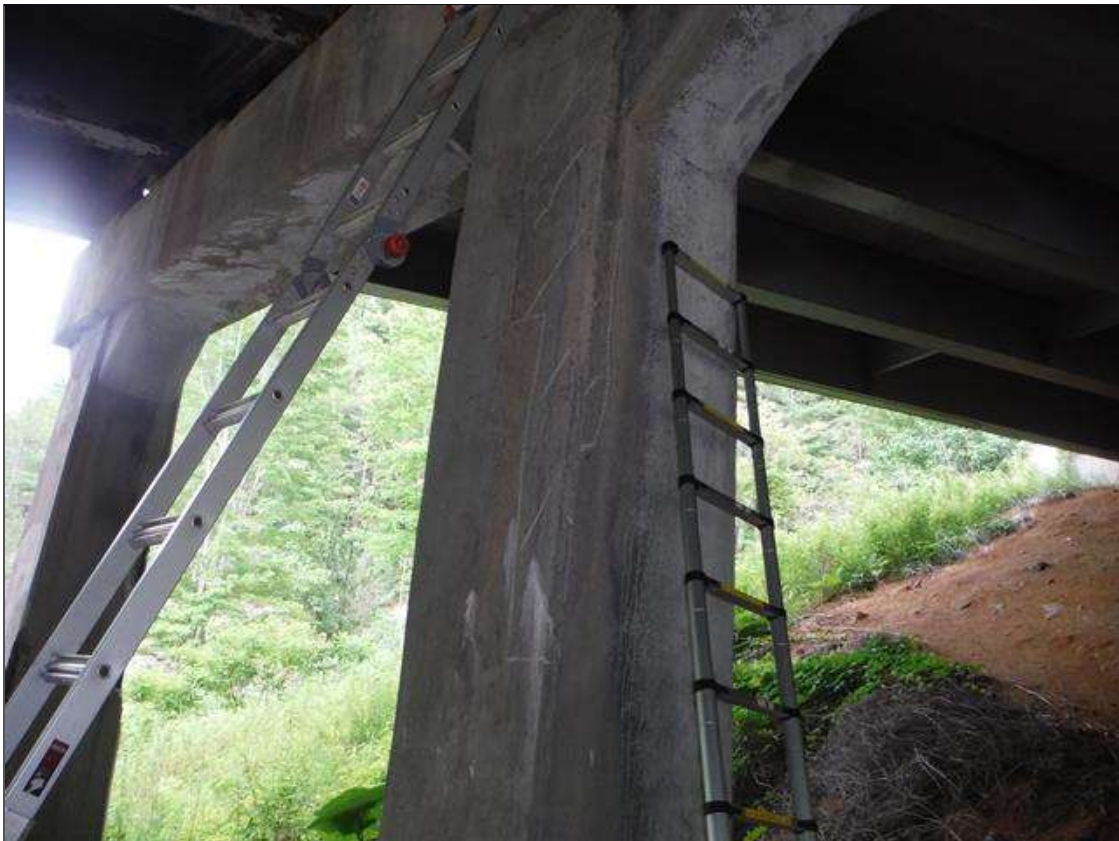
Bent 3 Pile 2: 84" X 14" AREA OF DELAMINATION ON WEST FACE

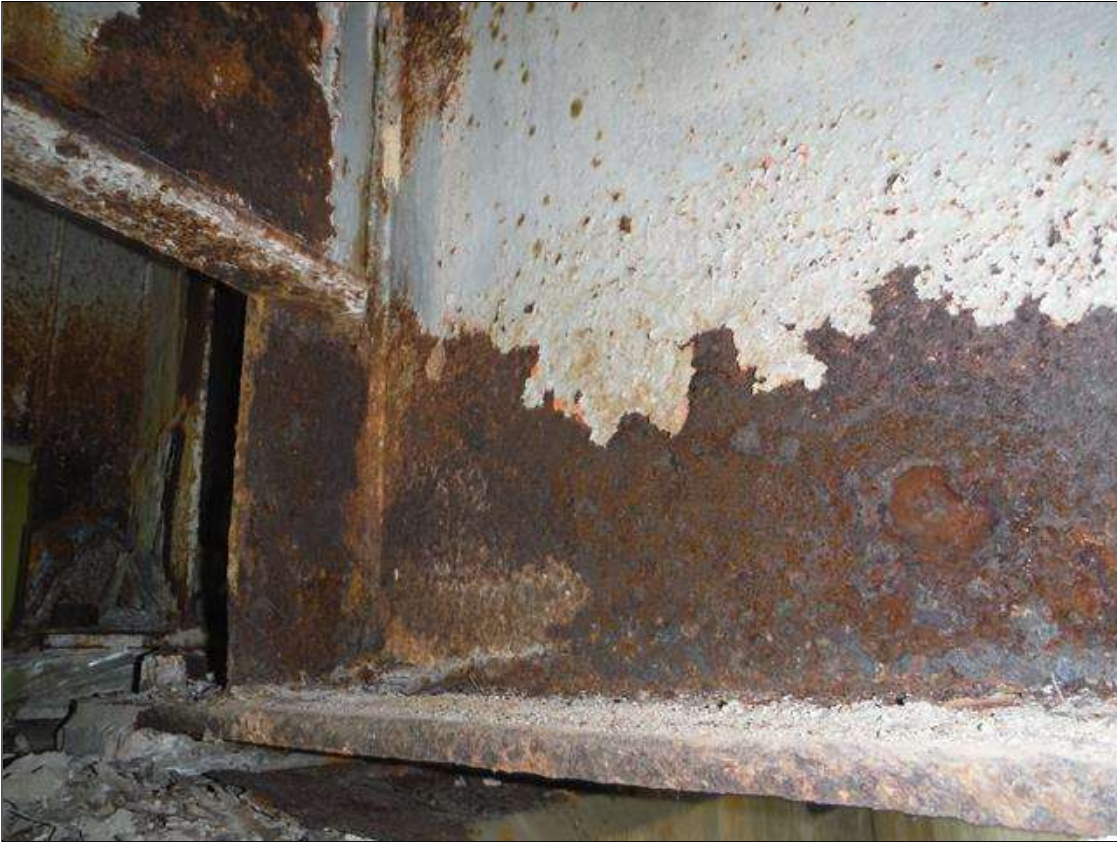
Span 3 Beam 5: 6 FT. OF CORROSION WITH 9/16" REMAINING SECTION IN LOWER WEB AND 3/4" REMAINING SECTION IN BOTTOM FLANGE AT BENT 3 (PM)

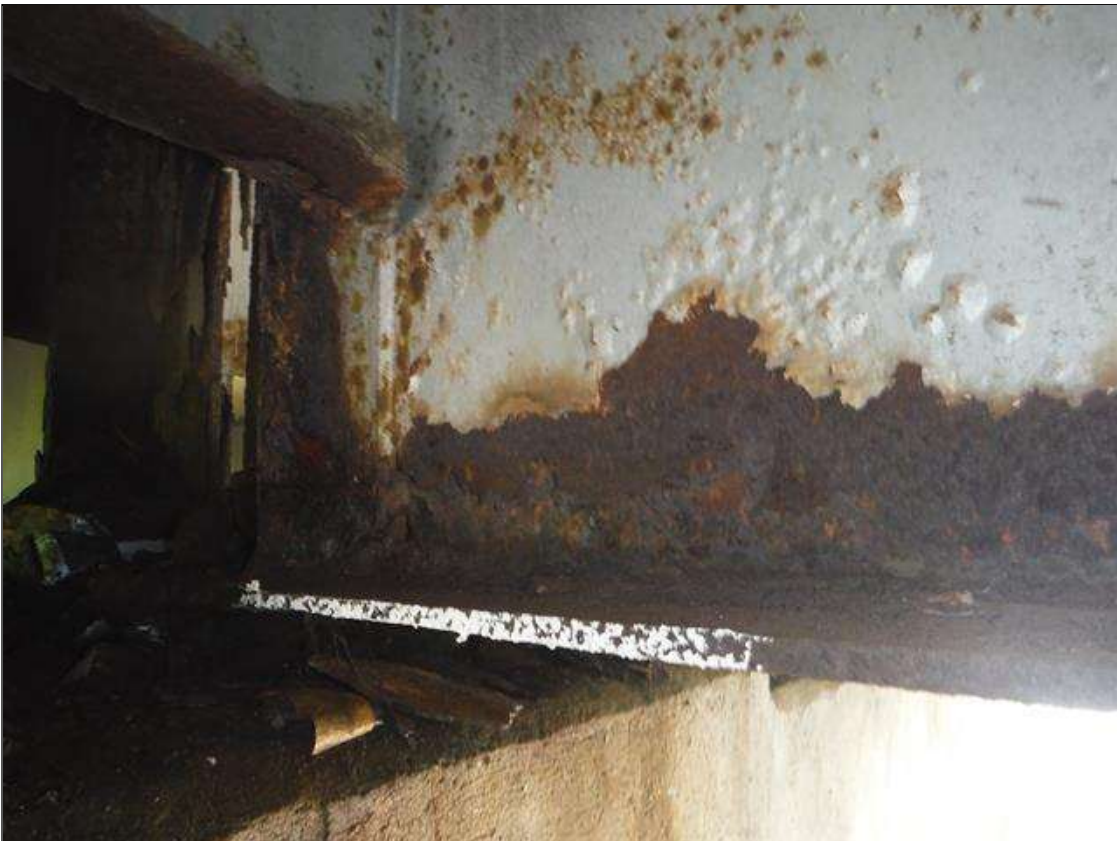
Span 3 Beam 6: 6 FT. OF CORROSION WITH 1/2" REMAINING SECTION IN LOWER WEB AND 7/16" REMAINING SECTION IN BOTTOM FLANGE AT BENT 3 (PM)

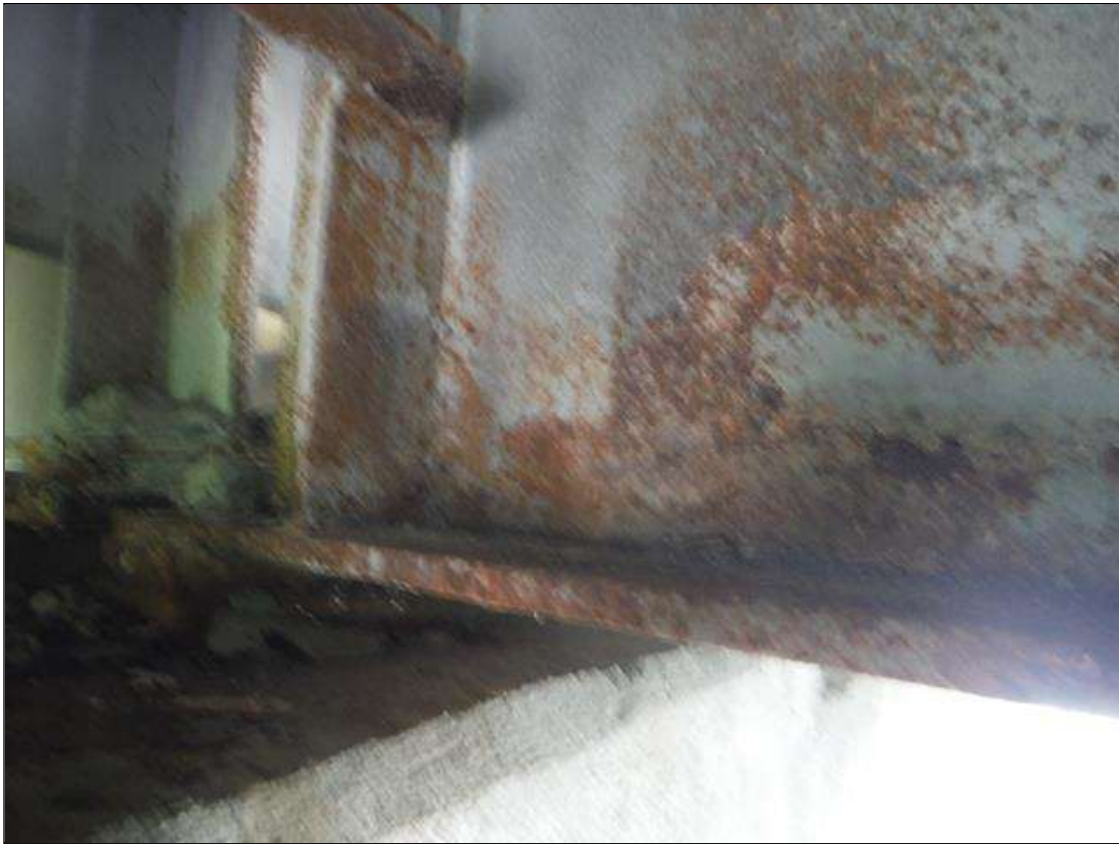
Span 3 Beam 7: 3 FT. OF CORROSION WITH 13/16" REMAINING SECTION IN BOTTOM FLANGE AT BENT 3

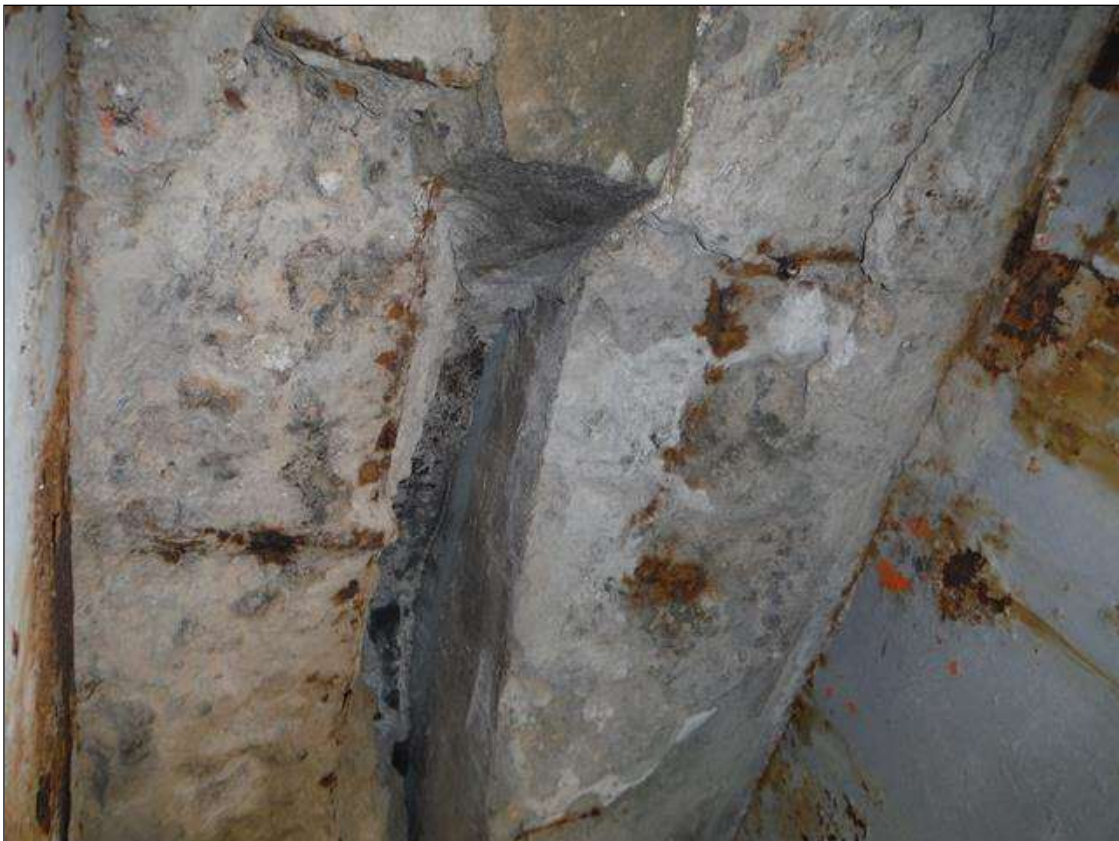
| Element Number | Defect Type | Defect Description | CS | CS Qty | Maint Qty | |
|---|---|---|---|---|---|---|
| 12 | Delamination/Spall | 36" X 11" X 3" DEEP SPALL WITH EXPOSED REBAR IN BOTTOM OF DECK BAY 8 AT BENT 3 | 3 | 3 | 3 | Square Feet |

Span 3 Deck: 36" X 11" X 3" DEEP SPALL WITH EXPOSED REBAR IN BOTTOM OF DECK BAY 8 AT BENT 3

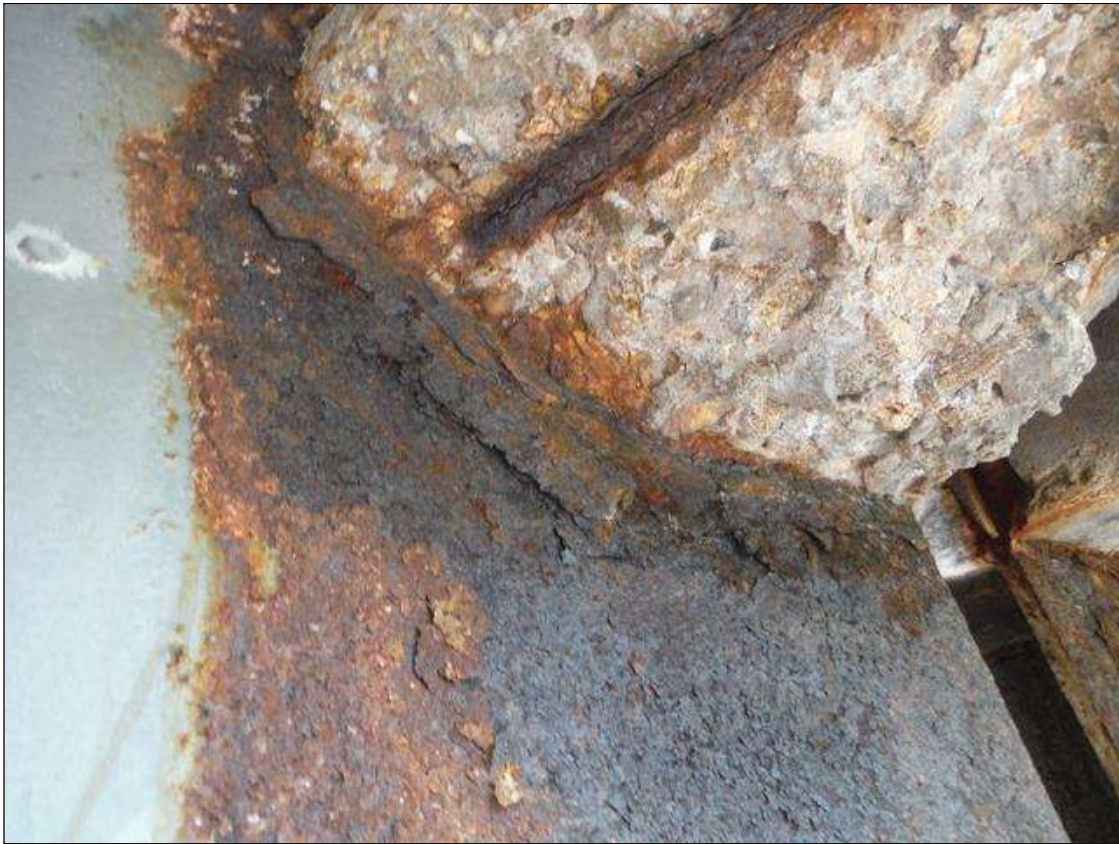
Span 3 Beam 10: 1 FT. OF CORROSION WITH 9/16" REMAINING SECTION IN WEB AROUND END DIAPHRAGM AT BENT 3

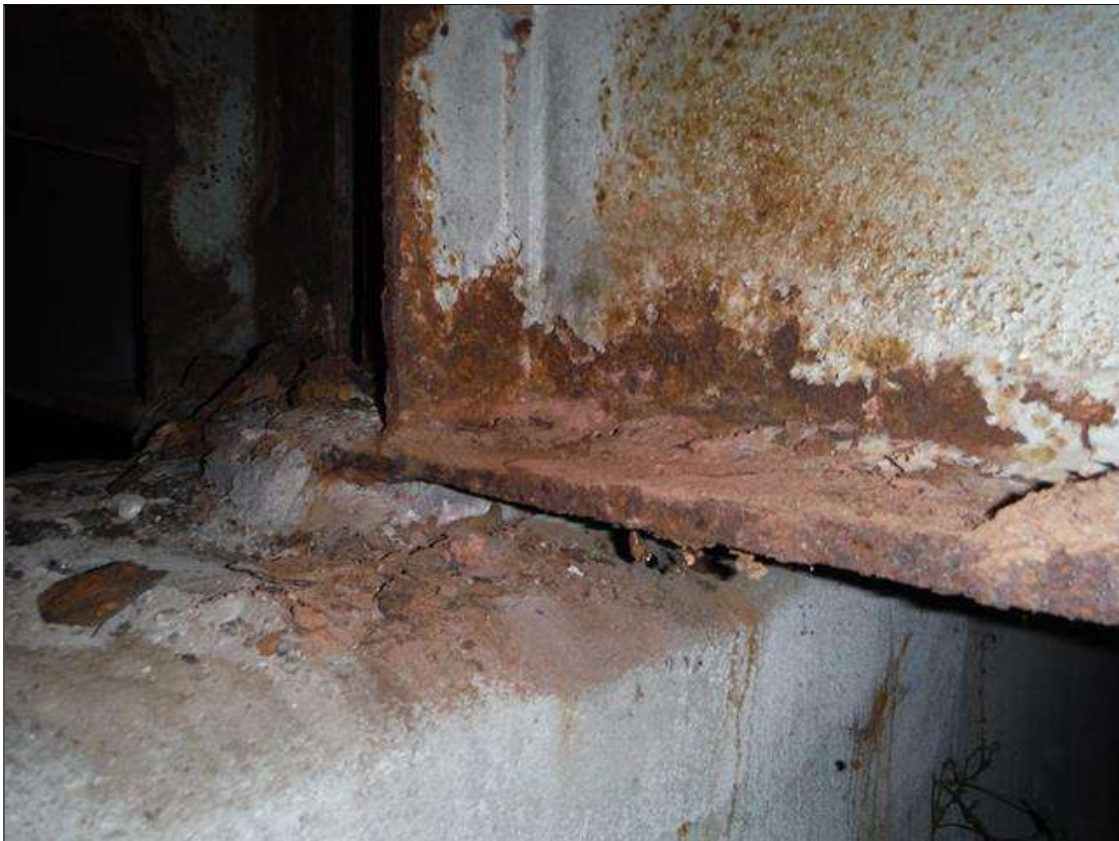
| Element Number | Element Name | Total Qty | CS1 Qty | CS2 Qty | CS3 Qty | CS4 Qty | |
|---|---|---|---|---|---|---|---|
| 107 | Corrosion | 3 FT. OF CORROSION WITH 1/2" REMAINING SECTION IN BOTTOM FLANGE AT BENT 1 (PM) | 3 | 3 | | 3 | Feet |

Span 1 Beam 6: 3 FT. OF CORROSION WITH 1/2" REMAINING SECTION IN BOTTOM FLANGE AT BENT 1 (PM)

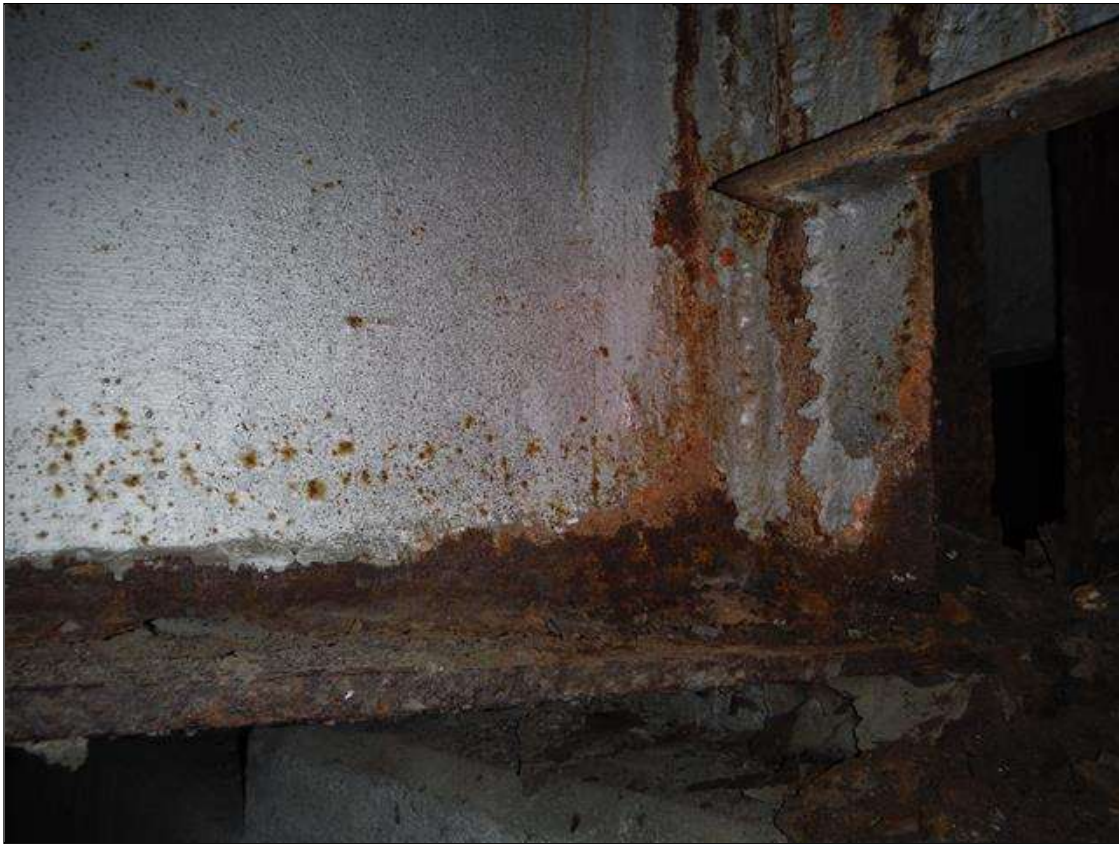
Span 3 Beam 6: 3 FT. OF CORROSION WITH 1/2" REMAINING SECTION IN BOTTOM FLANGE AND 2" X 1/2" HOLE IN BEARING STIFFENER AT BENT 2 (PM)

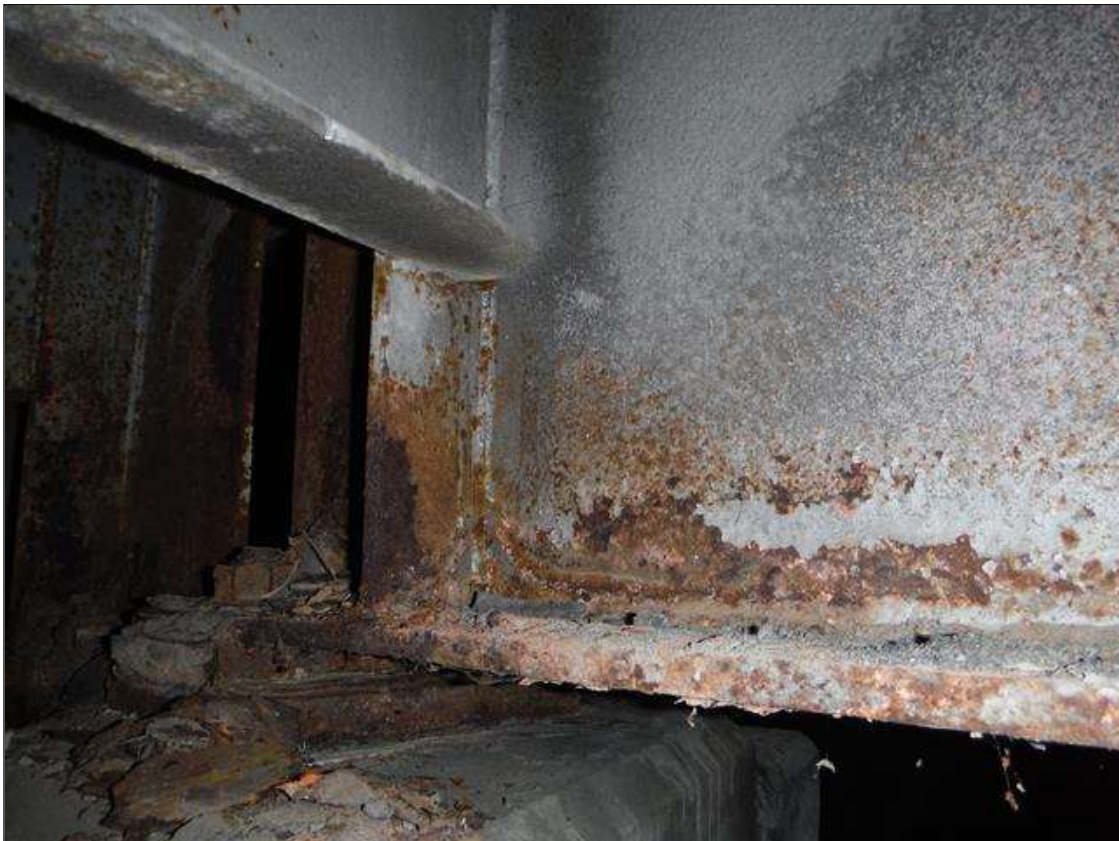
Span 4 Beam 1: 2 FT. OF CORROSION WITH 1/2" REMAINING SECTION IN BOTTOM FLANGE AT BENT 3 (PM)

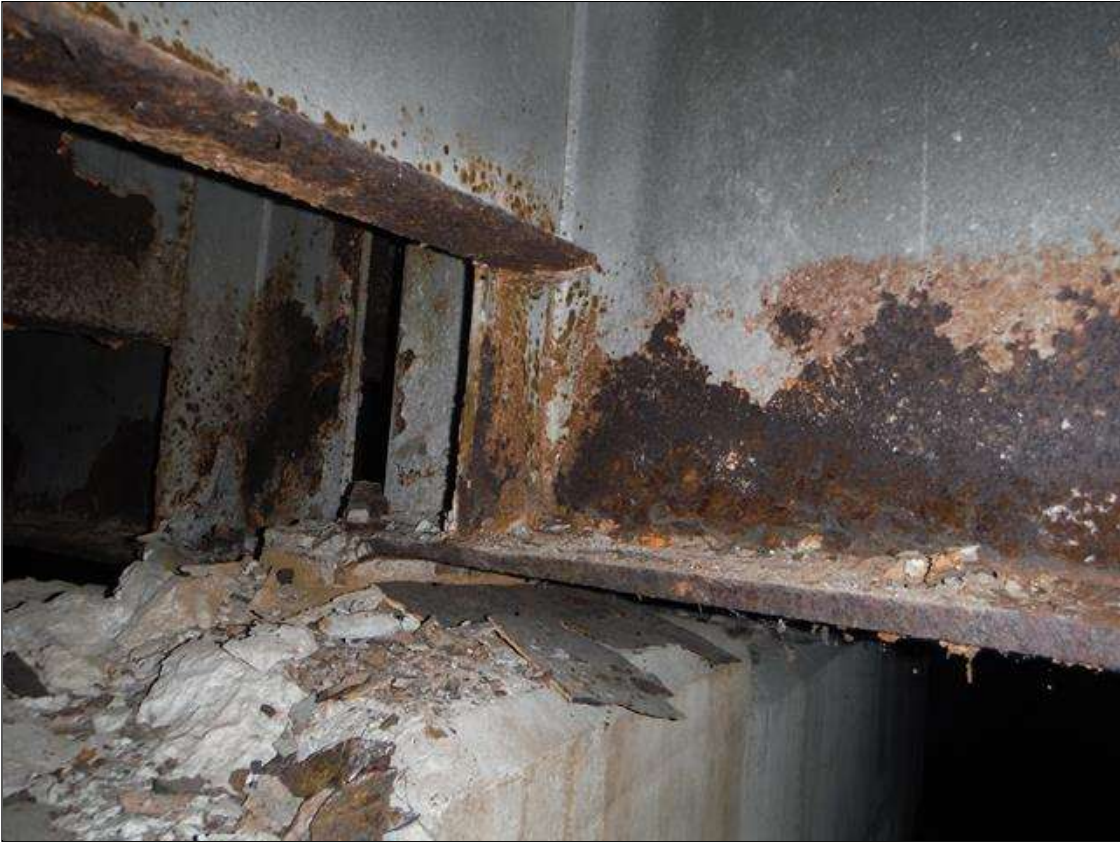
Span 4 Beam 2: 4 FT. OF CORROSION WITH 1/2" REMAINING SECTION IN LOWER WEB AND 1/2" REMAINING SECTION IN BOTTOM FLANGE AT BENT 3 (PM)

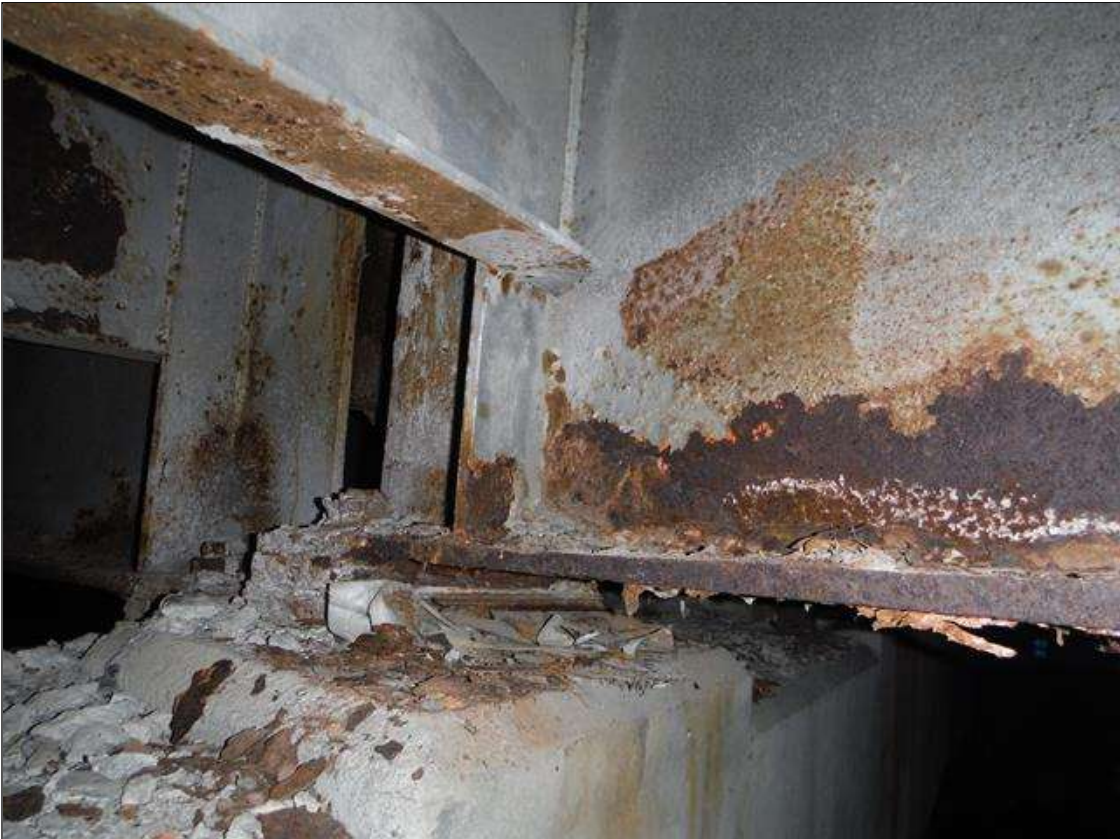
Span 4 Beam 3: 4 FT. OF CORROSION WITH 1/2" REMAINING SECTION IN LOWER WEB AND 9/16" REMAINING SECTION IN BOTTOM FLANGE AT BENT 3 (PM)

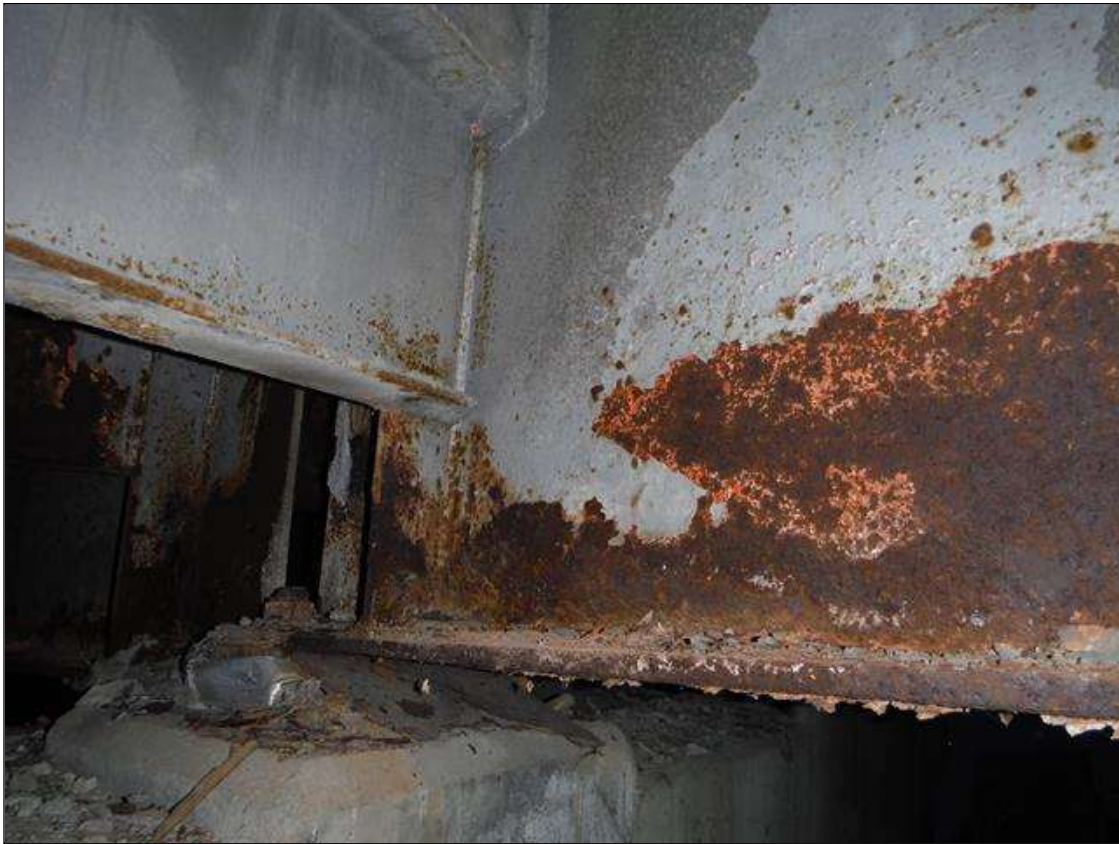
Span 4 Beam 4: 5 FT. OF CORROSION WITH 1/2" REMAINING SECTION IN LOWER WEB AND 9/16" REMAINING SECTION IN BOTTOM FLANGE AT BENT 3 (PM)

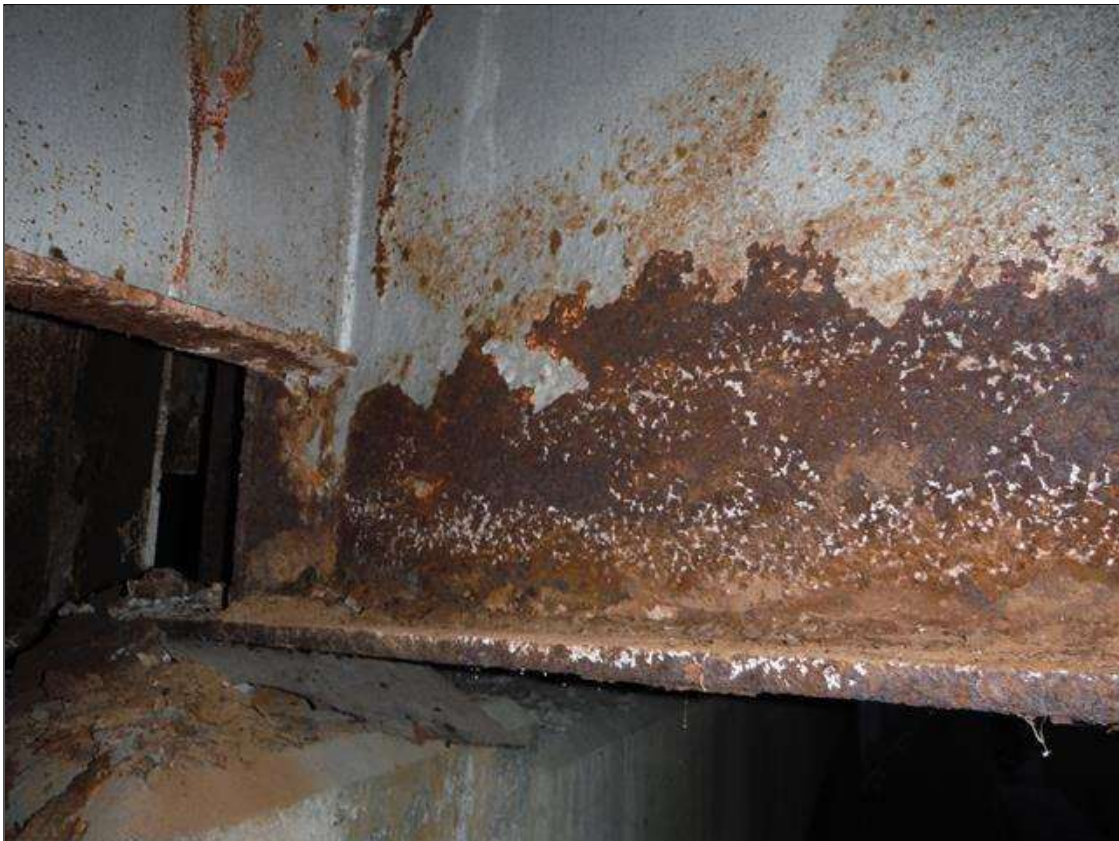
Span 4 Beam 5: 5 FT. OF CORROSION WITH 1/2" REMAINING SECTION IN LOWER WEB AND 5/8" REMAINING SECTION IN BOTTOM FLANGE AT BENT 3 (PM)

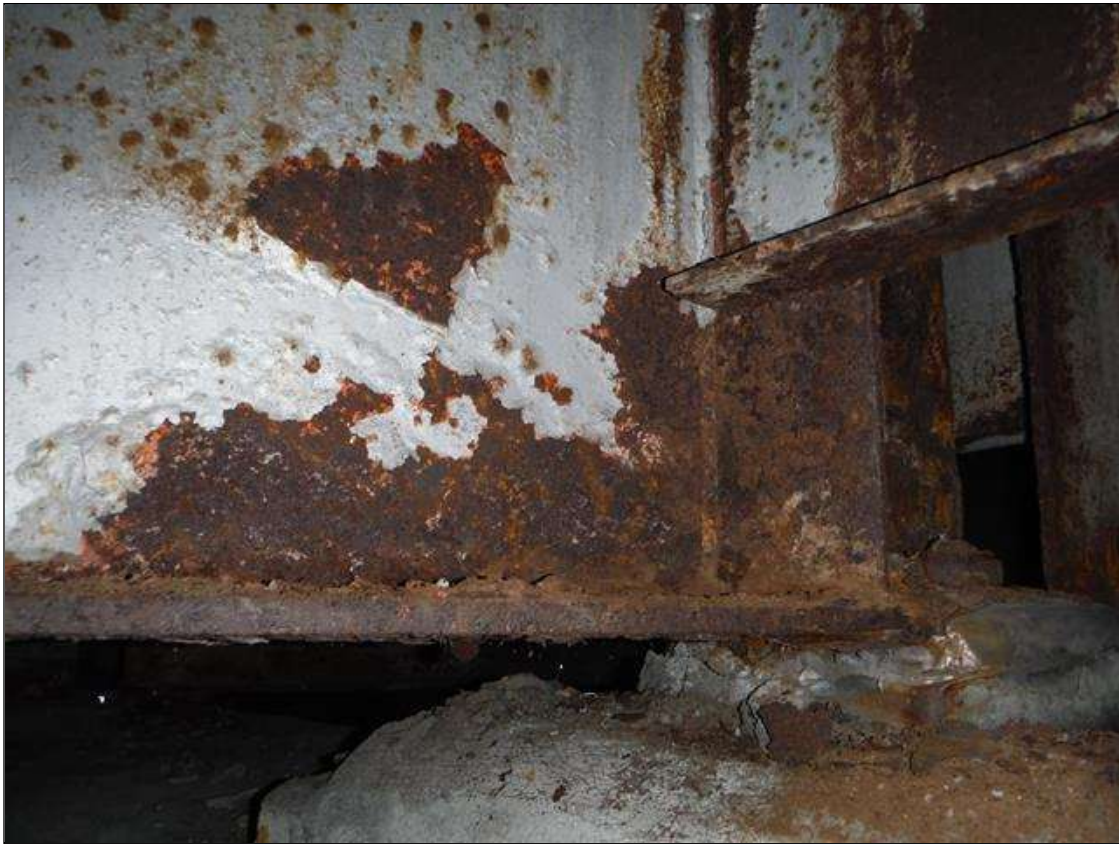
Span 4 Beam 6: 4 FT. OF CORROSION WITH 1/2" REMAINING SECTION IN LOWER WEB AND 5/8" REMAINING SECTION IN BOTTOM FLANGE AT BENT 3 (PM)

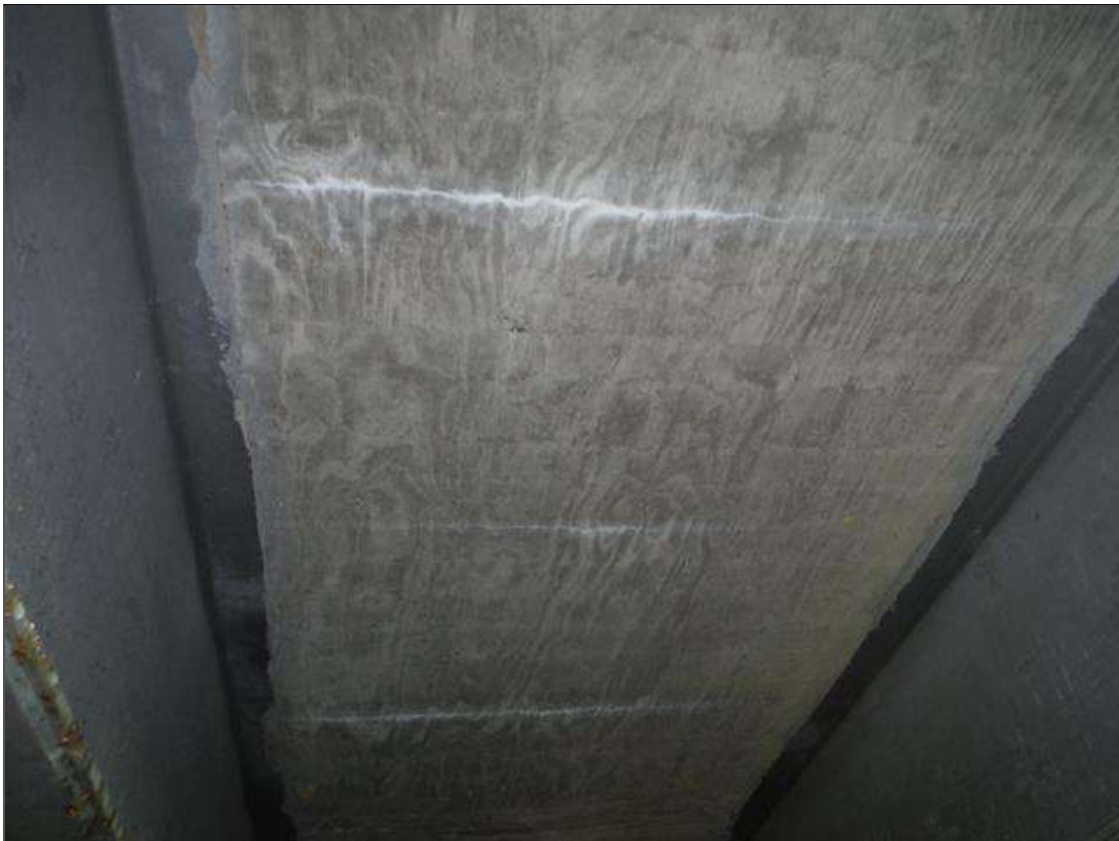
| Element Number | Defect Type | Defect Description | CS | CS Qty | Maint Qty | |
|---|---|---|---|---|---|---|
| 12 | Cracking (RC and Other) | 80 SF. OF TRANSVERSE HAIRLINE CRACKING WITH EFFLORESCENCE IN BOTTOM OF DECK BAYS 1-9 | 2 | 80 | 80 | Square Feet |

Span 1 Deck: 80 SF. OF TRANSVERSE HAIRLINE CRACKING WITH EFFLORESCENCE IN BOTTOM OF DECK BAYS 1-9

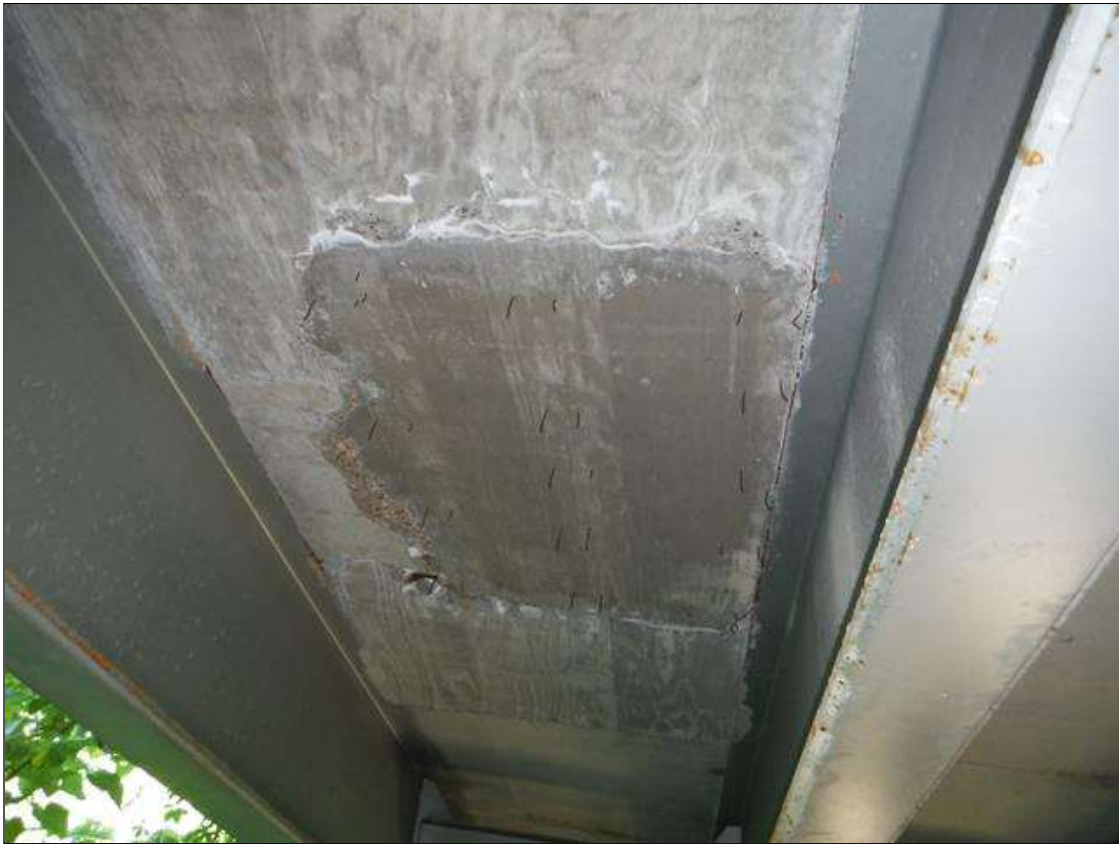
Span 1 Deck: 80 SF. OF PATCHED AREAS IN BOTTOM OF DECK BAYS 1-9
