NC DEPARTMENT OF TRANSPORTATION  
DIVISION OF HIGHWAYS  
STRUCTURE MANAGEMENT UNIT

## Structure Safety Report

### Routine Element Inspection - Contract

COUNTY: HAYWOOD STRUCTURE NUMBER: 430057 FREQUENCY: 24 MONTHS

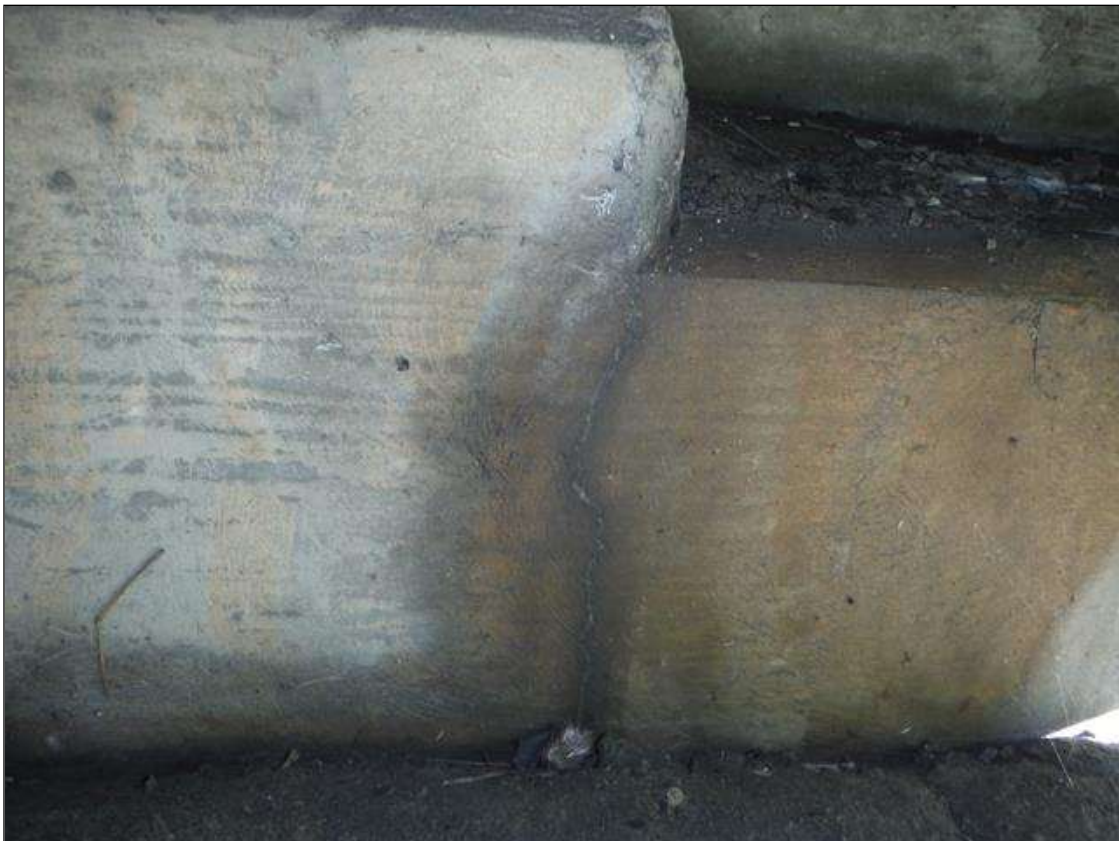
End Bent 2 Cap 1: 10" VERTICAL HAIRLINE CRACK UNDER BAY 9

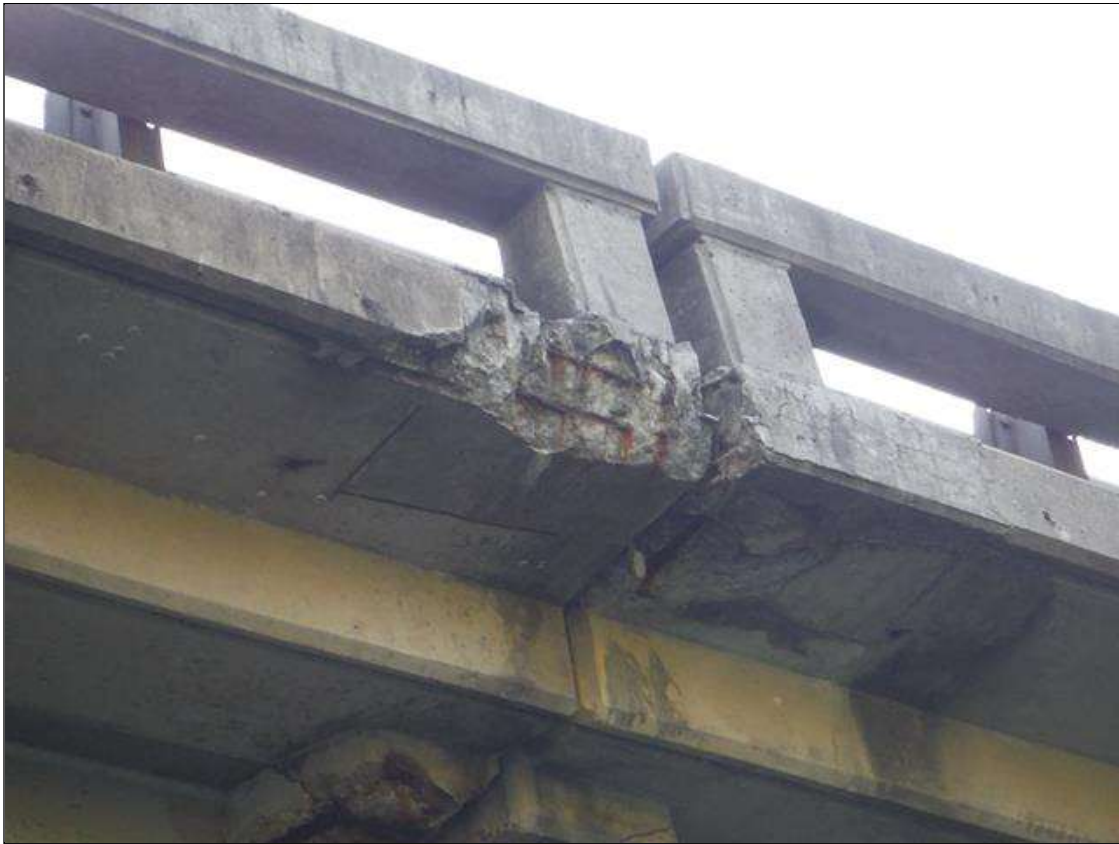
| Element Number | Defect Type | Defect Description | CS | CS Qty | Maint Qty | |
|---|---|---|---|---|---|---|
| 12 | Delamination/Spall | 24" X 9" X 4" DEEP SPALL IN EDGE OF DECK NORTH OVERHANG AT BENT 2 | 3 | 2 | 2 | Square Feet |

Span 3 Deck: 24" X 9" X 4" DEEP SPALL IN EDGE OF DECK NORTH OVERHANG AT BENT 2

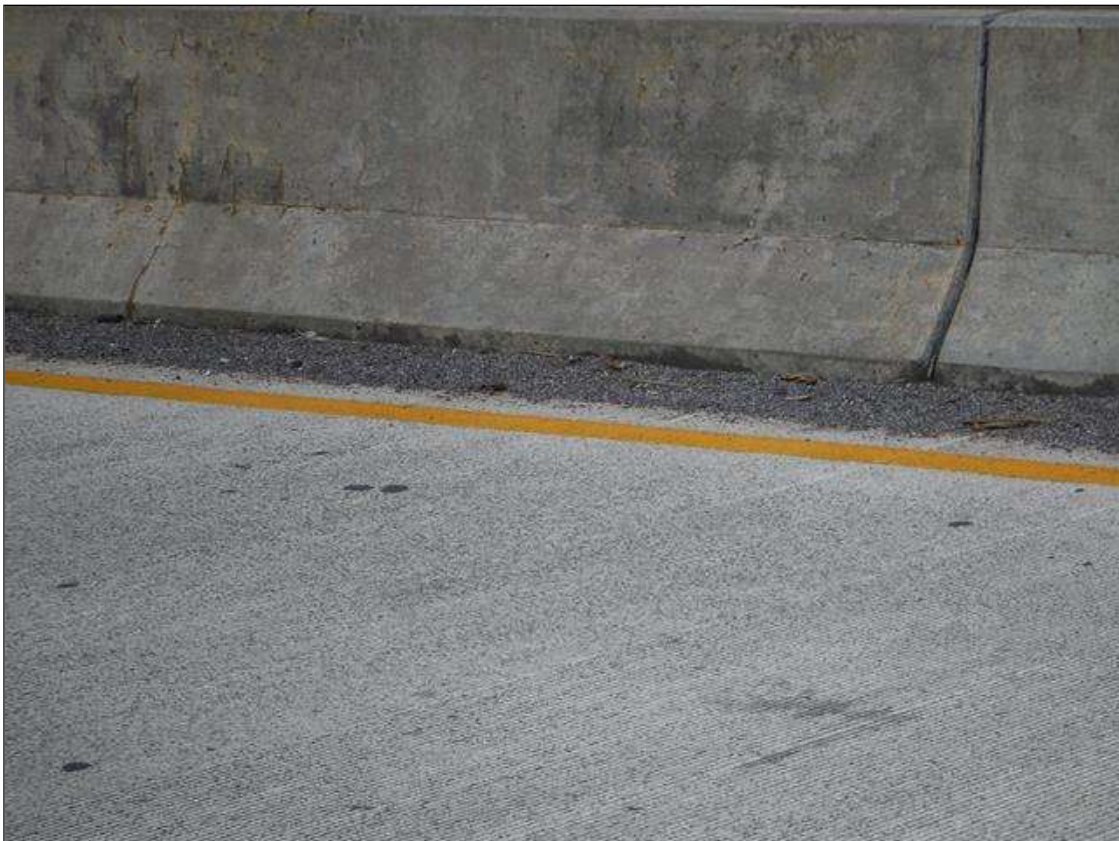
Details SAND AND GRAVEL ALONG EASTBOUND MEDIAN SHOULDER AND SOUTH SHOULDER

SAND AND GRAVEL ALONG EASTBOUND MEDIAN SHOULDER

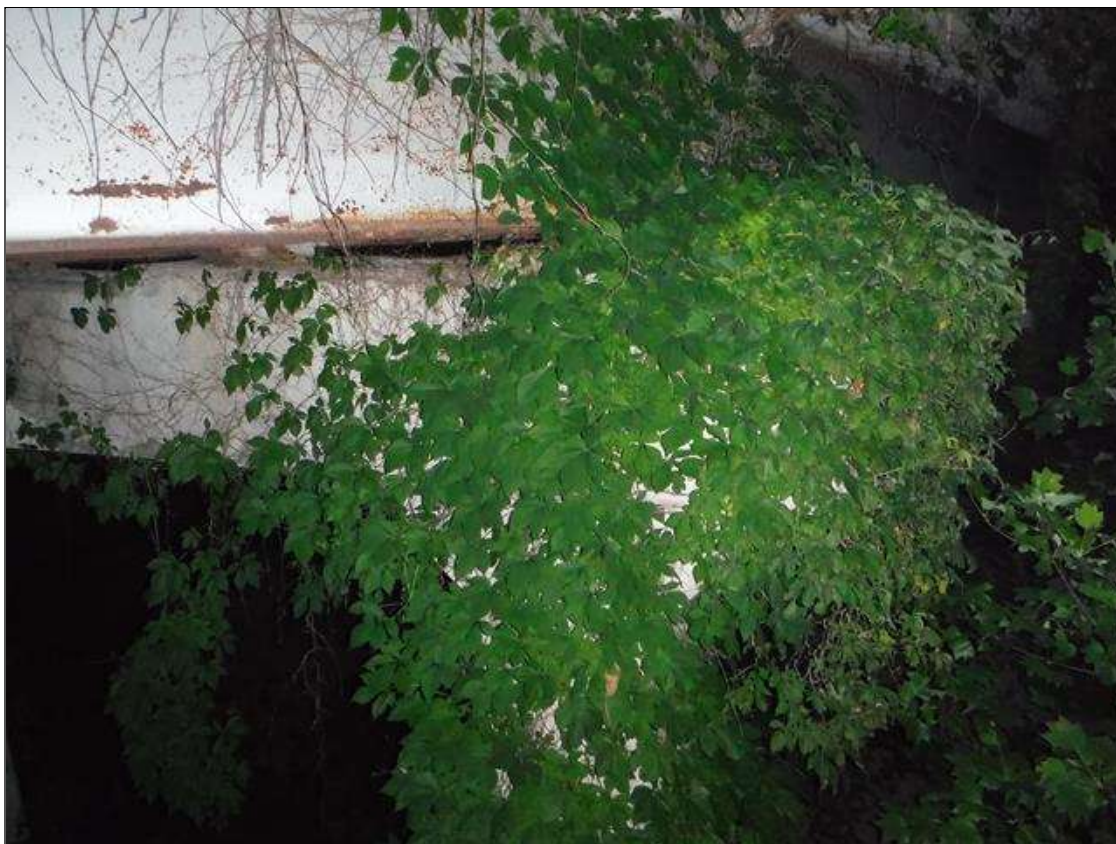
VEGETATION OVERGROWTH AT BENT 1 CAP NORTH OVERHANG

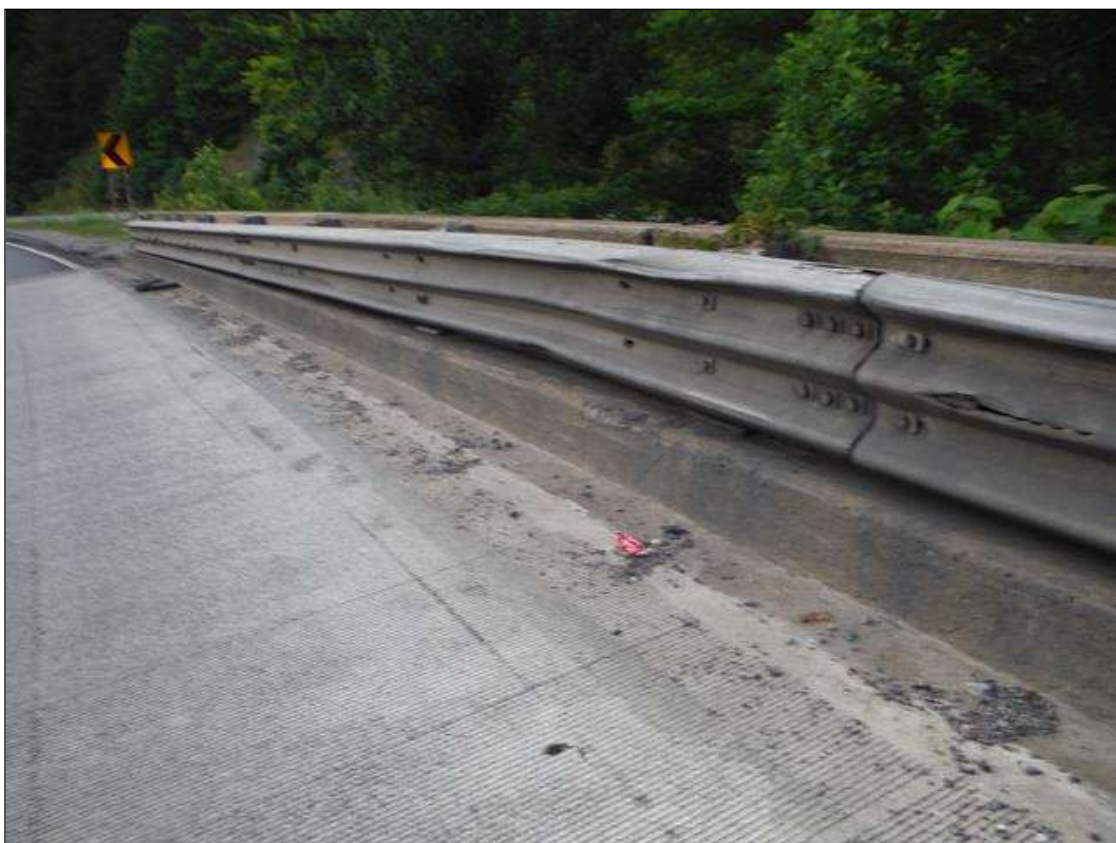
| Element Number | Defect Type | Defect Description | CS | CS Qty | Maint Qty | |
|---|---|---|---|---|---|---|
| 333 | Distortion | 66 FT. OF IMPACT DAMAGE TO METAL RAIL | 2 | 18 | | Feet |

Span 1 Left Bridge Rail: 66 FT. OF IMPACT DAMAGE TO METAL RAIL

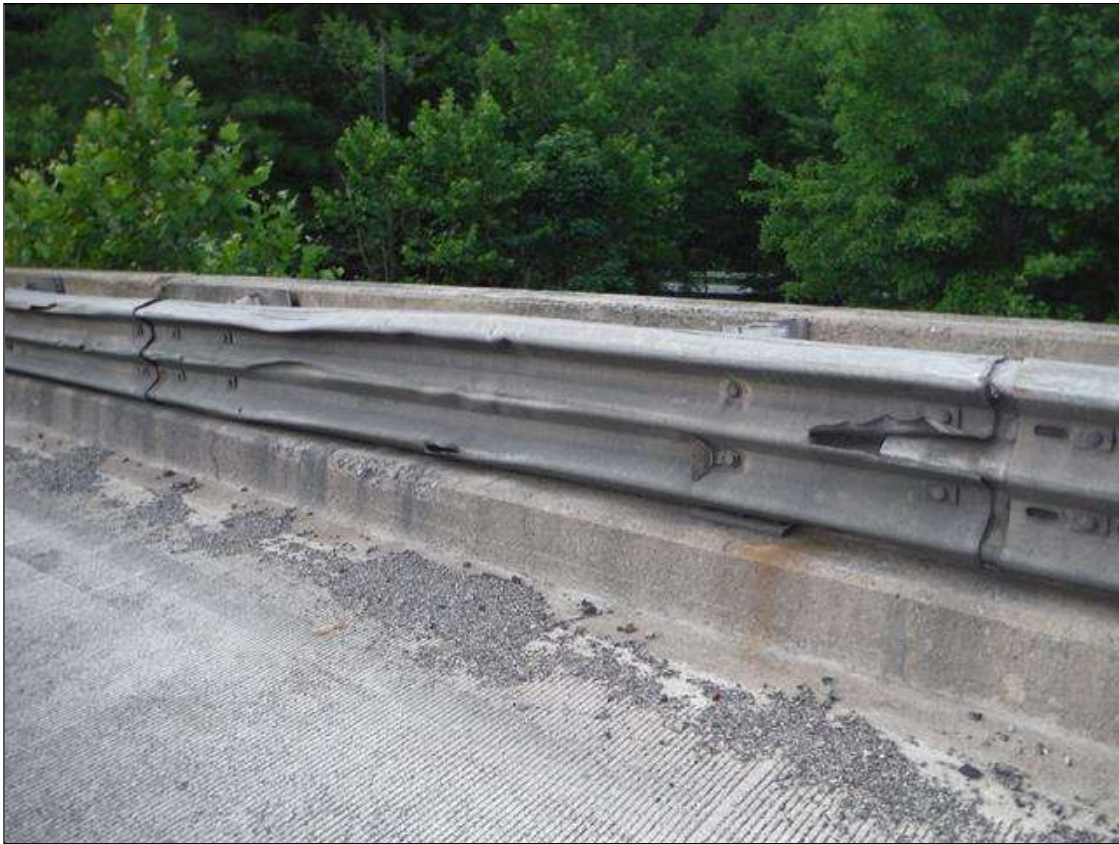
| 333 | Distortion | 25 FT. OF IMPACT DAMAGE TO METAL RAIL | 2 | 25 | Feet |

Span 2 Left Bridge Rail: 25 FT. OF IMPACT DAMAGE TO METAL RAIL

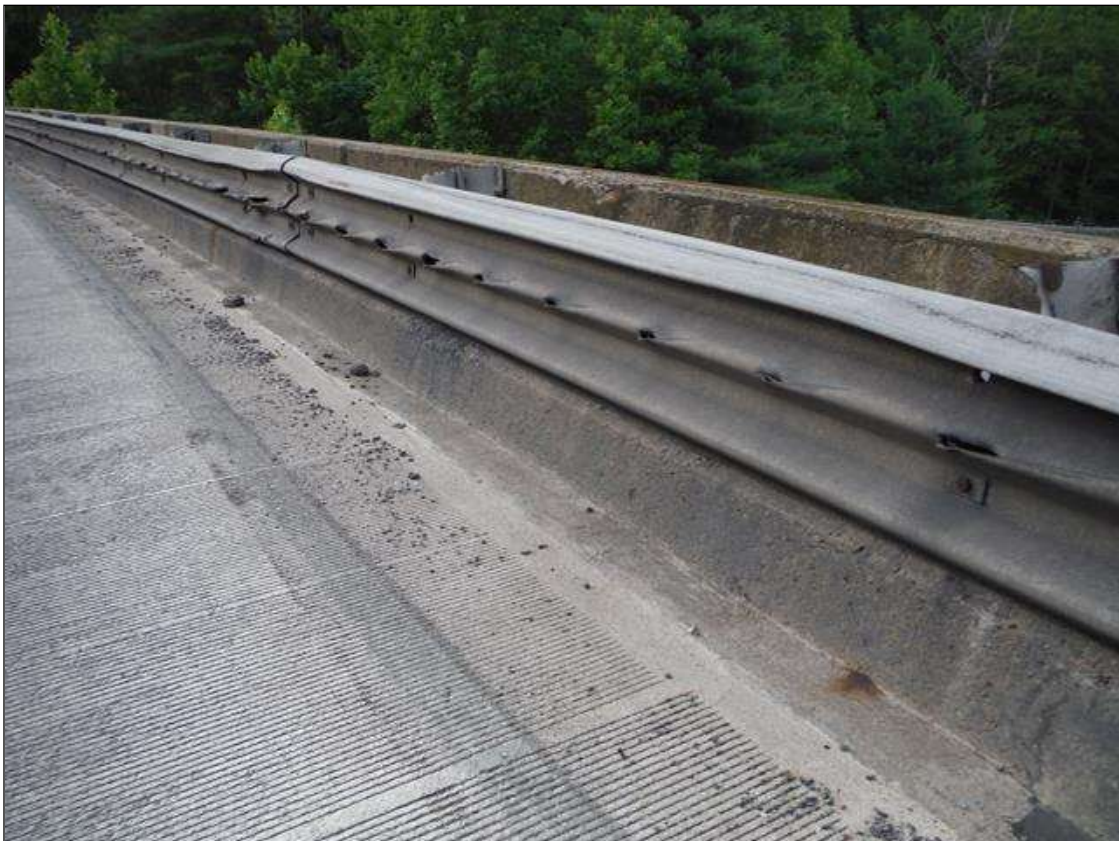
Span 3 Left Bridge Rail: 65 FT. OF IMPACT DAMAGE TO METAL RAIL

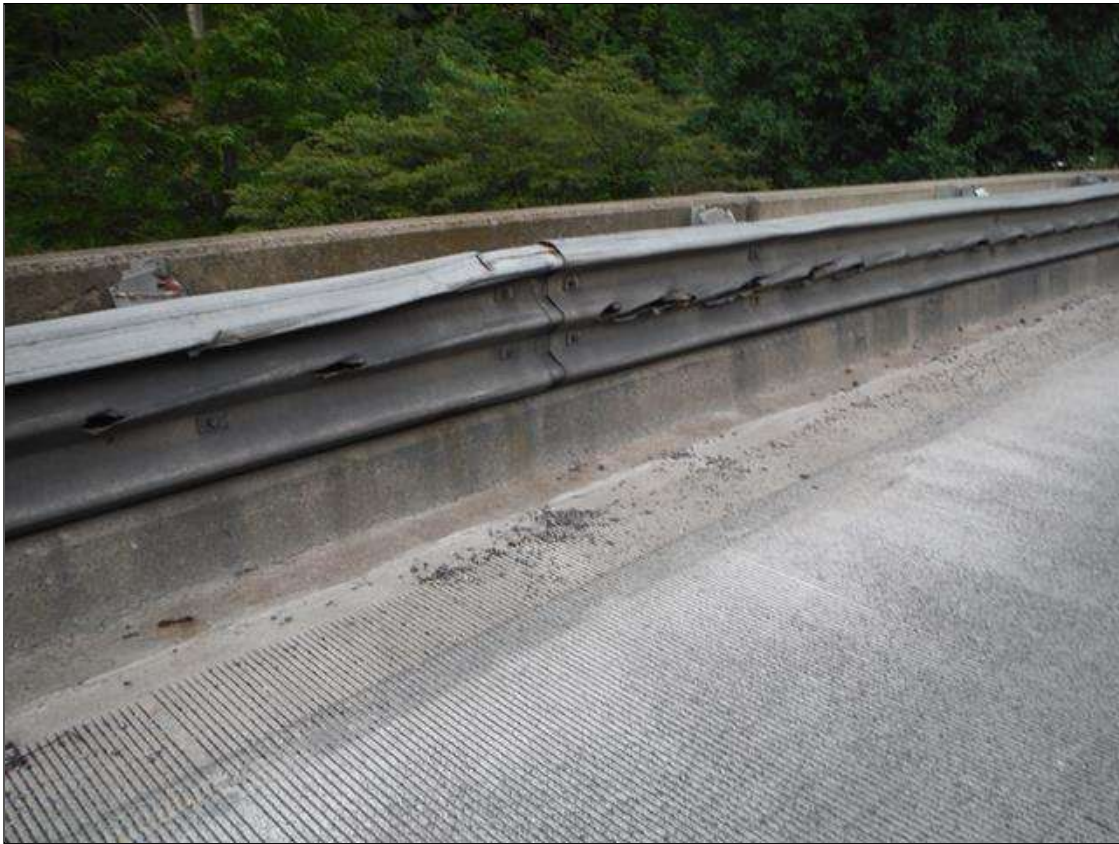
Span 4 Left Bridge Rail: 35 FT. OF IMPACT DAMAGE TO METAL RAIL

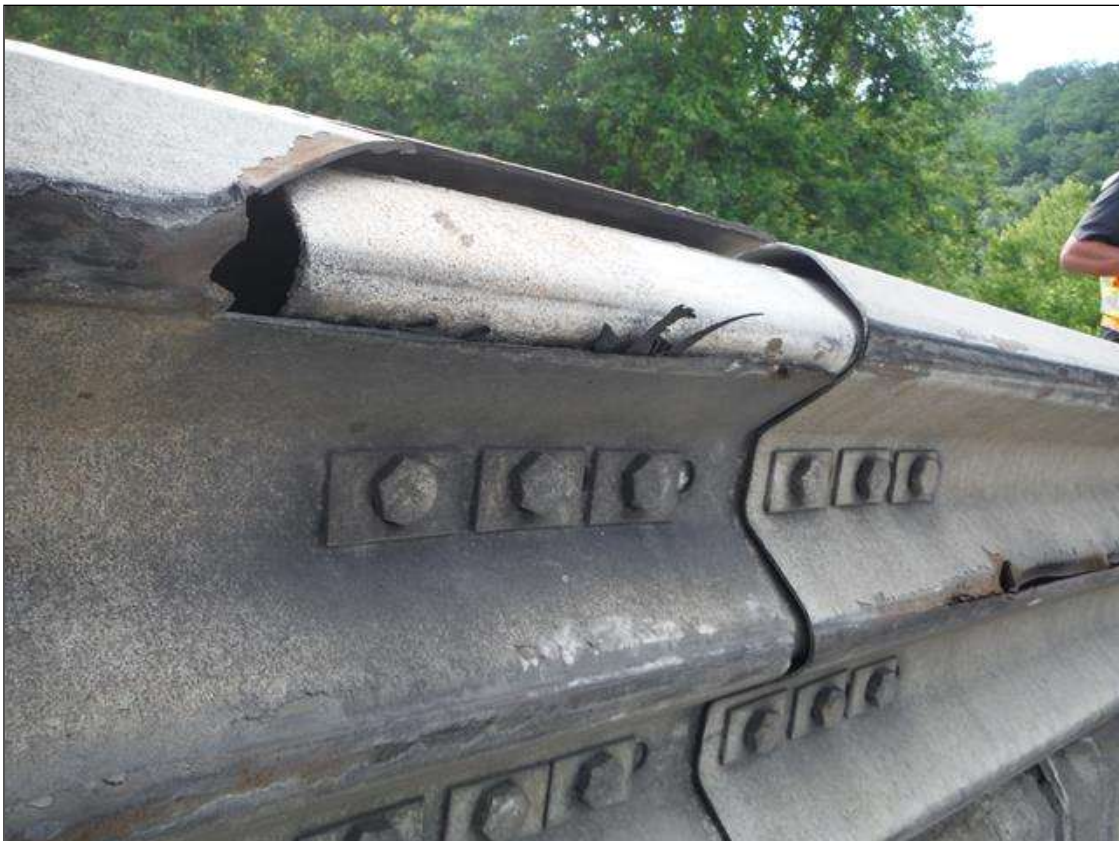
Span 4 Right Bridge Rail: 3 FT. OF GOUGES UP TO 18" X 3" IN METAL RAIL AT BENT 3

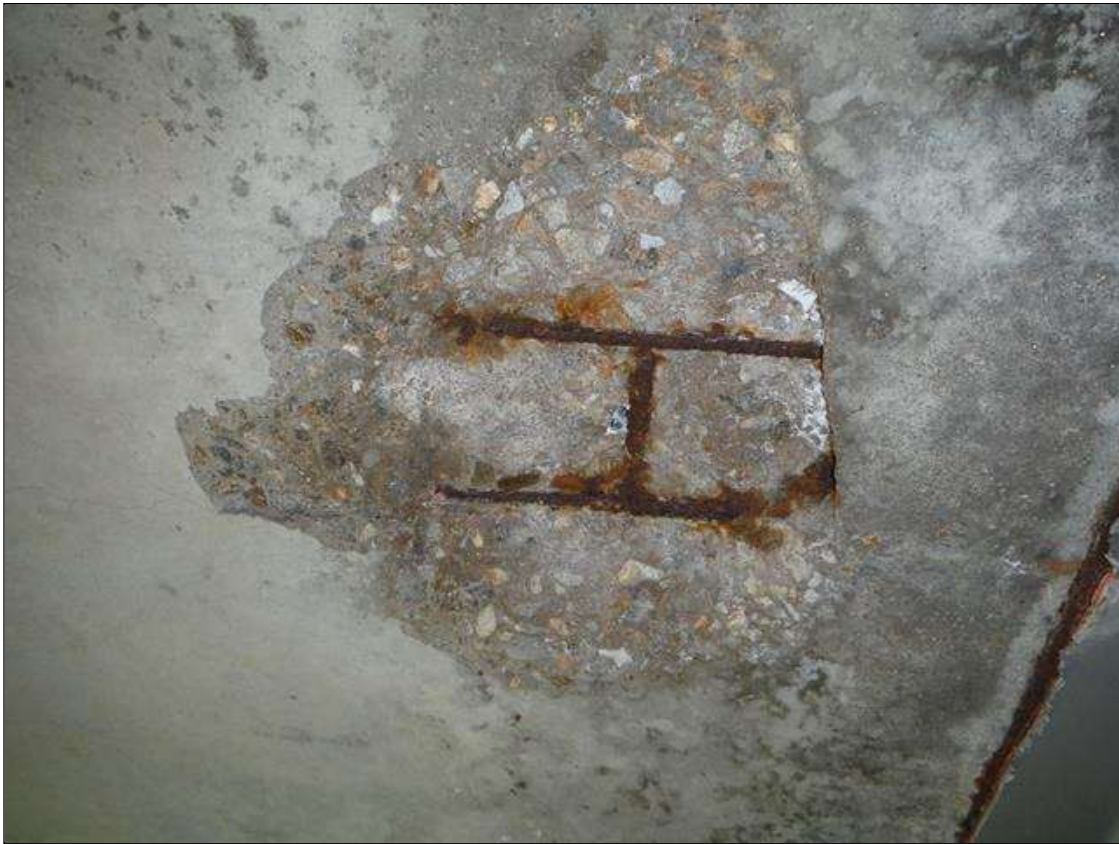
| Element Number | Defect Type | Defect Description | CS | CS Qty | Maint Qty | |
|---|---|---|---|---|---|---|
| 12 | Delamination/Spall | 18" DIAMETER X 2" DEEP SPALL WITH EXPOSED REBAR IN BOTTOM OF DECK BAY 9, 20 FT. FROM END BENT 1 | 3 | 2 | 2 | Square Feet |

Span 1 Deck: 18" DIAMETER X 2" DEEP SPALL WITH EXPOSED REBAR IN BOTTOM OF DECK BAY 9, 20 FT. FROM END BENT 1

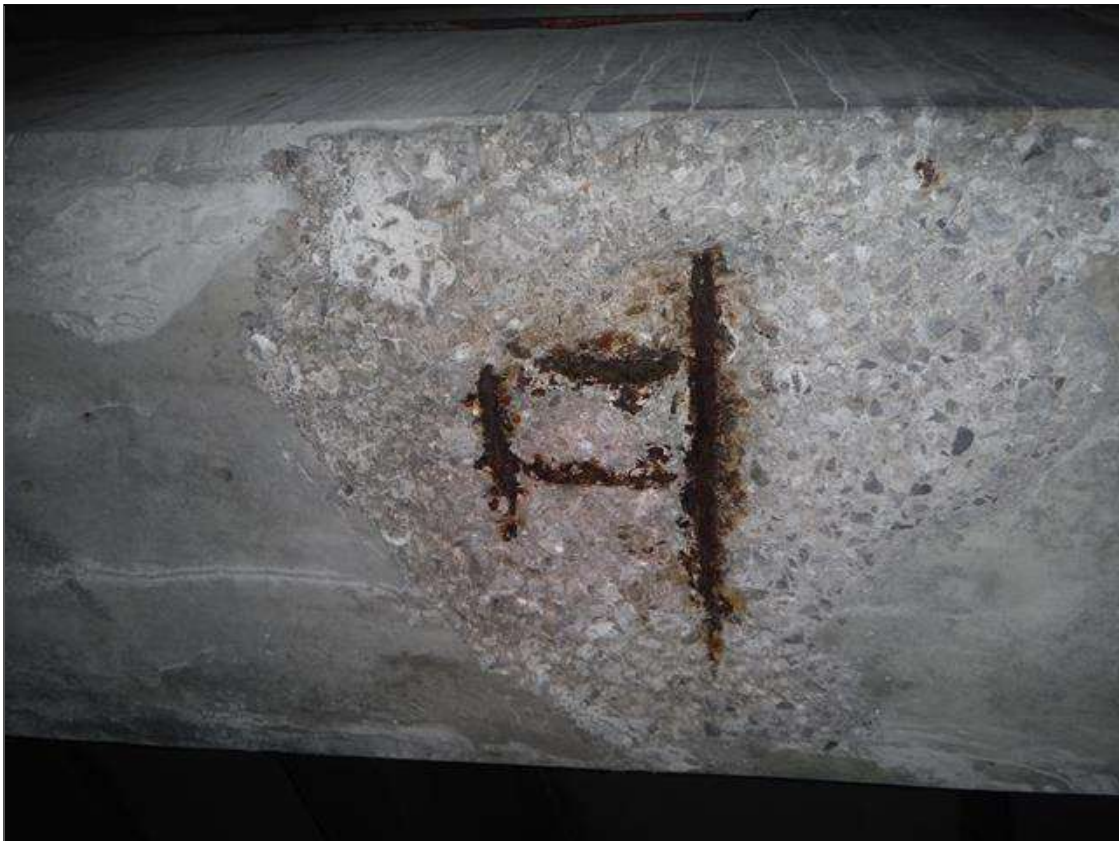
Bent 2 Cap 1: 36" X 33" X 2" DEEP SPALL WITH EXPOSED REBAR IN BOTTOM OF CAP BETWEEN COLUMN 1 AND 2

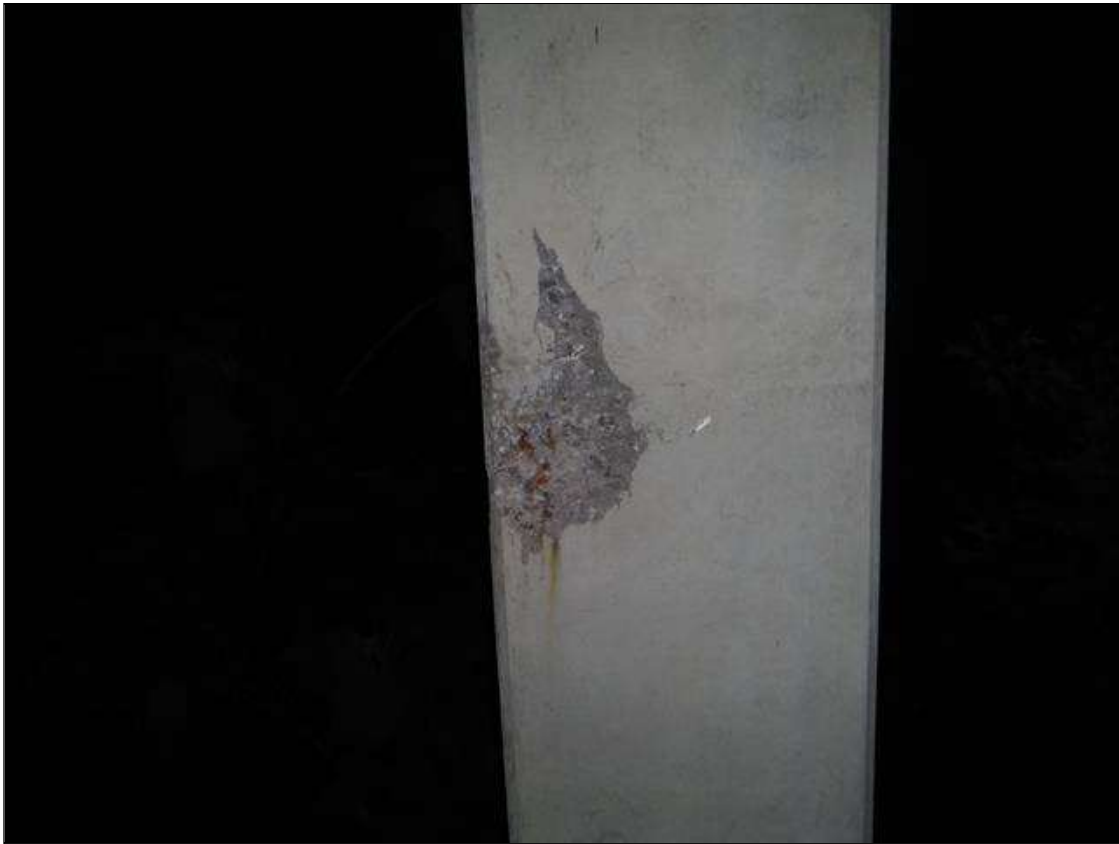
Bent 2 Pile 1: 24" X 12" X 1 1/2" DEEP SPALL WITH EXPOSED REBAR IN SOUTHEAST CORNER

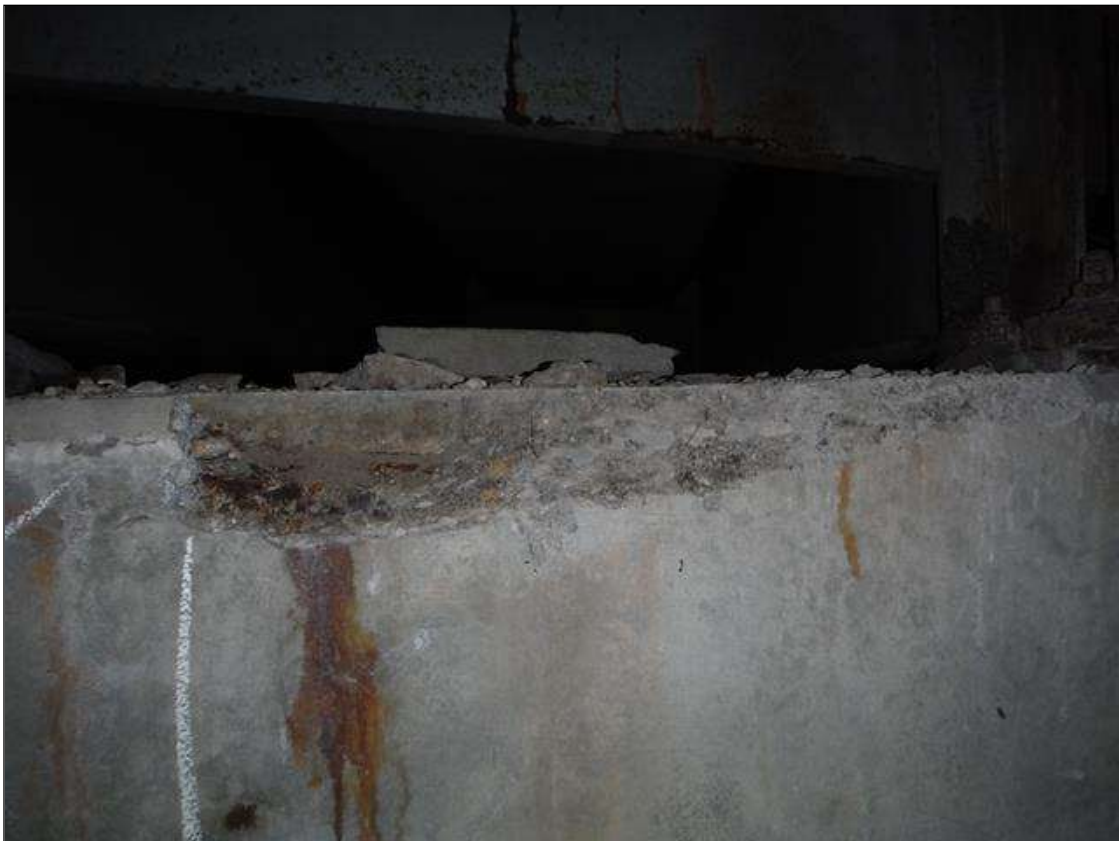
Bent 2 Cap 1: 30" X 4" X 4" DEEP SPALL WITH EXPOSED REBAR IN WEST FACE UNDER BAY 6

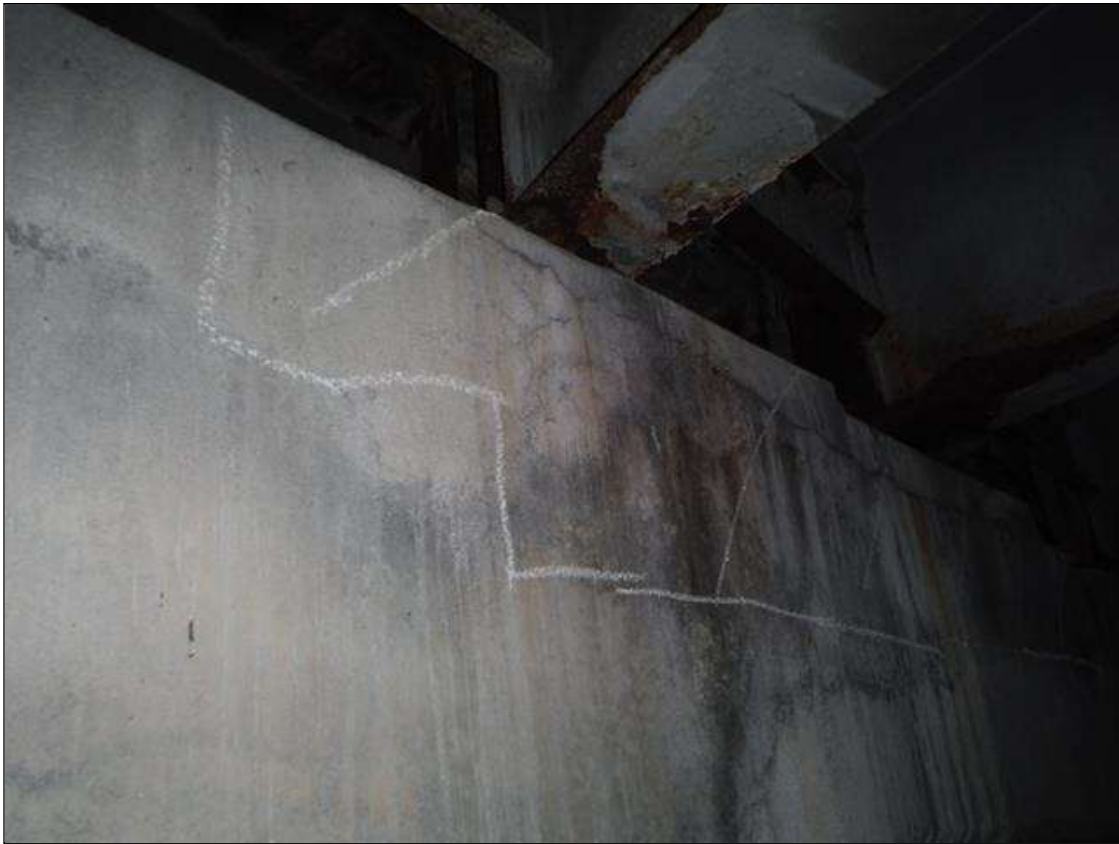
Bent 2 Cap 1: 102" X 20" DELAMINATION IN WEST FACE UNDER BAYS 5 AND 6

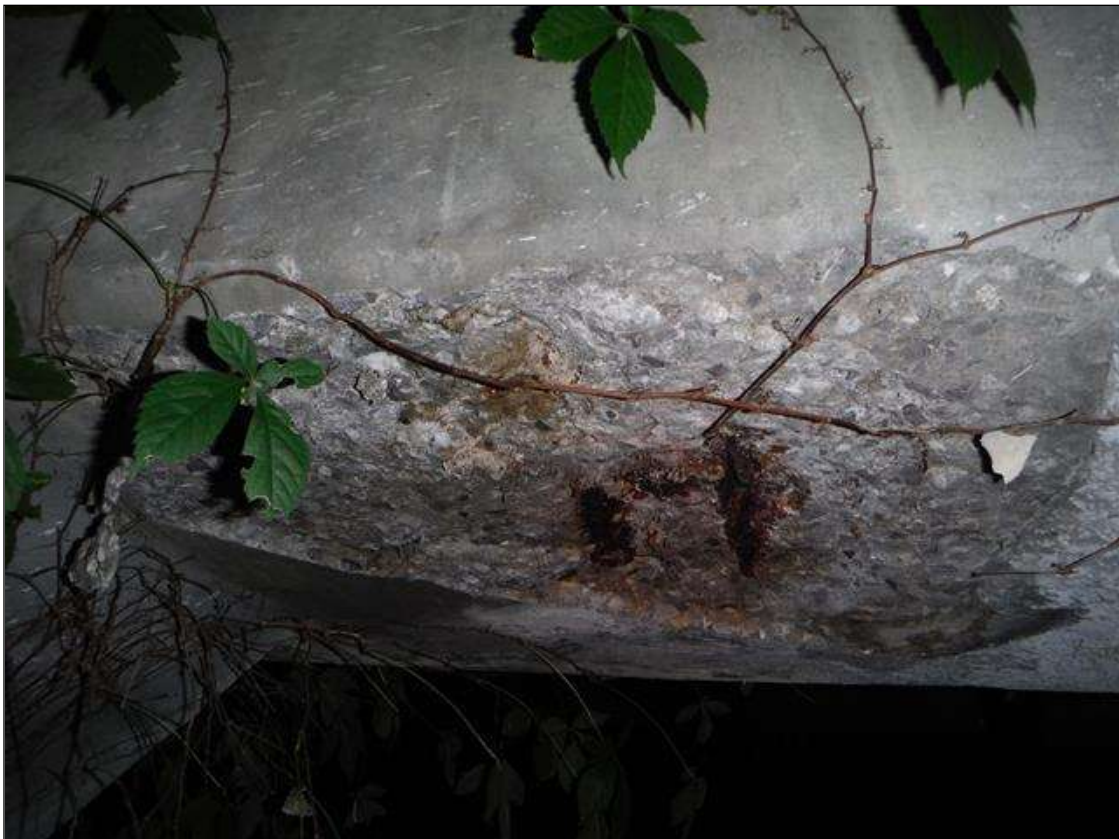
Bent 1 Cap 1: 33" X 33" X 2" DEEP SPALL WITH EXPOSED REBAR IN BOTTOM OF CAP BETWEEN COLUMN 3 AND 4
