NC DEPARTMENT OF TRANSPORTATION  
DIVISION OF HIGHWAYS  
STRUCTURE MANAGEMENT UNIT

## Structure Safety Report

### Routine Element Inspection - Contract

COUNTY: HAYWOOD STRUCTURE NUMBER: 430124 FREQUENCY: 24 MONTHS  
FACILITY CARRIED: I-40 MILE POST: 14.9  
LOCATION: 5 MI.W.JCT.US276  
FEATURE INTERSECTED: SR1338  
LATITUDE: 35° 40' 3.95" LONGITUDE: 82° 59' 40.3"  
SUPERSTRUCTURE: REINFORCED CONCRETE FLOOR ON I-BEAMS  
SUBSTRUCTURE: E.BT1:RC CAP/H-PILES;ABUT.2:RC CAP/ROCK;INT.BTS:RCP&BEAM  
SPANS: 2 @ 53'-2;1 @ 57'-8.5  
☐ FRACTURE CRITICAL ☐ TEMPORARY SHORING ☐ SCOUR CRITICAL ☐ SCOUR PLAN OF ACTION  
PRESENT CONDITION: Fair INSPECTION DATE: 05/08/2017  
POSTED SV: Not Posted POSTED TTST: Not Posted  
OTHER SIGNS PRESENT: NONE

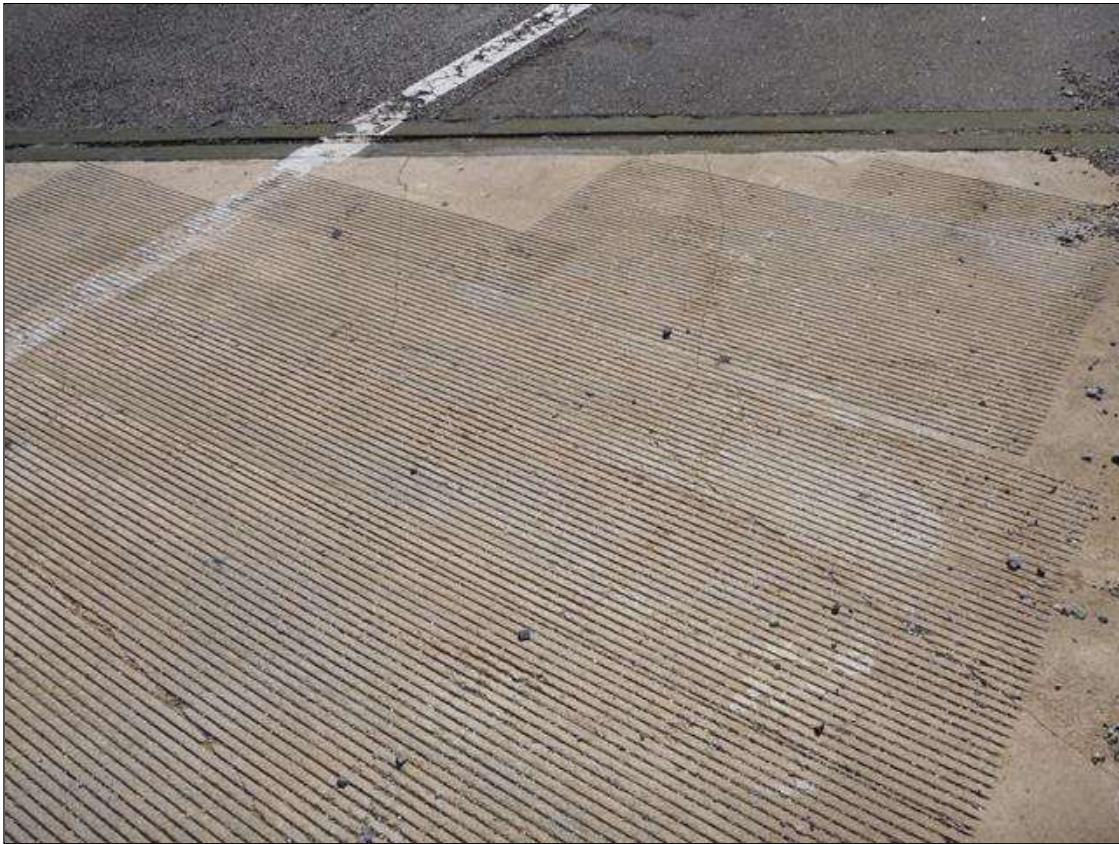
Span 3 Deck: DIAGONAL CRACKS (5) UP TO .03" OPEN 3' TO 4' APART IN EAST BOUND LANE AT SOUTHEAST CORNER END BENT 2 END.

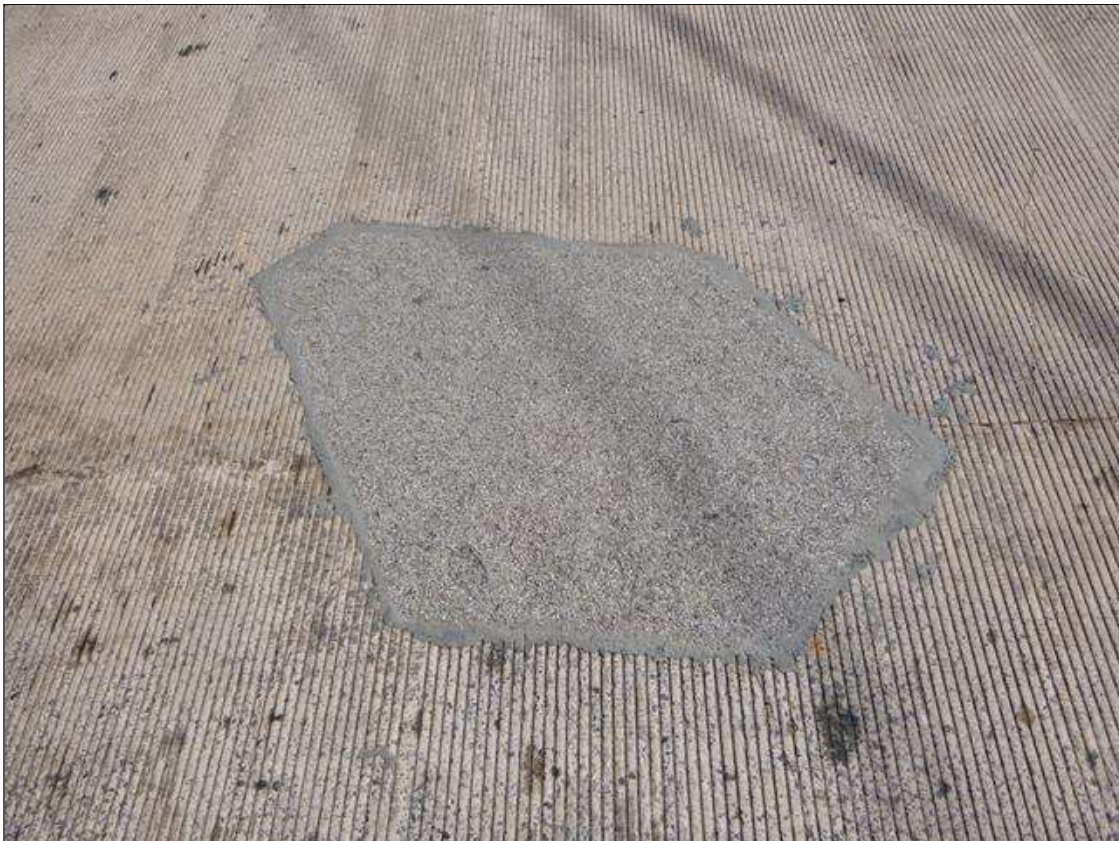
Span 3 Deck: PATCHED AREA 3' X 3' EAST BOUND LANE AT CENTERLINE 12' FROM END BENT 2 END.

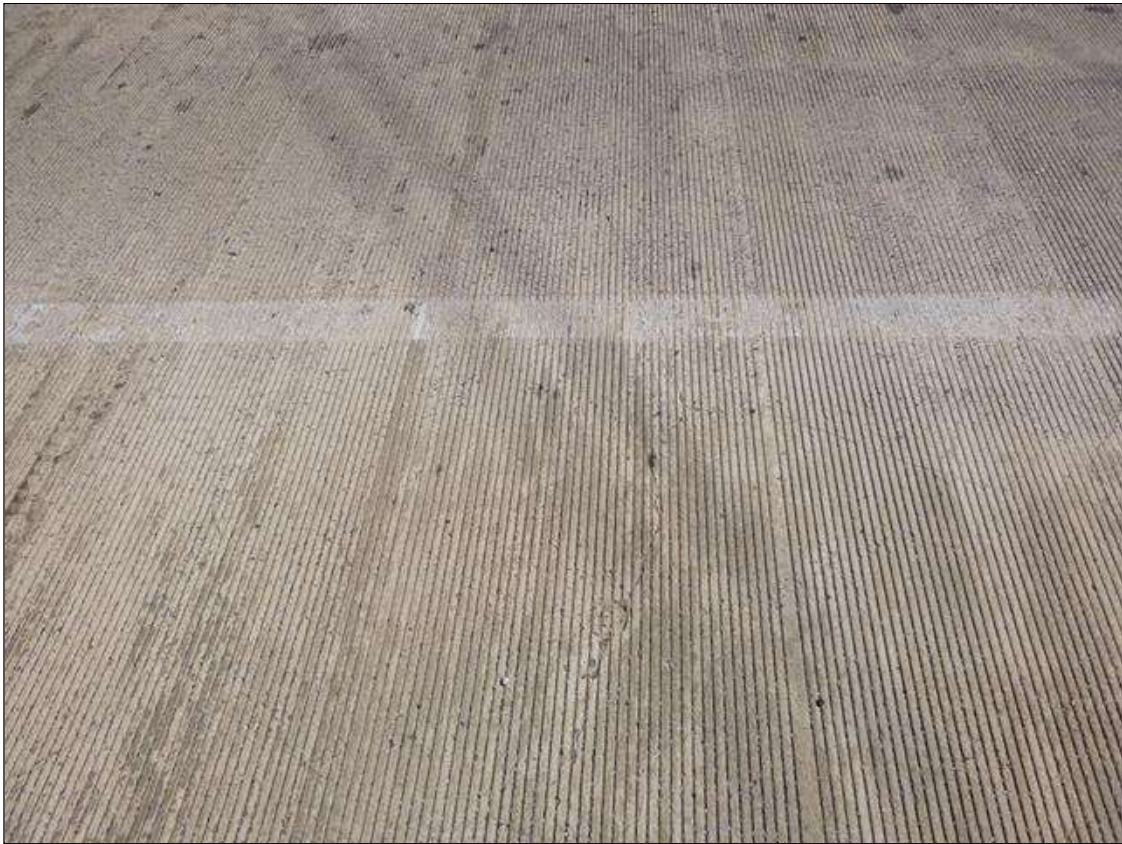
Span 3 Deck: MAP CRACKING UP TO .03" OPEN IN EAST BOUND LANE MID-SPAN AREA.

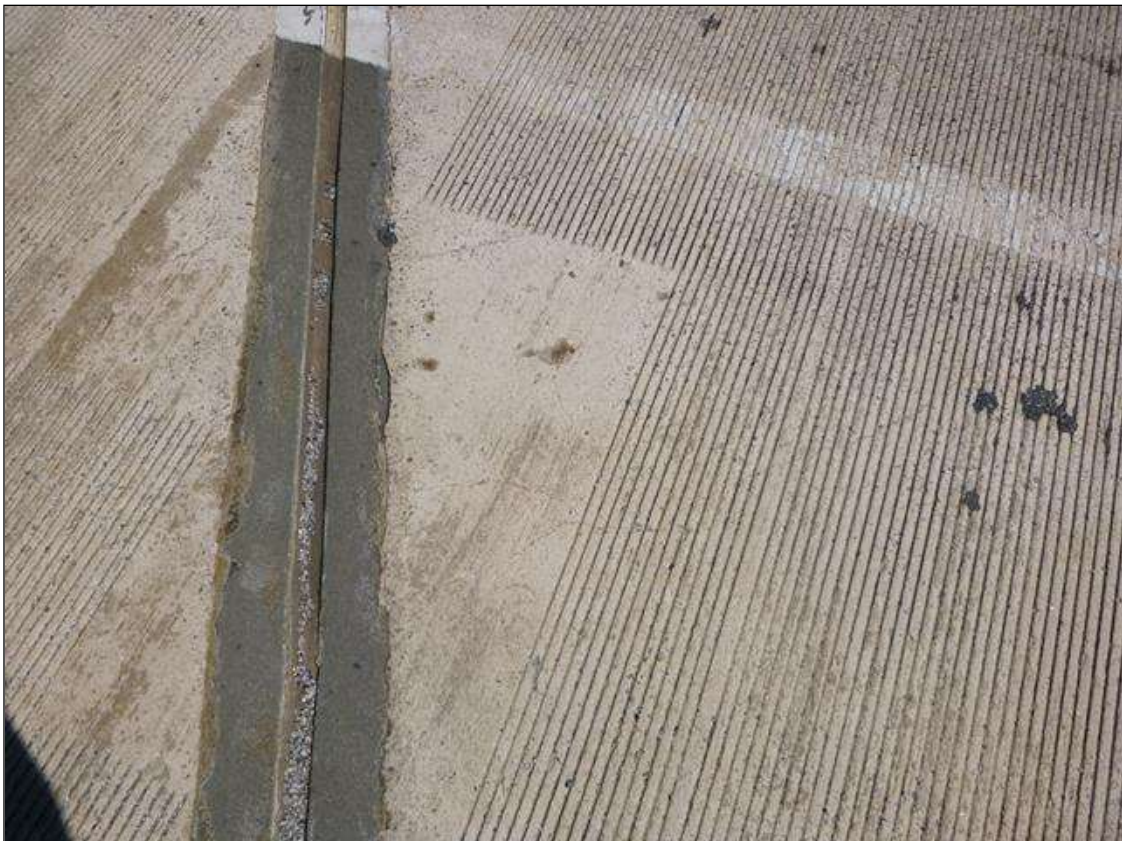
Span 3 Deck: MAP CRACKING UP TO .03" OPEN EAST BOUND LANE ALONG BENT 2 END.

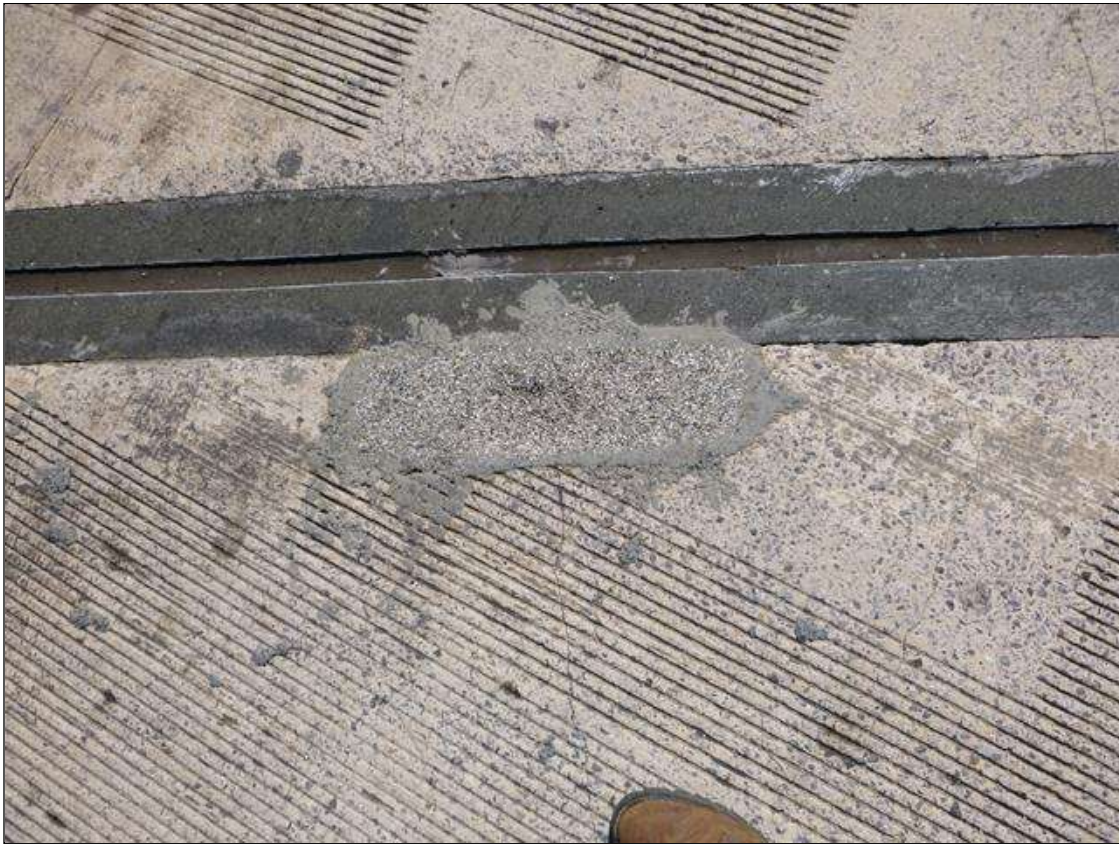
Span 2 Deck: PATCHED AREA 18" WIDE X 6" LONG EAST BOUND LANE AT BENT 2 END.

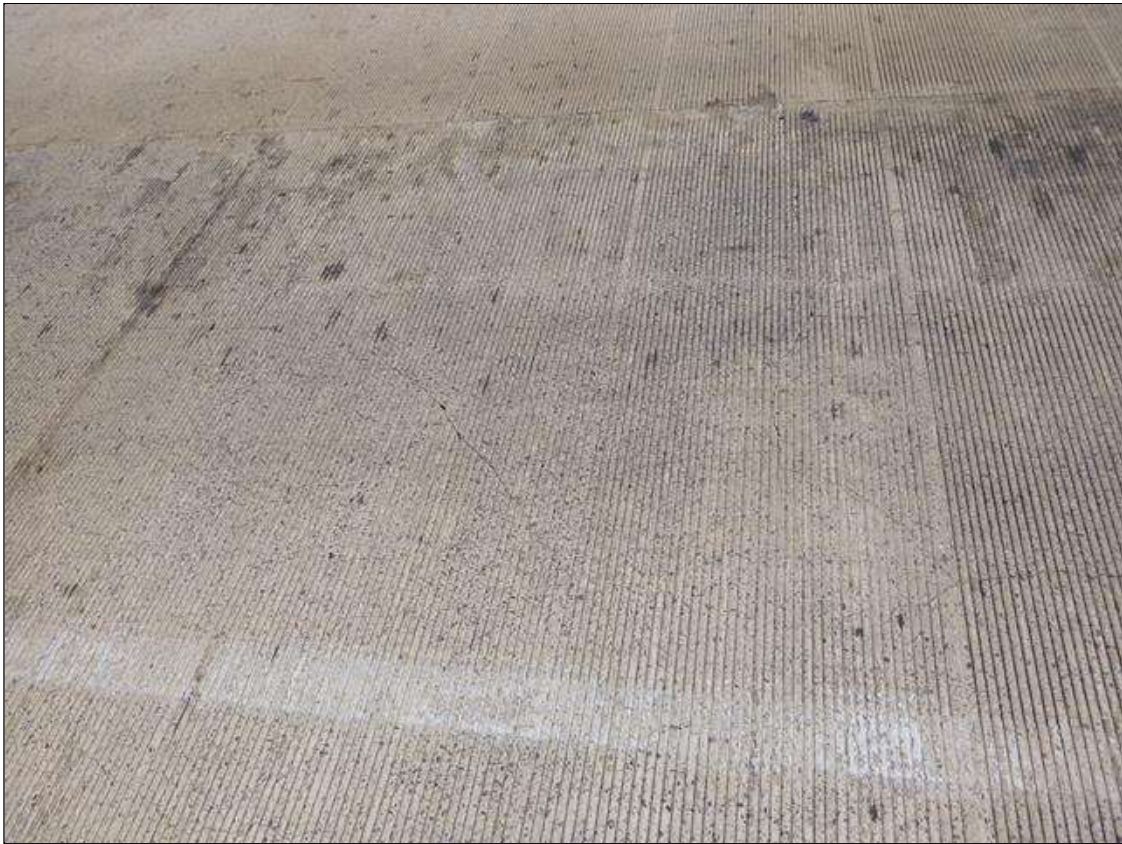
| Element Number | Defect Type | Defect Description | CS | CS Qty | Maint Qty |
|---|---|---|---|---|---|
| 12 | Cracking (RC and Other) | MAP CRACKING UP TO .03" OPEN IN MID-SPAN AREA. | 2 | 400 | 400 Square Feet |

Span 2 Deck: MAP CRACKING UP TO .03" OPEN IN MID-SPAN AREA.

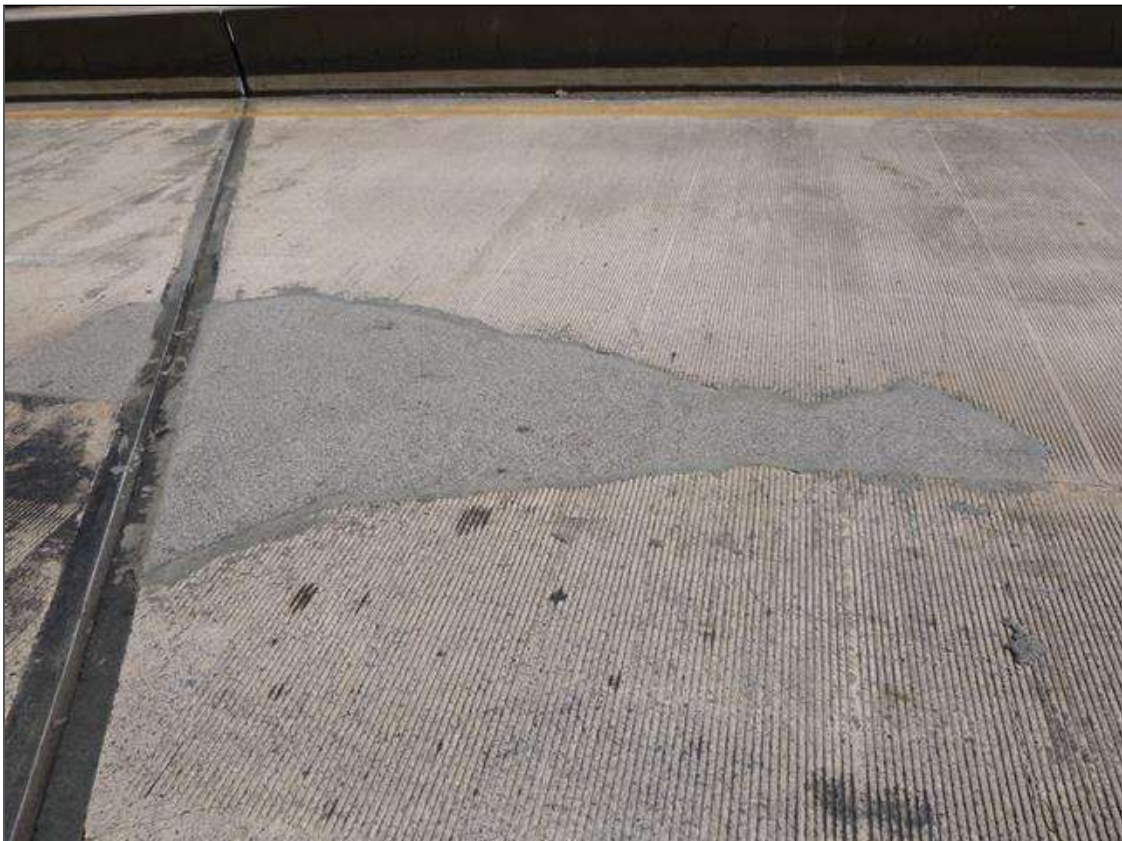
Span 2 Deck: PATCHED AREA 4' WIDE X 7' LONG IN RIGHT EAST BOUND LANE AT BENT 1 END.

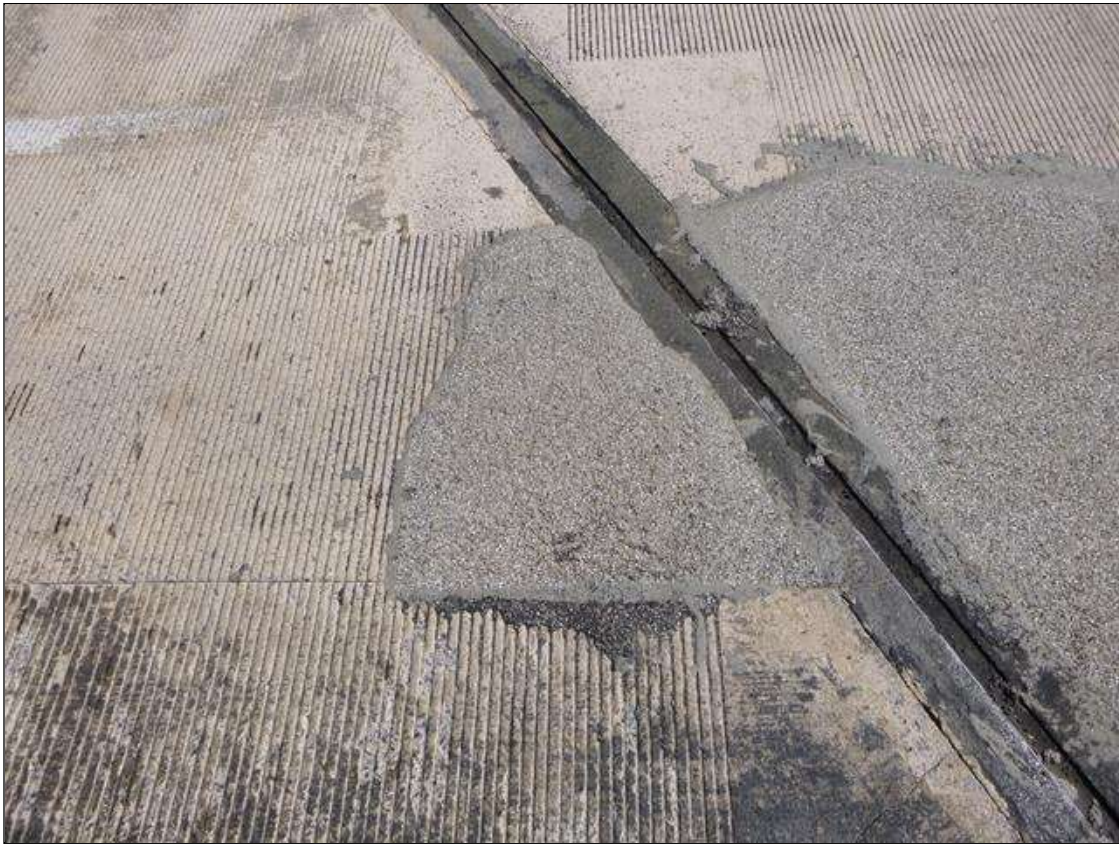
Span 1 Deck: PATCHED AREA 2' X 2' IN RIGHT EAST BOUND LANE AT BENT 1 END.

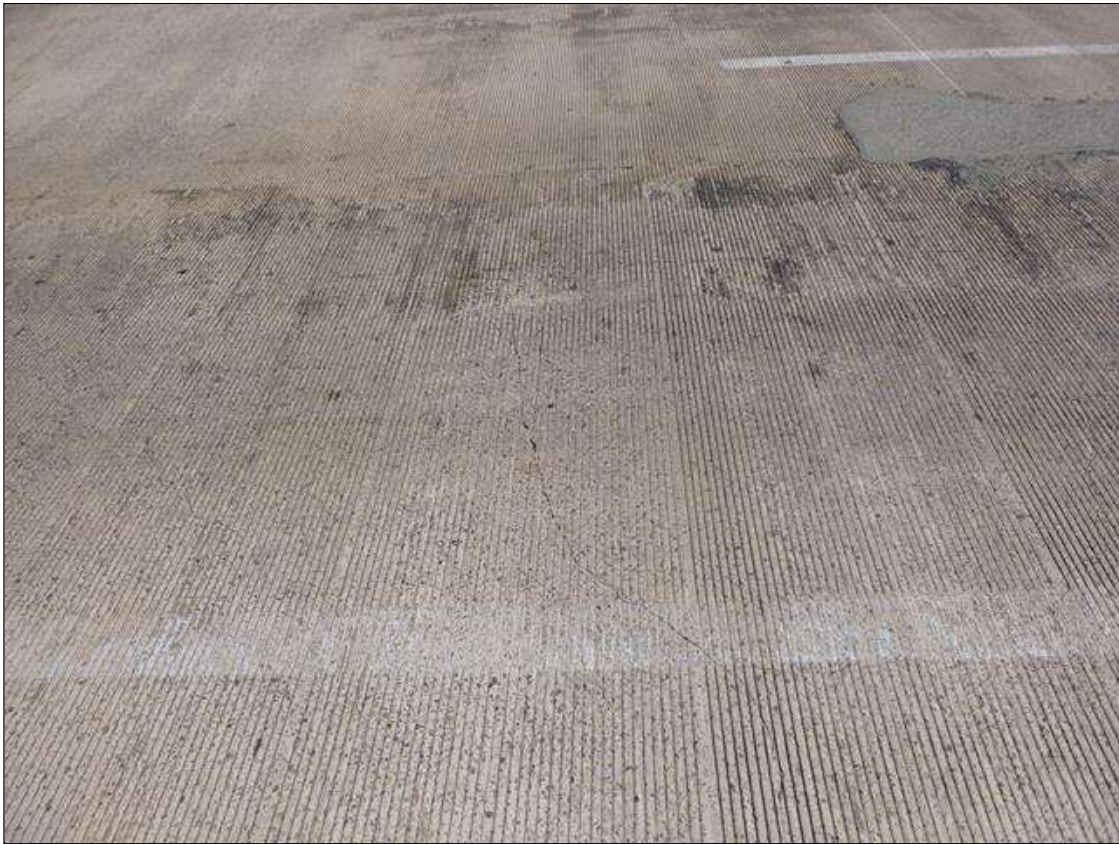
| Element Number | Defect Type | Defect Description | CS | CS Qty | Maint Qty | |
|---|---|---|---|---|---|---|
| 12 | Cracking (RC and Other) | MAP CRACKING UP TO .03" OPEN EAST BOUND LANE AT MID-SPAN AREA. | 2 | 400 | 400 | Square Feet |

Span 1 Deck: MAP CRACKING UP TO .03" OPEN EAST BOUND LANE AT MID-SPAN AREA.

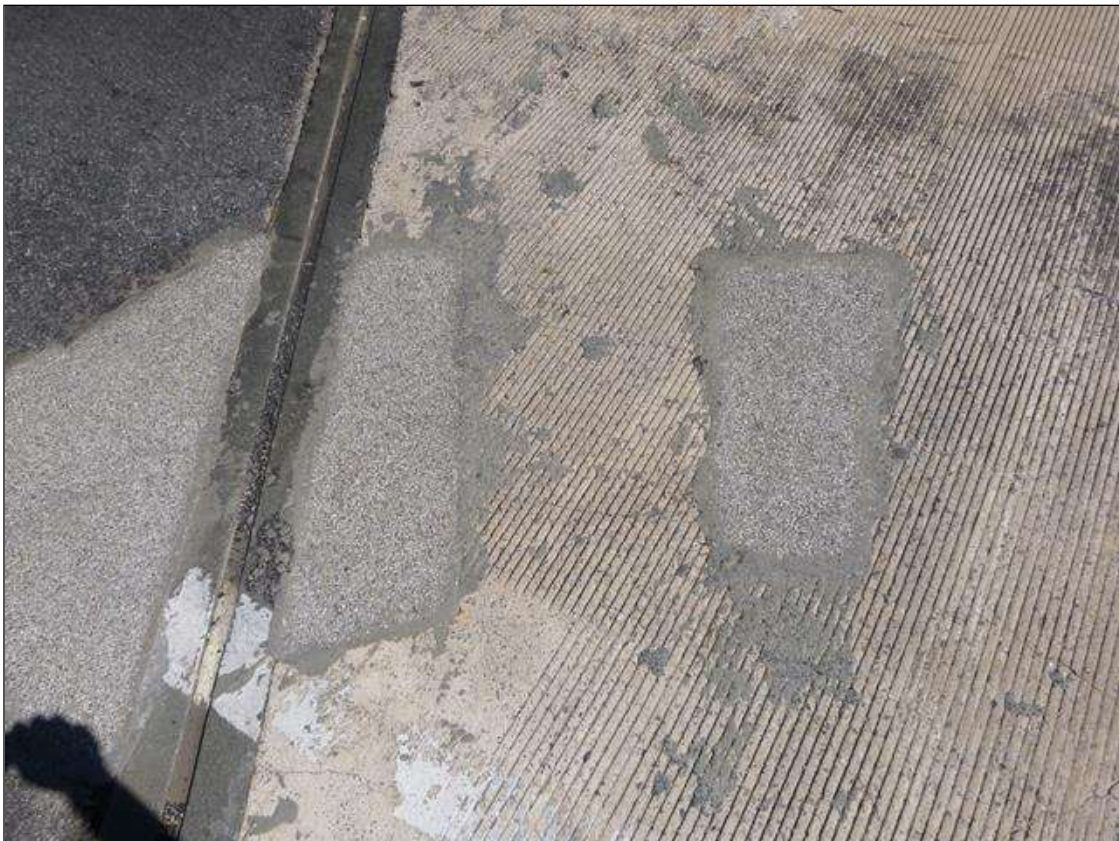
Span 1 Deck: PATCHED AREAS: (2) 24" WIDE X 10" LONG IN RIGHT EAST BOUND LANE END BENT 1 END.

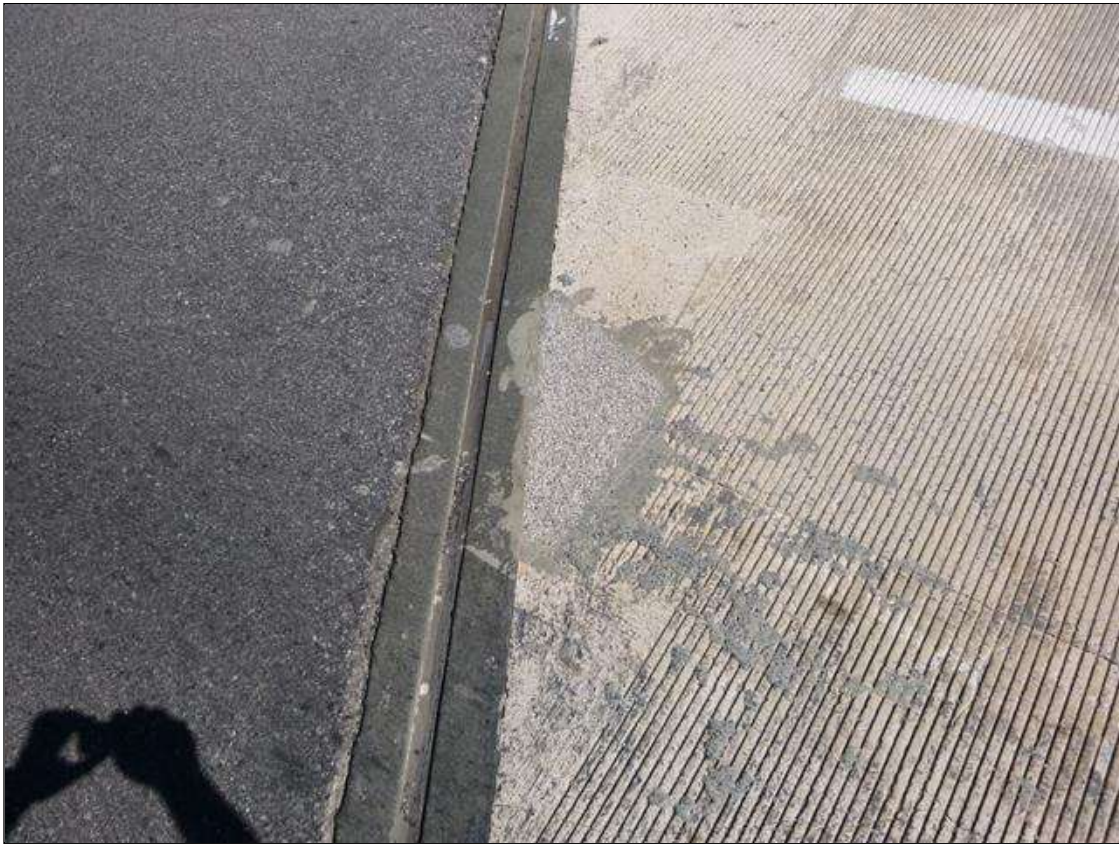
Span 1 Deck: PATCHED AREA 20" WIDE 4 X 10" LONG RIGHT EAST BOUND LANE AT END BENT 1 END.

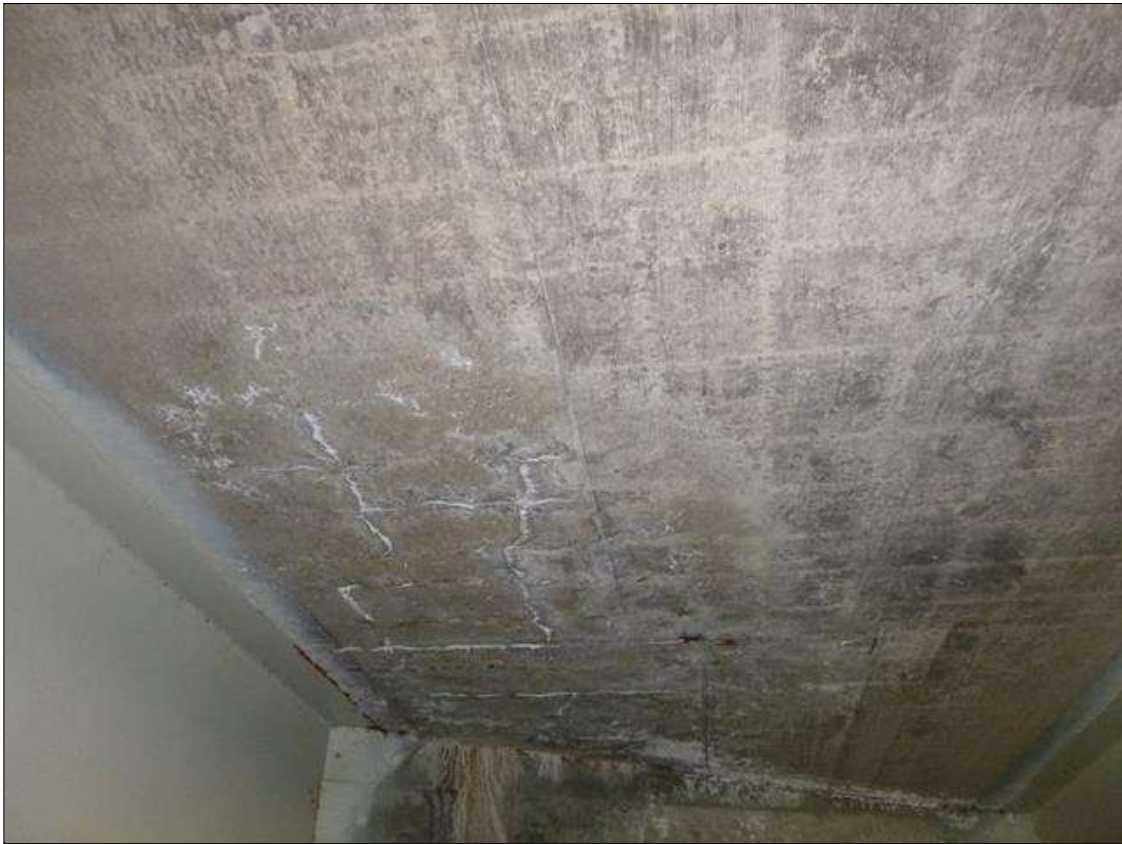
| Element Number | Defect Type | Defect Description | CS | CS Qty | Maint Qty | |
|---|---|---|---|---|---|---|
| 12 | Cracking (RC and Other) | MAP CRACKING UP TO .03" OPEN WITH EFFLORESCENCE AT BAY 8 END BENT 1 END. | 2 | 40 | 40 | Square Feet |

Span 1 Deck: MAP CRACKING UP TO .03" OPEN WITH EFFLORESCENCE AT BAY 8 END BENT 1 END.

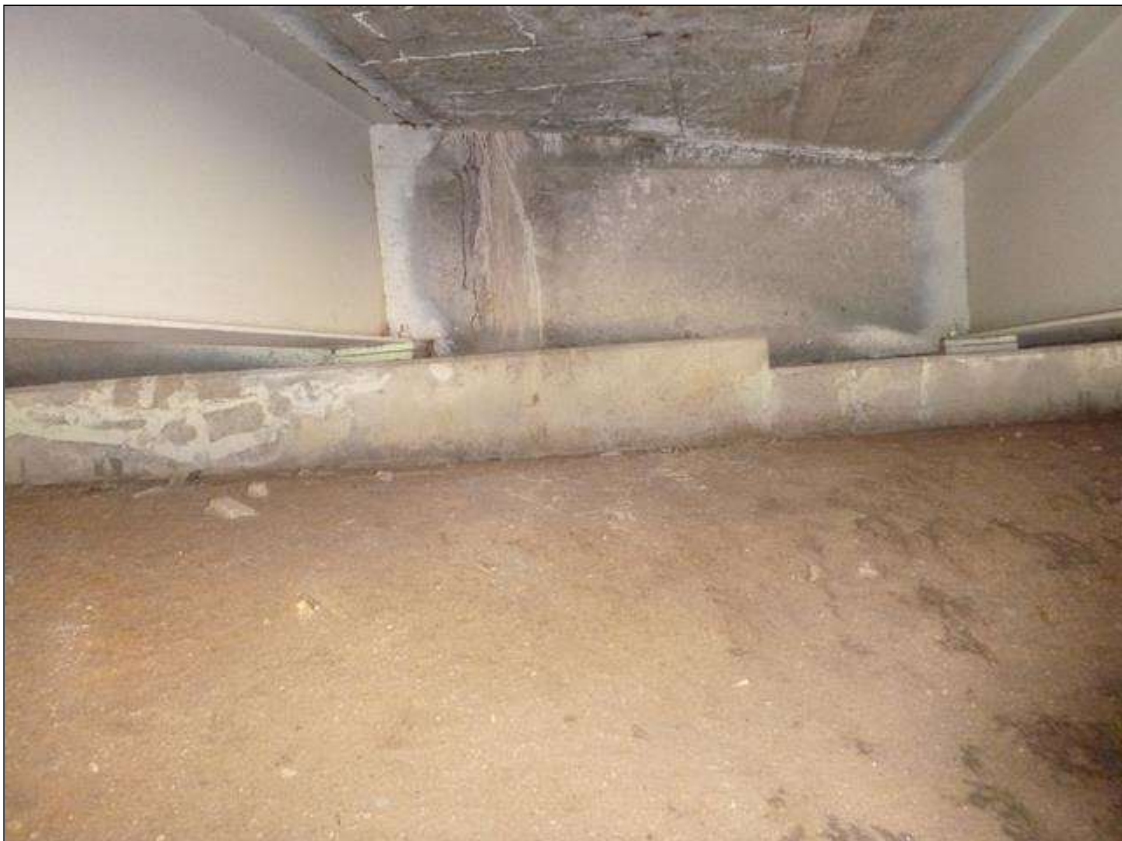
End Bent 1 Cap 1: SCATTERED EPOXY PATCHWORK FULL LENGTH OF CAP.

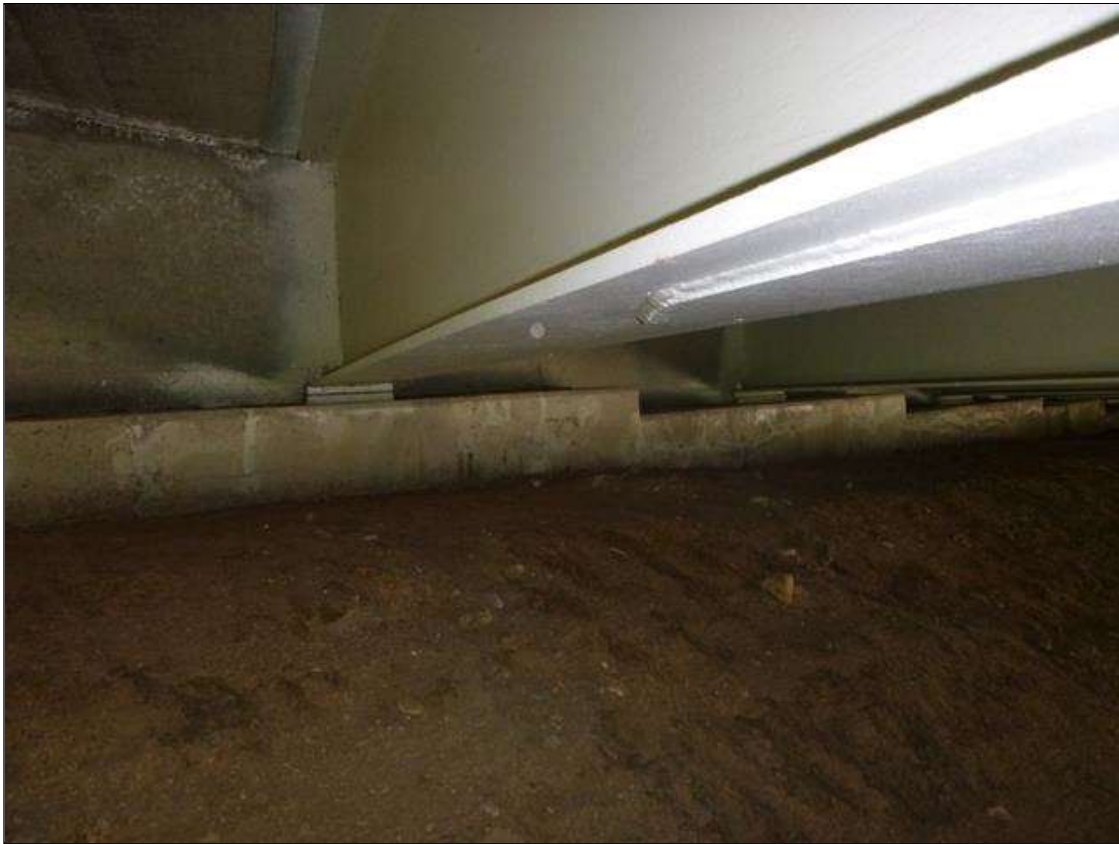
End Bent 1 Cap 1: HORIZONTAL CRACK .05" OPEN BEAM 6 TO BEAM 9.

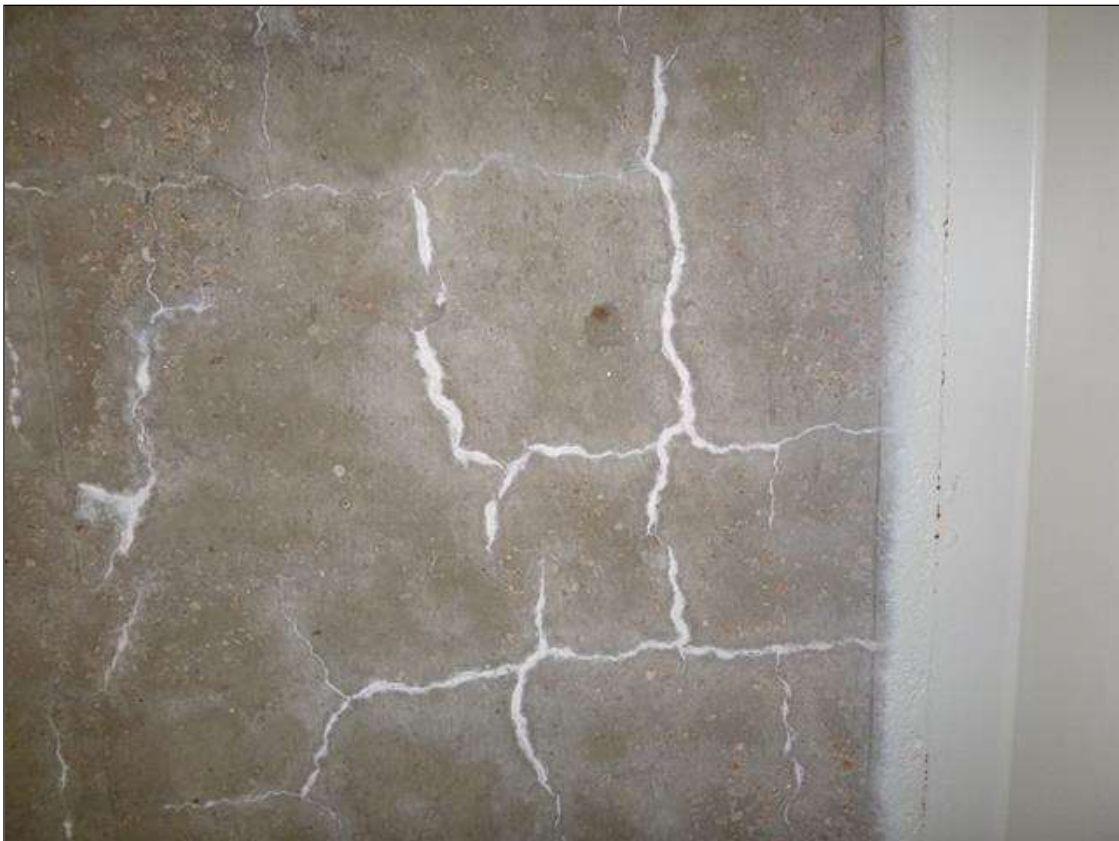
| Element Number | Defect Type | Defect Description | CS | CS Qty | Maint Qty | |
|---|---|---|---|---|---|---|
| 12 | Cracking (RC and Other) | MAP CRACKING .03" OPEN WITH EFFLORESCENCE AT BAY 2. SIMILAR IN BAY 3. | 2 | 160 | 160 | Square Feet |

Span 1 Deck: MAP CRACKING .03" OPEN WITH EFFLORESCENCE AT BAY 2. SIMILAR IN BAY 3.

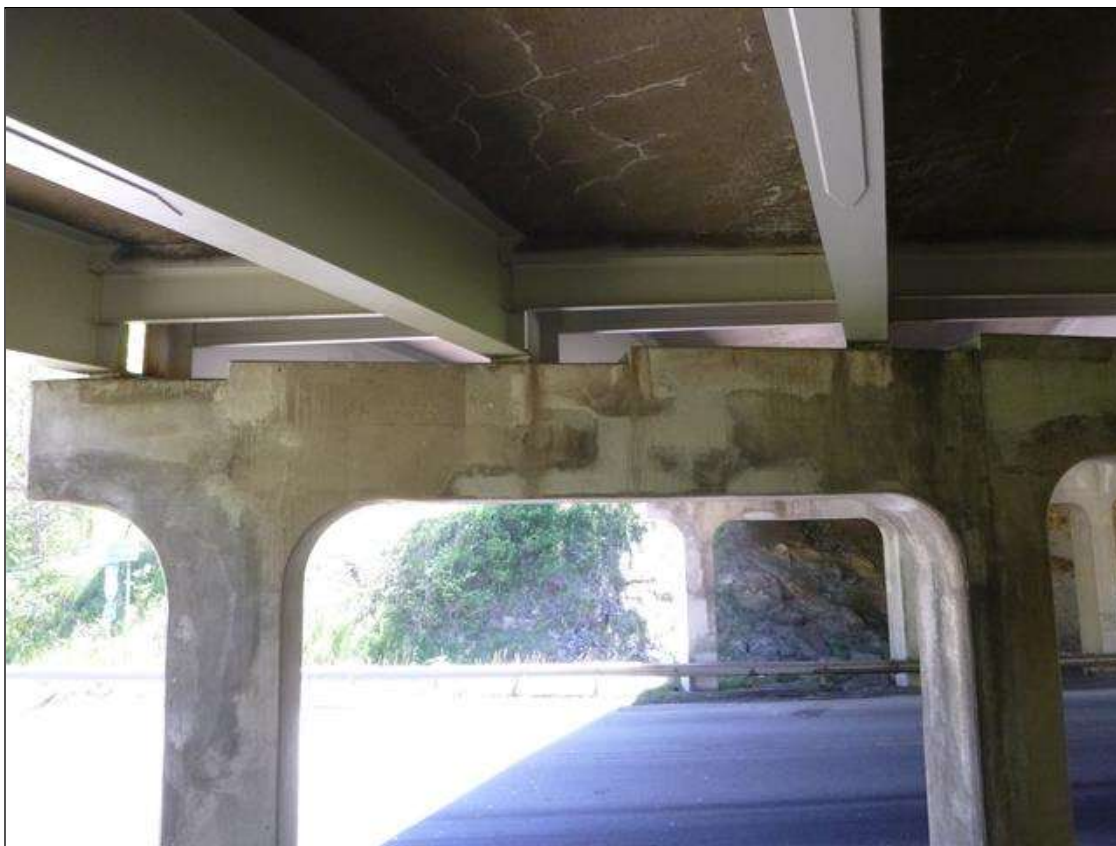
Bent 1 Cap 1: PATCHWORK LEFT END TO COLUMN 2 WEST FACE.

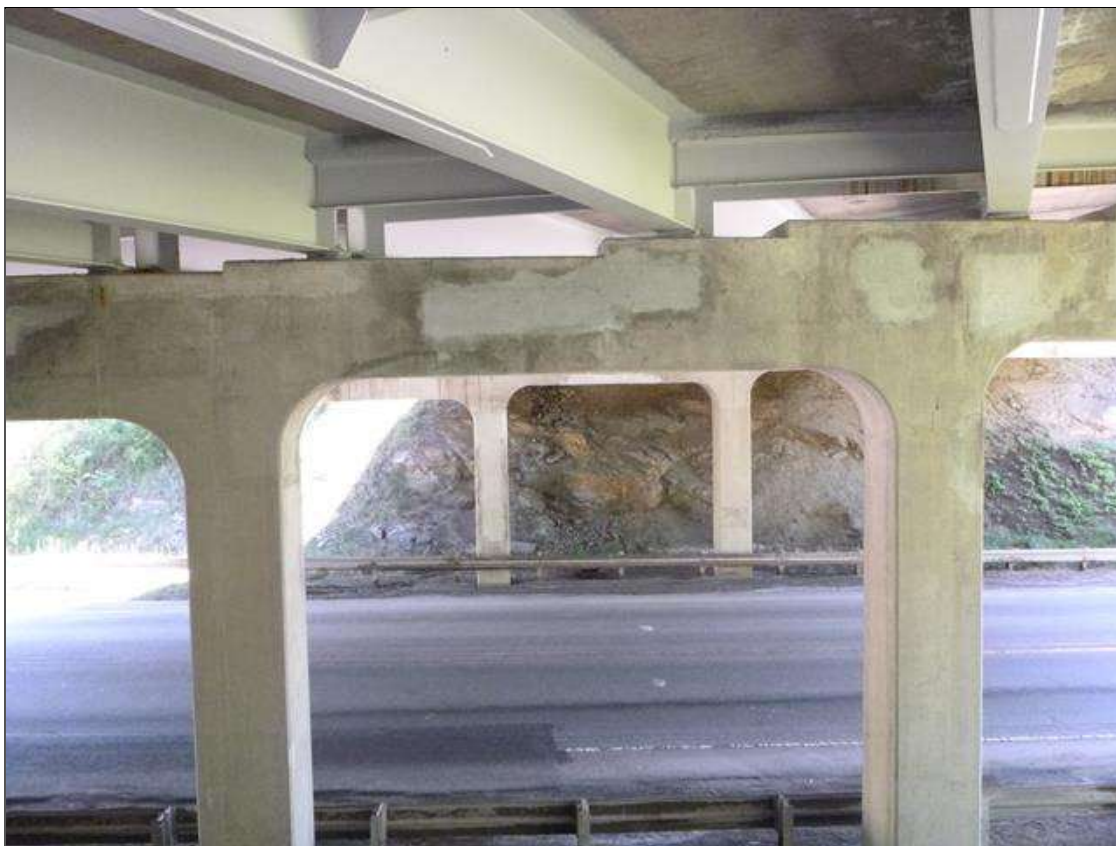
Bent 1 Cap 1: PATCHWORK COLUMN 3 TO COLUMN 4 WEST FACE.

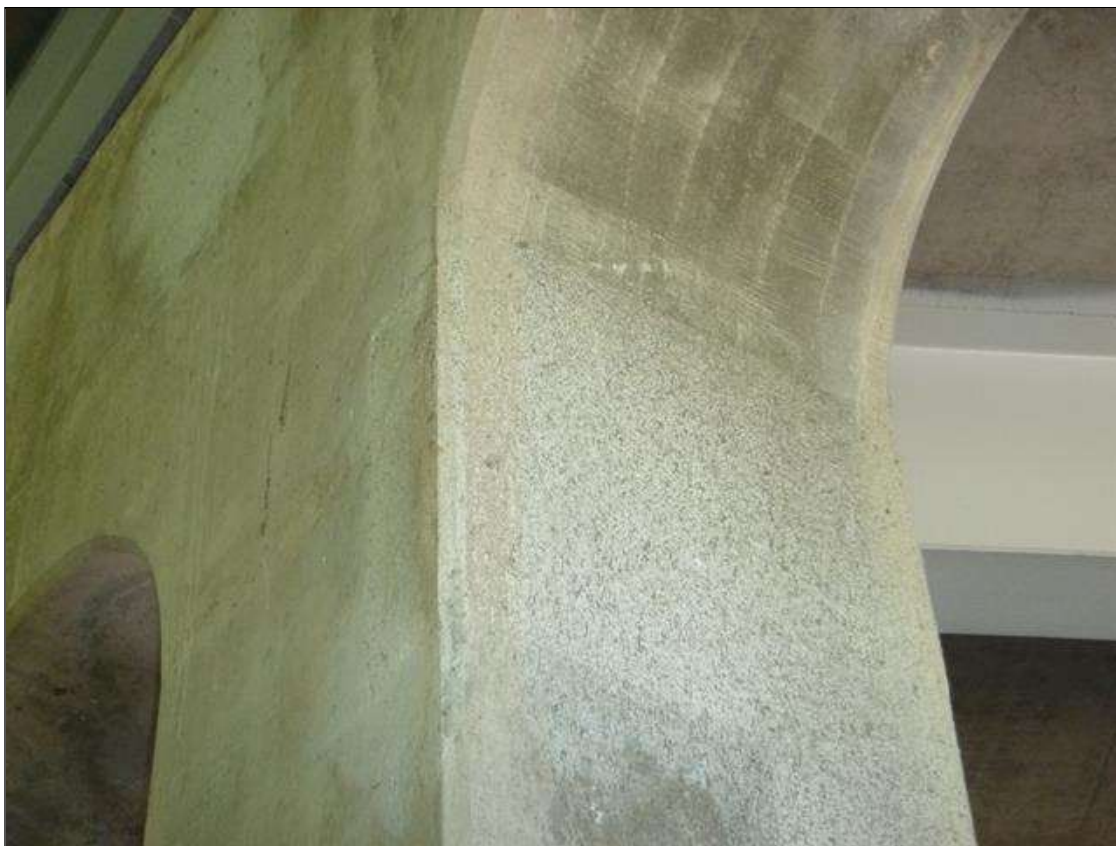
Bent 1 Pile 4: PATCHWORK 2' HIGH ON WEST AND SOUTH FACES.

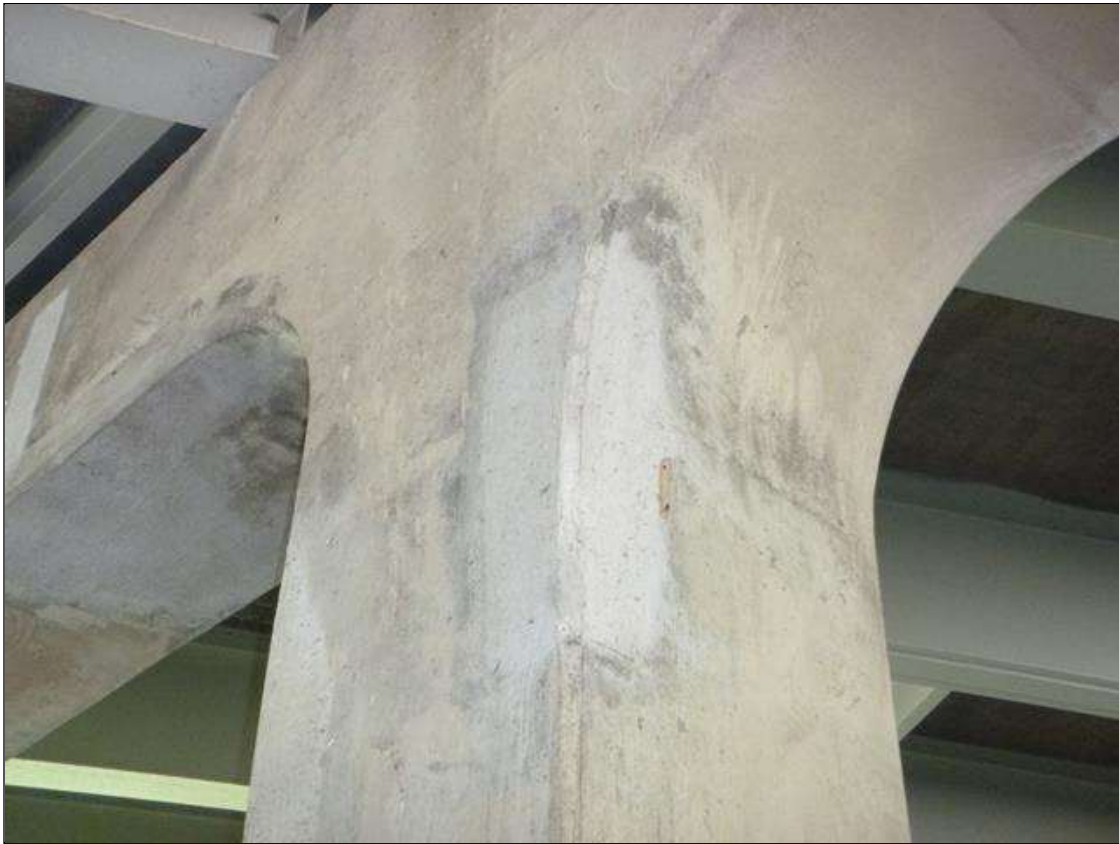
Bent 1 Pile 3: PATCHWORK 6" WIDE X 30" HIGH ON EAST AND NORTH FACES.

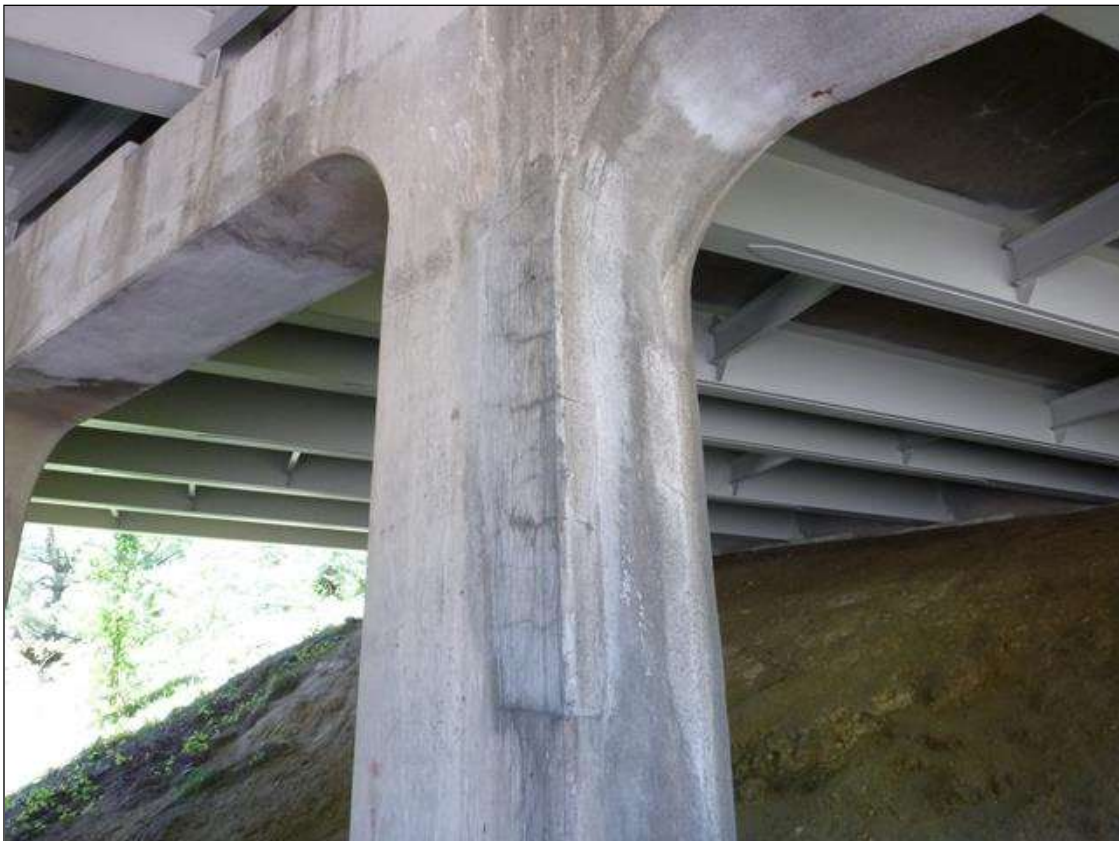
Bent 1 Pile 2: PATCHED AREA 5" WIDE AND 8" WIDE X 4' HIGH ON NORTHEAST CORNER WITH HORIZONTAL CRACKS 6" TO 1' APART.

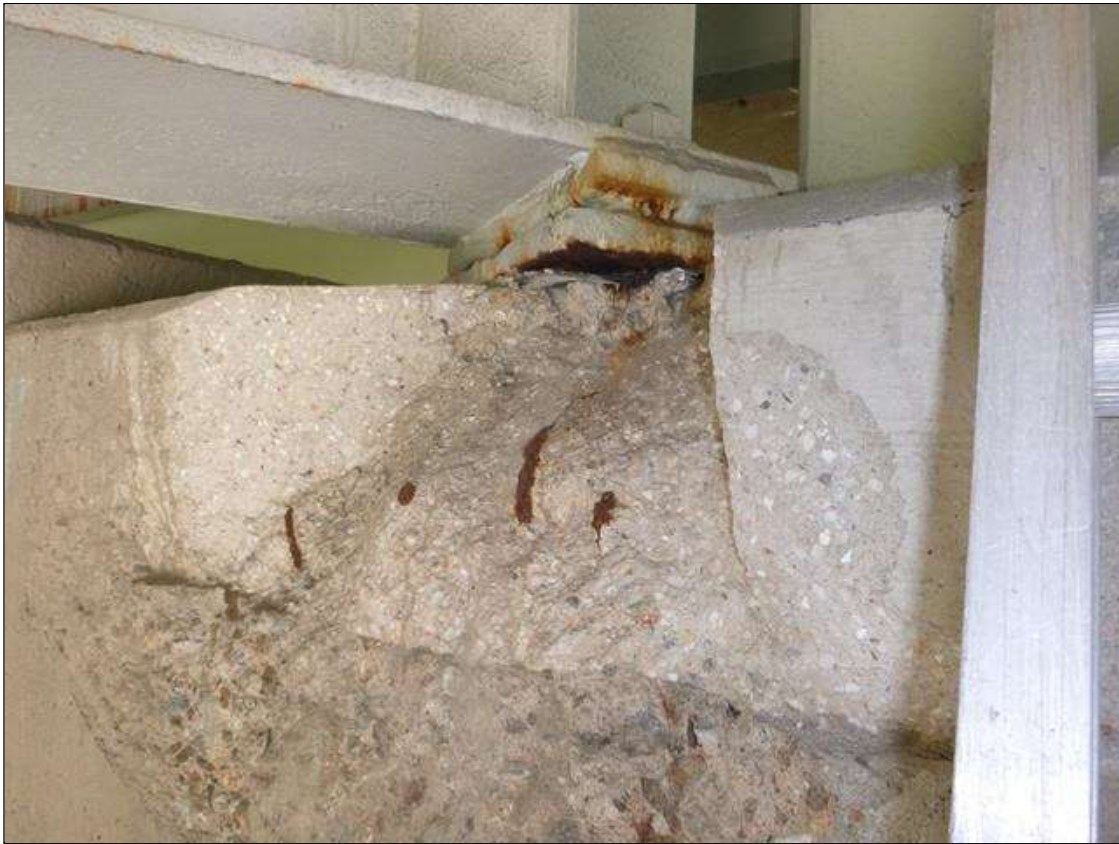
Bent 1 Cap 1: SPALL 2' WIDE X 18" HIGH X 5-1/2" DEEP WITH 15% LOSS OF BEARING UNDER BEAM 2 SPAN 2 SEAT.

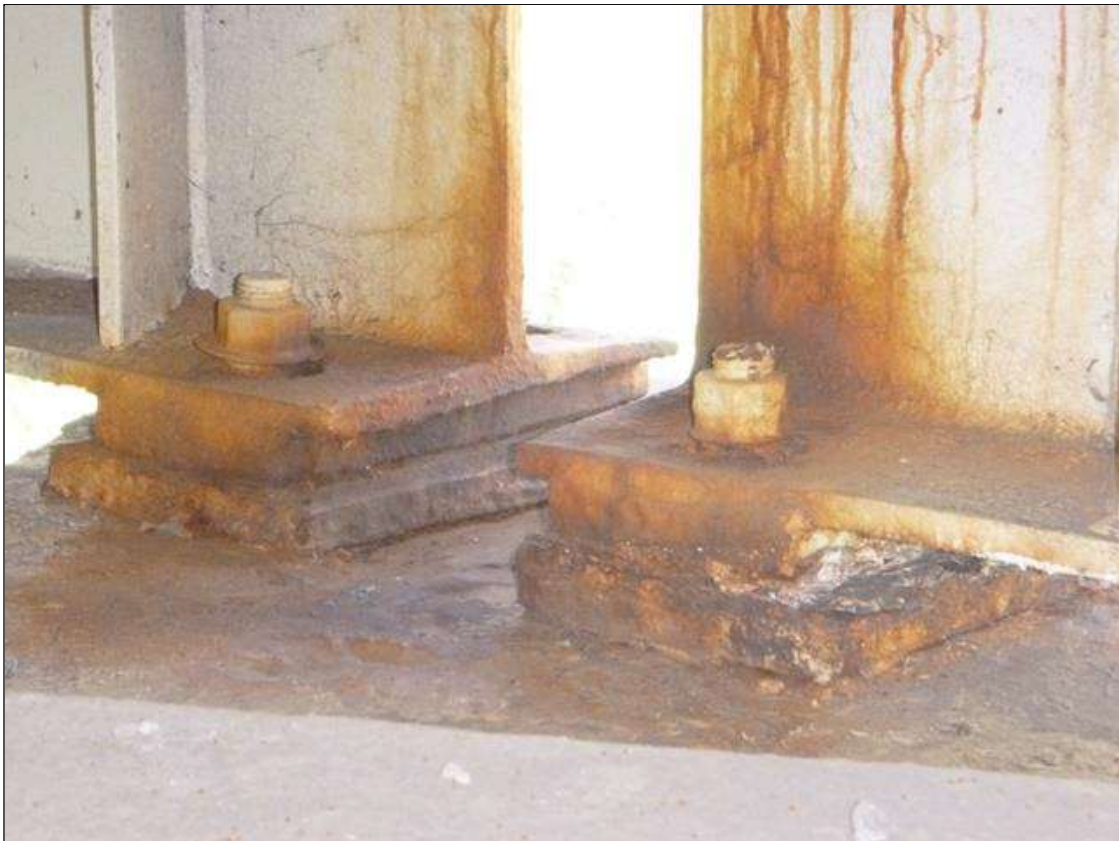
SPAN 2 BEAM 1 NEAR BEARING: PREVIOUS LOSS OF SECTION UP TO .06" ALONG PLATE EDGES AND ON PLATE SURFACES HAS BEEN CLEANED AND PAINTED WITH CORROSION ARRESTED.

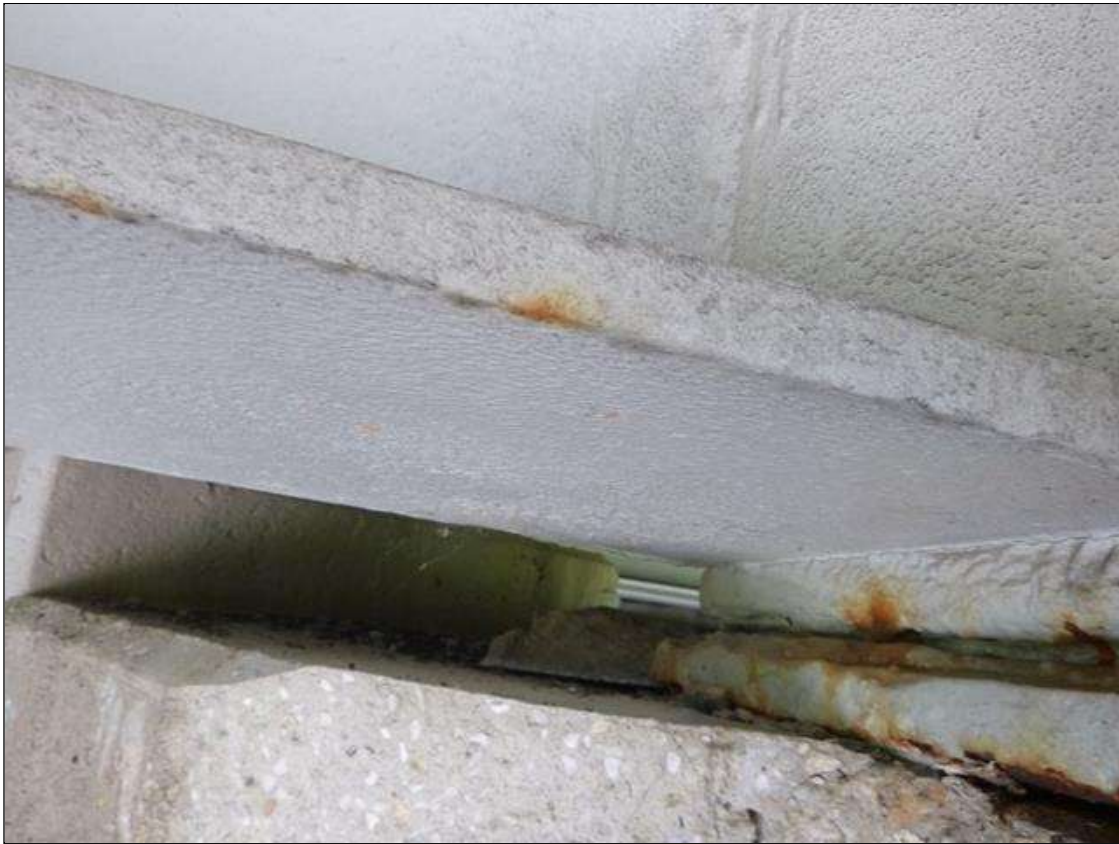
Span 2 Beam 2: PITTING UP TO .06" DEEP AT BOTH ENDS PLATE EDGE OUT 3', HOWEVER, BEAMS HAVE RECENTLY BEEN CLEANED AND PAINTED WITH CORROSION ARRESTED. SIMILAR AT EACH BEAM EACH SPAN.
