NC DEPARTMENT OF TRANSPORTATION  
DIVISION OF HIGHWAYS  
STRUCTURE MANAGEMENT UNIT

## Structure Safety Report

### Routine Element Inspection - Contract

COUNTY: HAYWOOD STRUCTURE NUMBER: 430124 FREQUENCY: 24 MONTHS  
FACILITY CARRIED: I-40 MILE POST: 14.9  
LOCATION: 5 MI.W.JCT.US276  
FEATURE INTERSECTED: SR1338  
LATITUDE: 35° 40' 3.95" LONGITUDE: 82° 59' 40.3"  
SUPERSTRUCTURE: REINFORCED CONCRETE FLOOR ON I-BEAMS  
SUBSTRUCTURE: E.BT1:RC CAP/H-PILES;ABUT.2:RC CAP/ROCK;INT.BTS:RCP&BEAM  
SPANS: 2 @ 53'-2;1 @ 57'-8.5  
☐ FRACTURE CRITICAL ☐ TEMPORARY SHORING ☐ SCOUR CRITICAL ☐ SCOUR PLAN OF ACTION  
PRESENT CONDITION: Fair INSPECTION DATE: 05/08/2017  
POSTED SV: Not Posted POSTED TTST: Not Posted  
OTHER SIGNS PRESENT: NONE

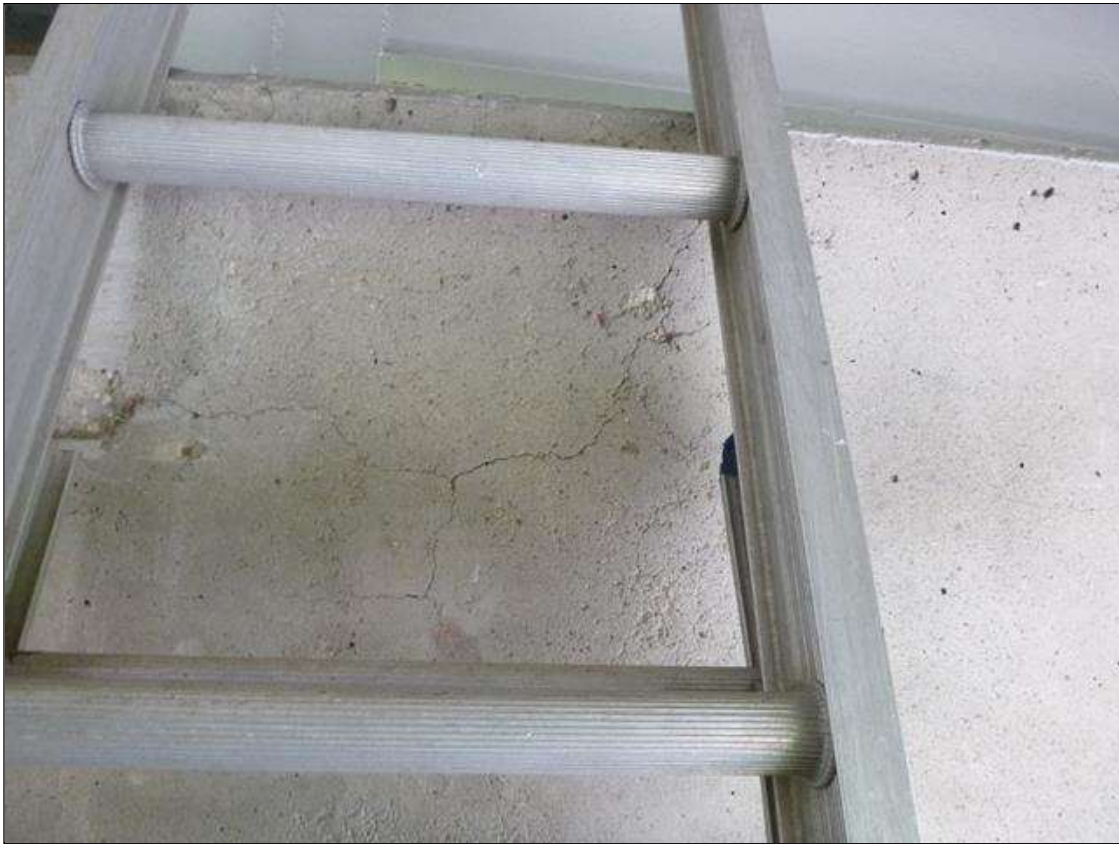
Bent 1 Cap 1: MAP CRACKING UP TO .02" OPEN BETWEEN BEAMS 1 AND 2 ON EAST FACE.

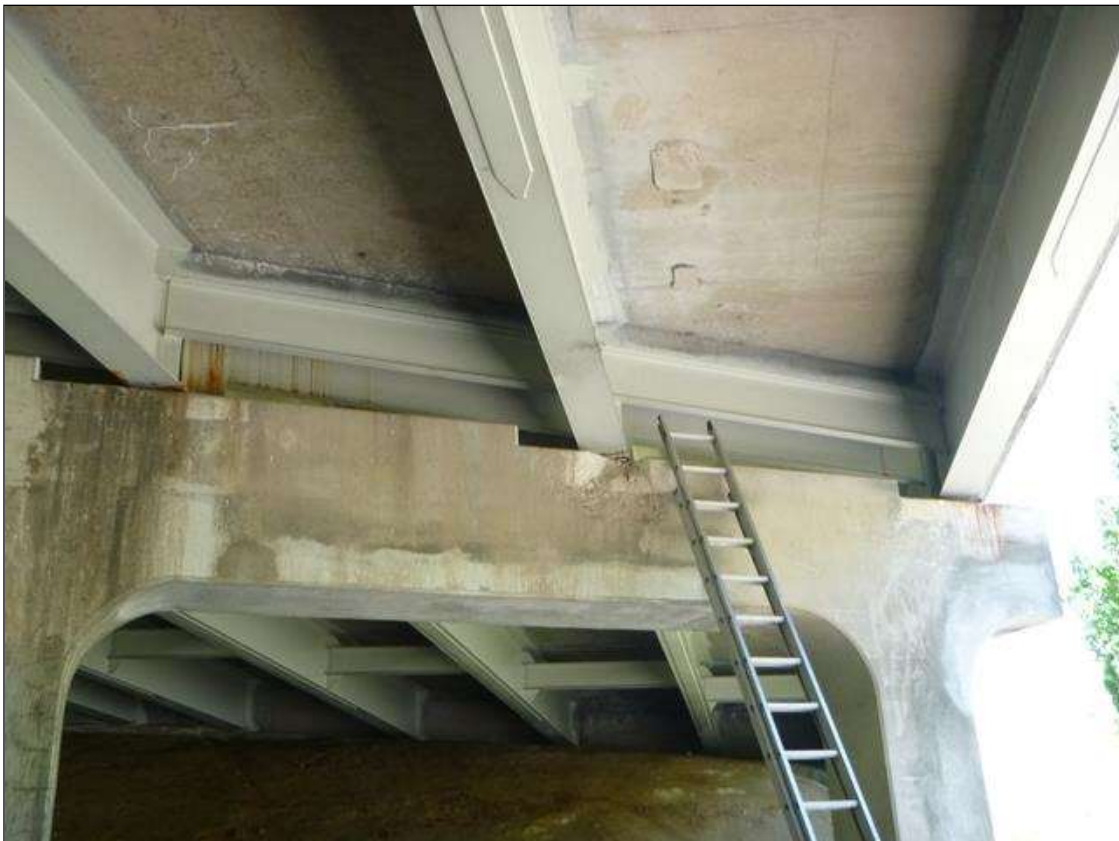
Bent 1 Cap 1: PATCHWORK LEFT END TO COLUMN 2 ON EAST FACE.

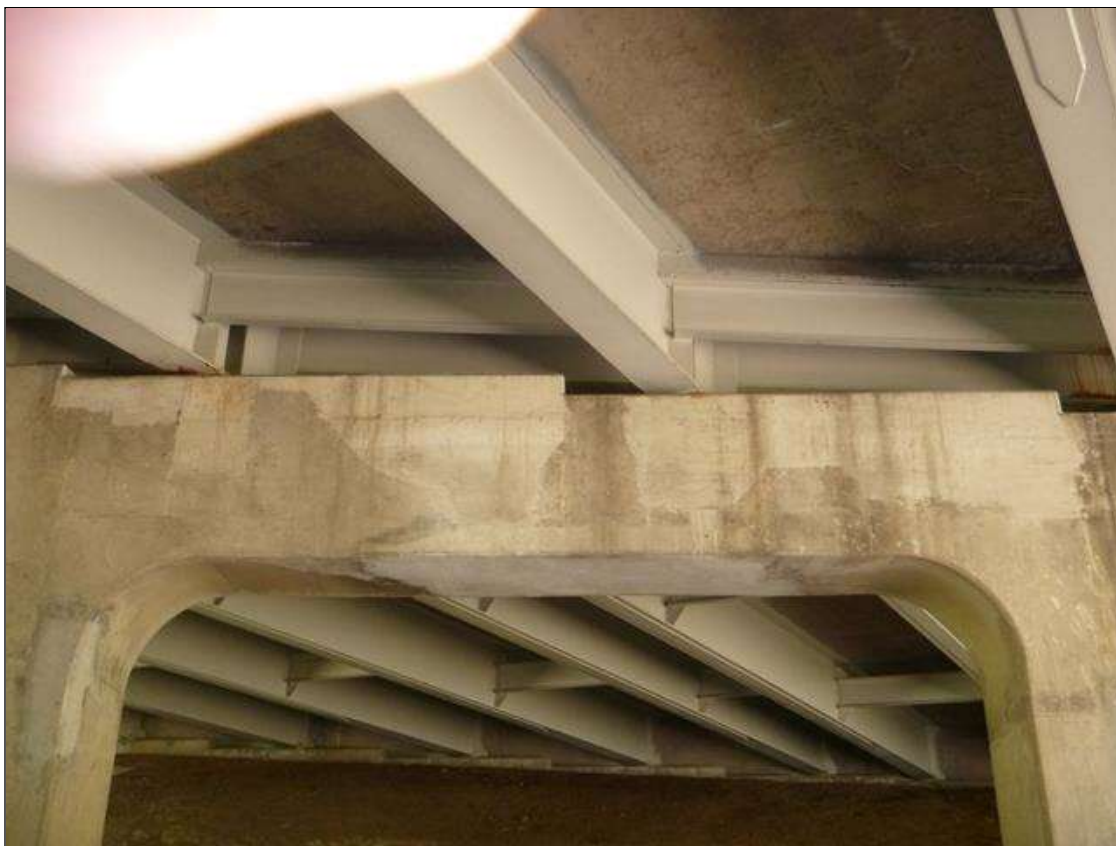
Bent 1 Cap 1: PATCHWORK COLUMN 2 TO COLUMN 3 EAST FACE.

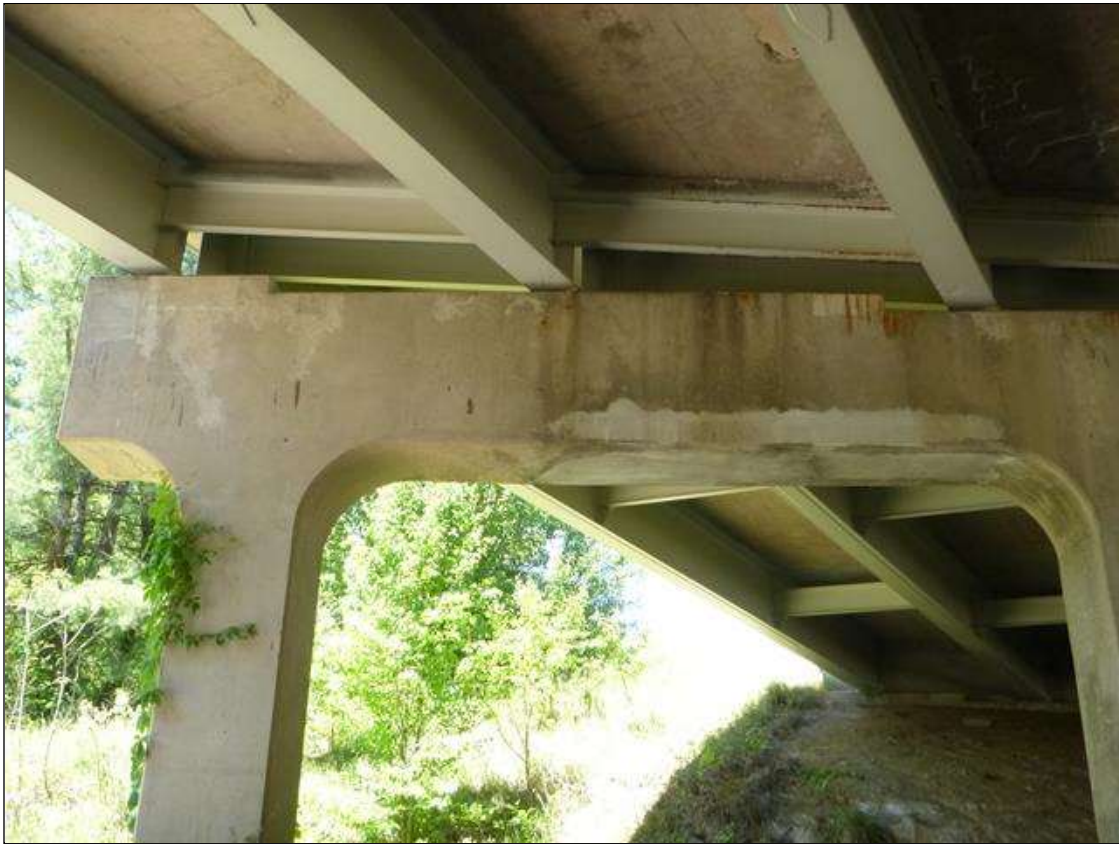
Bent 1 Cap 1: PATCHWORK COLUMN 4 TO RIGHT END.

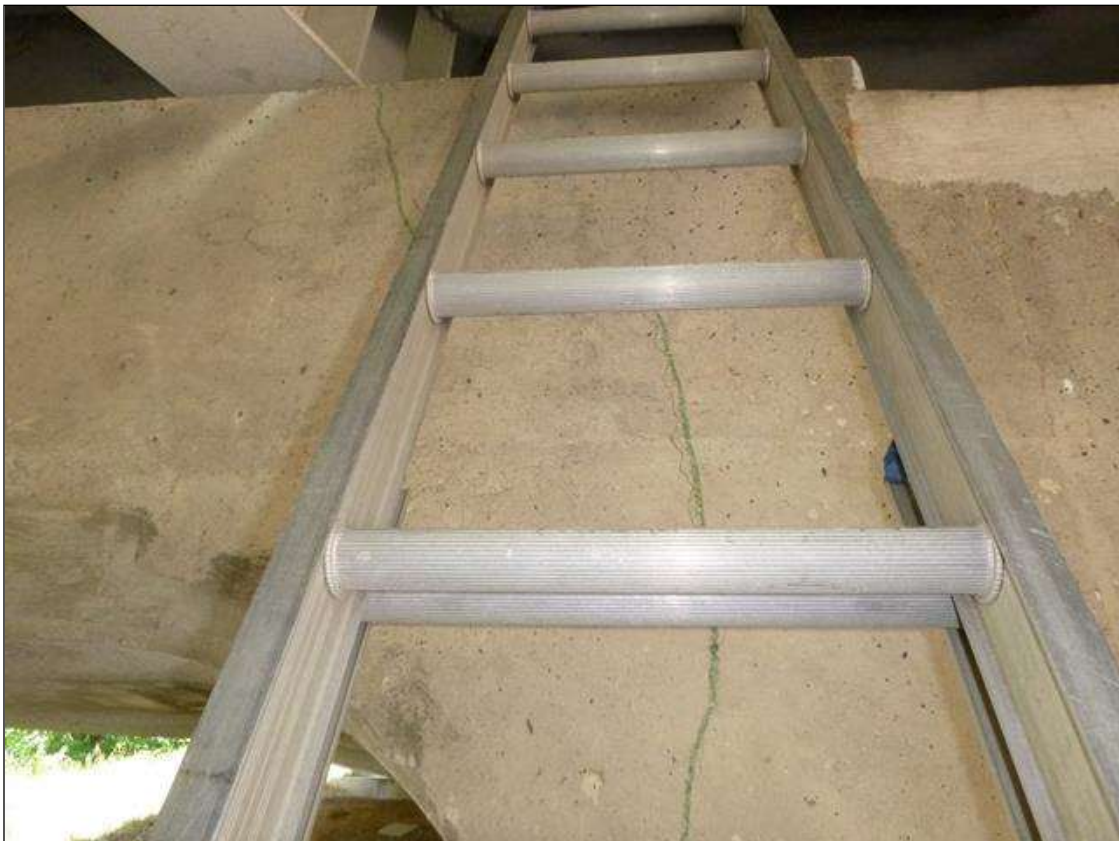
Bent 1 Cap 1: VERTICAL CRACK .02" OPEN 6' HIGH COLUMN 3 TO BEAM 6 SEAT ON EAST FACE.

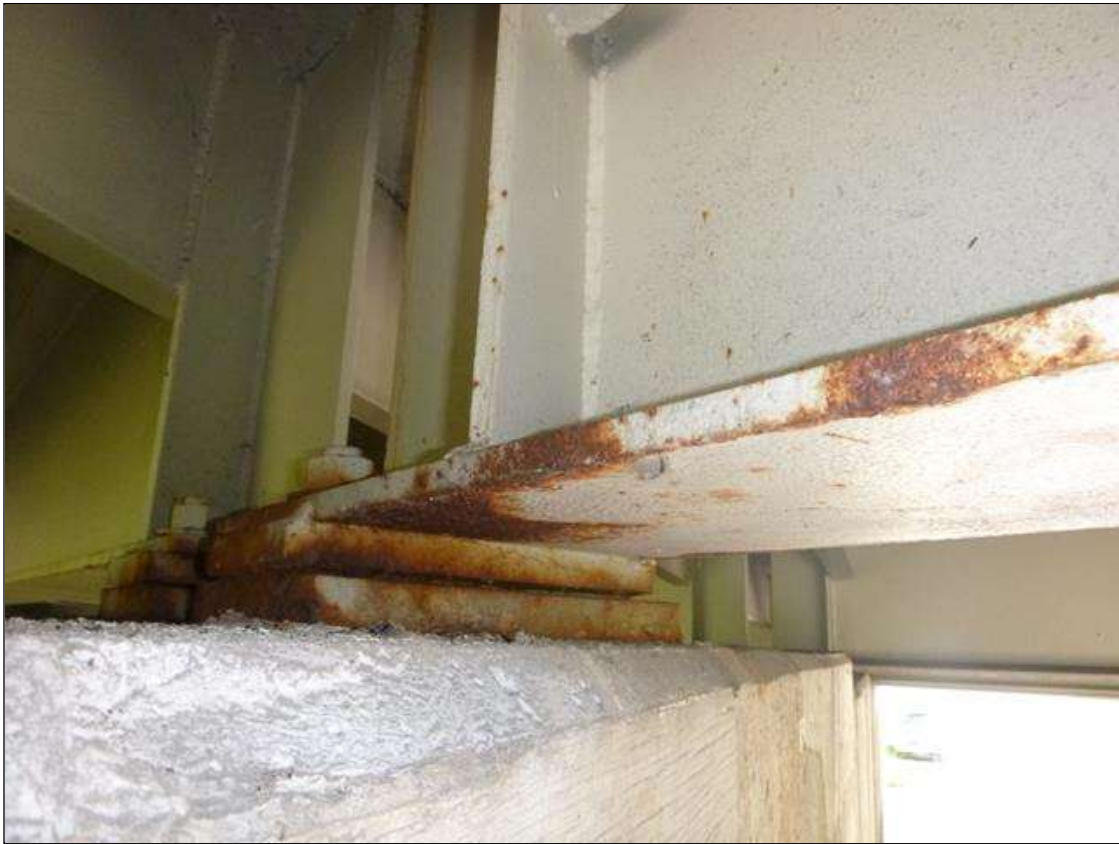
| Element Number | Defect Type | Defect Description | CS | CS Qty | Maint Qty | |
|---|---|---|---|---|---|---|
| 107 | Corrosion | ACTIVE FRECKLE SURFACE RUST 3' LONG AT BENT 1 END. | 2 | 3 | | Feet |

Span 2 Beam 5: ACTIVE FRECKLE SURFACE RUST 3' LONG AT BENT 1 END.

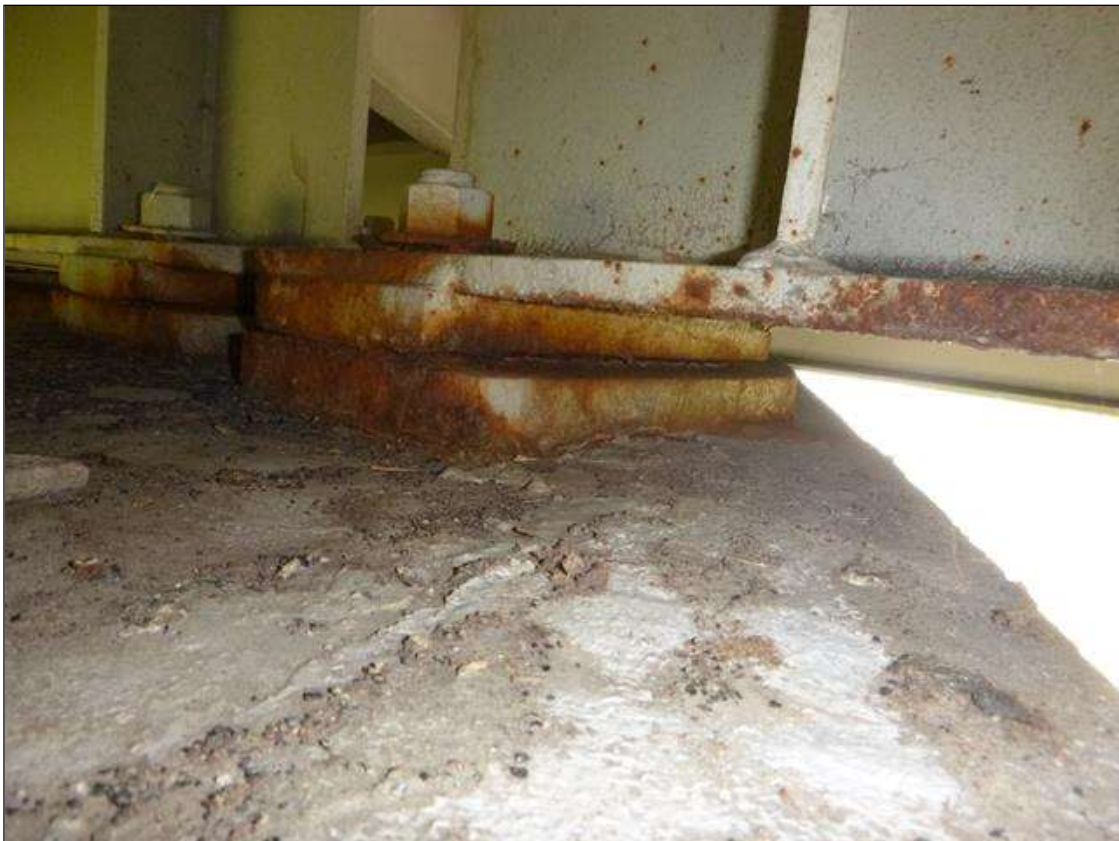
| Element Number | Defect Type | Defect Description | CS | CS Qty | Maint Qty | |
|---|---|---|---|---|---|---|
| 515 | Effectiveness (Steel Protective Coatings) | PAINT IS FAILING WITH RUST BLEED THRU PAINT. | 3 | 1 | 1 | Square Feet |

Span 2 Beam 5 Near Bearing: PAINT IS FAILING WITH RUST BLEED THRU PAINT.

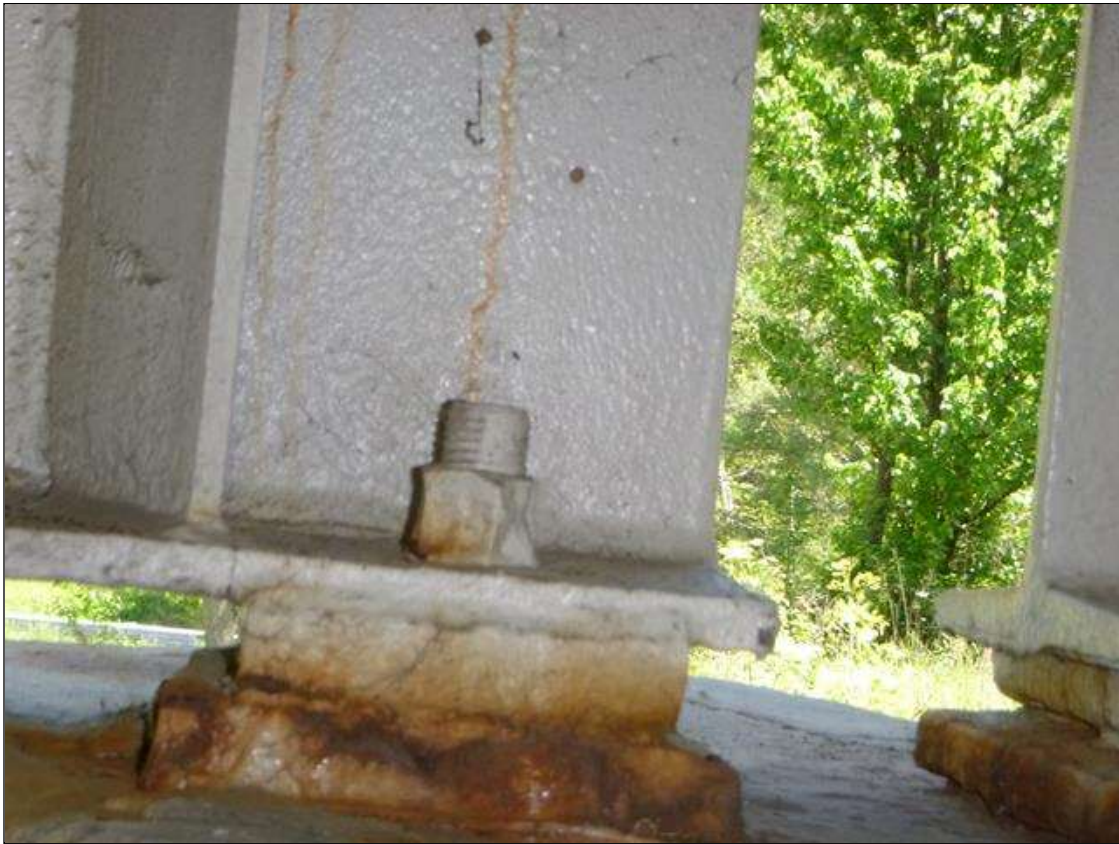
Span 2 Beam 1 Far Bearing: ANCHOR NUT HAS 50% LOSS OF SECTION HOWEVER HAS BEEN RECENTLY CLEANED AND PAINTED WITH CORROSION ARRESTED. SIMILAR AT SPAN 3 BEAM 1 NEAR BEARING.

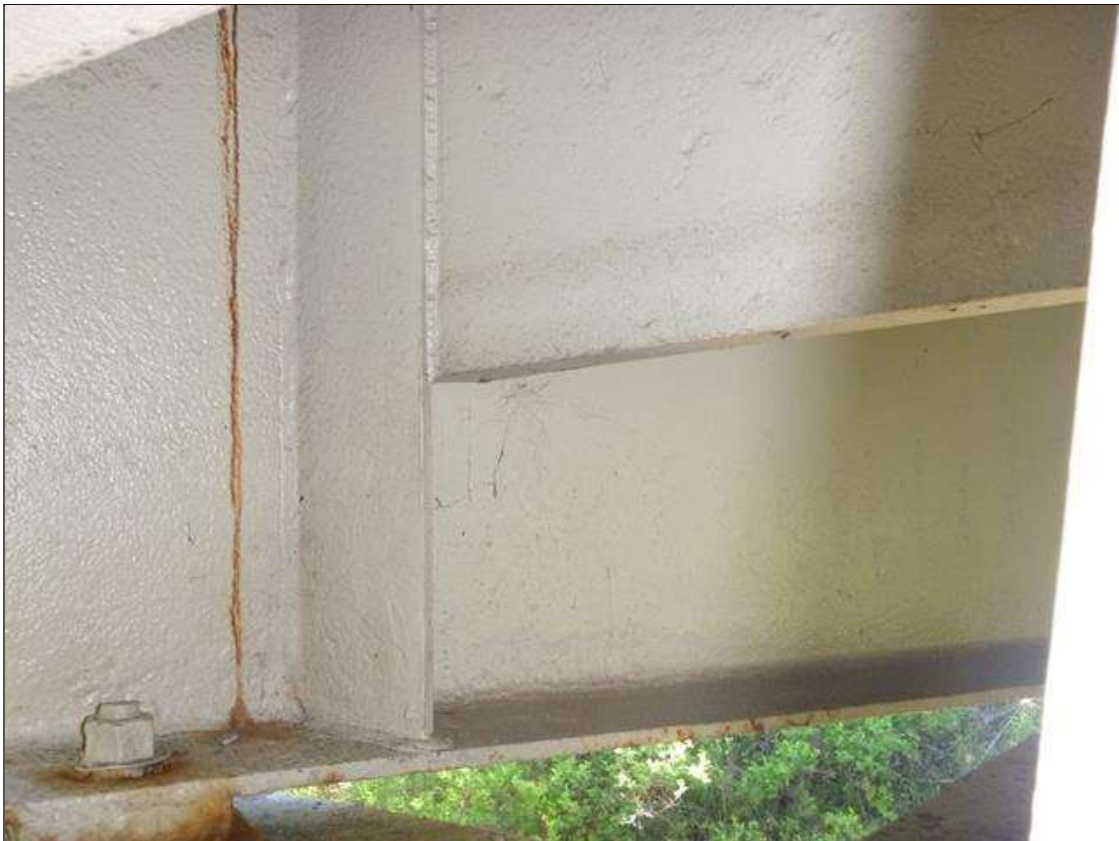
Span 3 Beam 1: PITTING UP TO .06" DEEP ON BOTTOM 3" OF WEB AND BOTTOM FLANGE 3' LONG, HOWEVER, BEAM HAS BEEN RECENTLY PAINTED AND CORROSION ARRESTED.

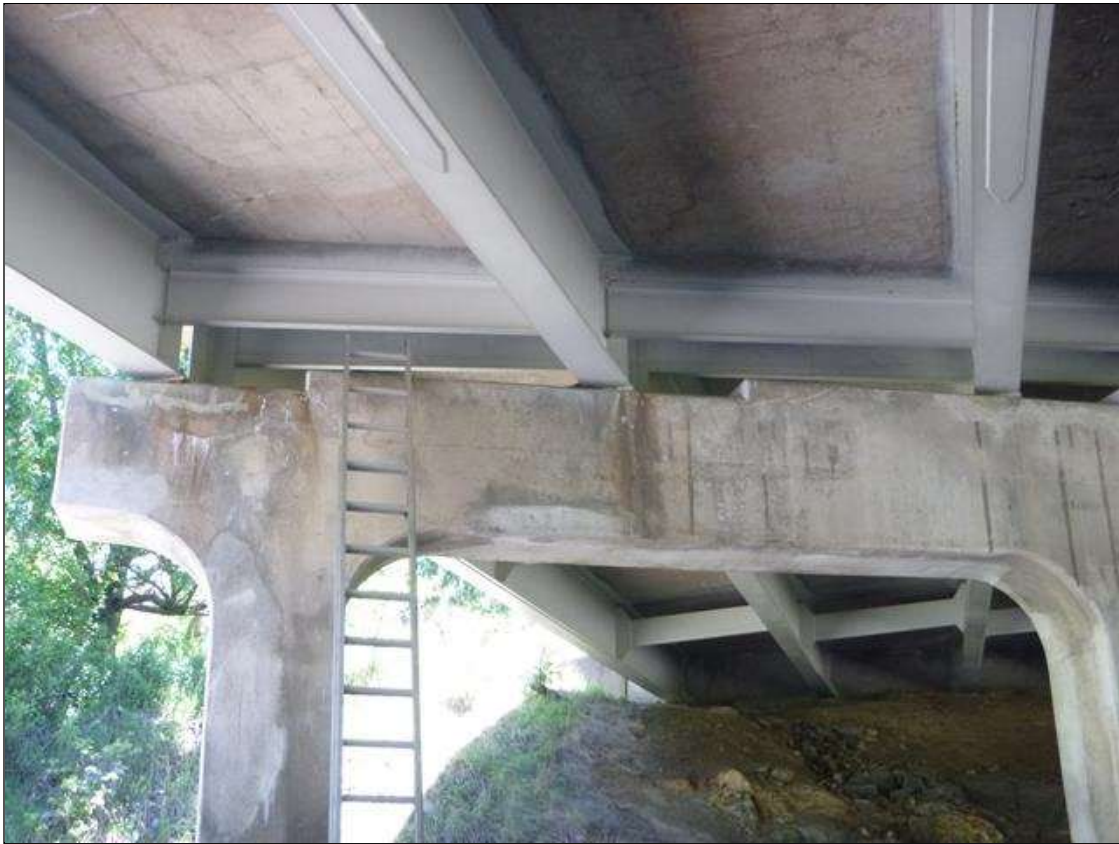
Bent 2 Cap 1: PATCHWORK LEFT END TO COLUMN 2 ON WEST FACE.

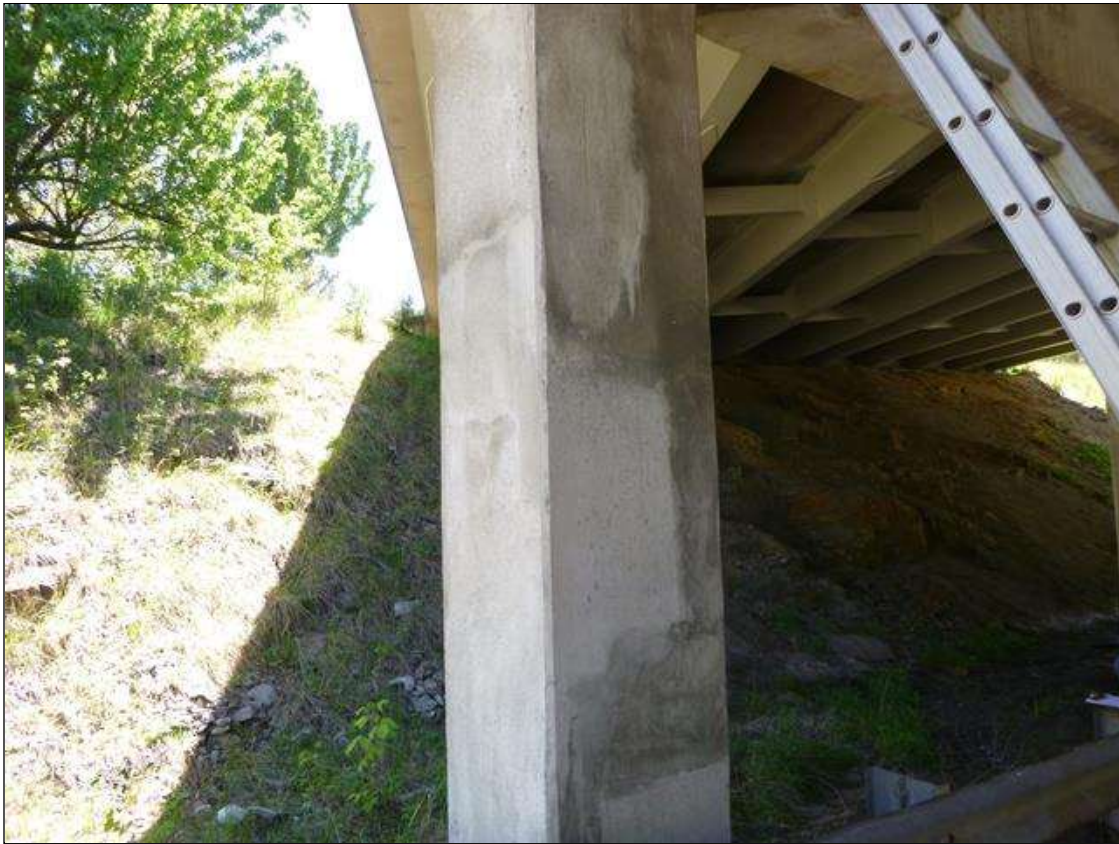
Bent 2 Pile 1: PATCHWORK FULL HEIGHT NORTH AND WEST FACES.

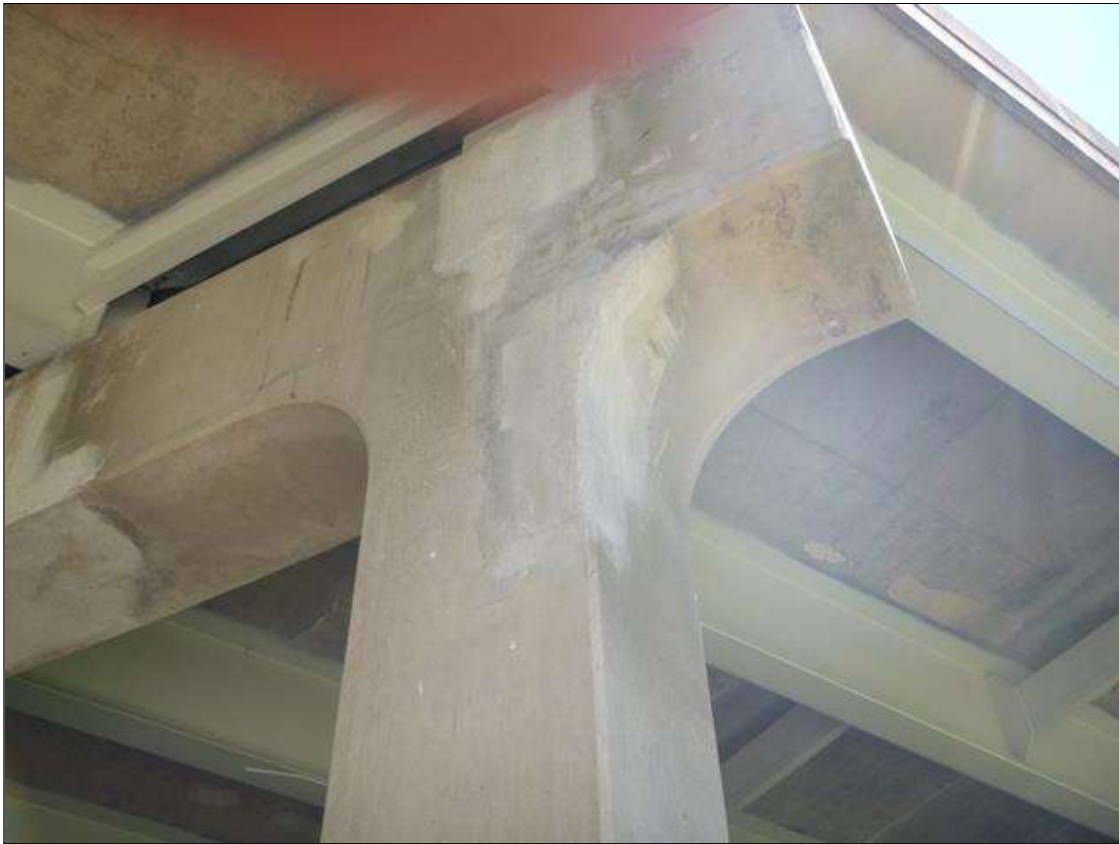
Bent 2 Pile 5: PATCHWORK TOP 3' HIGH ON WEST AND SOUTH FACES.

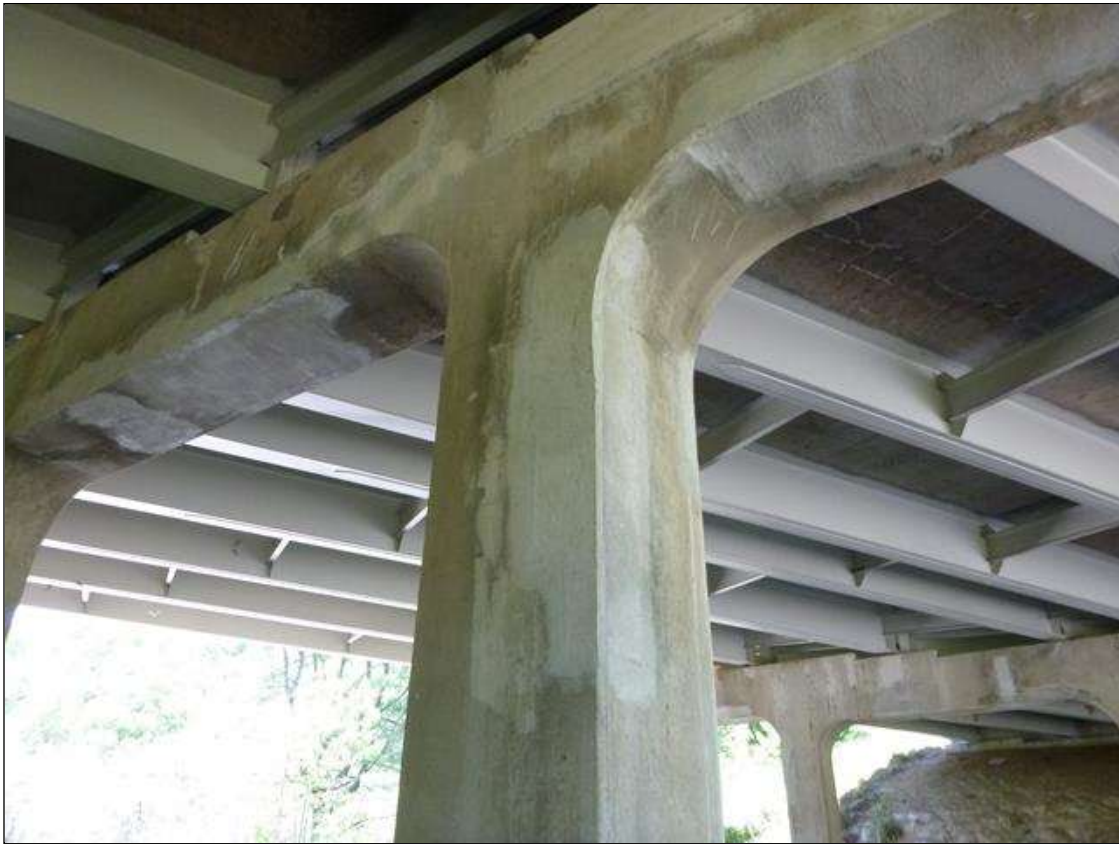
Bent 2 Pile 2: PATCHWORK ALONG TOP 5' ON NORTH AND EAST FACES.

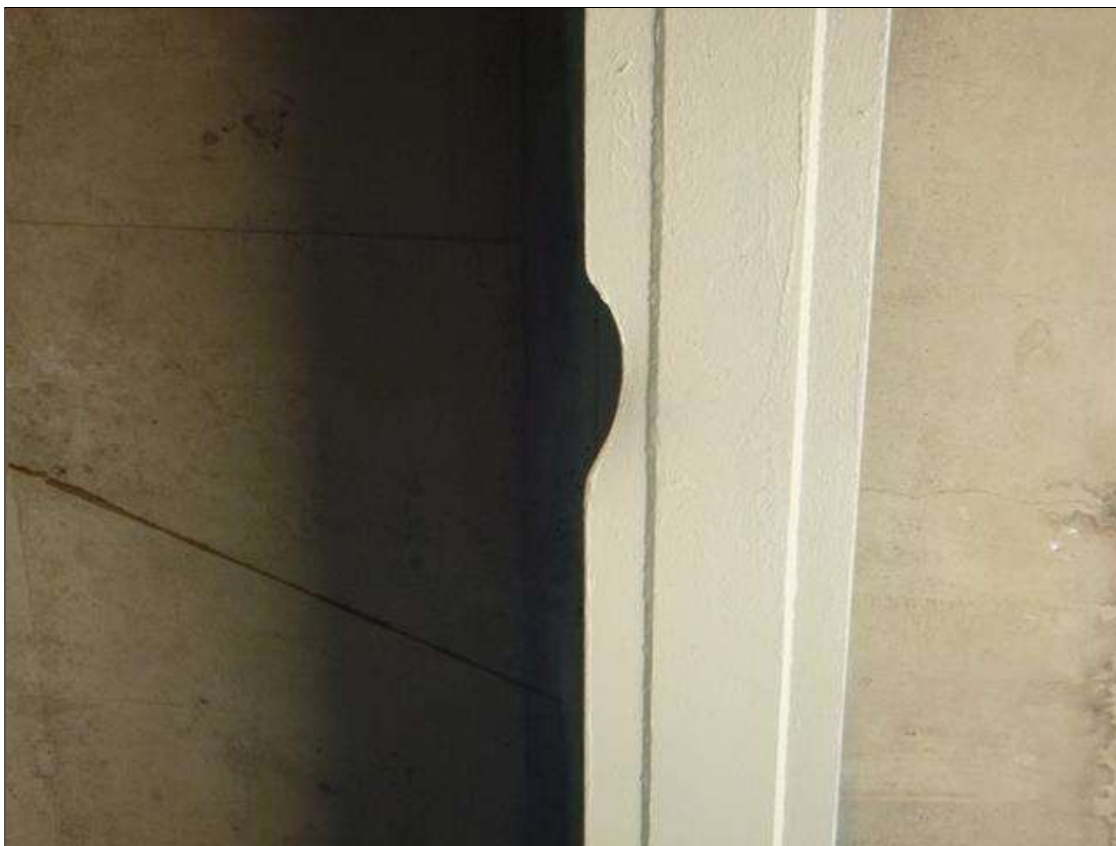
| Element Number | Defect Type | Defect Description | CS | CS Qty | Maint Qty | |
|---|---|---|---|---|---|---|
| 107 | Distortion | BOTTOM FLANGE HAS BEEN GROUND DOWN FOR REPAIR 1-1/2" WIDE X 10" LONG OVER NORTH BOUND LANE. | 2 | 1 | | Feet |

Span 2 Beam 1: BOTTOM FLANGE HAS BEEN GROUND DOWN FOR REPAIR 1-1/2" WIDE X 10" LONG OVER NORTH BOUND LANE.

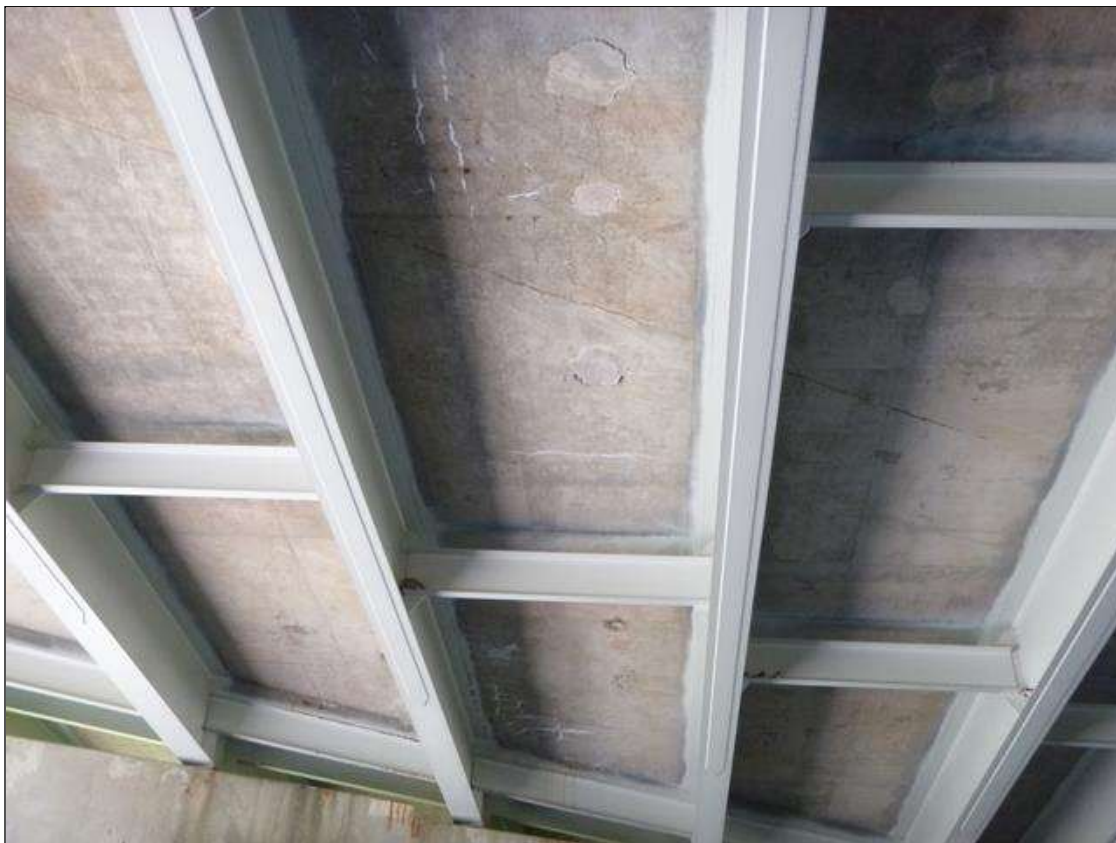
Span 2 Deck: NUMEROUS PATCHES IN UNDERSIDE AT BAY 7.

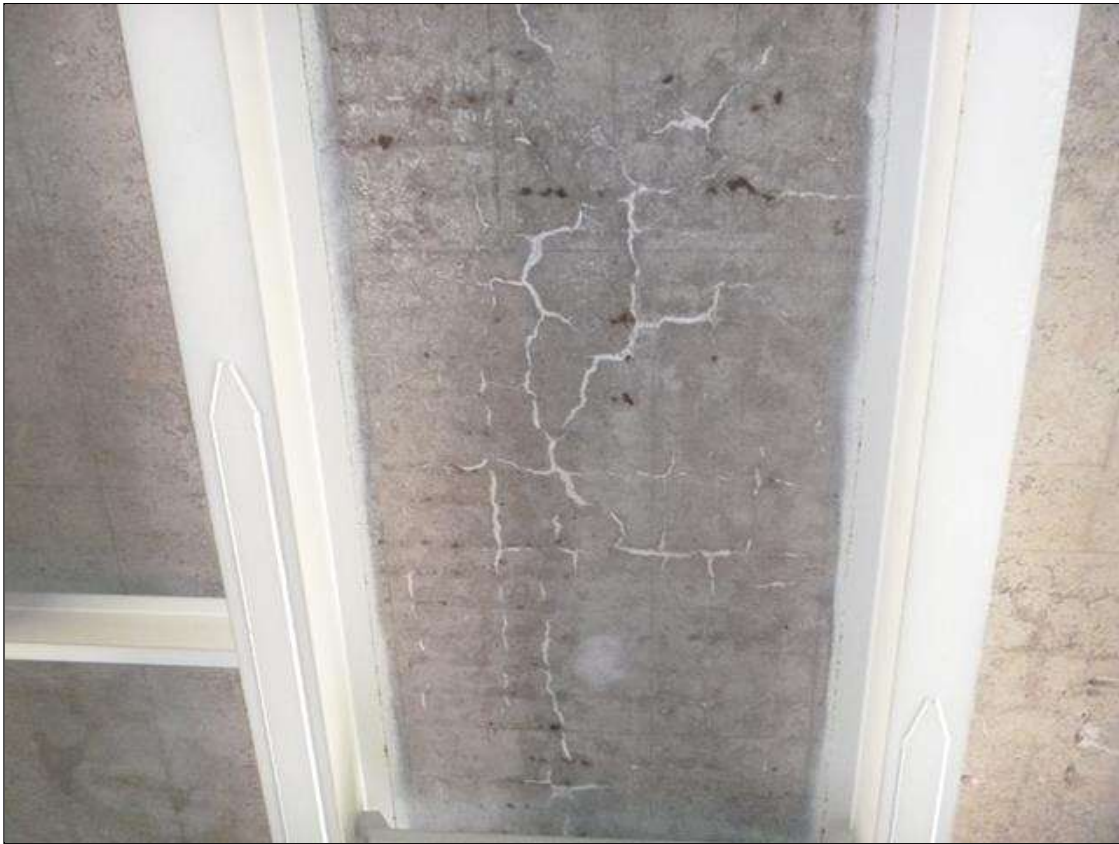
| Element Number | Defect Type | Defect Description | CS | CS Qty | Maint Qty |
|---|---|---|---|---|---|
| 12 | Cracking (RC and Other) | MAP CRACKING UP TO .03" OPEN WITH EFFLORESCENCE IN BAY 3 UNDERNEATH AT MID-SPAN. | 2 | 120 | 120 Square Feet |

Span 2 Deck: MAP CRACKING UP TO .03" OPEN WITH EFFLORESCENCE IN BAY 3 UNDERNEATH AT MID-SPAN.

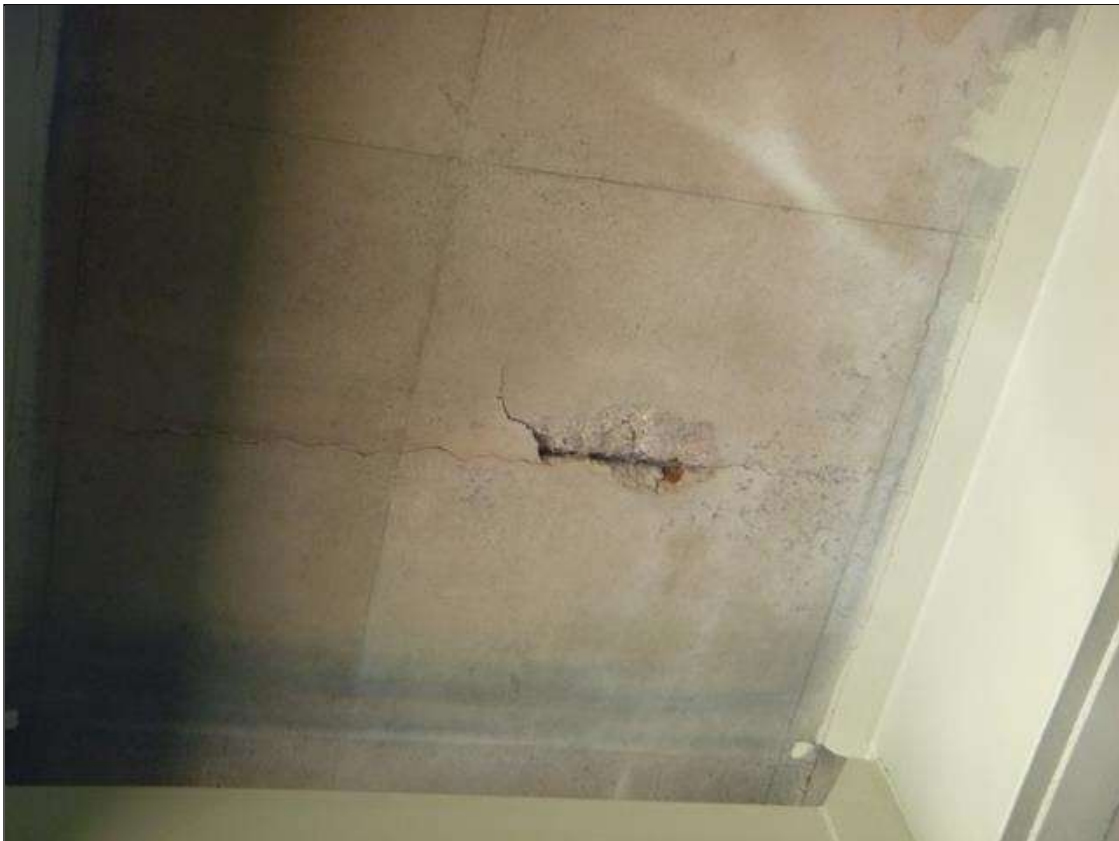
| Element Number | Defect Type | Defect Description | CS | CS Qty | Maint Qty |
|---|---|---|---|---|---|
| 12 | Delamination/Spall | SPALL 18" WIDE X 12" LONG X 2-1/2" DEEP AT BAY 1, 12' FROM BENT 1 END. | 3 | 2 | 2 Square Feet |

Span 2 Deck: SPALL 18" WIDE X 12" LONG X 2-1/2" DEEP AT BAY 1, 12' FROM BENT 1 END.

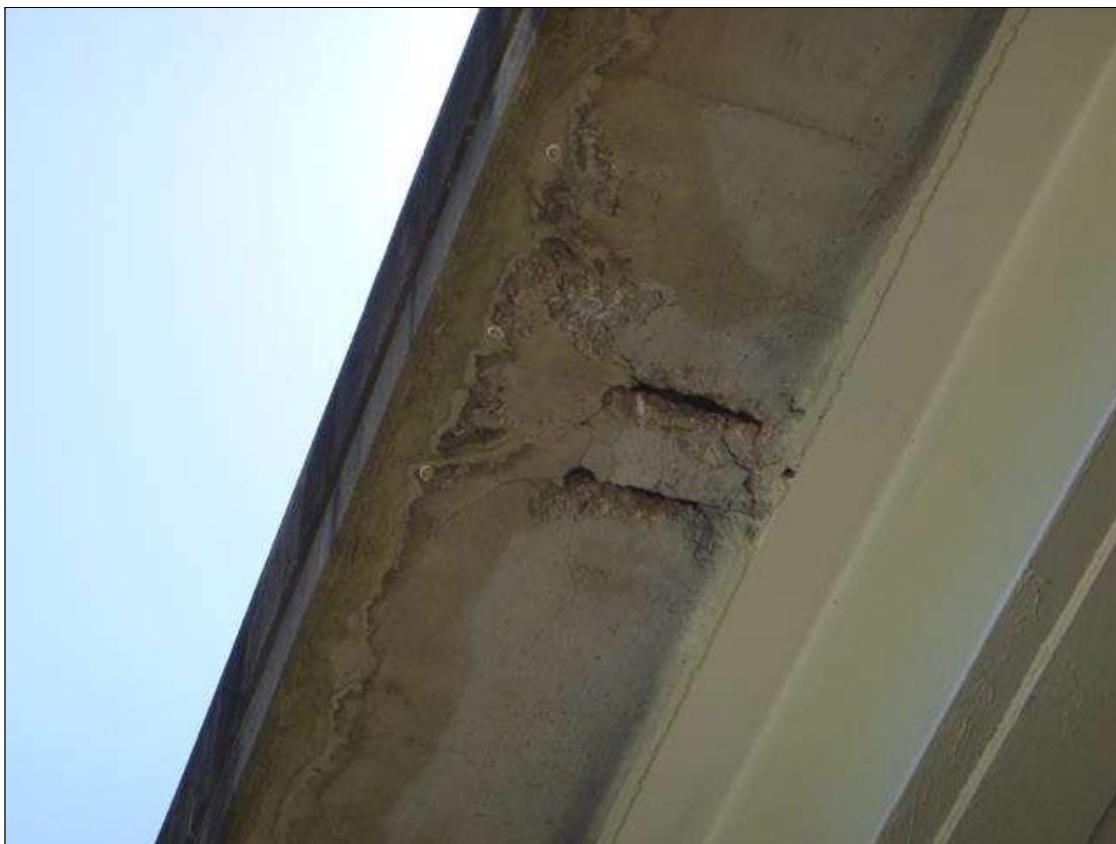
| Element Number | Defect Type | Defect Description | CS | CS Qty | Maint Qty |
|---|---|---|---|---|---|
| 12 | Delamination/Spall | SPALL 12" X 12" X 2" DEEP IN LEFT OVERHANG 12' FROM BENT 1 END. | 3 | 1 | 1 Square Feet |

Span 2 Deck: SPALL 12" X 12" X 2" DEEP IN LEFT OVERHANG 12' FROM BENT 1 END.

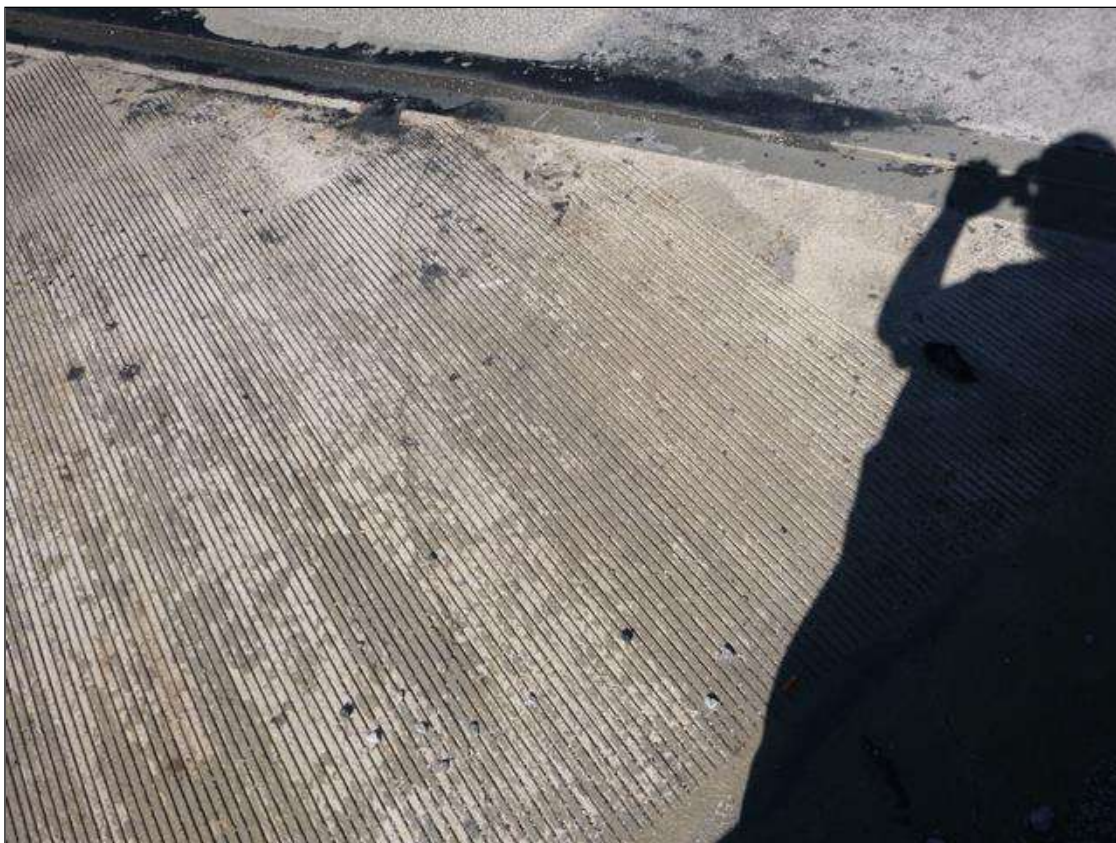
| Element Number | Defect Type | Defect Description | CS | CS Qty | Maint Qty | |
|---|---|---|---|---|---|---|
| 12 | Cracking (RC and Other) | DIAGONAL CRACKING .03" OPEN AT NORTHWEST CORNER END BENT 1 END. | 2 | 15 | 15 | Square Feet |

Span 1 Deck: DIAGONAL CRACKING .03" OPEN AT NORTHWEST CORNER END BENT 1 END.

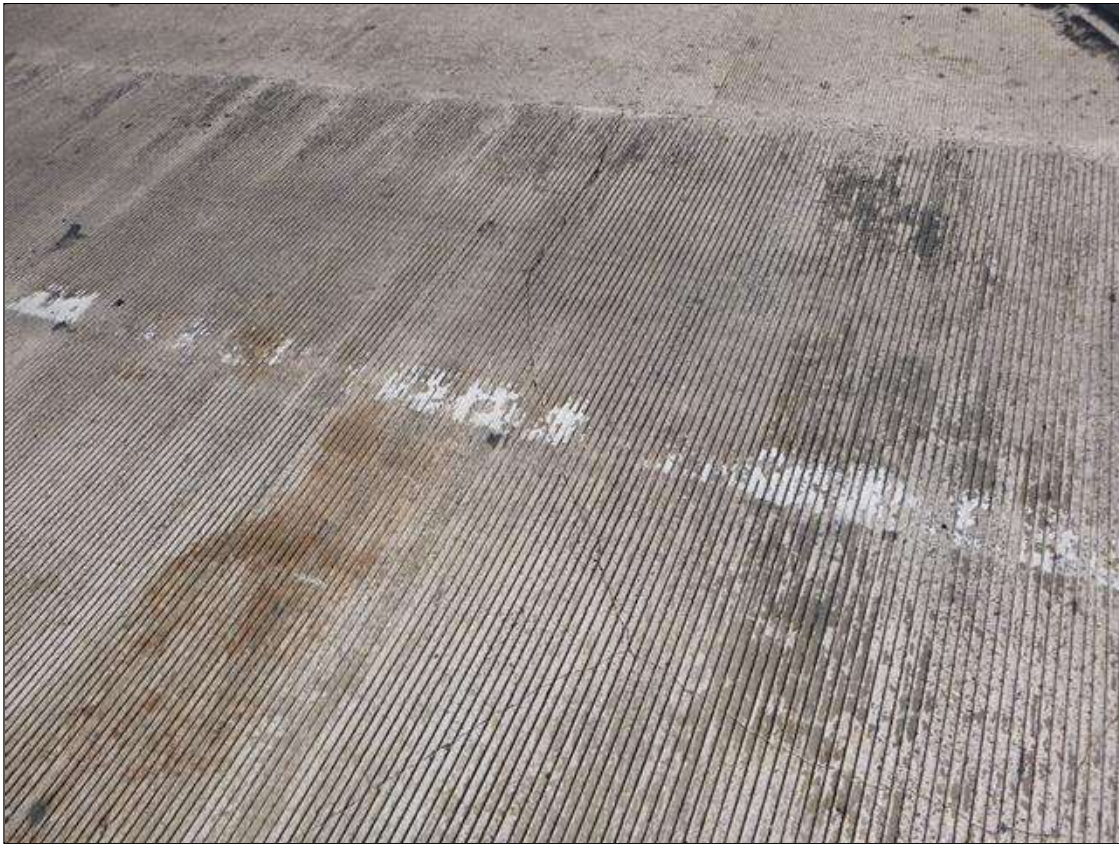
| Element Number | Defect Type | Defect Description | CS | CS Qty | Maint Qty | |
|---|---|---|---|---|---|---|
| 12 | Cracking (RC and Other) | TRANSVERSE CRACK .05" OPEN, EAST BOUND LANE AND WEST BOUND LANE 6' FROM END BENT 1 END. | 2 | 70 | 70 | Square Feet |

Span 1 Deck: TRRANSVERSE CRACK .05" OPEN, EAST BOUND LANE AND WEST BOUND LANE 6' FROM END BENT 1 END.

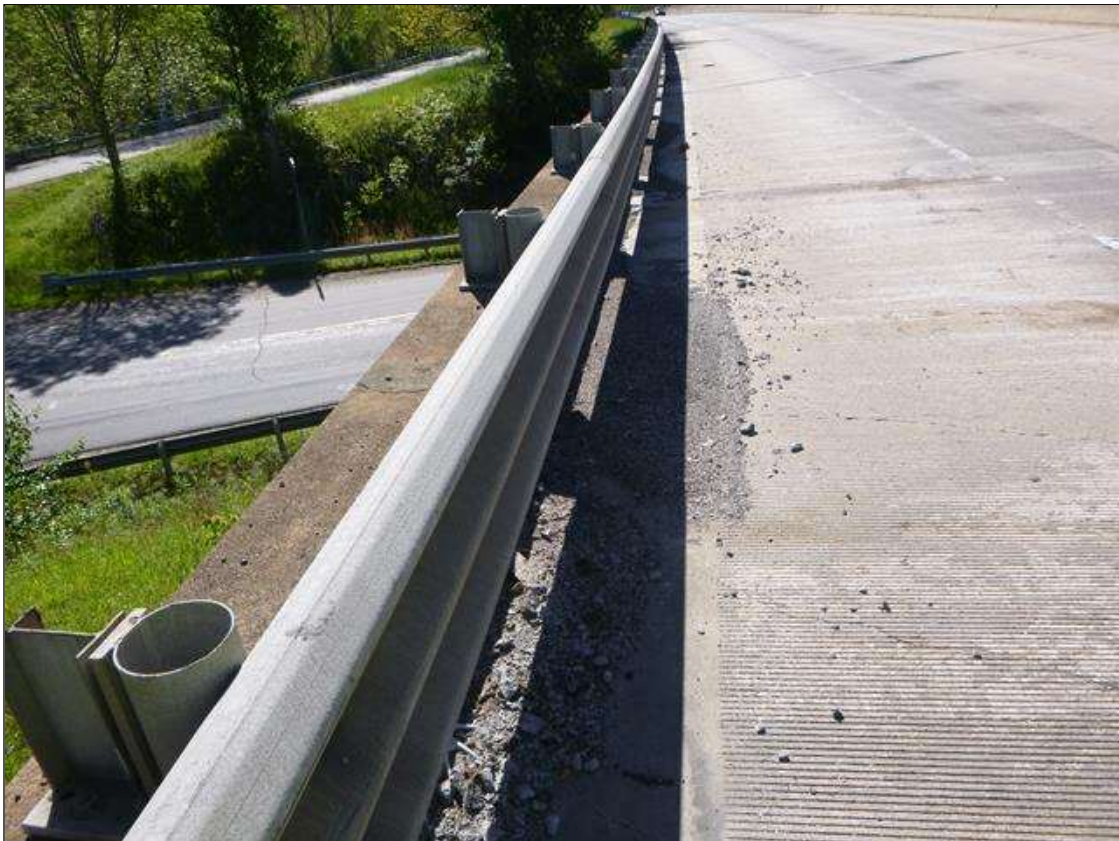
DECK DEBRIS ALONG BOTH SHOULDERS.

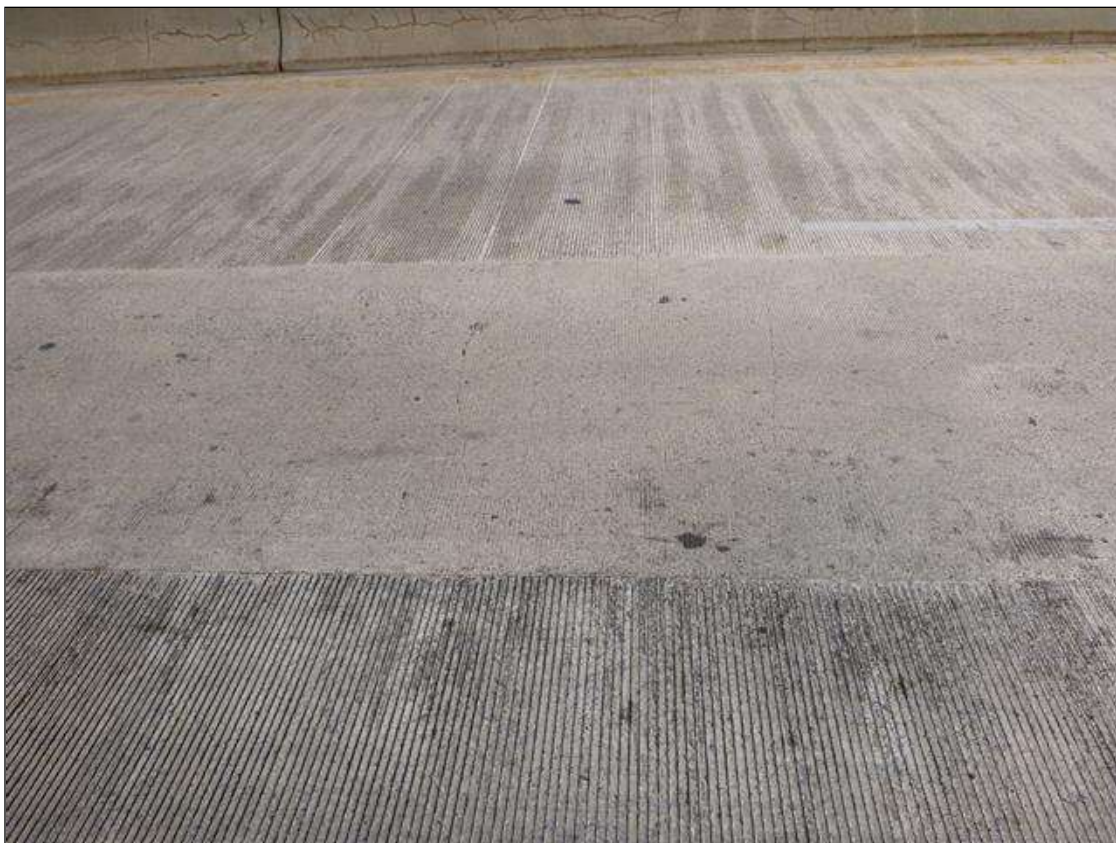
| Element Number | Defect Type | Defect Description | CS | CS Qty | Maint Qty | |
|---|---|---|---|---|---|---|
| 12 | Cracking (RC and Other) | TRANSVERSE CRACKS .03" OPEN 3' TO 5' APART FULL WIDTH. | 2 | 700 | 700 | Square Feet |

Span 1 Deck: TRANSVERSE CRACKS .03" OPEN 3' TO 5' APART FULL WIDTH.

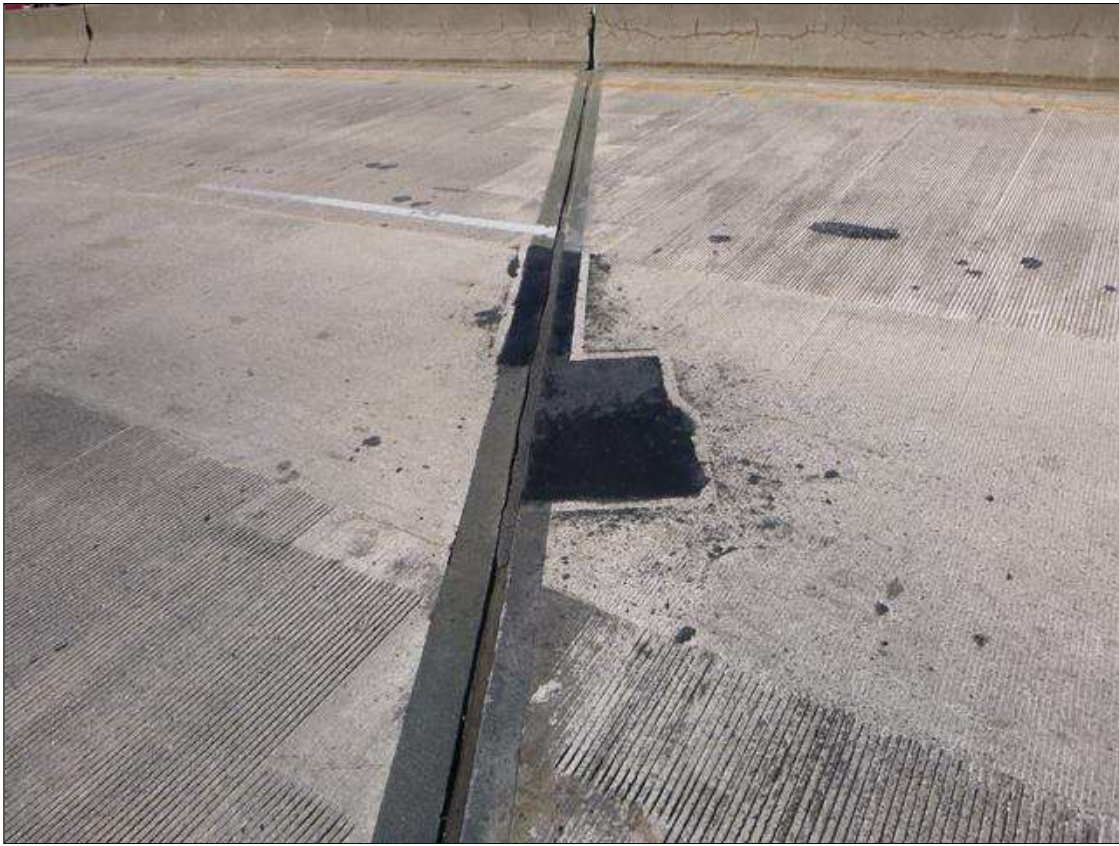
Span 1 Deck: PATCHED AREA 24" WIDE X 18" LONG LEFT WEST BOUND LANE AT BENT 1 END.
