NC DEPARTMENT OF TRANSPORTATION  
DIVISION OF HIGHWAYS  
STRUCTURE MANAGEMENT UNIT

## Structure Safety Report

### Routine Element Inspection - Contract

COUNTY: HAYWOOD STRUCTURE NUMBER: 430124 FREQUENCY: 24 MONTHS  
FACILITY CARRIED: I-40 MILE POST: 14.9  
LOCATION: 5 MI.W.JCT.US276  
FEATURE INTERSECTED: SR1338  
LATITUDE: 35° 40' 3.95" LONGITUDE: 82° 59' 40.3"  
SUPERSTRUCTURE: REINFORCED CONCRETE FLOOR ON I-BEAMS  
SUBSTRUCTURE: E.BT1:RC CAP/H-PILES;ABUT.2:RC CAP/ROCK;INT.BTS:RCP&BEAM  
SPANS: 2 @ 53'-2;1 @ 57'-8.5  
☐ FRACTURE CRITICAL ☐ TEMPORARY SHORING ☐ SCOUR CRITICAL ☐ SCOUR PLAN OF ACTION  
PRESENT CONDITION: Fair INSPECTION DATE: 05/08/2017  
POSTED SV: Not Posted POSTED TTST: Not Posted  
OTHER SIGNS PRESENT: NONE

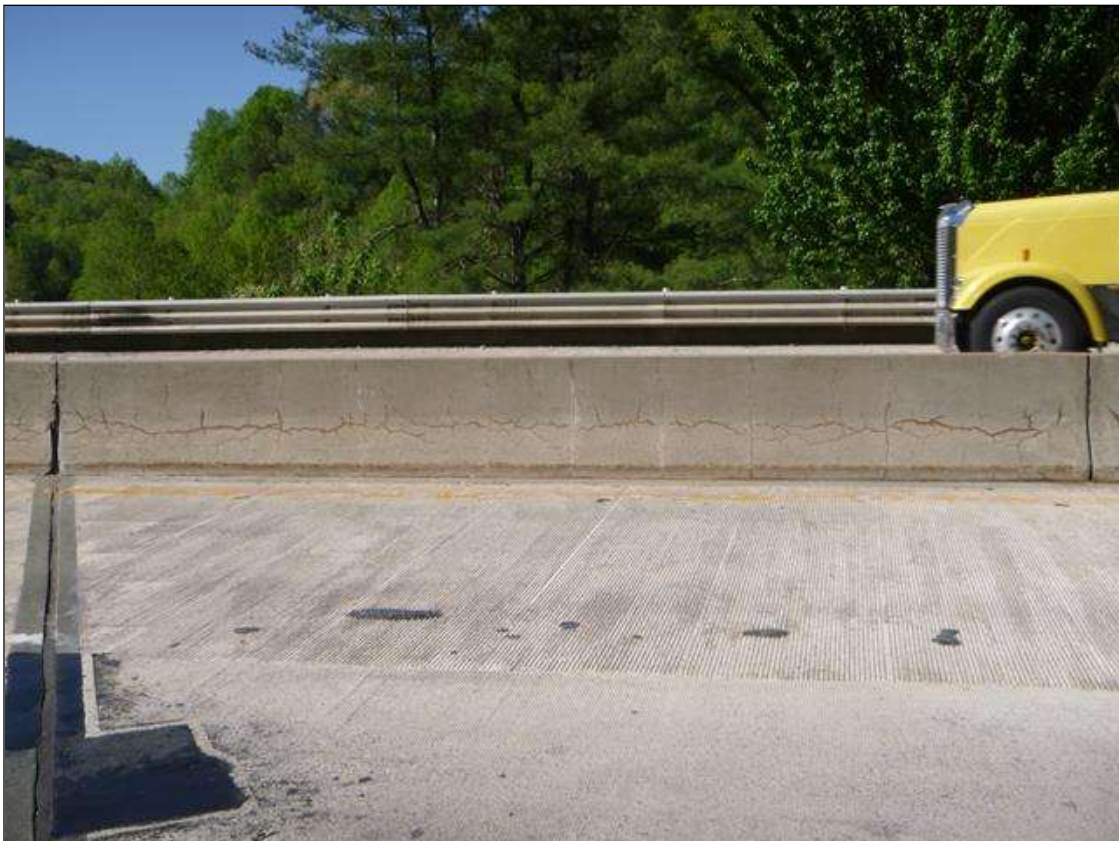
Span 1 Median Rail: HORIZONTAL CRACK UP TO .03" OPEN WITH EFFLORESCENCE AND SCATTERED VERTICAL CRACKS UP TO .03" OPEN 3' TO 8' APART.

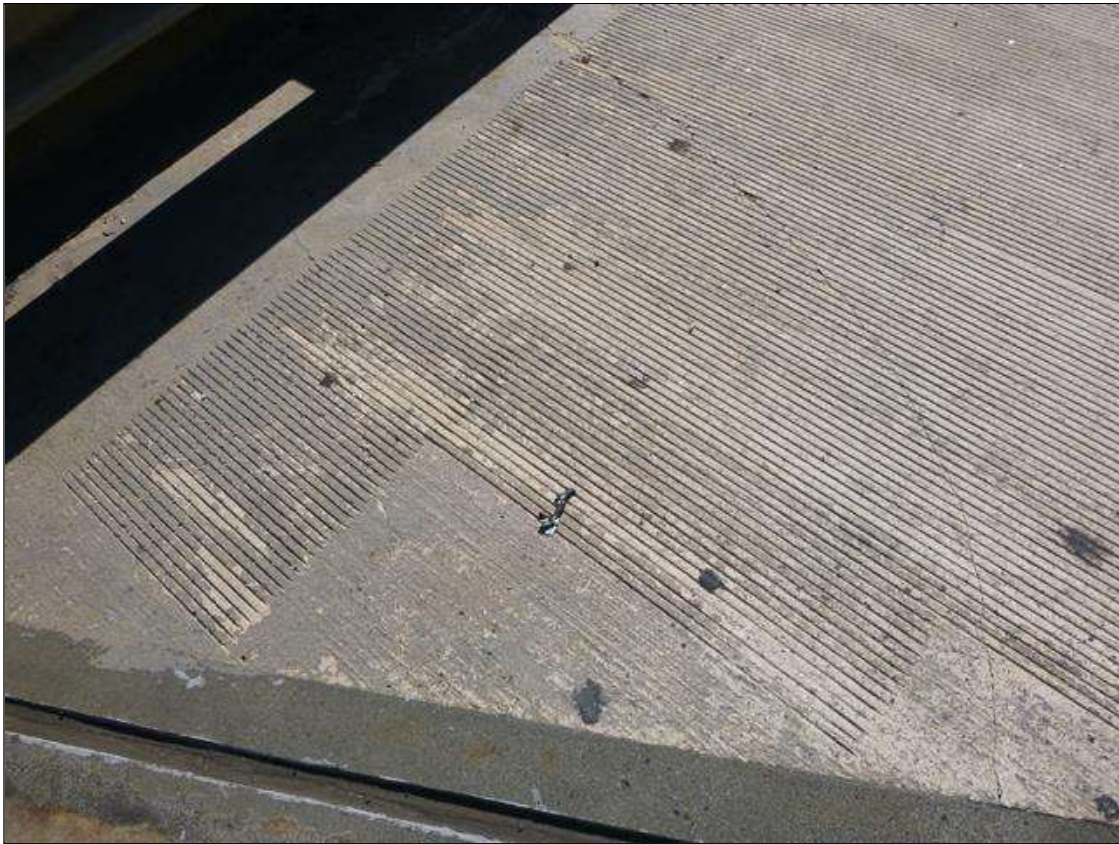
| Element Number | Defect Type | Defect Description | CS | CS Qty | Maint Qty |
|---|---|---|---|---|---|
| 12 | Cracking (RC and Other) | DIAGONAL CRACKS .04" OPEN 4' TO 6' APART WEST BOUND LANE AT BENT 1 END. | 2 | 40 | 40 Square Feet |

Span 2 Deck: DIAGONAL CRACKS .04" OPEN 4' TO 6' APART WEST BOUND LANE AT BENT 1 END.

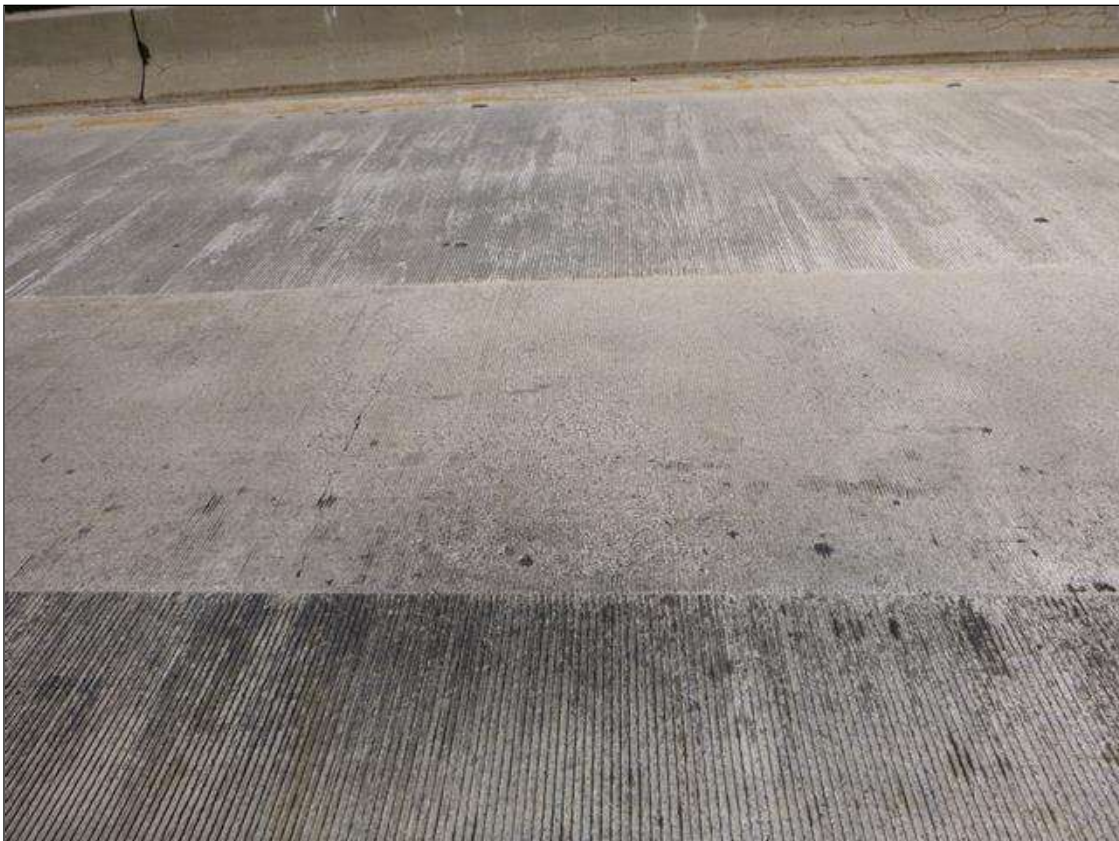
| Element Number | Defect Type | Defect Description | CS | CS Qty | Maint Qty |
|---|---|---|---|---|---|
| 12 | Cracking (RC and Other) | TRANSVERSE CRACKS UP TO .04" OPEN 3' TO 6' APART FULL WIDTH. | 2 | 850 | 850 Square Feet |

Span 2 Deck: TRANSVERSE CRACKS UP TO .04" OPEN 3' TO 6' APART FULL WIDTH.

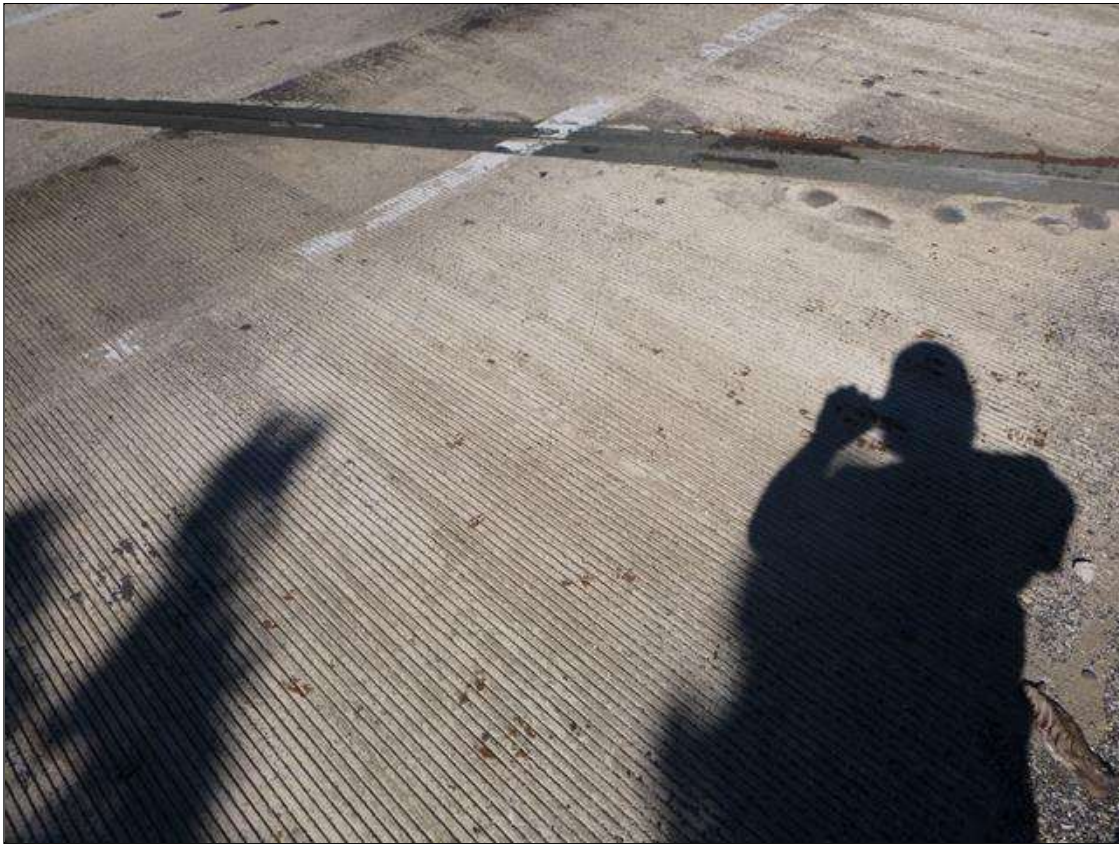
Span 3 Deck: DIAGONAL CRACKS (3) UP TO .03" OPEN, 4' TO 6' APART IN WEST BOUND LANE AT BENT 2 END.

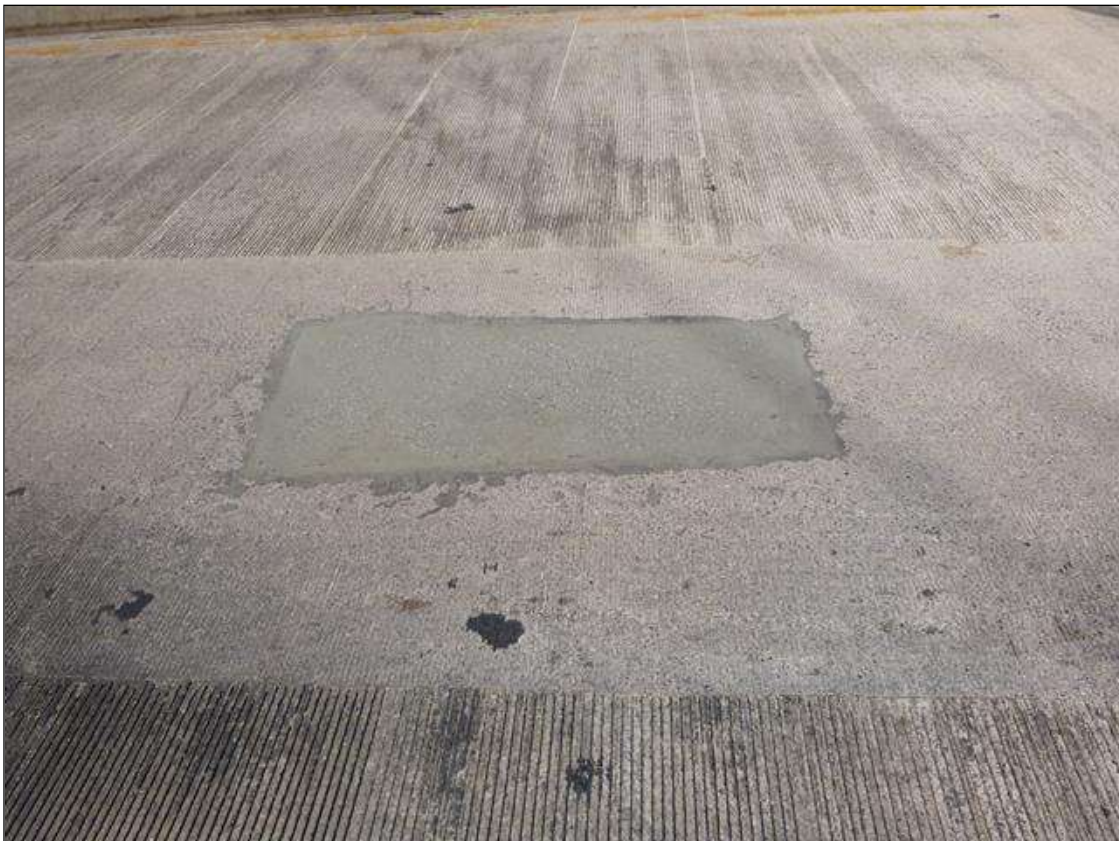
Span 3 Deck: PATCHED AREA 20" WIDE X 48" LONG IN LEFT WEST BOUND LANE 16' FROM BENT 2 END.

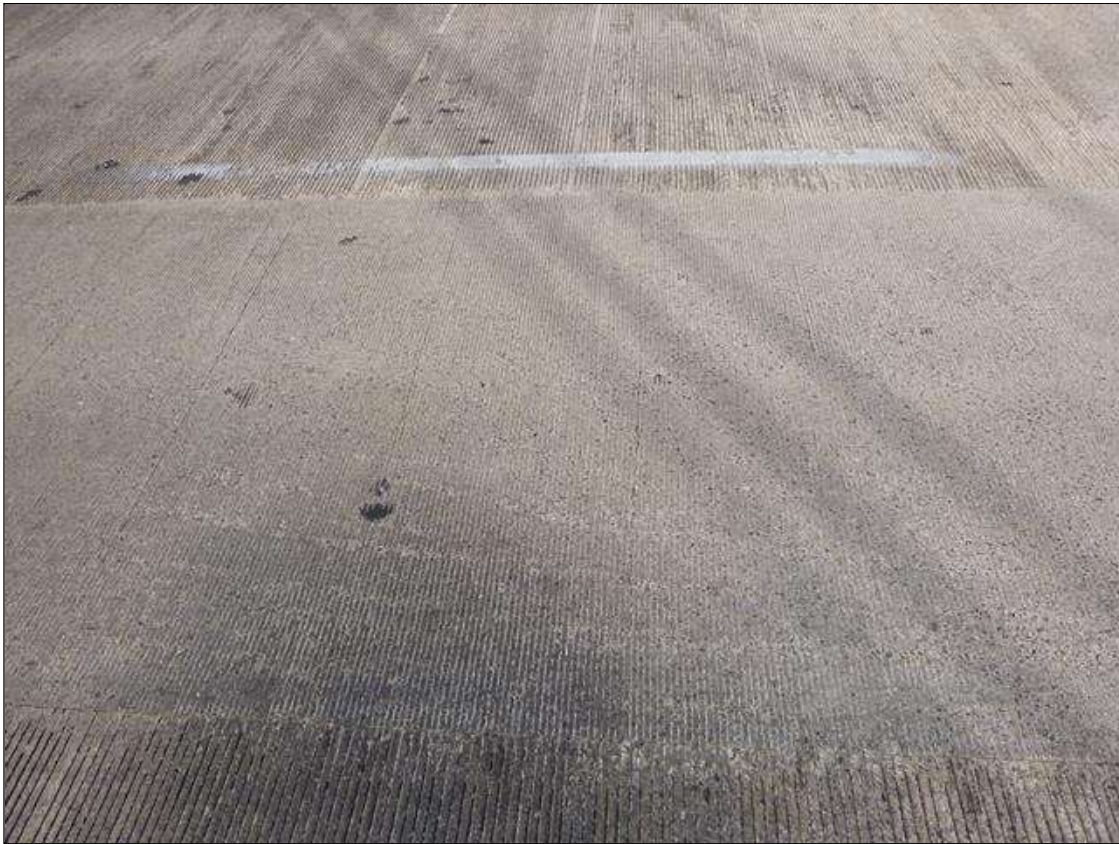
Span 3 Deck: TRANSVERSE CRACKS UP TO .04" OPEN 2' TO 3' APART FULL WIDTH.

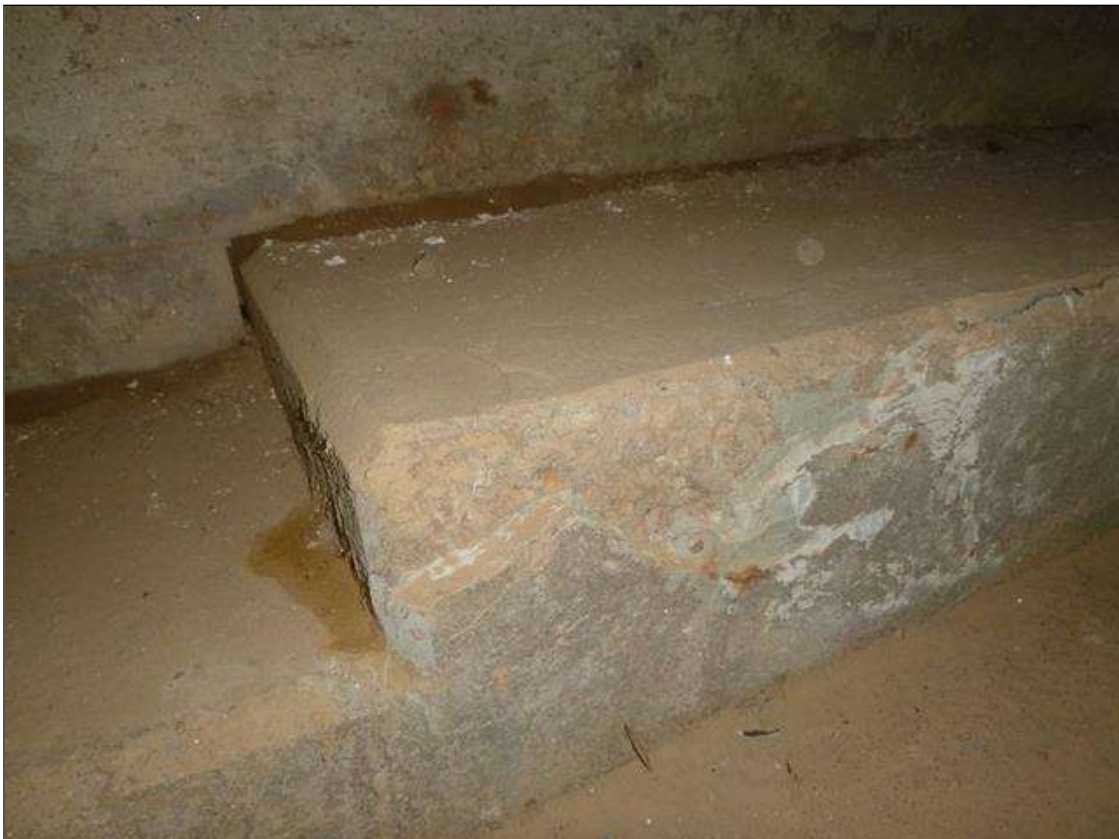
End Bent 2 Cap 1: SPALL 11" WIDE X 6" HIGH X 1/2" DEEP BETWEEN BEAMS 2 AND 3.

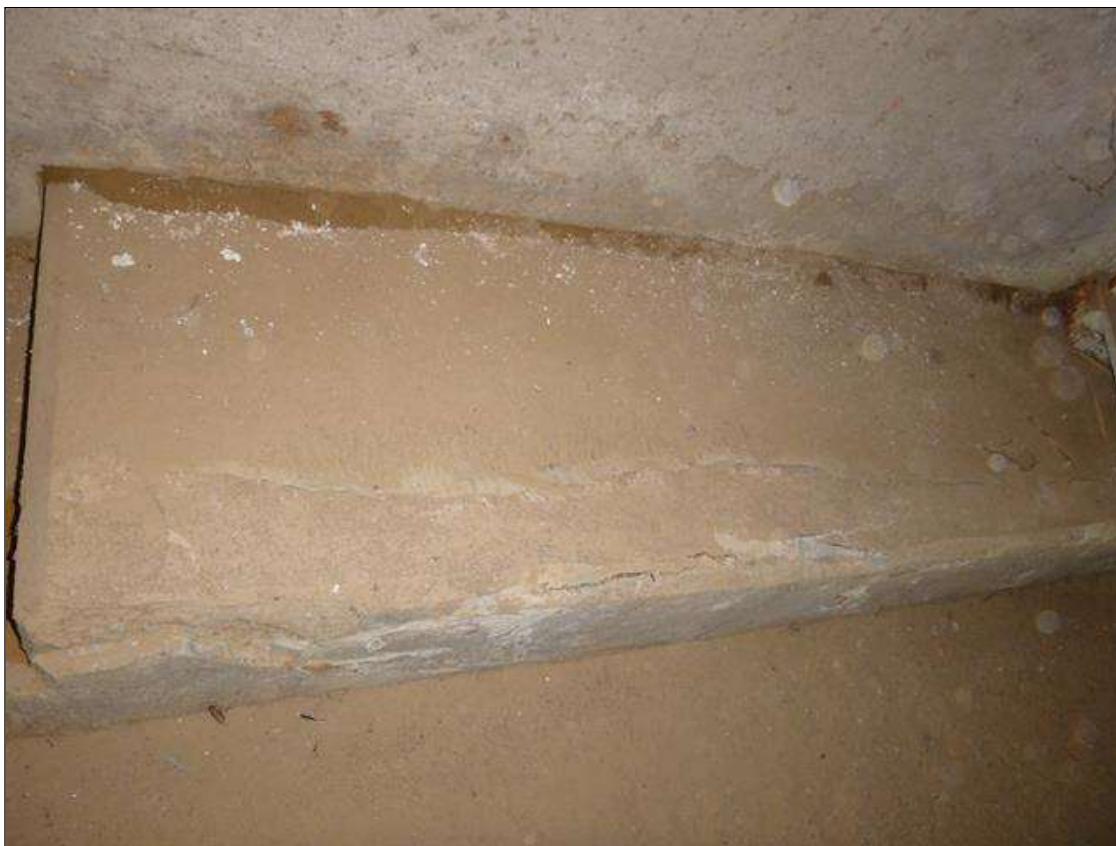
End Bent 2 Cap 1: LONGITUDINAL CRACK .05" OPEN AT BEAM 3.

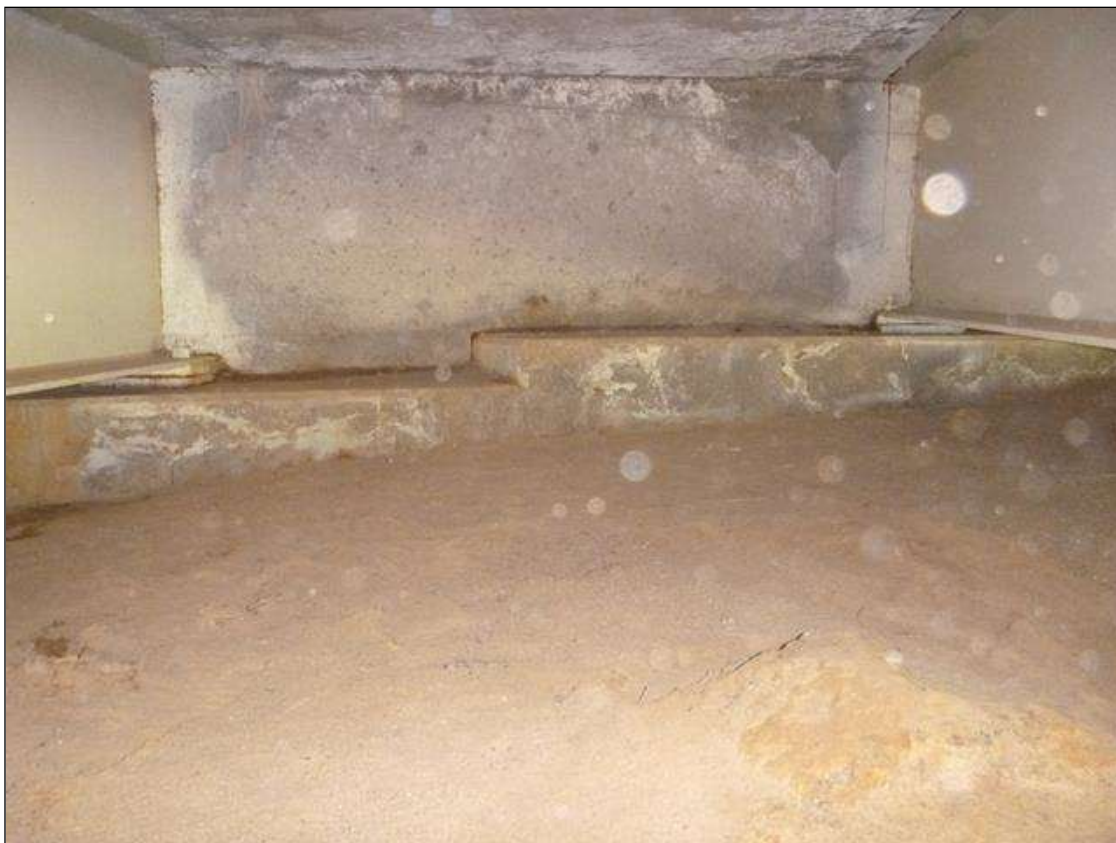
End Bent 2 Cap 1: PATCHWORK (EPOXY) FULL LENGTH OF CAP.

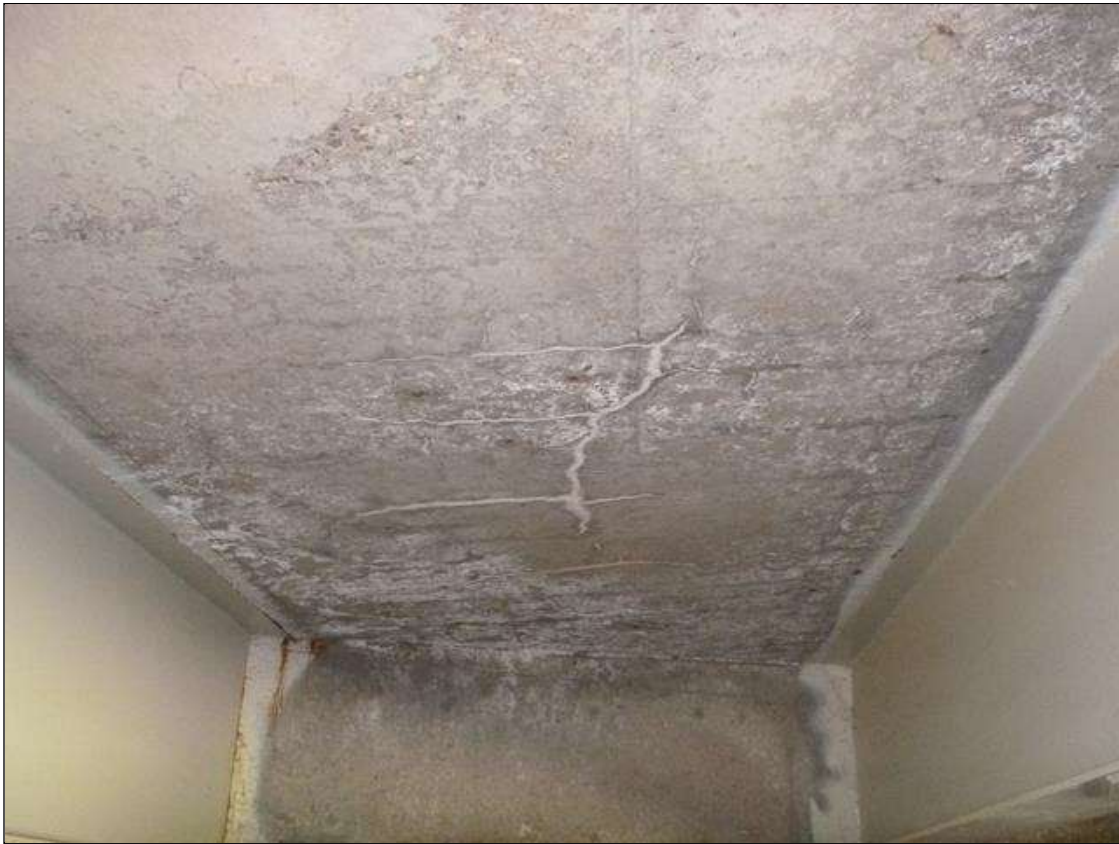
Span 3 Deck: LONGITUDINAL CRACK AND SURFACE EFFLORESCENCE IN LAST 12' AT BAY 3. SIMILAR IN BAY 4.

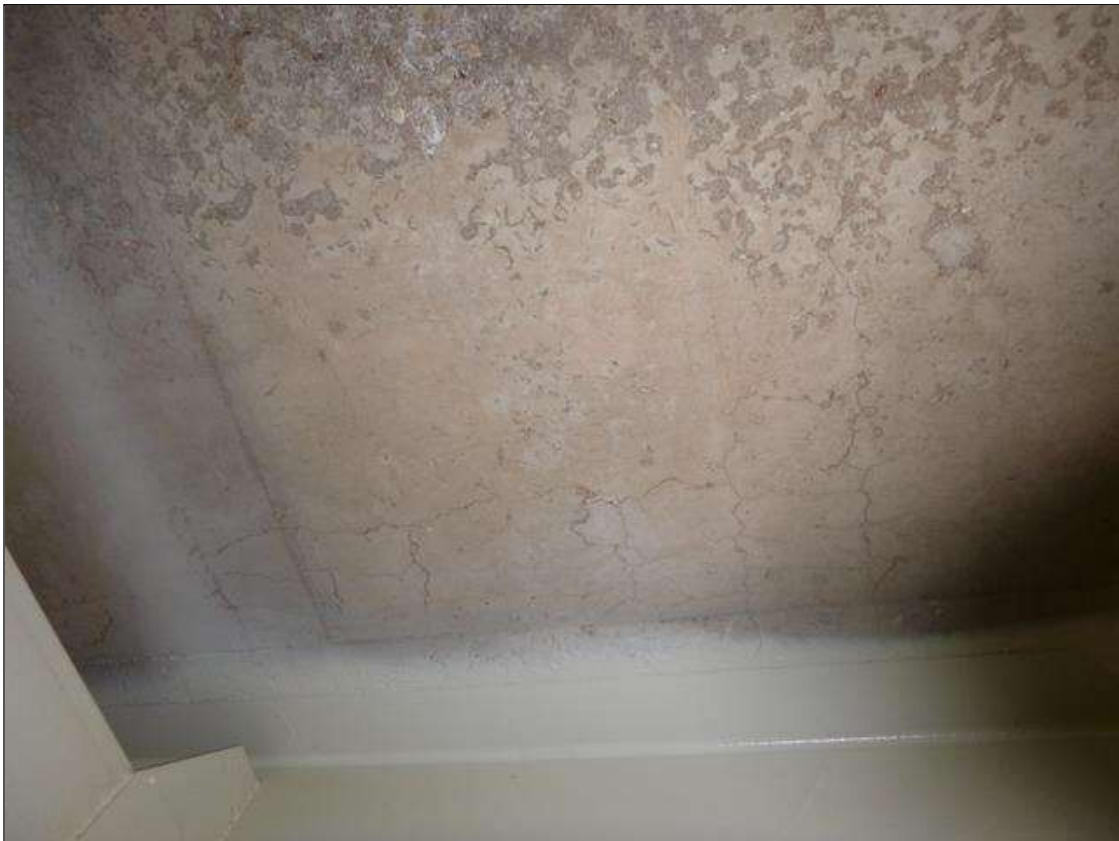
Span 3 Deck: MAP CRACKING UP TO .02" OPEN UNDERSIDE AT BAY 4.

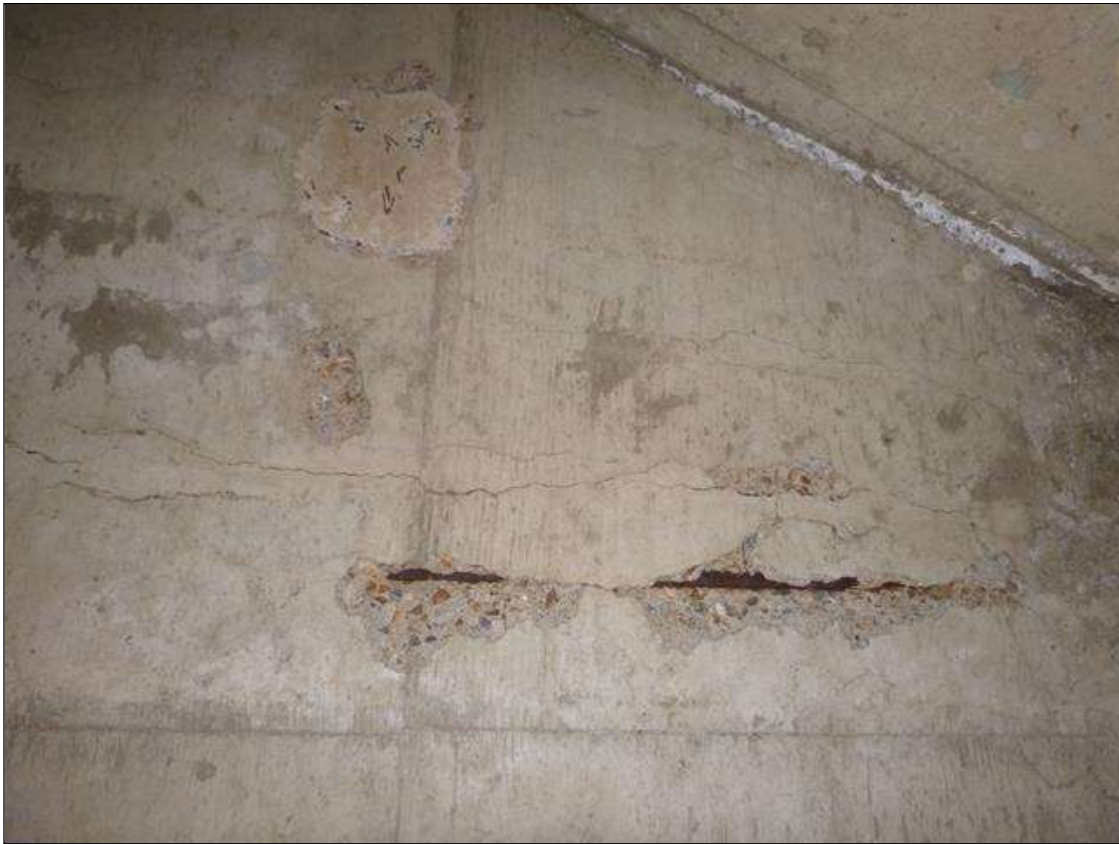
SPAN 3 DECK : SPALL 4' LONG X 6" WIDE X 1" DEEP WITH REBAR EXPOSED AND 12" X 12" PATCH AT BAY 6.

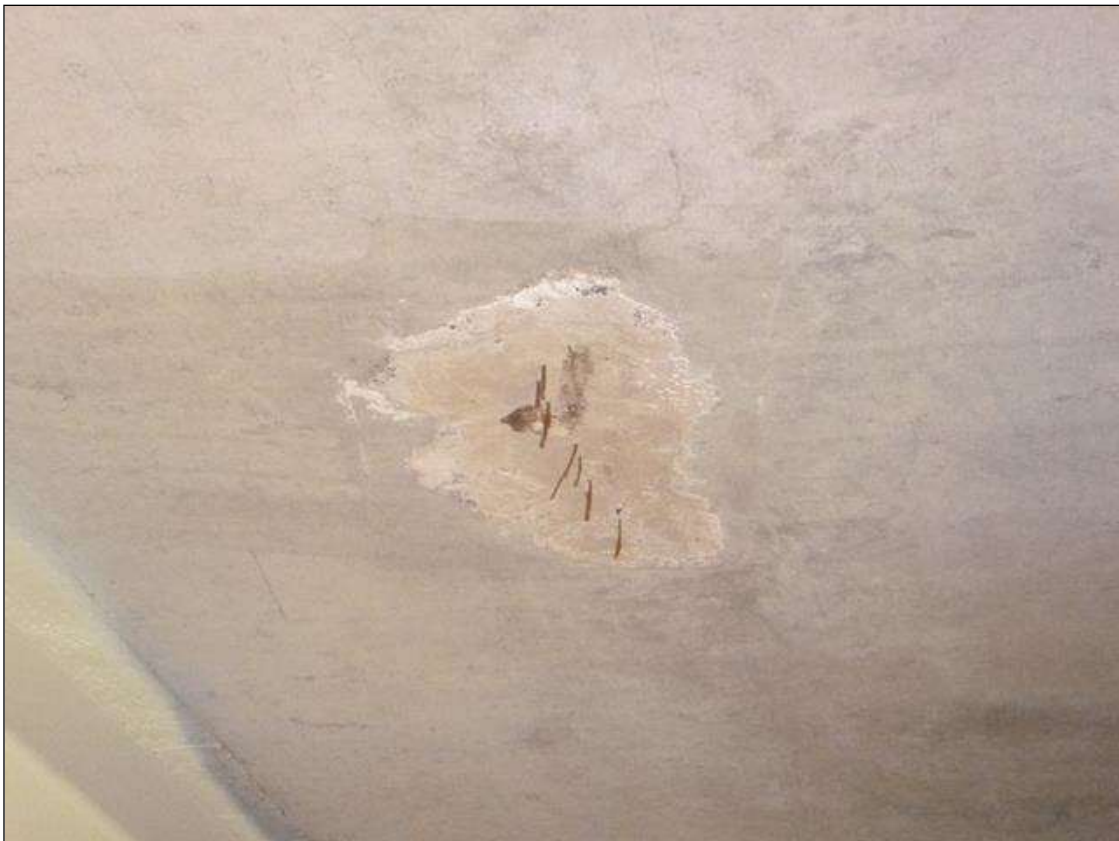
Span 3 Deck: PATCHED AREA 10" WIDE X 24" LONG IN BAY 7 6' FROM END BENT 2 END.

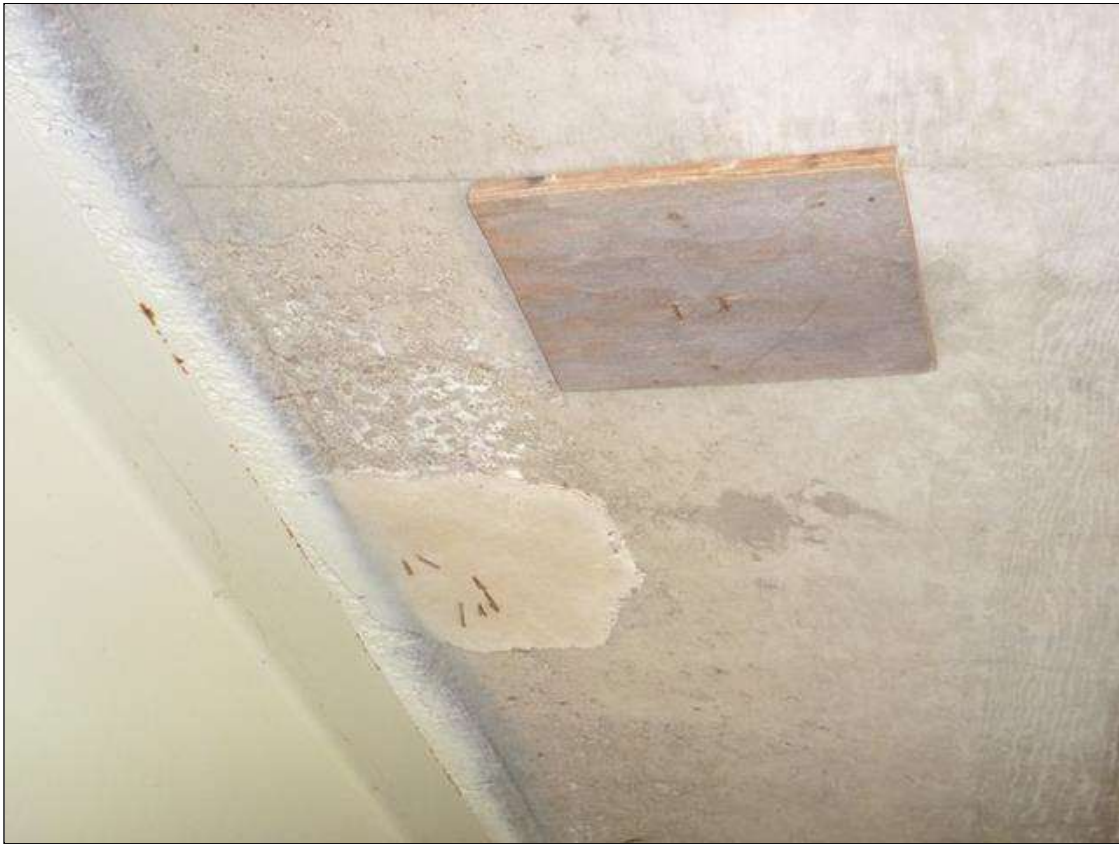
Span 3 Deck: PATCHED AREAS: (3) 10" X 10", 10" WIDE X 14" LONG AND 8" DIAMETER IN BAY 9 NEAR END BENT 2 END.

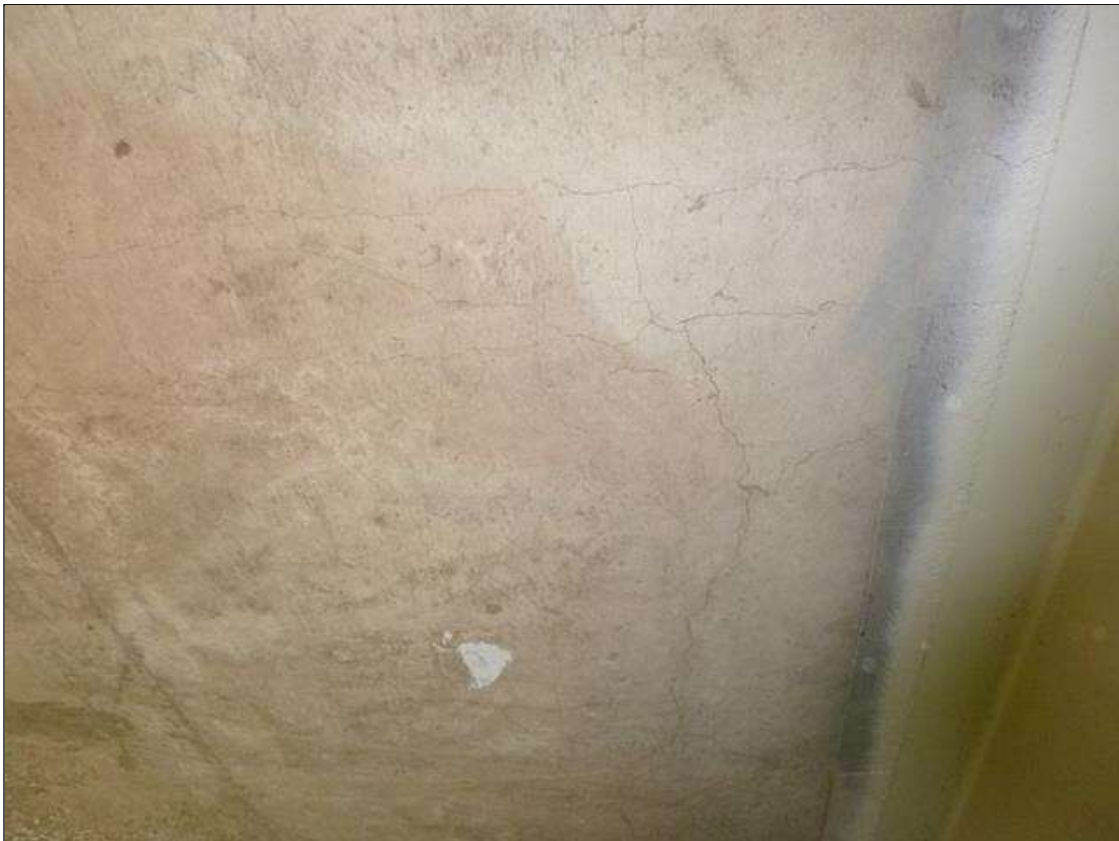
Span 3 Deck: MAP CRACKING UP TO .03" OPEN IN BAY 9 NEAR MID-SPAN.

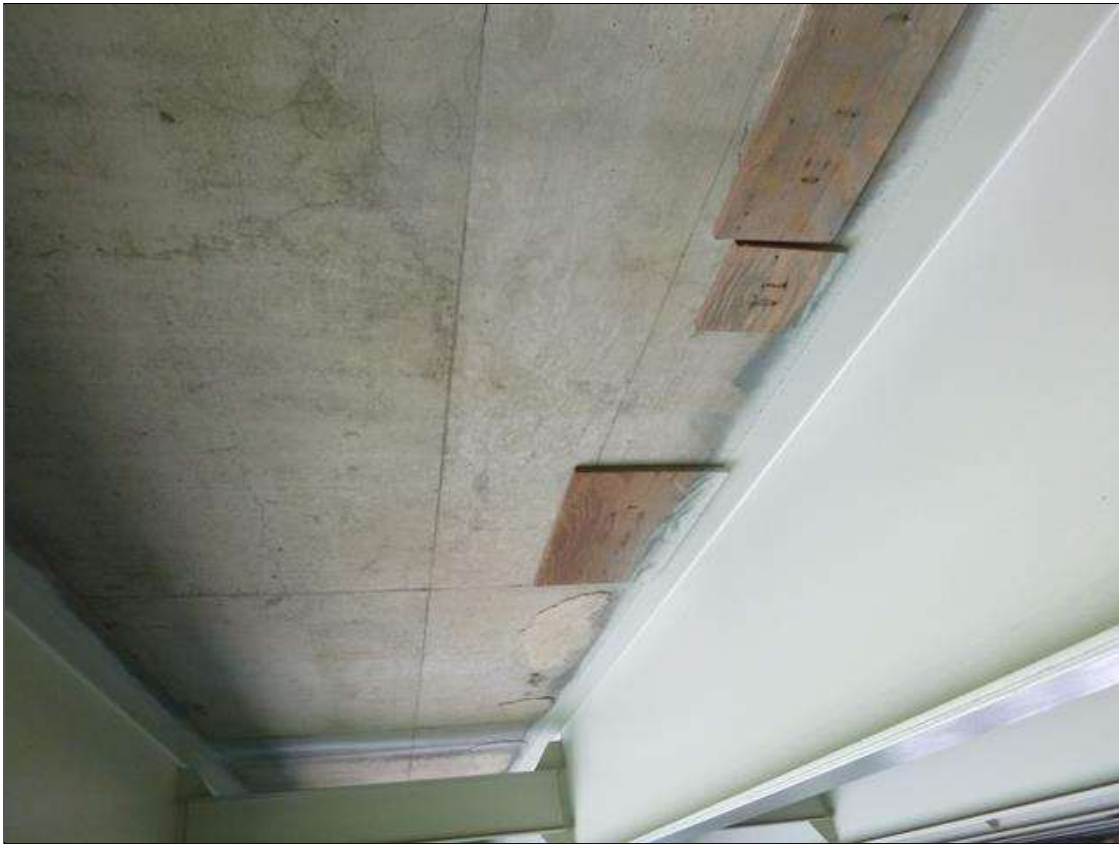
Span 3 Deck: SCATTERED PATCHED AREAS: (5) 10" WIDE X 36" LONG, 2' X 3', 18" WIDE X 36" LONG, 16" X 16", AND 16" WIDE X 4' LONG IN BAY 9 ALONG BEAM 9.
