## Structure Safety Report

### Routine Element Inspection - Contract

COUNTY: HAYWOOD STRUCTURE NUMBER: 430142 FREQUENCY: 24 MONTHS

FEATURE INTERSECTED: PIGEON RIVER

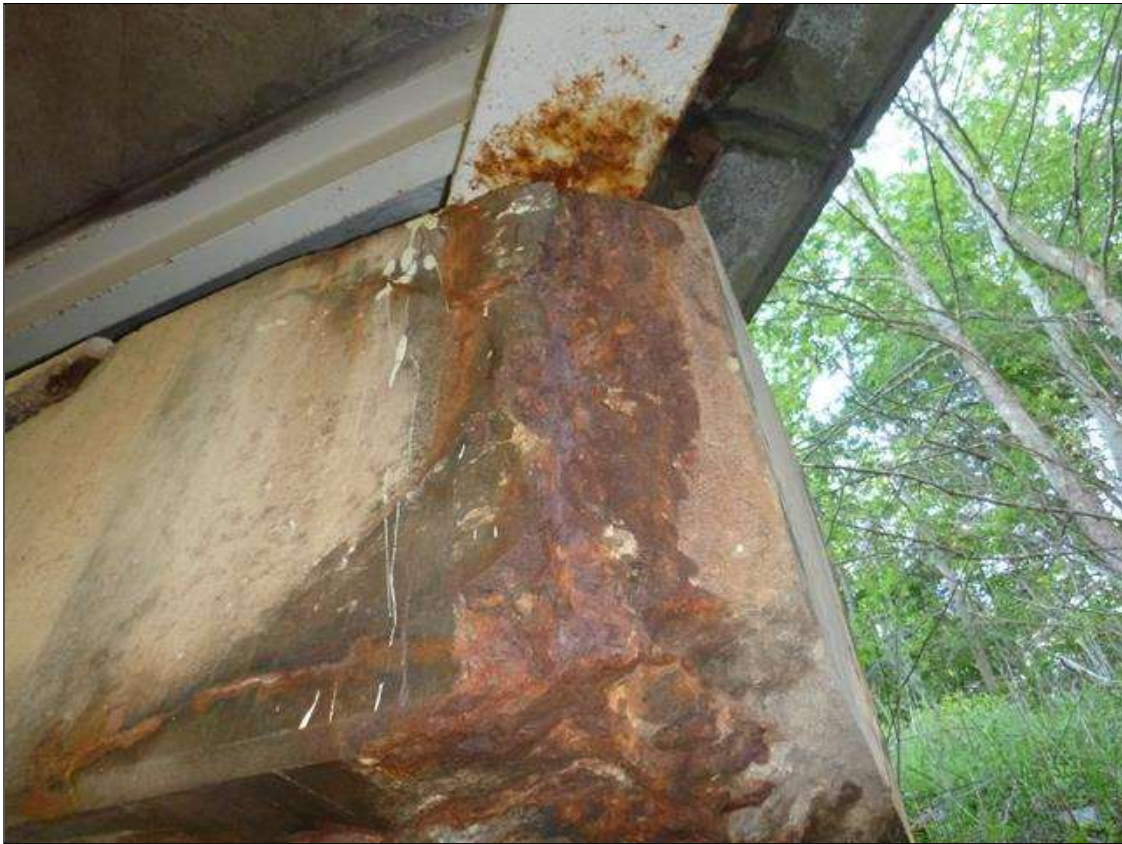
Bent 1 Cap 1: BENT 1 CAP, SPAN 2 SIDE HAS A SPALL, UNDER BEAM 1, 10 INCHES X 30 INCHES X 3 INCHES DEEP WITH EXPOSED REBAR

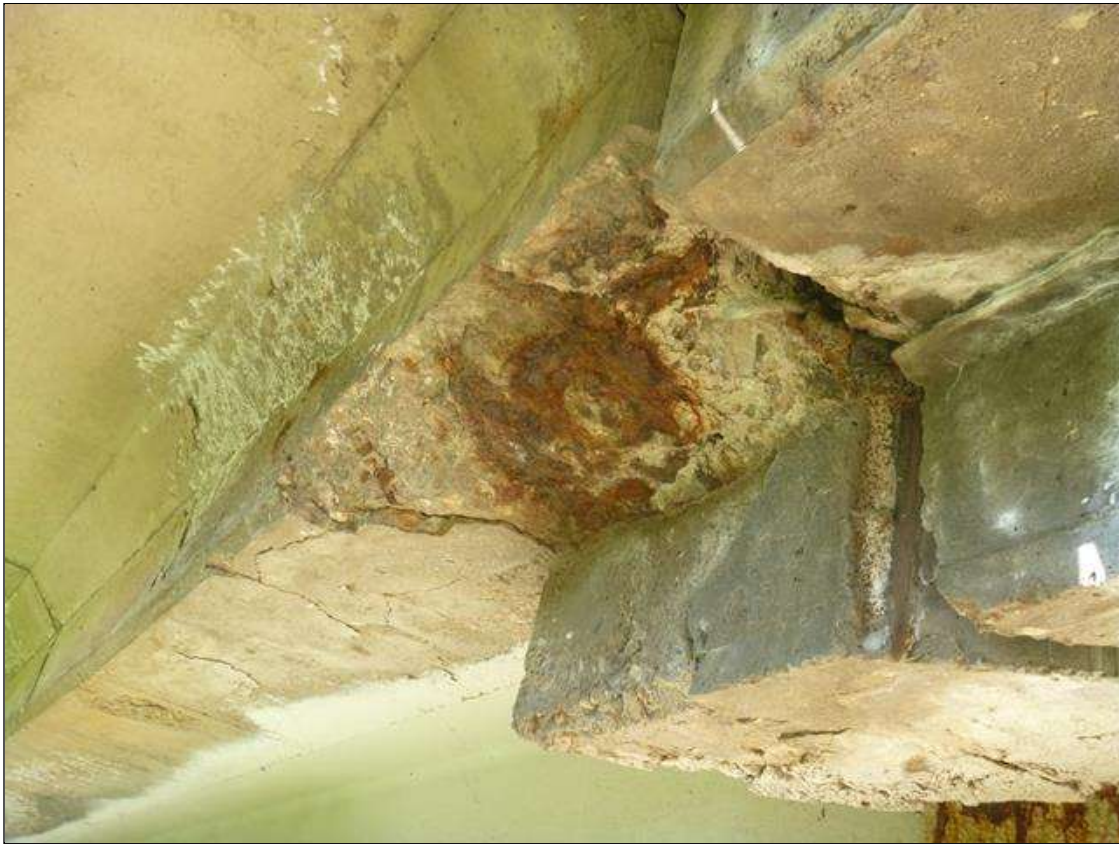
Span 5 Deck: SPAN 5, BOTTOM OF LEFT OVERHANG AT BENT 4 HAS A SPALL, 24 INCHES X 12 INCHES X 3 INCHES DEEP WITH EXPOSED REBAR, WITH ADJACENT DELAMINATION

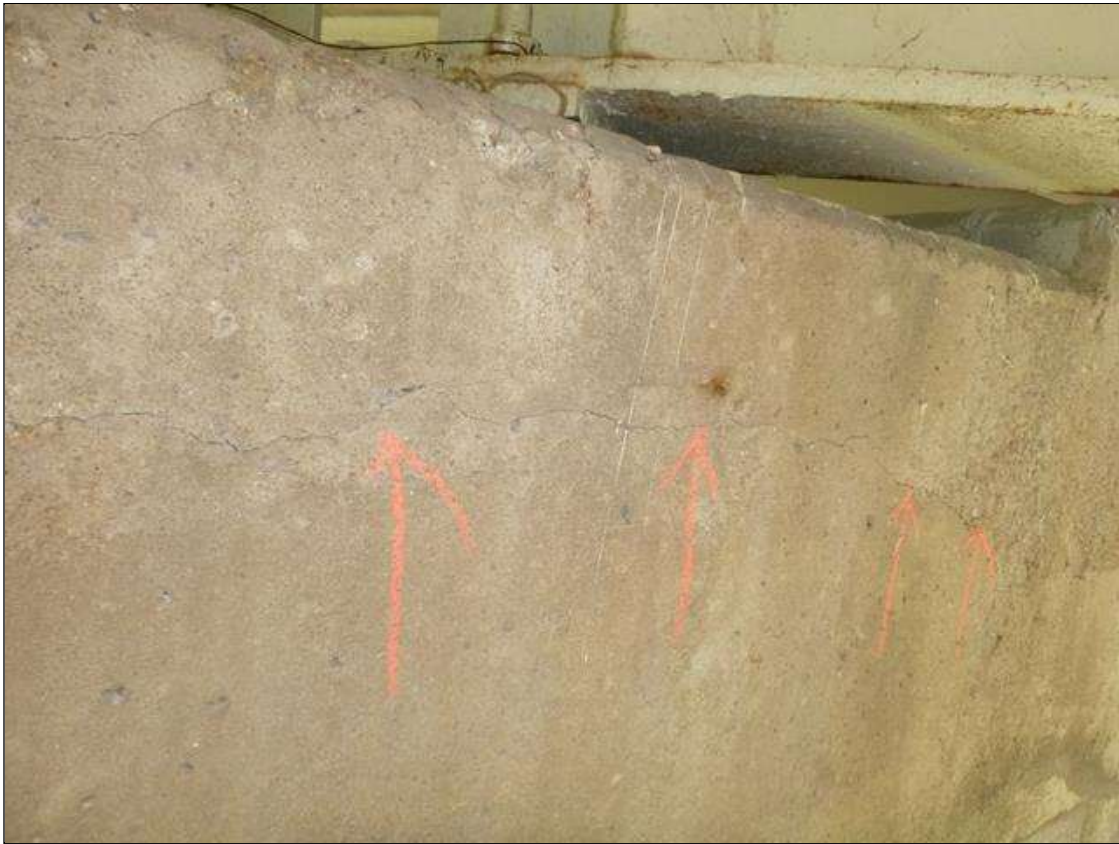
Bent 4 Cap 1: BENT 4 CAP, SPAN 4 SIDE HAS A 1/16 INCH WIDE LONGITUDINAL CRACK IN THE FACE OF THE CAP, 48 INCHES LONG, 7 INCHES DOWN FROM THE TOP EDGE UNDER BEAM 2, WITH ADJACENT DELAMINATION

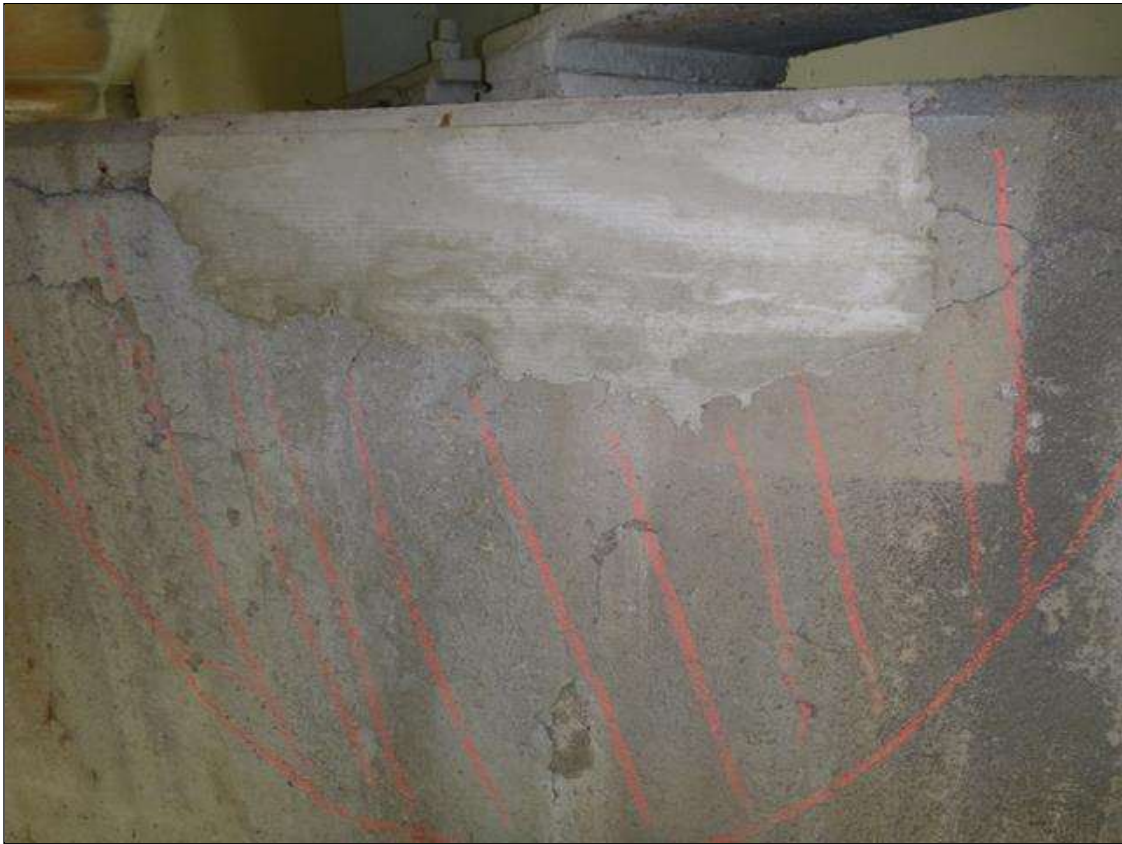
Bent 4 Cap 1: BENT 4 CAP SPAN 4 SIDE HAS AN AREA OF DELAMINATION IN THE FACE OF THE CAP, BAY 2, NEAR BEAM 3, 60 INCHES X 30 INCHES WITH 1/8 INCH SEPARATION X 3 INCHES ACROSS THE TOP

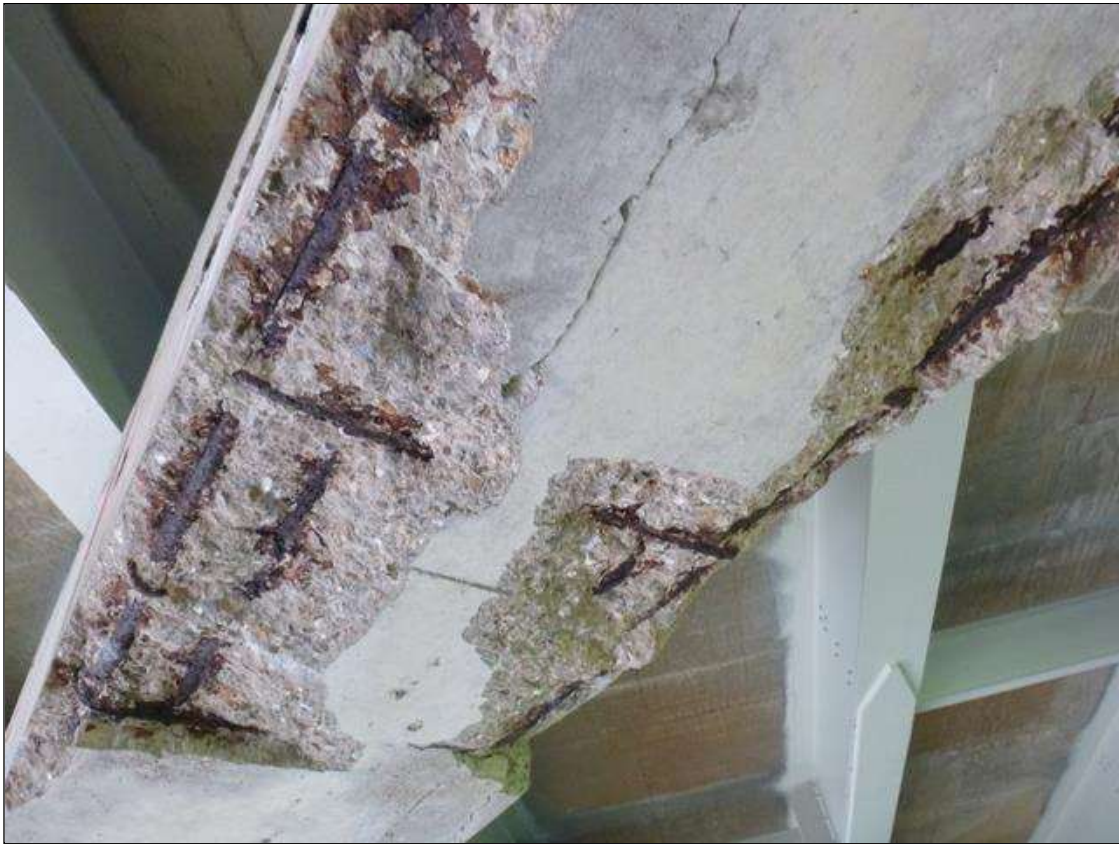
Bent 4 Cap 1: BENT 4 BOTTOM OF CAP BETWEEN PILES 3 AND 4 HAS AN AREA OF SPALLING, 7 FT. LONG X 36 INCHES WIDE X 3 INCHES DEEP WITH EXPOSED REBAR

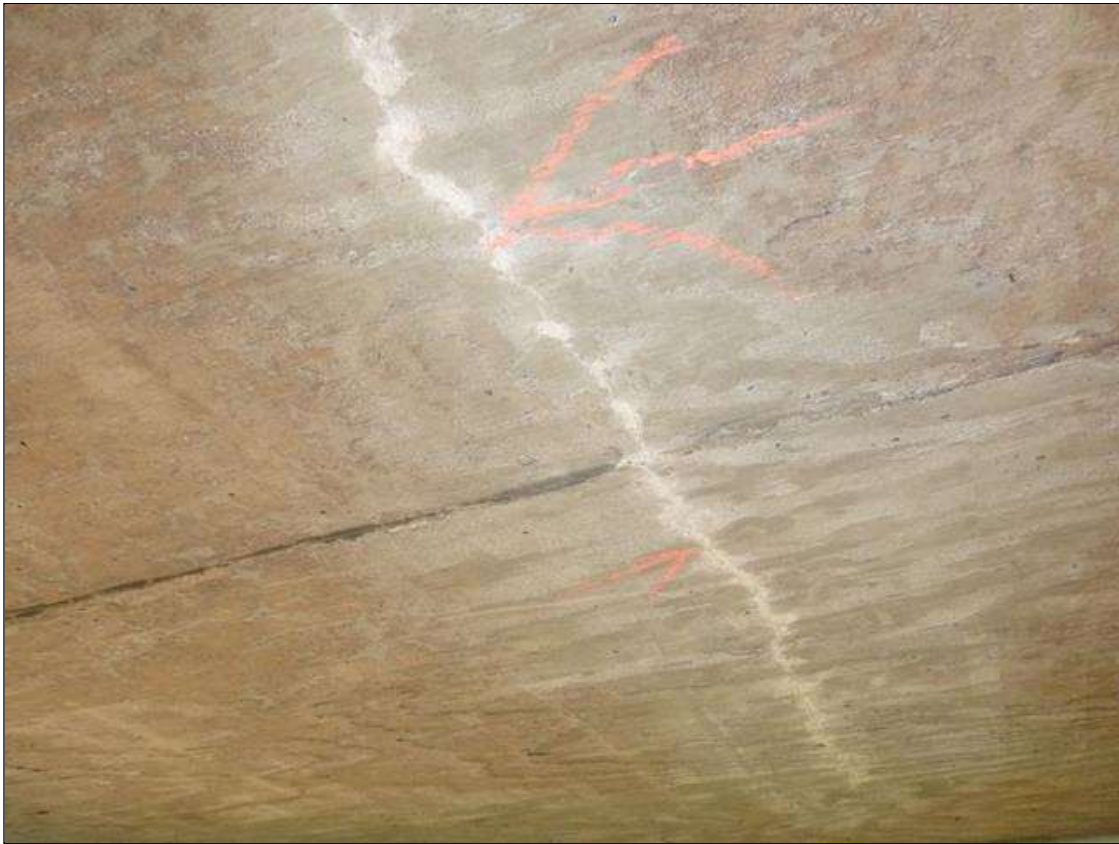
Span 4 Deck: SPAN 4, BOTTOM OF BAY 4 DECK HAS A HAIRLINE TRANSVERSE CRACK WITH EFFLO., 7 FT. LONG AT 3/4 POINT FOR A TOTAL OF 300 SQ. FT. THRU OUT THE BOTTOM OF THE SPAN

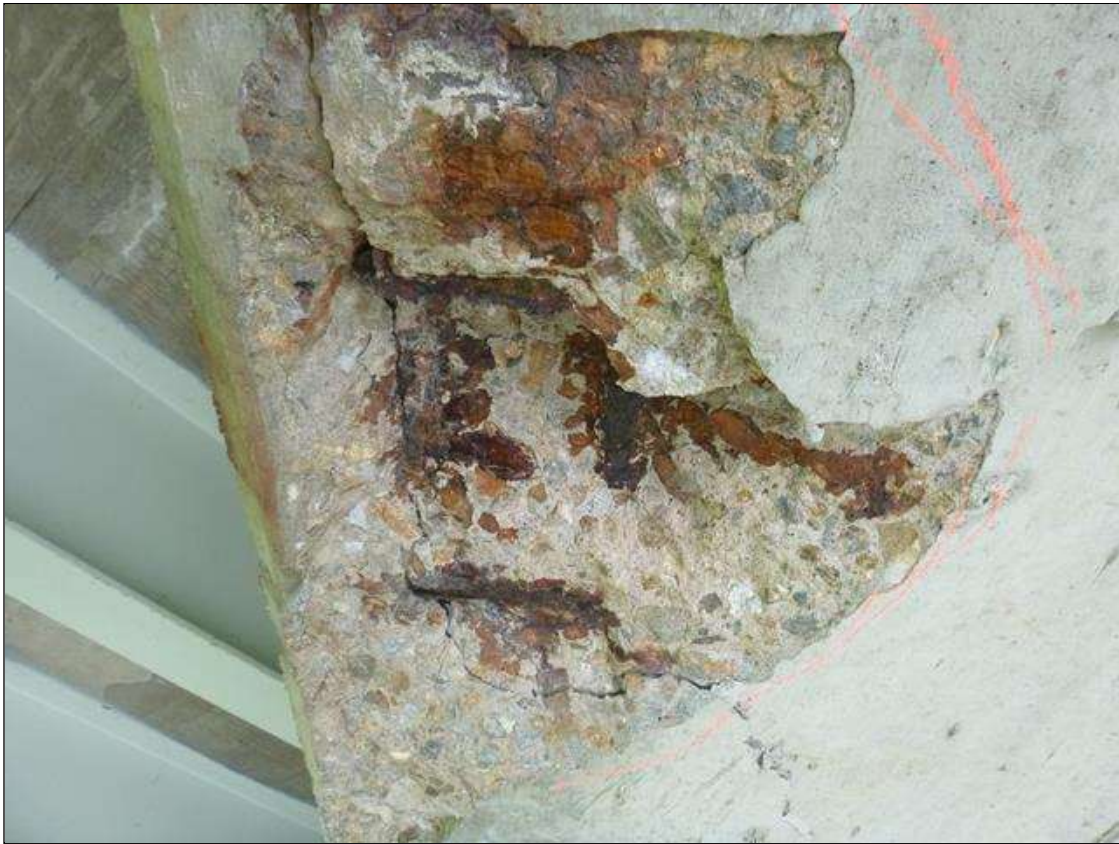
Bent 3 Cap 1: BENT 3, BOTTOM OF CAP HAS A SPALL, 24 INCHES X 12 INCHES X 3 INCHES DEEP WITH EXPOSED REBAR, BETWEEN PILES 2 AND 3

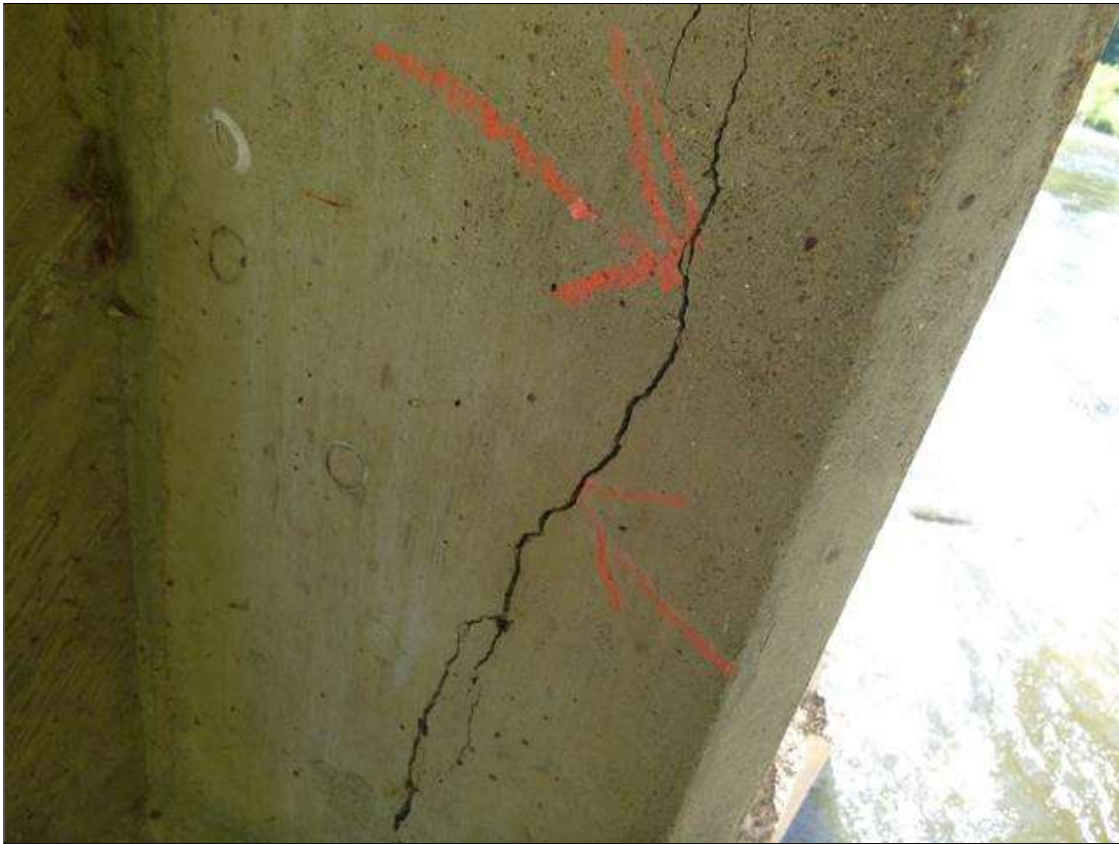
Bent 3 Pile 2: BENT 3, PILE 2 HAS A 3/16 INCH WIDE VERTICAL CRACK, IN THE WEST FACE NEAR THE SOUTHEAST CORNER, 15 FT. HIGH, ADJACENT TO THE STRUT

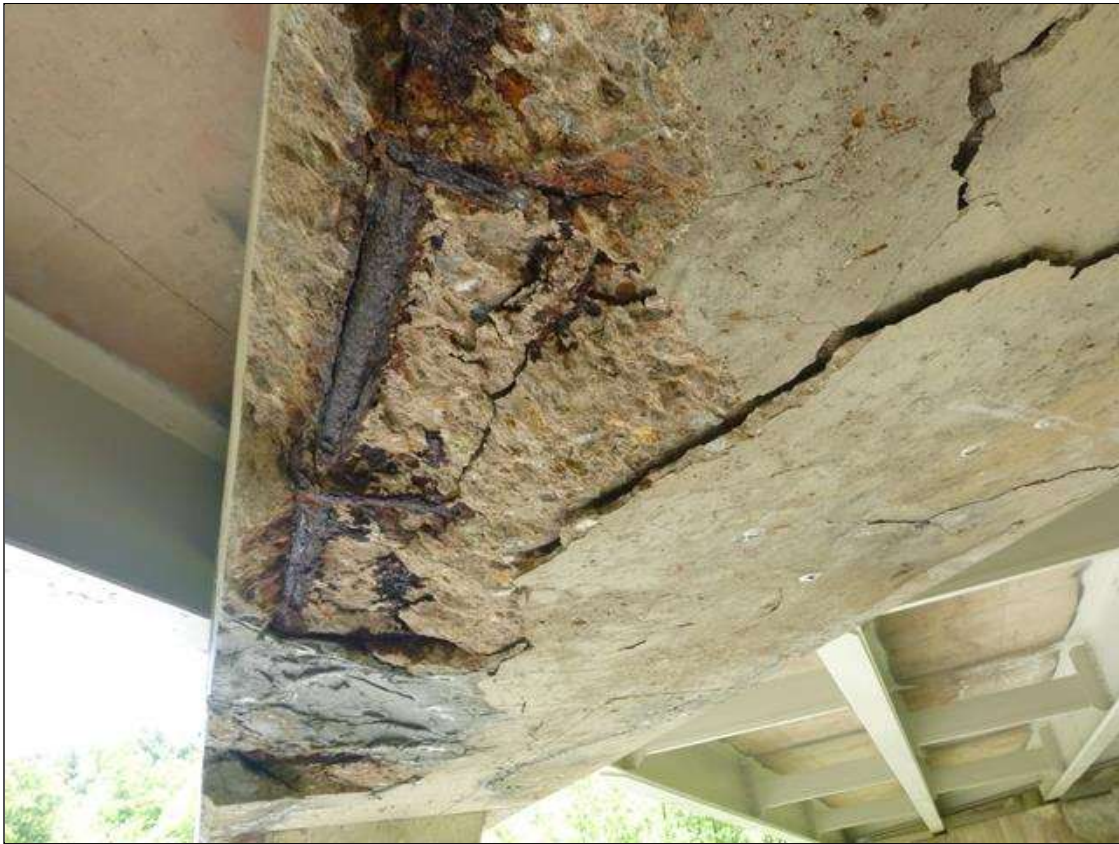
Bent 3 Cap 1: BENT 3 BOTTOM OF THE CAP HAS A SPALLED AREA BETWEEN PILES 1 AND 2', 80 INCHES X 16 INCHES X 3 INCHES DEEP WITH EXPOSED REBAR, NEAR SPAN 3 SIDE

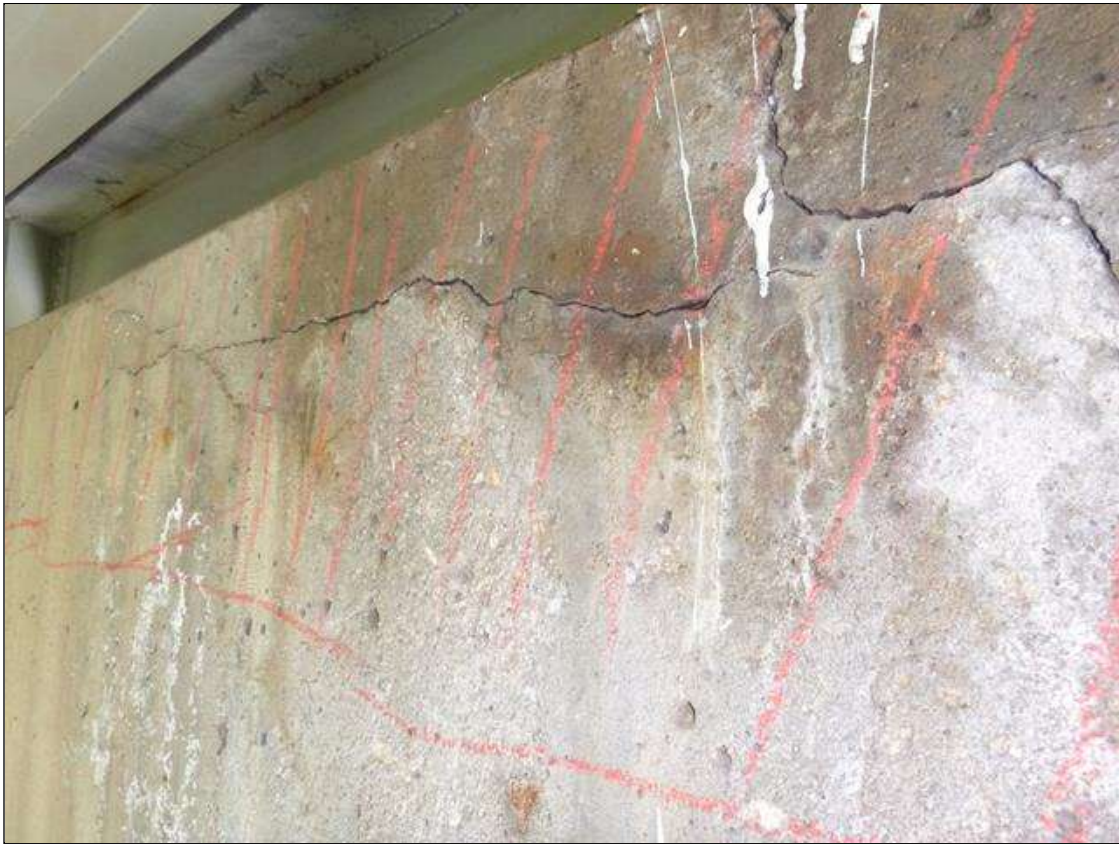
Bent 3 Cap 1: BENT 3 CAP, SPAN 4 SIDE HAS AN AREA OF DELAMINATION IN THE FACE OF THE CAP IN BAY 1 AND UNDER BEAM 1, 72 INCHES LONG X 14 INCHES HIGH WITH 3/16 INCH SEPARATION AND GOES 3 INCHES ACROSS THE TOP OF THE CAP

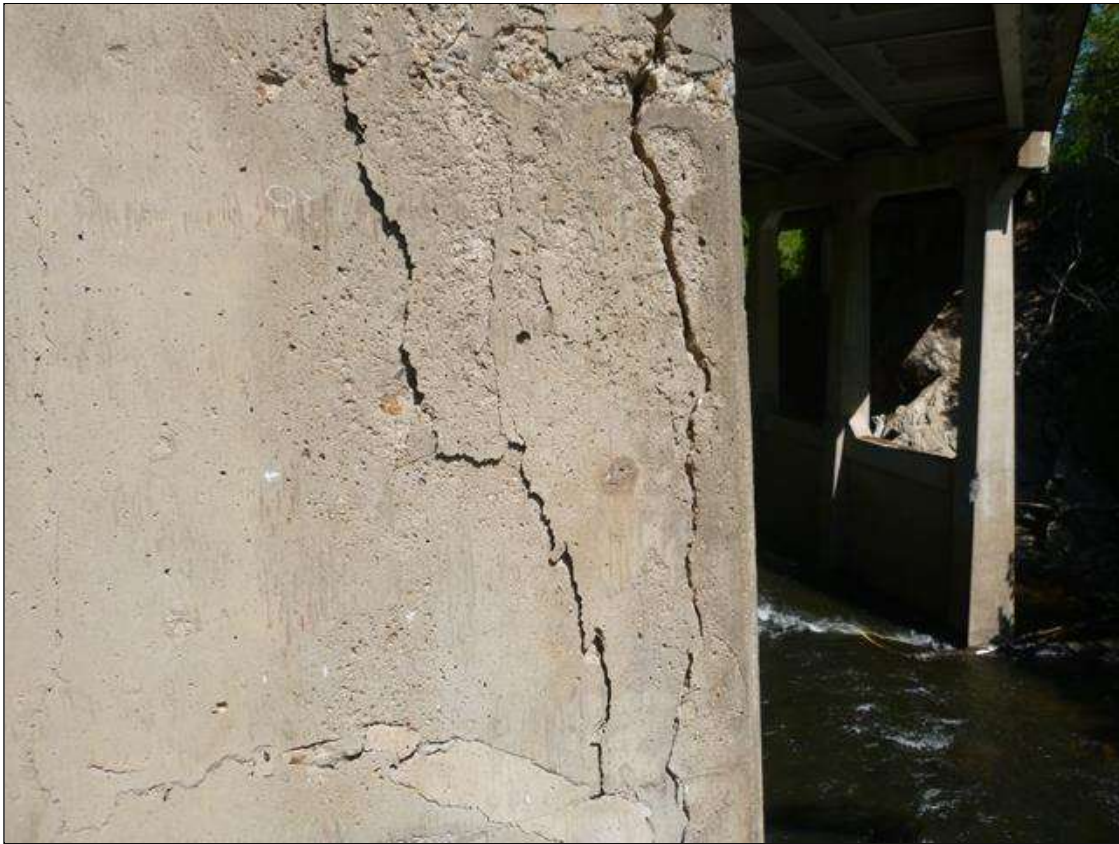
Bent 3 Pile 1: BENT 3, PILE 1 HAS AN AREA OF DELAMINATION ON THE NORTHWEST CORNER, 34 INCHES WIDE X 7 FT. HIGH, STARTING AT THE BOTTOM OF THE CAP, WITH UP TO 1 INCH SEPARATION

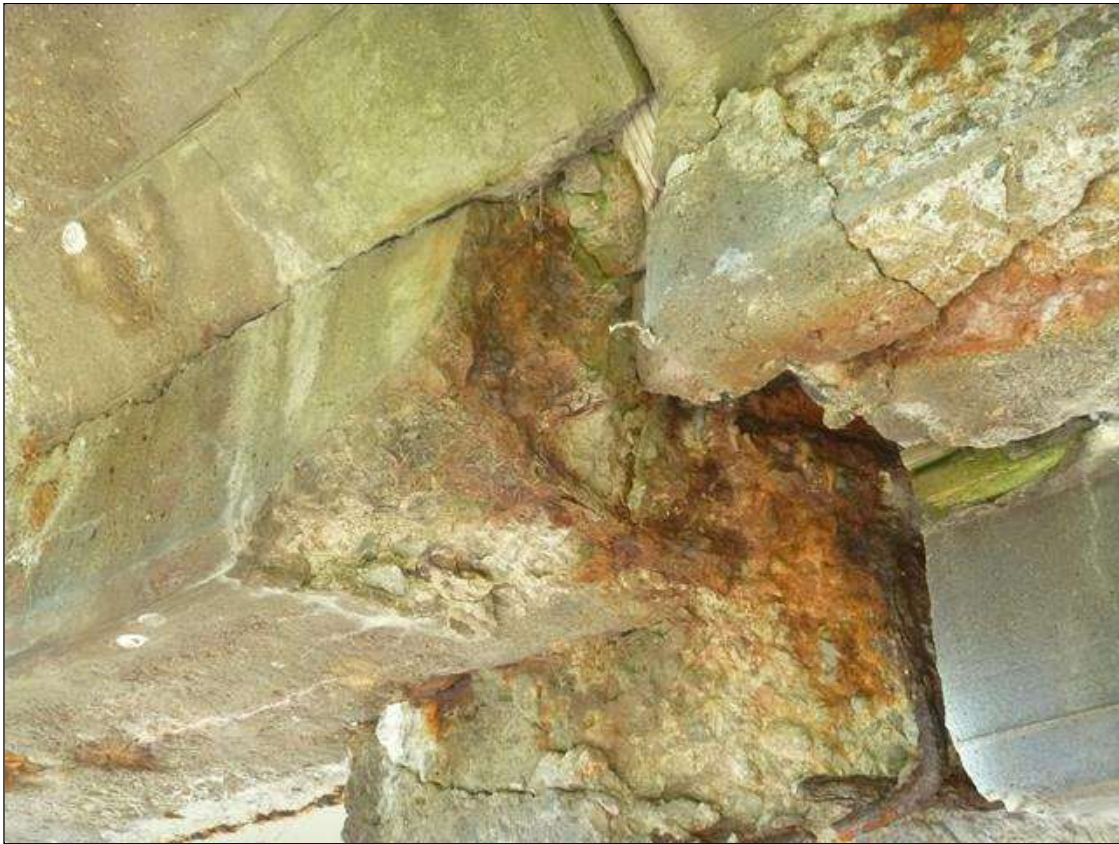
Span 4 Deck: SPAN 4, BOTTOM OF LEFT OVERHANG HAS A SPALL, 11 INCHES X 7 INCHES X 4 INCHES DEEP WITH EXPOSED REBAR

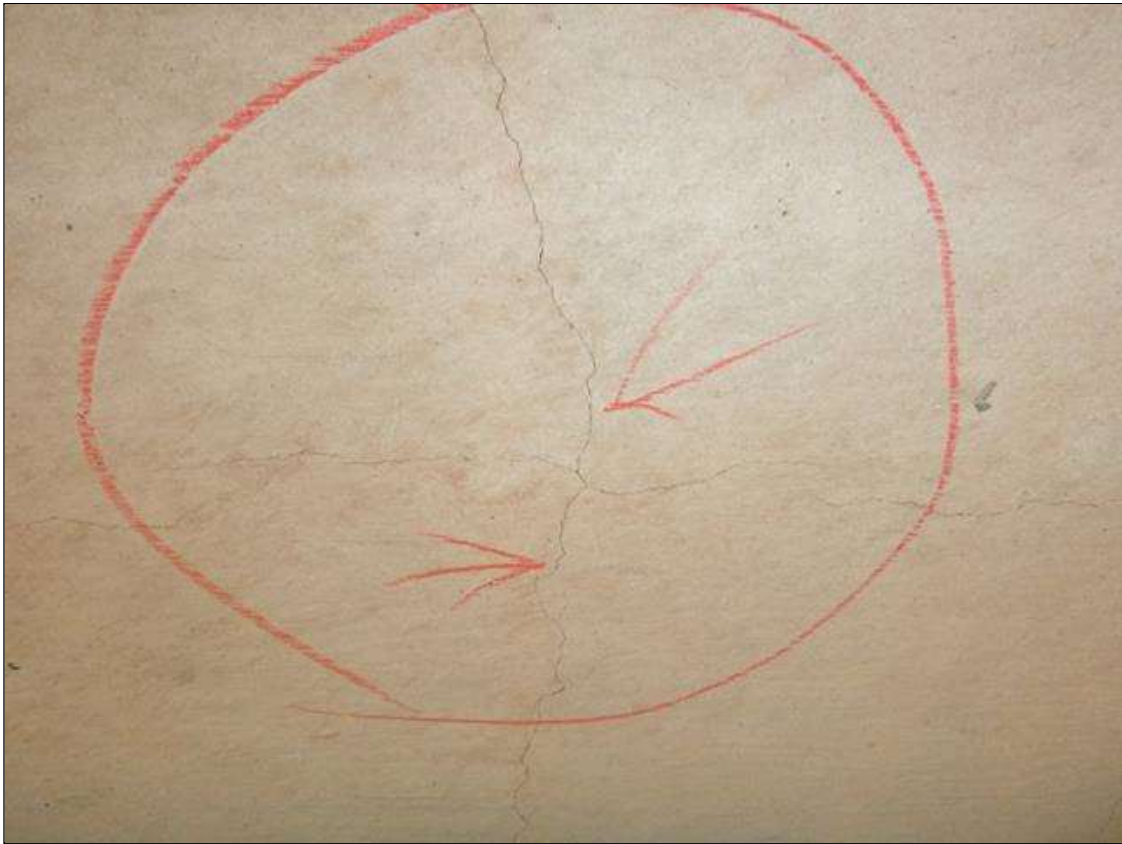
Span 3 Deck: SPAN 3, BOTTOM OF BAY 2 DECK HAS A 1 SQ. FT. AREA OF 1/32 INCH WIDE MAP CRACKING NEAR BENT 3 FOR A TOTAL OF 2100 SQ. FT. THRU OUT THE BOTTOM OF THE SPAN

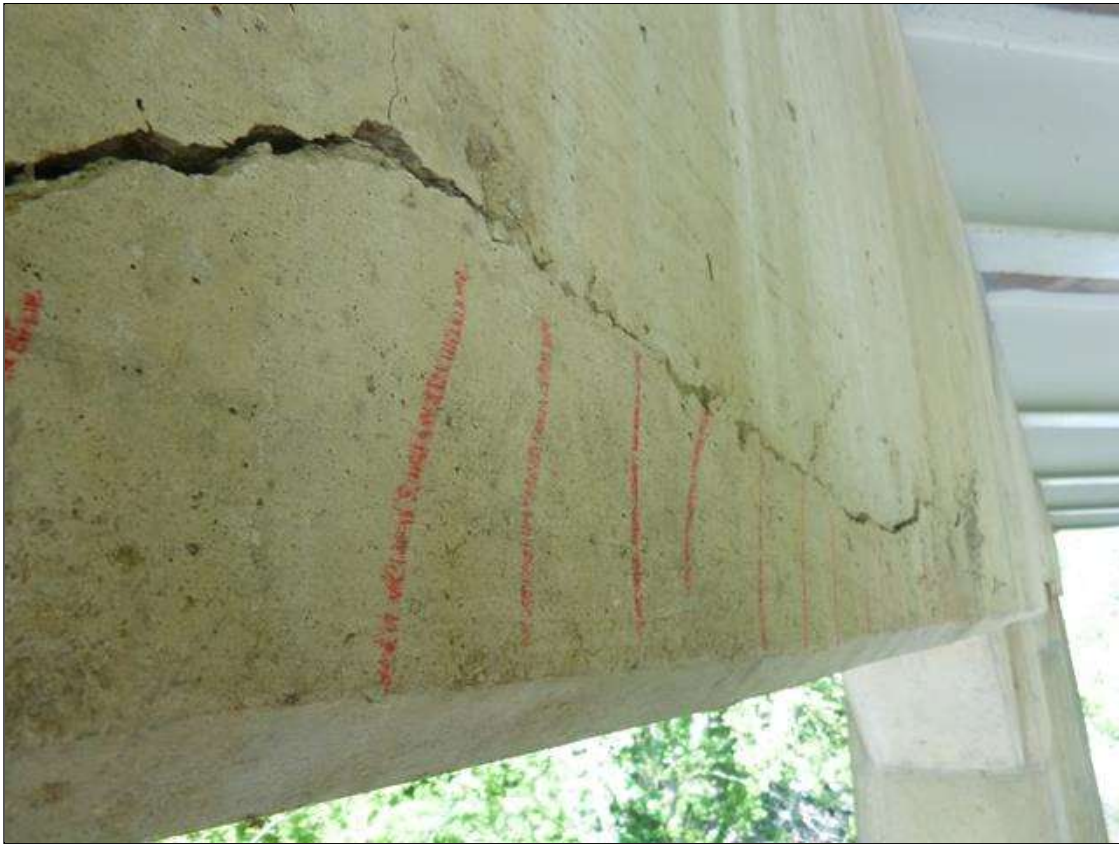
Bent 3 Cap 1: BENT 3 CAP, SPAN 3 SIDE HAS AN AREA OF DELAMINATION IN THE FACE OF THE CAP NEAR BOTTOM EDGE IN BAY 3, 11 FT. LONG X 8 INCHES HIGH WITH 1/4 INCH SEPARATION

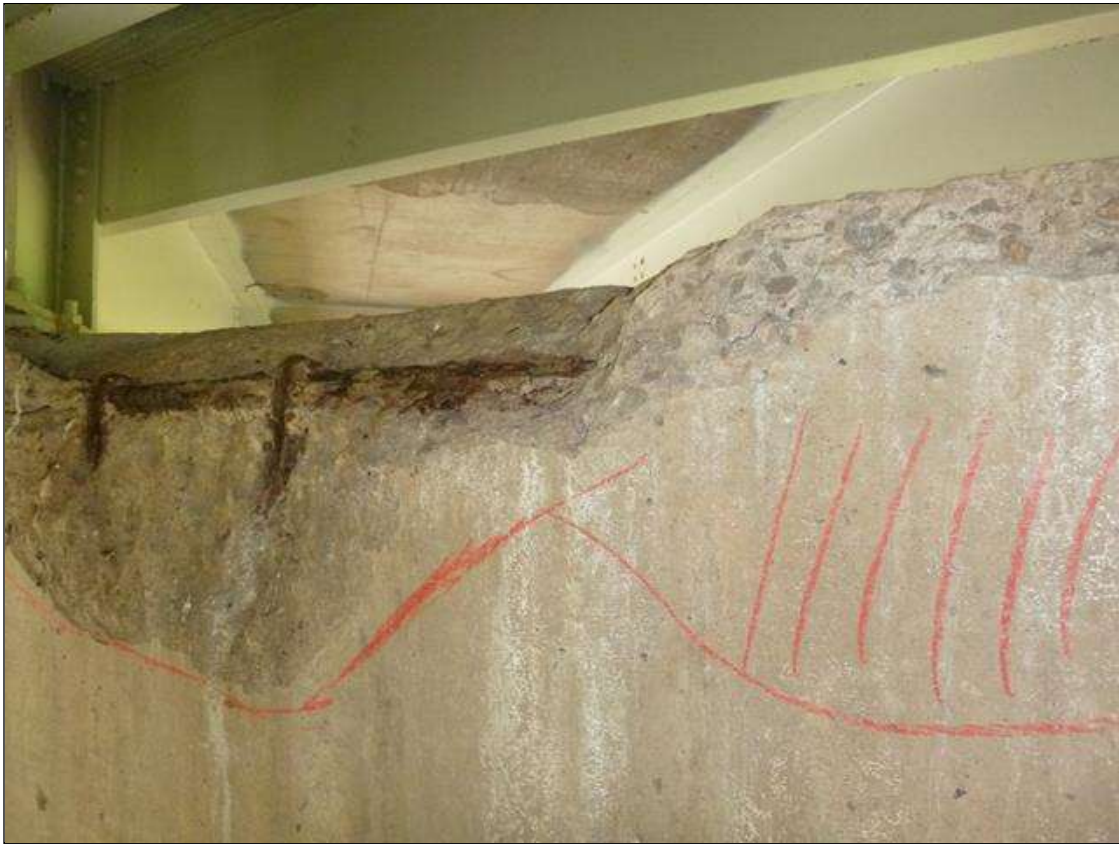
Bent 3 Cap 1: BENT 3 CAP, SPAN 3 SIDE HAS A SPALL ON THE FACE OF THE CAP IN BAY 5 AT TOP EDGE, 60 INCHES X 14 INCHES X 3 INCHES DEEP WITH EXPOSED REBAR WITH ADJACENT DELAMINATION NEAR BEAM 6

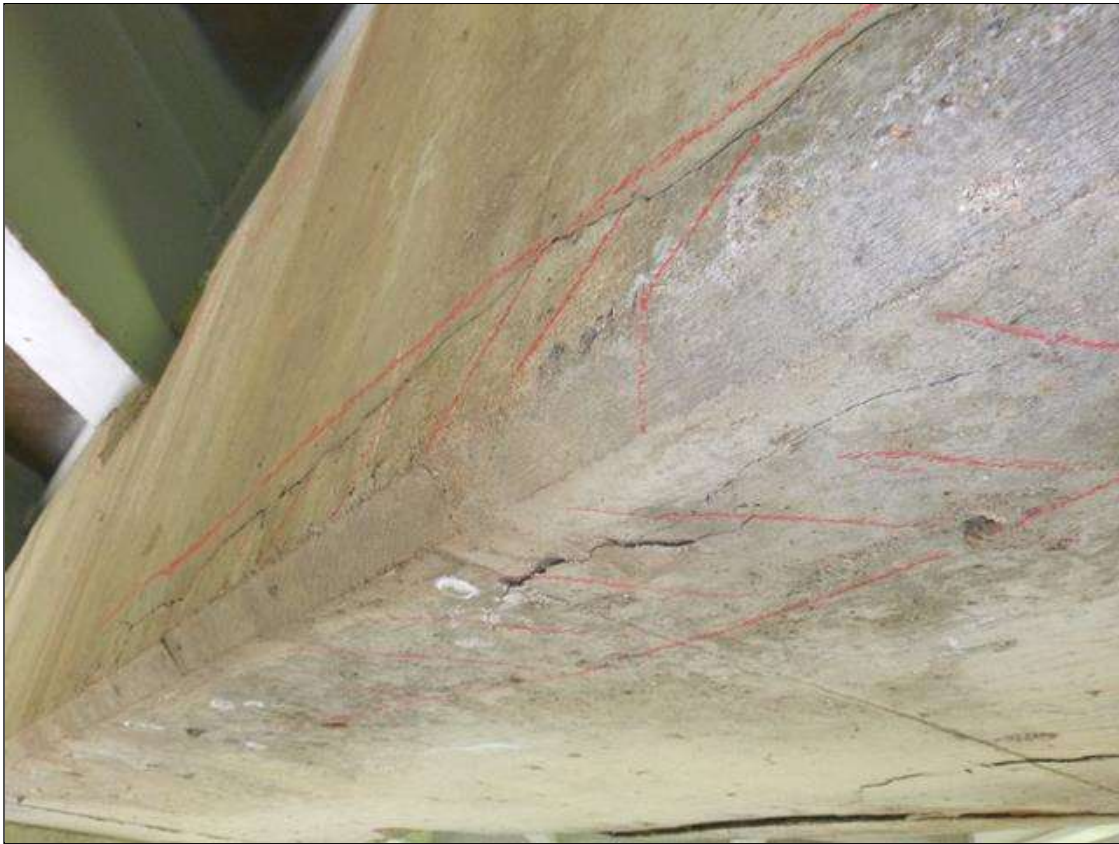
Bent 3 Cap 1: BENT 3 CAP, SPAN 3 SIDE, BOTTOM EDGE, BETWEEN PILES 3 AND 4 HAS AN AREA OF DELAMINATION 60 INCHES X 4 INCHES UP THE FACE X 6 INCHES ACROSS THE BOTTOM, NEAR PILE 4

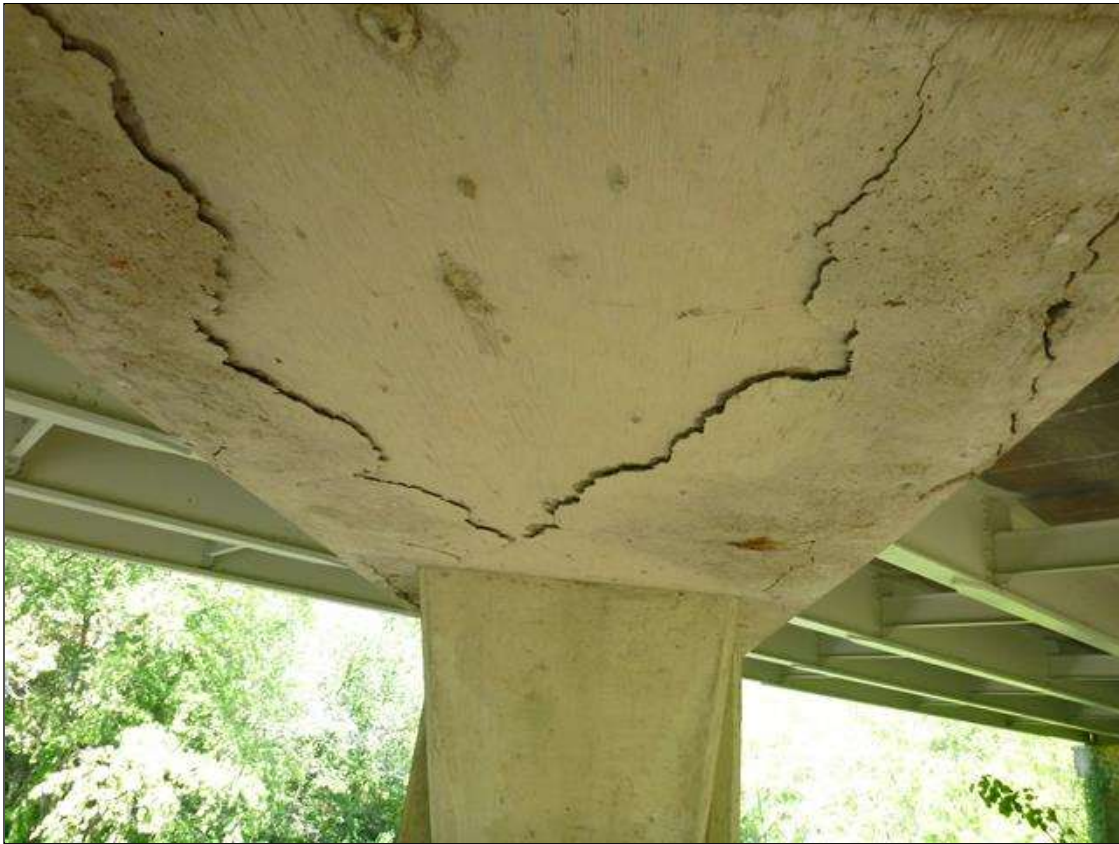
Bent 2 Cap 1: BENT 2 CAP, BETWEEN PILES 2 AND 3 HAS AN AREA OF DELAMINATION IN THE BOTTOM, 12 FT. LONG X 36 INCHES WIDE AND GOES UP ON BOTH FACES UP TO 4 INCHES HIGH WITH 1/4 INCH SEPARATION

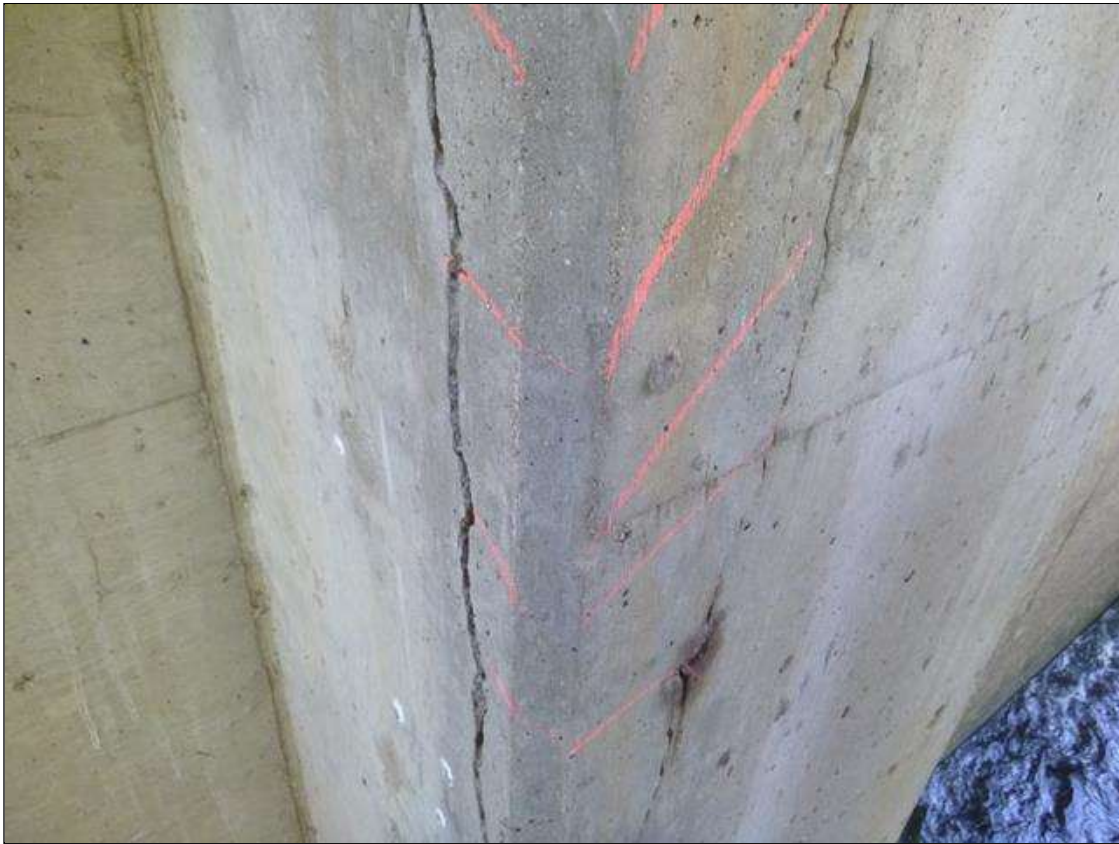
Bent 2 Pile 2: BENT 2, PILE 2 HAS AN AREA OF DELAMINATION IN THE NORTHWEST CORNER, 9 INCHES WIDE X 12 FT. HIGH ADJACENT TO STRUT WITH RUST STAINS

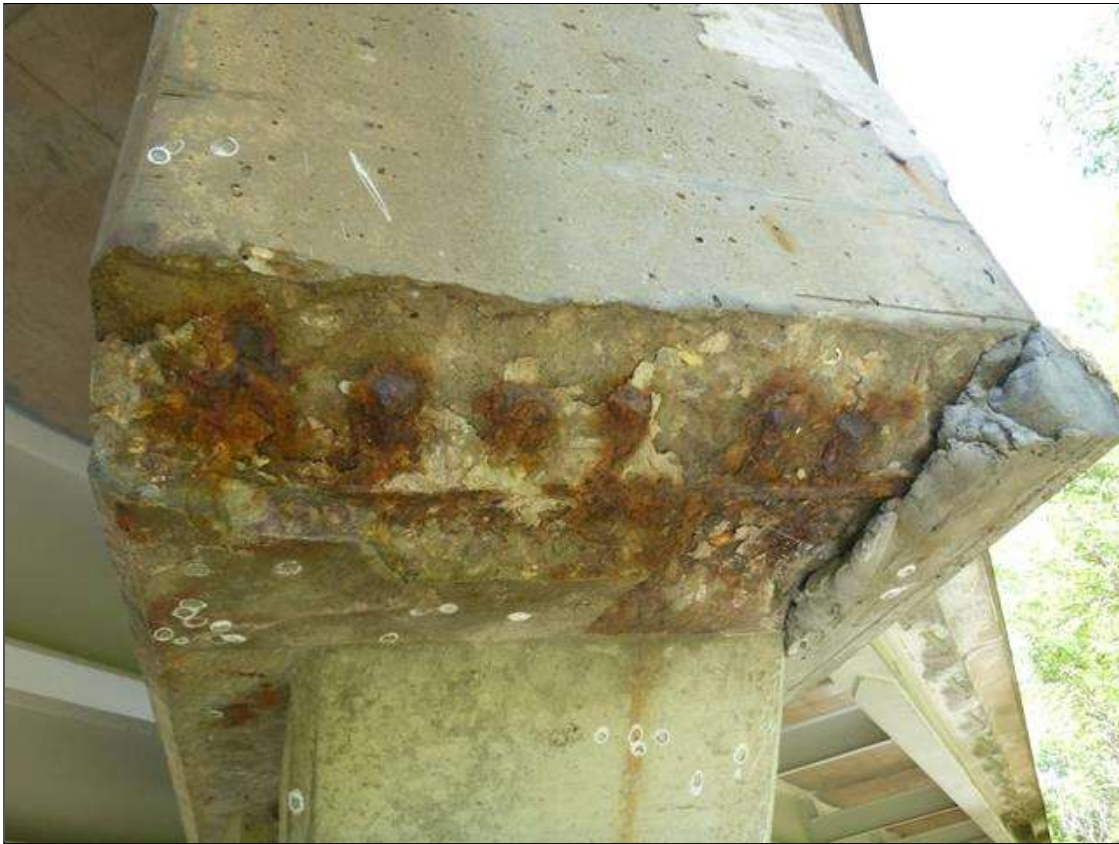
BENT 2 CAP, LEFT BOTTOM END HAS A SPALL, 14 INCHES X 32 INCHES X 3 INCHES DEEP WITH REBAR EXPOSED

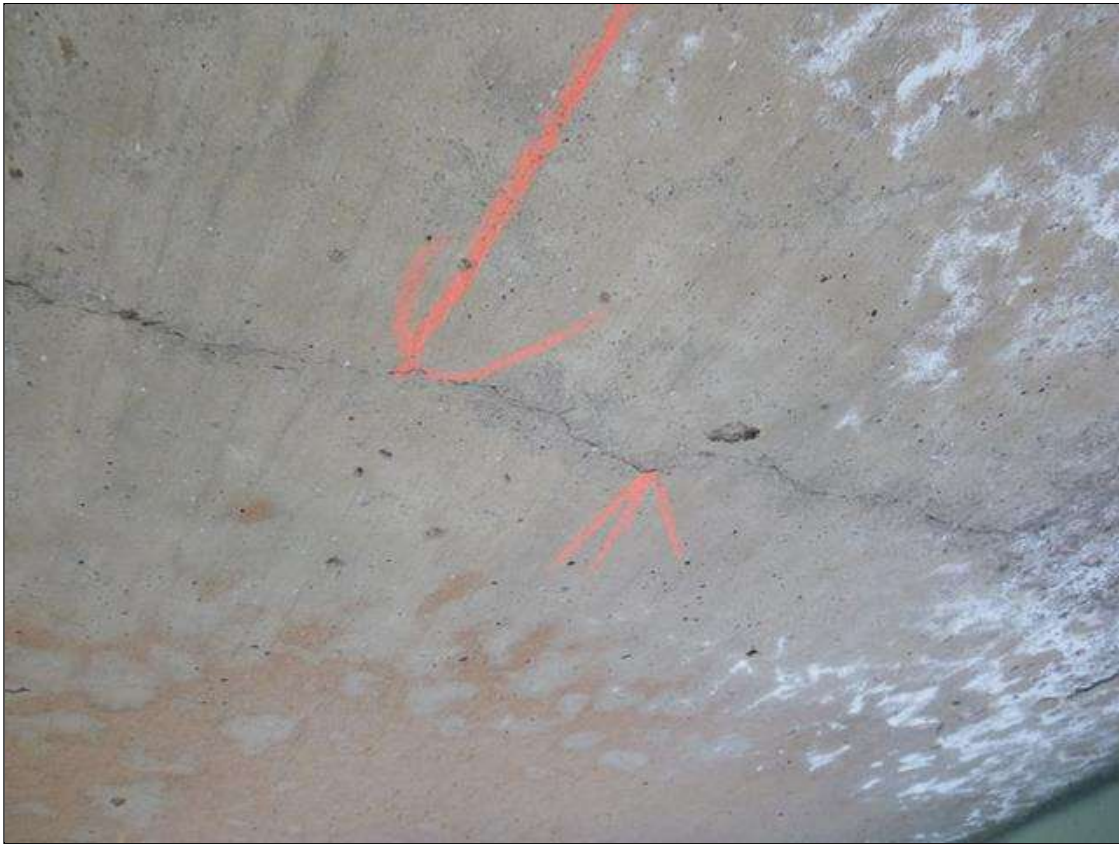
Span 2 Deck: SPAN 2, BOTTOM OF BAY 1 DECK HAS A HAIRLINE TRANSVERSE CRACK, 7 FT. LONG NEAR BENT 2 FOR A TOTAL OF 375 SQ. FT. THRU OUT THE BOTTOM OF THE SPAN

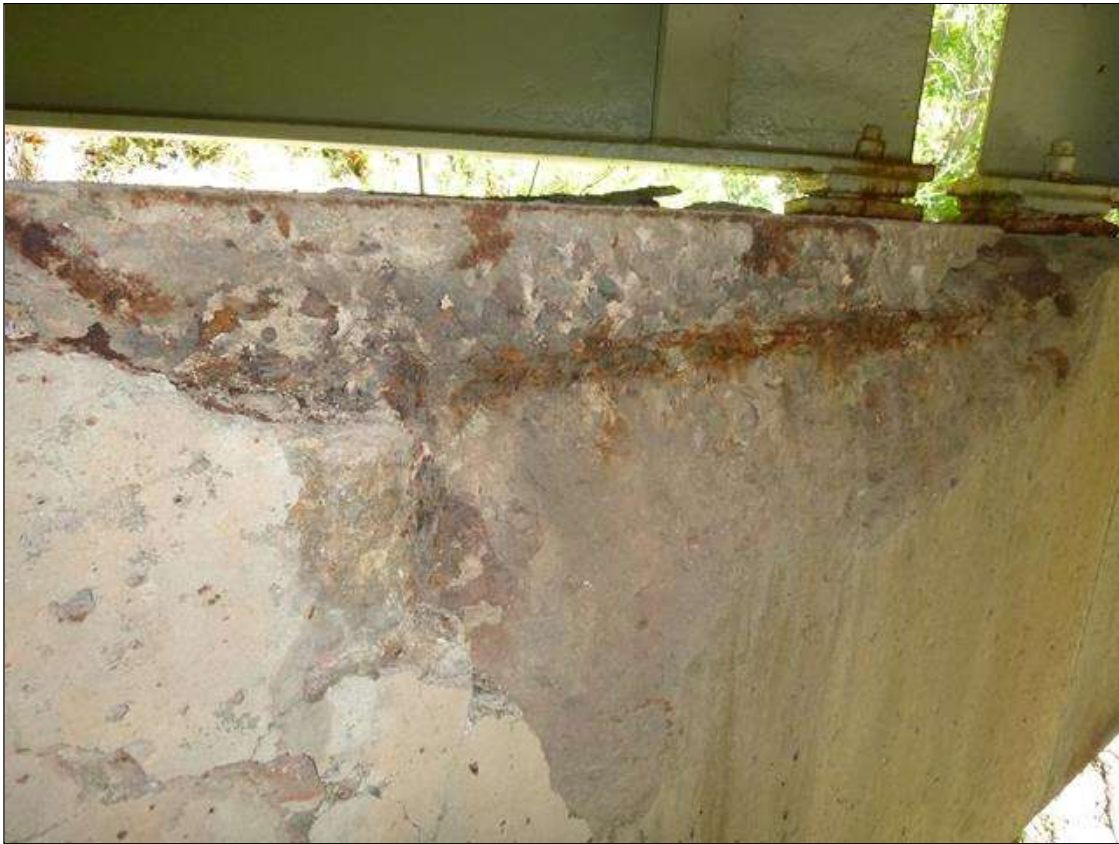
Bent 1 Cap 1: BENT 1 CAP, SPAN 2 SIDE IN BAY 1 NEAR TOP EDGE HAS A SPALL, 48 INCHES X 14 INCHES X 3 INCHES DEEP WITH EXPOSED REBAR, WITH DELAMINATION 10 INCHES ACROSS THE TOP IN THIS AREA

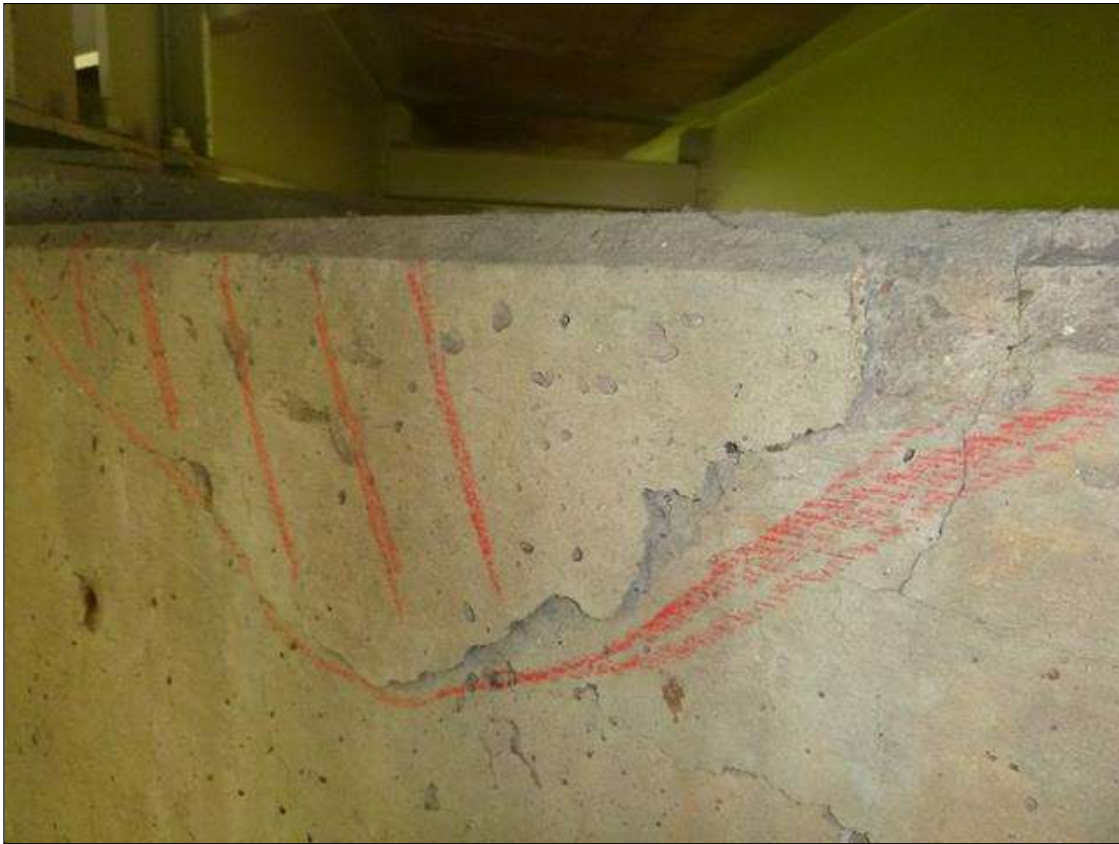
Bent 1 Cap 1: BENT 1 CAP, SPAN 2 SIDE HAS AN AREA OF DELAMINATION IN THE FACE OF THE CAP, NEAR TOP EDGE IN BAY 1, NEAR BEAM 2, 32 INCHES LONG X 9 INCHES DOWN THE FACE X 3 INCHES ACROSS THE TOP

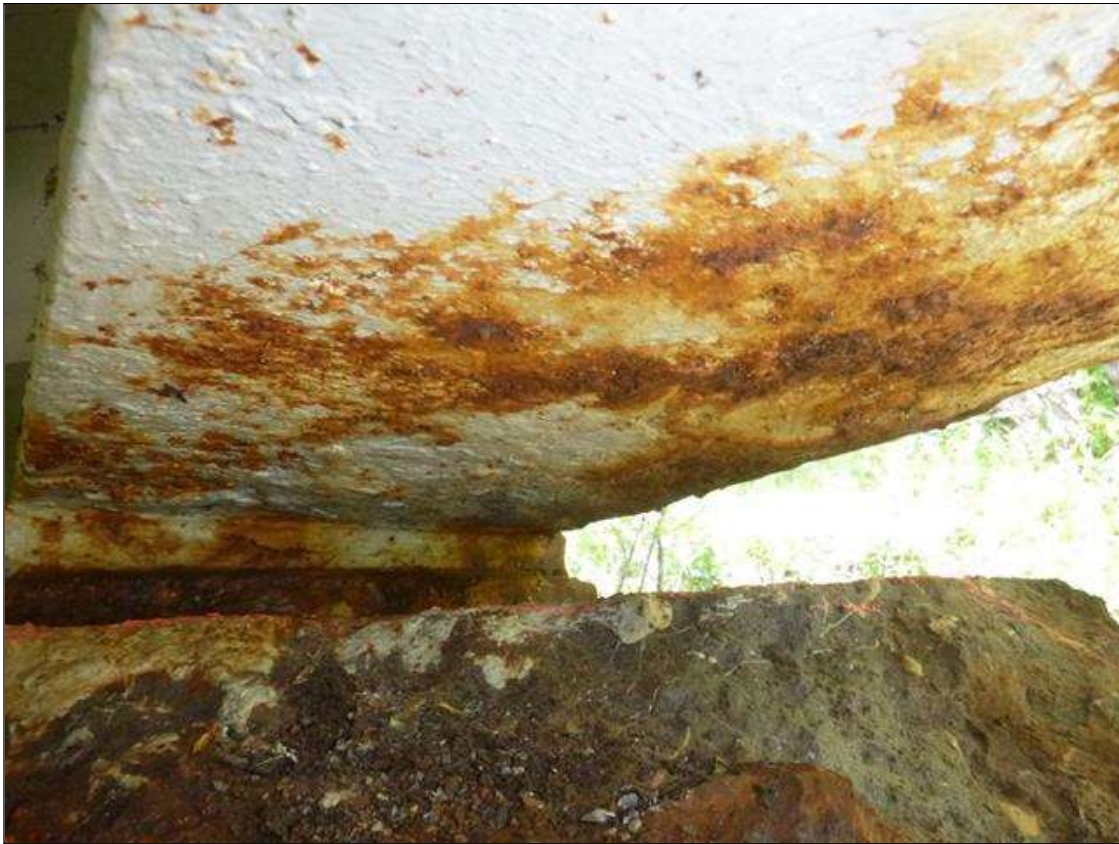
Span 2 Beam 1: SPAN 2, BEAM 1 AT BENT 1 HAS 1/8 INCH SECTION LOSS ON THE BOTTOM OF THE BOTTOM FLANGE, FROM THE FACE OF THE BEARING OUT 18 INCHES X FULL WIDTH WITH 7/8 INCH REMAINING, PREVIOUS SECTION LOSS HAS BEEN PAINTED OVER AND RUST IS STARTING TO BLEED THRU
