## Structure Safety Report

### Routine Element Inspection - Contract

COUNTY: HAYWOOD STRUCTURE NUMBER: 430142 FREQUENCY: 24 MONTHS

FEATURE INTERSECTED: PIGEON RIVER

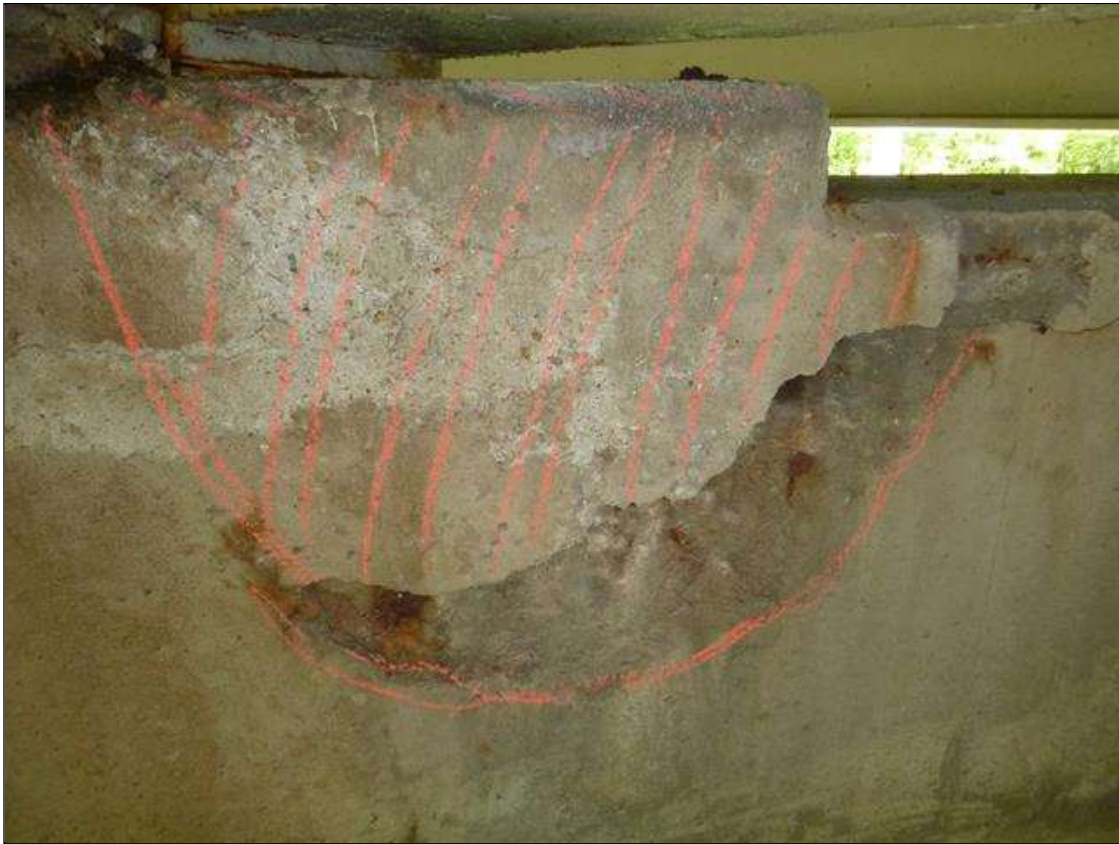
Bent 4 Cap 1: BENT 4 CAP, SPAN 5 SIDE HAS A SPALL ON THE FACE OF THE CAP UNDER BEAM 2, 24 INCHES X 7 INCHES X 2 INCHES DEEP WITH ADJACENT DELAMINATION

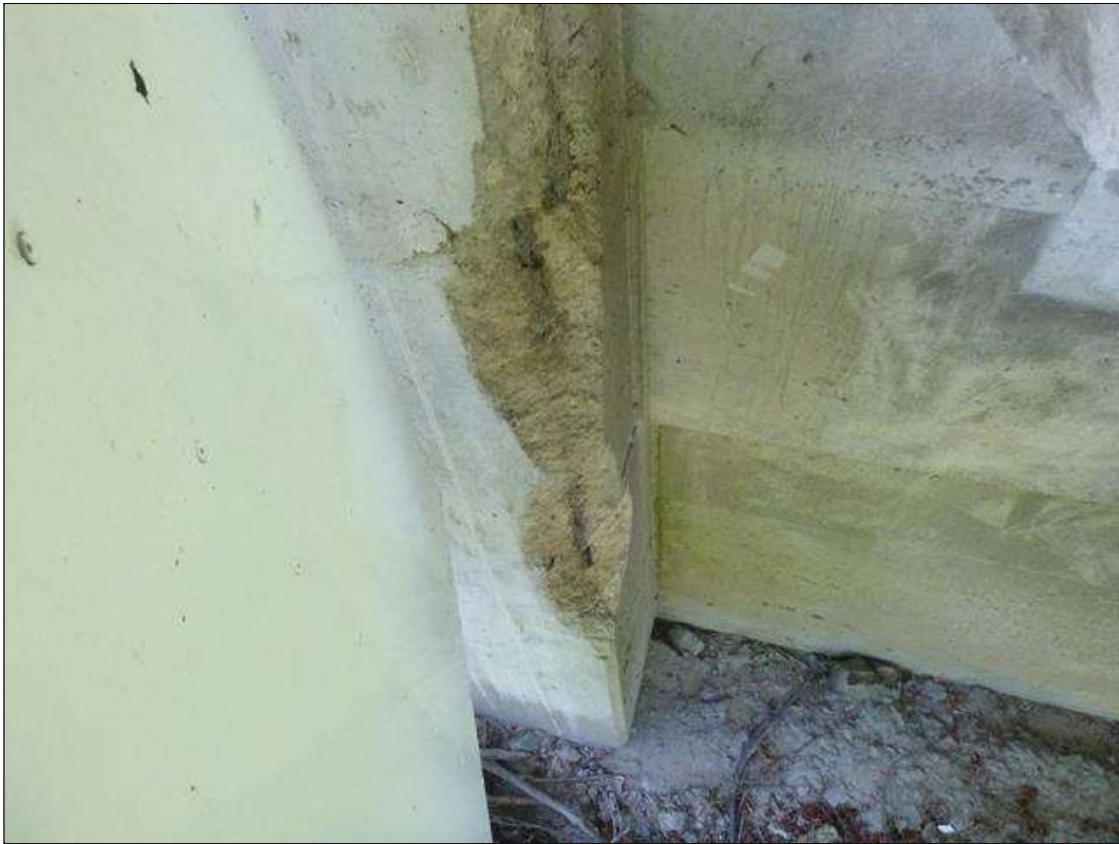
Bent 4 Pile 2: BENT 4, PILE 2 HAS A SPALL ON THE SOUTHWEST CORNER, 10 INCHES WIDE X 6FT. HIGH X 3 INCHES DEEP WITH EXPOSED REBAR, STARTING 4 FT. FROM GROUNDLINE

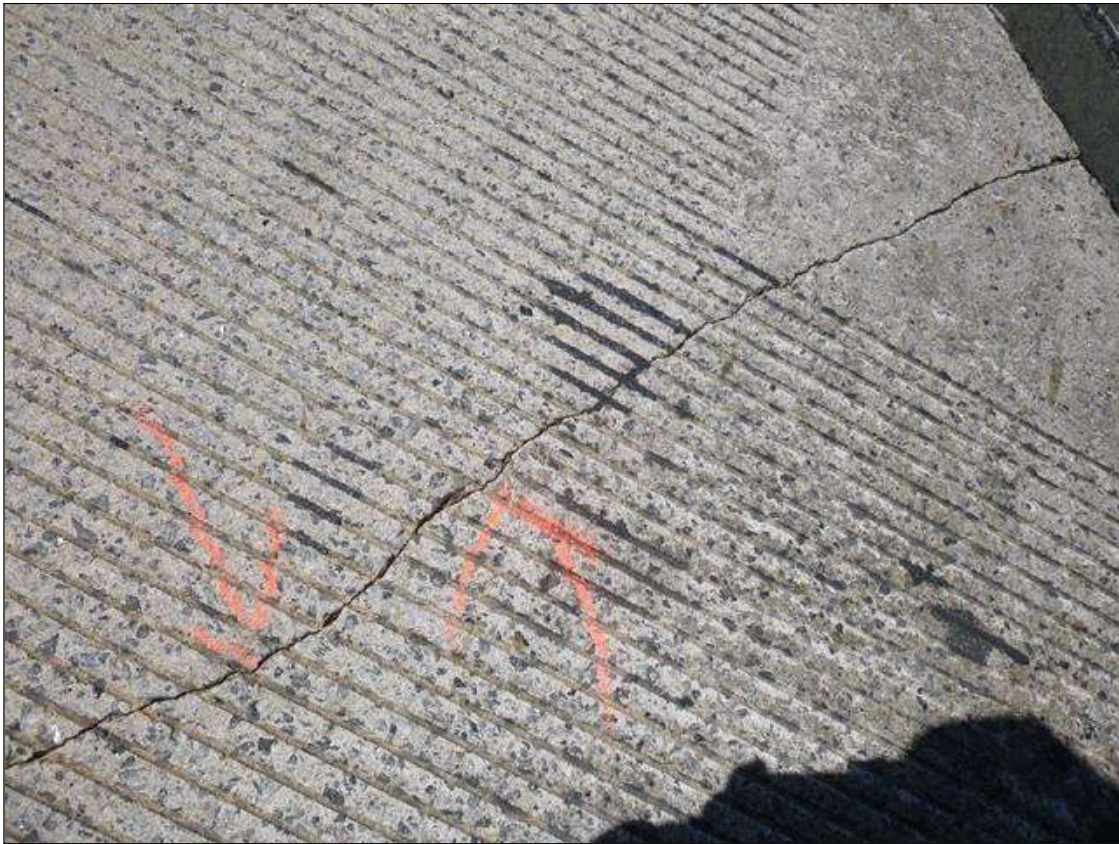
| Element Number | Defect Type | Defect Description | CS | CS Qty | Maint Qty | |
|---|---|---|---|---|---|---|
| 12 | Cracking (RC and Other) | SPAN 1, TOP OF THE DECK HAS A 1/16 WIDE DIAGONAL CRACK, 20 FT. LONG, 9 FT. FROM THE LEFT RAIL AT END BENT 1 FOR A TOTAL OF 300 SQ. FT. OF DIAGONAL CRACKING THRU OUT THE TOP OF THE WEST AND EAST BOUND LANES | 3 | 300 | 300 | Square Feet |

Span 1 Deck: SPAN 1, TOP OF THE DECK HAS A 1/16 WIDE DIAGONAL CRACK, 20 FT. LONG, 9 FT. FROM THE LEFT RAIL AT END BENT 1 FOR A TOTAL OF 300 SQ. FT. OF DIAGONAL CRACKING THRU OUT THE TOP OF THE WEST AND EAST BOUND LANES

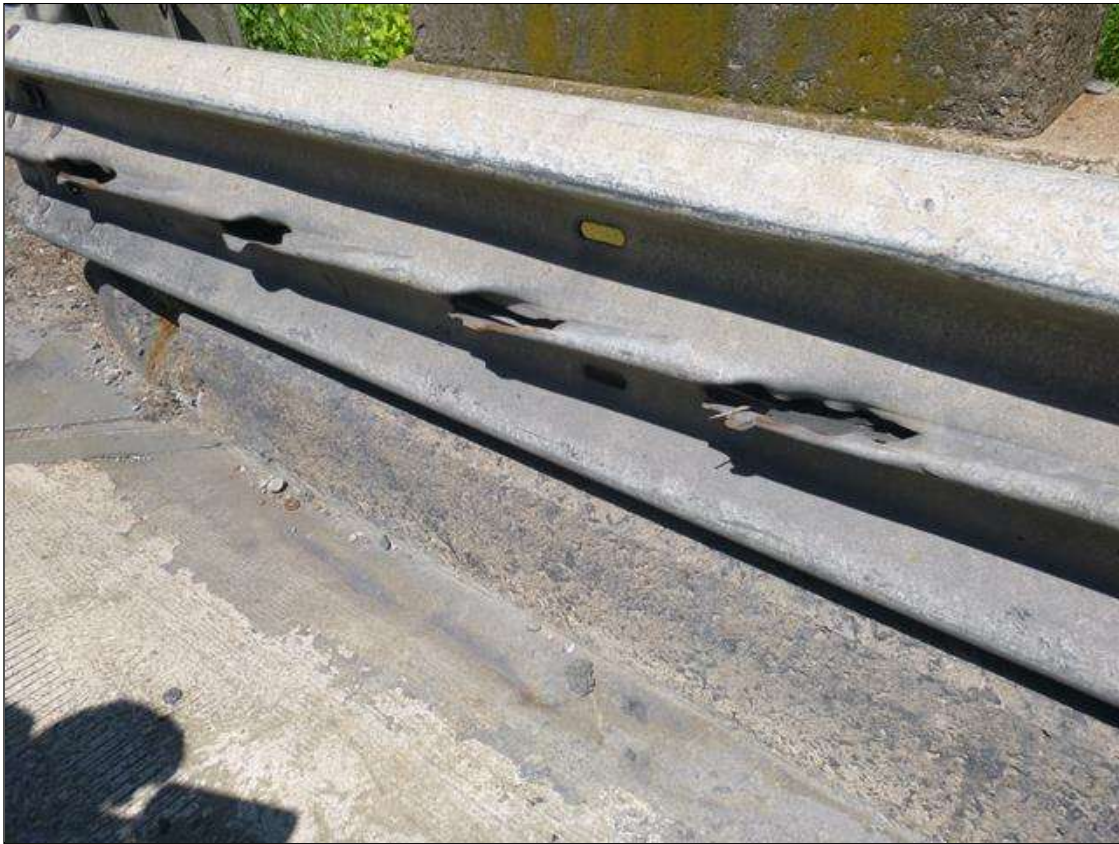
| Element Number | Defect Type | Defect Description | CS | CS Qty | Maint Qty |
|---|---|---|---|---|---|
| 330 | Damage | SPAN 1, LEFT METAL RAIL HAS 6 FT. OF 2 INCH WIDE TEARS THRU OUT THE RAIL | 2 | 6 | 6 Feet |

Span 1 Left Bridge Rail: SPAN 1, LEFT METAL RAIL HAS 6 FT. OF 2 INCH WIDE TEARS THRU OUT THE RAIL

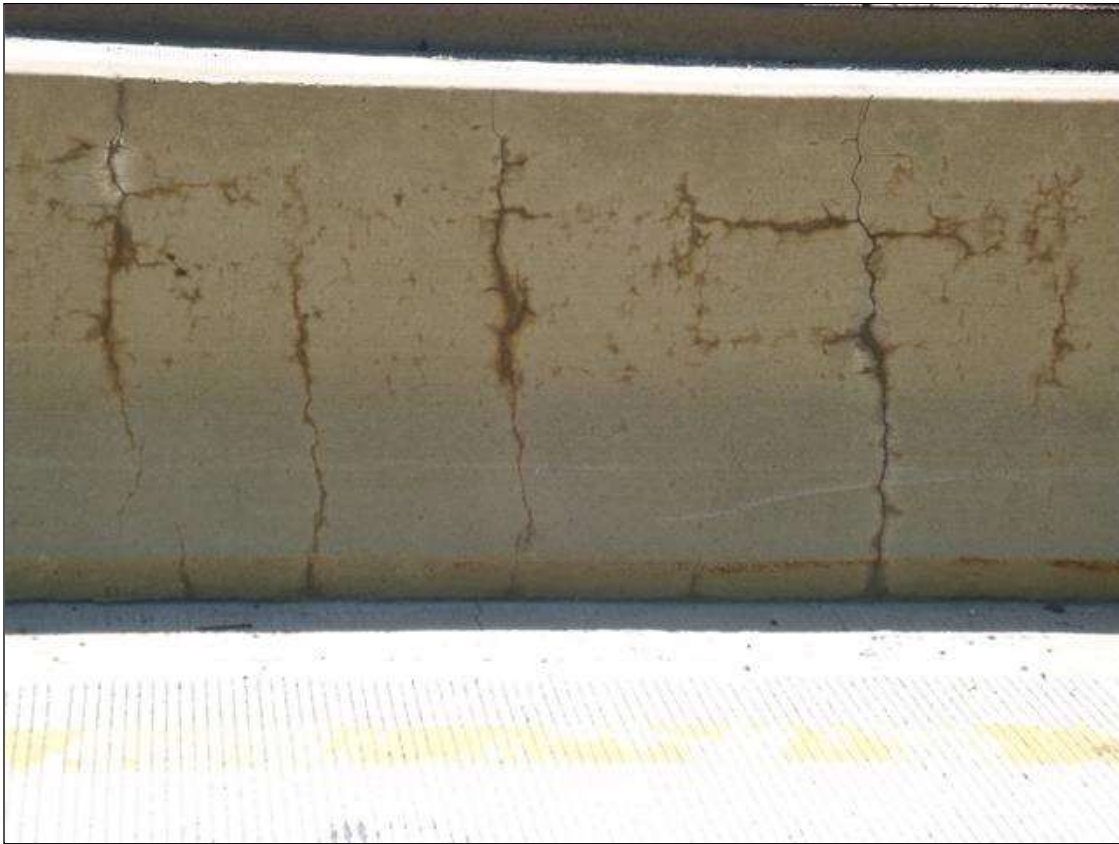
| Element Number | Defect Type | Defect Description | CS | CS Qty | Maint Qty | |
|---|---|---|---|---|---|---|
| 331 | Cracking (RC and Other) | SPAN 1 MEDIAN RAIL HAS HAIRLINE TO 1/16 INCH WIDE CRACKING THRU OUT THE LENGTH OF THE RAIL | 3 | 76 | 76 | Feet |

Span 1 Median Rail: SPAN 1 MEDIAN RAIL HAS HAIRLINE TO 1/16 INCH WIDE CRACKING THRU OUT THE LENGTH OF THE RAIL

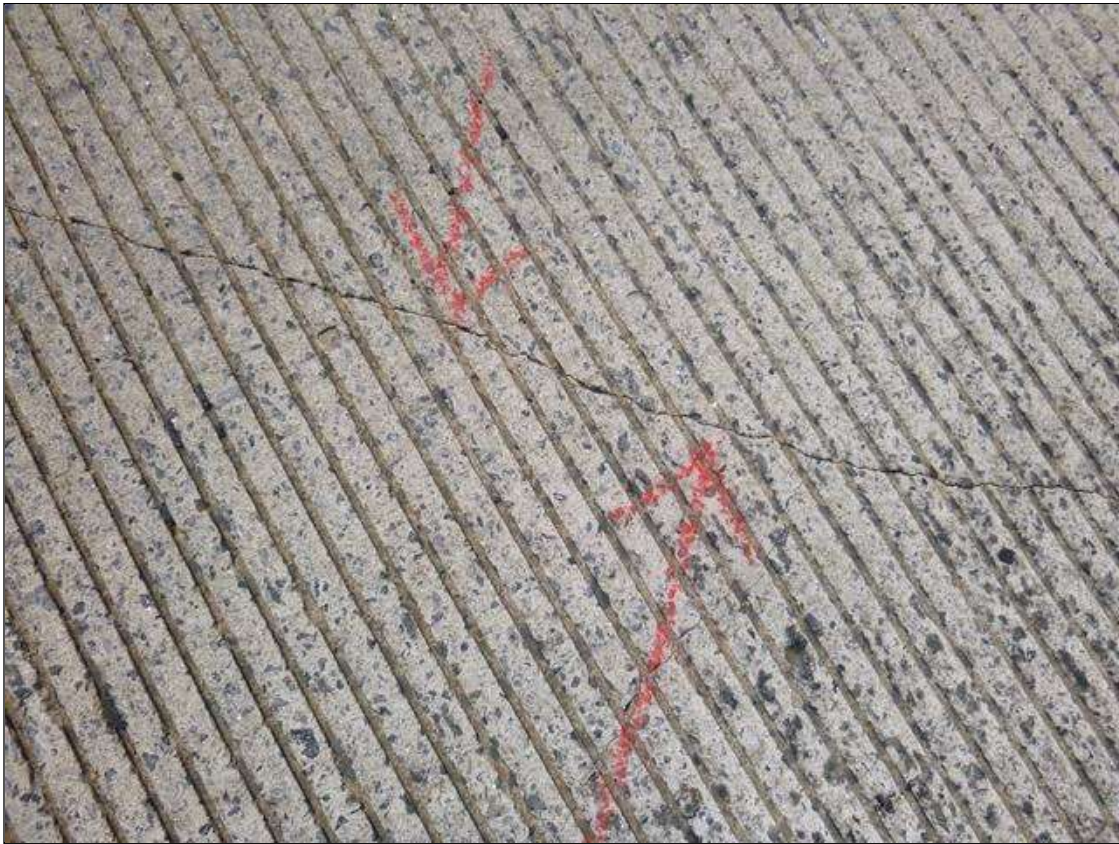
Span 2 Deck: SPAN 2, TOP OF THE DECK HAS A 1/16 INCH WIDE DIAGONAL CRACK, 10 FT. LONG AT BENT 1, 9 FT. FROM THE LEFT RAIL, FOR A TOTAL OF 280 SQ. FT. OF DIAGONAL CRACKING THRU OUT THE TOP OF THE SPAN, WEST AND EAST BOUND LANES

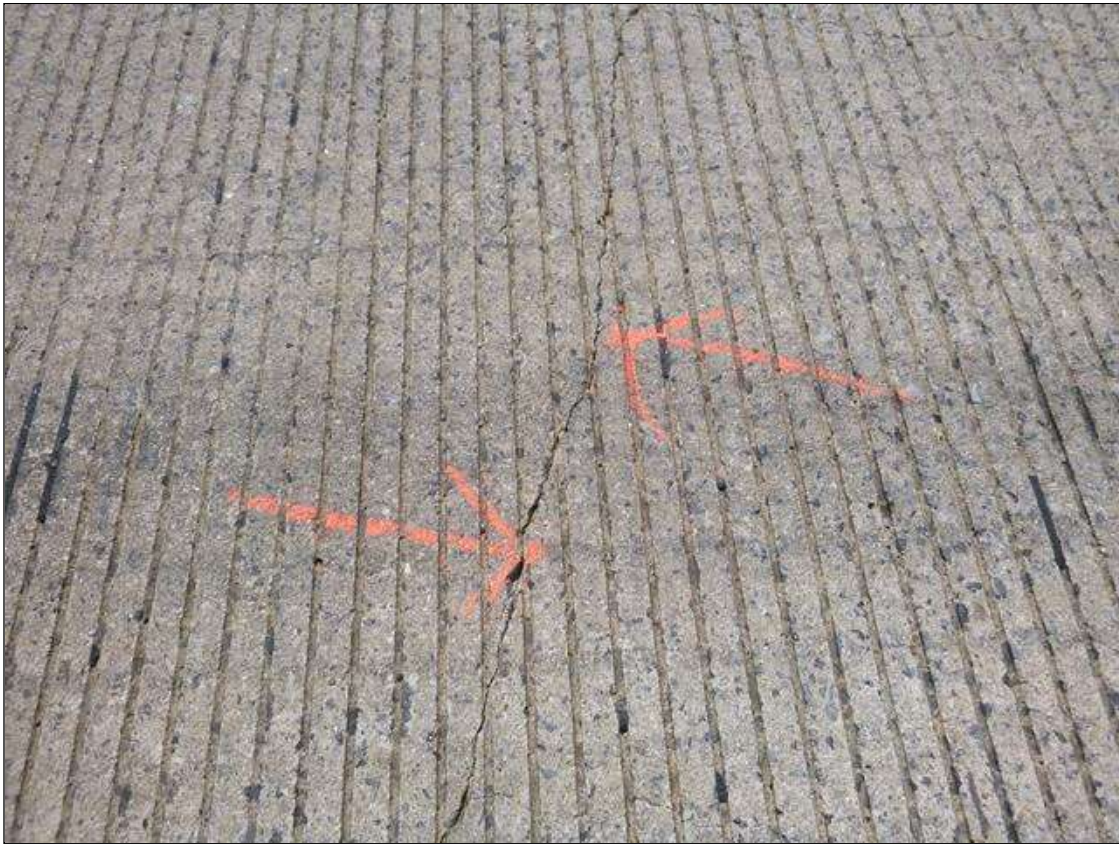
Span 2 Deck: SPAN 2 TOP OF THE DECK HAS A 1/16 INCH WIDE TRANSVERSE CRACK AT THE 2/3 POINT, 12 FT. LONG FOR A TOTAL OF 500 SQ. FT. THRU OUT THE TOP OF THE SPAN, WEST AND EAST BOUND LANES

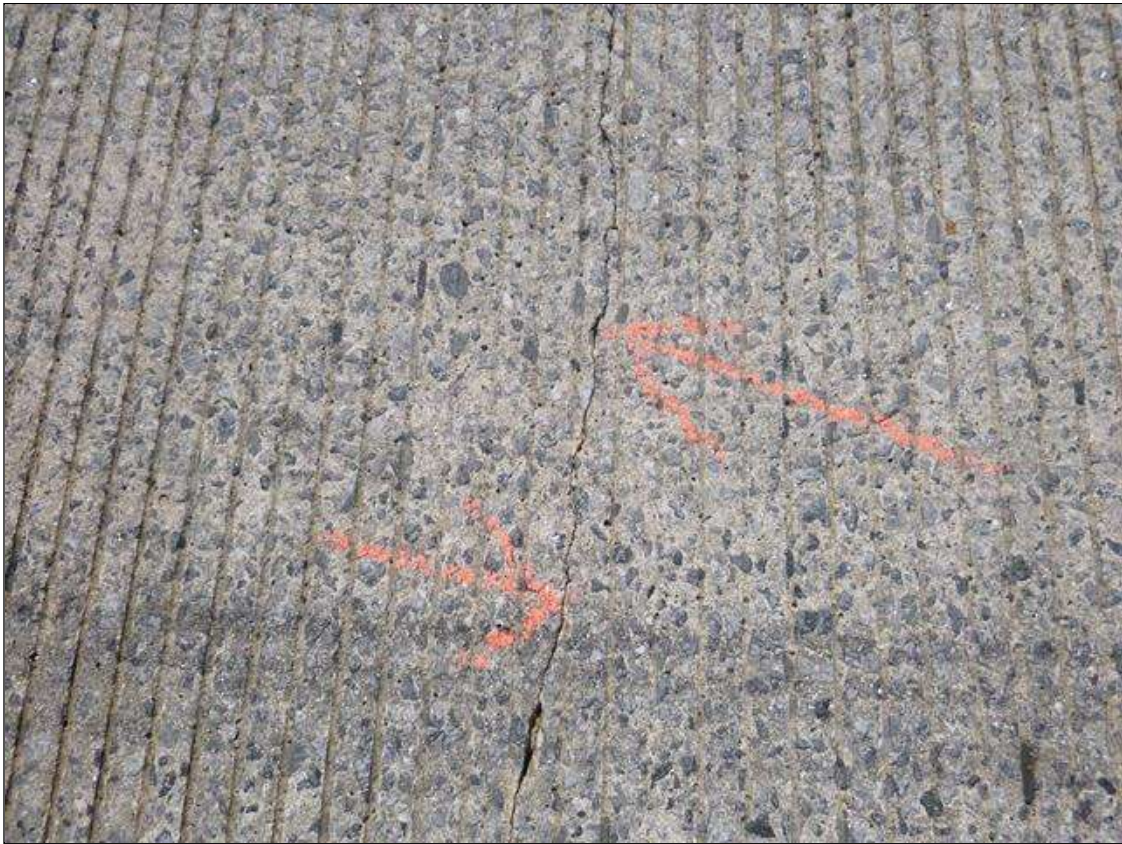
Span 3 Deck: SPAN 3 TOP OF THE DECK HAS A 1/16 INCH WIDE TRANSVERSE CRACK AT THE 1/3 POINT, 12 FT. LONG FOR A TOTAL OF 550 SQ. FT. THRU OUT THE SPAN, WEST AND BOUND LANES

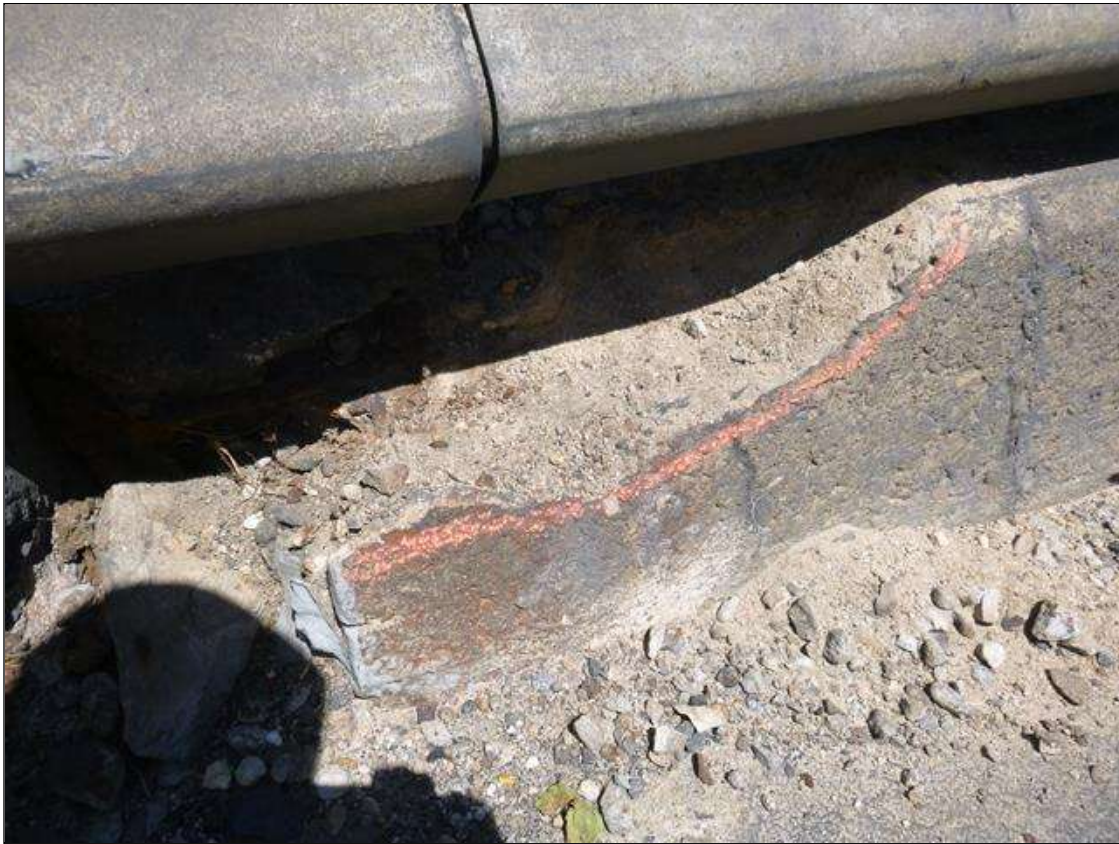
Span 4 Left Bridge Rail: SPAN 4, LEFT CURB AT BENT 3 HAS A SPALL, 16 INCHES LONG X 4 INCHES HIGH X 5 INCHES DEEP WITH EXPOSED REBAR

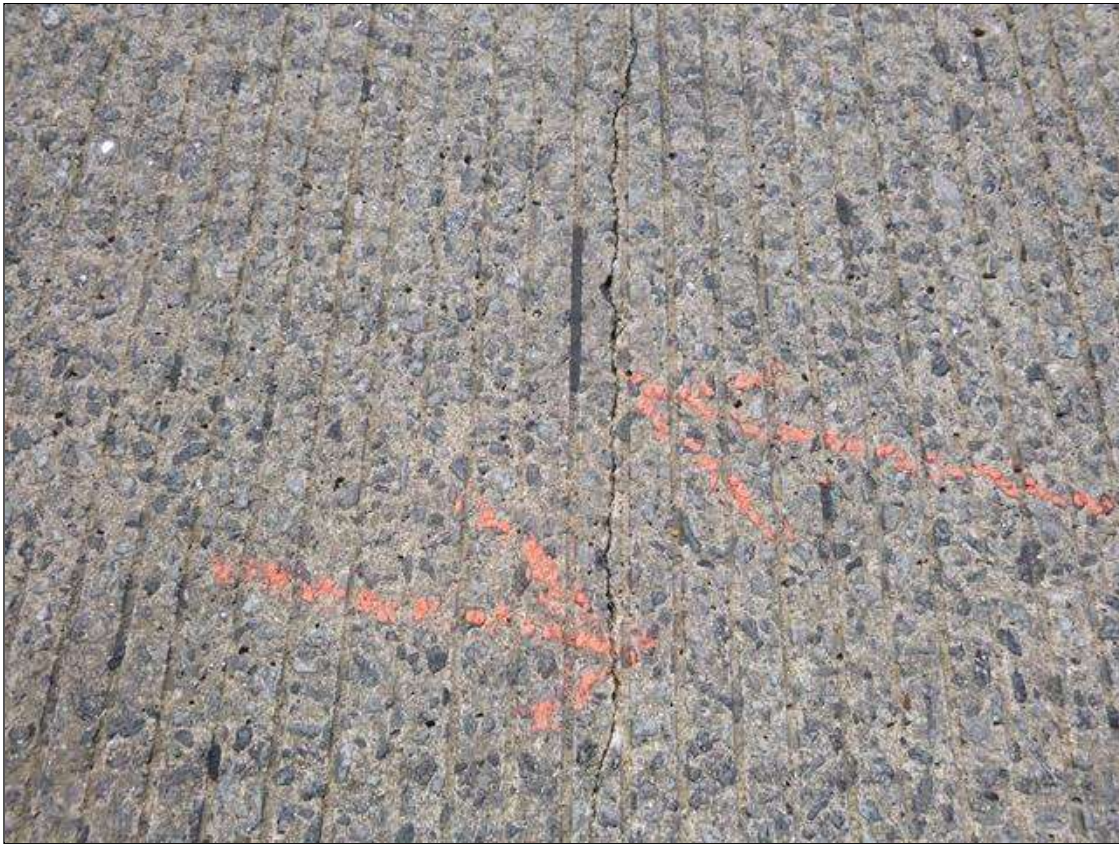
Span 4 Deck: SPAN 4 TOP OF THE DECK HAS A 1/16 INCH WIDE TRANSVERSE CRACK, AT THE 3/4 POINT, 12 FT. LONG FOR A TOTAL OF 770 SQ. FT. THRU OUT THE TOP OF THE WEST AND EAST BOUND LANES

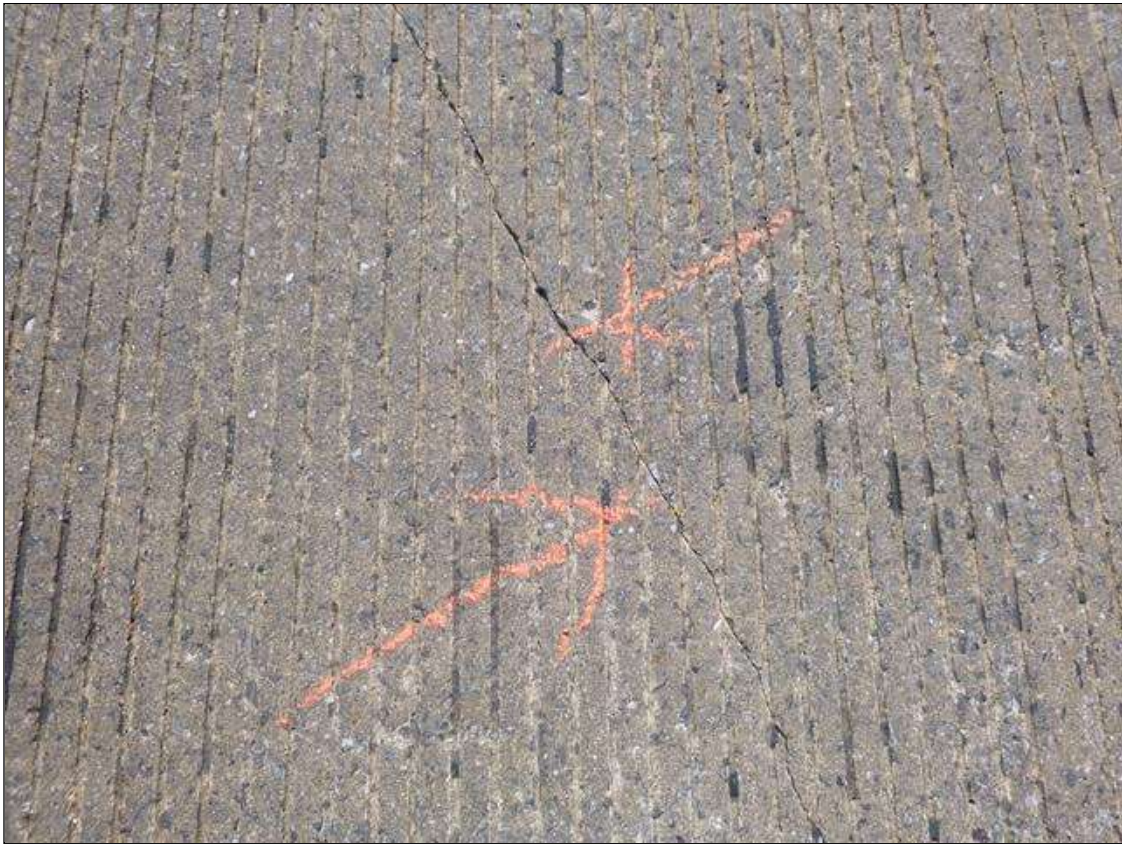
Span 5 Deck: SPAN 5, TOP OF THE DECK HAS A 1/16 INCH WIDE DIAGONAL CRACK AT BENT 4, 8 FT. LONG FOR A TOTAL OF 360 SQ. FT. THRU OUT THE SPAN IN THE WEST AND EAST BOUND LANES

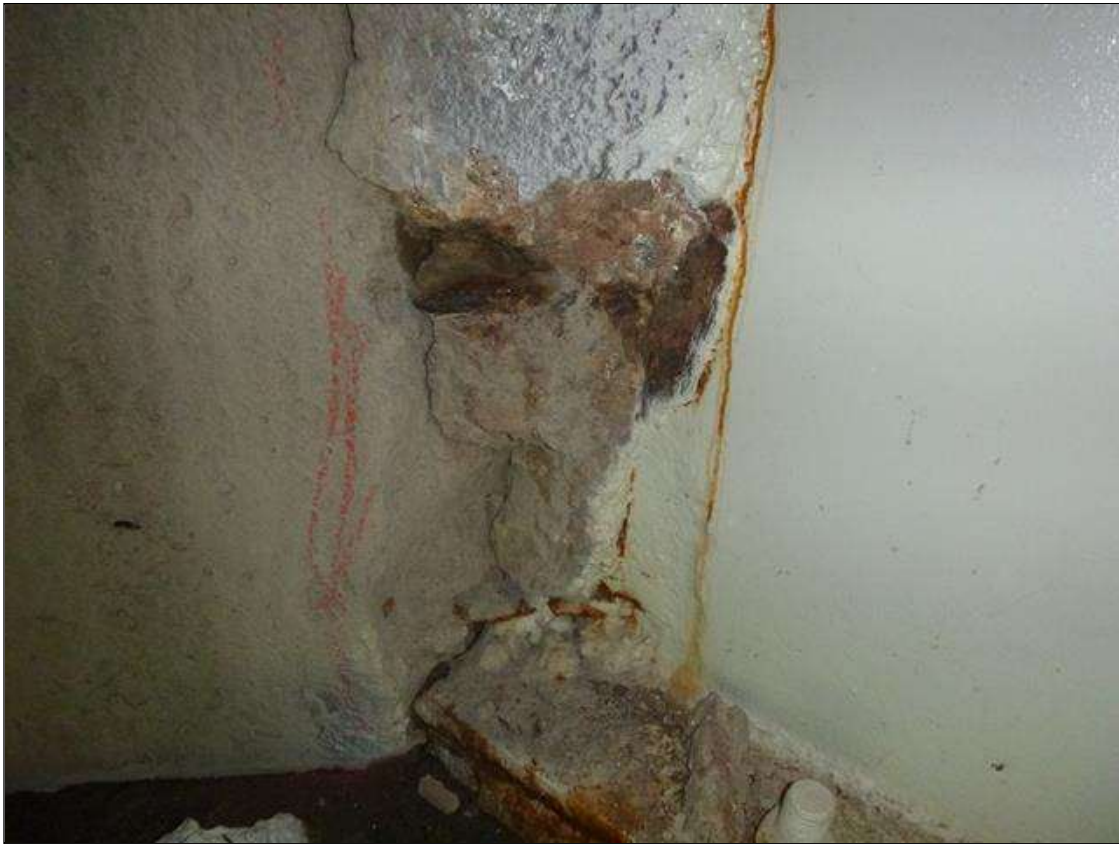
End Bent 2 Abutment/Backwall : END BENT 2 ABUTMENT HAS A SPALL, 8 INCHES WIDE X 16 INCHES HIGH X 4 INCHES DEEP WITH REBAR EXPOSED, ADJACENT TO THE LEFT SIDE OF BEAM 3

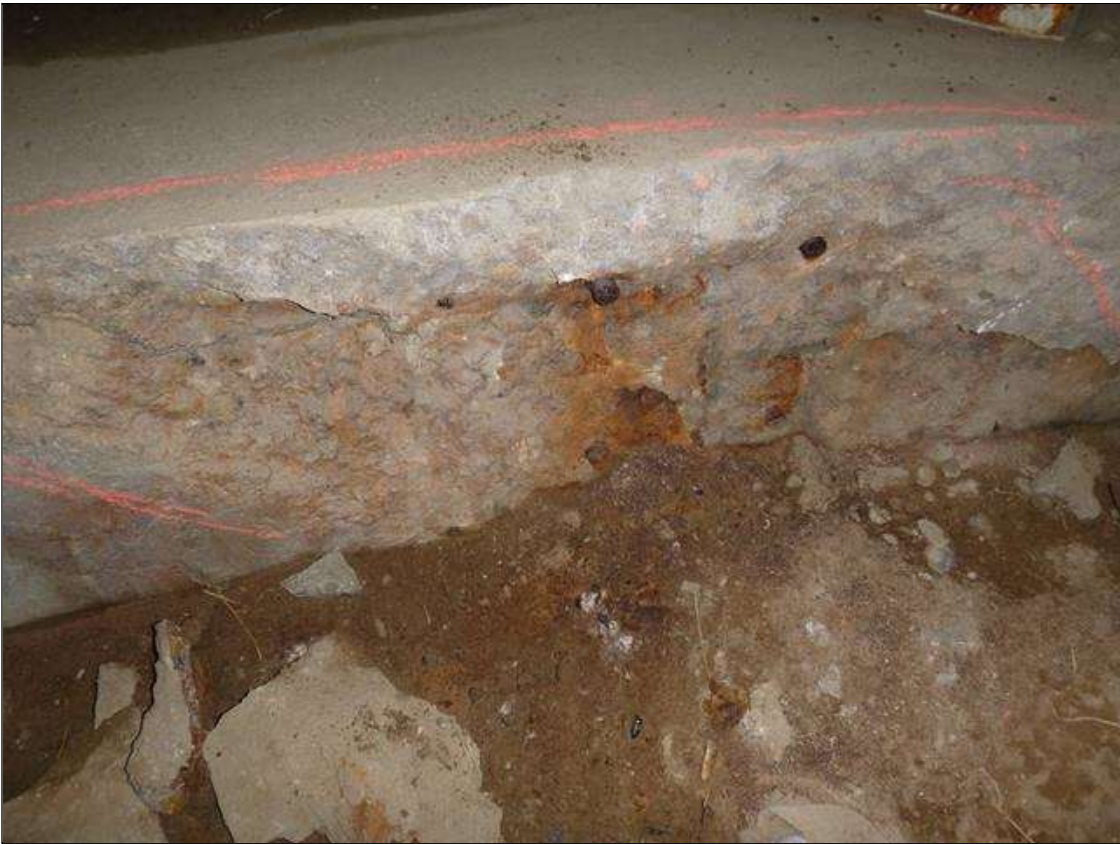
End Bent 2 Cap 1: END BENT 2 FACE OF CAP HAS A SPALL, 38 INCHES LONG X 12 INCHES HIGH X 1.5 INCHES DEEP AT BAY 3

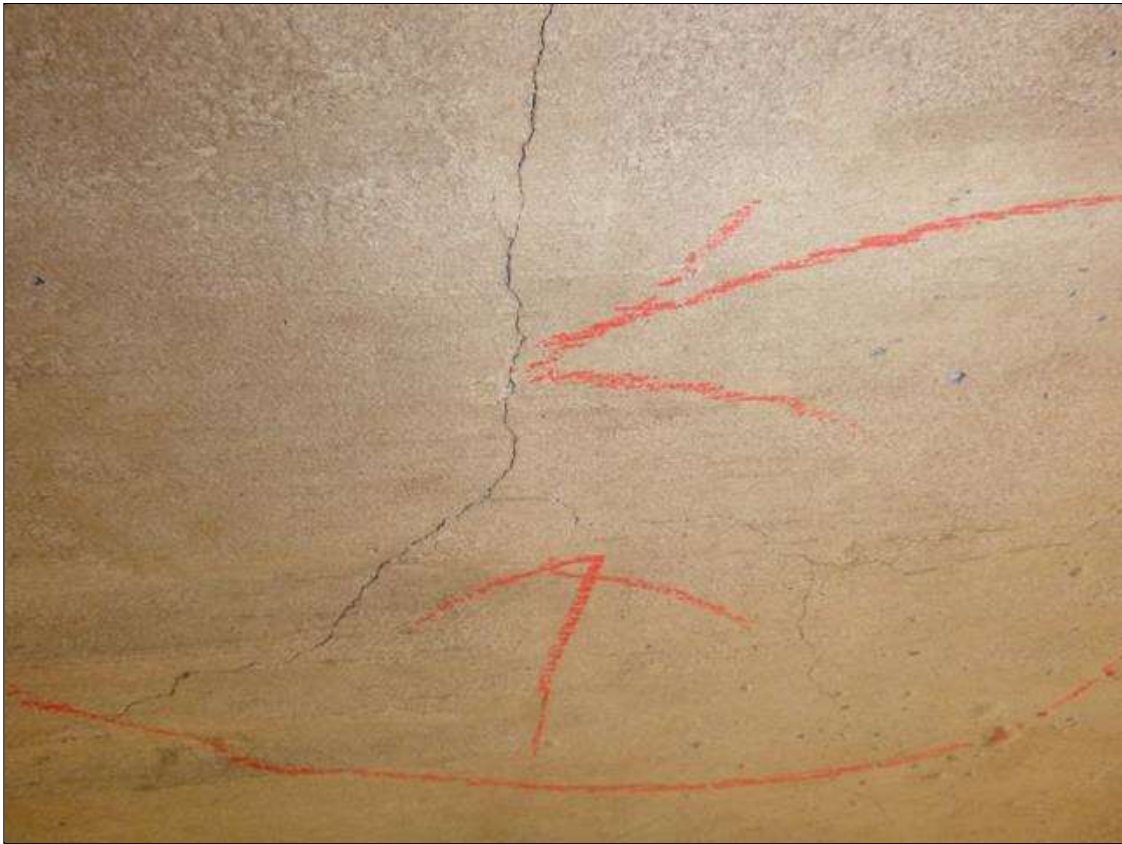
Span 5 Deck: SPAN 5 BOTTOM OF BAY 7 DECK HAS 1 SQ. FT. OF 1/32 INCH WIDE MAP CRACKING, 8 FT. FROM END BENT 2 FOR A TOTAL OF 2150 SQ. FT. THRU OUT THE BOTTOM OF THE SPAN

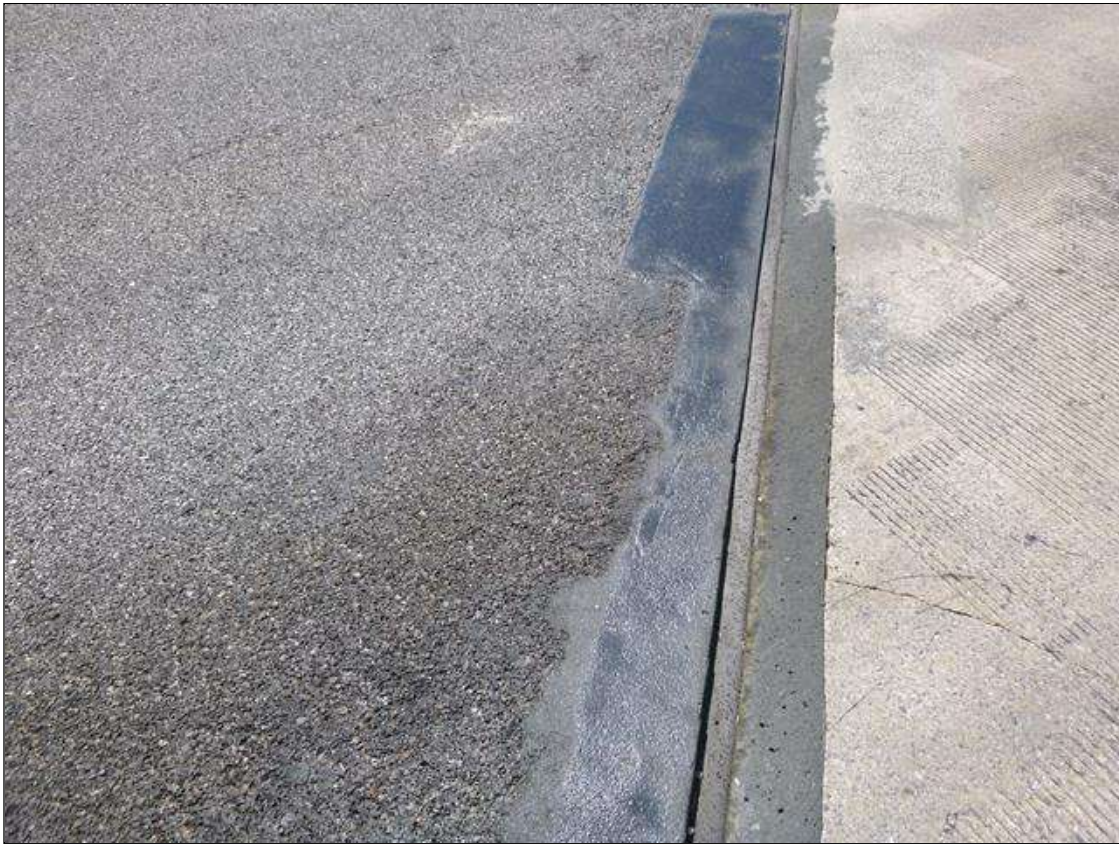
END BENT 2 ASPHALT WEARING SURFACE APPROACH ROADWAY HAS A 16 FT. LONG X 12 INCH WIDE PATCH, ADJACENT TO END BENT 2 JOINT IN THE WEST BOUND LANES

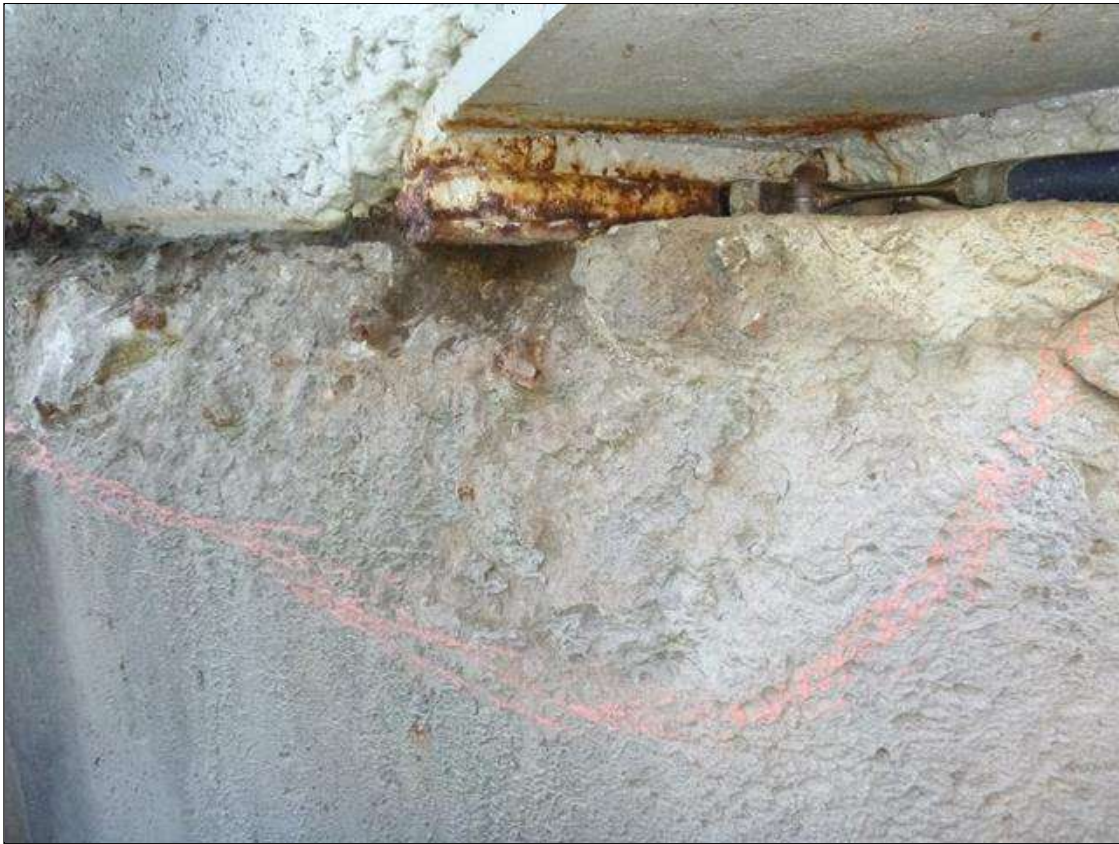
End Bent 1 Abutment/Backwall : END BENT 1 ABUTMENT UNDER BEAM 8 HAS A SPALL, 48 INCHES LONG X 12 INCHES HIGH X 4 INCHES DEEP UNDER BEAM 8 BEARING AREA, WITH EXPOSED REBAR, CONCRETE AT BRIDGE SEAT ADJACENT TO BEARING IS DELAMINATED

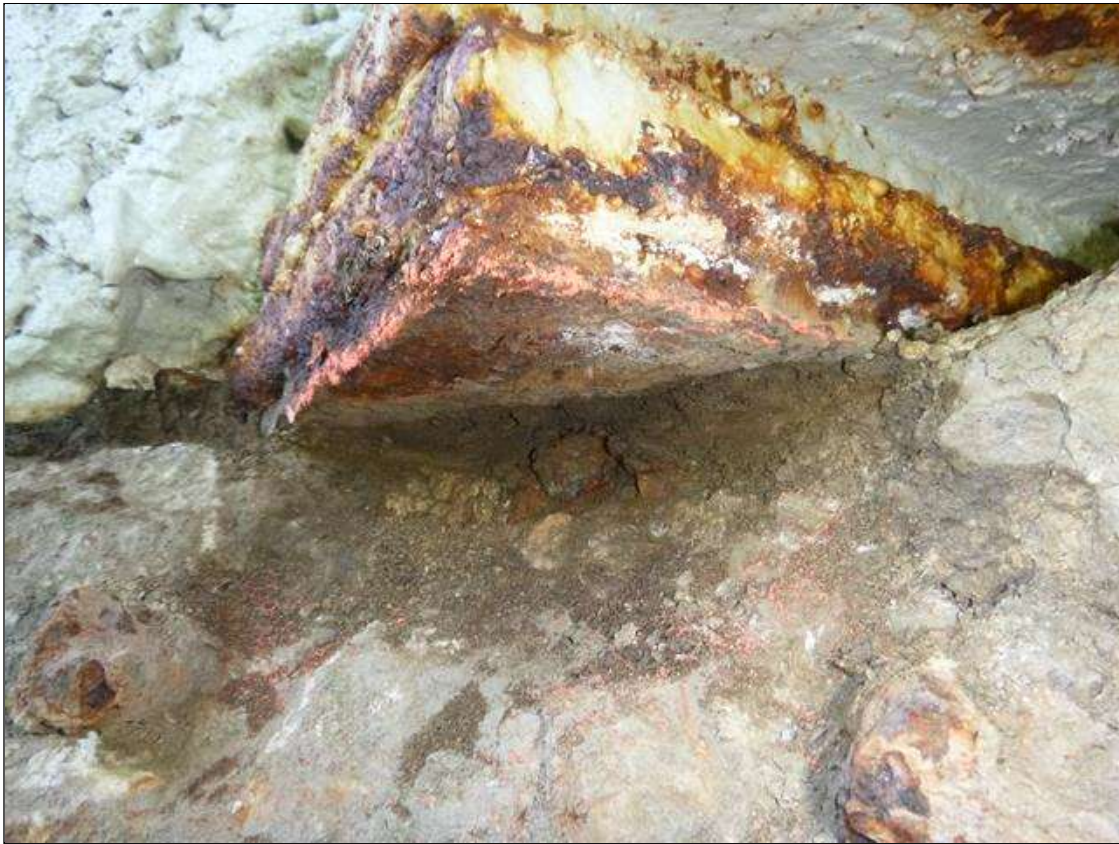
SPAN 1, BEAM 1 NEAR BEARING HAS A 5 INCHES X 6 INCH X 2.5 INCH VERTICALLY AREA WITH OUT BEARING

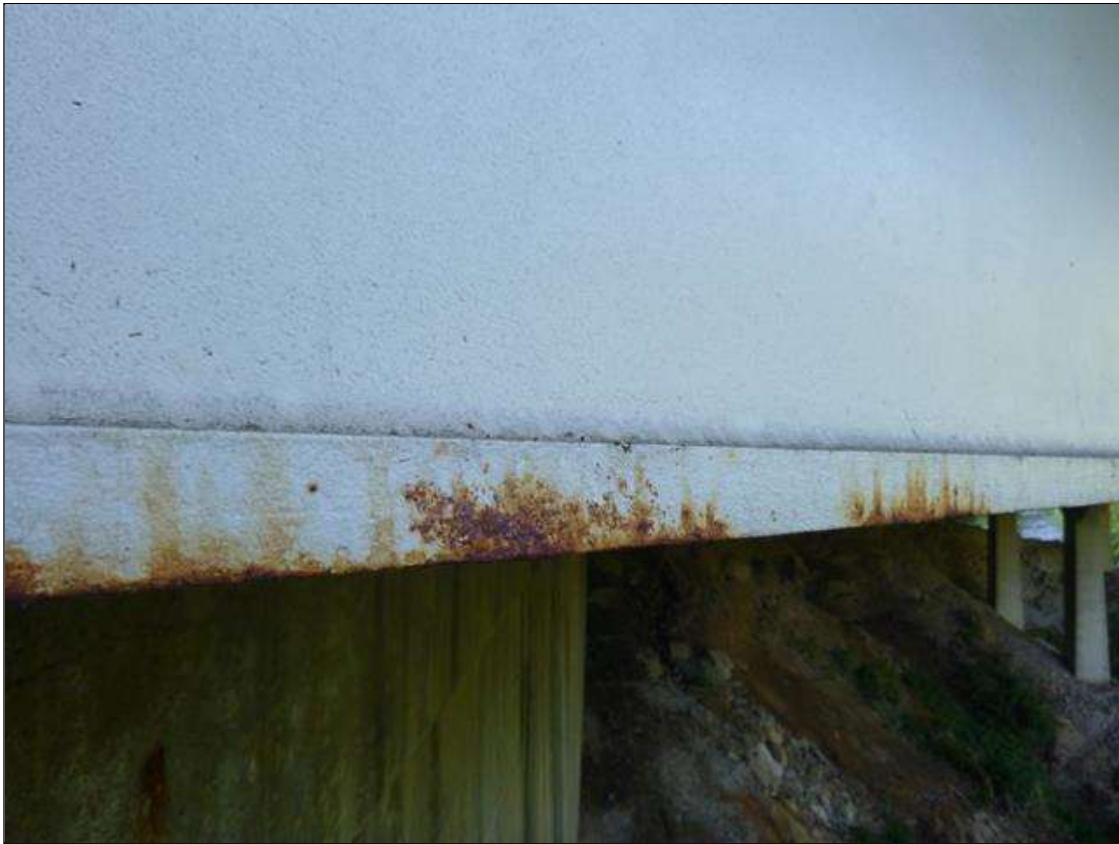
| Span 1 | | Beam 8 | | | | | |
|---|---|---|---|---|---|---|---|
| 107 | Corrosion | SPAN 1, BEAM 8 HAS 18 FT. OF FRECKLED RUST ON THE EDGES OF THE BOTTOM FLANGE THRU OUT THE LENGTH OF THE BEAM | 2 | 18 | | Feet | |
| 515 | Effectiveness (Steel Protective Coatings) | PROTECTIVE COATING HAS STARTED TO FAIL DUE TO RUST | 2 | 18 | 18 | Square Feet | |

Span 1 Beam 8: SPAN 1, BEAM 8 HAS 18 FT. OF FRECKLED RUST ON THE EDGES OF THE BOTTOM FLANGE THRU OUT THE LENGTH OF THE BEAM

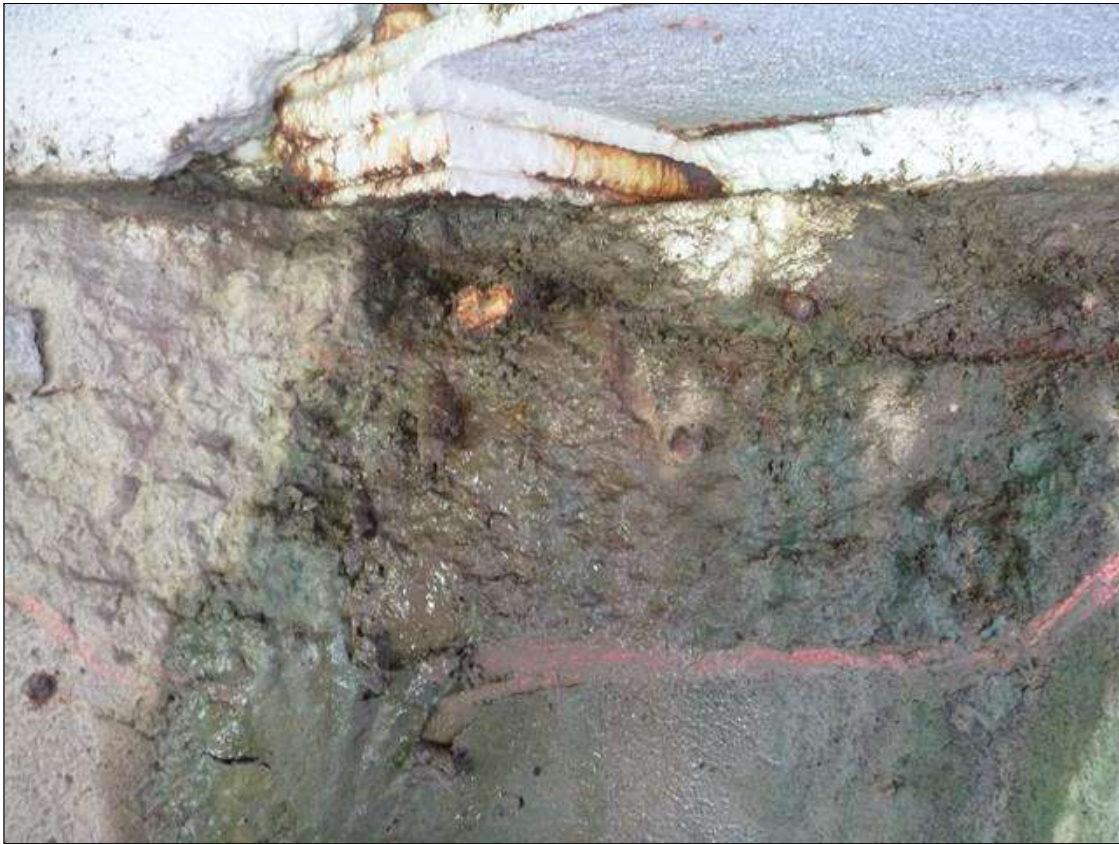
End Bent 1 Abutment/Backwall : END BENT 1 ABUTMENT UNDER BEAM 6 HAS A SPALL, 36 INCHES LONG X 12 INCHES HIGH X 4 INCHES DEEP WITH EXPOSED REBAR, WITH AN AREA OF 4 INCHES X 5 INCHES X 4 INCHES VERTICALLY OF LOST BEARING DUE TO SPALL

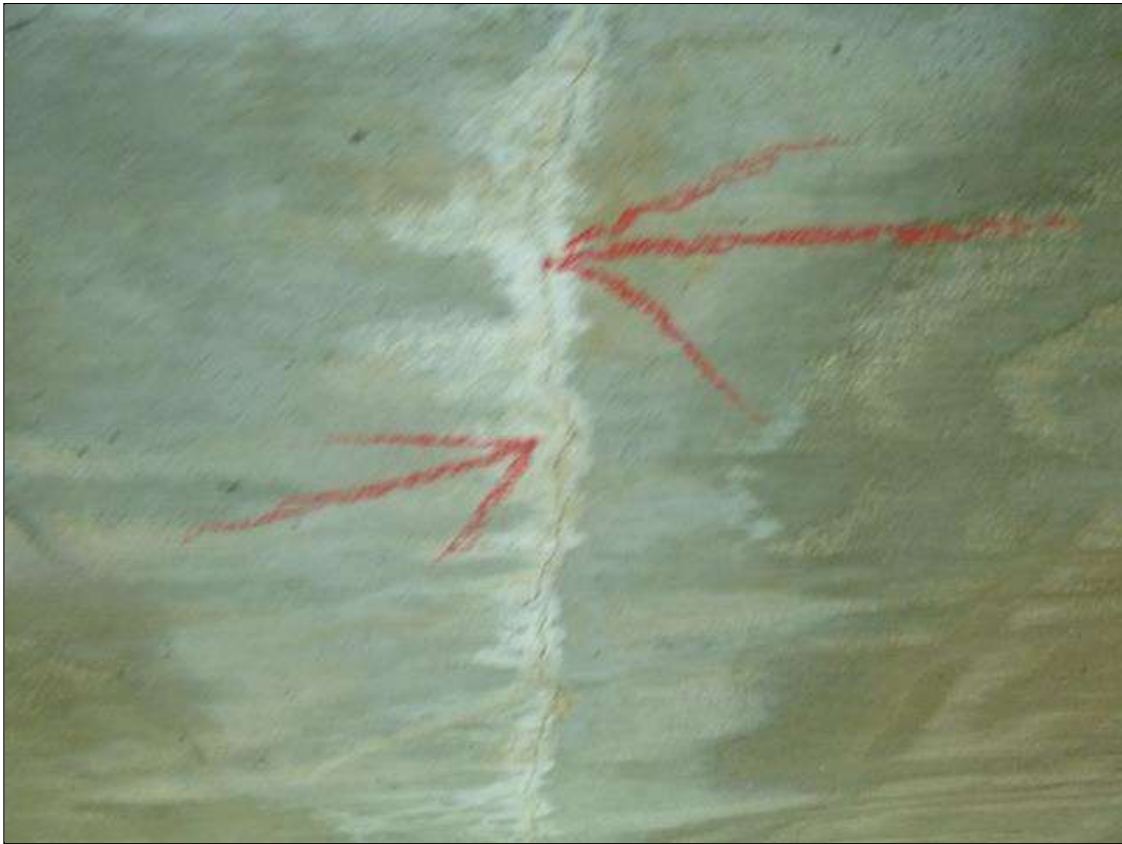
| Element Number | Defect Type | Defect Description | CS | CS Qty | Maint Qty | |
|---|---|---|---|---|---|---|
| 12 | Cracking (RC and Other) | SPAN 1, BOTTOM OF BAY 6 DECK HAS A HAIRLINE TRANSVERSE CRACK, 7 FT. LONG WITH EFFLO., 8 FT. FROM END BENT 1, FOR A TOTAL OF 290 SQ. FT. THRU OUT THE BOTTOM OF THE SPAN | 2 | 290 | 290 | Square Feet |

Span 1 Deck: SPAN 1, BOTTOM OF BAY 6 DECK HAS A HAIRLINE TRANSVERSE CRACK, 7 FT. LONG WITH EFFLO., 8 FT. FROM END BENT 1, FOR A TOTAL OF 290 SQ. FT. THRU OUT THE BOTTOM OF THE SPAN

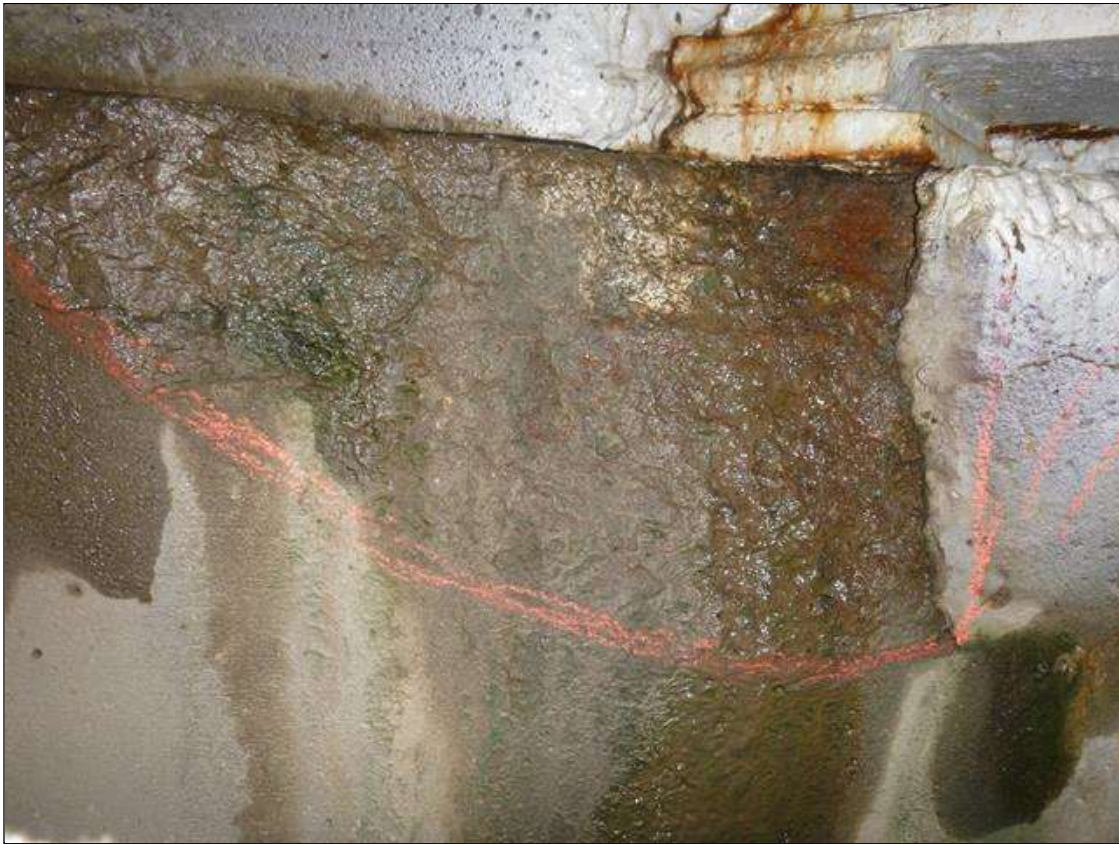
End Bent 1 Abutment/Backwall : END BENT 1 ABUTMENT HAS A SPALL UNDER BEAM 5, 24 INCHES LONG X 12 INCHES HIGH X 4 INCHES DEEP, WITH AN AREA 6 INCHES X 2.5 INCHES OF LOST BEARING DUE TO SPALL, WITH ADJACENT DELAMINATION

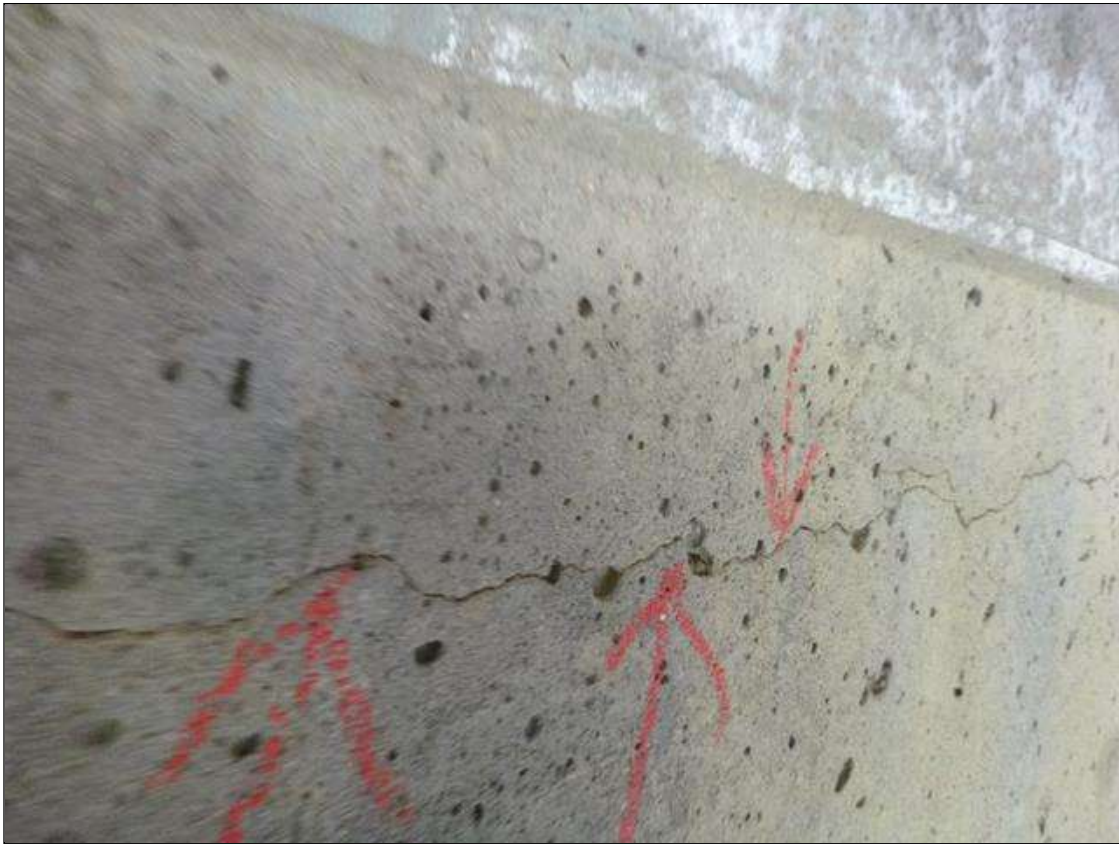
End Bent 1 Abutment/Backwall : END BENT 1 ABUTMENT HAS A 1/8 INCH WIDE LONGITUDINAL CRACK , 48 FT. LONG, 4 INCHES DOWN FROM TOP OF BRIDGE SEAT, FROM LEFT END OF ABUTMENT TO BEAM 5, WITH DELAMINATION

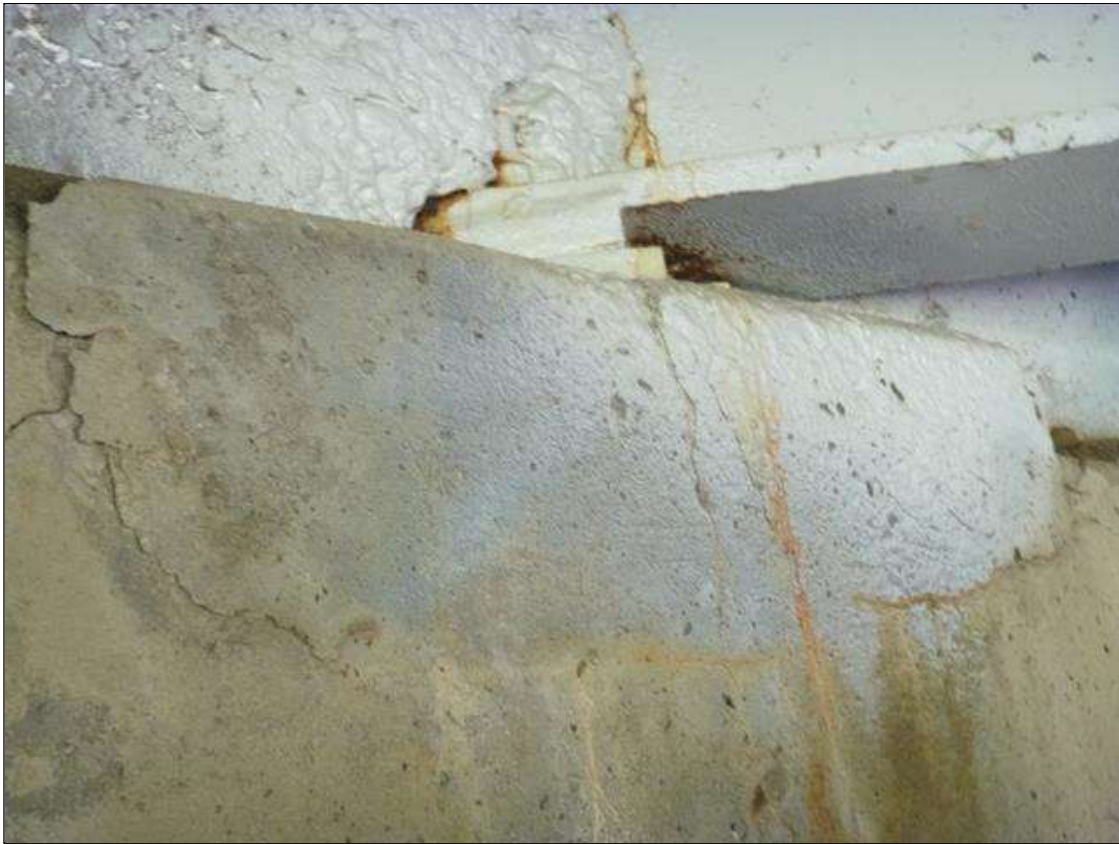
End Bent 1 Abutment/Backwall : END BENT 1 ABUTMENT UNDER BEAM 2 HAS AN AREA OF DELAMINATION IN THE FACE, 36 INCHES X 12 INCHES WITH 1/8 INCH SEPARATION
