## Structure Safety Report

### Routine Element Inspection - Contract

COUNTY: HAYWOOD STRUCTURE NUMBER: 430142 FREQUENCY: 24 MONTHS

FEATURE INTERSECTED: PIGEON RIVER

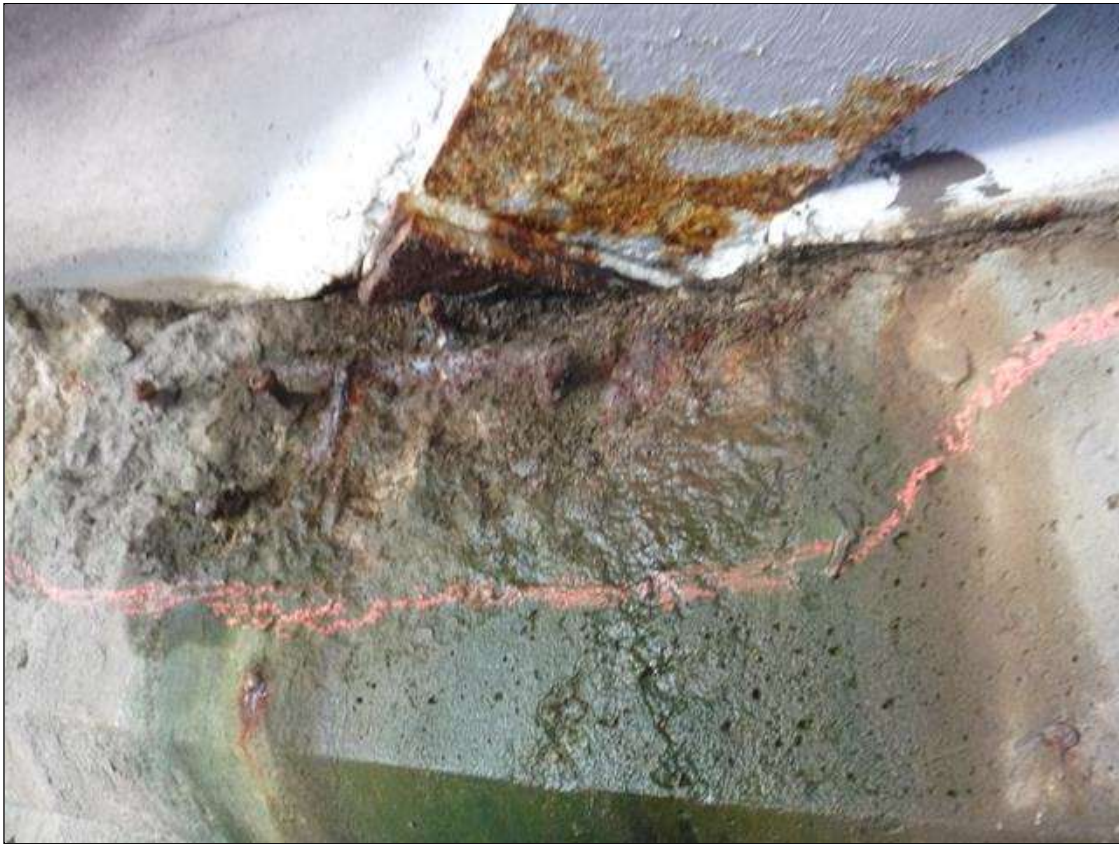
End Bent 1 Abutment/Backwall : END BENT 1 ABUTMENT HAS A SPALL UNDER BEAM 1, 48 INCHES LONG X 14 INCHES HIGH X 5 INCHES DEEP, WITH AN AREA 6 INCHES X 8 INCHES OF LOST BEARING DUE TO SPALL, WITH ADJACENT DELAMINATION

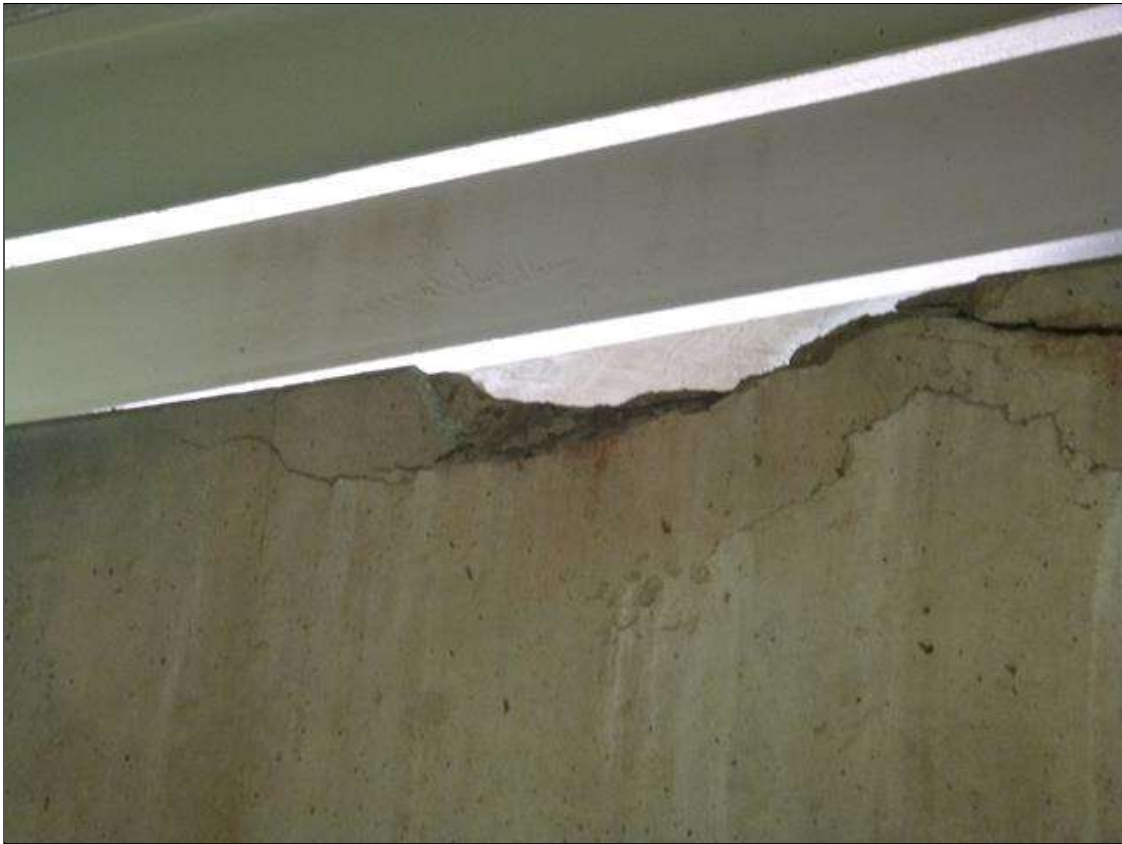
Bent 1 Cap 1: BENT 1 CAP, SPAN 1 SIDE IN BAY 2 HAS A SPALL, 36 INCHES LONG X 8 INCHES HIGH X 5 INCHES DEEP WITH REBAR EXPOSED, WITH ADJACENT DELAMINATION, NEAR TOP EDGE

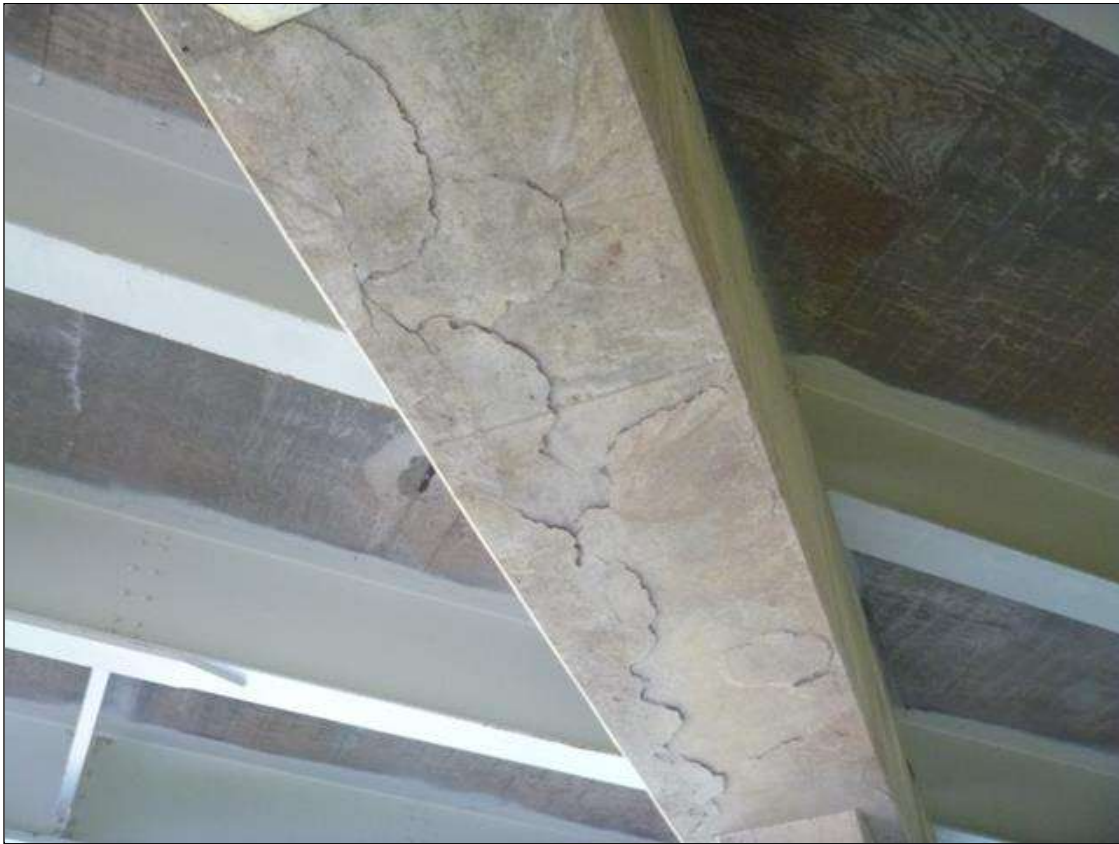
Bent 1 Cap 1: BENT 1 BOTTOM OF CAP BETWEEN PILES 2 AND 3 HAS AN AREA OF DELAMINATION , 12 FT. X 36 INCHES WITH UP TO 1/2 INCH SEPARATION

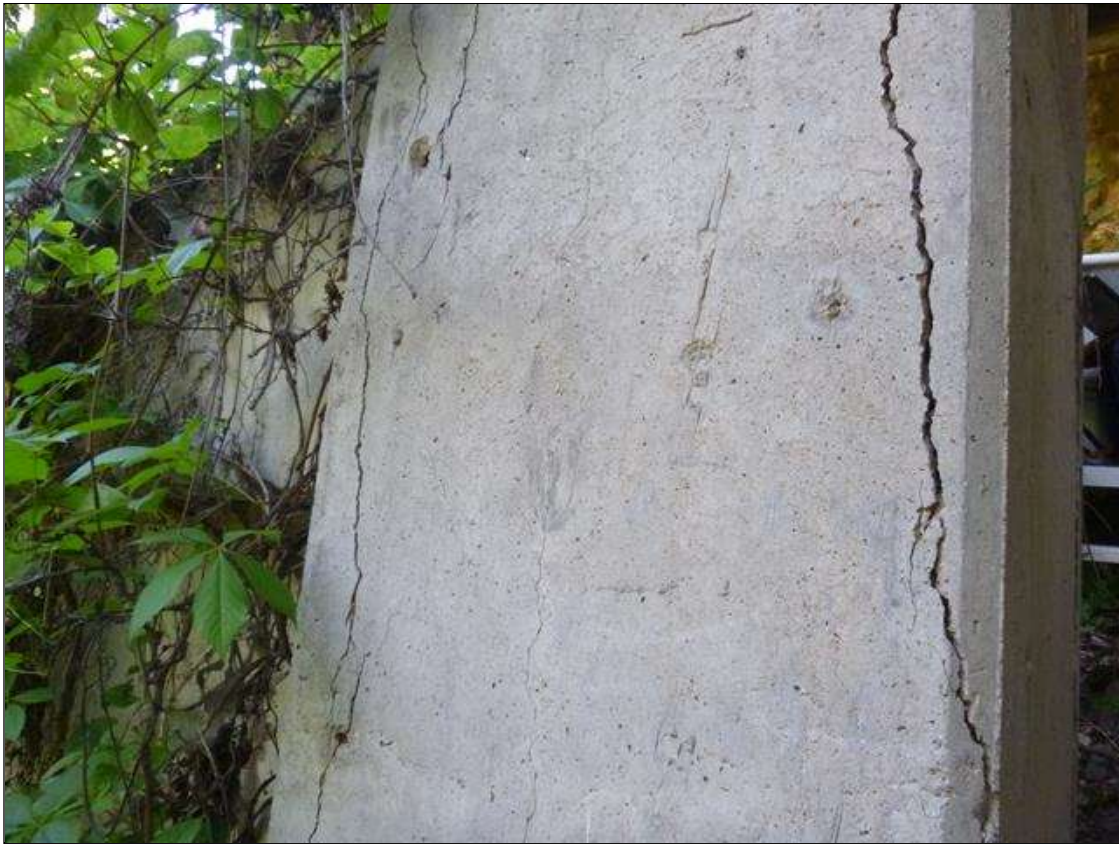
Bent 1 Pile 4: EAST FACE HAS MULTIPLE 1/8" - 1/4" WIDE VERTICAL CRACKS NEAR THE CORNERS.

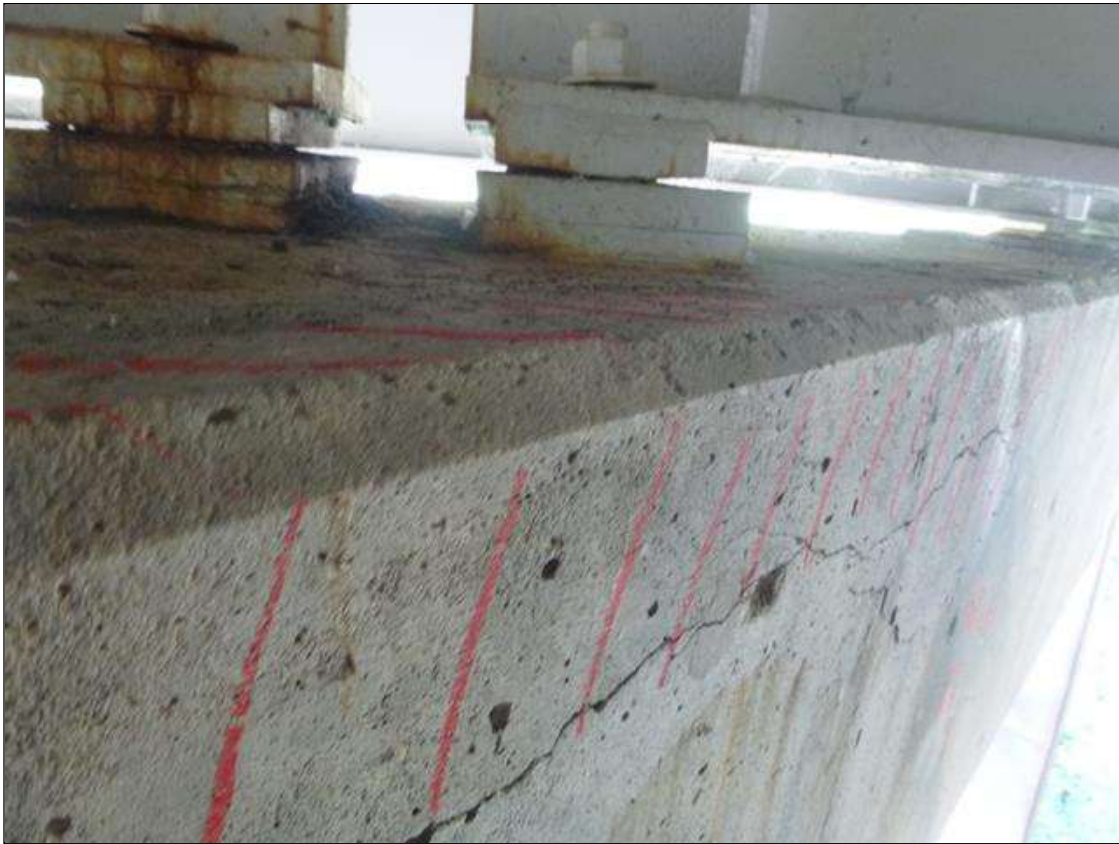
Bent 1 Cap 1: BENT 1 CAP, SPAN 1 SIDE UNDER BEAM 6 HAS AN AREA OF DELAMINATION NEAR TOP EDGE IN THE FACE OF THE CAP, 48 INCHES X 8 INCHES DOWN THE FACE X 5 INCHES ACROSS THE TOP, WITH 1/8 INCH SEPARATION, BEAM 6 BEARING AREA IS SOUND

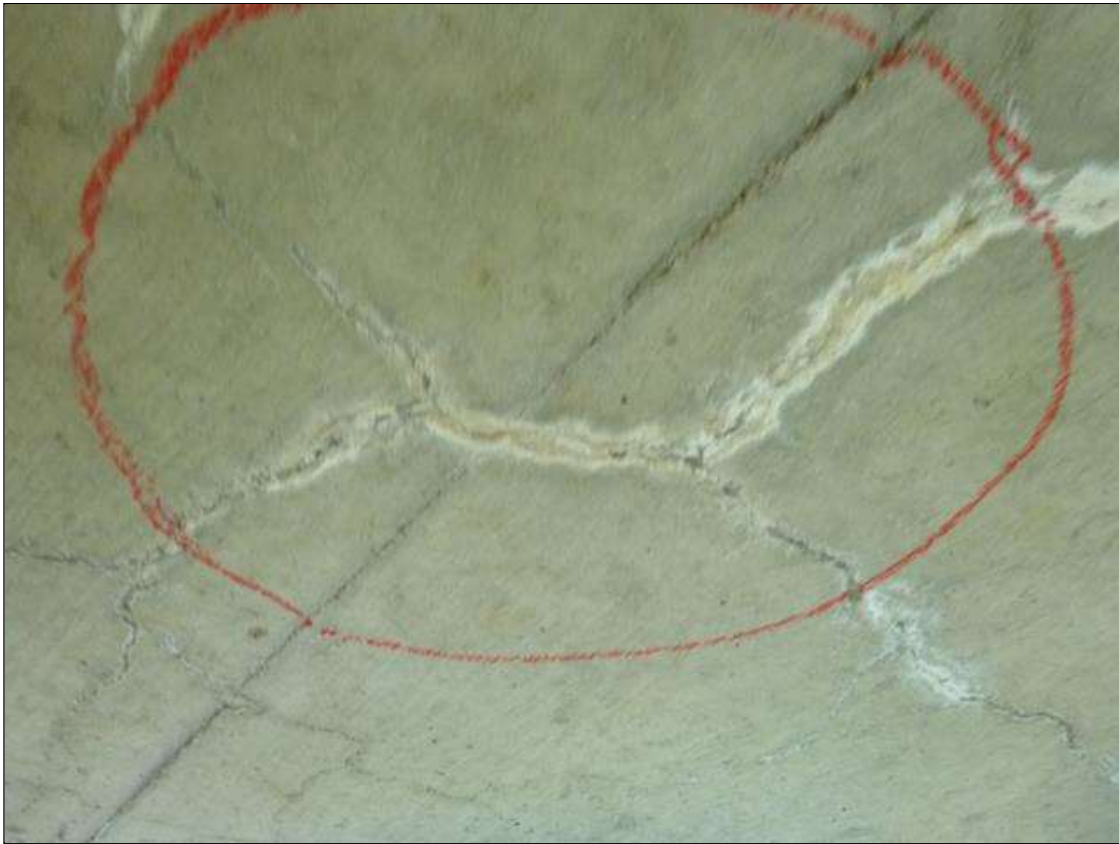
| Element Number | Defect Type | Defect Description | CS | CS Qty | Maint Qty | |
|---|---|---|---|---|---|---|
| 12 | Cracking (RC and Other) | SPAN 1 BOTTOM OF BAY 6 DECK HAS A 1 SQ. FT. AREA OF 1/32 INCH WIDE MAP CRACKING AT BENT 1, FOR A TOTAL OF 1800 SQ. FT. THRU OUT BOTTOM OF THE SPAN | 3 | 1,800 | 1,800 | Square Feet |

Span 1 Deck: SPAN 1 BOTTOM OF BAY 6 DECK HAS A 1 SQ. FT. AREA OF 1/32 INCH WIDE MAP CRACKING AT BENT 1, FOR A TOTAL OF 1800 SQ. FT. THRU OUT BOTTOM OF THE SPAN

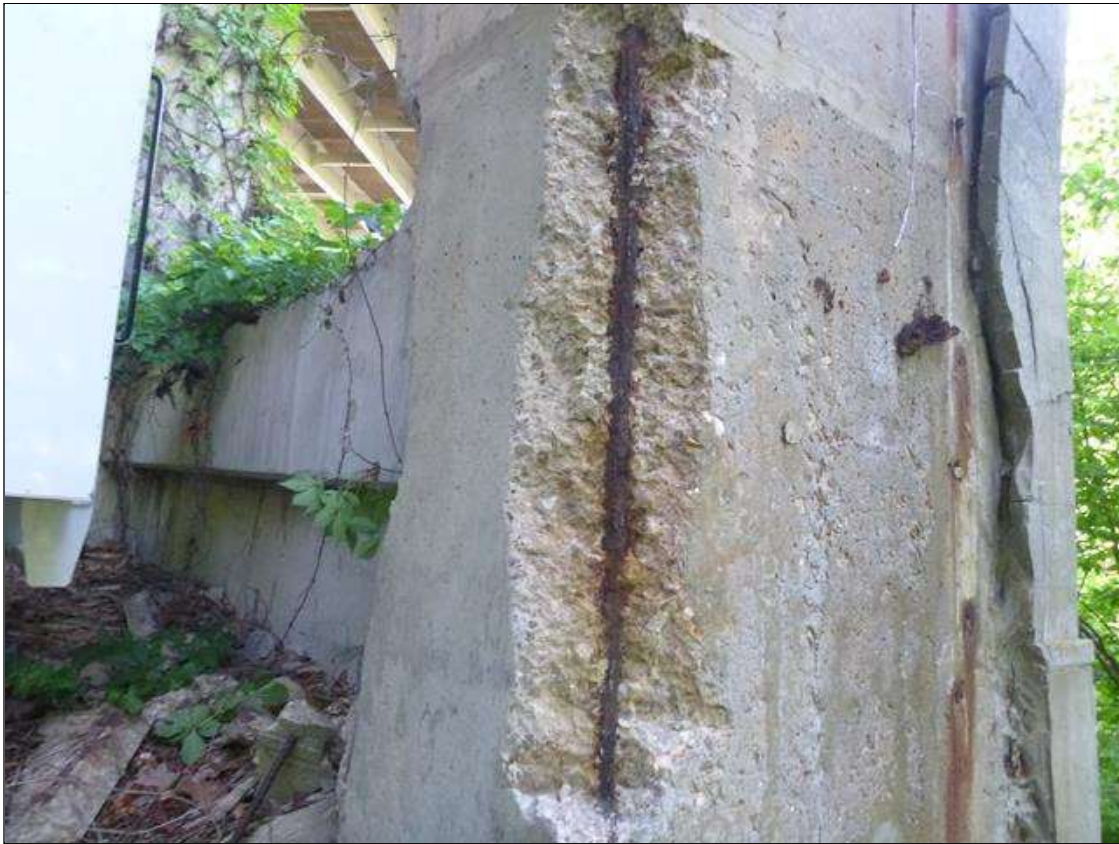
Bent 1 Pile 5: BENT 1, PILE 5 HAS A SPALL ON THE SOUTHWEST CORNER, 10 INCHES WIDE X 60 INCHES HIGH X 3 INCHES DEEP WITH EXPOSED REBAR, STARTING 3 FT. ABOVE GROUND LINE

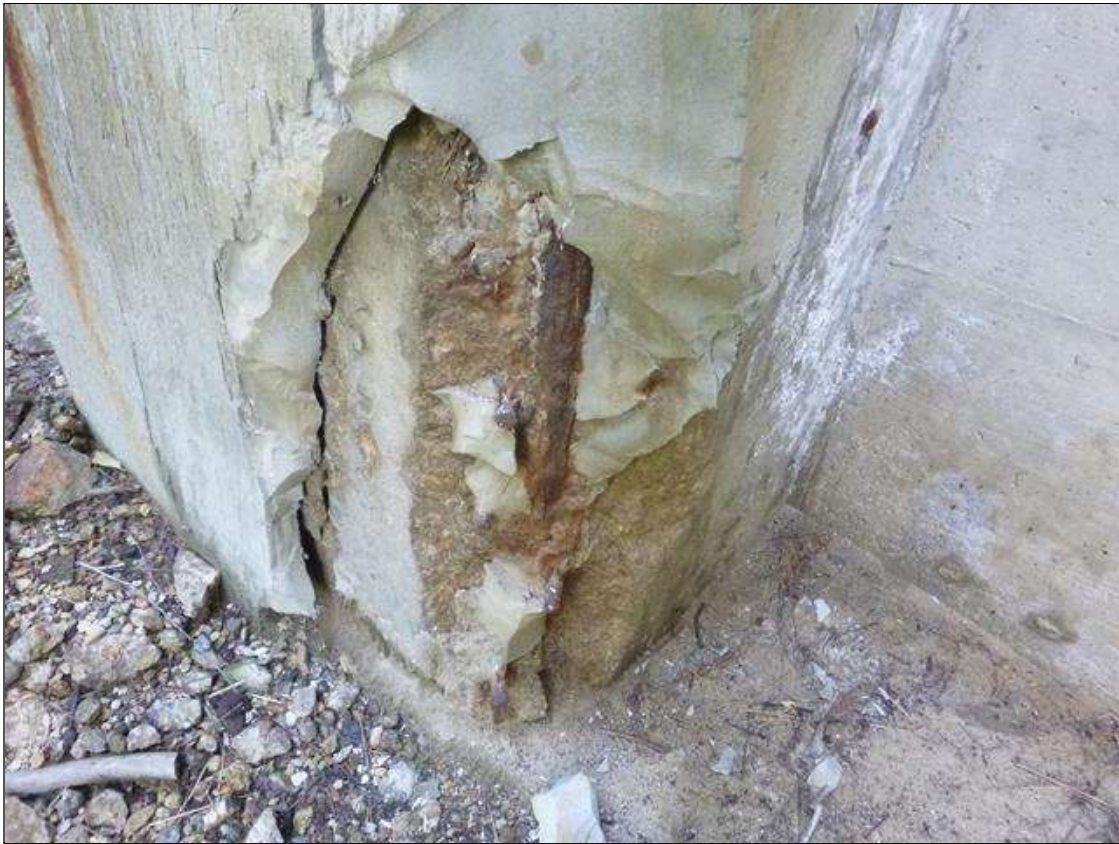
Bent 1 Pile 5: BENT 1, PILE 5 HAS A SPALL ON THE NORTHEAST CORNER, 10 INCHES WIDE X 28 INCHES HIGH X 3 INCHES DEEP WITH EXPOSED REBAR, STARTING AT GROUND LINE

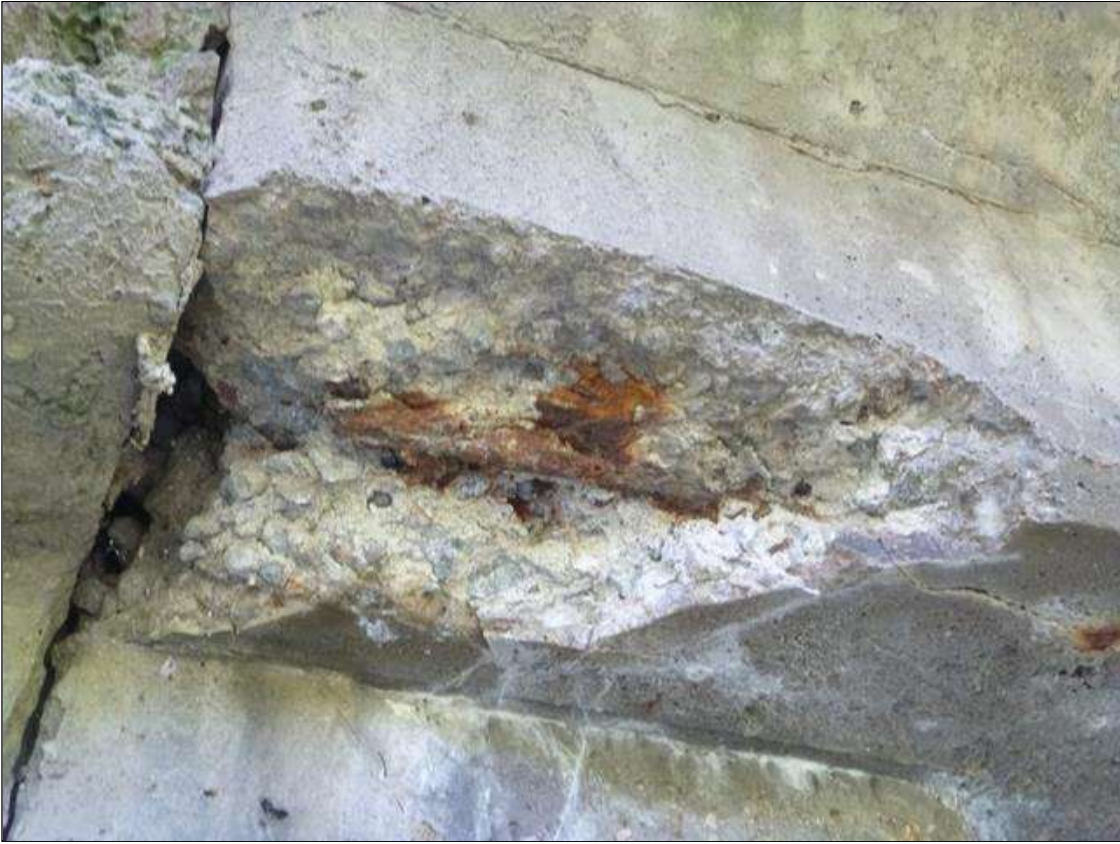
Span 2 Deck: SPAN 2, BOTTOM OF RIGHT OVERHANG AT BENT 1 HAS A SPALL, 7 INCHES X 14 INCHES X 3 INCHES DEEP WITH EXPOSED REBAR

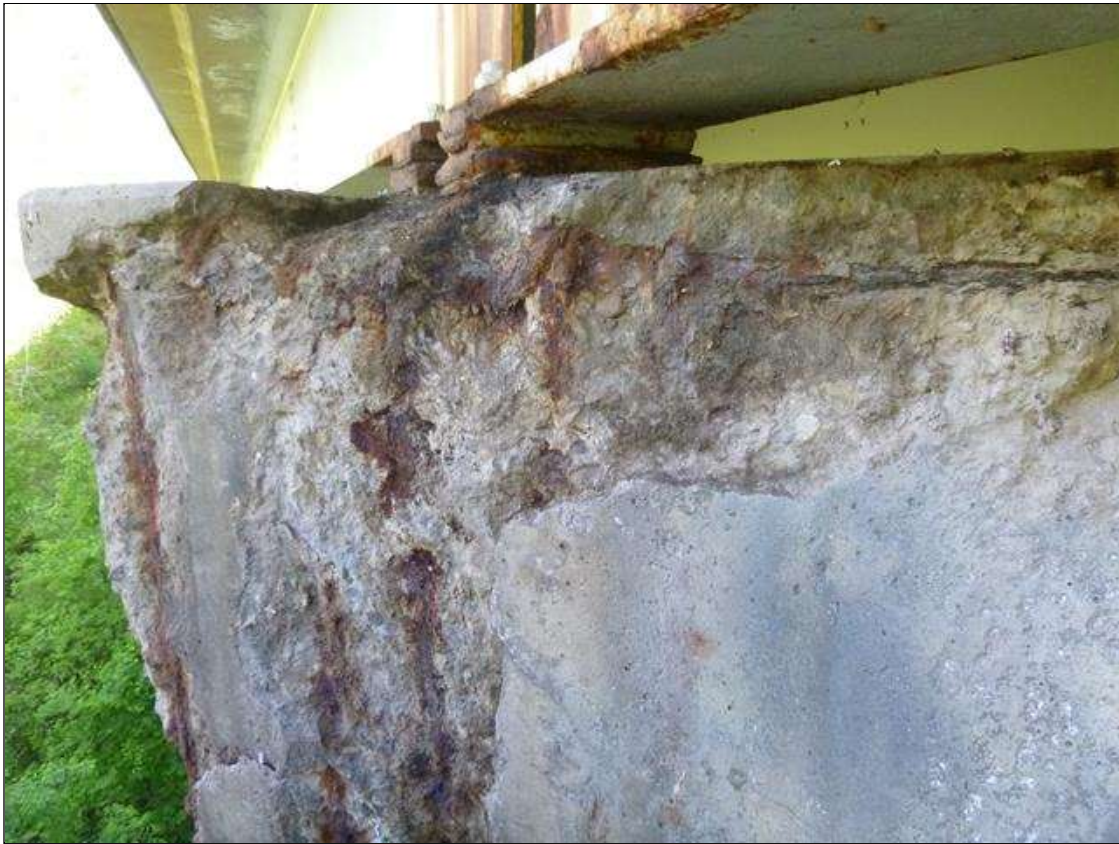
Bent 1 Cap 1: BENT 1 CAP, SPAN 2 SIDE HAS A SPALL ON THE FACE OF THE CAP, FROM RIGHT END OF CAP OVER 6 FT. LONG X UP TO 36 INCHES HIGH X 3 INCHES DEEP WITH REBAR EXPOSED, SPALL GOES ACROSS TOP OF CAP AT RIGHT SIDE OF BEAM 8 BEARING AREA 14 INCHES X 2.5 INCHES DEEP, BEARING AREA IS SOUND

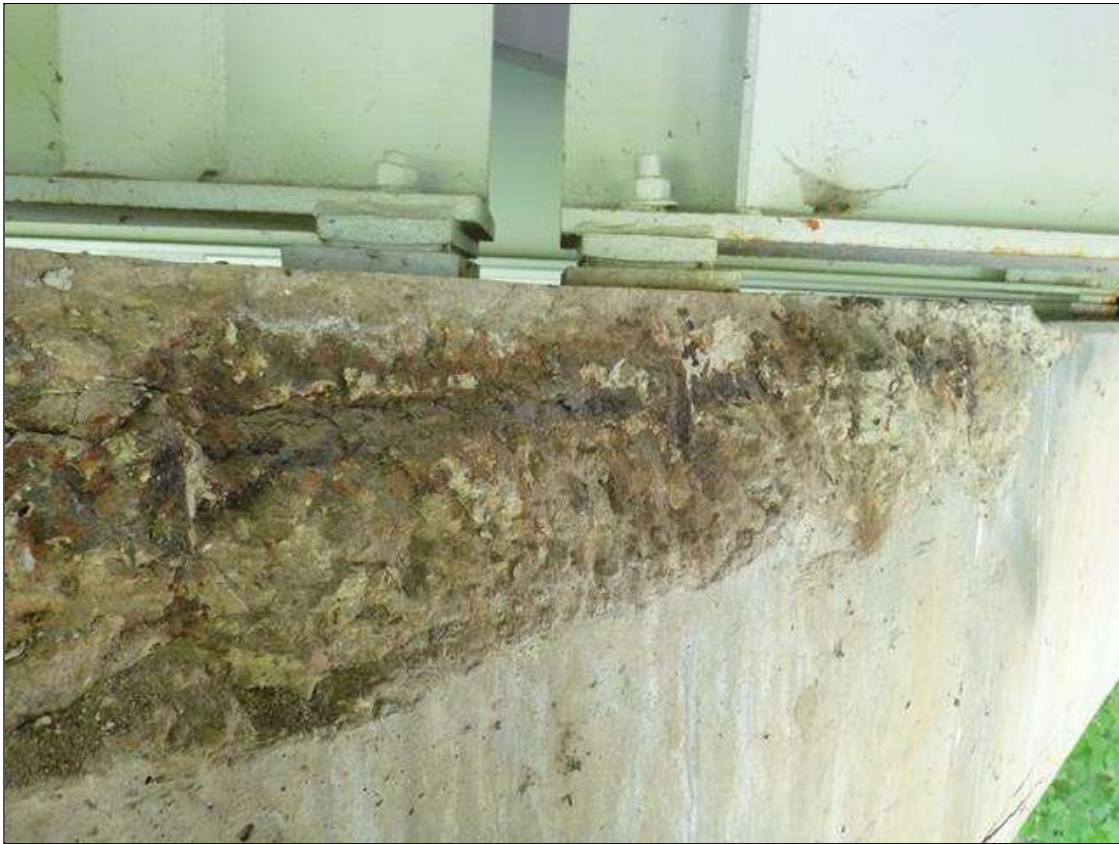
Bent 1 Cap 1: BENT 1 CAP, SPAN 2 SIDE IN BAY 7 AND UNDER BEAM 7 HAS A SPALL IN THE FACE OF THE CAP NEAR TOP EDGE WITH REBAR EXPOSED, 10 FT. LONG X 9 INCHES HIGH X 2.5 INCHES DEEP, DELAMINATION GOES ACROSS THE TOP OF THE CAP IN BAY 7, 10 INCHES

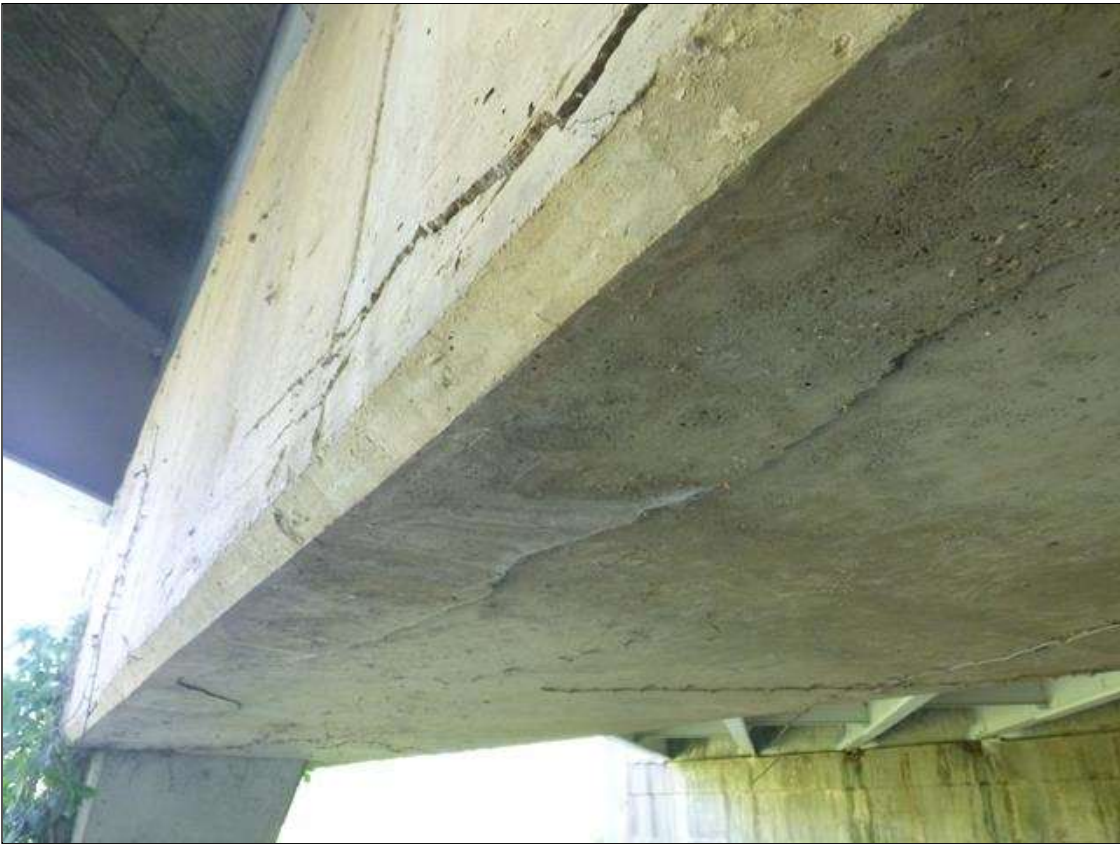
Bent 1 Cap 1: BENT 1 CAP, SPAN 2 SIDE HAS AN AREA OF DELAMINATION IN THE BOTTOM CORNER OF THE CAP, UNDER BEAM 7, 6 FT. LONG X 12 INCHES WIDE, WITH 1/4 INCH SEPARATION

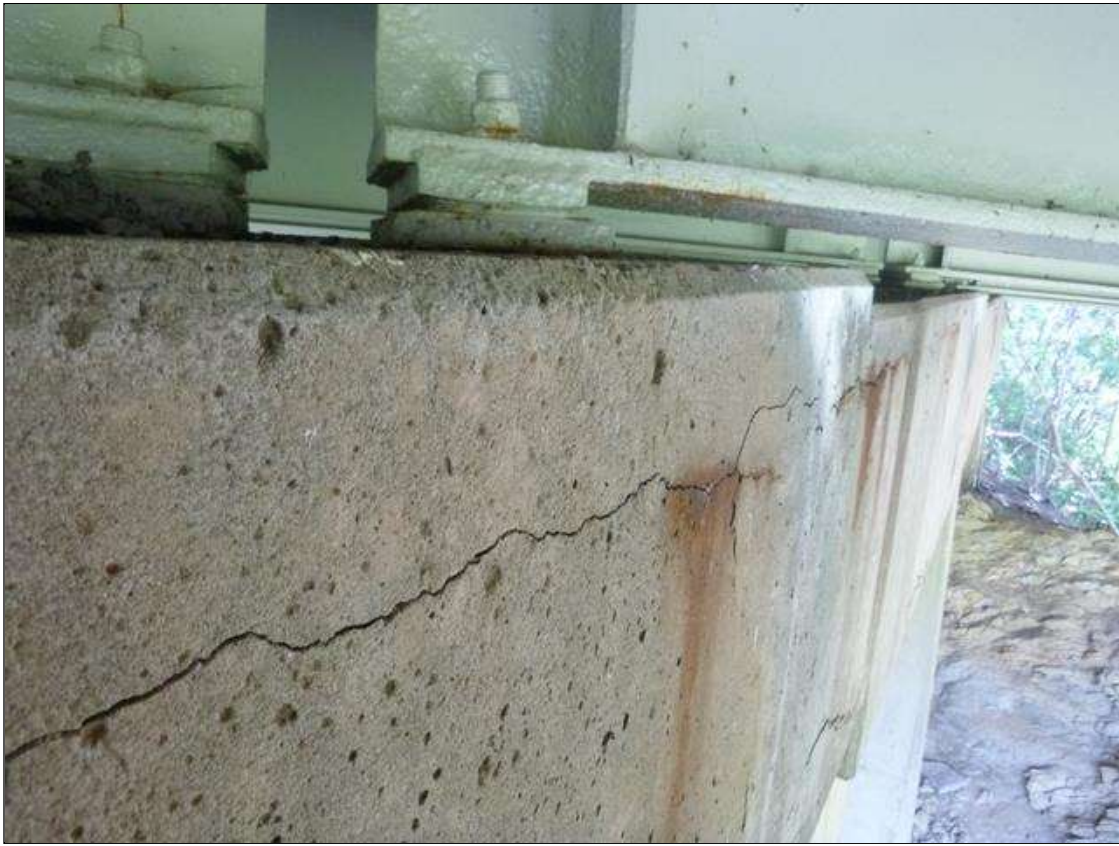
Bent 1 Cap 1: BENT 1 CAP, SPAN 2 SIDE HAS AN AREA OF DELAMINATION IN THE FACE OF THE CAP, NEAR TOP EDGE IN BAYS 4 AND 5, 20 FT. LONG X 12 INCHES HIGH ON THE FACE X 5 INCHES ACROSS THE TOP WITH RUST STAINS AND 1/4 INCH WIDE SEPARATION

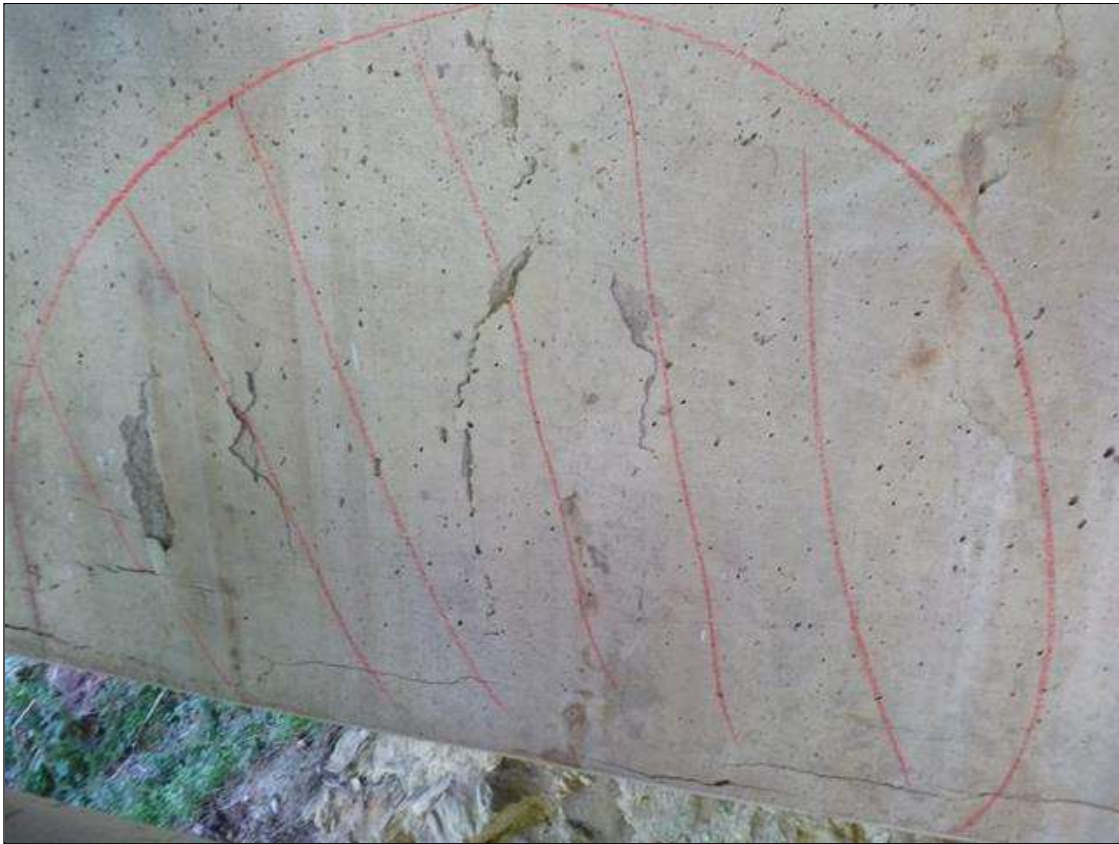
Bent 1 Cap 1: BENT 1 CAP, SPAN 2 SIDE HAS AN AREA OF DELAMINATION IN THE FACE OF THE CAP IN BAY 3 UNDER BEAM 4, 53 INCHES X 35 INCHES WITH 1/4 INCH SEPARATION

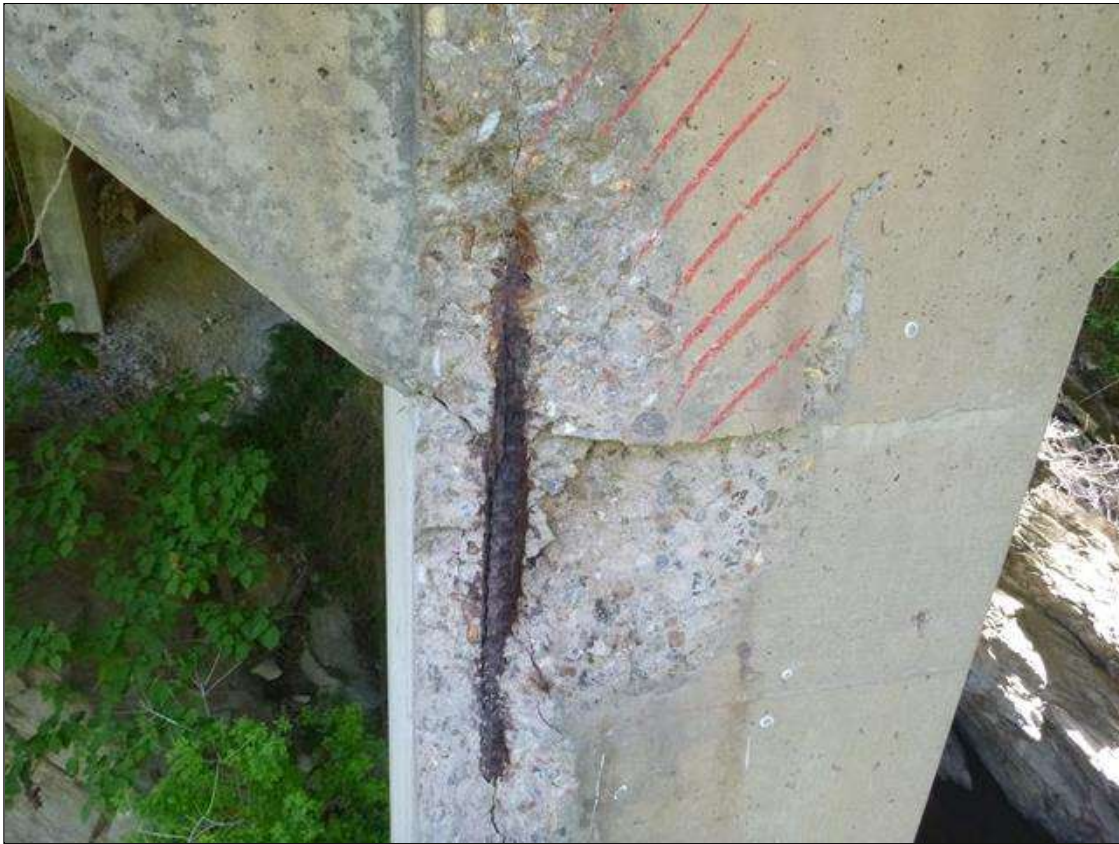
Bent 2 Pile 5: BENT 2, PILE 5 HAS A SPALL ON THE SOUTHEAST CORNER, 16 INCHES WIDE X 40 INCHES HIGH X 3 INCHES DEEP WITH EXPOSED REBAR AND ADJACENT DELAMINATION, SPALL STARTS 8 INCHES FROM BOTTOM OF CAP

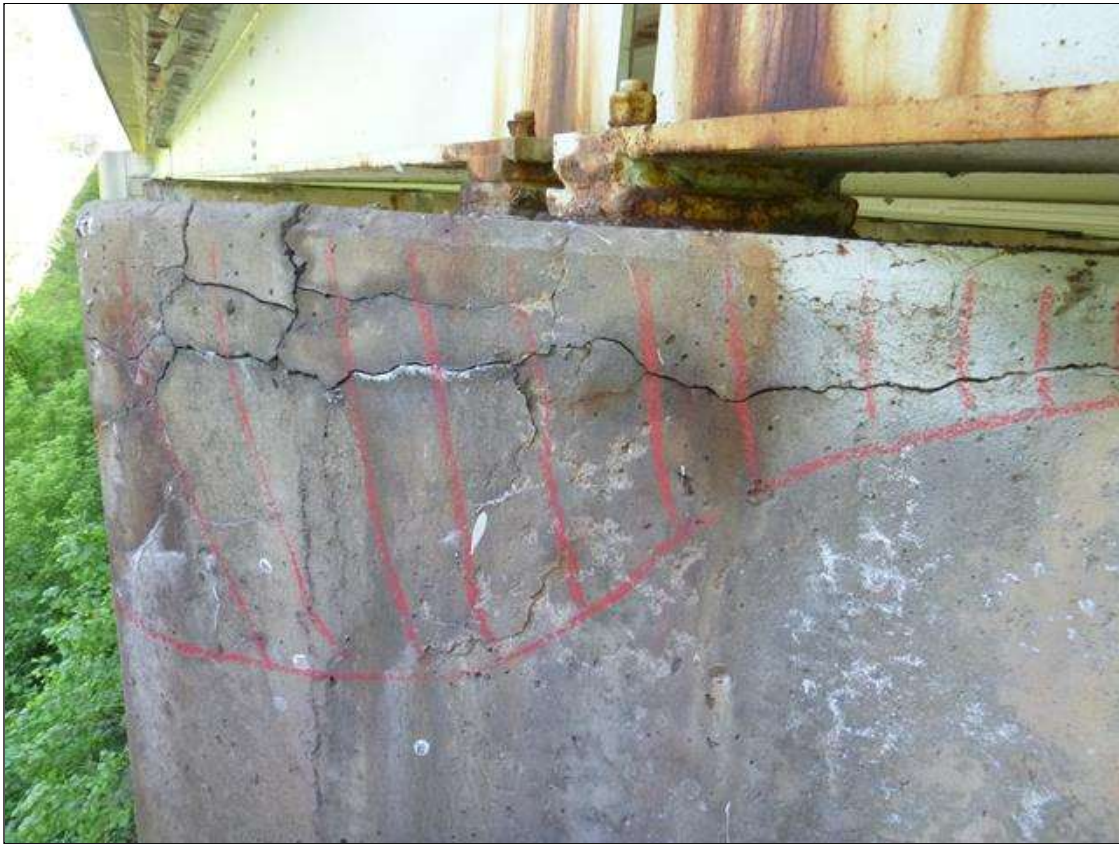
Bent 2 Cap 1: BENT 2 CAP, SPAN 3 SIDE HAS AN AREA OF DELAMINATION IN THE FACE OF THE CAP, UNDER BEAM 8, 50 INCHES X 21 INCHES WITH 3/16 INCH SEPARATION, AND GOES ACROSS TOP OF CAP 10 INCHES ADJACENT TO BEAM 8 BEARING AREA

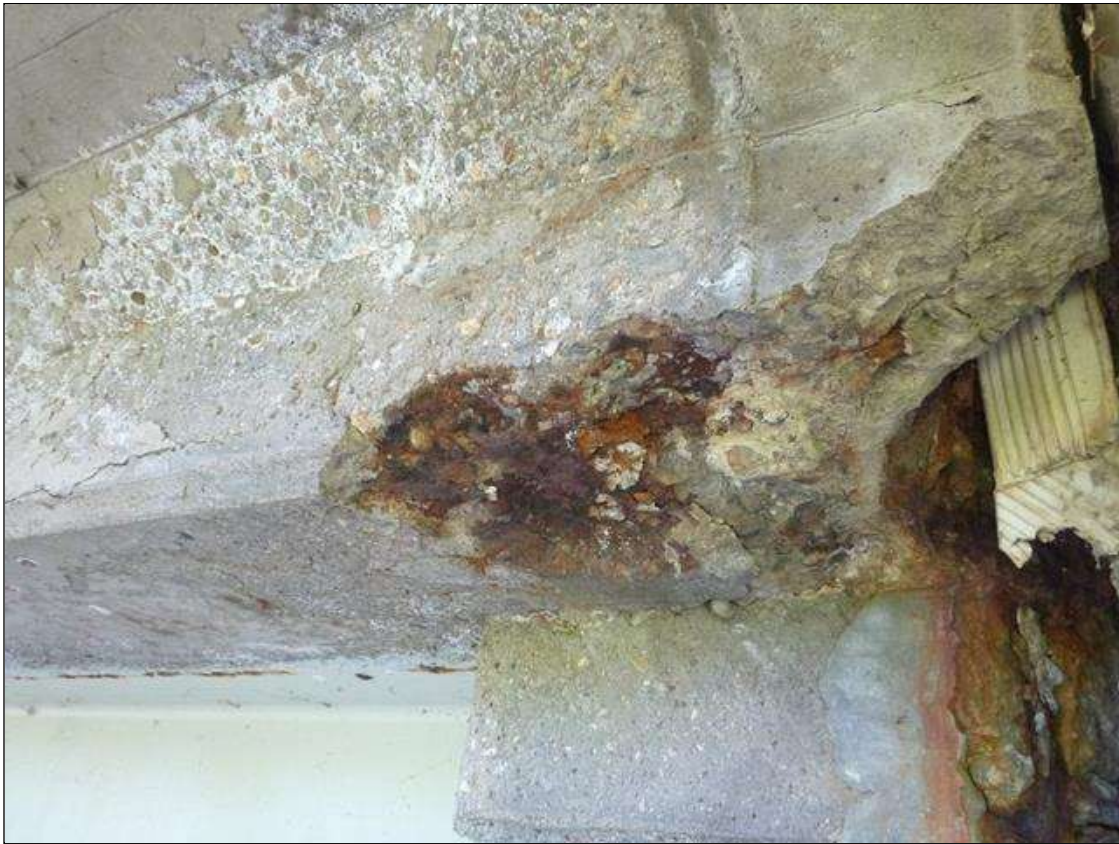
Span 2 Deck: SPAN 2 DECK, BOTTOM OF RIGHT OVERHANG AT BENT 2 HAS A SPALL, 12 INCHES X 10 INCHES X 2 INCHES DEEP WITH EXPOSED REBAR

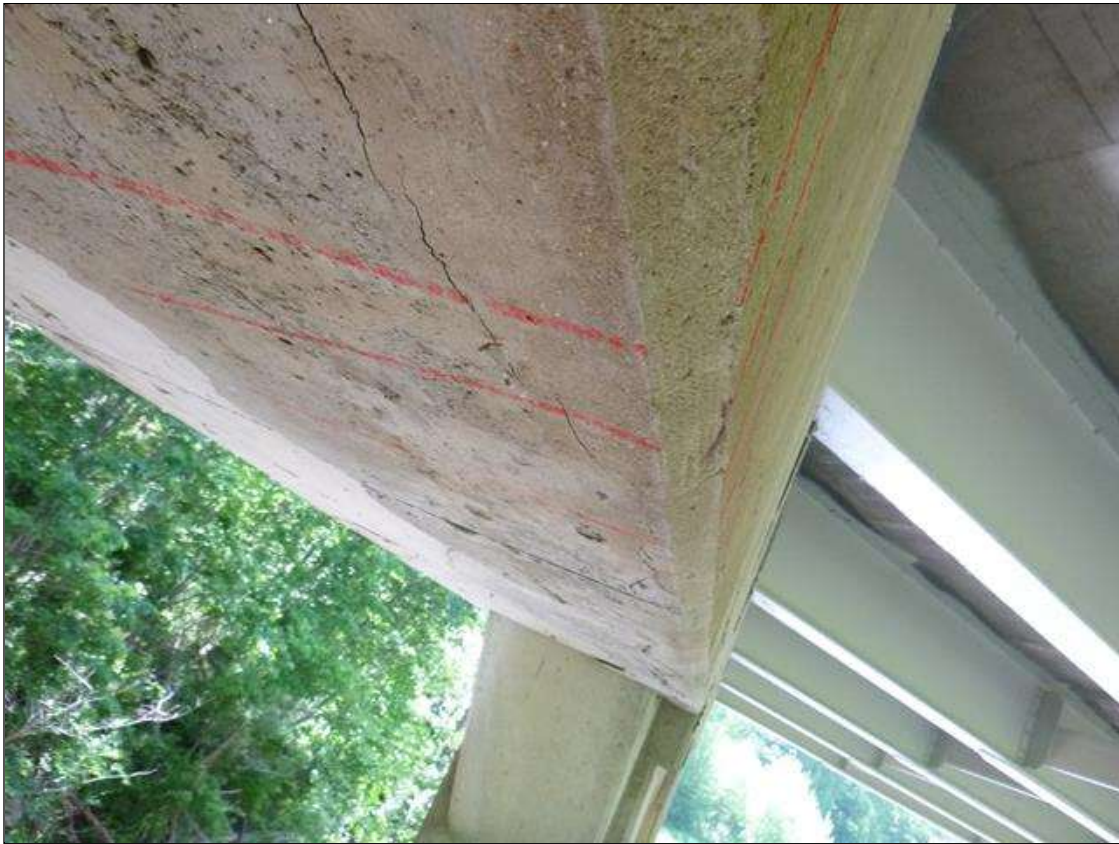
Bent 2 Cap 1: BENT 2 CAP, SPAN 3 SIDE HAS AN AREA OF DELAMINATION IN THE BOTTOM CORNER, IN BAY 5, 14 FT. LONG X 8 INCHES UP THE FACE X 14 INCHES ACROSS THE BOTTOM, WITH 1/8 INCH SEPARATION, WITH RUST STAINS

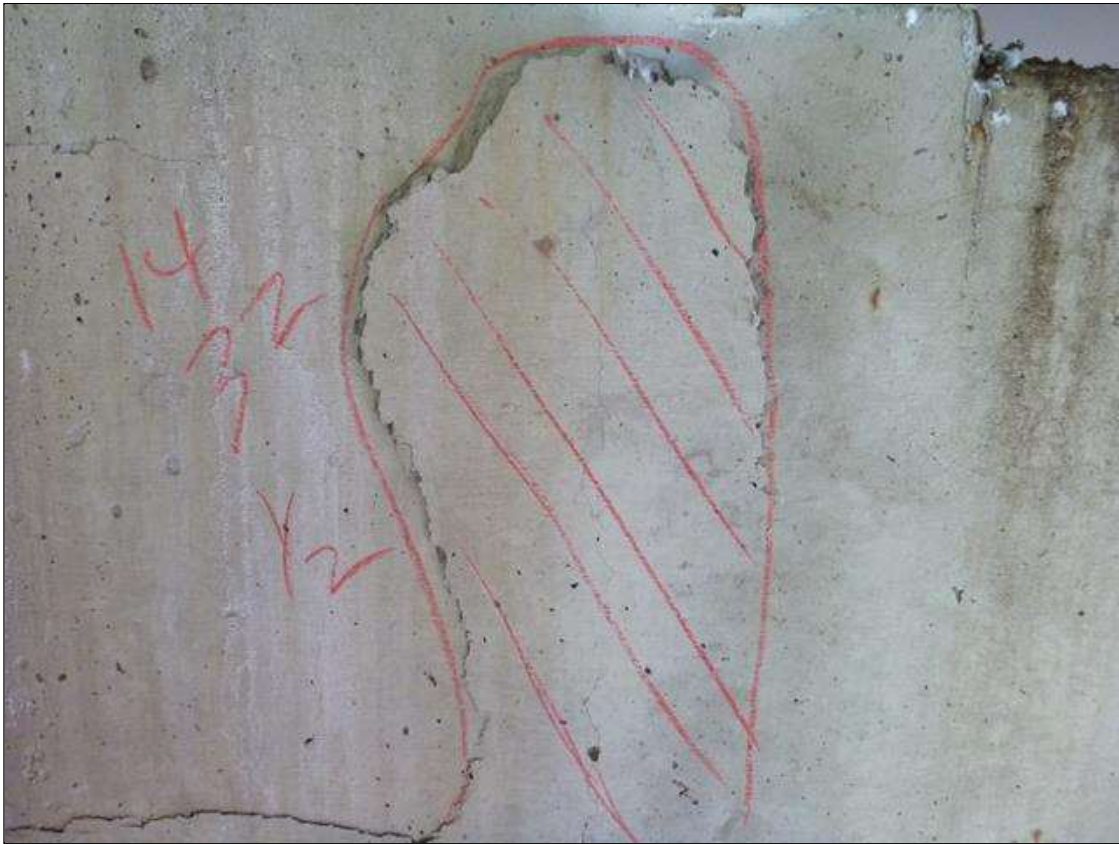
Bent 2 Cap 1: BENT 2 CAP, SPAN 3 SIDE HAS AN AREA OF DELAMINATION ON THE FACE OF THE CAP, UNDER BEAM 5, 14 INCHES X 32 INCHES WITH 1/2 INCH SEPARATION

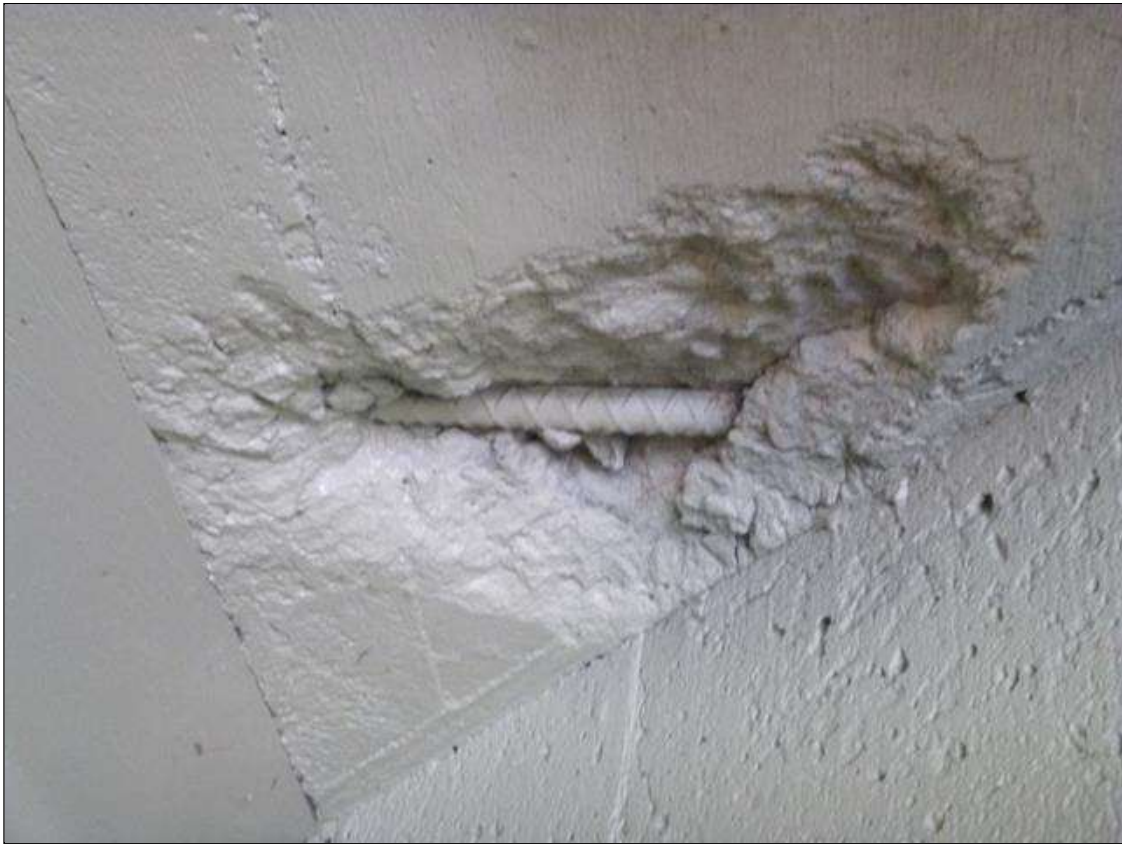
Span 4 Deck: SPAN 4, BOTTOM OF BAY 6 DECK, AT BENT 4 HAS A SPALL, NEAR BEAM 6, 10 INCHES IN DIAMETER X 2.5 INCHES DEEP WITH EXPOSED REBAR

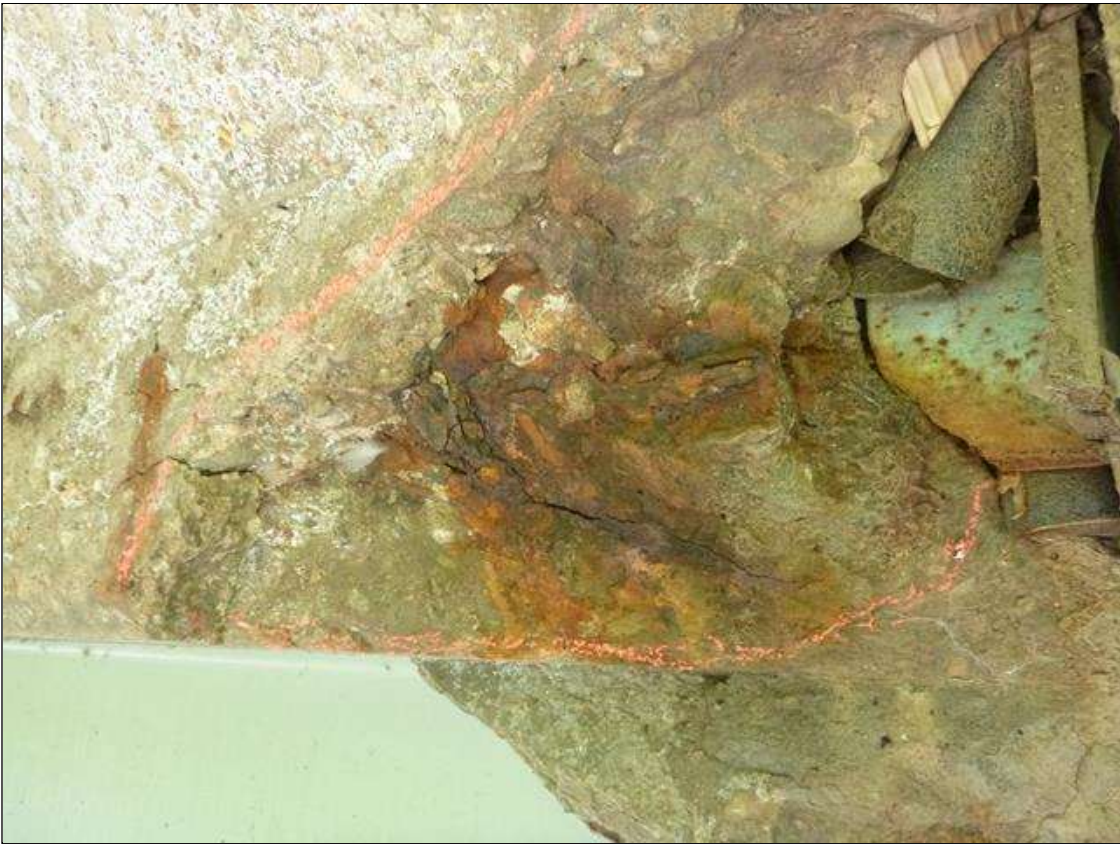
Span 4 Deck: SPAN 4, BOTTOM OF RIGHT OVERHANG AT BENT 4 HAS A SPALL, 9 INCHES X 12 INCHES X 1.5 INCHES DEEP WITH REBAR EXPOSED

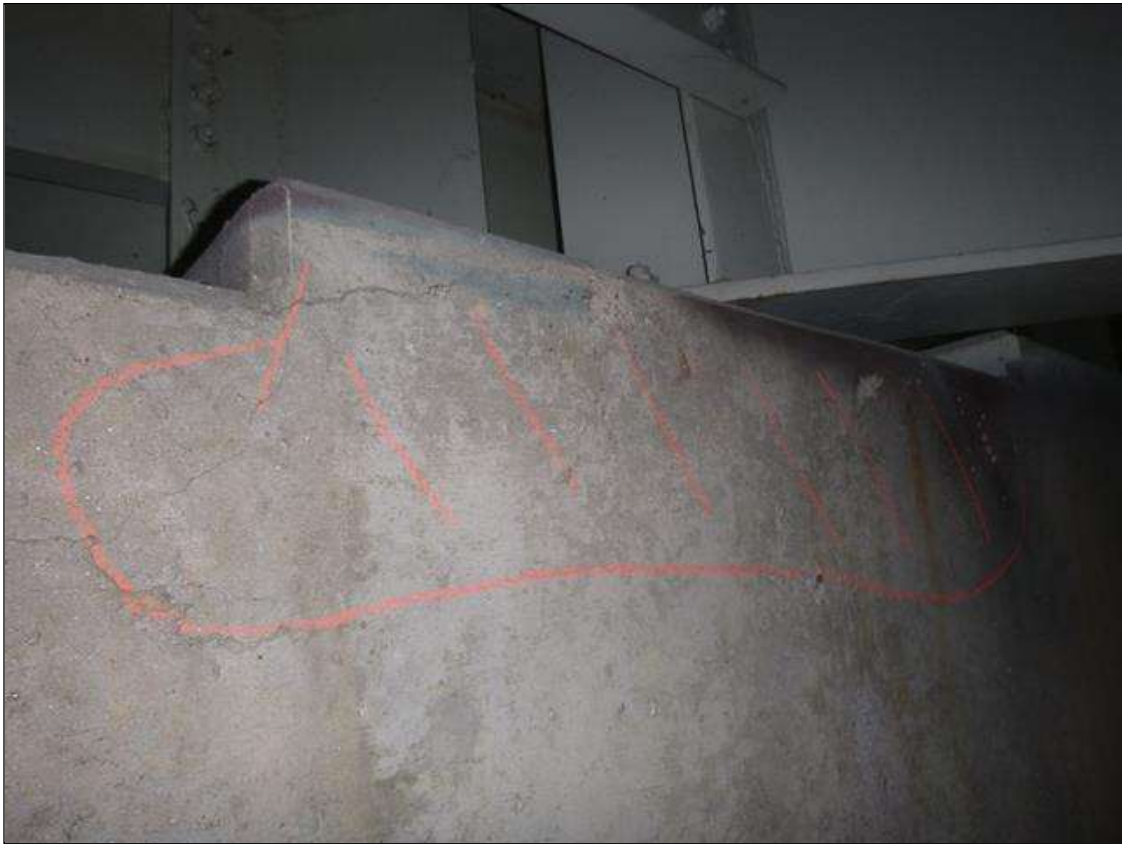
Bent 1 Cap 1: BENT 1 CAP, SPAN 1 SIDE HAS AN AREA OF DELAMINATION IN THE FACE OF THE CAP IN BAY 1, NEAR TOP EDGE, UNDER BEAM 2, 4 FT. LONG X 1 FT. HIGH
