NC DEPARTMENT OF TRANSPORTATION  
DIVISION OF HIGHWAYS  
STRUCTURE MANAGEMENT UNIT

## Structure Safety Report

### Routine Element Inspection - Contract

COUNTY: HAYWOOD STRUCTURE NUMBER: 430159 FREQUENCY: 24 MONTHS  
FACILITY CARRIED: I-40 MILE POST: 18.7  
LOCATION: 1.8 MI.W.JCT.US276  
FEATURE INTERSECTED: SR1338  
LATITUDE: 35° 37' 31.64" LONGITUDE: 83° 0' 31.41"  
SUPERSTRUCTURE: REINFORCED CONCRETE FLOOR ON I-BEAMS

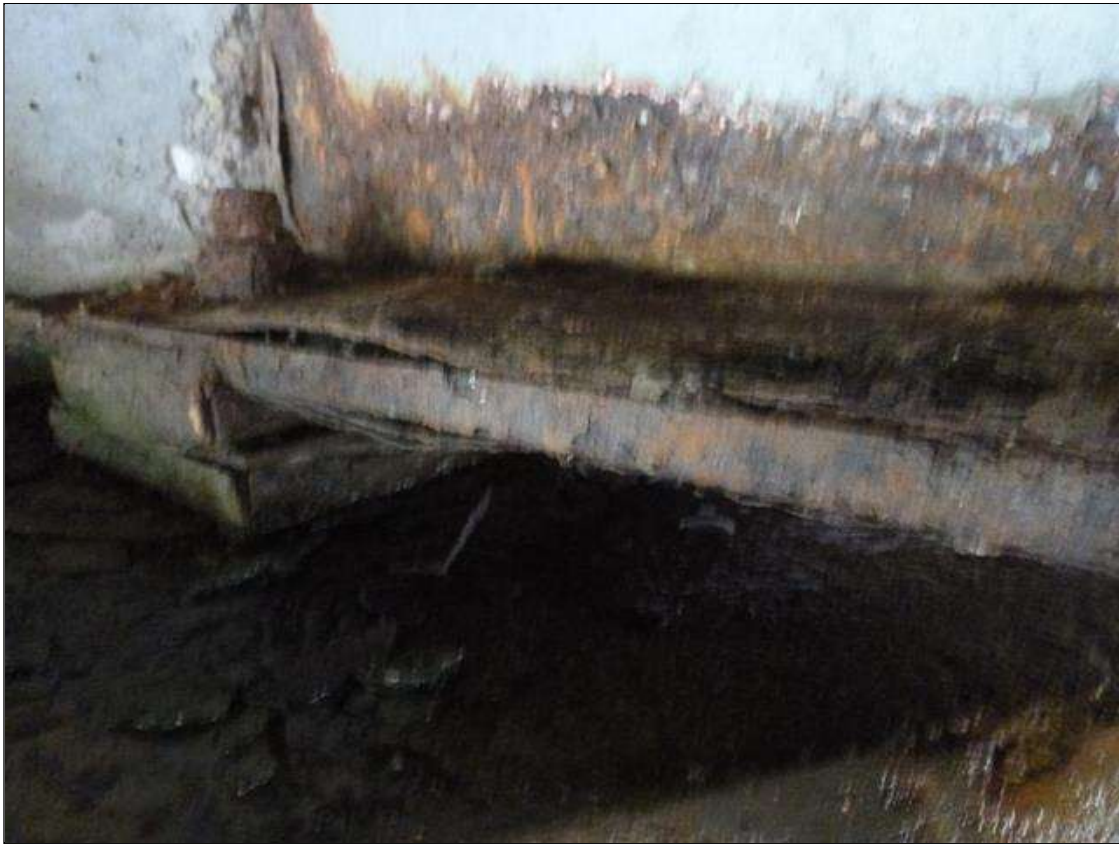
| Element Number | Defect Type | Defect Description | CS | CS Qty | Maint Qty | |
|---|---|---|---|---|---|---|
| 107 | Corrosion | Span 1 Beam 1: SPAN 1 BEAM 1 AT END BENT 1 HAS 1/8 INCH SECTION LOSS ON THE BOTTOM FLANGES FROM THE BEAM END OUT 3 FT. X FULL WIDTH WITH 9/16 INCH REMAINING AND 1/16 INCH SECTION LOSS IN THE LOWER WEB FROM THE BEAM END OUT 2 FT. X 4 INCHES HIGH WITH 9/16 INCH REMAINING | 3 | 3 | 3 | Feet |

Span 1 Beam 1: SPAN 1 BEAM 1 AT END BENT 1 HAS 1/8 INCH SECTION LOSS ON THE BOTTOM FLANGES FROM THE BEAM END OUT 3 FT. X FULL WIDTH WITH 9/16 INCH REMAINING AND 1/16 INCH SECTION LOSS IN THE LOWER WEB FROM THE BEAM END OUT 2 FT. X 4 INCHES HIGH WITH 9/16 INCH REMAINING

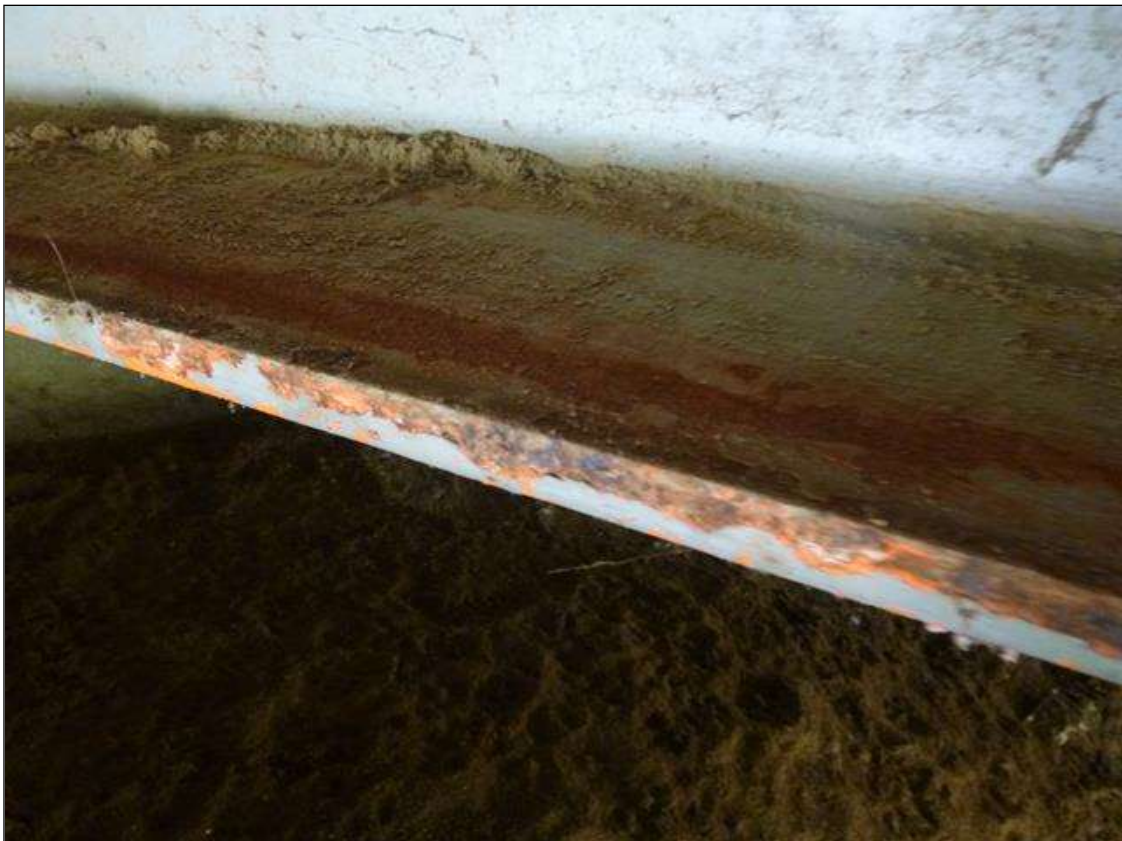
| Element Number | Defect Type | Defect Description | CS | CS Qty | Maint Qty | |
|---|---|---|---|---|---|---|
| 107 | Corrosion | SPAN 1, BEAM 2 HAS 25 FT. OF FRECKLED RUST THRU OUT THE LENGTH OF THE BEAM | 2 | 25 | | Feet |

SPAN 1, BEAM 2 HAS 25 FT. OF FRECKLED RUST THRU OUT THE LENGTH OF THE BEAM

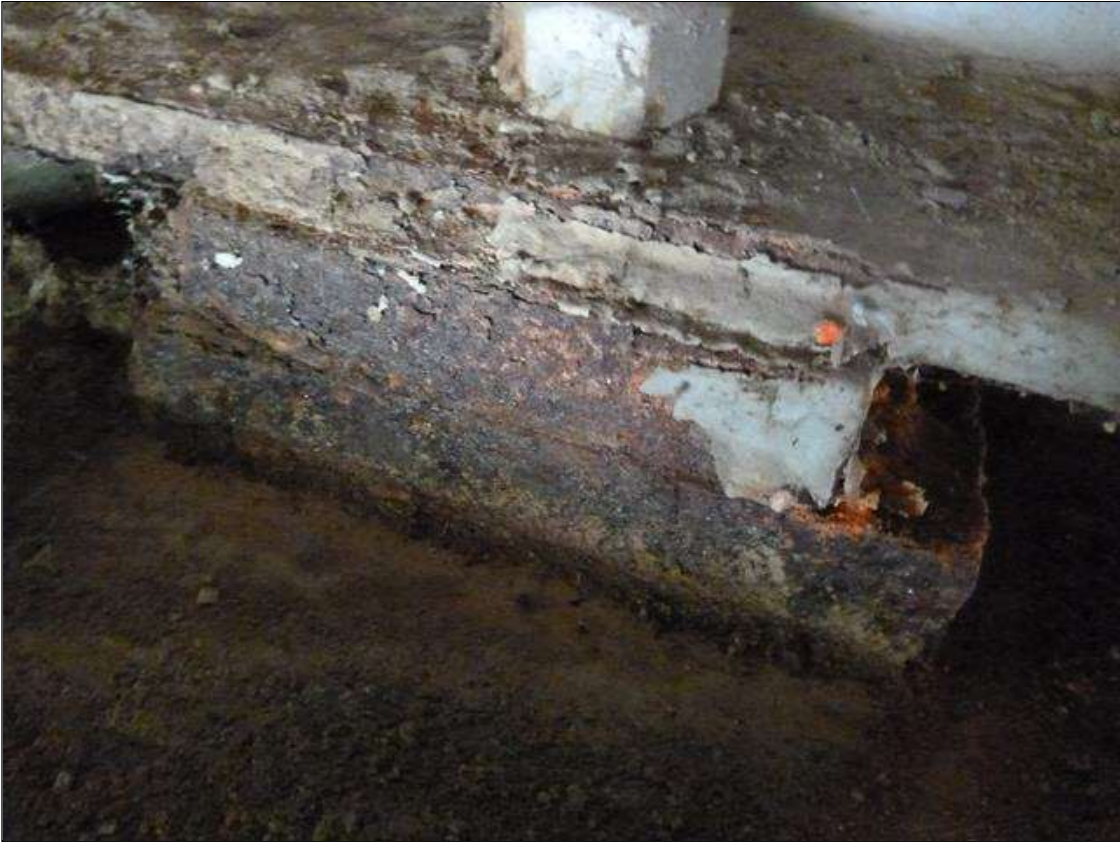
Span 1 Beam 3 Near Bearing: SPAN 1 BEAM 3 NEAR BEARING HAS 1/32 INCH SECTION LOSS

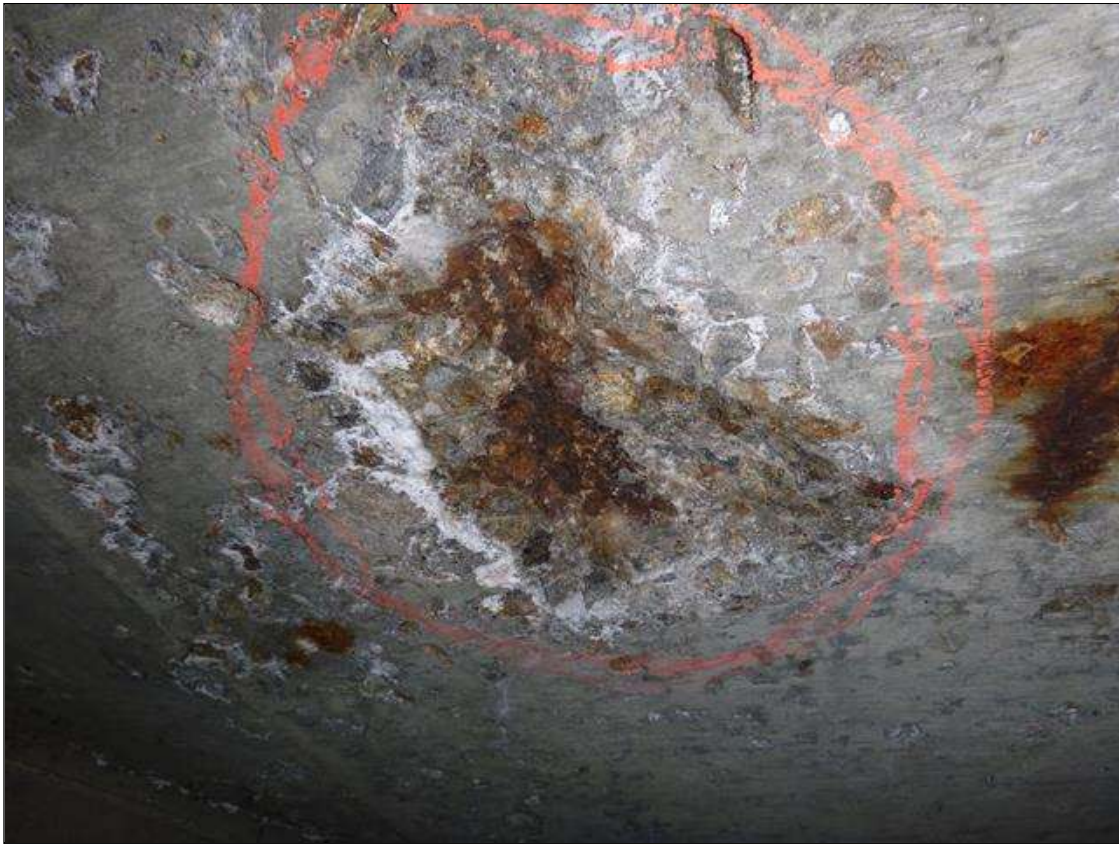
| Element Number | Defect Type | Defect Description | CS | CS Qty | Maint Qty | |
|---|---|---|---|---|---|---|
| 12 | Exposed Rebar | SPAN 1, BOTTOM OF DECK, BAY 4 AT END BENT 1 HAS A SPALL, 9 INCHES X 7 INCHES X 1.5 INCHES DEEP WITH REBAR EXPOSED | 3 | 1 | 1 | Square Feet |

Span 1 Deck: SPAN 1, BOTTOM OF DECK, BAY 4 AT END BENT 1 HAS A SPALL, 9 INCHES X 7 INCHES X 1.5 INCHES DEEP WITH REBAR EXPOSED

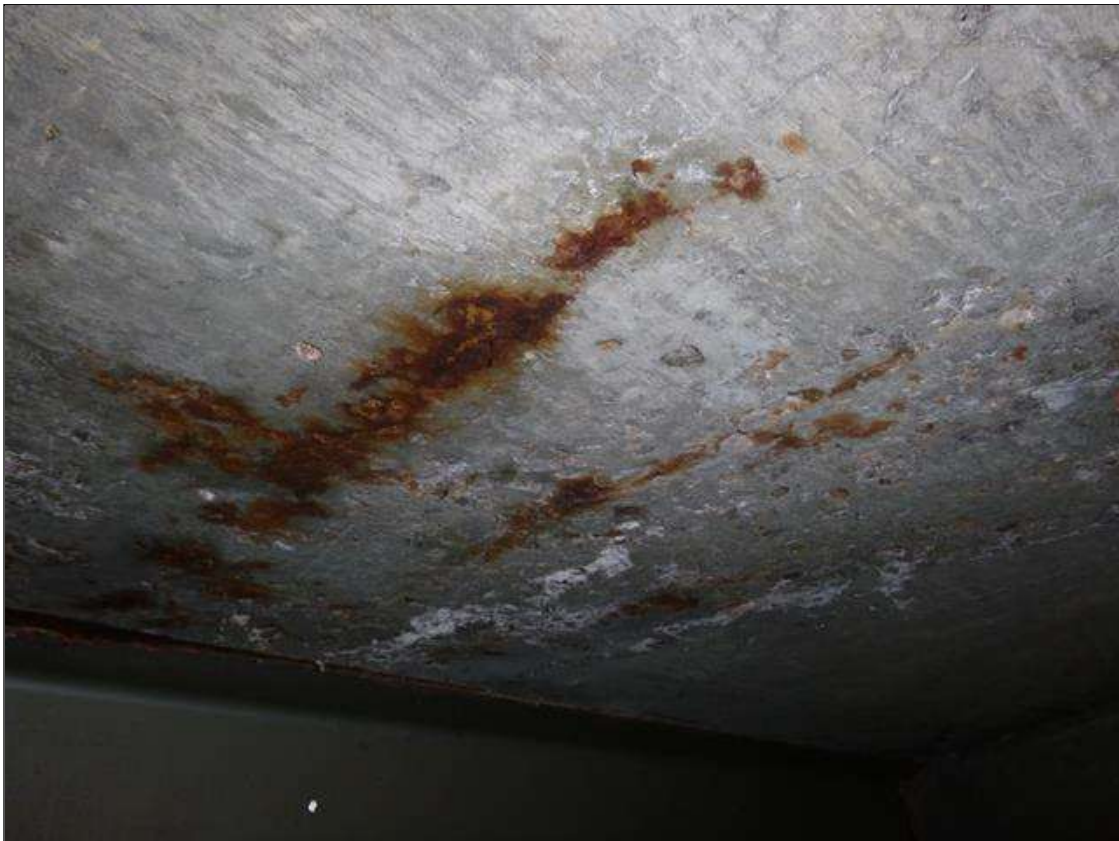
| Element Number | Defect Type | Defect Description | CS | CS Qty | Maint Qty | |
|---|---|---|---|---|---|---|
| 12 | Delamination/Spall | SPAN 1, BOTTOM OF DECK IN BAY 4, NEAR END BENT 1 HAS AN AREA OF DELAMINATION, 24 INCHES X 40 INCHES WITH 1/8 INCH SEPARATION WITH RUST STAINS AND EFFLO. | 3 | 6 | 6 | Square Feet |

Span 1 Deck: SPAN 1, BOTTOM OF DECK IN BAY 4, NEAR END BENT 1 HAS AN AREA OF DELAMINATION, 24 INCHES X 40 INCHES WITH 1/8 INCH SEPARATION WITH RUST STAINS AND EFFLO.

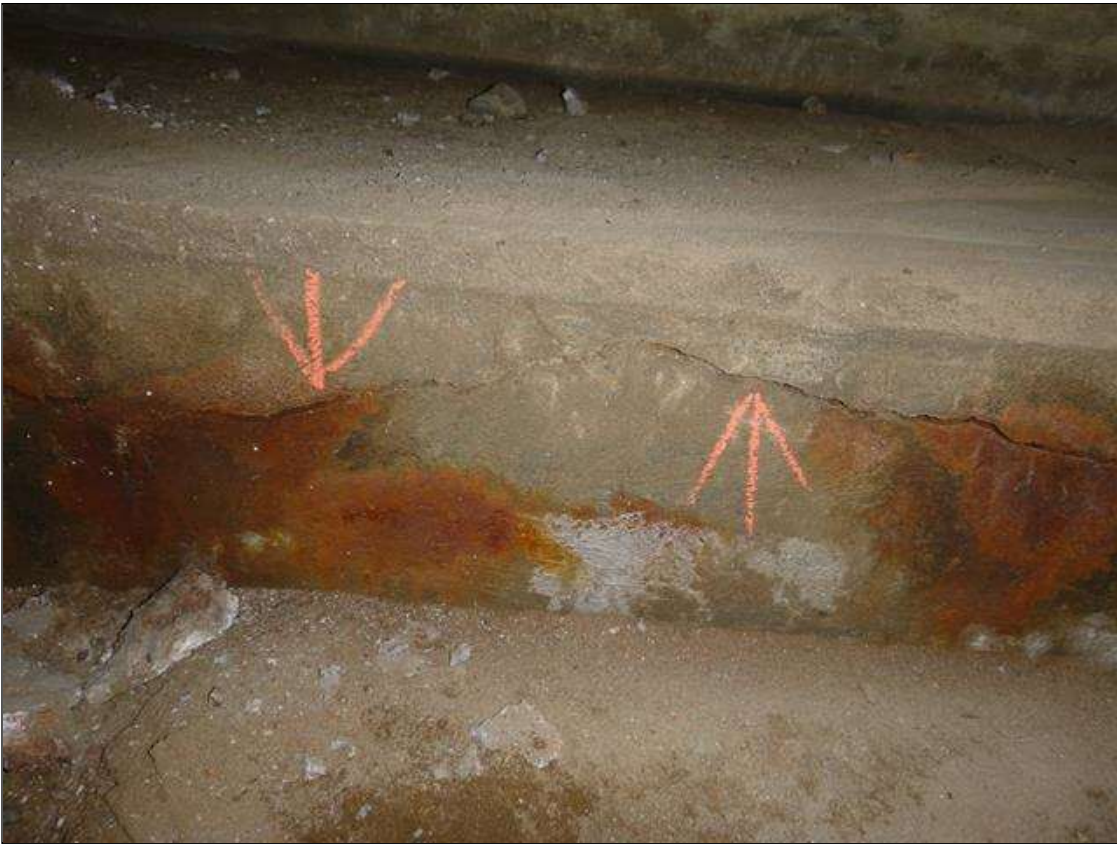
End Bent 1 Cap 1: END BENT 1, FACE OF CAP HAS A 1/4 INCH WIDE LONGITUDINAL CRACK IN BAYS 4 AND 5, 10 FT. LONG WITH RUST STAINS, PHOTO TAKEN IN BAY 4

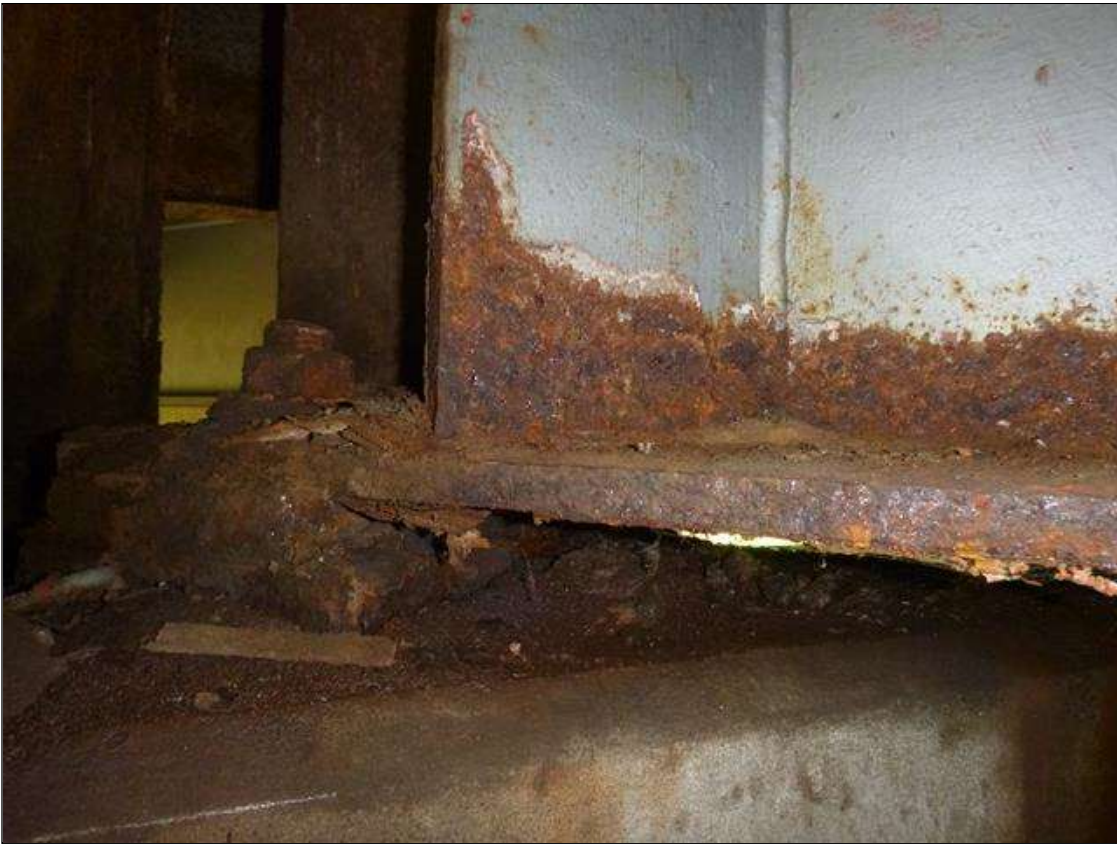
| Element Number | Defect Type | Defect Description | CS | CS Qty | Maint Qty | |
|---|---|---|---|---|---|---|
| 107 | Corrosion | Span 1 Beam 3: SPAN 1, BEAM 3 AT BENT 1 HAS 1/16 INCH SECTION LOSS ON THE BOTTOM FLANGE X FULL WIDTH FROM THE BEAM END OUT 2 FT. WITH 1/2 INCH REMAINING, THE LOWER WEB HAS 1/32 INCH SECTION LOSS FROM THE BEAM END OUT 2 FT. X 4 INCHES HIGH WITH 15/32 INCH REMAINING | 3 | 2 | 2 | Feet |

Span 1 Beam 3: SPAN 1, BEAM 3 AT BENT 1 HAS  $\frac{1}{16}$  INCH SECTION LOSS ON THE BOTTOM FLANGE X FULL WIDTH FROM THE BEAM END OUT 2 FT. WITH  $\frac{1}{2}$  INCH REMAINING, THE LOWER WEB HAS  $\frac{1}{32}$  INCH SECTION LOSS FROM THE BEAM END OUT 2 FT. X 4 INCHES HIGH WITH  $\frac{15}{32}$  INCH REMAINING

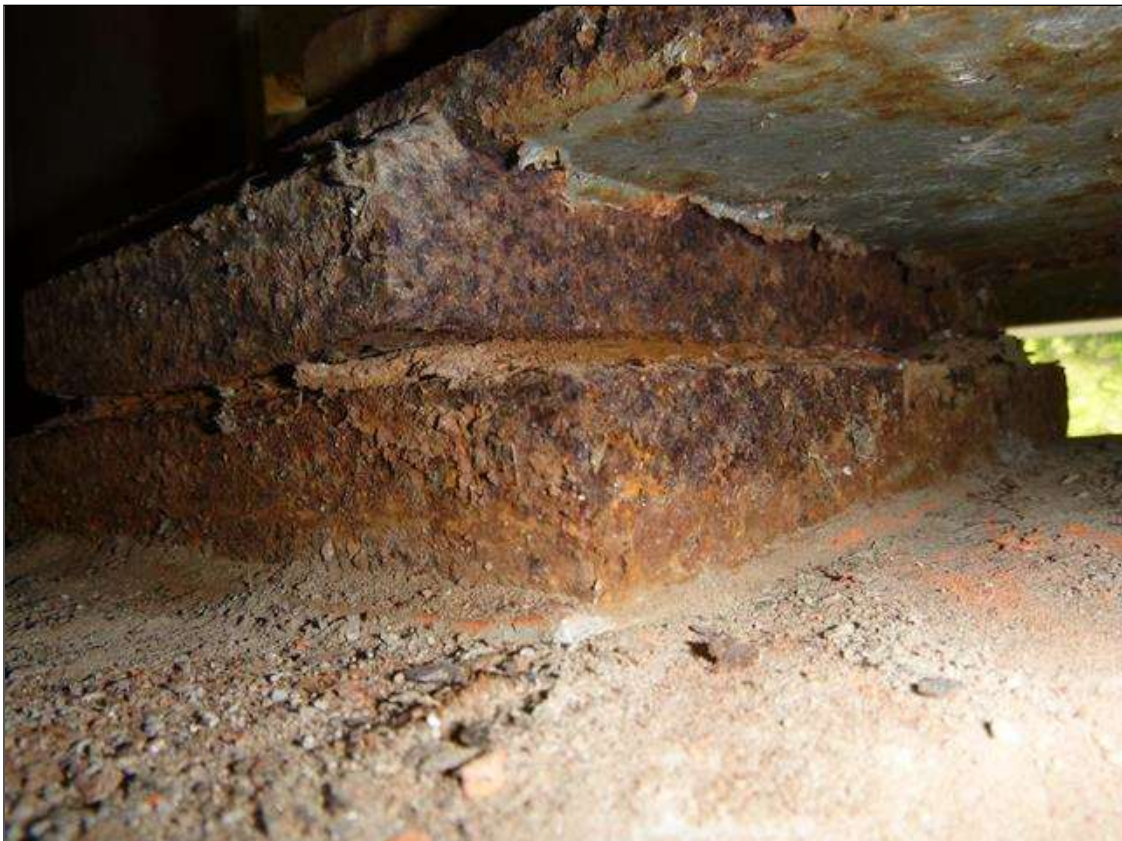
Span 1 Beam 5 Far Bearing: SPAN 1, BEAM 5 FAR BEARING HAS FRECKLED RUST

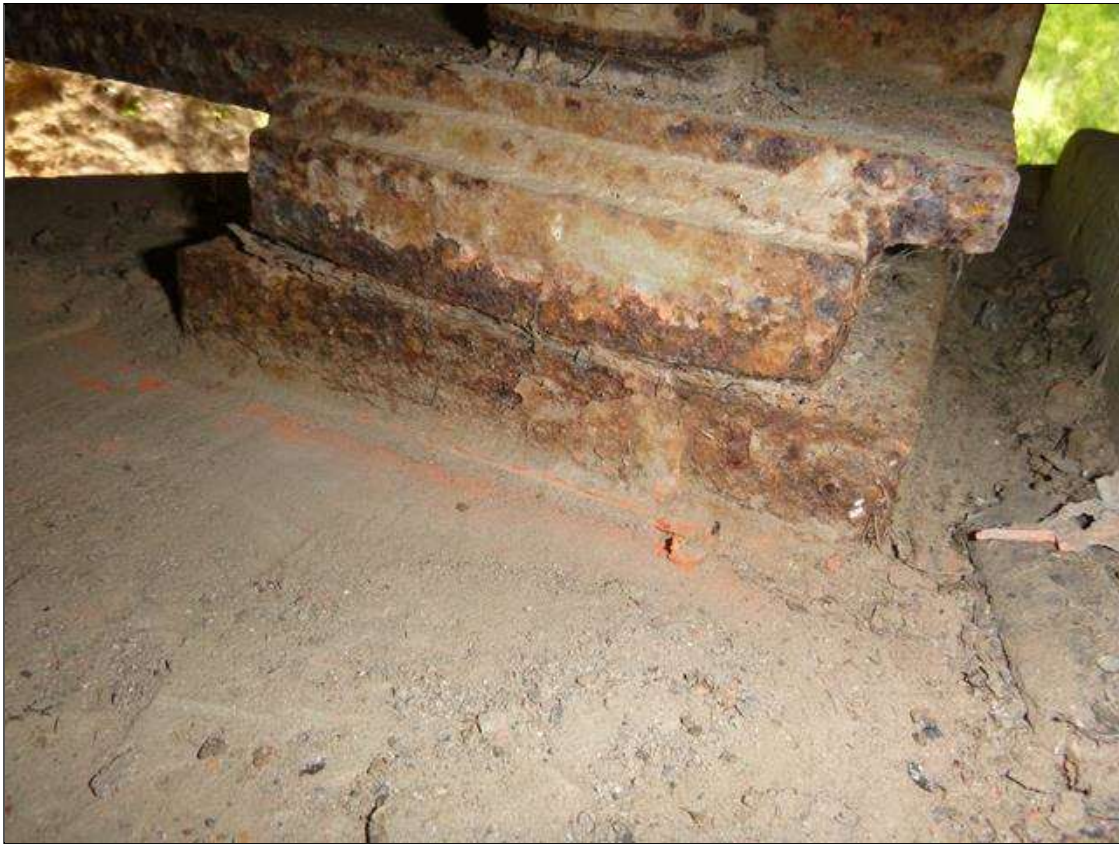
Span 2 Beam 5 Near Bearing: SPAN 2, BEAM 5 NEAR BEARING HAS 1/32 INCH SECTION LOSS

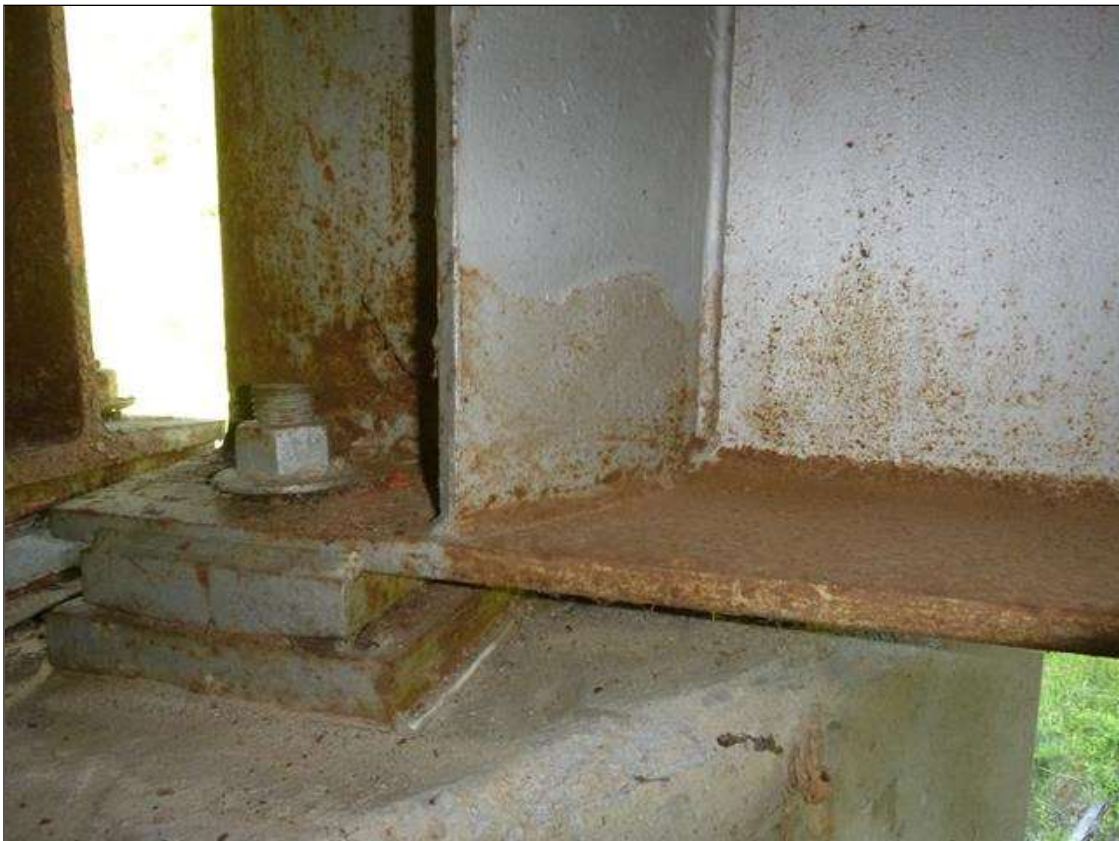
Span 1 Beam 10: SPAN 1, BEAM 10 HAS 33 FT. OF FRECKLED RUST THRU OUT THE LENGTH OF THE BEAM

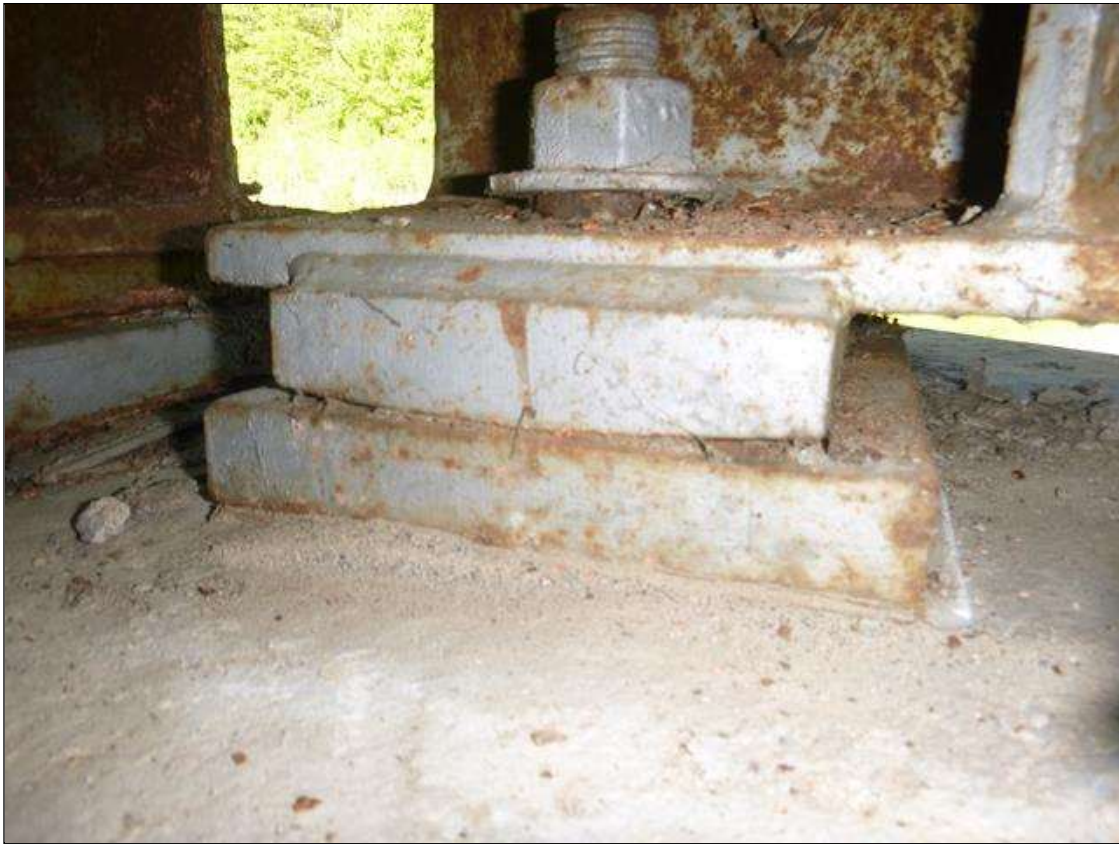
Span 1 Beam 10 Far Bearing: SPAN 1, BEAM 10 FAR BEARING HAS FRECKLED RUST

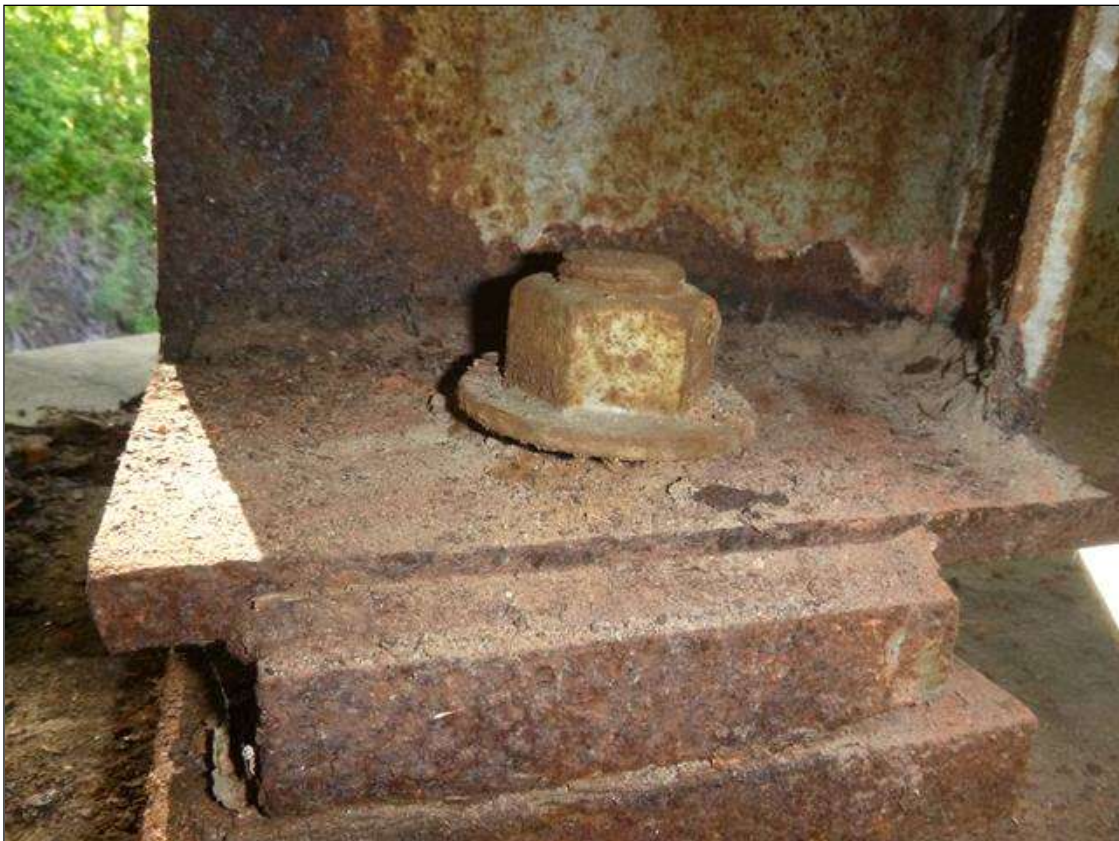
Span 2 Beam 1: SPAN 2, BEAM 1 AT BENT 1 HAS 1/32 INCH SECTION LOSS ON THE BOTTOM FLANGE FROM THE BEAM END OUT 1 FT. X FULL WIDTH WITH 19/32 INCH REMAINING

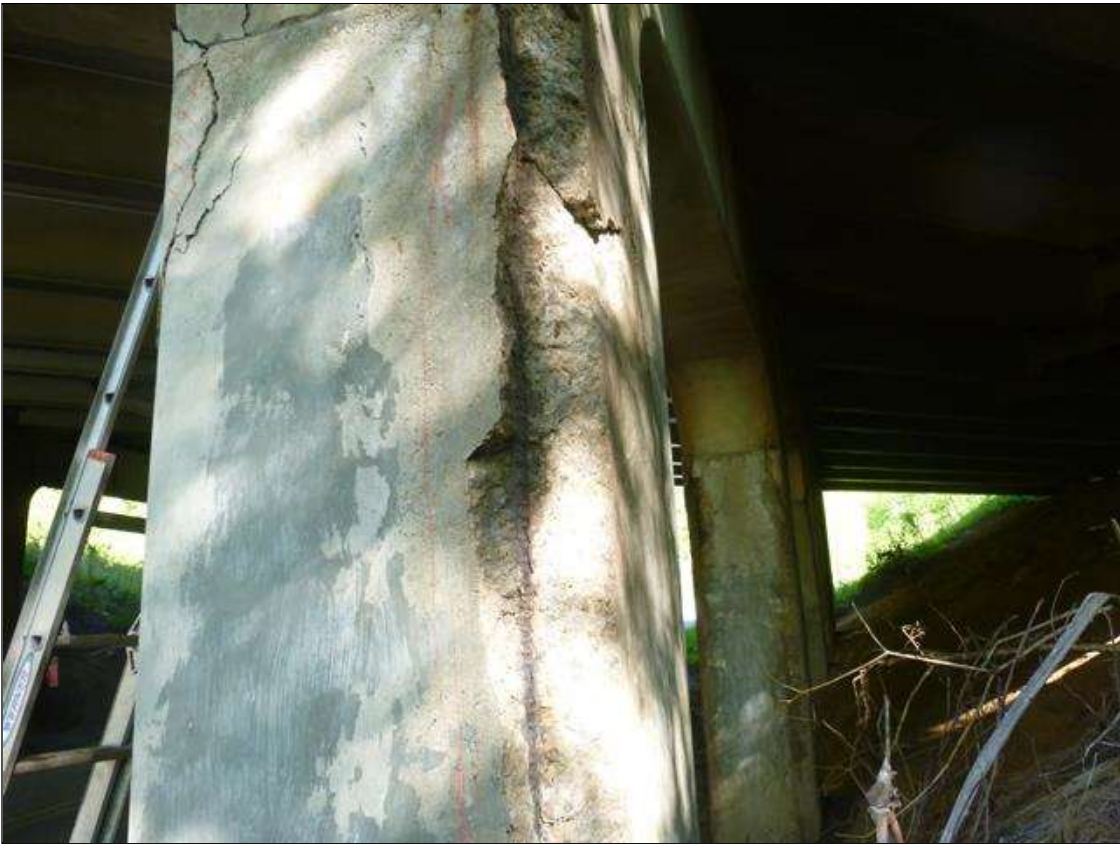
Bent 1 Pile 1: BENT 1, PILE 1 HAS A SPALL ON THE NORTHWEST CORNER, 12 INCHES WIDE X 6 FT. HIGH X 4 INCHES DEEP WITH EXPOSED REBAR, STARTING 2 FT. BELOW THE BOTTOM OF THE CAP

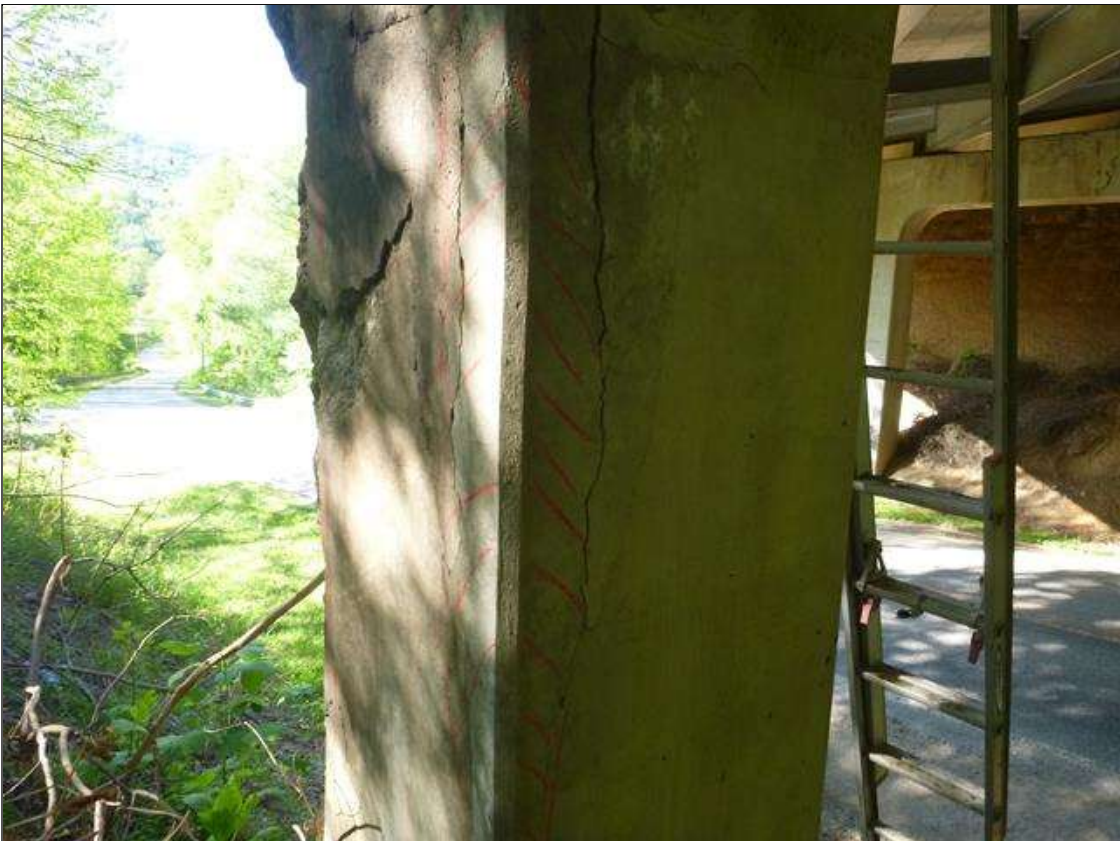
Bent 1 Pile 1: BENT 1, PILE 1 HAS AN AREA OF DELAMINATION ON THE SOUTHWEST CORNER, 10 INCHES WIDE X 5 FT. HIGH WITH 1/4 INCH SEPARATION, STARTING 2 FT. BELOW THE BOTTOM OF THE CAP

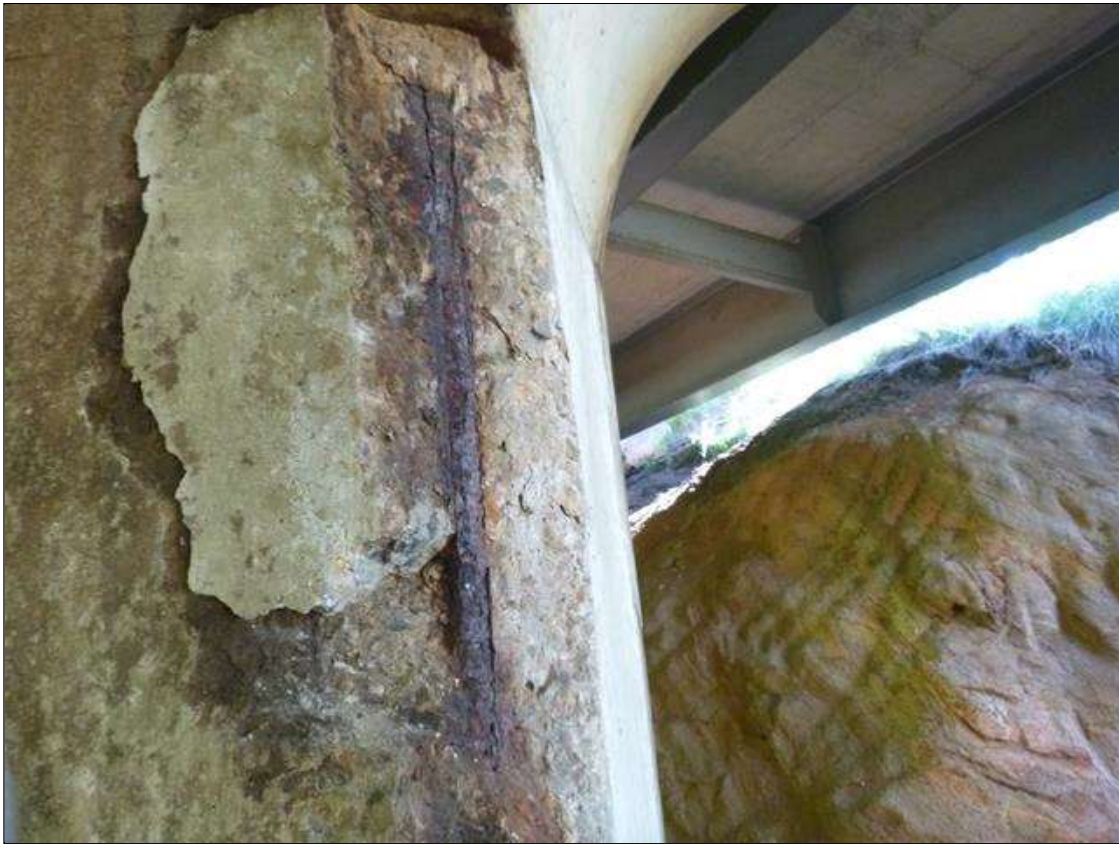
Bent 1 Pile 2: BENT 1, PILE 2 HAS A SPALL ON THE NORTHEAST CORNER, 12 INCHES WIDE X 32 INCHES HIGH X 4 INCHES DEEP WITH EXPOSED REBAR, STARTING 2 FT. BELOW THE BOTTOM OF THE CAP

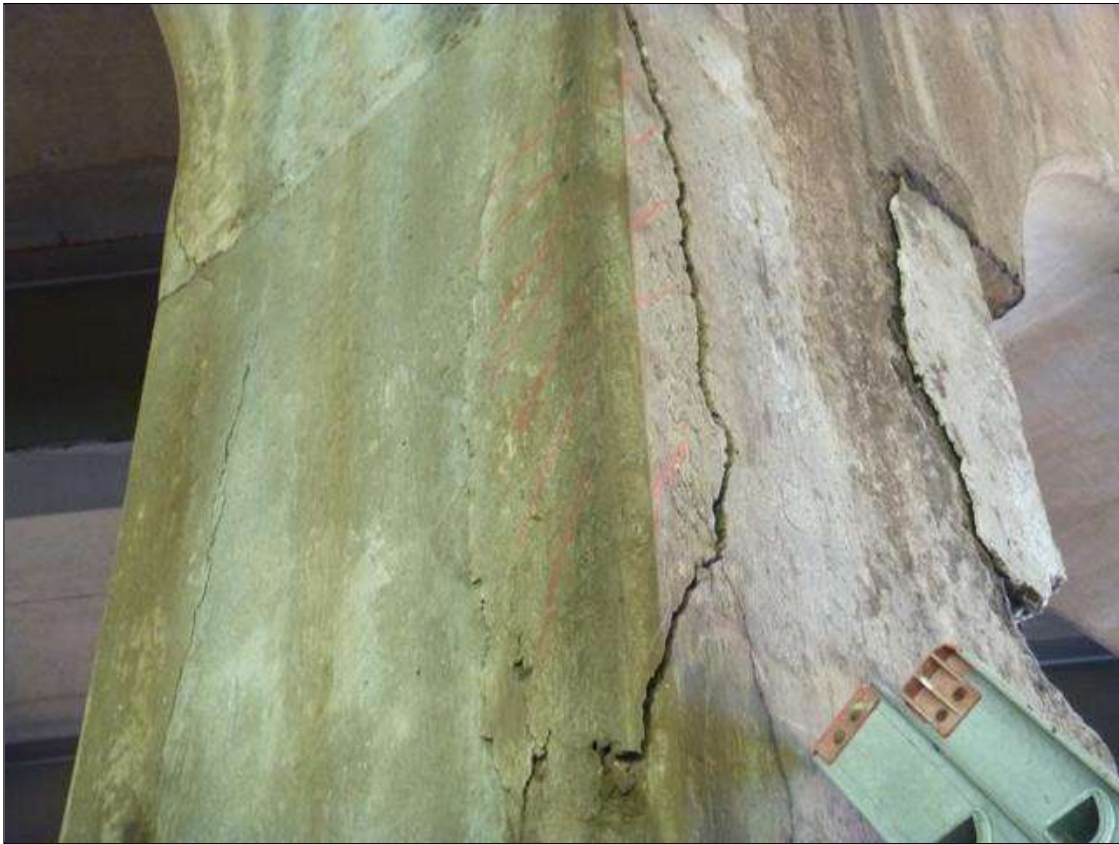
Bent 1 Pile 2: BENT 1, PILE 2 HAS AN AREA OF DELAMINATION ON THE SOUTHEAST CORNER, 10 INCHES WIDE X 36 INCHES HIGH WITH 1/2 INCH WIDE SEPARATION, STARTING 2 FT. BELOW THE BOTTOM OF THE CAP

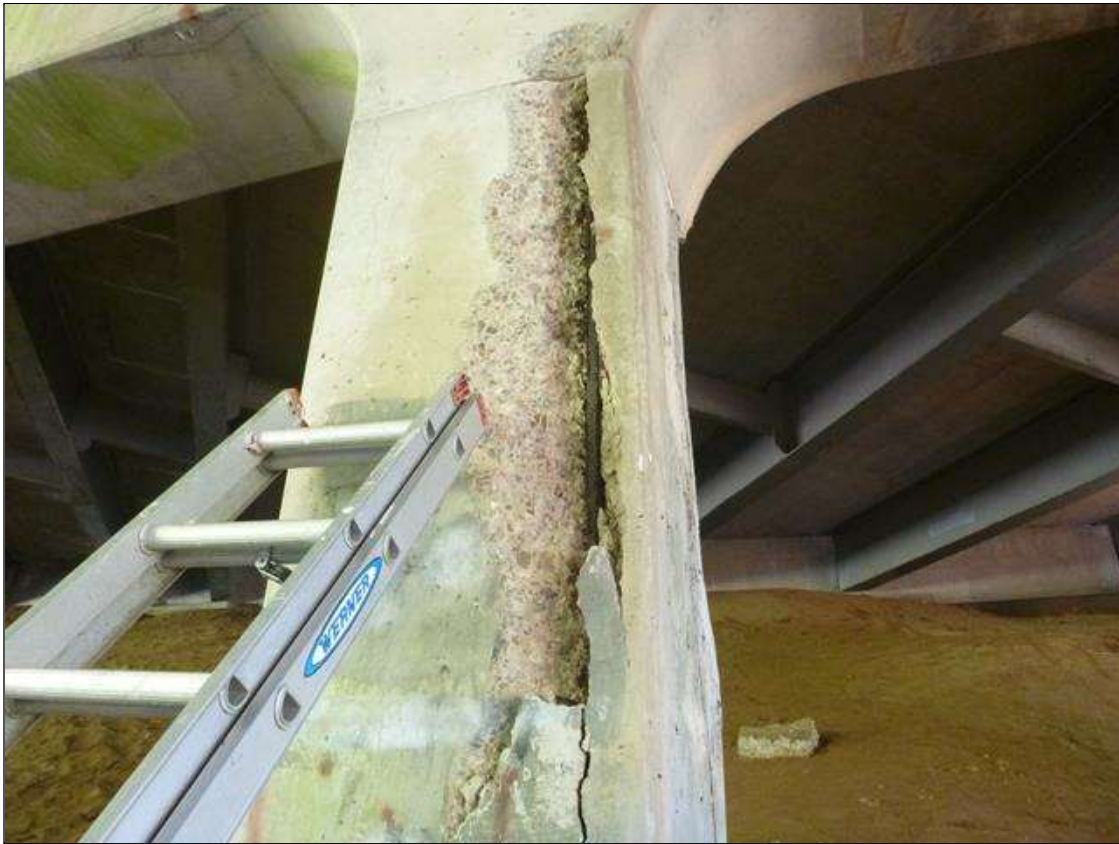
Bent 1 Pile 3: BENT 1, PILE 3 HAS A SPALL ON THE EAST FACE, 12 INCHES WIDE X 5 FT. HIGH X 4 INCHES DEEP WITH EXPOSED REBAR, STARTING 2 FT. BELOW THE BOTTOM OF THE CAP, WITH ADJACENT DELAMINATION BELOW THE SPALL, WITH 1/4 INCH SEPARATION

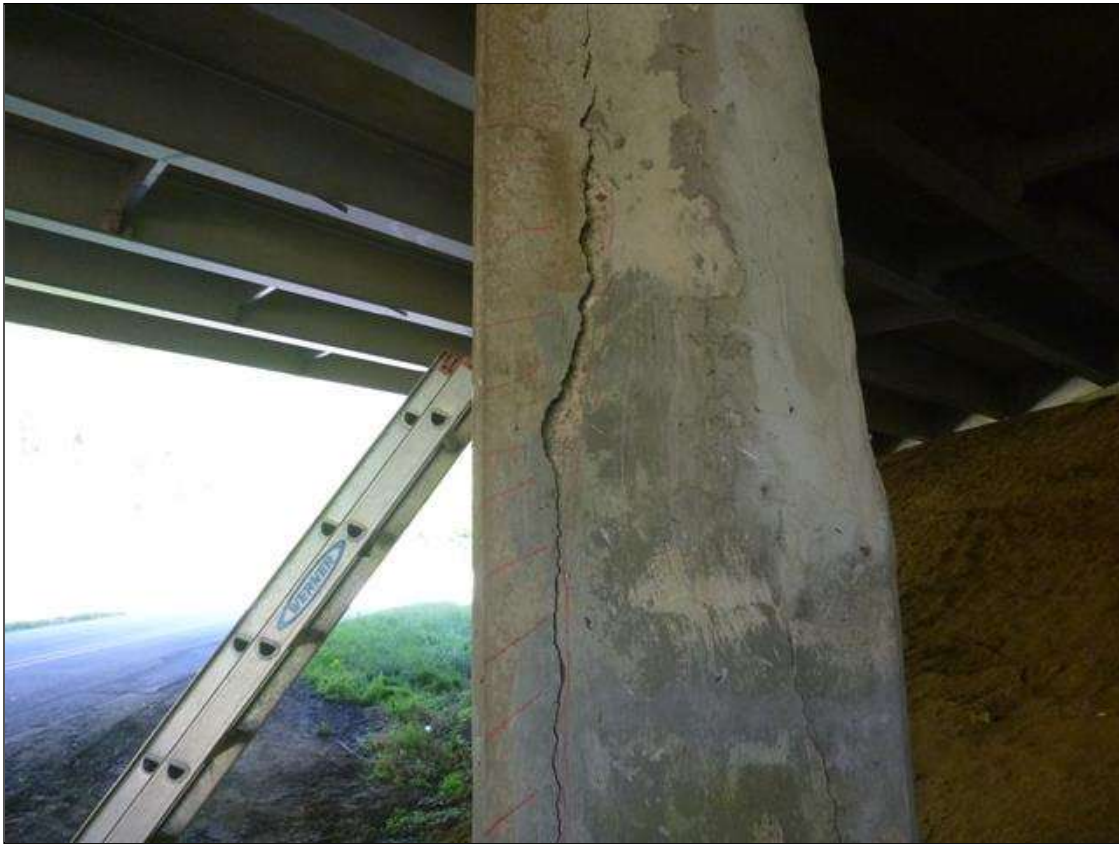
Bent 1 Pile 3: BENT 1, PILE 3 HAS AN AREA OF DELAMINATION ON THE NORTH FACE, NEAR THE NORTHEAST CORNER, 10 INCHES WIDE X 6 FT. HIGH WITH UP TO 3 INCH WIDE SEPARATION

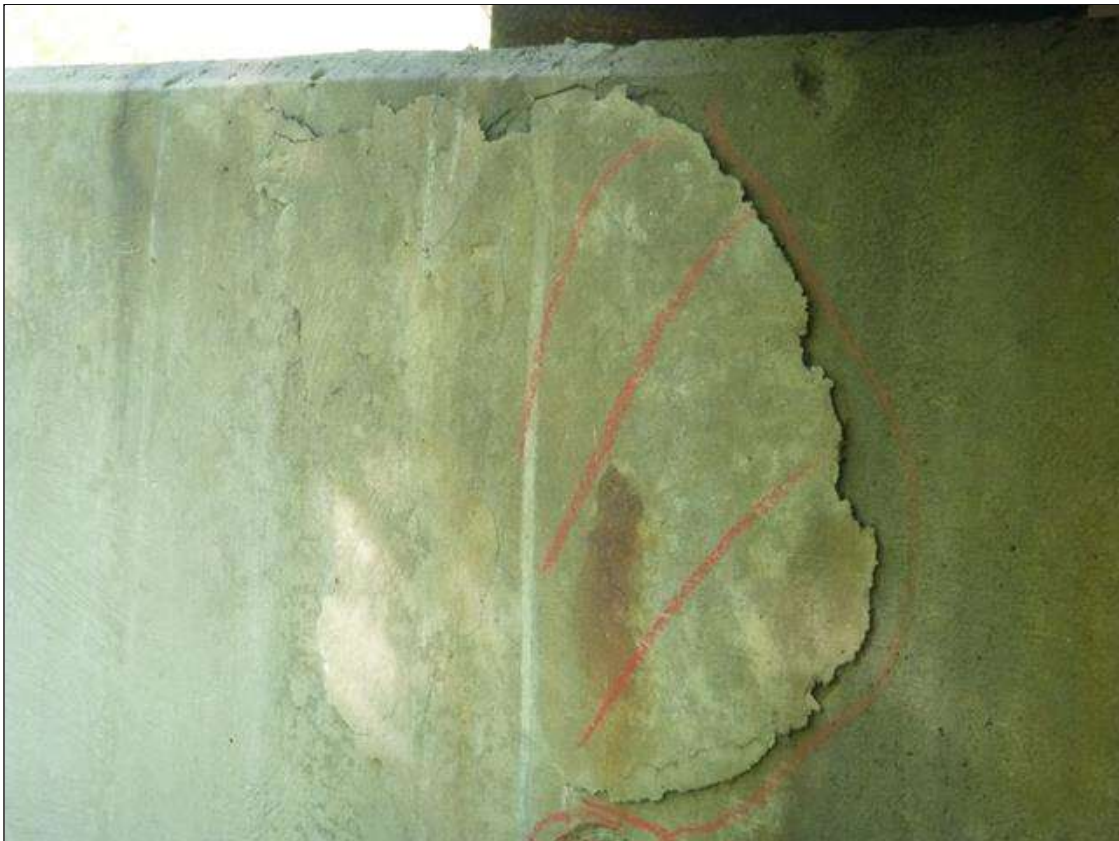
Bent 1 Cap 1: BENT 1 CAP, SPAN 1 SIDE HAS AN AREA OF DELAMINATION IN THE FACE OF THE CAP, 15 INCHES IN DIAMETER WITH 1/4 INCH SEPARATION, NEAR TOP EDGE AT BEAM 1, WITH RUST STAINS

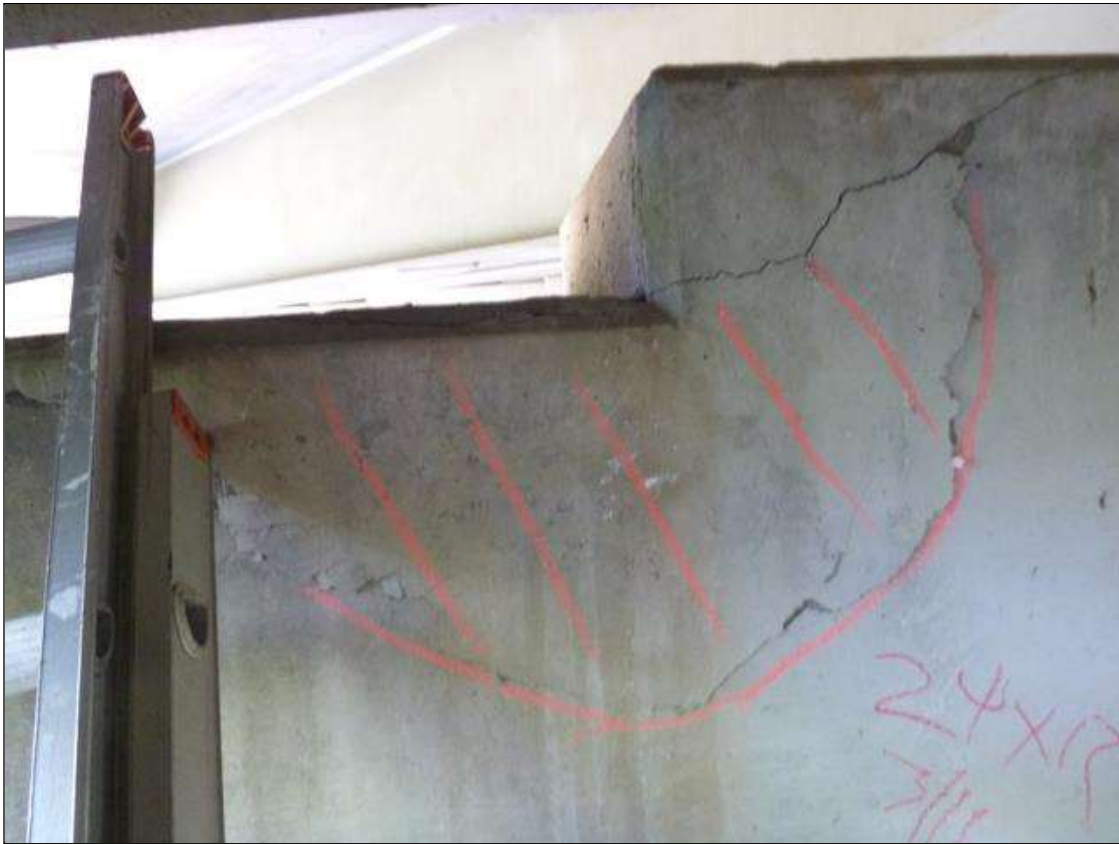
Bent 1 Cap 1: BENT 1 CAP, SPAN 1 SIDE AT BAY 1 HAS AN AREA OF DELAMINATION IN THE FACE OF THE CAP, 24 INCHES X 12 INCHES WITH 3/16 INCH SEPARATION, NEAR TOP EDGE

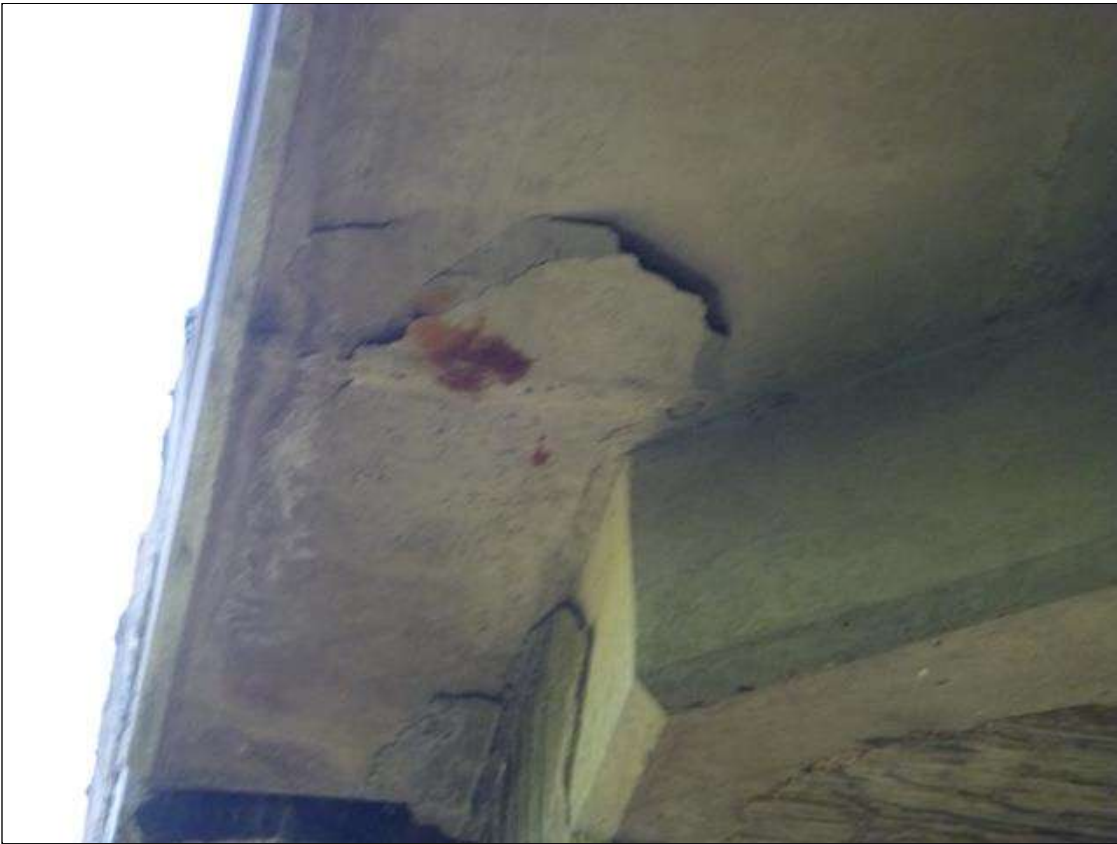
| Element Number | Defect Type | Defect Description | CS | CS Qty | Maint Qty | |
|---|---|---|---|---|---|---|
| 12 | Delamination/Spall | SPAN 1, BOTTOM OF LEFT OVERHANG AT BENT 1 HAS AN AREA OF DELAMINATION 12 INCHES IN DIAMETER WITH 1/2 INCH SEPARATION WITH RUST STAINS | 3 | 1 | 1 | Square Feet |

Span 1 Deck: SPAN 1, BOTTOM OF LEFT OVERHANG AT BENT 1 HAS AN AREA OF DELAMINATION 12 INCHES IN DIAMETER WITH 1/2 INCH SEPARATION WITH RUST STAINS

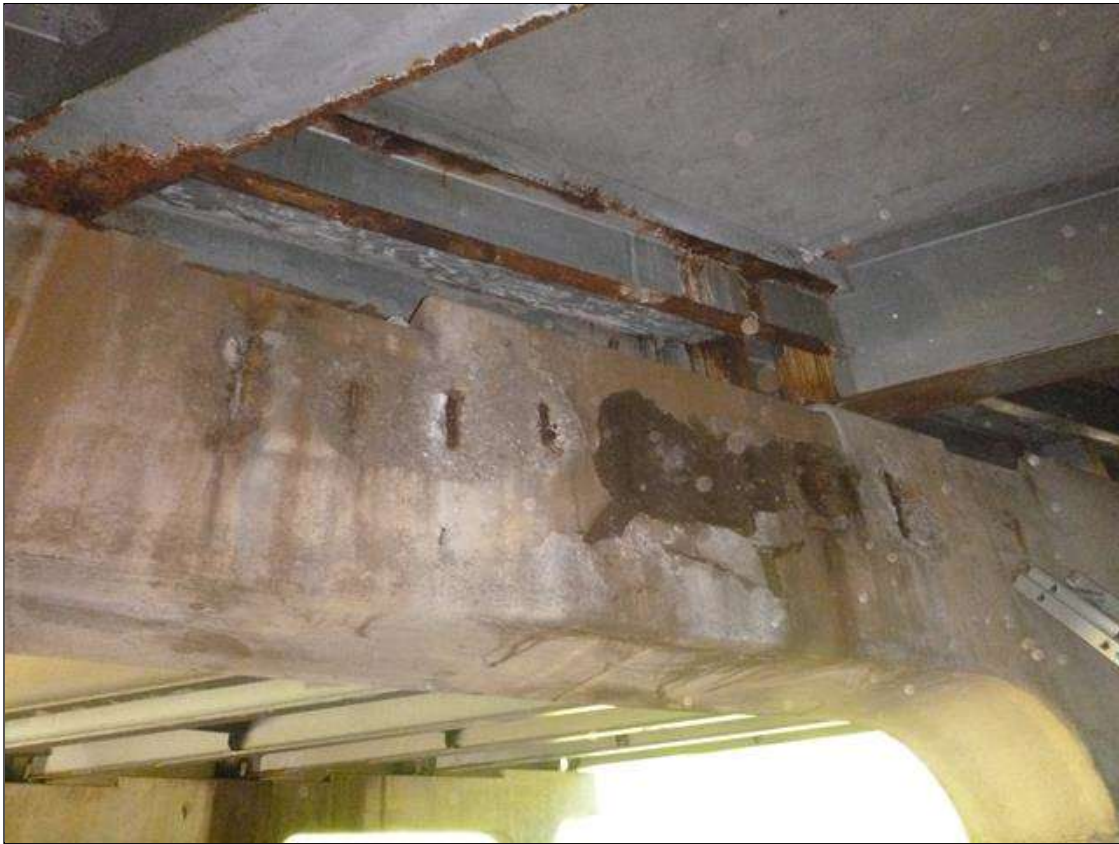
Bent 1 Cap 1: BENT 1 CAP, SPAN 1 SIDE HAS AN AREA OF SPALLING BETWEEN PILES 2 AND 3 IN THE FACE OF THE CAP, 9 FT. LONG X 16 INCHES HIGH X 1.5 INCHES DEEP WITH EXPOSED REBAR
