NC DEPARTMENT OF TRANSPORTATION  
DIVISION OF HIGHWAYS  
STRUCTURE MANAGEMENT UNIT

## Structure Safety Report

### Routine Element Inspection - Contract

COUNTY: HAYWOOD STRUCTURE NUMBER: 430159 FREQUENCY: 24 MONTHS  
FACILITY CARRIED: I-40 MILE POST: 18.7  
LOCATION: 1.8 MI.W.JCT.US276  
FEATURE INTERSECTED: SR1338  
LATITUDE: 35° 37' 31.64" LONGITUDE: 83° 0' 31.41"  
SUPERSTRUCTURE: REINFORCED CONCRETE FLOOR ON I-BEAMS

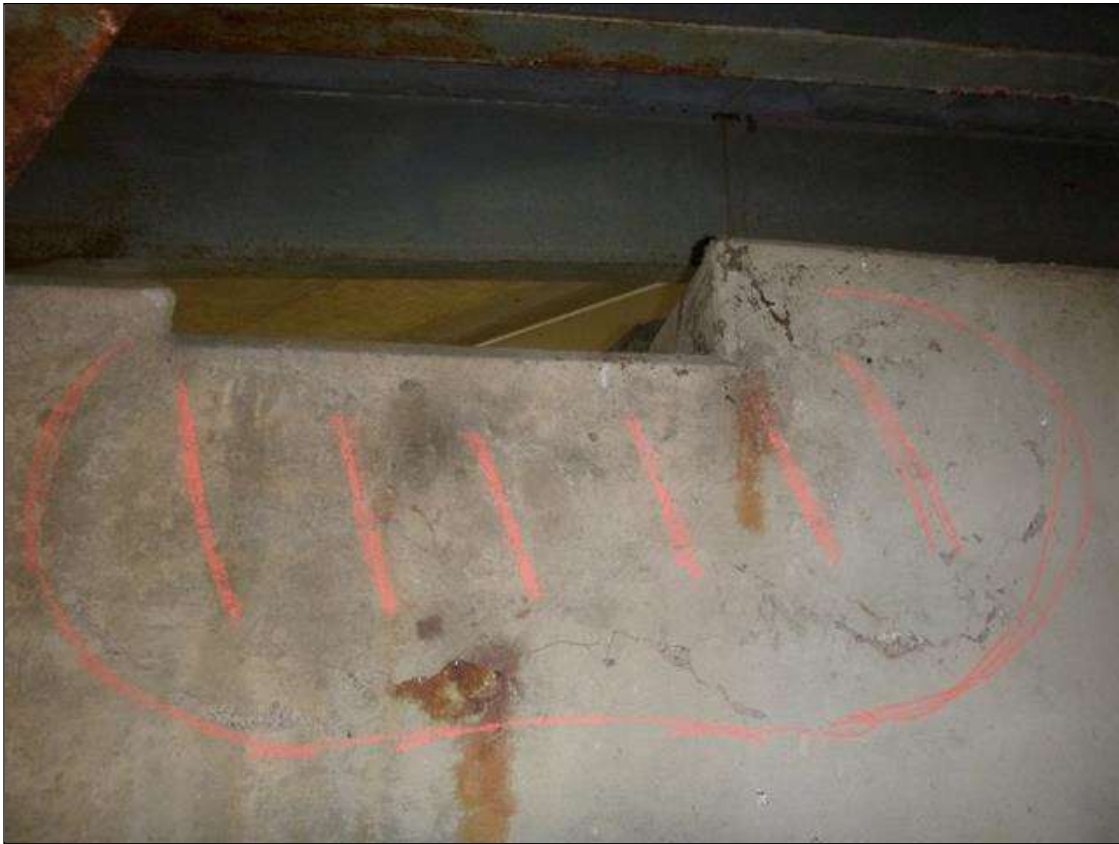
Bent 1 Cap 1: BENT 1 CAP, SPAN 1 SIDE HAS AN AREA OF DELAMINATION IN THE FACE OF THE CAP AT BAY 4, NEAR BEAM 4, 40 INCHES LONG X 16 INCHES HIGH WITH 1/4 INCH SEPARATION AND RUST STAINS NEAR TOP EDGE OF CAP

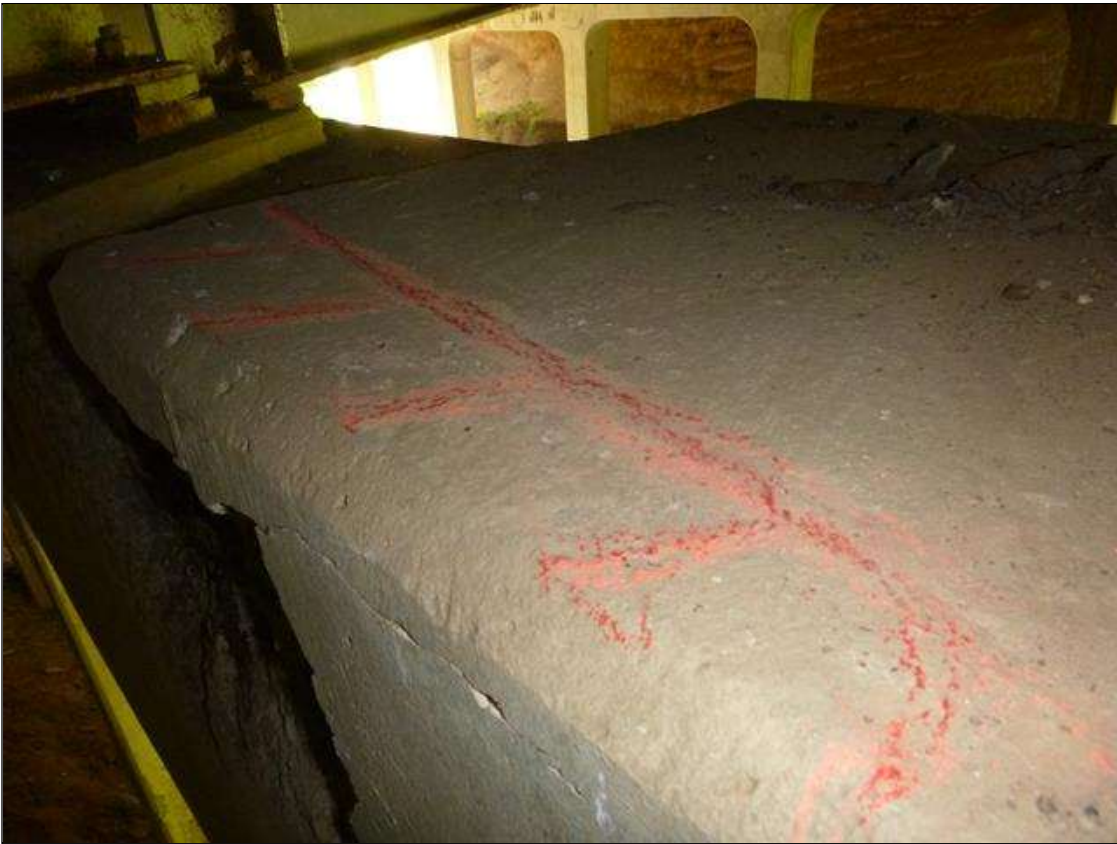
Bent 1 Cap 1: BENT 1 CAP HAS AN AREA OF DELAMINATION IN THE TOP OF THE CAP, NEAR TOP EDGE AT SPAN 1 SIDE 24 INCHES LONG X 5 INCHES WIDE AT BAY 5

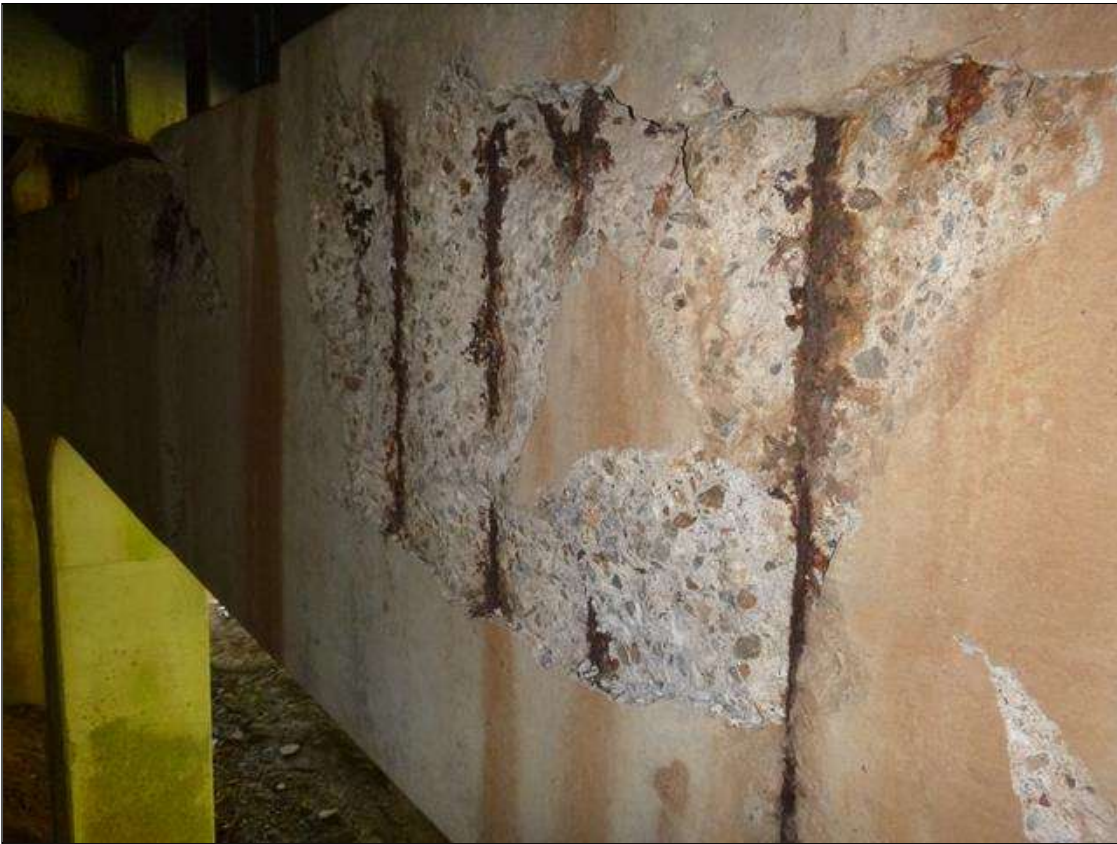
Bent 1 Cap 1: BENT 1 CAP, SPAN 1 SIDE HAS AN AREA OF SPALLING IN THE FACE OF THE CAP, STARTING AT BAY 4 RUNNING 11 FT. LONG INTO BAY 6, 16 INCHES HIGH X 3 INCHES DEEP WITH EXPOSED REBAR

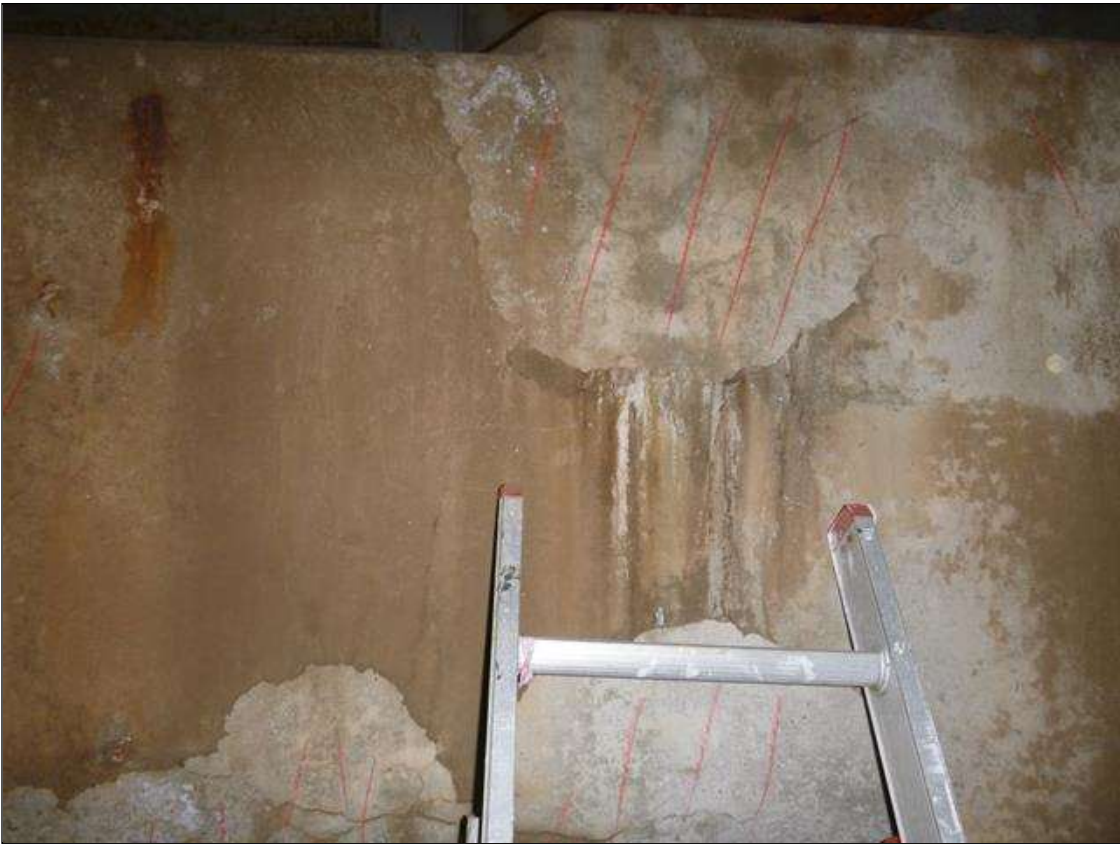
Bent 1 Cap 1: BENT 1 CAP, SPAN 1 SIDE HAS AN AREA OF DELAMINATION IN THE FACE OF THE CAP STARTING IN BAY 6 RUNNING 7 FT. LONG INTO BAY 7, 24 INCHES HIGH WITH 1/2 INCH SEPARATION

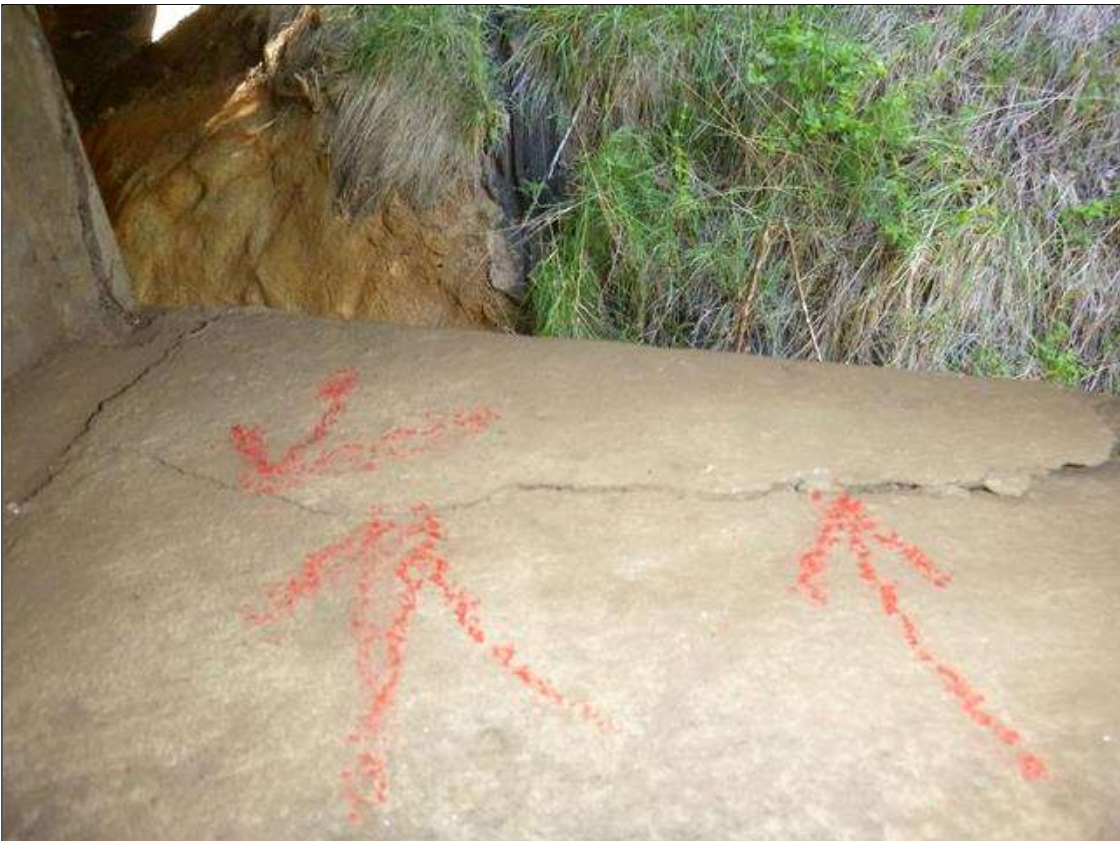
Bent 1 Cap 1: BENT 1 CAP, BAY 1, NEAR THE TOP EDGE IN SPAN 1 HAS A 1/8 INCH WIDE CRACK, 16 INCHES LONG

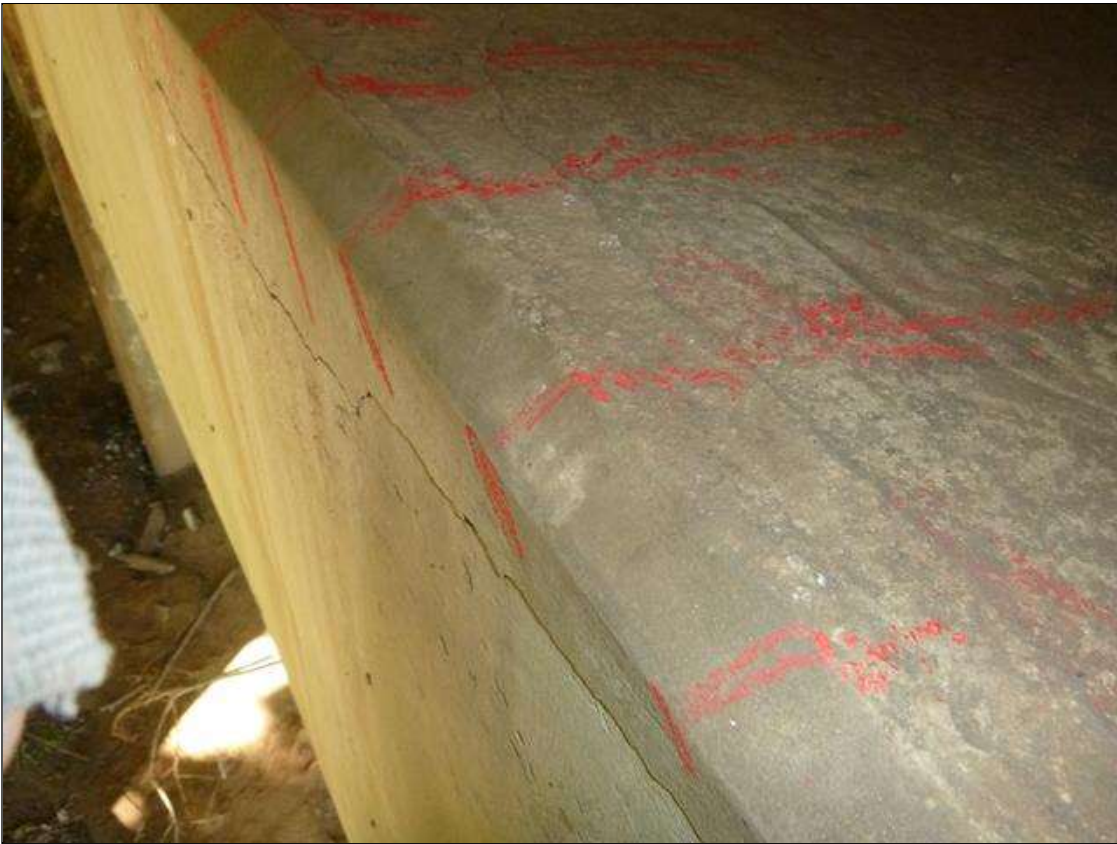
Bent 1 Cap 1: BENT 1 CAP, SPAN 2 SIDE HAS AN AREA OF DELAMINATION IN BAY 1, AT TOP EDGE, 26 INCHES LONG X 5 INCHES WIDE ACROSS THE TOP AND UP TO 3 INCHES HIGH DOWN THE FACE

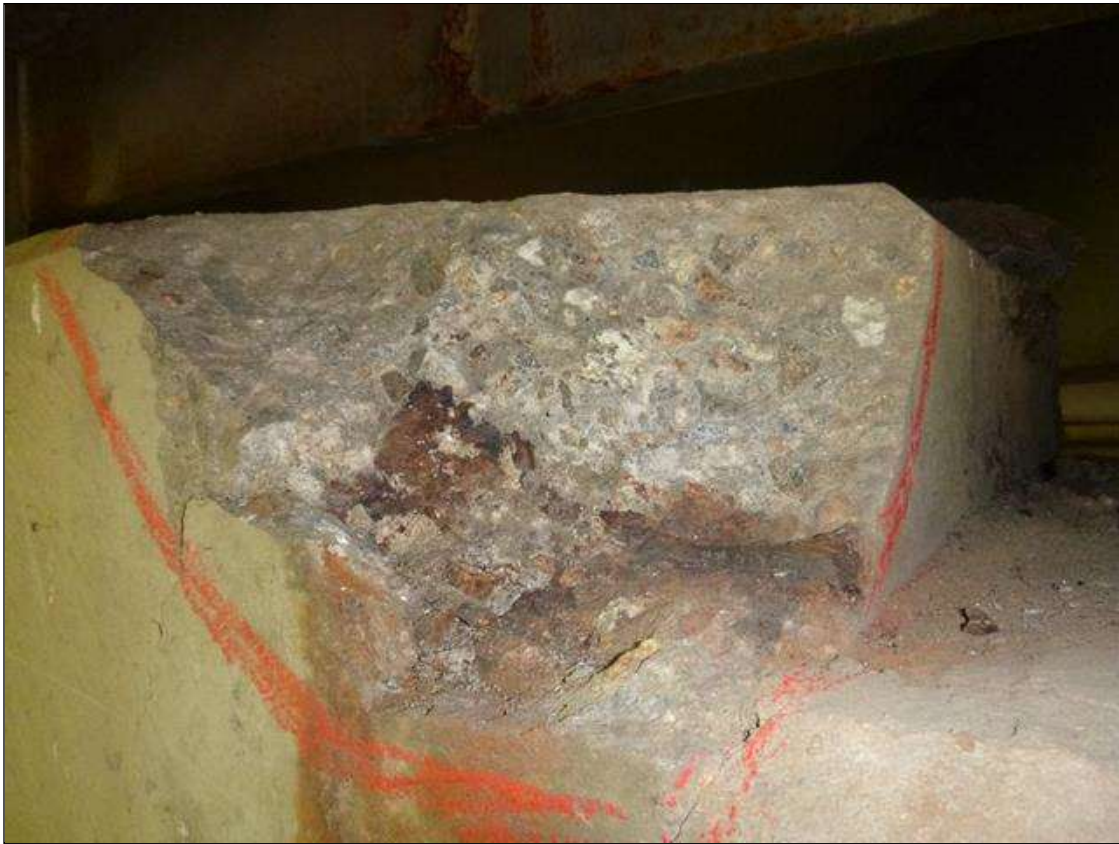
Bent 1 Cap 1: BENT 1 CAP, SPAN 2 SIDE HAS A SPALL ON THE TOP EDGE IN BAY 4, AT CAP STEPUP, 10 INCHES X 7 INCHES X 4 INCHES DEEP WITH REBAR EXPOSED REBAR

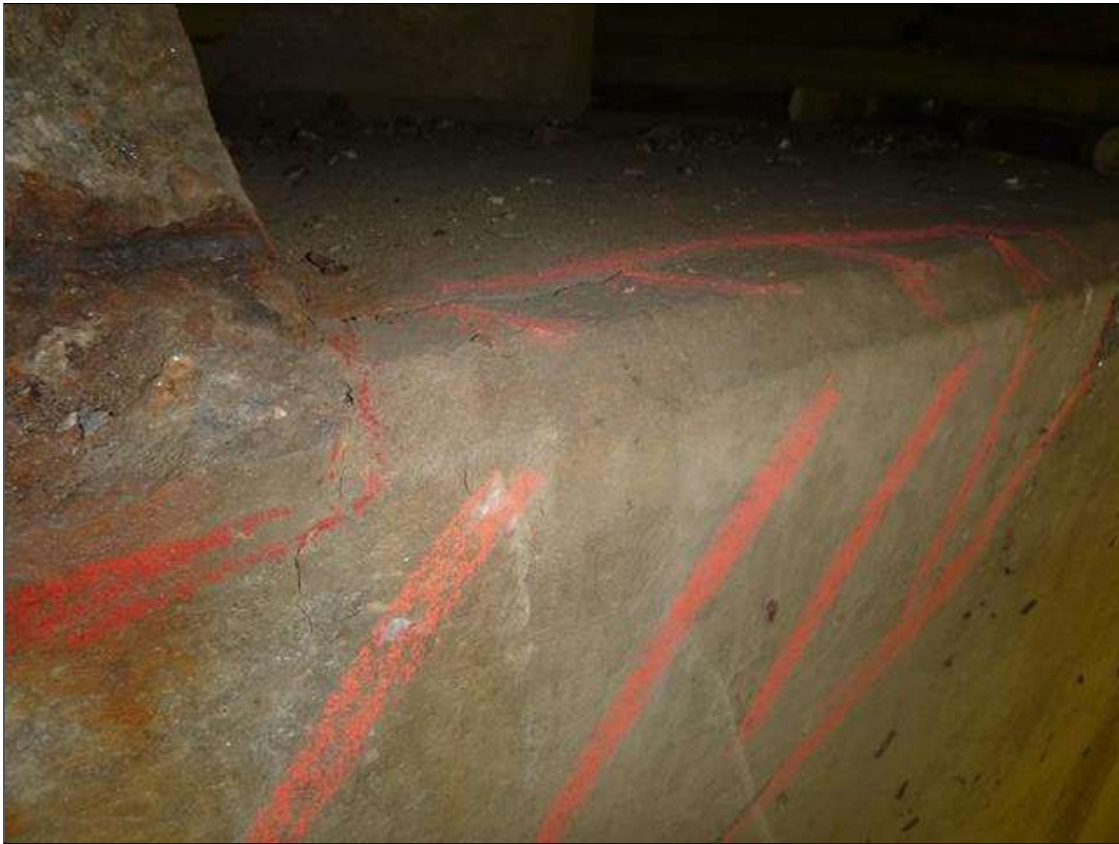
Bent 1 Cap 1: BENT 1 CAP, SPAN 2 SIDE HAS AN AREA OF DELAMINATION IN THE FACE OF THE CAP IN BAY 4 NEAR TOP EDGE, 24 INCHES LONG X 10 INCHES DOWN THE FACE X 2 INCHES ACROSS THE TOP WITH 1/8 INCH SEPARATION

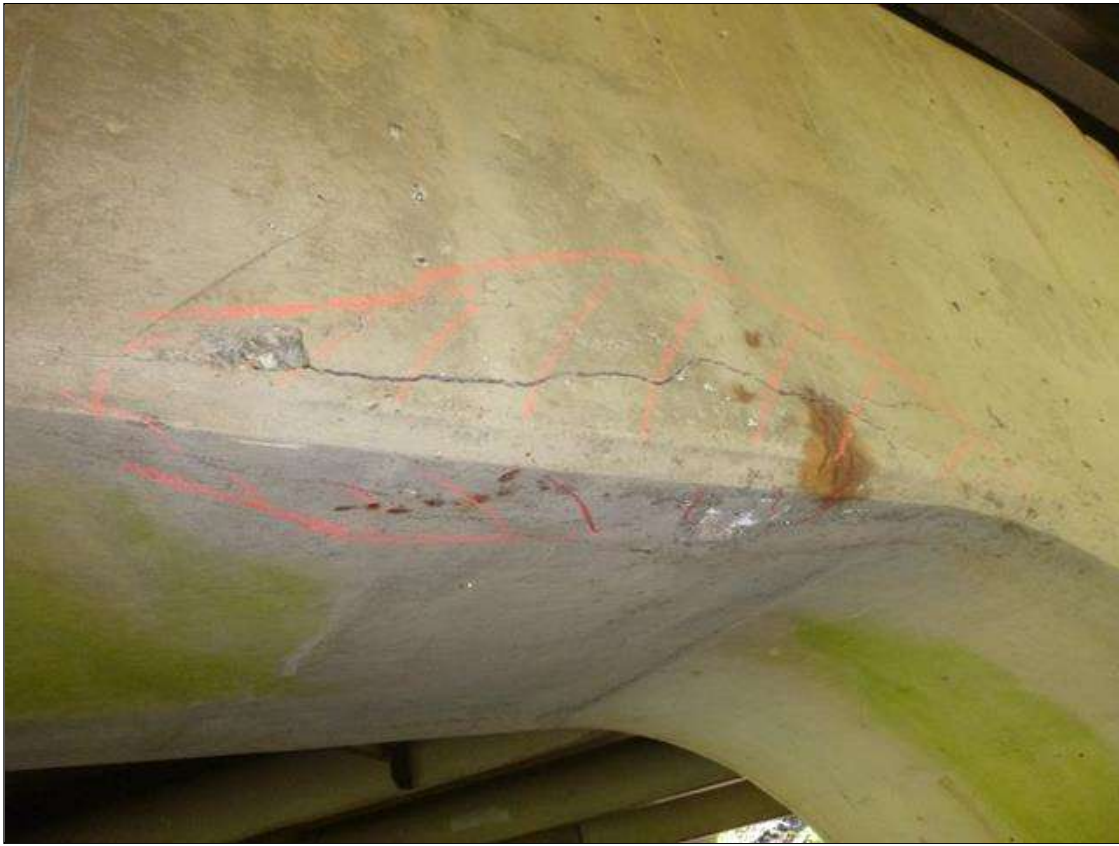
Bent 1 Cap 1: BENT 1 CAP, SPAN 2 SIDE HAS AN AREA OF DELAMINATION IN THE FACE OF THE CAP AT THE BOTTOM EDGE UNDER BEAM 5, 29 INCHES LONG X 7 INCHES HIGH ON THE FACE X 5 INCHES ACROSS THE BOTTOM WITH 1/8 INCH SEPARATION AND RUST STAINS

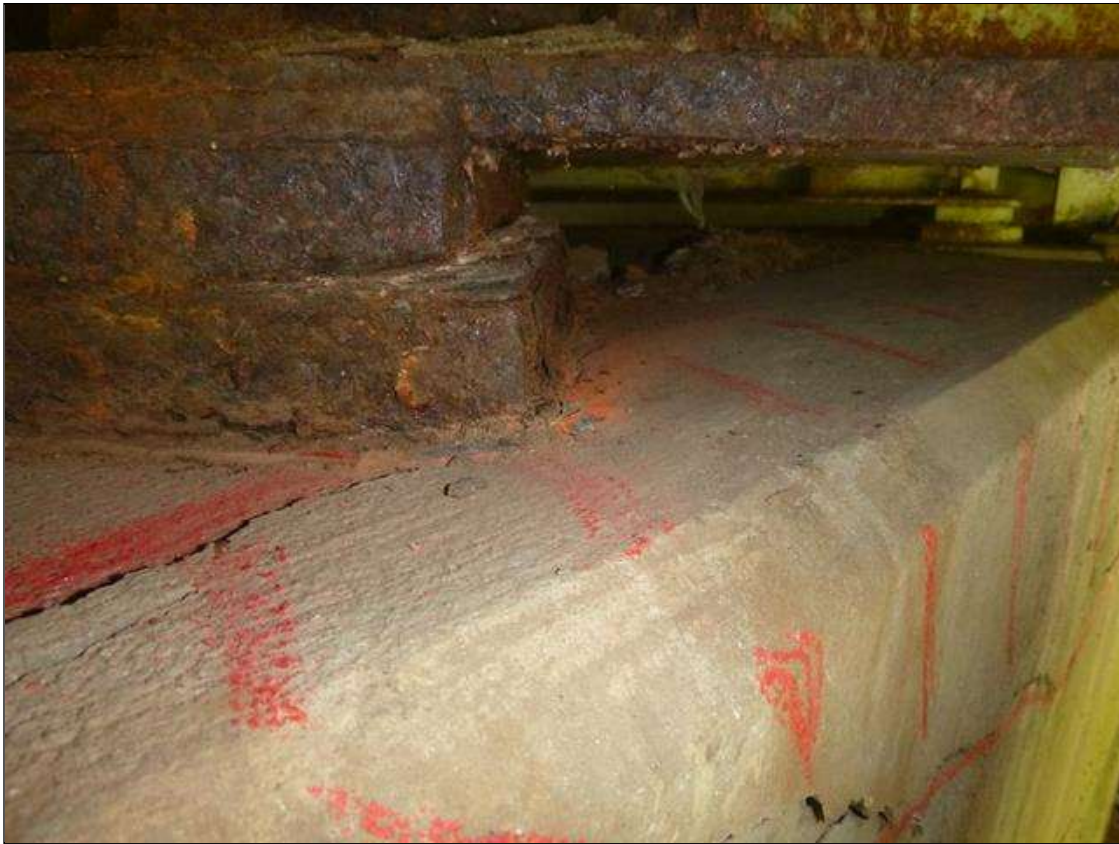
Bent 1 Cap 1: BENT 1 CAP, SPAN 2 SIDE HAS AN AREA OF DELAMINATION AT THE TOP EDGE UNDER BEAM 6, 28 INCHES LONG X 9 INCHES HIGH ON THE FACE X 5 INCHES ACROSS THE TOP WITH 1/8 INCH SEPARATION, CRACK ON TOP RUNS ADJACENT TO BEARING AT THIS BEAM

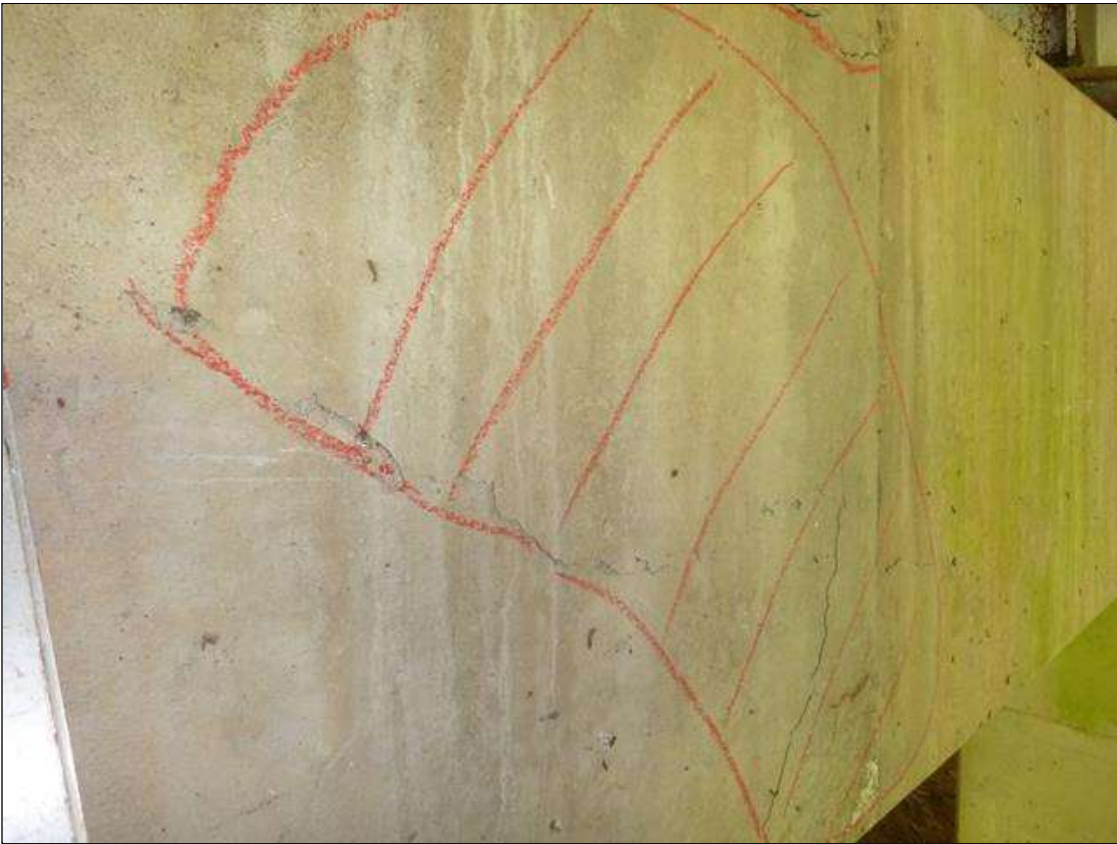
Bent 1 Cap 1: BENT 1 CAP, SPAN 2 SIDE HAS AN AREA OF DELAMINATION IN THE FACE OF THE CAP IN BAY 5, 24 INCHES X 29 INCHES WITH 1/8 INCH SEPARATION

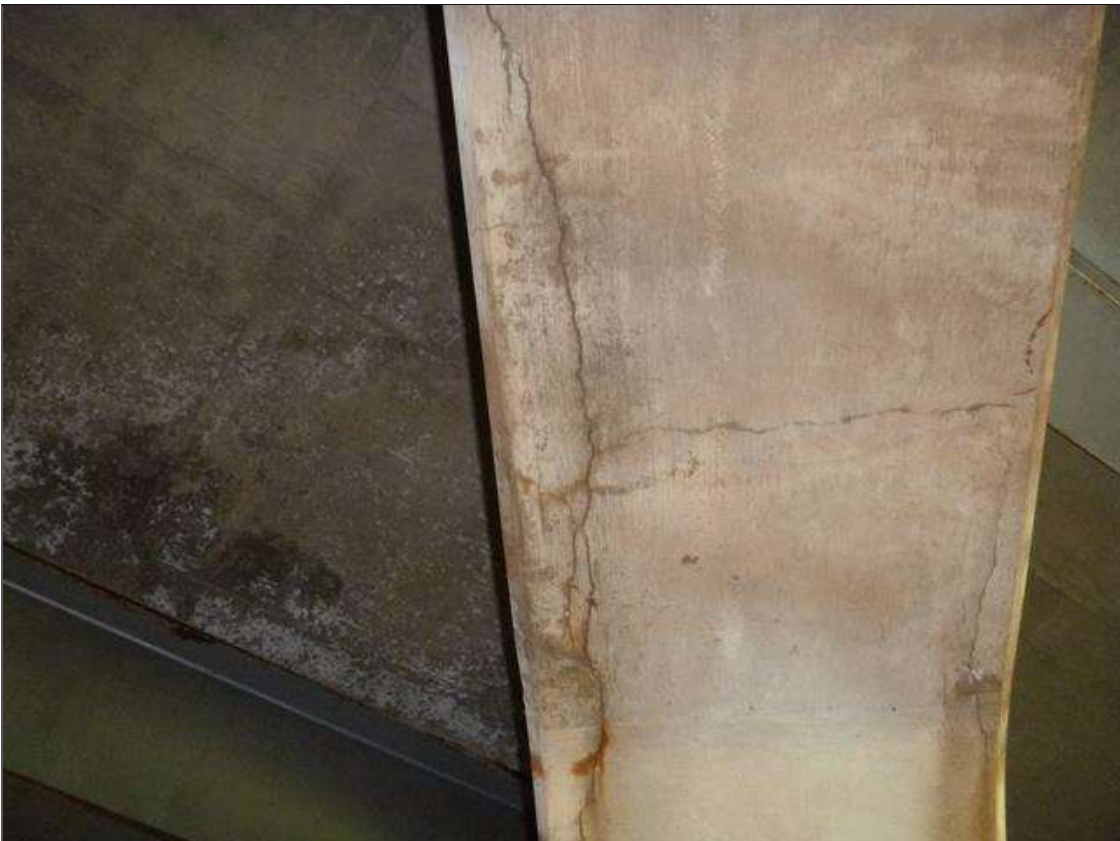
Bent 1 Cap 1: BENT 1 CAP, SPAN 1 SIDE HAS AN AREA OF DELAMINATION IN THE BOTTOM, BETWEEN PILES 4 AND 5, 5 FT. LONG X 6 INCHES WIDE WITH 1/4 INCH SEPARATION WITH RUST STAINS

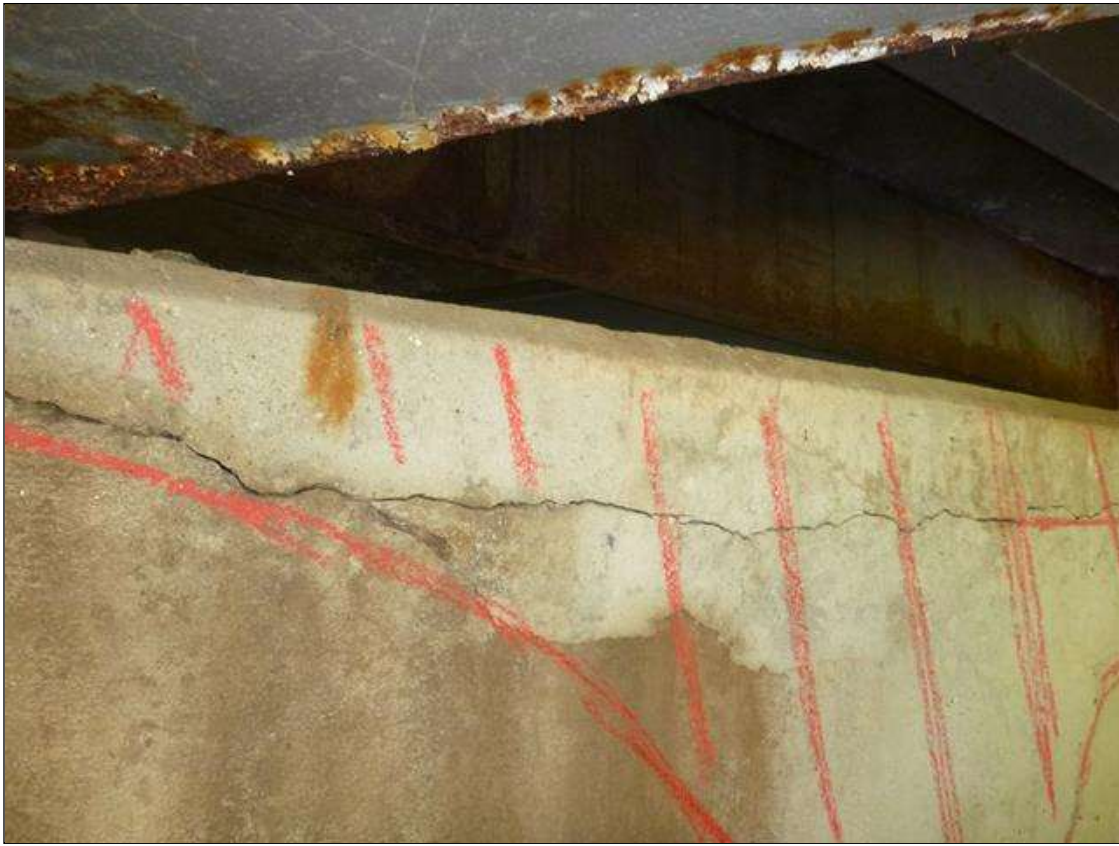
Bent 1 Cap 1: BENT 1 CAP, SPAN 2 SIDE HAS AN AREA OF DELAMINATION IN THE TOP AND FACE IN BAY 6, NEAR BEAM 7, 60 INCHES LONG X 18 INCHES DOWN THE FACE X UP TO 6 INCHES ACROSS THE TOP, WITH 1/2 INCH SEPARATION, DOES NOT AFFECT BEAM 7 BEARING

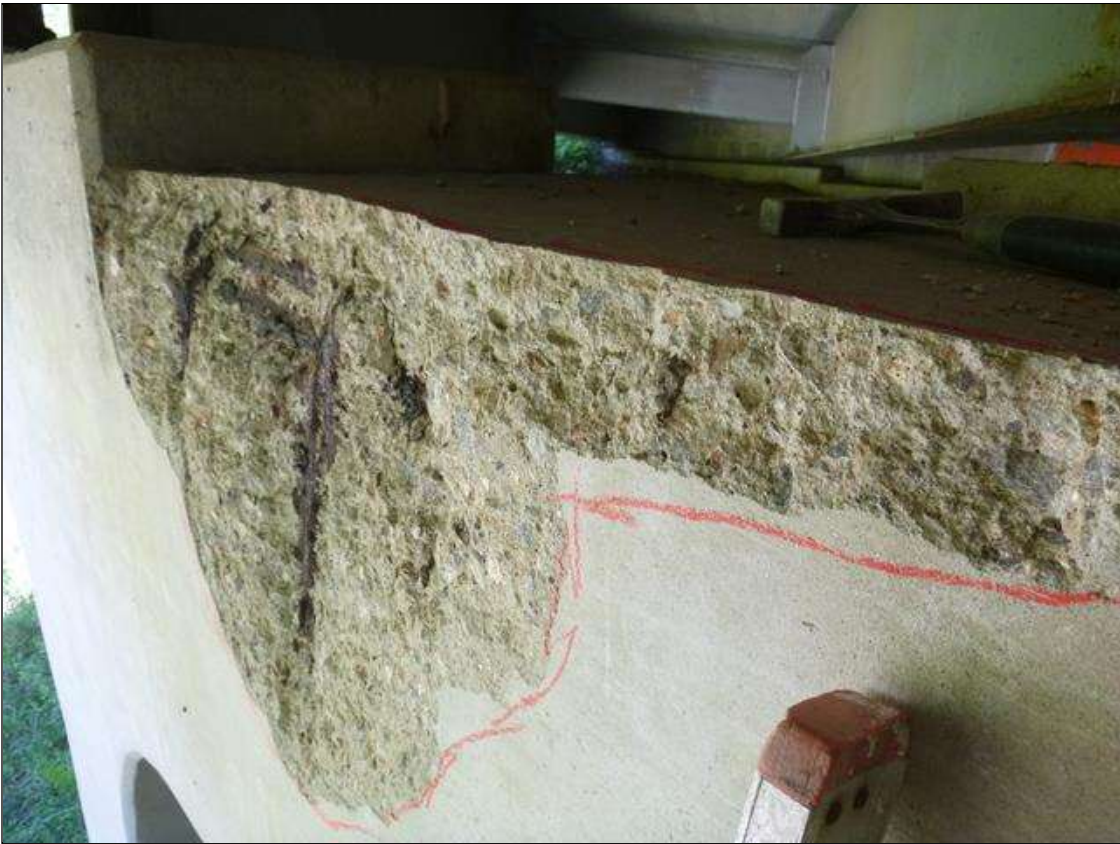
Bent 1 Cap 1: BENT 1 CAP, SPAN 2 SIDE HAS A SPALL ON THE FACE OF THE CAP IN BAY 9, 44 INCHES X 24 INCHES X 3.5 INCHES DEEP WITH EXPOSED REBAR, NEAR TOP EDGE

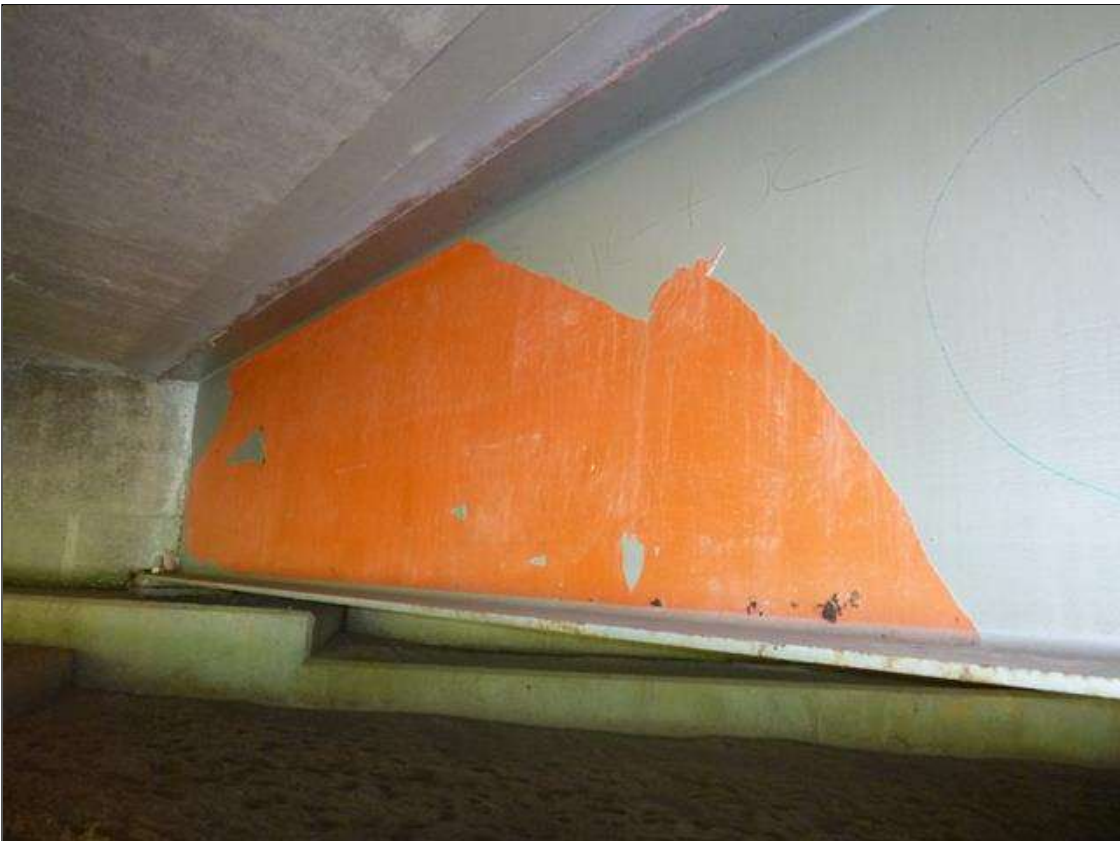
| Element Number | Defect Type | Defect Description | CS | CS Qty | Maint Qty | |
|---|---|---|---|---|---|---|
| 515 | Peeling/Bubbling/Cracking (steel Protective Coatings) | SPAN 1, BEAM 8 HAS 25 SQ. FT. OF PAINT PEELING FROM THE RIGHT WEB NEAR END BENT 1 | 2 | 25 | 25 | Square Feet |

Span 1 Beam 8: SPAN 1, BEAM 8 HAS 25 SQ. FT. OF PAINT PEELING FROM THE RIGHT WEB NEAR END BENT

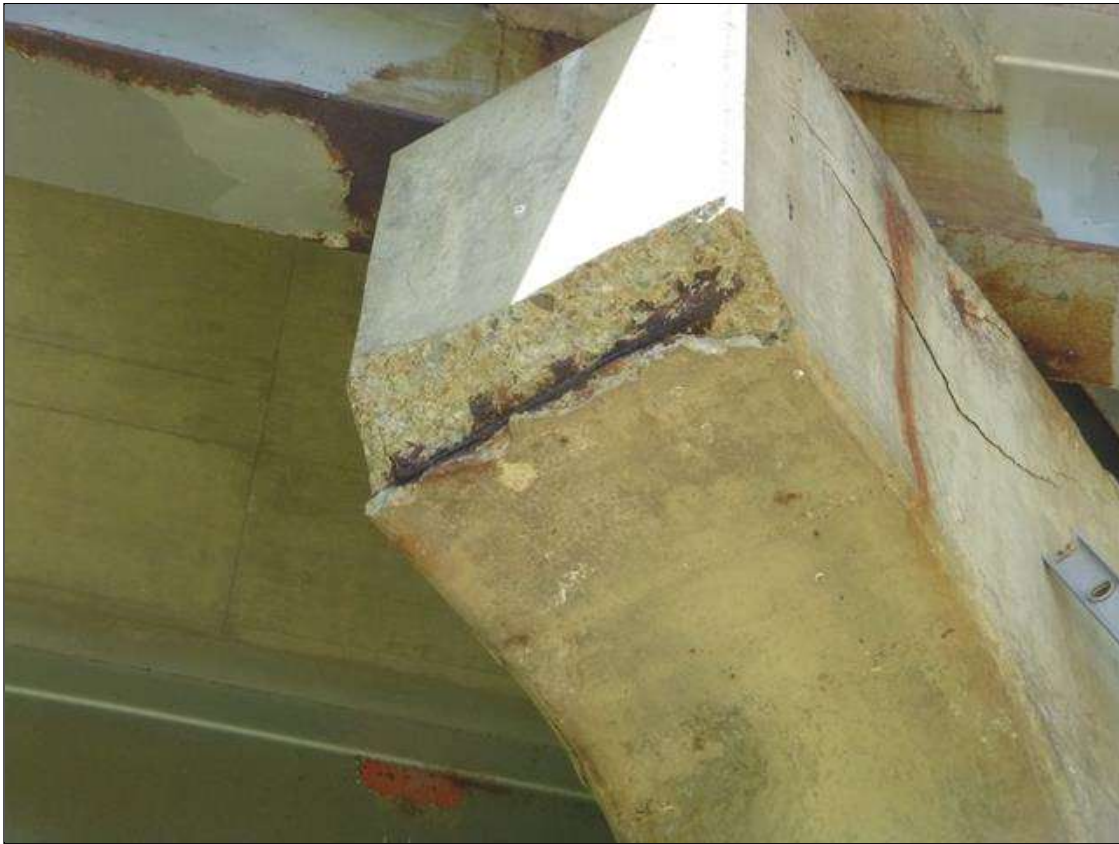
Bent 2 Cap 1: BENT 2 CAP, LEFT END HAS A SPALL ON THE BOTTOM EDGE, 2.5 FT. LONG X 10 INCHES HIGH X 4 INCHES DEEP WITH REBAR EXPOSED

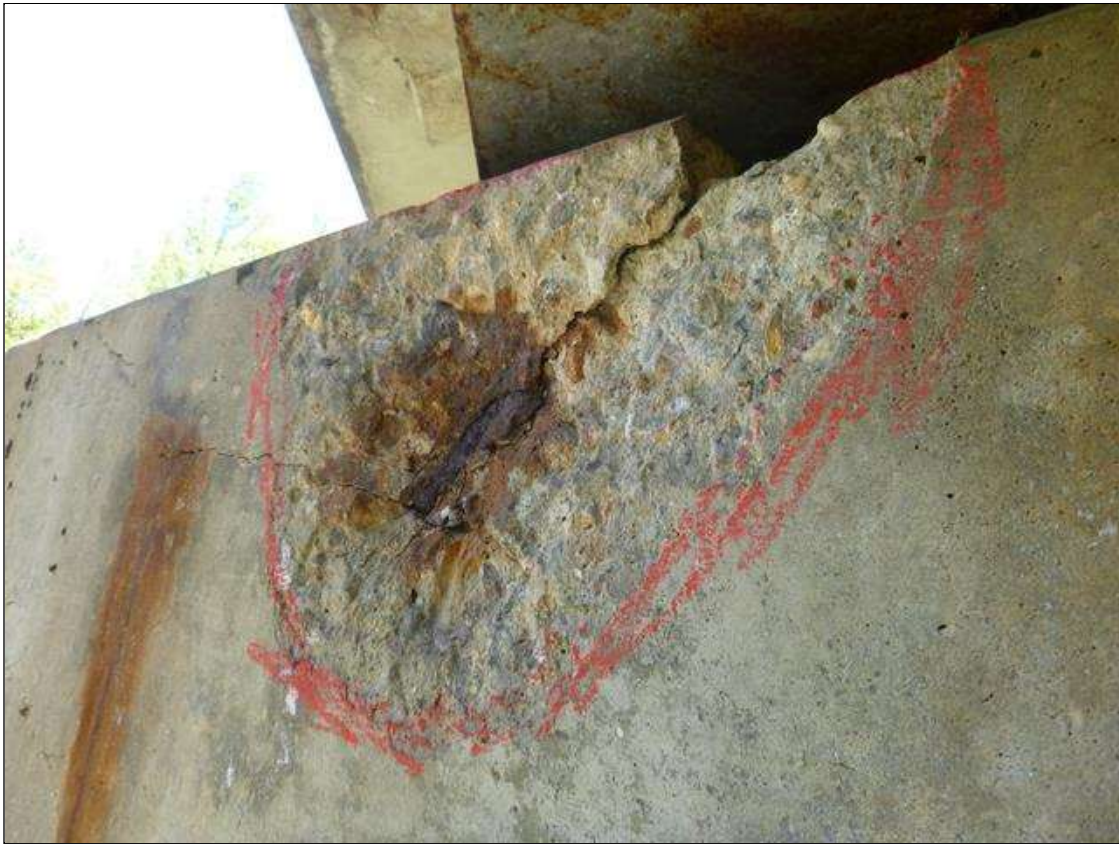
Bent 2 Cap 1: BENT 2 CAP SPAN 2 SIDE HAS A SPALL ON THE FACE OF THE CAP UNDER BEAM 1, 14 INCHES X 10 INCHES X 1.5 INCHES DEEP WITH REBAR EXPOSED

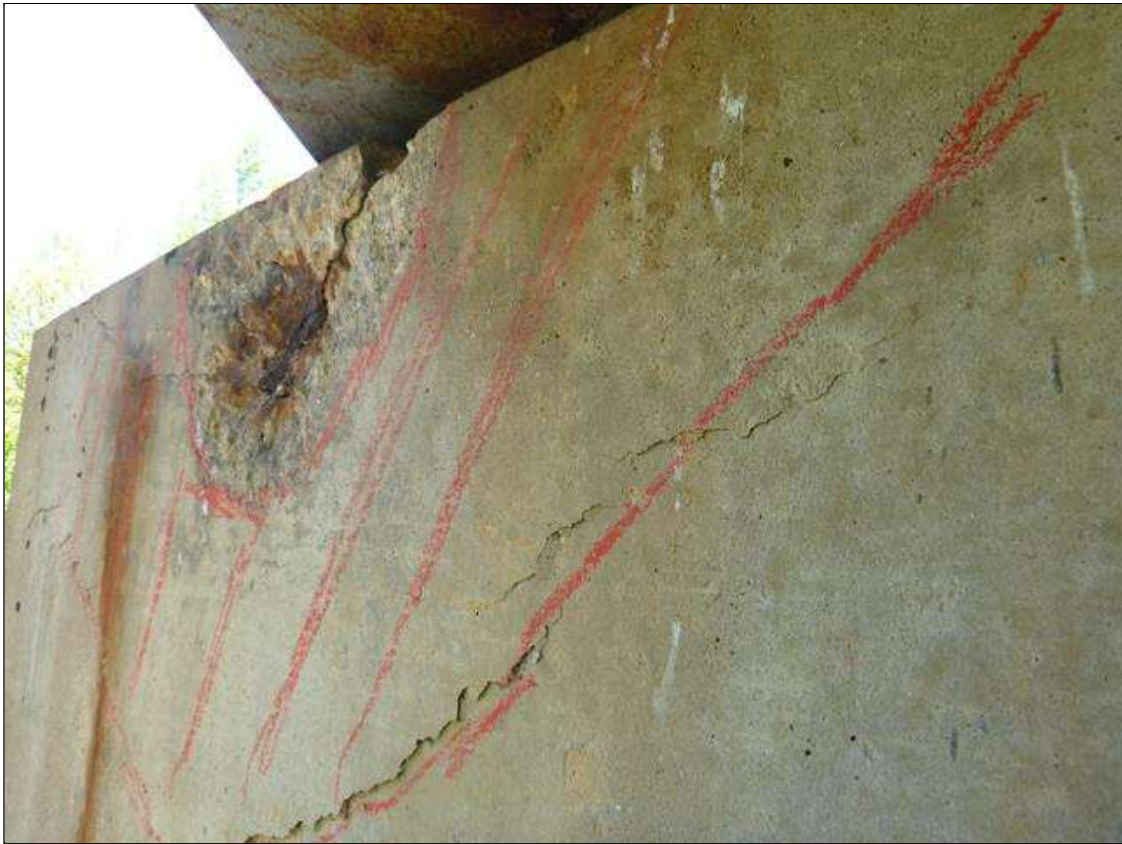
Bent 2 Cap 1: BENT 2 CAP, SPAN 2 SIDE HAS AN AREA OF DELAMINATION IN THE FACE OF THE CAP UNDER BEAM 1 NEAR TOP EDGE, 48 INCHES LONG X 20 INCHES HIGH AND GOES ACROSS THE TOP OF THE CAP 4 INCHES ADJACENT TO THE BEARING AT BEAM 1, WITH 3/16 INCH SEPARATION WITH RUST STAINS

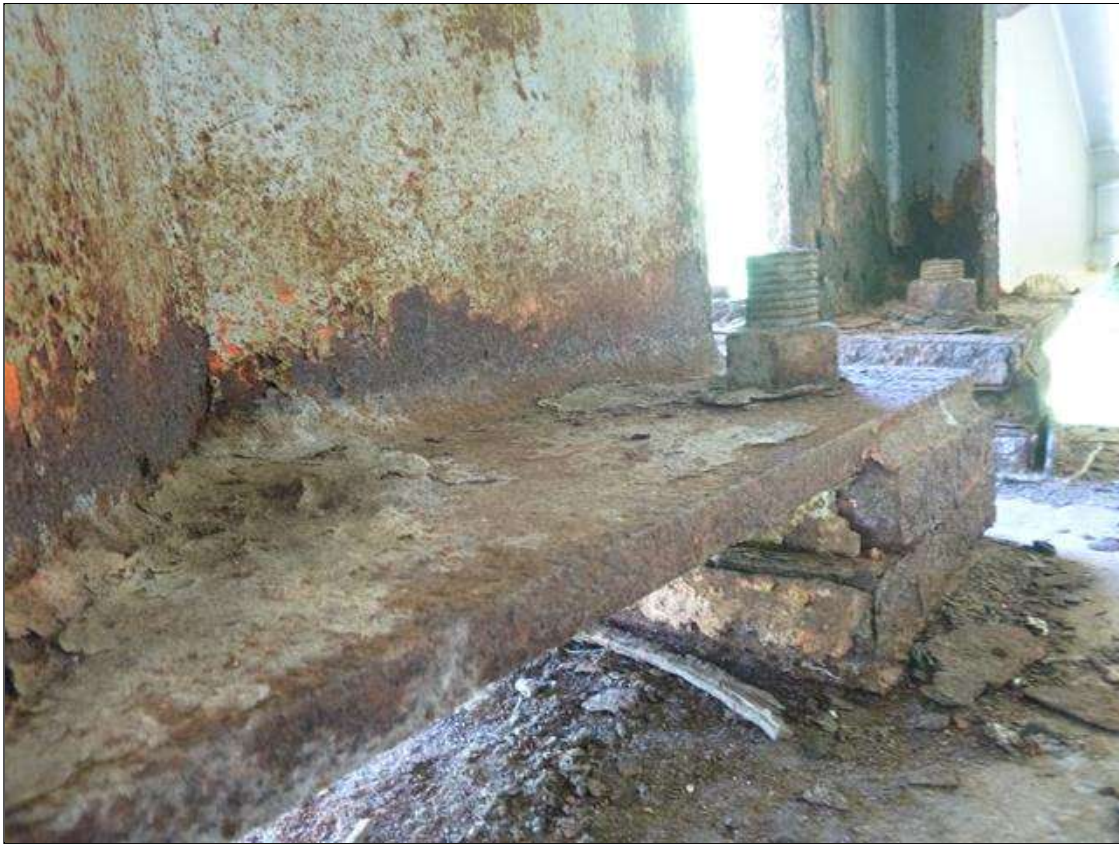
Span 2 Beam 1: SPAN 2, BEAM 1 AT BENT 2 HAS 1/32 INCH SECTION LOSS ON THE BOTTOM FLANGE FROM THE BEAM END OUT 1 FT. X FULL WIDTH WITH 19/32 INCH REMAINING

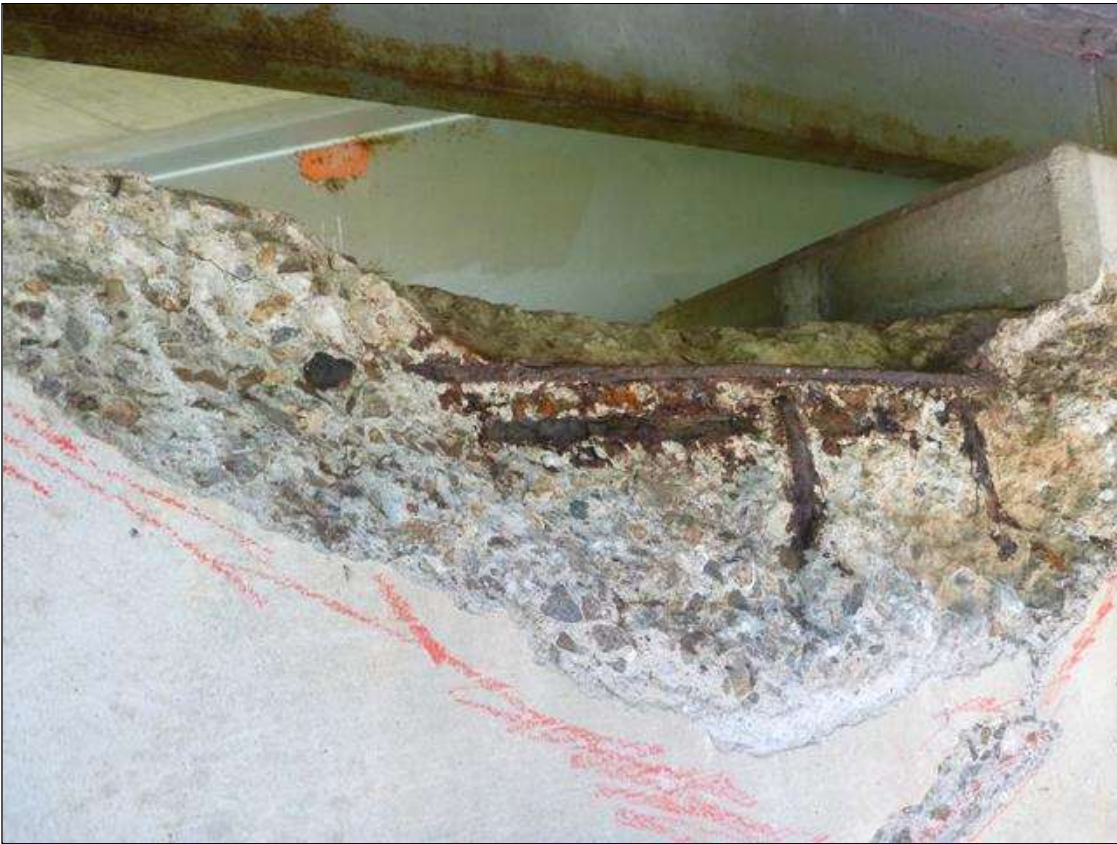
Bent 2 Cap 1: BENT 2 CAP, SPAN 2 SIDE HAS A SPALL ON THE FACE OF THE CAP IN BAY 1, NEAR BEAM 1, 40 INCHES LONG X 15 INCHES HIGH X UP TO 8 INCHES DEEP, NEAR TOP EDGE

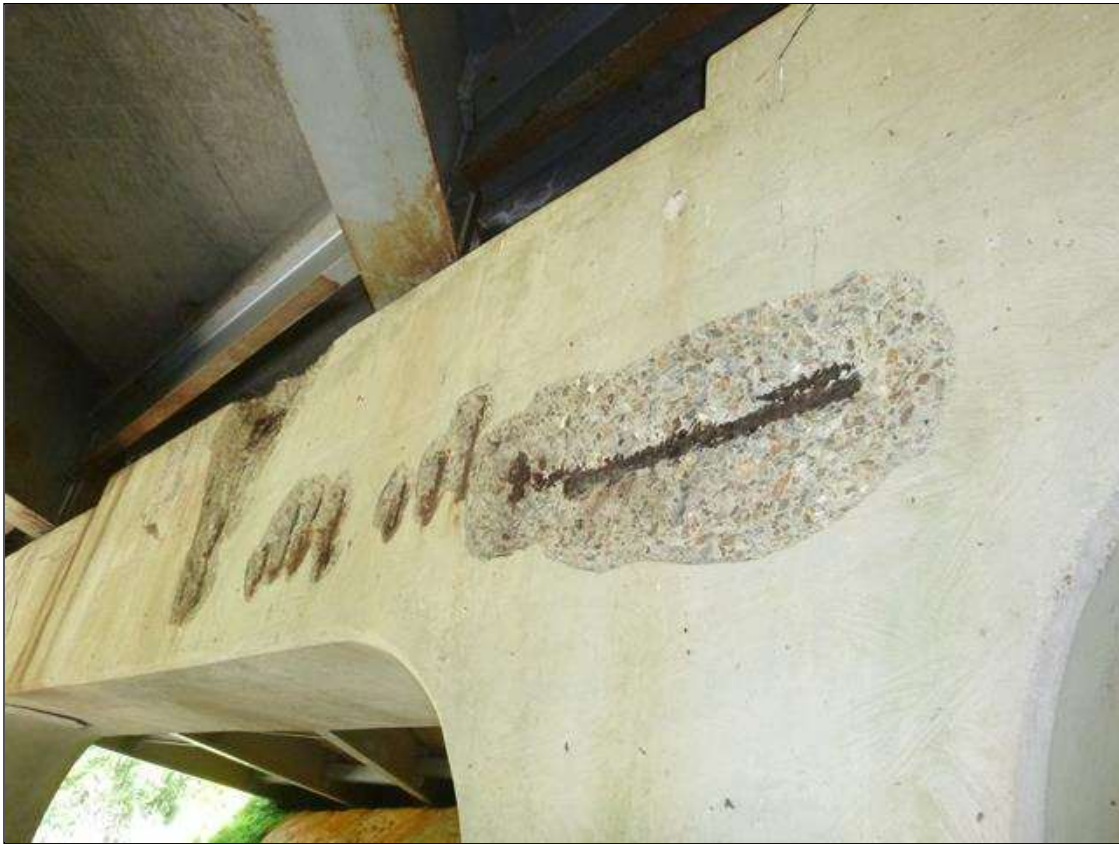
Bent 2 Cap 1: BENT 2 CAP, SPAN 2 SIDE HAS AN AREA OF SPALLING IN THE FACE OF THE CAP IN BAYS 3 AND 4, 8 FT. LONG X UP TO 2.5 FT. HIGH X 2.5 INCHES DEEP WITH REBAR EXPOSED

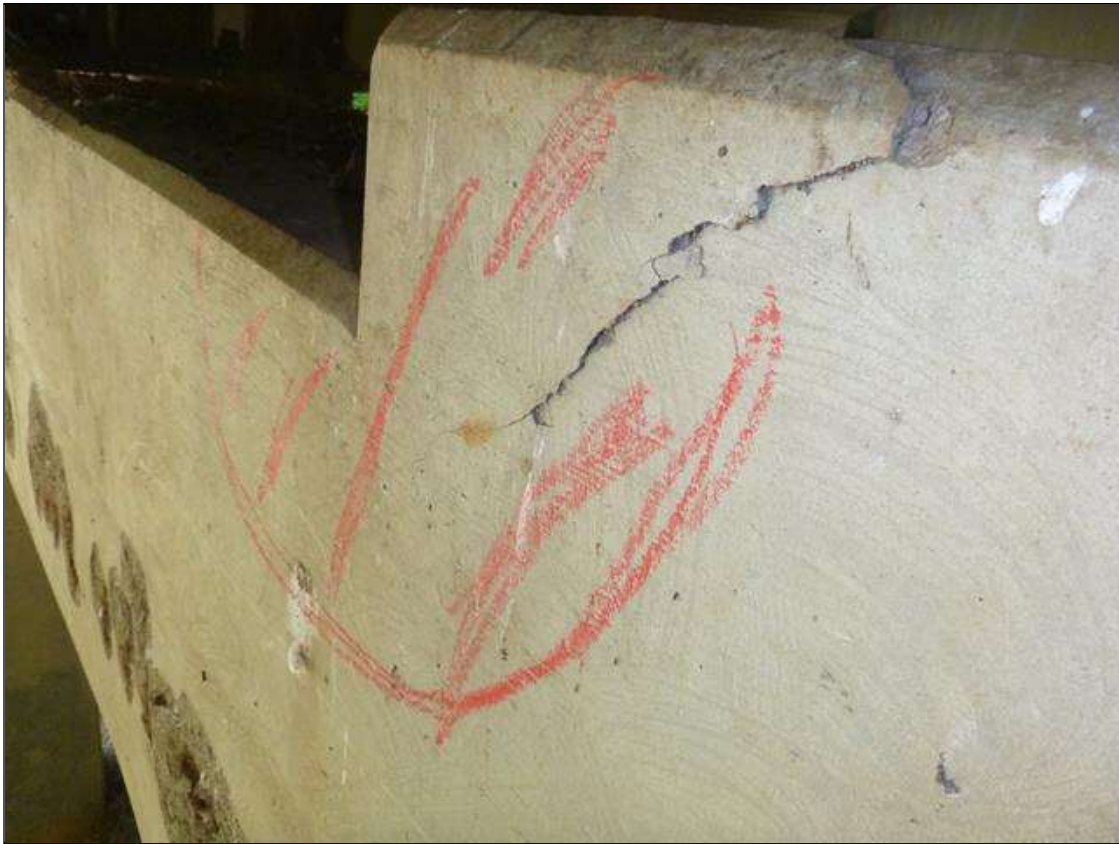
Bent 2 Cap 1: BENT 2 CAP, SPAN 2 SIDE HAS AN AREA OF DELAMINATION IN THE FACE OF THE CAP IN BAY 4, 21 INCHES X 12 INCHES, NEAR TOP EDGE AND GOES ACROSS THE TOP OF THE CAP 4 INCHES WITH 3/16 INCH SEPARATION

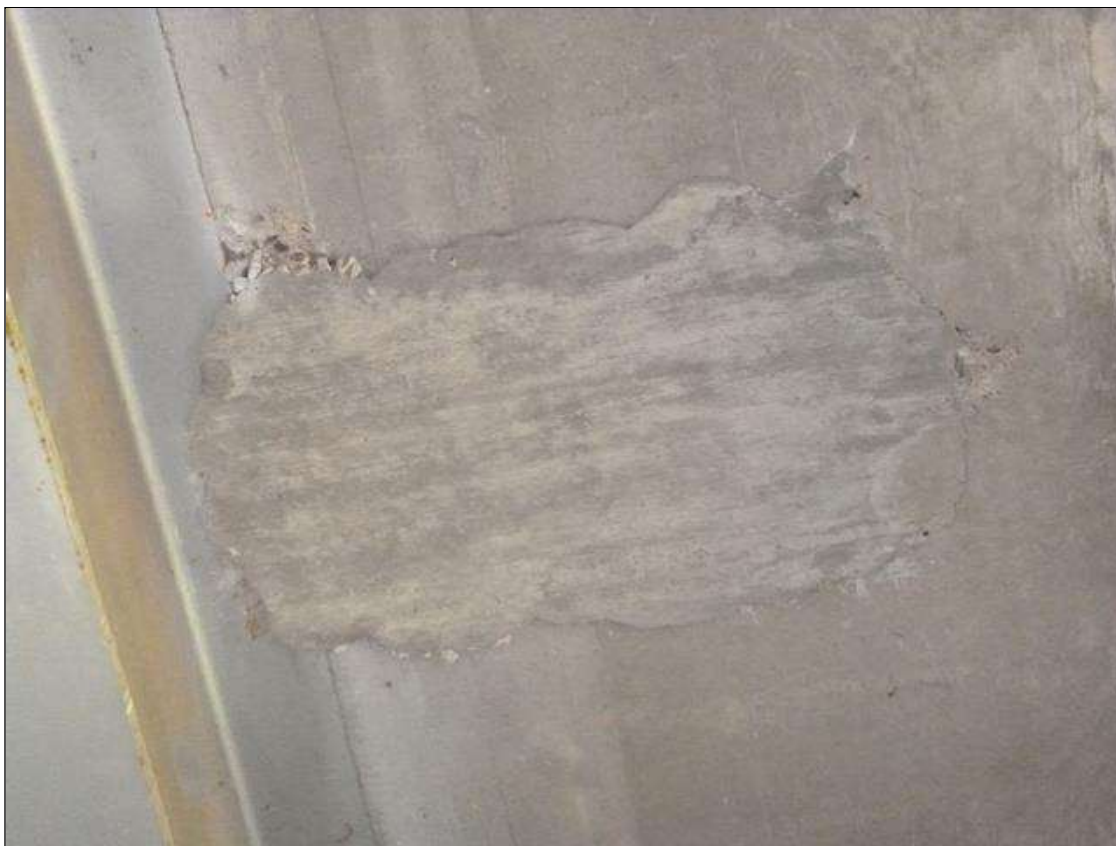
Span 2 Deck: SPAN 2 BAY 4 BOTTOM OF DECK, 6 FT. FROM BENT 2 HAS A PATCH, 20 INCHES X 30 INCHES
