NC DEPARTMENT OF TRANSPORTATION  
DIVISION OF HIGHWAYS  
STRUCTURE MANAGEMENT UNIT

## Structure Safety Report

### Routine Element Inspection - Contract

COUNTY: HAYWOOD STRUCTURE NUMBER: 430159 FREQUENCY: 24 MONTHS  
FACILITY CARRIED: I-40 MILE POST: 18.7  
LOCATION: 1.8 MI.W.JCT.US276  
FEATURE INTERSECTED: SR1338  
LATITUDE: 35° 37' 31.64" LONGITUDE: 83° 0' 31.41"  
SUPERSTRUCTURE: REINFORCED CONCRETE FLOOR ON I-BEAMS

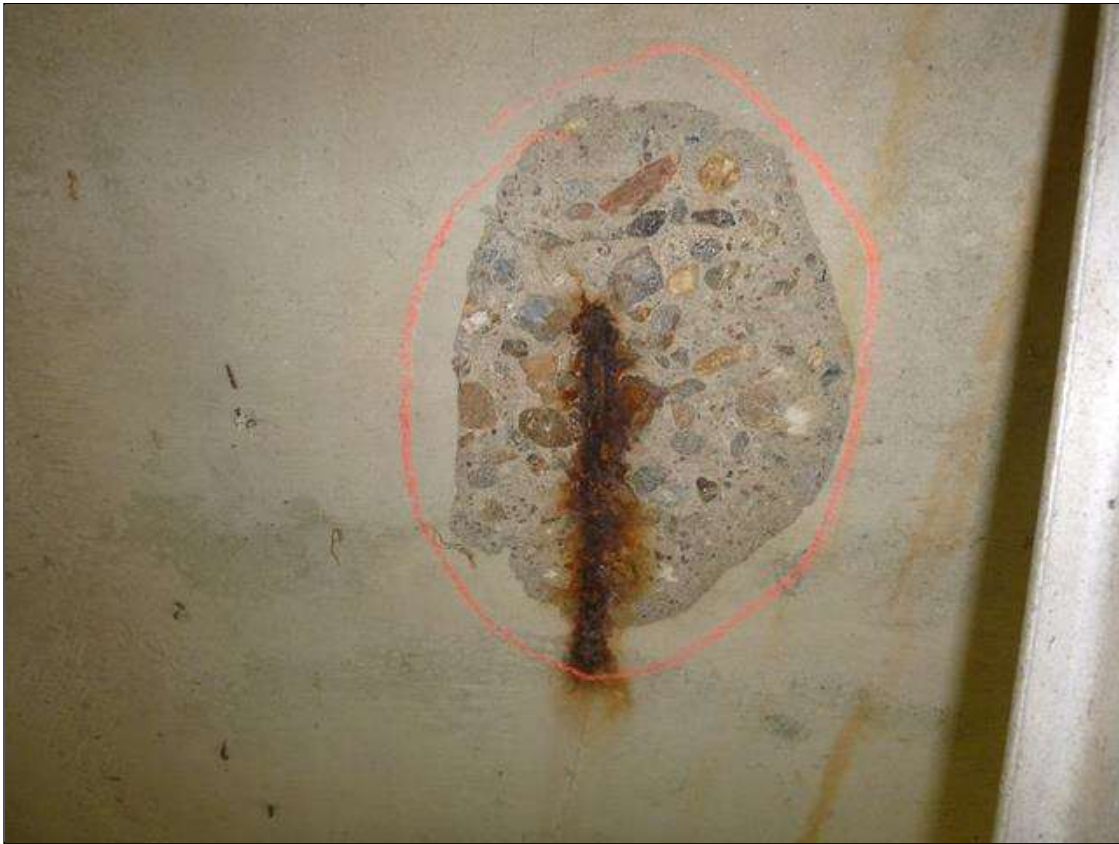
Bent 2 Cap 1: BENT 2 CAP, SPAN 2 SIDE HAS A SPALL ON THE FACE OF THE CAP IN BAY 7, 6 INCHES X 8 INCHES X 1/2 INCH DEEP WITH REBAR EXPOSED

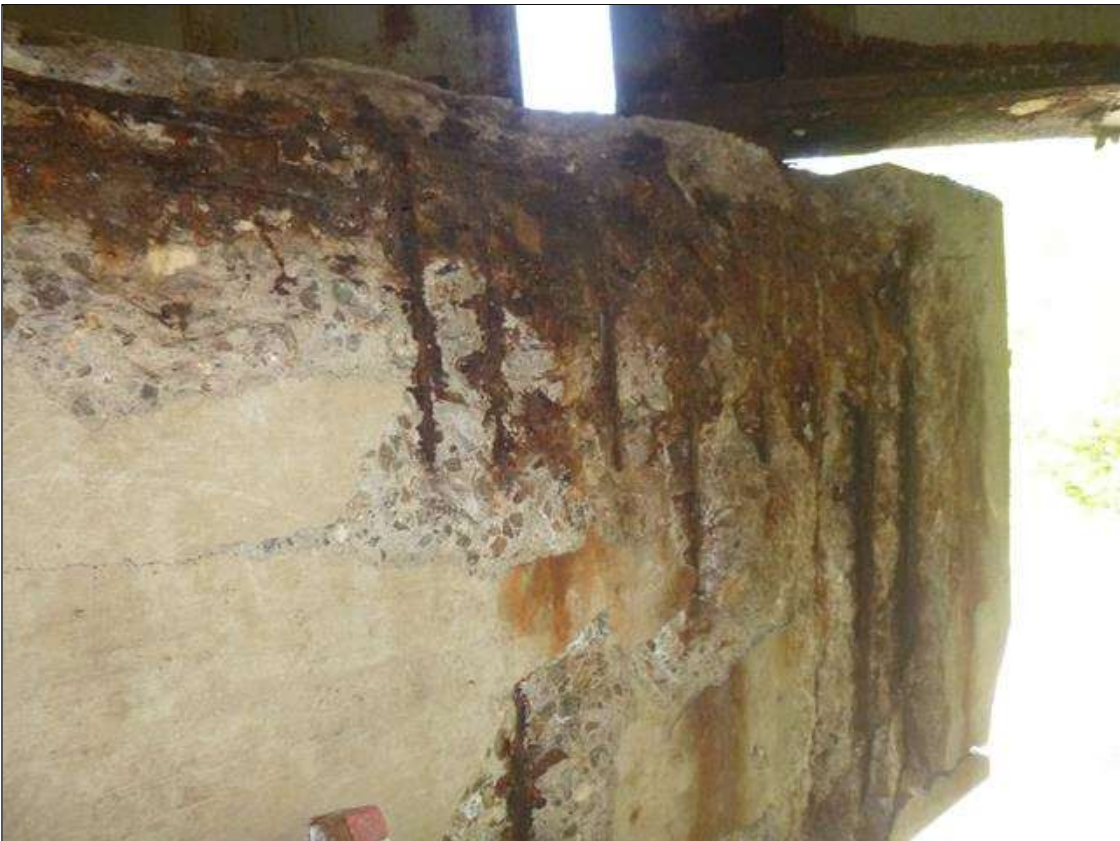
Bent 2 Cap 1: BENT 2 CAP, SPAN 3 SIDE HAS A SPALL STARTS UNDER BEAM 1 AND RUNS 9 FT. LONG IN BAY 1 X UP TO 36 INCHES HIGH X 3 INCHES DEEP WITH EXPOSED REBAR, BEARING AREA AT BEAM 1 IS SOUND

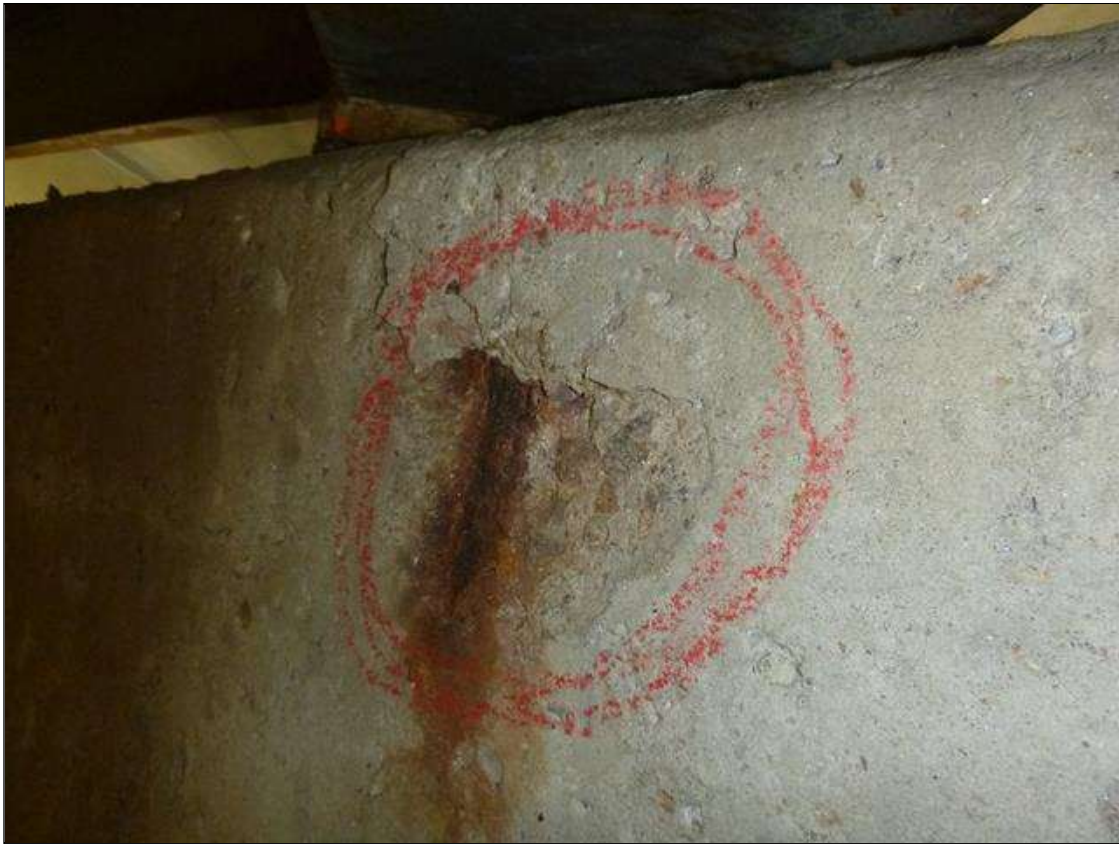
Bent 2 Cap 1: BENT 2 CAP, SPAN 3 SIDE HAS A SPALL IN THE FACE OF THE CAP UNDER BEAM 2, 5 INCHES X 4 INCHES X 3/4 INCH DEEP WITH EXPOSED REBAR, NEAR TOP EDGE

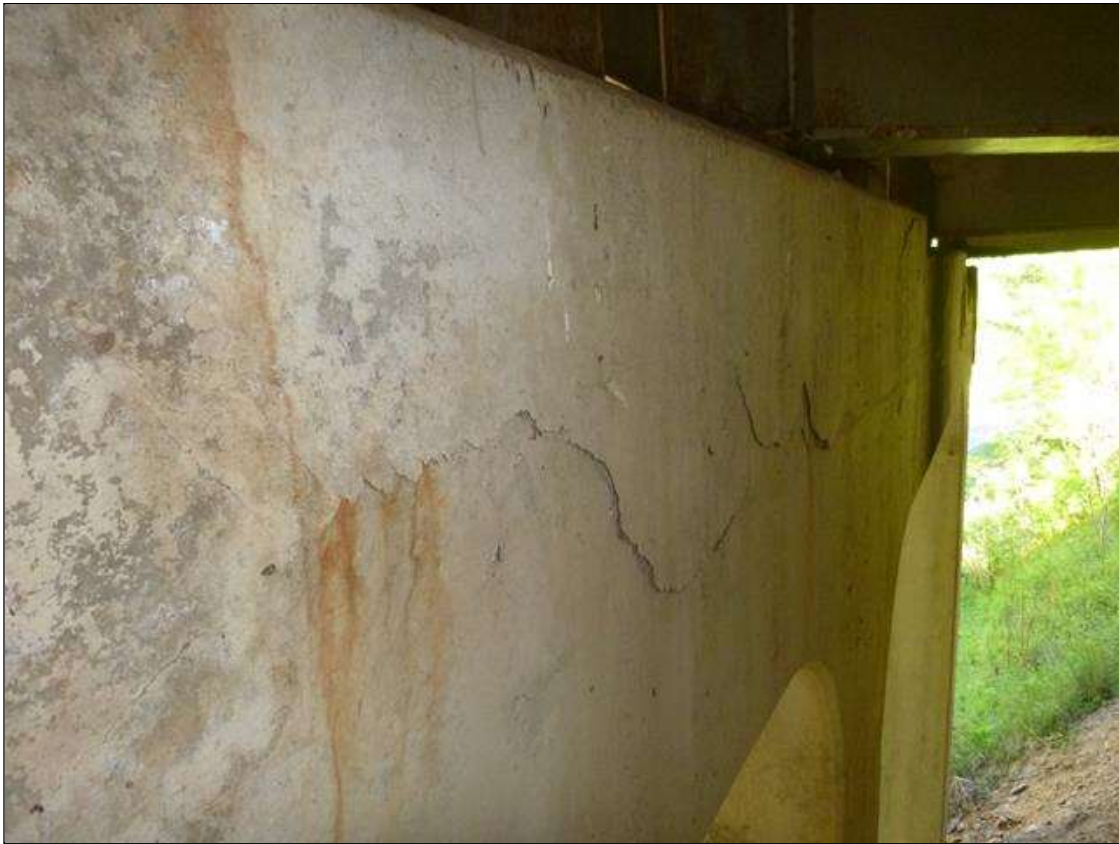
Bent 2 Cap 1: BENT 2 CAP, SPAN 3 SIDE HAS AN AREA OF DELAMINATION IN THE FACE OF THE CAP 15 FT. LONG STARTING AT BAY 2 RUNNING TO BEAM 4, X 18 INCHES HIGH X 5 INCHES ACROSS THE TOP OF THE CAP WITH 1/4 INCH SEPARATION, BEAM 3 BEARING AREA IS SOUND

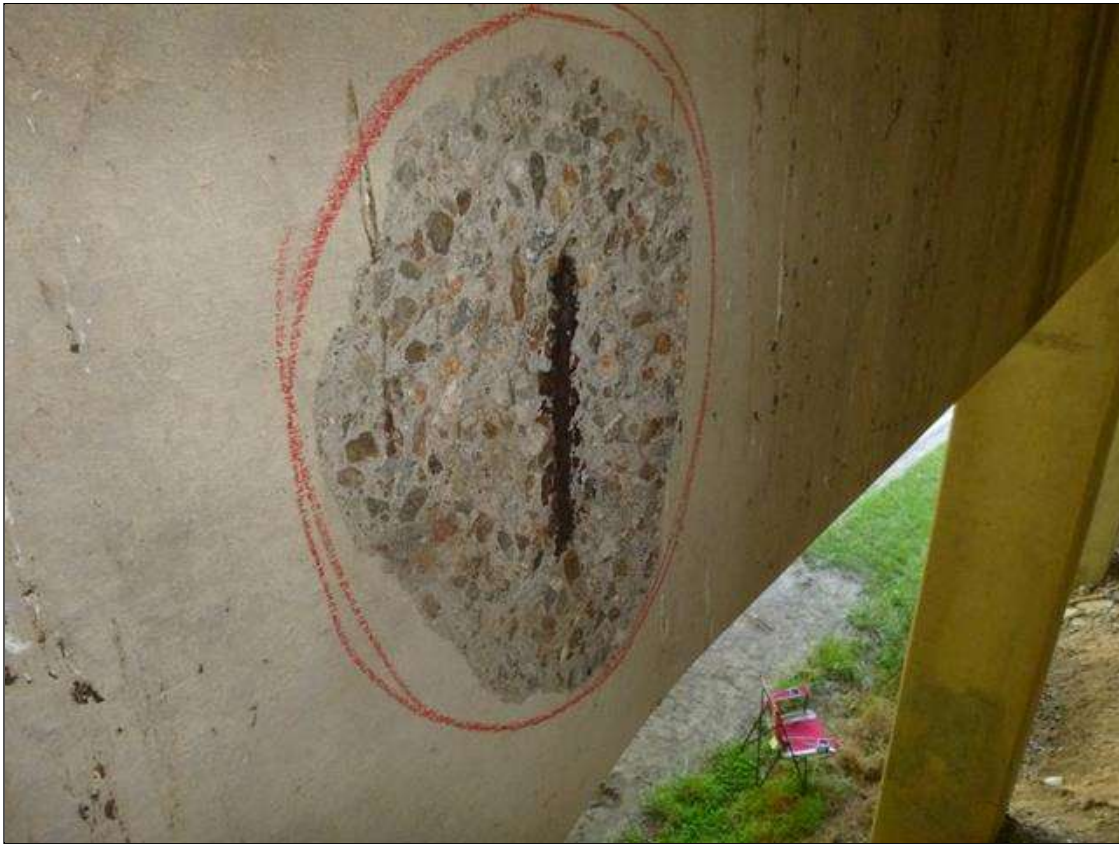
Bent 2 Cap 1: BENT 2 CAP, SPAN 3 SIDE HAS A SPALL ON THE FACE OF THE CAP IN BAY 4, 14 INCHES X 17 INCHES X 3/4 INCH DEEP WITH EXPOSED REBAR

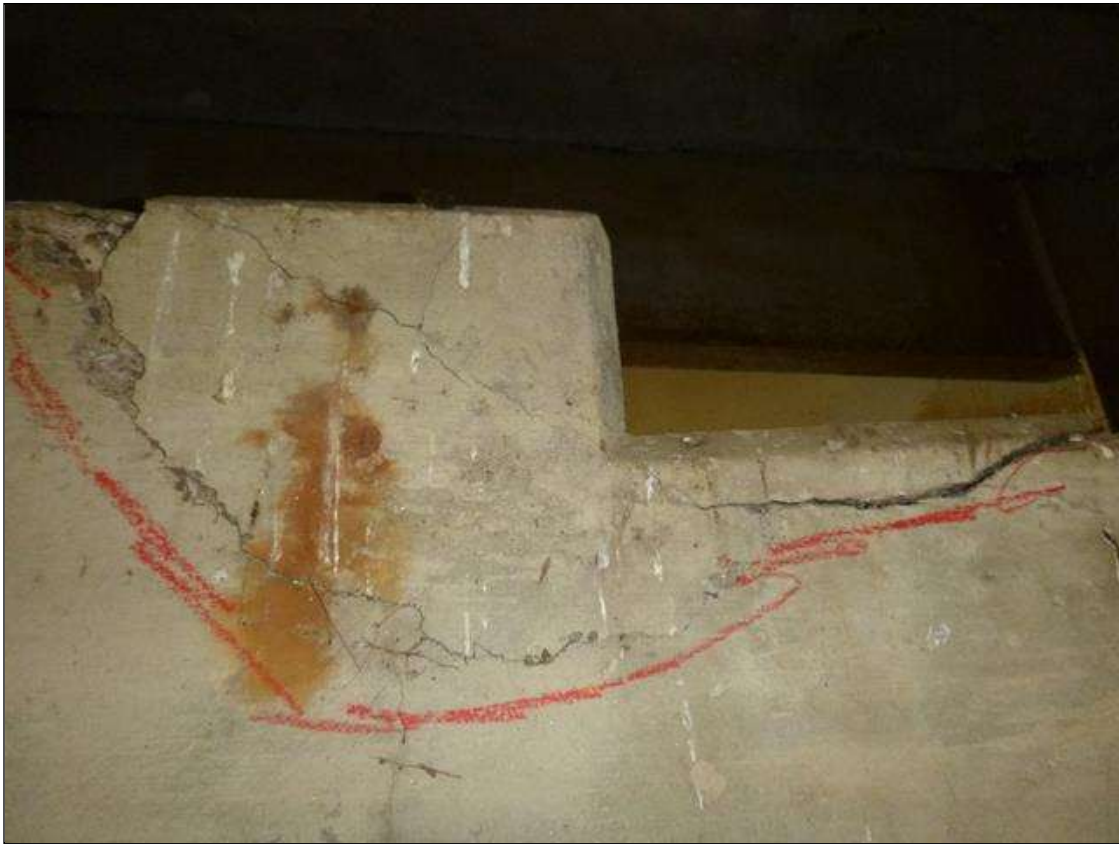
Bent 2 Cap 1: BENT 2 CAP, SPAN 3 SIDE HAS AN AREA OF DELAMINATION IN THE FACE OF THE CAP IN BAY 4 AT TOP EDGE, 24 INCHES X 12 INCHES AND ACROSS THE TOP OF THE CAP 9 INCHES WITH 1/4 INCH SEPARATION

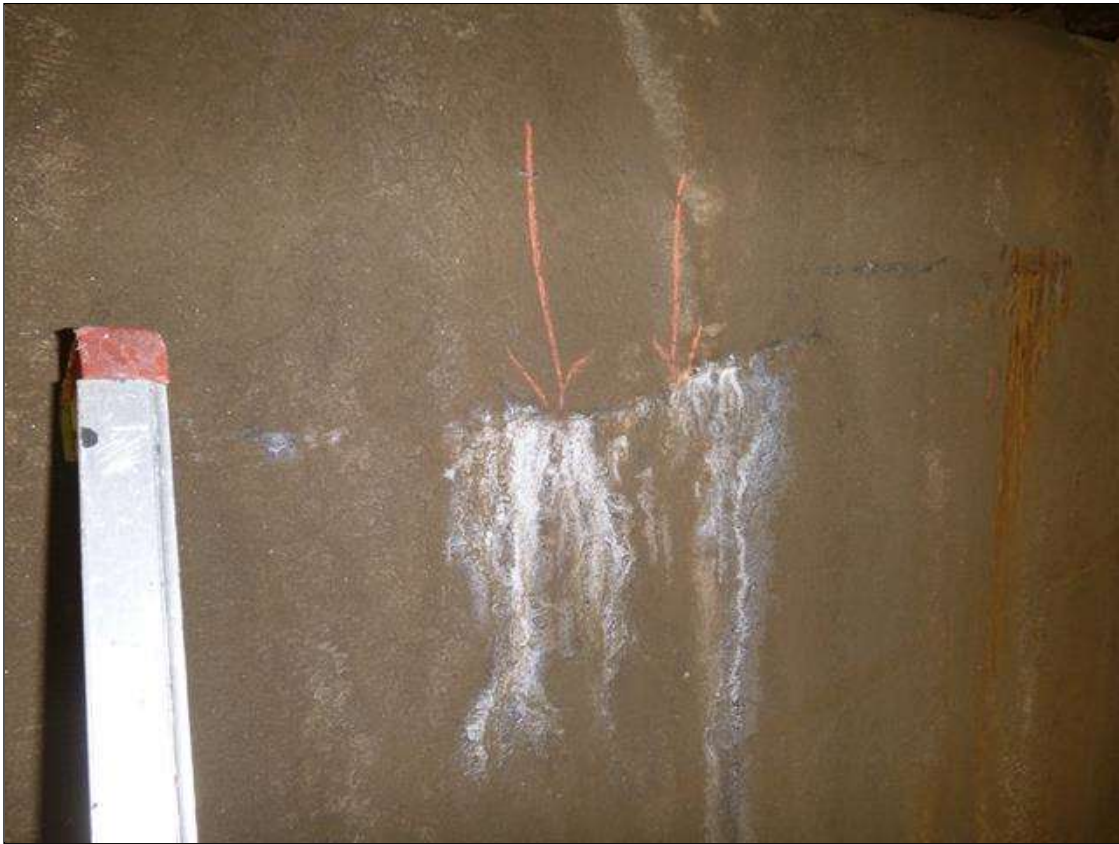
Bent 2 Cap 1: BENT 2 CAP, SPAN 3 SIDE HAS A HAIRLINE, 12 INCH LONG, LONGITUDINAL CRACK WITH EFFLO. IN BAY 8, NEAR TOP EDGE

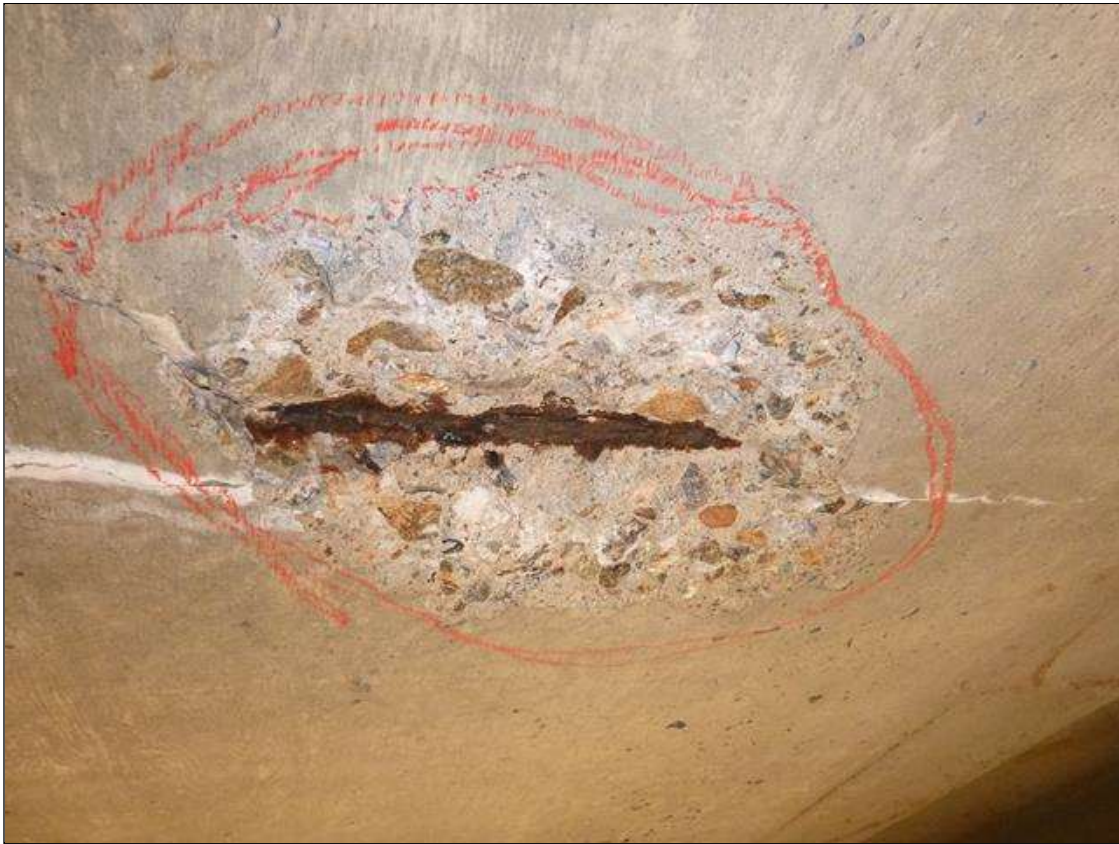
Span 3 Deck: SPAN 3 BOTTOM OF BAY 9 DECK HAS A SPALL, 8 INCHES X 11 INCHES X 1 INCH DEEP WITH EXPOSED REBAR , 16 FT. FROM END BENT 2

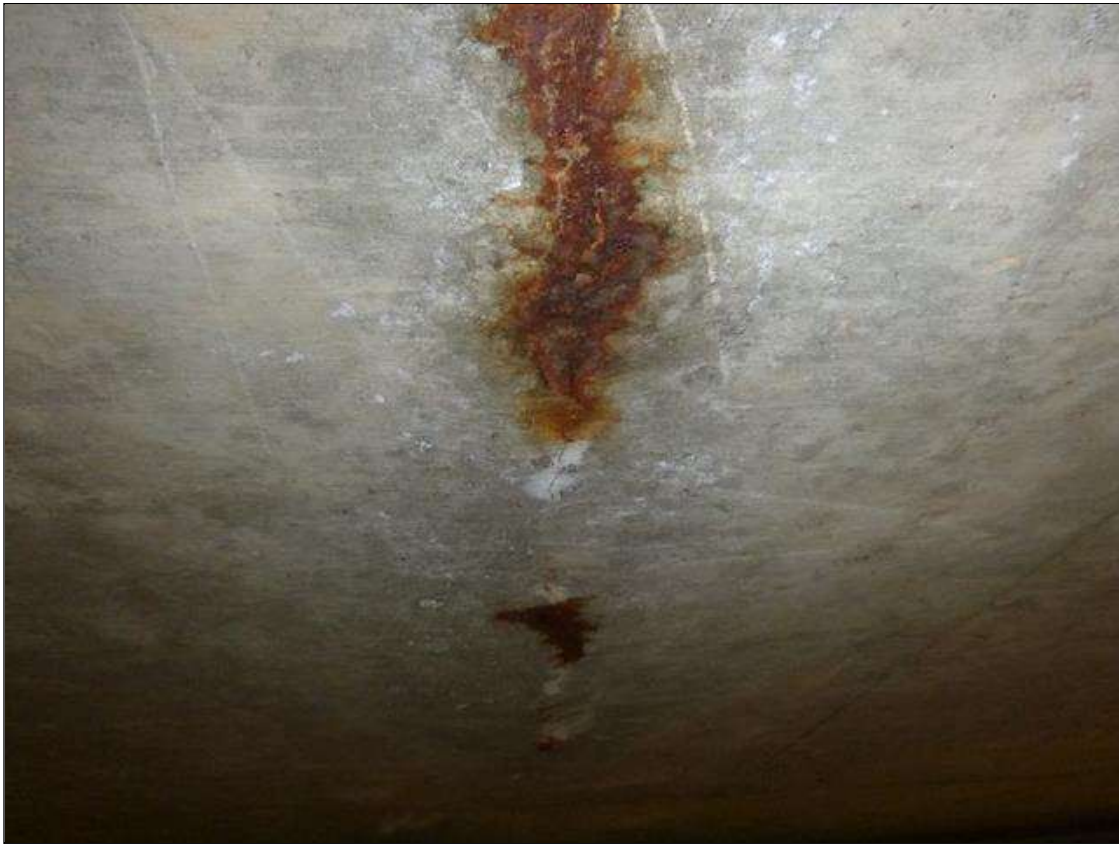
Span 3 Deck: SPAN 3, BAY 6 BOTTOM OF THE DECK HAS A HAIRLINE TRANSVERSE CRACK AT 2/3 POINT, 3 FT. LONG WITH EFFLO. AND RUST STAINS, FOR A TOTAL OF 120 SQ. FT. THRU OUT THE BOTTOM OF THE DECK WITH OR WITHOUT EFFLO. AND RUST STAINS

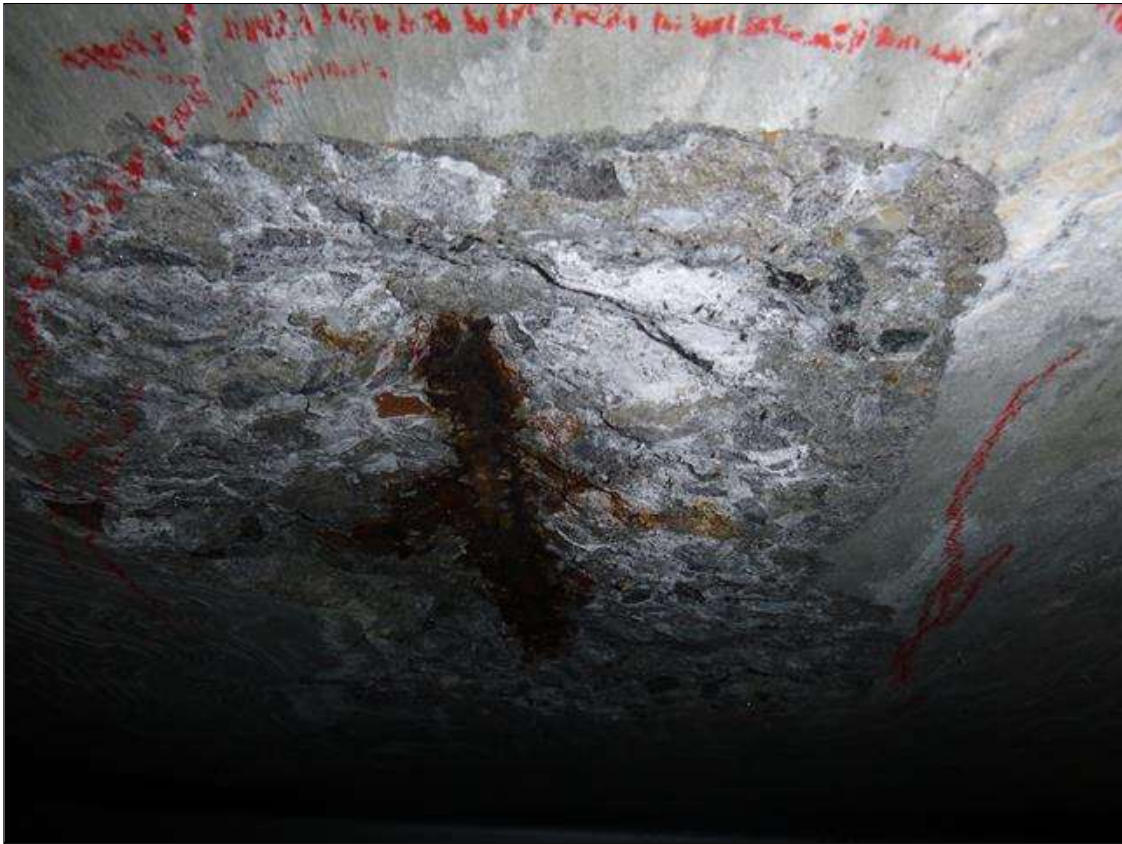
Span 3 Deck: SPAN 3 BOTTOM OF DECK, BAY 4, 6 FT. FROM END BENT 2 HAS A SPALL, 9 INCHES X 16 INCHES X 1 INCH DEEP WITH REBAR EXPOSED

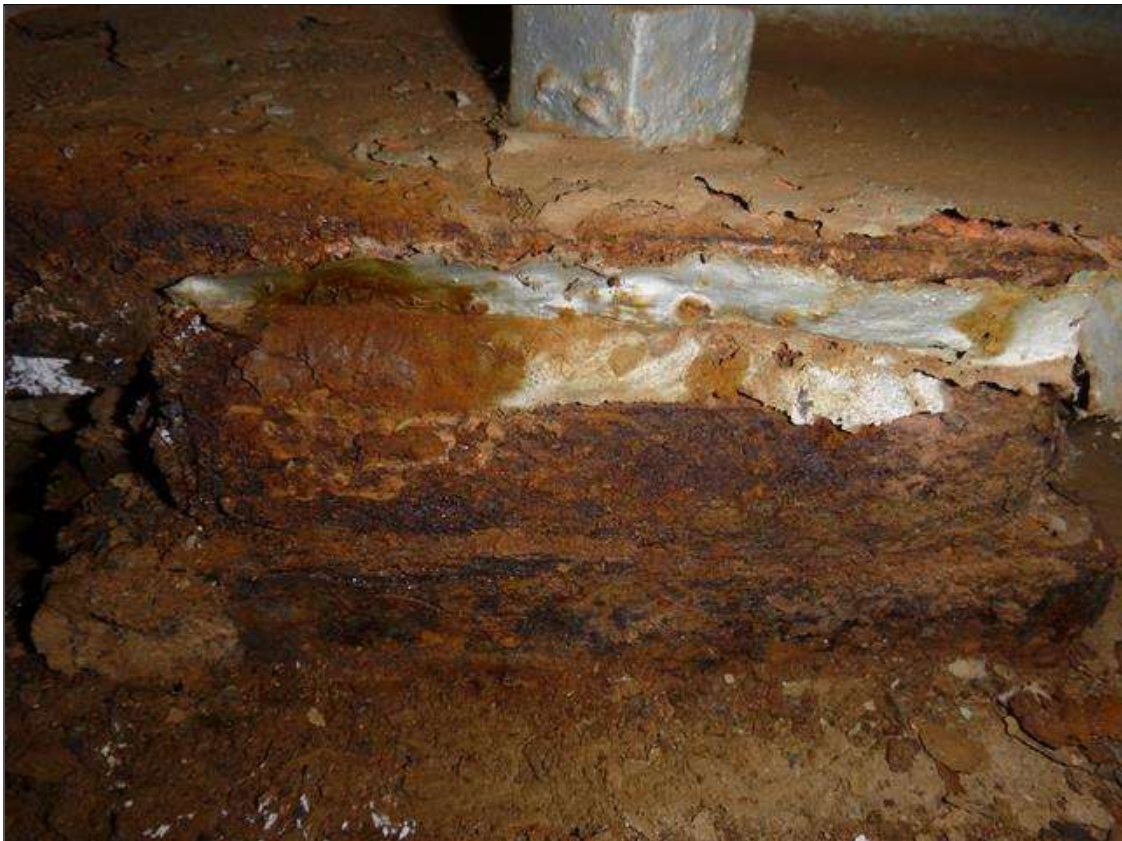
Span 3 Beam 5 Far Bearing: SPAN 3, BEAM 5 FAR BEARING HAS 1/32 INCH SECTION LOSS

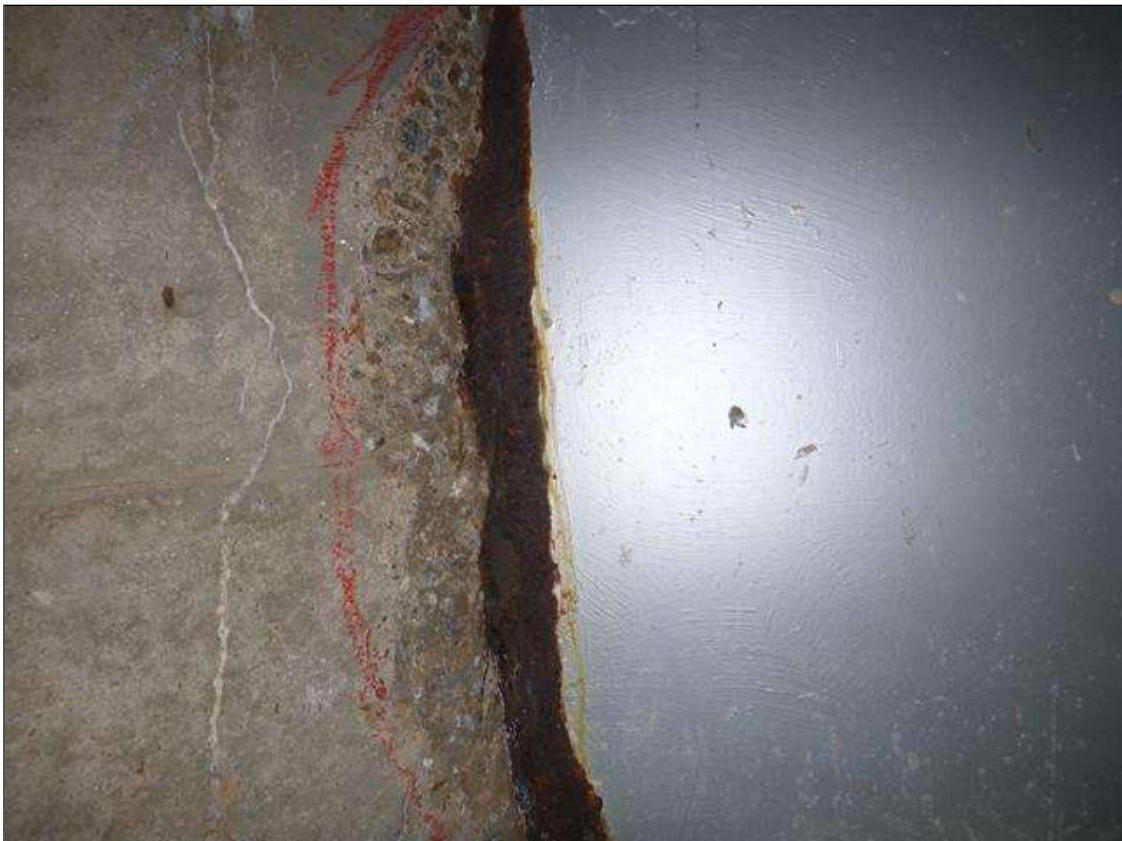
End Bent 2 Abutment/Backwall : END BENT 2 ABUTMENT HAS A SPALL ADJACENT TO BEAM 4, 24 INCHES HIGH X 4 INCHES WIDE X 1.5 INCHES DEEP IN BAY 3

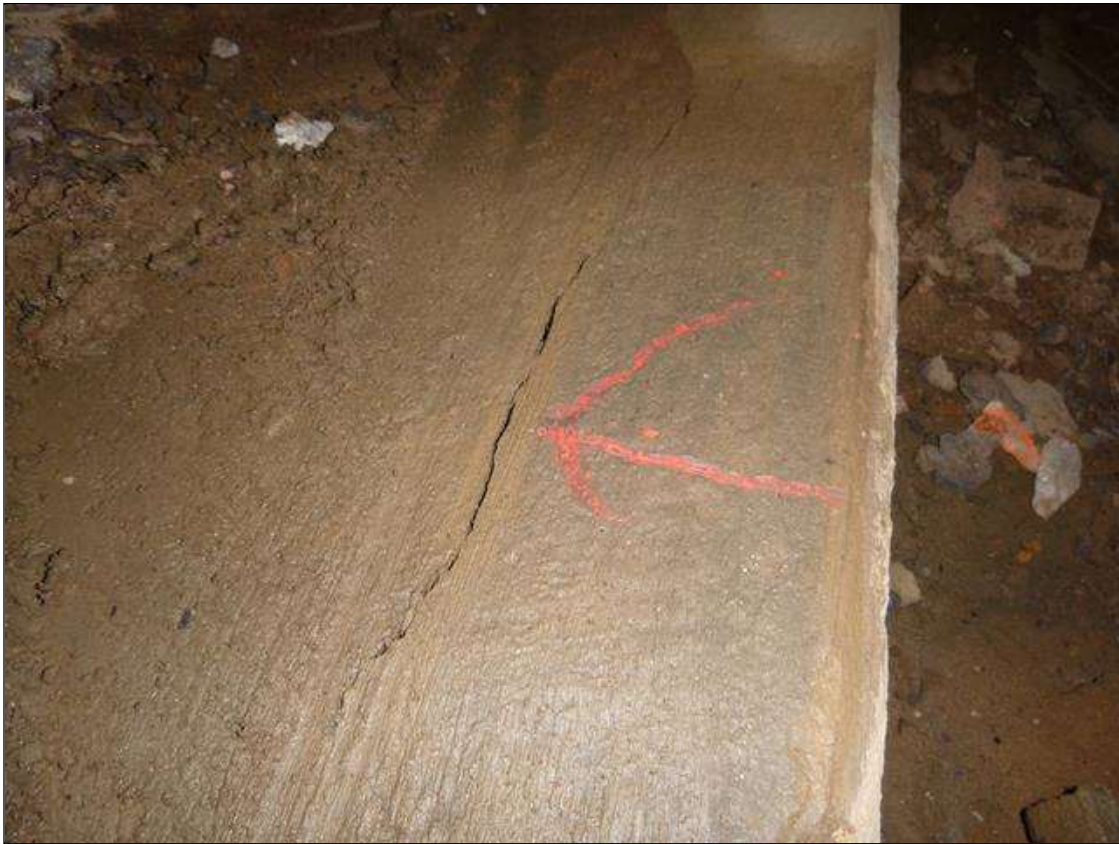
End Bent 2 Cap 1: END BENT 2 CAP, BAY 3 HAS A LONGITUDINAL CRACK IN THE TOP, 1/8 INCH WIDE X 4 FT. LONG, 4 INCHES FROM THE FRONT EDGE

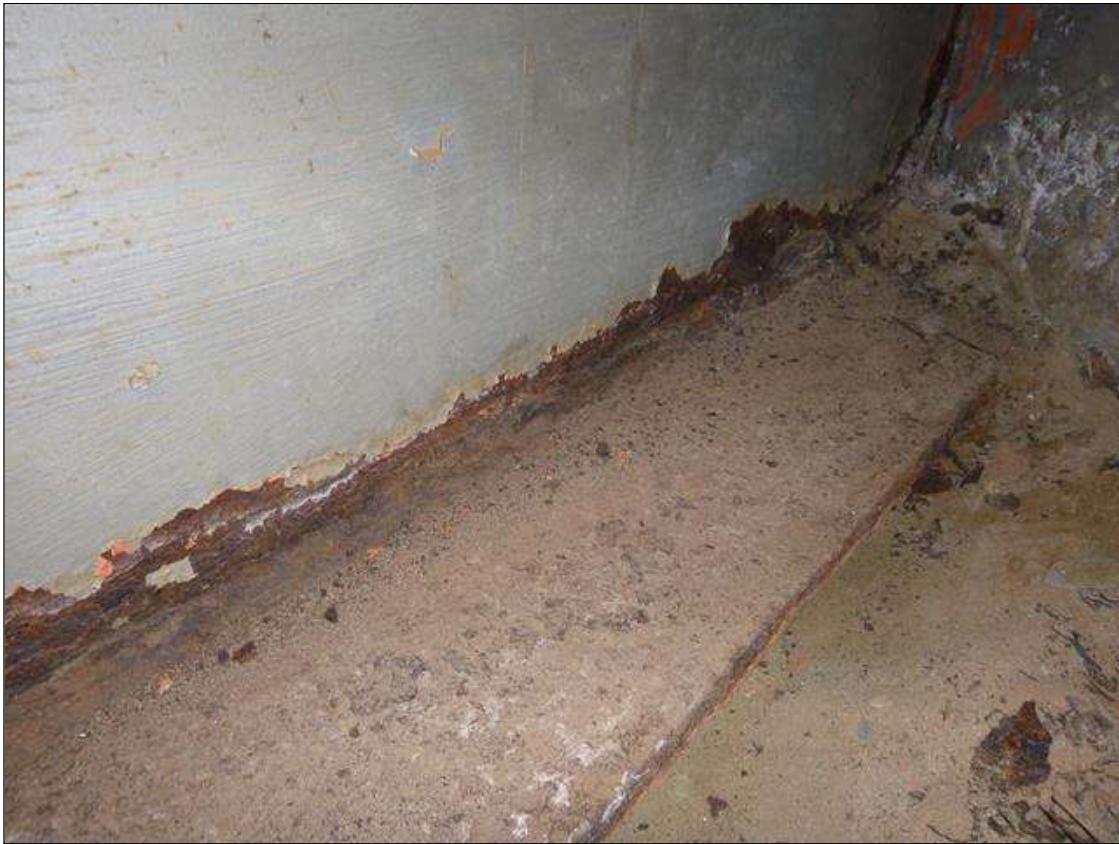
Span 3 Beam 3: SPAN 3, BEAM 3 AT END BENT 2 HAS  $\frac{1}{32}$  INCH SECTION LOSS ON THE BOTTOM FLANGE FROM THE CENTERLINE OF BEARING OUT 3 FT. X FULL WIDTH WITH  $\frac{31}{32}$  INCH REMAINING, THE WEB HAS  $\frac{1}{32}$  INCH SECTION LOSS IN THE LOWER WEB FROM THE CENTERLINE OF BEARING OUT 3 FT. X 3 INCHES HIGH WITH  $\frac{23}{32}$  INCH REMAINING

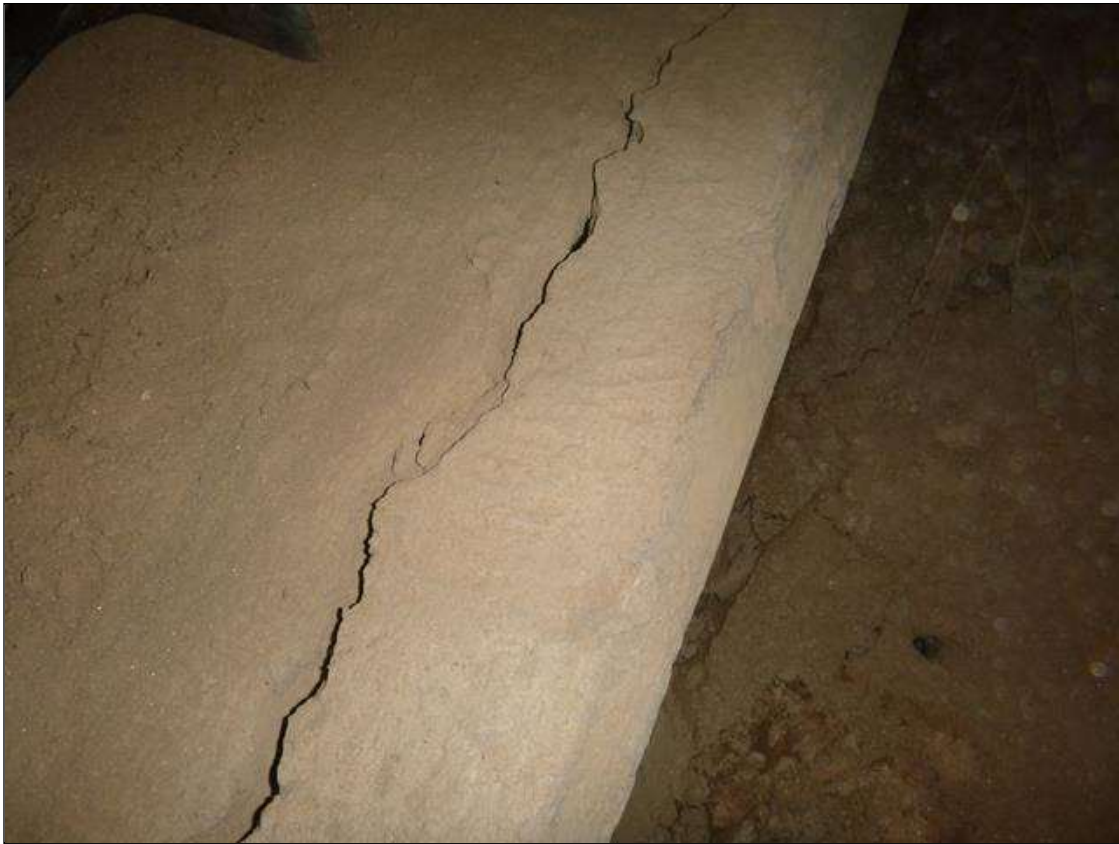
End Bent 2 Cap 1: END BENT 2 CAP, BAY 2 HAS AN AREA OF DELAMINATION IN THE TOP AND FACE, 8 FT. LONG WITH 1/4 INCH SEPARATION, 4 INCHES ACROSS THE TOP X 6 INCHES DOWN THE FRONT FACE, PHOTO TAKEN AT TOP OF CAP

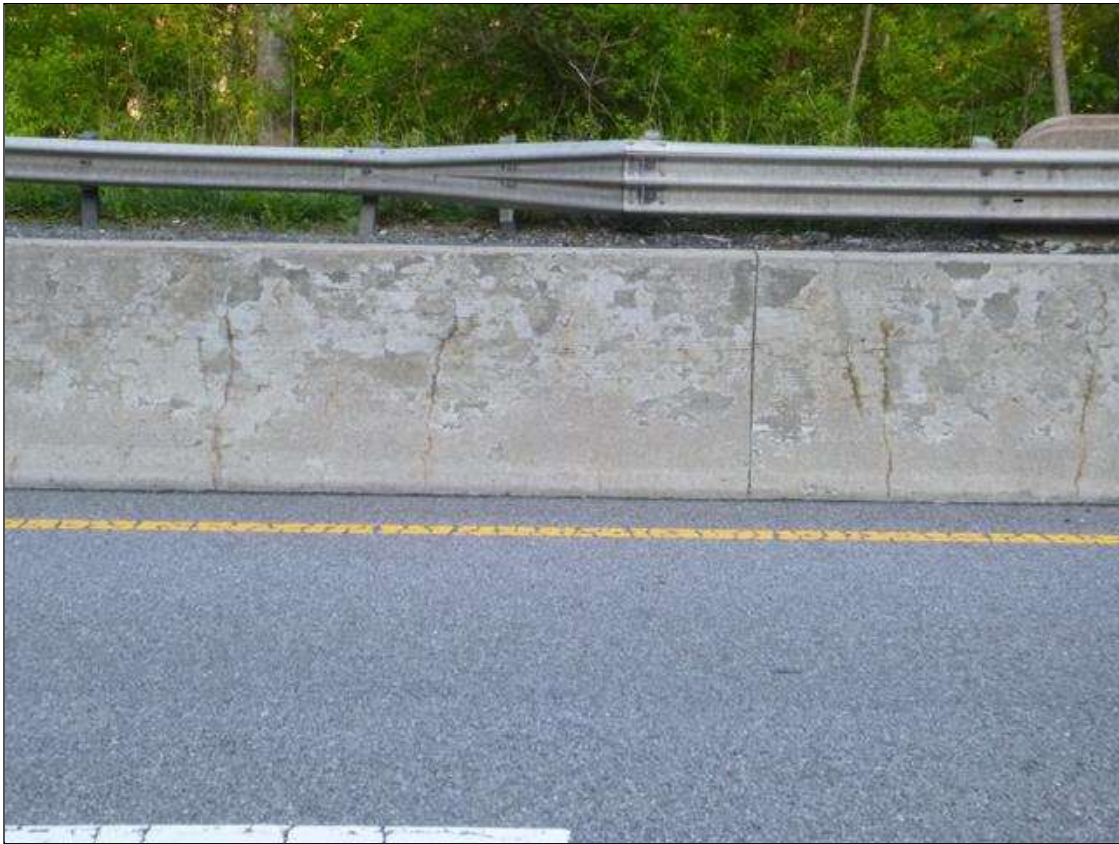
| Element Number | Defect Type | Defect Description | CS | CS Qty | Maint Qty | |
|---|---|---|---|---|---|---|
| 331 | Cracking (RC and Other) | SPAN 1 MEDIAN RAIL HAS 38 FT. OF HAIRLINE TO 1/16 INCH WIDE MAP CRACKING THRU OUT RAIL | 3 | 38 | 38 | Feet |

Span 1 Median Rail: SPAN 1 MEDIAN RAIL HAS 38 FT. OF HAIRLINE TO 1/16 INCH WIDE MAP CRACKING THRU OUT RAIL

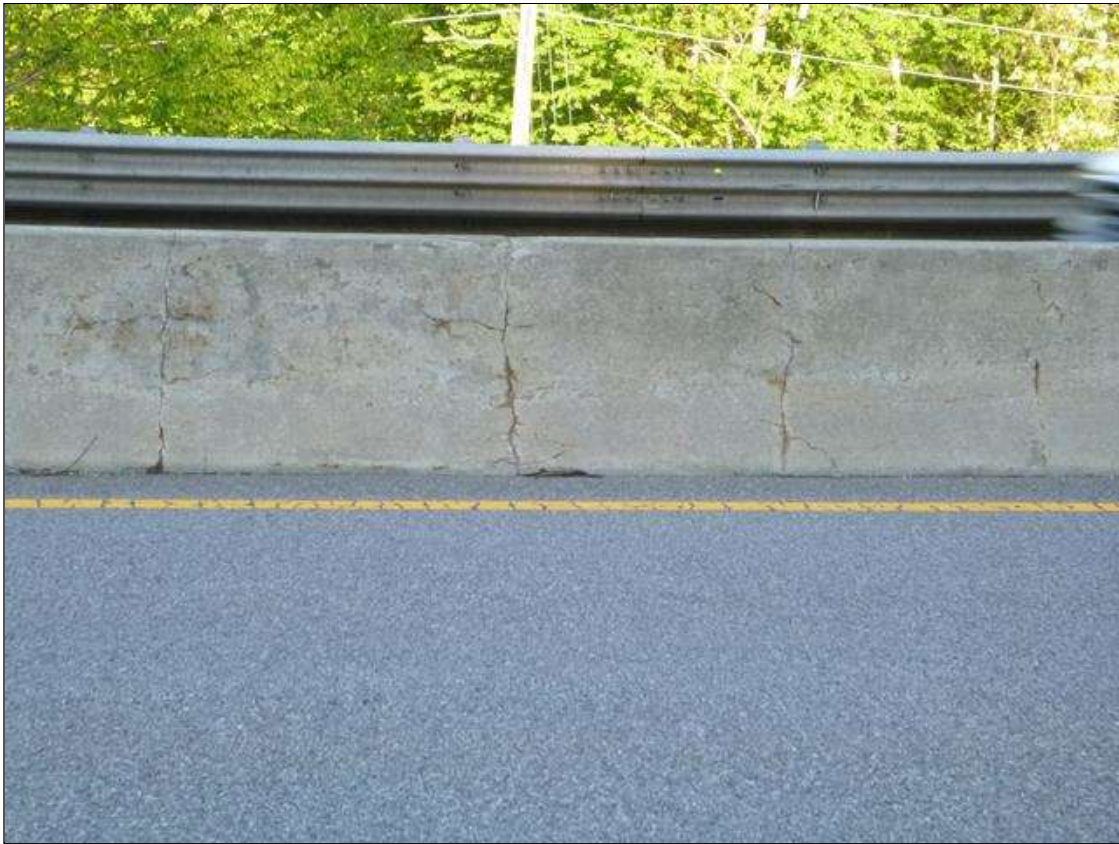
Span 3 Median Rail: SPAN 3 MEDIAN RAIL HAS 75 FT. OF HAIRLINE TO 1/16 INCH WIDE MAP CRACKING THRU OUT RAIL

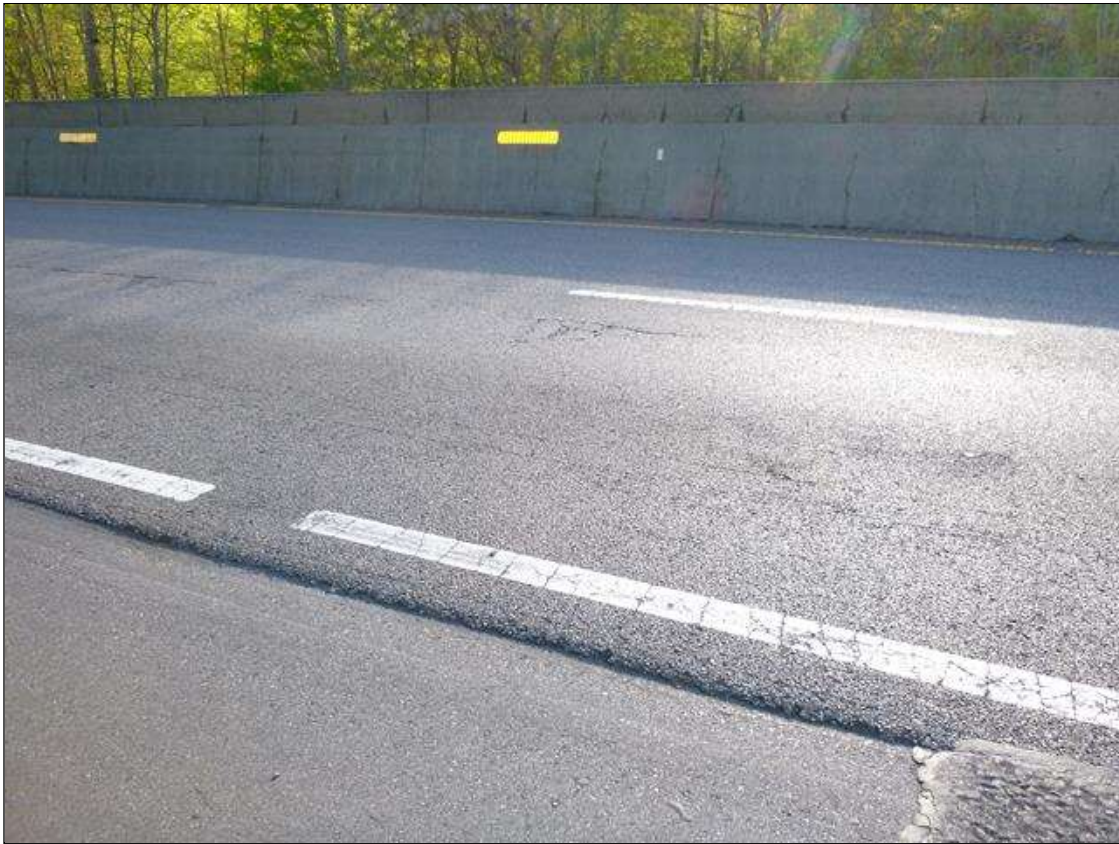
END BENT 2 ASPHALT WEARING SURFACE APPROACH GOOD CONDITION, WEST BOUND LANES

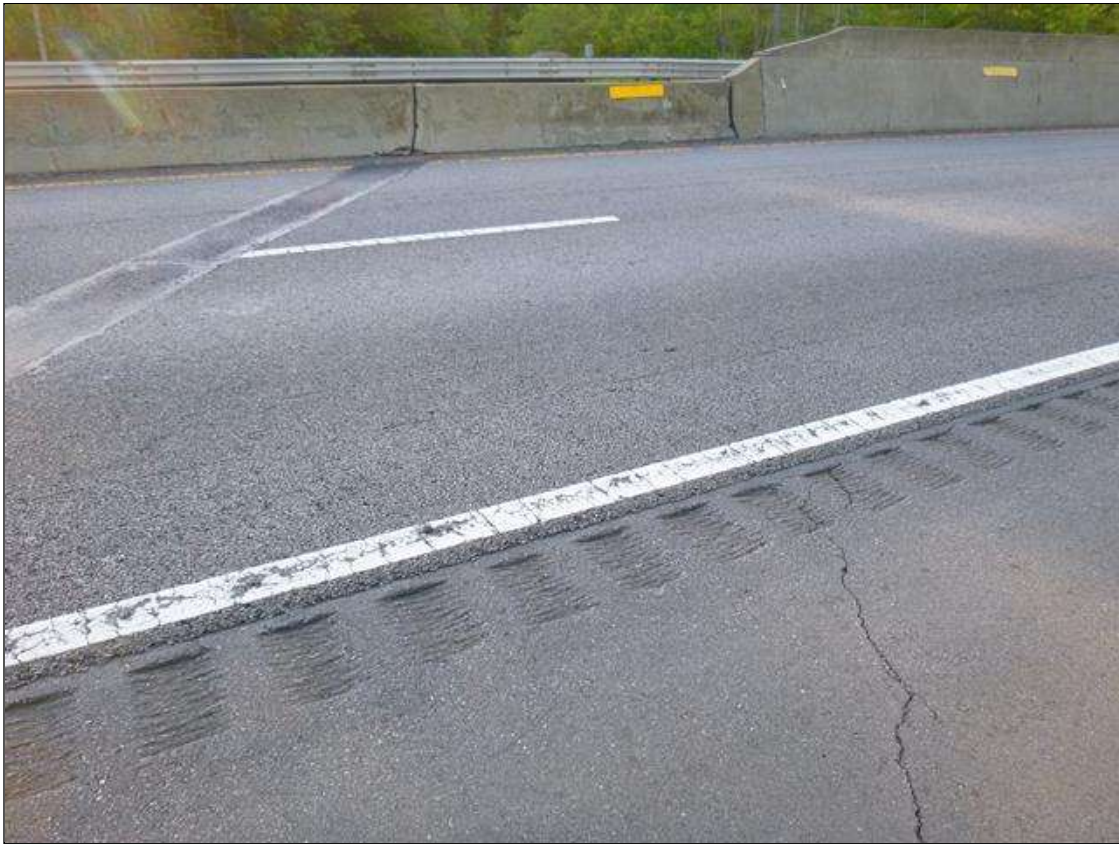
END BENT 1 ASPHALT WEARING SURFACE APPROACH GOOD CONDITION, WEST BOUND LANES
