NC DEPARTMENT OF TRANSPORTATION  
DIVISION OF HIGHWAYS  
STRUCTURE MANAGEMENT UNIT

## Structure Safety Report

### Routine Element Inspection - Contract

COUNTY: HAYWOOD STRUCTURE NUMBER: 430171 FREQUENCY: 24 MONTHS

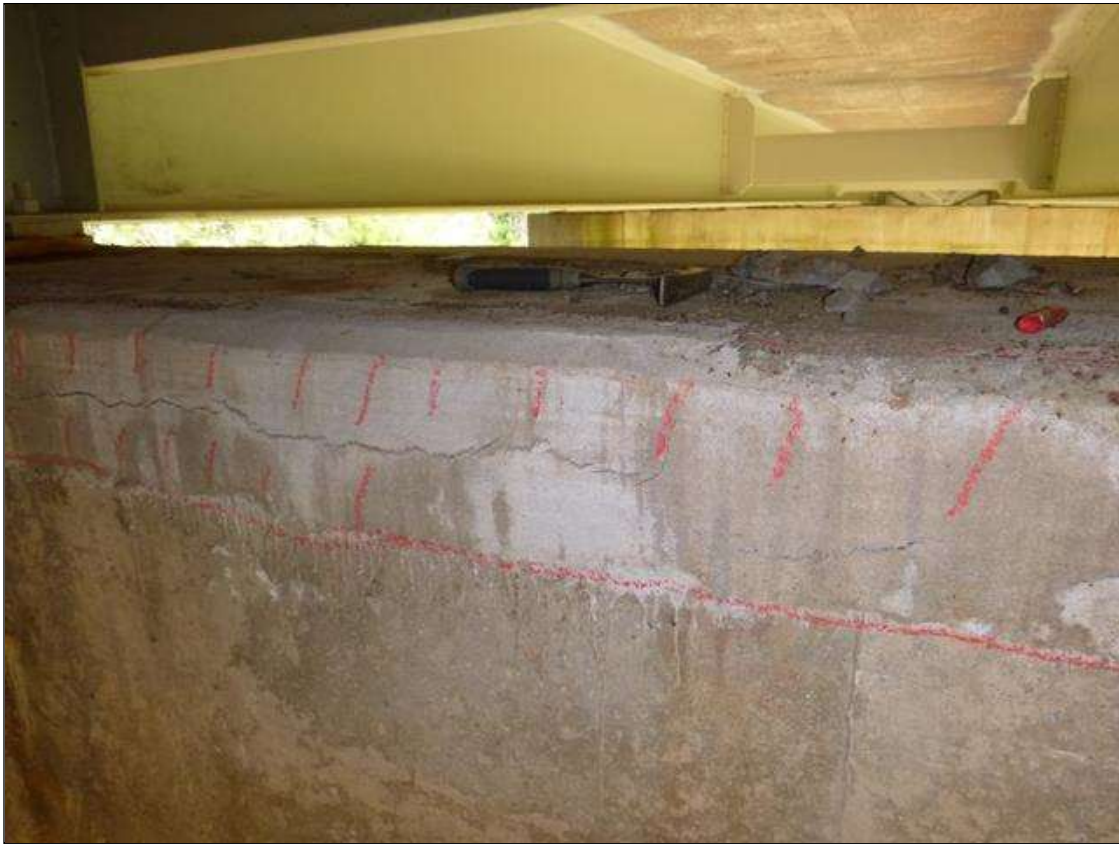
Bent 5 Cap 1: BENT 5 CAP, SPAN 6 SIDE, BAY 4 AT TOP EDGE HAS A PATCHED AREA WITH 1/8 INCH WIDE LONGITUDINAL CRACKING , 5 FT. LONG X 6 INCHES DOWN THE FACE AND GOES 3 INCHES ACROSS THE TOP

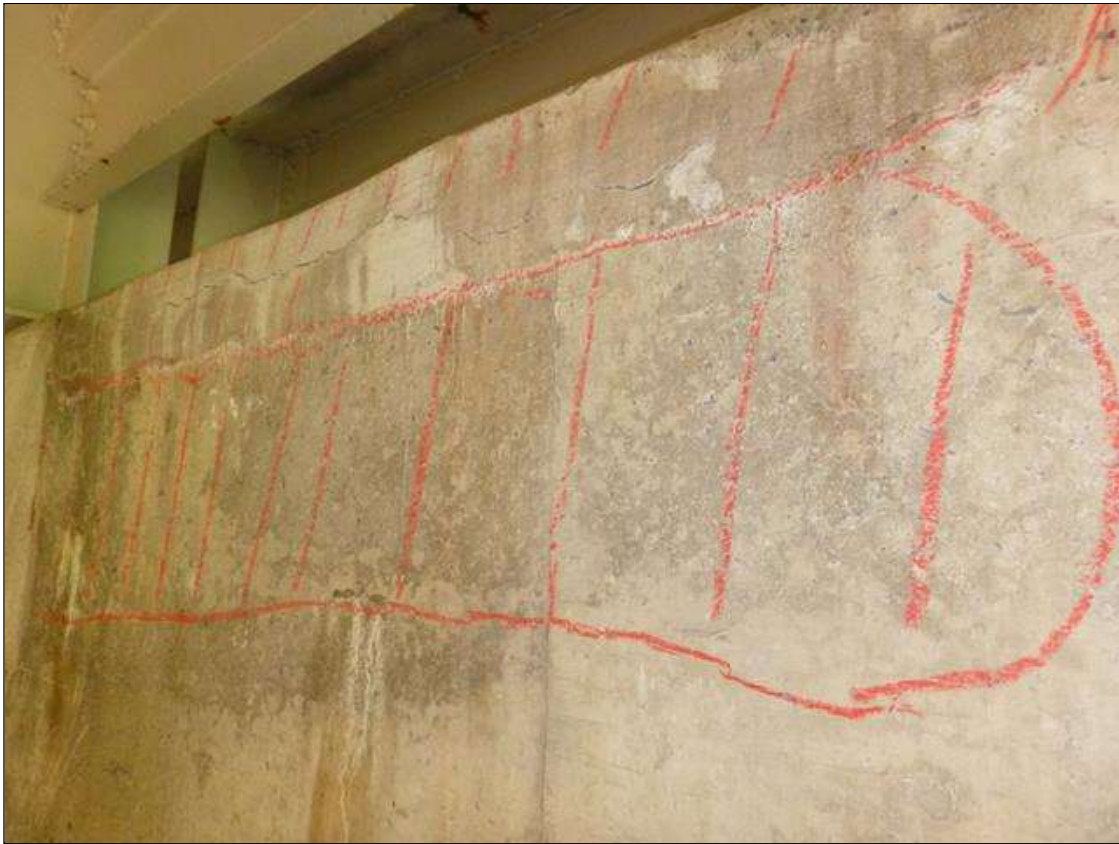
Bent 5 Cap 1: BENT 5 CAP, SPAN 6 SIDE HAS AN AREA OF DELAMINATION IN THE FACE OF THE CAP IN BAY 4. 5 FT. LONG X 1 FT. HIGH

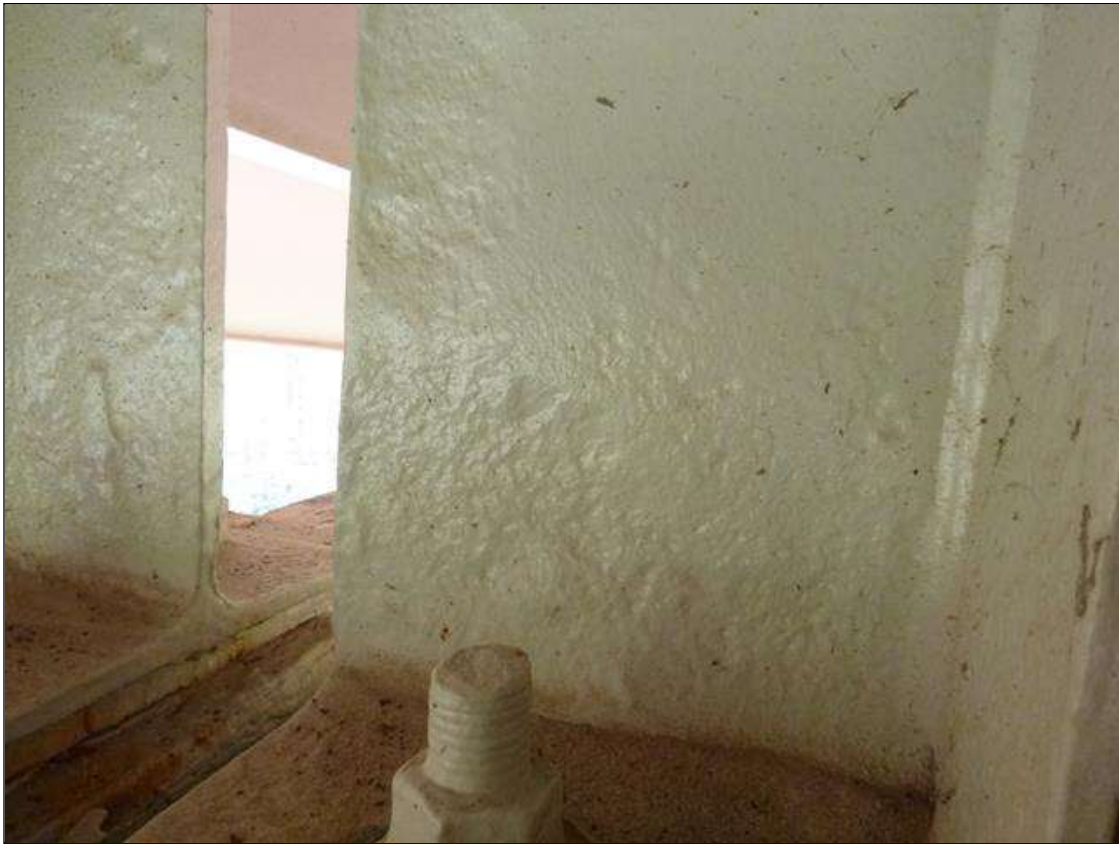
Span 6 Beam 4: SPAN 6, BEAM 4 AT BENT 5 HAS 1/16 INCH SECTION IN THE WEB FROM THE BEAM END OUT 10 INCHES X 12 INCHES HIGH WITH 9/16 INCH REMAINING, PAINTED OVER

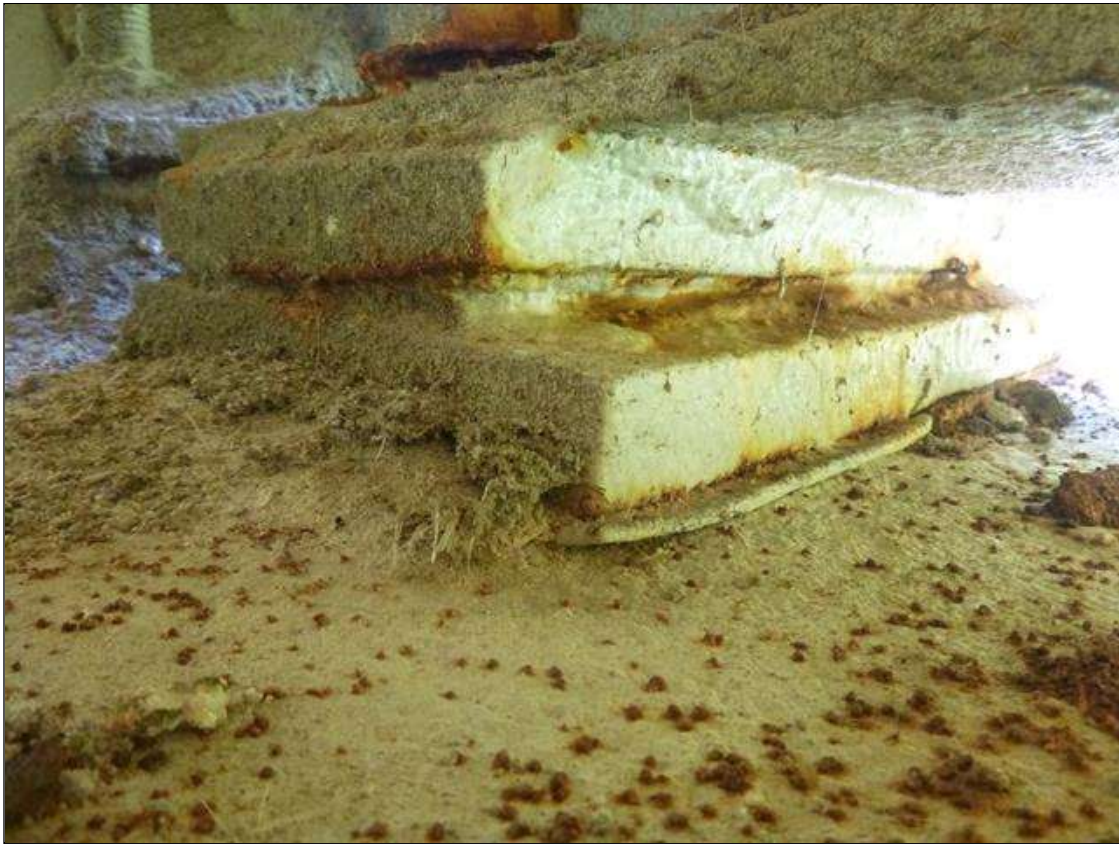
Span 6 Beam 1 Near Bearing: SPAN 6, BEAM 1 NEAR BEARING HAS FRECKLED RUST

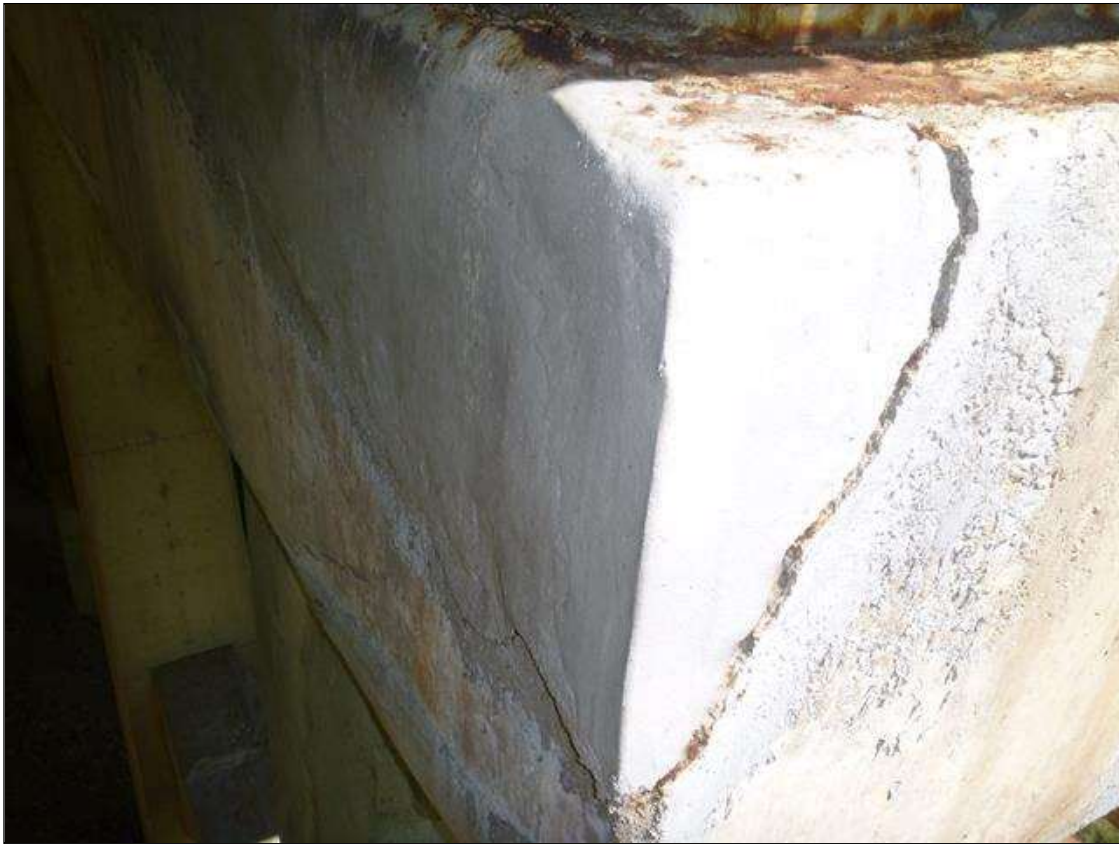
Bent 5 Cap 1: BENT 5 CAP, SPAN 6 SIDE HAS A PATCHED AREA IN THE FACE OF THE CAP, STARTING AT THE LEFT END OF THE CAP, 104 INCHES LONG AND UP TO 16 INCHES HIGH WITH DELAMINATION AND UP TO 1 INCH WIDE CRACKING

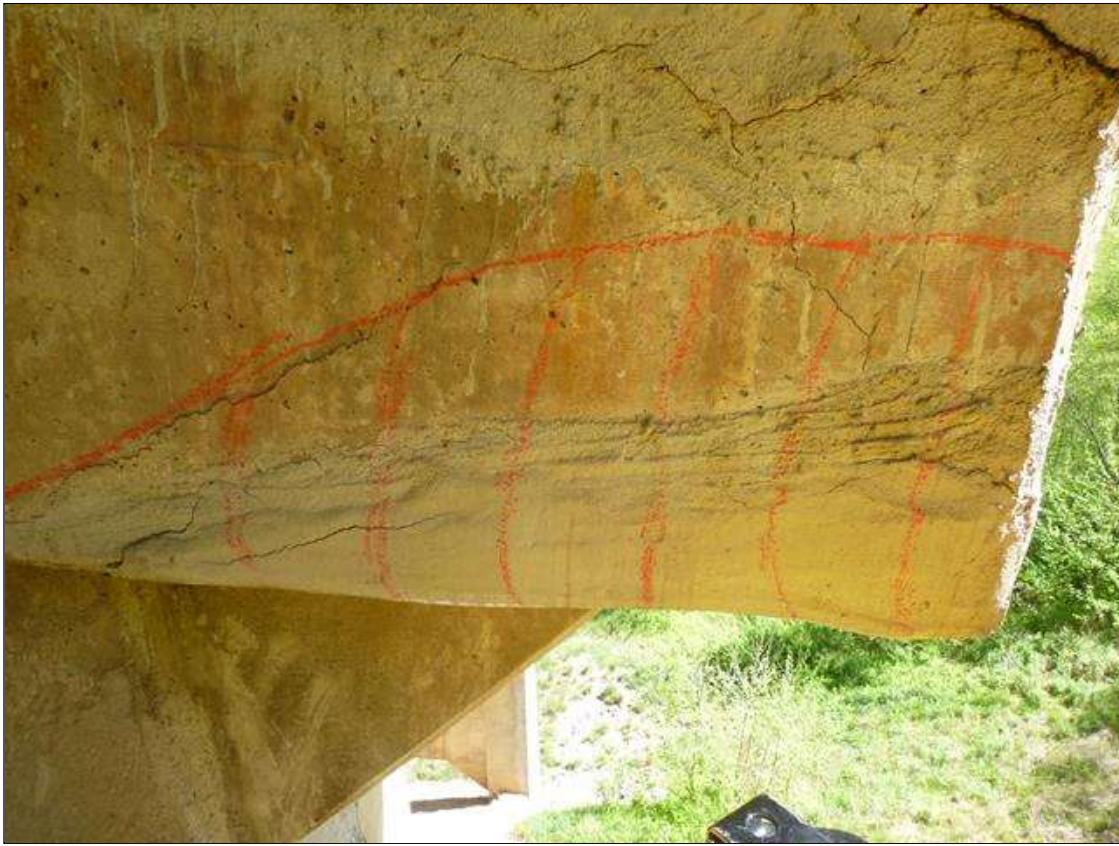
Bent 5 Cap 1: BENT 5 CAP, SPAN 6 SIDE HAS AN AREA OF DELAMINATION IN THE FACE OF THE CAP, UNDER BEAM 1, 36 INCHES X 14 INCHES, WITH 1/8 INCH SEPARATION, NEAR THE BOTTOM EDGE AT THE END OF THE CAP

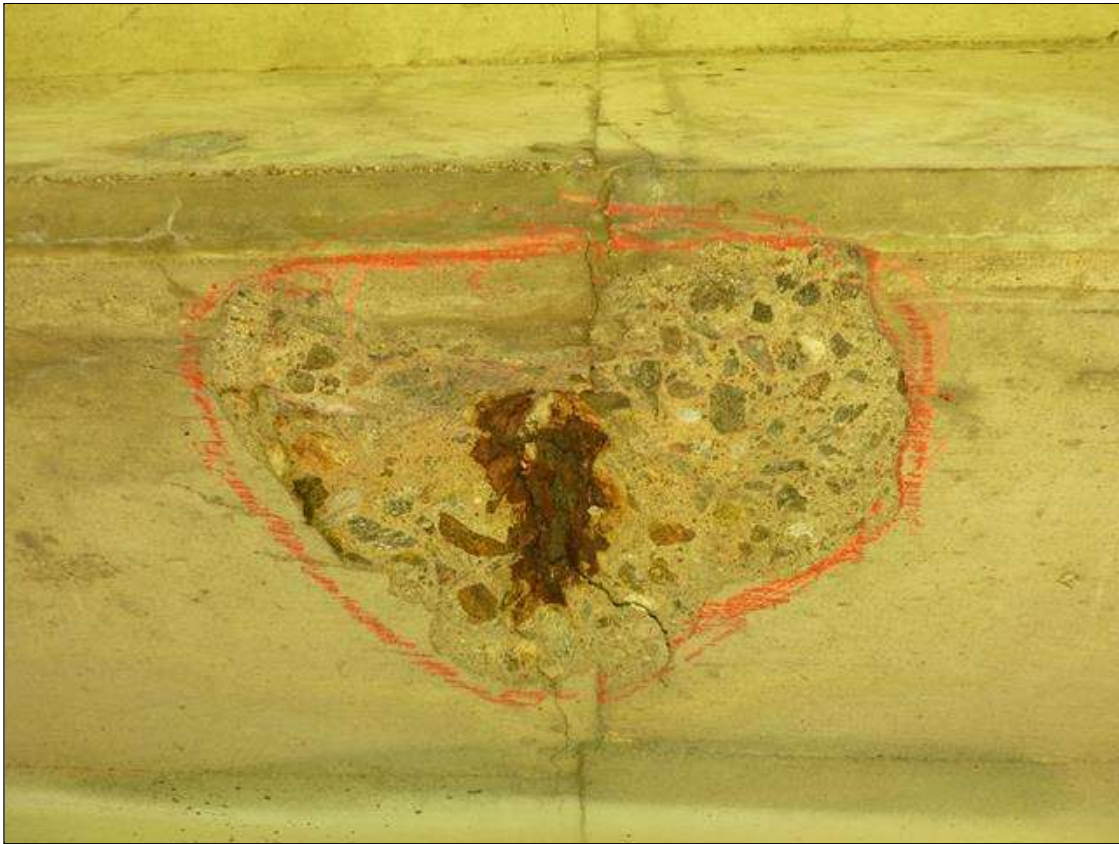
SPAN 5, BOTTOM OF LEFT OVERHANG, 5 FT. FROM BENT 5 HAS A 8 INCH DIAMETER X 2 INCH DEEP SPALL WITH REBAR EXPOSED, FOR A TOTAL OF 3 SQ. FT. OF SPALLS WITH REBAR EXPOSED IN THE LEFT OVERHANG

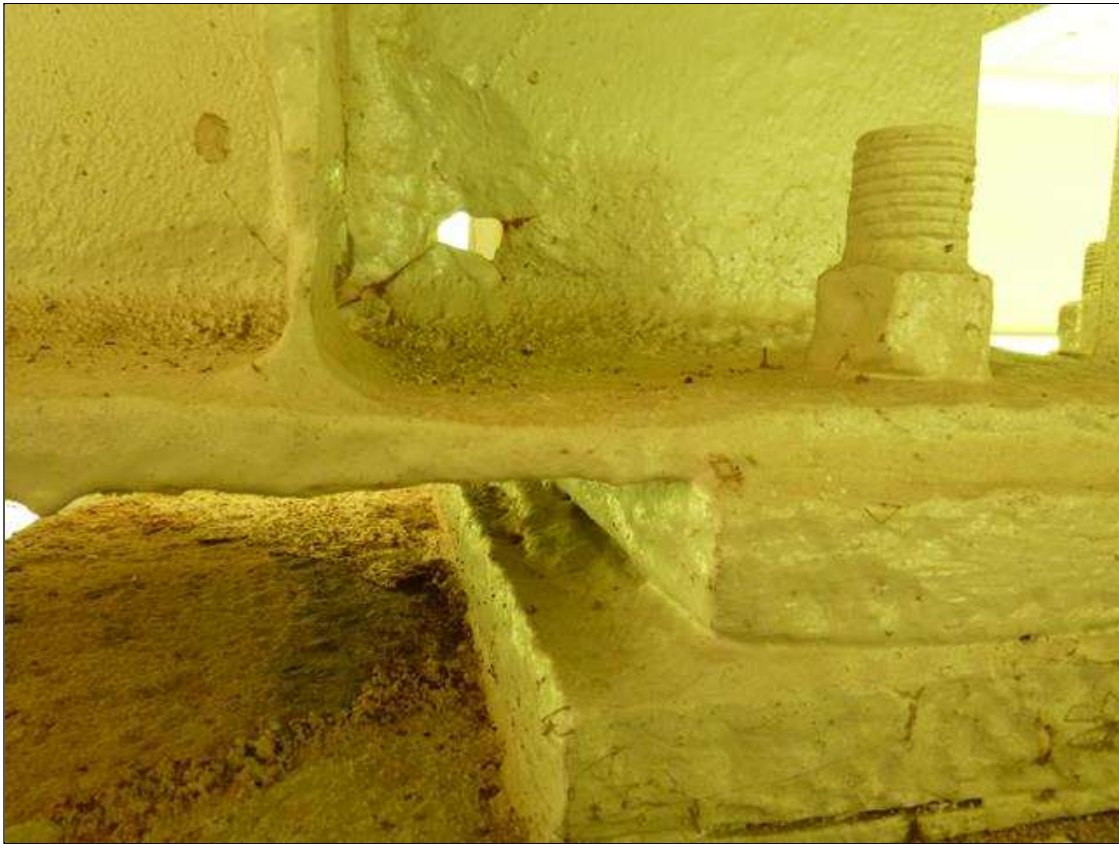
Span 5 Beam 2: SPAN 5, BEAM 2 AT BENT 5 HAS A 1 INCH DIAMETER HOLE RUSTED THRU THE WEB, 7.5 INCHES FROM THE END OF THE BEAM AND 1 INCH ABOVE THE BOTTOM FLANGE, THE BOTTOM FLANGE HAS 3/8 INCH SECTION LOSS FROM FACE OF BEARING OUT 2 INCHES X FULL WIDTH WITH 1/4 INCH REMAINING, PREVIOUS SECTION LOSS TO BEAM HAS BEEN PAINTED OVER

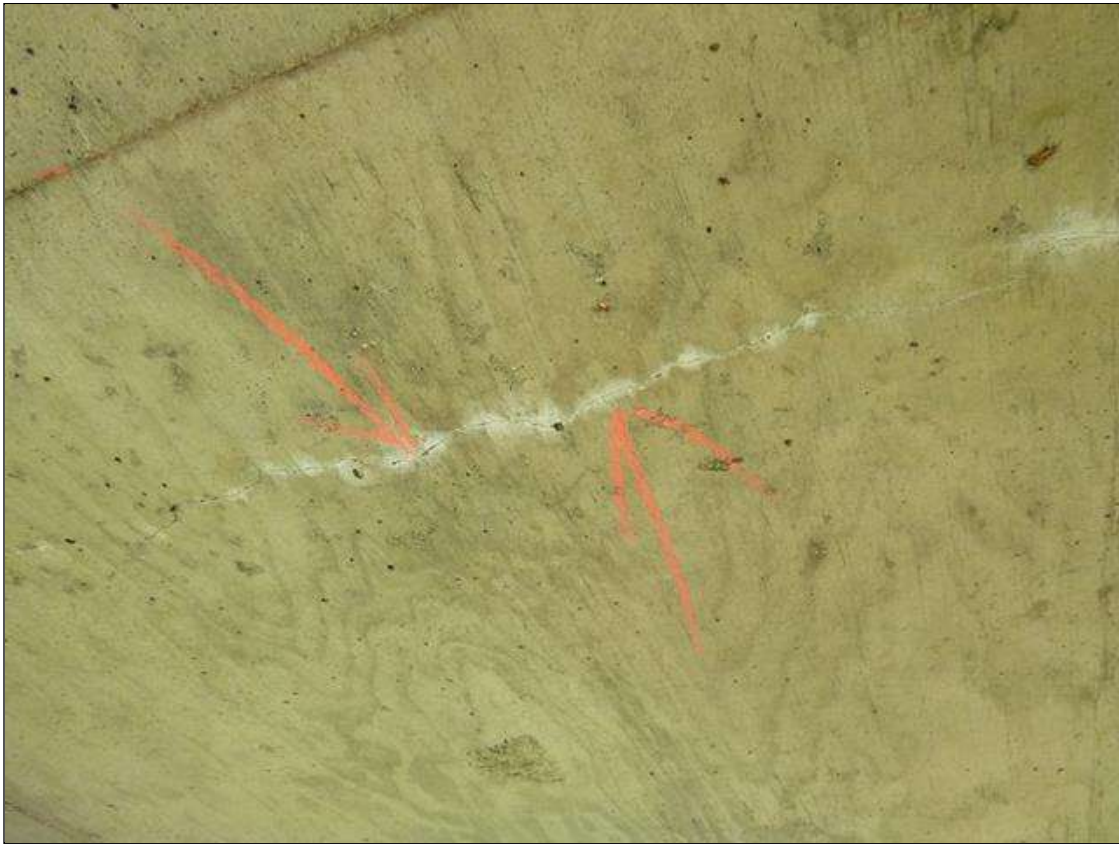
Span 5 Deck: SPAN 5, BOTTOM OF DECK IN BAY 1 HAS A HAIRLINE TRANSVERSE CRACK , 6 FT. LONG, WITH OR WITHOUT EFFLO., 14 FT. FROM BENT 5 CAP, FOR A TOTAL OF 200 SQ. FT. THRU OUT THE SPAN

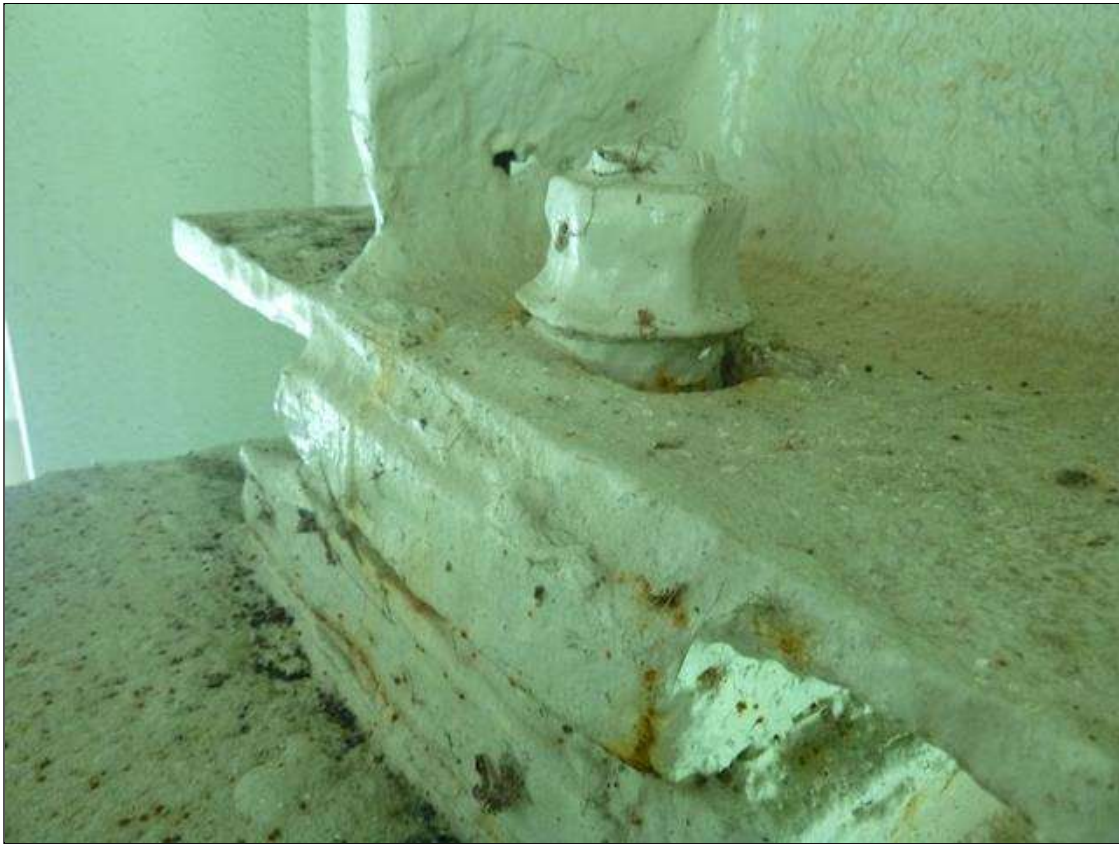
Span 5 Beam 3: SPAN 5, BEAM 3 AT BENT 4 HAS 1/8 INCH SECTION LOSS ON THE BOTTOM FLANGE, STARTING 2 INCHES OUT FROM FACE OF BEARING X 2 INCHES LONG X FULL WIDTH WITH 1/2 INCH REMAINING, THE VERTICAL WEB STIFFNER ON THE RIGHT SIDE HAS A 1/2 INCH DIAMETER HOLE RUSTED THRU NEAR THE BOTTOM AT THE BEARING AREA, THE WEB HAS 1/16 INCH SECTION LOSS FROM THE END OF THE BEAM OUT 10 INCHES AND 4 INCHES UP FROM THE BOTTOM WITH 9/16 INCH REMAINING

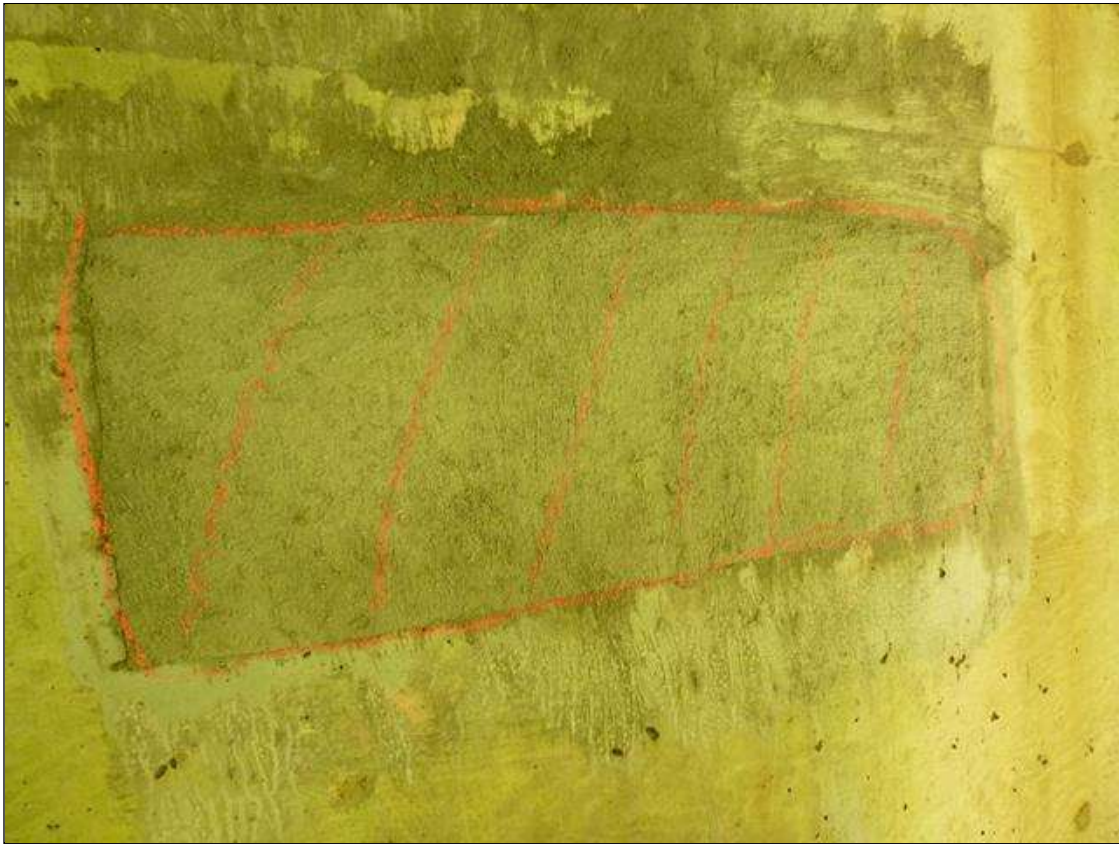
Bent 4 Cap 1: BENT 4 CAP, SPAN 5 SIDE HAS AN AREA OF DELAMINATION IN THE FACE OF THE CAP, 6 FT. UNDER BEAM 3, 36 INCHES X 12 INCHES

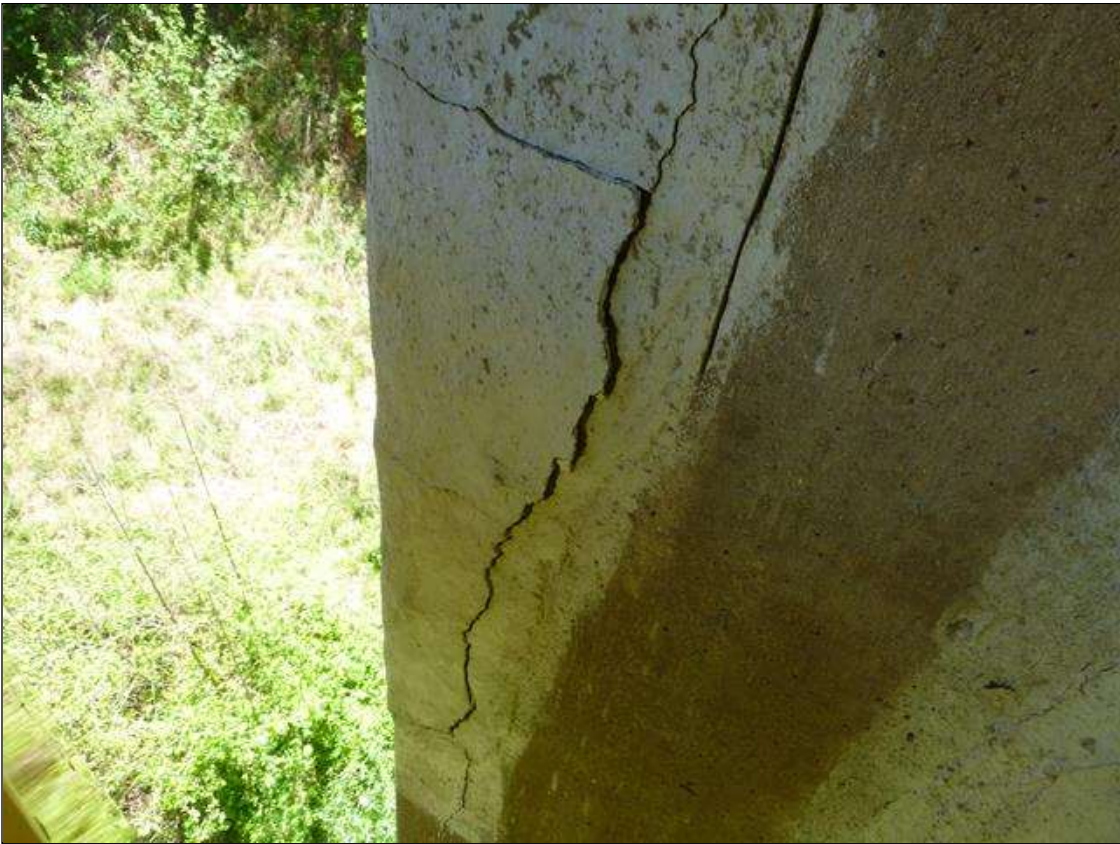
Bent 4 Pile 1: BENT 4, PILE 1 HAS A DELAMINATED PATCHED AREA ON THE NORTHWEST CORNER, 24 INCHES X 60 INCHES, 9 FT. FROM THE BOTTOM OF THE CAP WITH 1/2 INCH SEPARATION

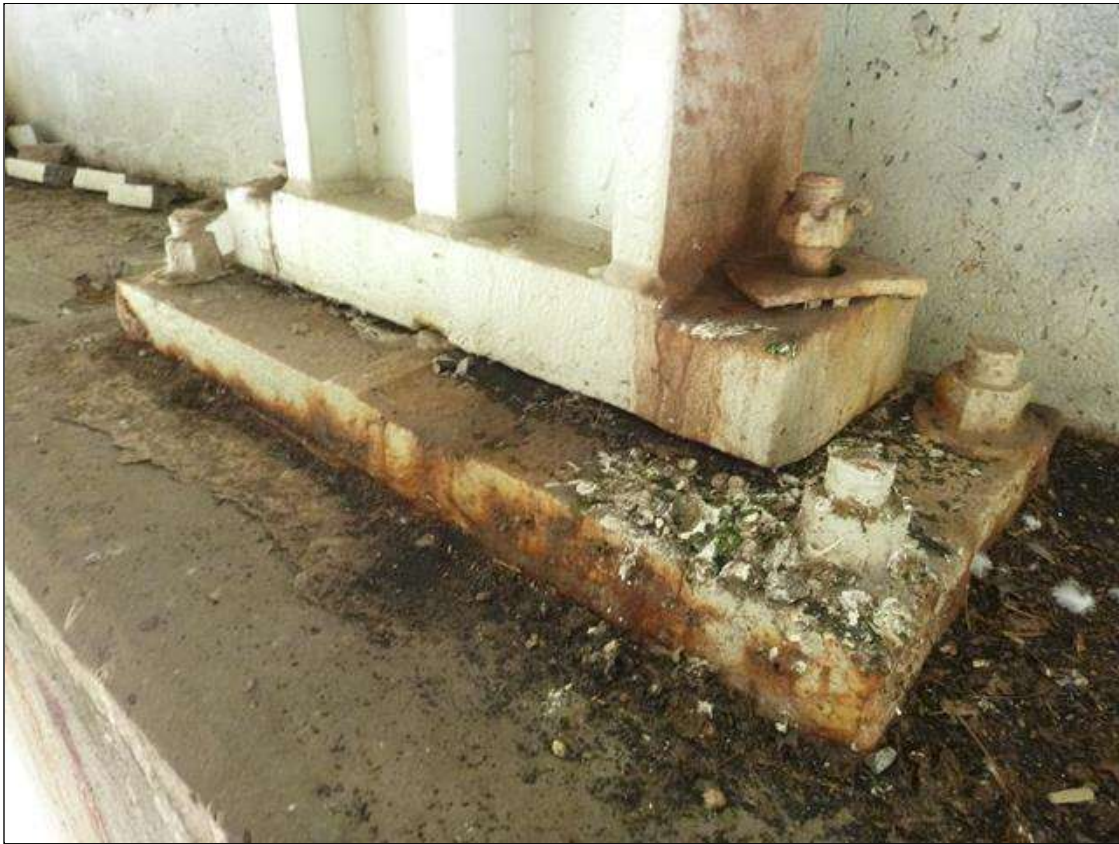
Span 2 Beam 4 Far Bearing: SPAN 2, BEAM 4 FAR BEARING HAS FRECKLED RUST

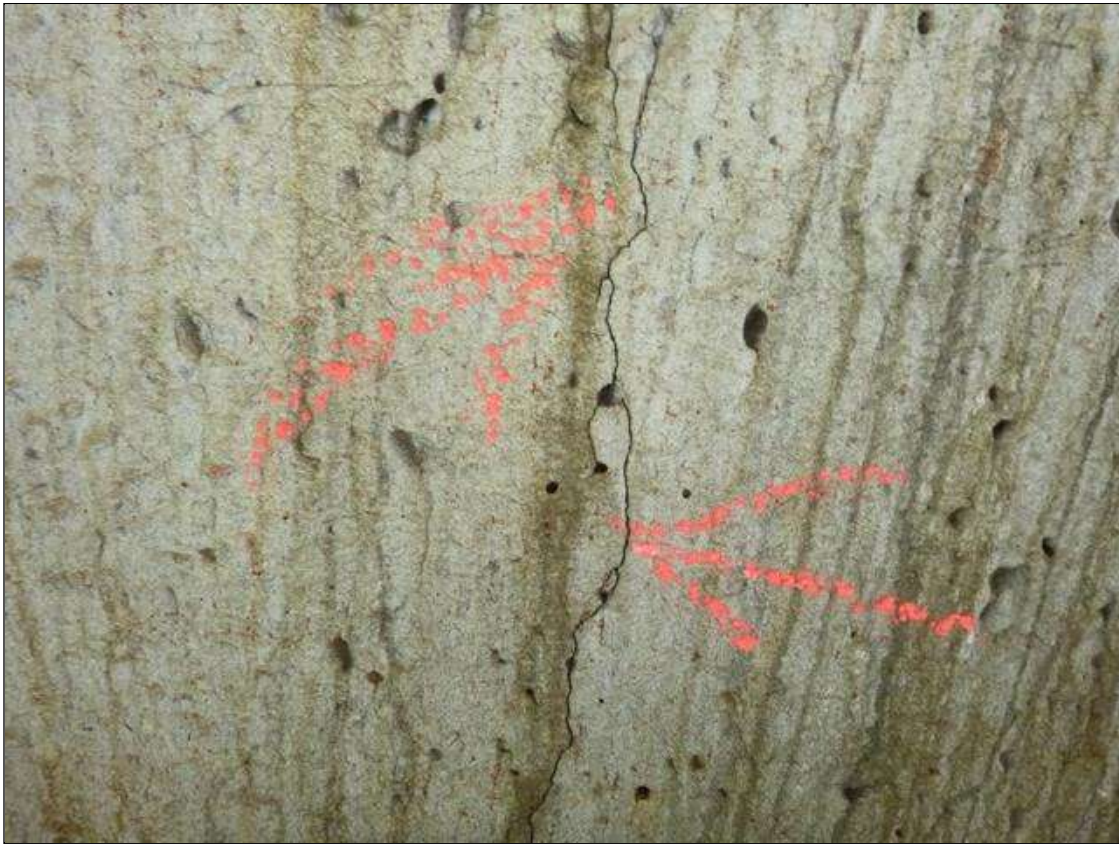
Bent 4 Cap 1: BENT 4 CAP, SPAN 4 SIDE HAS A 1/16 INCH WIDE VERTICAL CRACK, 59 INCHES TALL, ( FULL HEIGHT), BETWEEN GIRDERS 2 AND 3, FOR A TOTAL OF 10 VERTICAL CRACKS THRU OUT CAP

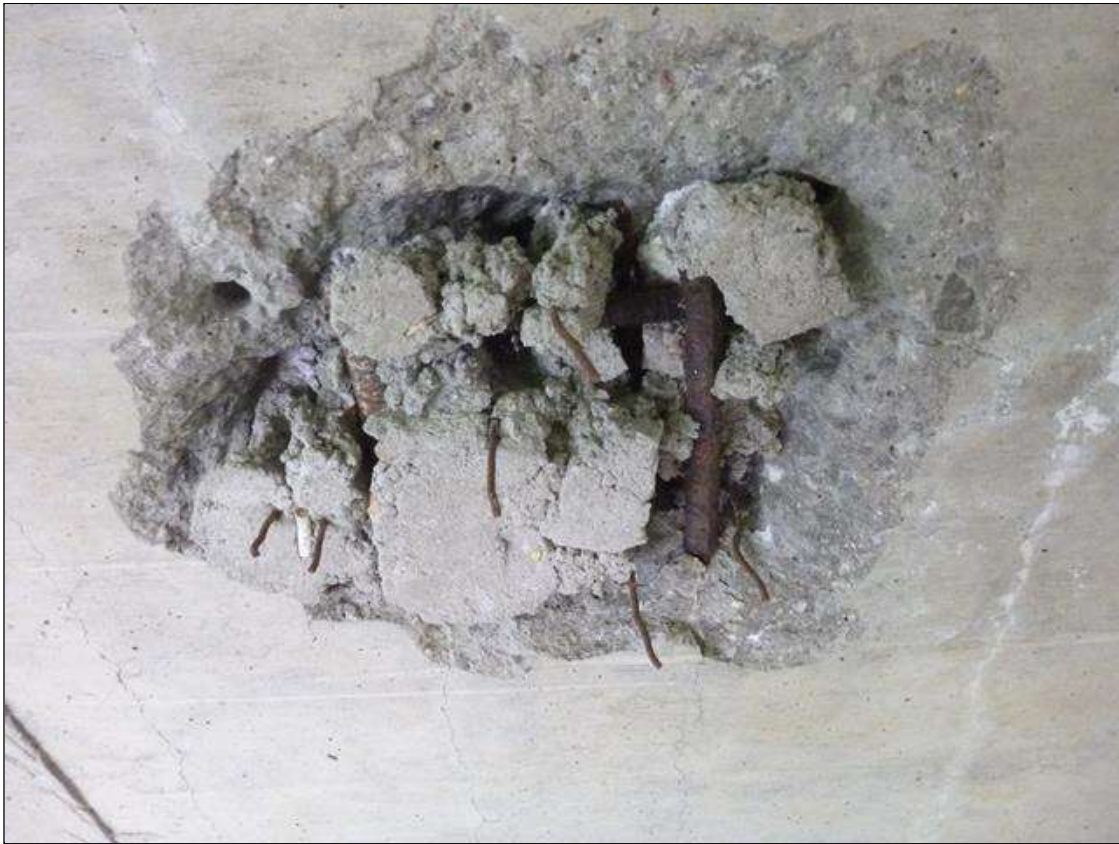
Span 4 Deck: SPAN 4, BAY 4, BOTTOM OF DECK HAS A PATCHED AREA THAT HAS FAILED, 30 FT. FROM BENT 4, 15 INCHES IN DIAMETER X 4 INCHES DEEP WITH REBAR EXPOSED

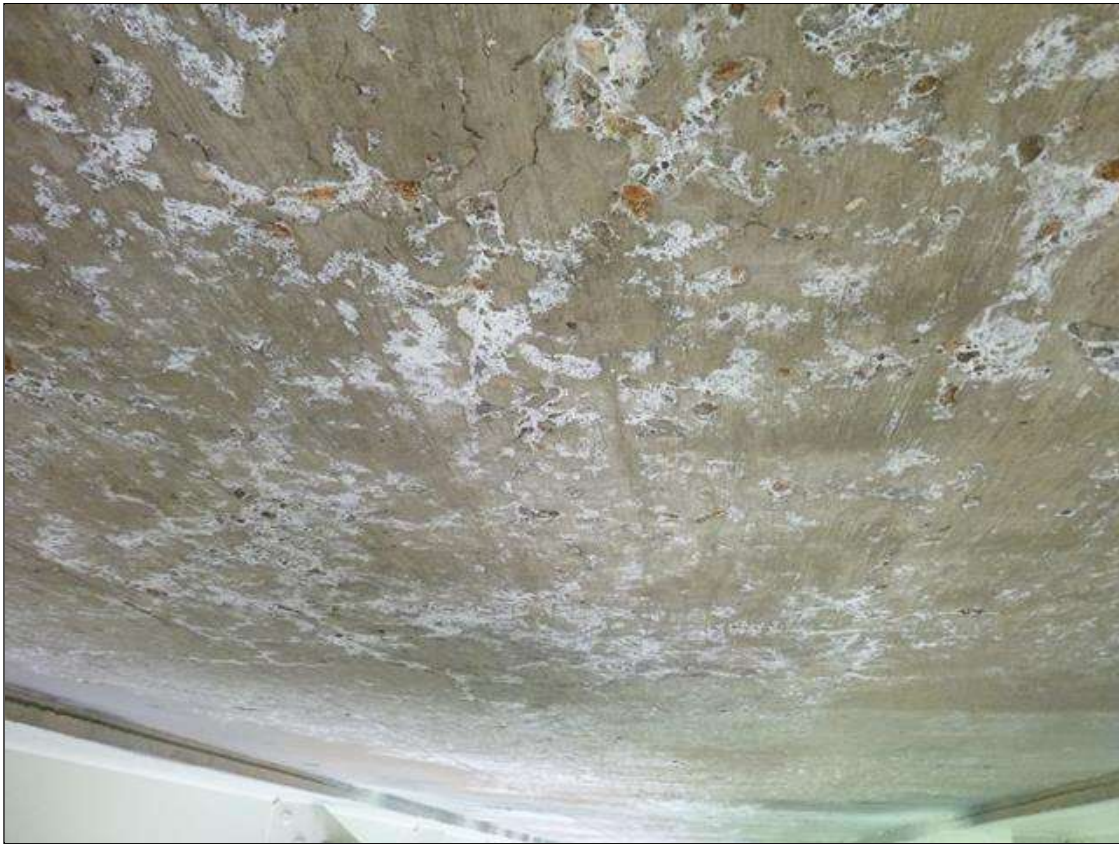
Span 4 Deck: SPAN 4, BAY 2, BOTTOM OF THE DECK HAS A 5 SQ. FT. AREA OF HAIRLINE MAP CRACKING WITH EFFLO. , FOR A TOTAL OF 1800 SQ. FT. THRU OUT THE BOTTOM OF THE SPAN WITH OR WITHOUT EFFLO.

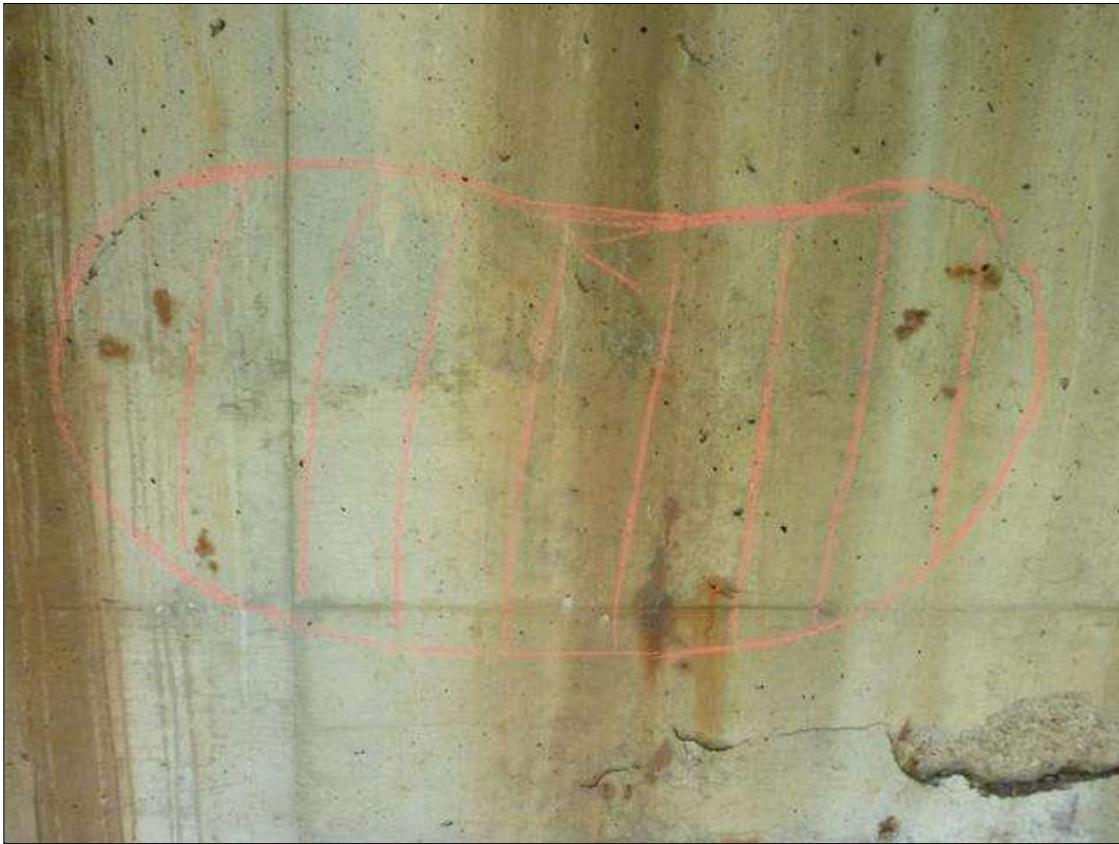
Bent 3 Cap 1: BENT 3 CAP, SPAN 4 SIDE HAS AN AREA OF DELAMINATION IN THE FACE OF THE CAP IN BAY 4, 53 INCHES X 24 INCHES WITH 1/8 INCH SEPARATION

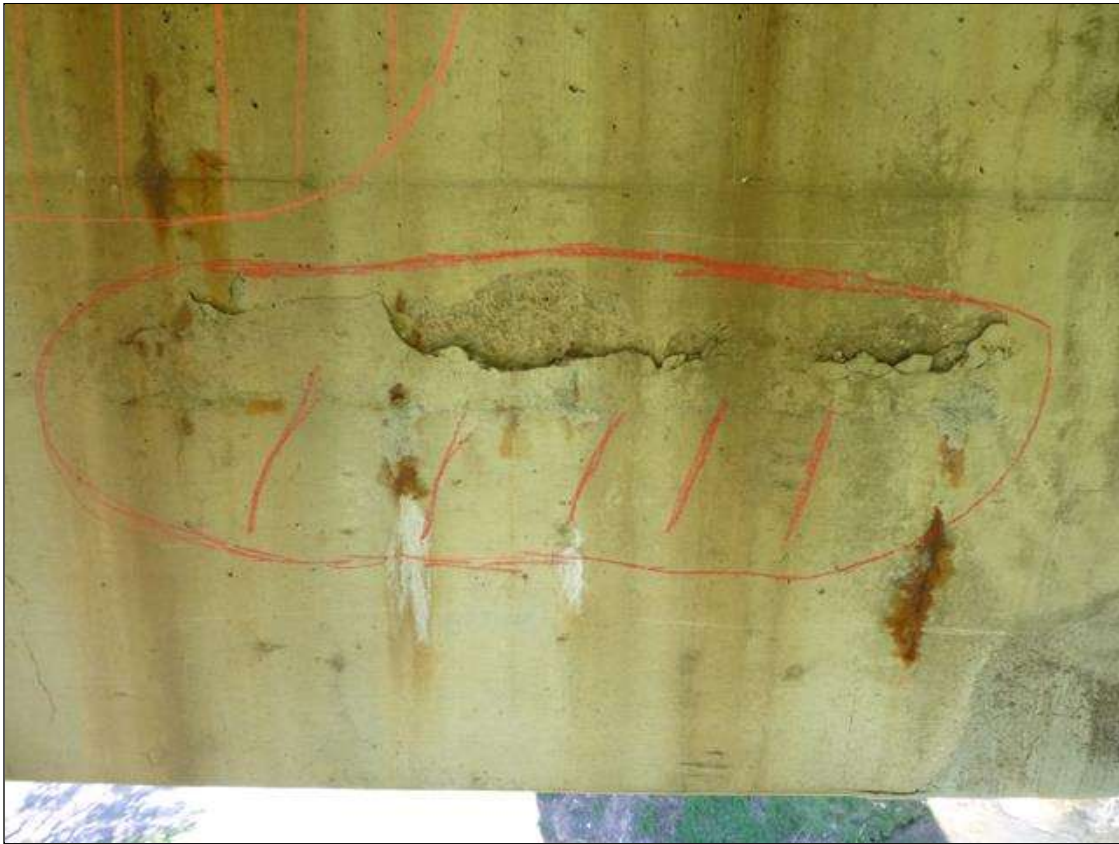
Bent 3 Cap 1: BENT 3 CAP, SPAN 4 SIDE HAS AN AREA OF DELAMINATION IN THE FACE OF THE CAP IN BAY 4, 4 FT. BELOW THE TOP OF THE CAP, 24 INCHES X 72 INCHES WITH 1 INCH DEEP ADJACENT SPALLING AND RUST STAINS

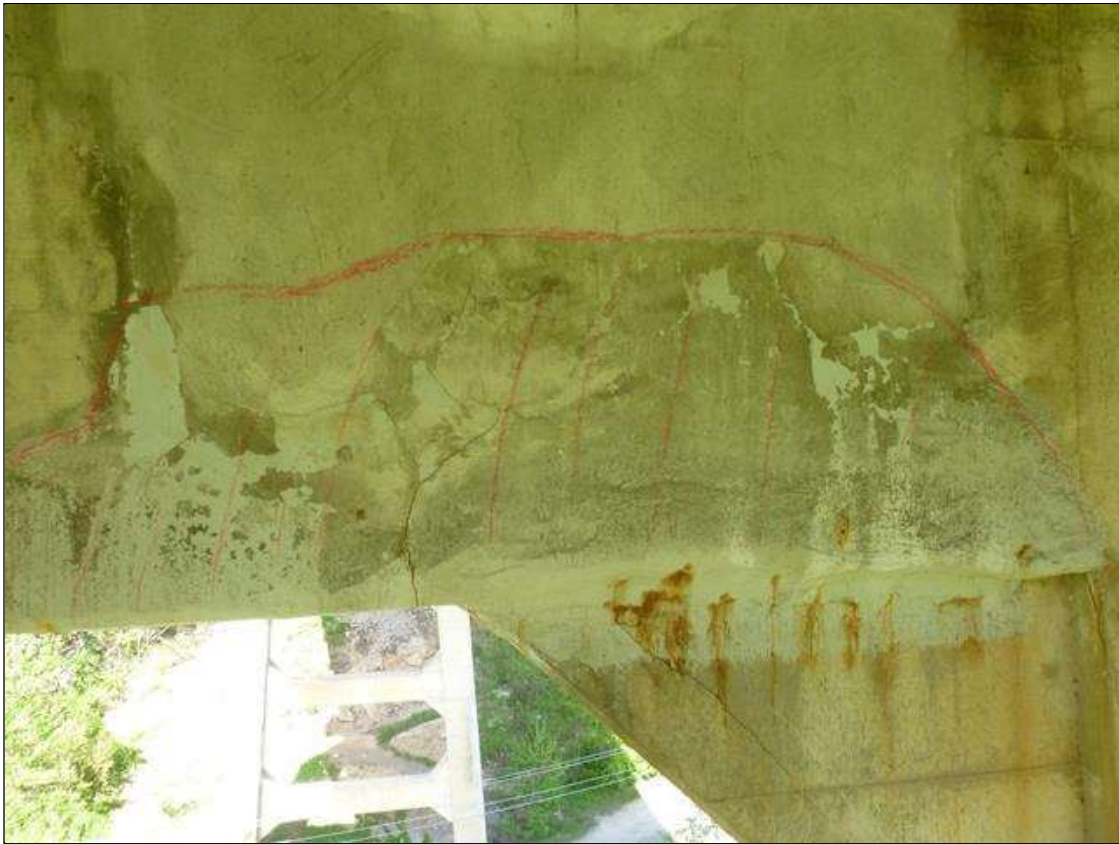
Bent 3 Cap 1: BENT 3 CAP, SPAN 4 SIDE HAS A DELAMNATED PATCHED AREA IN BAY 3, STARTING 4.5 FT. DOWN FROM THE TOP OF THE CAP, 9 FT. LONG X 30 INCHES HIGH AND GOES ACROSS THE BOTTOM OF THE CAP 6 INCHES WITH 1/16 INCH WIDE CRACKING AND RUST STAINS

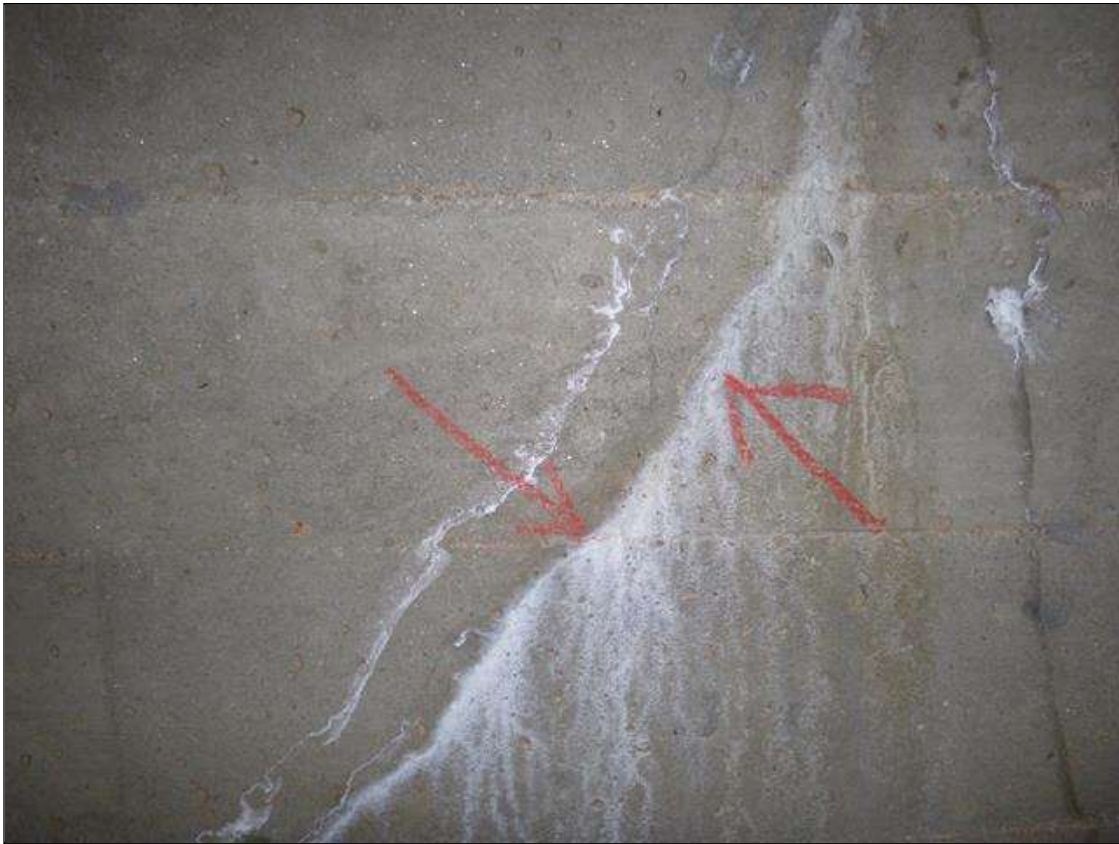
End Bent 2 Abutment/Backwall : END BENT 2 ABUTMENT, BAY 1 HAS 3 DIAGONAL HAIRLINE CRACKS WITH EFFLO, 3 FT. LONG, FOR A TOTAL OF 6 FT. OF CRACKING THRU OUT ABUTMENT

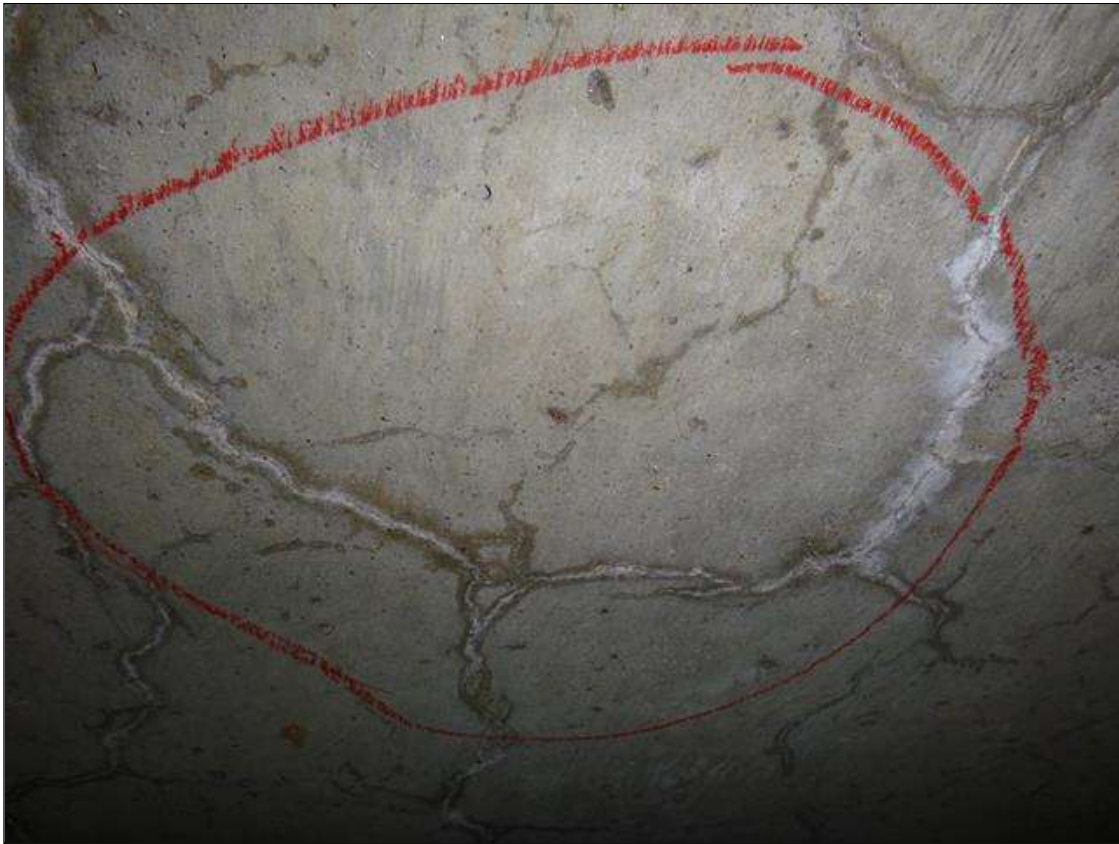
Span 6 Deck: SPAN 6, BAY 2 BOTTOM OF DECK HAS A 1 SQ. FT. AREA OF HAIRLINE MAP CRACKING WITH EFFLO., 15 FT. FROM END BENT 2 FOR A TOTAL OF 600 SQ. FT. THRU OUT THE BOTTOM OF THE DECK WITH OR WITHOUT EFFLO.

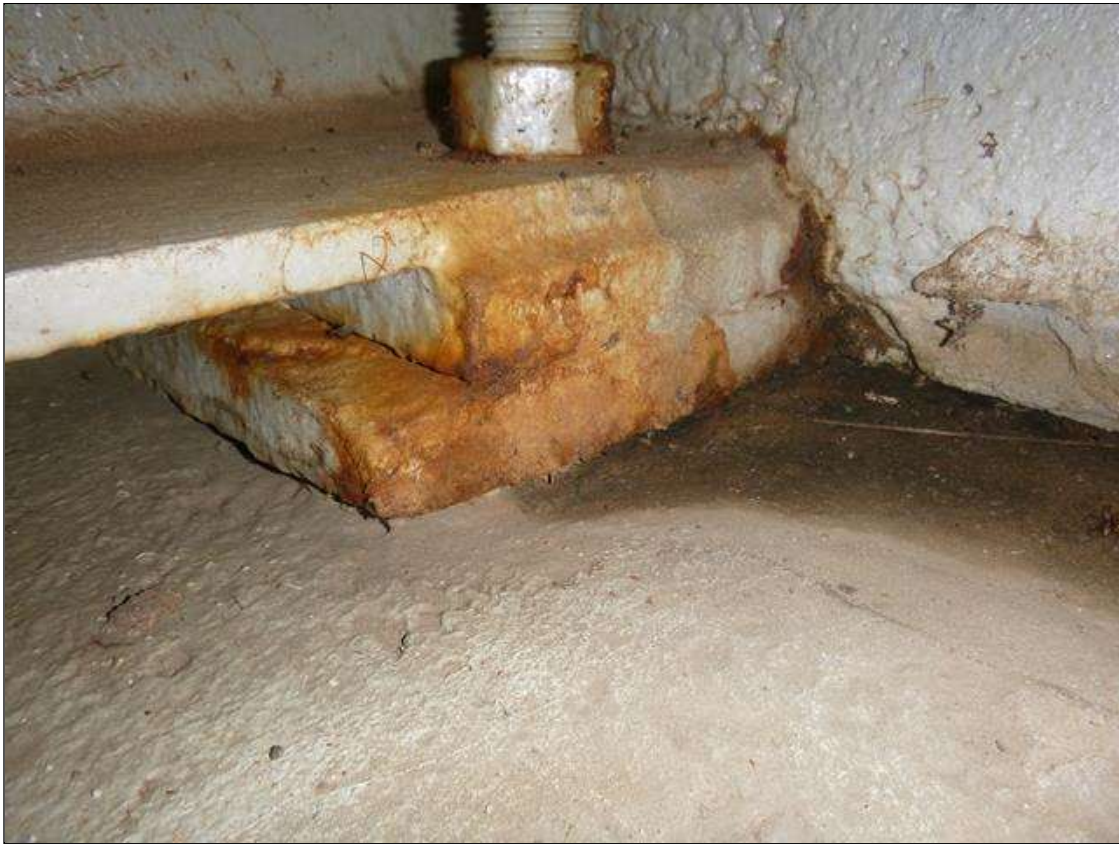
Span 6 Beam 1 Far Bearing: SPAN 6, BEAM 1 FAR BEARING HAS FRECKLED RUST

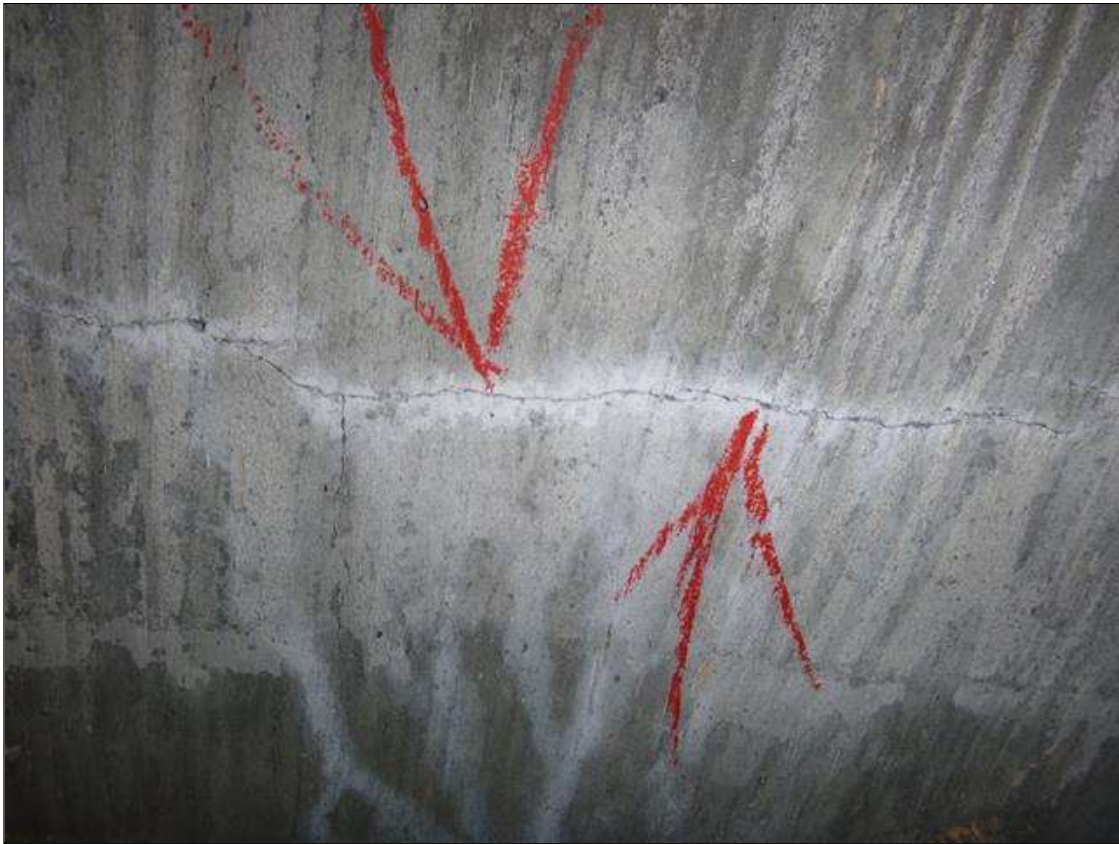
Span 6 Deck: SPAN 6, BAY 4 BOTTOM OF THE DECK HAS A 1/32 INCH WIDE X 7 FT. LONG TRANSVERSE CRACK WITH EFFLO., 18 FT. FROM END BENT 2 FOR A TOTAL OF 300 SQ. FT. WITH OR WITHOUT EFFLO. THRU OUT SPAN
