NC DEPARTMENT OF TRANSPORTATION  
DIVISION OF HIGHWAYS  
STRUCTURE MANAGEMENT UNIT

## Structure Safety Report

### Routine Element Inspection - Contract

COUNTY: HAYWOOD STRUCTURE NUMBER: 430171 FREQUENCY: 24 MONTHS

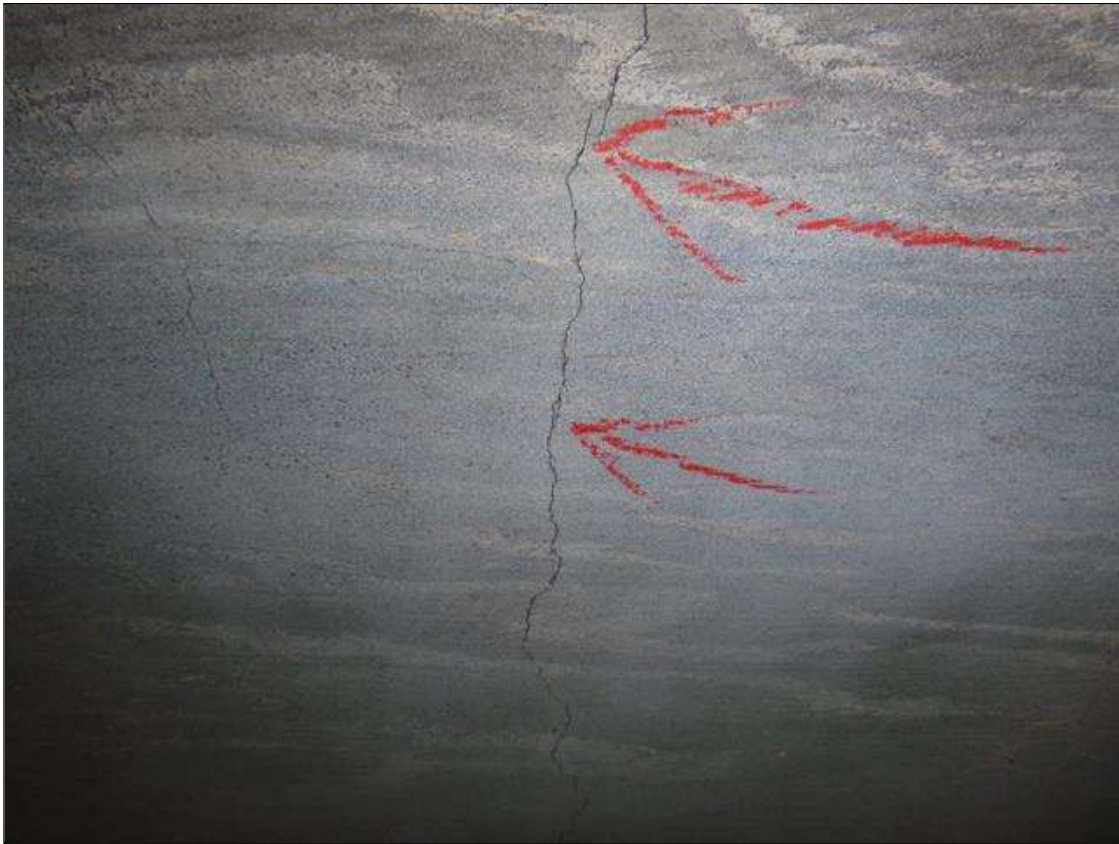
Span 6 Deck: SPAN 6, BAY 4, BOTTOM OF THE DECK HAS A 1/32 INCH WIDE LONGITUDINAL CRACK, 10 FT. LONG, STARTING 20 FT. FROM END BENT 2

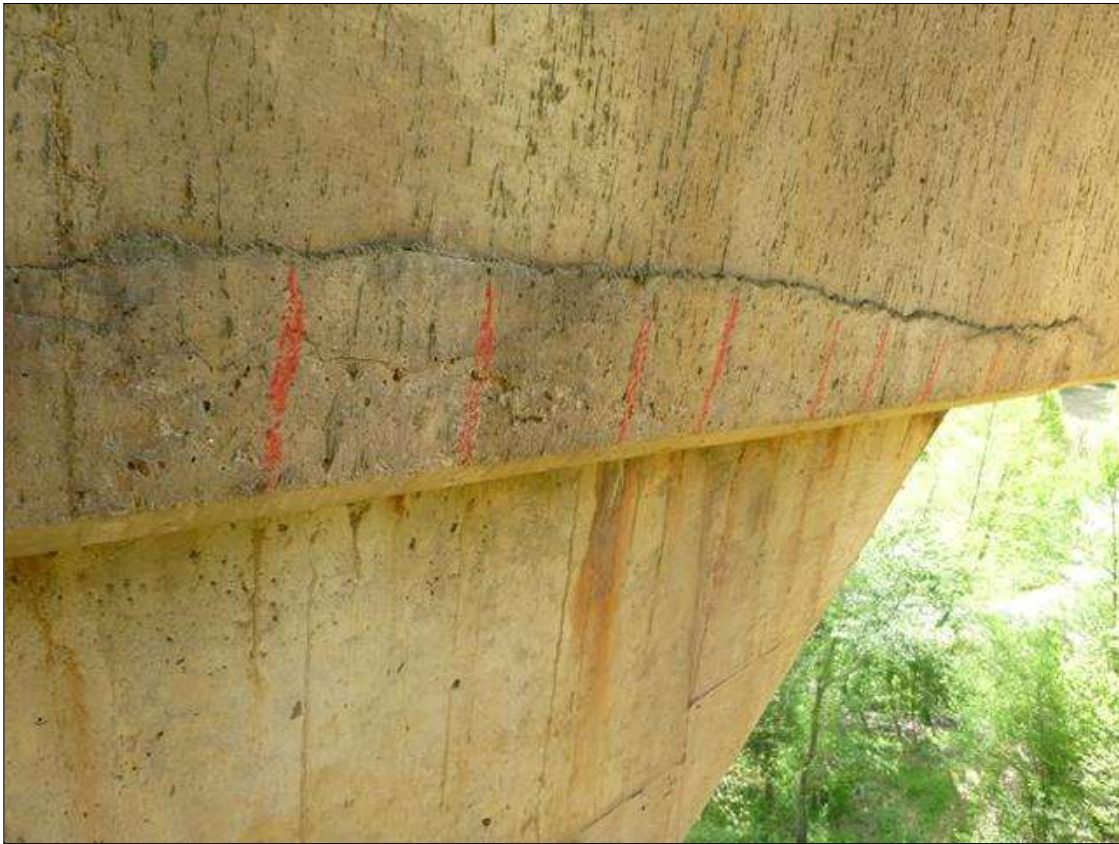
Bent 3 Cap 1: BENT 3 CAP, SPAN 4 SIDE HAS AN AREA OF DELAMINATION IN THE FACE OF THE CAP, IN BAY 1 AT BOTTOM EDGE, 7 FT. LONG X 5 INCHES WIDE WITH 1/8 INCH SEPARATION

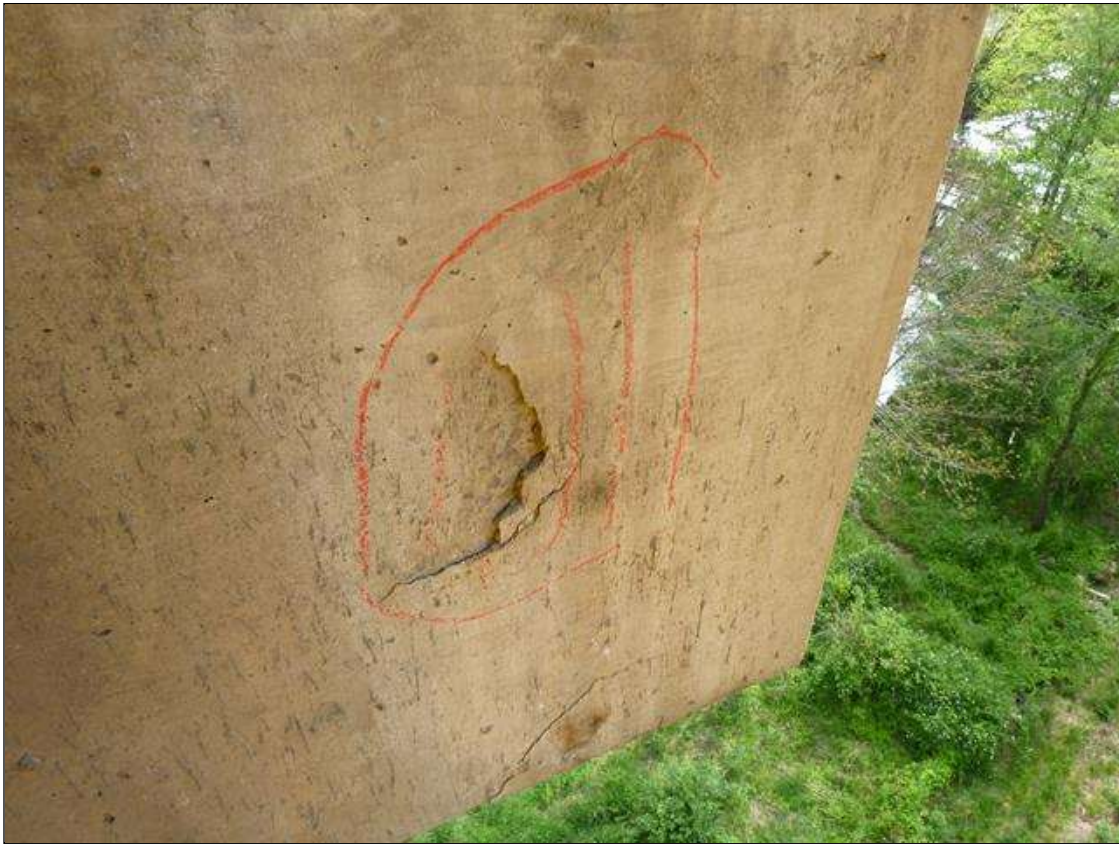
Bent 3 Cap 1: BENT 3 CAP, SPAN 4 SIDE HAS AN AREA OF DELAMINATION IN THE FACE OF THE CAP, UNDER BEAM 1, NEAR BOTTOM EDGE, 20 INCHES IN DIAMETER WITH 1/2 INCH DEEP SPALLING

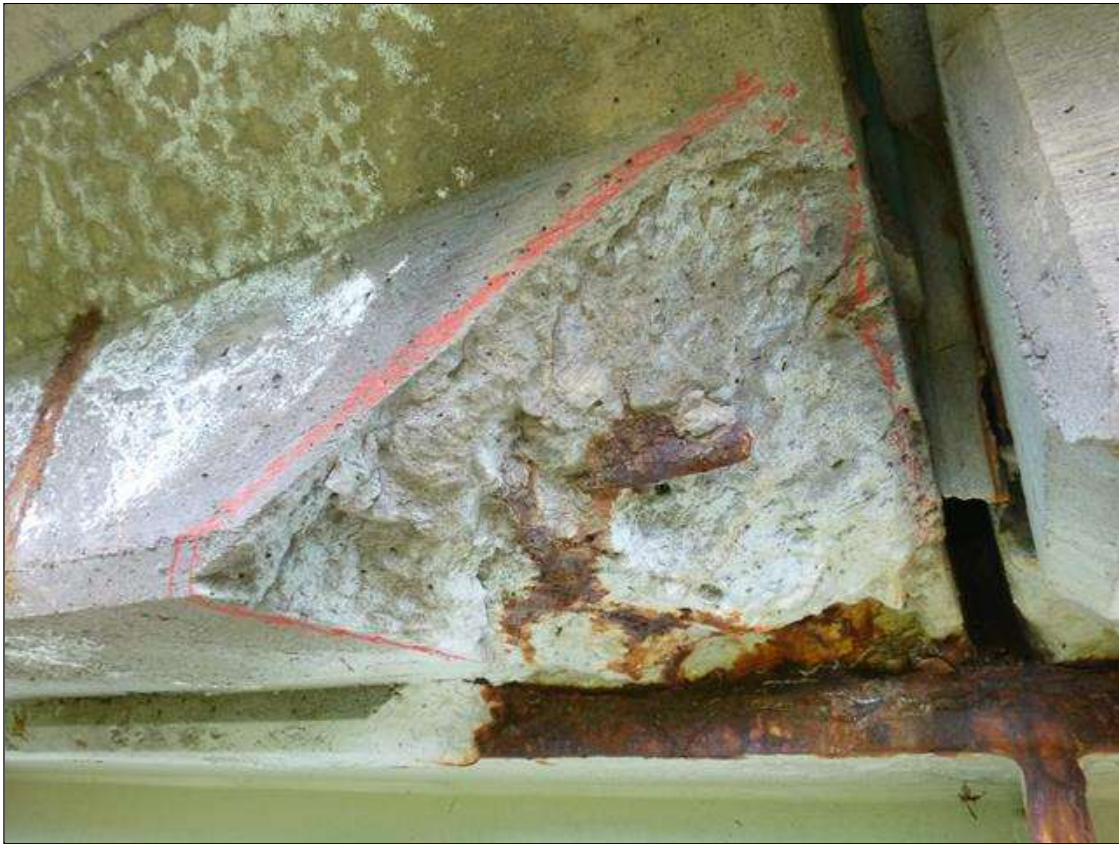
Span 4 Deck: SPAN 4, BOTTOM OF LEFT OVERHANG AT BENT 3 HAS A SPALL, 14 INCHES X 14 INCHES X 4 INCHES DEEP WITH EXPOSED REBAR

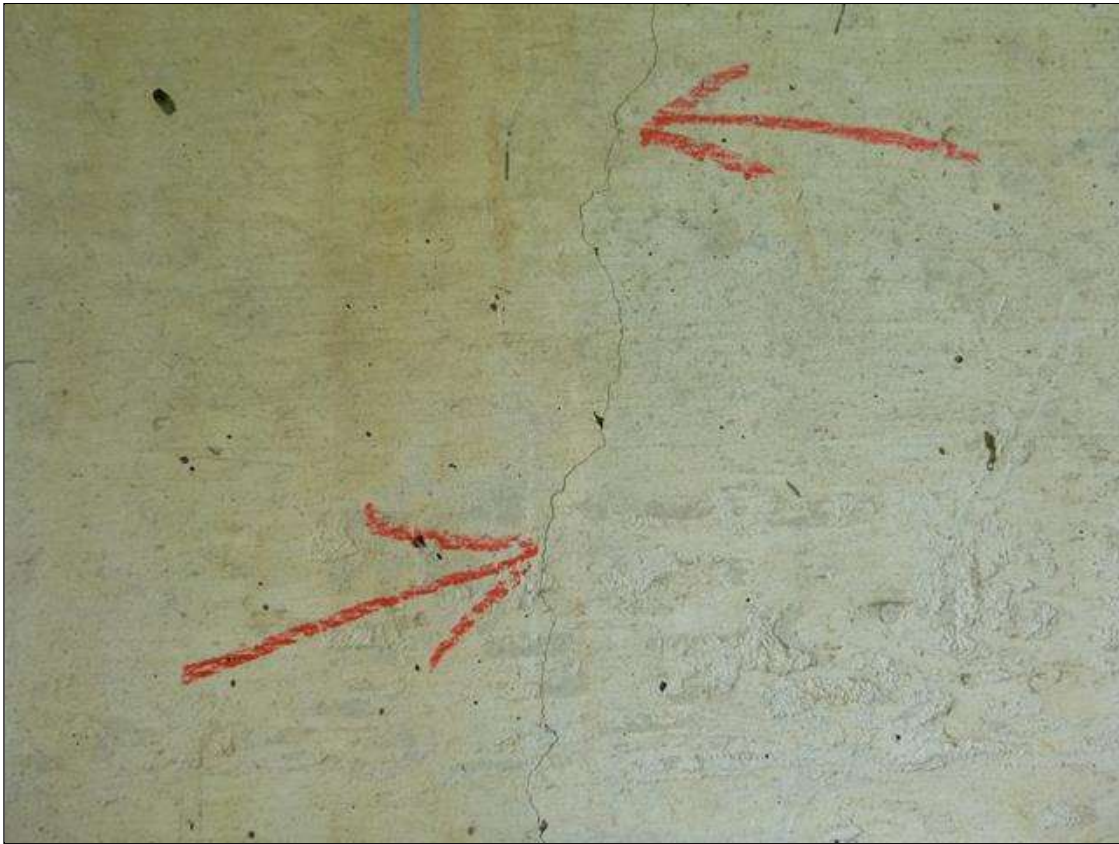
Bent 2 Cap 1: BENT 2 CAP, SPAN 3 SIDE HAS A HAIRLINE VERTICAL CRACK UNDER BEAM 2 IN THE FACE OF THE CAP, 4 FT. LONG

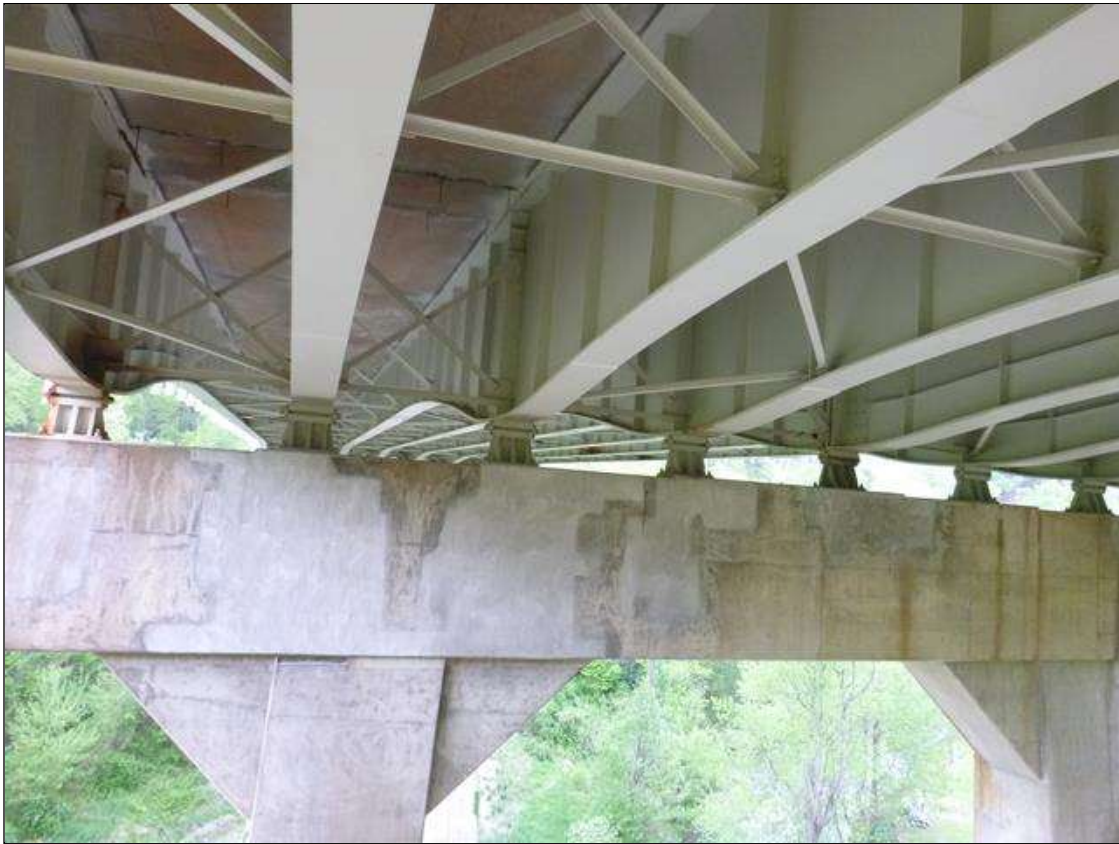
Bent 2 Cap 1: BENT 2 CAP, SPAN 2 SIDE HAS 20 FT. OF SOUND PATCHES IN THE FACE OF THE CAP

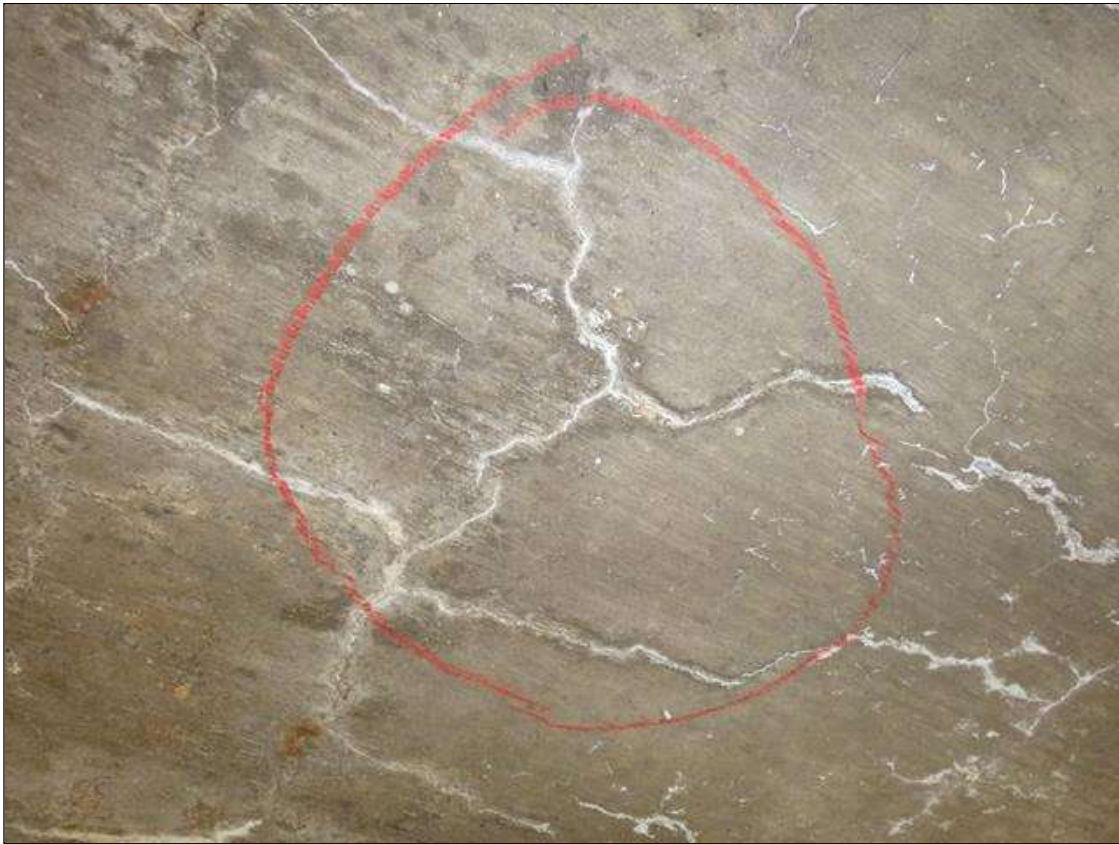
| Element Number | Defect Type | Defect Description | CS | CS Qty | Maint Qty | |
|---|---|---|---|---|---|---|
| 12 | Cracking (RC and Other) | SPAN 2, BOTTOM OF DECK, BAY 2 HAS A 1. SQ. FT. AREA OF HAIRLINE MAP CRACKING WITH EFFLO, 20 FT. FROM BENT 2, FOR A TOTAL OF 3000 SQ. FT. WITH OR WITHOUT | 3 | 3,000 | 3,000 | Square Feet |

Span 2 Deck: SPAN 2, BOTTOM OF DECK, BAY 2 HAS A 1. SQ. FT. AREA OF HAIRLINE MAP CRACKING WITH EFFLO, 20 FT. FROM BENT 2, FOR A TOTAL OF 3000 SQ. FT. WITH OR WITHOUT EFFLO. THRU OUT THE BOTTOM OF THE SPAN

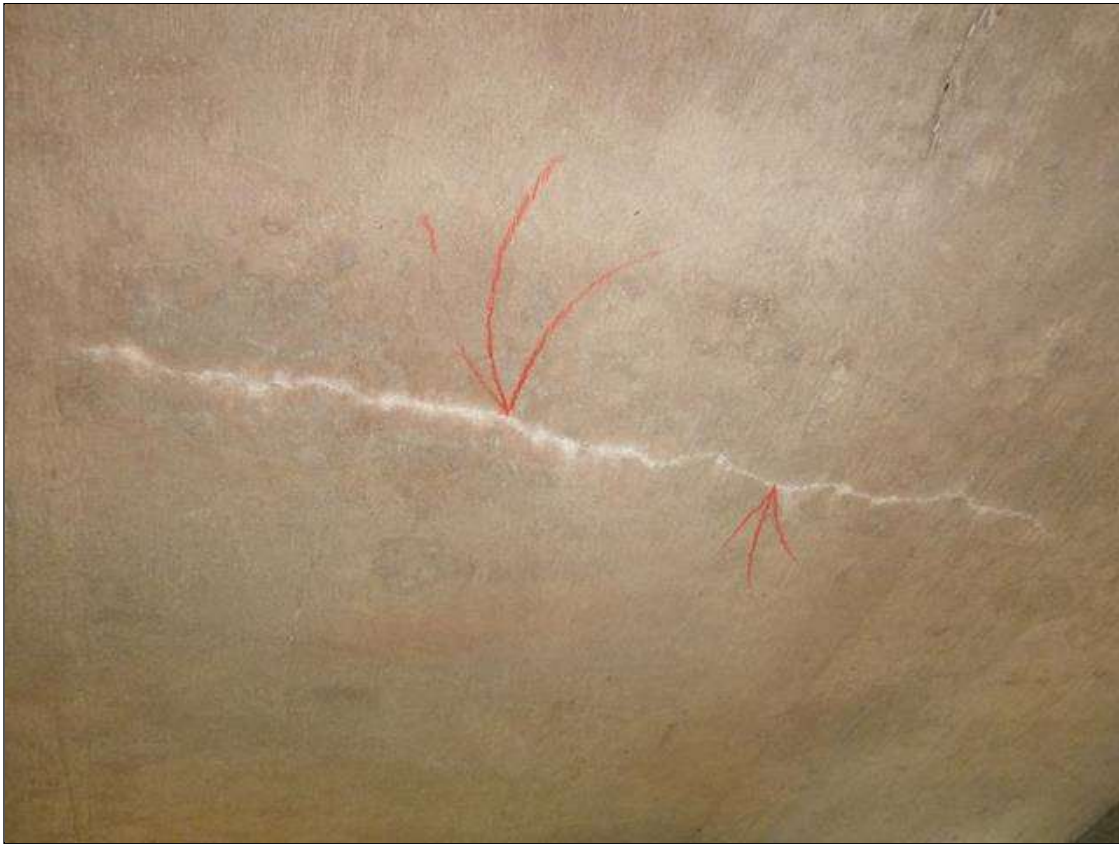
Span 2 Deck: SPAN 2, BOTTOM OF DECK, BAY 4 HAS A HAIRLINE TRANSVERSE CRACK WITH EFFLO. 25 FT. FROM BENT 2, 5 FT. LONG FOR A TOTAL OF 400 SQ. FT. WITH OR WITHOUT EFFLO. THRU OUT THE BOTTOM OF THE SPAN

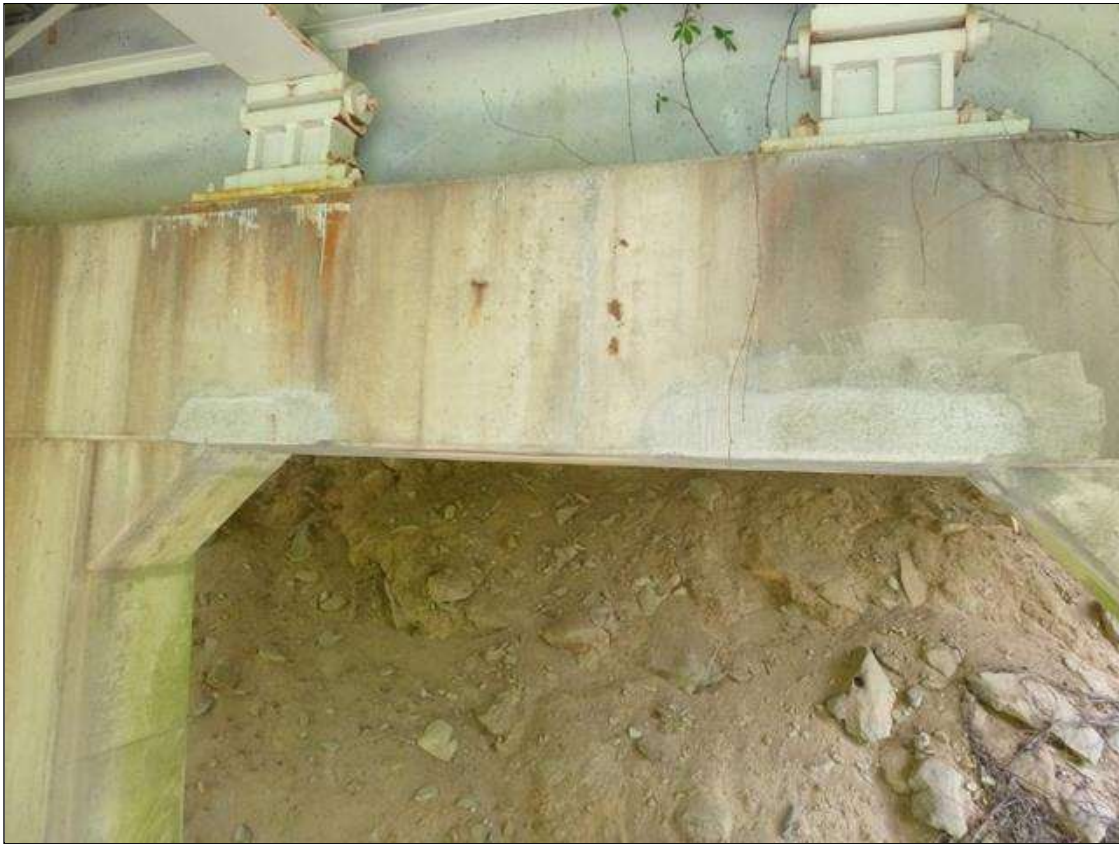
Bent 1 Cap 1: BENT 1 CAP, SPAN 2 SIDE HAS 2 PATCHES IN THE FACE NEAR THE BOTTOM EDGE, 6 FT. LONG

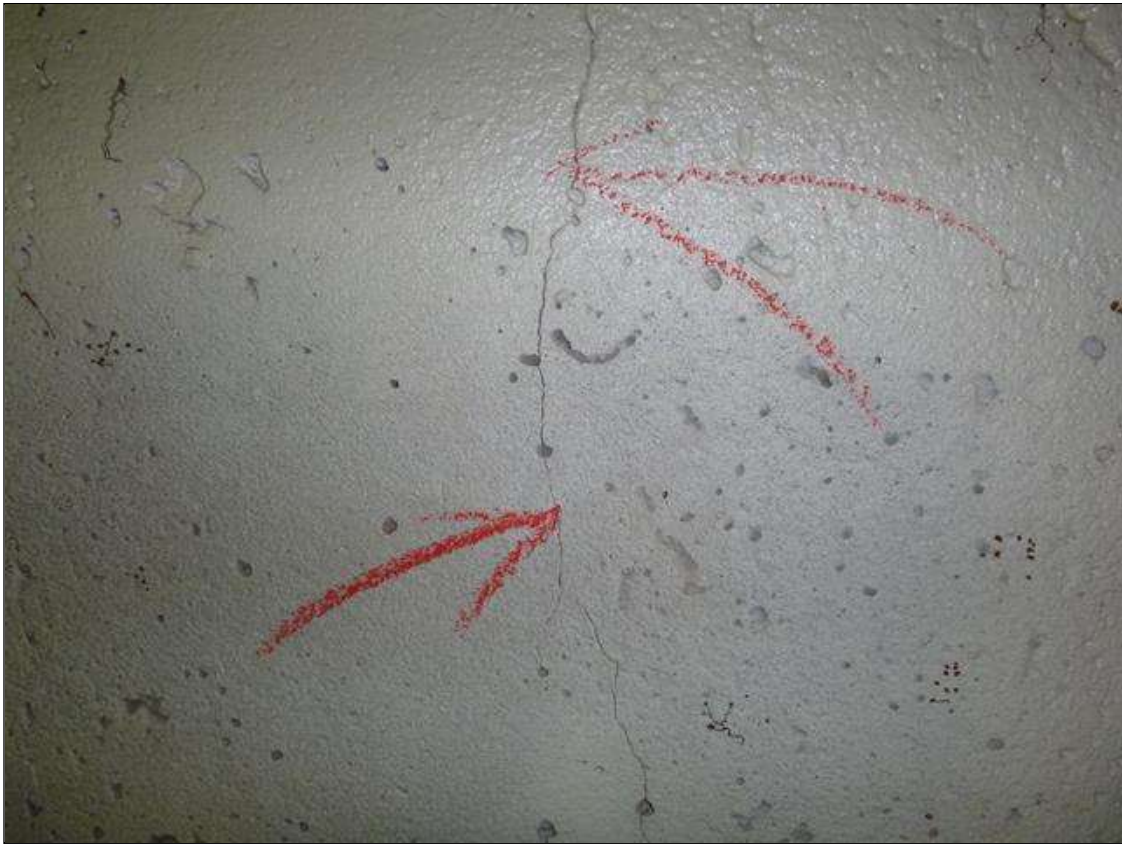
Bent 1 Cap 1: BENT 1 CAP, SPAN 2 SIDE HAS A 1/16 INCH WIDE VERTICAL CRACK IN THE FACE OF THE STEPUP, 59 INCHES TALL, ( FULL HEIGHT), BETWEEN GIRDERS 4 AND 5, FOR A TOTAL OF 5 VERTICAL CRACKS THRU OUT CAP

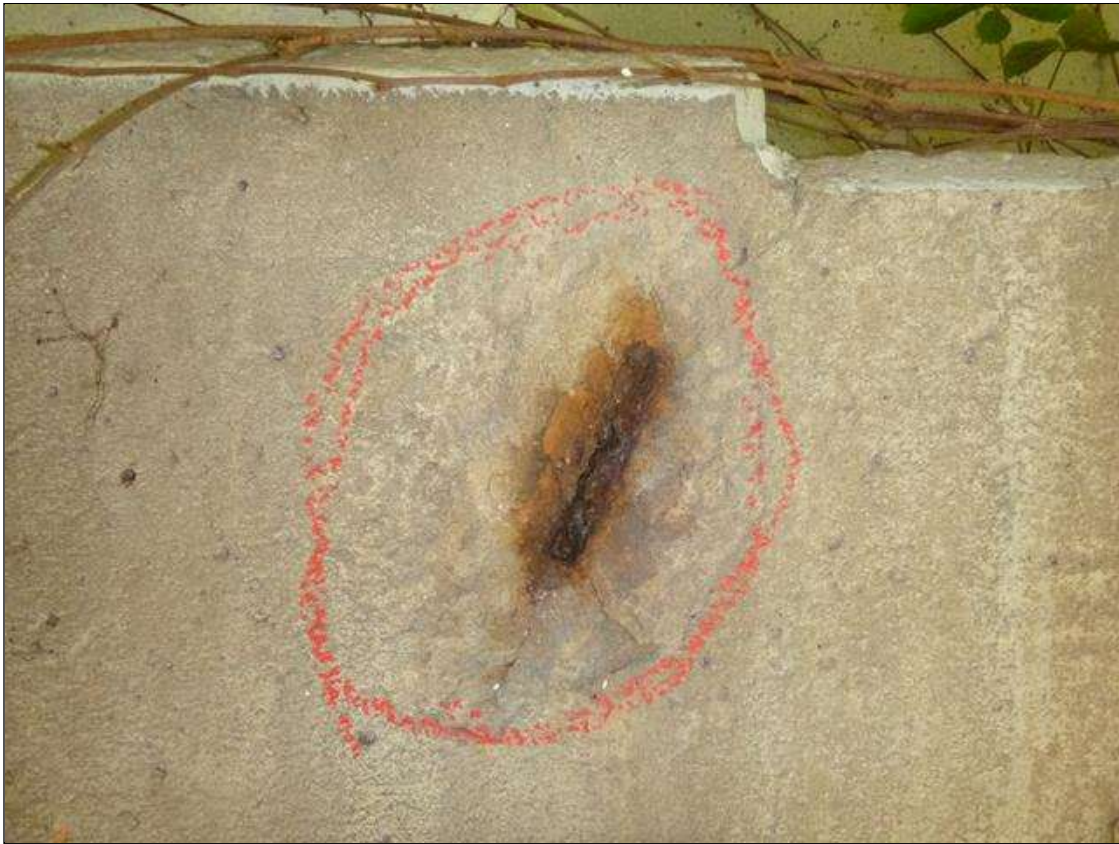
Bent 1 Cap 1: BENT 1 CAP, SPAN 2 SIDE HAS A SPALL IN THE FACE OF THE CAP UNDER BEAM 3, 7 INCHES IN DIAMETER X 3/4 INCH DEEP WITH REBAR EXPOSED

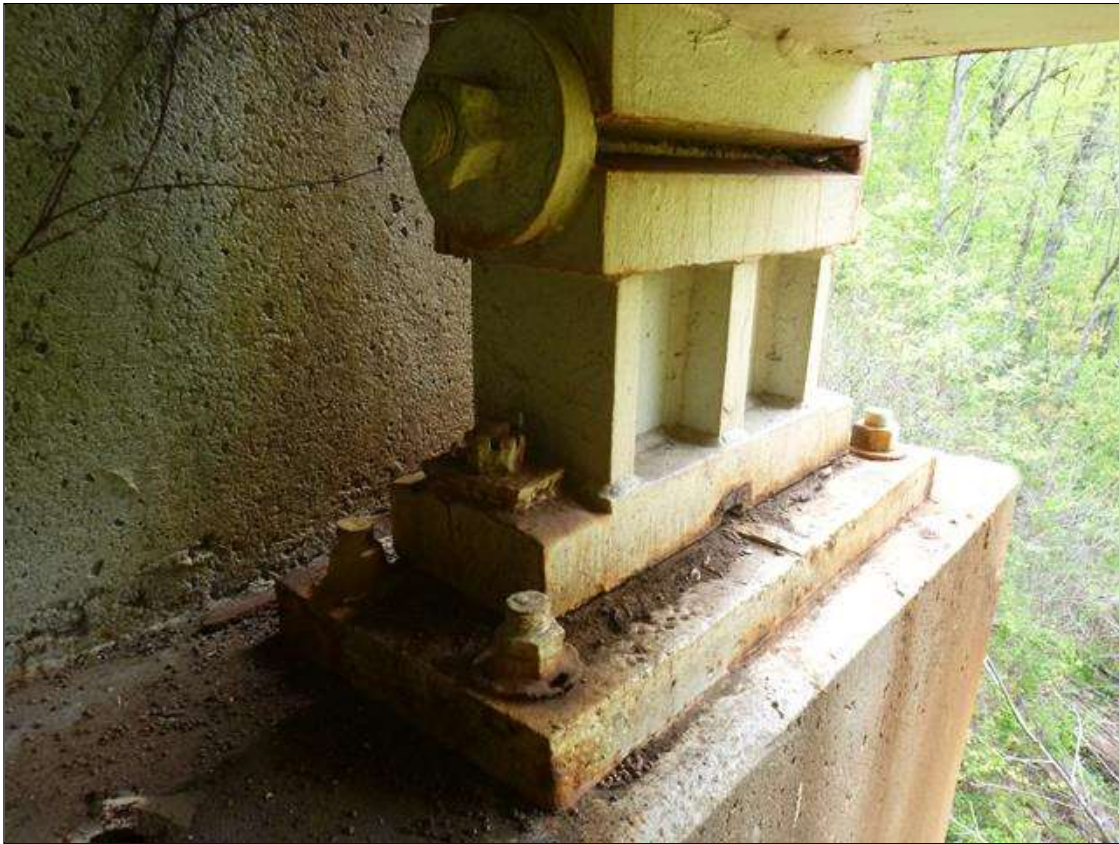
Span 2 Beam 1 Near Bearing: SPAN 2, BEAM 1 NEAR BEARING HAS FRECKLED RUST

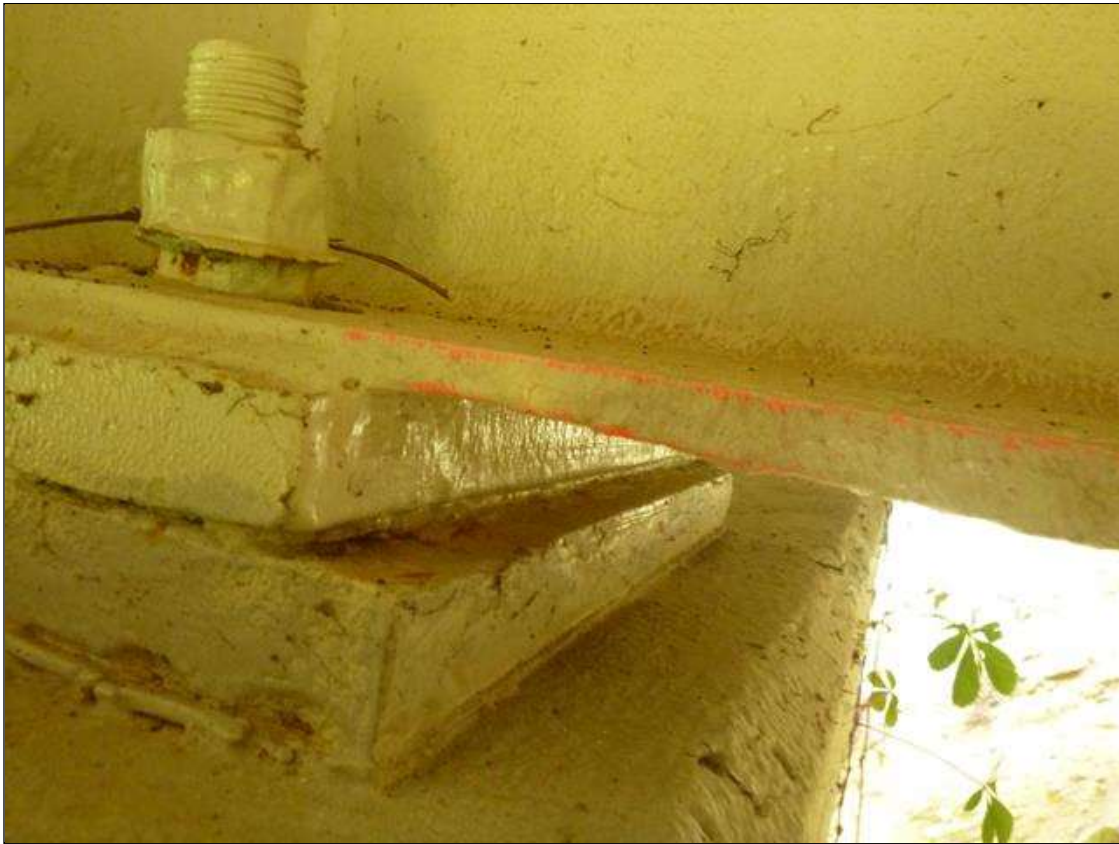
| Element Number | Defect Type | Defect Description | CS | CS Qty | Maint Qty | |
|---|---|---|---|---|---|---|
| 107 | Corrosion | SPAN 1, BEAM 3 AT BENT 1 HAS 3/16 INCH SECTION LOSS FROM PREVIOUS RUST ON THE BOTTOM LEFT FLANGE, STARTING AT THE FACE OF THE BEARING, 3 INCHES LONG X 3 INCHES WIDE WITH 7/16 INCH REMAINING, ALL BEAMS AND BEARINGS HAVE BEEN CLEANED AND PAINTED | 2 | 1 | | Feet |

Span 1 Beam 3: SPAN 1, BEAM 3 AT BENT 1 HAS 3/16 INCH SECTION LOSS FROM PREVIOUS RUST, ON THE BOTTOM LEFT FLANGE, STARTING AT THE FACE OF THE BEARING, 3 INCHES LONG X 3 INCHES WIDE WITH 7/16 INCH REMAINING, ALL BEAMS AND BEARINGS HAVE BEEN CLEANED AND PAINTED IN ALL SPANS

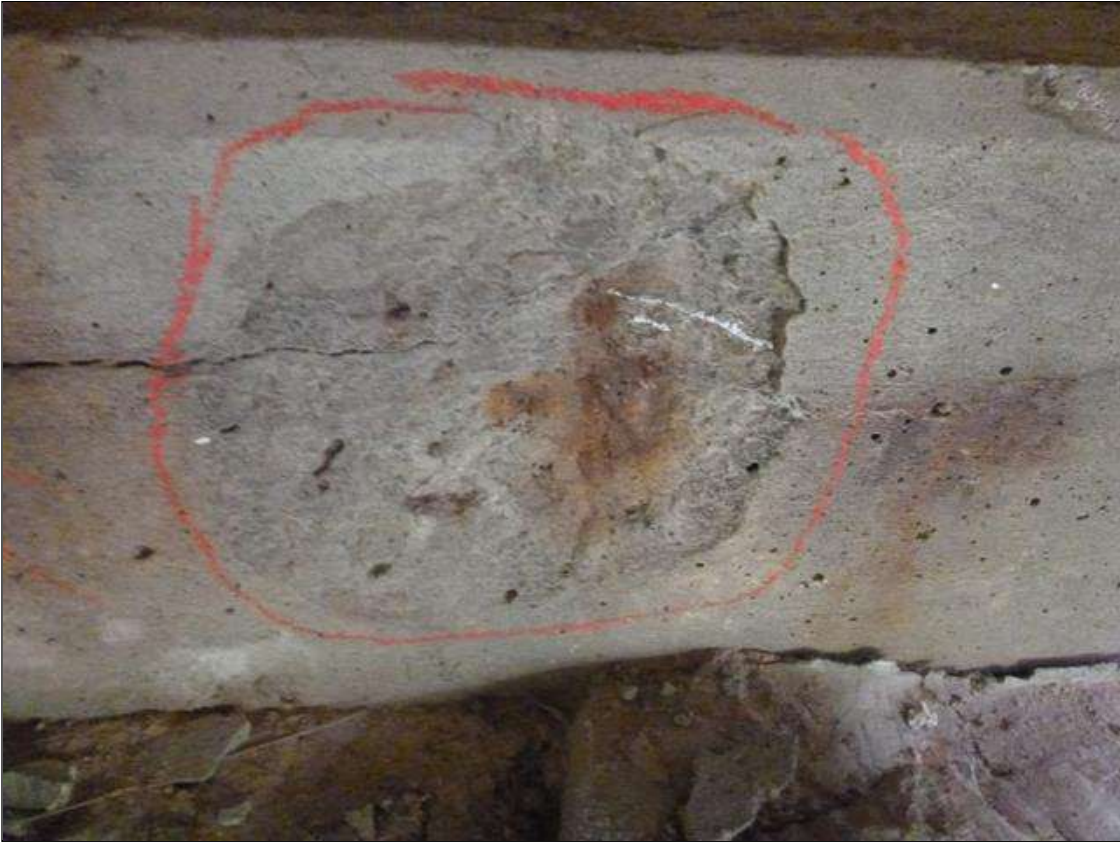
End Bent 1 Cap 1: END BENT 1, FACE OF CAP HAS A SPALL IN BAY 1, 8 INCHES IN DIAMETER X 1 INCH DEEP

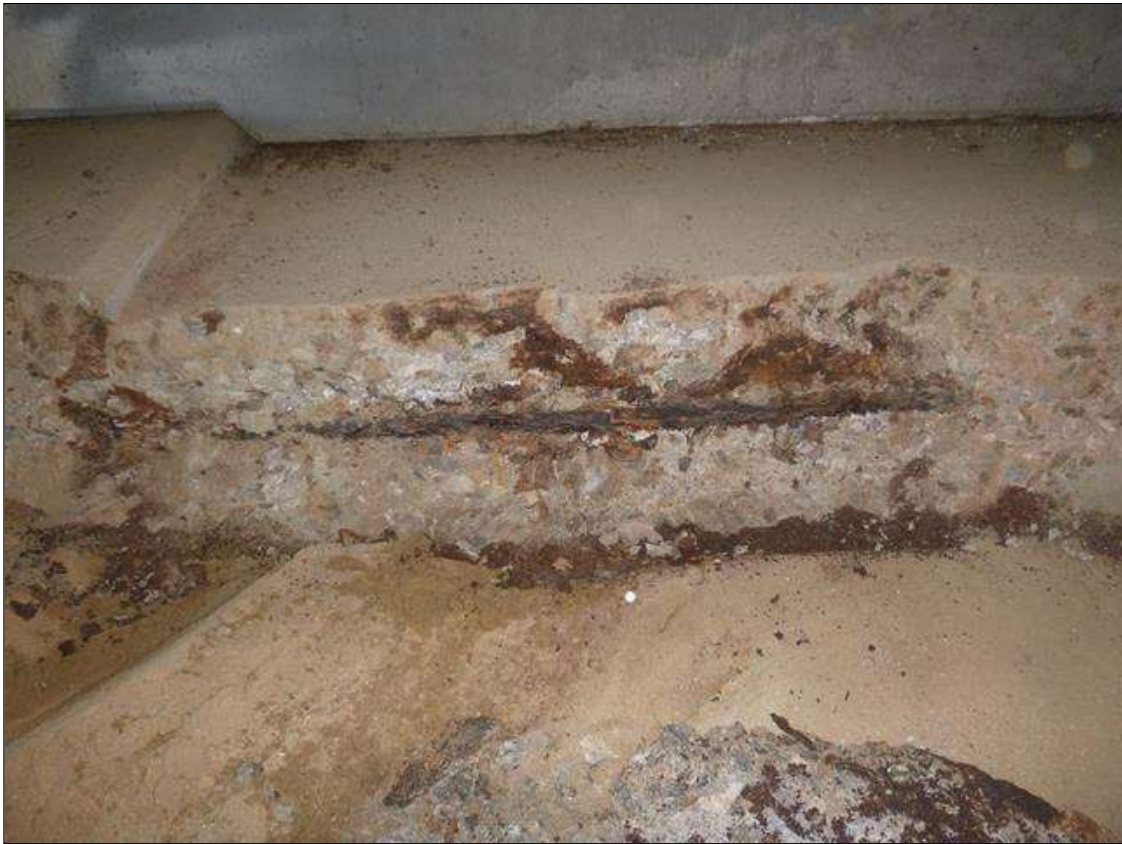
End Bent 1 Cap 1: END BENT 1, FACE OF CAP HAS A SPALL IN BAY 2, 6 FT. LONG X 11 INCHES WIDE X 3 INCHES DEEP WITH EXPOSED REBAR

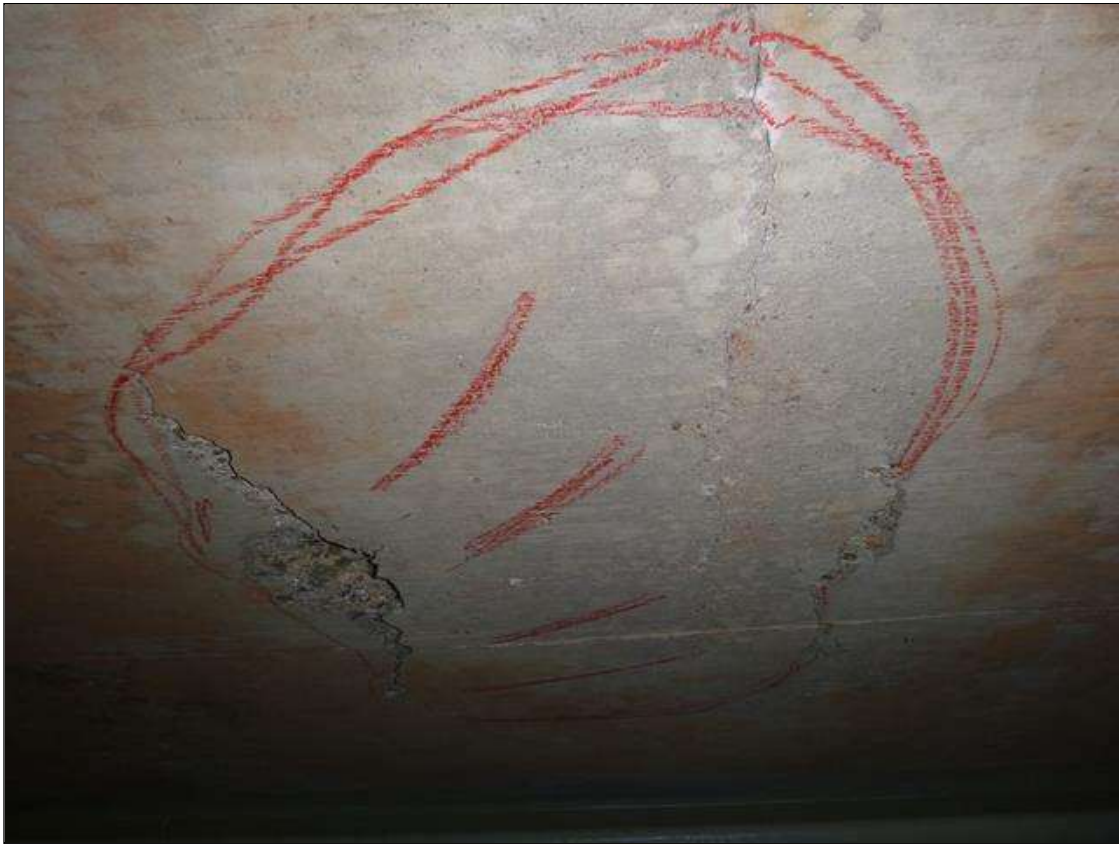
| Element Number | Defect Type | Defect Description | CS | CS Qty | Maint Qty | |
|---|---|---|---|---|---|---|
| 12 | Delamination/Spall | SPAN 1, BAY 3 BOTTOM OF THE DECK HAS AN AREA OF DELAMINATION, 5 FT. FROM END BENT 1, 18 INCHES X 36 INCHES, WITH ADJACENT 1/2 INCH DEEP SPALLING | 3 | 4 | 4 | Square Feet |

Span 1 Deck: SPAN 1, BAY 3 BOTTOM OF THE DECK HAS AN AREA OF DELAMINATION, 5 FT. FROM END BENT 1, 18 INCHES X 36 INCHES, WITH ADJACENT 1/2 INCH DEEP SPALLING

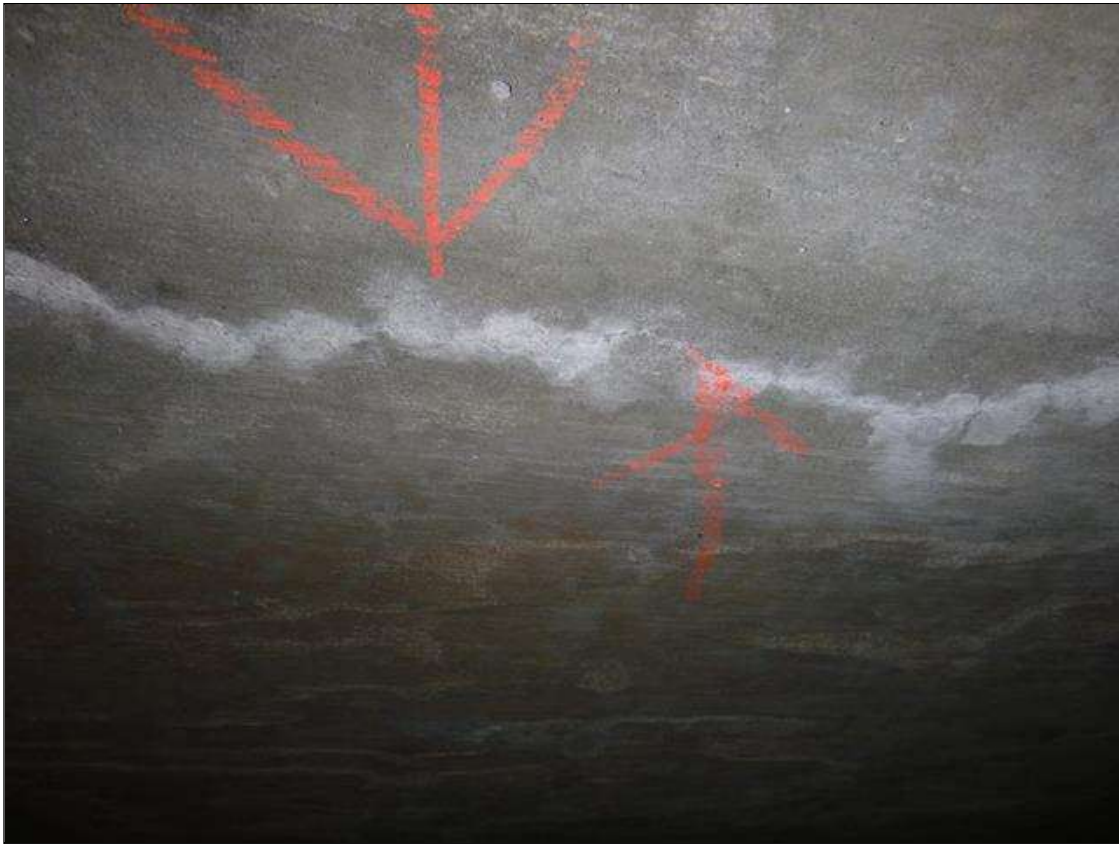
| Element Number | Defect Type | Defect Description | CS | CS Qty | Maint Qty | |
|---|---|---|---|---|---|---|
| 12 | Cracking (RC and Other) | SPAN 1, BAY 4 BOTTOM OF THE DECK HAS A HAIRLINE 7 FT. LONG TRANSVERSE CRACK WITH EFFLO. 14 FT. FROM END BENT 1, FOR A TOTAL OF 95 SQ. FT. WITH OR WITHOUT EFFLO. THRU OUT BOTTOM OF SPAN | 2 | 95 | 95 | Square Feet |

Span 1 Deck: SPAN 1, BAY 4 BOTTOM OF THE DECK HAS A HAIRLINE 7 FT. LONG TRANSVERSE CRACK WITH EFFLO. 14 FT. FROM END BENT 1, FOR A TOTAL OF 95 SQ. FT. WITH OR WITHOUT EFFLO. THRU OUT BOTTOM OF SPAN

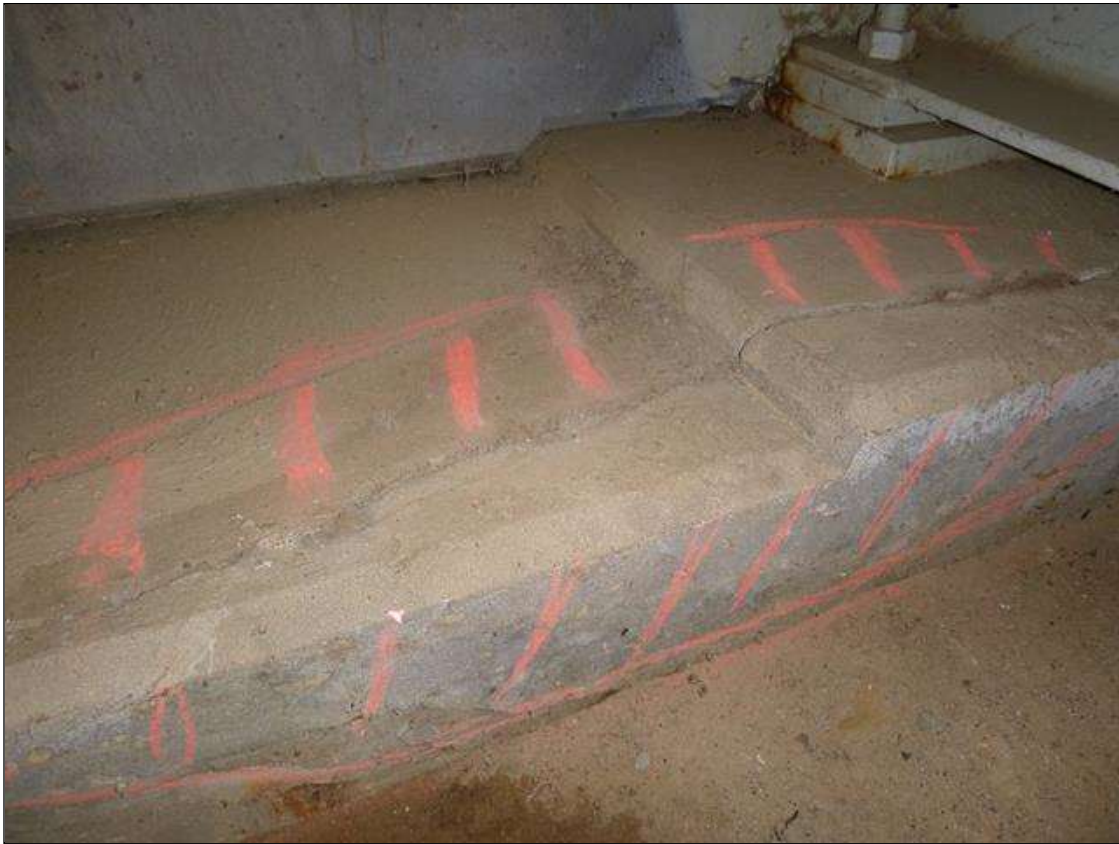
End Bent 1 Cap 1: END BENT 1 TOP AND FACE OF CAP HAS AN AREA OF DELAMINATION IN BAY 7 NEAR BEAM 7, 4 FT. LONG X 9 INCHES ACROSS THE TOP X 7 INCHES DOWN THE FACE WITH 1/2 INCH SEPARATION

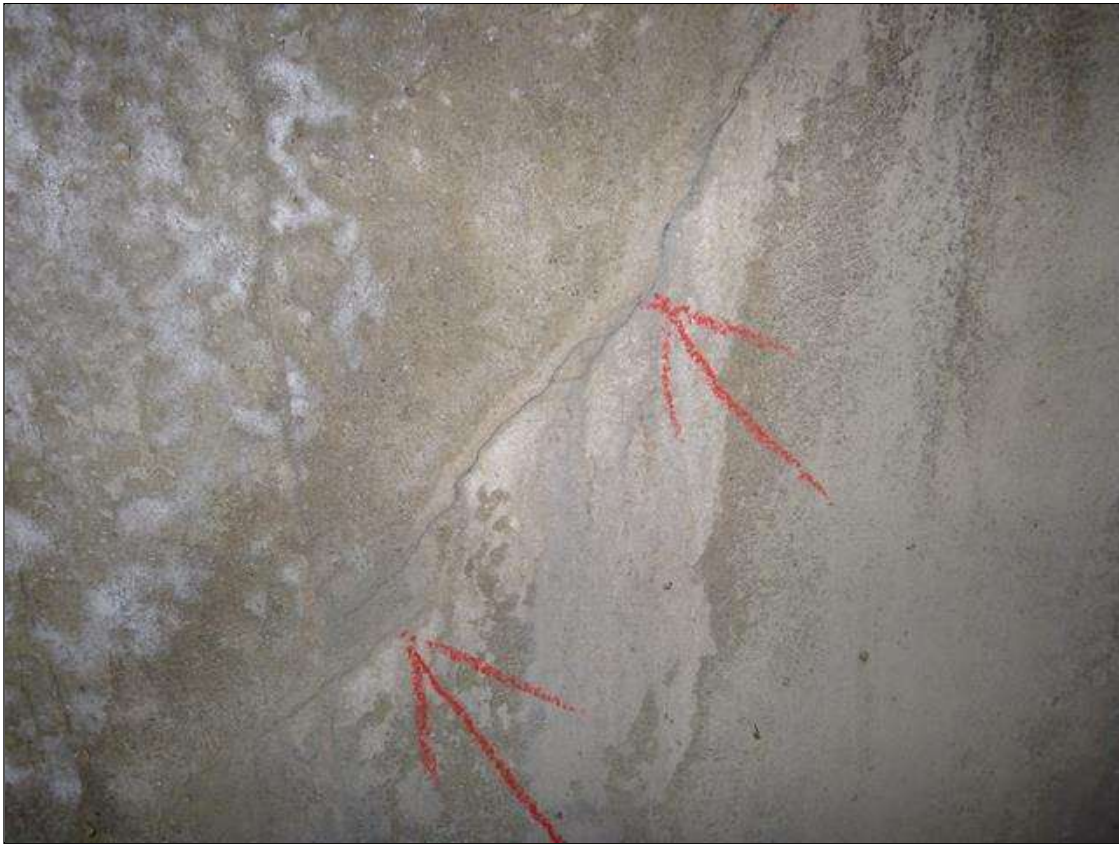
End Bent 1 Abutment/Backwall : END BENT 1 ABUTMENT HAS A 1/16 INCH WIDE X 3 FT. LONG DIAGONAL CRACK IN BAY 7

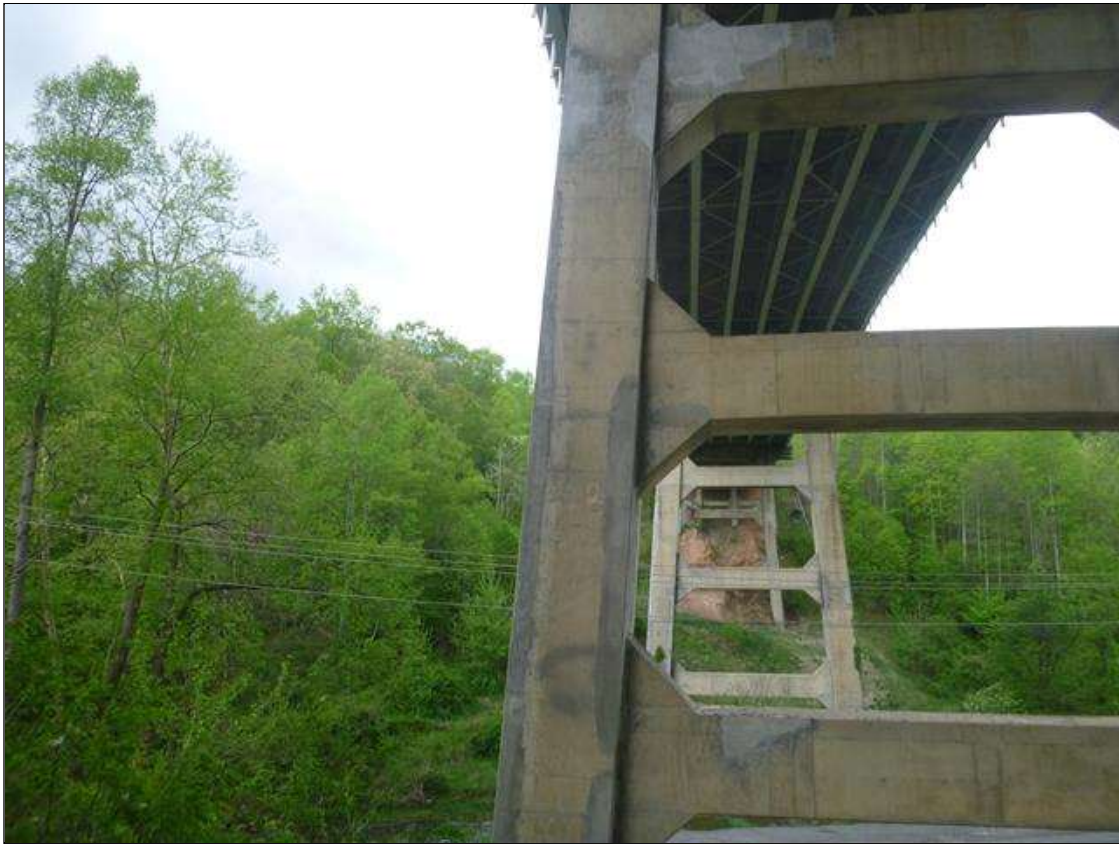
Bent 2 Pile 1: BENT 2, PILE 1 HAS BEEN PATCHED ON THE NORTHWEST AND SOUTHWEST CORNERS, PATCHES ARE SOUND

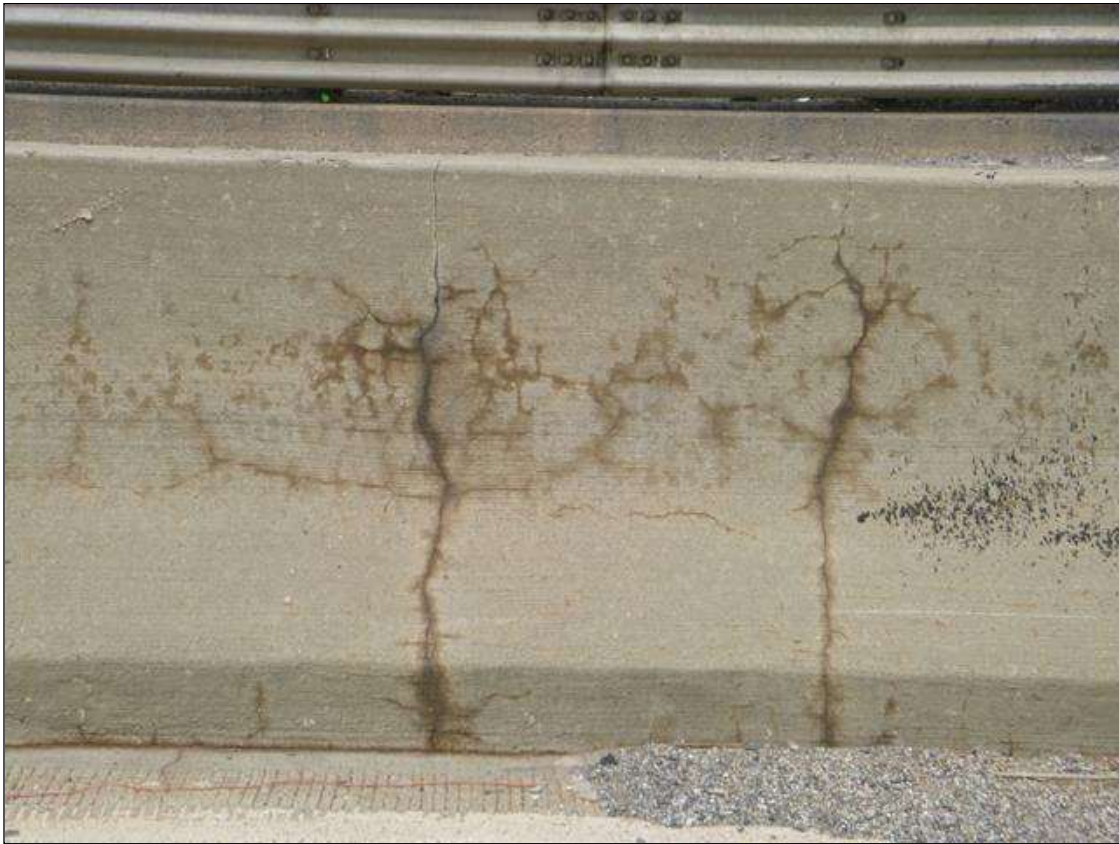
331 Cracking (RC and Other) SPAN 1 MEDIAN RAIL HAS 50 FT. OF HAIRLINE TO 1/16 INCH WIDE CRACKING THRU OUT THE SPAN 3 50 50 Feet

Span 1 Median Rail: SPAN 1 MEDIAN RAIL HAS 50 FT. OF HAIRLINE TO 1/16 INCH WIDE CRACKING THRU OUT THE SPAN

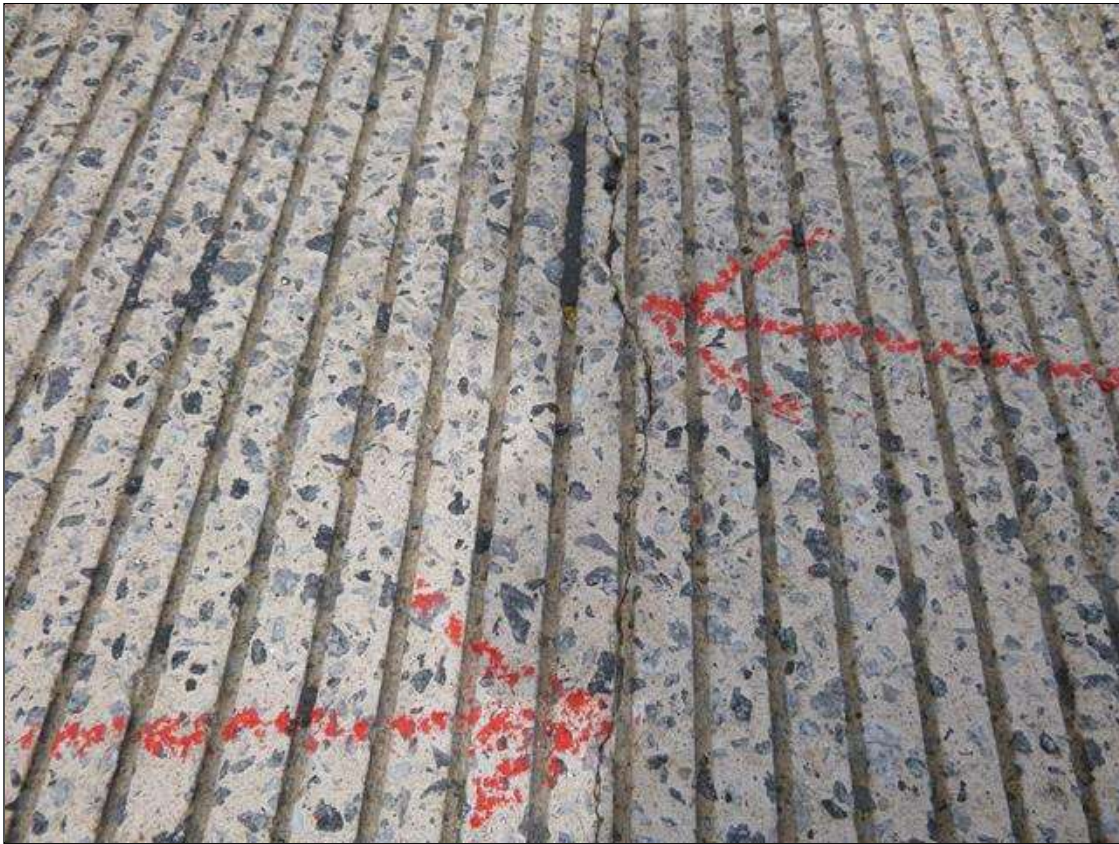
| Element Number | Defect Type | Defect Description | CS | CS Qty | Maint Qty | |
|---|---|---|---|---|---|---|
| 12 | Cracking (RC and Other) | SPAN 1, TOP OF DECK HAS 7, 1/16 INCH WIDE TRANSVERSE CRACK X 12 FT. LONG AT MID-SPAN OF WEST BOUND LANES FOR A TOTAL OF 185 SQ. FT. THRU OUT THE WEST AND EAST BOUND LANES | 3 | 185 | 185 | Square Feet |

Span 1 Deck: SPAN 1, TOP OF DECK HAS A 1/16 INCH WIDE TRANSVERSE CRACK X 12 FT. LONG AT MID-SPAN, OF THE WEST BOUND LANES FOR A TOTAL OF 185 SQ. FT. THRU OUT THE EAST AND WEST BOUND LANES

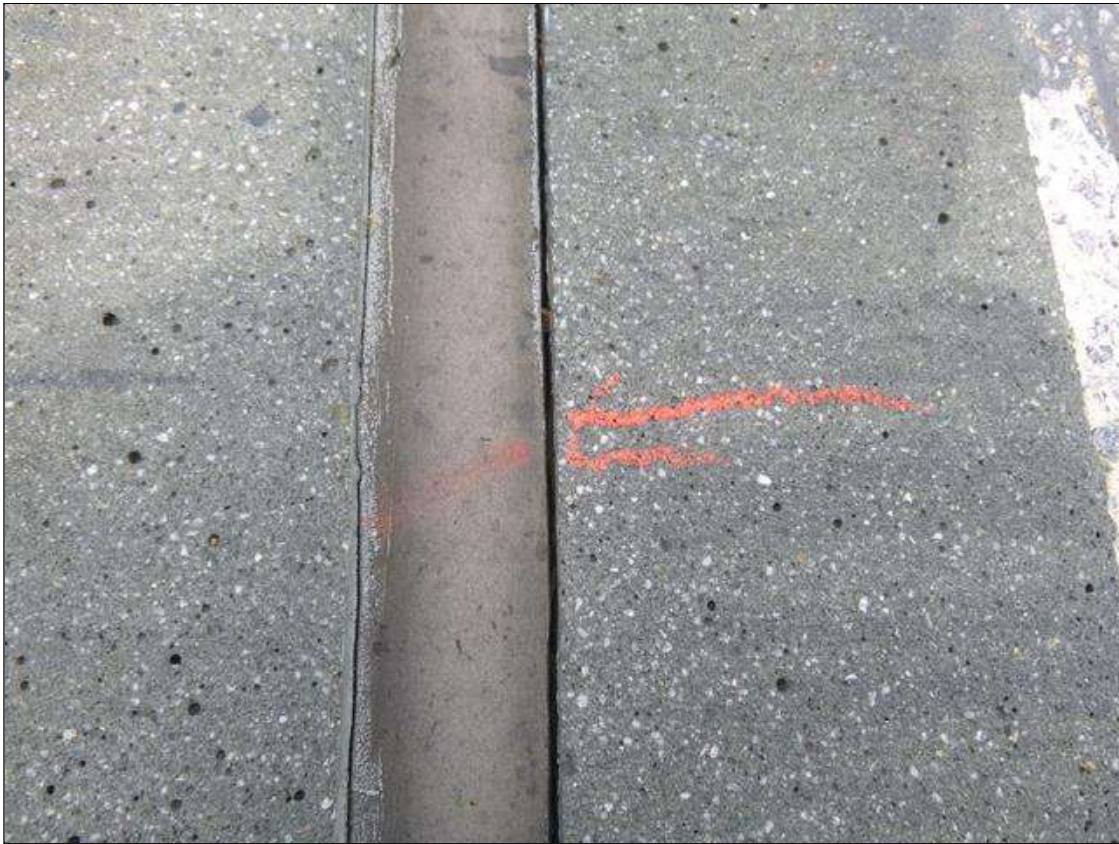
Expansion Joint : BENT 1 JOINT HAS 24 FT. OF LOSS OF ADHESION, 1/8 INCH WIDE X 1 INCH DEEP IN THE WEST BOUND LANES
