NC DEPARTMENT OF TRANSPORTATION  
DIVISION OF HIGHWAYS  
STRUCTURE MANAGEMENT UNIT

## Structure Safety Report

### Routine Element Inspection - Contract

COUNTY: HAYWOOD STRUCTURE NUMBER: 430171 FREQUENCY: 24 MONTHS

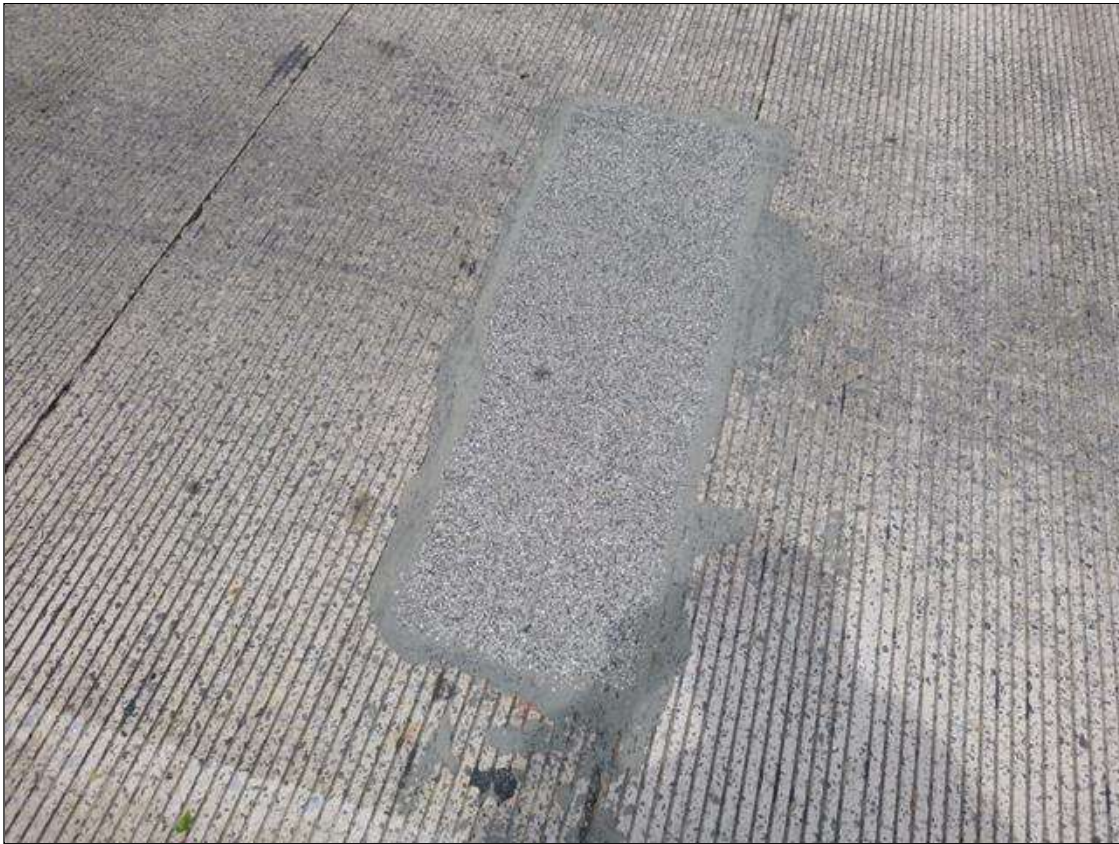
Span 2 Deck: SPAN 2, TOP OF THE DECK HAS 16 INCH X 44 INCH PATCH, 4 FT. FROM THE LEFT RAIL, 54 FROM BENT 1

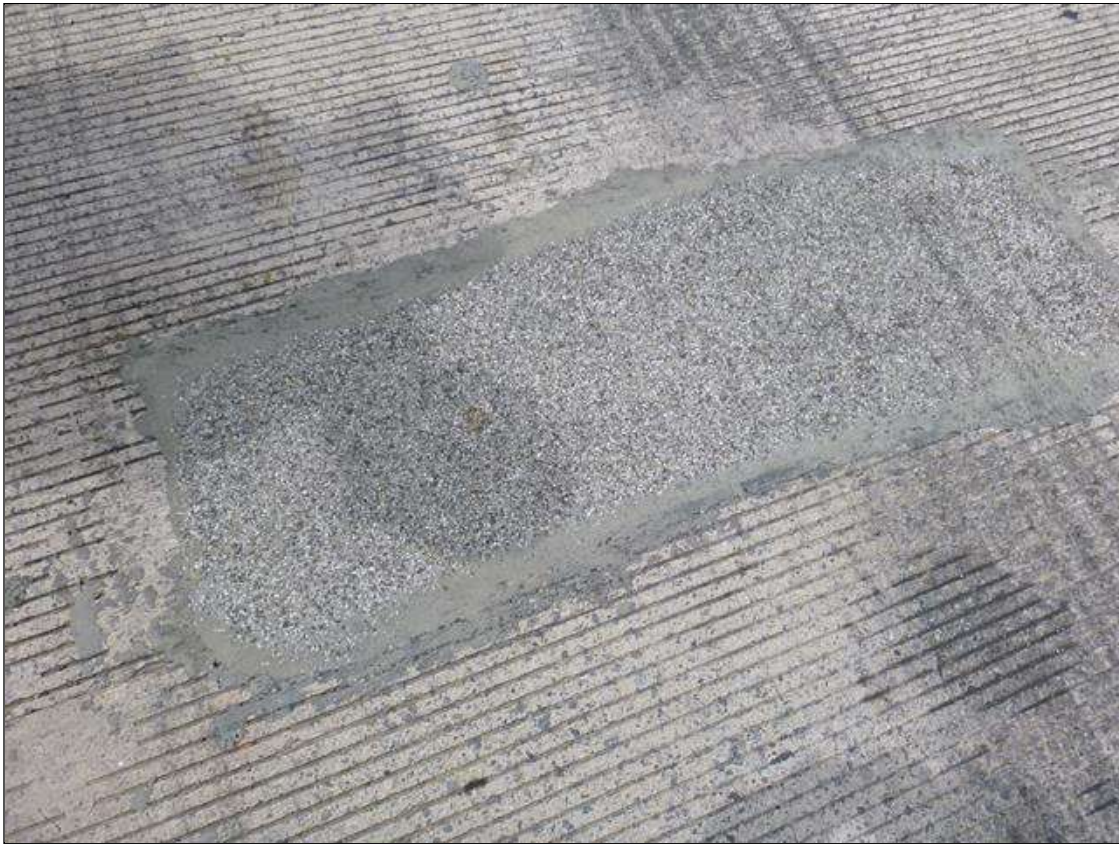
Span 3 Deck: SPAN 3, TOP OF THE DECK HAS A PATCH, 12 INCHES X 48 INCHES, 5 FT. FROM THE LEFT RAIL, 20 FT. FROM BENT 3, FOR A TOTAL OF 120 SQ. FT. OF PATCHES THRU OUT THE TOP OF SPAN 2 WEST BOUND LANES

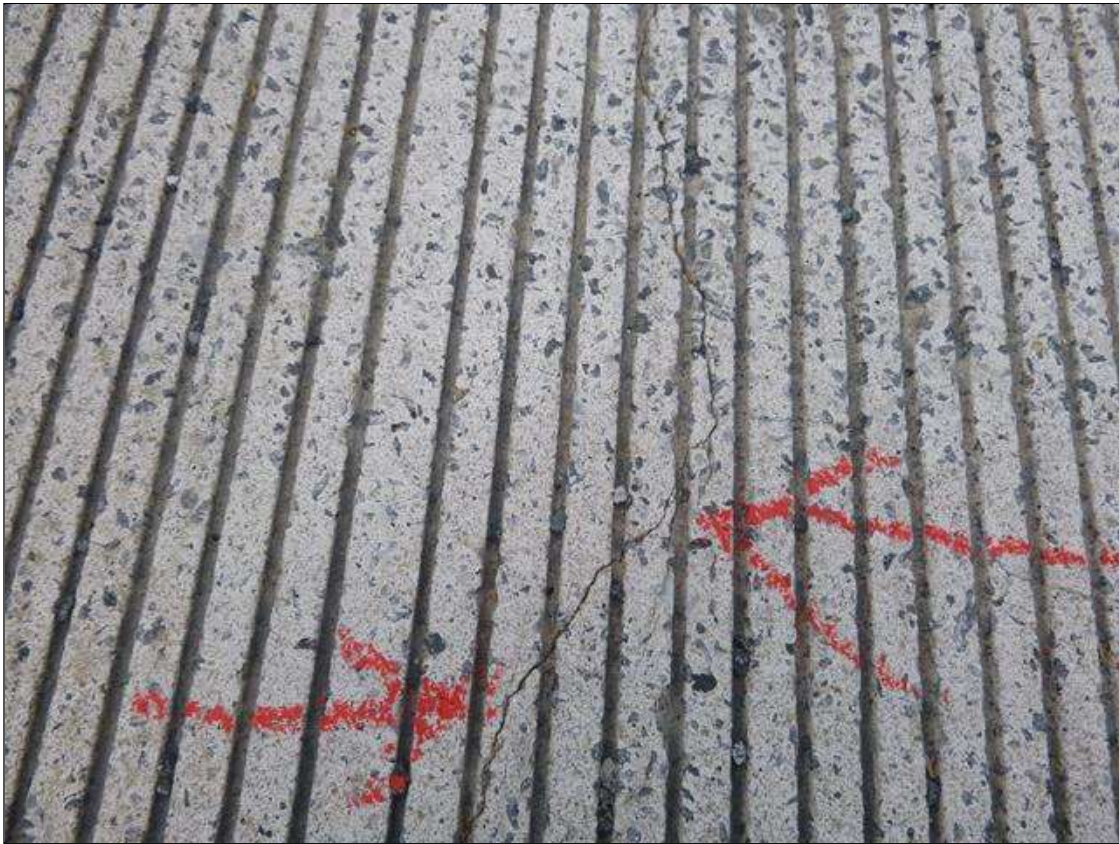
Span 4 Deck: SPAN 4, TOP OF DECK HAS 320 SQ. FT. OF 1/16 INCH WIDE TRANSVERSE CRACKING THRU OUT THE TOP OF SPAN 4 WEST AND EAST BOUND LANES

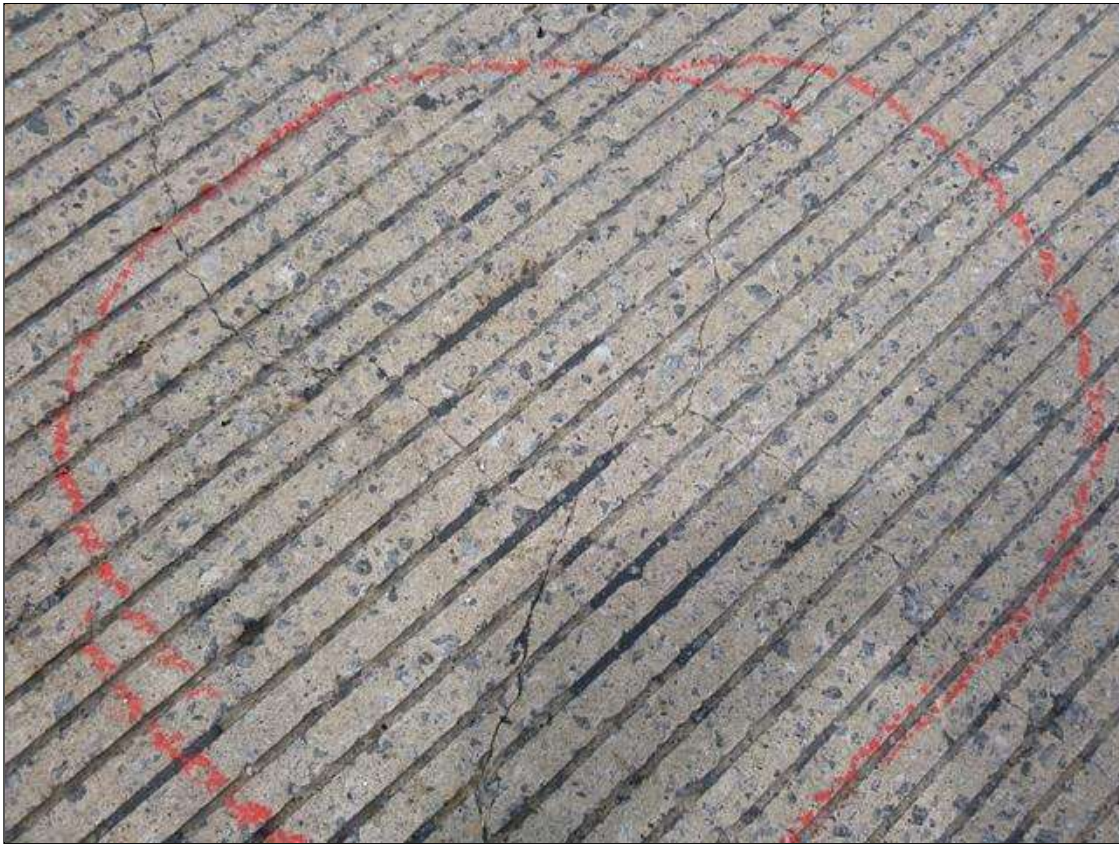
Span 4 Deck: SPAN 4 TOP OF THE DECK HAS 1 SQ. FT. AREA OF 1/16 INCH WIDE MAP CRACKING AT CENTERLINE OF ROADWAY AT MID-SPAN FOR A TOTAL OF 220 SQ. FT. OF CRACKING THRU OUT THE TOP OF THE WEST AND EAST BOUND LANES

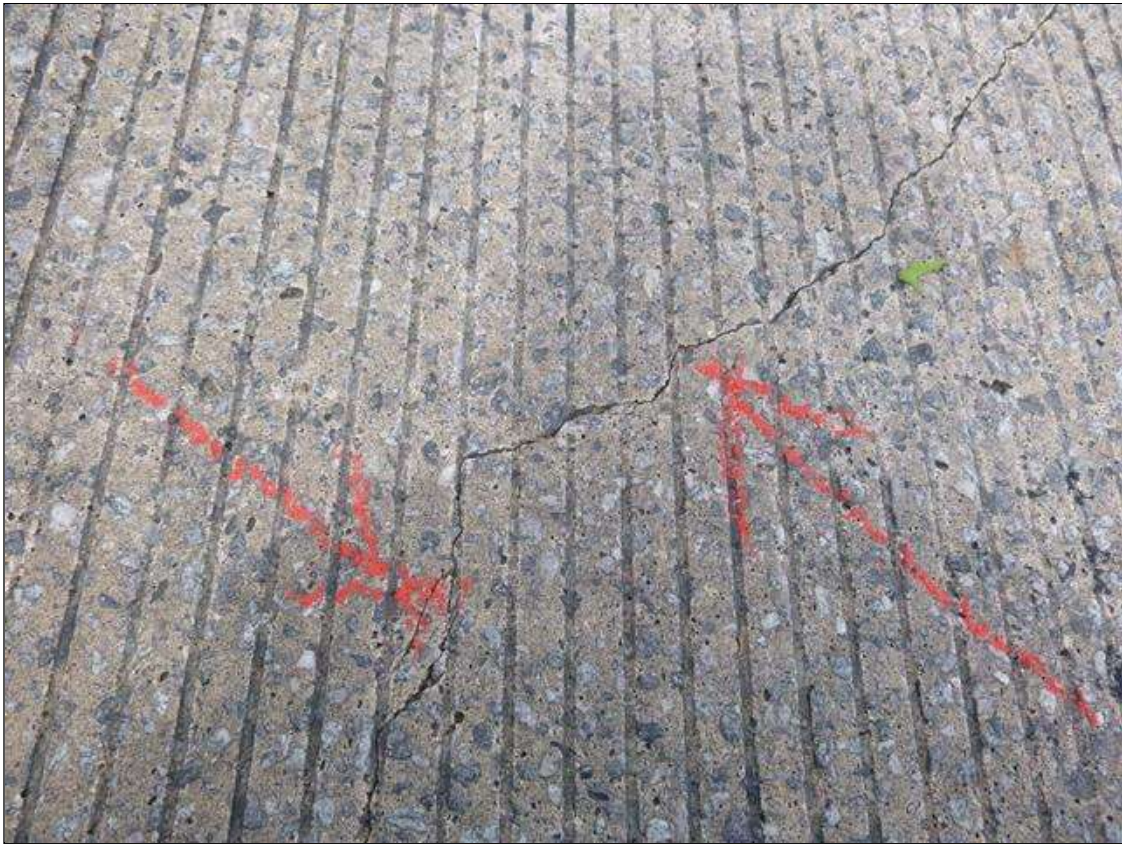
Span 5 Deck: SPAN 5 TOP OF THE DECK HAS A 1/16 INCH WIDE DIAGONAL CRACK, 10 FT. LONG, STARTING AT BENT 4, FOR A TOTAL OF 100 FT. OF CRACKING THRU OUT THE WEST AND EAST BOUND LANES

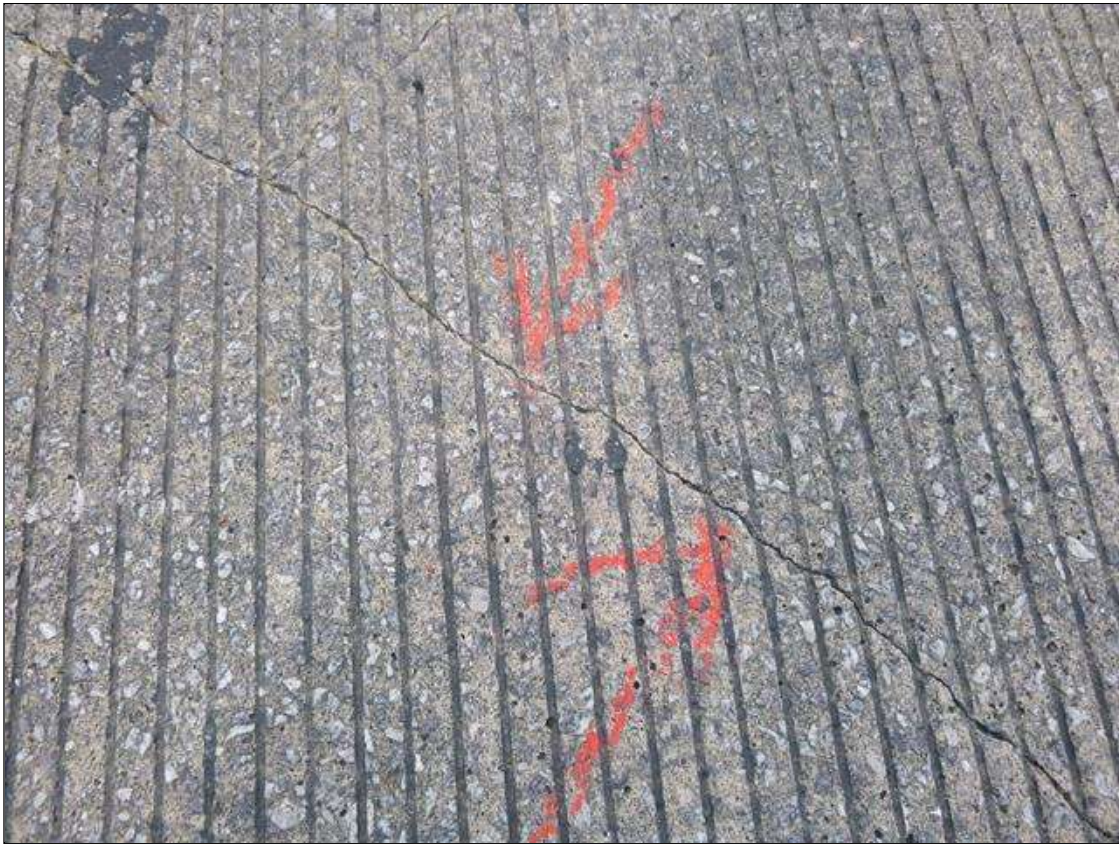
Span 6 Deck: SPAN 6, TOP OF THE DECK HAS 1/16 INCH WIDE X 12 FT. LONG DIAGONAL CRACK AT END BENT 2, FOR A TOTAL OF 150 SQ. FT. THRU OUT THE WEST AND EAST BOUND LANES

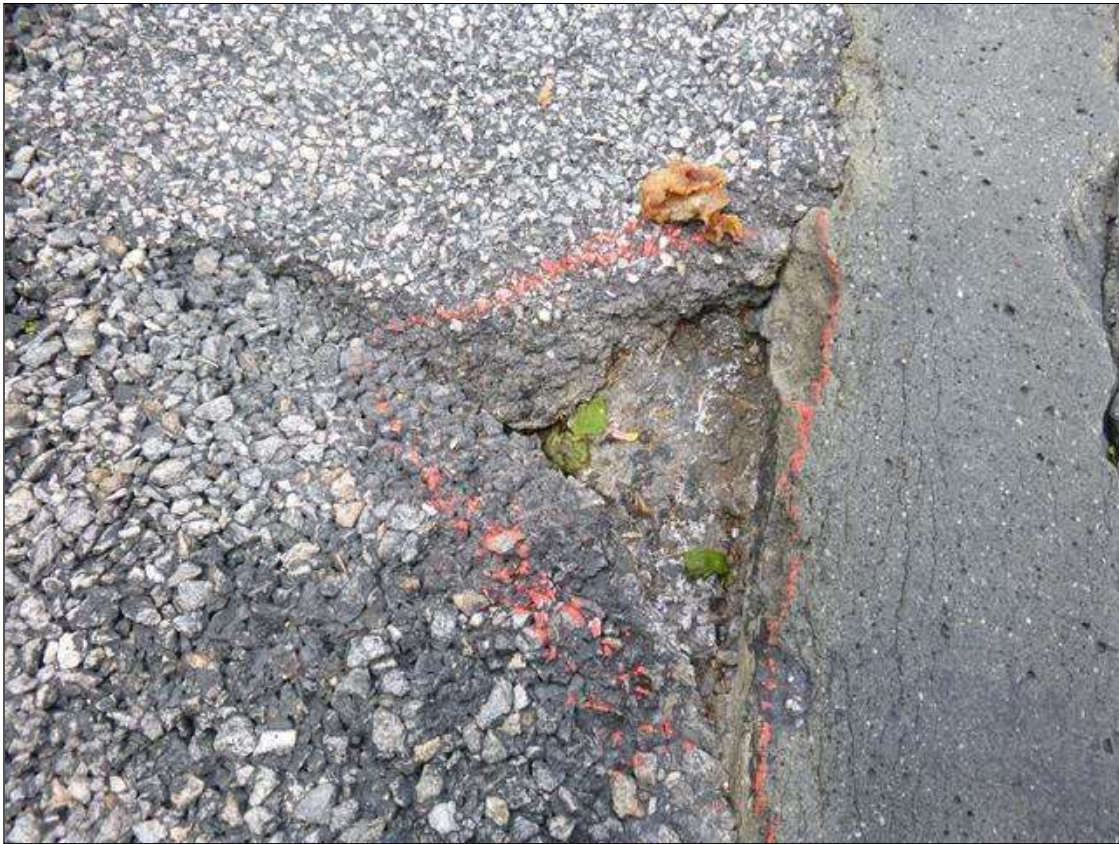
END BENT 2 ASPHALT WEARING SURFACE APPROACH HAS A 8 INCH X 5 INCH X 2` INCH DEEP VOID AT CENTERLINE OF ROADWAY AT END BENT 2 JOINT, WEST BOUND LANES

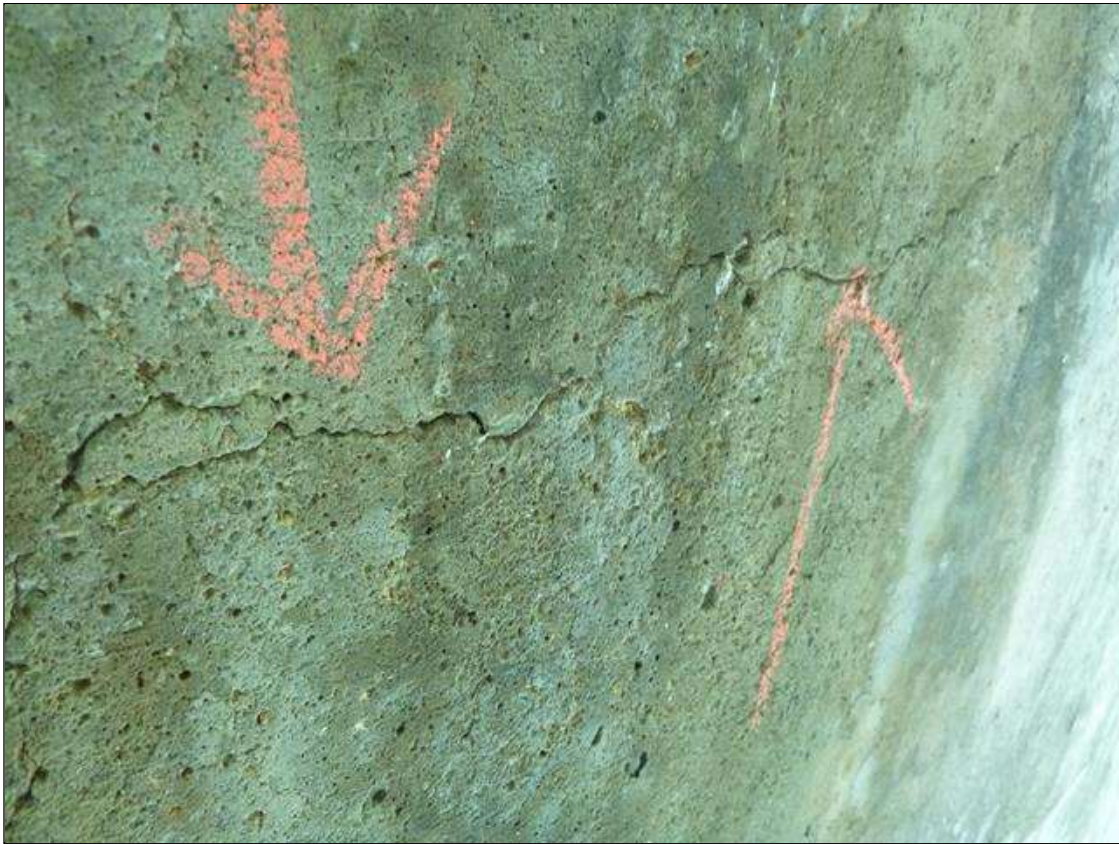
Bent 2 Cap 1: BENT 2 CAP, SPAN 3 SIDE HAS A 1/32 INCH WIDE LONGITUDINAL CRACK IN THE FACE OF THE CAP, NEAR TOP EDGE, UNDER BEAM 5, 6 FT. LONG

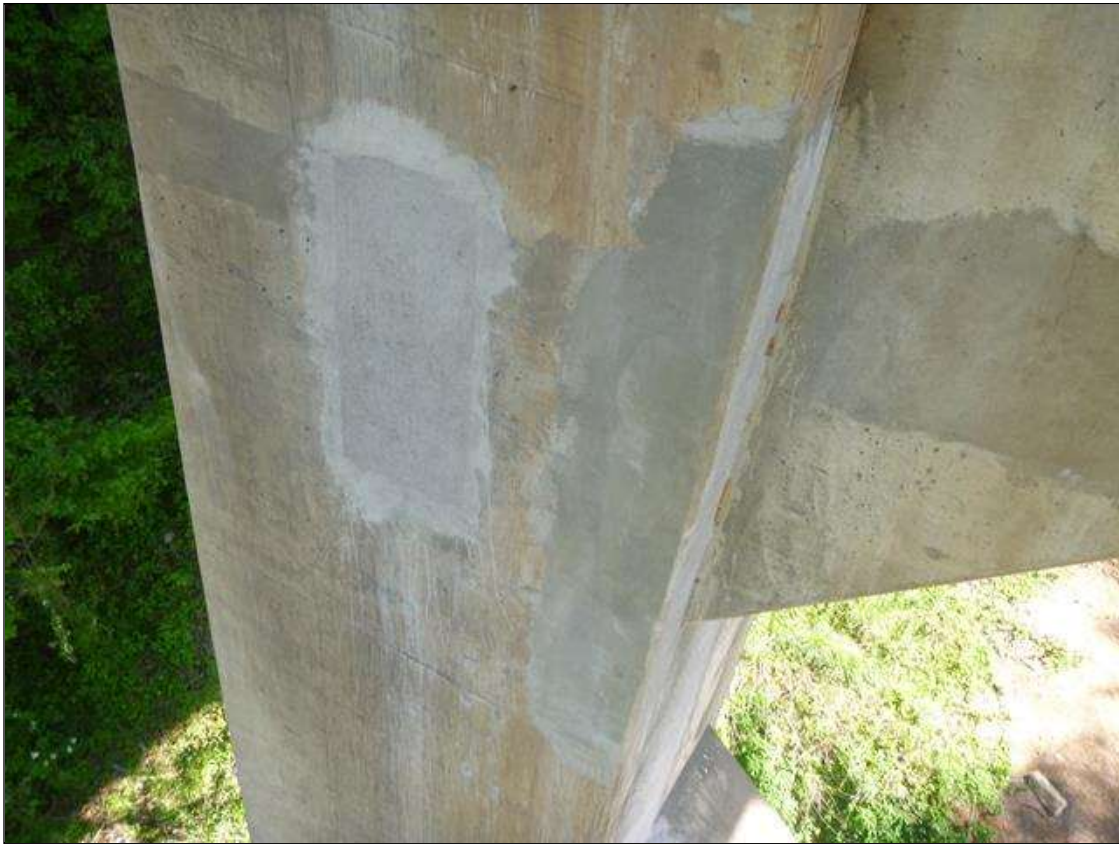
Bent 2 Pile 2: BENT 2, PILE 2 HAS SEVERAL PATCHES IN GOOD CONDITION, PHOTO TAKEN ON THE EAST FACE

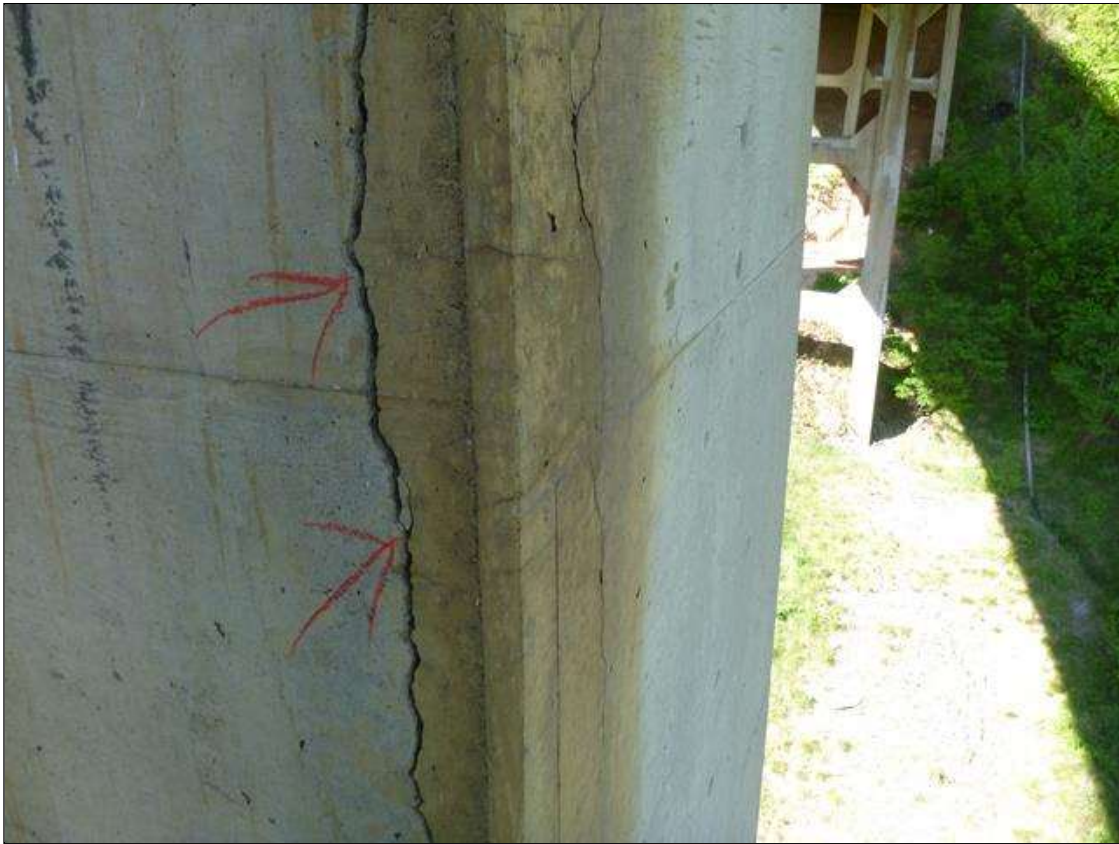
Bent 3 Pile 2: BENT 3, PILE 2 HAS AN AREA OF DELAMINATION ON THE SOUTHWEST CORNER, 20 FT. HIGH X 20 INCHES WIDE WITH UP TO 3/4 INCH WIDE SEPARATION, STARTING 6 FT. BELOW THE BOTTOM OF THE CAP

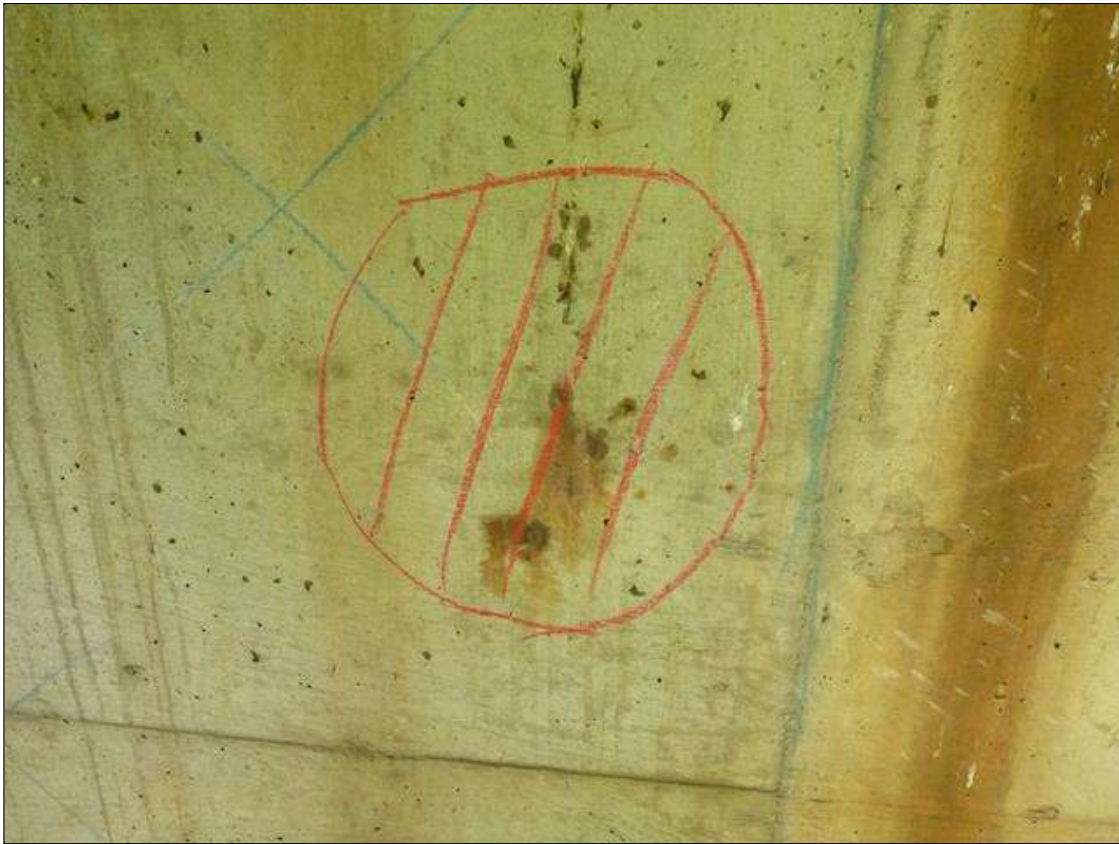
Bent 3 Cap 1: BENT 3 CAP, SPAN 4 SIDE HAS AN AREA OF DELAMINATION IN THE FACE OF THE CAP AT BEAM 6, 16 INCHES IN DIAMETER, WITH RUST STAINS

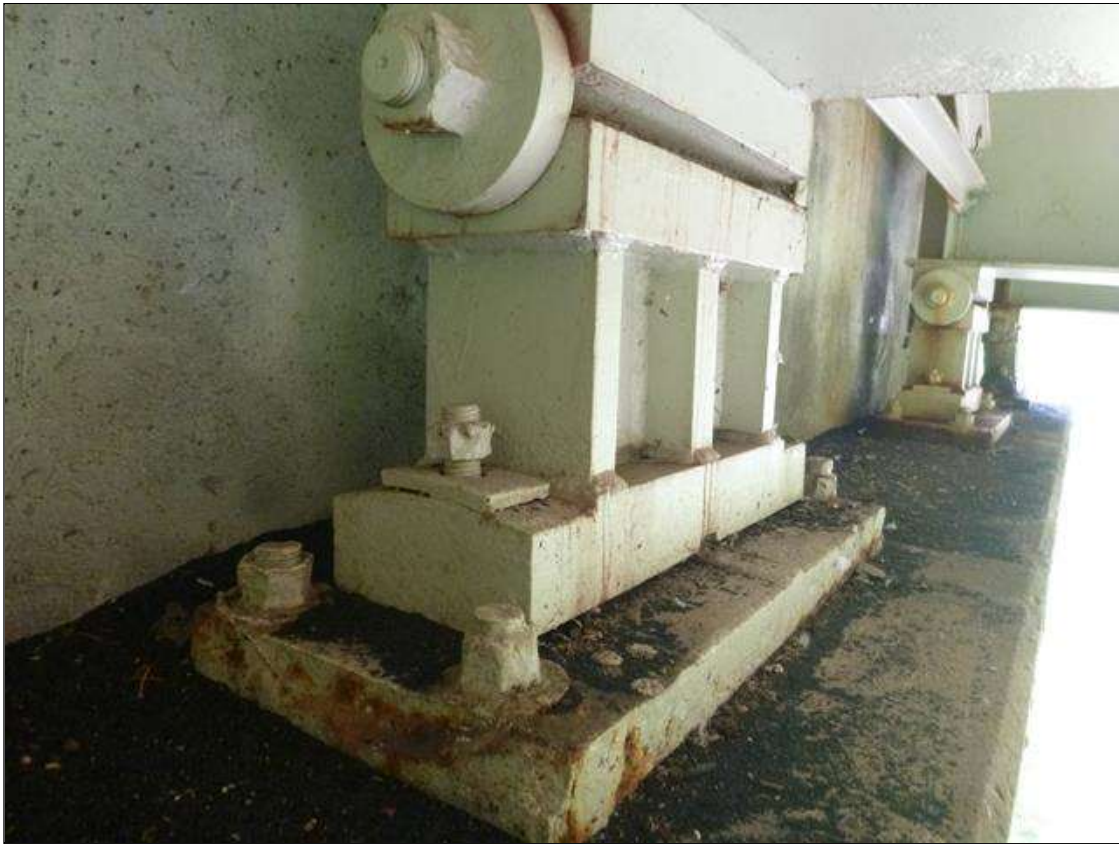
Span 2 Beam 6 Far Bearing: SPAN 2, BEAM 6 FAR BEARING HAS FRECKLED RUST

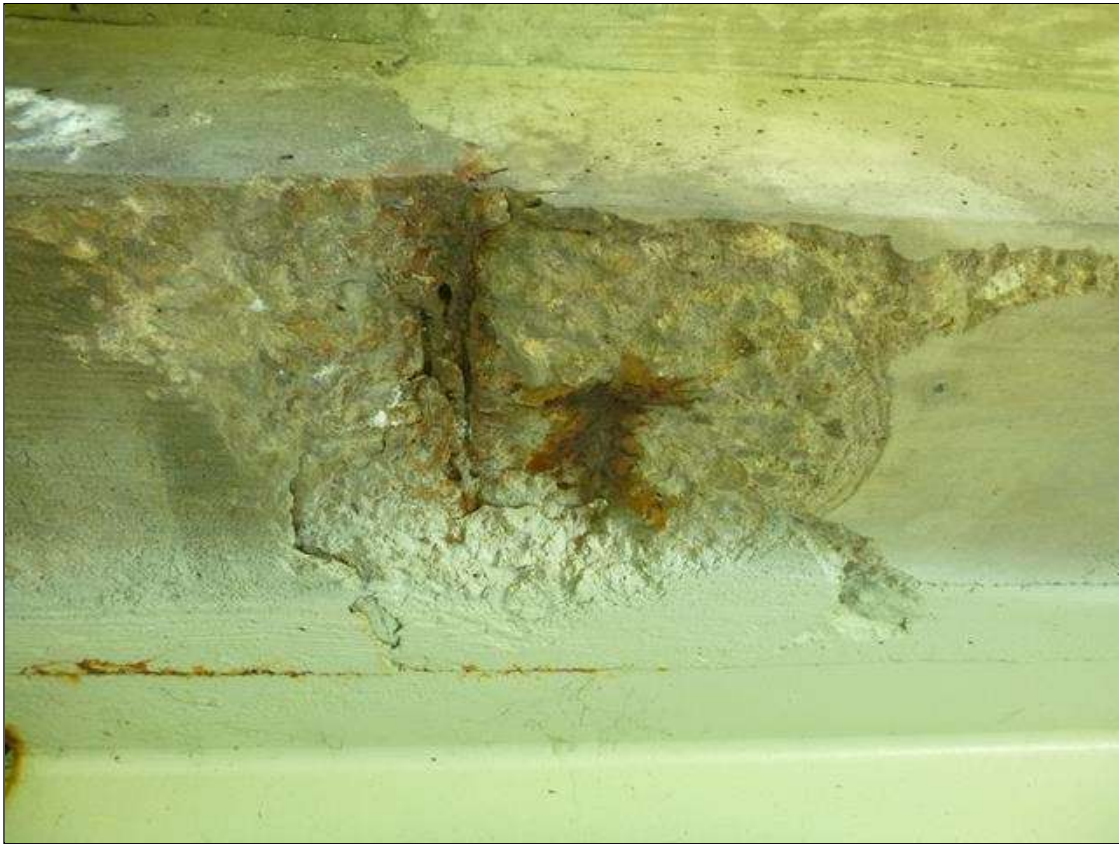
Span 5 Deck: SPAN 5, BOTTOM OF RIGHT OVERHANG AT BENT 4 HAS A SPALL, 12 INCHES X 15 INCHES X 1.5 INCHES DEEP WITH EXPOSED REBAR

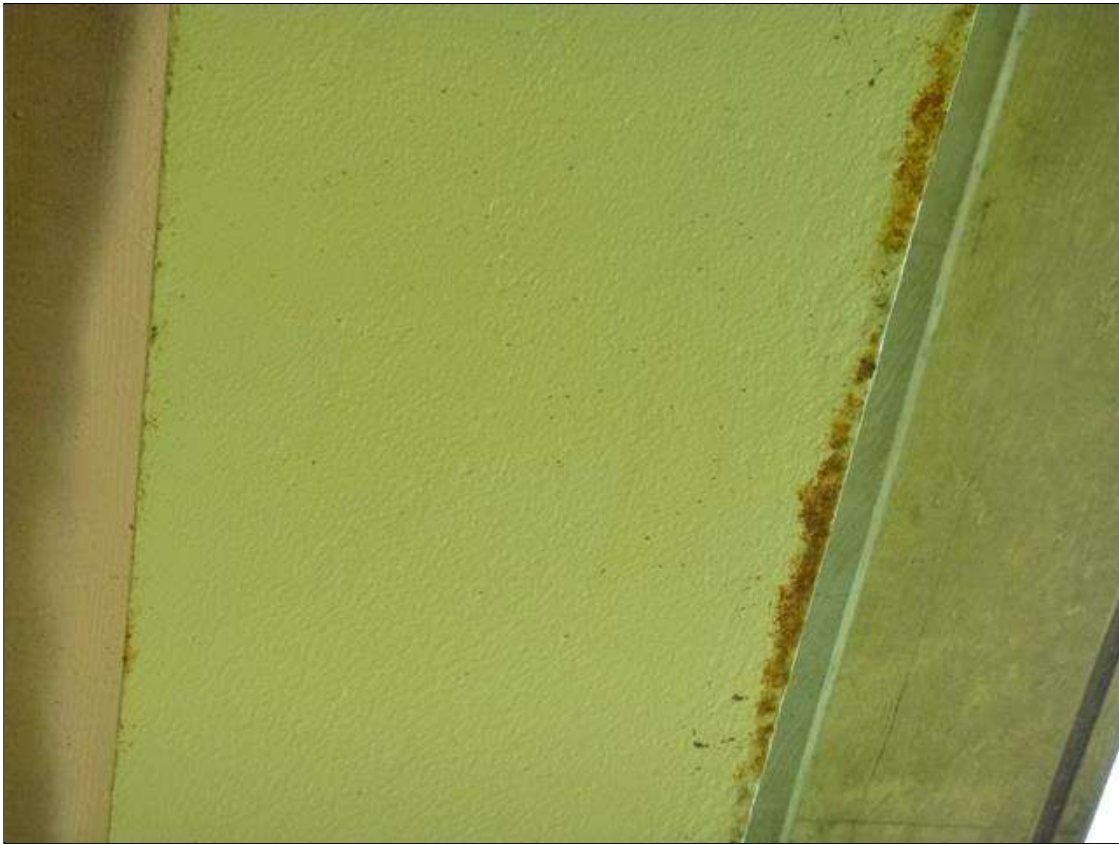
Span 5 Beam 1: SPAN 5, BEAM 1 HAS 20 FT. OF FRECKLED RUST ON THE EDGES OF THE FLANGES THRU OUT THE LENGTH OF THE BEAM

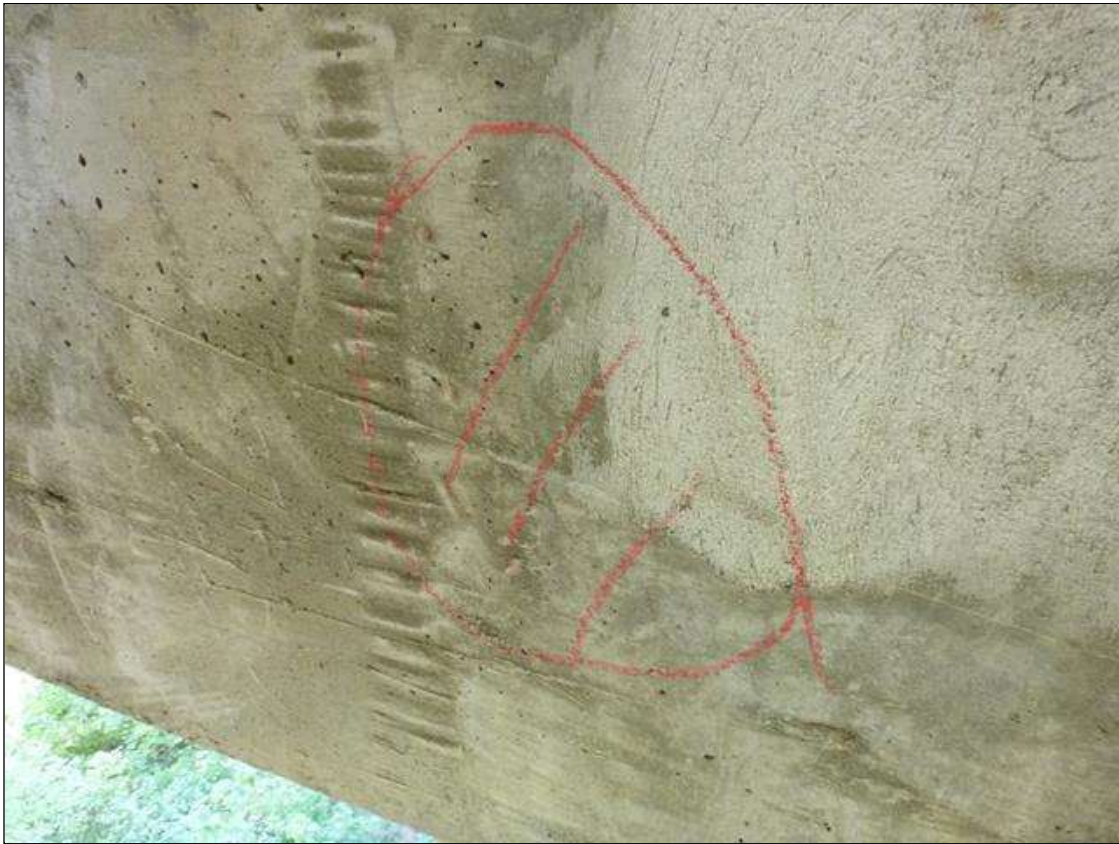
Bent 5 Cap 1: BENT 5 CAP, SPAN 6 SIDE HAS AN AREA OF DELAMINATION IN THE FACE OF THE CAP IN BAY 5  
NEAR BEAM 6, 12 INCHES IN DIAMETER

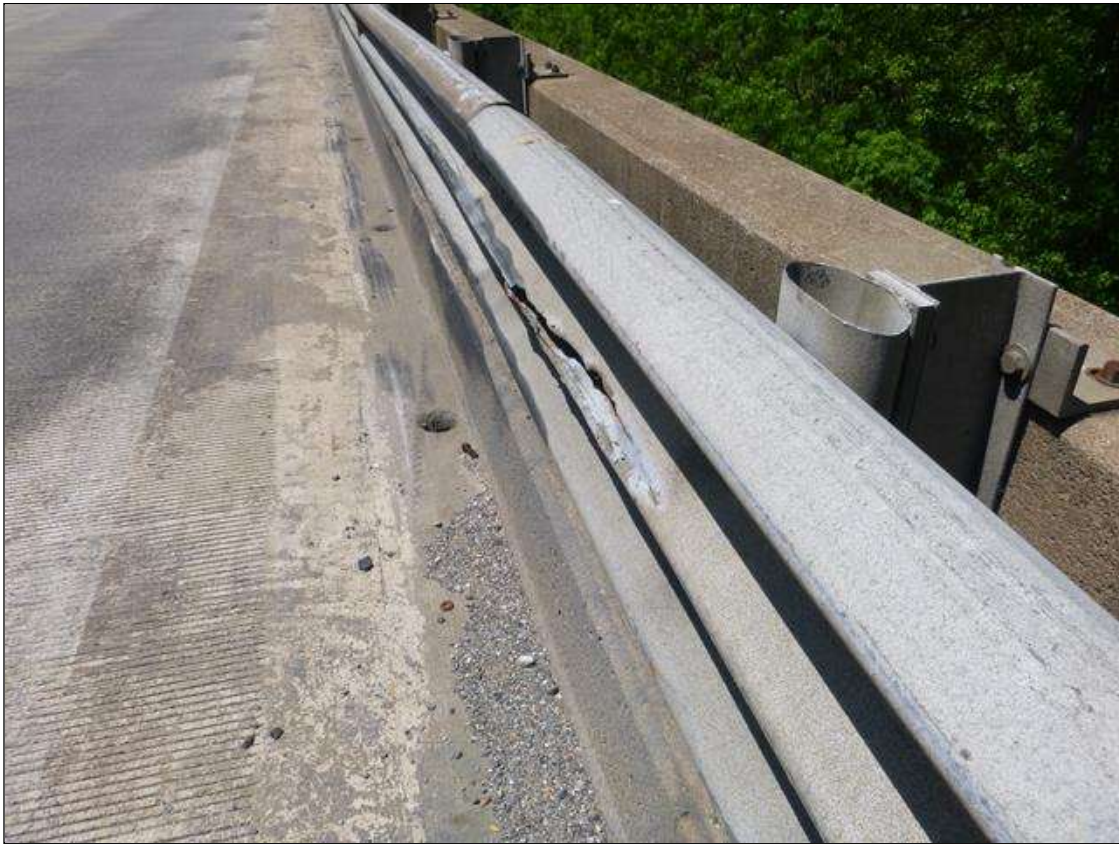
Span 2 Right Bridge Rail: SPAN 2, RIGHT RAIL HAS 25 FT. OF DAMAGE, STARTING 12 FT. FROM BENT 1

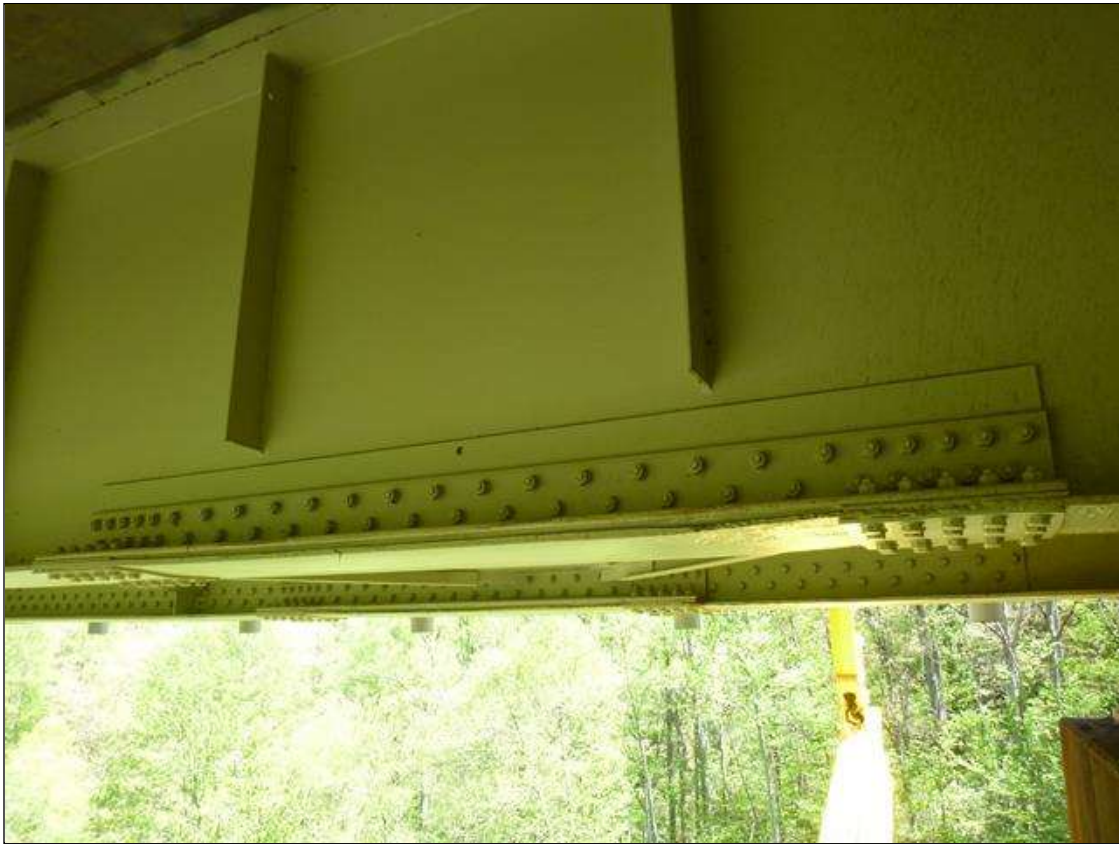
SPAN 4, GIRDER 2 HAS STEEL PLATE BEAM REPAIR TO BOTTOM FLANGE AND WEB, STARTING 29 INCHES FROM THE END OF THE BEAM AT BENT 4, 10 FT. LONG, GIRDER 3 REPAIR STARTS 27 INCHES FROM THE END OF THE GIRDER, GIRDER 1 STARTS REPAIR 7 FT. 3 INCHES FROM END OF GIRDER

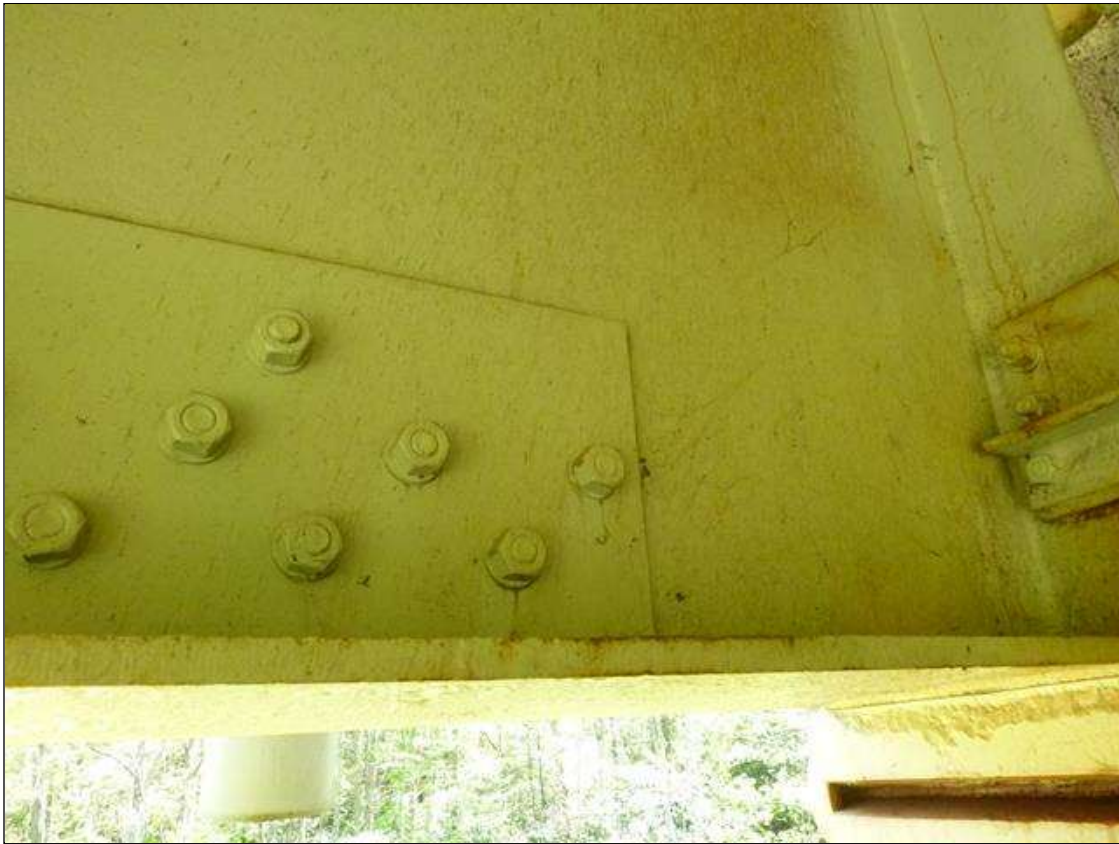
SPAN 4, GIRDER 1 HAS A REPAIR TO THE LOWER PORTION OF THE WEB, STARTING 27 INCHES FROM THE END OF THE GIRDER AT BENT 4, 32 FT.- 2 INCHES LONG

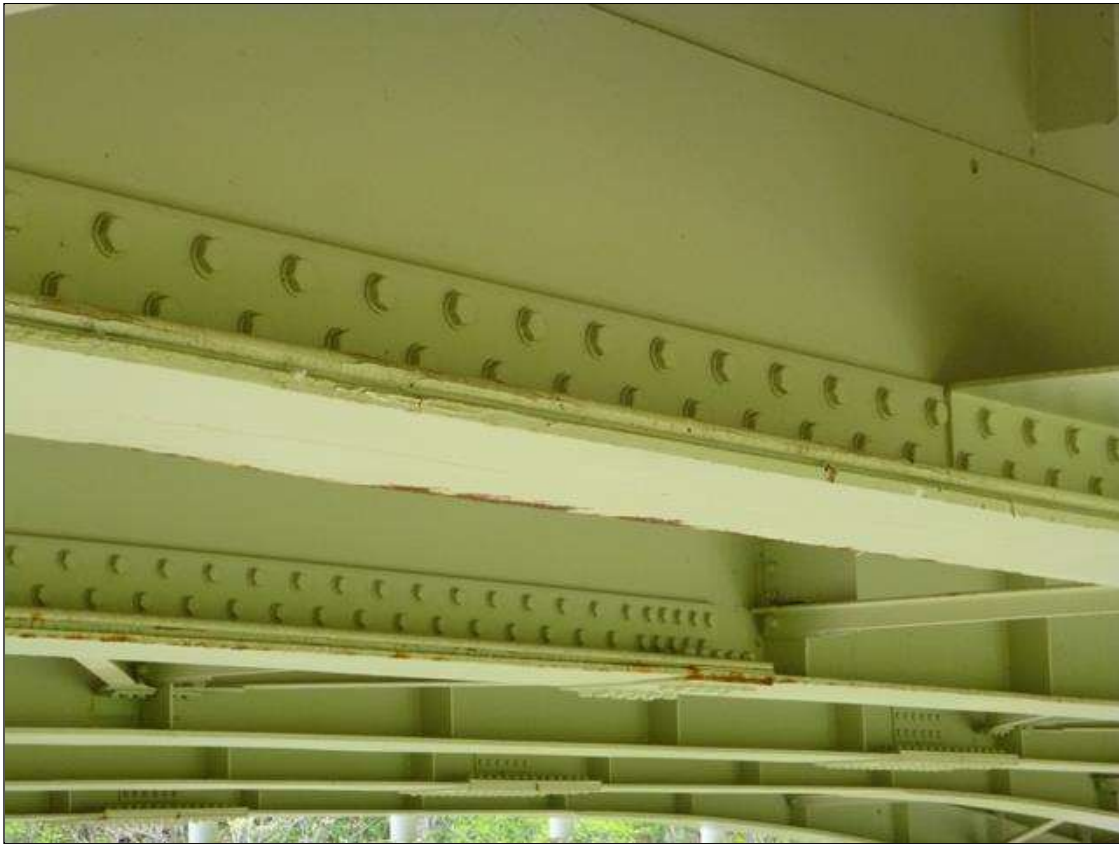
SPAN 2, BEAM 4, BOTTOM FLANGE AND WEB REPAIR, 50 FT. EAST OF BENT 2, SAME AT BEAMS 1,2 AND 5

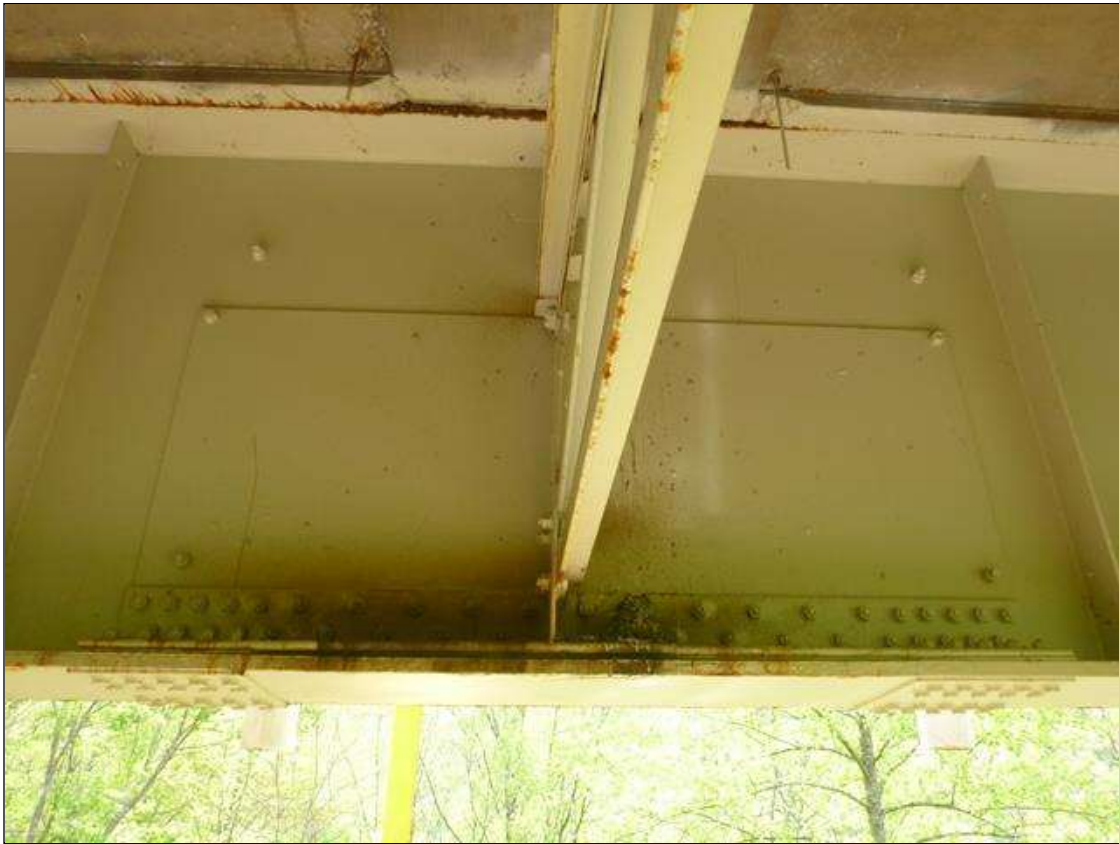
SPAN 2, BEAM 1 HAS A BOTTOM FLANGE AND WEB REPAIR NEAR MID-SPAN

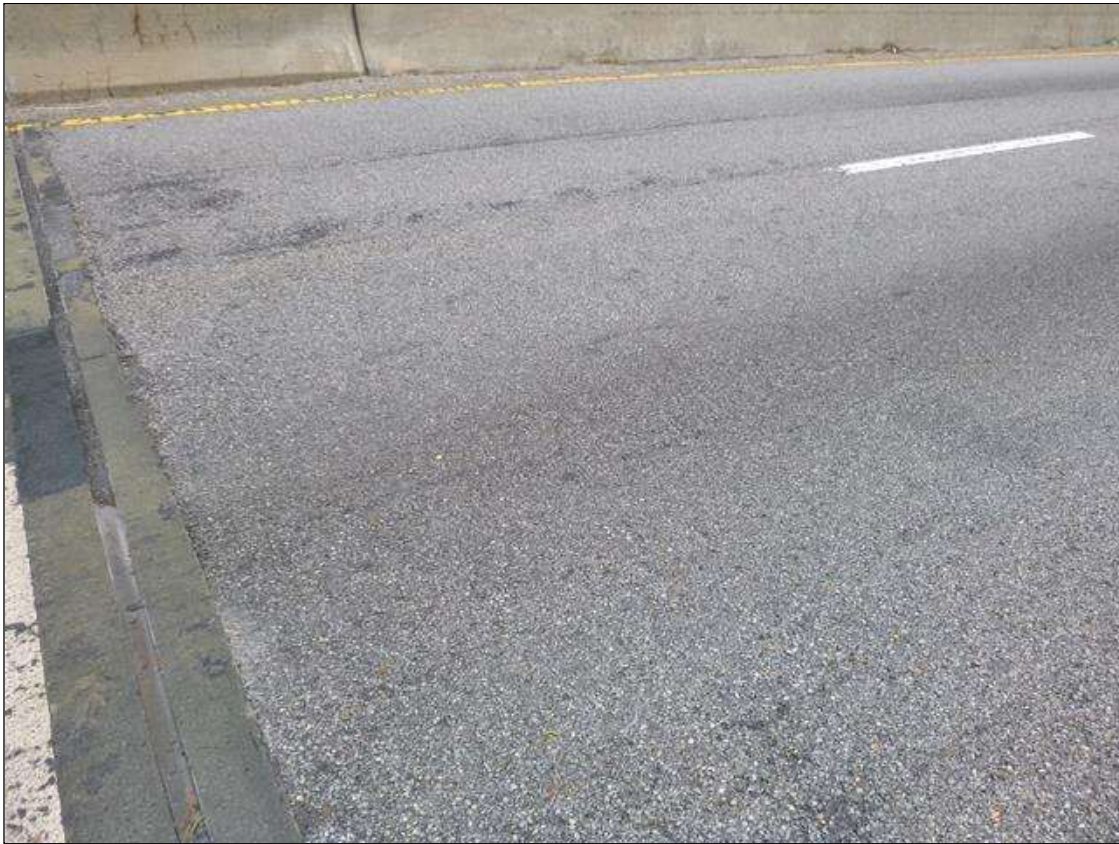
END BENT 1 ASPHALT WEARING SURFACE APPROACH GOOD CONDITION
