NC DEPARTMENT OF TRANSPORTATION  
DIVISION OF HIGHWAYS  
STRUCTURE MANAGEMENT UNIT

## Structure Safety Report

### Routine Element Inspection

COUNTY: CUMBERLAND STRUCTURE NUMBER: 250052 FREQUENCY: 24 MONTHS

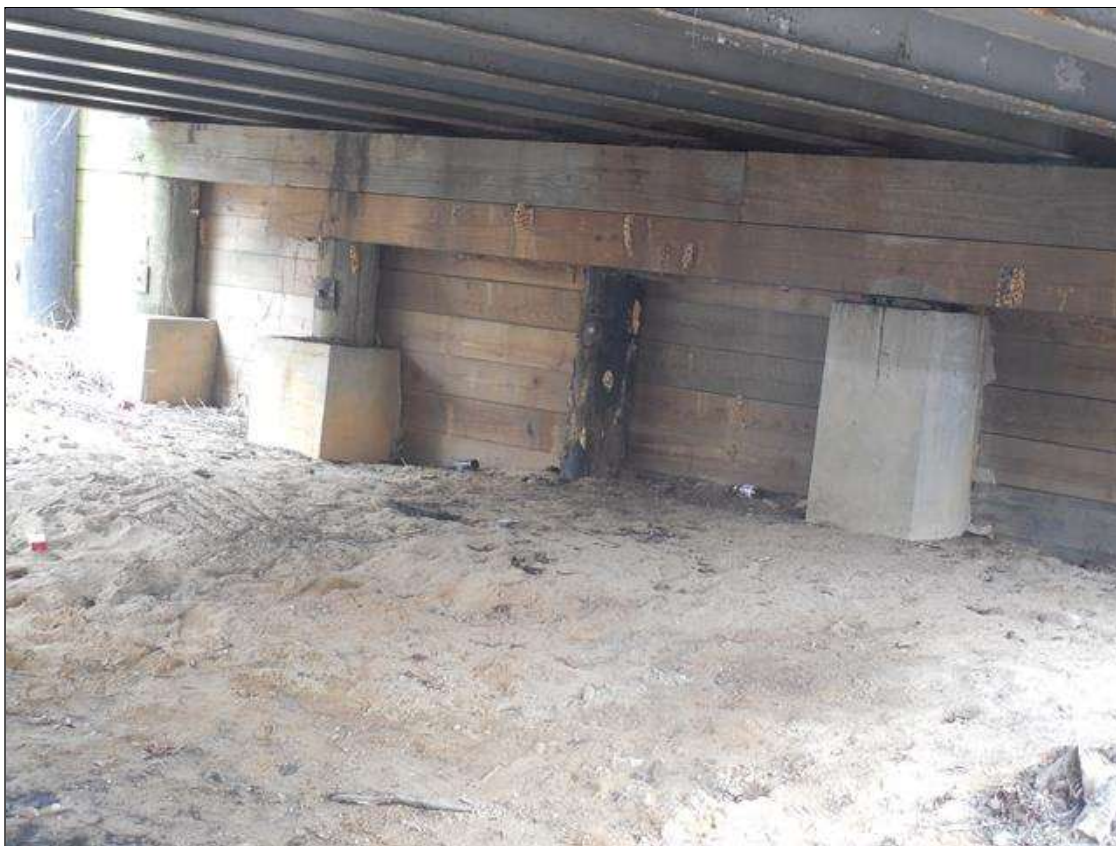
PILES 3, 5, AND 6 ENCASED IN CONCRETE AT END BENT 1 ( PHOTO # 5915 )

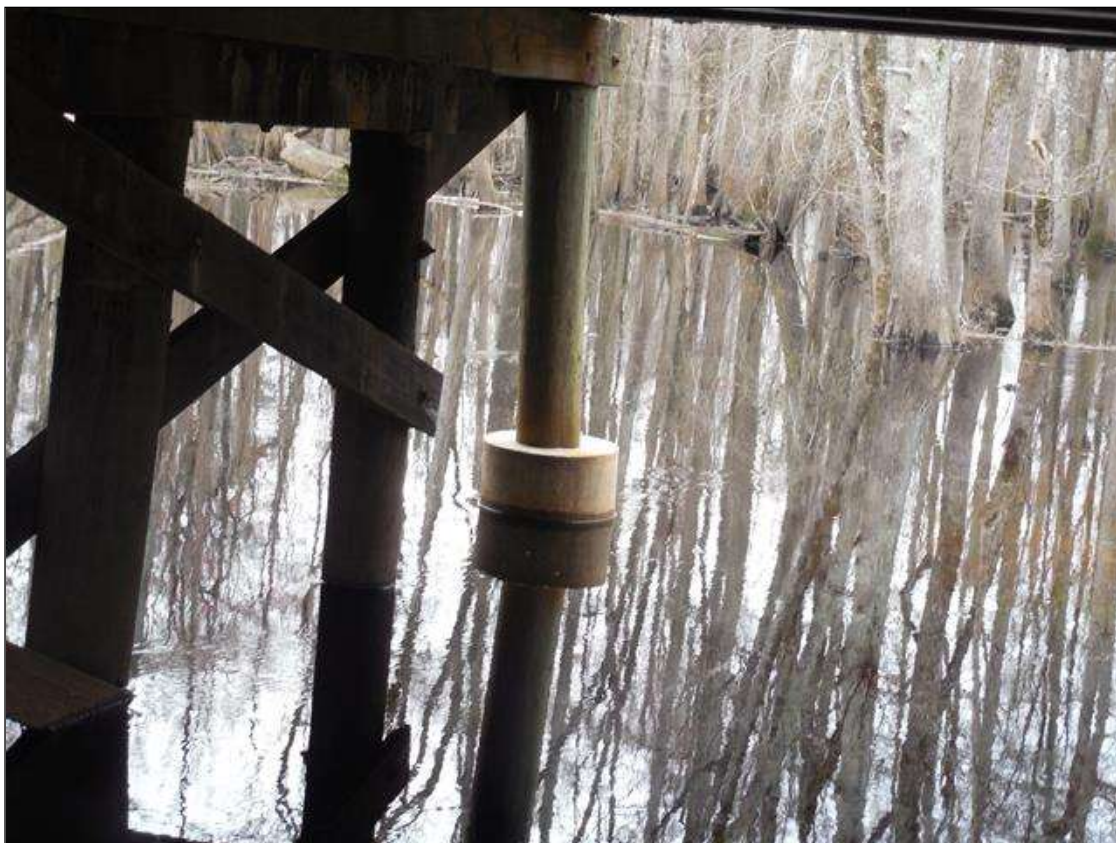
PILE 6 AT BENT 1 ENCASED IN CONCRETE ( PHOTO # 5916 )

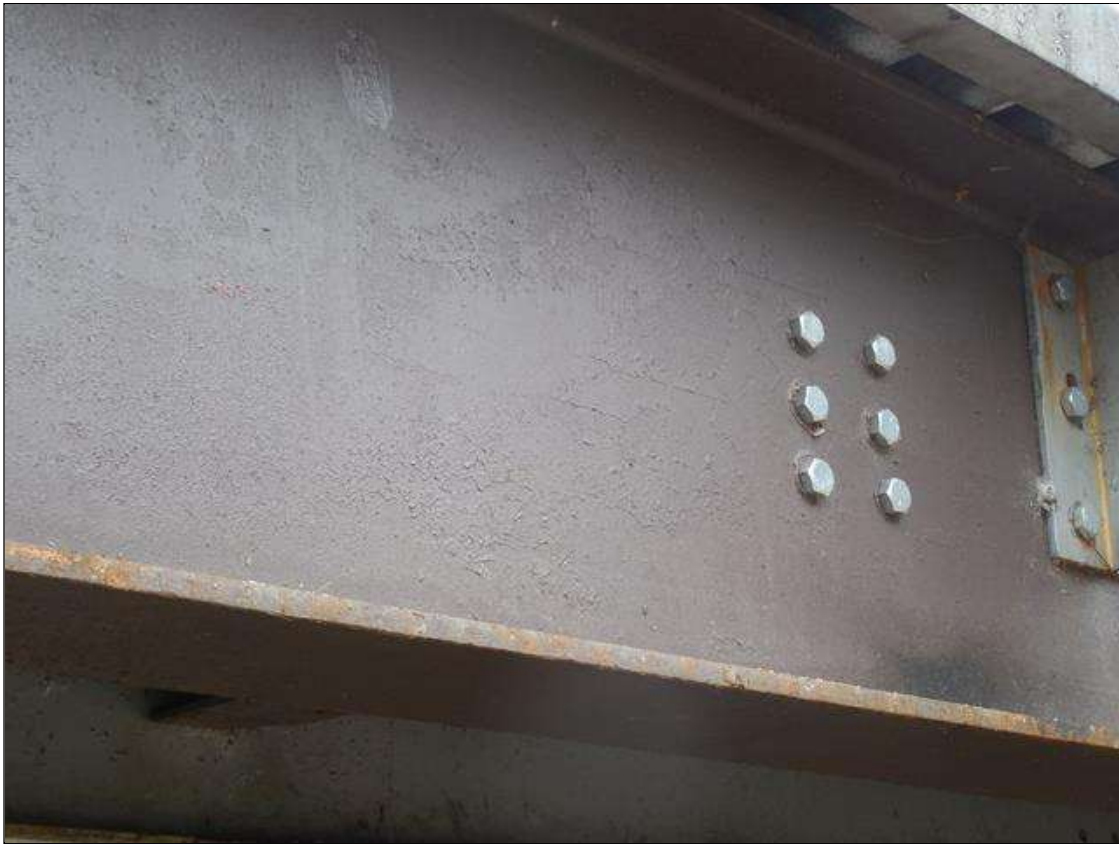
BEAM 1 IN SPAN 1 HAS BEEN REPLACED ( PHOTO# 5917 )  
30 Square Feet of Peeling/Bubbling/Cracking (steel Protective Coatings): Finish coats only.

BEAM 1 IN SPAN 1 HAS BEEN REPLACED ( PHOTO# 5917 )

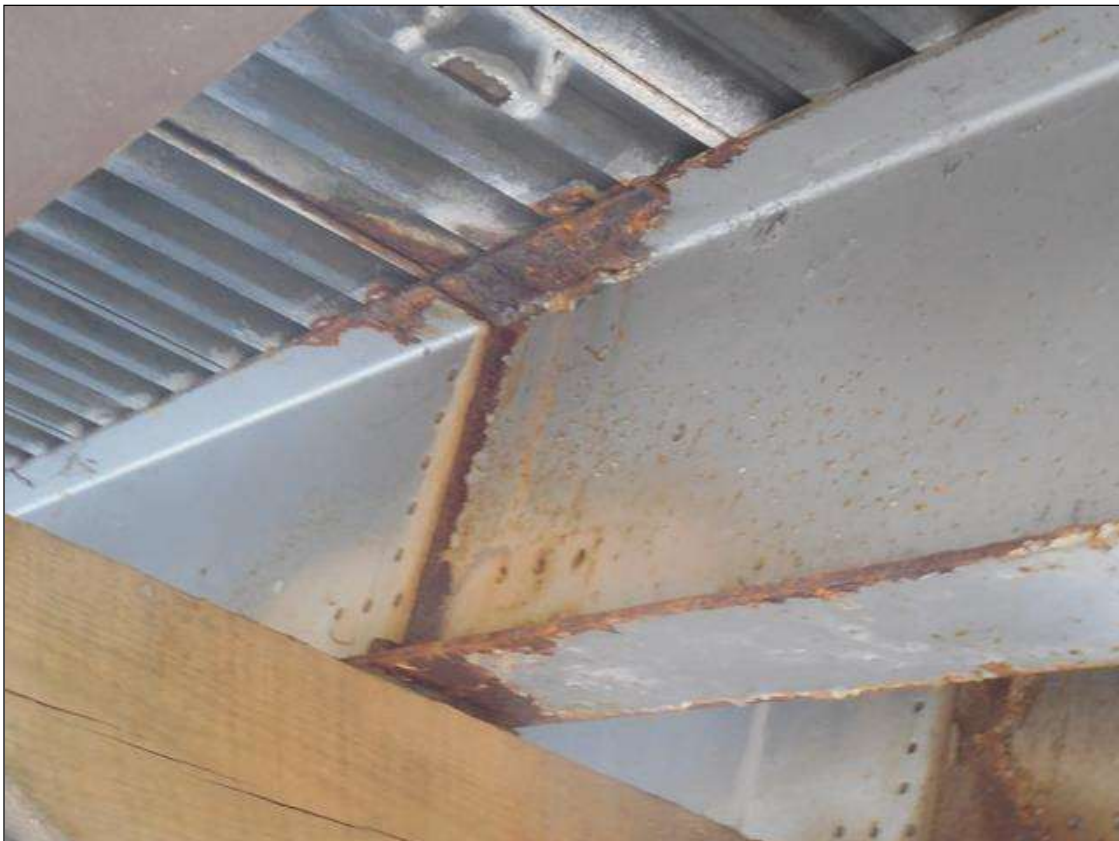
2 Feet of Corrosion: Section loss is evident or pack rust is present but does not warrant structural review. RUST WITH SECTION LOSS 1/16" IN FLANGE WITH 7/16" REMAINING AT BENT 1  
2 Square Feet of Effectiveness (Steel Protective Coatings): Limited effectiveness.  
30 Square Feet of Peeling/Bubbling/Cracking (steel Protective Coatings): Finish coats only.  
2 Feet of Corrosion: Section loss is evident or pack rust is present but does not warrant structural review. 1/8" SECTION LOSS IN WEB 3/8" REMAINING AND 1/4" REMAINING IN BOTTOM FLANGE AT END BENT 1, BAY 1 SIDE  
2 Square Feet of Effectiveness (Steel Protective Coatings): Limited effectiveness. 2' AT END BENT 1 END

Span 1 Beam 2: 2 Feet of Corrosion: Section loss is evident or pack rust is present but does not warrant structural review. RUST WITH SECTION LOSS 1/16" IN FLANGE WITH 7/16" REMAINING

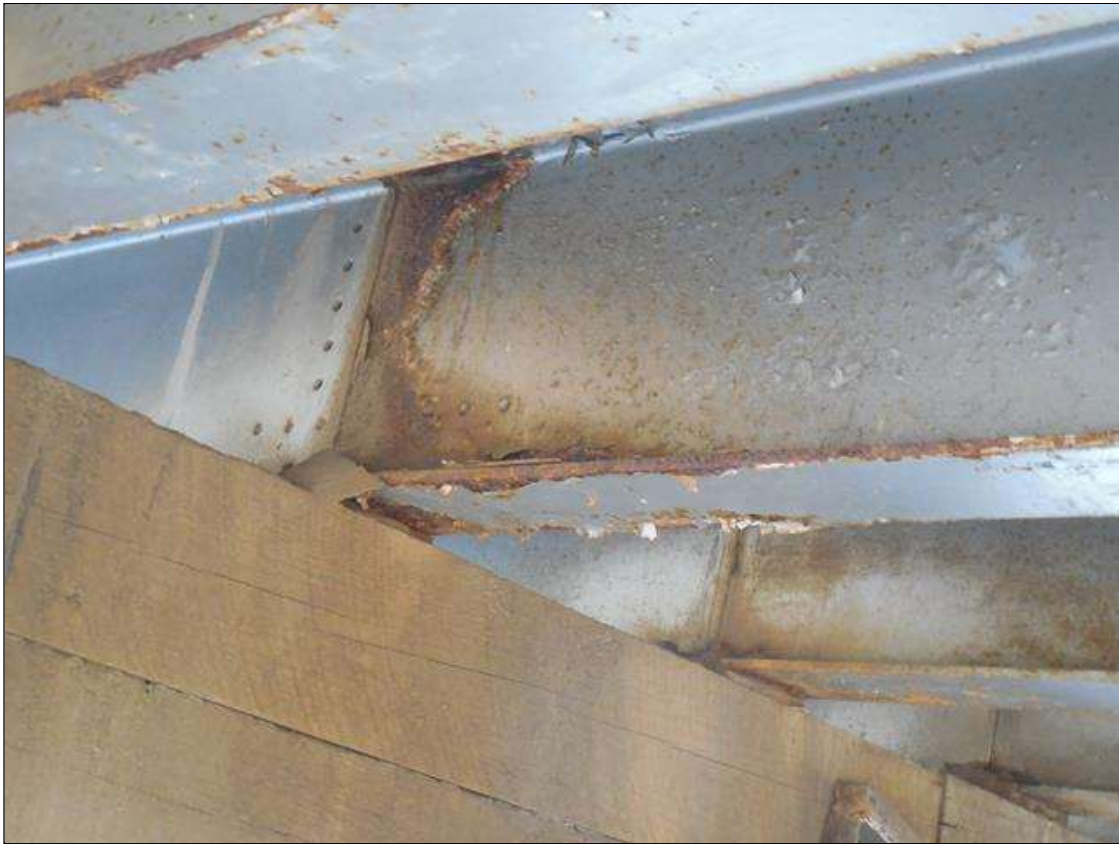
2 Feet of Corrosion: Section loss is evident or pack rust is present but does not warrant structural review. SECTION LOSS WITH 7/16" REMAINING IN FLANGE AT BENT 1  
2 Square Feet of Effectiveness (Steel Protective Coatings): Limited effectiveness.

Span 1 Beam 3: 2 Feet of Corrosion: Section loss is evident or pack rust is present but does not warrant structural review. SECTION LOSS WITH 7/16" REMAINING IN FLANGE

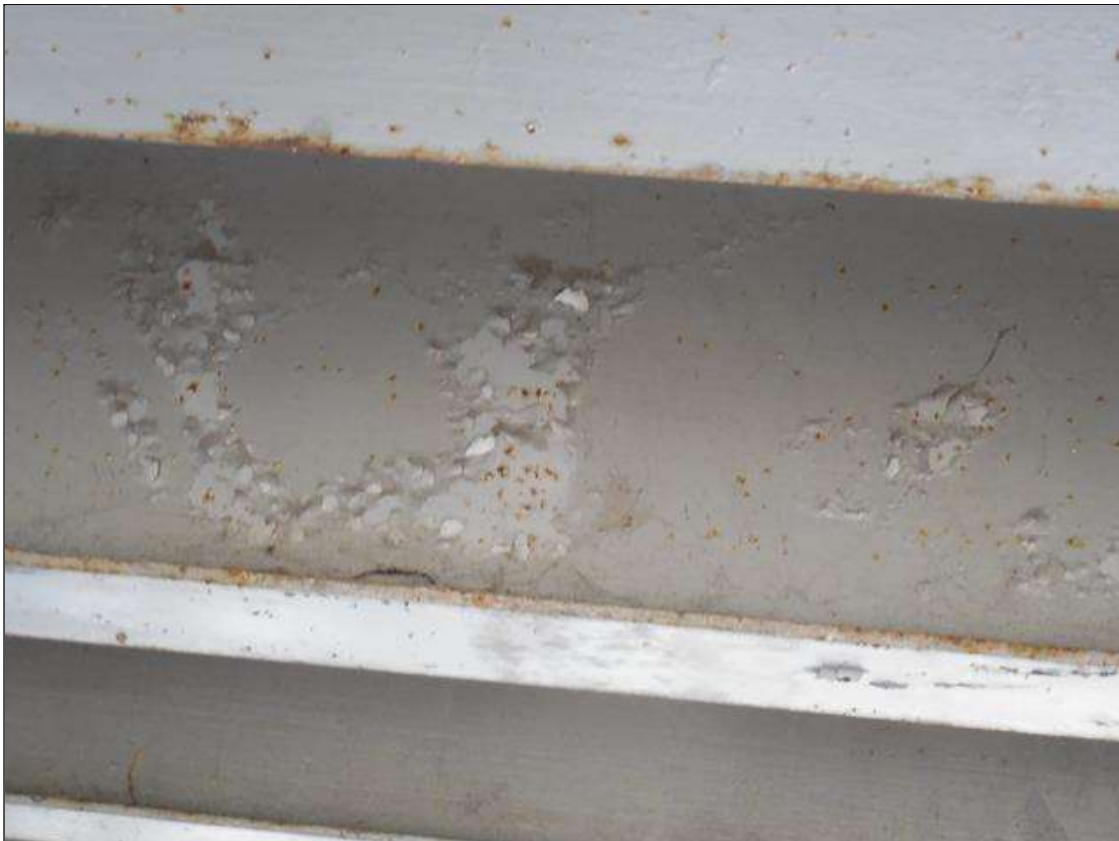
Span 1 Beam 2: 30 Square Feet of Peeling/Bubbling/Cracking (steel Protective Coatings): Finish coats only.

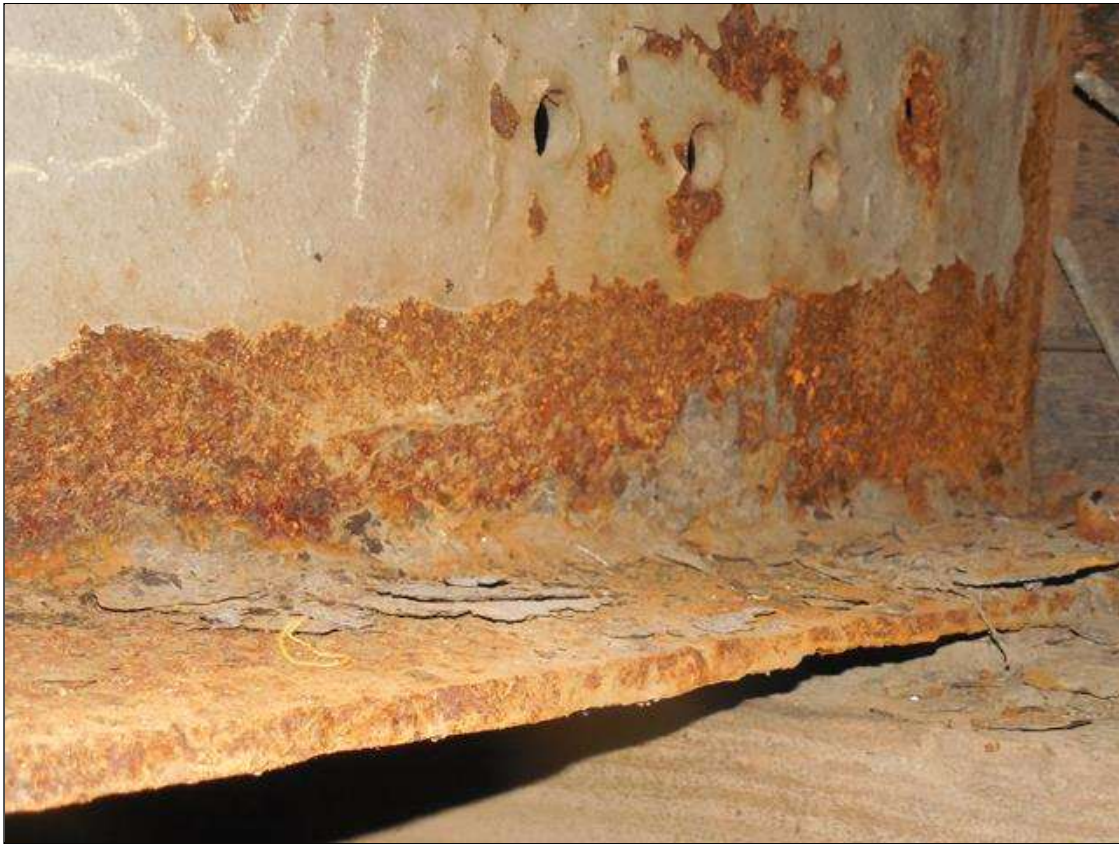
Span 1 Beam 2: 2 Feet of Corrosion: Section loss is evident or pack rust is present but does not warrant structural review. 1/8" SECTION LOSS IN WEB 3/8" REMAINING AND 1/4" REMAINING IN BOTTOM FLANGE AT END BENT 1, BAY 1 SIDE

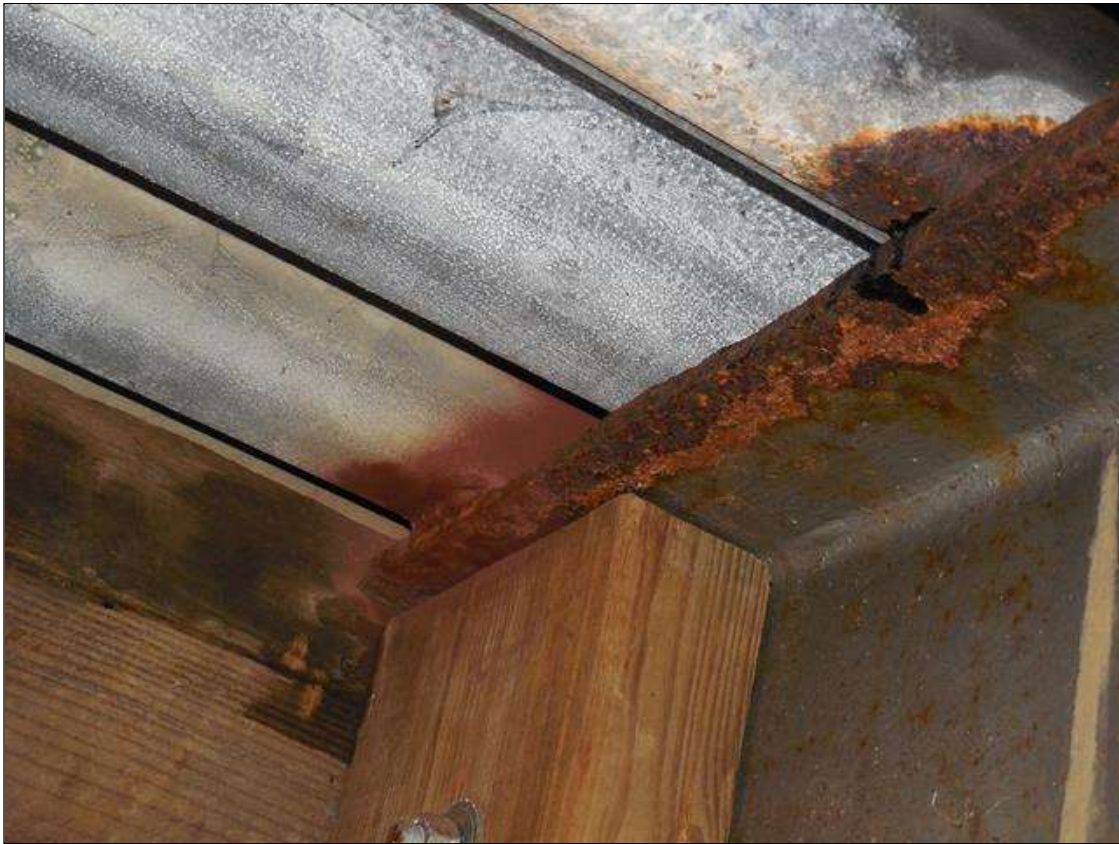
2 Feet of Corrosion: Section loss is evident or pack rust is present but does not warrant structural review. 1/8" SECTION LOSS 4" WIDE ON TOP FLANGE WITH 3/8" REMAINING BAY 6 AT END BENT 1  
2 Square Feet of Effectiveness (Steel Protective Coatings): Limited effectiveness. AT END BENT 1

Span 1 Beam 6: 2 Feet of Corrosion: Section loss is evident or pack rust is present but does not warrant structural review. 1/8" SECTION LOSS 4" WIDE ON TOP FLANGE WITH 3/8" REMAINING BAY 6 AT END BENT 1

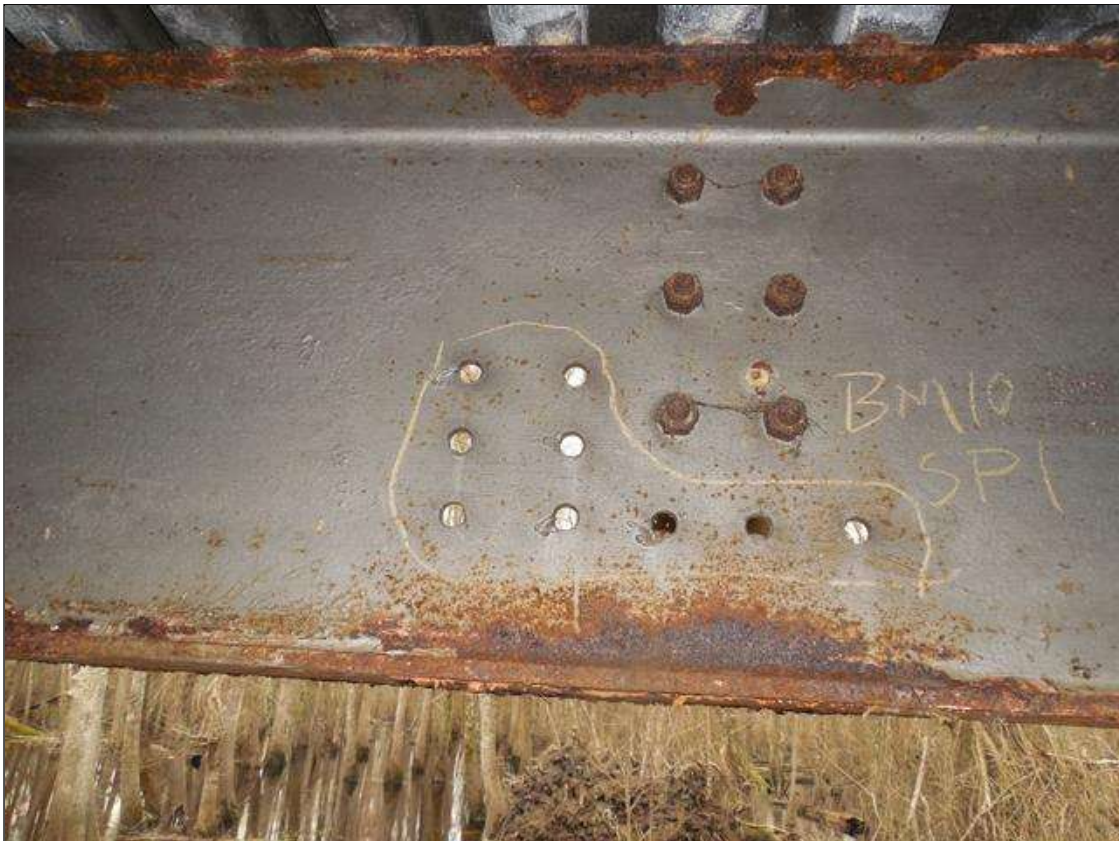
RECYCLED BEAMS ALL BEAMS HAVE DRILLED HOLES IN WEB AT BOTH ENDS AND AT 1/3 , 2/3 POINTS IN ALL SPANS SEE SKETCH ( PHOTO# 5924 )

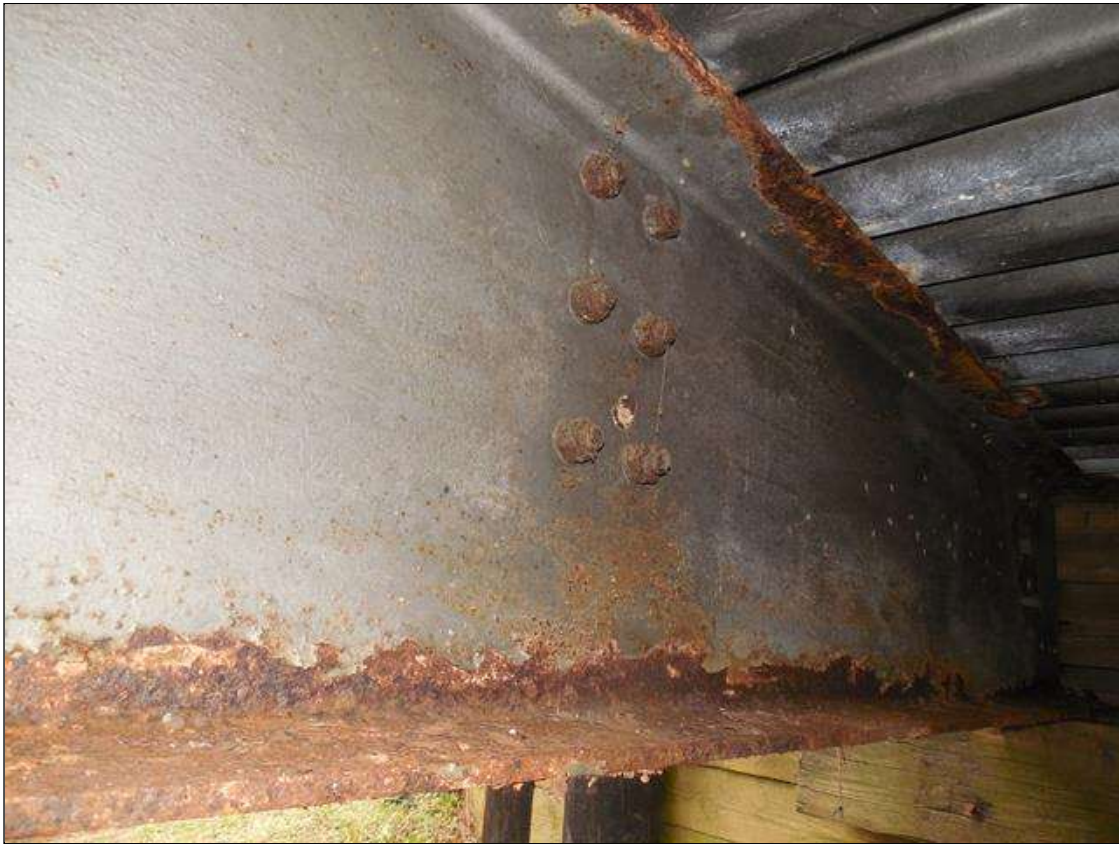
20 Feet of Corrosion: Section loss is evident or pack rust is present but does not warrant structural review. BOTH FLANGES HAVE 1/8" SECTION LOSS WITH 3/8" REMAINING  
40 Square Feet of Effectiveness (Steel Protective Coatings): Limited effectiveness.

Span 1 Beam 10: 20 Feet of Corrosion: Section loss is evident or pack rust is present but does not warrant structural review. BOTH FLANGES HAVE 1/8" SECTION LOSS WITH 3/8" REMAINING

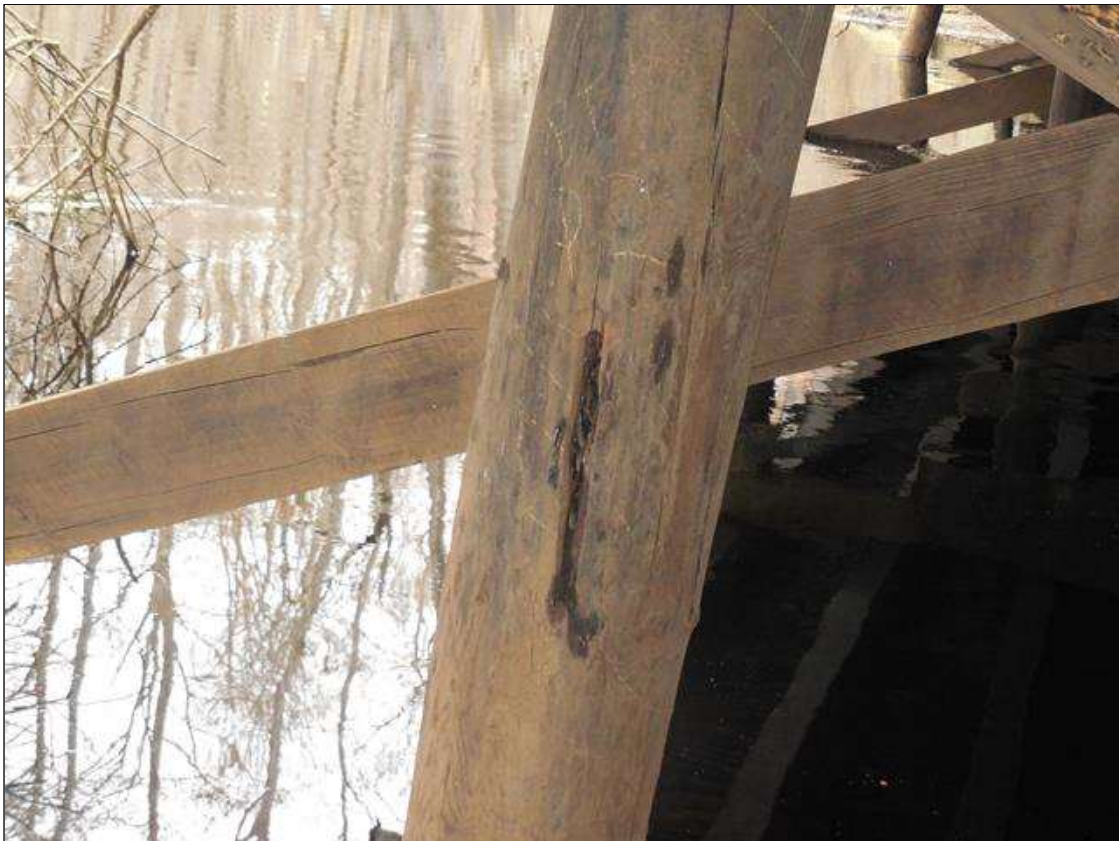
Bent 1 Pile 2: 1 Each of Decay/Section Loss: Affects less than 10% of the member section DECAYED 2' HIGH X 2" WIDE X 1 1/2" DEEP ON SPAN 1 FACE

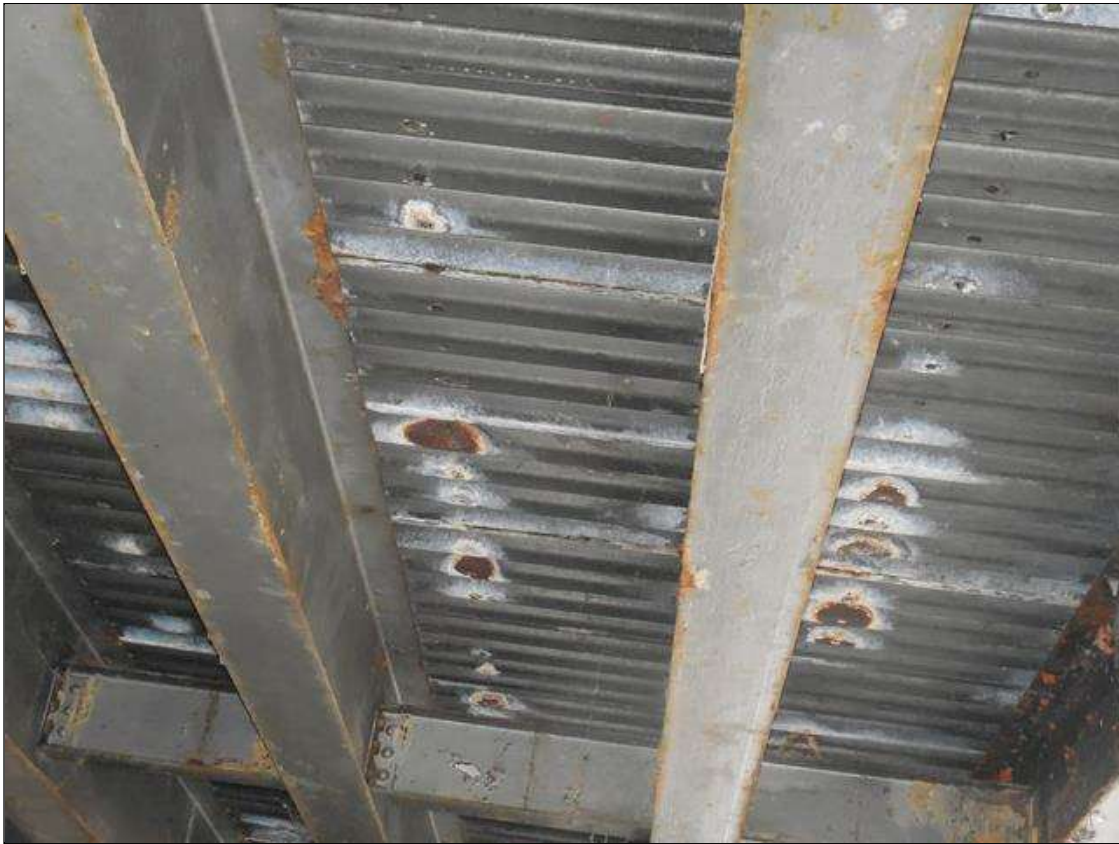
Span 2 Deck: 80 Square Feet of Corrosion: Section loss is evident or pack rust is present but does not warrant structural review. SPOTS OF RUST IN UNDERSIDE OF DECK AT ALL BAYS

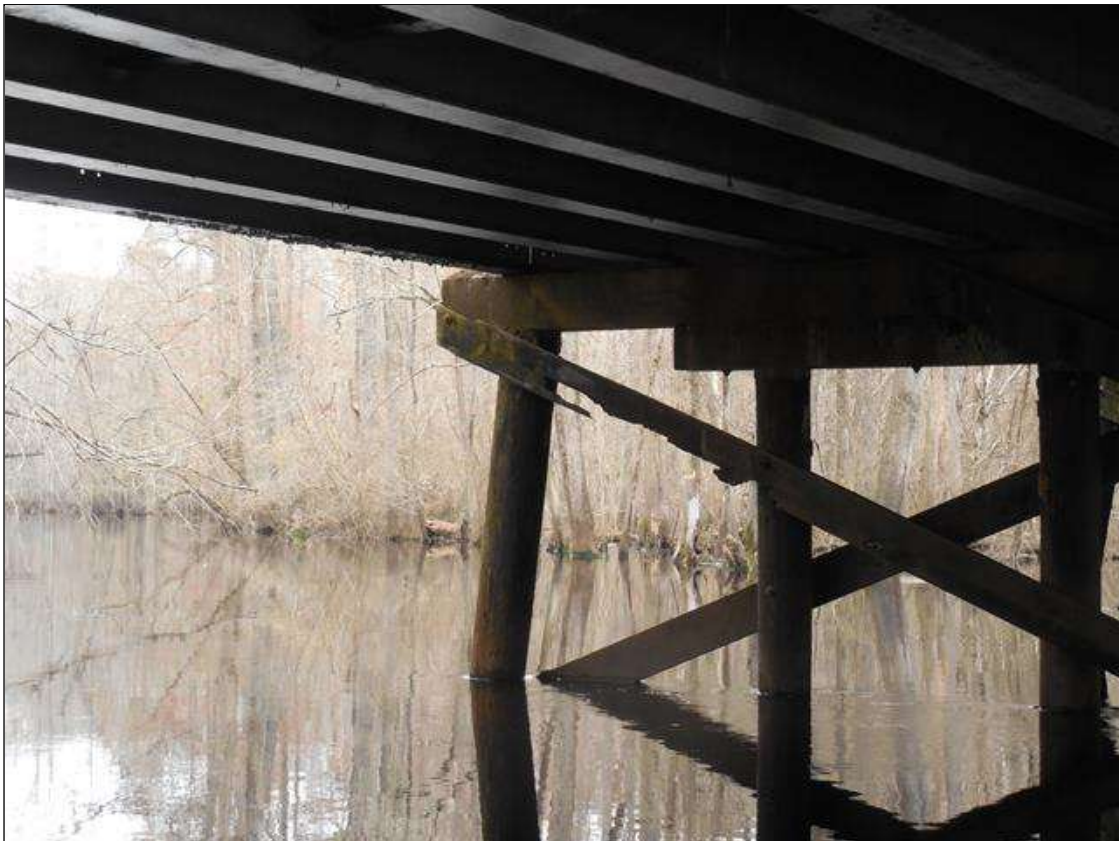
Bent 2 Pile 1: 1 Each of Decay/Section Loss: Affects less than 10% of the member section DECAYED TIMBER CROSSBRACE AT PILE 1 8 FT.

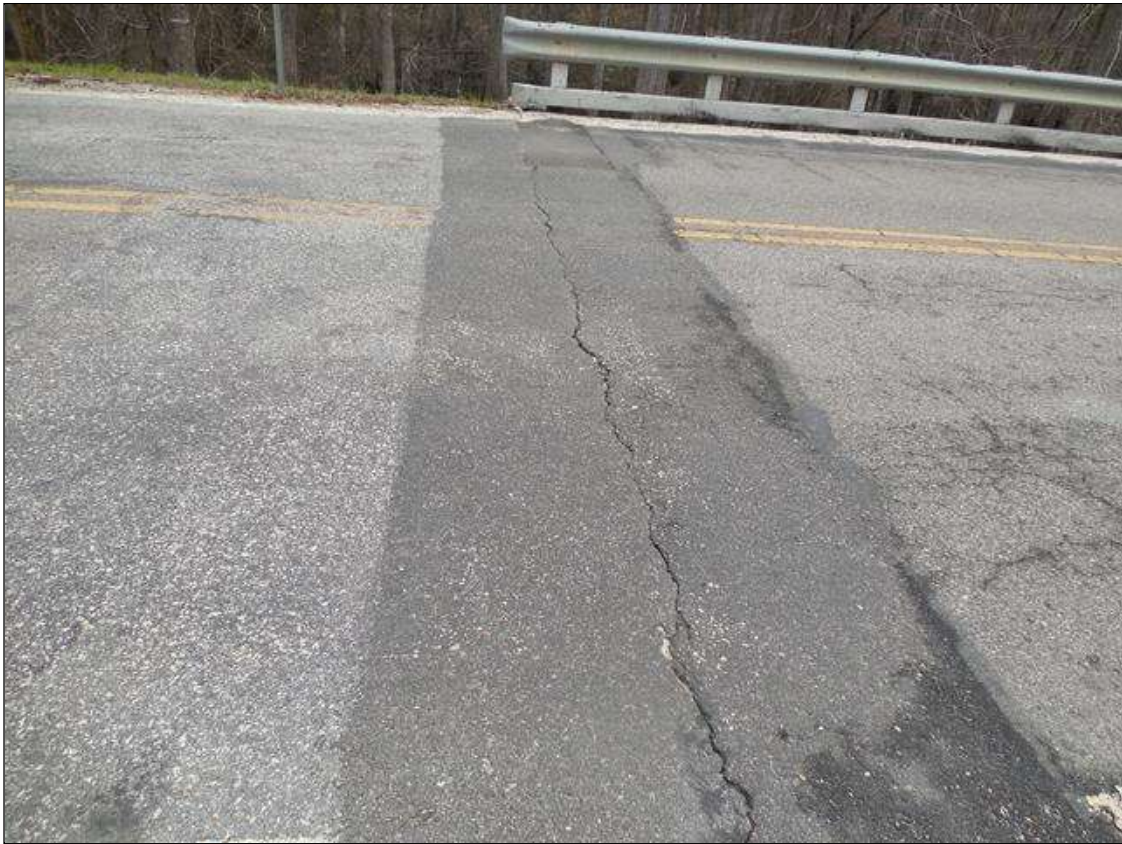
1/8" WIDE TRANSVERSE CRACK IN WEST APPROACH ASPHALT WEARING SURFACE OVER END BENT 1

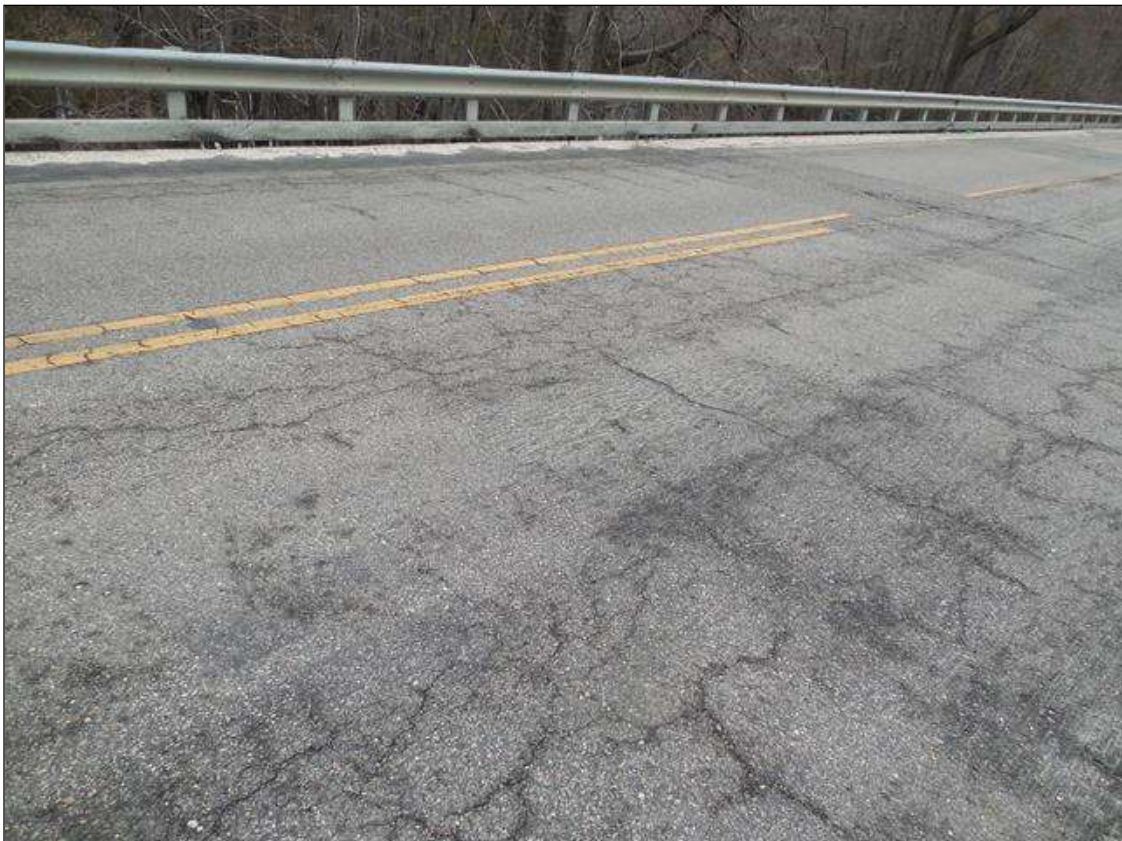
Span 1 Wearing Surface: 700 Square Feet of Crack (Wearing Surface): Width of more than 0.05 in. or spacing of less than 1.0 ft. MAP CRACKING IN SPAN 1 ASPHALT WEARING SURFACE

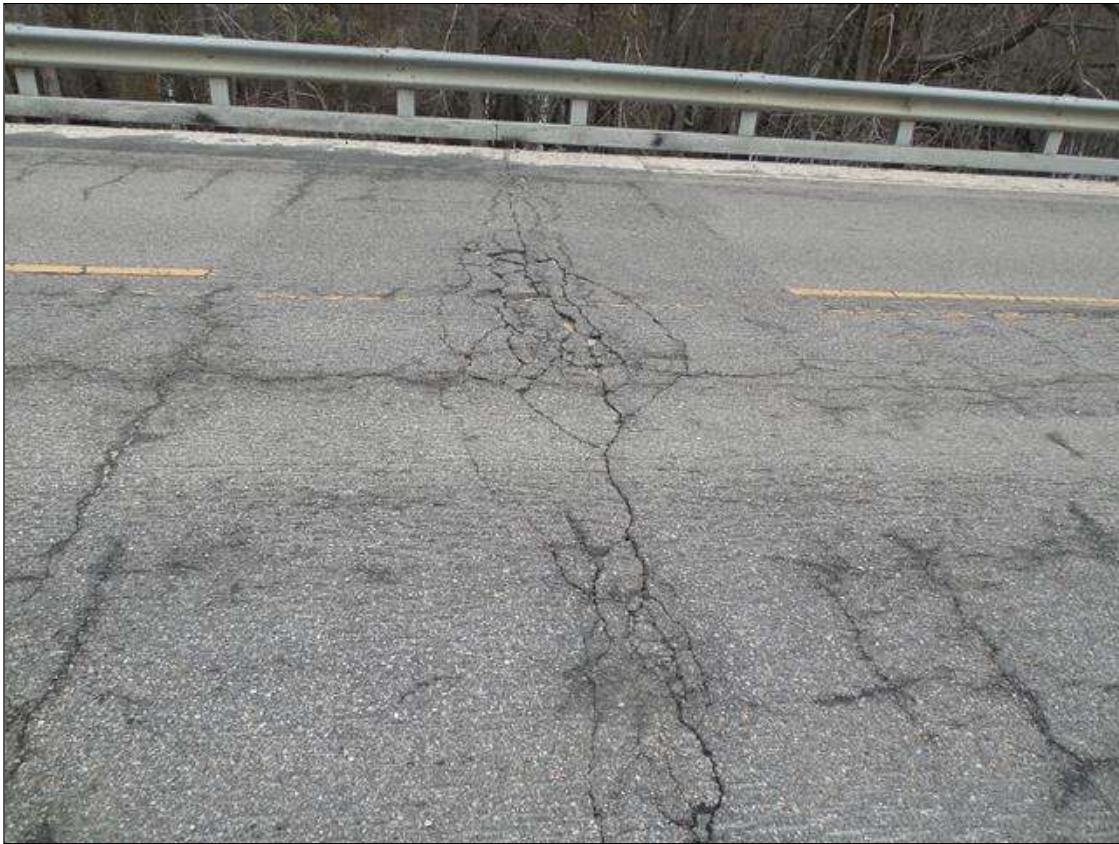
Span 1 Wearing Surface: 28 Square Feet of Crack (Wearing Surface): Width of more than 0.05 in. or spacing of less than 1.0 ft. 1/2" TRANSVERSE CRACKS OVER BENT 1

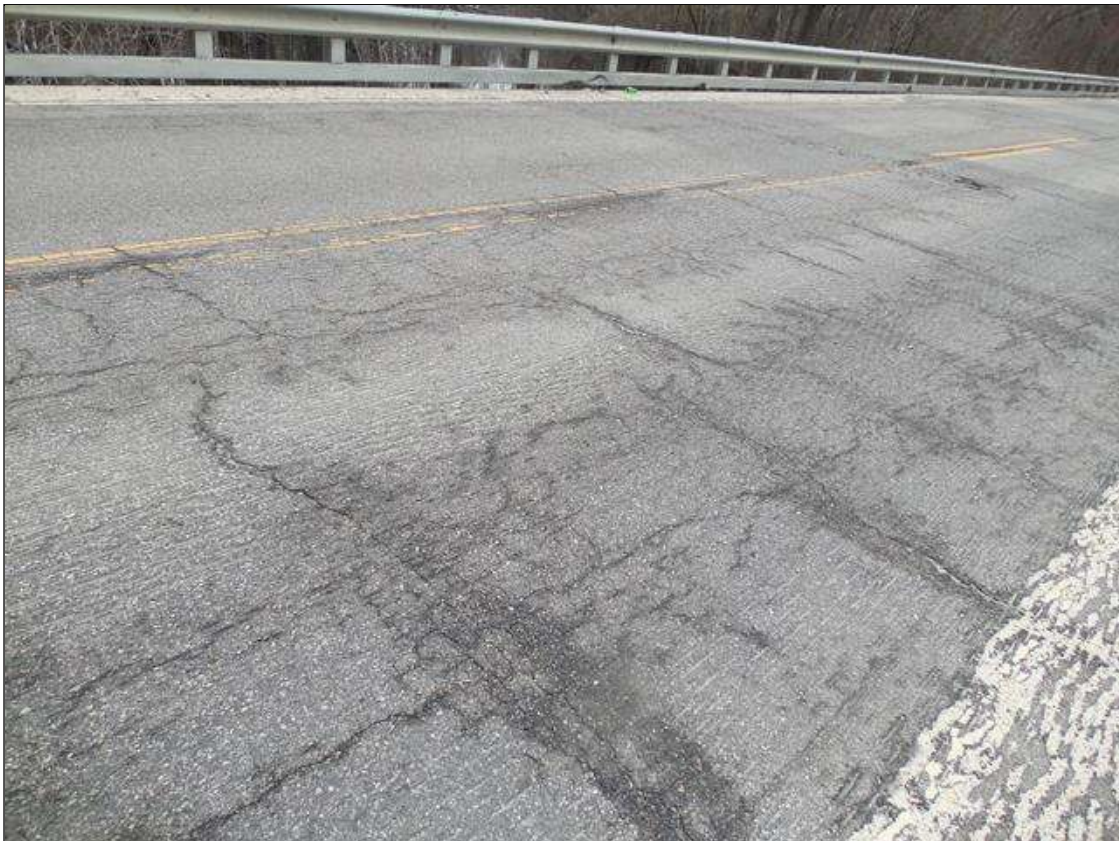
650 Square Feet of Crack (Wearing Surface): Width of more than 0.05 in. or spacing of less than 1.0 ft. 1/8" MAP CRACKING

Span 2 Wearing Surface: 650 Square Feet of Crack (Wearing Surface): Width of more than 0.05 in. or spacing of less than 1.0 ft. 1/8" MAP CRACKING

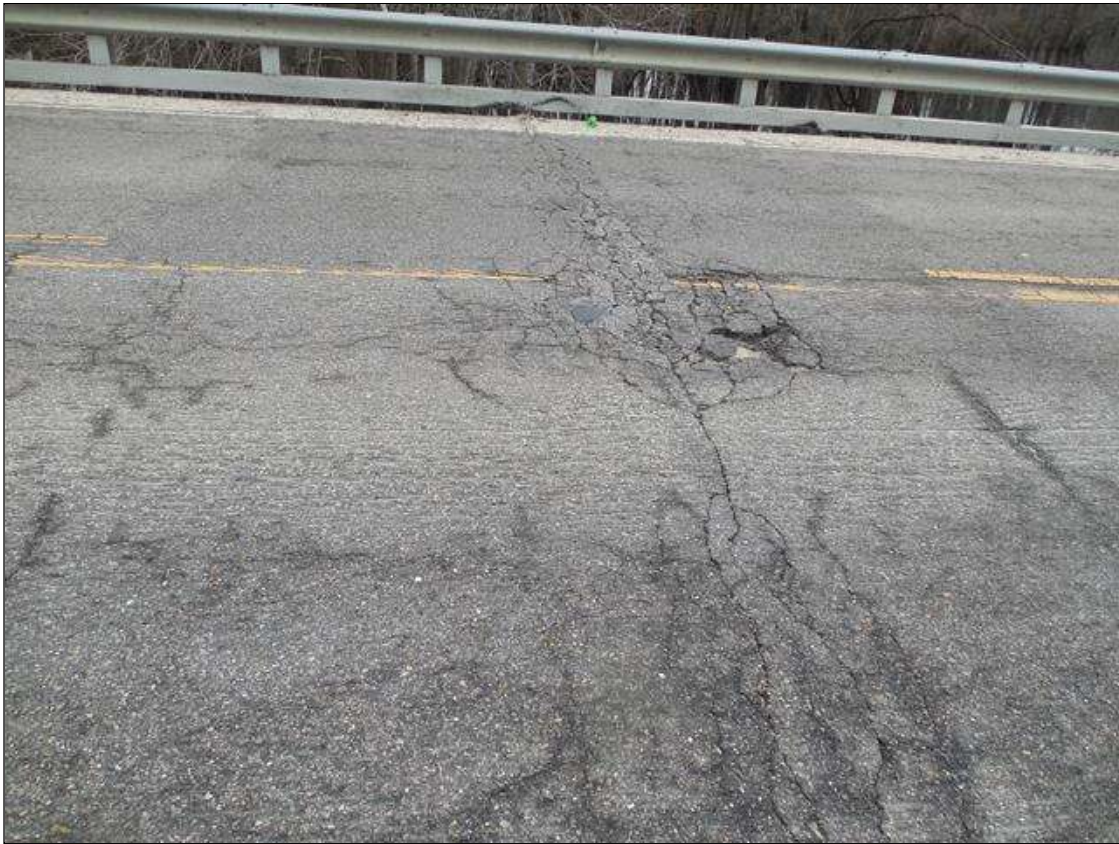
28 Square Feet of Crack (Wearing Surface): Width of more than 0.05 in. or spacing of less than 1.0 ft. 1/8" TRANSVERSE CRACKS OVER BENT 2

Span 2 Wearing Surface: 28 Square Feet of Crack (Wearing Surface): Width of more than 0.05 in. or spacing of less than 1.0 ft. 1/8" TRANSVERSE CRACKS OVER BENT 2

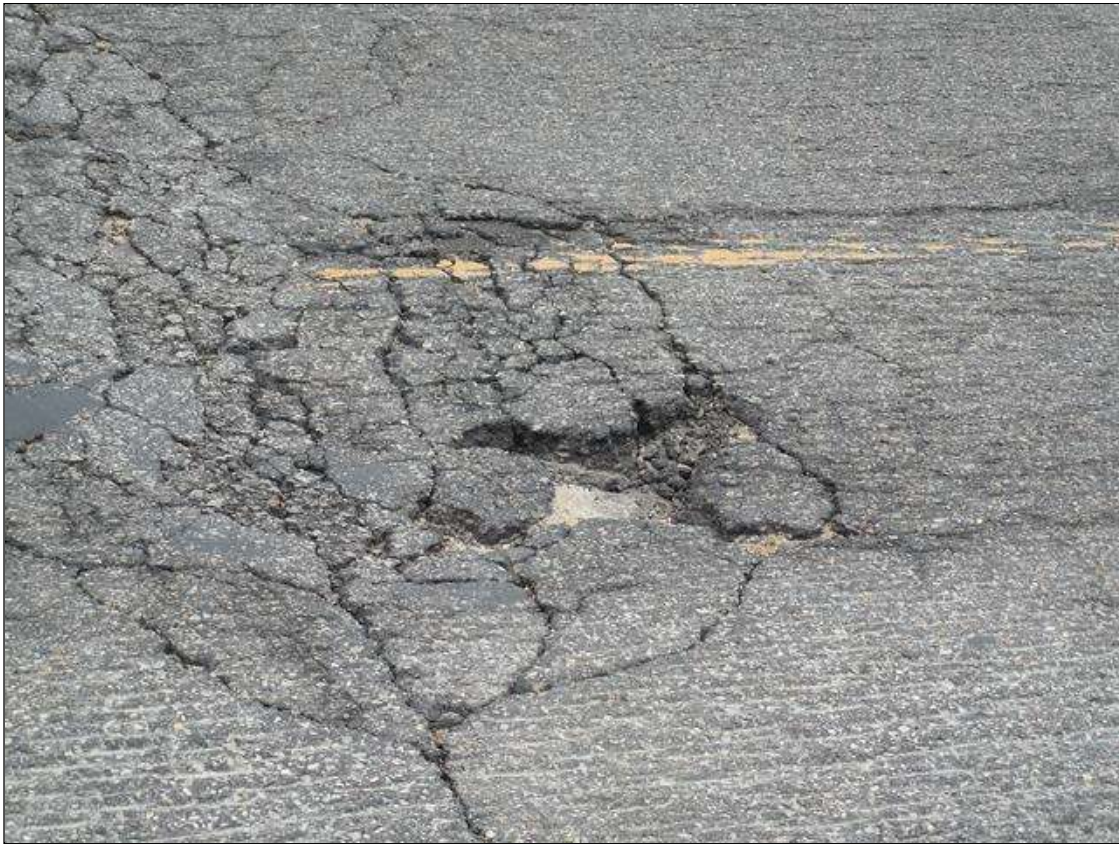
4 Square Feet of Delamination/Spall/Patched Area/Pothole (Wearing Surfaces): Spall 1 in. deep or greater or 6 in. diameter or greater. Patched area that is unsound or showing distress. Full depth pothole. 4' DIAMETER X 2" DEEP SPALL

Span 3 Wearing Surface: 4 Square Feet of Delamination/Spall/Patched Area/Pothole (Wearing Surfaces): Spall 1 in. deep or greater or 6 in. diameter or greater. Patched area that is unsound or showing distress. Full depth pothole. 4' DIAMETER X 2" DEEP SPALL

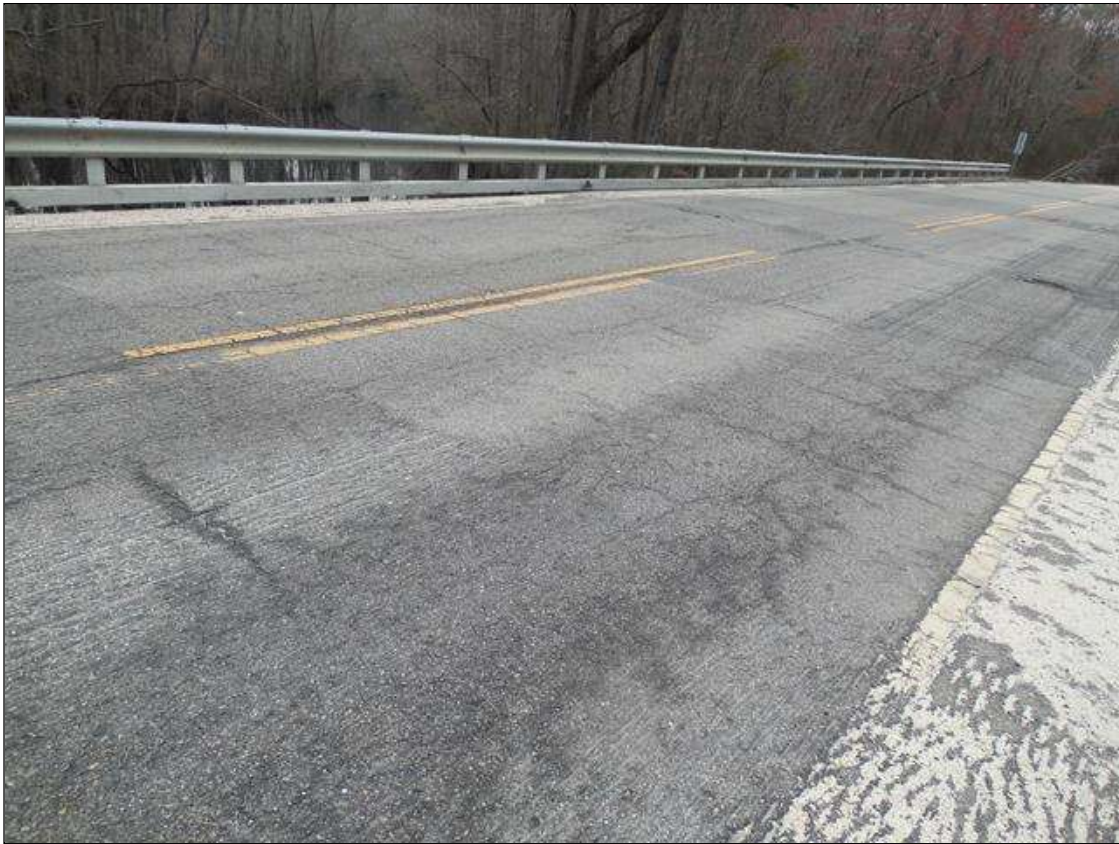
600 Square Feet of Crack (Wearing Surface): Width of more than 0.05 in. or spacing of less than 1.0 ft. 1/8" MAP CRACKING

Span 3 Wearing Surface: 600 Square Feet of Crack (Wearing Surface): Width of more than 0.05 in. or spacing of less than 1.0 ft. 1/8" MAP CRACKING

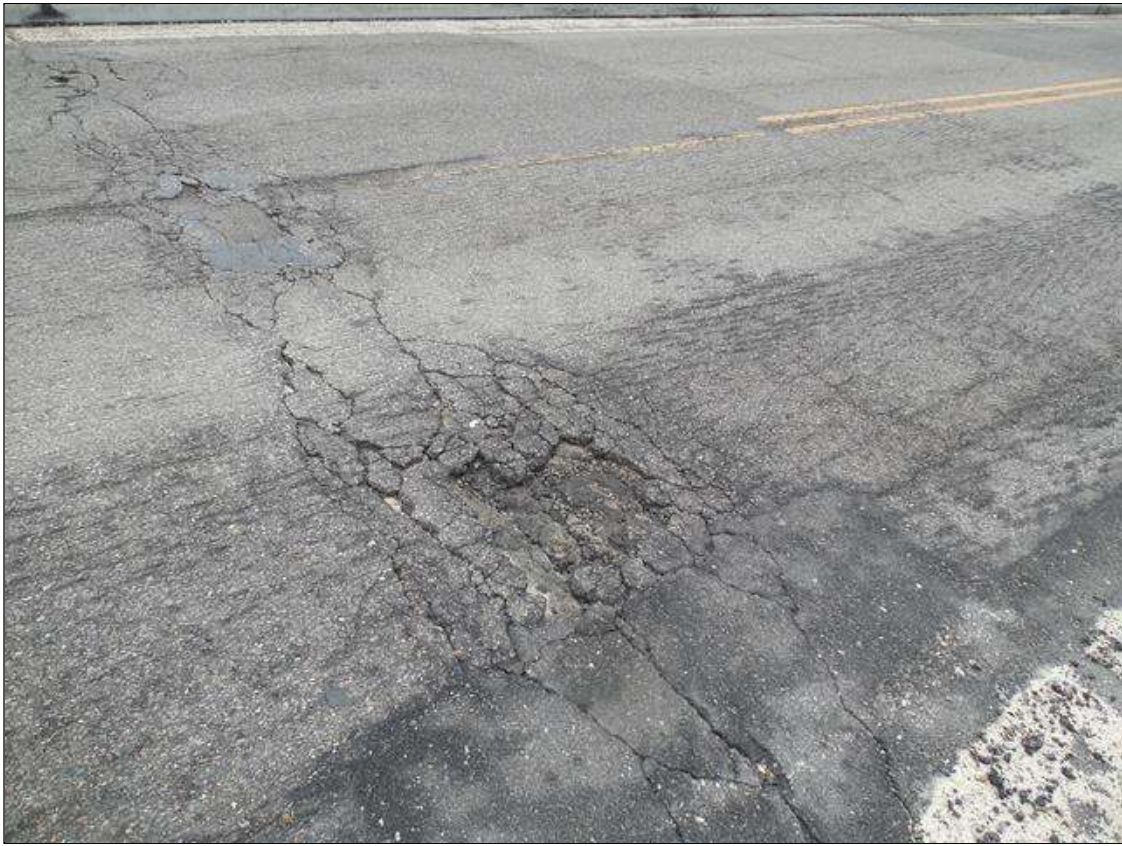
3 Square Feet of Delamination/Spall/Patched Area/Pothole (Wearing Surfaces): Spall 1 in. deep or greater or 6 in. diameter or greater. Patched area that is unsound or showing distress. Full depth pothole. SPALL 3' DIAMETER X 3" DEEP IN EAST BOUND LANE AT BENT 3

Span 4 Wearing Surface: 3 Square Feet of Delamination/Spall/Patched Area/Pothole (Wearing Surfaces): Spall 1 in. deep or greater or 6 in. diameter or greater. Patched area that is unsound or showing distress. Full depth pothole.  
SPALL 3' DIAMETER X 3" DEEP IN EAST BOUND LANE AT BENT 3

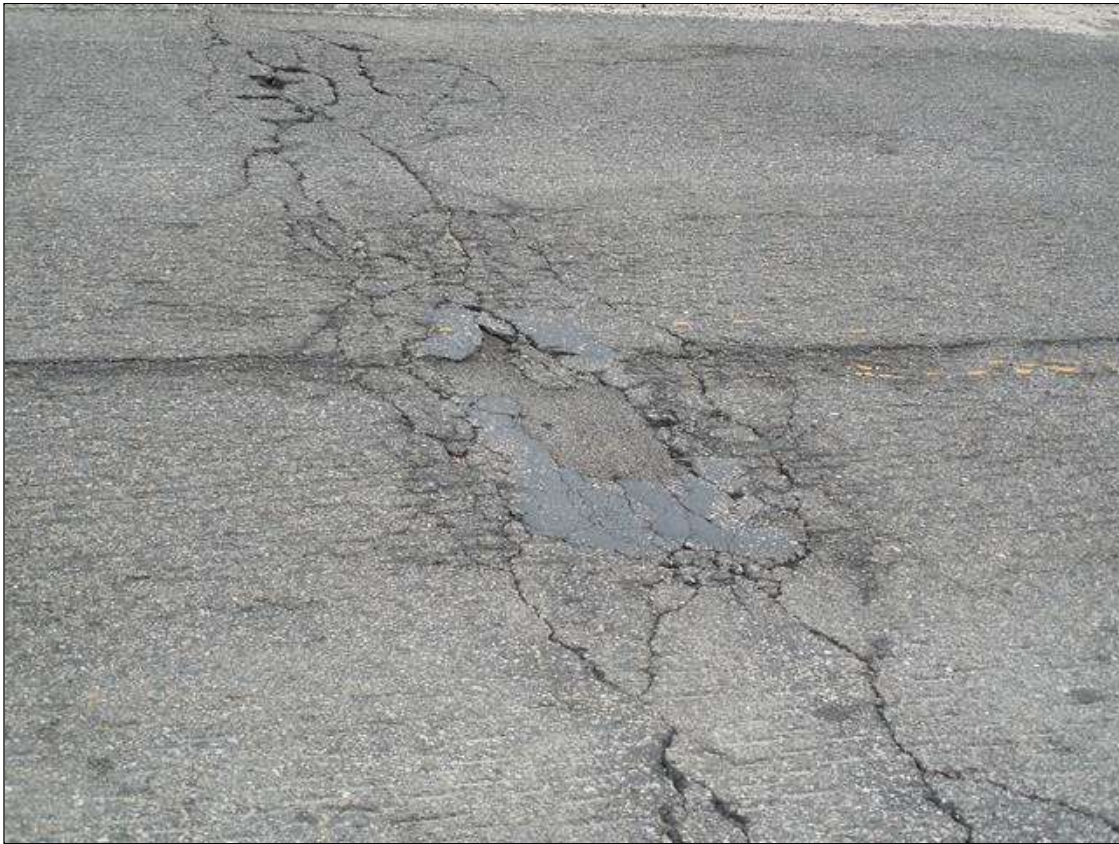
2 Square Feet of Delamination/Spall/Patched Area/Pothole (Wearing Surfaces): Delaminated. Spall less than 1 in. deep or less than 6 in. diameter. Patched area that is sound. Partial depth pothole. PATCH AT CENTERLINE

Span 4 Wearing Surface: 2 Square Feet of Delamination/Spall/Patched Area/Pothole (Wearing Surfaces):  
Delaminated. Spall less than 1 in. deep or less than 6 in. diameter. Patched area that is sound. Partial depth pothole.  
PATCH AT CENTERLINE
