NC DEPARTMENT OF TRANSPORTATION  
DIVISION OF HIGHWAYS  
STRUCTURE MANAGEMENT UNIT

## Structure Safety Report

### Routine Element Inspection

COUNTY: CUMBERLAND STRUCTURE NUMBER: 250052 FREQUENCY: 24 MONTHS

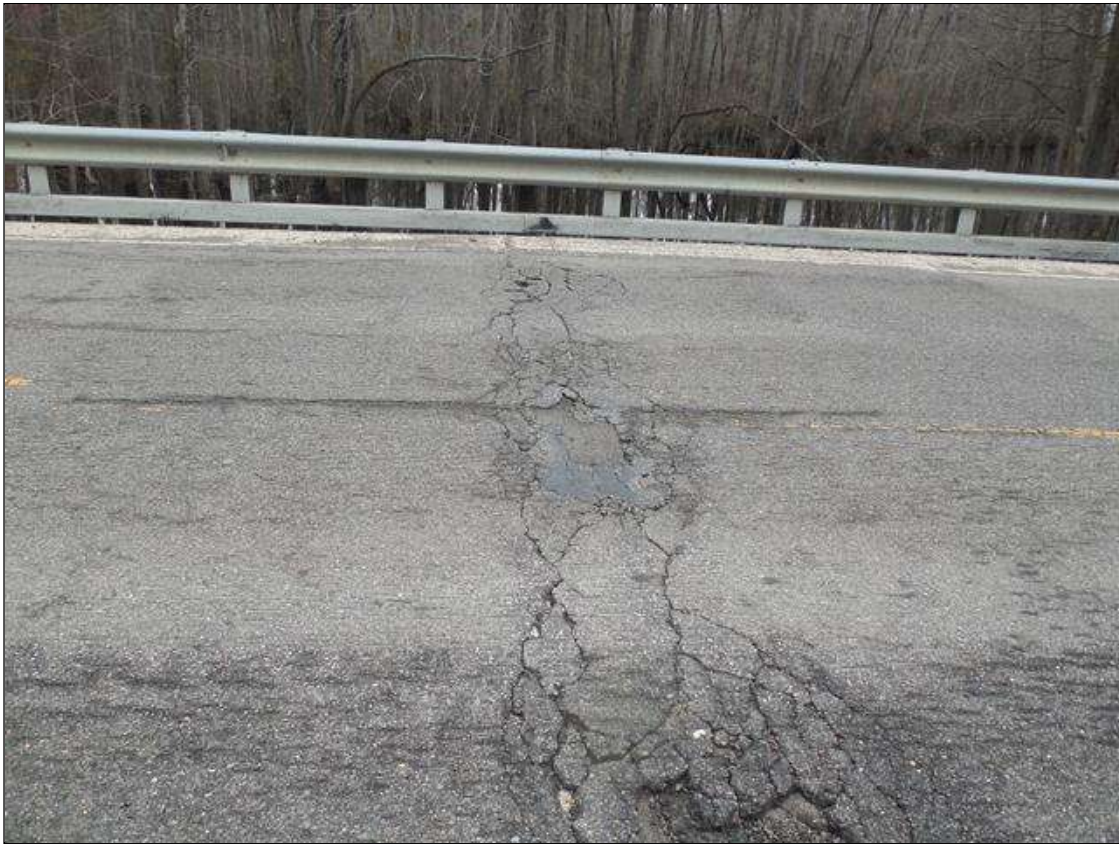
28 Square Feet of Crack (Wearing Surface): Width of more than 0.05 in. or spacing of less than 1.0 ft. 1/2" TRANSVERSE CRACKS OVER BENT 3

Span 4 Wearing Surface: 28 Square Feet of Crack (Wearing Surface): Width of more than 0.05 in. or spacing of less than 1.0 ft. 1/2" TRANSVERSE CRACKS OVER BENT 3

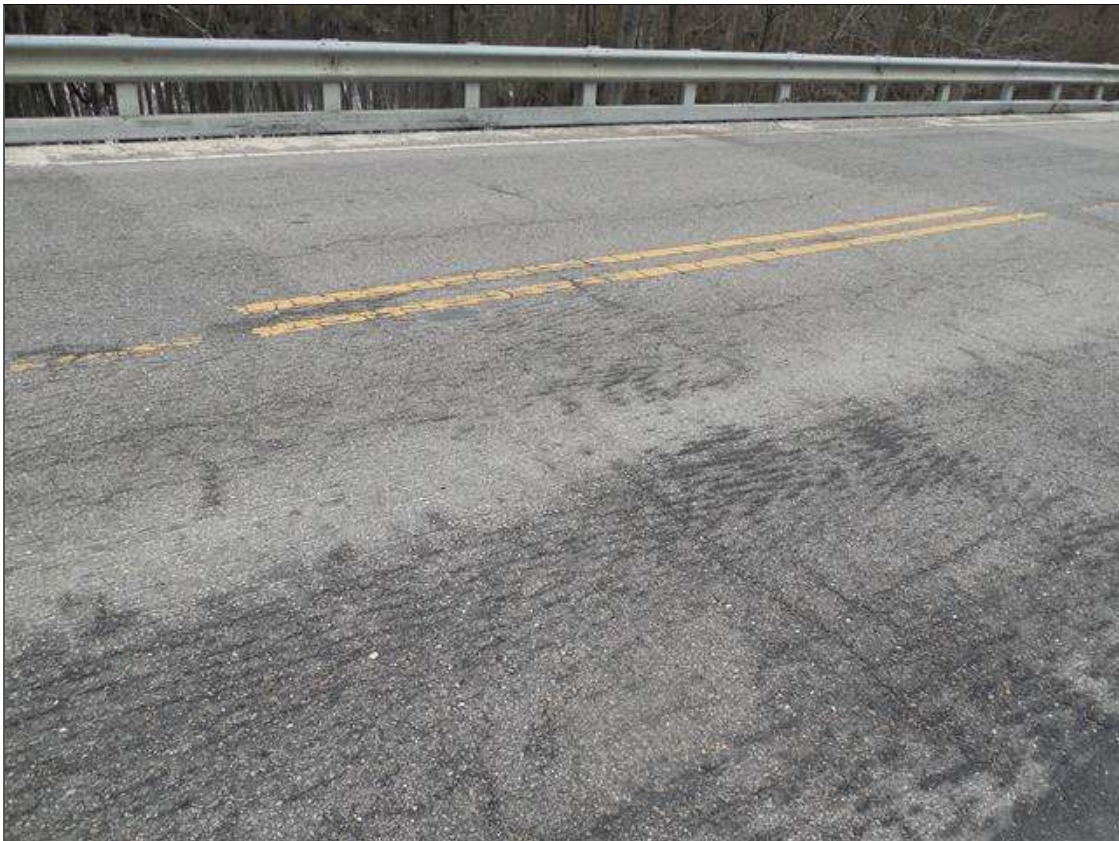
475 Square Feet of Crack (Wearing Surface): Width of more than 0.05 in. or spacing of less than 1.0 ft. 1/8" MAP CRACKING

Span 4 Wearing Surface: 475 Square Feet of Crack (Wearing Surface): Width of more than 0.05 in. or spacing of less than 1.0 ft. 1/8" MAP CRACKING

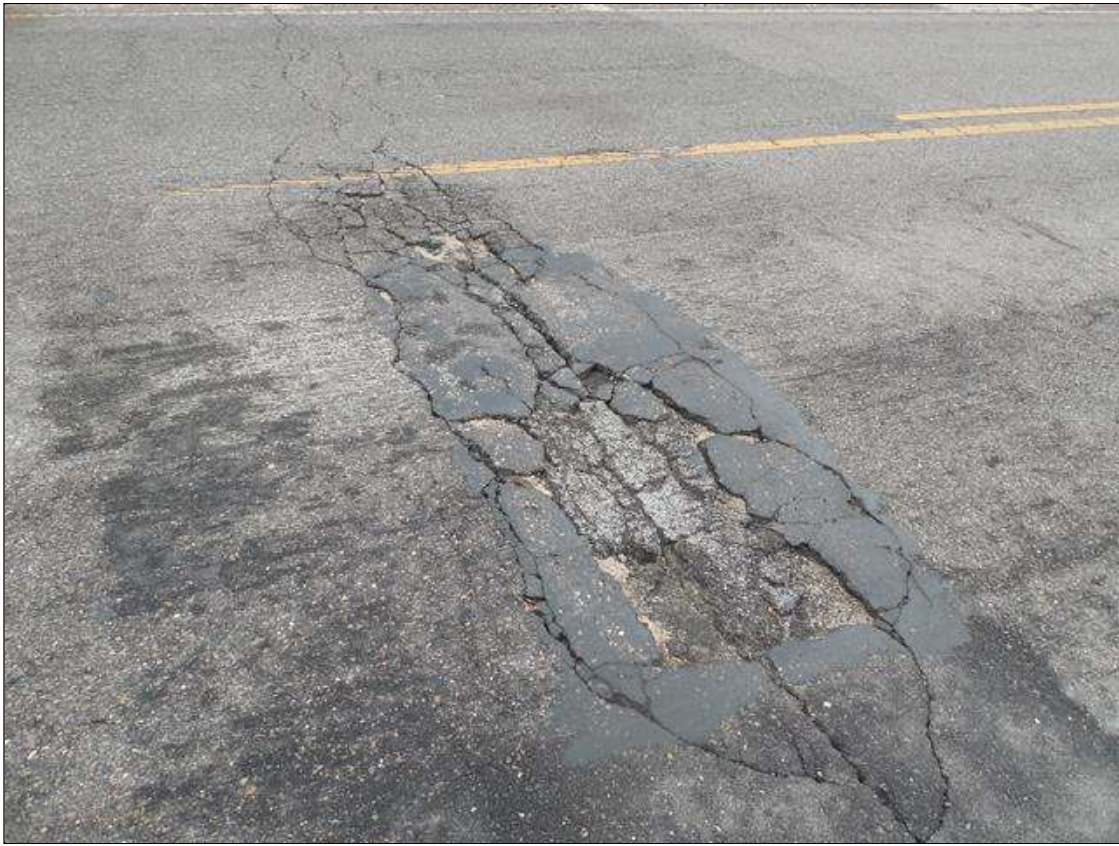
6 Square Feet of Delamination/Spall/Patched Area/Pothole (Wearing Surfaces): Spall 1 in. deep or greater or 6 in. diameter or greater. Patched area that is unsound or showing distress. Full depth pothole. SPALL 6' WIDE OVER BENT 4 IN EAST BOUND LANE

Span 4 Wearing Surface: 6 Square Feet of Delamination/Spall/Patched Area/Pothole (Wearing Surfaces): Spall 1 in. deep or greater or 6 in. diameter or greater. Patched area that is unsound or showing distress. Full depth pothole.  
SPALL 6' WIDE OVER BENT 4 IN EAST BOUND LANE

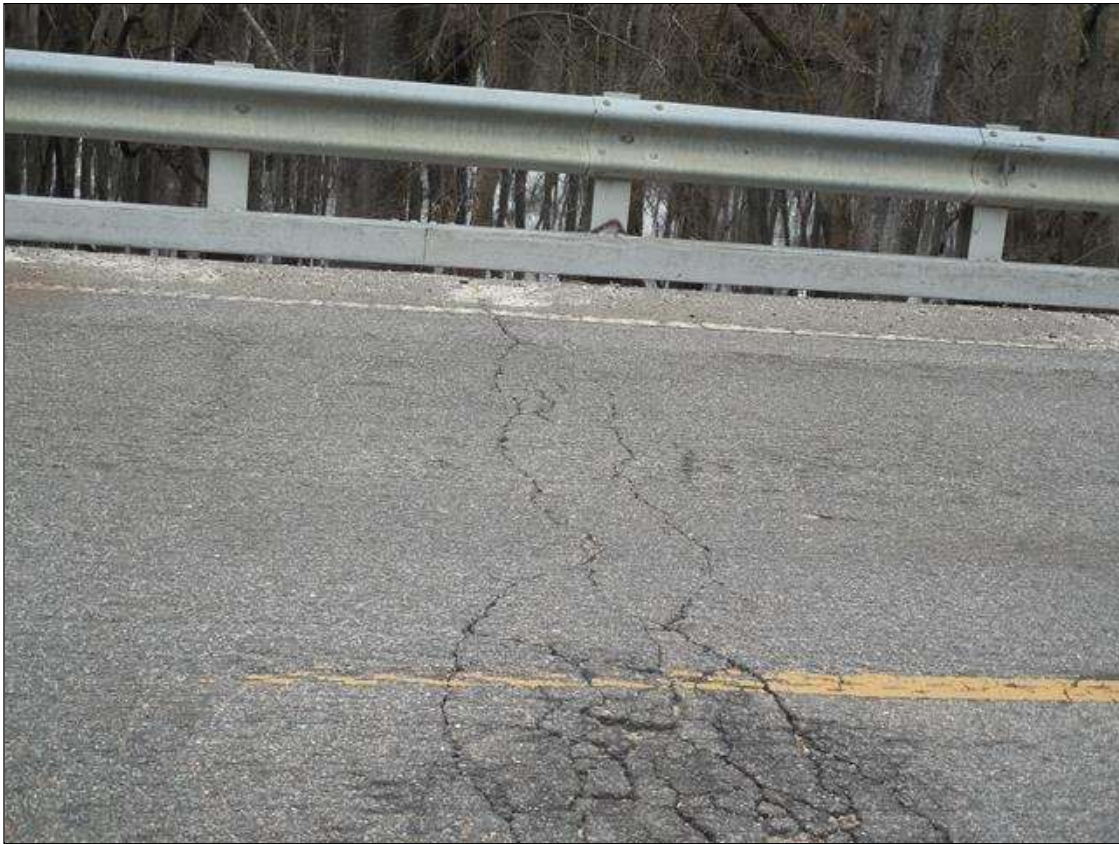
28 Square Feet of Crack (Wearing Surface): Width of more than 0.05 in. or spacing of less than 1.0 ft. 1/8" WIDE TRANSVERSE CRACKS OVER BENT 4

Span 4 Wearing Surface: 28 Square Feet of Crack (Wearing Surface): Width of more than 0.05 in. or spacing of less than 1.0 ft. 1/8" WIDE TRANSVERSE CRACKS OVER BENT 4

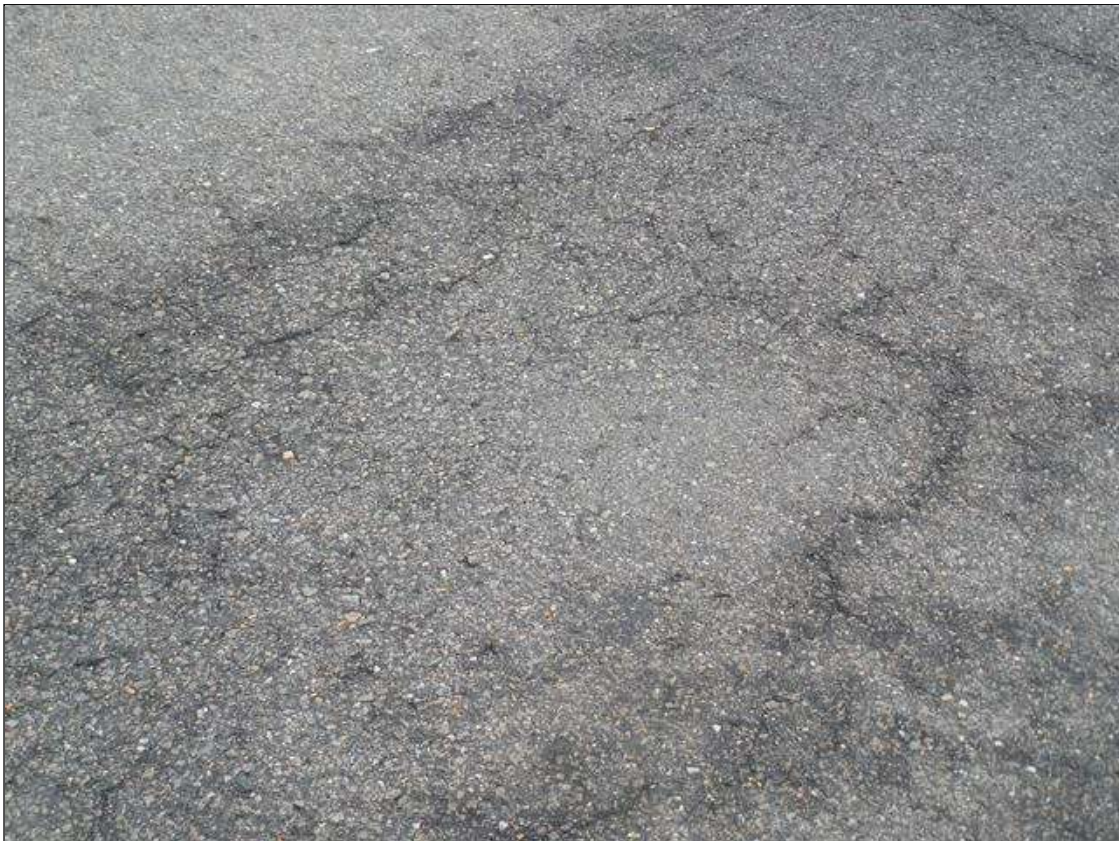
Span 5 Wearing Surface: 475 Square Feet of Crack (Wearing Surface): Width of more than 0.05 in. or spacing of less than 1.0 ft. 1/8" MAP CRACKING

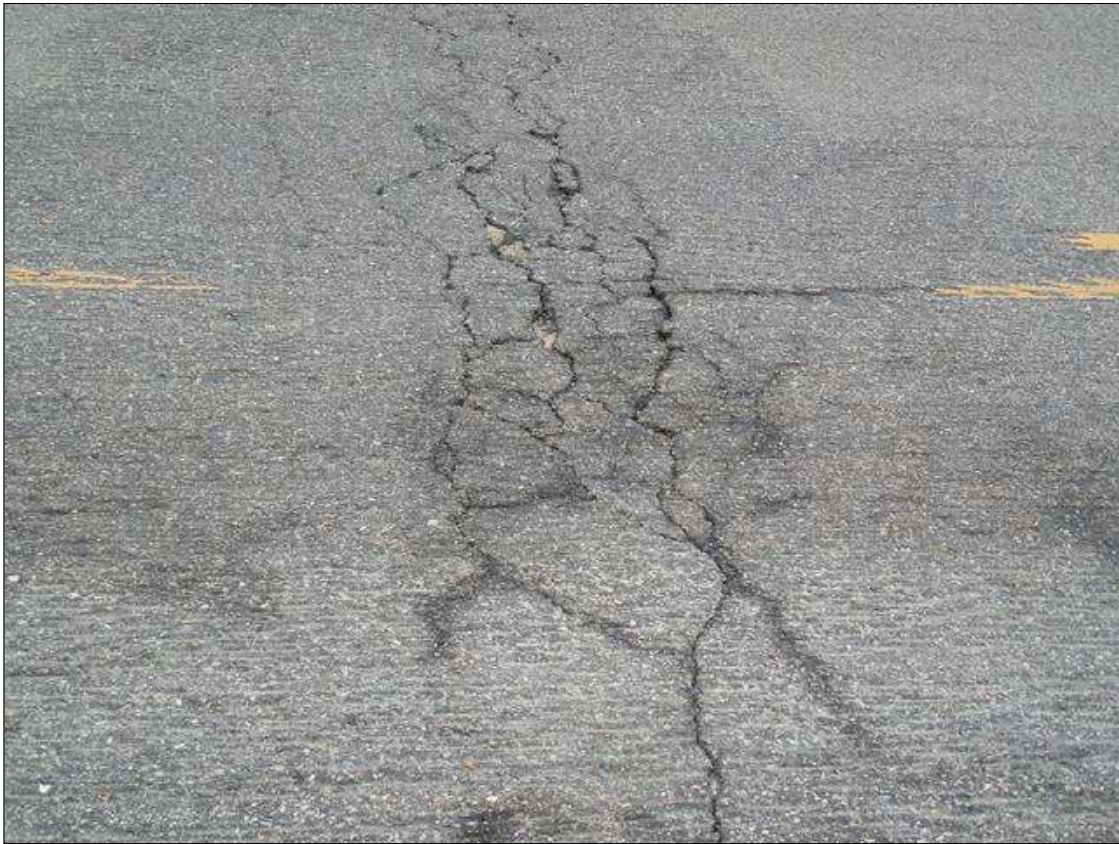
Span 5 Wearing Surface: 56 Square Feet of Crack (Wearing Surface): Width of more than 0.05 in. or spacing of less than 1.0 ft. 1/2" WIDE TRANSVERSE CRACKS , 2' WIDE OVER BENT 5

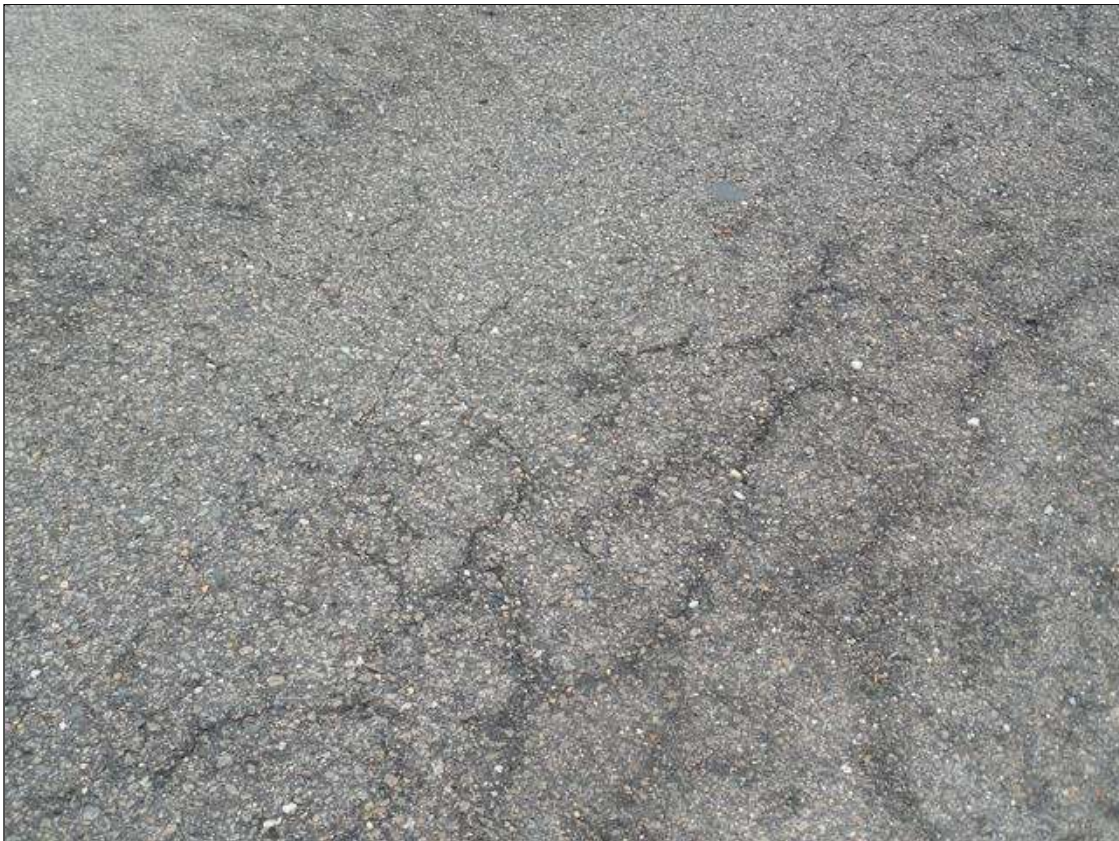
480 Square Feet of Crack (Wearing Surface): Width of more than 0.05 in. or spacing of less than 1.0 ft. 1/8" MAP CRACKING

Span 6 Wearing Surface: 480 Square Feet of Crack (Wearing Surface): Width of more than 0.05 in. or spacing of less than 1.0 ft. 1/8" MAP CRACKING

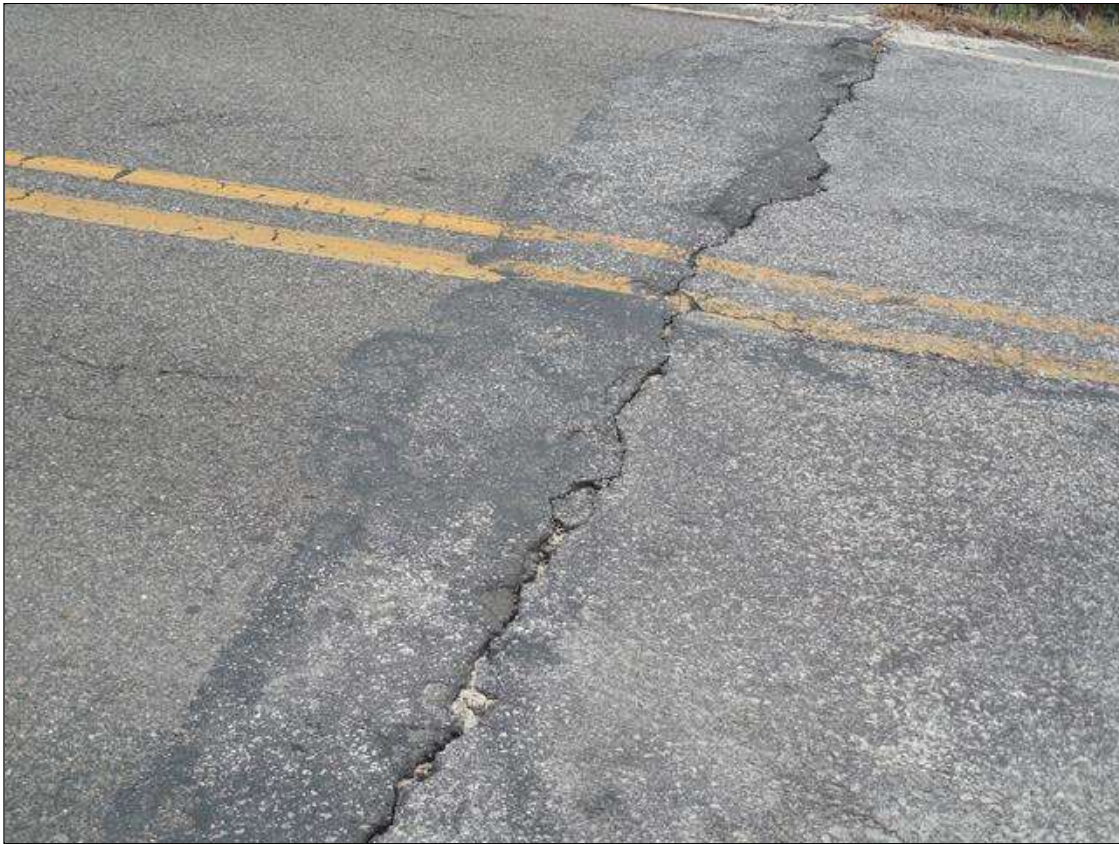
1/4" TRANSVERSE CRACK WITH 1/2" SETTLEMENT IN EAST APPROACH ASPHALT WEARING SURFACE OVER  
END BENT 2

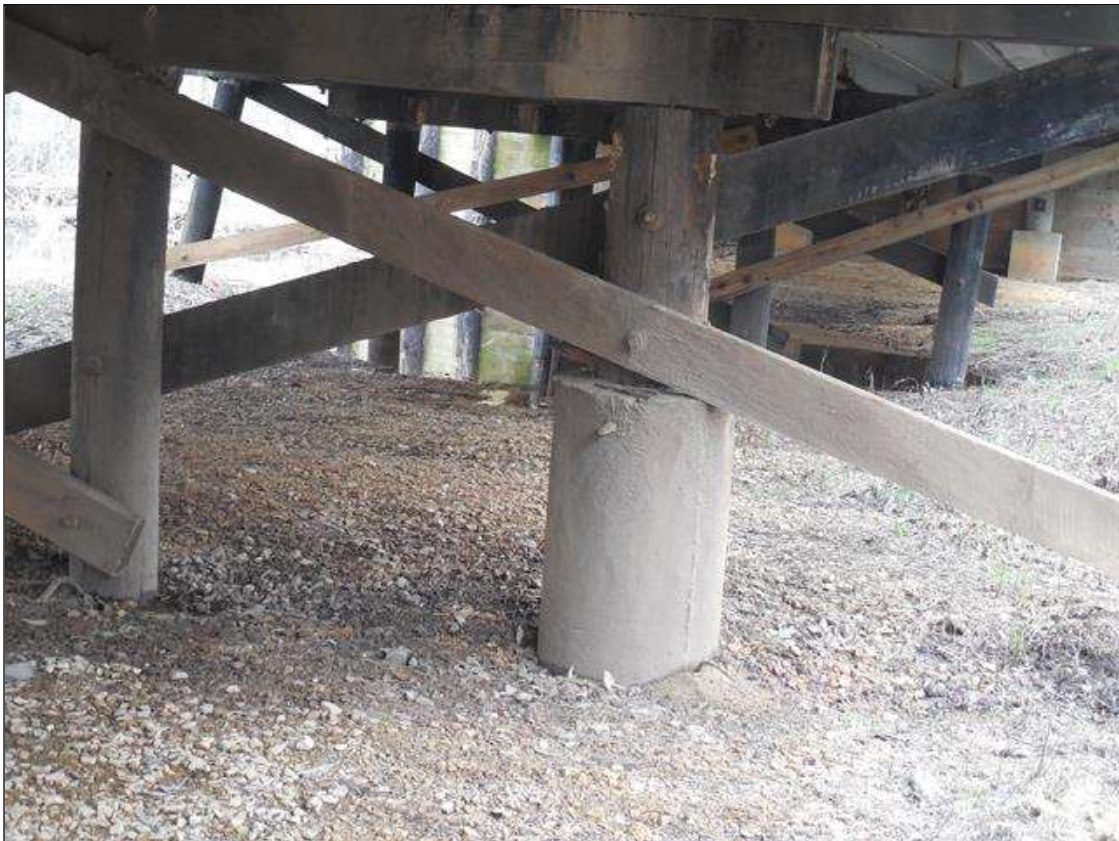
PILE 5 AT BENT 4 ENCASED IN CONCRETE ( PHOTO # 5957 )

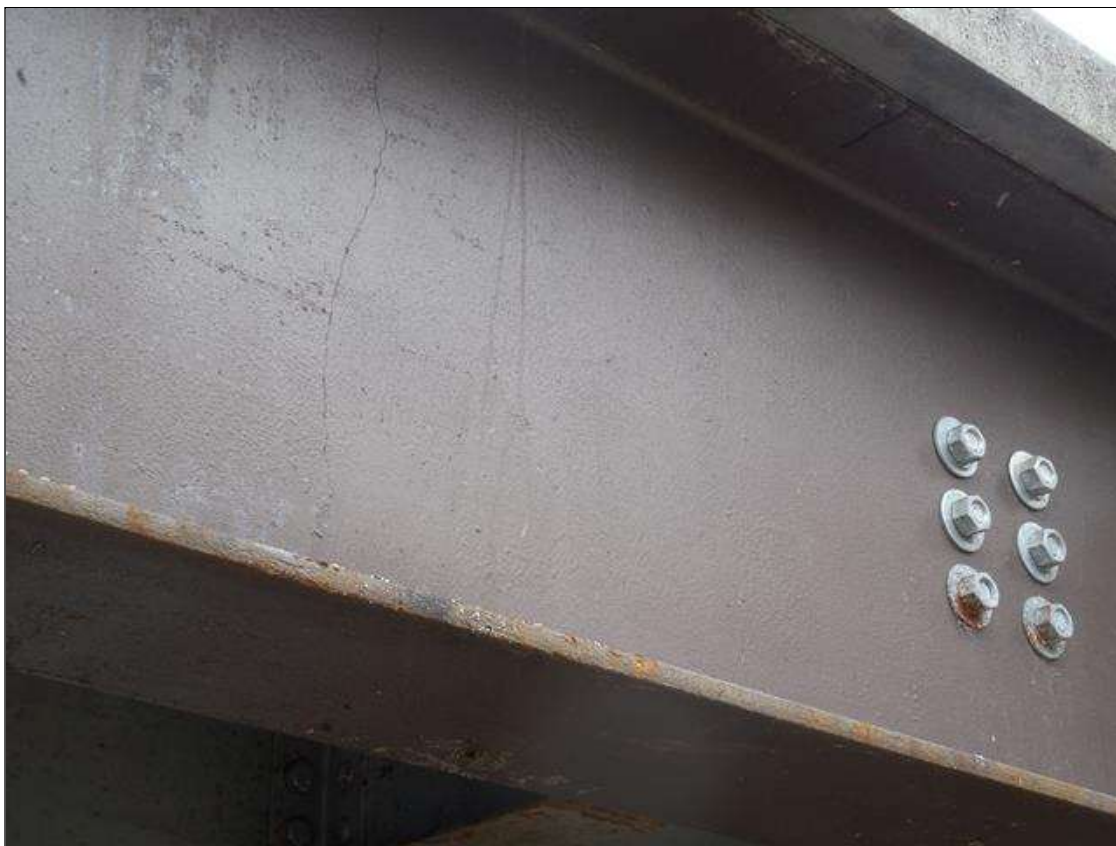
BEAM 10 IN SPAN 4 REPLACED ( PHOTO # 5958 )

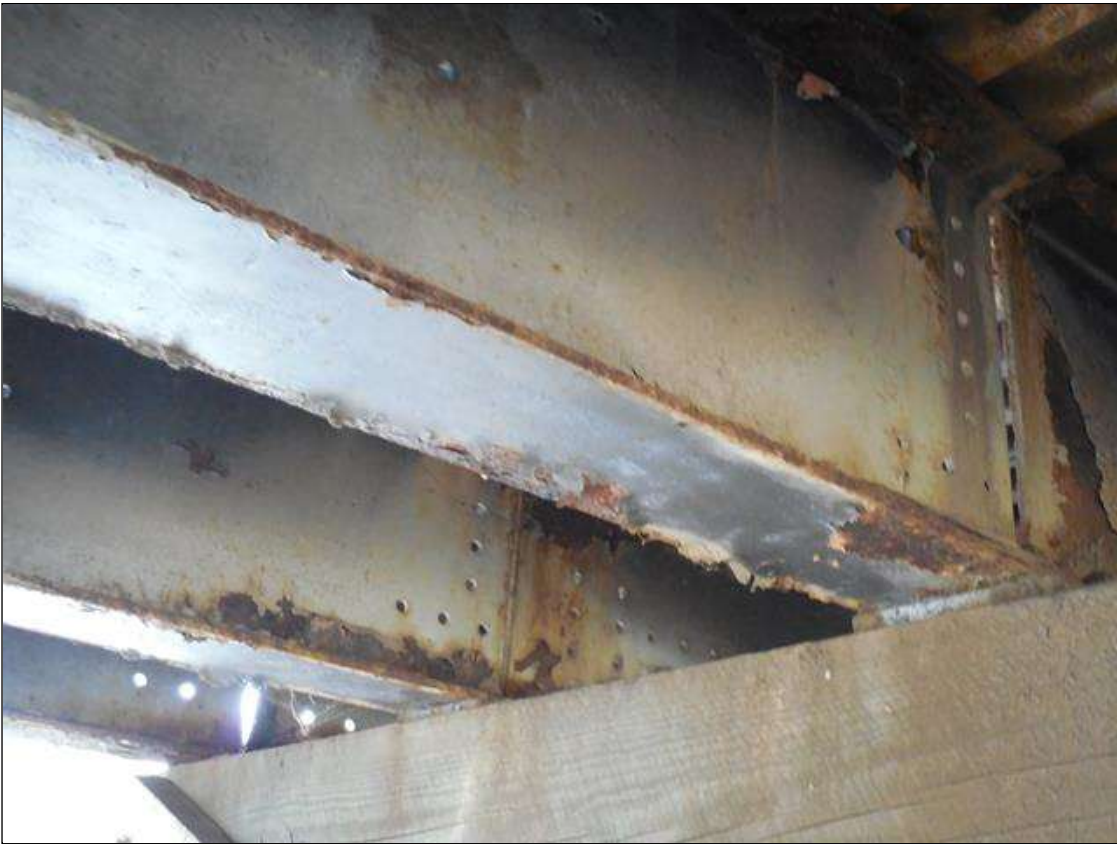
4 Feet of Corrosion: Freckled Rust. Corrosion of the steel has initiated. PAINT PEELING AND SURFACE RUST NO SECTION LOSS AT BENT 4 END  
 16 Square Feet of Effectiveness (Steel Protective Coatings): Limited effectiveness. PAINT PEELING AND SURFACE RUST AT BENT 4 END

Span 4 Beam 3: 4 Feet of Corrosion: Freckled Rust. Corrosion of the steel has initiated. PAINT PEELING AND SURFACE RUST NO SECTION LOSS AT BENT 4 END

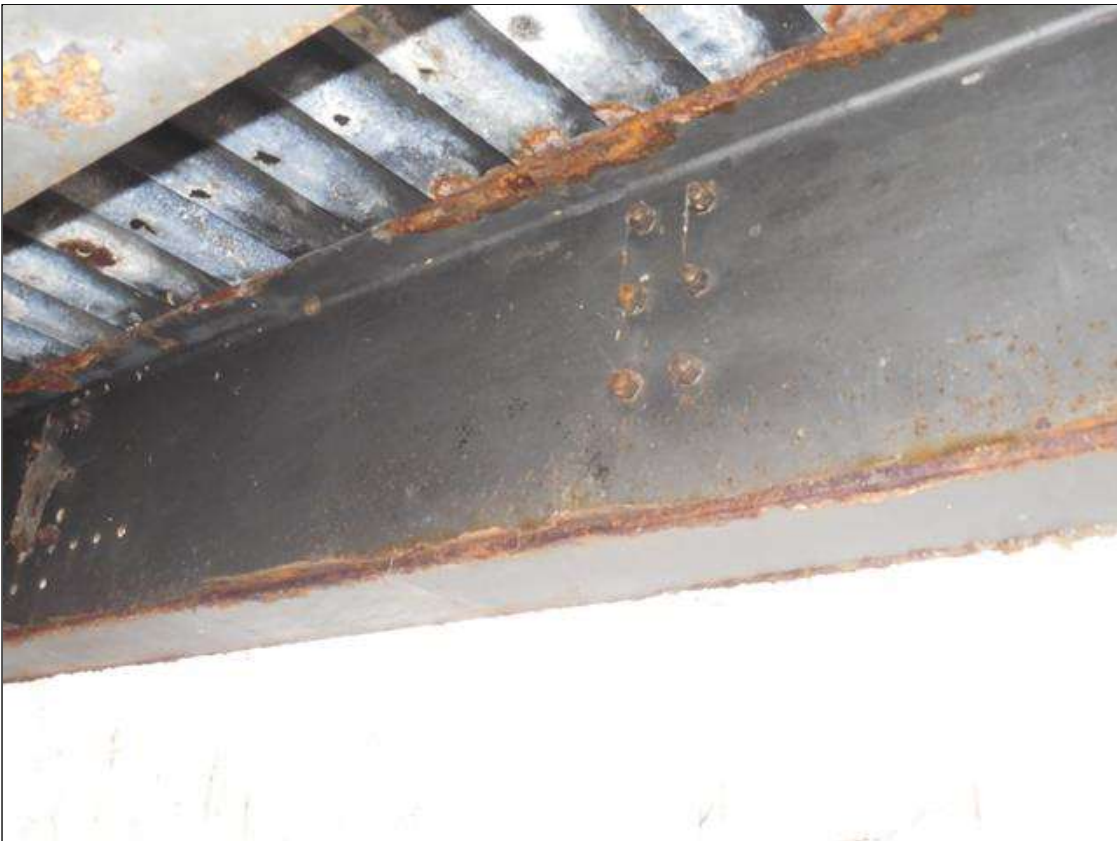
Span 4 Beam 1: 20 Feet of Corrosion: Section loss is evident or pack rust is present but does not warrant structural review. RUST WITH 1/16" SECTION LOSS IN BOTTOM FLANGE 7/16" REMAINING

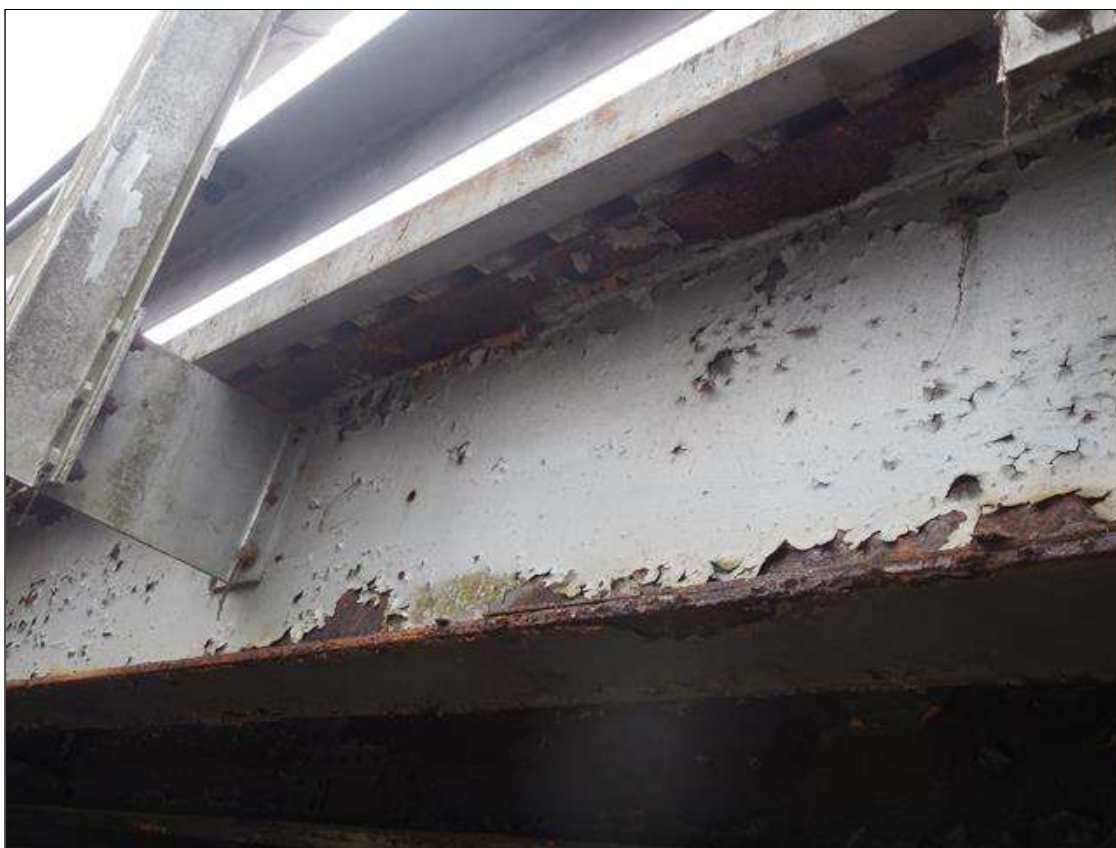
Span 5 Beam 1: 190 Square Feet of Peeling/Bubbling/Cracking (steel Protective Coatings): Finish coats only.

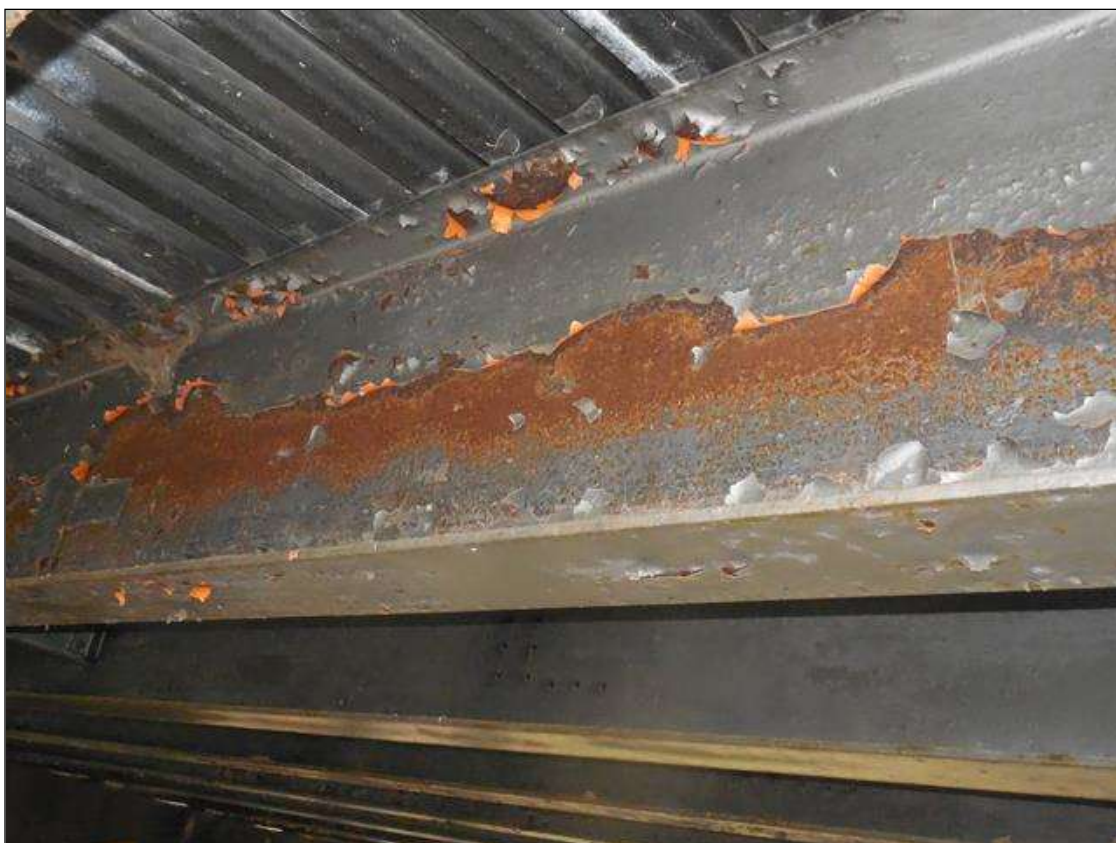
Span 5 Beam 2: 217 Square Feet of Peeling/Bubbling/Cracking (steel Protective Coatings): Finish and primer coats.

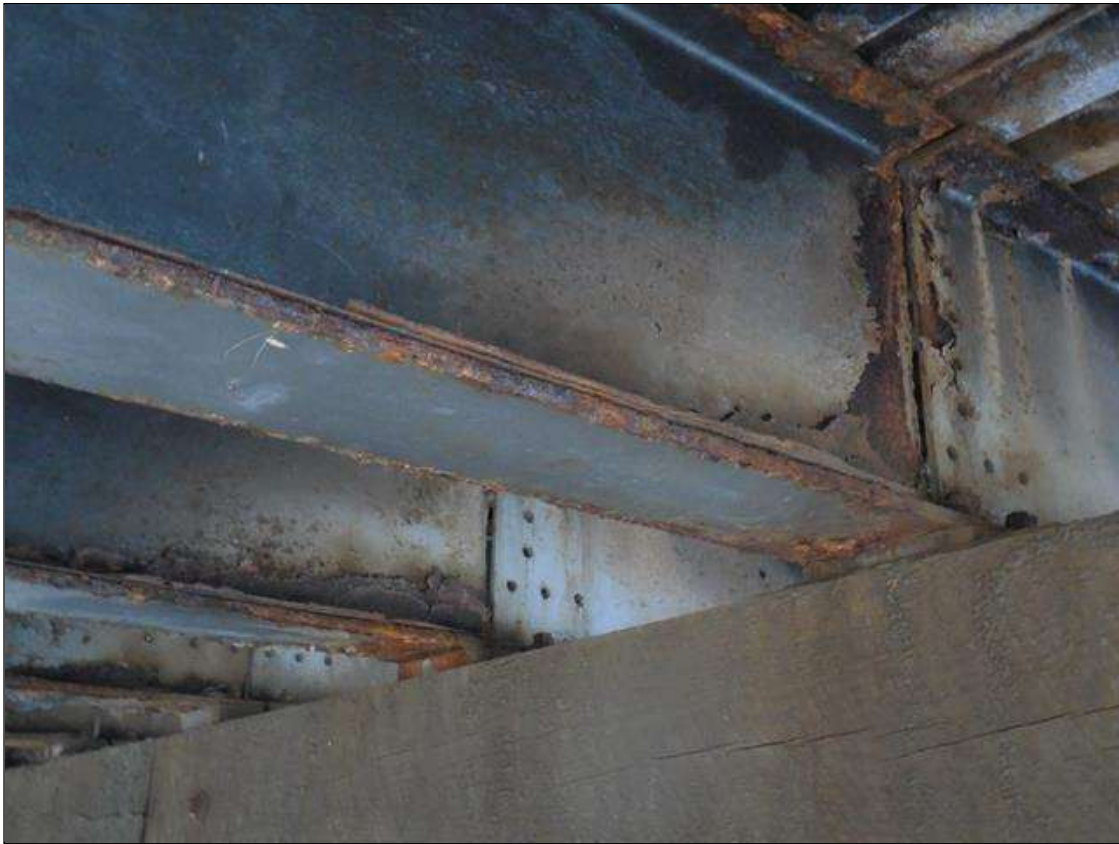
5 Feet of Corrosion: Section loss is evident or pack rust is present but does not warrant structural review. PAINT PEELING  
 RUST AND SCALING WITH NO SECTION LOSS  
 10 Square Feet of Peeling/Bubbling/Cracking (steel Protective Coatings): Finish and primer coats.

Span 5 Beam 3: 5 Feet of Corrosion: Section loss is evident or pack rust is present but does not warrant structural review. PAINT PEELING RUST AND SCALING WITH NO SECTION LOSS

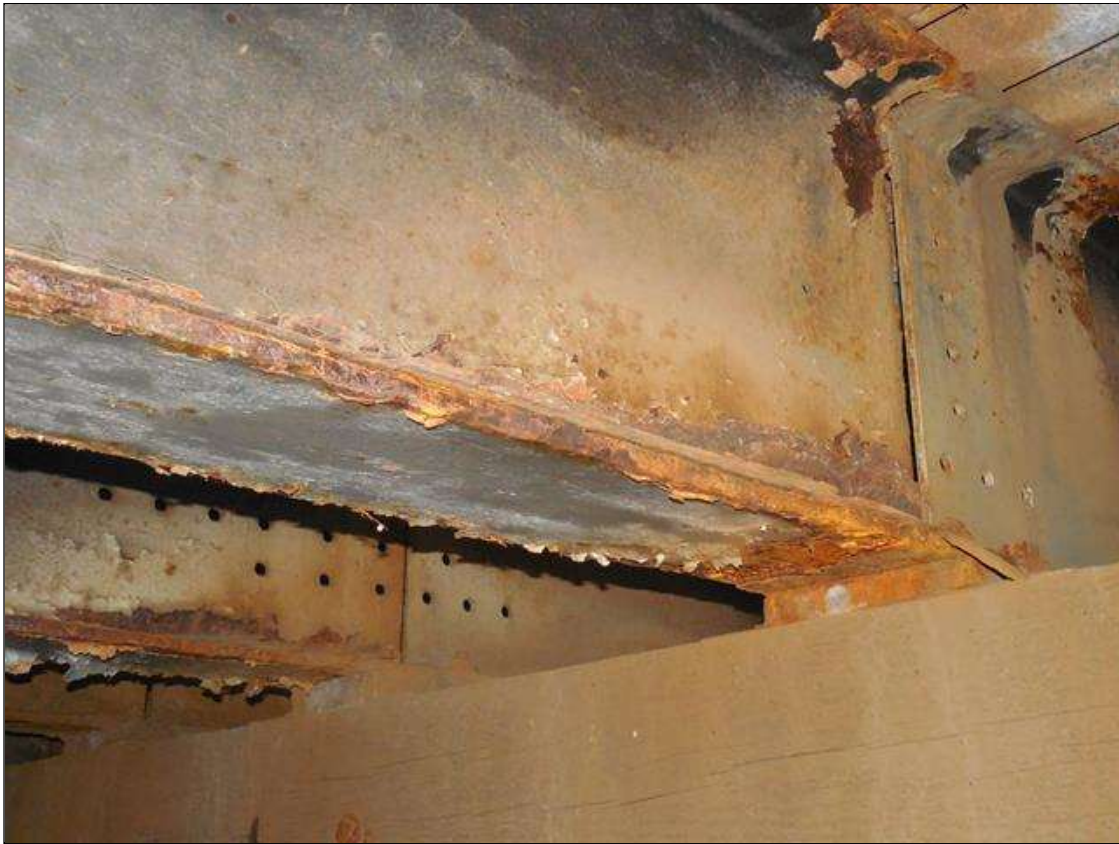
Span 5 Beam 4: 5 Feet of Corrosion: Section loss is evident or pack rust is present but does not warrant structural review.

RUST WITH 1/8" SECTION LOSS IN BOTTOM FLANGE WITH 3/8" REMAINING AT BENT 4 END

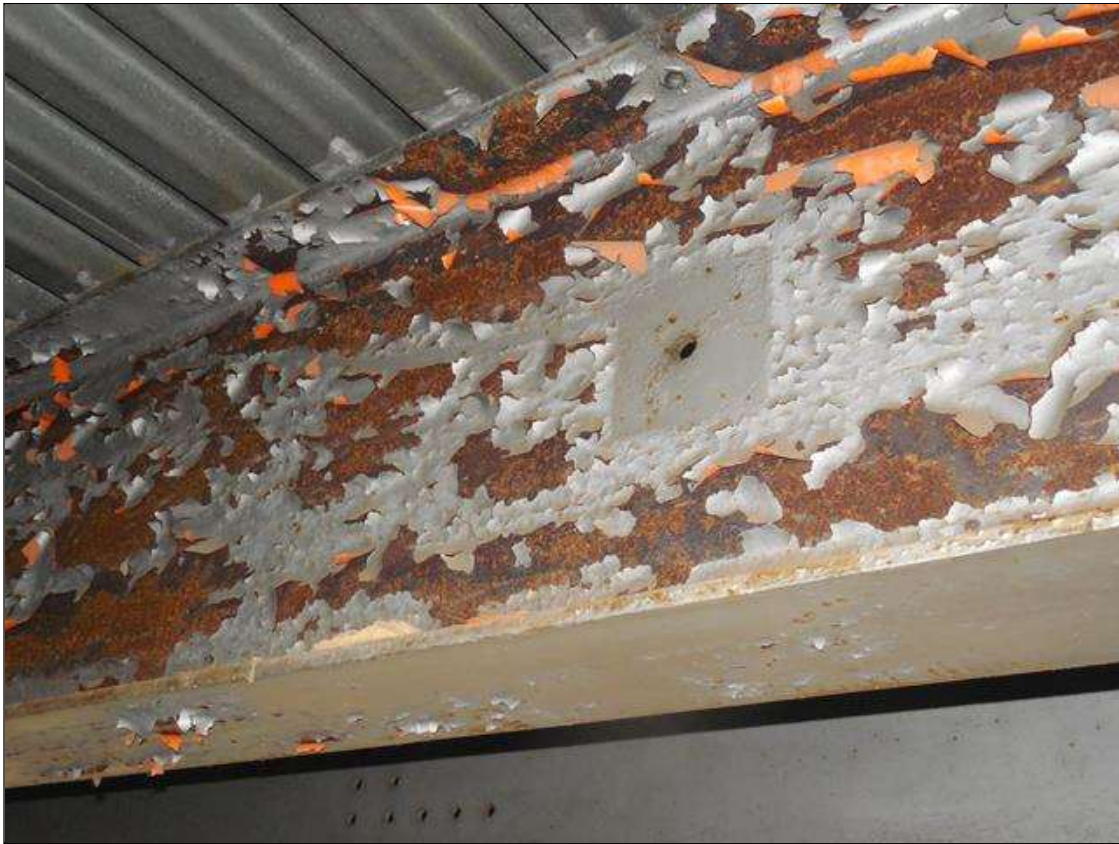
Span 5 Beam 5: 217 Square Feet of Peeling/Bubbling/Cracking (steel Protective Coatings): Finish and primer coats.

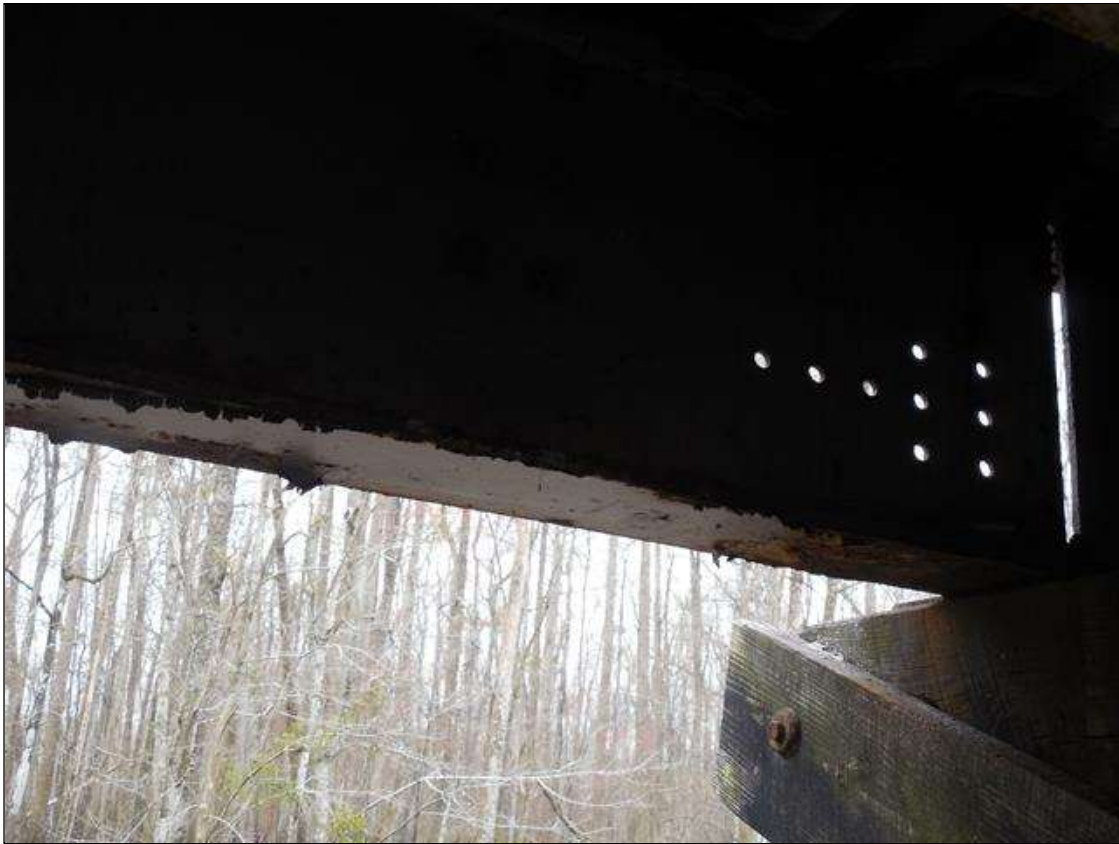
6 Feet of Corrosion: Section loss is evident or pack rust is present but does not warrant structural review.  
 PAINT PEELING AND RUST WITH SCALING IN BOTTOM FLANGE AT BENT 4 END  
 50 Square Feet of Peeling/Bubbling/Cracking (steel Protective Coatings): Finish and primer coats.

Span 5 Beam 10: 6 Feet of Corrosion: Section loss is evident or pack rust is present but does not warrant structural review.  
PAINT PEELING AND RUST WITH SCALING IN BOTTOM FLANGE AT BENT 4 END

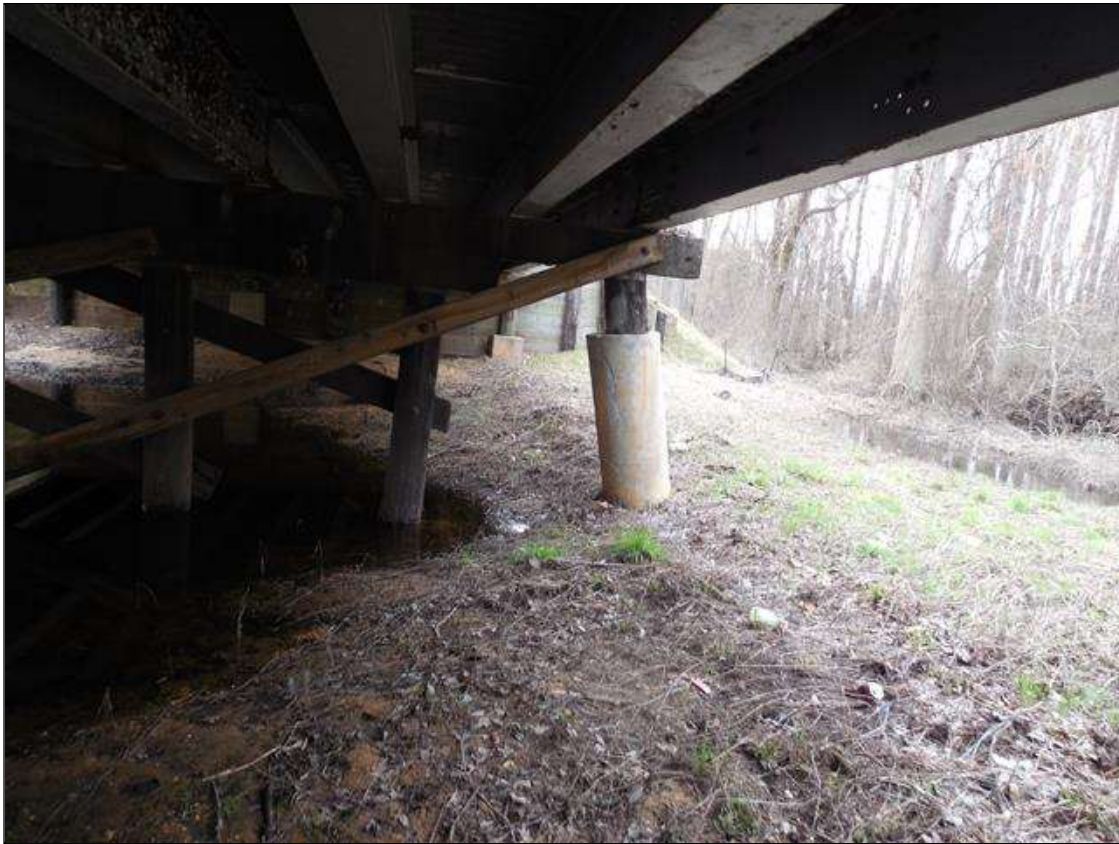
PILE 6 AT BENT 5 ENCASED IN CONCRETE ( PHOTO # 5969 )

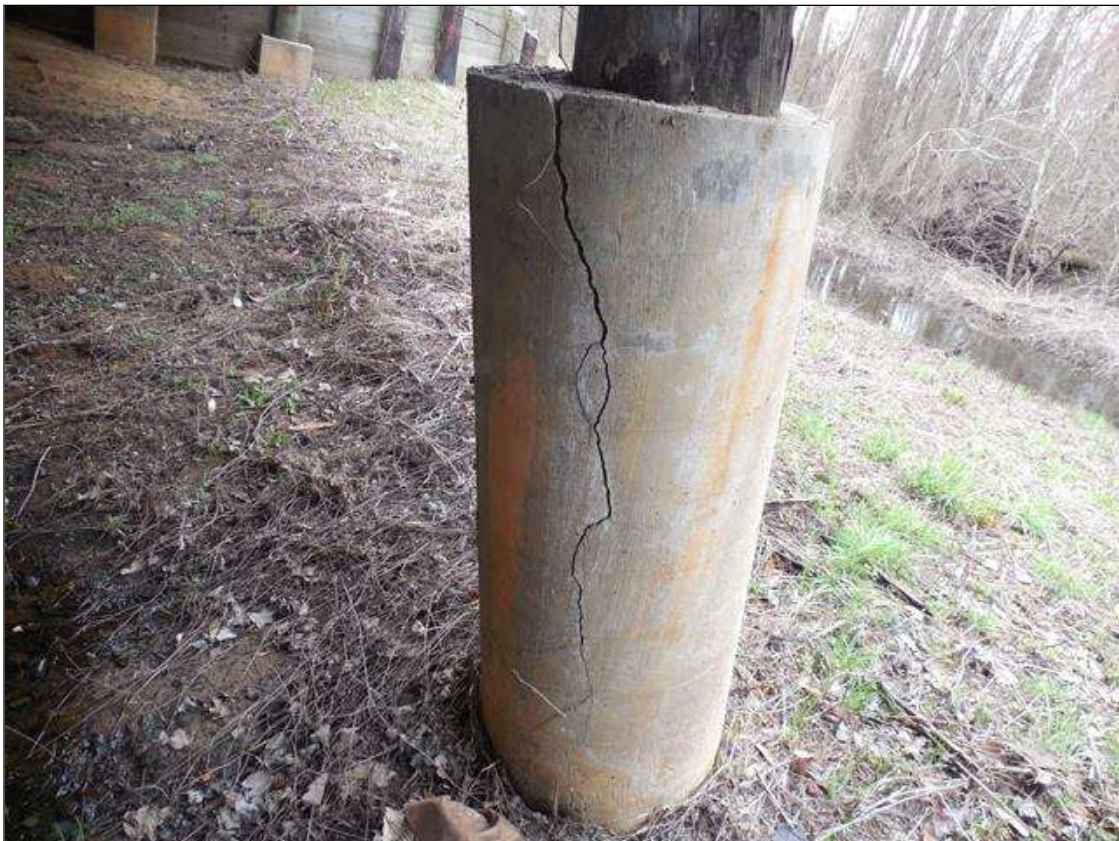
1/4" VERTICAL CRACK IN PILE 6 ENCASEMENT AT SPAN 5 FACE, BENT 5 ( PHOTO # 5970 )

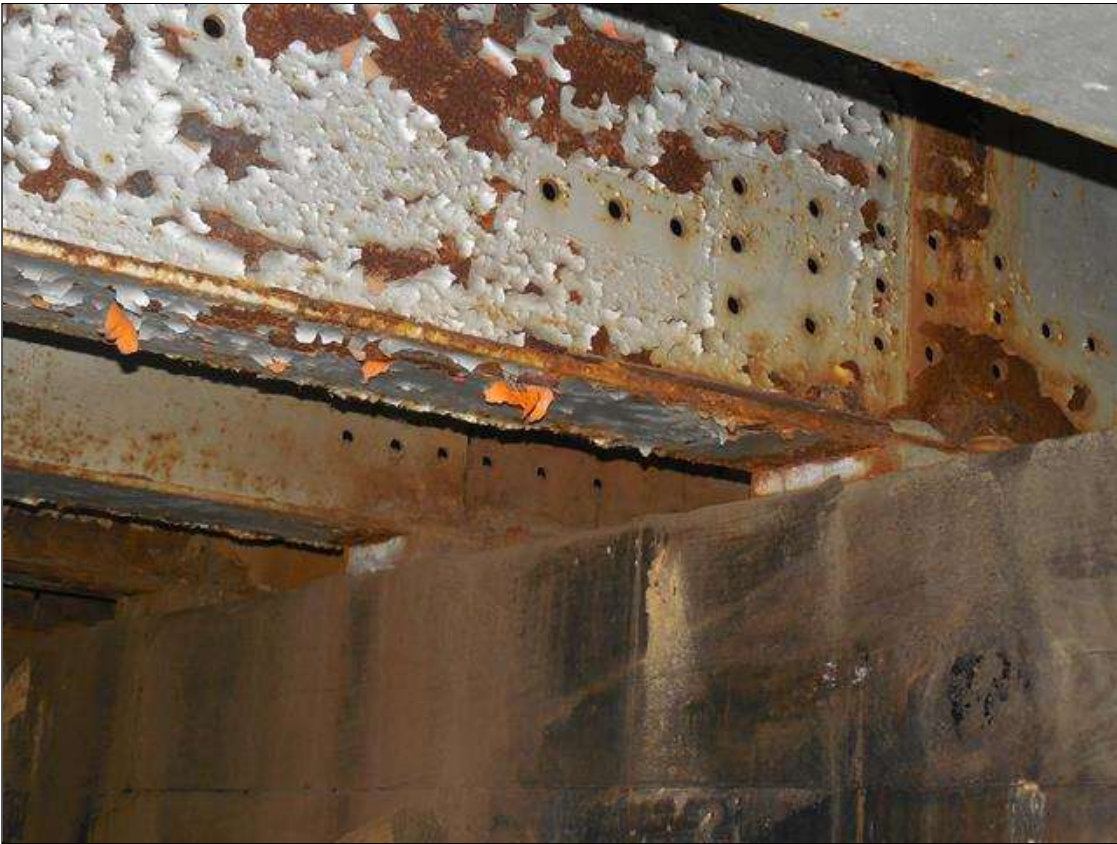
Span 5 Beam 7: 2 Feet of Corrosion: Section loss is evident or pack rust is present but does not warrant structural review. RUST AND SCALING AT BENT 5 END

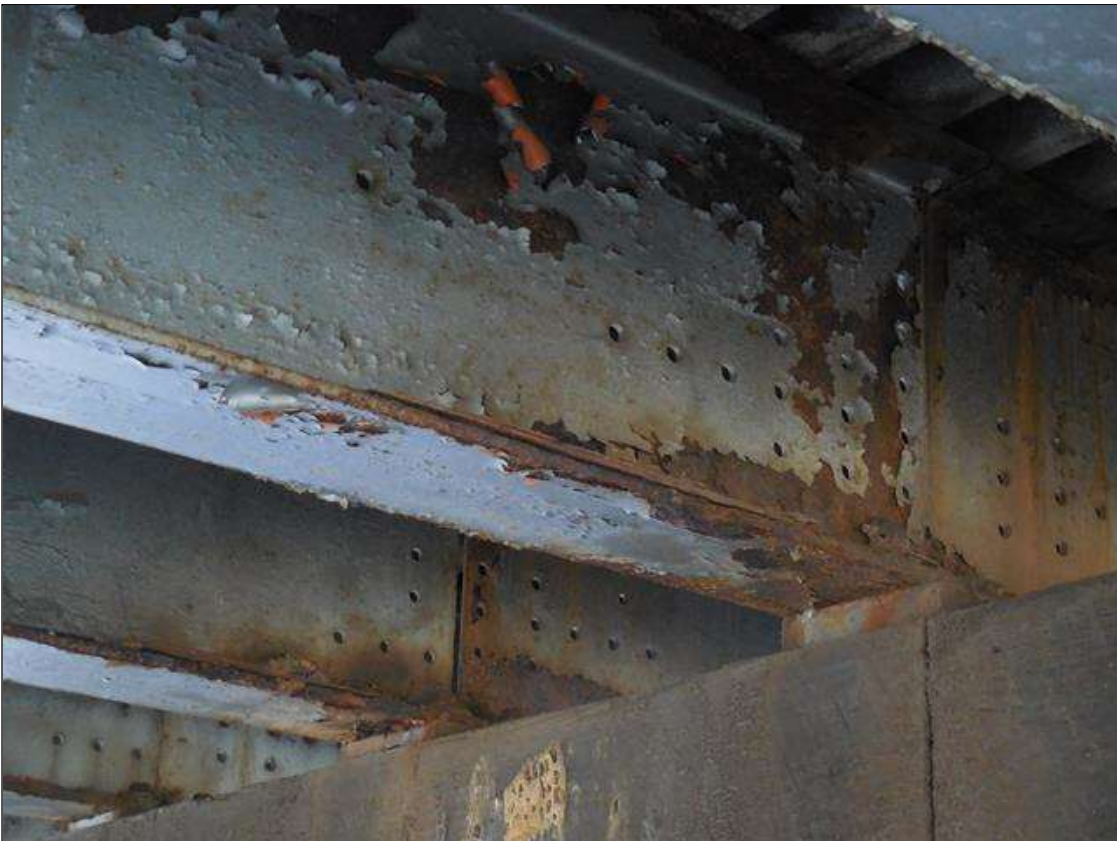
Span 5 Beam 5: 3 Feet of Corrosion: Section loss is evident or pack rust is present but does not warrant structural review. RUST AND SCALING AT BENT 5 END

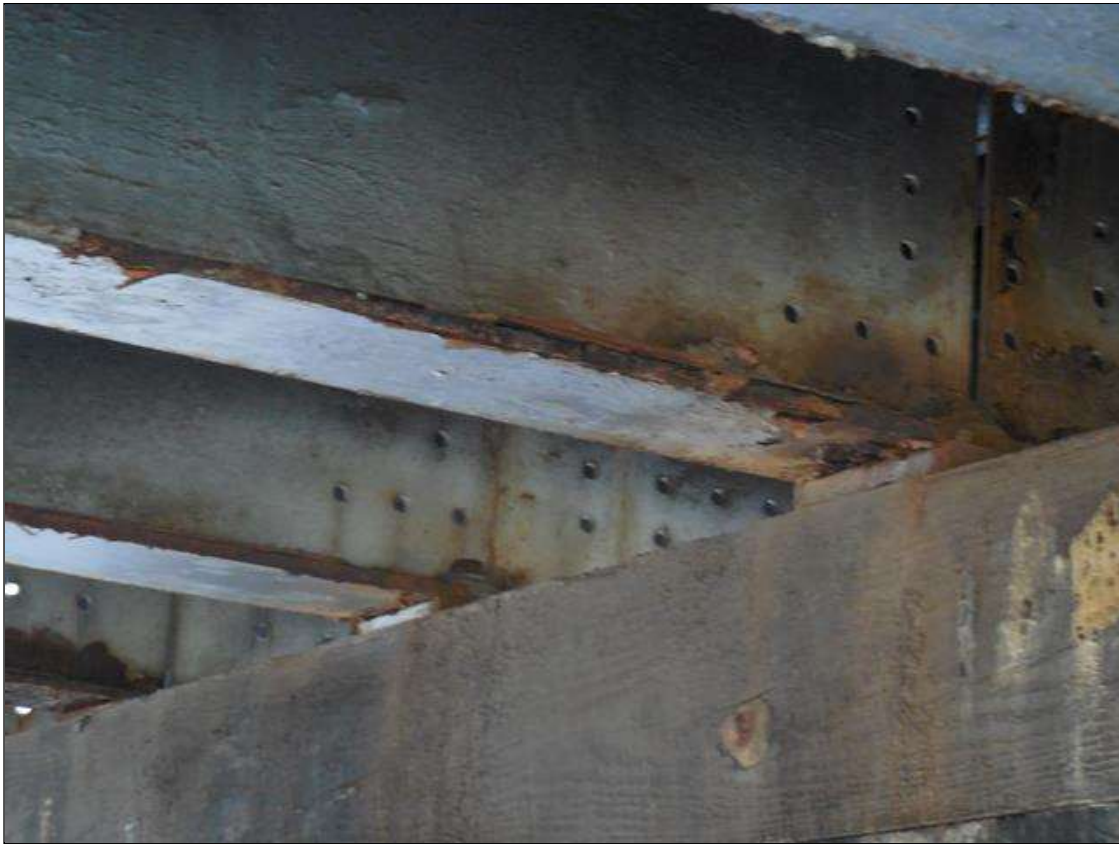
Span 5 Beam 4: 3 Feet of Corrosion: Section loss is evident or pack rust is present but does not warrant structural review. RUST AND SCALING AT BENT 5 END
