NC DEPARTMENT OF TRANSPORTATION  
DIVISION OF HIGHWAYS  
STRUCTURE MANAGEMENT UNIT

## Structure Safety Report

### Routine Element Inspection

COUNTY: CUMBERLAND STRUCTURE NUMBER: 250052 FREQUENCY: 24 MONTHS

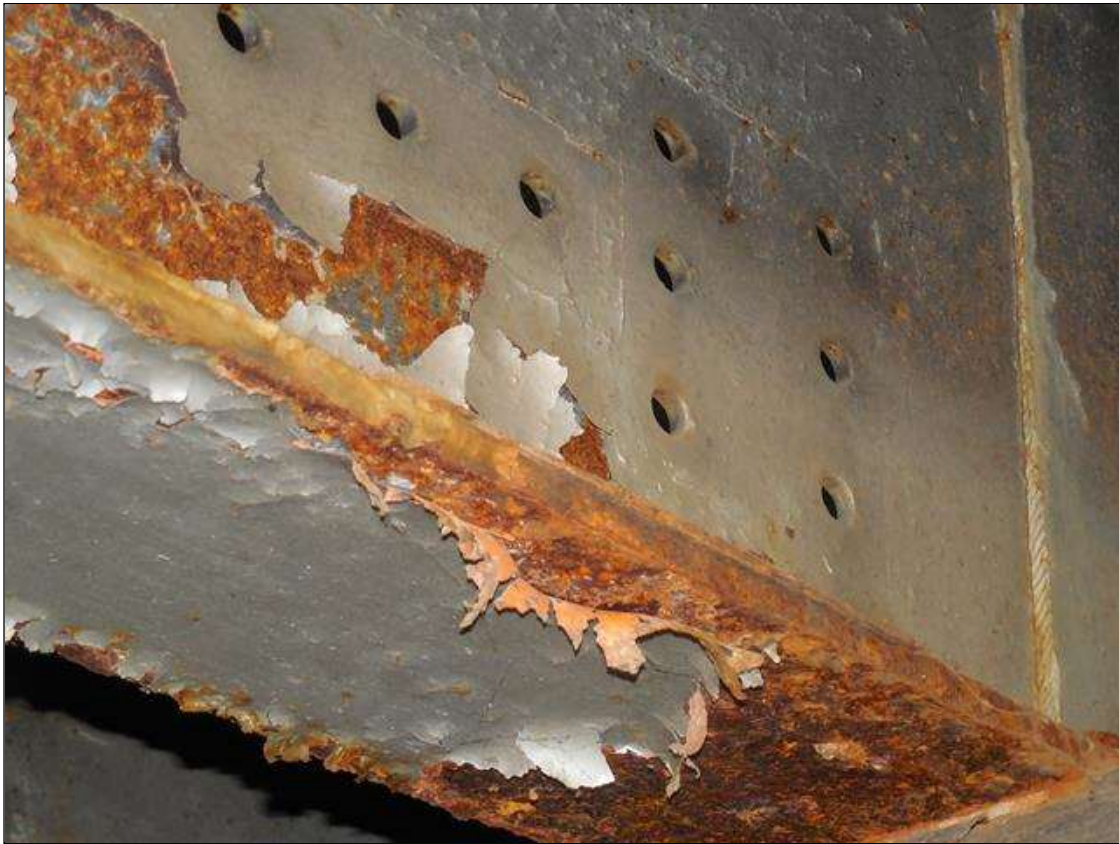
Span 5 Beam 2: 3 Feet of Corrosion: Section loss is evident or pack rust is present but does not warrant structural review.  
RUST AND SCALING AT BENT 5 END

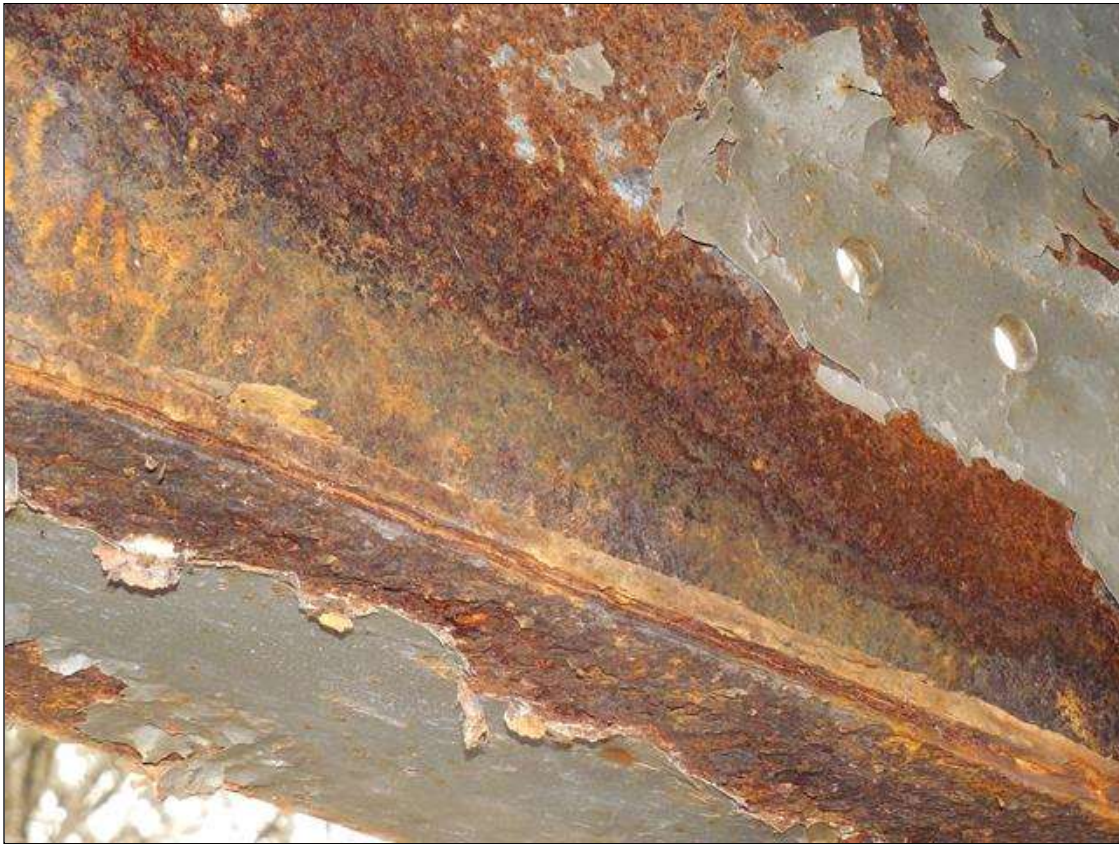
Span 5 Beam 1: 5 Feet of Corrosion: Section loss is evident or pack rust is present but does not warrant structural review.  
RUST AND SCALING AT BENT 5 END

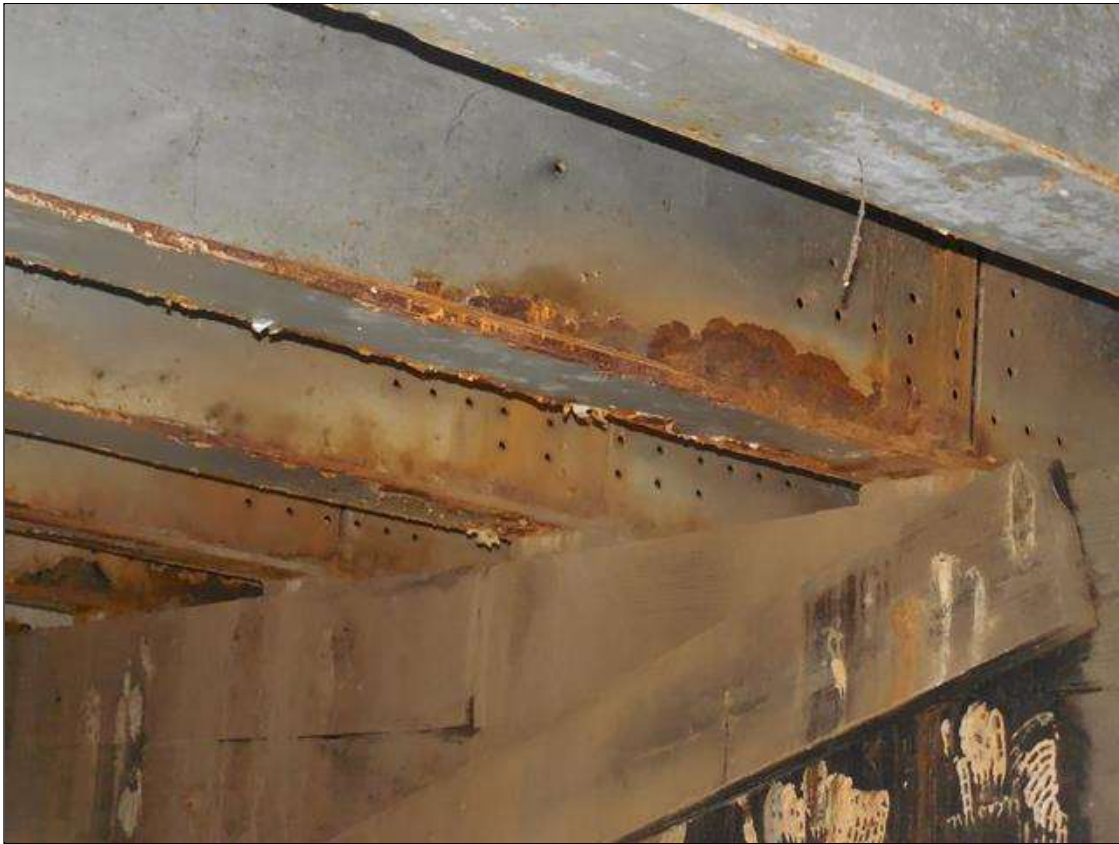
Span 6 Beam 4: 6 Feet of Corrosion: Section loss is evident or pack rust is present but does not warrant structural review. RUST AND SCALING AT BENT 5 END

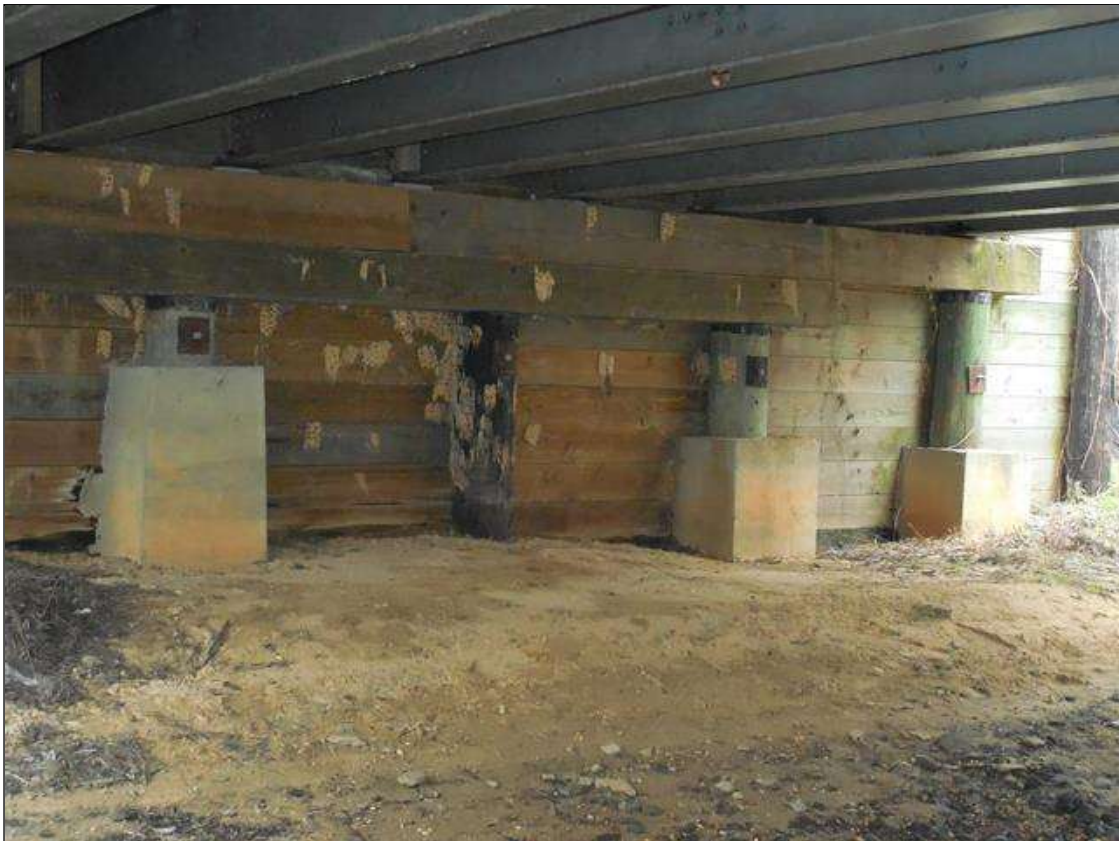
END BENT 2 PILES 3, 5, AND 6 ENCASED IN CONCRETE ( PHOTO # 5979 )

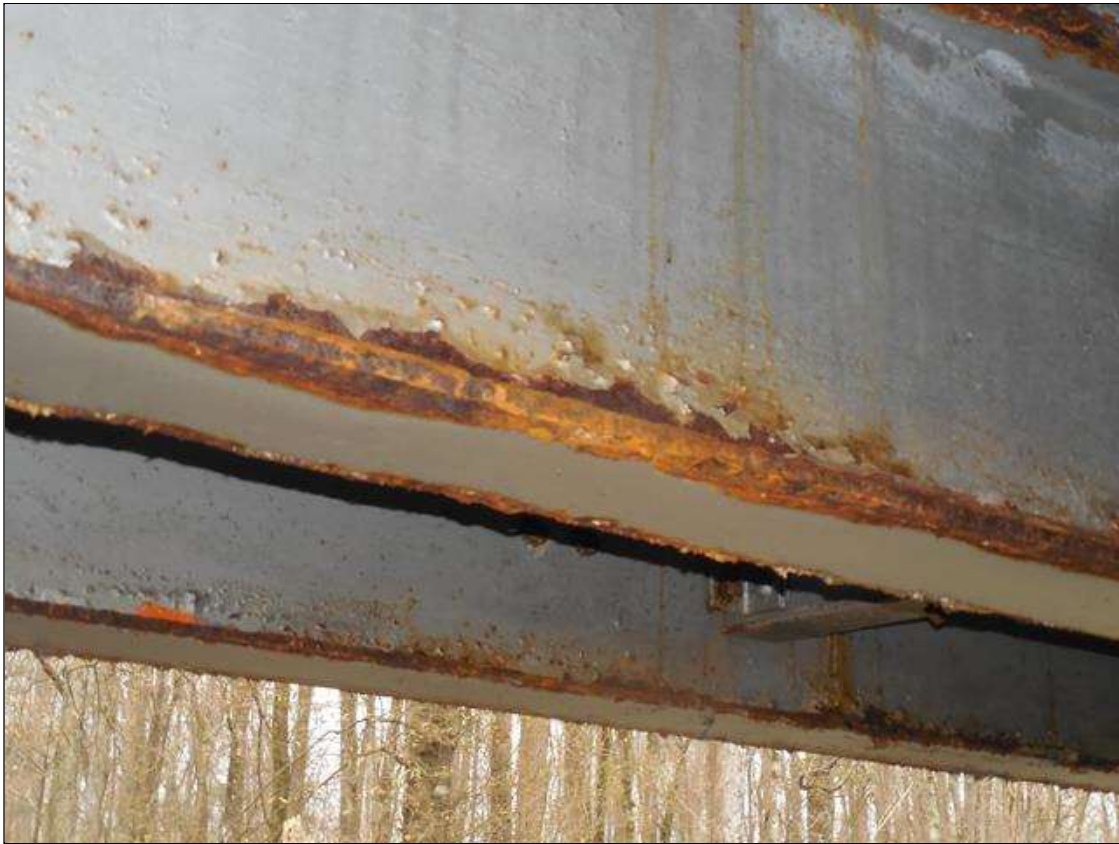
Span 6 Beam 9: 6 Feet of Corrosion: Section loss is evident or pack rust is present but does not warrant structural review.  
RUST AND SCALING IN BOTTOM FLANGE AT 10' FROM END BENT 2

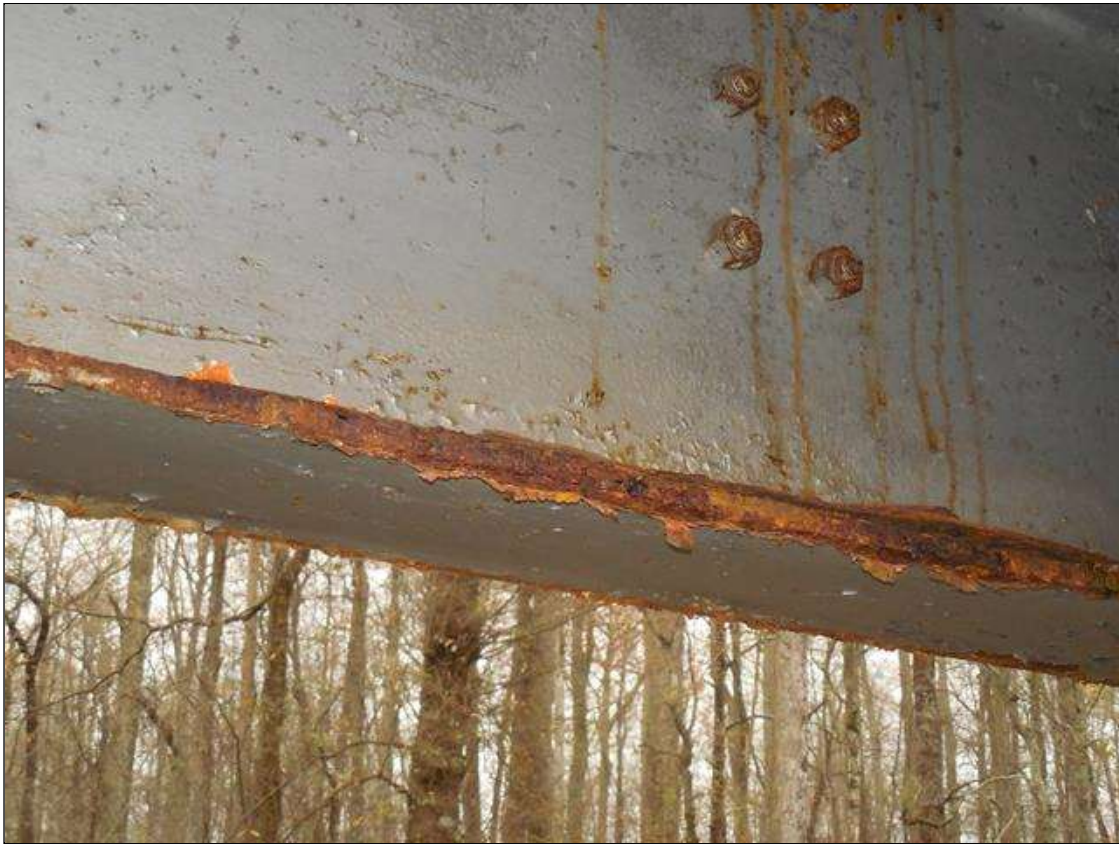
Span 6 Beam 10: 8 Feet of Corrosion: Section loss is evident or pack rust is present but does not warrant structural review.  
RUST AND SCALING IN BOTTOM FLANGE AT MID SPAN
