# Structure Safety Report

## Routine Element Inspection

COUNTY: COLUMBUS STRUCTURE NUMBER: 230389 FREQUENCY: 24 MONTHSFACILITY CARRIED: US701 MILE POST: \_\_\_\_\_LOCATION: 500"N.JCT.SR1005FEATURE INTERSECTED: PRONG CREEKLATITUDE: 34° 26' 0.59" LONGITUDE: 78° 43' 52.72"SUPERSTRUCTURE: TRIPLE 8"X9"RCBC;50"ALONG CENTERLINE CULVERT

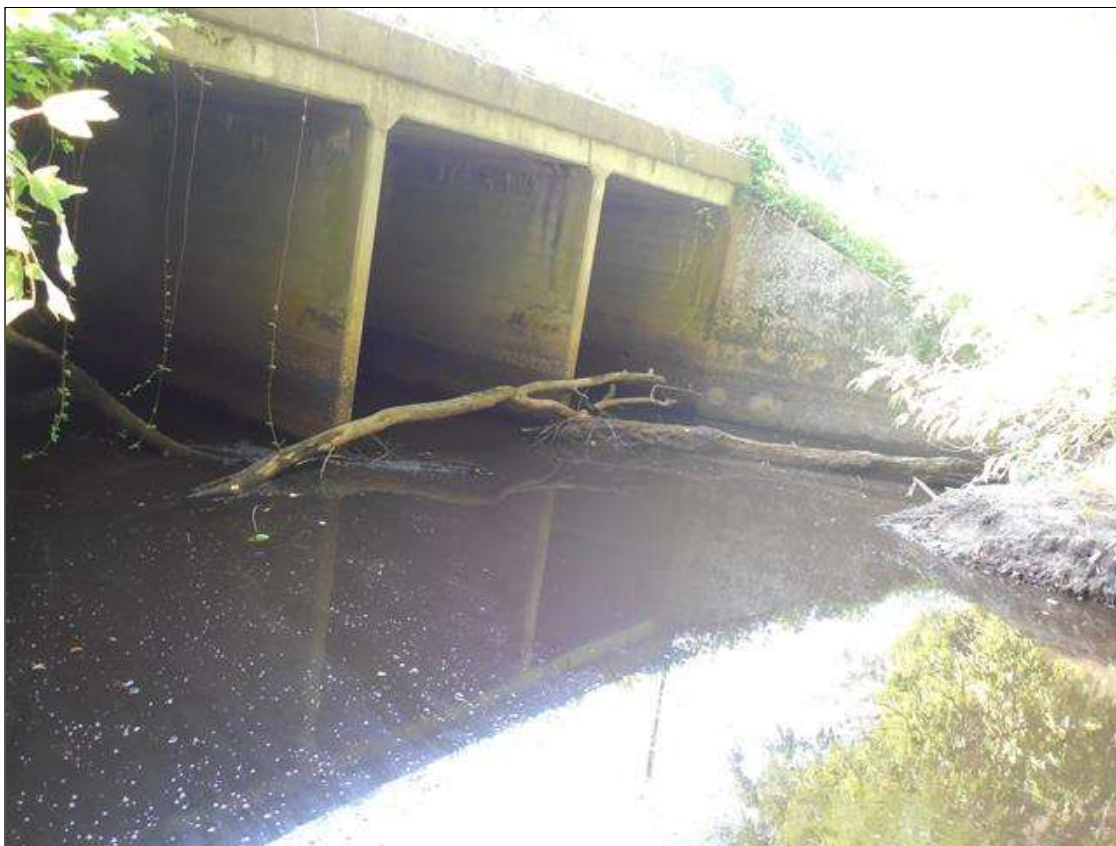
**Details** DRIFT AT WEST END 20 HOURS

DRIFT AT WEST END 20 HOURS

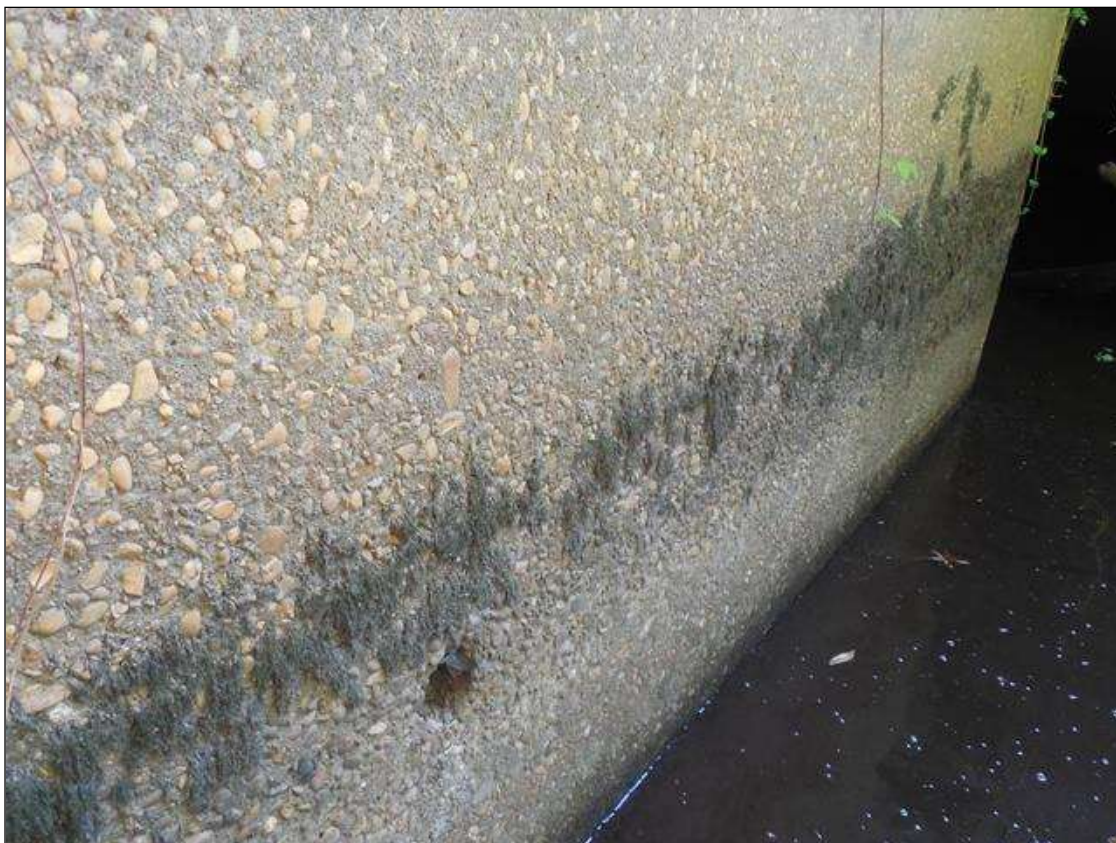
**Details** EXPOSED AGGREGATE 20' LONG X 4' HIGH IN WINGWALL AT SOUTHWEST CORNER, SIMILAR AT ALL CORNERS  
TOTAL 320 SQ. FT.

EXPOSED AGGREGATE 20' LONG X 4' HIGH IN WINGWALL AT SOUTHWEST CORNER, SIMILAR AT ALL CORNERS TOTAL 320 SQ. FT.

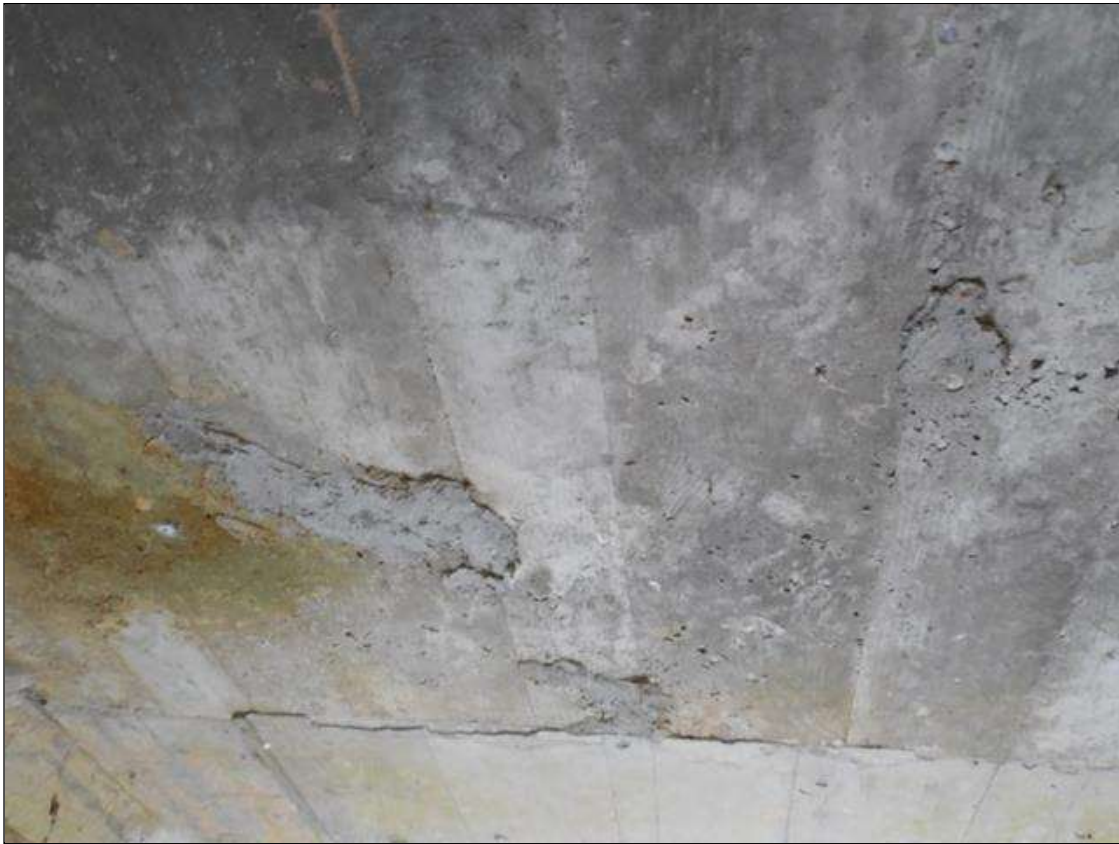
3 Feet of Delamination/Spall/Patched Area: Delaminated. Spall 1 in. or less deep or 6 in. or less in diameter. Patched area that is sound. SOUND REPAIRS IN TOP SLAB AT EAST END

Barrel 3 Section 1: 3 Feet of Delamination/Spall/Patched Area: Delaminated. Spall 1 in. or less deep or 6 in. or less in diameter. Patched area that is sound. SOUND REPAIRS IN TOP SLAB AT EAST END

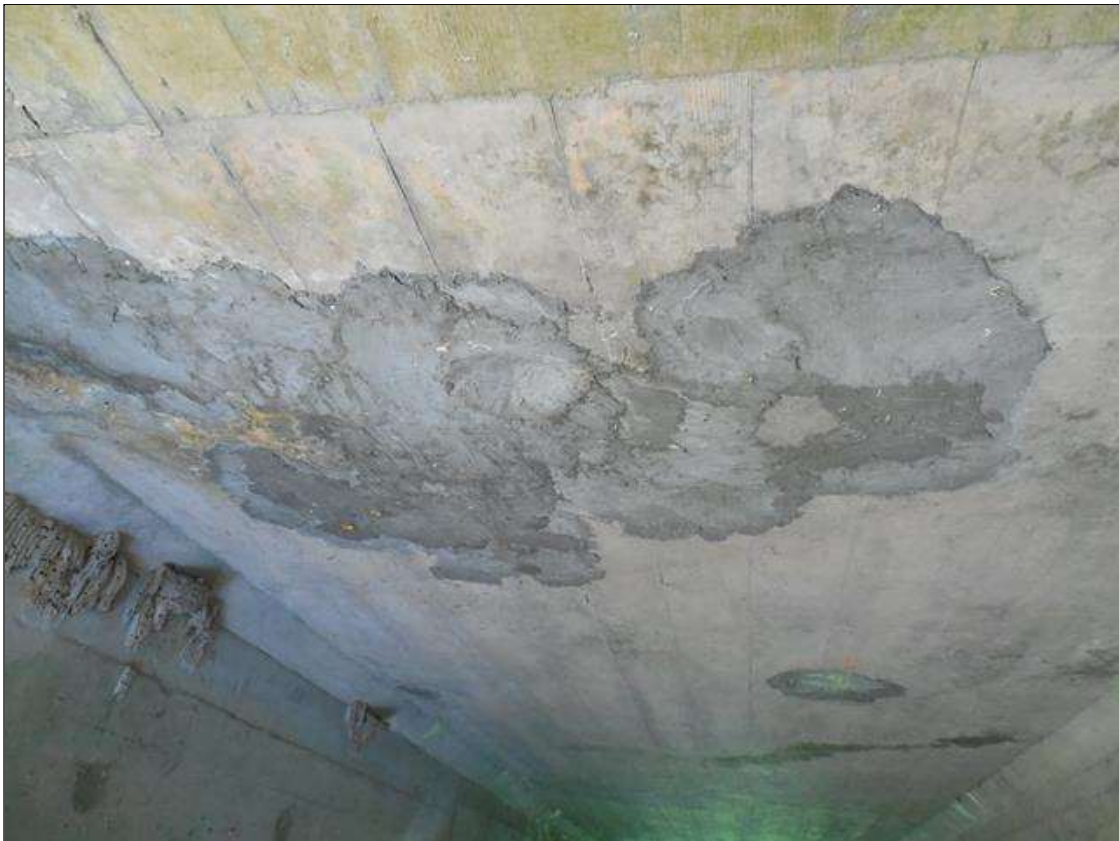
10 Feet of Delamination/Spall/Patched Area: Delaminated. Spall 1 in. or less deep or 6 in. or less in diameter. Patched area that is sound. SOUND REPAIRS IN TOP SLAB AT 15' FROM EAST END

Barrel 2 Section 1: 10 Feet of Delamination/Spall/Patched Area: Delaminated. Spall 1 in. or less deep or 6 in. or less in diameter. Patched area that is sound. SOUND REPAIRS IN TOP SLAB AT 15' FROM EAST END

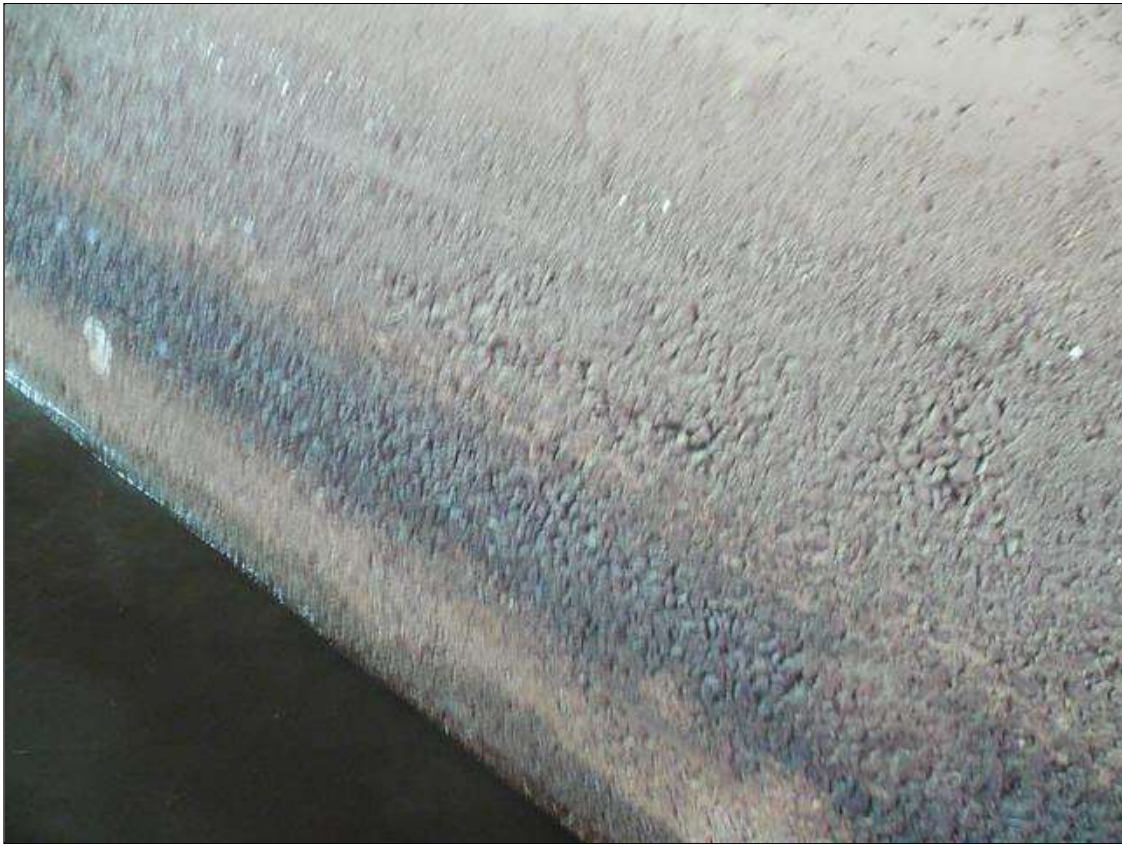
EXPOSED AGGREGATE IN WALLS 3' HIGH

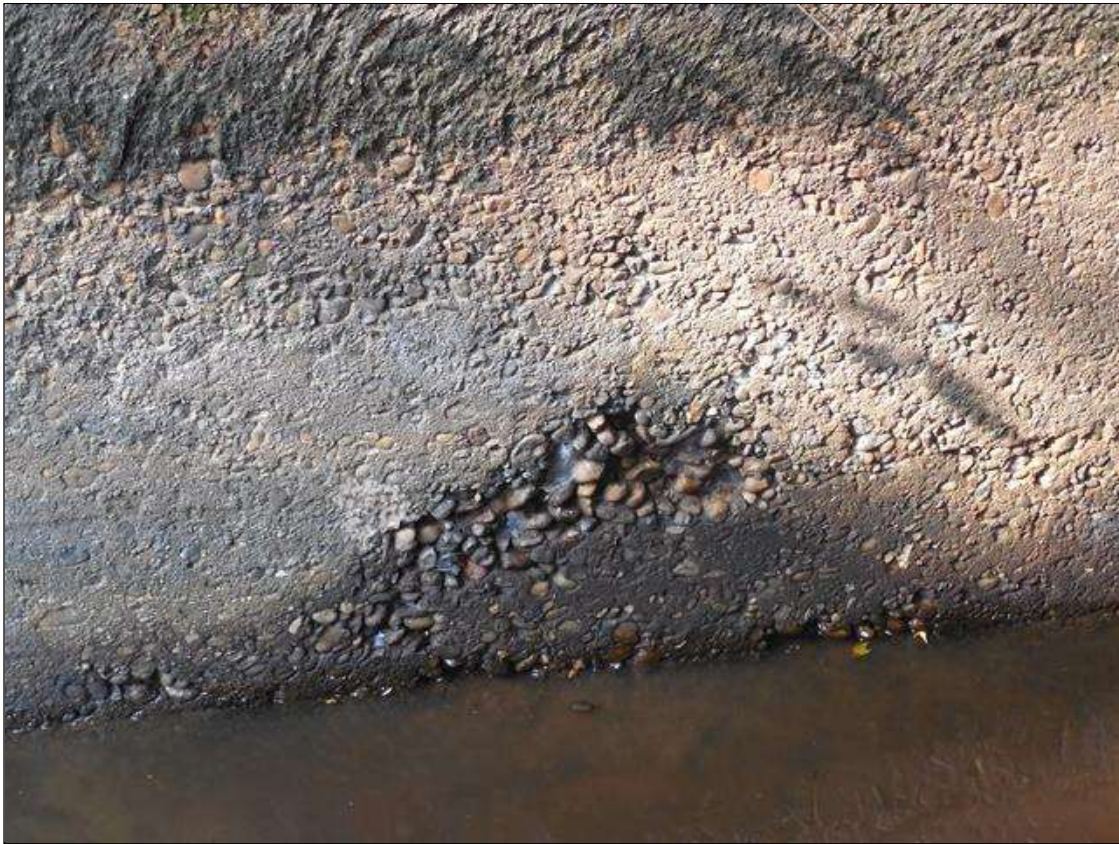
2 Feet of Delamination/Spall/Patched Area: Spall greater than 1 in. deep or greater than 6 in. diameter. Patched area that is unsound or showing distress. Does not warrant structural review. SPALL 14" LONG X 6" HIGH X 2" DEEP IN SOUTH WALL AT 5' FROM EAST END

Barrel 1 Section 1: 2 Feet of Delamination/Spall/Patched Area: Spall greater than 1 in. deep or greater than 6 in. diameter. Patched area that is unsound or showing distress. Does not warrant structural review. SPALL 14" LONG X 6" HIGH X 2" DEEP IN SOUTH WALL AT 5' FROM EAST END

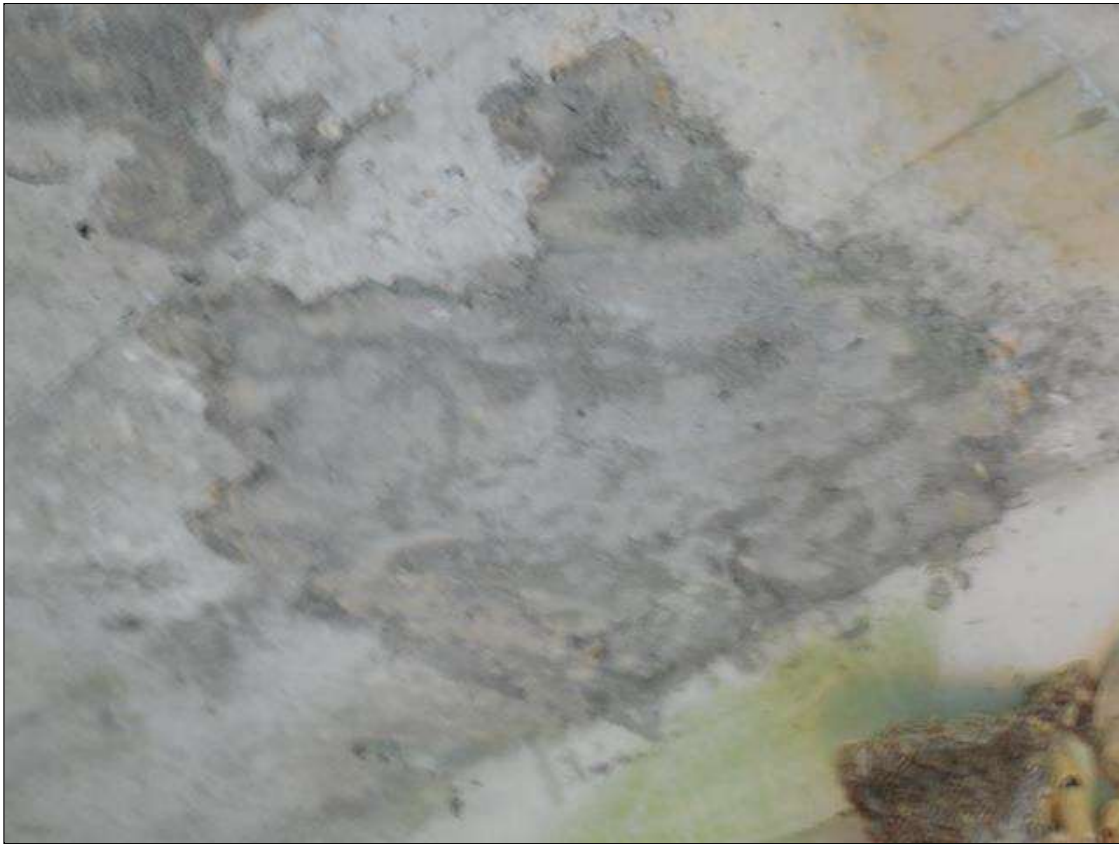
2 Feet of Delamination/Spall/Patched Area: Delaminated. Spall 1 in. or less deep or 6 in. or less in diameter. Patched area that is sound. SOUND PATCH IN TOP SLAB AT 10' FROM EAST END

Barrel 1 Section 1: 2 Feet of Delamination/Spall/Patched Area: Delaminated. Spall 1 in. or less deep or 6 in. or less in diameter. Patched area that is sound. SOUND PATCH IN TOP SLAB AT 10' FROM EAST END
