NC DEPARTMENT OF TRANSPORTATION  
DIVISION OF HIGHWAYS  
STRUCTURE MANAGEMENT UNIT

## Structure Safety Report Supplemental Element Inspection

COUNTY: COLUMBUS STRUCTURE NUMBER: 230188 FREQUENCY: None

FEATURE INTERSECTED: BRIER CREEK

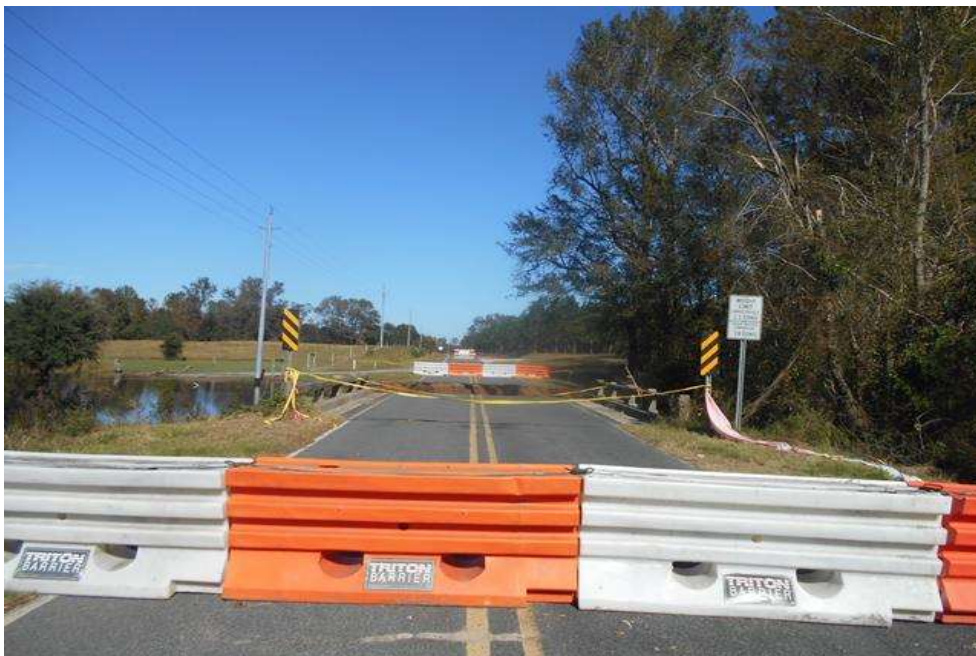
LOOKING EAST ROAD CLOSED

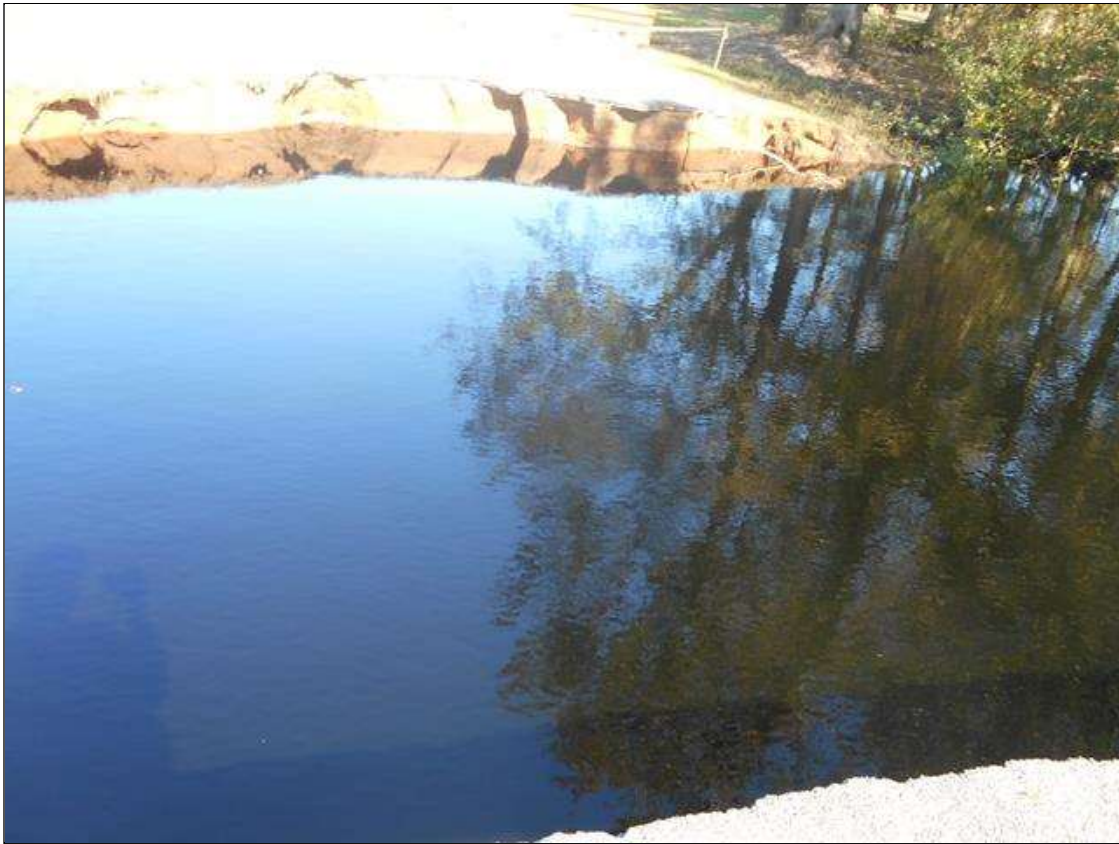
| <b>Details</b> | STREAM CHANNEL HAS MOVED EAST WITH SCOUR BEHIND ABUTMENT 2 NOT SURE IF STRUCTURE CAN BE REPAIRED / OR REPLACEMENT . | | | | | | |

EAST APPROACH WASHOUT BEHIND ABUTMENT 2 30' LONG X 34' WIDE X 13' DEEP ( 13,260 SQ. FT. ) PM  
ISSUED

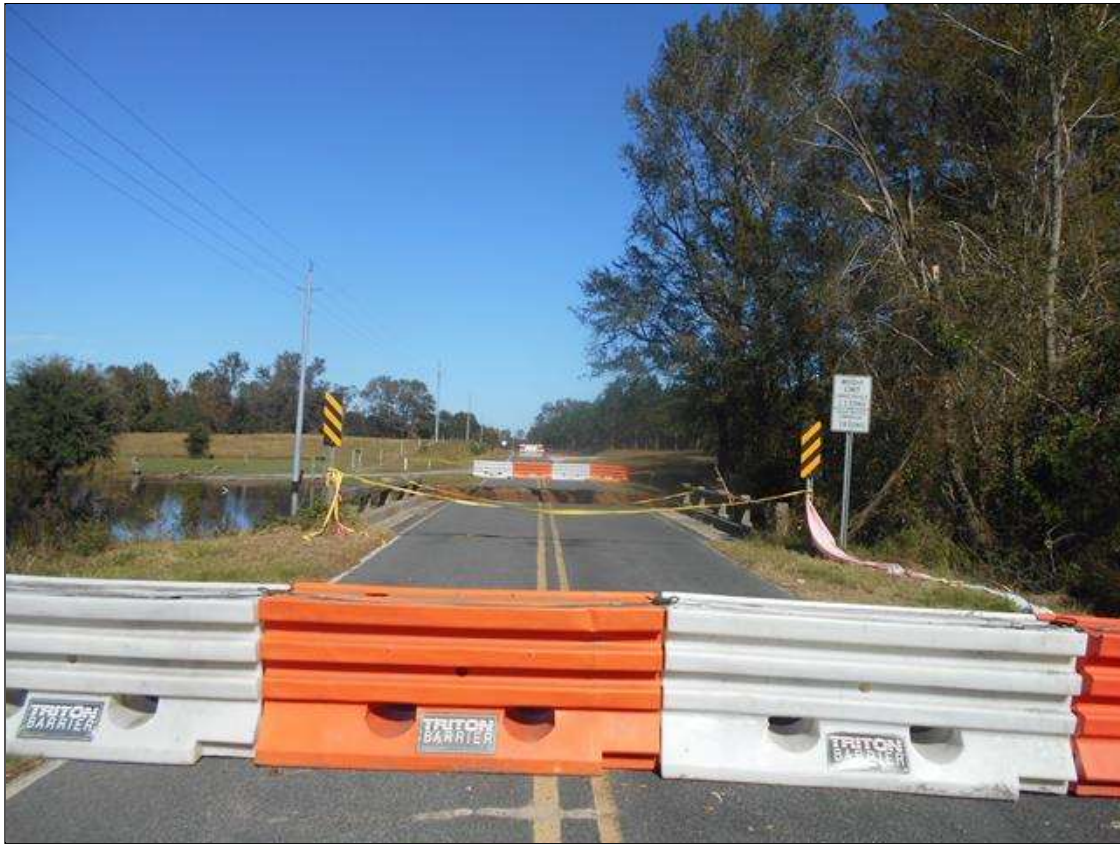
LOOKING EAST ROAD CLOSED
