NC DEPARTMENT OF TRANSPORTATION  
DIVISION OF HIGHWAYS  
STRUCTURE MANAGEMENT UNIT

## Structure Safety Report

### Routine Element Inspection - Contract

COUNTY: CALDWELL STRUCTURE NUMBER: 130262 FREQUENCY: 24 MONTHS

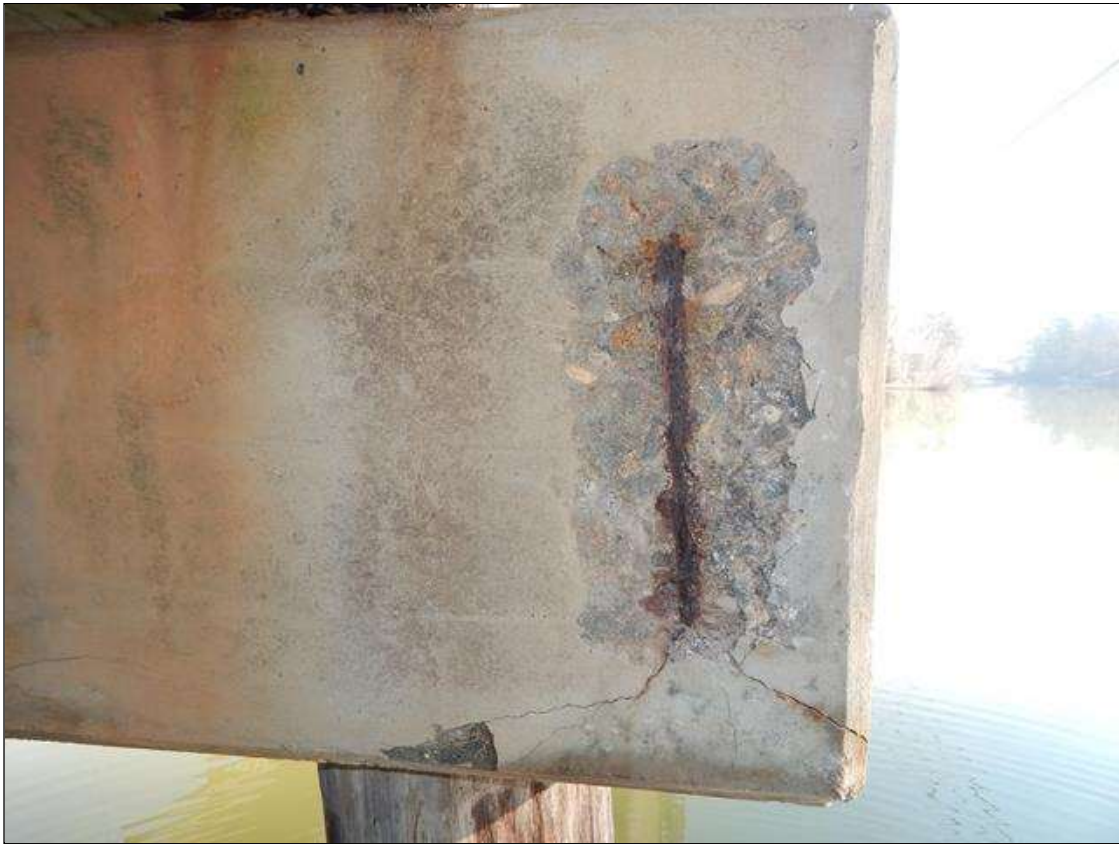
Bent 1 Cap : 11" x 19" x 1" deep spall with exposed rebar on Span 1 face at South end

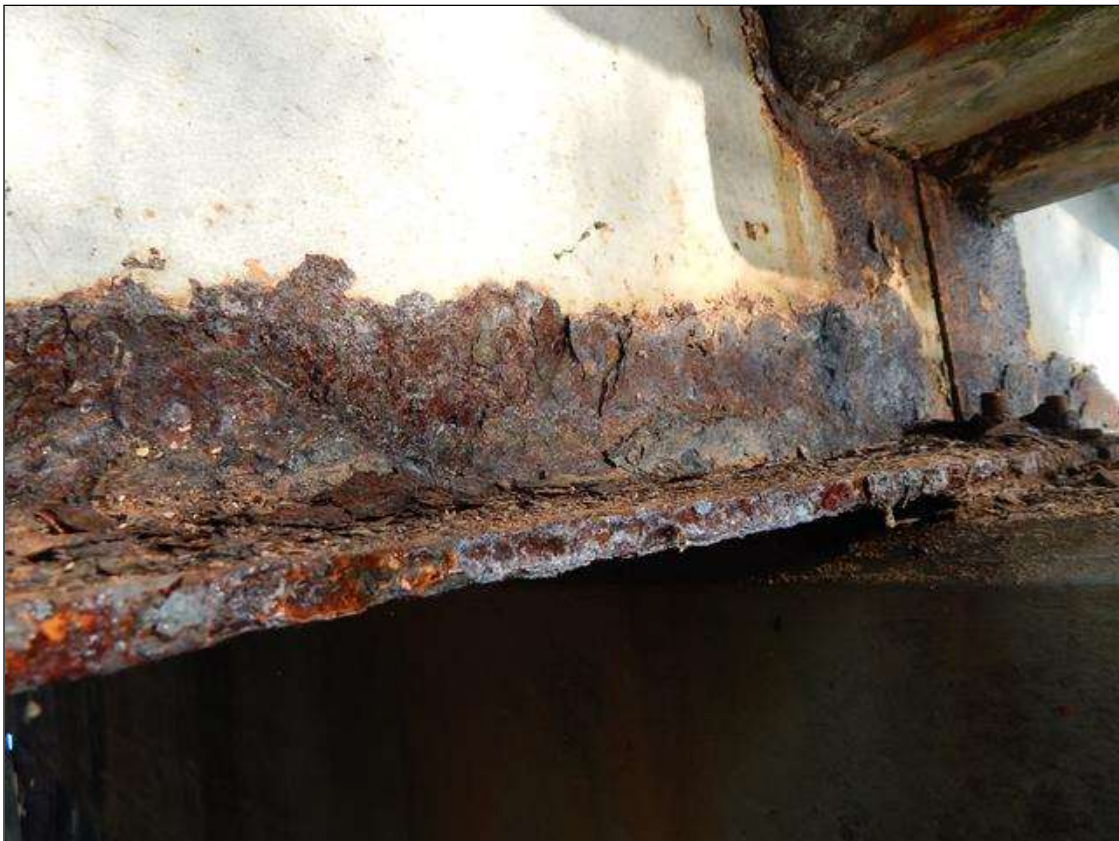
Span 1 Beam 4: 25" x 4" area of 1/4" section loss (1/2" remaining) on both sides of bottom flange

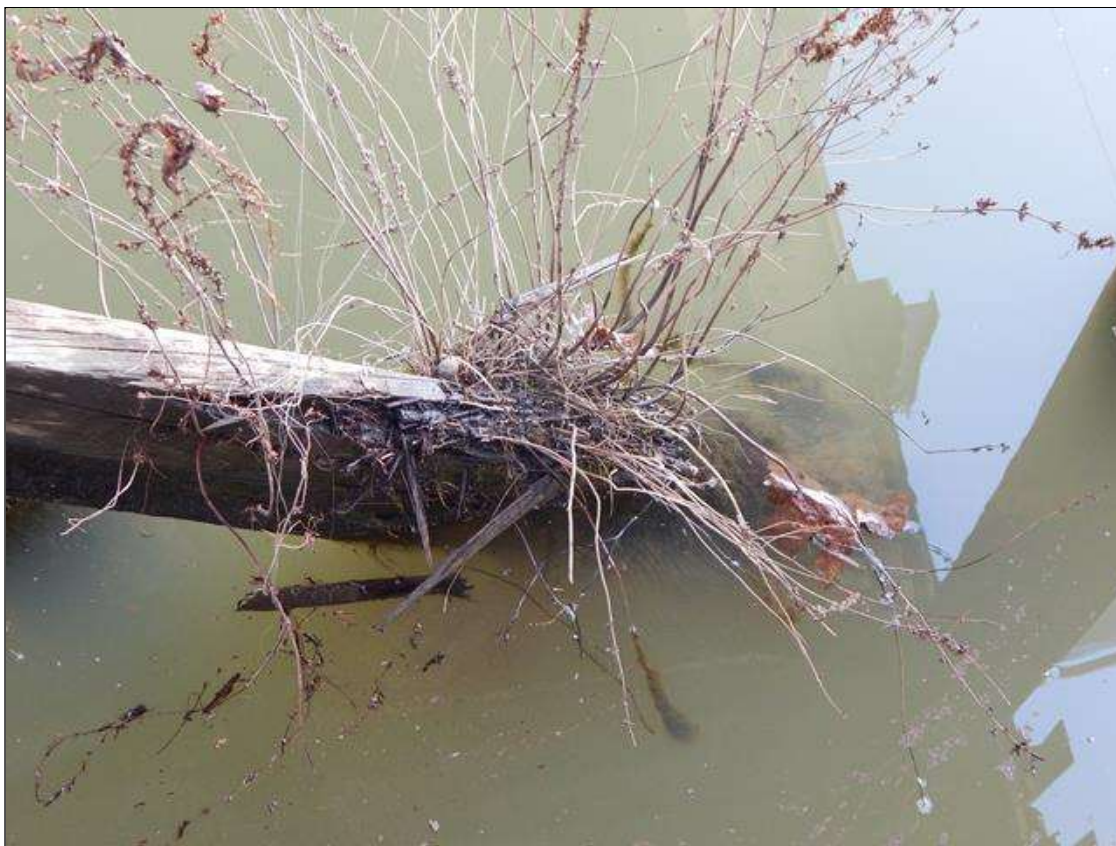
22" x 4" x 2" area of decay in Span 1 crosstie at Bent 1 (Other locations similar)

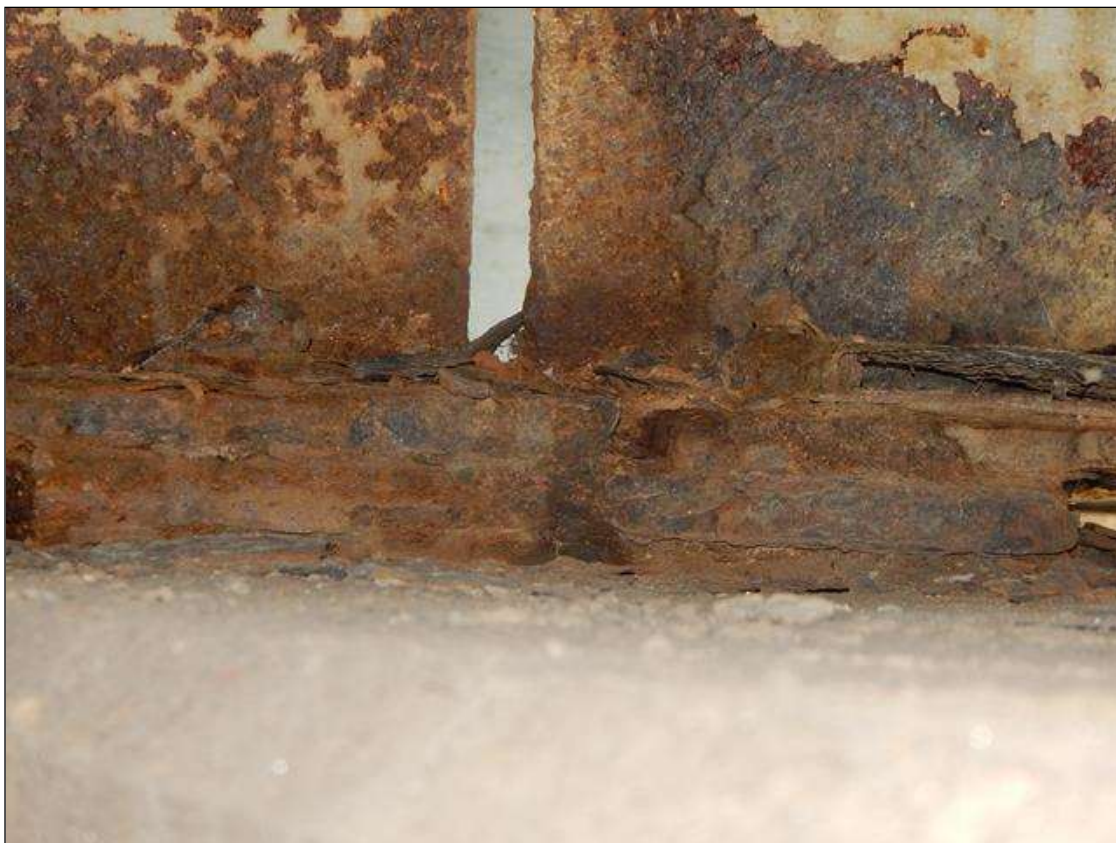
Span 1 Beam 2 Far Bearing : Peeling paint with flaking rust

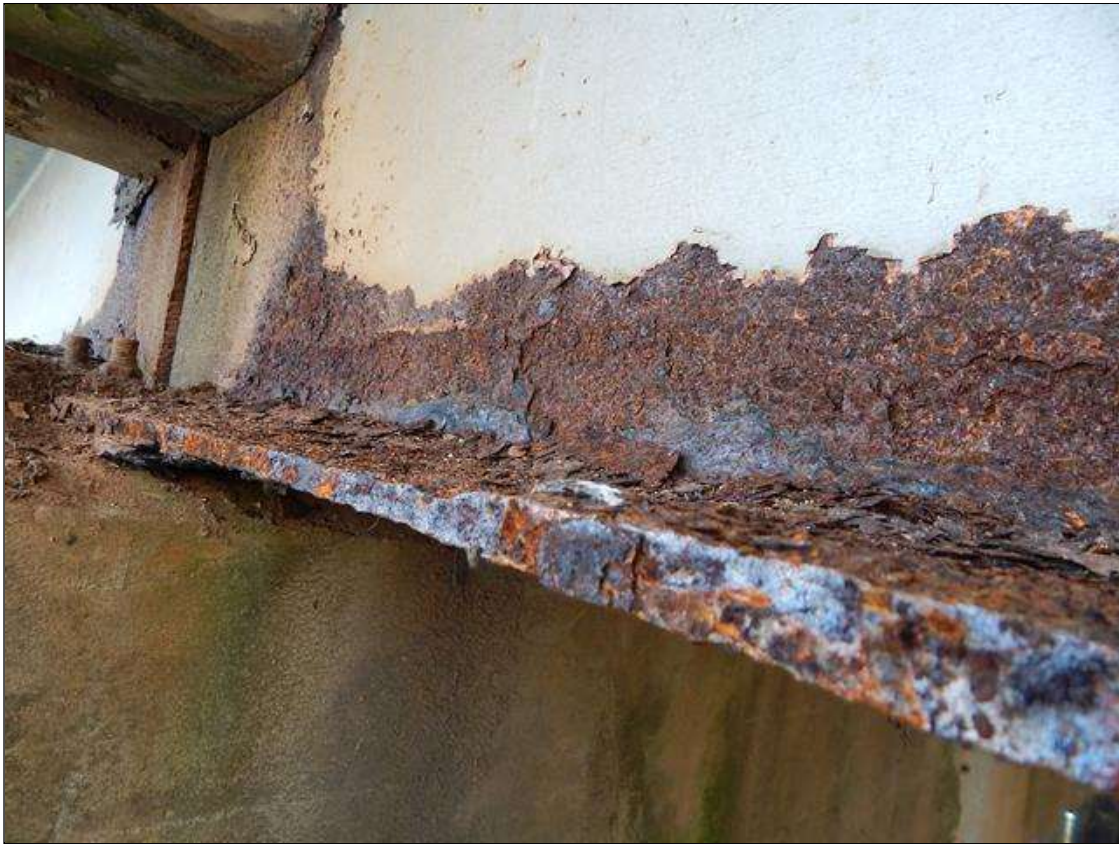
Span 1 Beam 1: 26" x 4" area of 3/8" section loss (3/8" remaining) on both sides of bottom flange at Bent 1

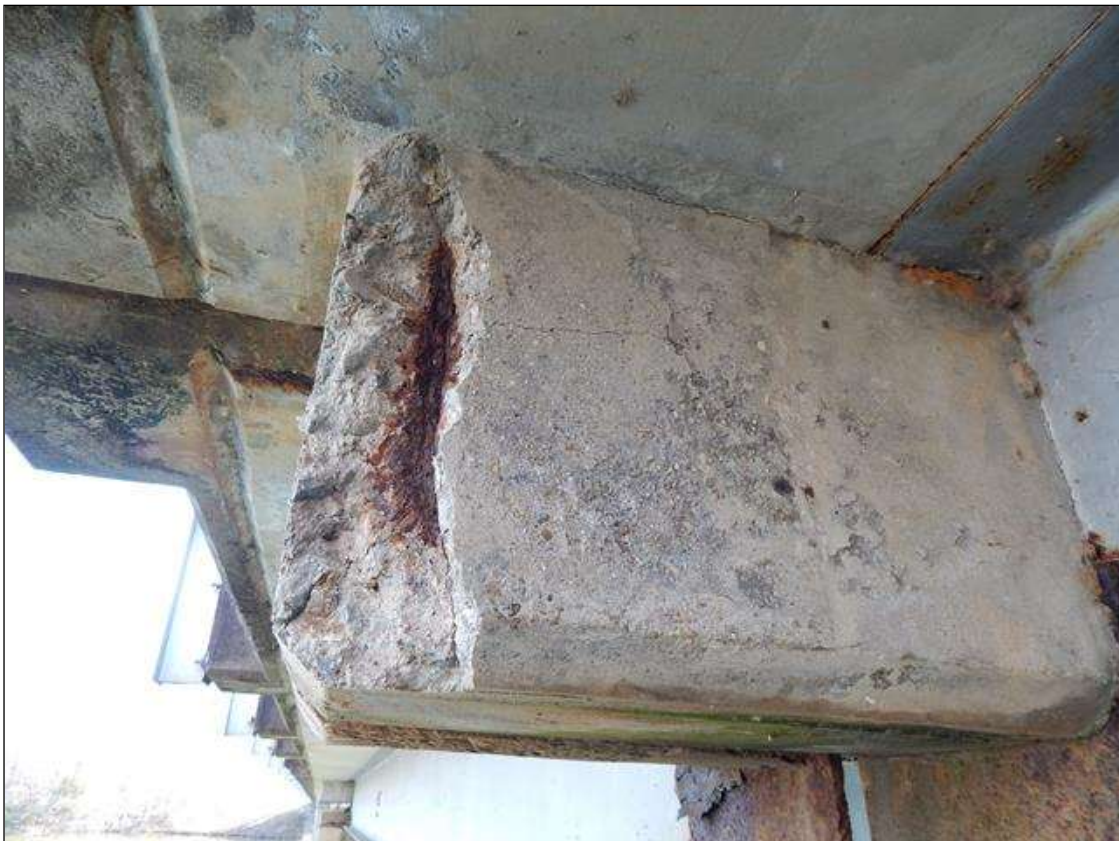
4" x 12" x 2" deep spall with exposed rebar on Bent 1 diaphragm in Span 1 at North end

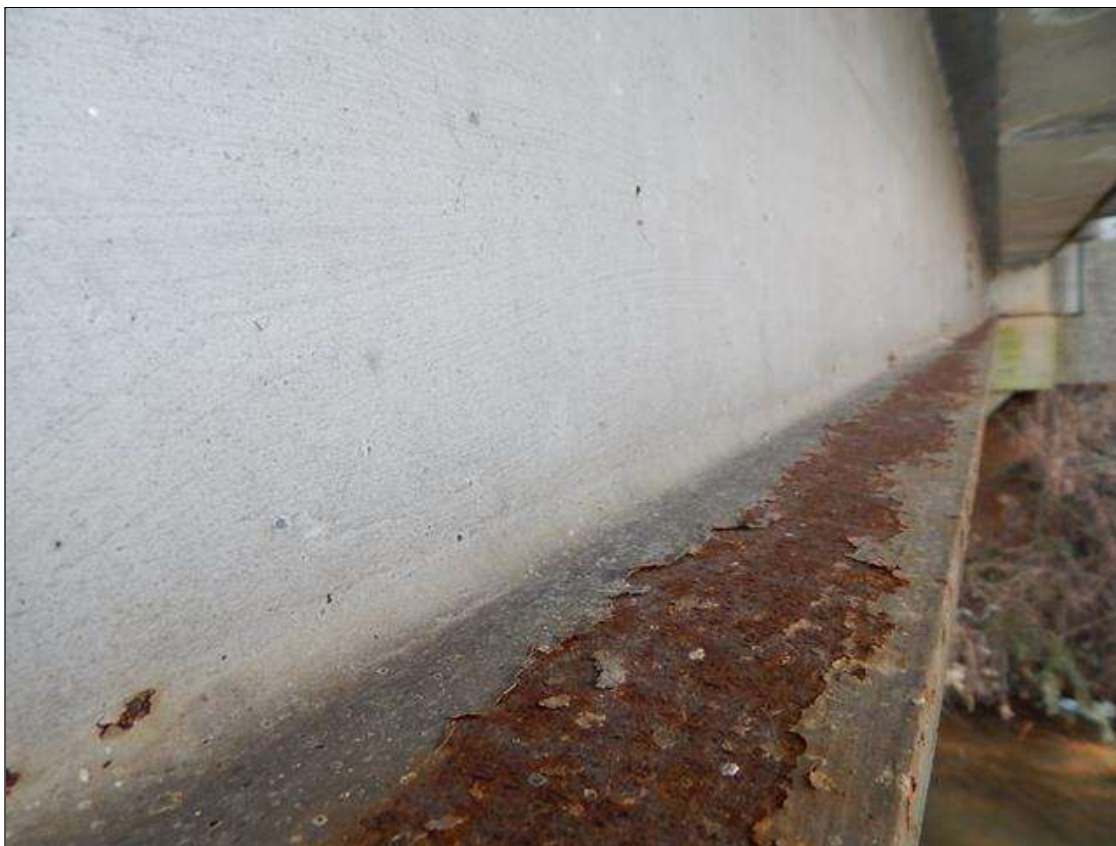
Span 1 Beam 1: Full length peeling paint with rust on both sides of bottom flange

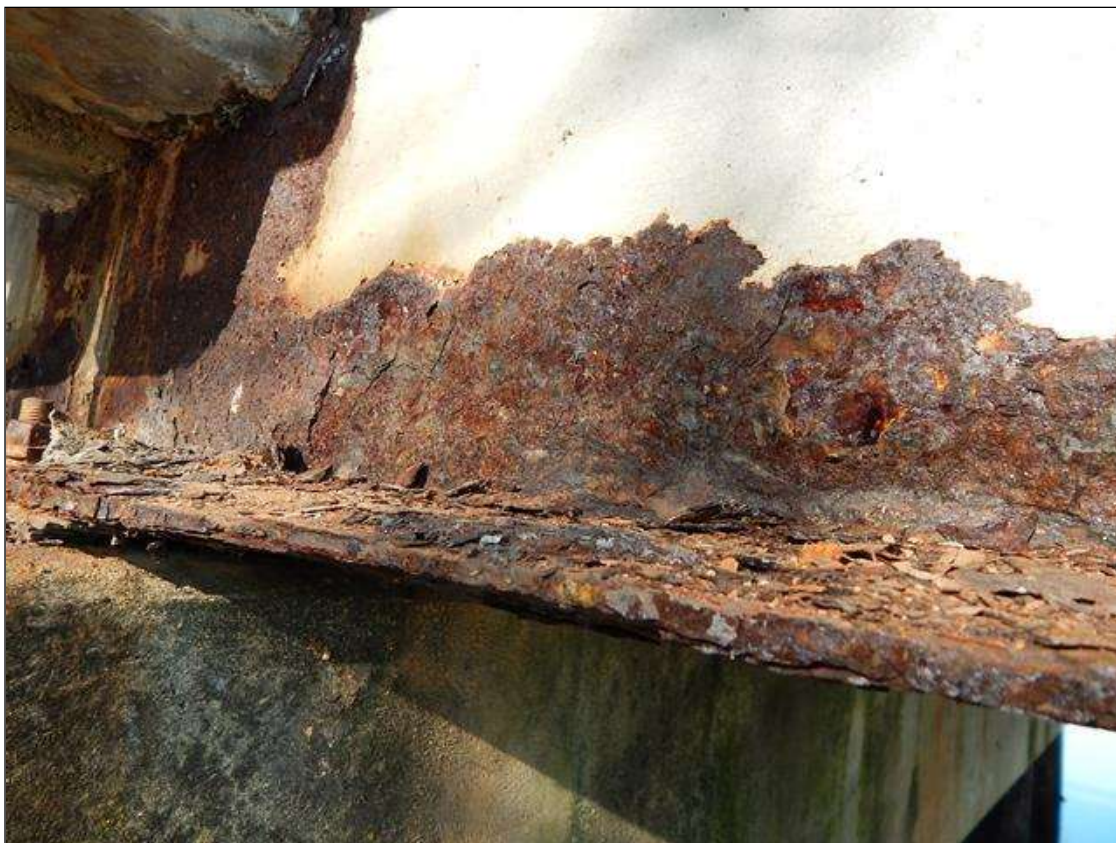
Span 2 Beam 4: 24" x 3" area of 1/2" section loss (1/4" remaining) on both sides of bottom flange at Bent 1

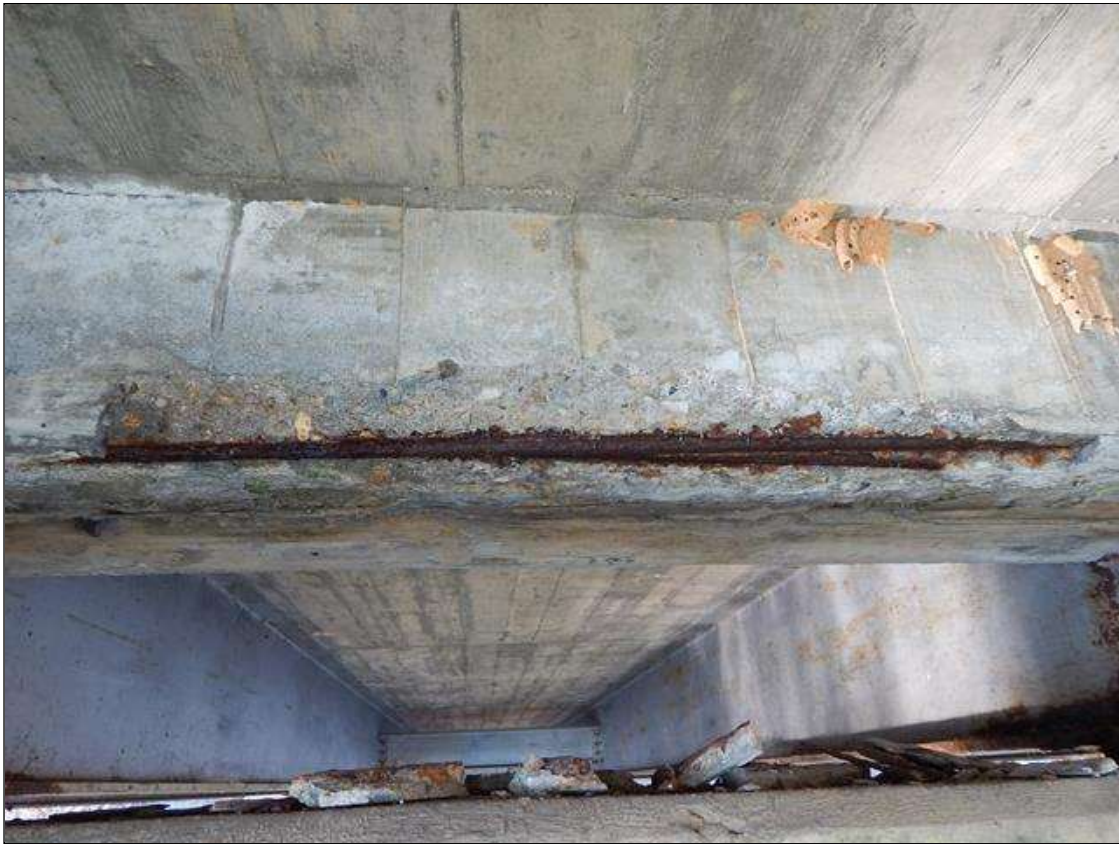
42" x 4" x 4" deep spall with exposed rebar on Bent 1 diaphragm in Bay 2 of Span 2 (Other locations similar)

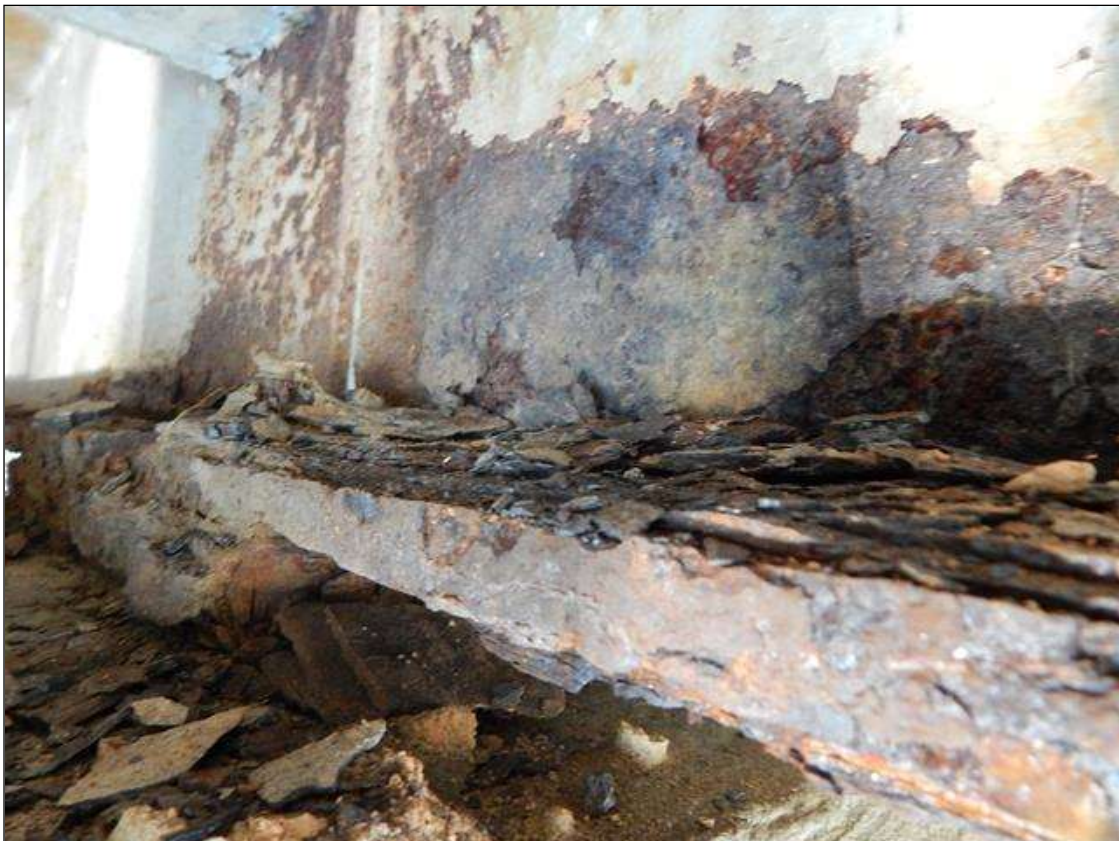
Span 2 Beam 2: 6" x 3" area of 1/4" section loss (1/2" remaining) on both sides of bottom flange at Bent 1

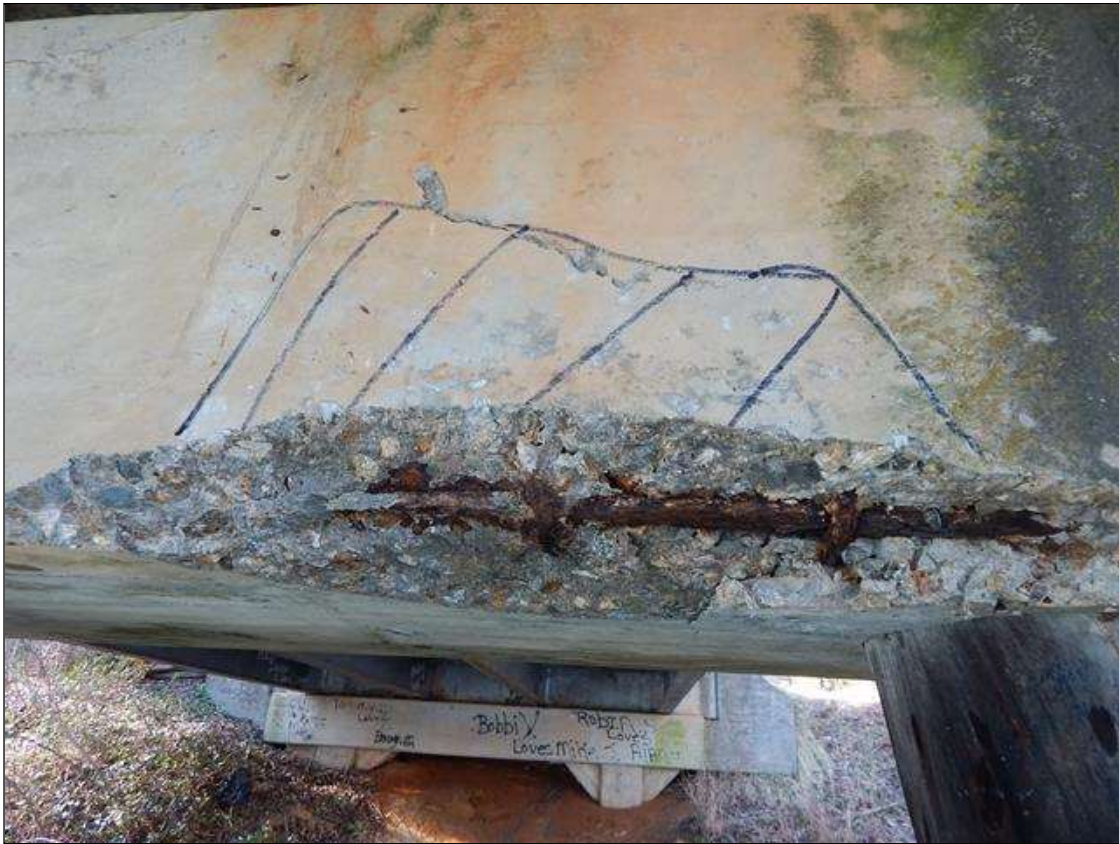
Bent 1 Cap : 43" x 12" x 9" deep spall with exposed rebar and area of delamination on Span 2 face between Piles 1 and 2

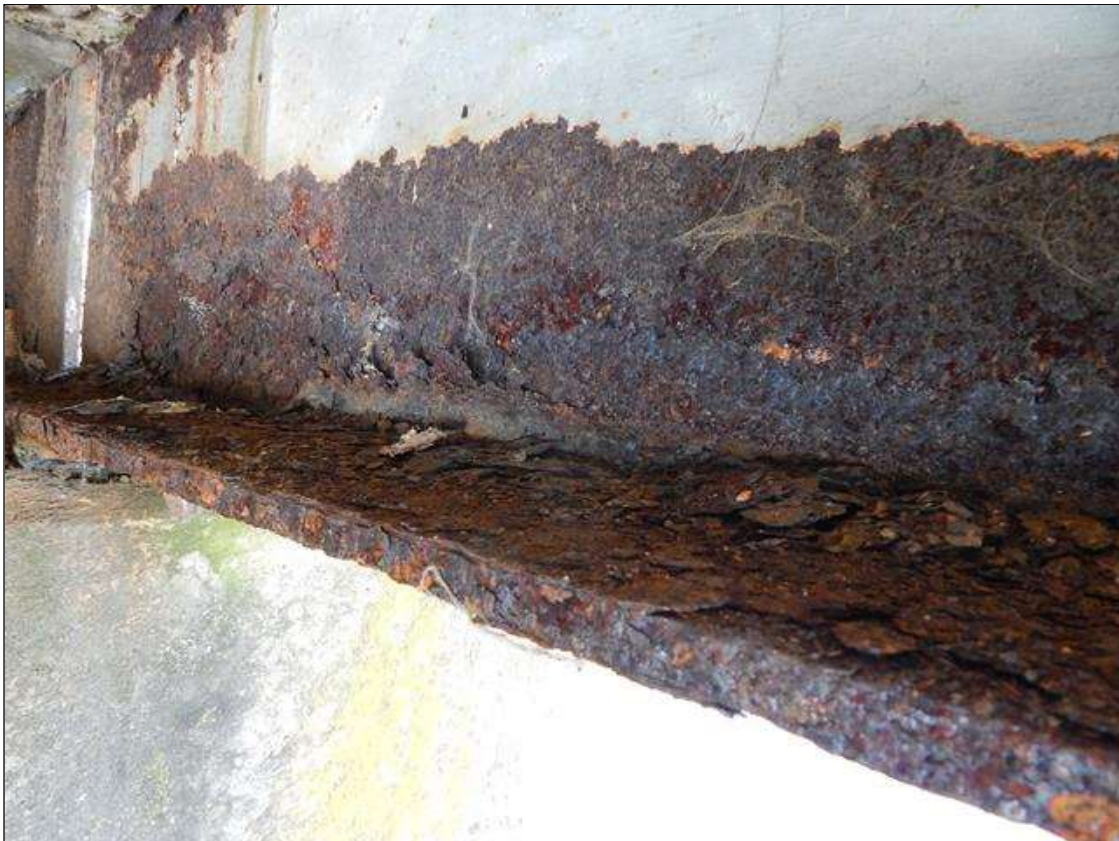
Span 2 Beam 1: 21" x 3" area of 1/4" section loss (1/2" remaining) on both sides of bottom flange at Bent 1

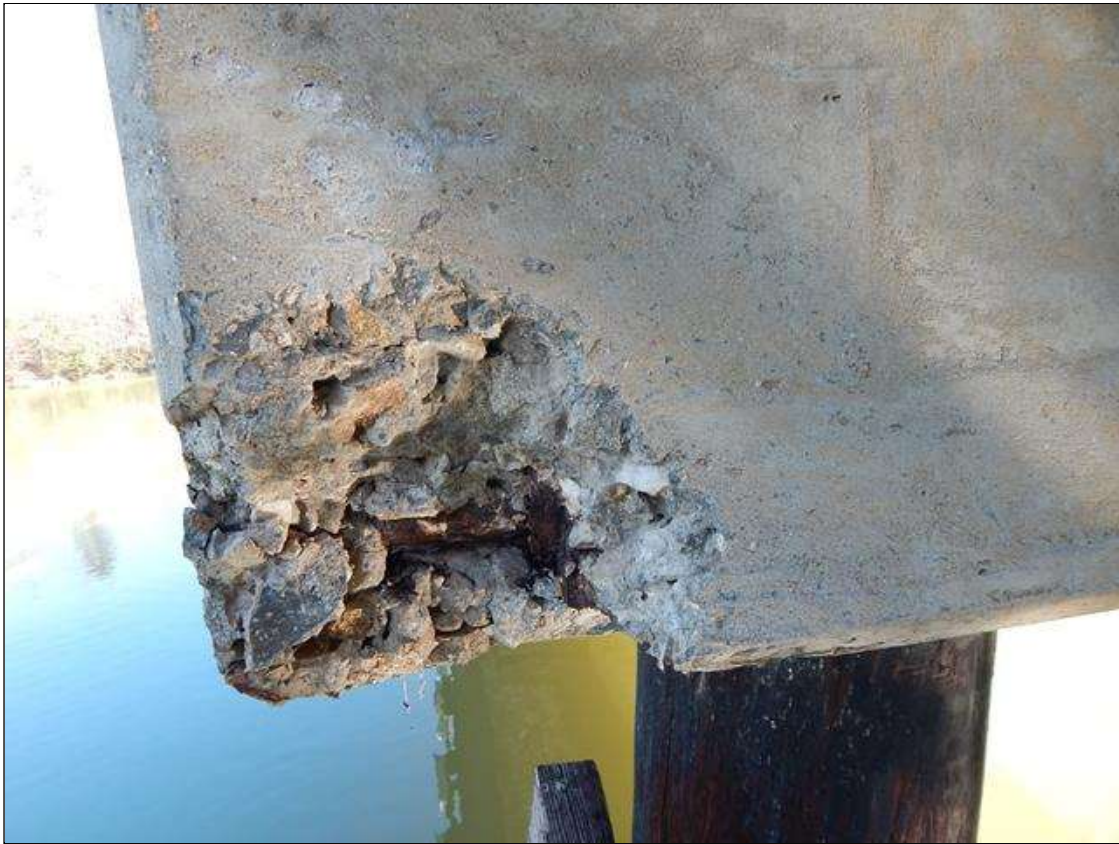
Bent 3 Cap : 9" x 8" x 3" deep spall with exposed rebar on Span 3 face at North end

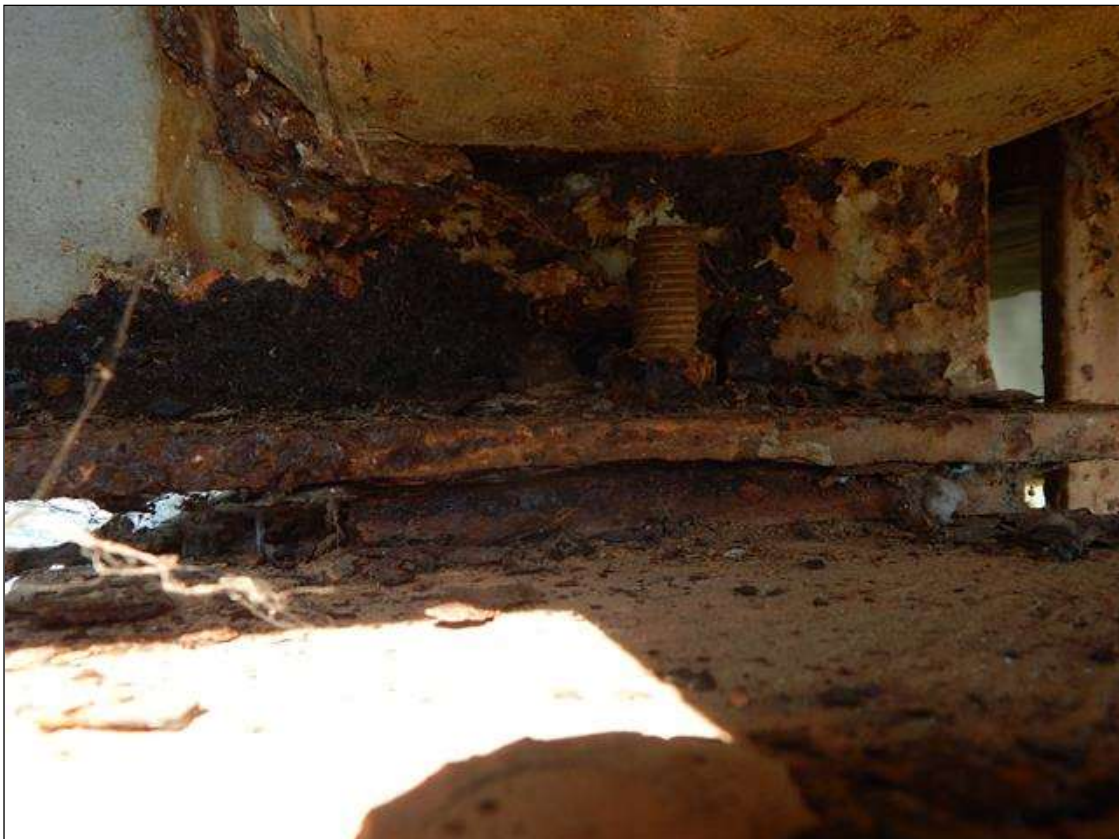
Span 3 Beam 4: 5" x 1" area of 1/8" section loss (3/8" remaining) for both sides of bottom flange at Bent 3

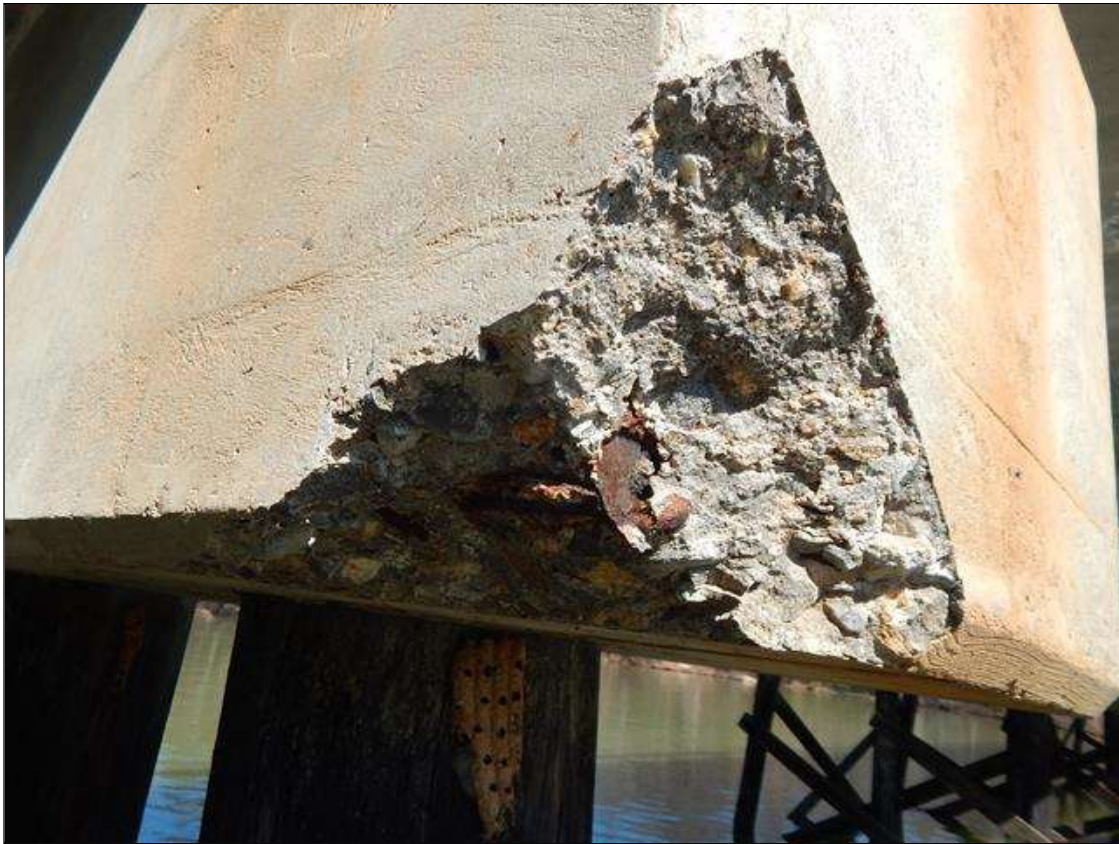
Bent 3 Cap : 13" x 7" x 8" deep spall with exposed rebar on Span 3 face at South end

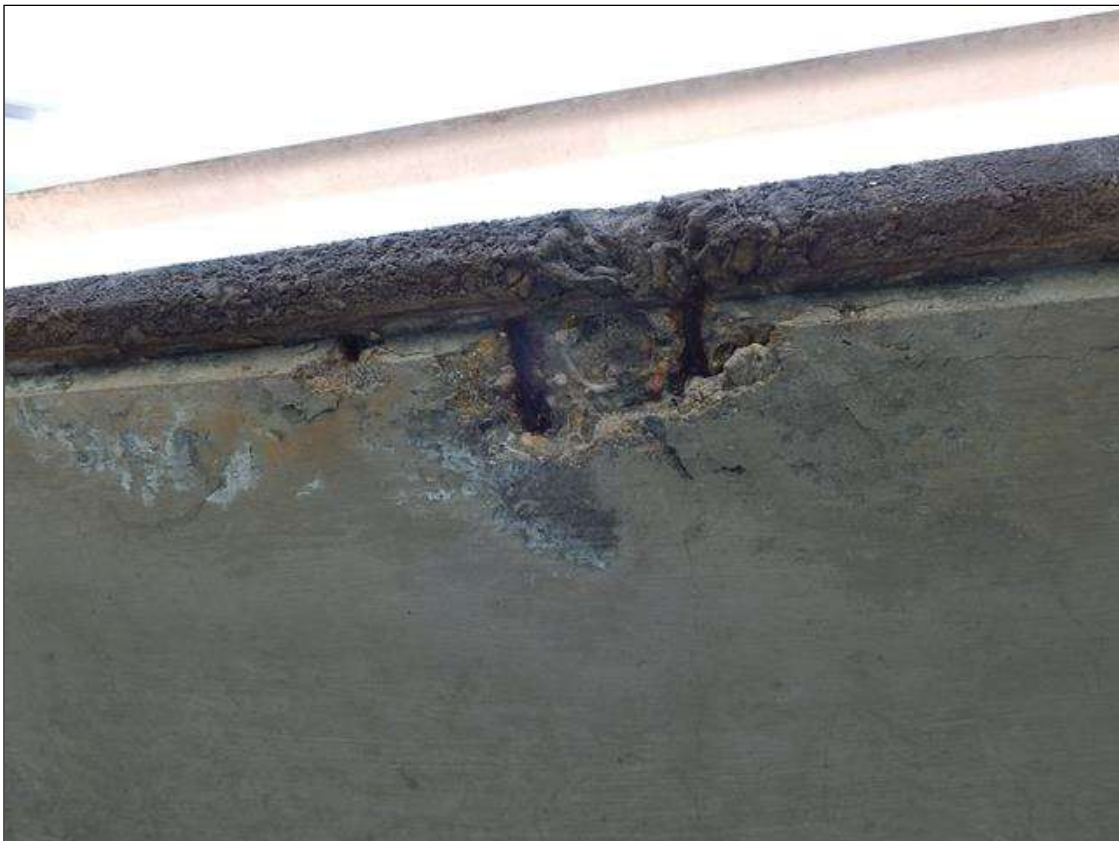
Span 4 Deck: (4) up to 4" x 9" x 1" deep spall with exposed rebar in North overhang

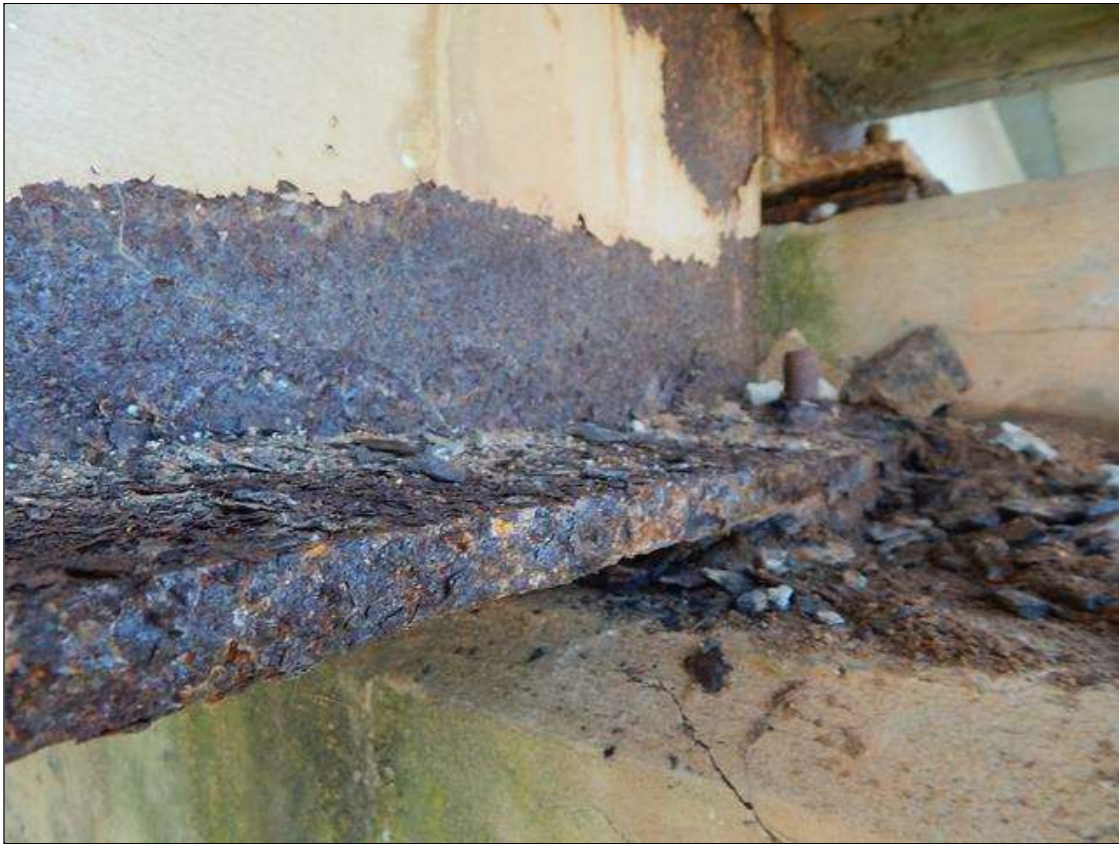
Span 4 Beam 1: 9" x 2" area of 1/8" section loss (5/8" remaining) on left side of bottom flange at Bent 3

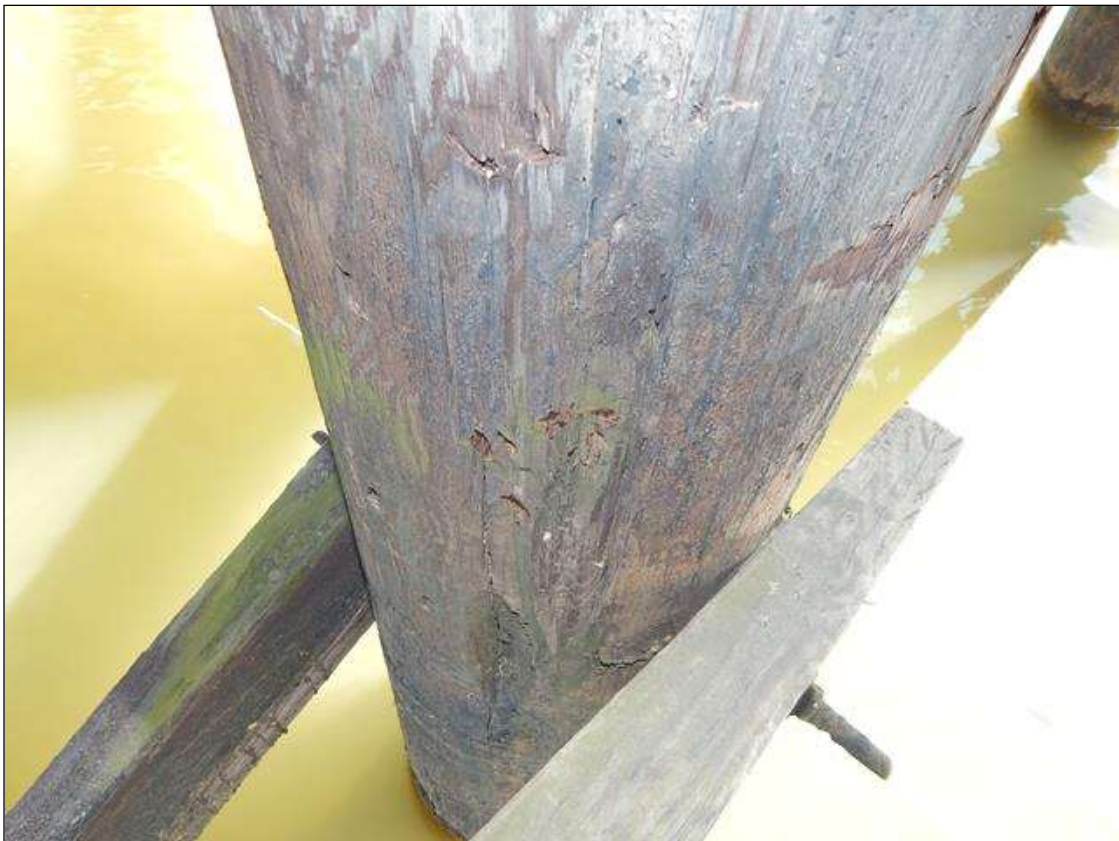
Bent 4 Pile 3: (2) up to 14" x 2" x 1/2" deep area of decay on North face

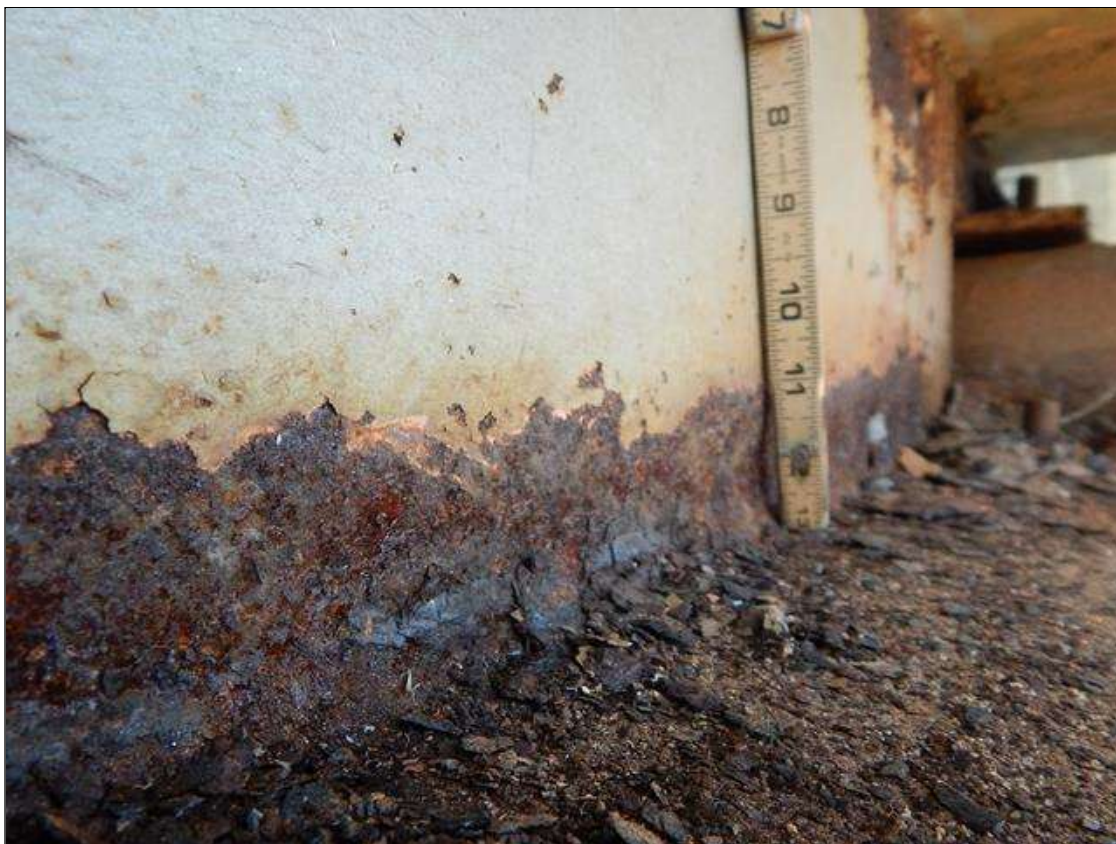
Span 4 Beam 4: 27" x 2" area of 1/8" section loss (3/8" remaining) in web at Bent 4

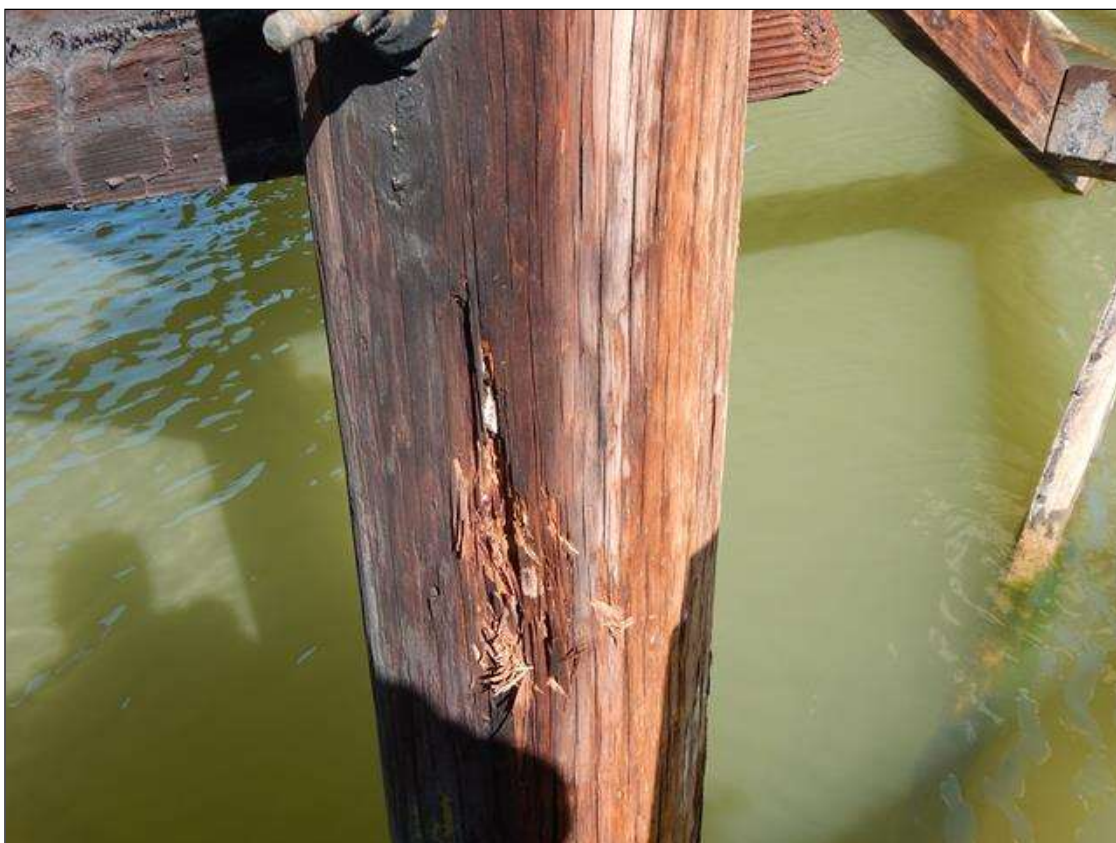
Bent 4 Pile 4: 11" x 1 1/2" x 1" deep area of decay on Span 4 face

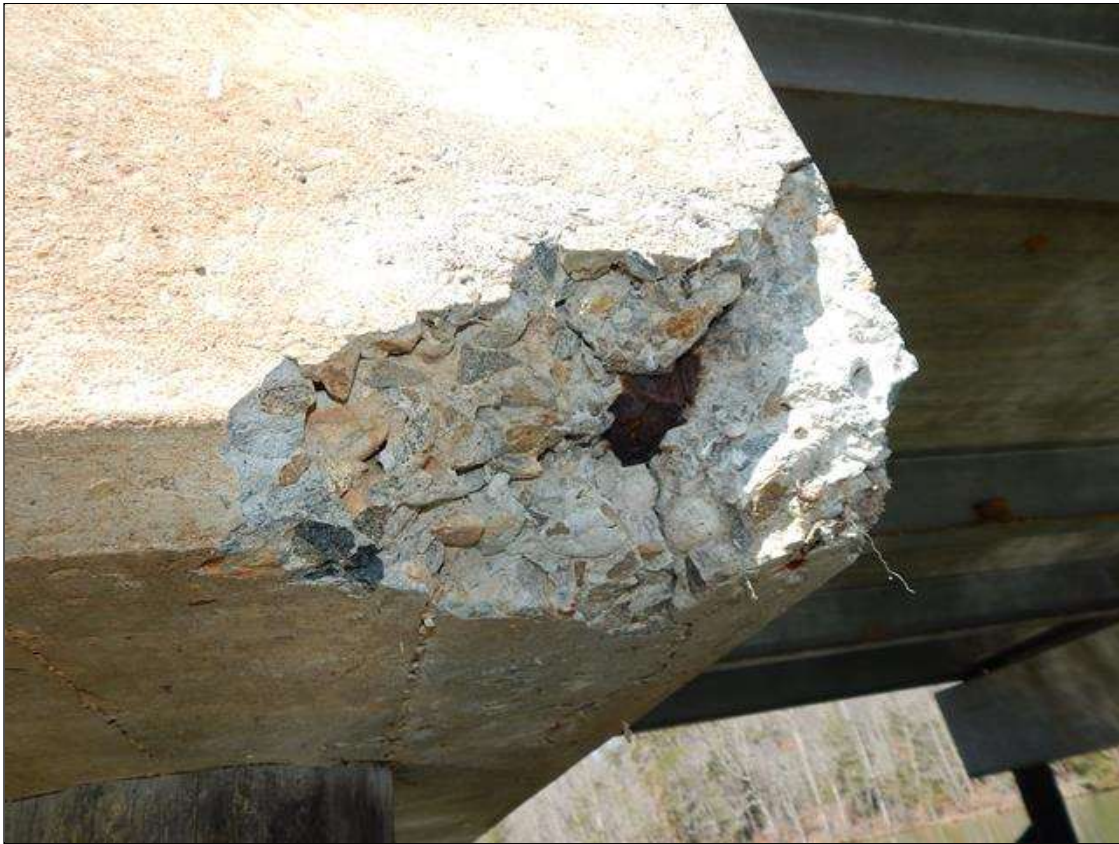
Bent 4 Cap : 11" x 6" x 4" deep spall with exposed rebar on South face

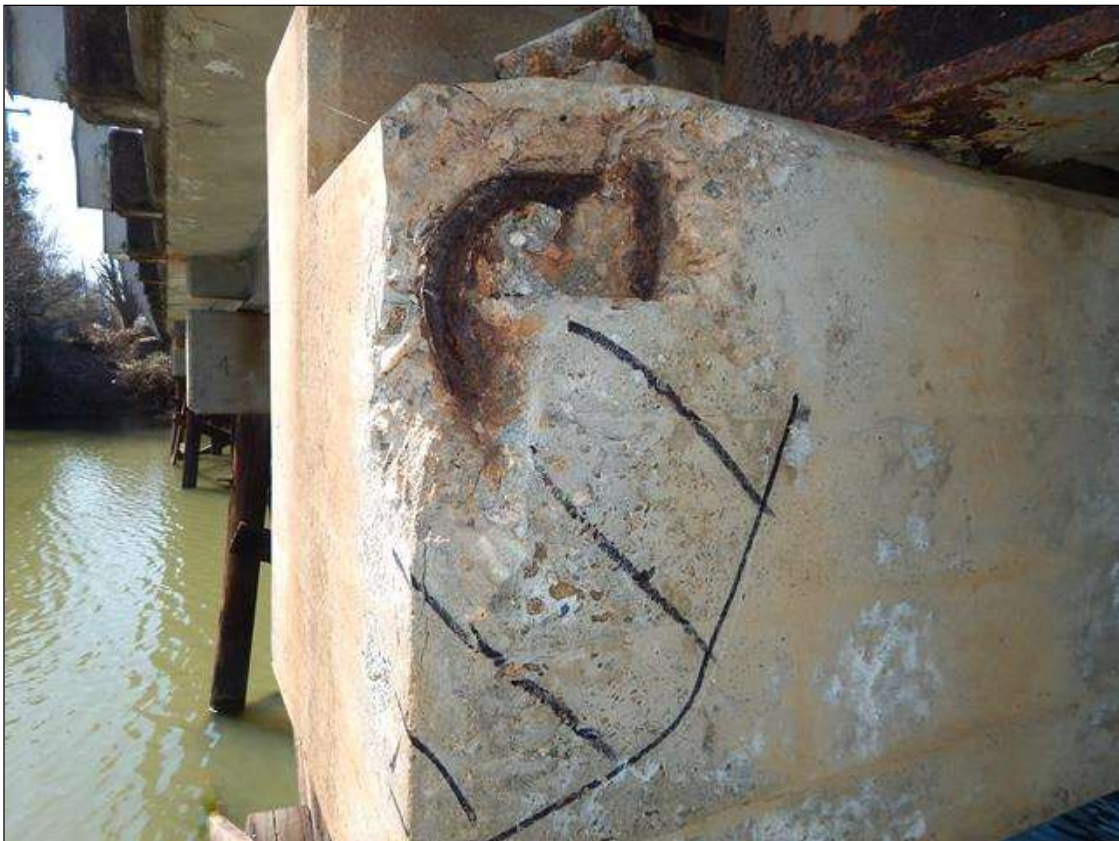
Bent 5 Cap : 11" x 18" x 3" deep spall with exposed rebar and area of delamination at Southeast corner

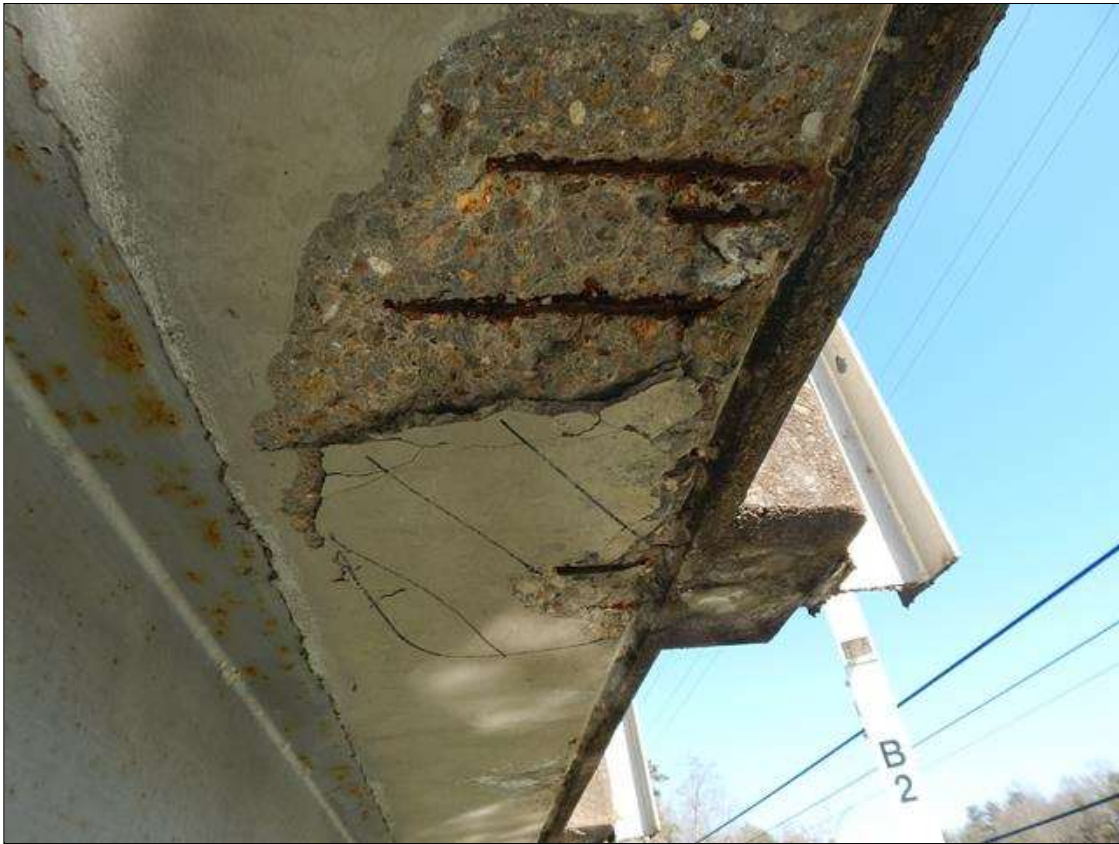
Span 6 Deck: 34" x 15" x 1" deep spall with exposed rebar and area of delamination in South overhang

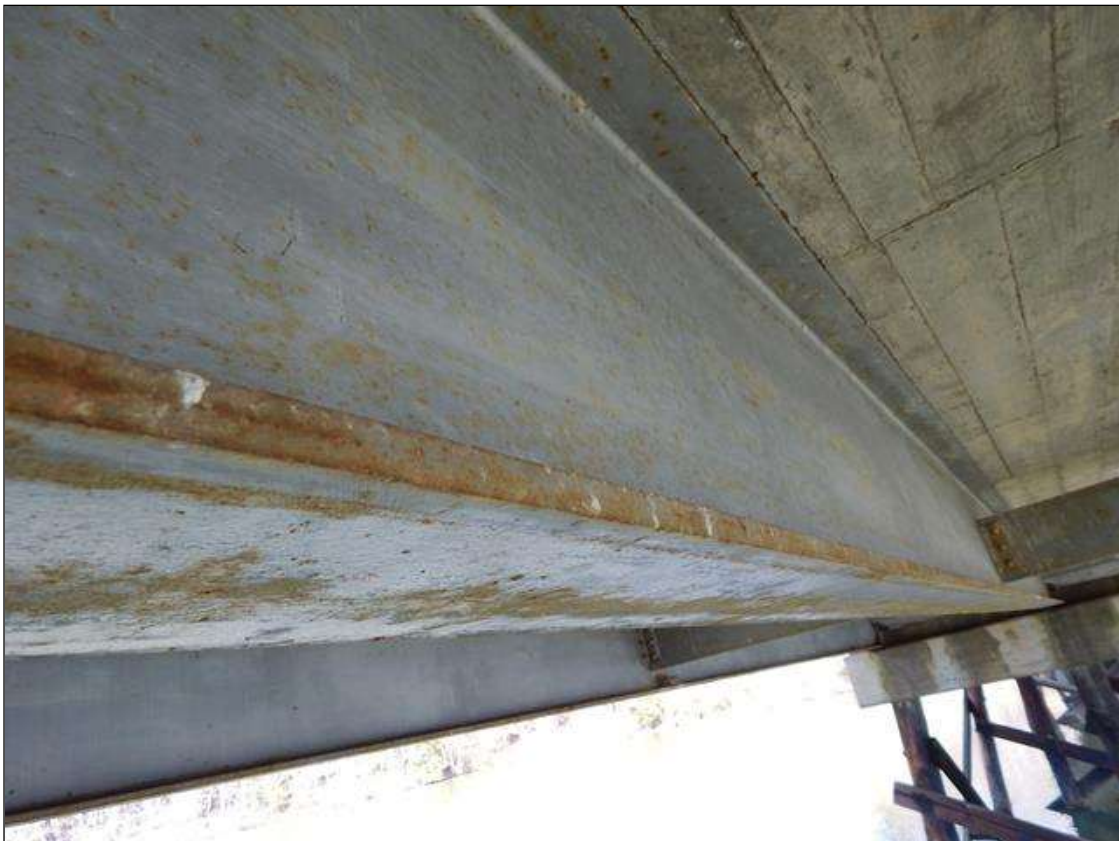
Span 6 Beam 2: Full length surface rust on both flanges and web
