NC DEPARTMENT OF TRANSPORTATION  
DIVISION OF HIGHWAYS  
STRUCTURE MANAGEMENT UNIT

## Structure Safety Report

### Routine Element Inspection - Contract

COUNTY: CALDWELL STRUCTURE NUMBER: 130262 FREQUENCY: 24 MONTHS

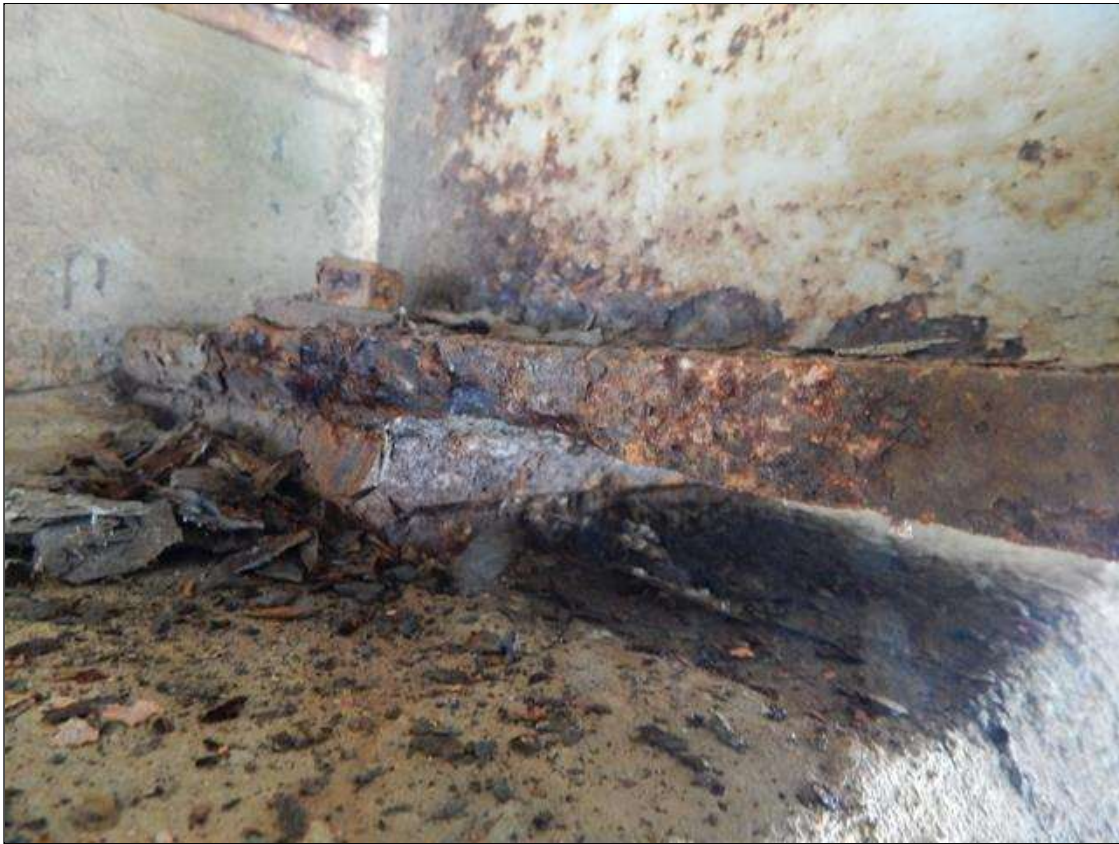
Span 6 Beam 2: 3" x 3" area of 1/8" section loss (5/8" remaining) on both sides of bottom flange at Bent 5

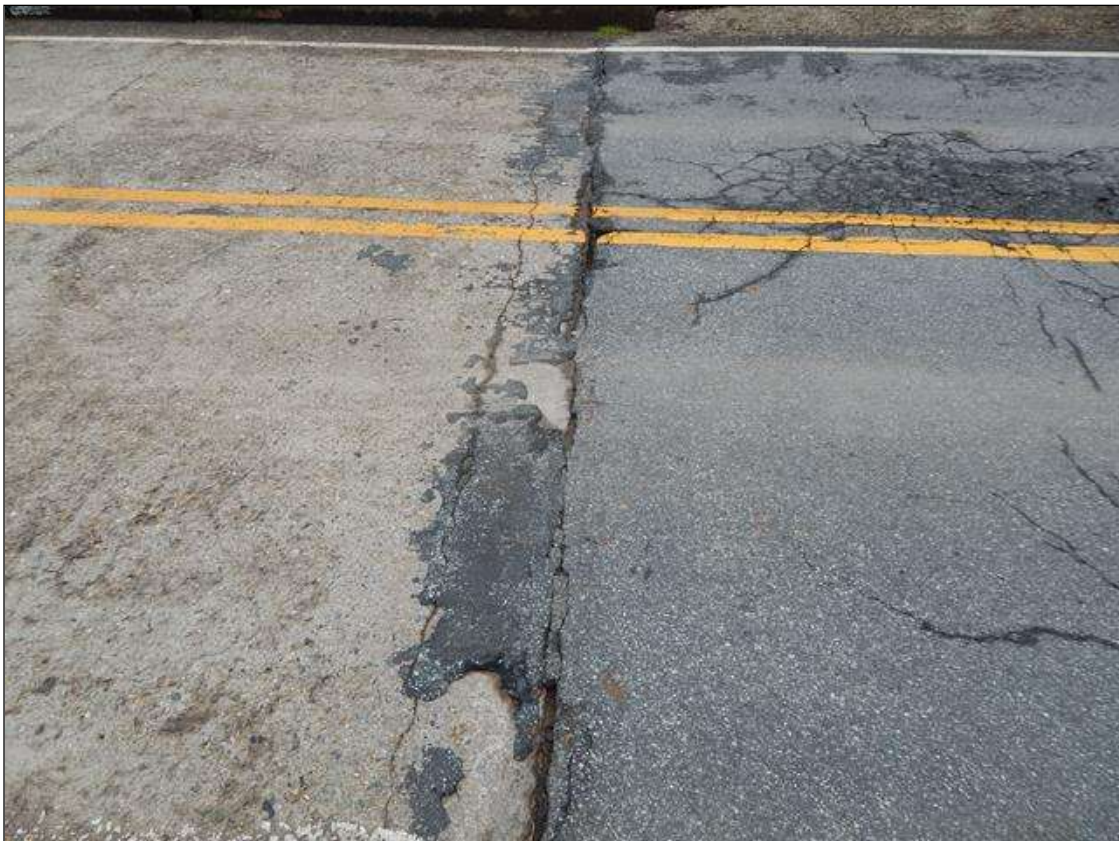
(4) up to 38" x 6" x 2" deep area of missing asphalt wearing surface at End Bent 1

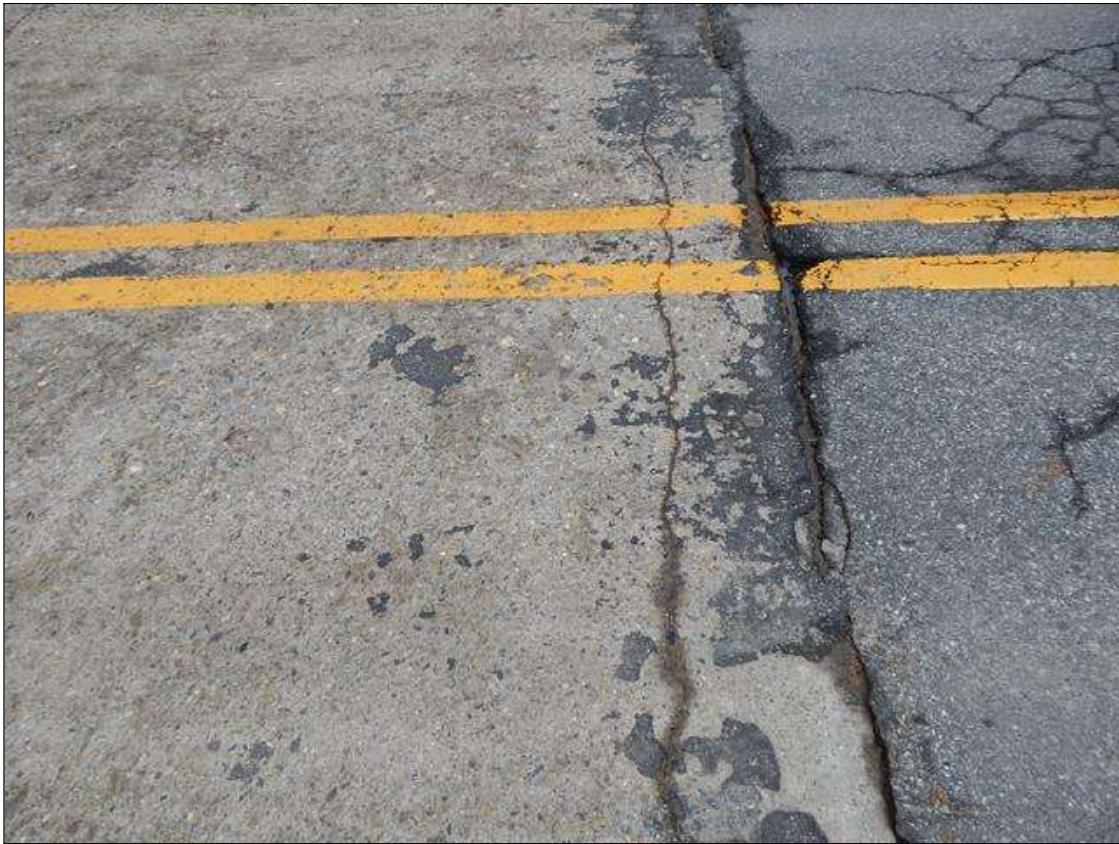
Span 1 Deck: 72 square feet 1/16" transverse cracks

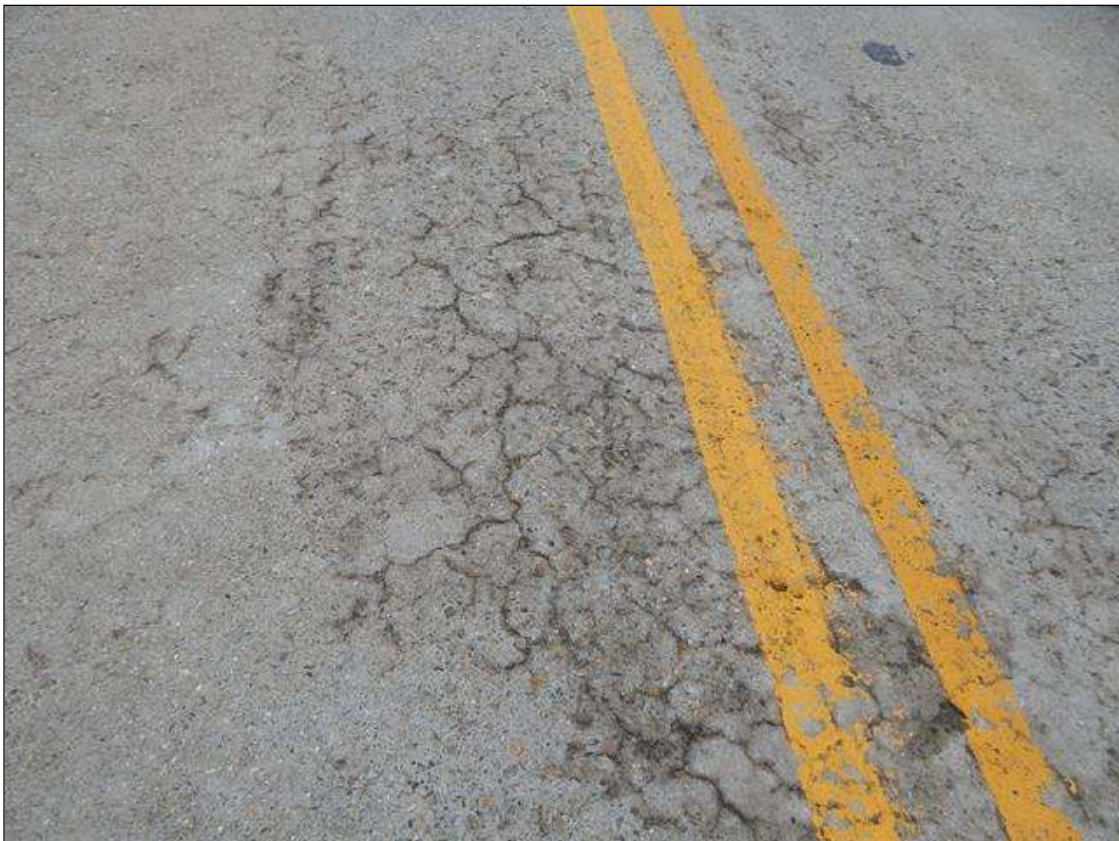
Span 1 Deck: 220 square feet hairline map cracking

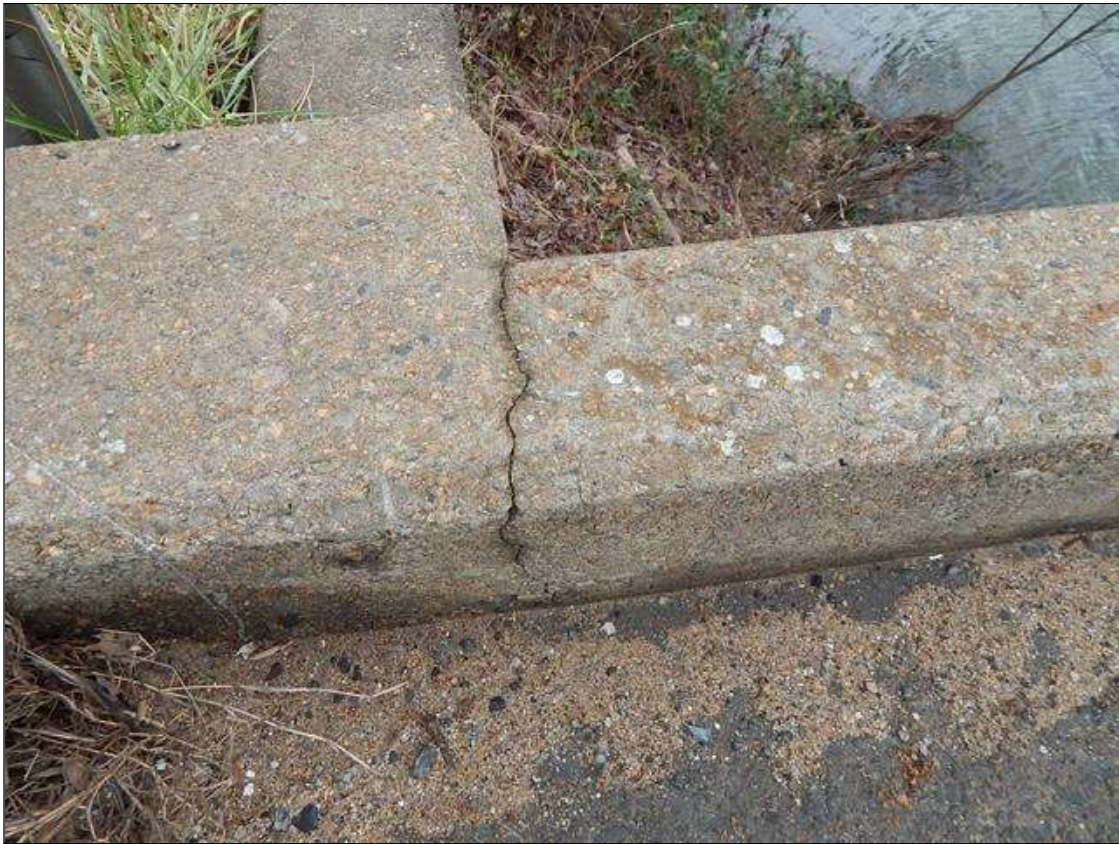
Span 1 Left Bridge Rail: 5' hairline vertical and transverse cracks in curb

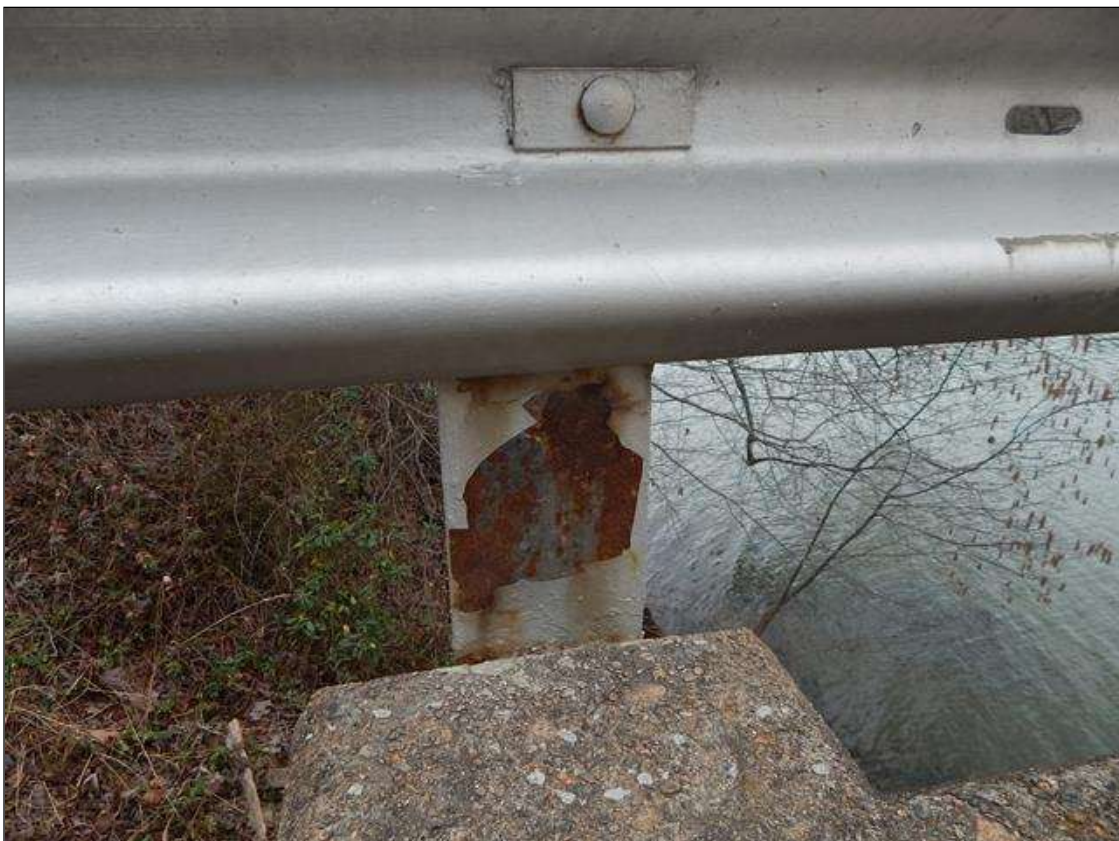
Span 1 Left Bridge Rail: Peeling paint with rust on 6 posts

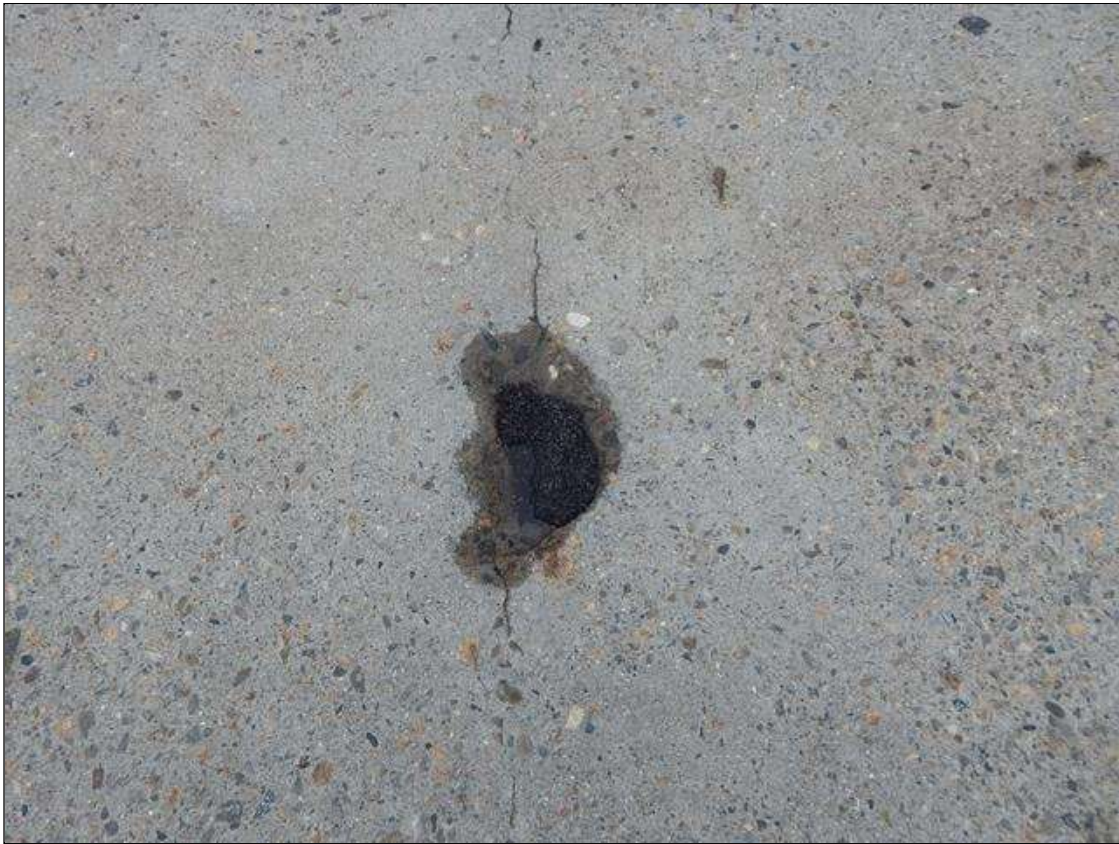
Span 3 Deck: 11" x 6" x 1" deep spall in Eastbound lane

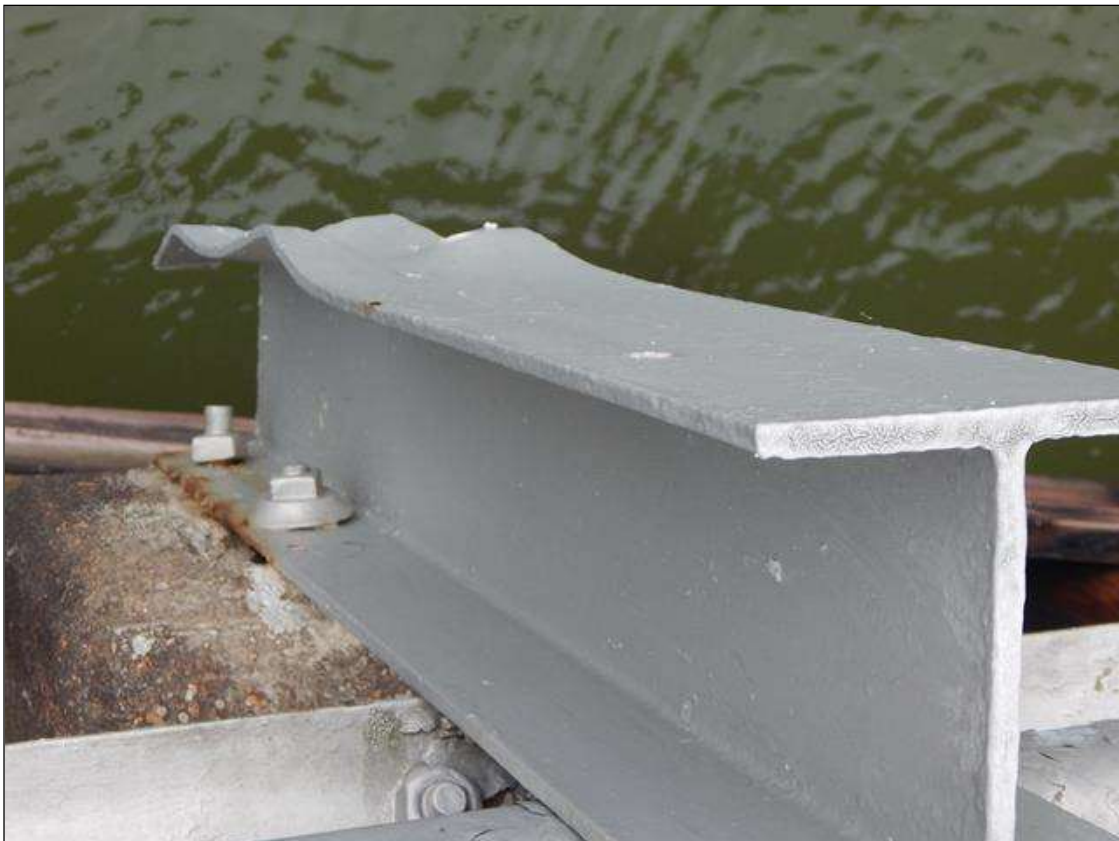
Span 5 Right Bridge Rail: Damage to 3 rail post flange

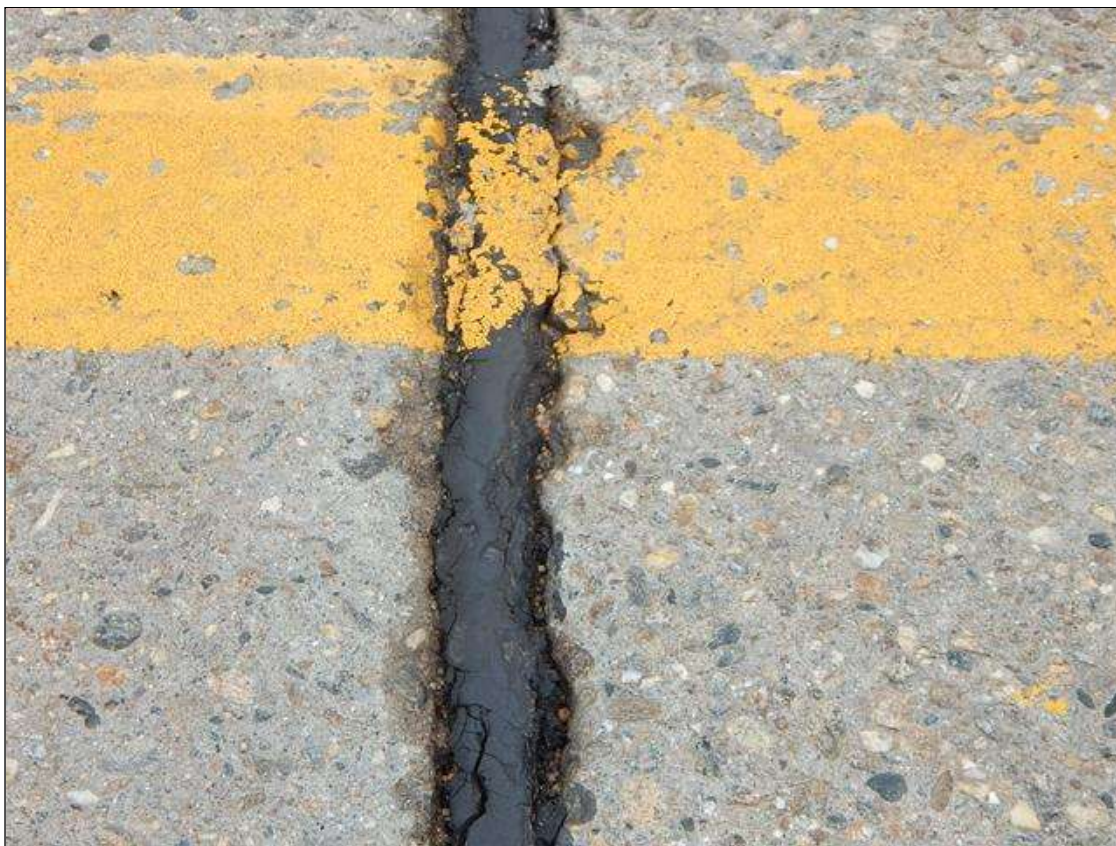
Expansion Joint 6 : 9' of cracked joint material

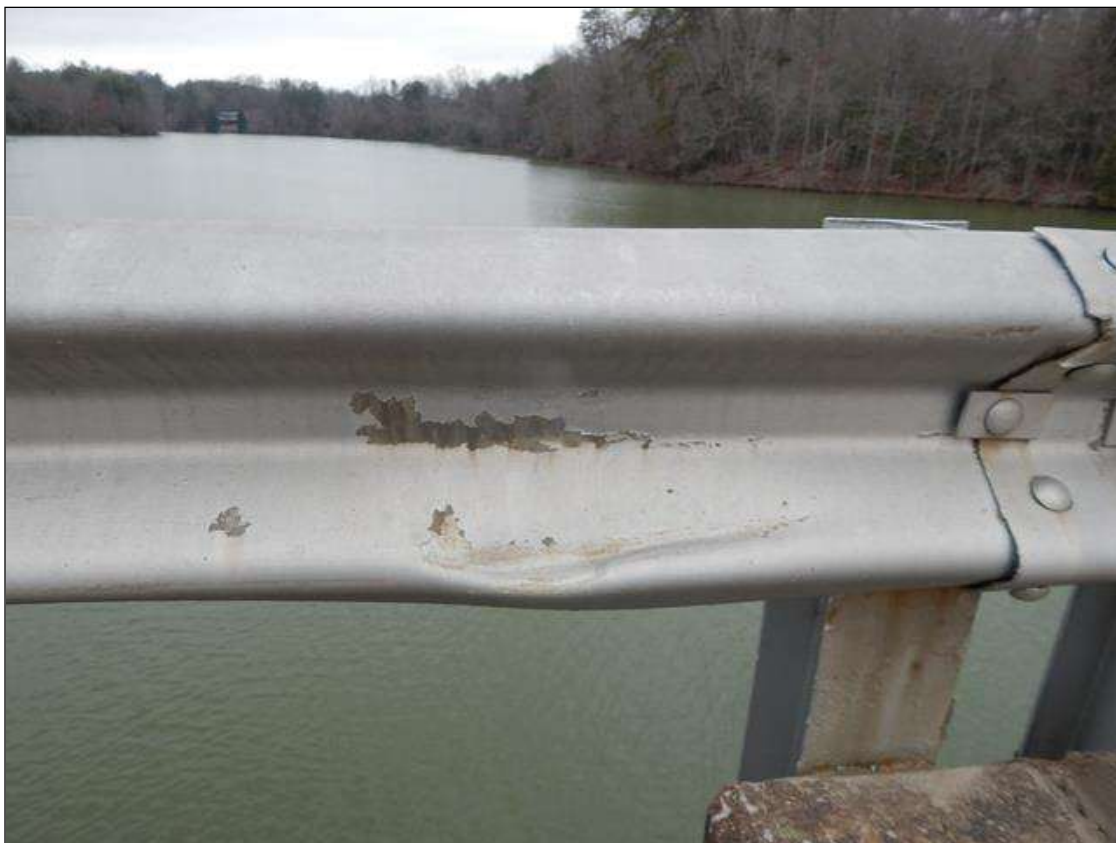
Span 6 Left Bridge Rail: 1' impact damage near Bent 6

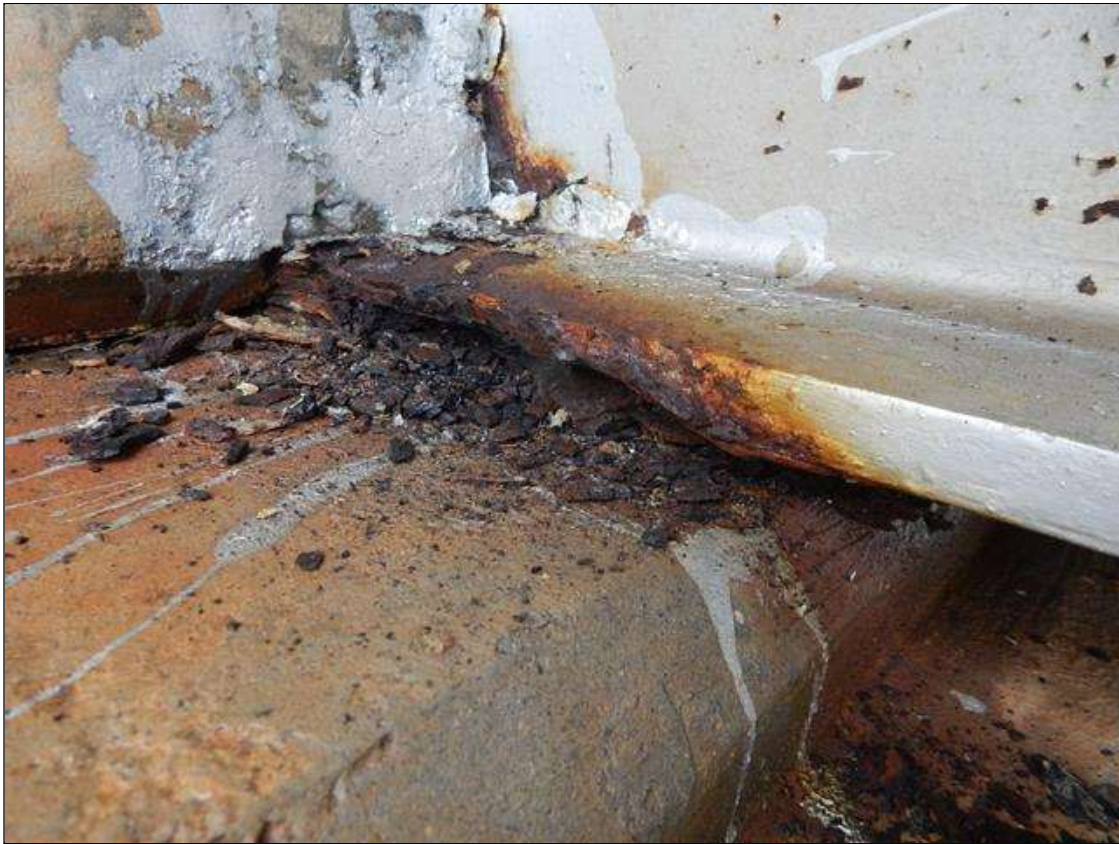
Span 12 Beam 1: 7" x 3" area of 1/4" section loss (1/2" remaining) in left side of bottom flange at End Bent 2

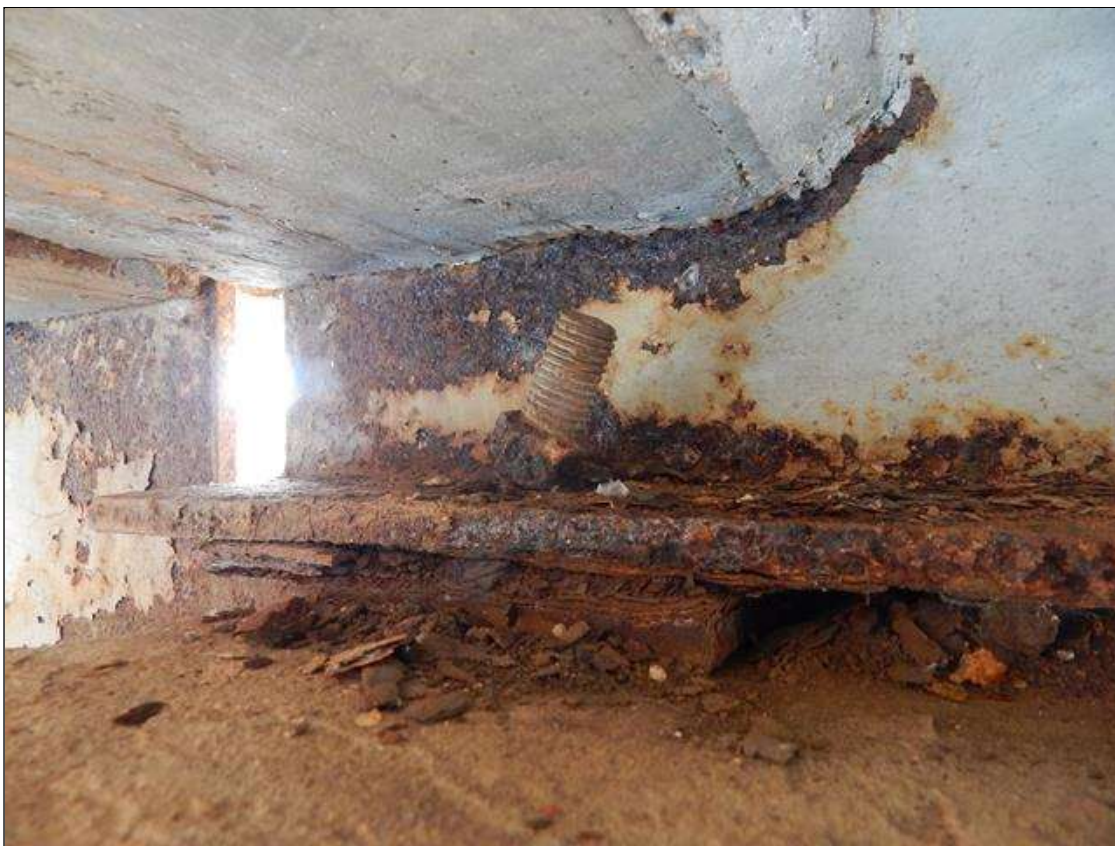
Span 9 Beam 1 Near Bearing : Loose anchor bolt on right side

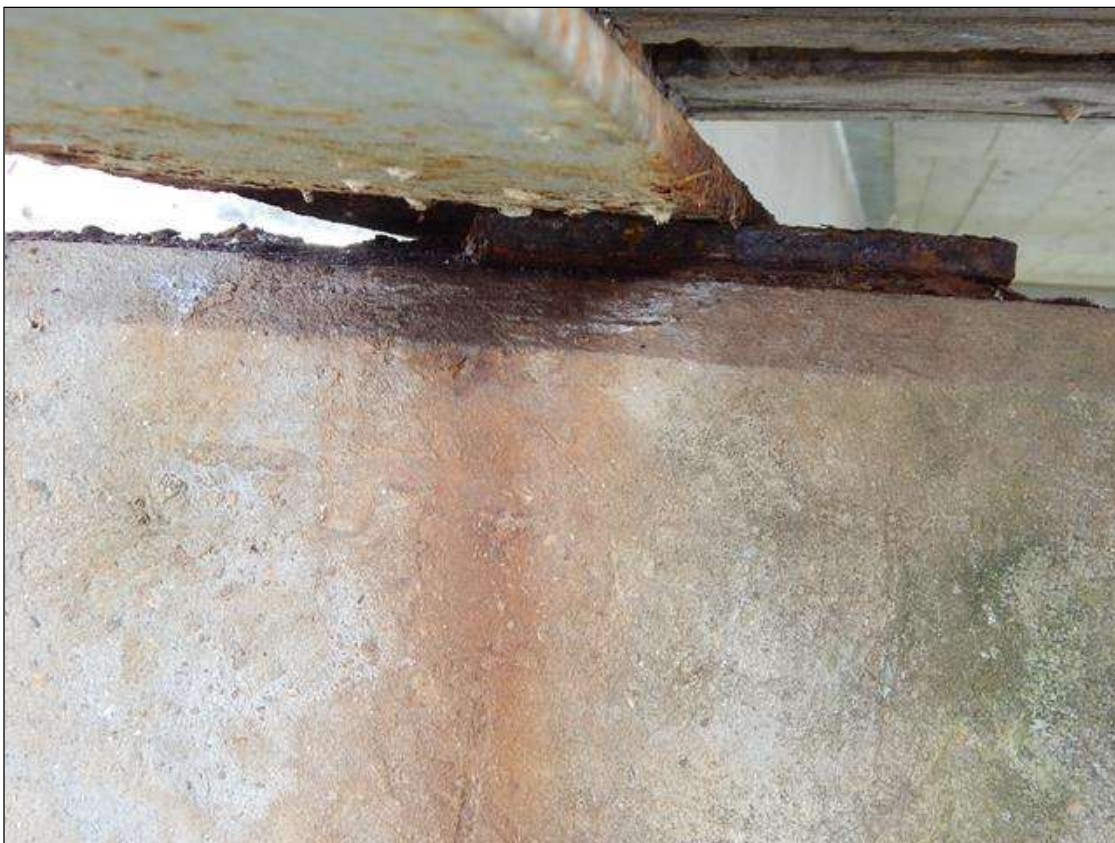
Span 9 Beam 4 Near Bearing : Up to 3 1/2" x 7" loss of bearing area

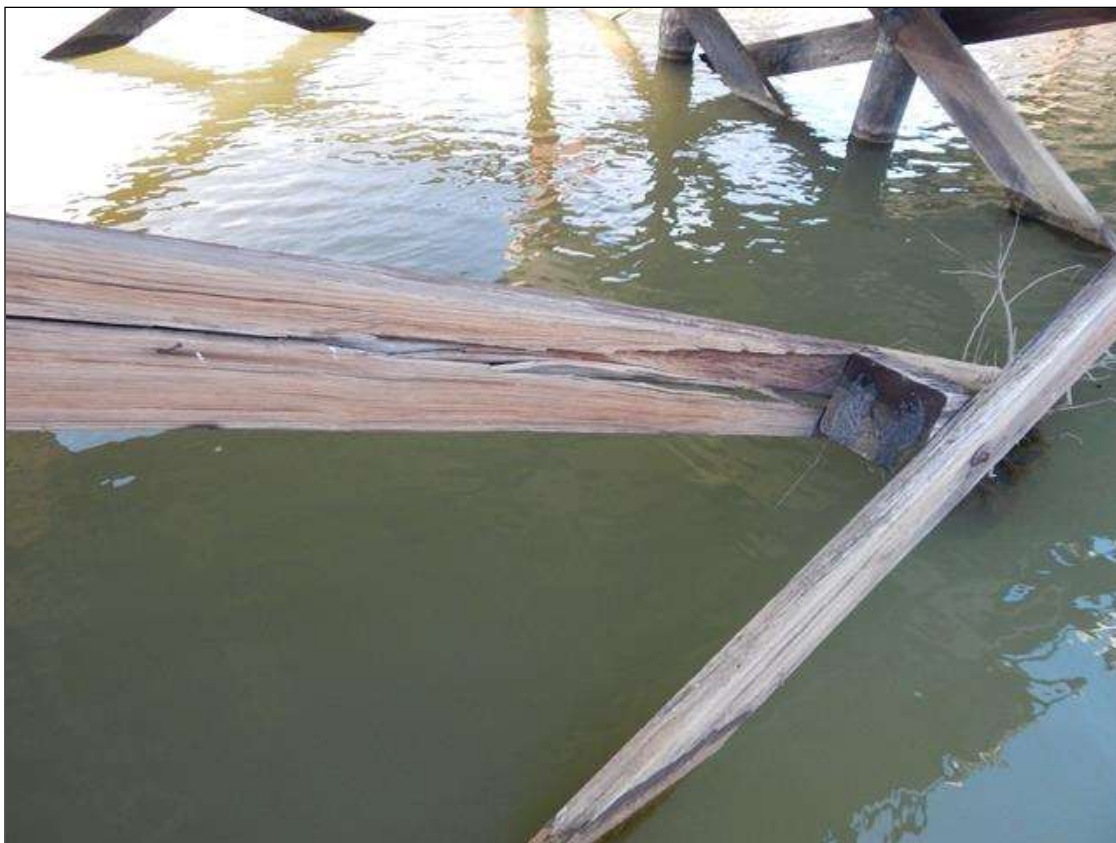
9' x 2" x 3 1/2" deep area of decay on Bent 9 crossties in Span 9 at South end

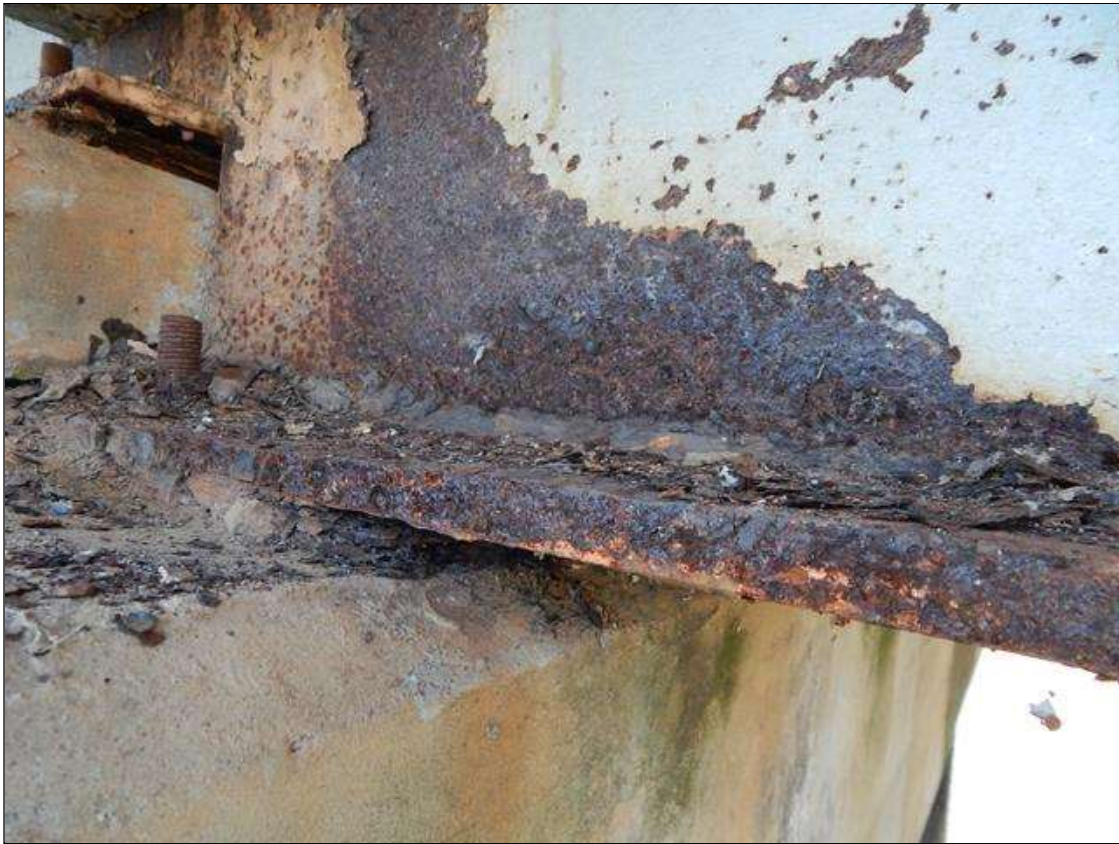
Span 10 Beam 4: 12" x 3" area of 1/16" section loss (11/16" remaining) on right side of bottom flange

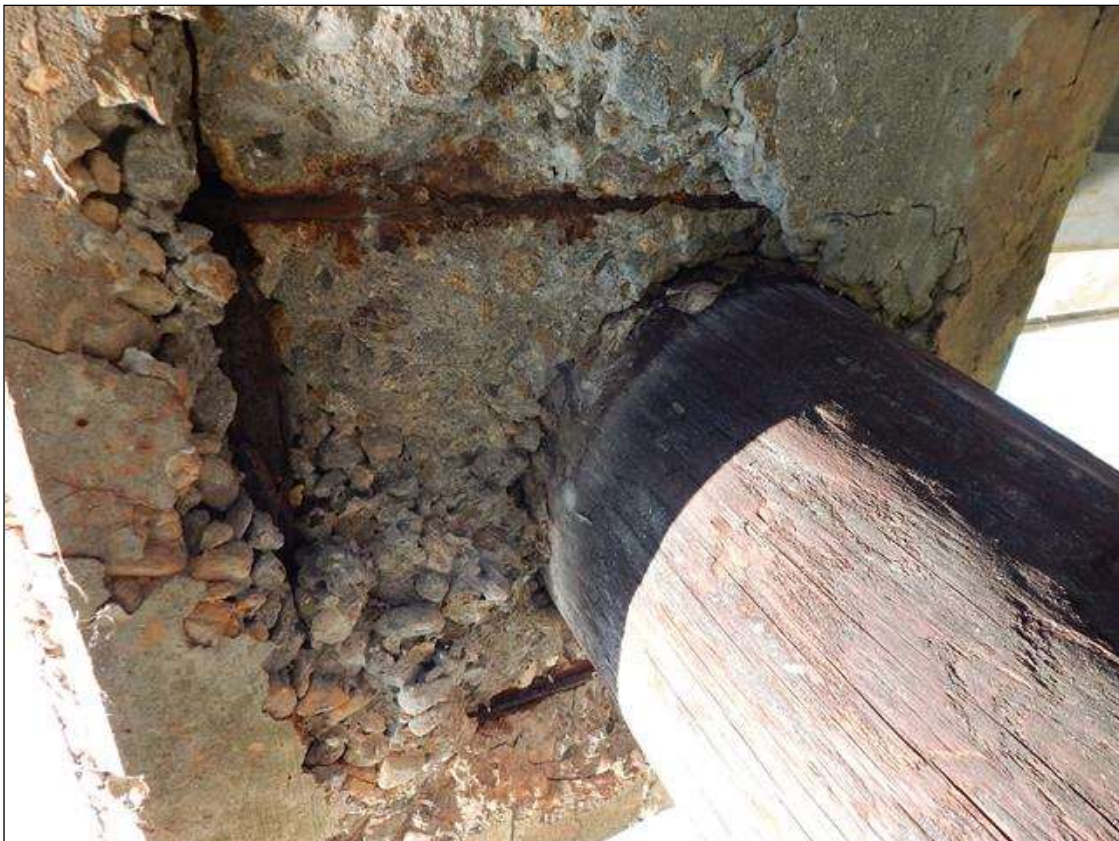
Bent 10 Cap: 44" x 22" x 3" deep spall with exposed rebar on bottom of cap at Pile 1

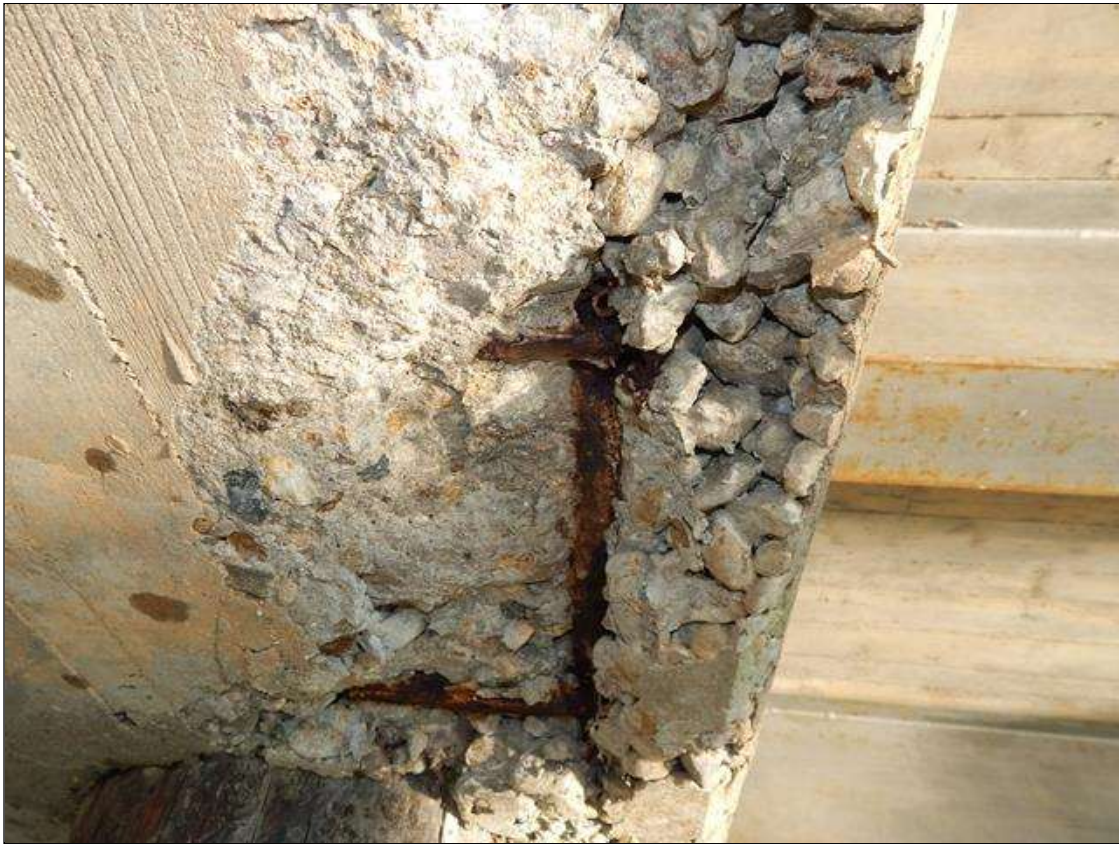
Bent 10 Cap : 24" x 11" x 2" deep spall with exposed rebar at bottom of cap between Piles 2 and 3

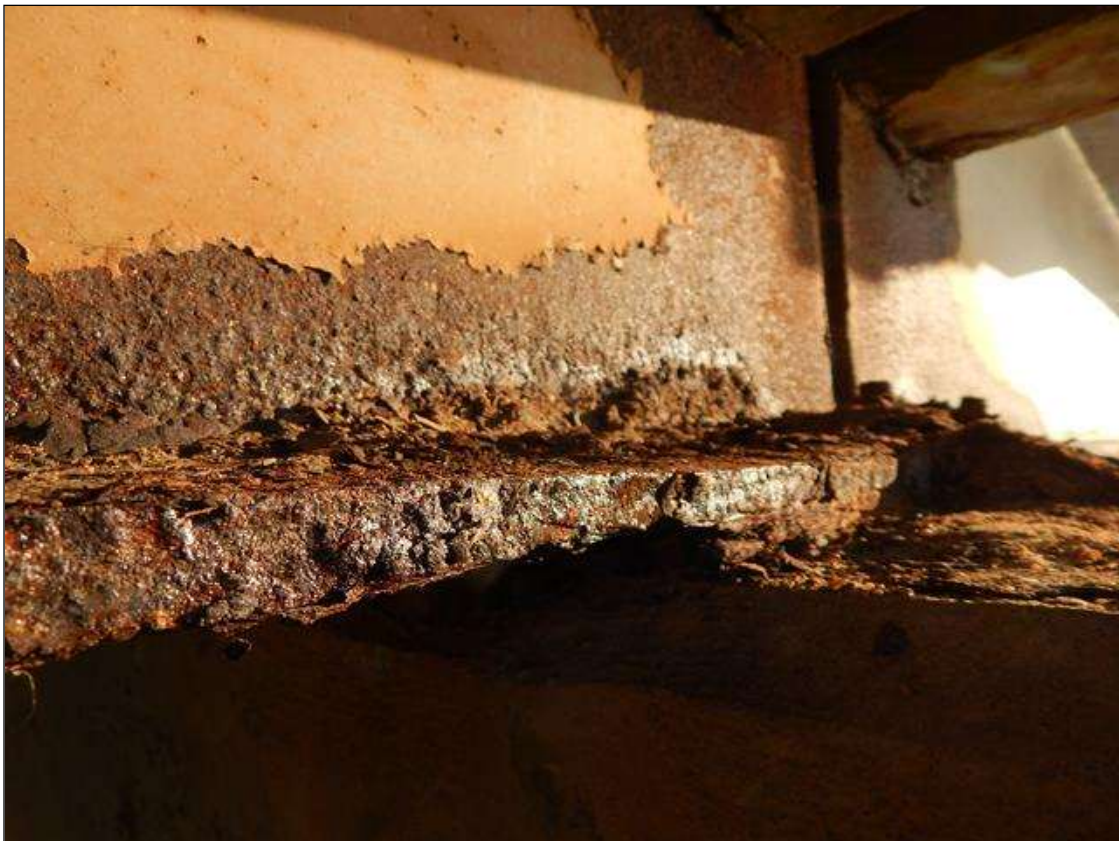
Span 11 Beam 1: 11" x 4" area of 1/8" section loss (5/8" remaining) both sides of bottom flange at Bent 10

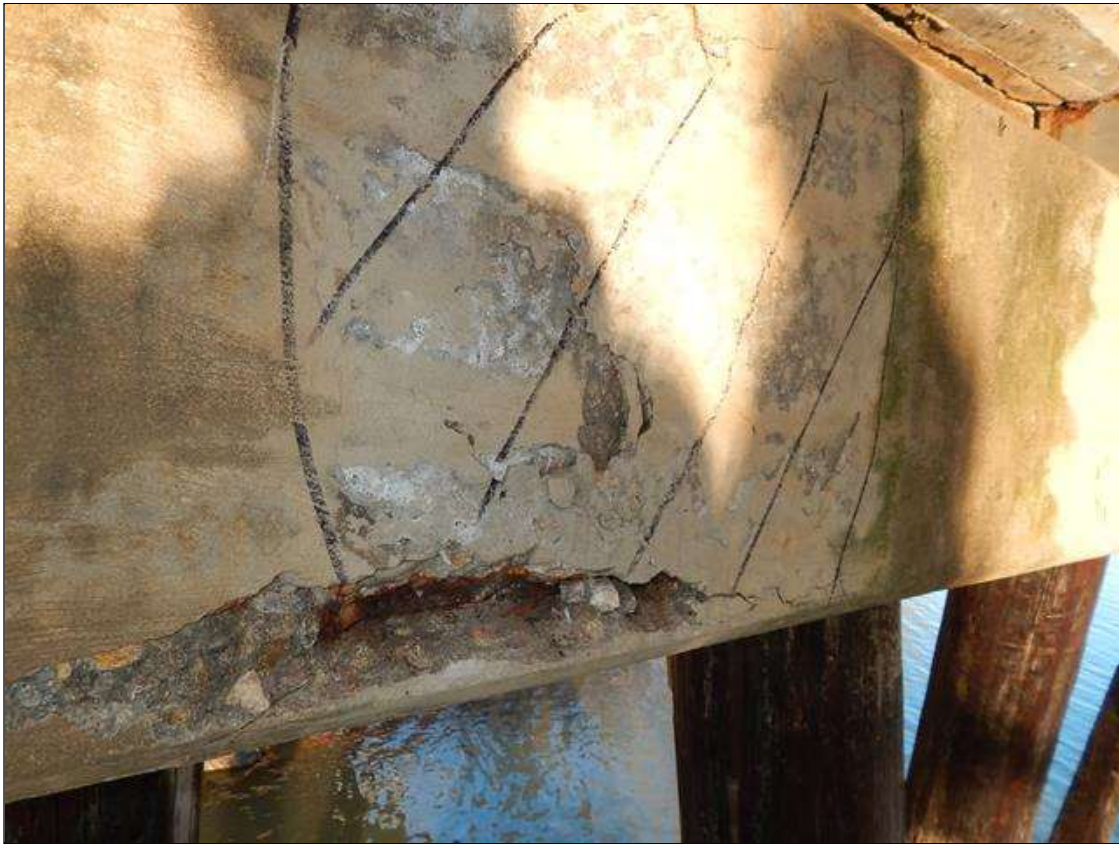
Bent 11 Cap : 18" x 3" x 1 1/2" deep spall with exposed rebar on Span 11 face under Bay 2

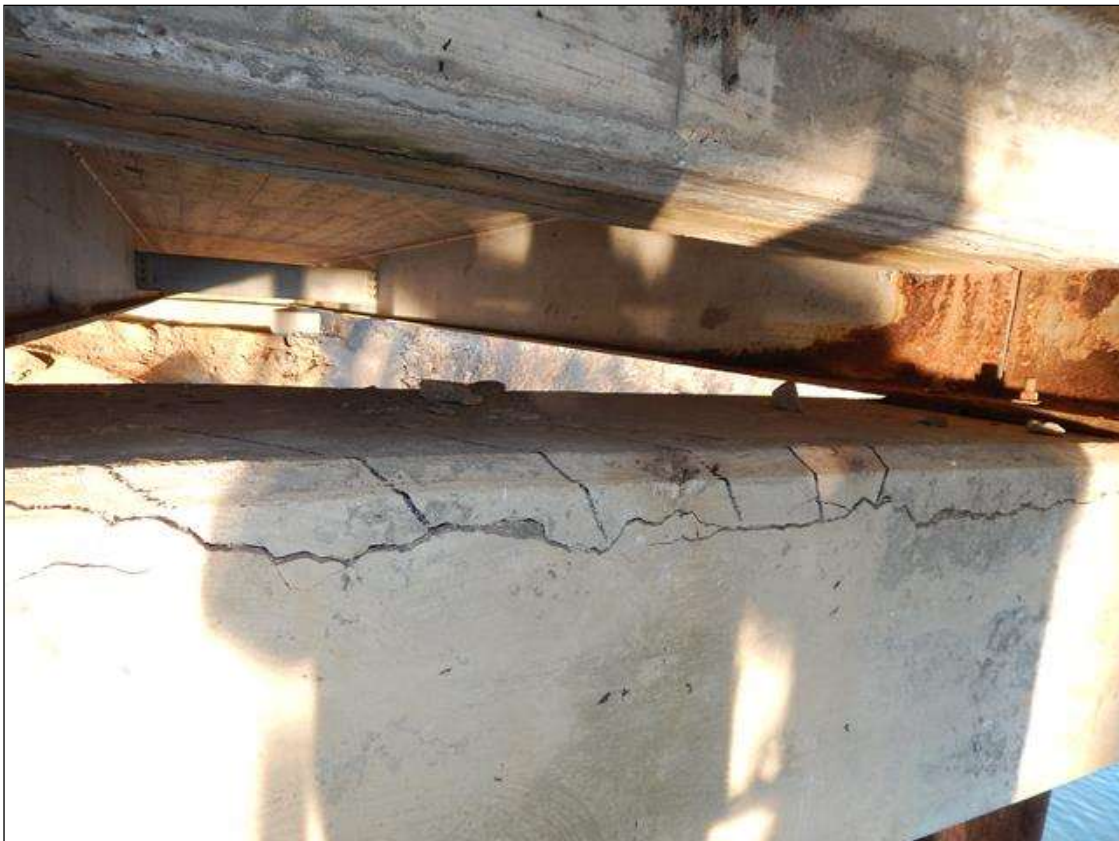
Bent 11 Cap : 6' up to 1/4" horizontal crack with 39" x 13" area of delamination on Span 11 face under Bay 3

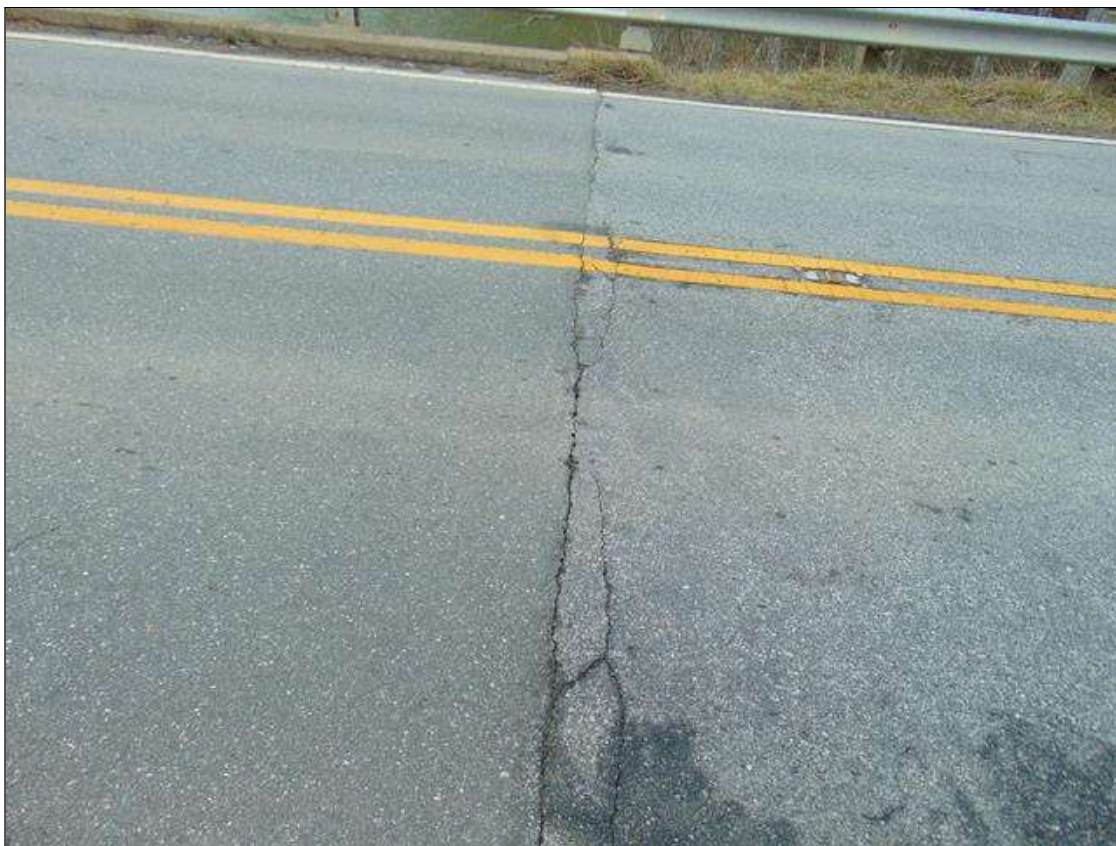
Span 12 Wearing Surface: 22 square feet hairline transverse crack at End Bent 2

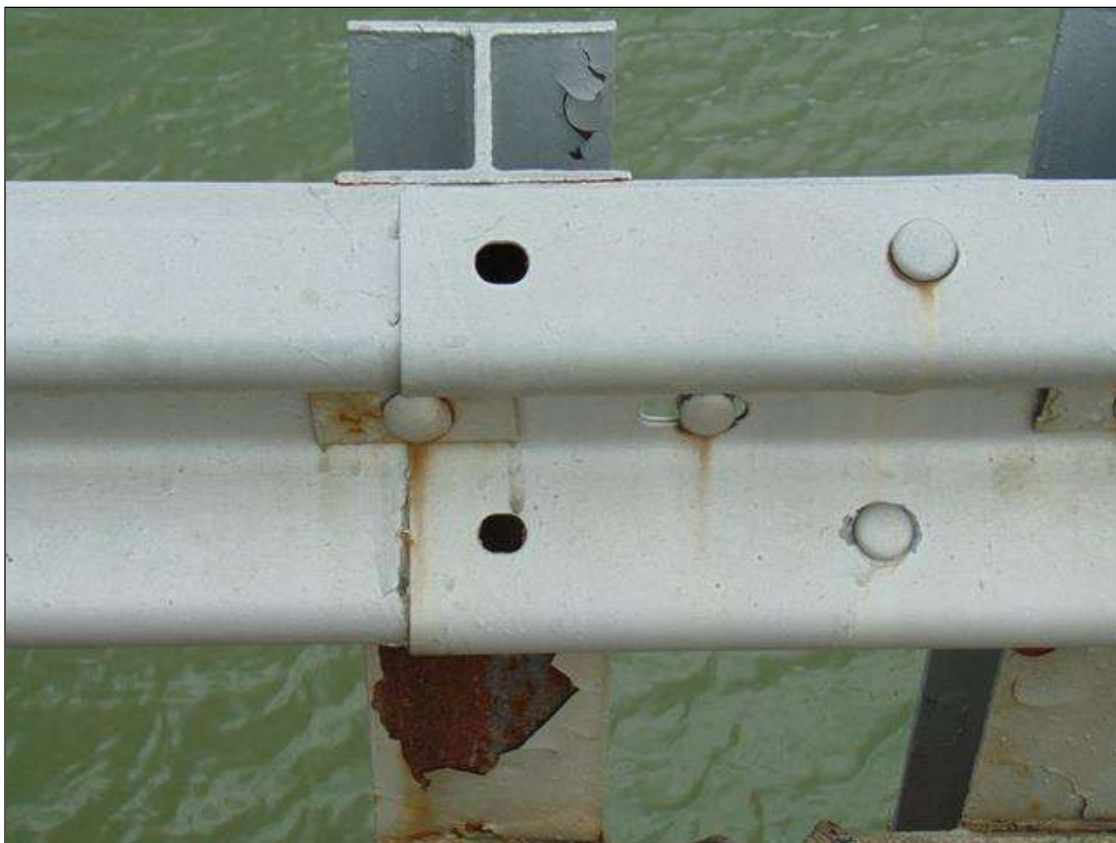
Span 10 Right Bridge Rail: (2) missing connection bolts on rail

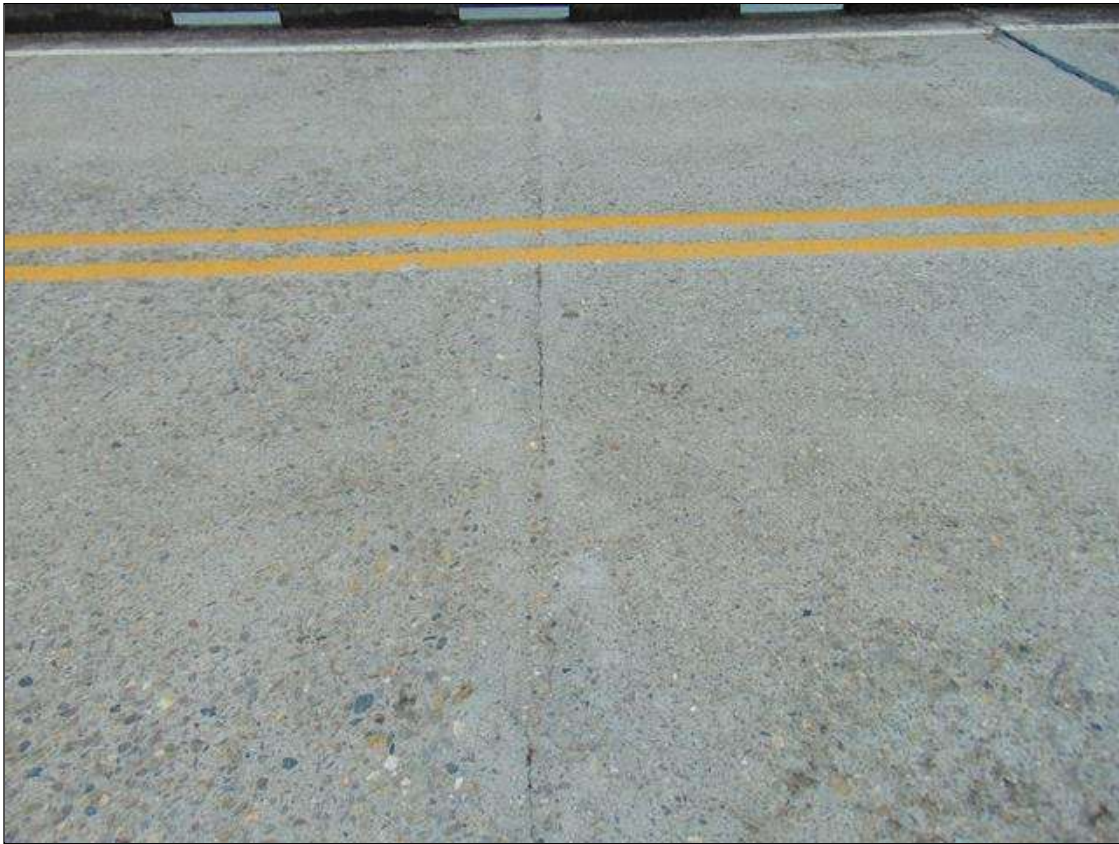
Span 10 Deck: 70 square feet hairline transverse cracks

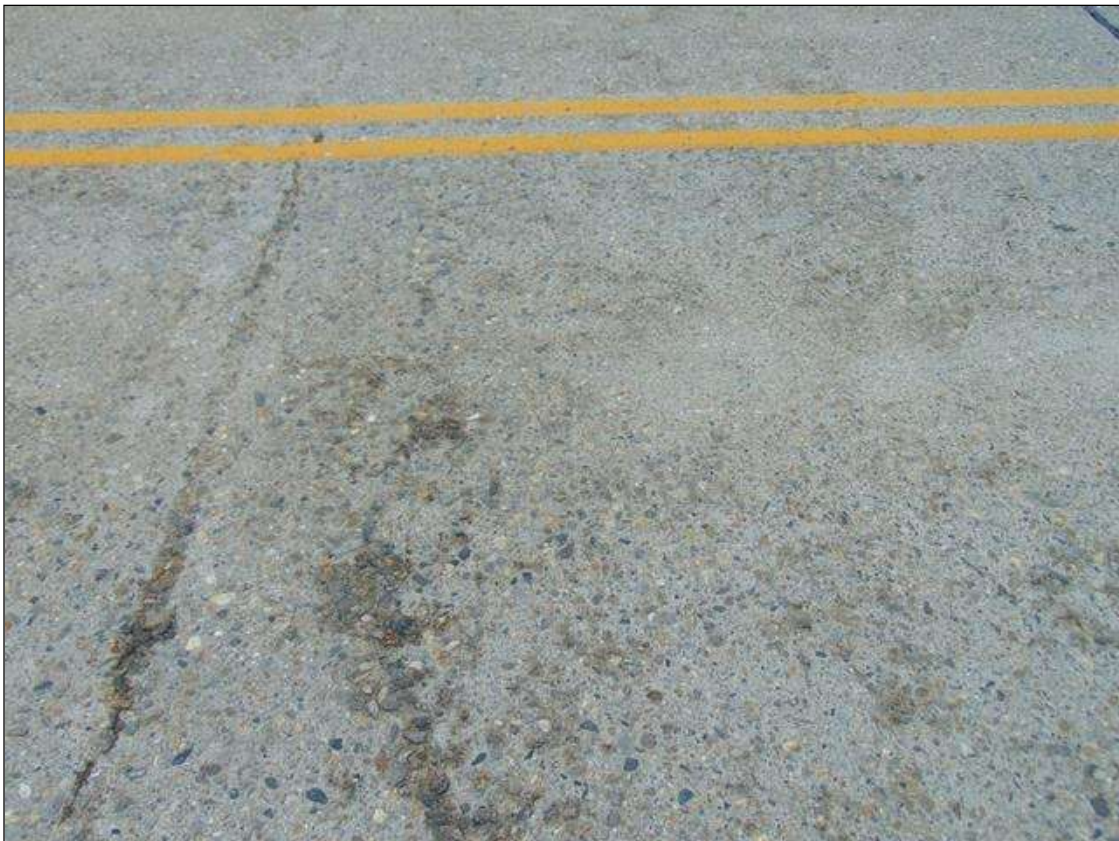
Span 10 Deck: 490 square feet weathered concrete with exposed aggregate
